# Smith Aquatic & Fitness Center Condition Assessment Report

March 13, 2020

**VAE Project No. 20001**

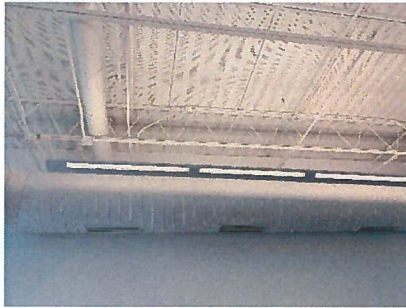
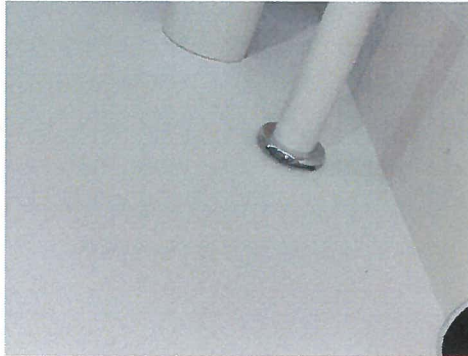
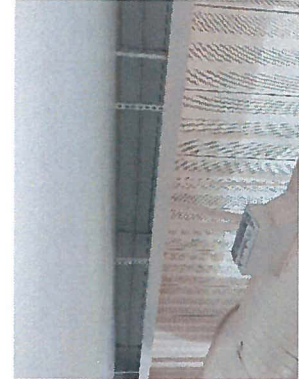
**Figure 21**

- The dividing wall between the Natatorium and office areas has the potential for leakage around doors to the spectator seating area, louvers and ductwork into the second floor mechanical room, miscellaneous piping and electrical penetrations in the wall, and along the top, sides, and bottom of the wall. Prior work to seal the louver and duct penetrations appears to be holding. Piping and electrical penetrations in the wall generally appear sealed. An escutcheon on a pipe near the west end of the wall was loose, demonstrating the piping is not sealed to the gyp board wall finish. The ends of the dividing wall terminate to masonry on the west side of the building. Sealant may have been installed between the wall track and masonry wall, but no sealant is apparent between the gyp board and CMU. The top of the dividing wall is also subject to air transfer through the acoustical roof

deck. It appears a thin sheathing was previously added to cover the acoustical deck between the wall and a structural framing line approximately 16" off the wall into the Natatorium, however there are gaps in the sheathing and between the sheathing and the wall and steel beams that may allow air to transfer.

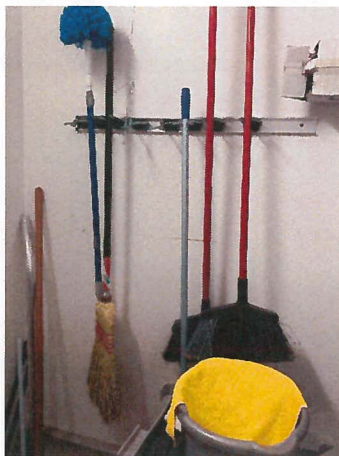
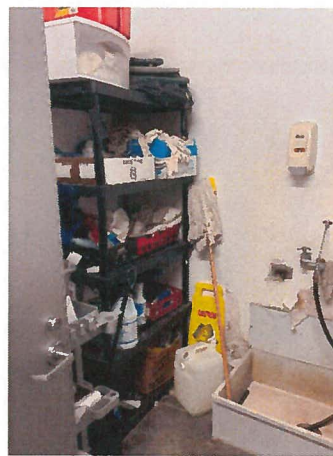
Figure 32

- AV equipment is limited within the building. There are several TV monitors in the fitness center, a message board TV in the lobby, and score board/message board in the Natatorium. All appeared in good condition.
- A cleaning agent spill is located under a shelving unit in the Janitor/Supply Room 106. A conduit rough-in through the metal deck/exposed structural ceiling of Janitor/Supply Room 106 is not sealed to the metal deck and open with pull string and no wiring. This may connect to an unused electrical box under the reception desk.
- Elevator appears to be in good condition. No indication of problems with elevator operation from City staff.

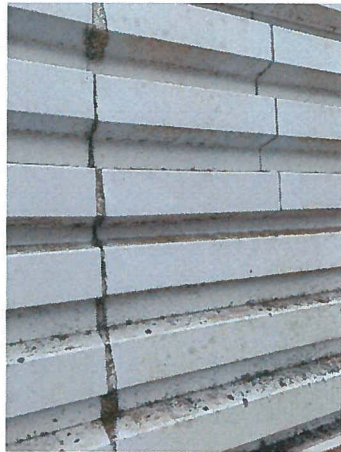
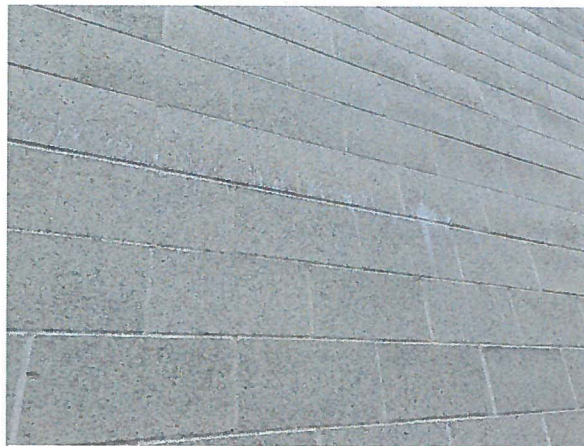
**Figure 39**

- Exterior metal cladding generally appears in good condition. Dirt and debris have collected on the horizontal siding installation. Generally caulking for this system is concealed. Caulk is showing some wear where exposed in a few joints above the horizontal sunshade at the union of Natatorium and main entrance lobby on the building front (east side).
- Exterior ground face CMU walls appear in very good condition. A small area of efflorescence was noted on the north wall near the northeast building corner, but this tends to blend with the ground face CMU color.

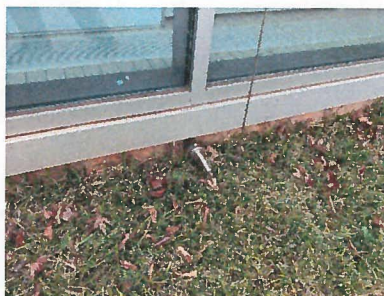
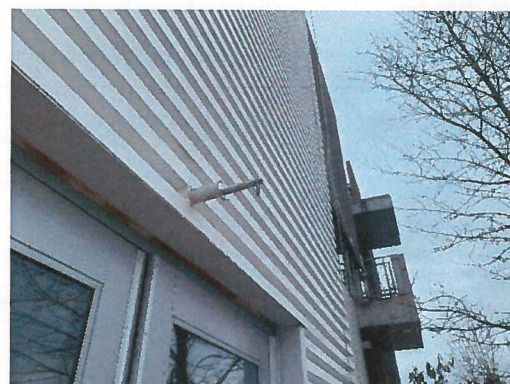
**Figure 42**

- Cables to support vertical vine growth along the west exterior wall have limited use. Only one is in use for vertical vine growth. One cable is missing and at least two others are loose at the bottom and hanging free.

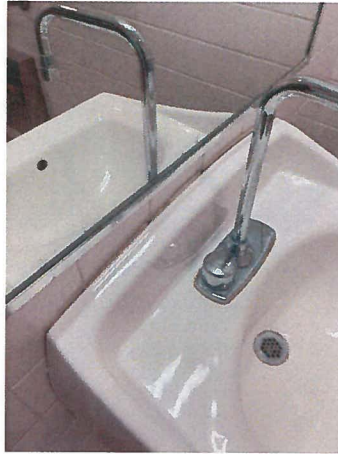
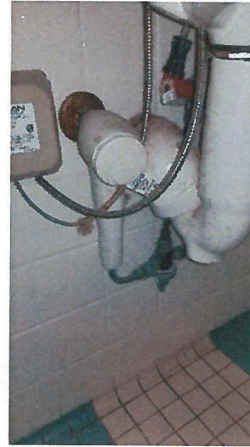
**Figure 59**

and first floor family restrooms. The lavatory piping in the Men's and Women's Locker Rooms was not observable. Some of the strainers at lavatory drains have rust.

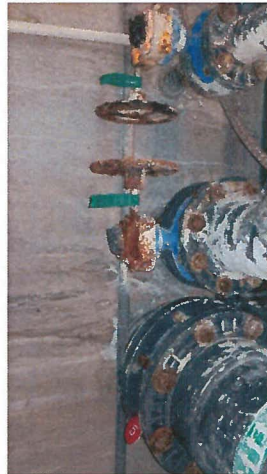
**Figure 64**

The pool filter and treatment equipment in the first floor mechanical room varies in condition. Plastic components appear to be in good condition. Metal pipe shows corrosion. The worst conditions are in the pump room below the grating. Components in this area show significant corrosion and the pump casings are rusting. These elements will likely require replacement within 5-10 years.

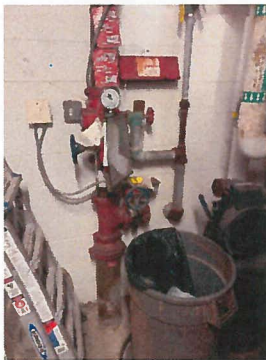
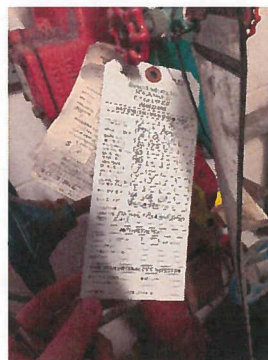
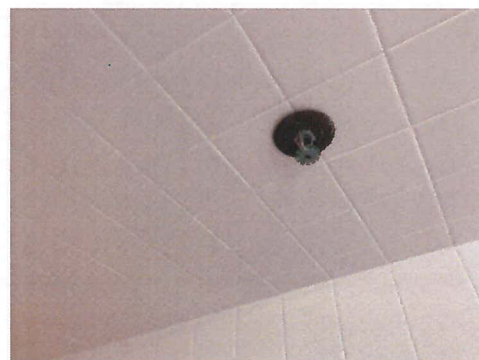
**Figure 66**

The building is protected by an automatic fire sprinkler system with piping and heads located throughout the building. Piping, specifically the fittings, exhibit more signs of corrosion than typical of a building of this age. The fittings on the blow down at the sprinkler riser are highly corroded. Inspection cards on the sprinkler riser assembly demonstrate annual testing with last inspection in 1/14/20. Sprinkler heads and escutcheons are painted white and generally appear in good condition throughout acoustical ceiling areas. It appears a plain finished head and escutcheon was used in the ADA shower of Women's Toilet Room 108B as both are highly corroded. Sprinkler heads to mechanical spaces were not readily observable.

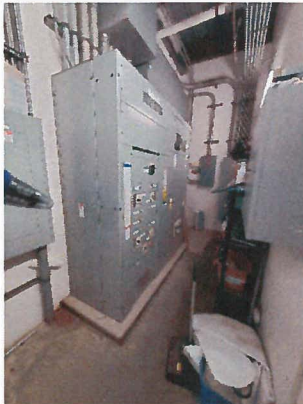
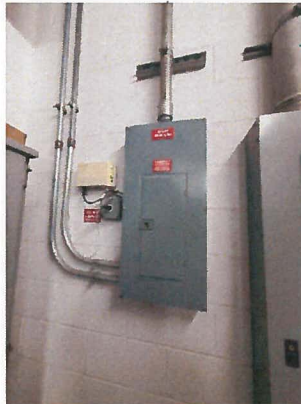
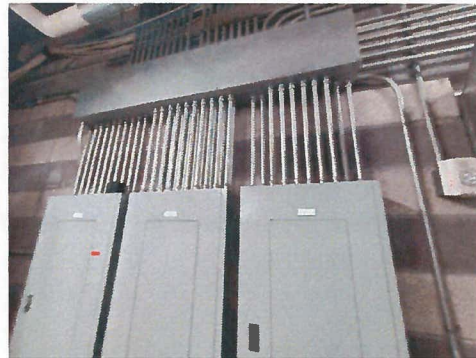
**Figure 69**

The building has a 208/120-volt, 3 phase, 1,600 amp service entrance switchboard and main circuit breaker that appear to be in good condition. The service equipment is protected by transient voltage surge protection equipment located near the service entrance switchboard. The switchboard feeds several branch circuit breaker panelboards located throughout the facility that all appear to be in good condition with no apparent over-dutied branch circuit breakers. One of the branch circuit breaker panels adjacent to PDU-1 was observed to have a cable entering the panel without the proper fitting to protect the cable insulation from the sharp edges of the panel penetration. The electrical service switchboard and branch circuit panelboards all appear to be in good condition, parts and circuit breakers are still available; there are no recommendations for these panels.

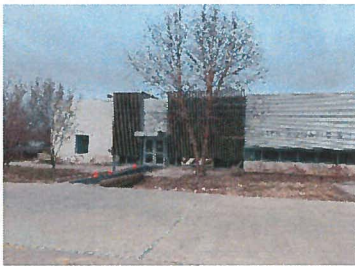
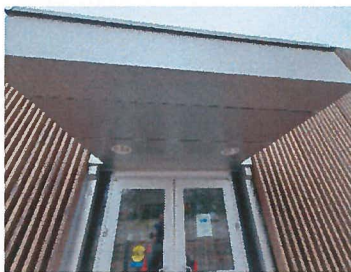
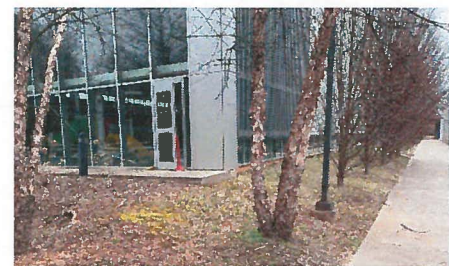
**Figure 80**

The main entrance on the front of the building has two recess mounted compact fluorescent light fixtures with only one of them on a battery backup. These two light fixtures do not provide the VCC required emergency light level to a safe dispersal area or the public way during a power outage. Obstacles in the way of the safe area include passing over a wood bridge with a ditch on both sides. This area has no emergency egress lighting from the building to a safe dispersal area or the public way.

Egress on the north end of the Natatorium discharges onto a sidewalk along that end of the building, however the sidewalk does not connect to the parking lot. Egress components typical connect the public way exterior of the building per the VCC.
