WALKER UPPER ELEMENTARY SCHOOL
1564 DAIRY ROAD
CHARLOTTESVILLE, VIRGINIA

ECS PROJECT NO. 46:6713

CITY OF CHARLOTTESVILLE - FACILITIES DEVELOPMENT

Reference: Facility Condition Assessment Report for Walker Upper Elementary School, 1564 Dairy Road, Charlottesville, Virginia

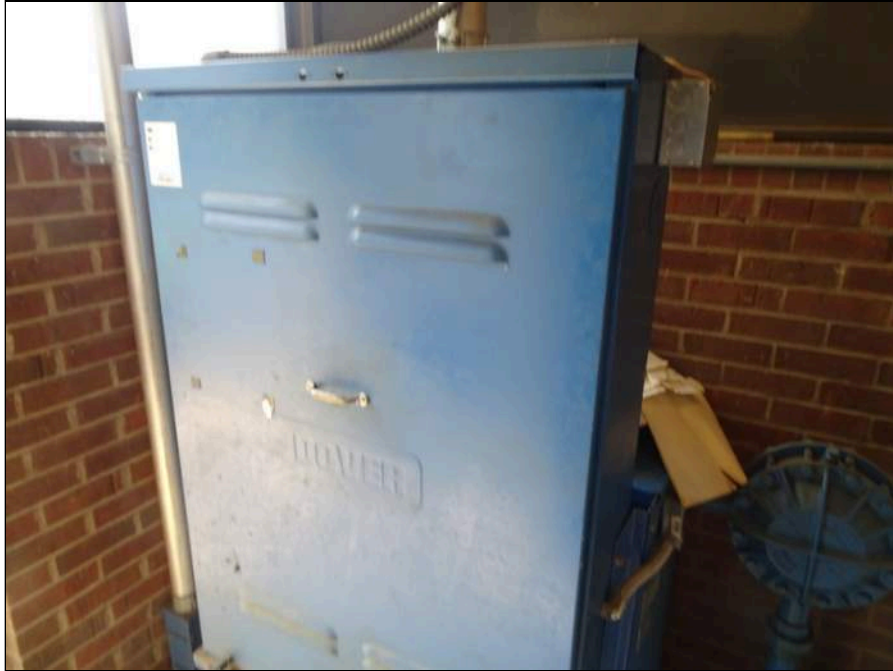
78 - Elevator cab
