BUFORD MIDDLE SCHOOL
1000 CHERRY AVENUE
CHARLOTTESVILLE, VIRGINIA

ECS PROJECT NO. 46:6713

CITY OF CHARLOTTESVILLE - FACILITIES DEVELOPMENT

Reference: Facility Condition Assessment Report for Buford Middle School, 1000 Cherry Avenue,
Charlottesville, Virginia

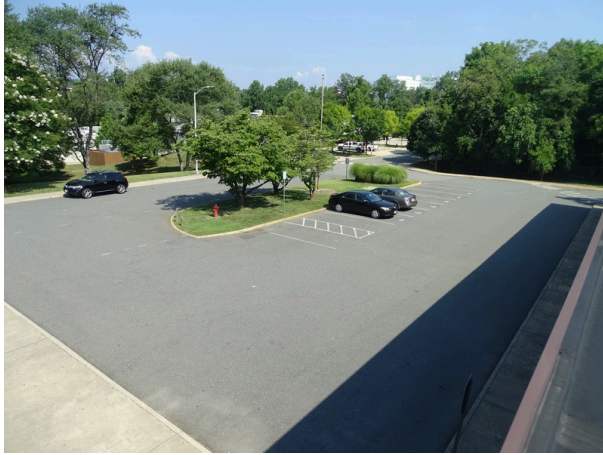
Asphalt-paved drive lanes and parking areas are located on the north and south side of the site which also provides access to the site. Additional parking is provided along the southern drive lane. The asphalt pavement was observed to be in generally good to fair condition with minor cracks observed on the pavement. Striping was in fair condition. The expected useful life of asphalt pavement is 20 years. We have provided allowances to repair the cracked areas of asphalt pavement.

Asphalt pavements north side of the site

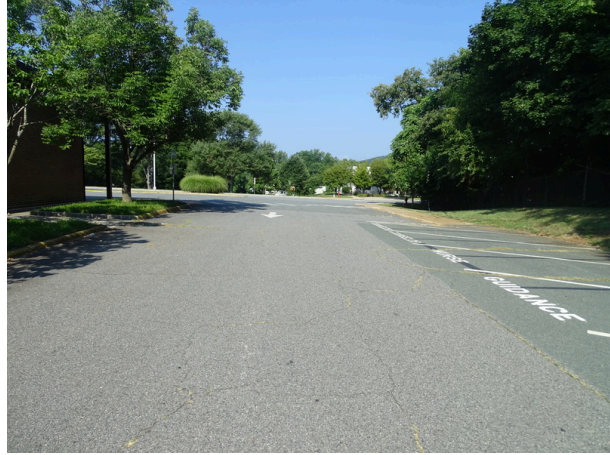
Asphalt pavements southeast entrance drive
lane

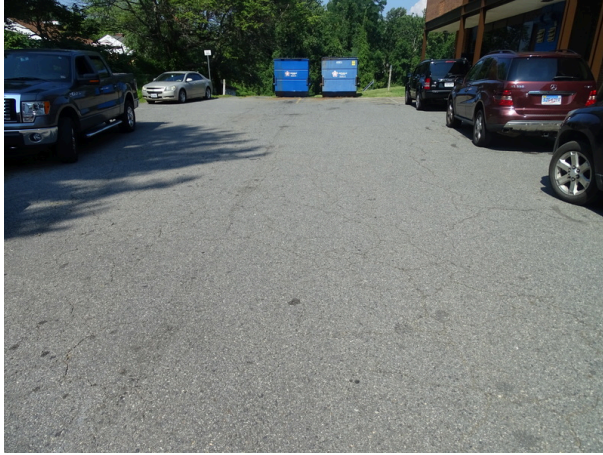
Asphalt pavement area at southwest area of the site

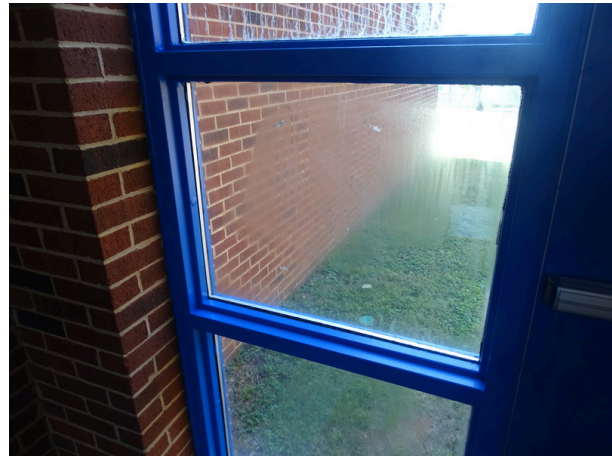
Typical exterior window - note fog inside the glass

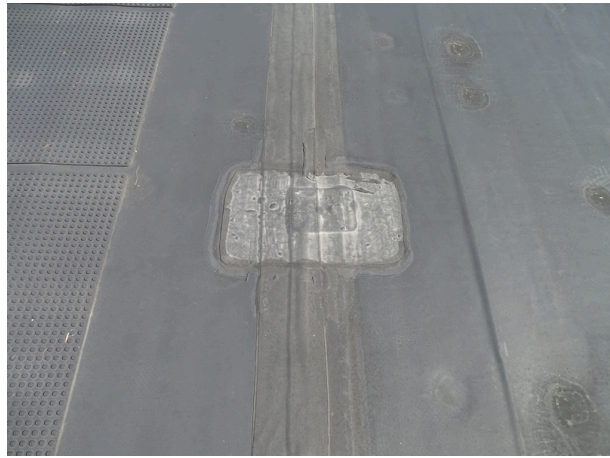
Single-ply roofing system - note patching

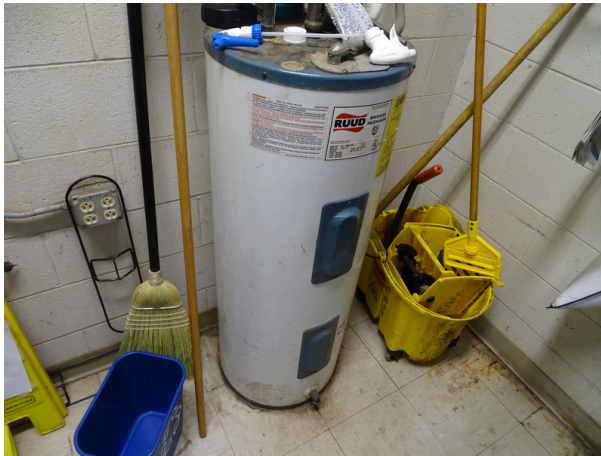
Electric water heater located in janitor's closet

The expected useful life of water heaters is approximately 15 years with proper maintenance. We recommend the water heaters be replaced during the study period.

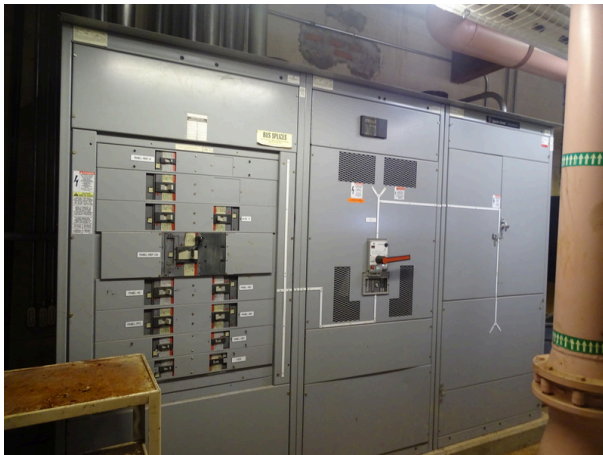
The main electrical switchgear was manufactured by General Electric. The switchgear was in good condition.

Main electrical switchgear

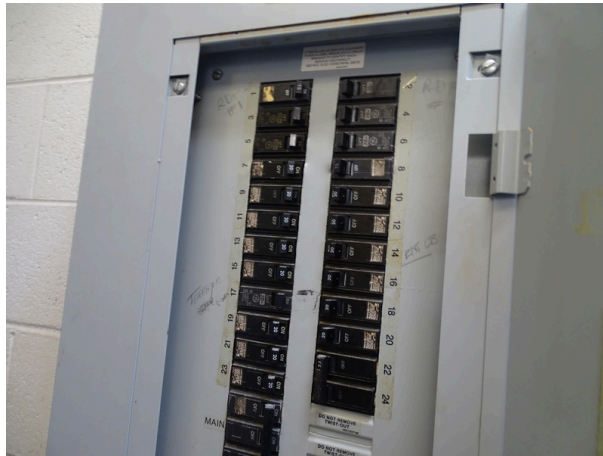
Power is distributed by copper wire from circuit breaker panels located throughout the building. The expected useful life of sub-panels is 50 years with proper maintenance. Some of the the circuit breaker panels were reportedly recently replaced. The circuit breaker panels were observed to be in generally good to fair condition. We recommend replacing the remainder of the older circuit breaker panels.

Typical newer electrical circuit breaker panel

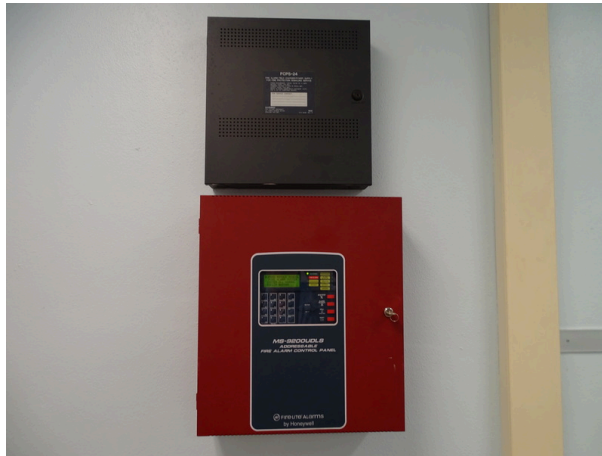
The fire alarm system was observed but not tested. A fire control pane is located in the Main Office. The fire control panel was observed to be in good condition. Emergency exit signs and lighting, pull stations, fire extinguishers, smoke detectors, and alarm bells and strobes are located throughout the building.

Fire alarm control panel

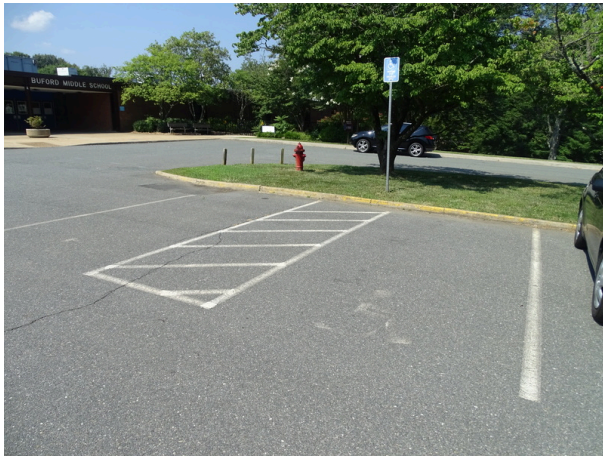
The parking area serving the property has a total of approximately 41 parking spaces. Of the parking spaces, Two are accessible with Two being van accessible. Accessibility requires that two accessible parking spaces be provided in parking areas with a total of 26 to 50 spaces. One in six of the accessible parking spaces are required to be van accessible. A minimum of a 60-inch wide access aisle is required to be provided for every two accessible parking spaces. Accessible aisles were observed to be provided. The number of parking spaces does meet accessibility requirements.

Accessible parking spaces

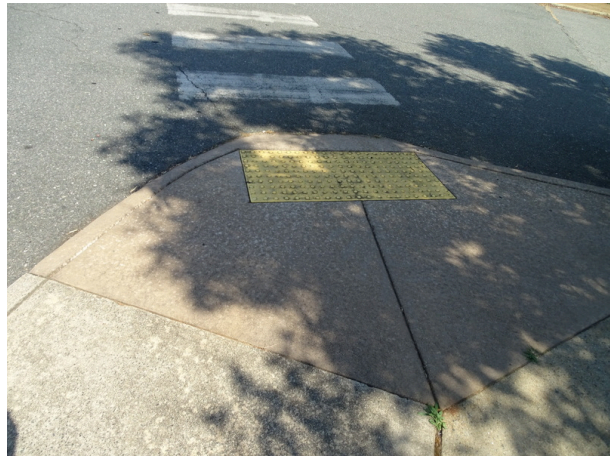
Accessible curb cut ramp with truncated domes

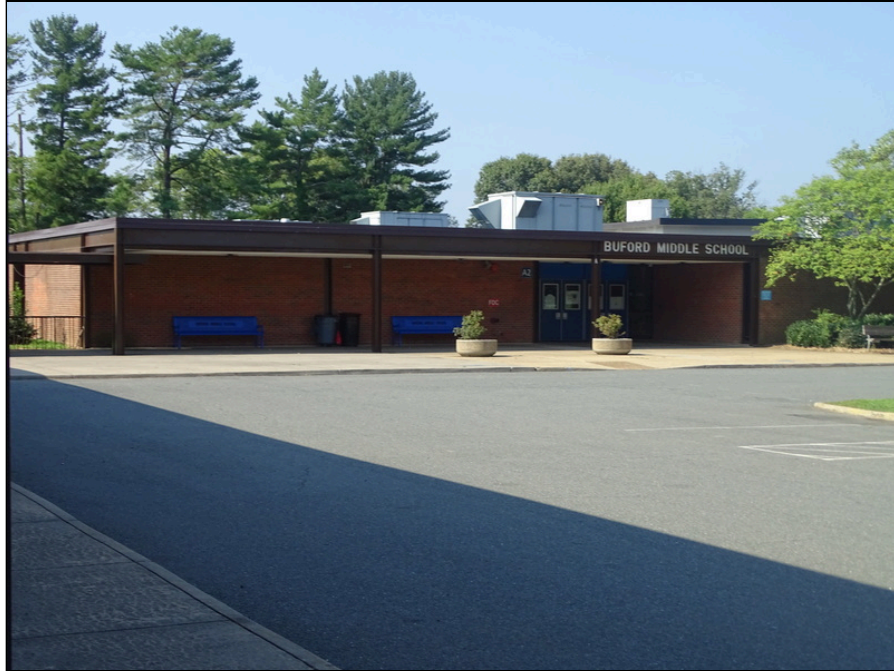
1 - Buford Middle School

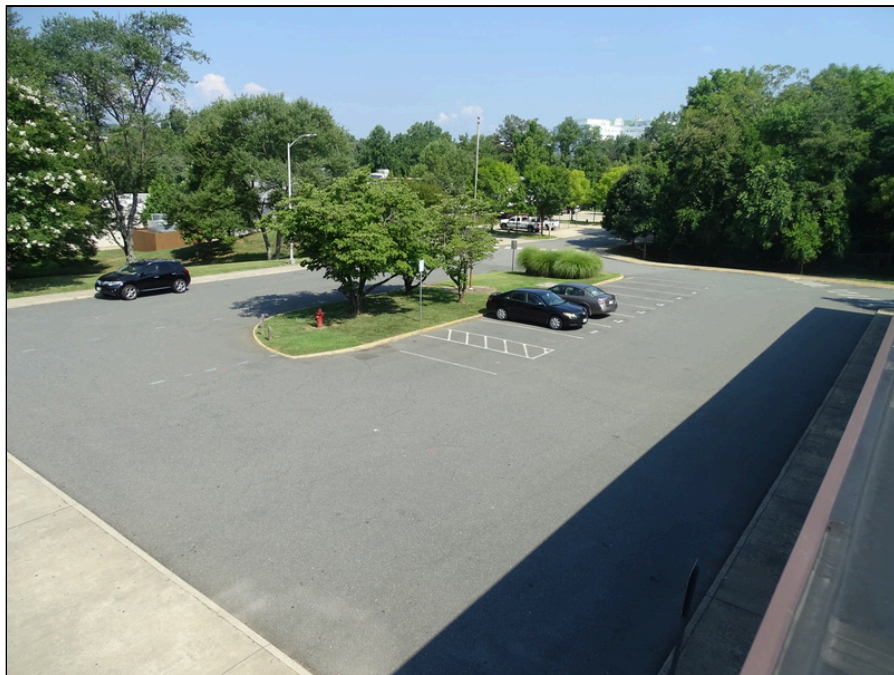
2 - Asphalt pavements north side of the site

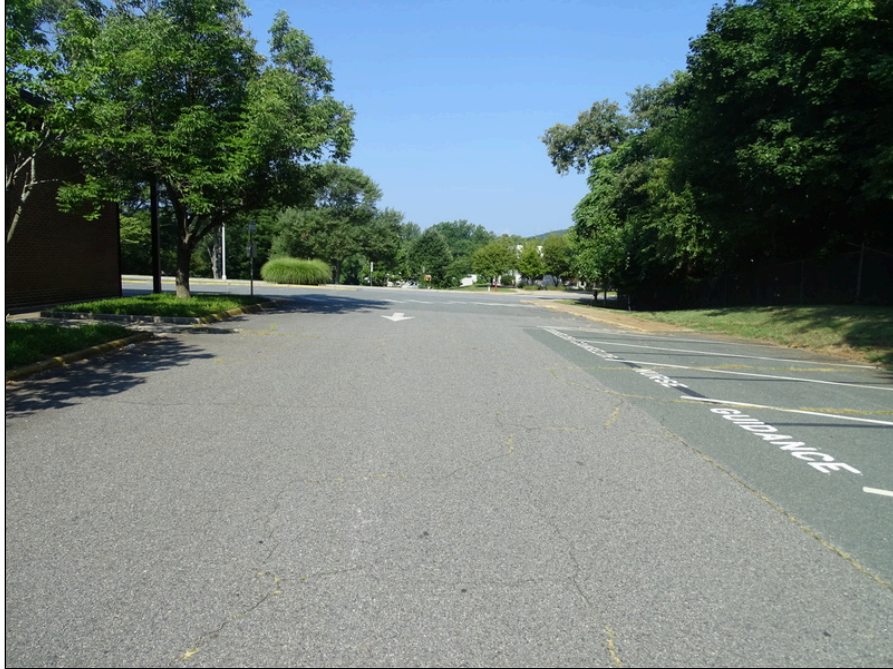
3 - Asphalt pavements southeast entrance drive lane

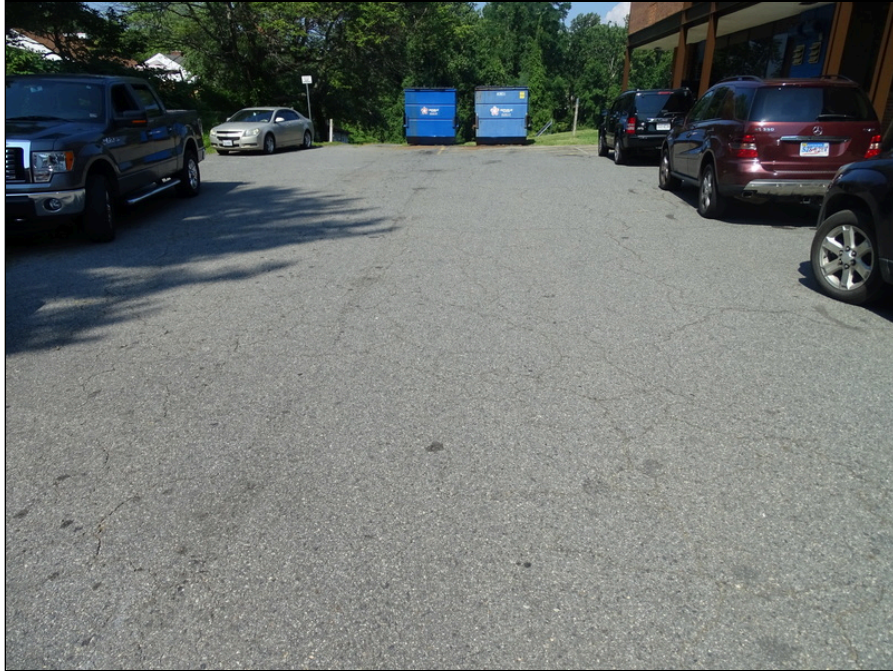
7 - Asphalt pavement area at southwest area of the site

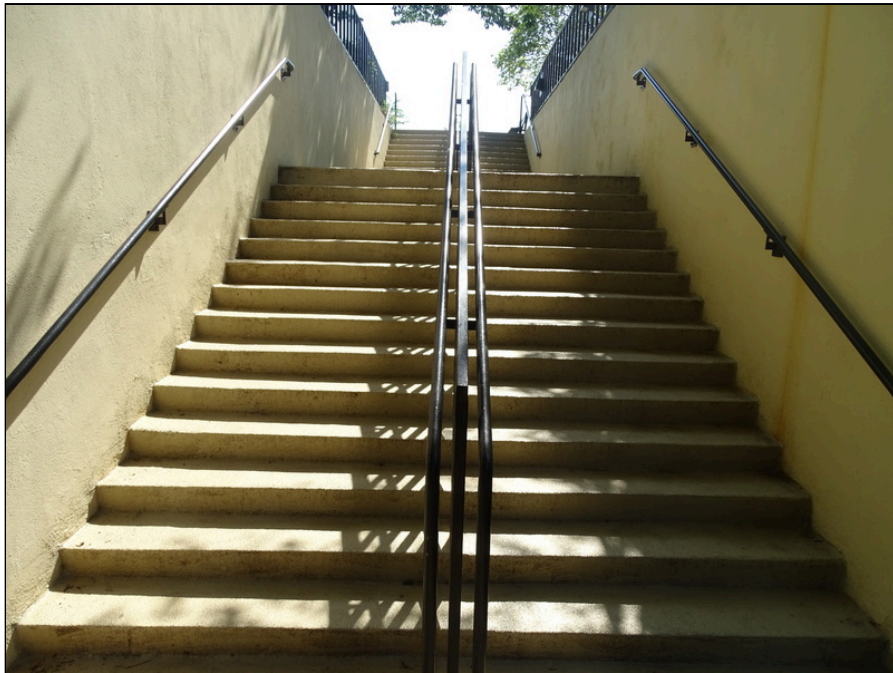
12 - Steps at north end of the site

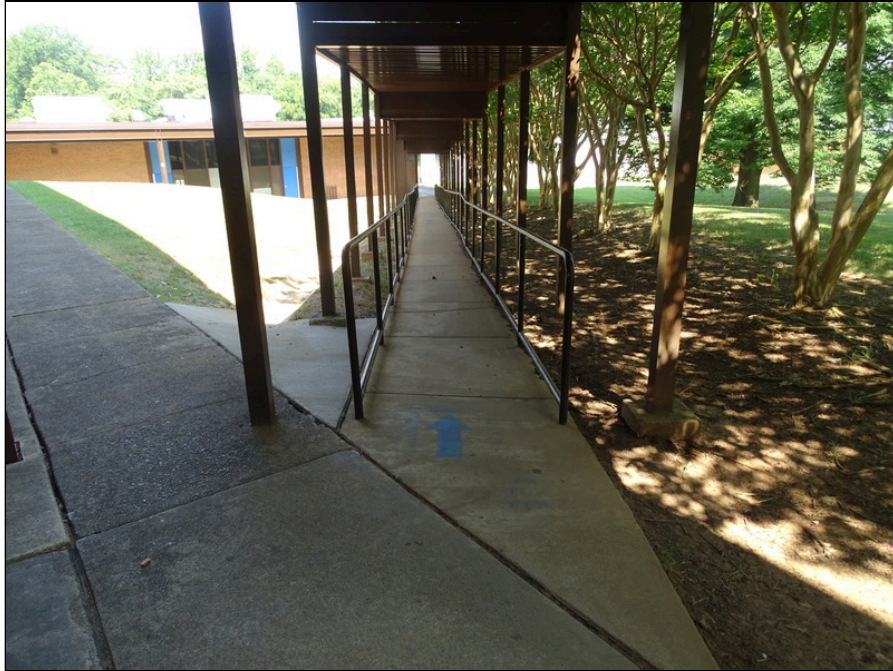
13 - Ramp to Building C (Gym)

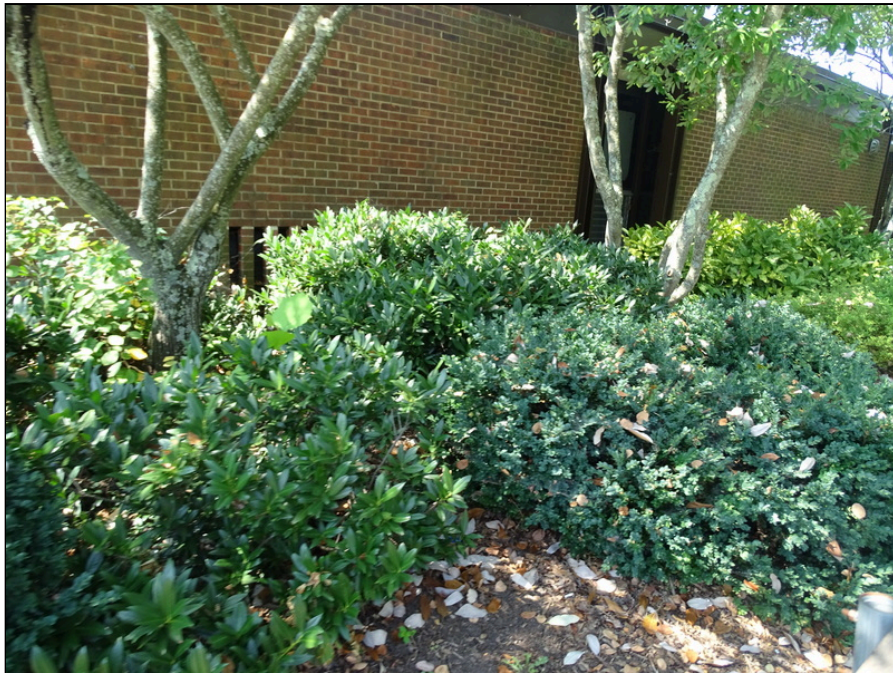
14 - Landscaping at north end of the site

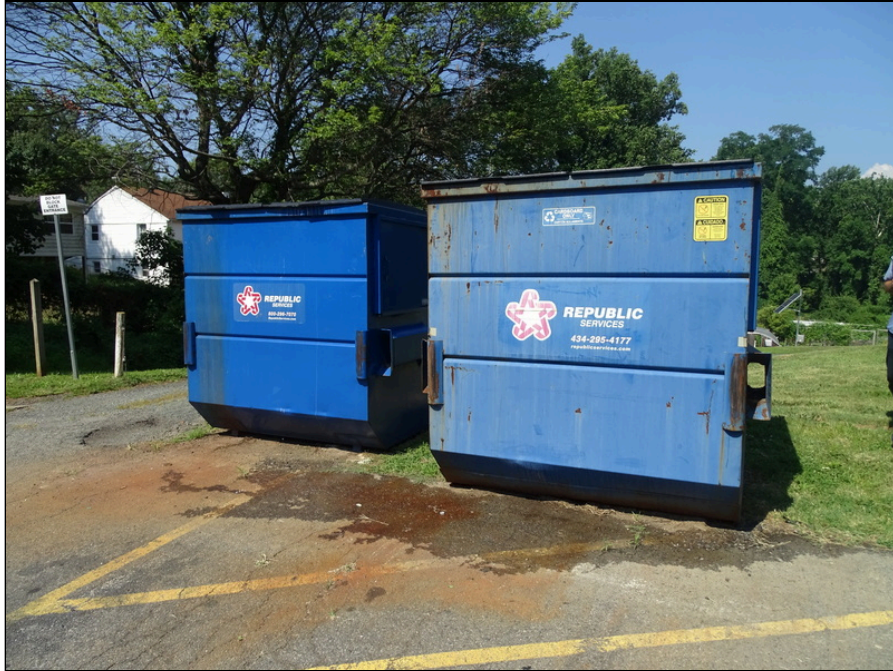
15 - Dumpster area at southwest area of the site

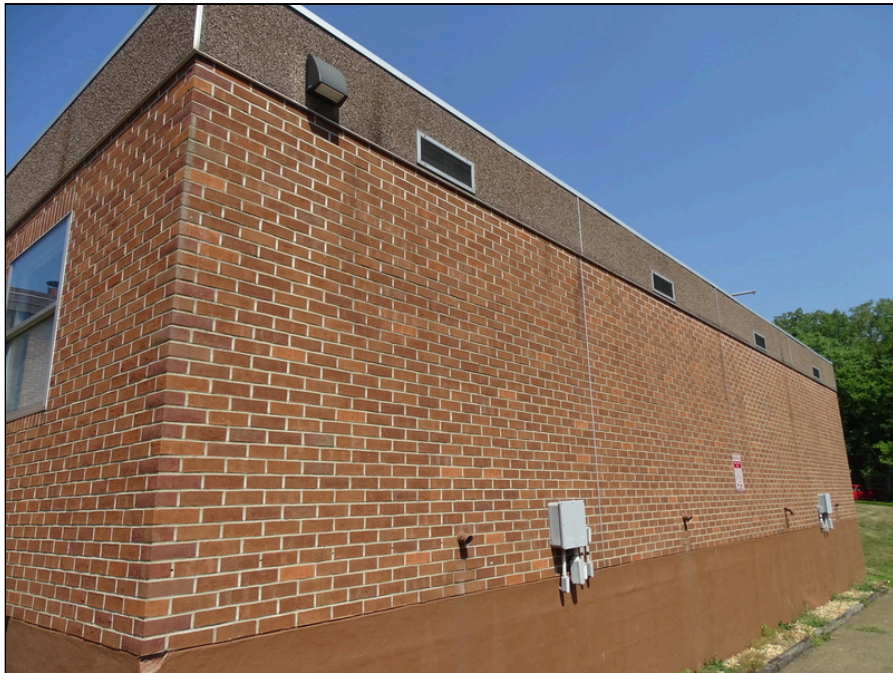
16 - Building exterior northeast side of the building

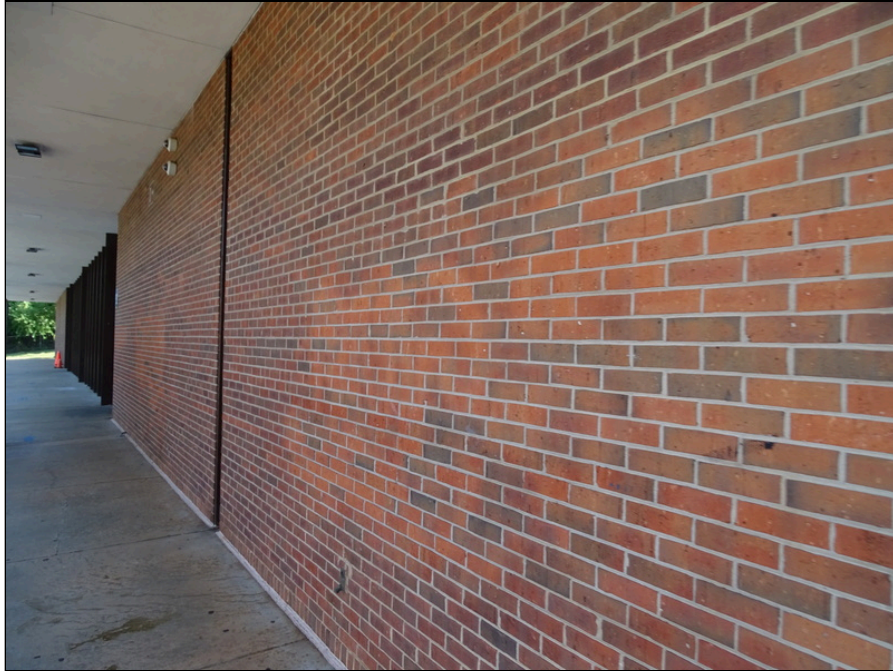
17 - Building exterior north side of the building

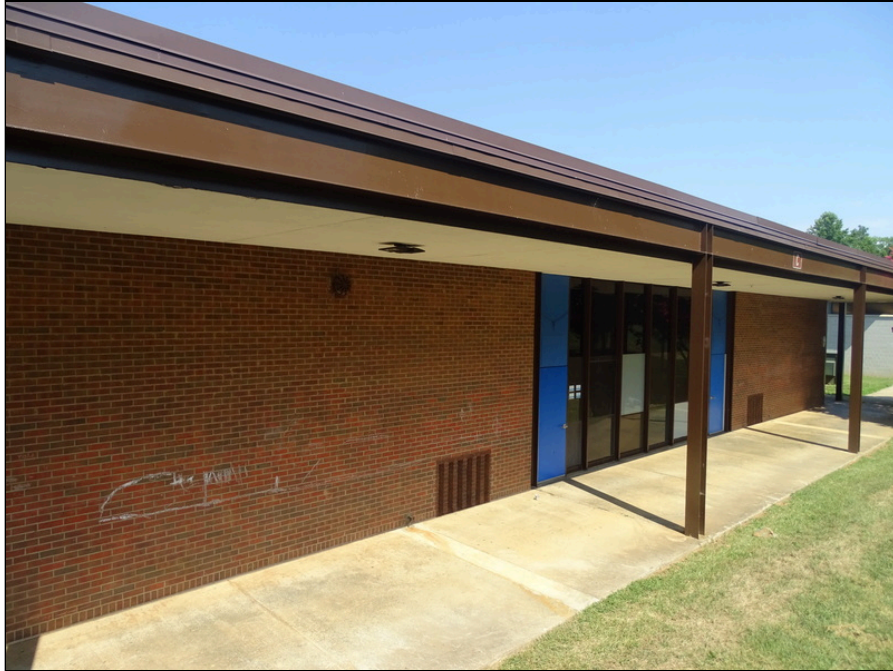
19 - Building exterior - note need cleaning

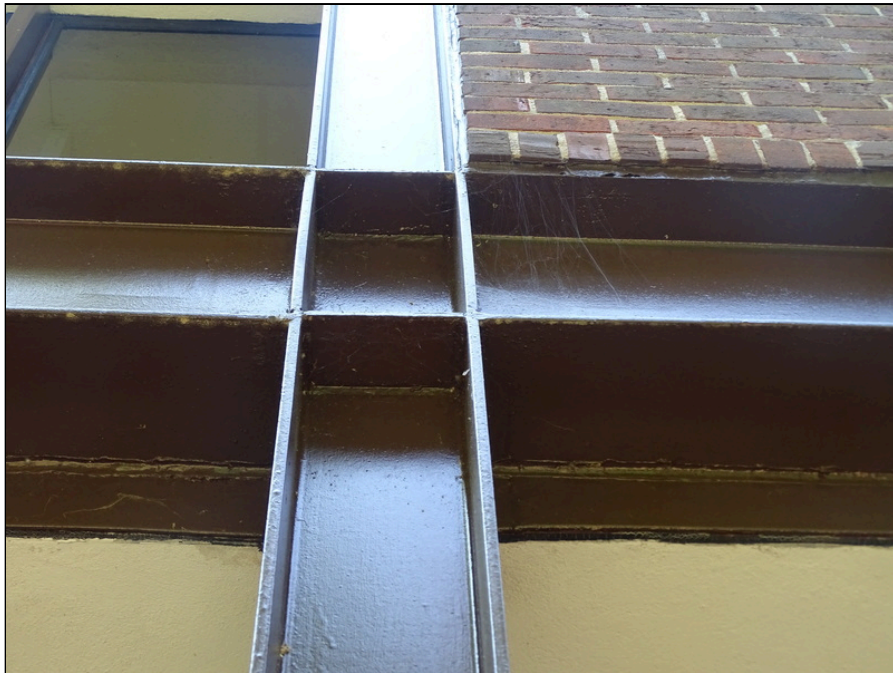
20 - Building exterior west side of the building

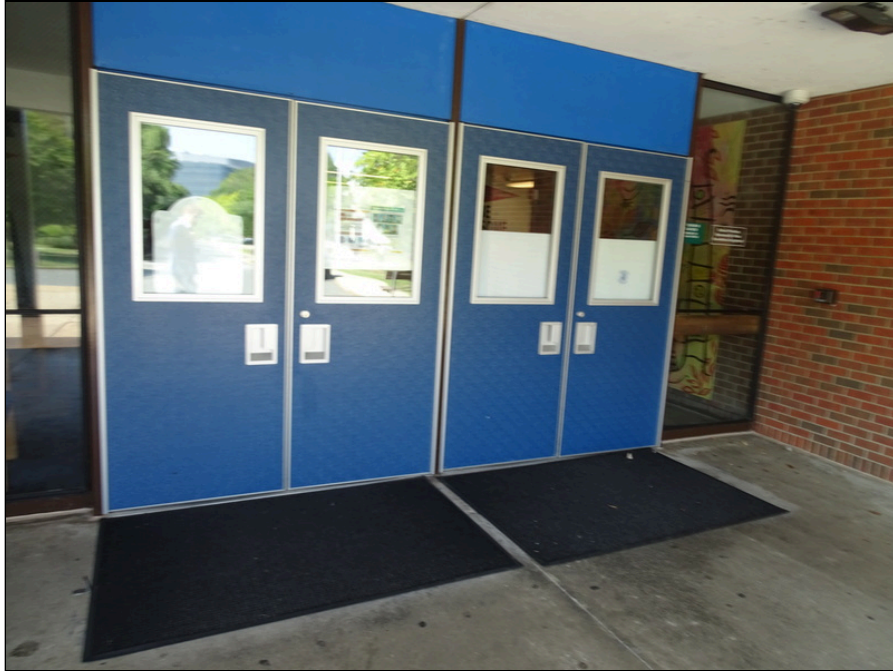
21 - Main entrance doors

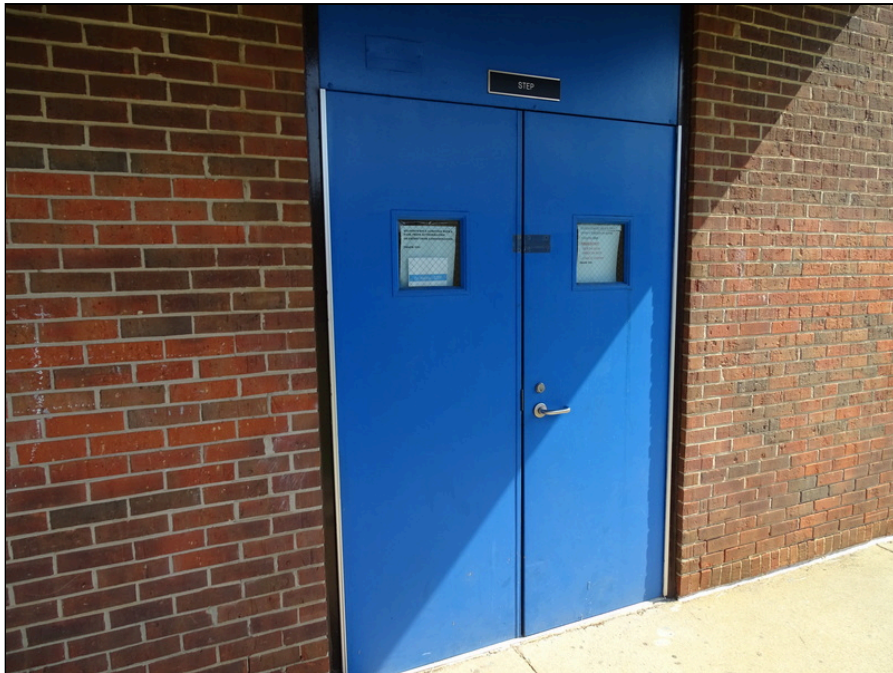
22 - Typical personnel doors

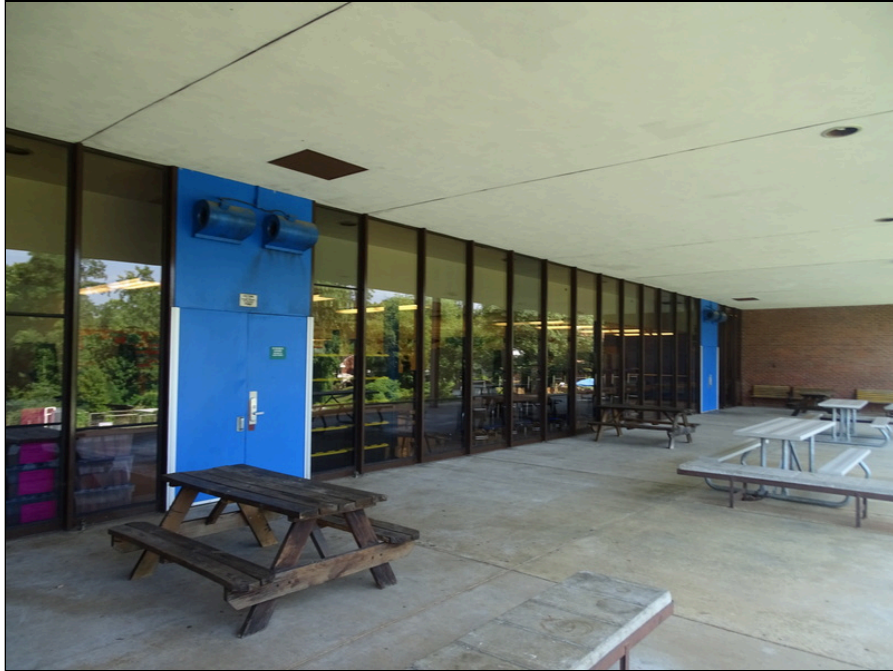
23 - Typical exterior window

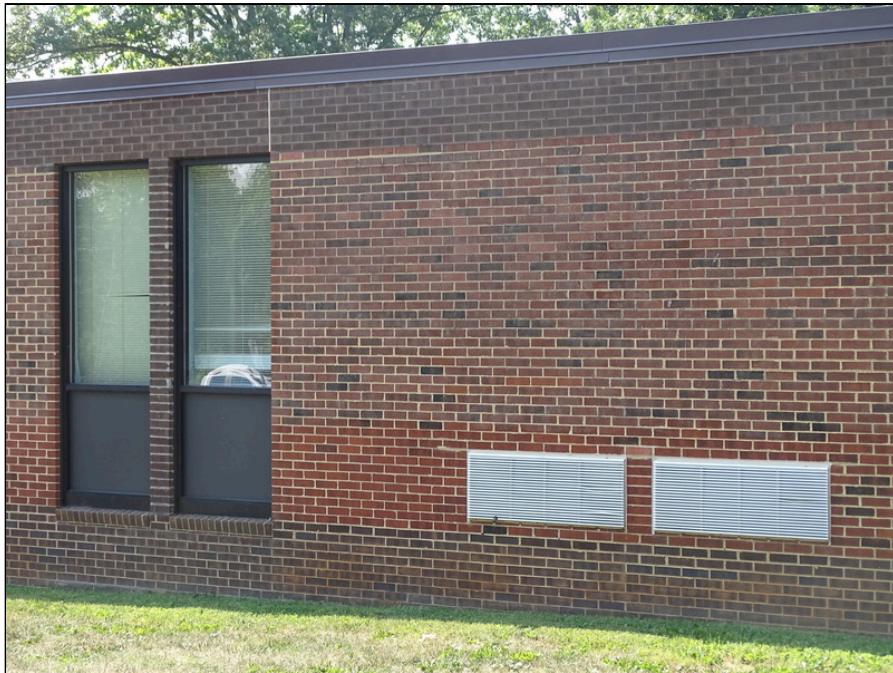
24 - Typical exterior window

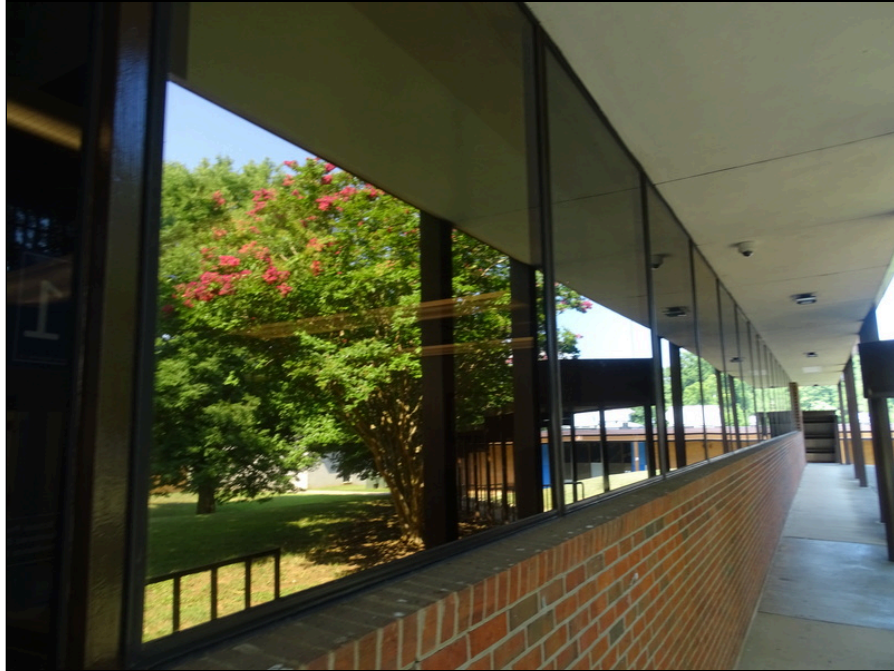
25 - Older exterior windows - note reportedly wide temperature fluctuation in offices

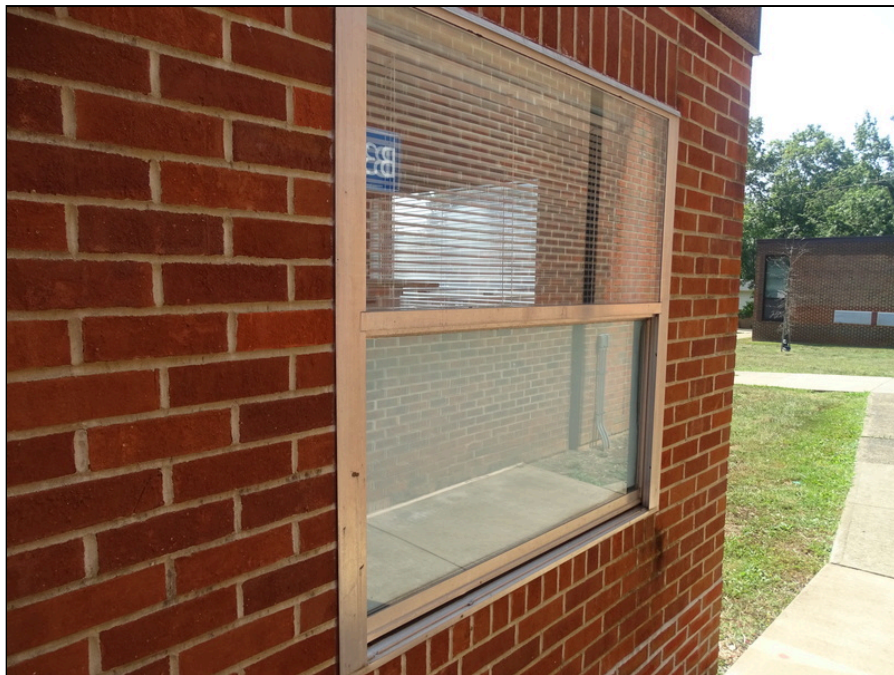
26 - Typical operable exterior windows

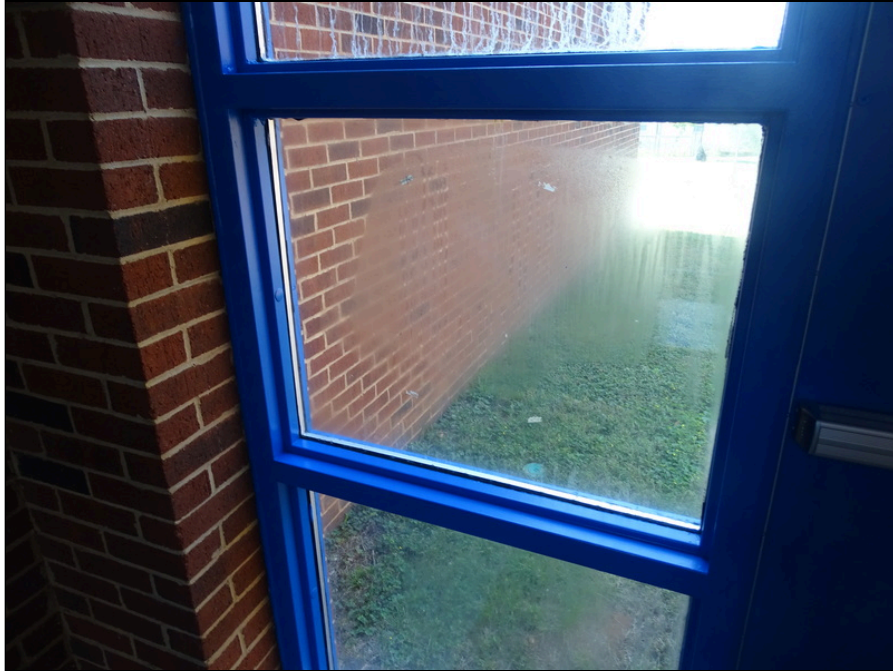
27 - Typical exterior window - note fog inside the glass

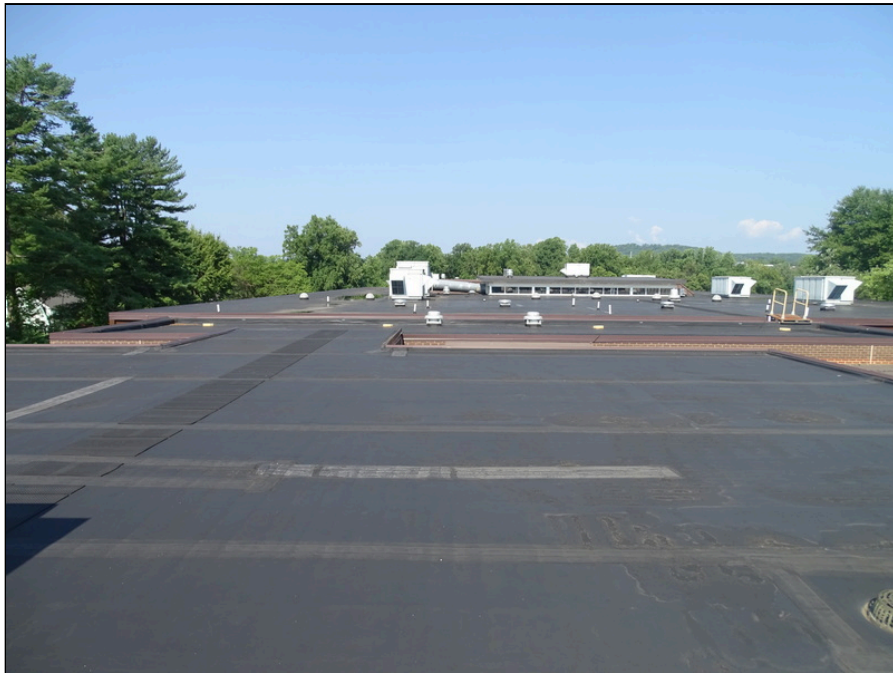
30 - Single-ply roofing system looking west

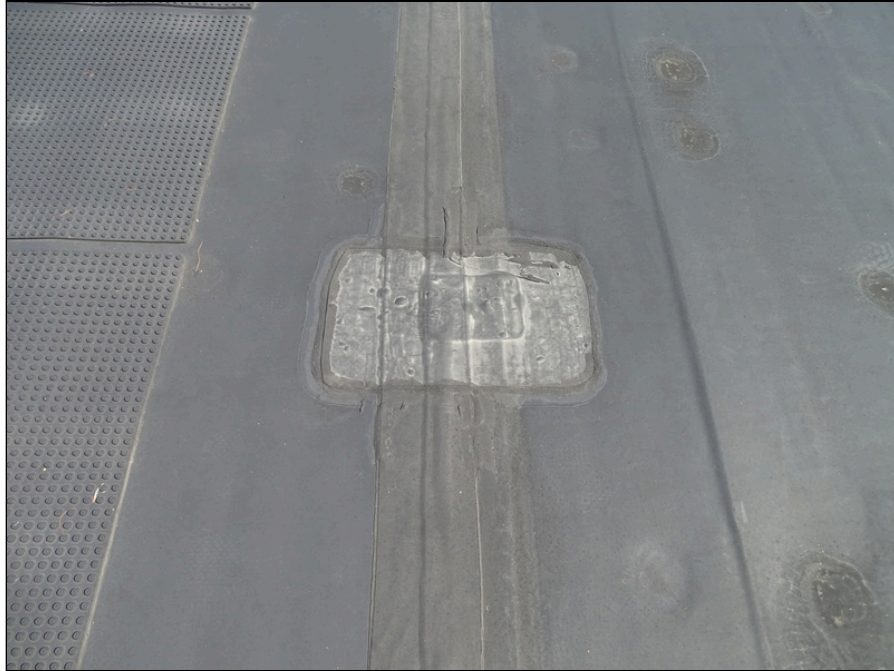
31 - Single-ply roofing system - note patching

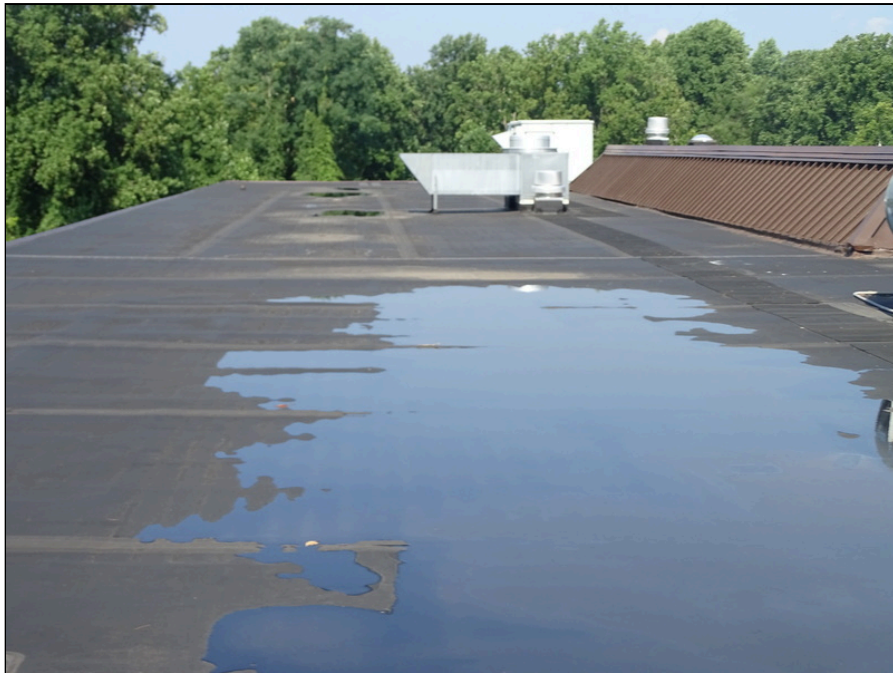
34 - Single-ply roofing system - note ponding

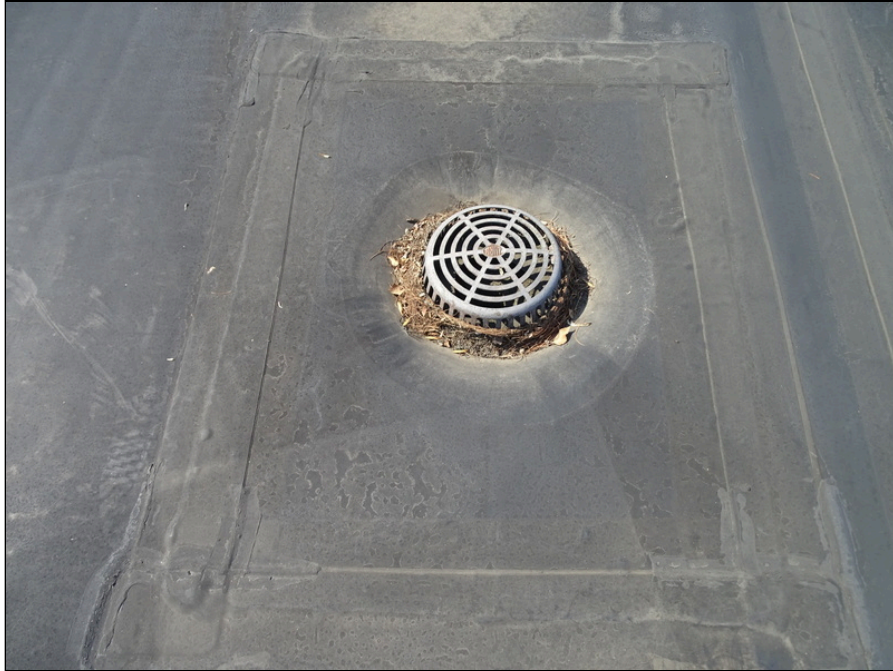
35 - Typical internal drain

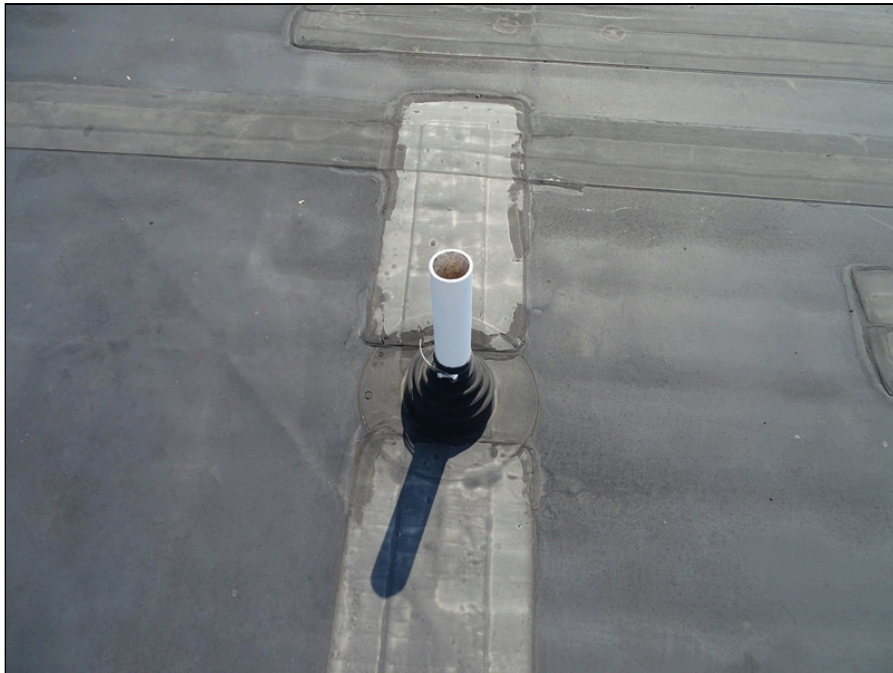
36 - Typical plumbing penetration

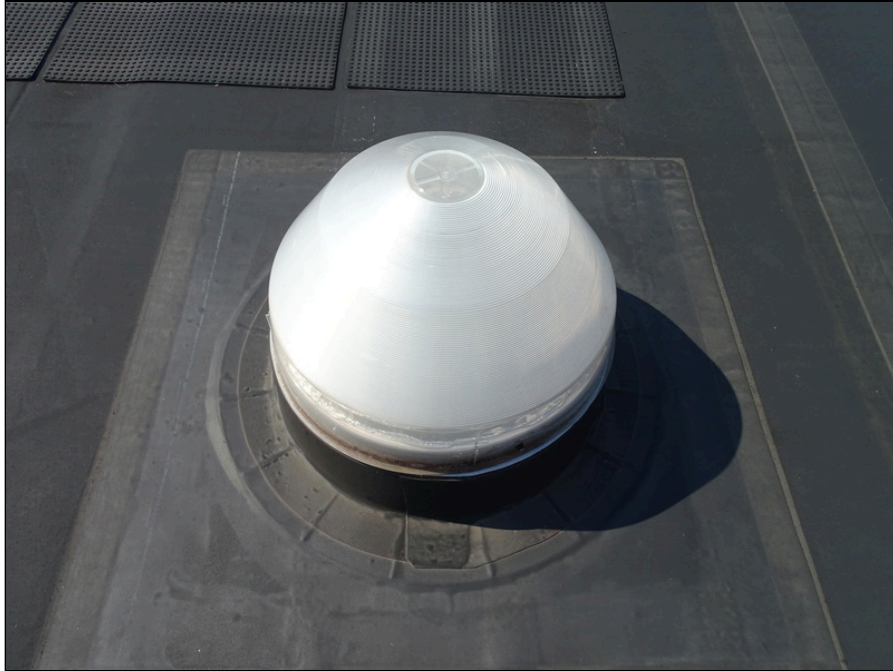
37 - Typical skylights

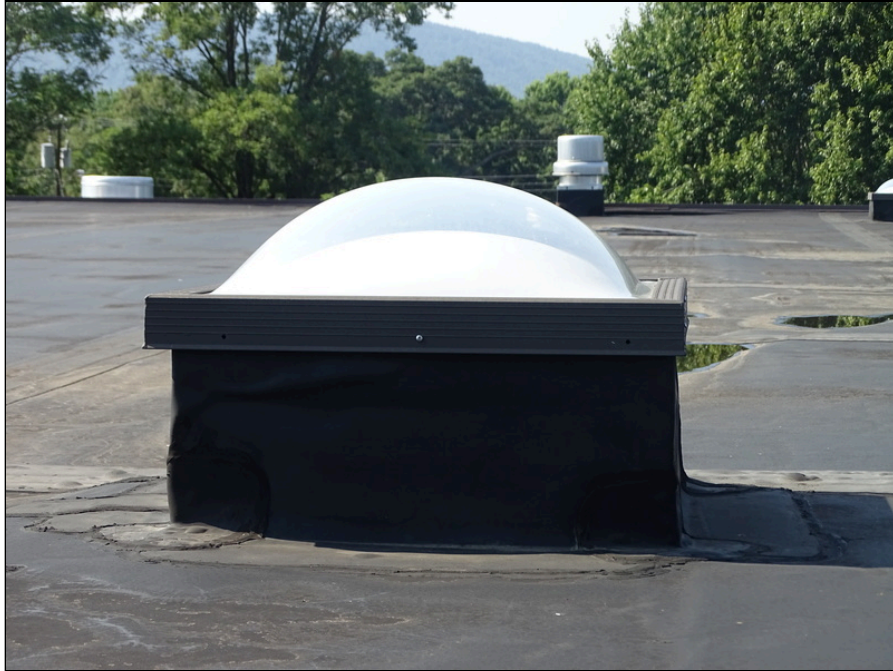
39 - Typical skylights

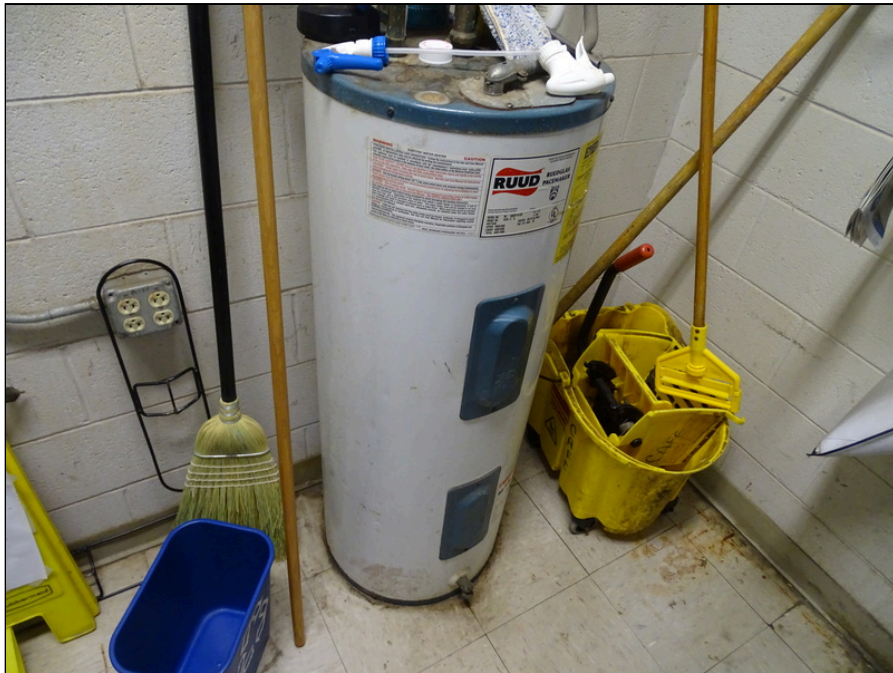
40 - Electric water heater located in janitor's closet

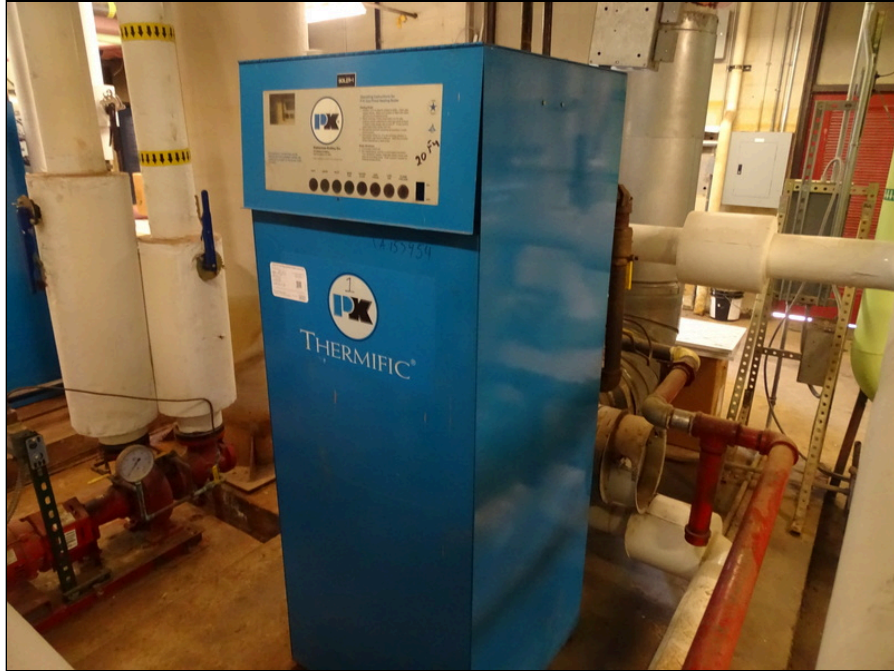
41 - Boiler located in main utility room

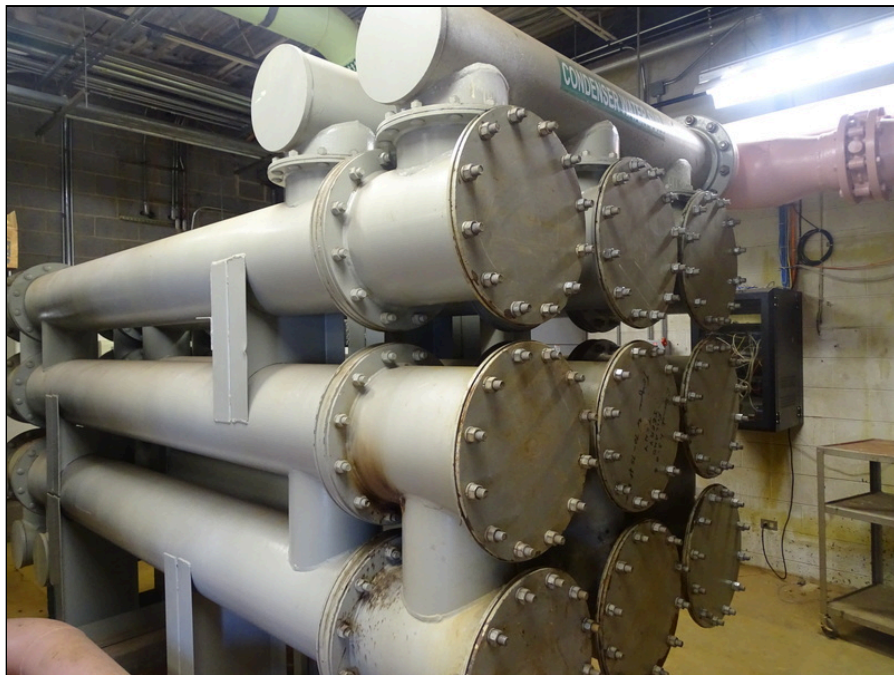
42 - chiller located in main utility room

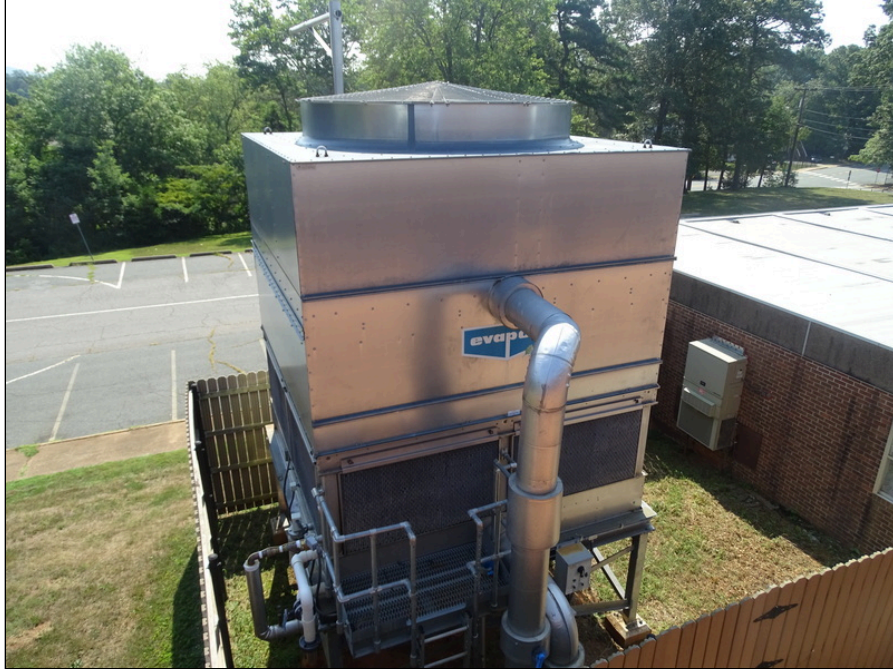
43 - Cooling Tower located at east end of the site

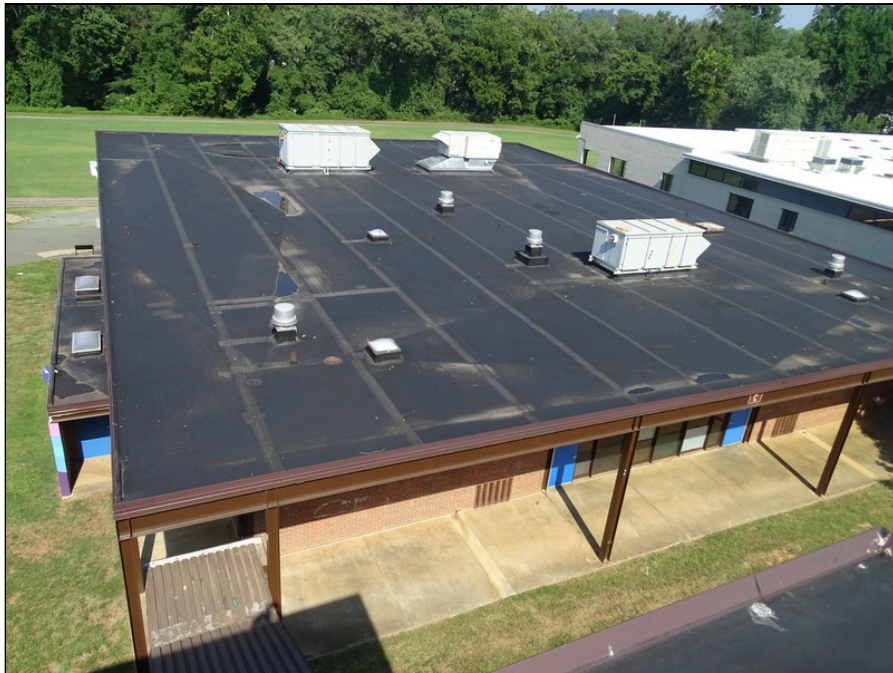
44 - Typical Make Up Air Unit located on roof
