BUFORD MIDDLE SCHOOL
1000 CHERRY AVENUE
CHARLOTTESVILLE, VIRGINIA

ECS PROJECT NO. 46:6713

CITY OF CHARLOTTESVILLE - FACILITIES DEVELOPMENT

Reference: Facility Condition Assessment Report for Buford Middle School, 1000 Cherry Avenue,
Charlottesville, Virginia

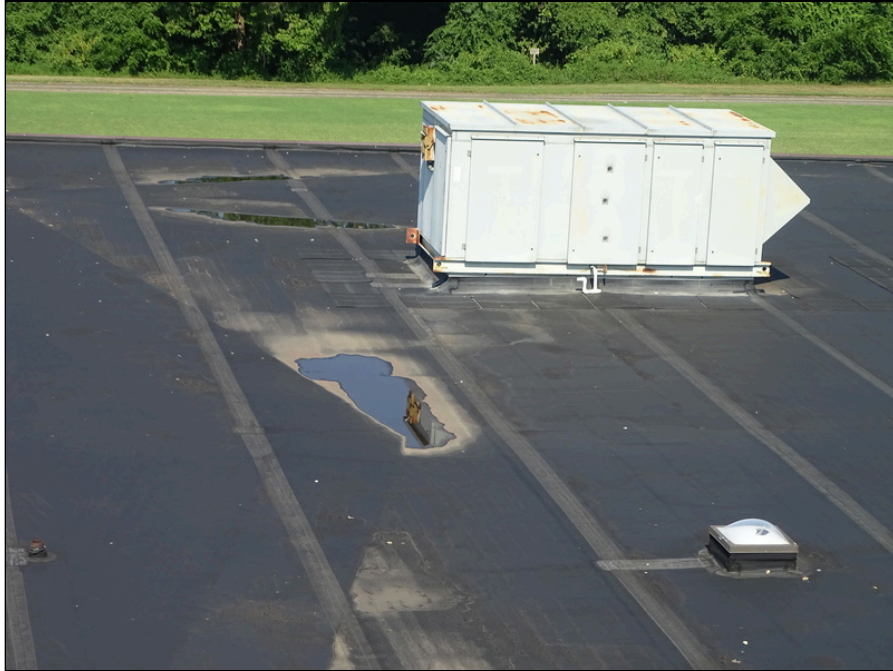
45 - Typical Make Up Air Unit located on roof

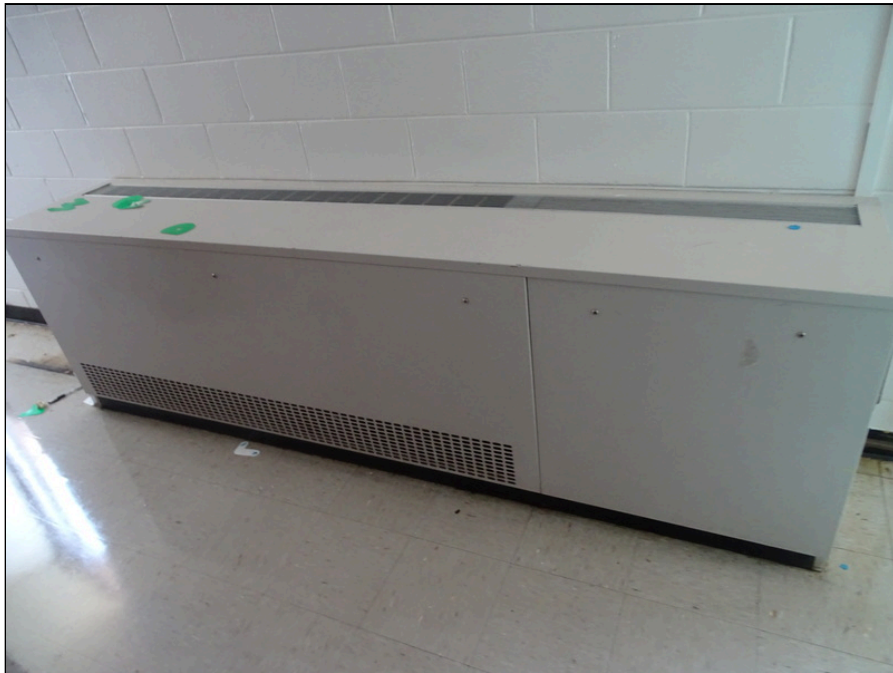
46 - Typical Water Source Heat Pump

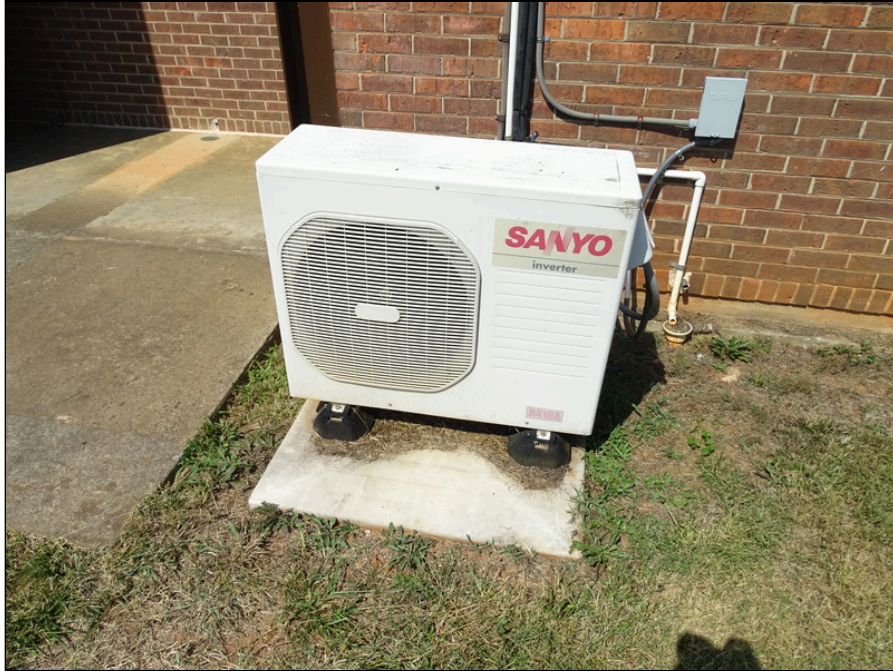
47 - Split System for IT room

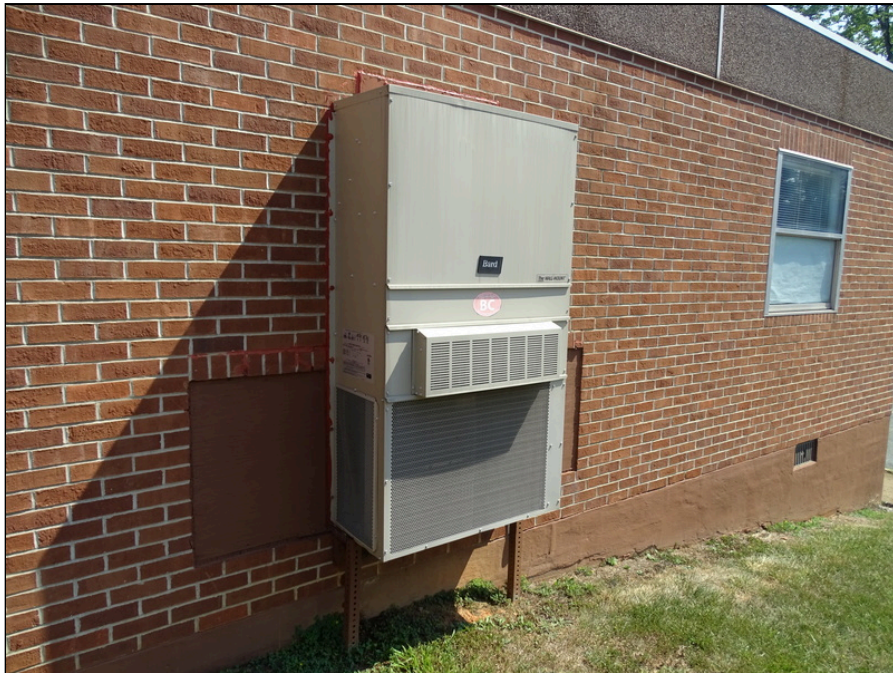
48 - Wall mounted air conditioner unit

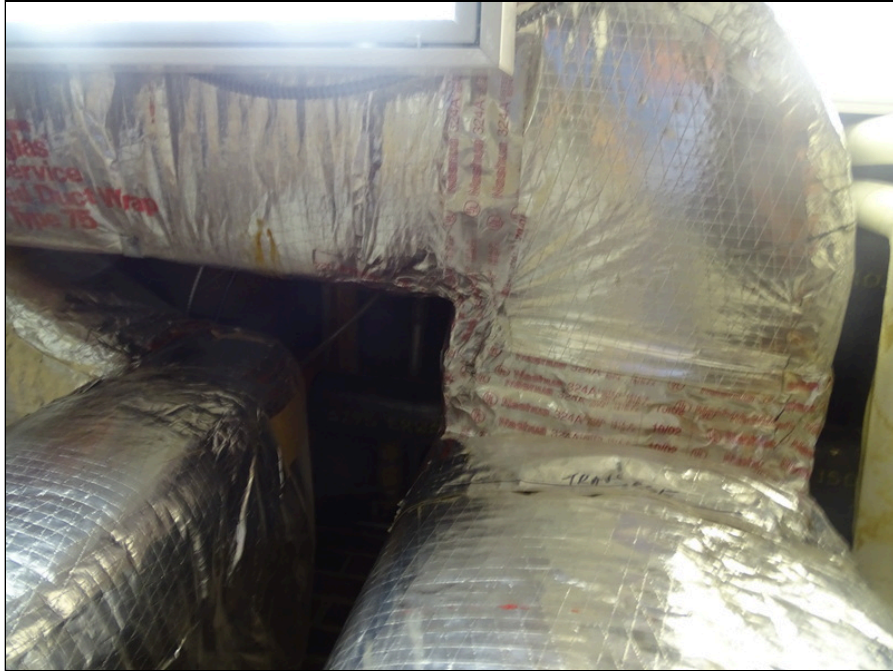
49 - Typical mechanical duct

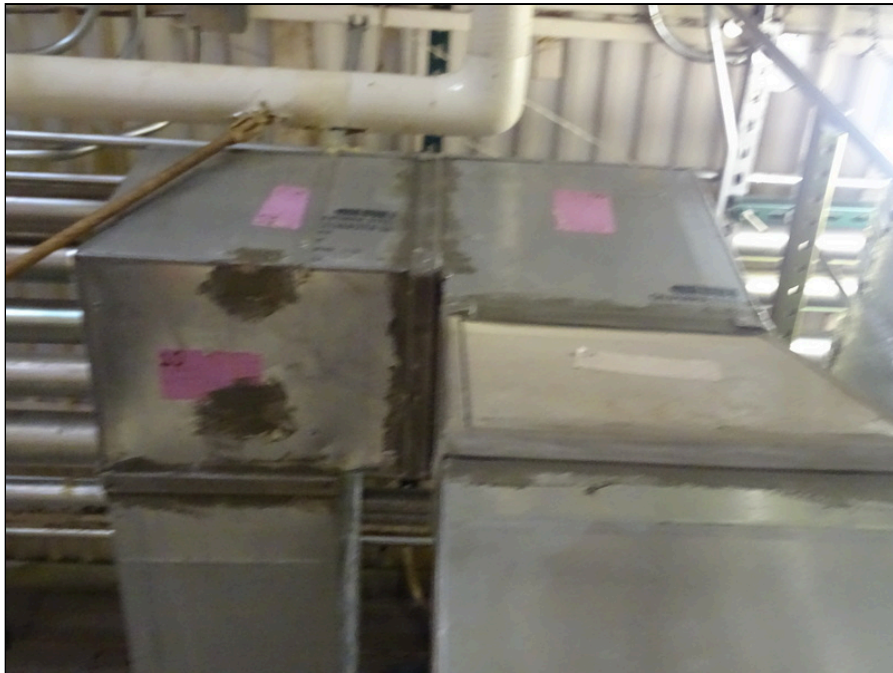
50 - Typical mechanical duct

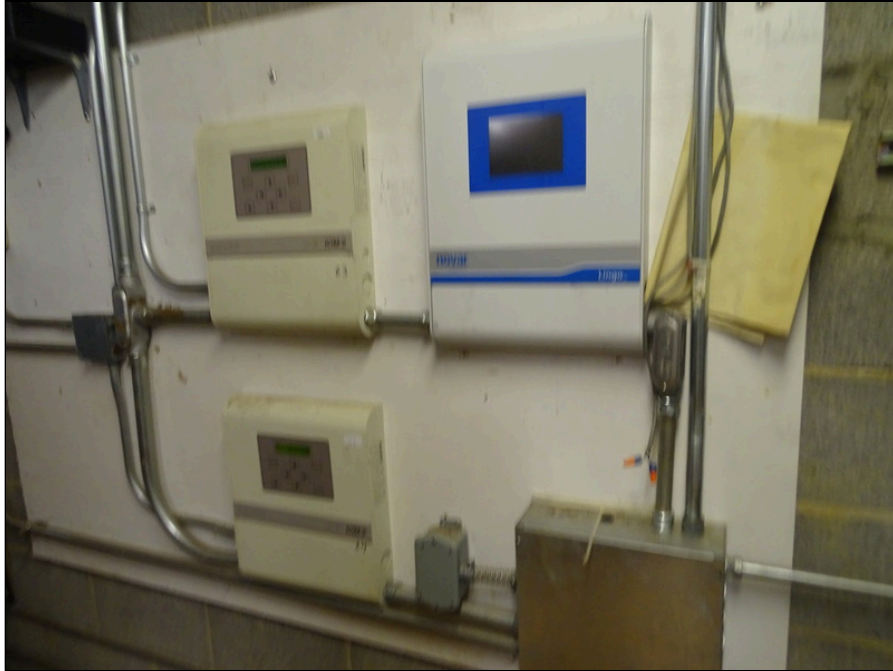
51 - Energy Management System

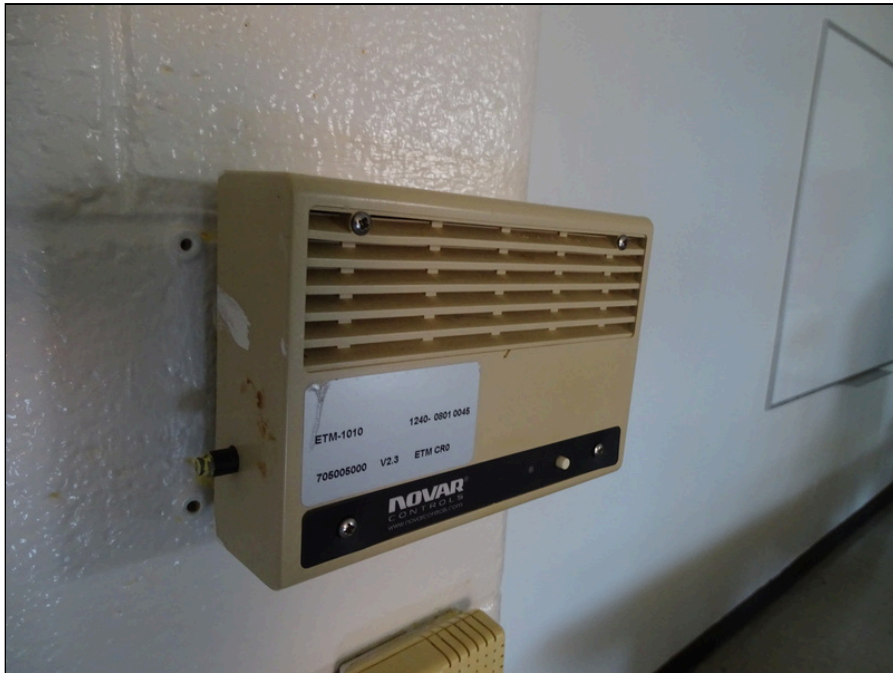
52 - Typical controls

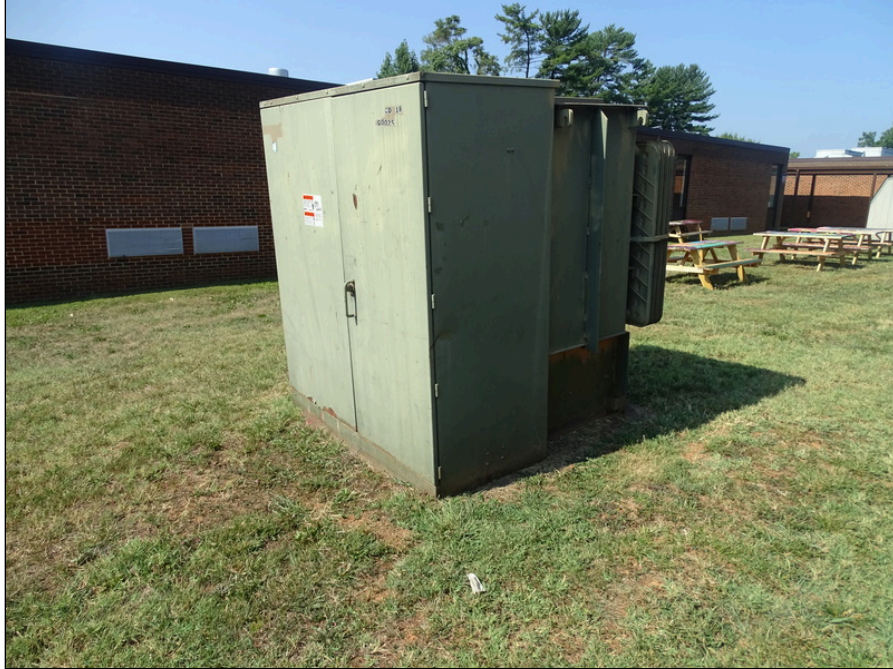
53 - Electric utility transformer

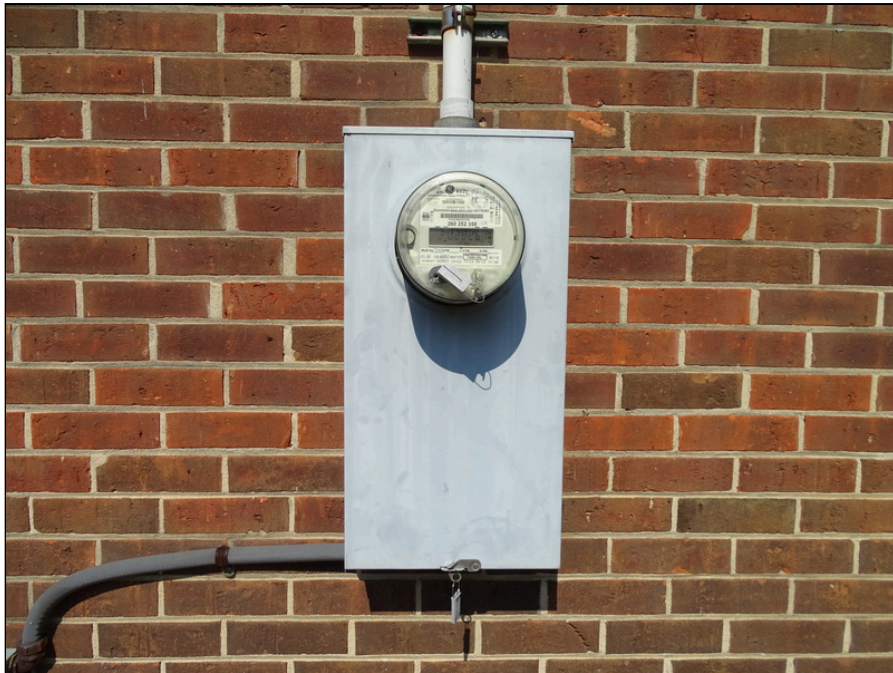
54 - Electric utility meter

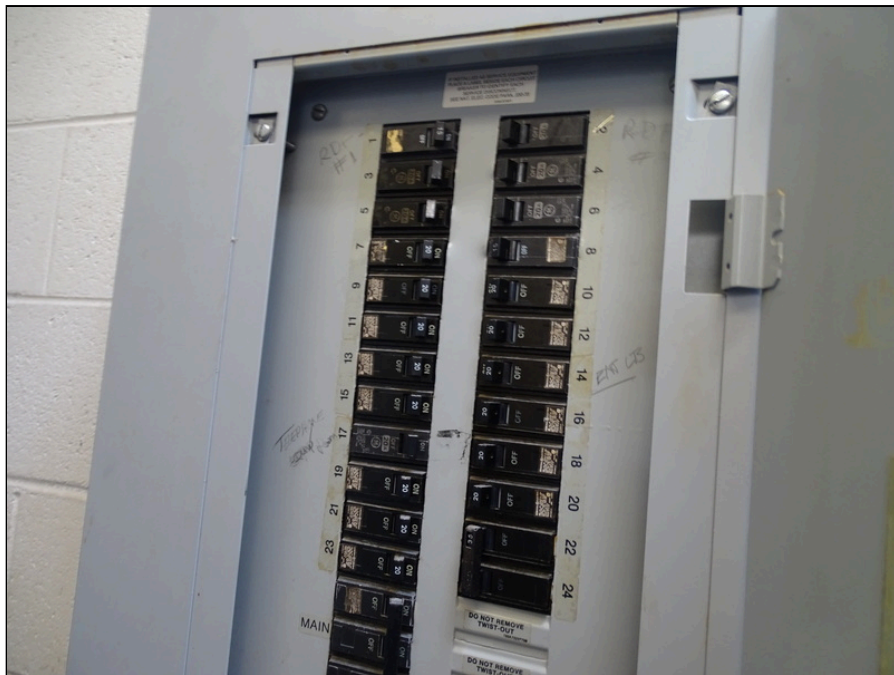
56 - Typical newer electrical circuit breaker panel

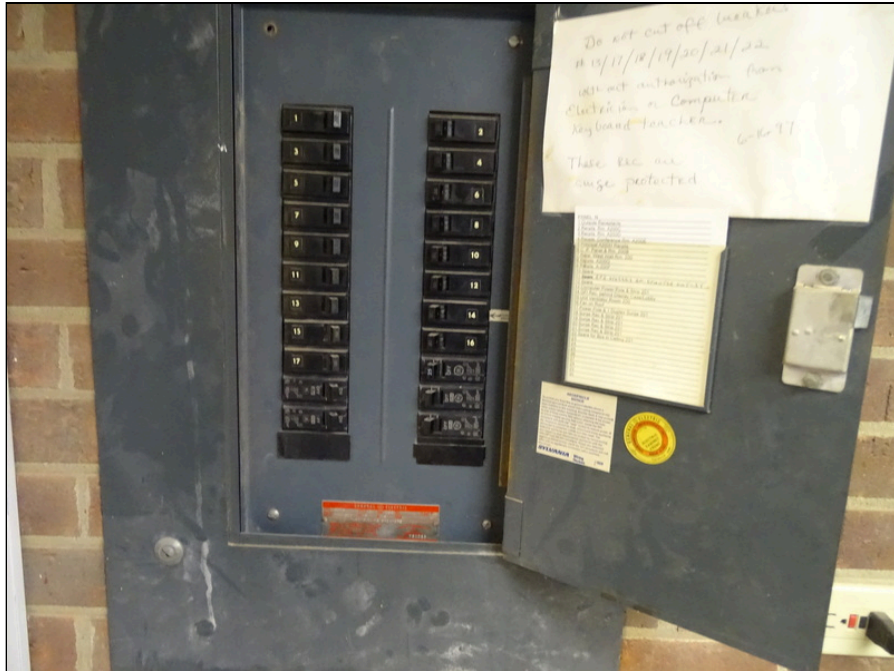
57 - Typical older electrical circuit breaker panel

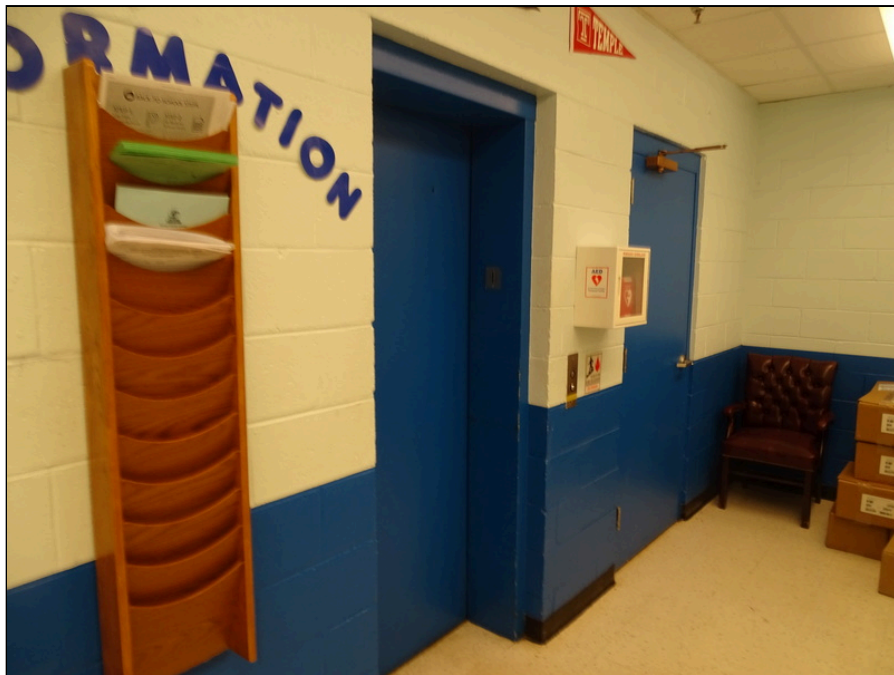
58 - Elevator cab

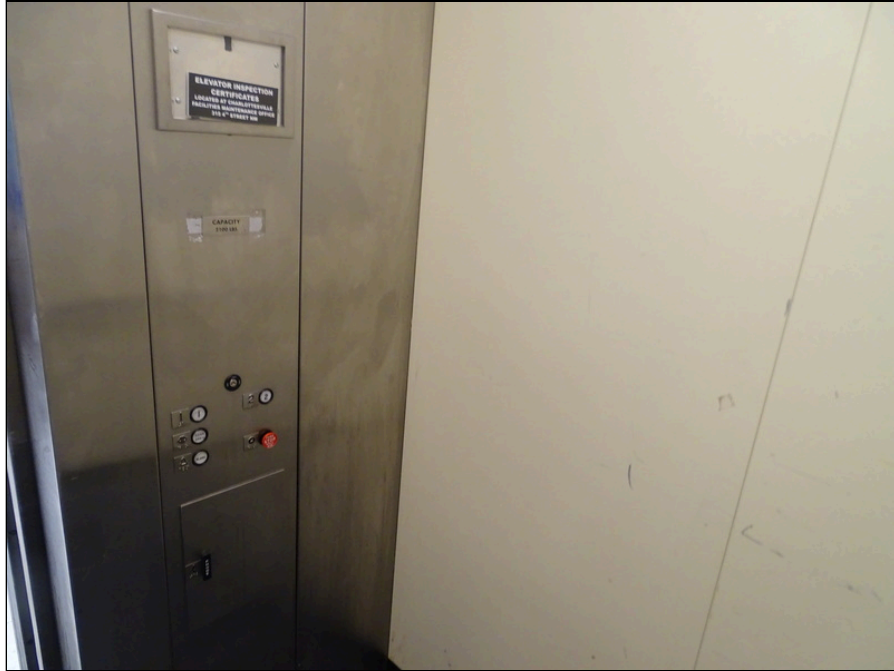
59 - Elevator cab interior

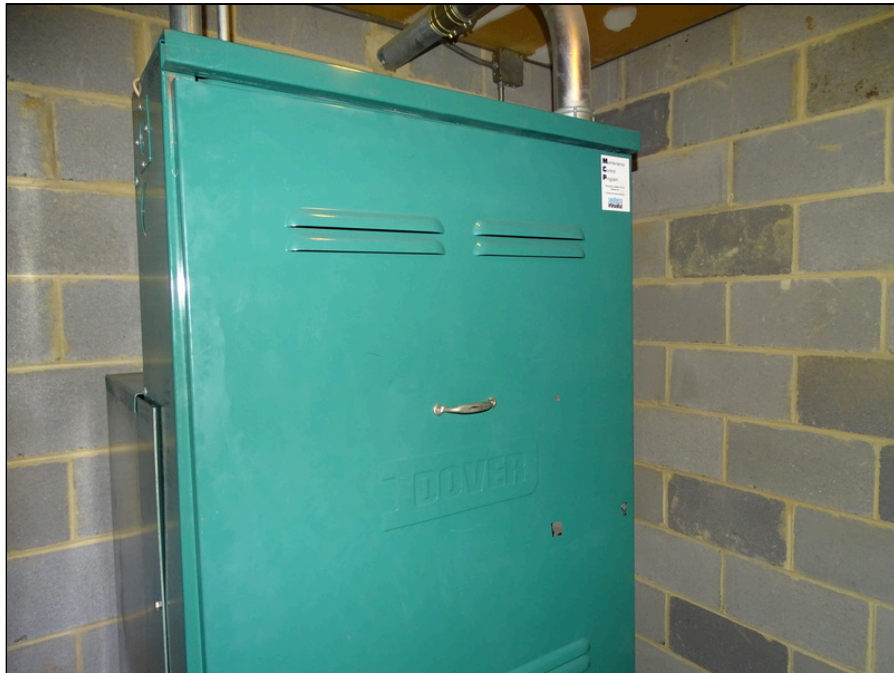
60 - Elevator machine and controls

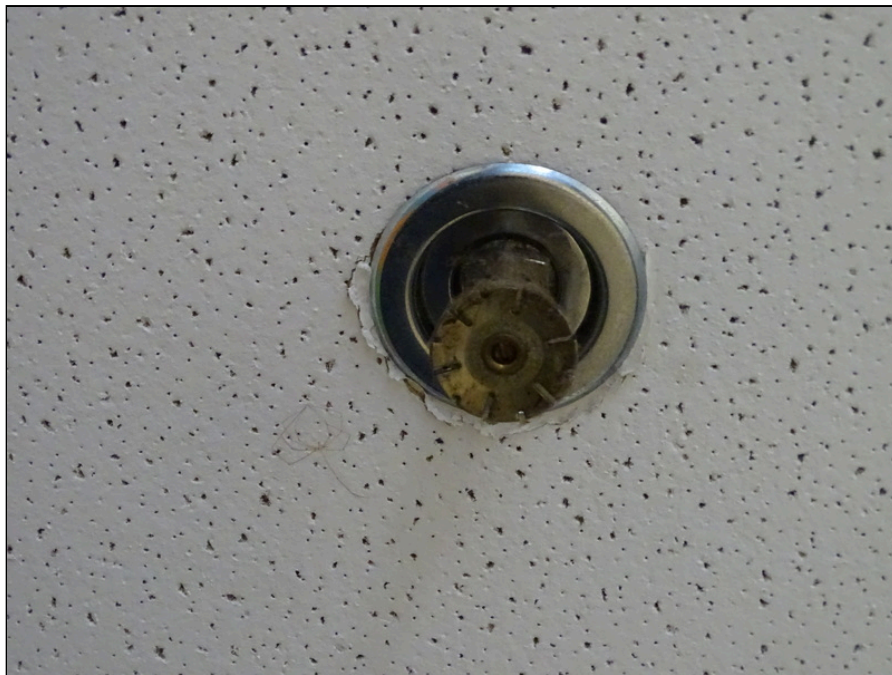
62 - Typical fire sprinkler head

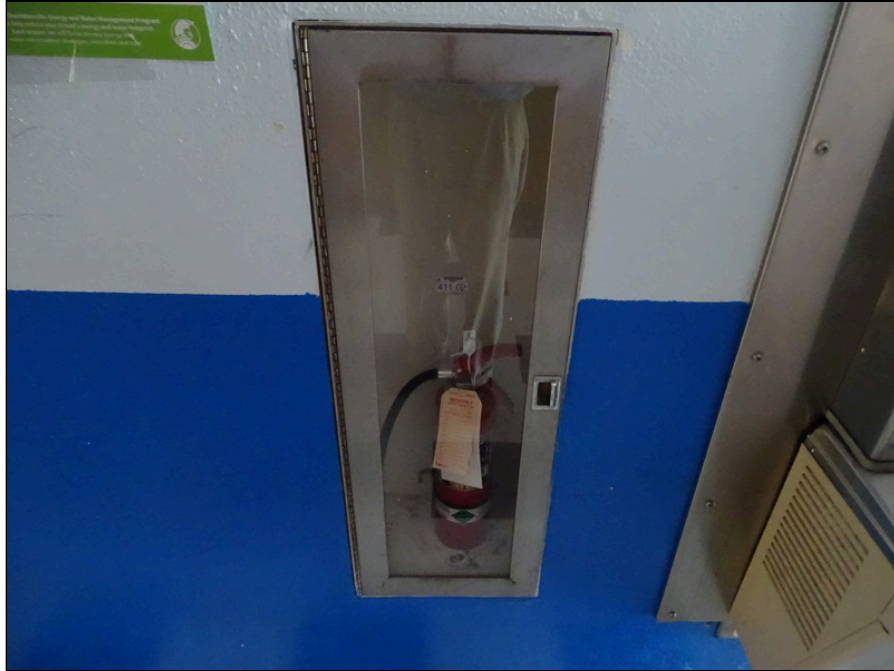
63 - Typical fire extinguisher

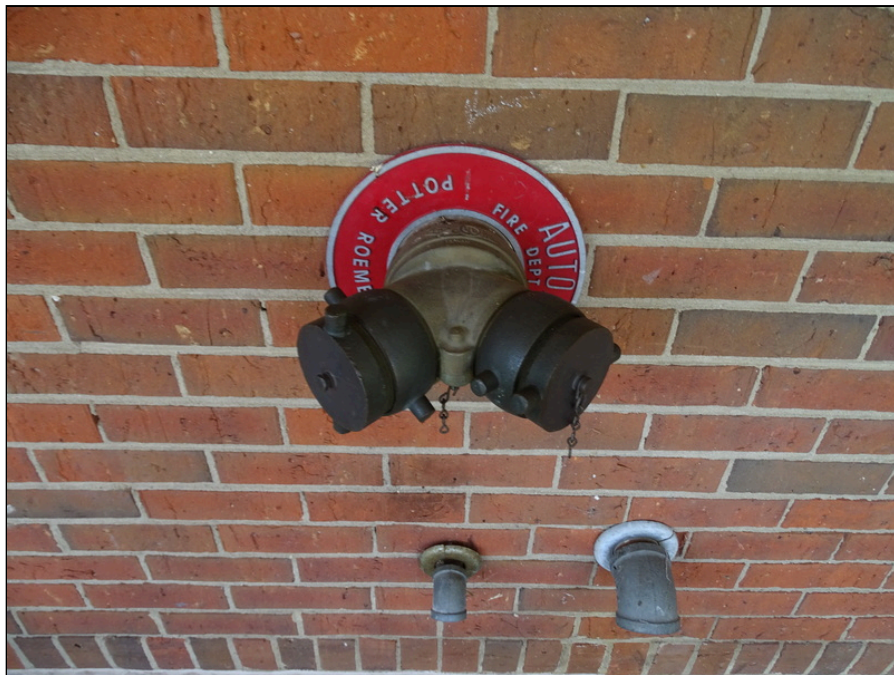
64 - Fire Department Connections

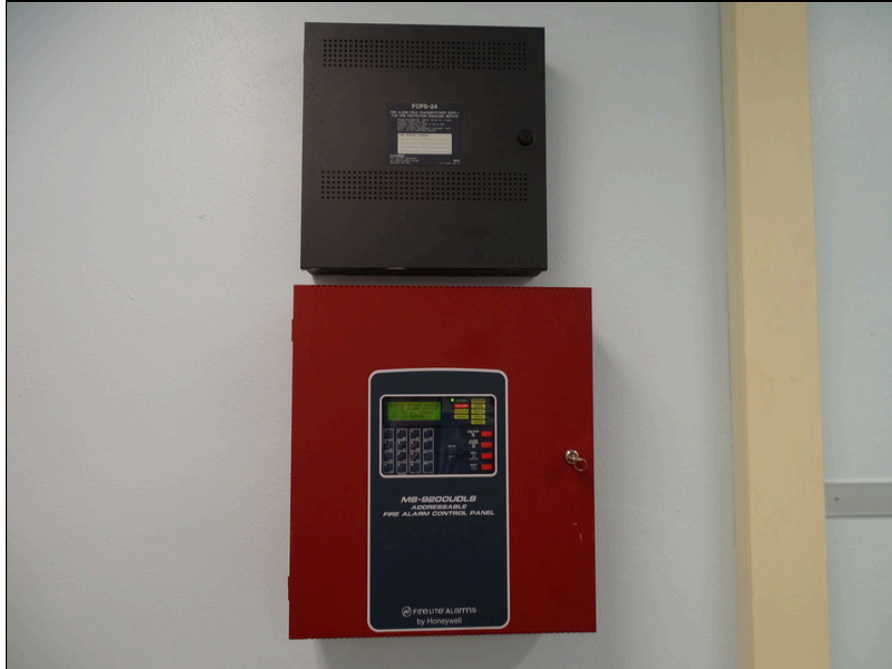
65 - Fire alarm control panel

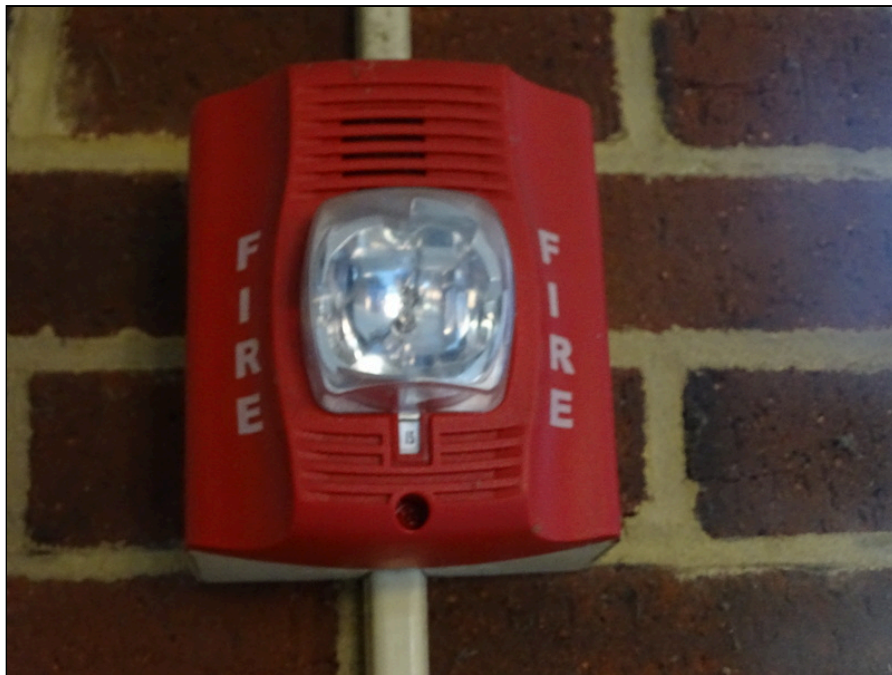
66 - Typical fire alarm bell, strobe

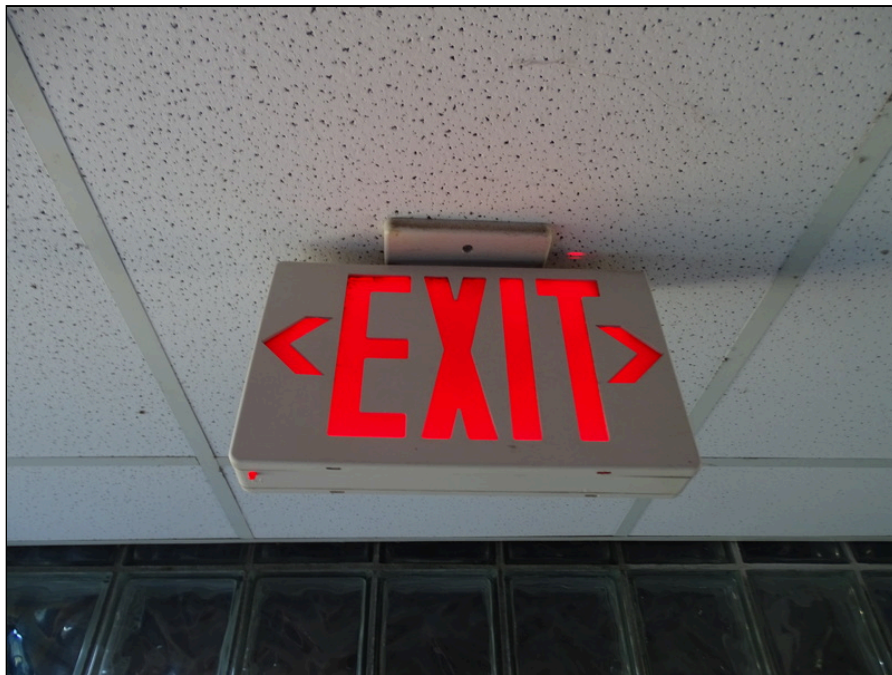
68 - Typical exit sign

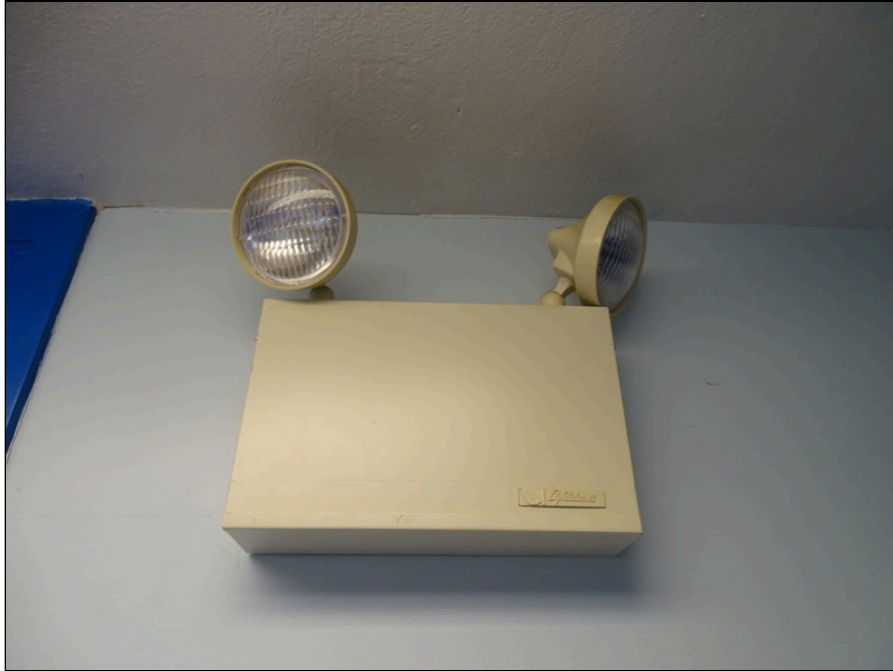
69 - Emergency light

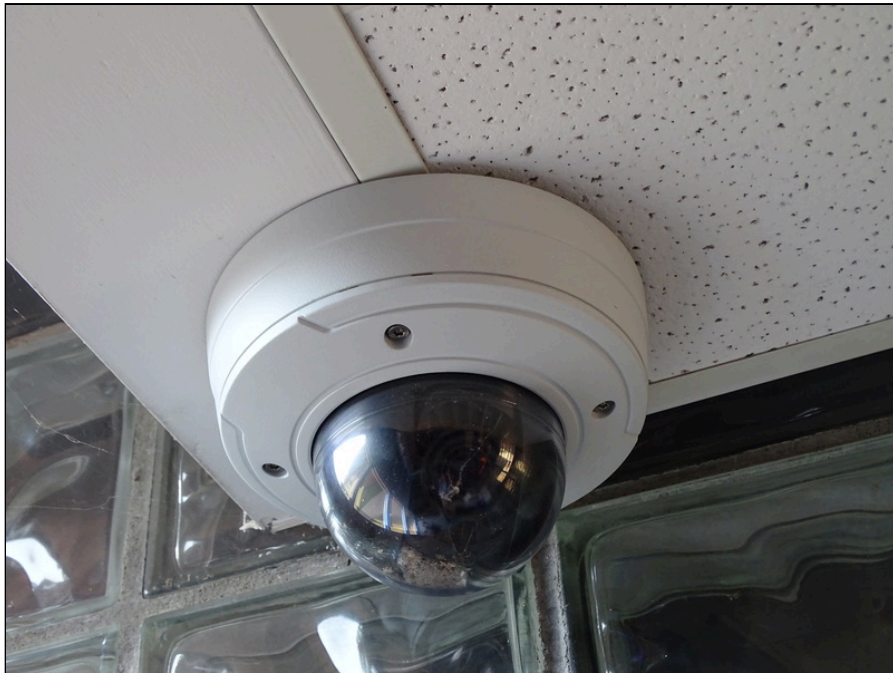
70 - Typical security camera

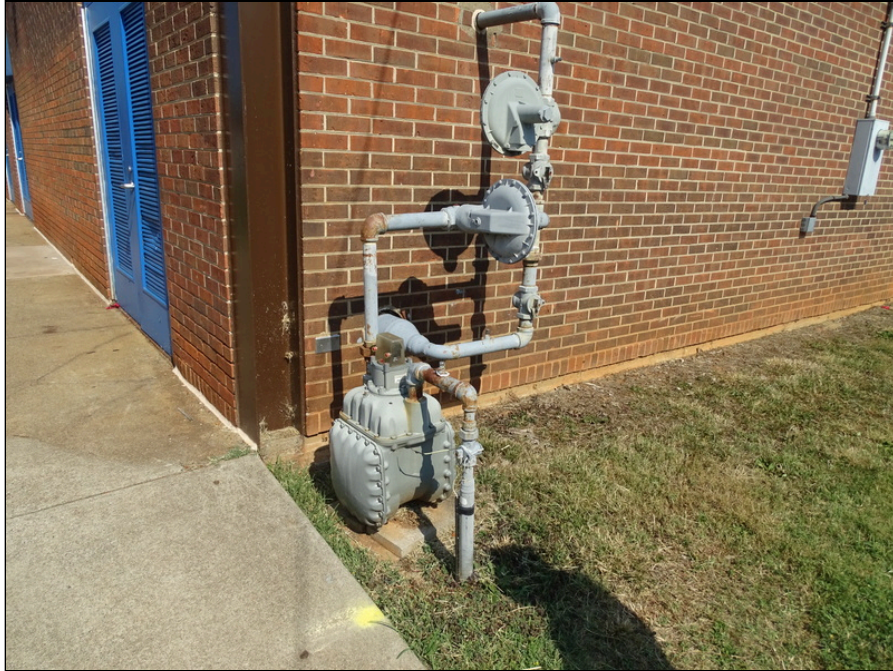
71 - Typical gas meter

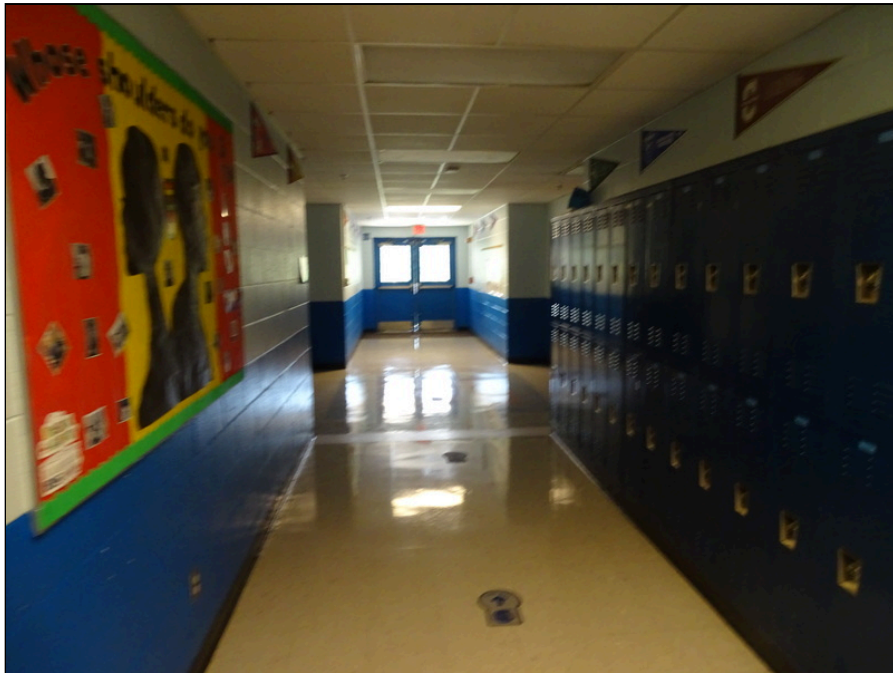
72 - Interior finishes of corridor area

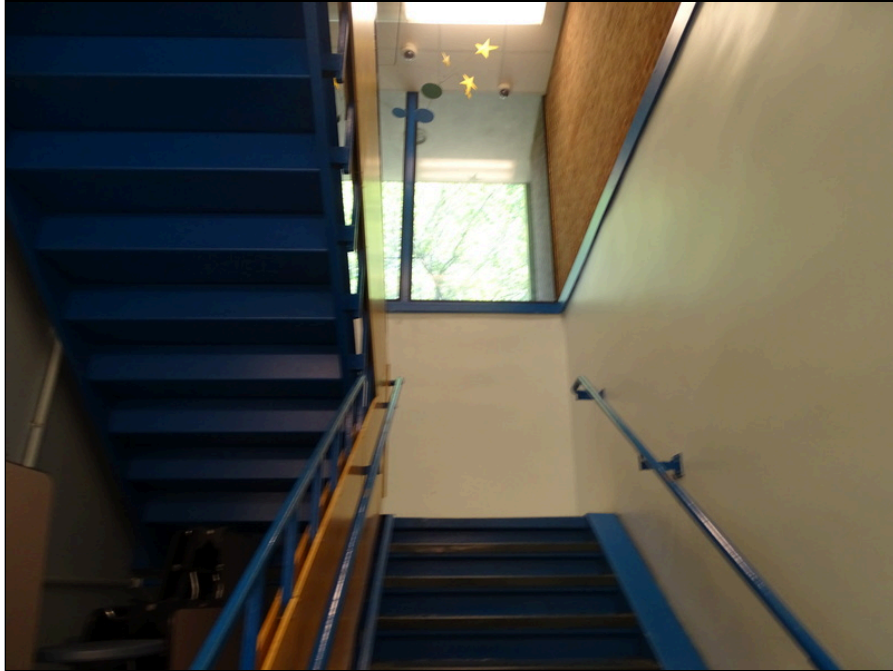
73 - Interior finishes of stair area

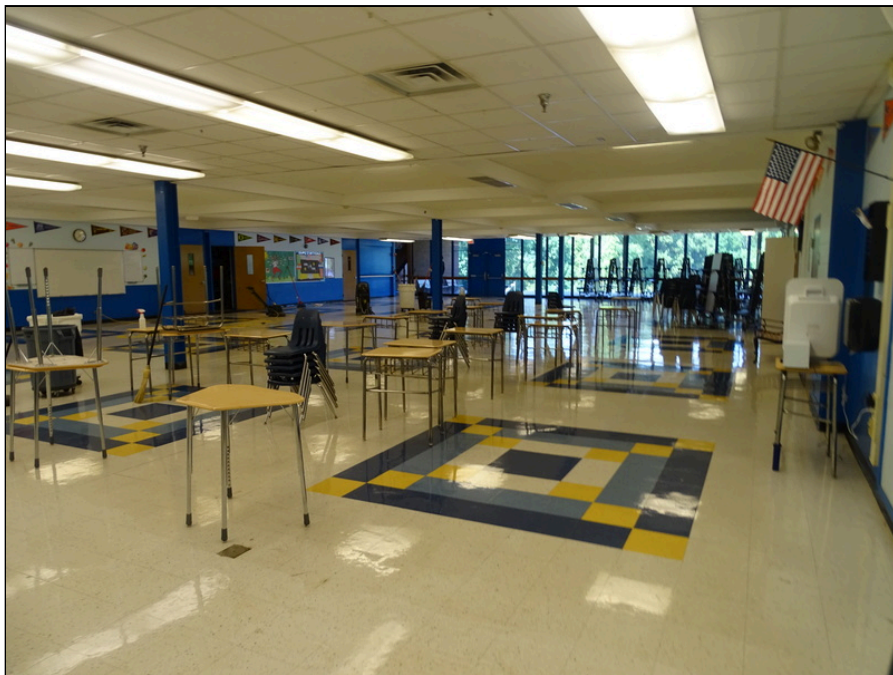
74 - Interior finishes of cafeteria area

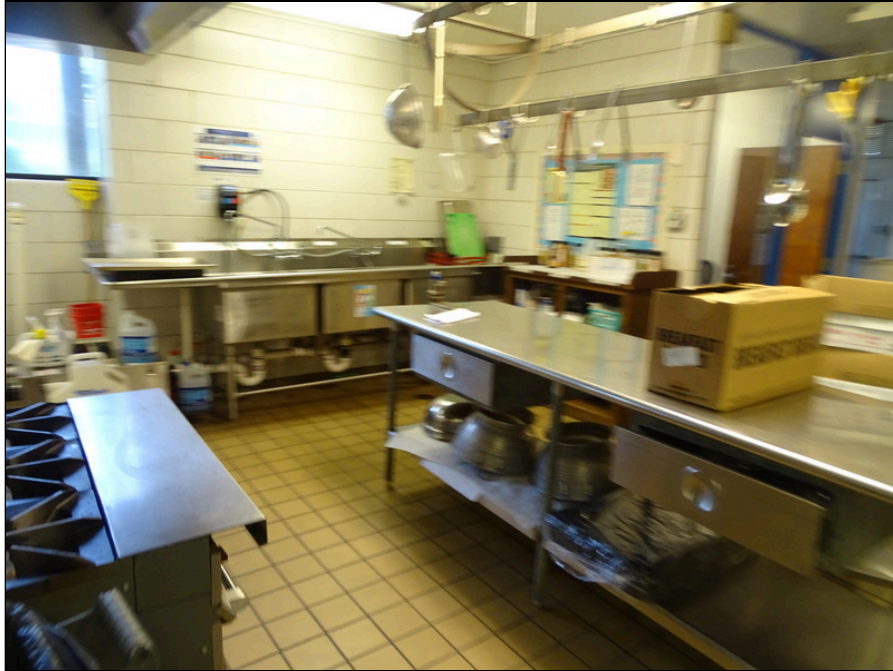
75 - Interior finishes of kitchen area

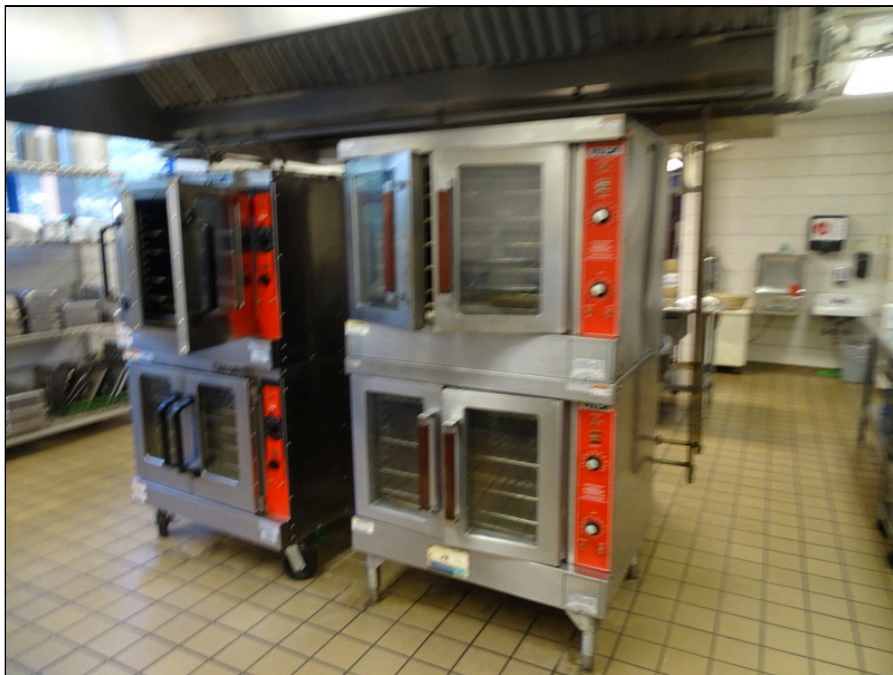
76 - Interior finishes of kitchen area

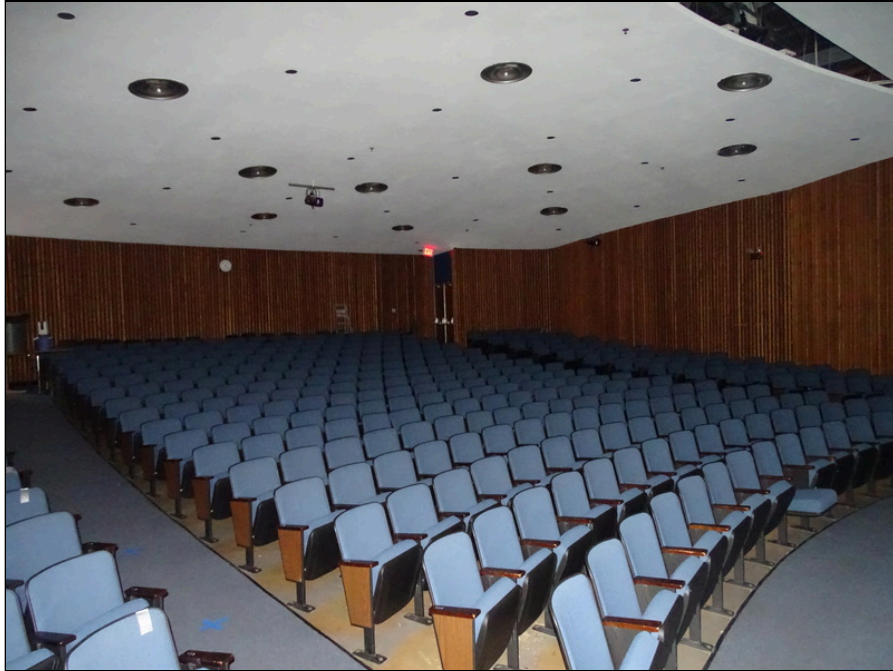
77 - Interior finishes of auditorium area

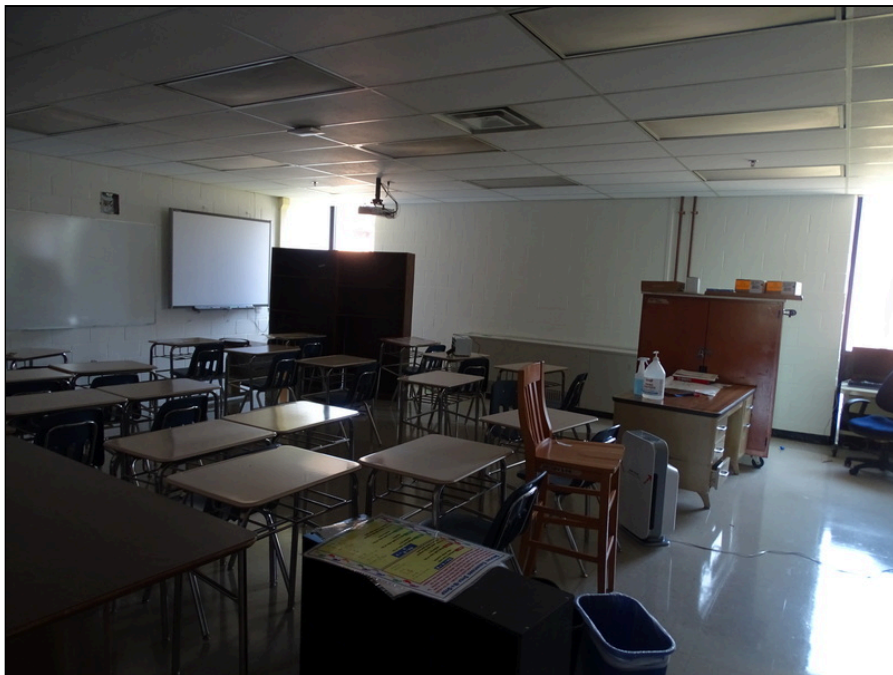
78 - Interior finishes of classroom area

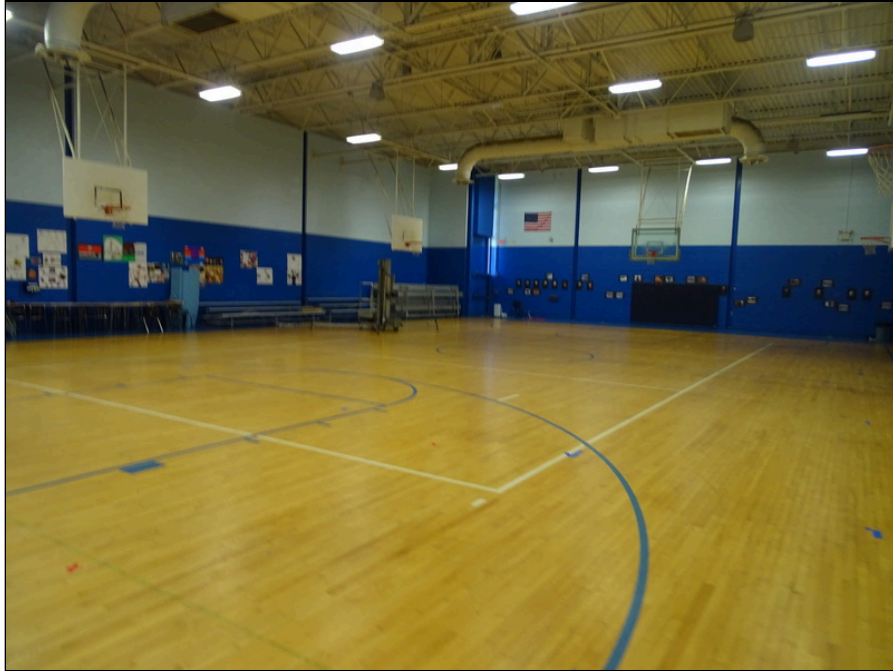
79 - Interior finishes of gym area

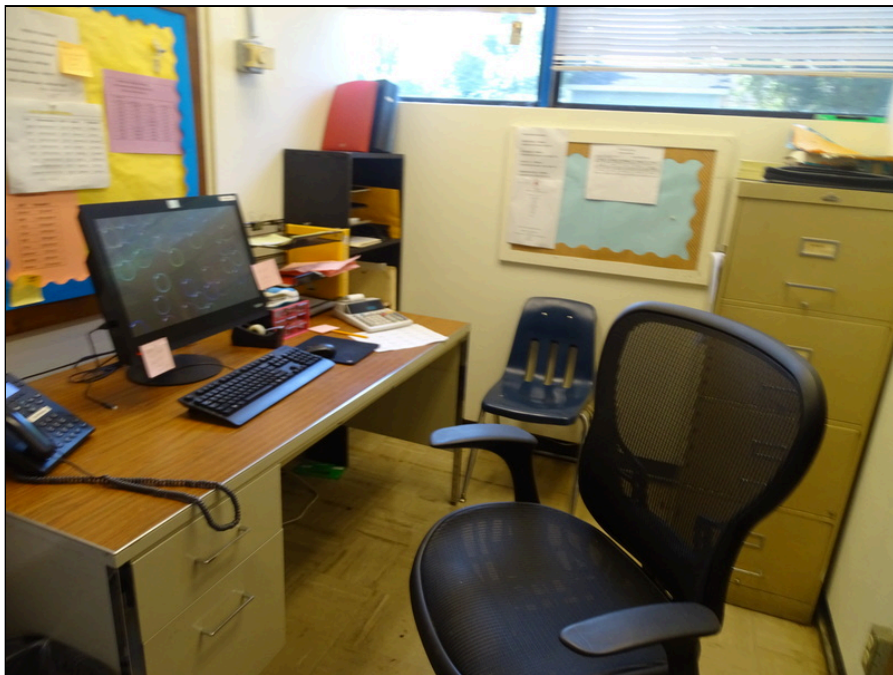
80 - Typical office area interior

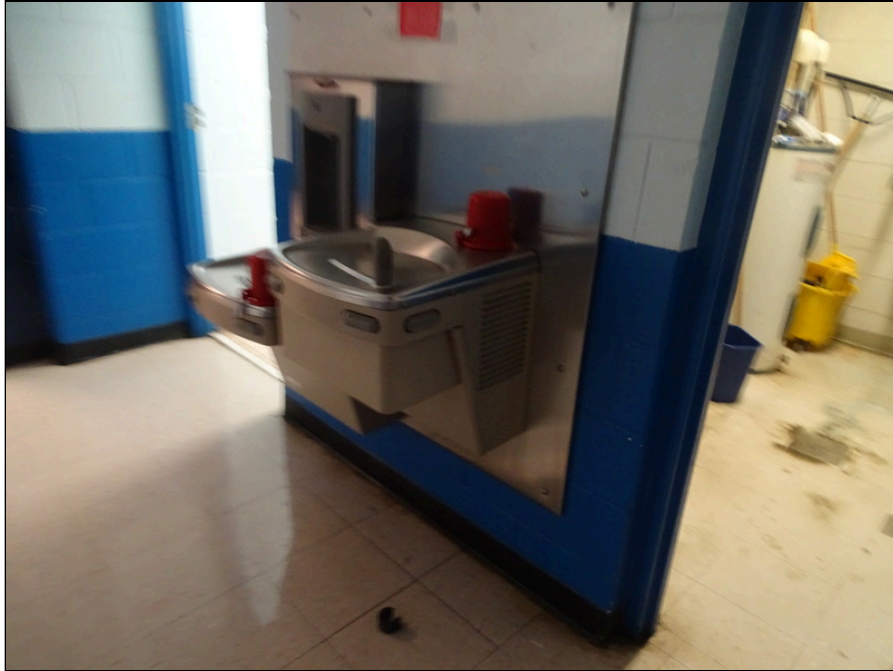
81 - Typical water fountain

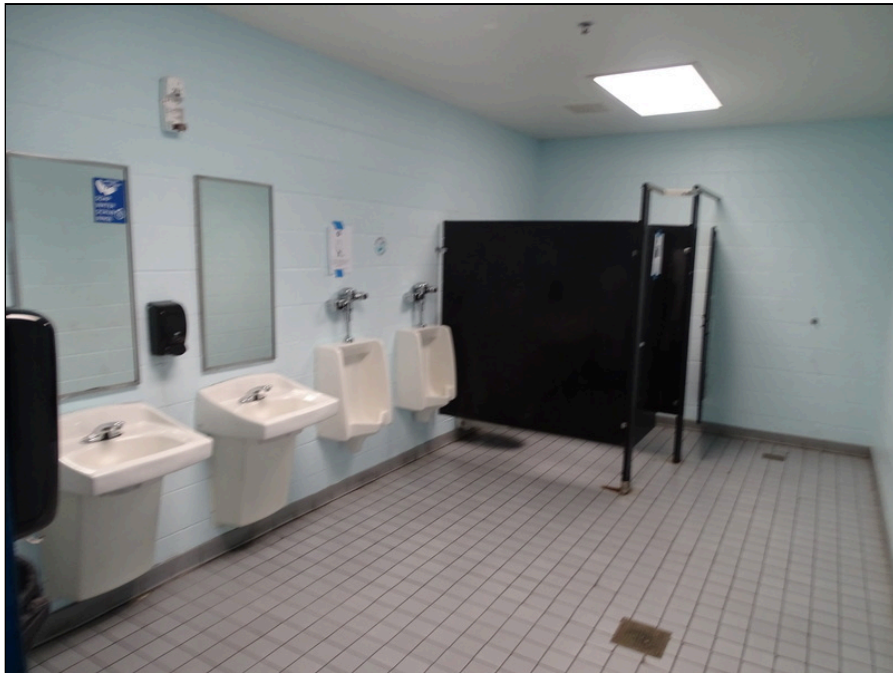
82 - Interior finishes of restroom area

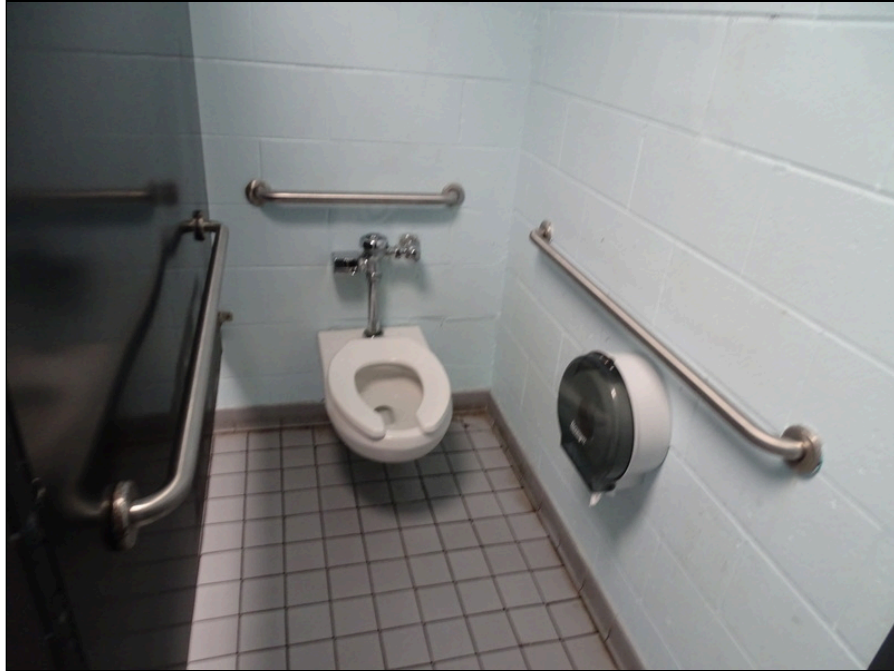
83 - Interior finishes of restroom area

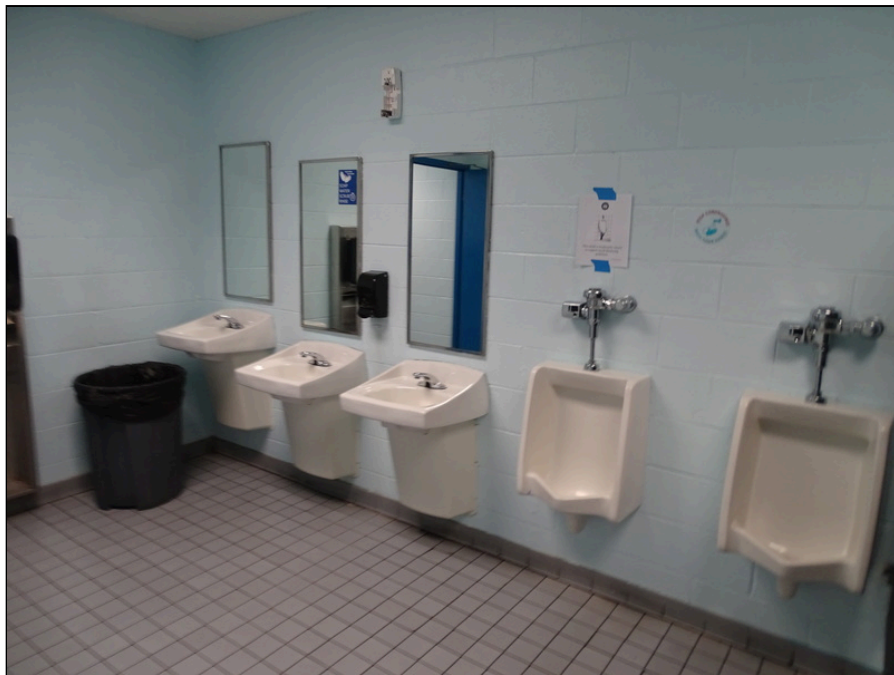
84 - Interior finishes of restroom area

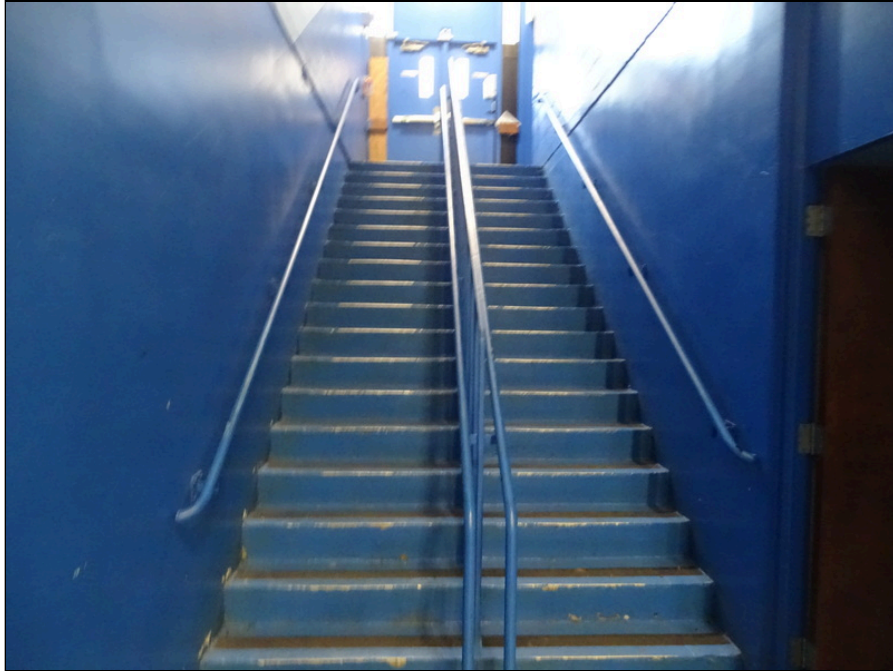
85 - Interior finishes of stair area
