BUFORD MIDDLE SCHOOL
1000 CHERRY AVENUE
CHARLOTTESVILLE, VIRGINIA

ECS PROJECT NO. 46:6713

CITY OF CHARLOTTESVILLE - FACILITIES DEVELOPMENT

Reference: Facility Condition Assessment Report for Buford Middle School, 1000 Cherry Avenue,
Charlottesville, Virginia

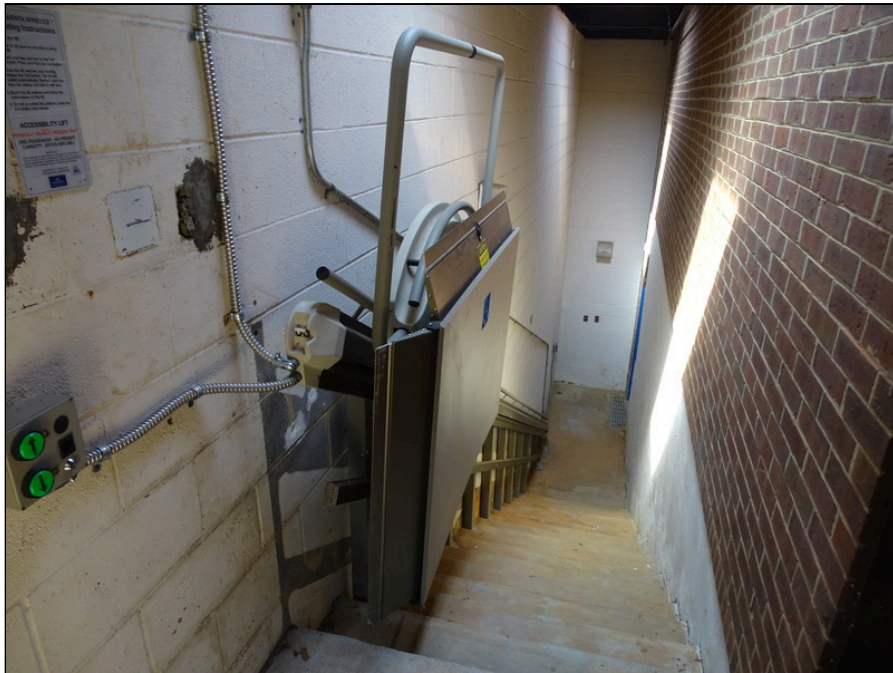
86 - Typical accessible chair lift

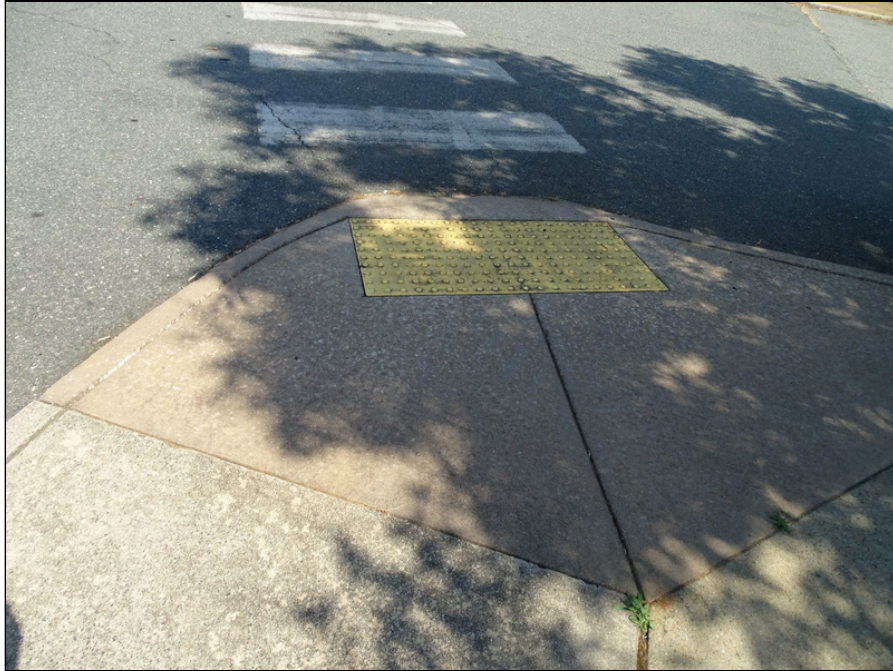
87 - Accessible curb cut ramp with truncated domes

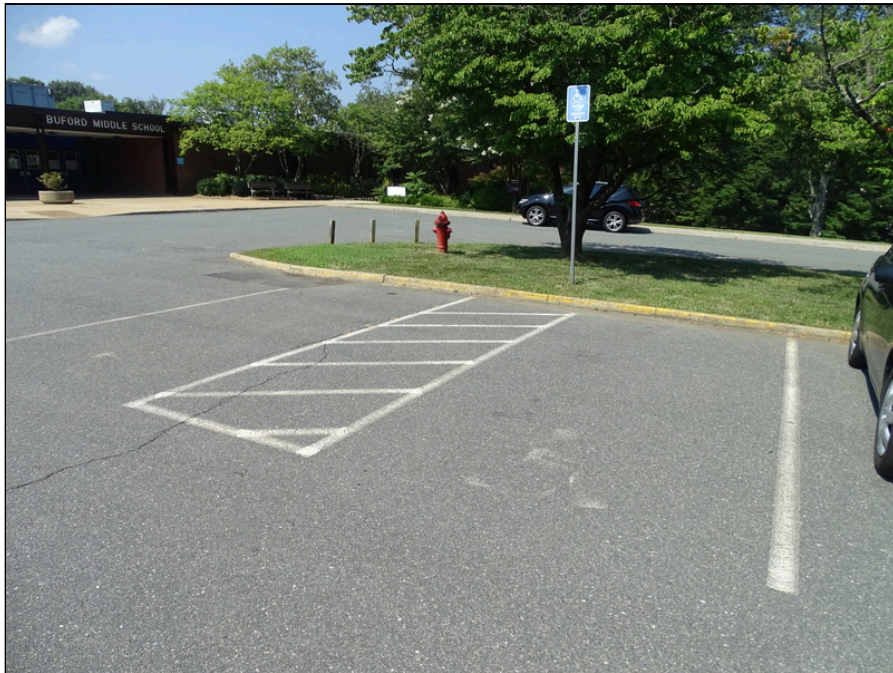
88 - Accessible parking spaces

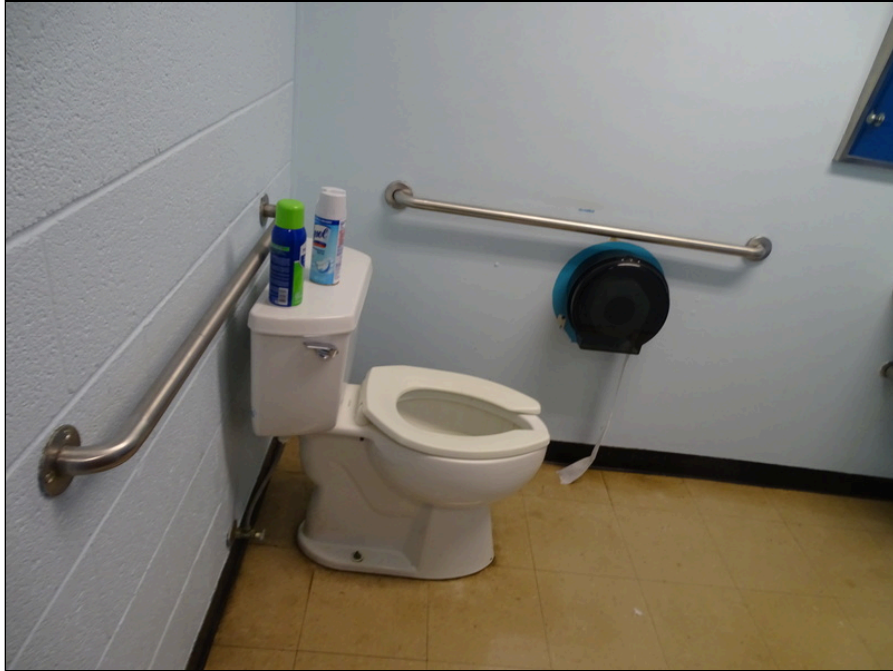
89 - Typical accessible restroom
