BURNLEY MORAN ELEMENTARY SCHOOL  
1300 LONG STREET  
CHARLOTTESVILLE, VIRGINIA

ECS PROJECT NO. 46:6713

CITY OF CHARLOTTESVILLE - FACILITIES DEVELOPMENT

Reference: Facility Condition Assessment Report for Burnley Moran Elementary School, 1300 Long Street, Charlottesville, Virginia

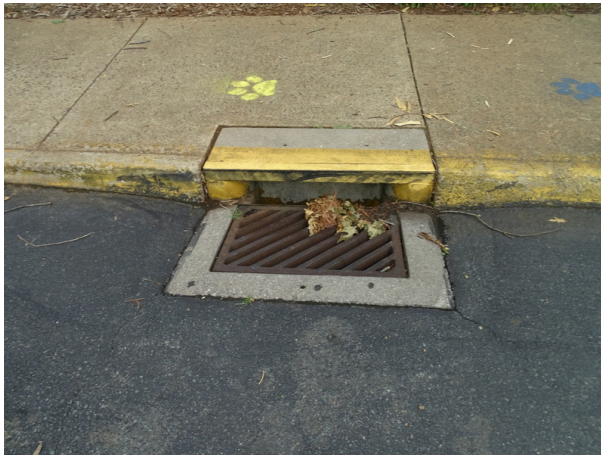
Typical storm water drainage

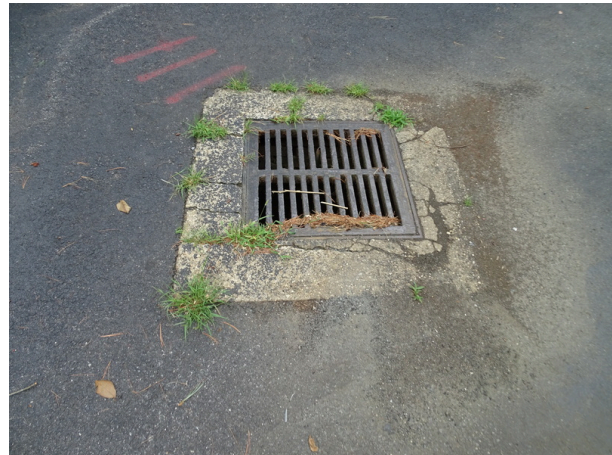
Typical storm water drainage

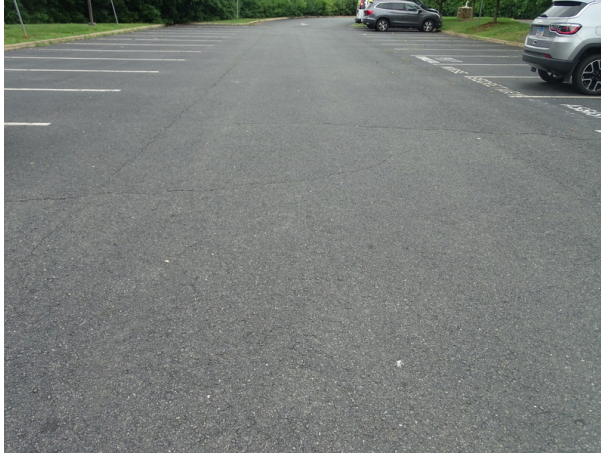
Asphalt drive lane at west side of the site

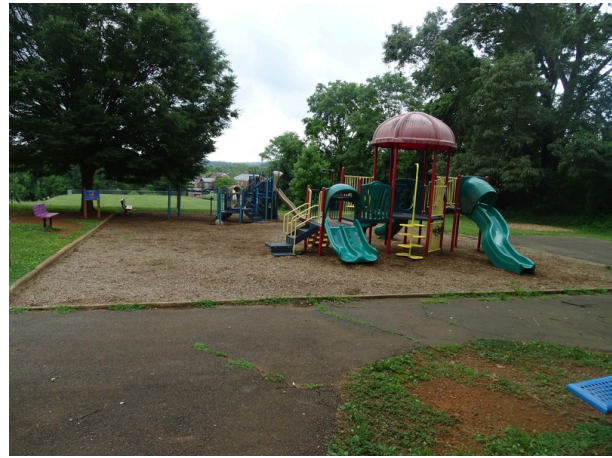
Playground equipment at south end of site

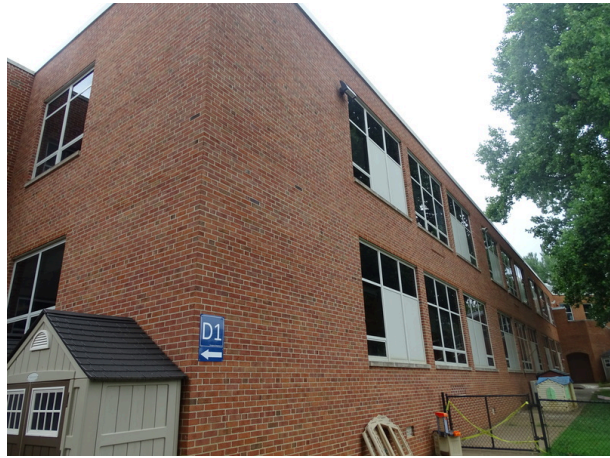
Building exterior south side of the building

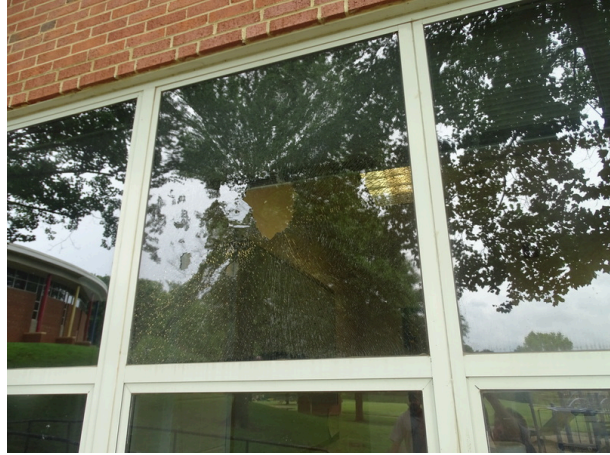
Typical exterior windows

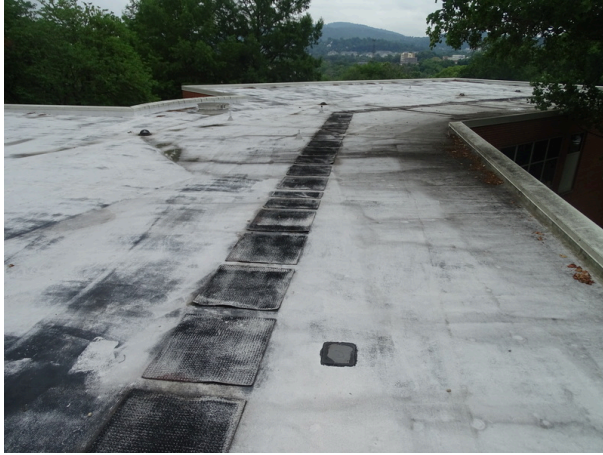
Single-ply membrane roofing system east side of the building

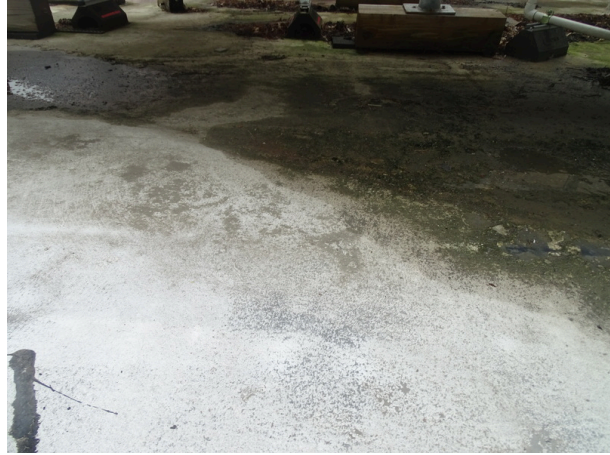
Single-ply membrane roofing system - note ponding

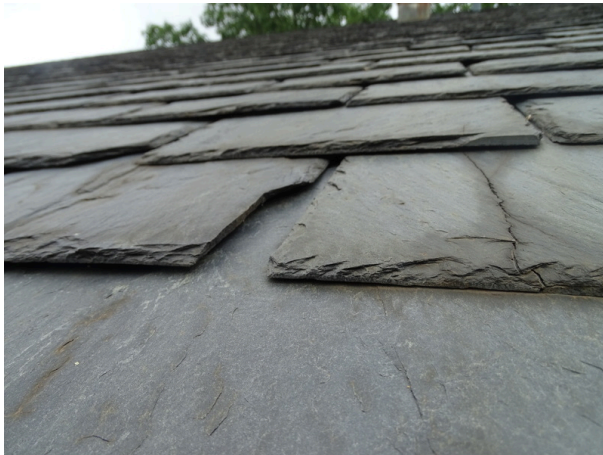
Slate shingle roofing system

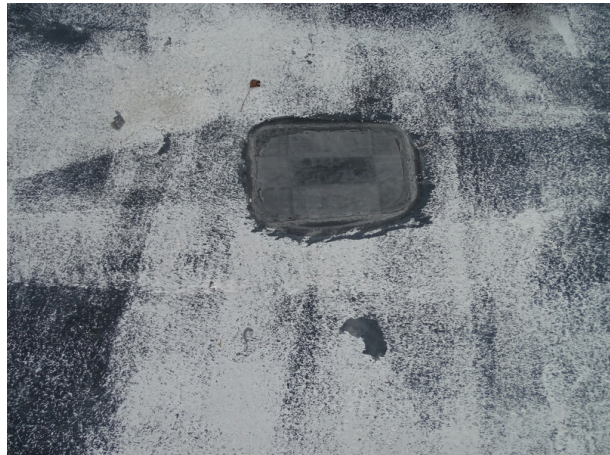
Typical roof patch

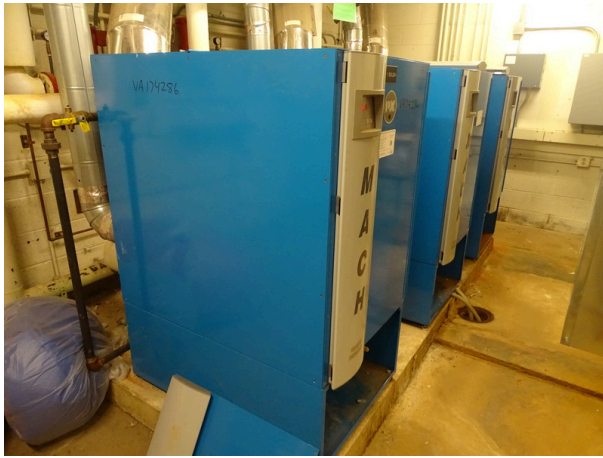
Boilers located in mechanical room

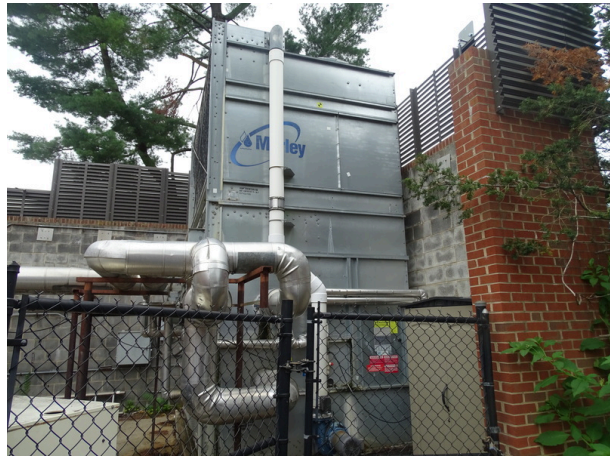
Cooling Tower at north side of the building

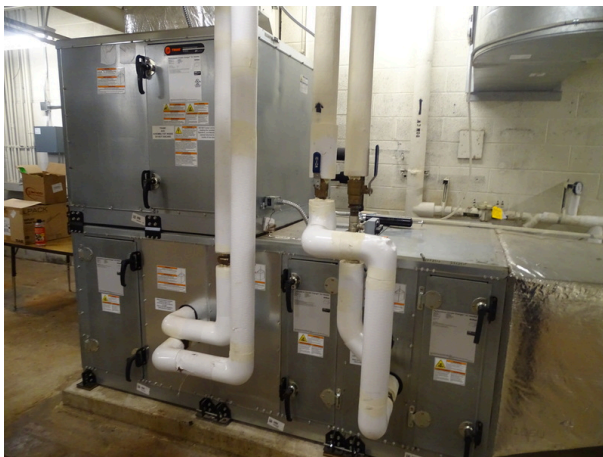
Air Handler Unit in mechanical room

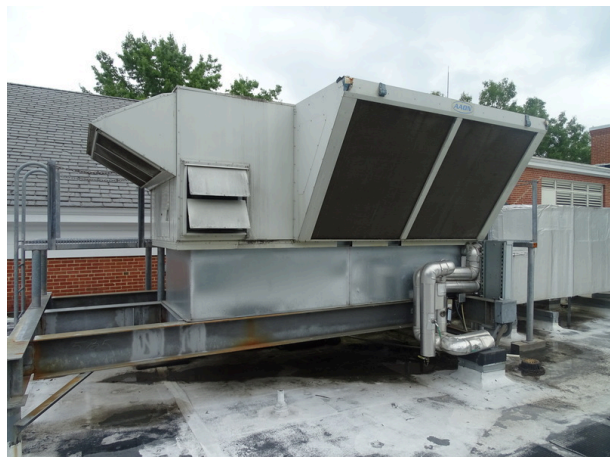
Typical Package Unit

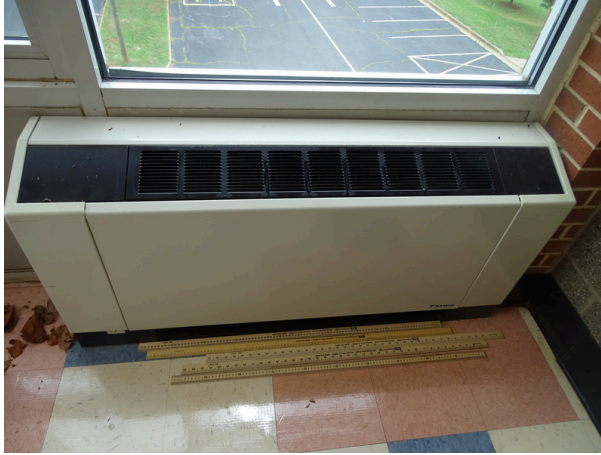
Typical Water Source Heat Pump

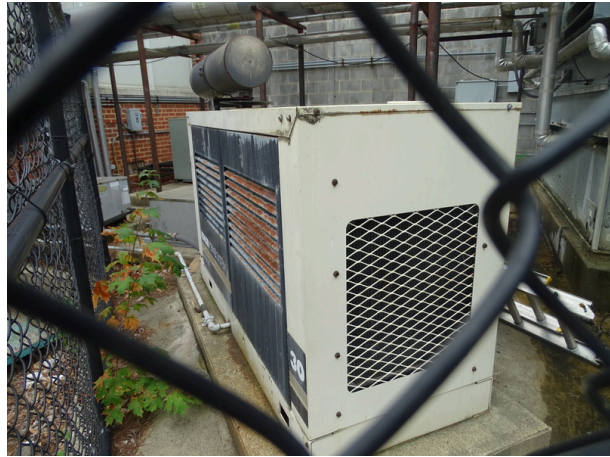
Emergency power generator

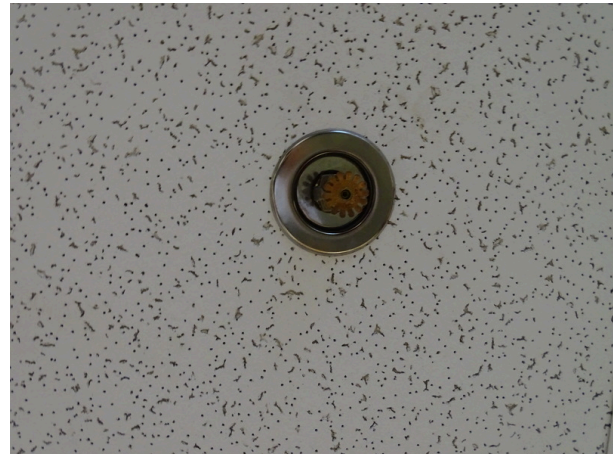
Typical fire sprinkler head

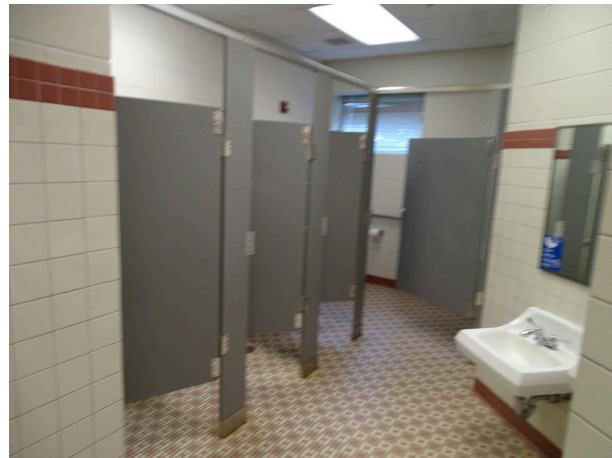
Restroom area interior finishes

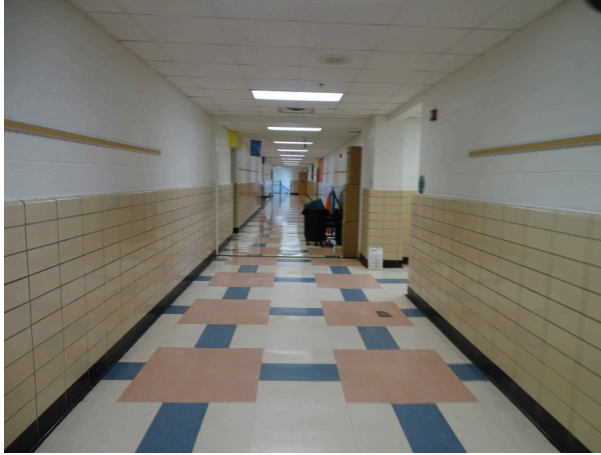
Typical corridor interior finishes

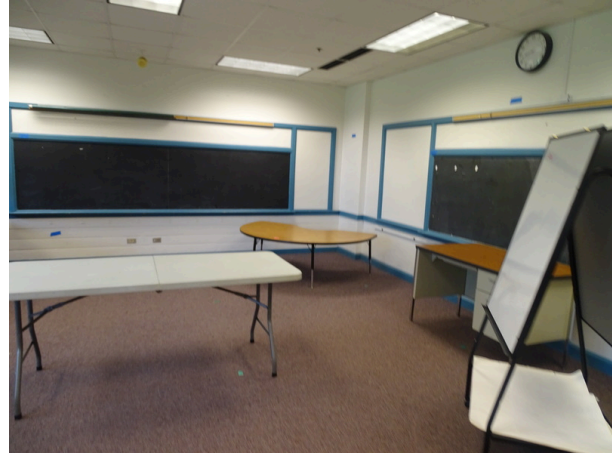
Typical classroom area interior finishes

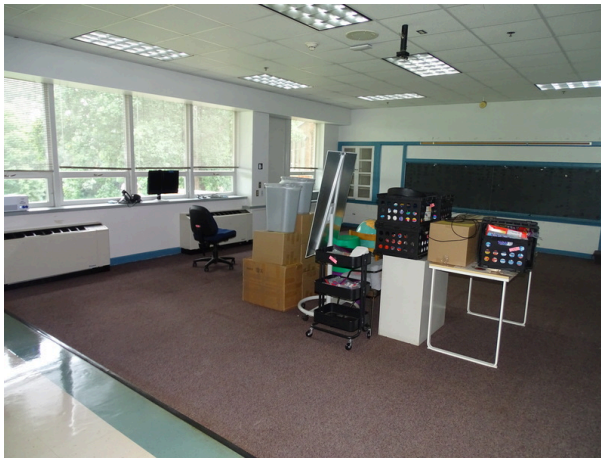
Typical classroom area interior finishes

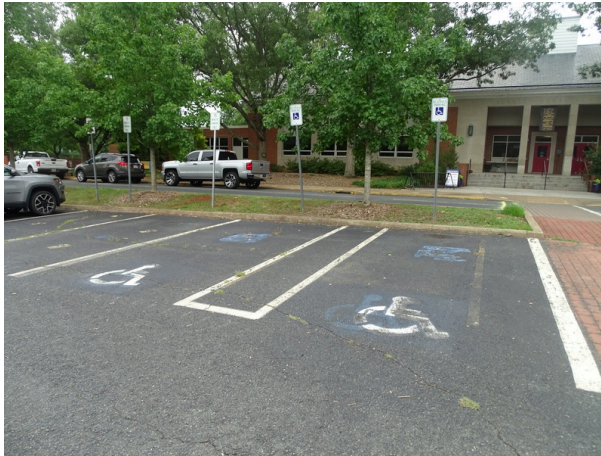
Accessible parking spaces

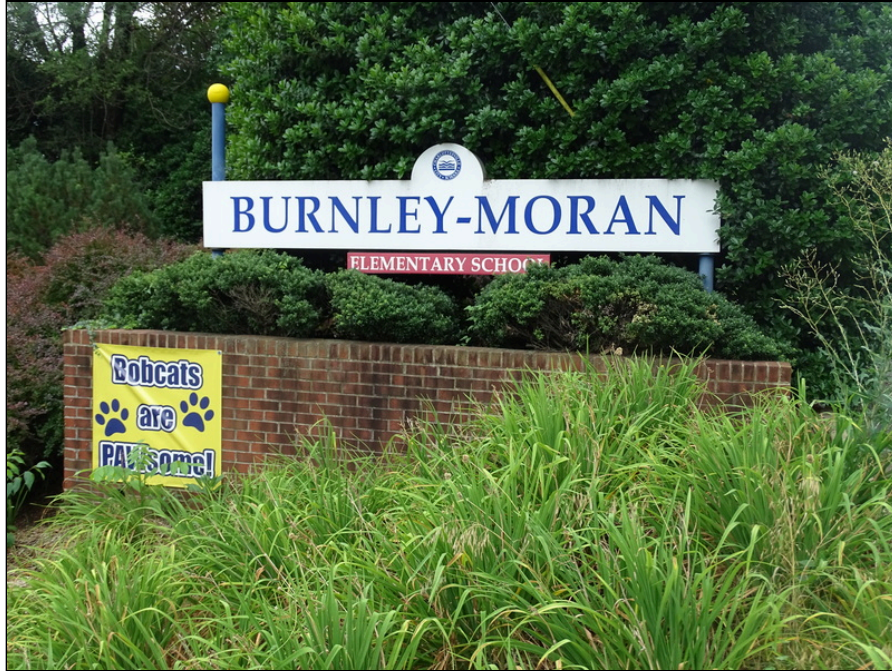
1 - Monument sign

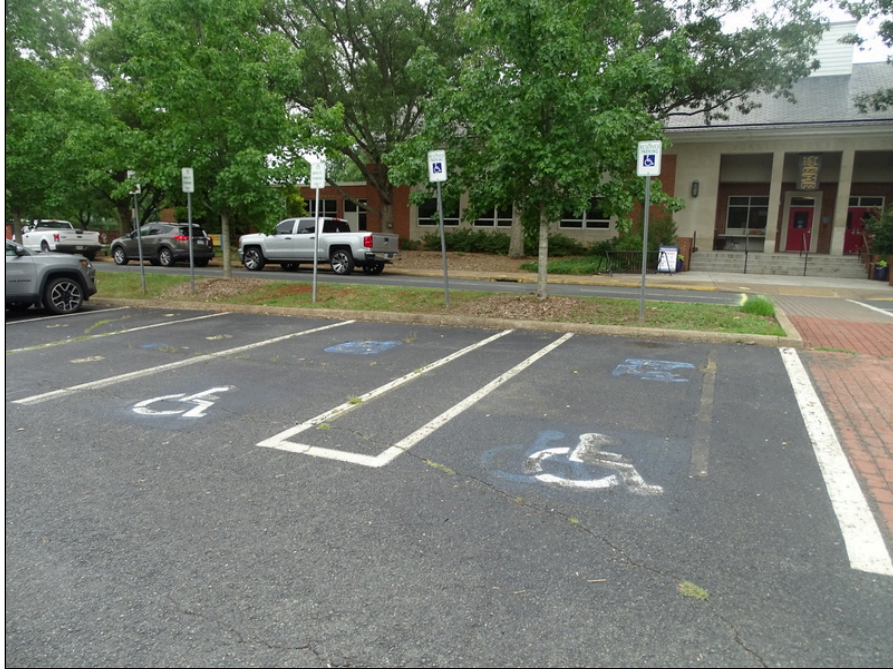
7 - Accessible Asphalt parking area at the center of the site

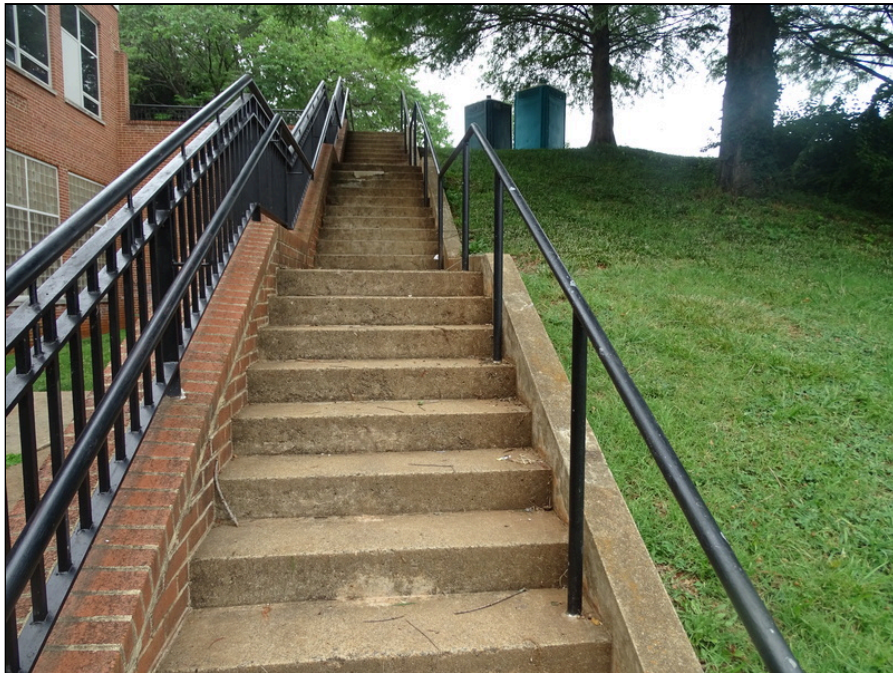
14 - Typical exterior concrete steps

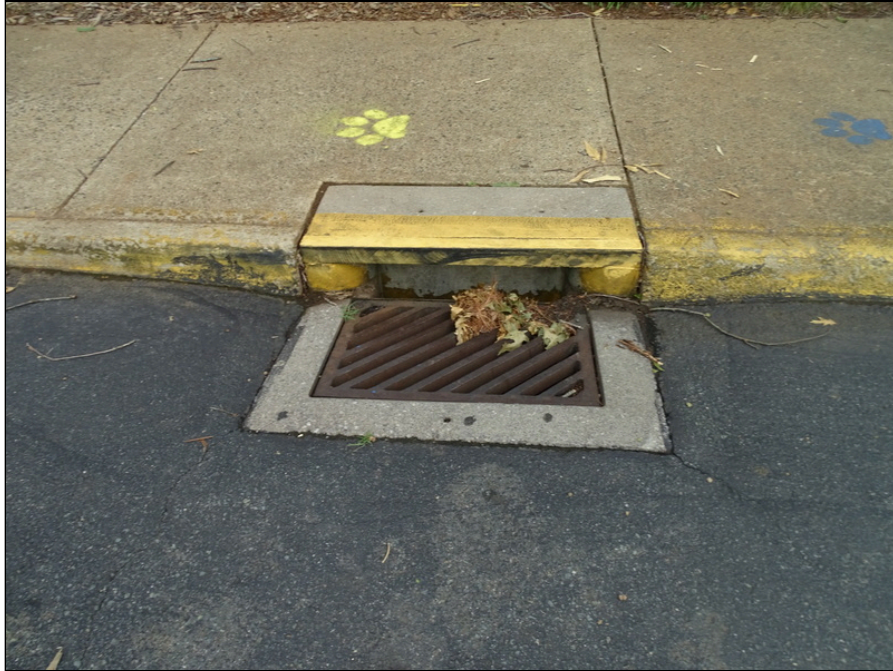
17 - Typical storm water drainage

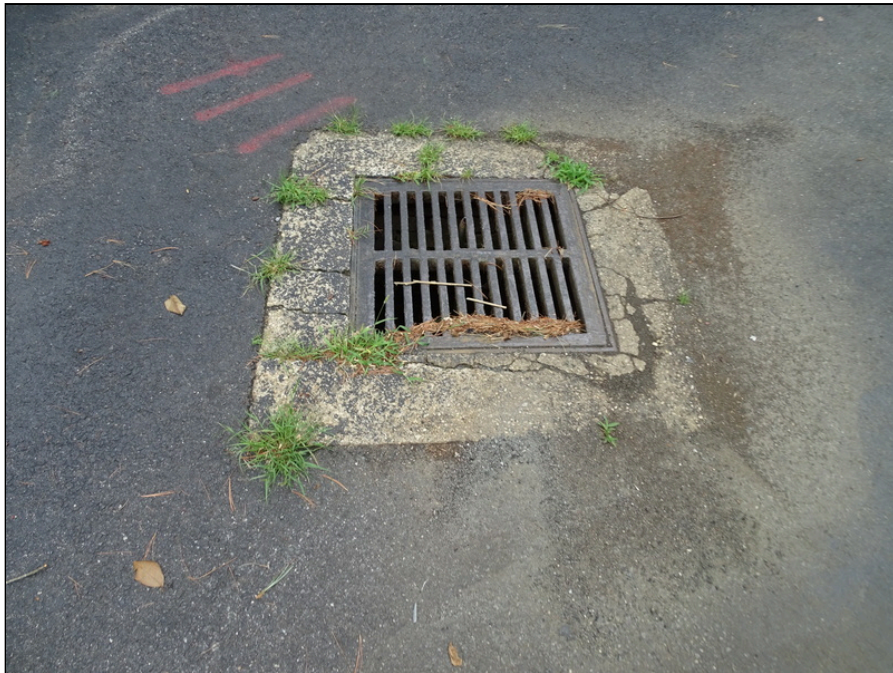
18 - Typical storm water drainage

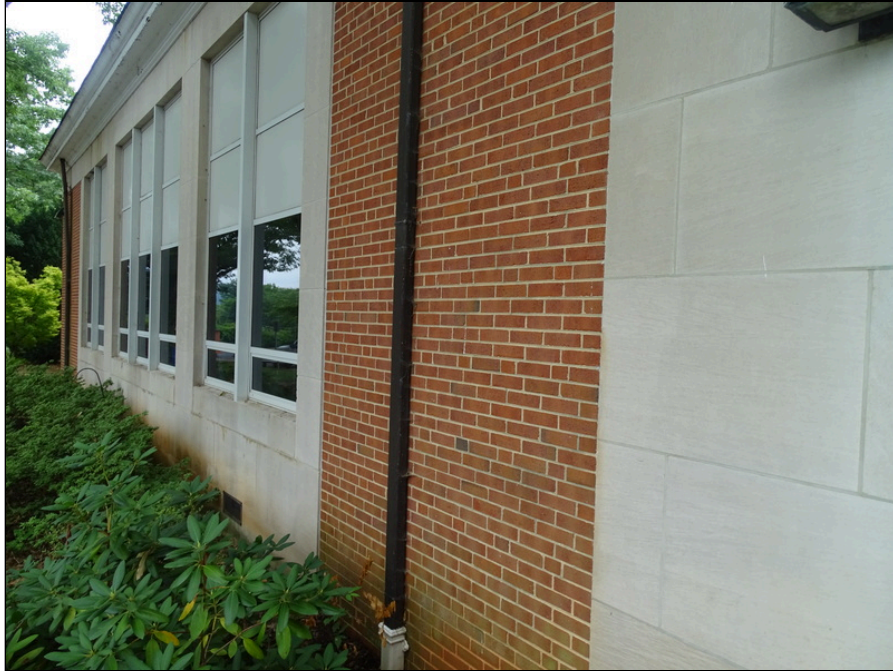
19 - Typical downspout

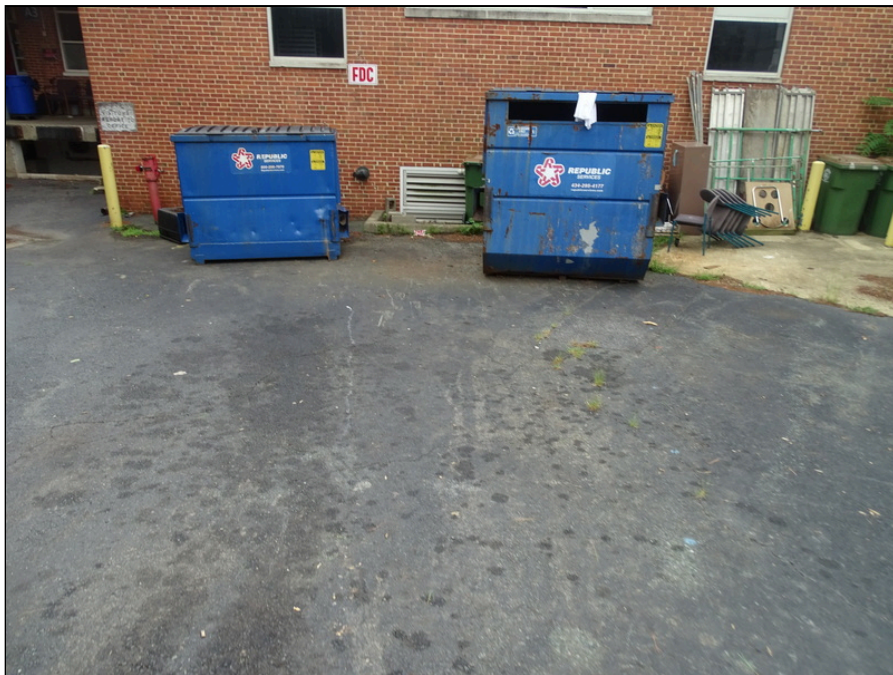
20 - Dumpster area at northwest side of the building

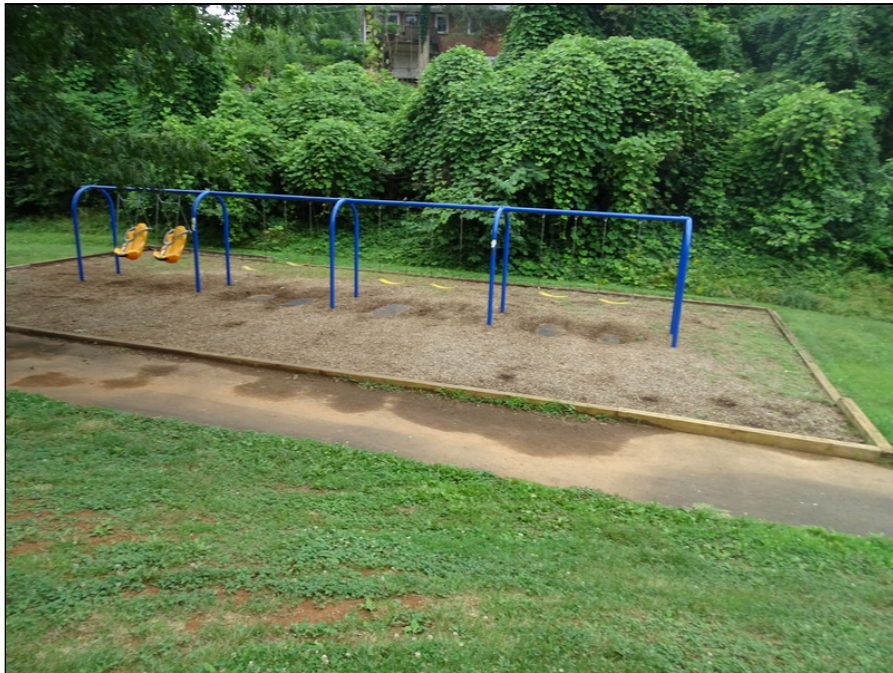
22 - Playground equipment at south end of site

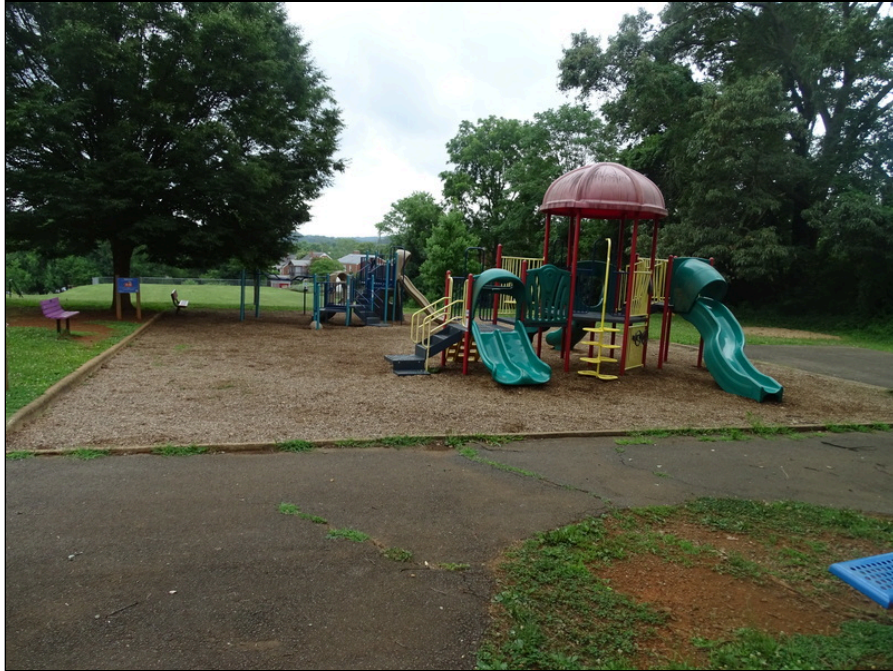
23 - Playground equipment at south end of site

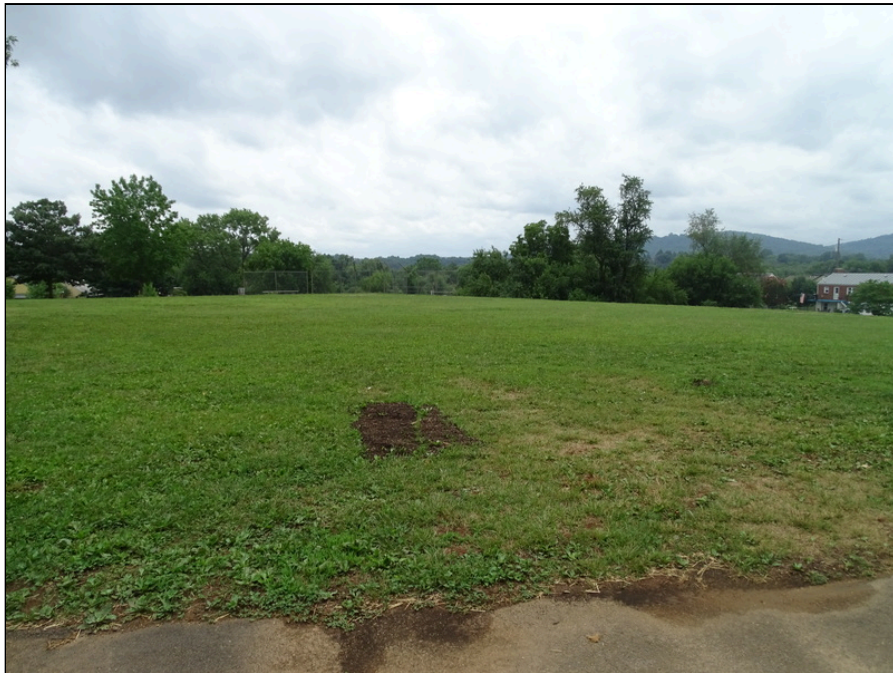
24 - Lawn area at west side of the building

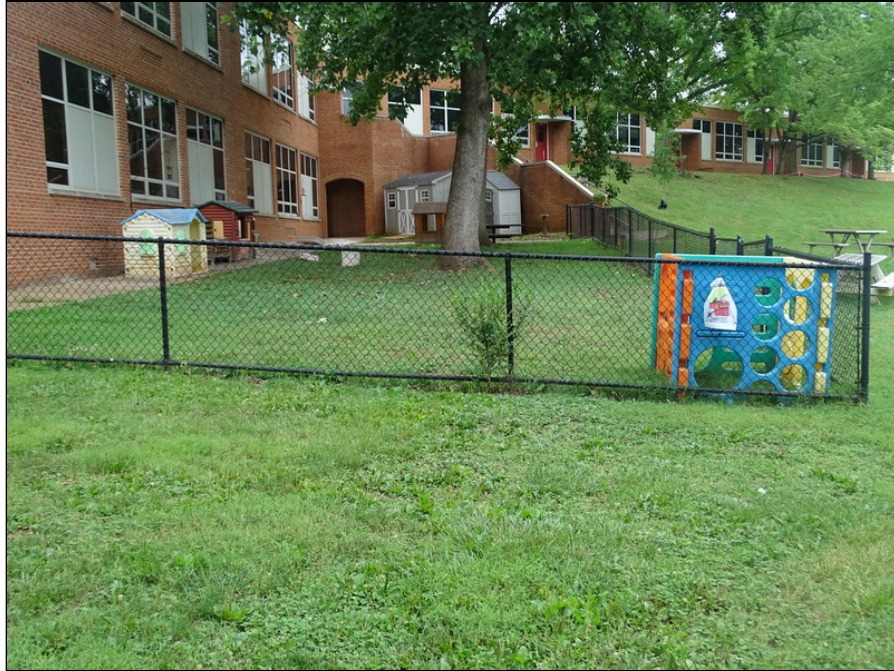
27 - Typical landscape overview

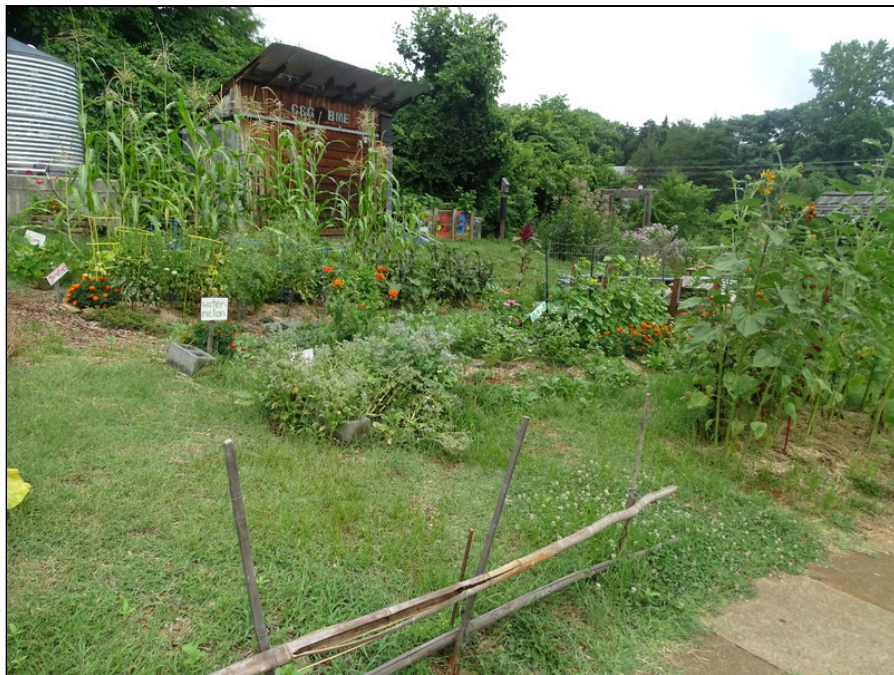
28 - Typical landscape overview

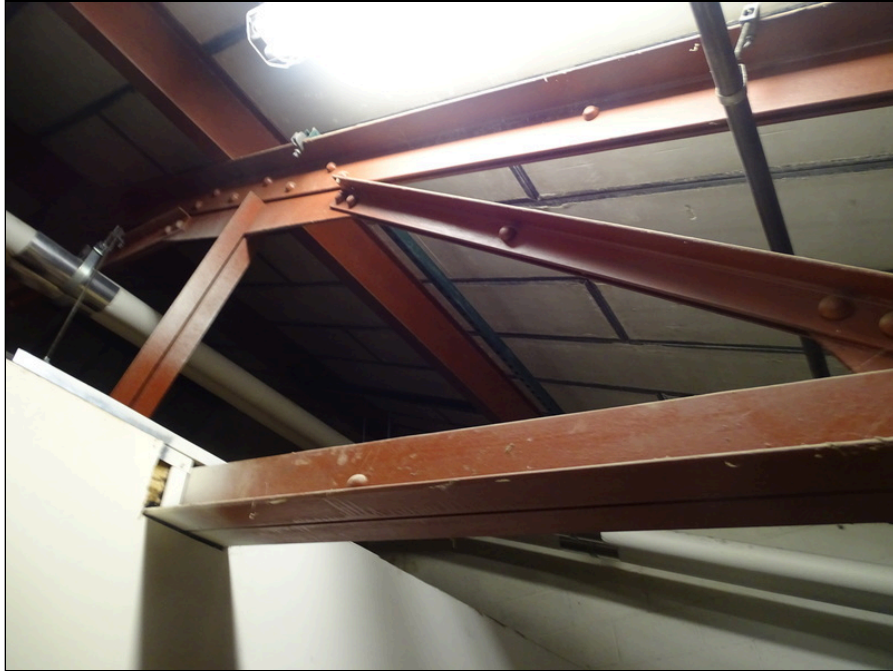
29 - Building framing

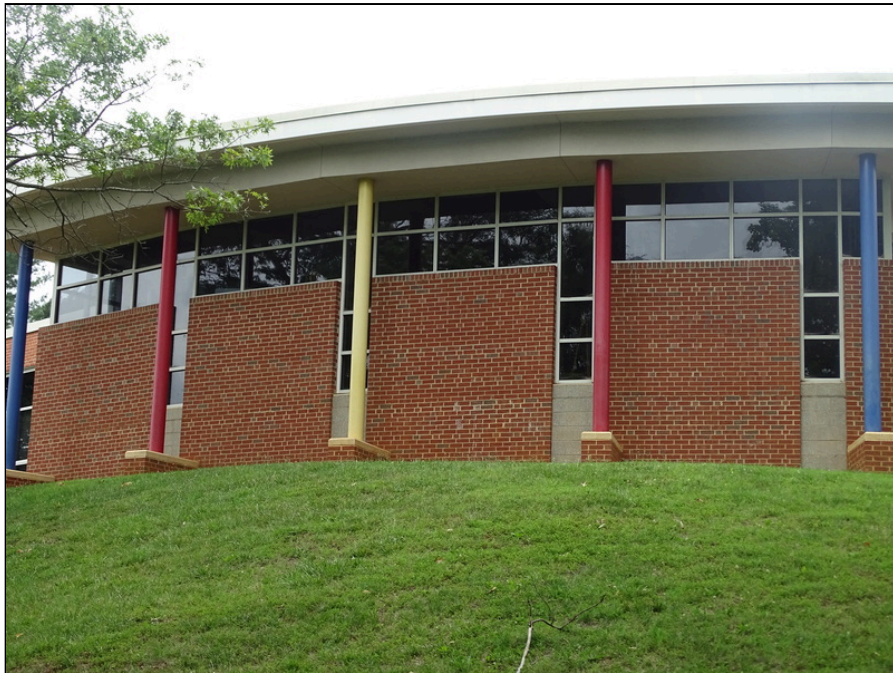
30 - Building exterior finishes

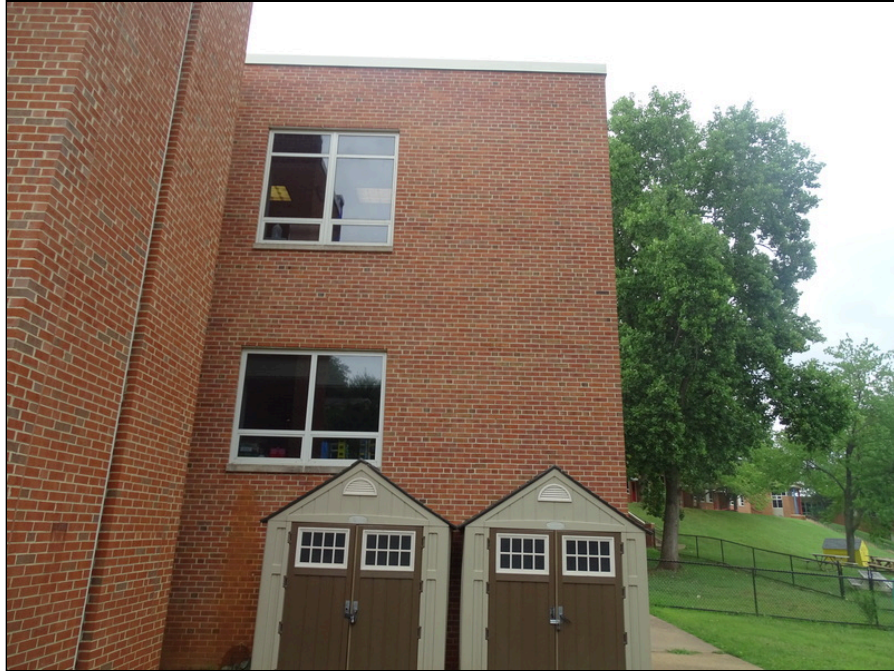
31 - Building exterior finishes

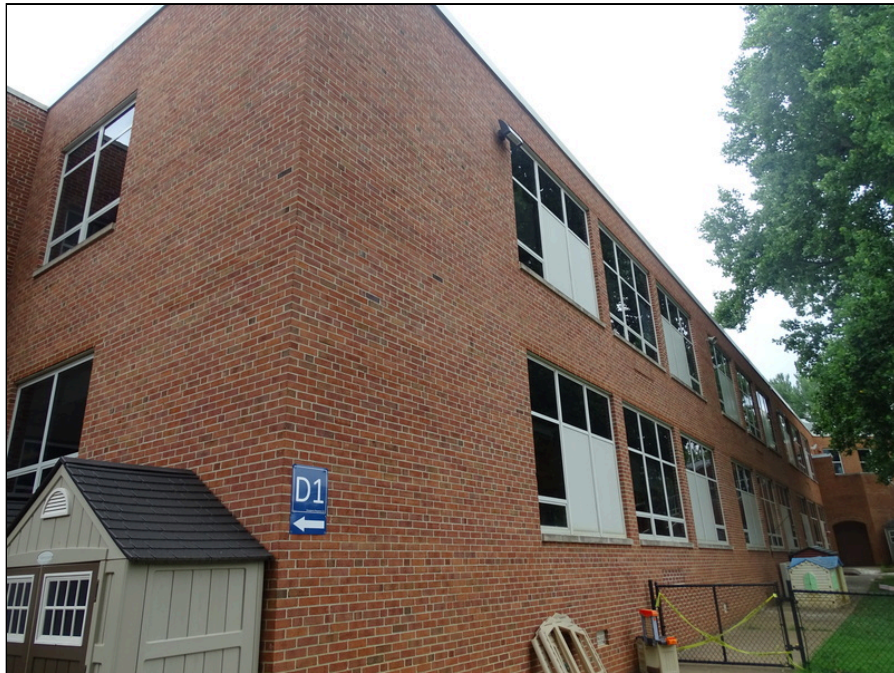
32 - Building exterior south side of the building

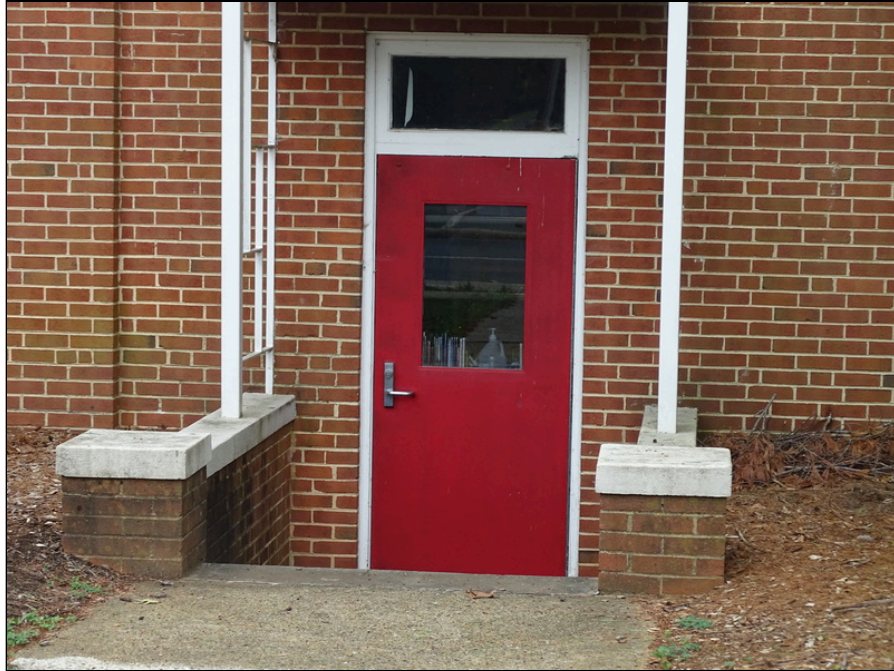
35 - Exterior door at east entrance

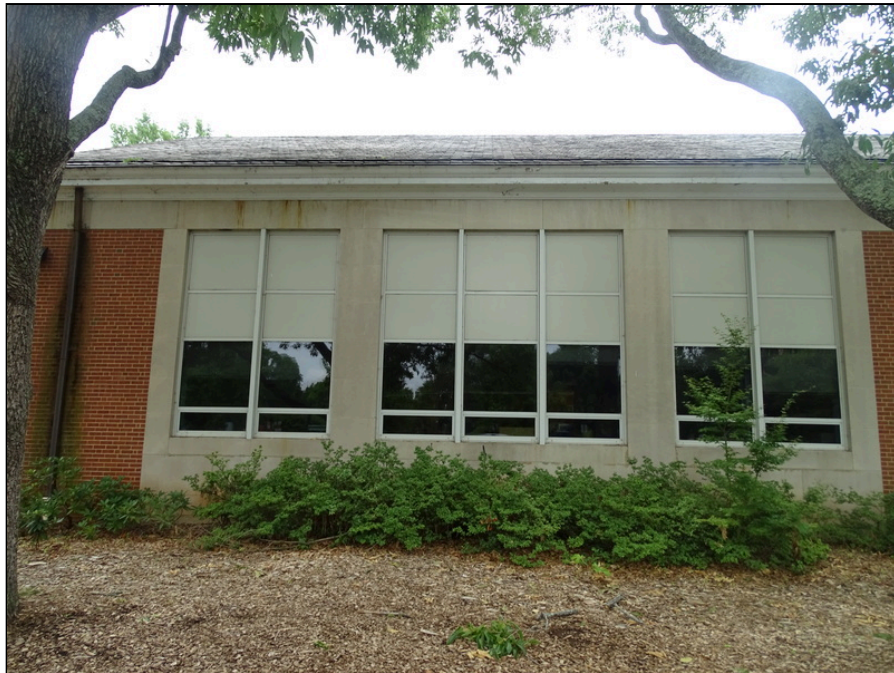
36 - Typical exterior windows

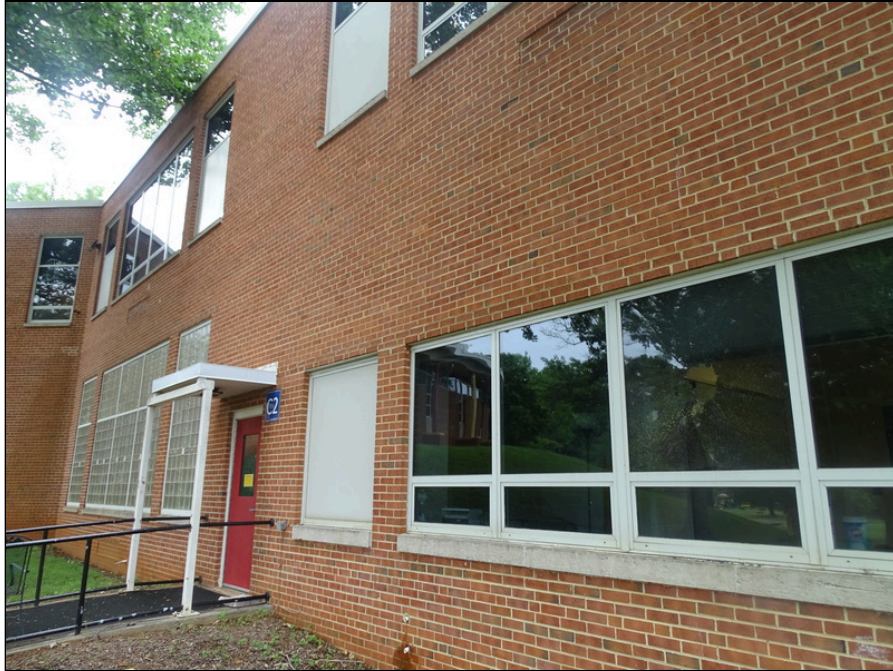
37 - Typical exterior windows

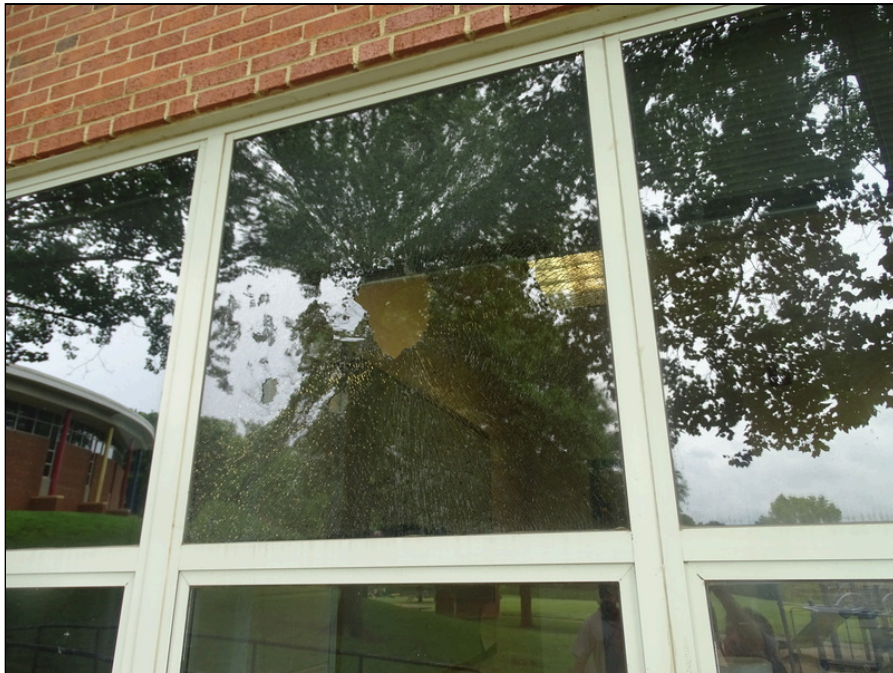
38 - Typical exterior windows

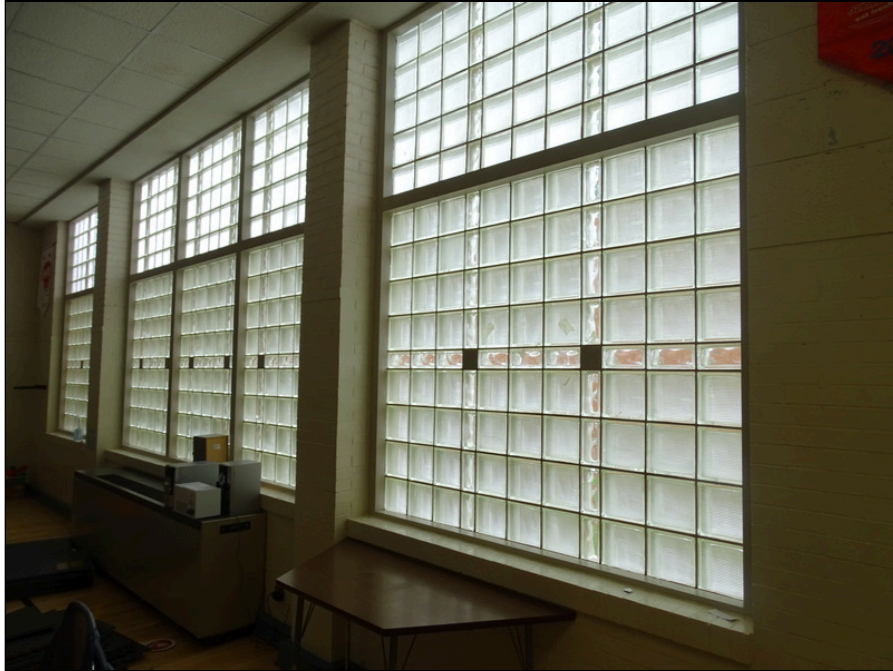
39 - Typical exterior windows

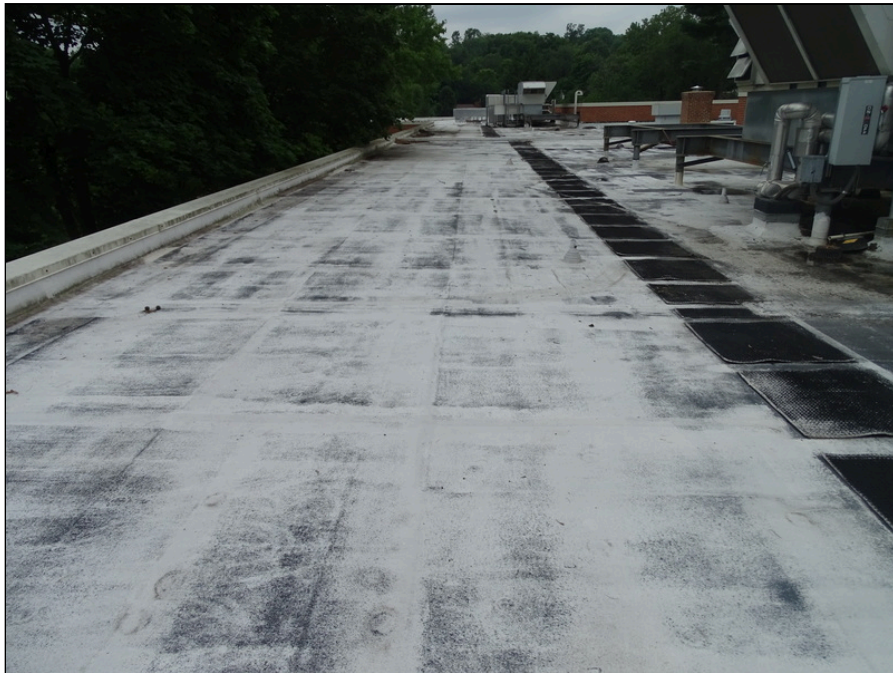
42 - Single-ply membrane roofing system

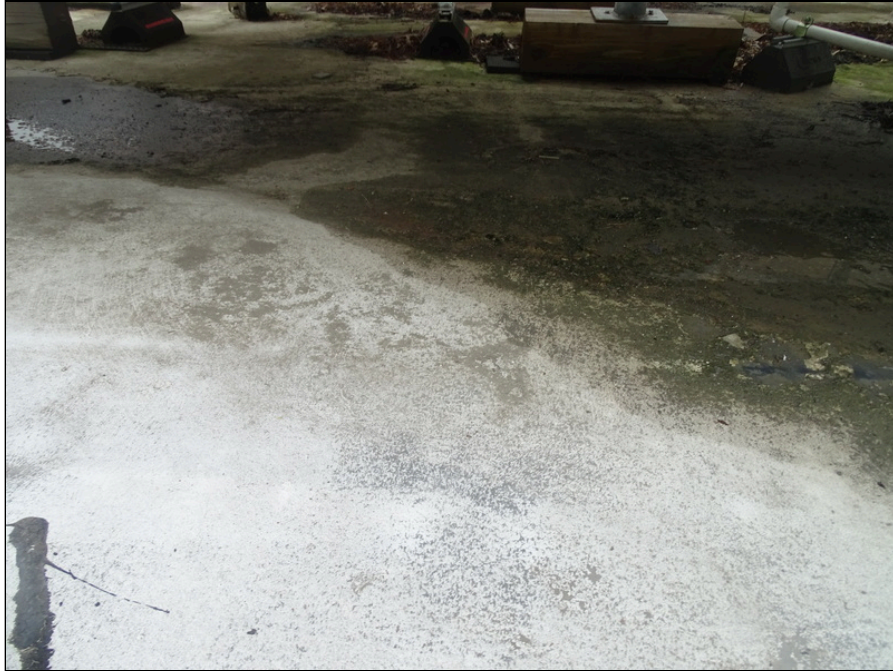
43 - Single-ply membrane roofing system - note ponding

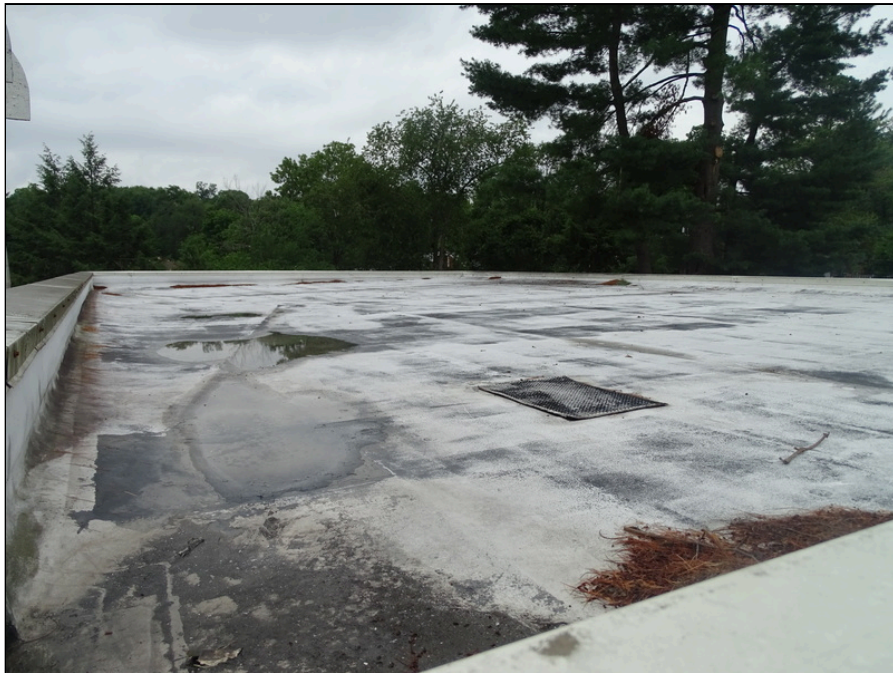
44 - Single-ply membrane roofing system - note ponding

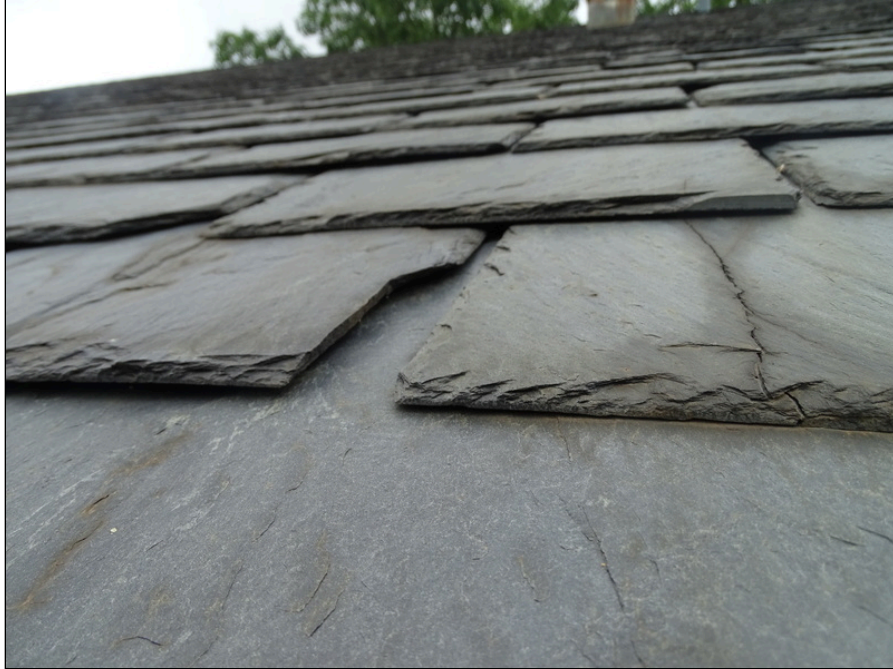
45 - Slate shingle roofing system

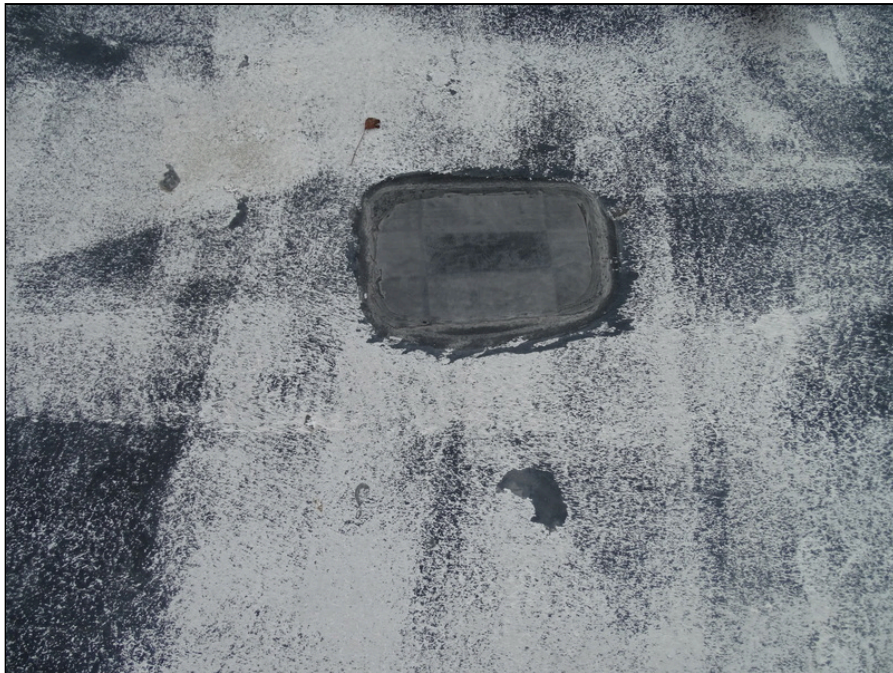
46 - Typical roof patch

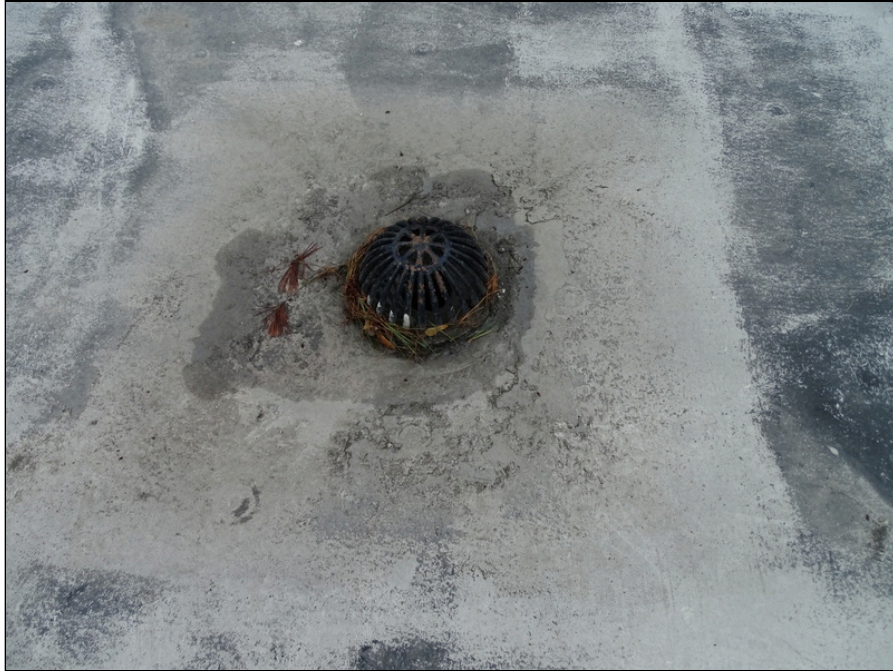
47 - Internal roof drain - note debris needing routine maintenance
