BURNLEY MORAN ELEMENTARY SCHOOL  
1300 LONG STREET  
CHARLOTTESVILLE, VIRGINIA

ECS PROJECT NO. 46:6713

CITY OF CHARLOTTESVILLE - FACILITIES DEVELOPMENT

Reference: Facility Condition Assessment Report for Burnley Moran Elementary School, 1300 Long Street, Charlottesville, Virginia

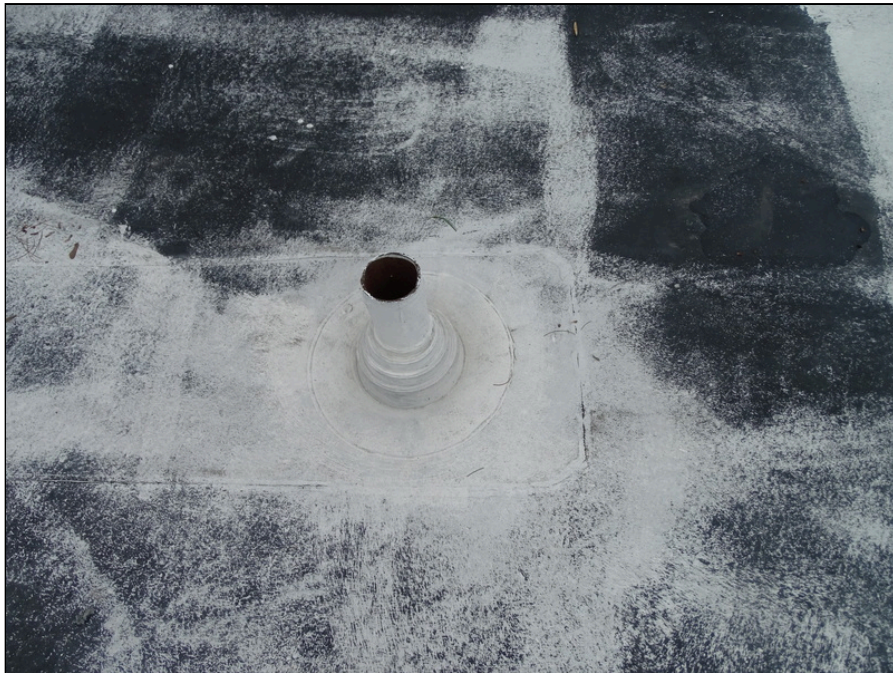
48 - Typical plumbing penetration

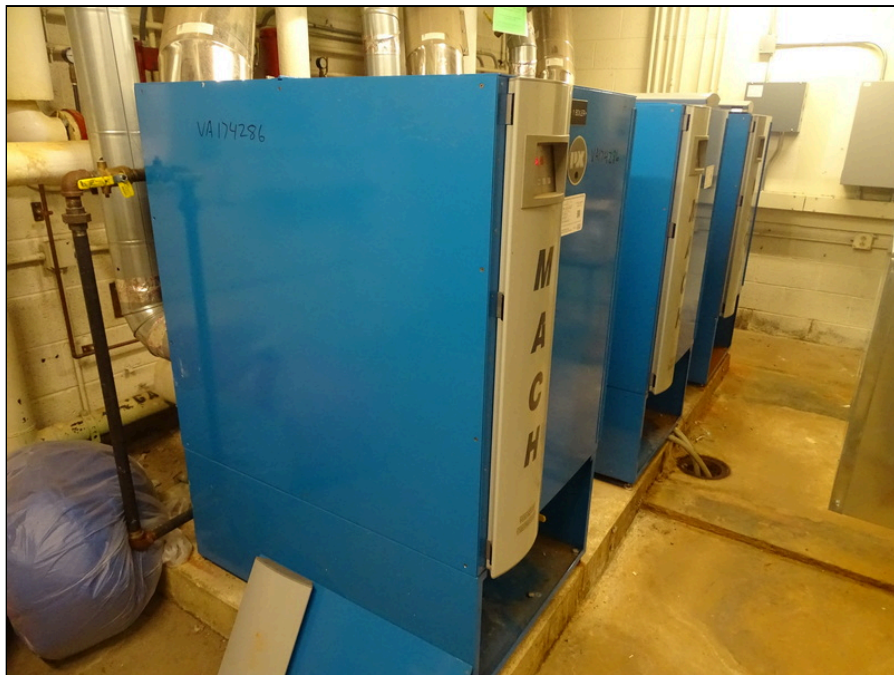
56 - Boilers located in mechanical room

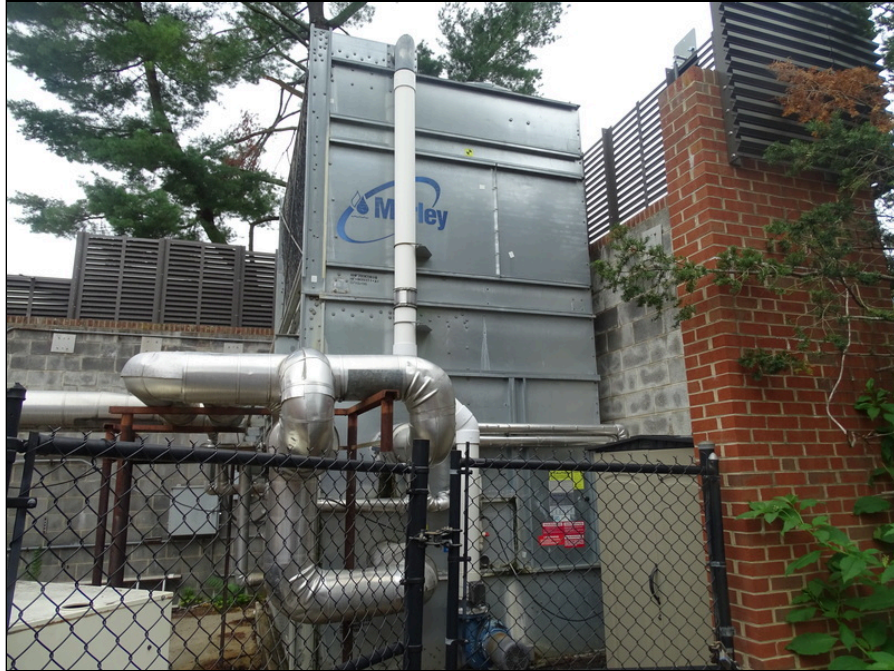
57 - Cooling Tower at north side of the building

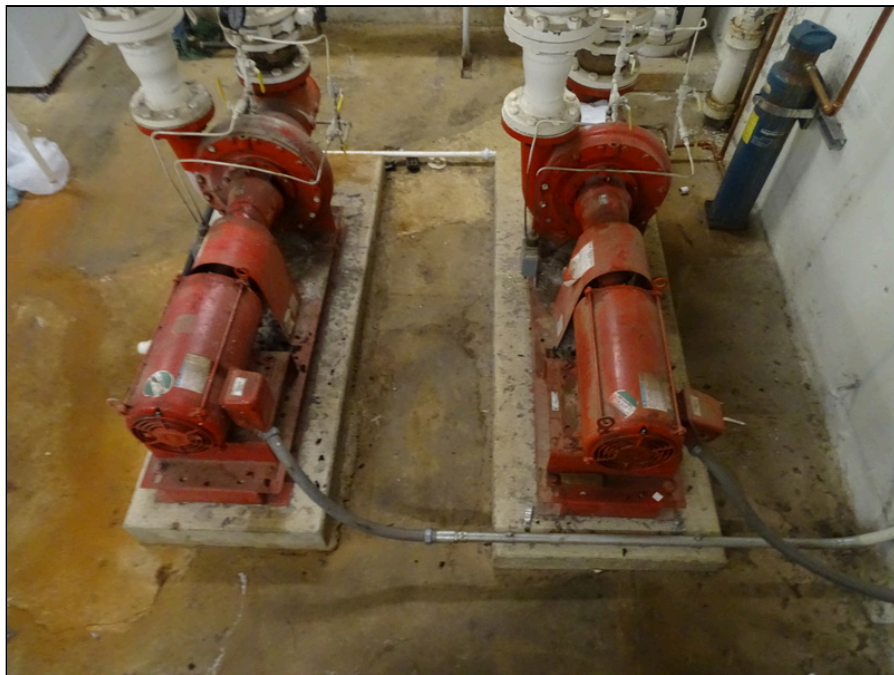
58 - Central plant pumps located in mechanical room

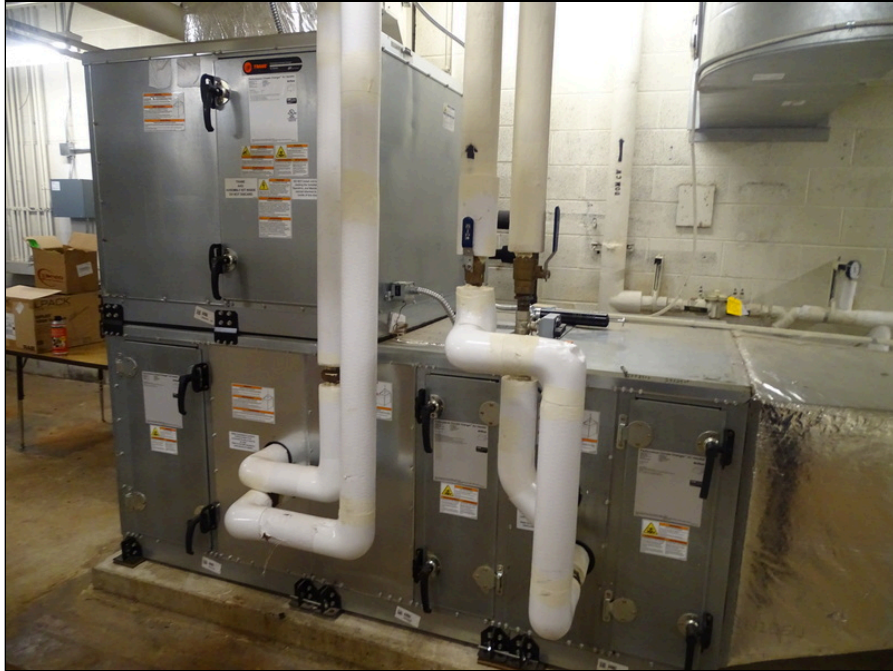
59 - Air Handler Unit in mechanical room

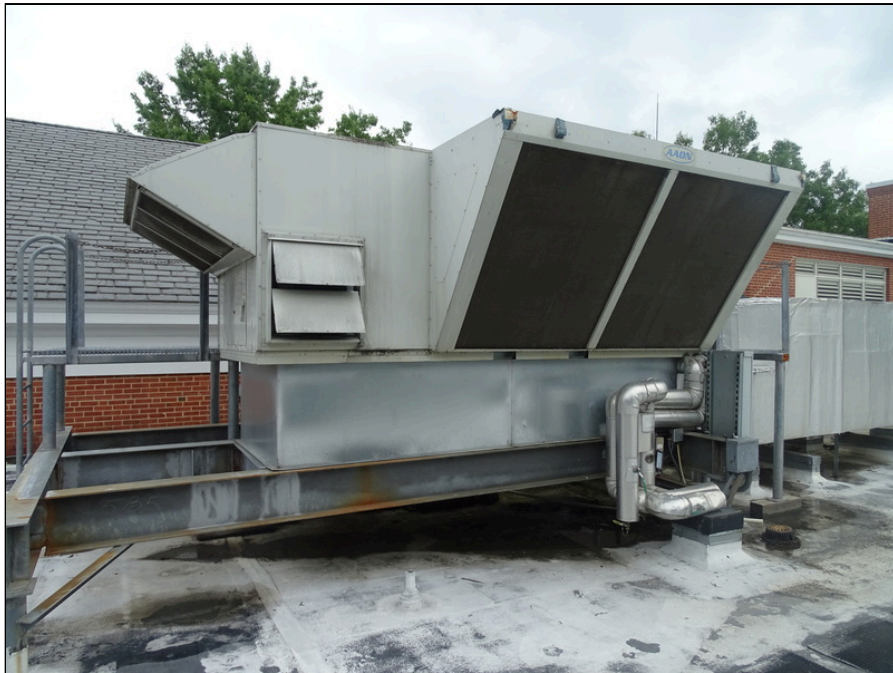
60 - Typical Package Unit

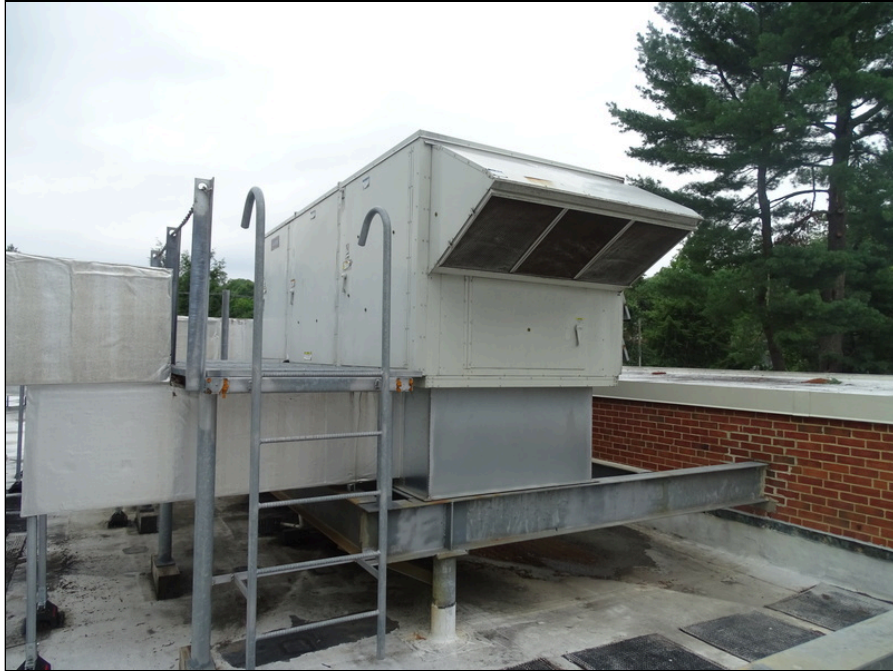
61 - Typical Package Unit

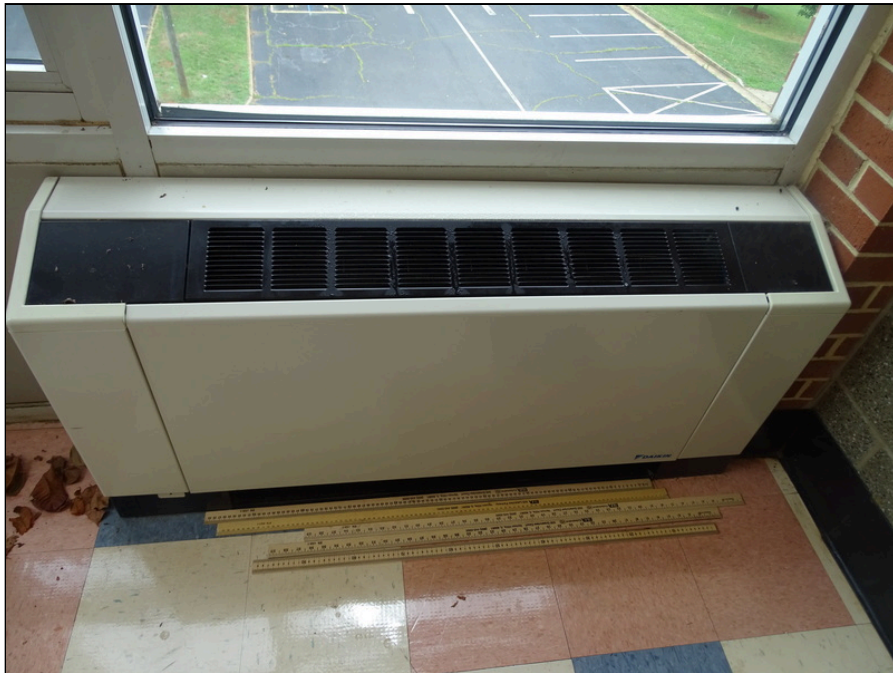
62 - Typical Water Source Heat Pump

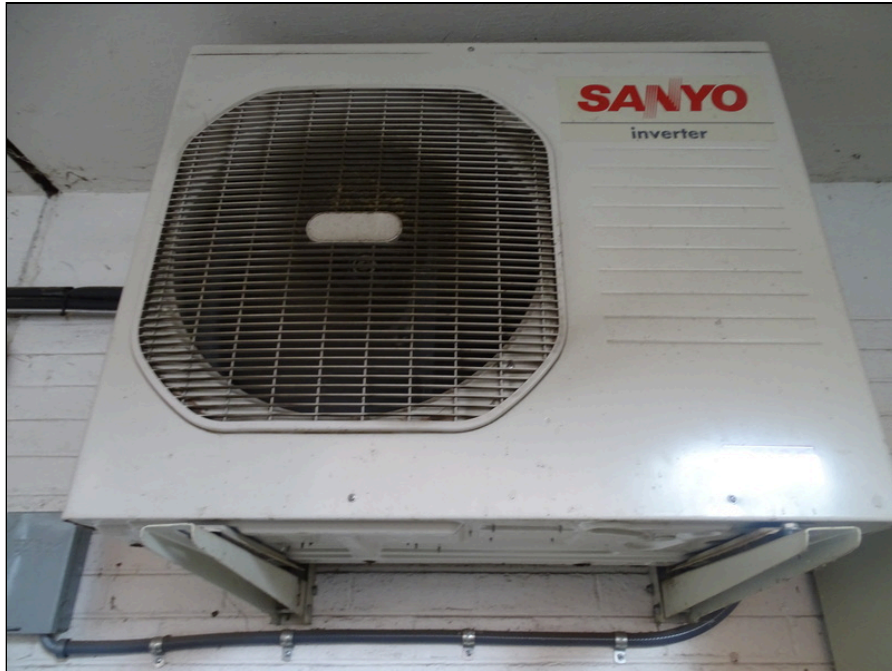
63 - Split system

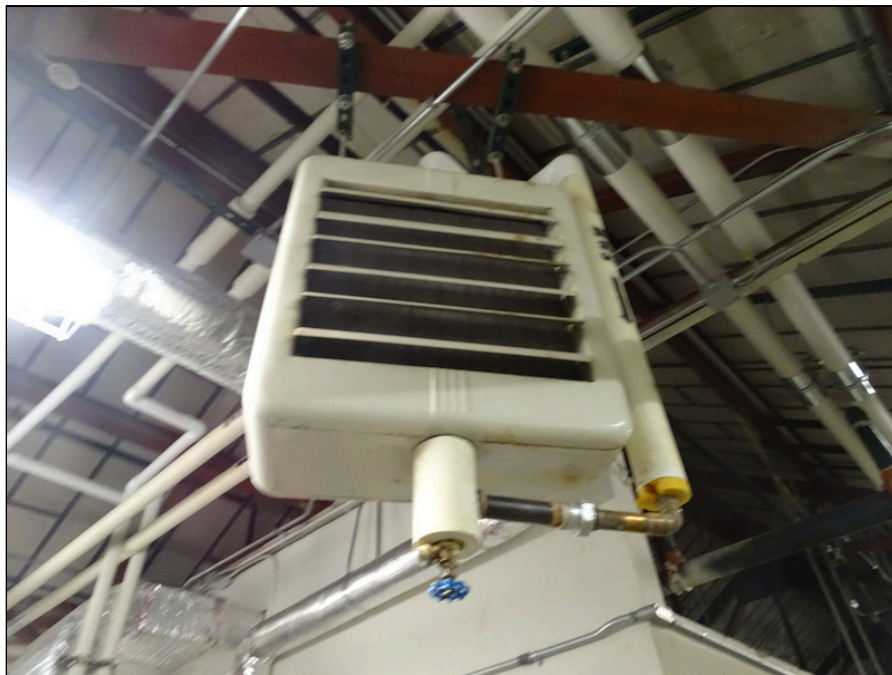
64 - Typical space heater

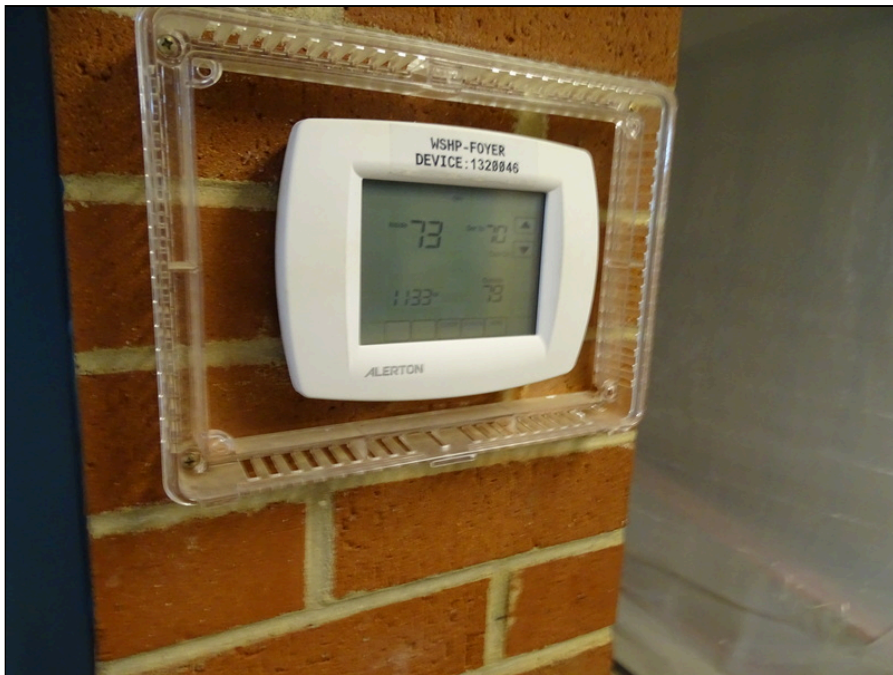
66 - Typical digital thermostat8333

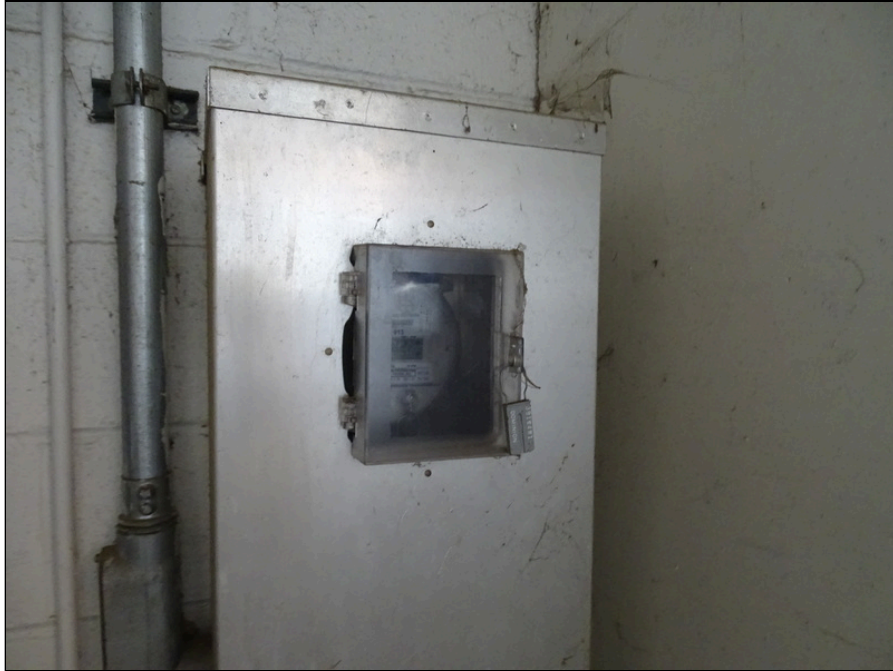
67 - Main electrical meter

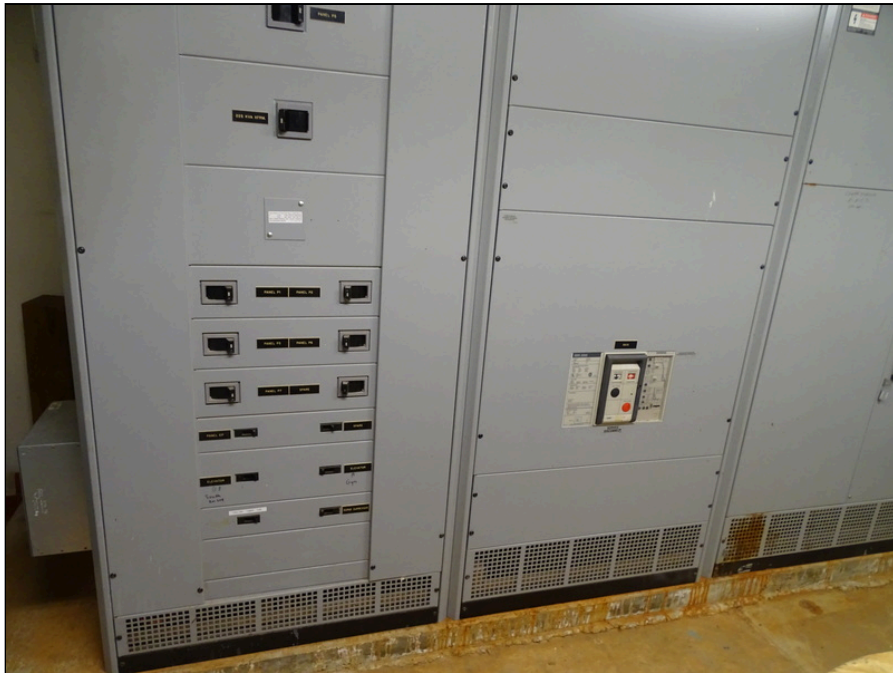
68 - Main electrical switchgear

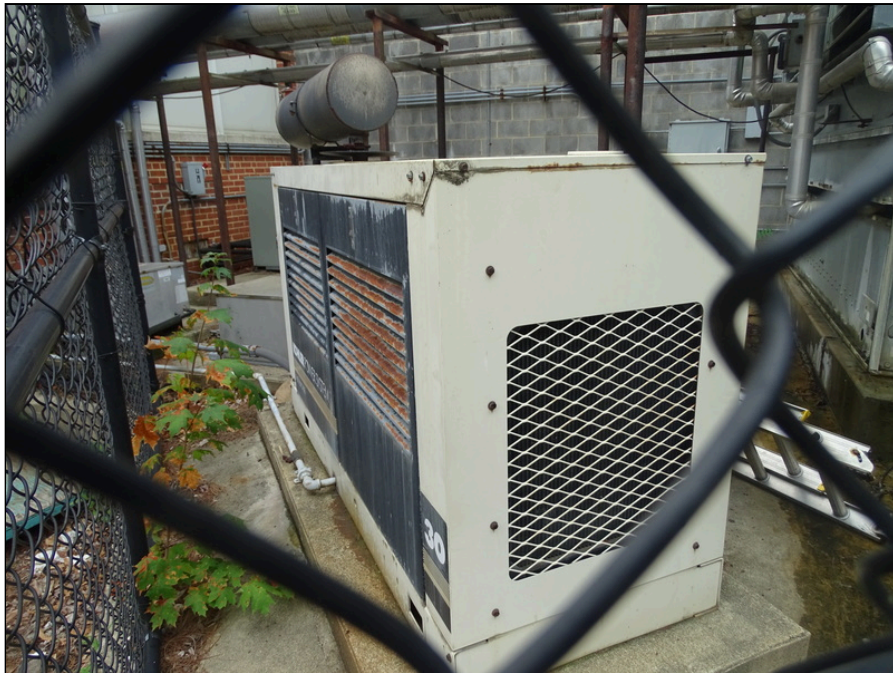
70 - Emergency power generator

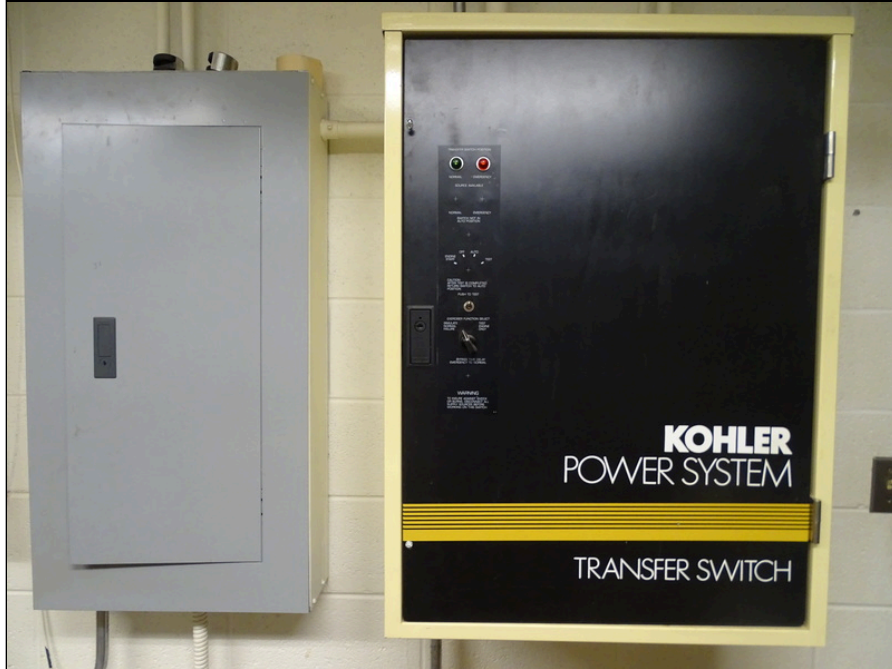
71 - Emergency power transfer switch

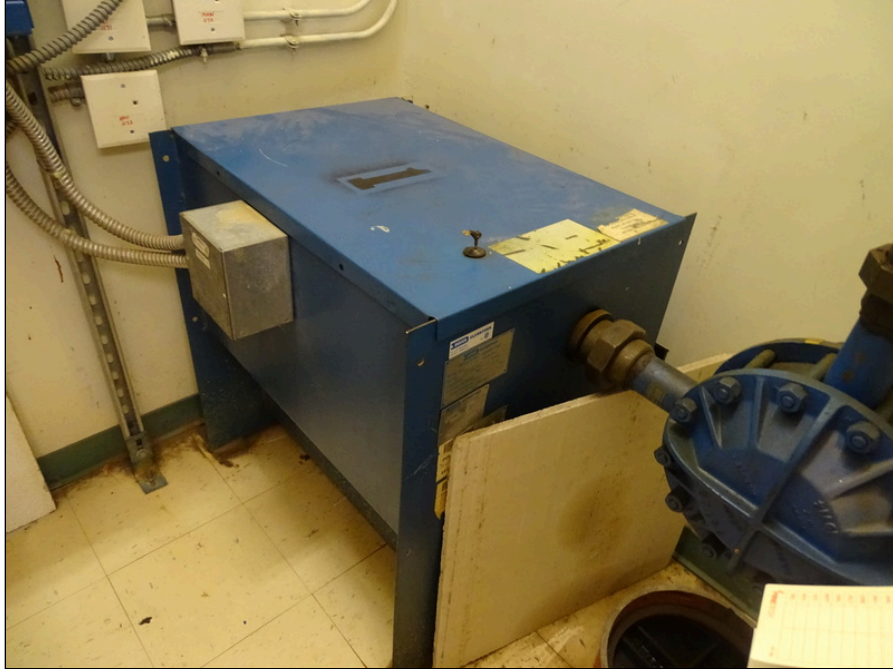
73 - Typical elevator machine and controls

1.6 Repair elevator phone for two way communication.

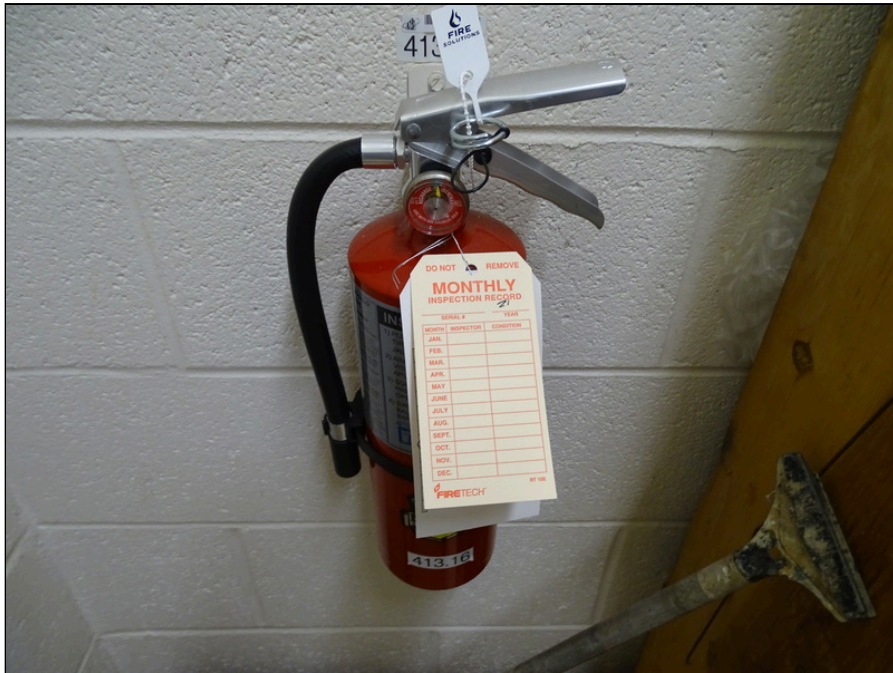
74 - Typical fire extinguisher

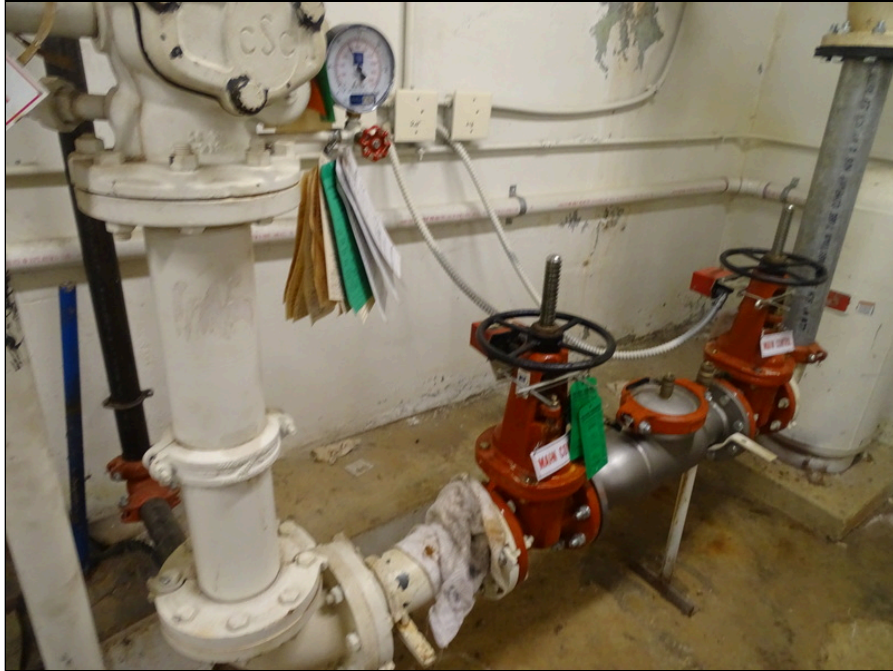
75 - Fire sprinkler system

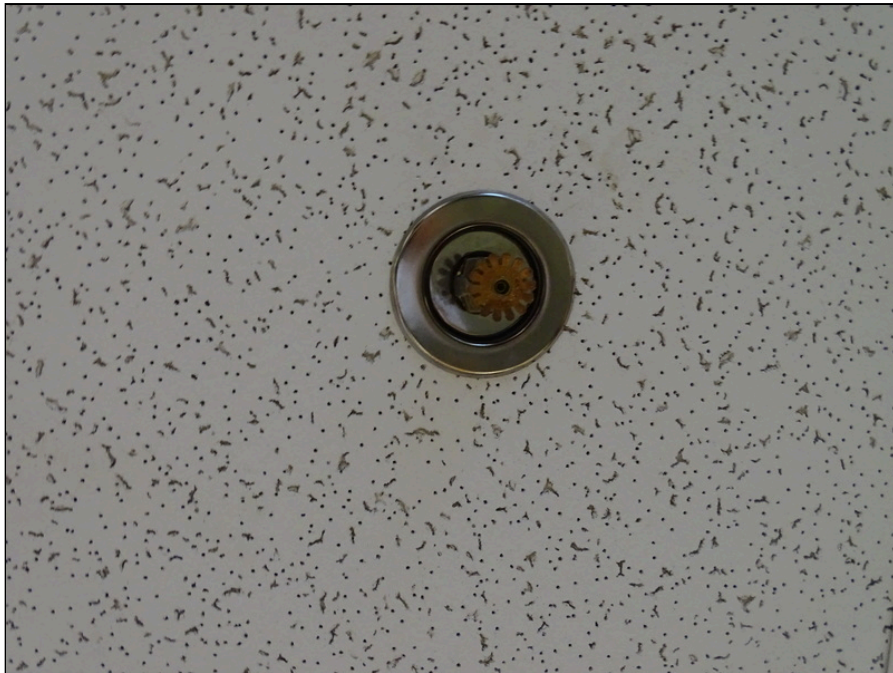
76 - Typical fire sprinkler head

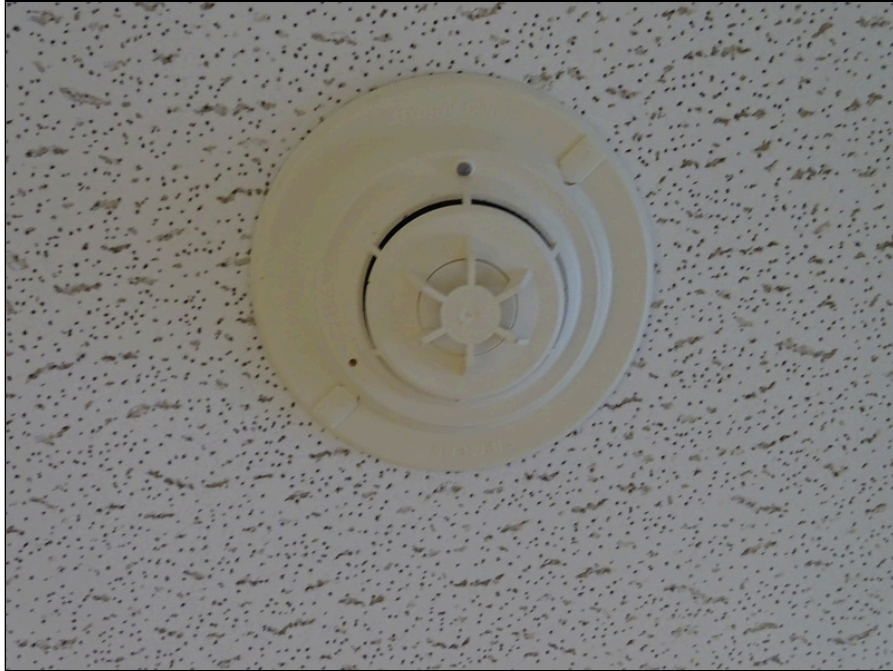
77 - Typical smoke detector

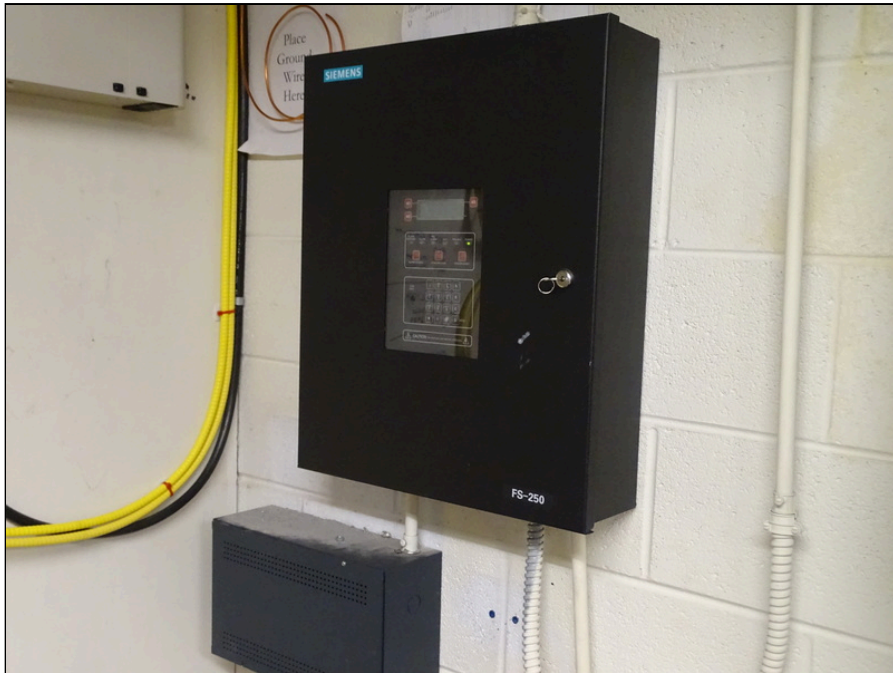
78 - Fire alarm controls

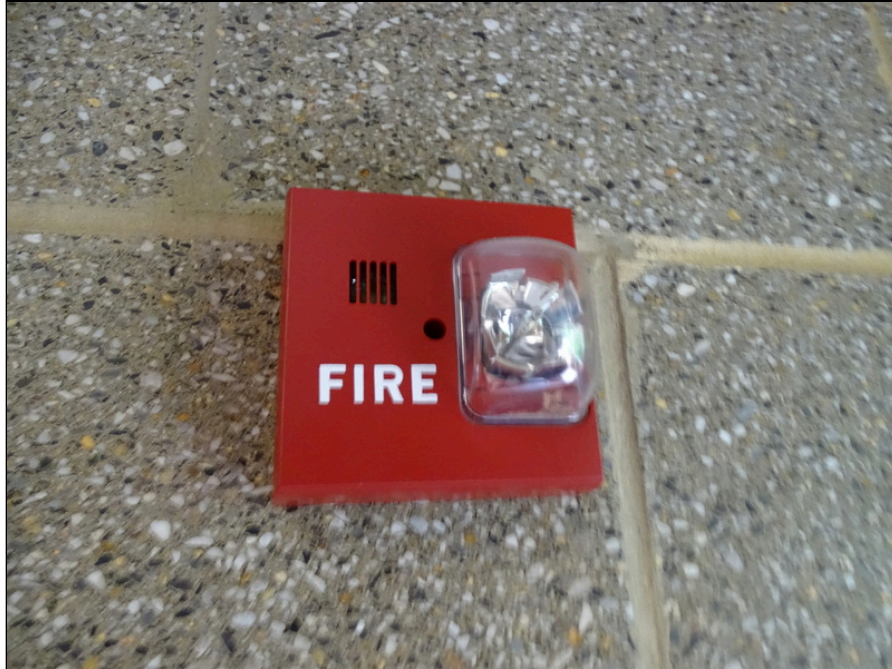
79 - Fire alarm strobe and bell

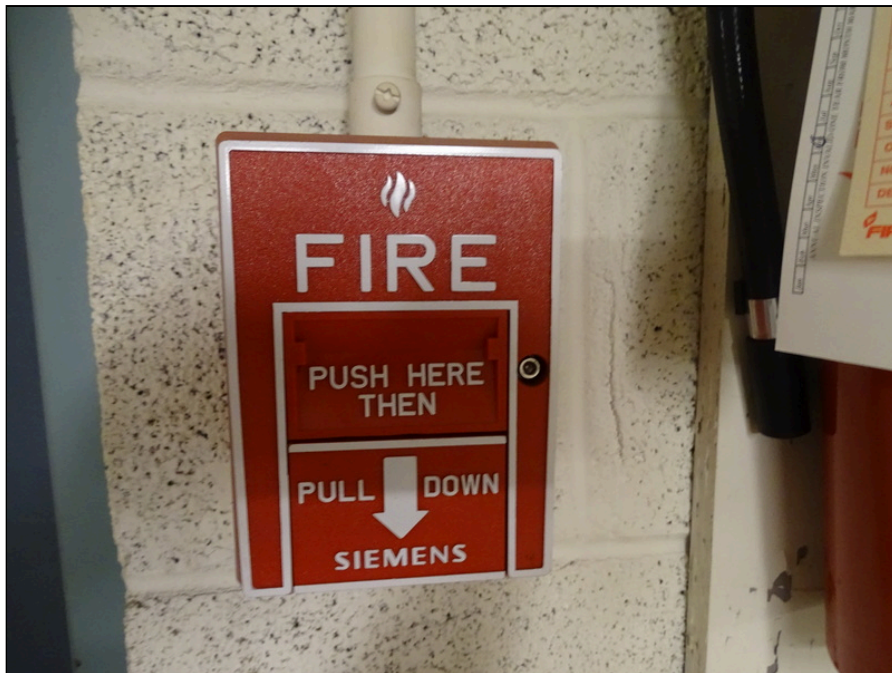
80 - Typical pul down station

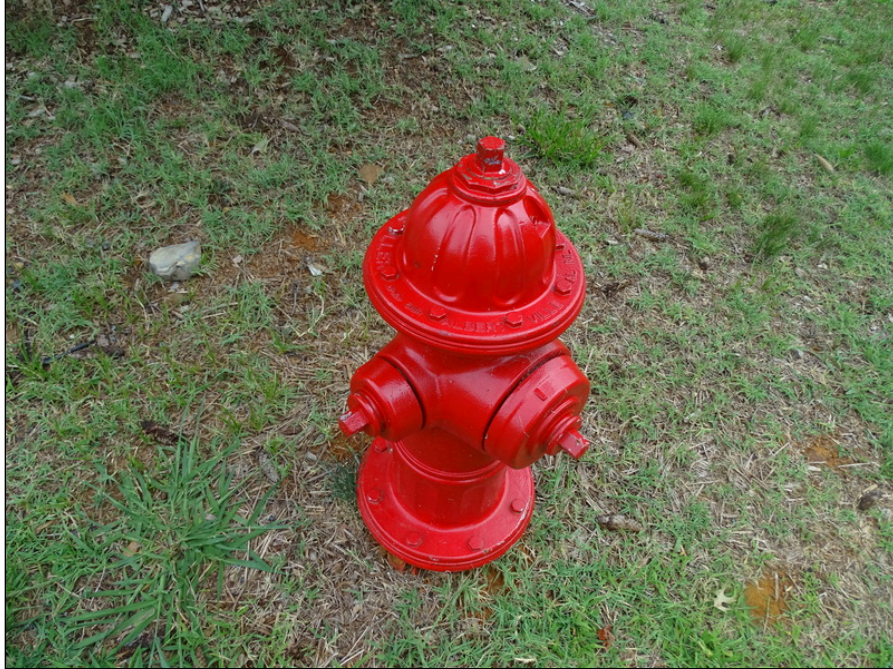
81 - Typical fire hydrant

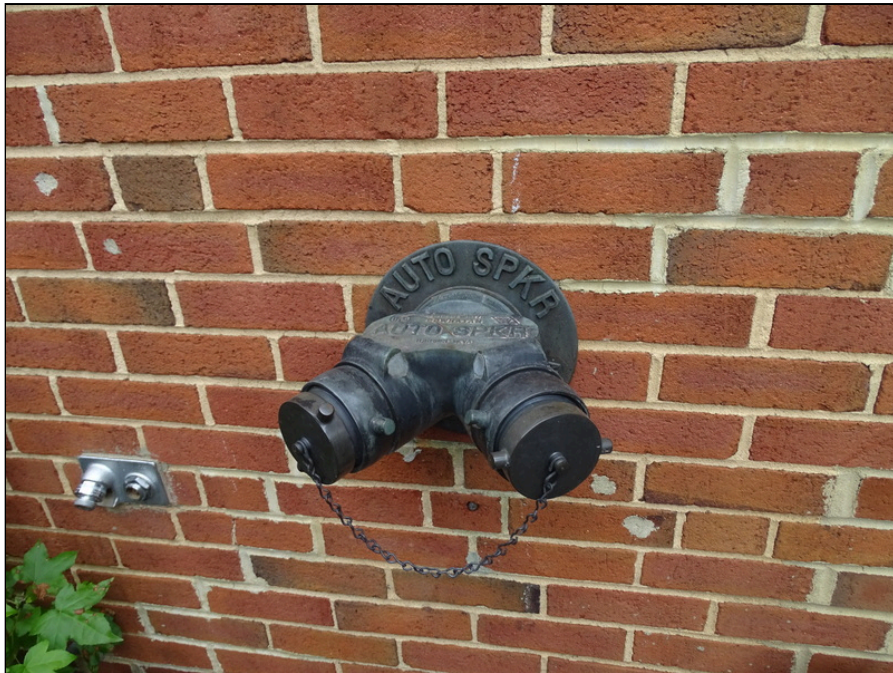
82 - Fire Department connection

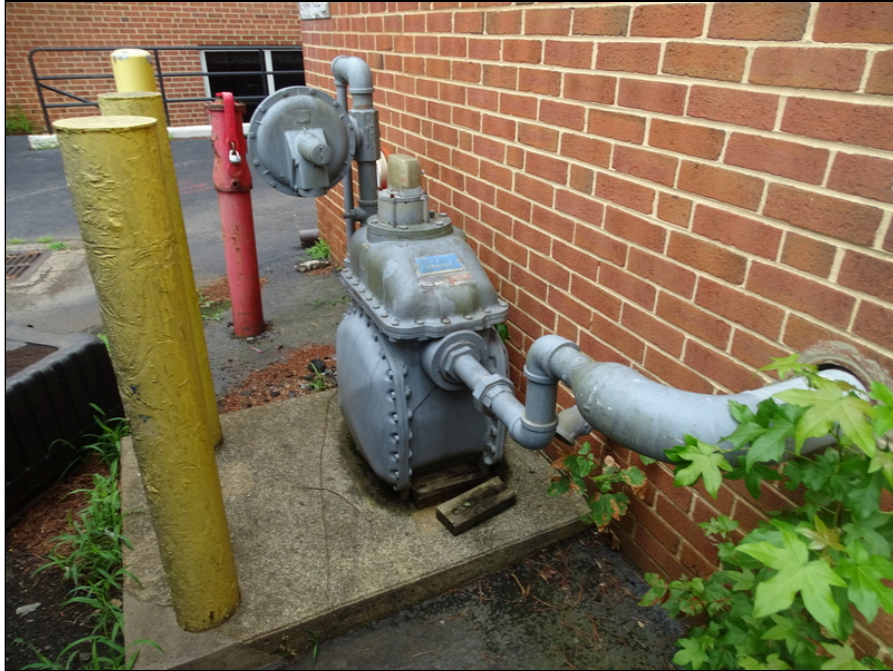
83 - Typical gas meter

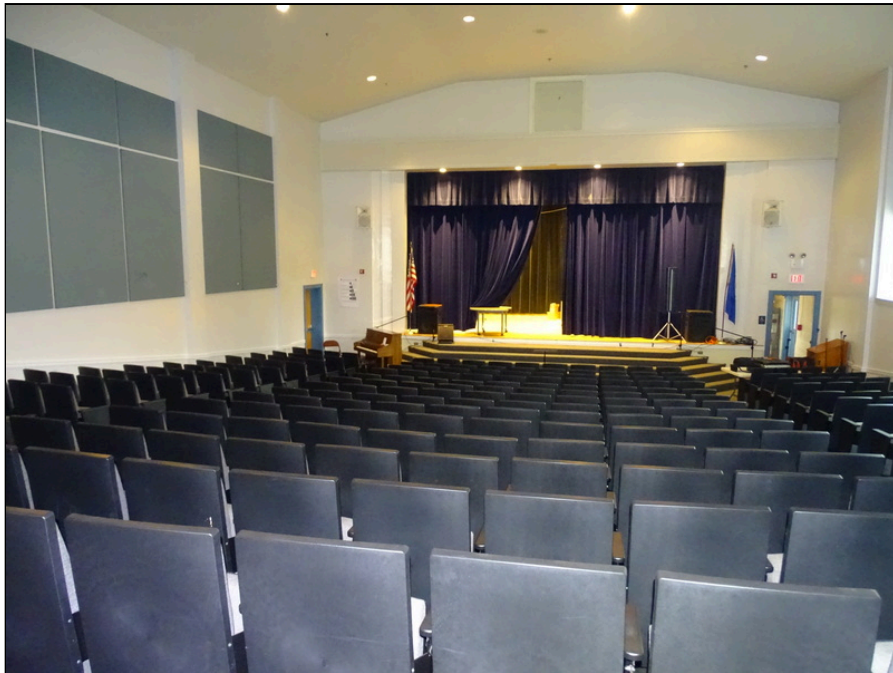
84 - Auditorium area interior finishes

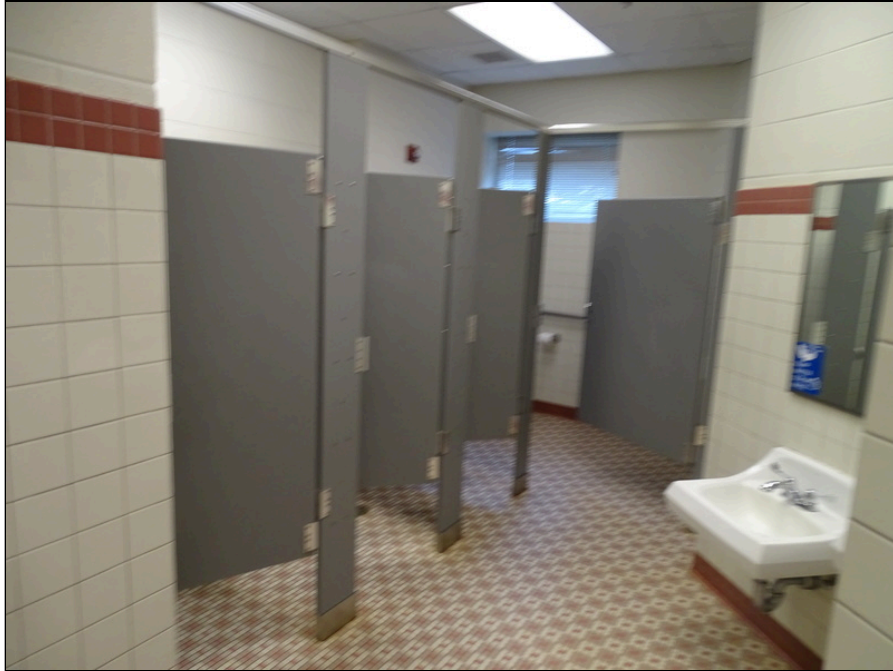
85 - Restroom area interior finishes

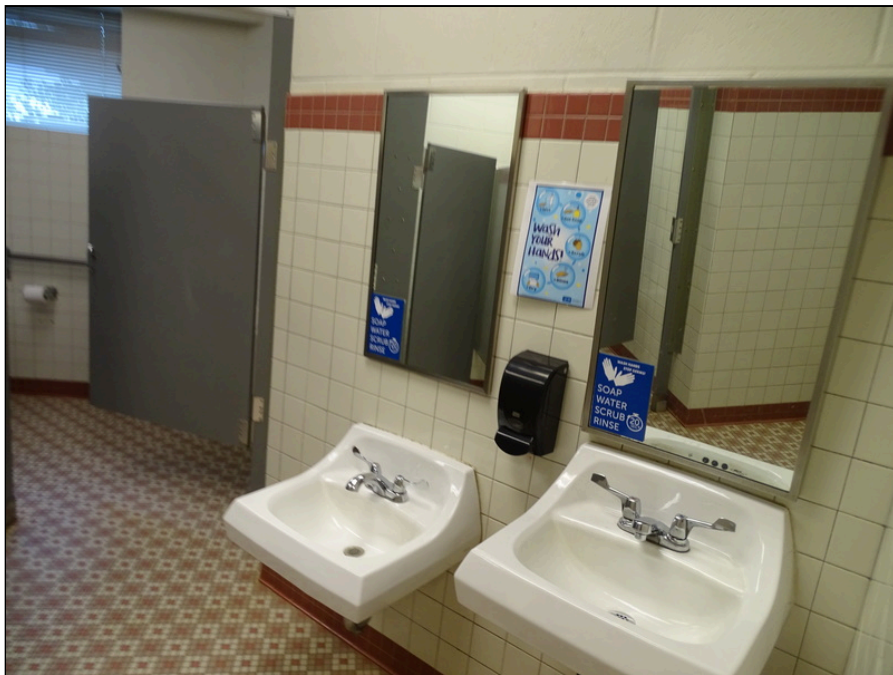
86 - Restroom area interior finishes

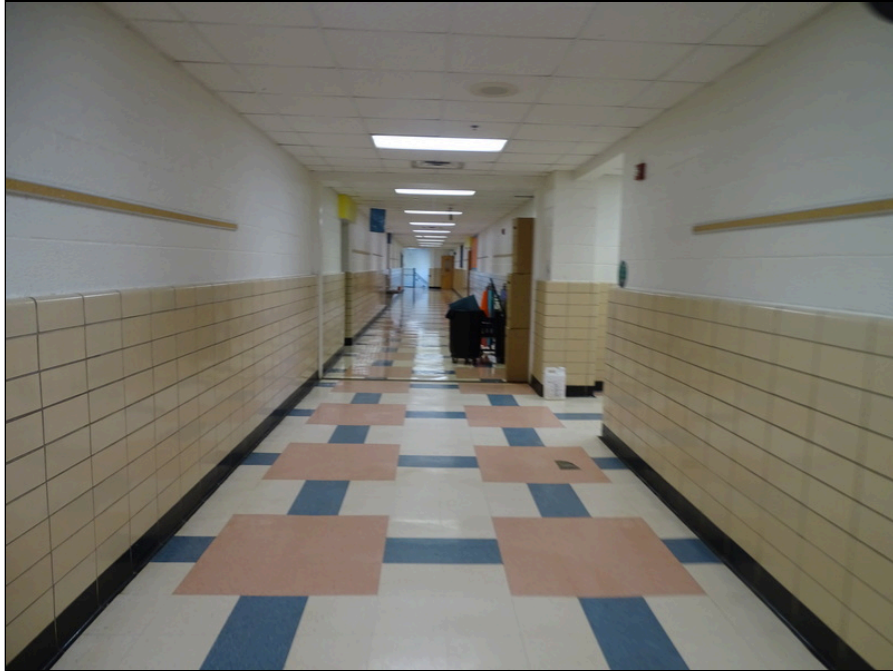
87 - Typical corridor interior finishes

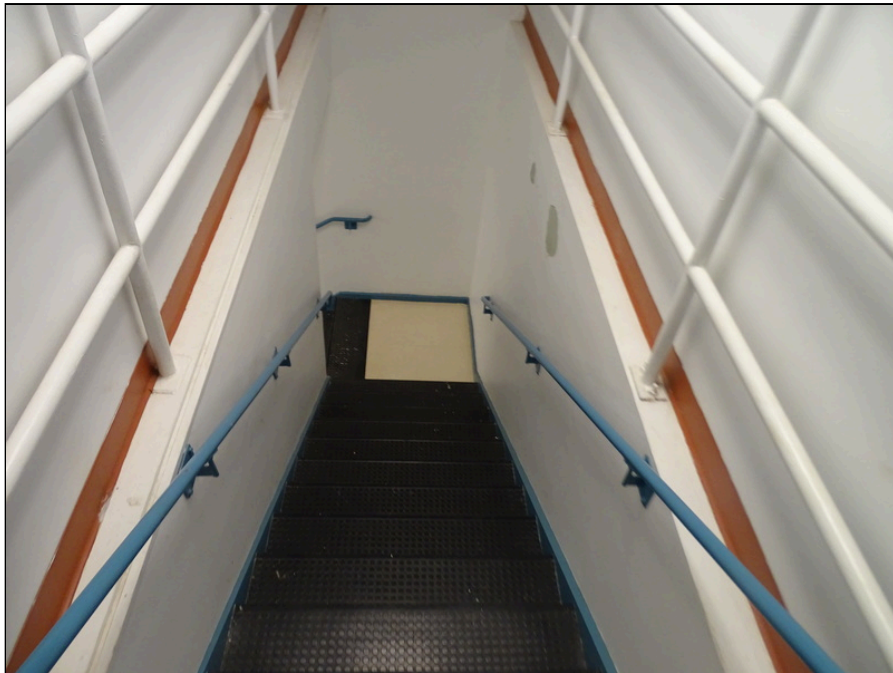
88 - Typical stairwell interior finishes

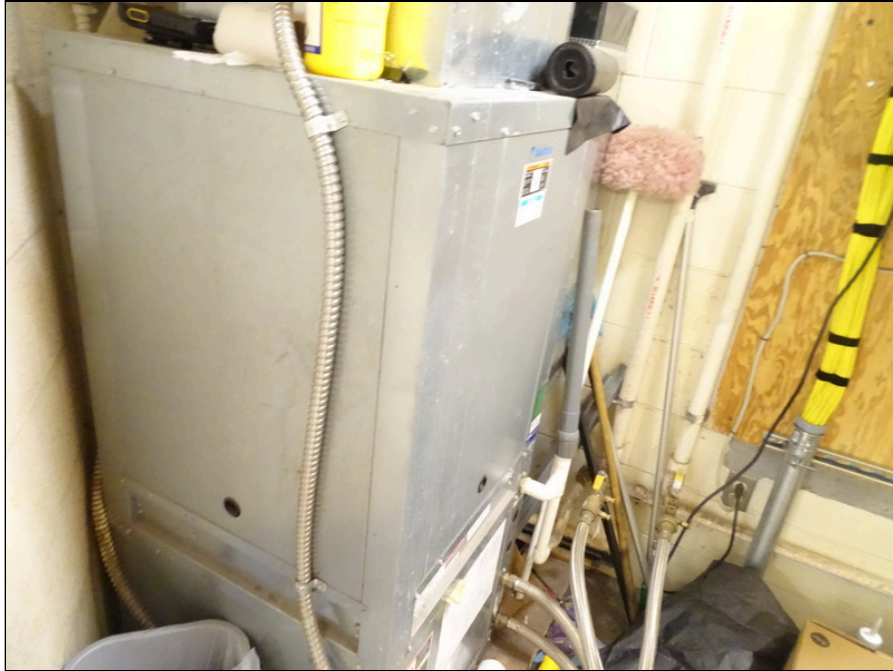
89 - Typical utility room interior finishes

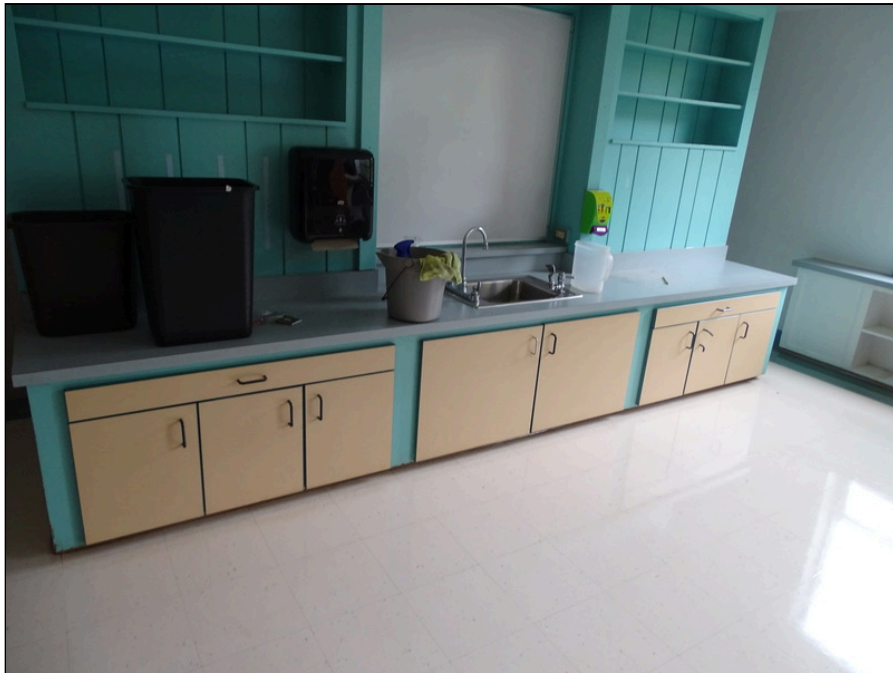
90 - Typical kitchen area interior finishes

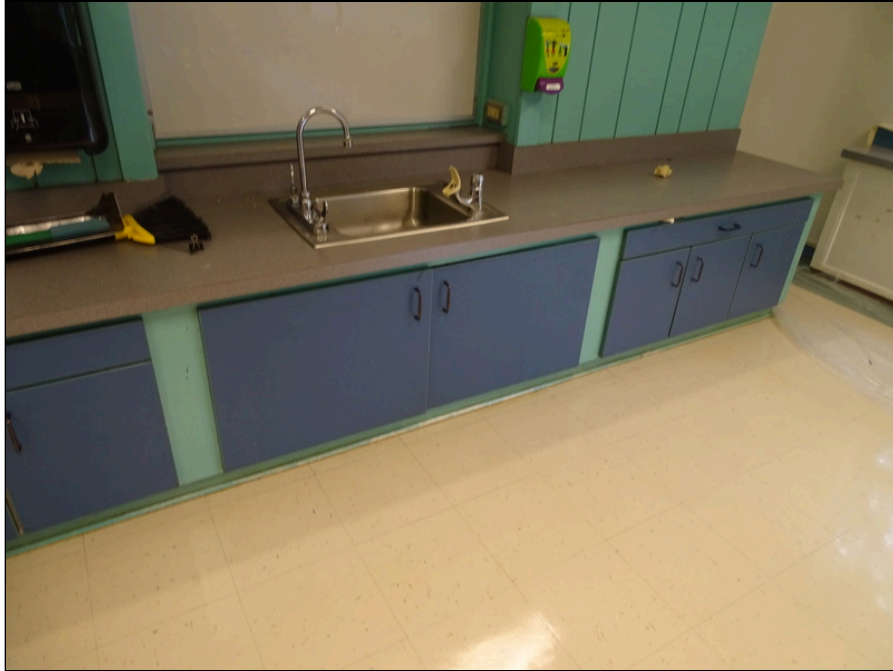
91 - Typical kitchen area interior finishes

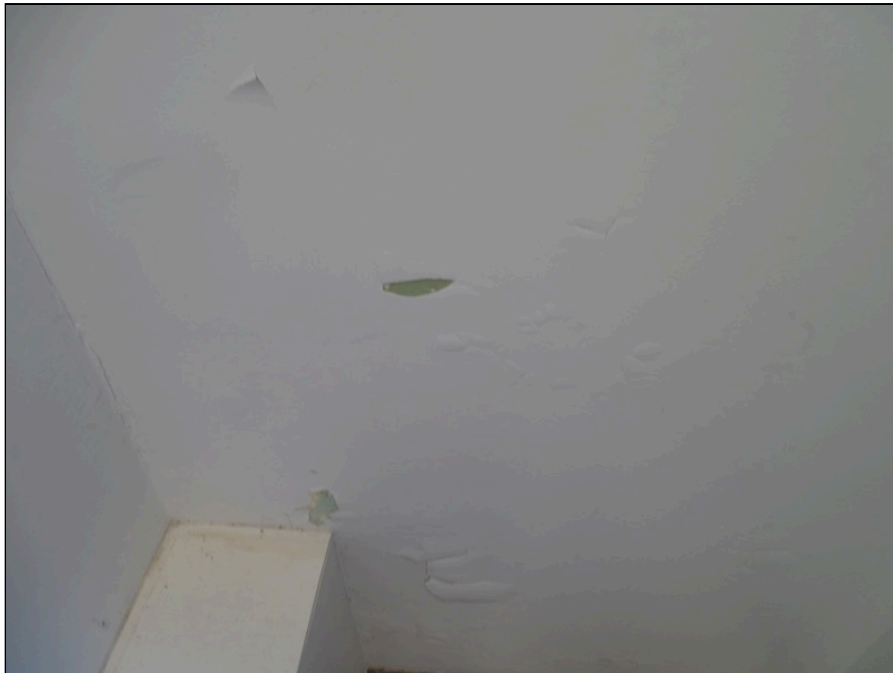
92 - Interior ceiling - note peeled paint

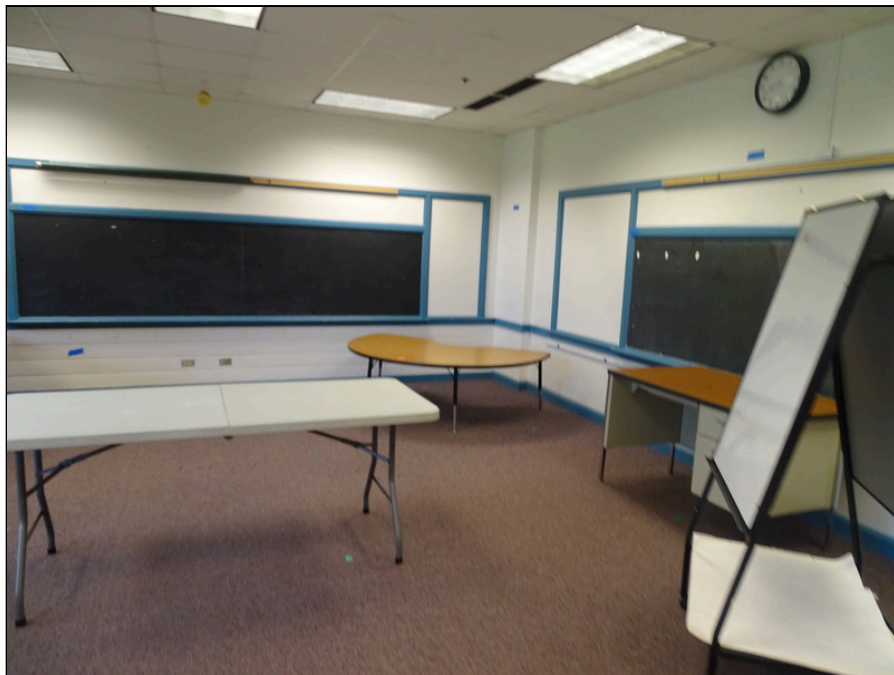
94 - Typical classroom area interior finishes

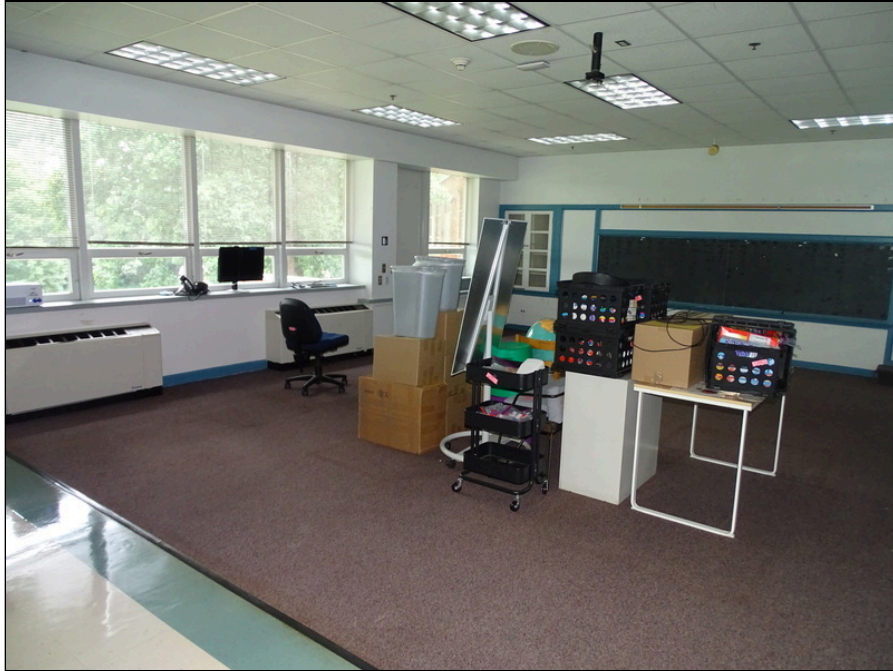
95 - Typical classroom area interior finishes

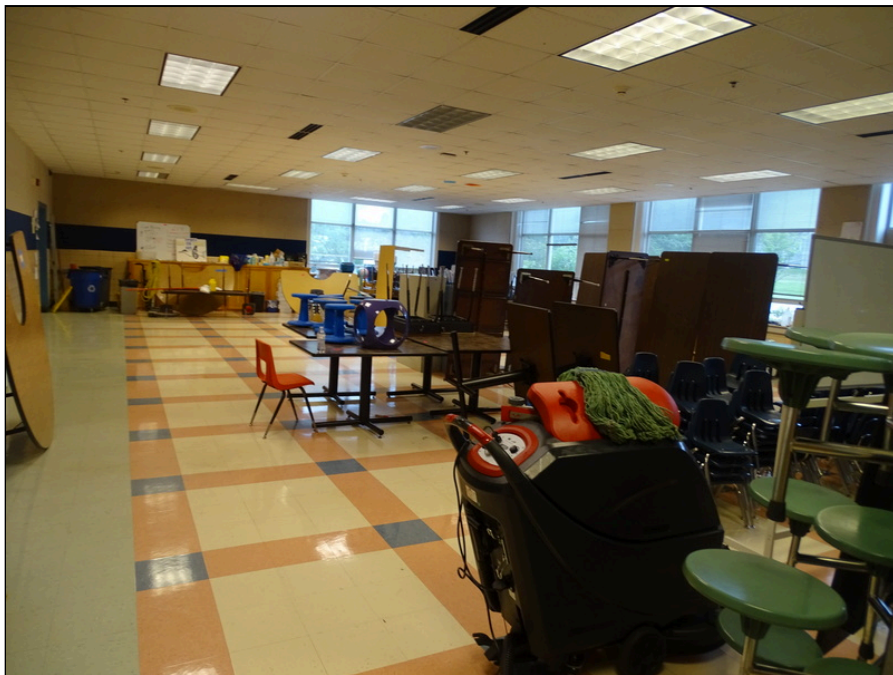
96 - Cafeteria area interior finishes
