BURNLEY MORAN ELEMENTARY SCHOOL  
1300 LONG STREET  
CHARLOTTESVILLE, VIRGINIA

ECS PROJECT NO. 46:6713

CITY OF CHARLOTTESVILLE - FACILITIES DEVELOPMENT

Reference: Facility Condition Assessment Report for Burnley Moran Elementary School, 1300 Long Street, Charlottesville, Virginia

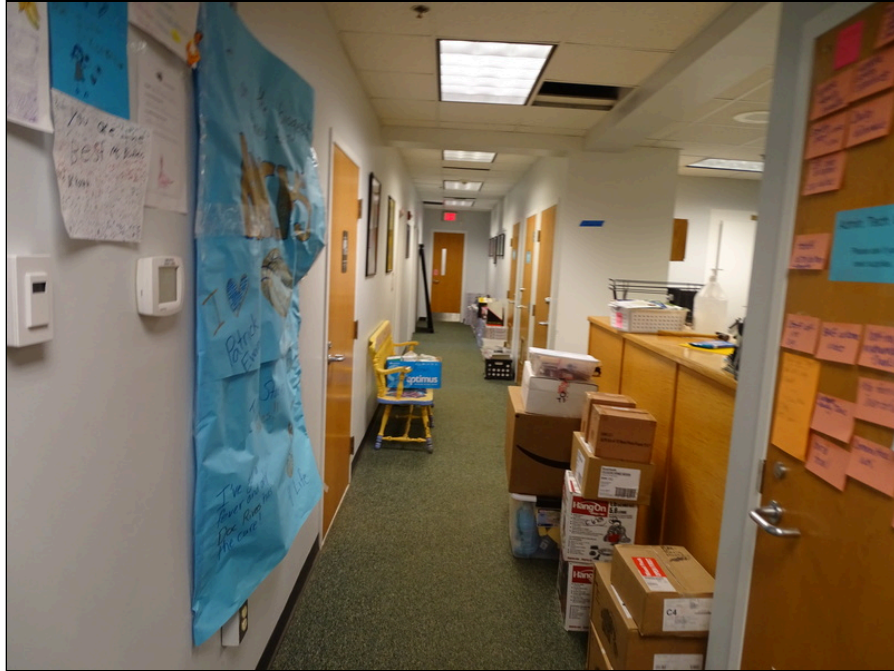
99 - typical corridor area interior

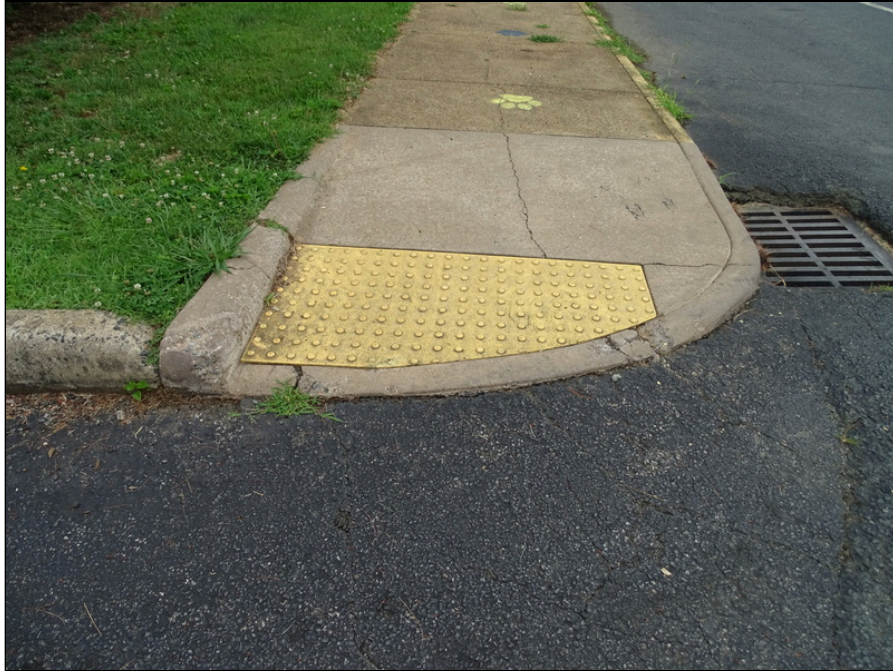
103 - Concrete curb cut ramp with truncated domes

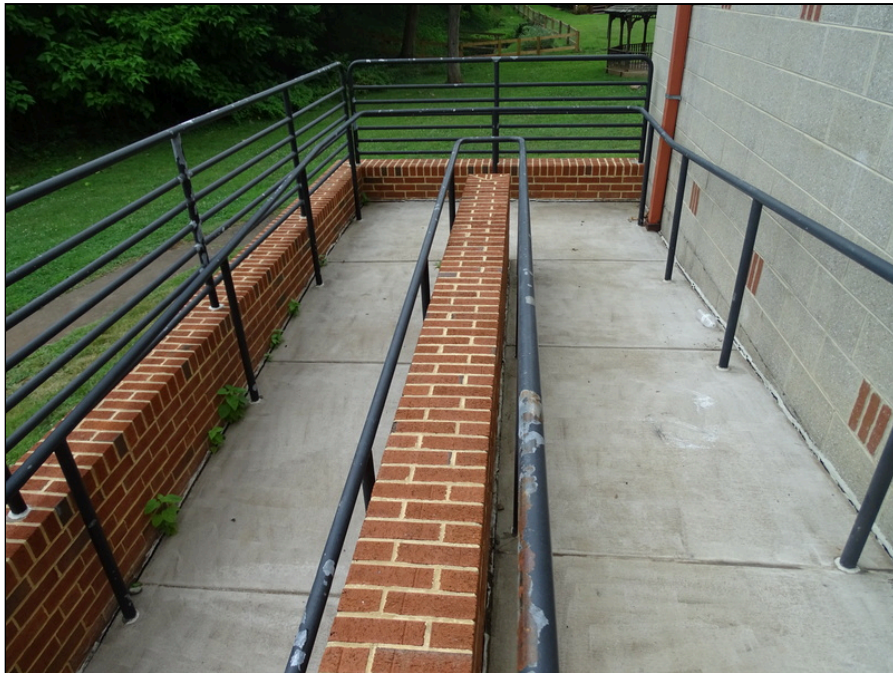
104 - Accessible ramp

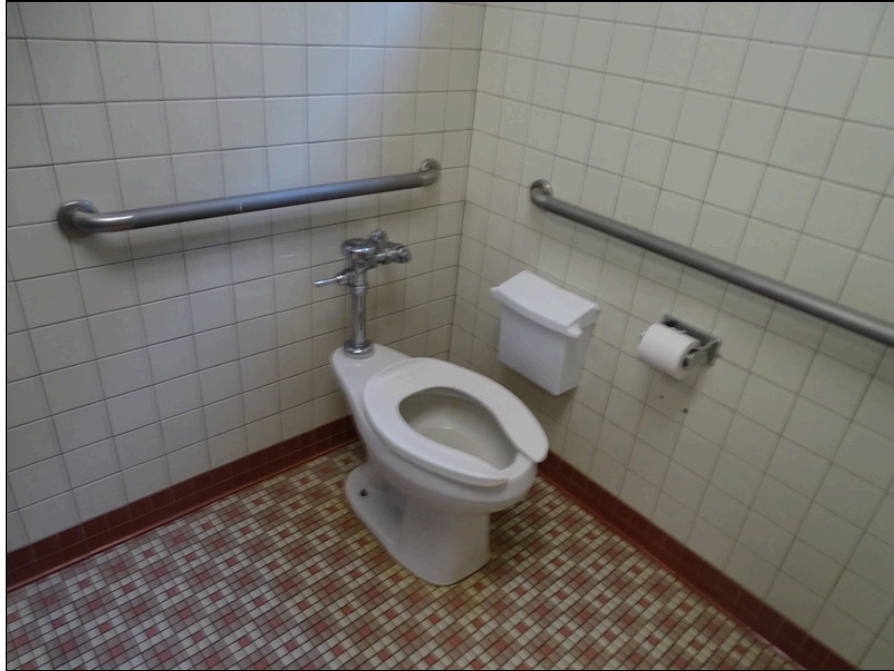
105 - Accessible restroom

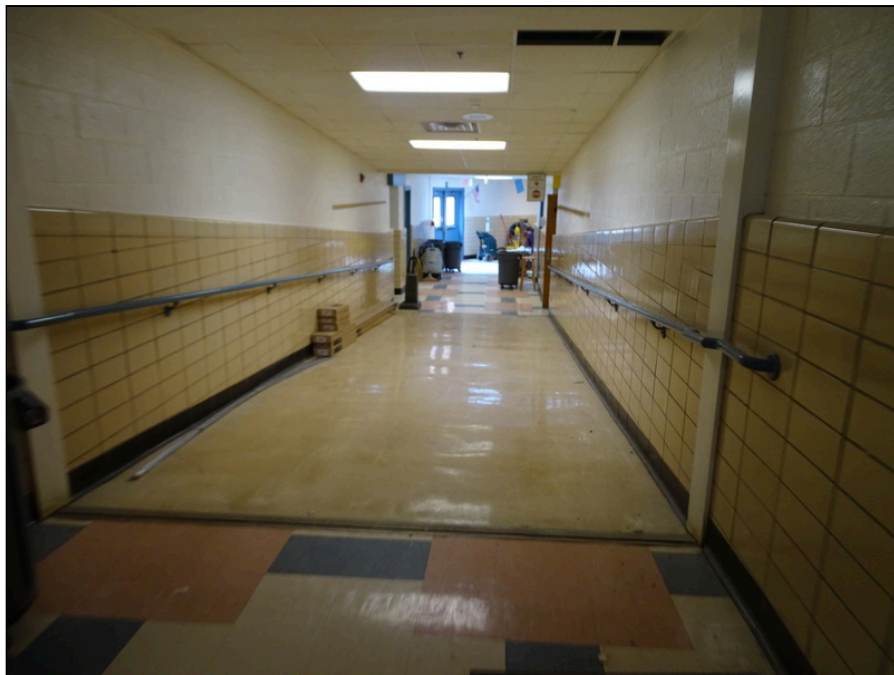
106 - Accessible interior ramp
