DOWNTOWN TRANSIT CENTER
615 WATER STREET
CHARLOTTESVILLE, VIRGINIA

ECS PROJECT NO. 46:6713

CITY OF CHARLOTTESVILLE - FACILITIES DEVELOPMENT

Reference: Facility Condition Assessment Report for Downtown Transit Center, 615 Water Street,
Charlottesville, Virginia

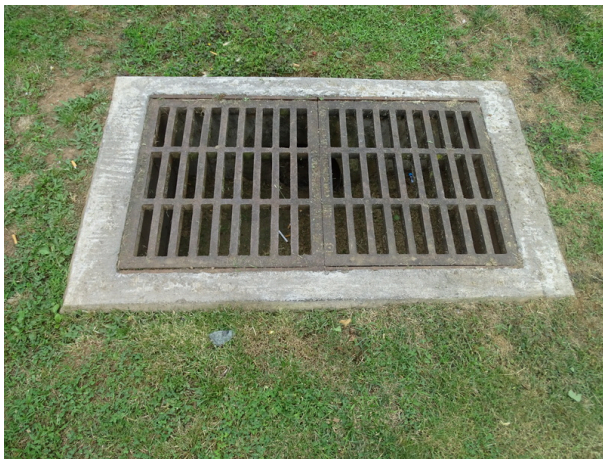
Typical stormwater drainage

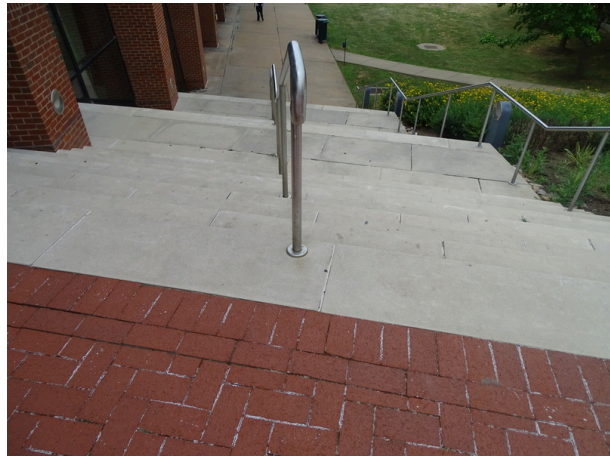
Concrete steps at the west side of the building

3.2.5 Flatwork																													
REPLACE CONCRETE SIDEWALK AND REPAIR CONCRETE STEPS AS NEEDED	25	24	1	1	LS	\$10,000.00	\$10,000	100%	\$2,500									\$2,500					\$2,500					\$2,500	\$10,000

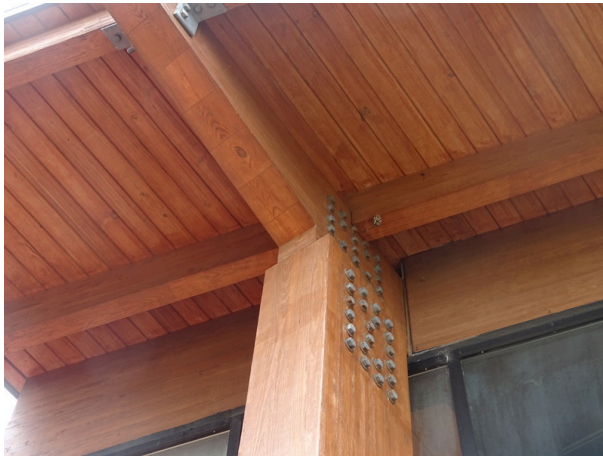
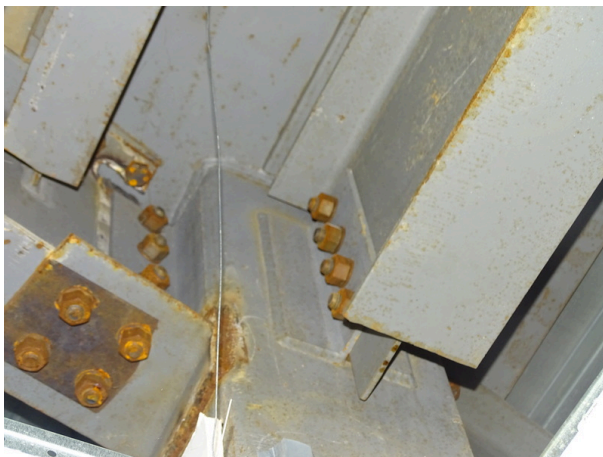
The structure of the building consists of heavy timber, structural steel, and concrete masonry unit walls. There are concrete slab on grade lower level floor concrete decks for upper floor levels. The structural frame of the building was generally in good condition.

Structural framing

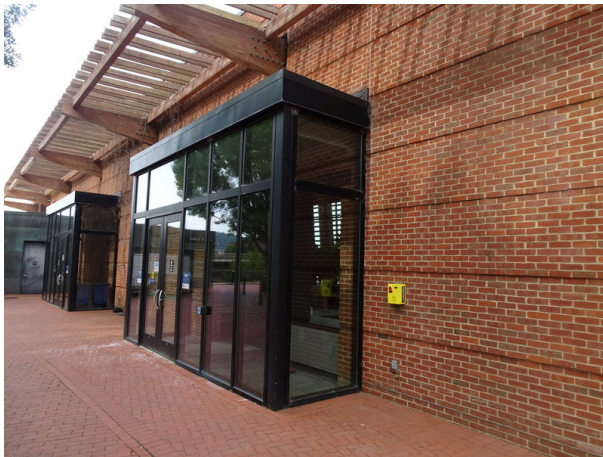
There is wood pergola on the east and south sides of the building. There is a wood shade screen located on the upper elevations of the west side of the building. The wood accent materials were weathered and cracking was observed. The wood accent was in fair condition. We recommend an allowance to treat the wood accent materials.

Building exterior east side of the building

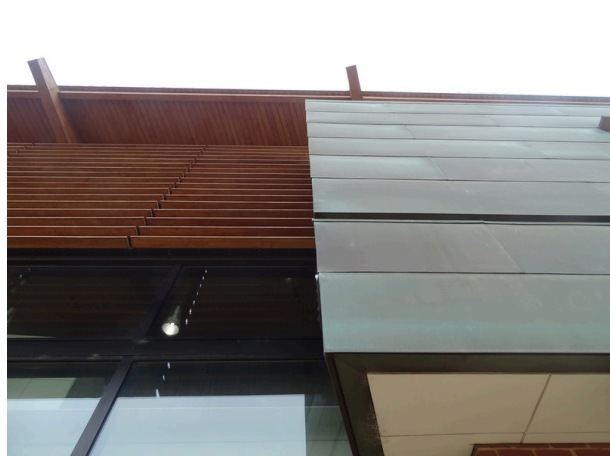
Building exterior southwest side of the building

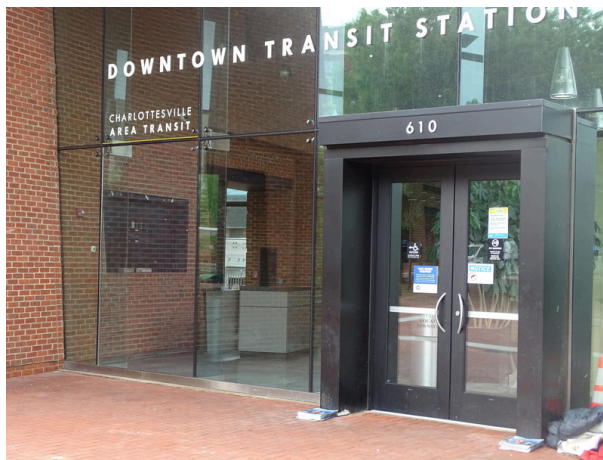
Main entrance doors north entrance

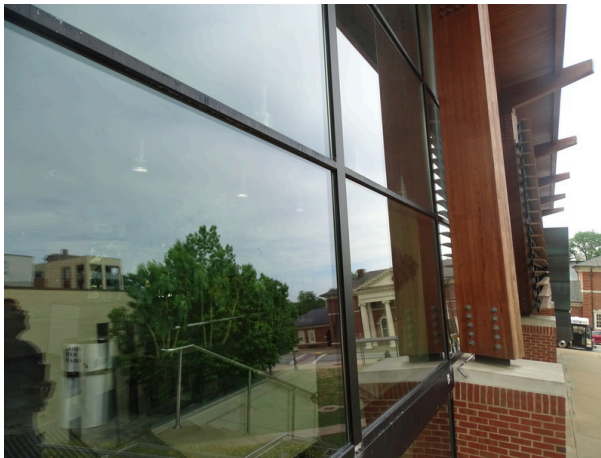
The window gaskets were generally in fair condition based on their age. The typical useful life of window gaskets is 20 years. We recommend replacing the window gaskets during the report period.

Typical exterior window

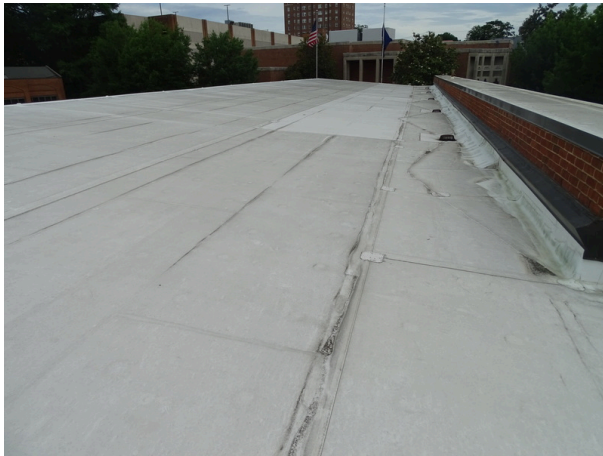
Single-ply membrane roofing system looking
north

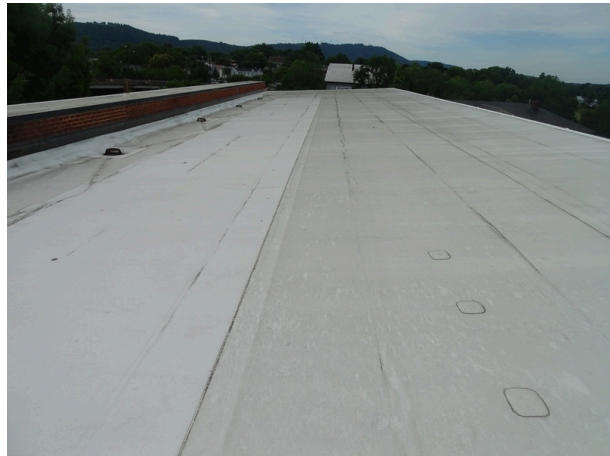
Single-ply membrane roofing system looking
south

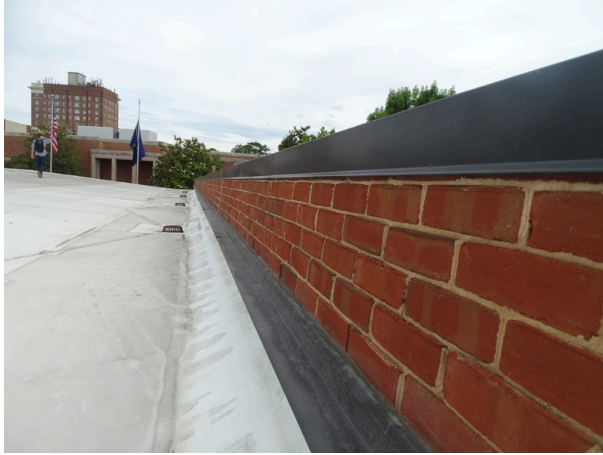
Parapet wall

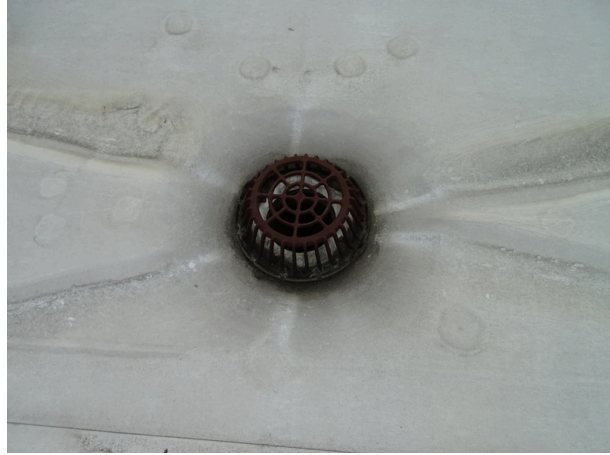
Typical internal drain

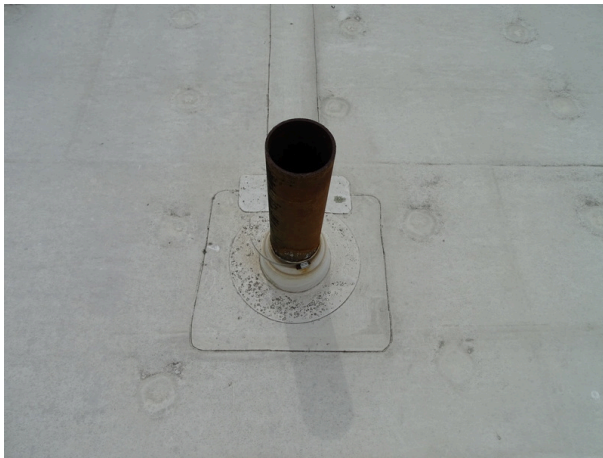
Typical plumbing penetration

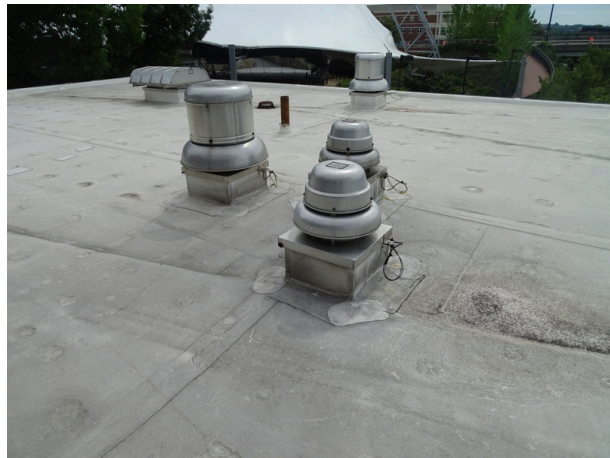
Typical exhaust fan

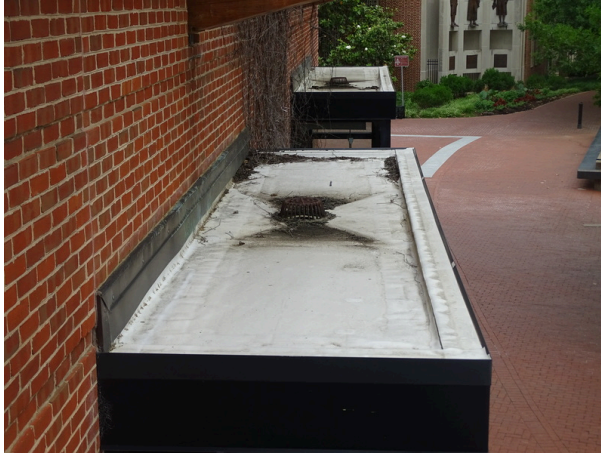
Single-ply membrane roofing system

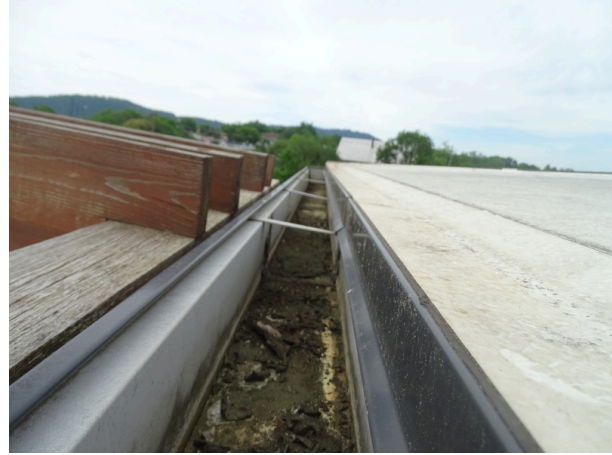
Typical gutter

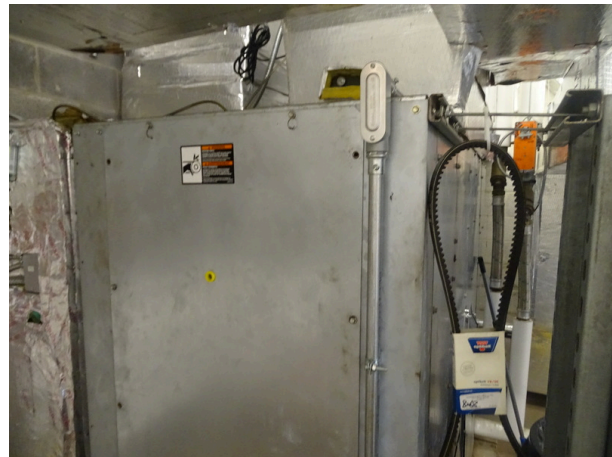
Package air conditioning equipment located in main utility room

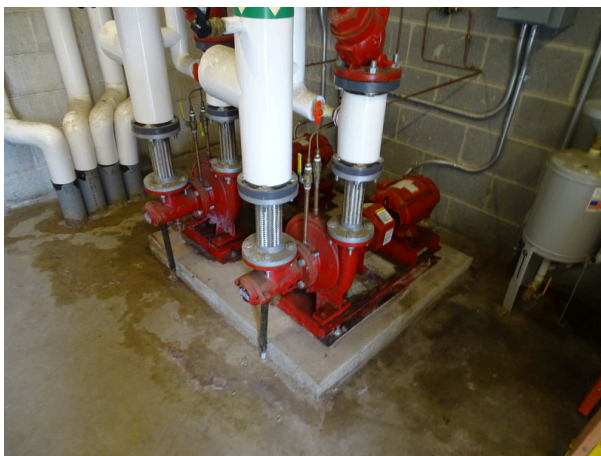
Typical central plant pumps

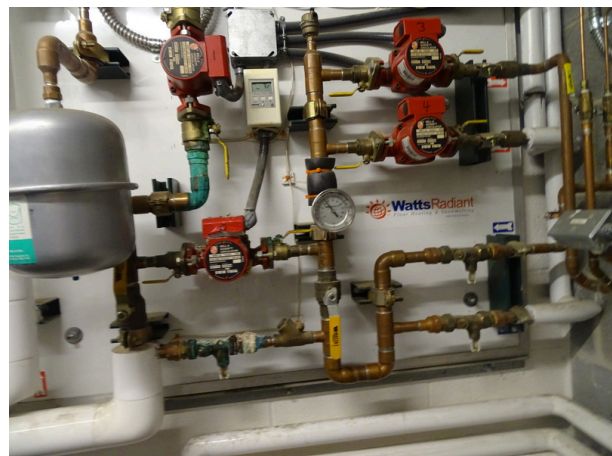
Radiant floor heating system

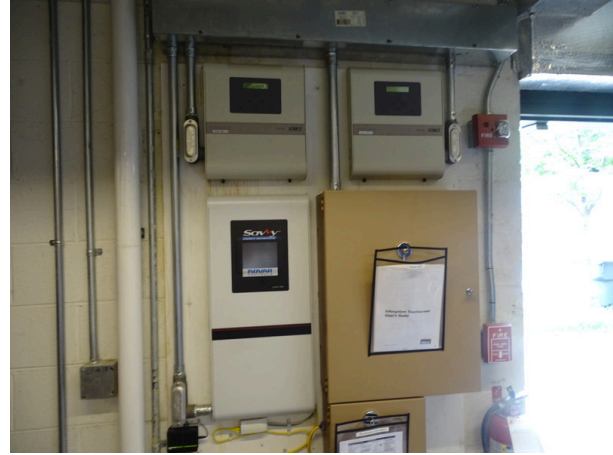
Energy Management System

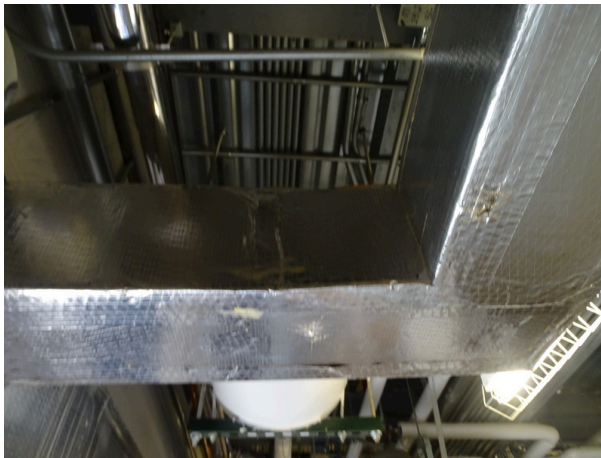
Typical mechanical duct

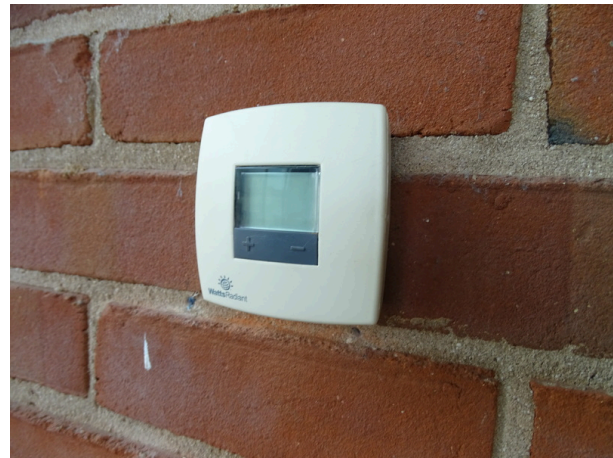
Typical thermostat control

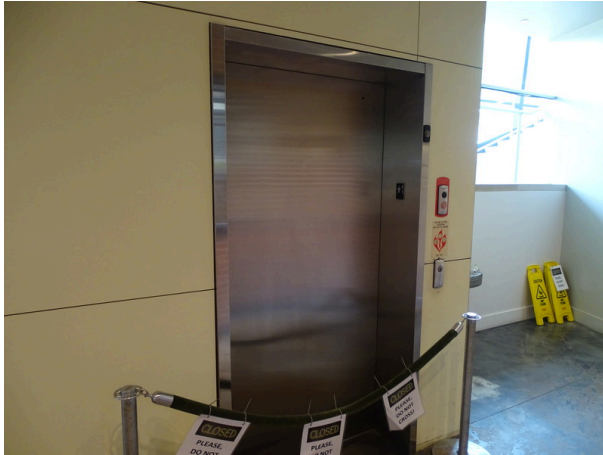
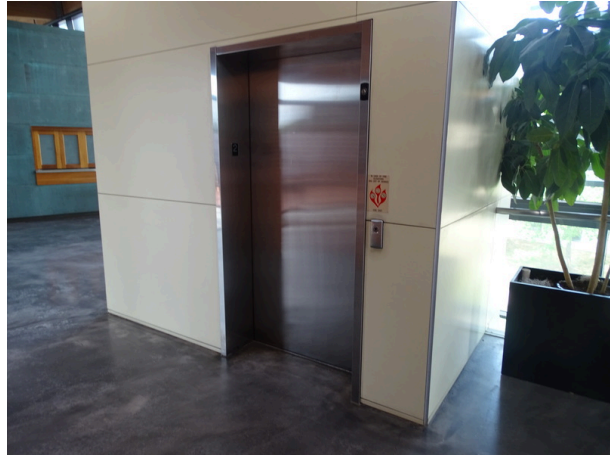
A passenger elevator was located at the center portion of the building. The capacity was rated at 2,500 pounds and. Routine maintenance is considered adequate to keep the elevator system in good condition during the projection period of this report. The last annual inspection was performed in August 2016 by E&F Elevator Inspections and Consulting, Inc. and monthly maintenance is provided by Southern Elevator. The inspection reports are included in an appendix of this report.

Elevator system

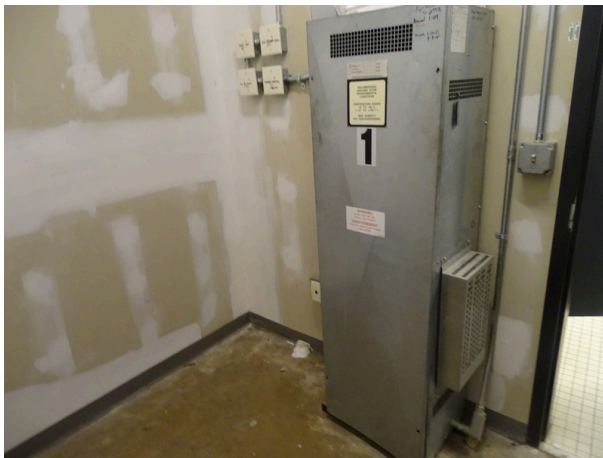
Elevator machine and controls

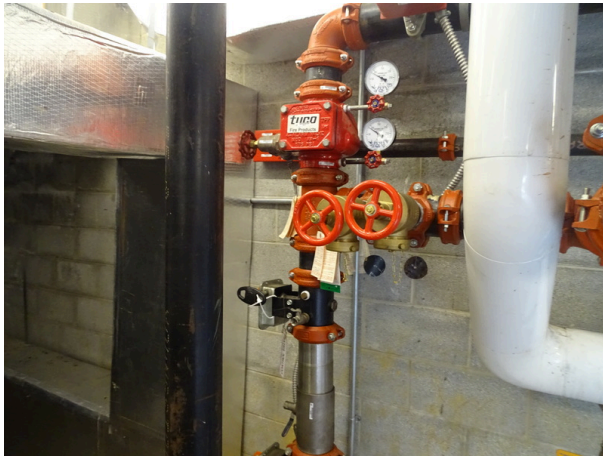
Fire sprinkler system

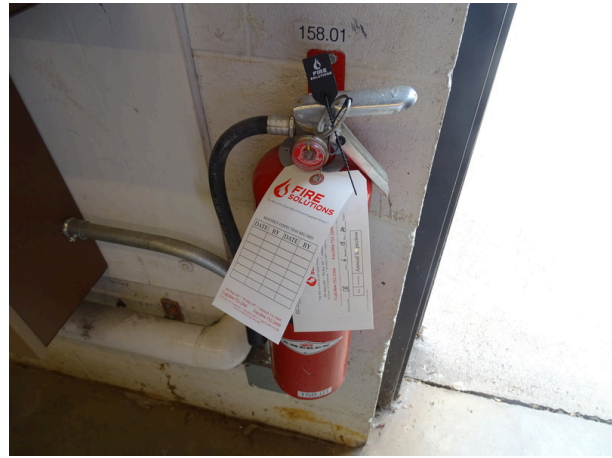
Typical fire extinguisher

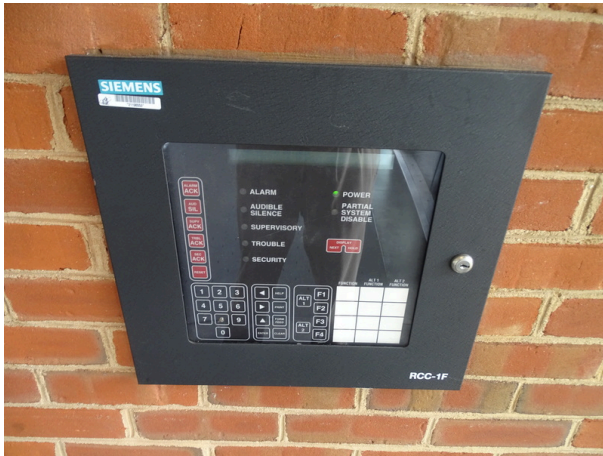
Fire alarm annunciator

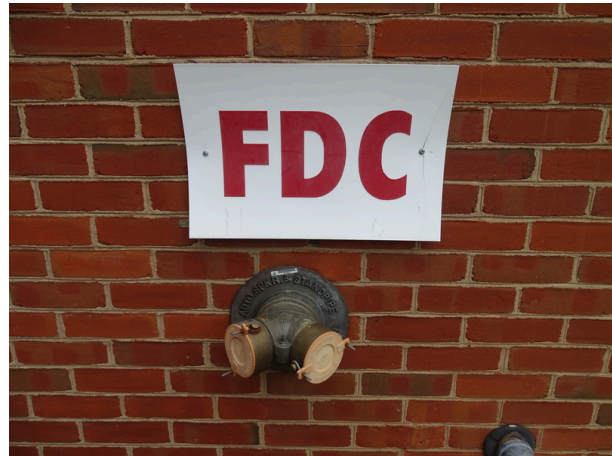
Fire Department connections

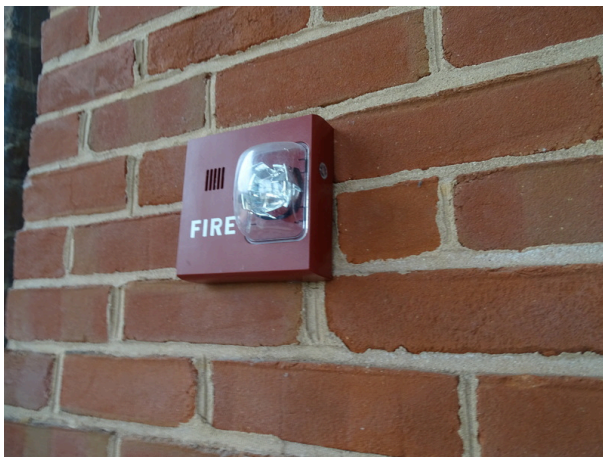
Typical fire alarm bell and strobe

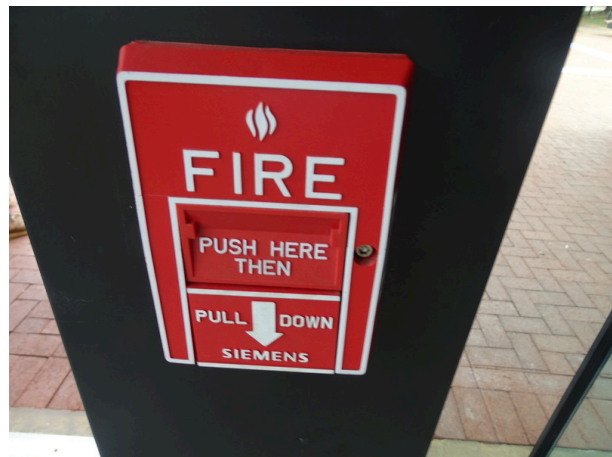
Typical fire alarm pull station

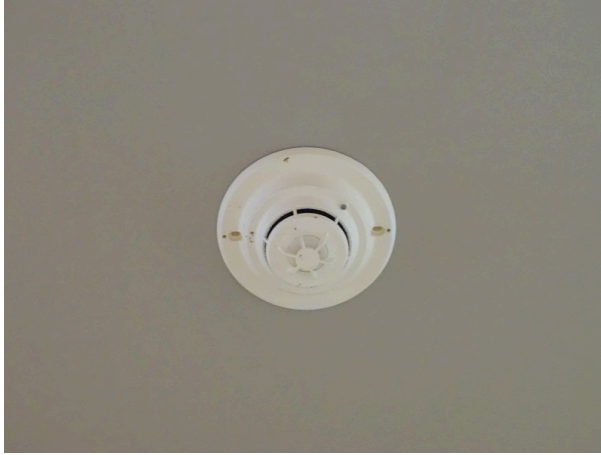
Typical smoke detector

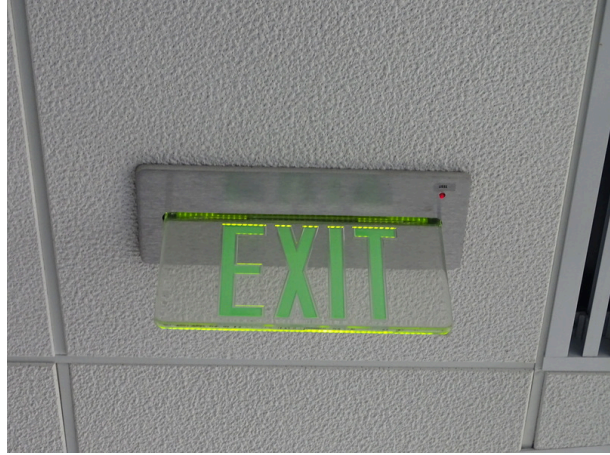
Typical exit sign

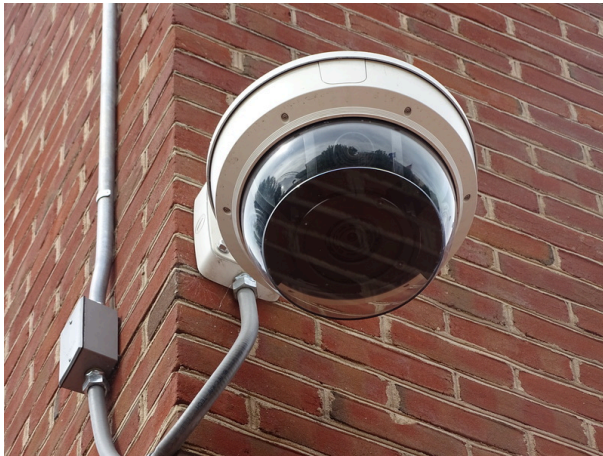
The building is monitored 24-hours a day by a computerized security system with cameras. Security cameras were observed at locations at the building interior and exterior. The security system was generally in good to fair condition.

Typical security camera

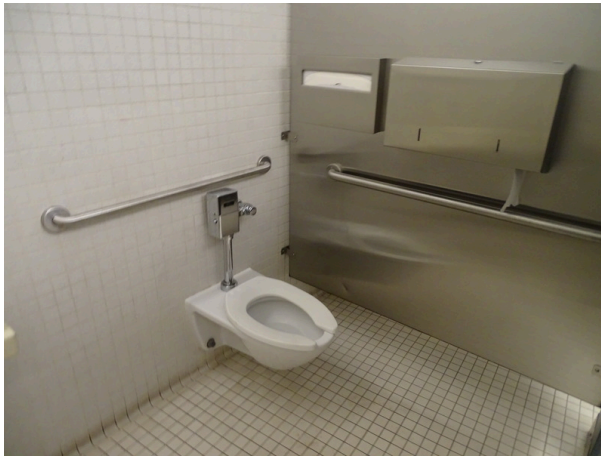
Accessible toilet

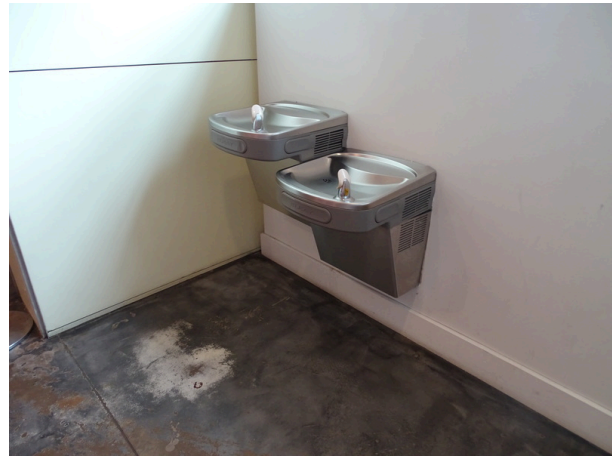
Accessible drinking fountains

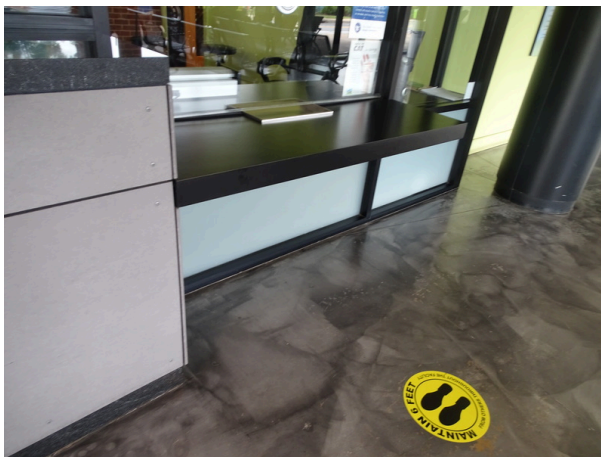
Accessible counter for commercial transactions

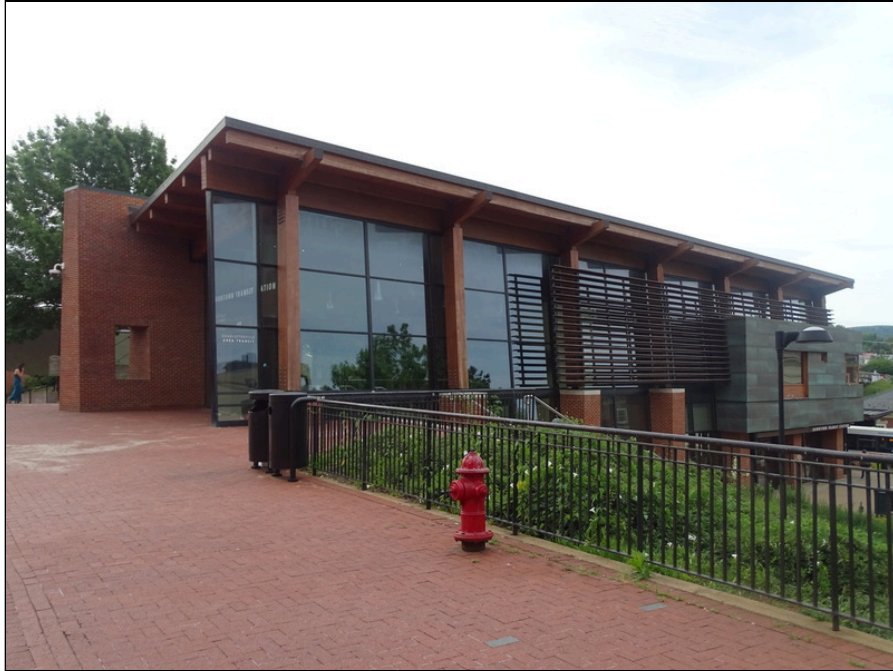
1 - Downtown Transit Center Facility

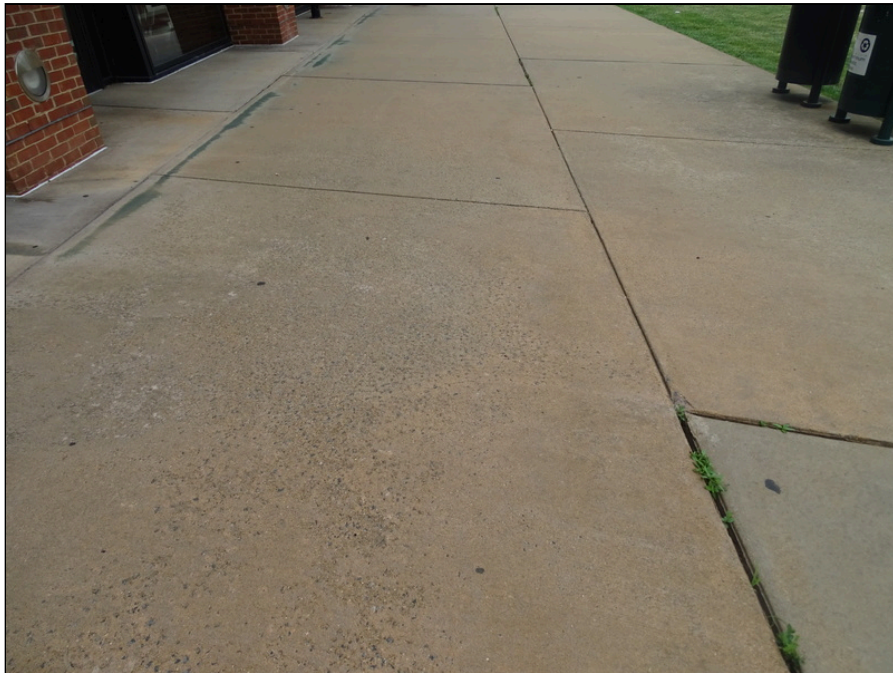
2 - Concrete sidewalk at the south side of the building

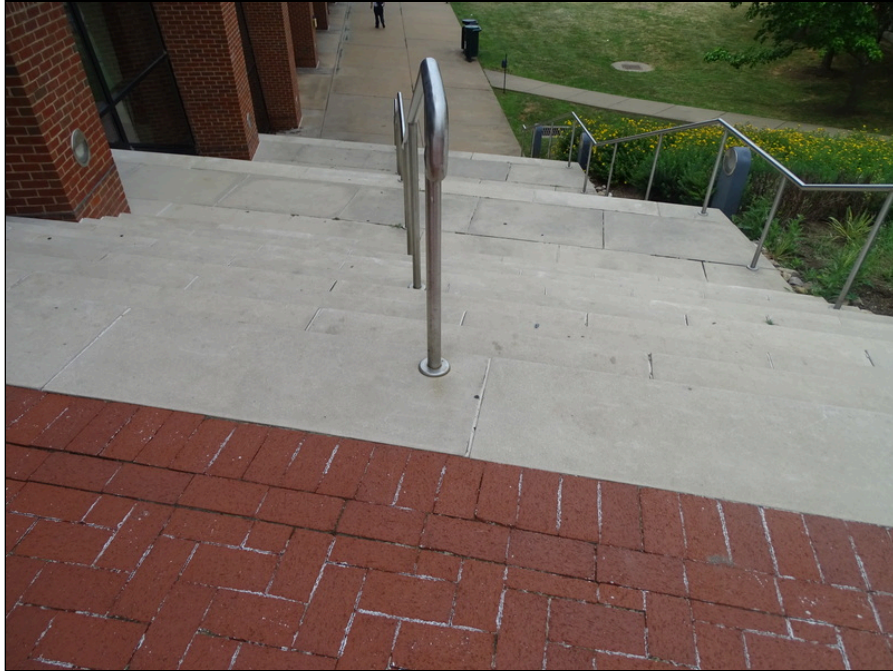
3 - Concrete steps at the west side of the building

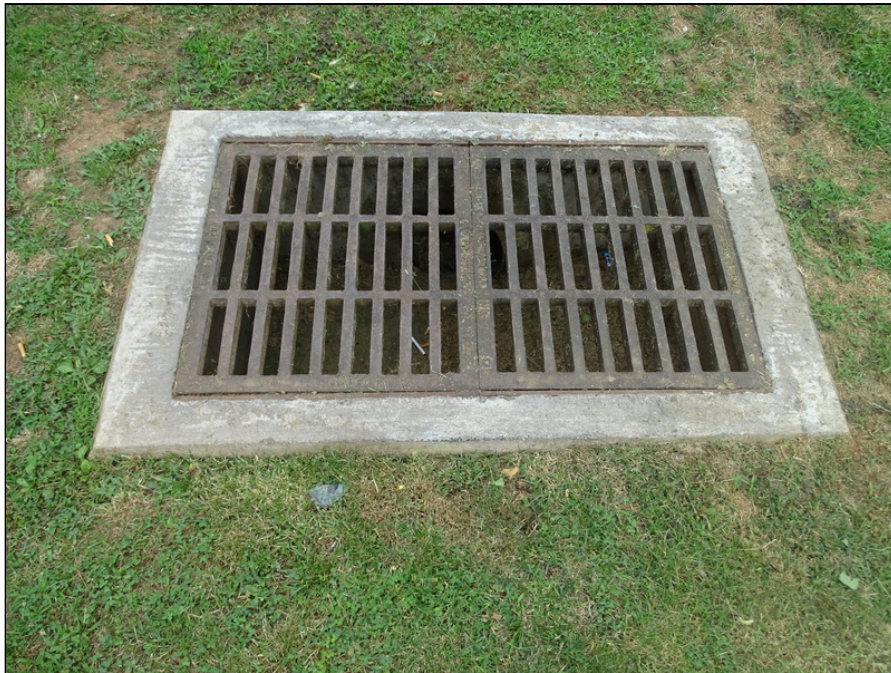
6 - Typical stormwater drainage

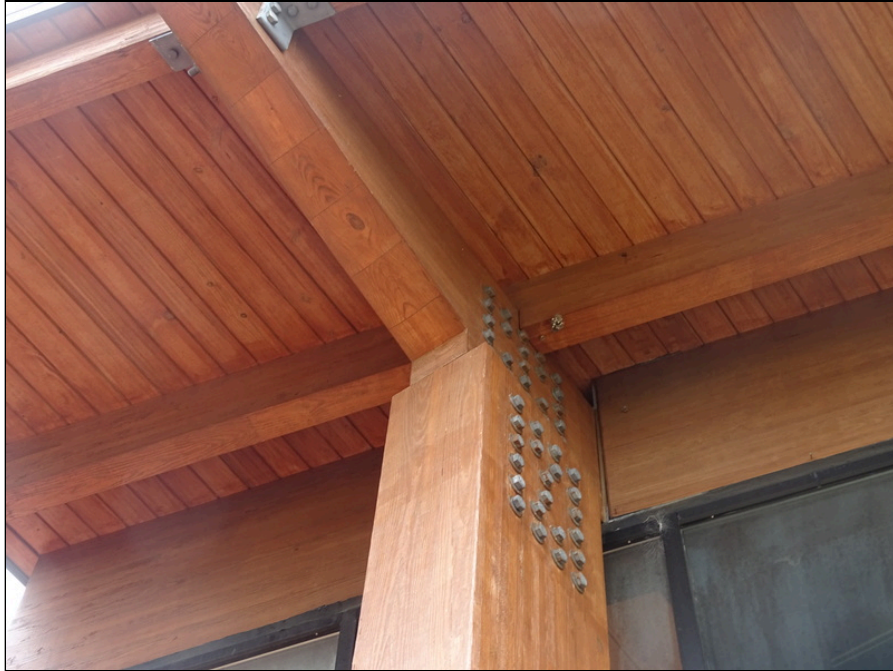
7 - Structural framing

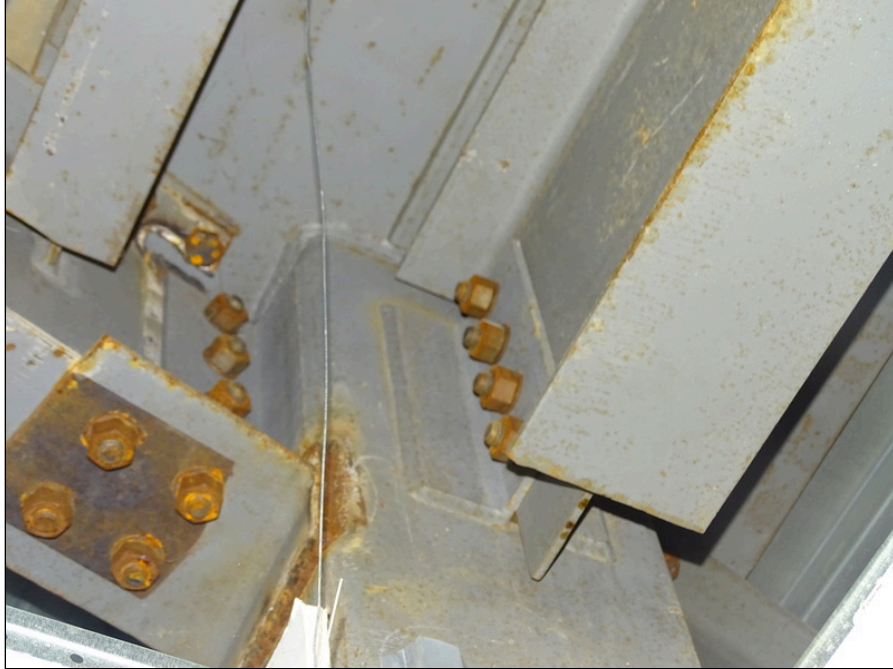
9 - Structural framing

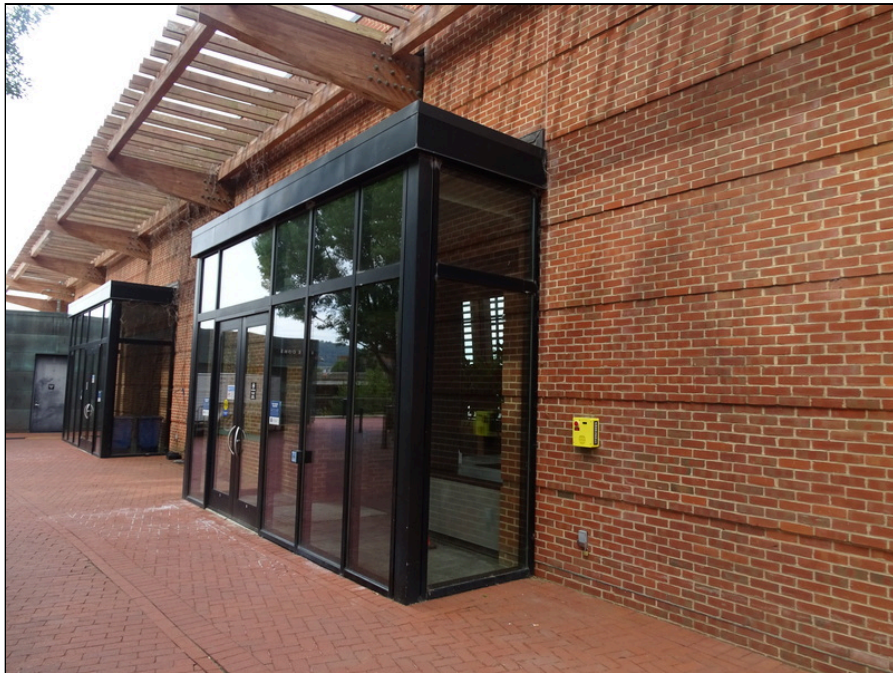
10 - Building exterior east side of the building

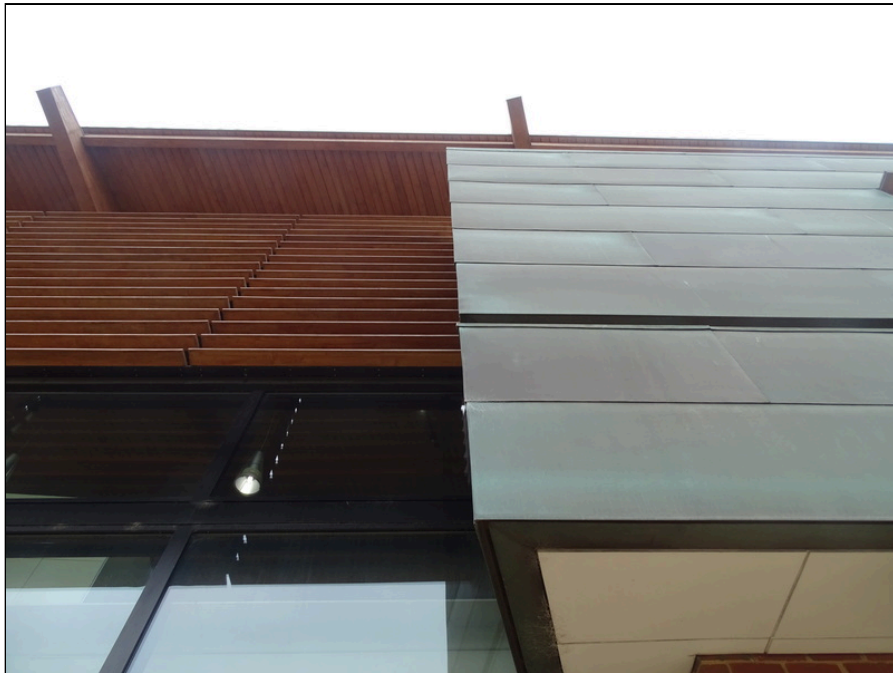
16 - Building exterior southwest side of the building

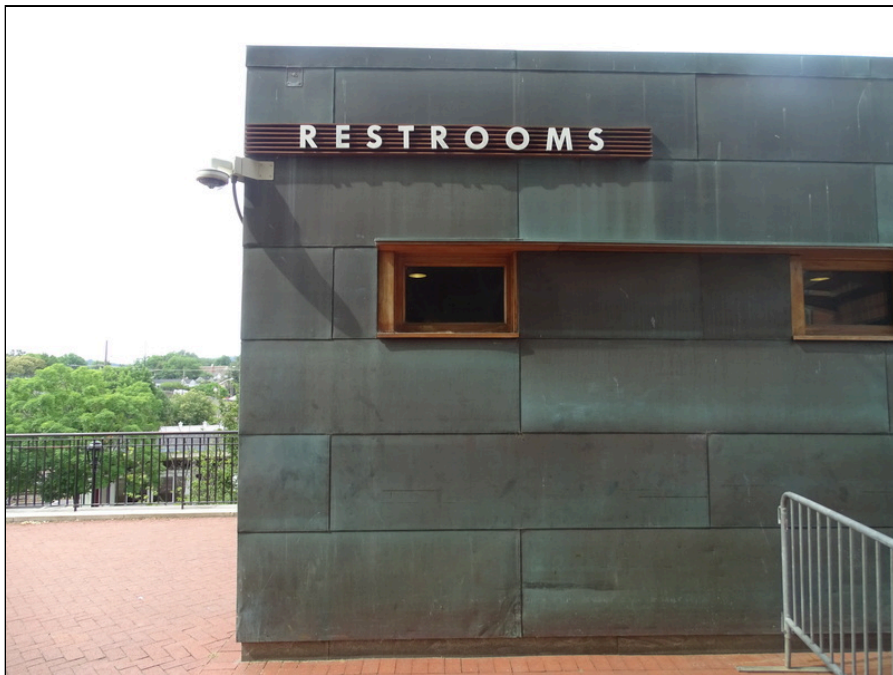
18 - Restrooms exterior

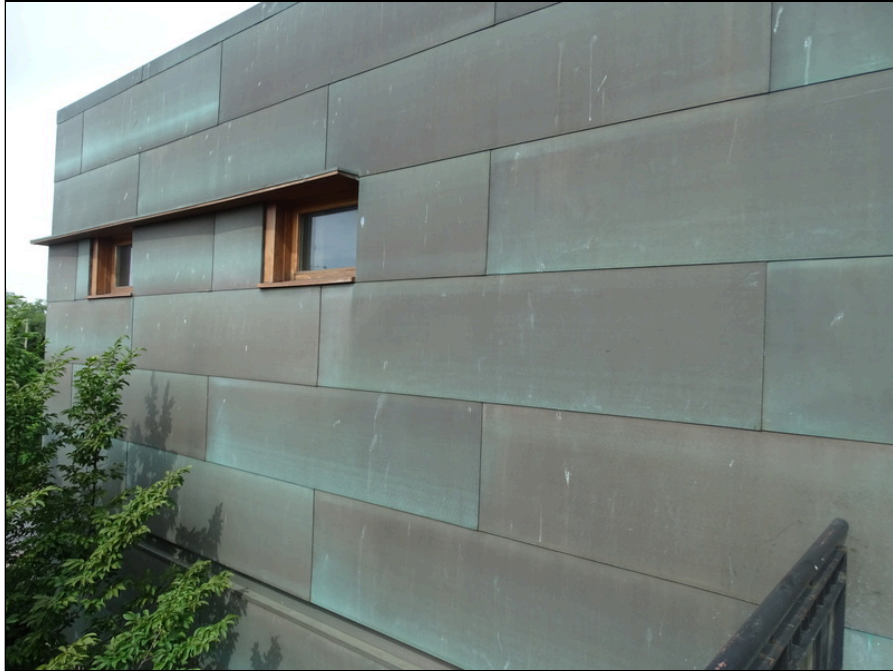
19 - Restrooms exterior

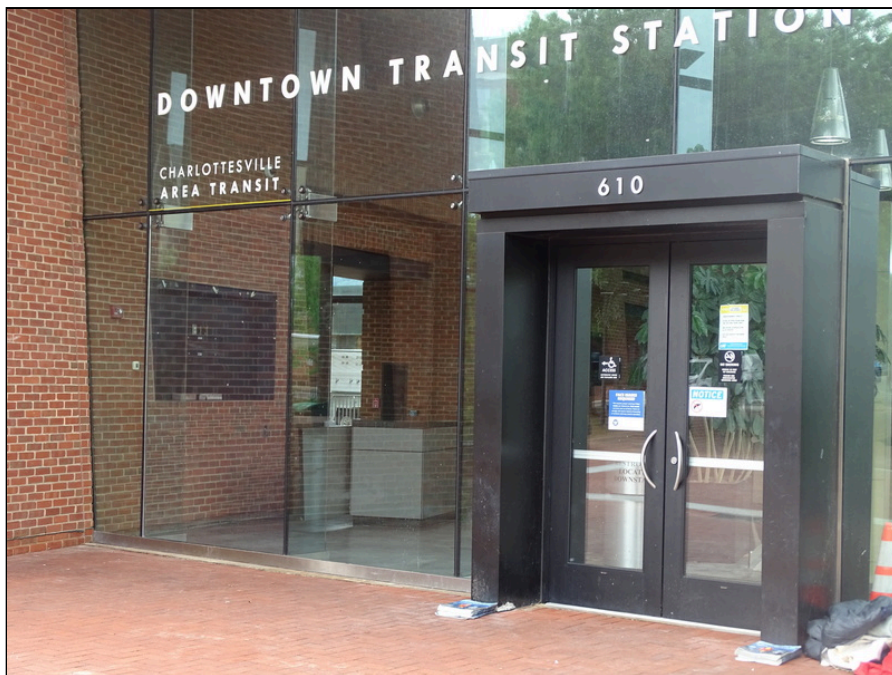
20 - Main entrance doors north entrance

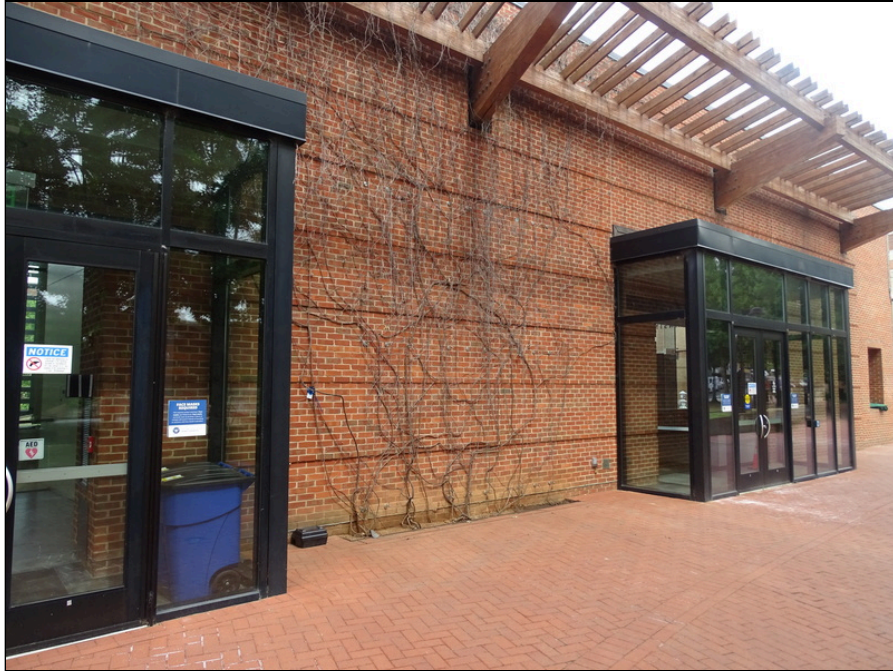
21 - Main entrance doors east entrance

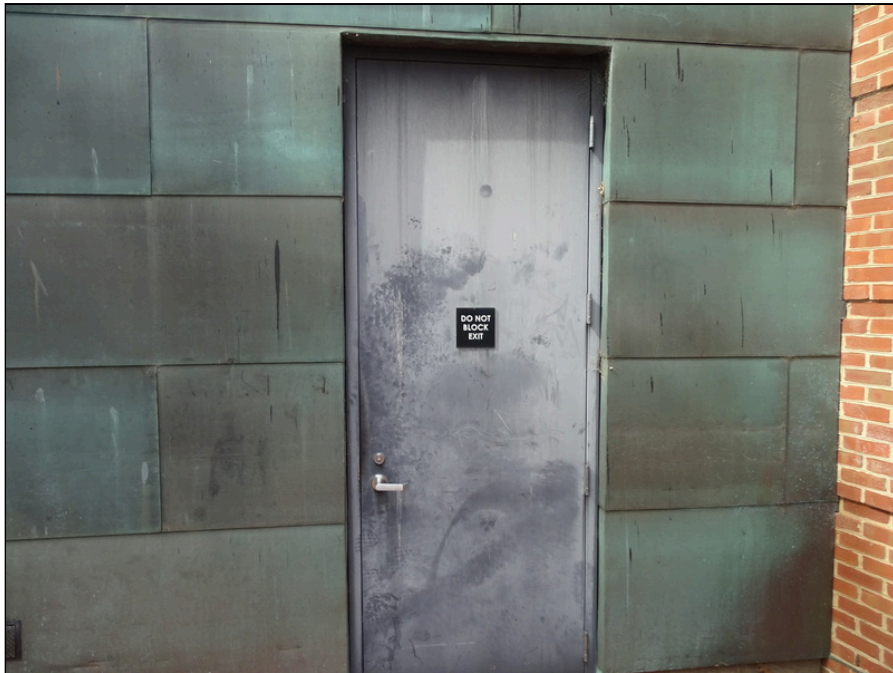
22 - Restrooms exterior door

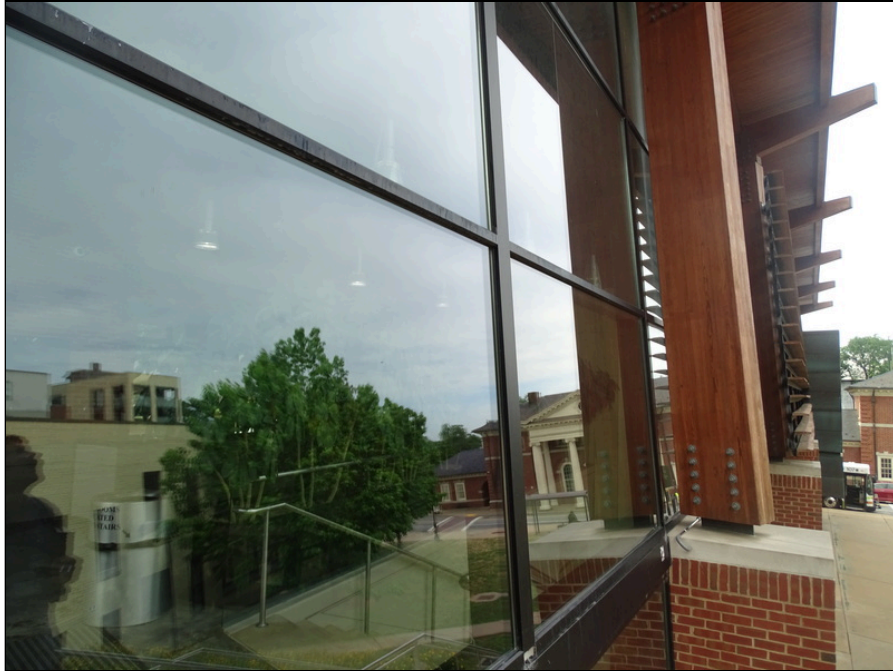
23 - Typical exterior window

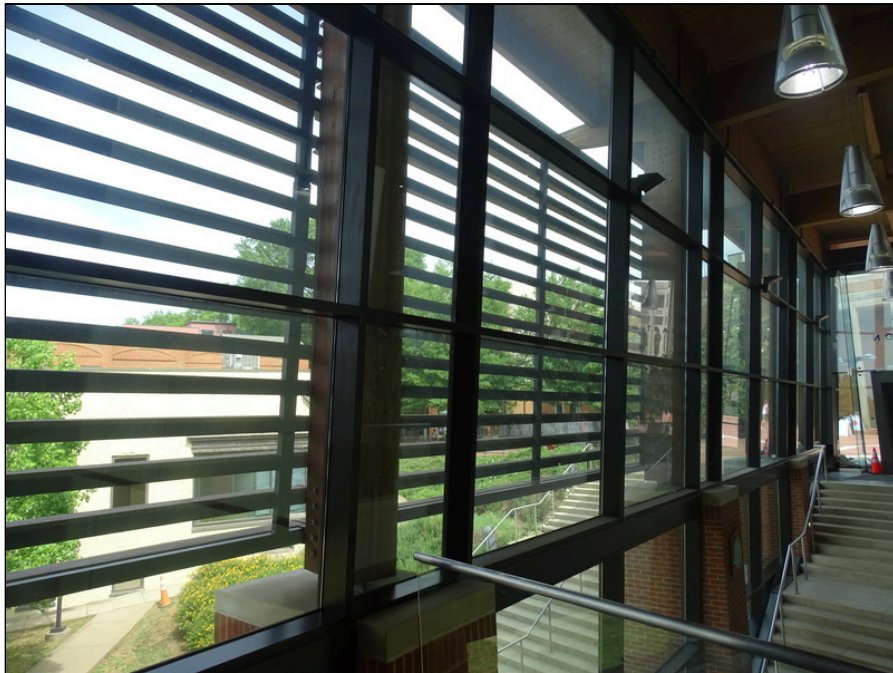
24 - Windows on west side of the building

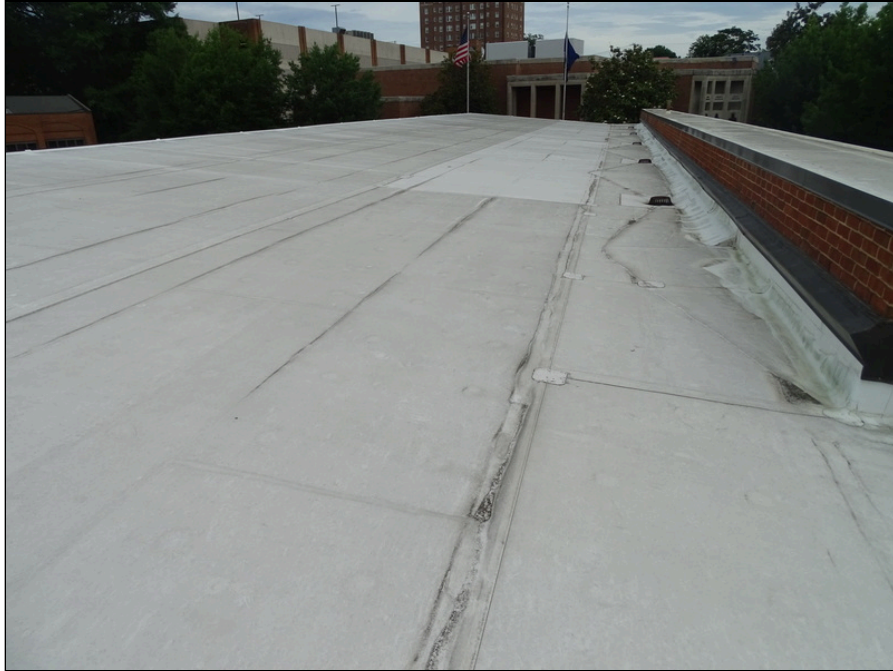
27 - Single-ply membrane roofing system looking north

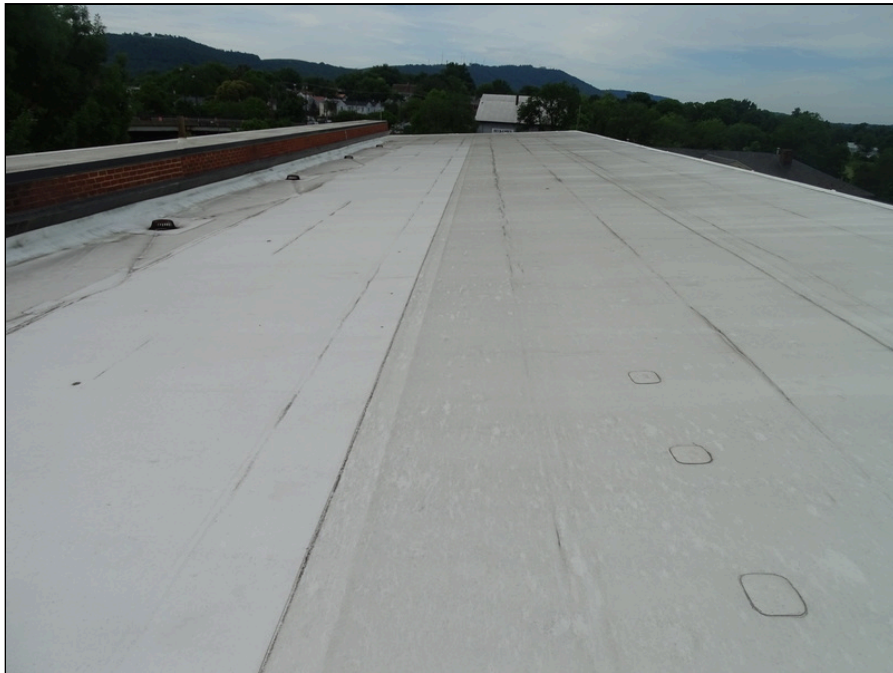
28 - Single-ply membrane roofing system looking south

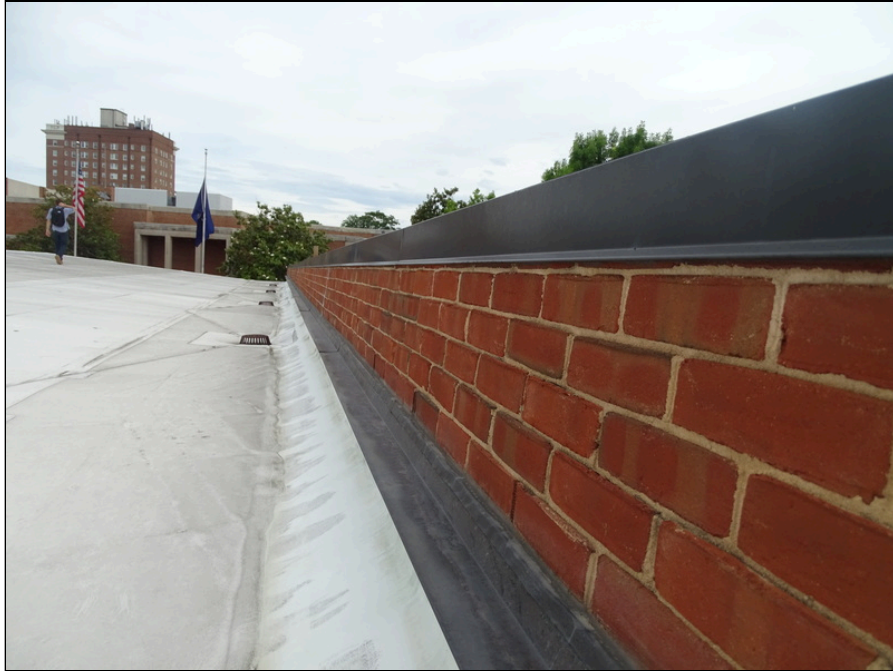
31 - Parapet wall

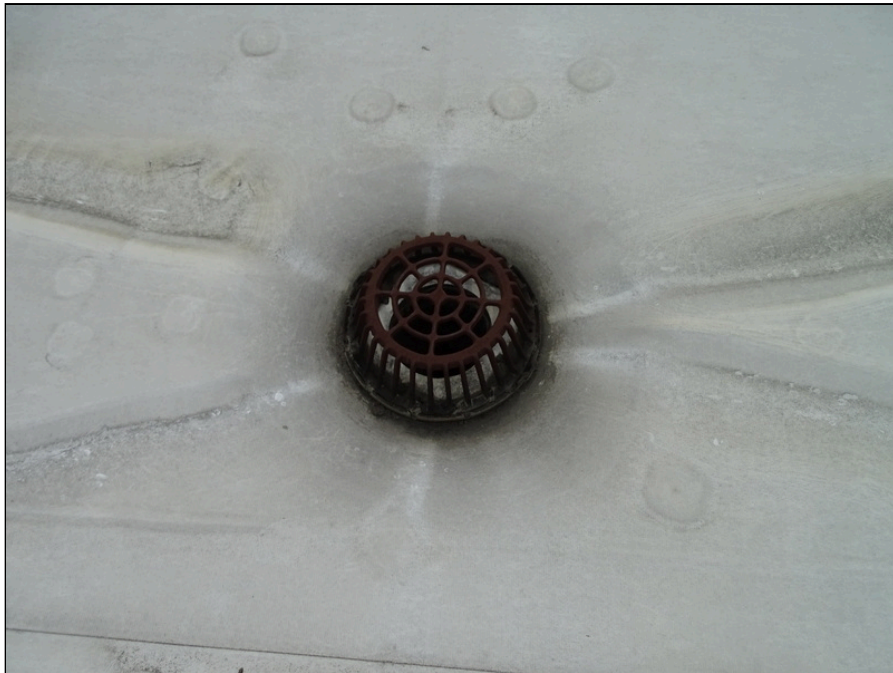
32 - Typical internal drain

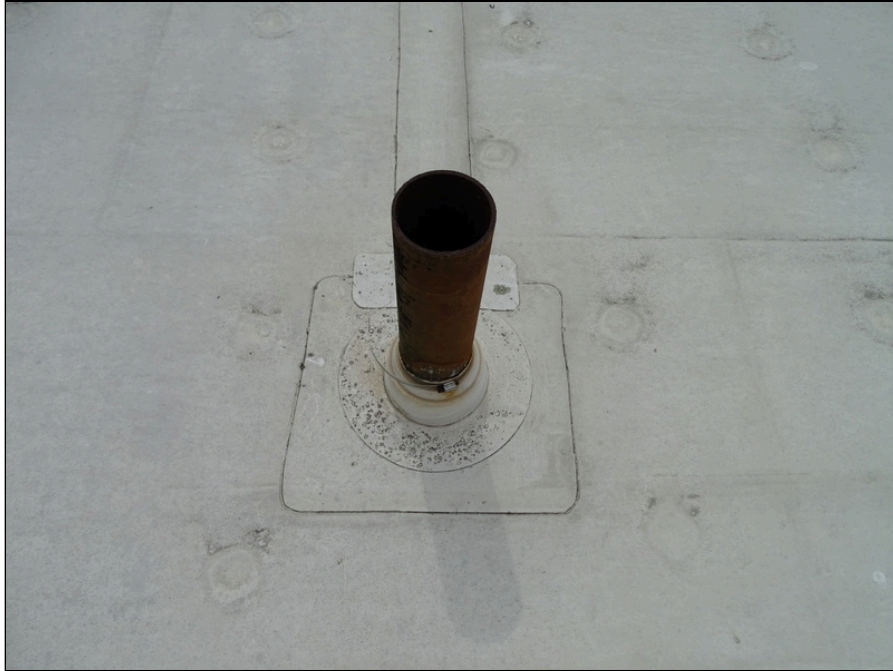
33 - Typical plumbing penetration
