DOWNTOWN TRANSIT CENTER
615 WATER STREET
CHARLOTTESVILLE, VIRGINIA

ECS PROJECT NO. 46:6713

CITY OF CHARLOTTESVILLE - FACILITIES DEVELOPMENT

Reference: Facility Condition Assessment Report for Downtown Transit Center, 615 Water Street,
Charlottesville, Virginia

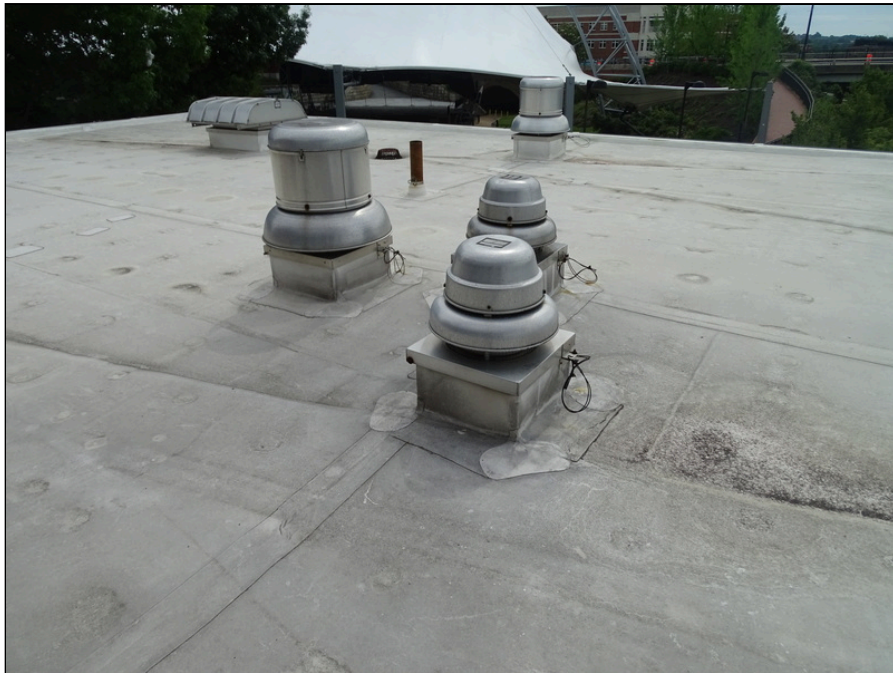
34 - Typical exhaust fan

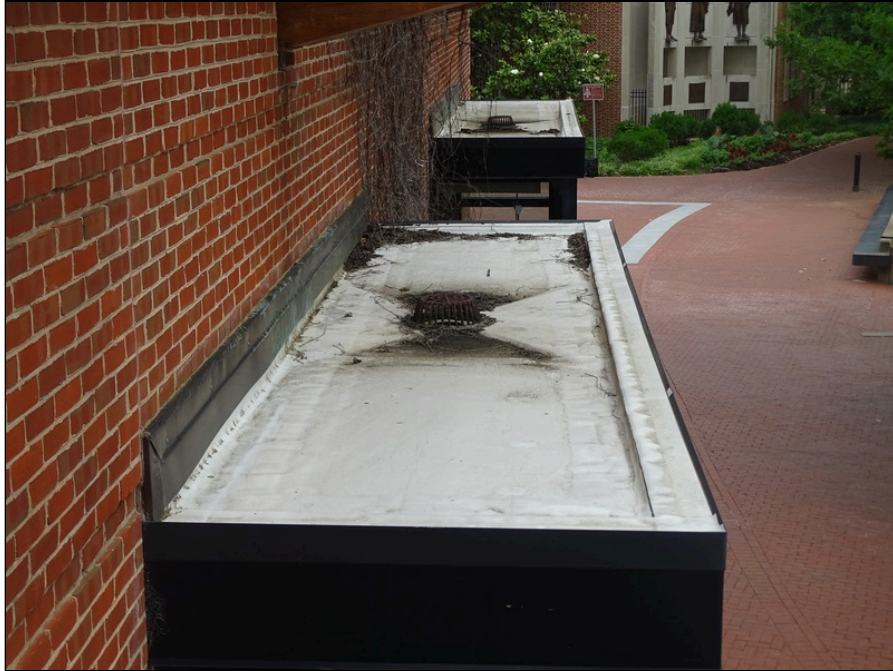
35 - Single-ply membrane roofing system

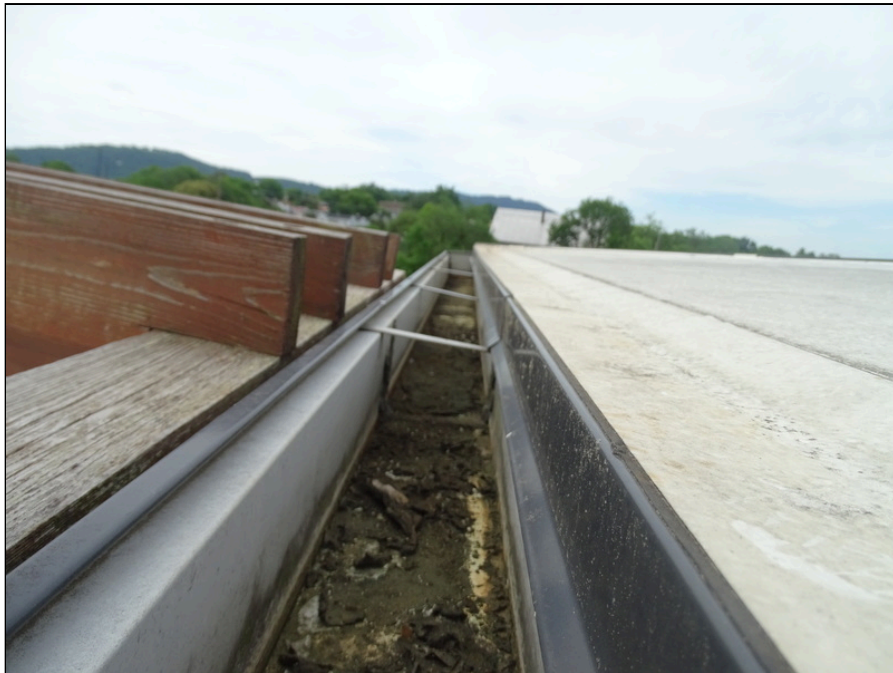
36 - Typical gutter

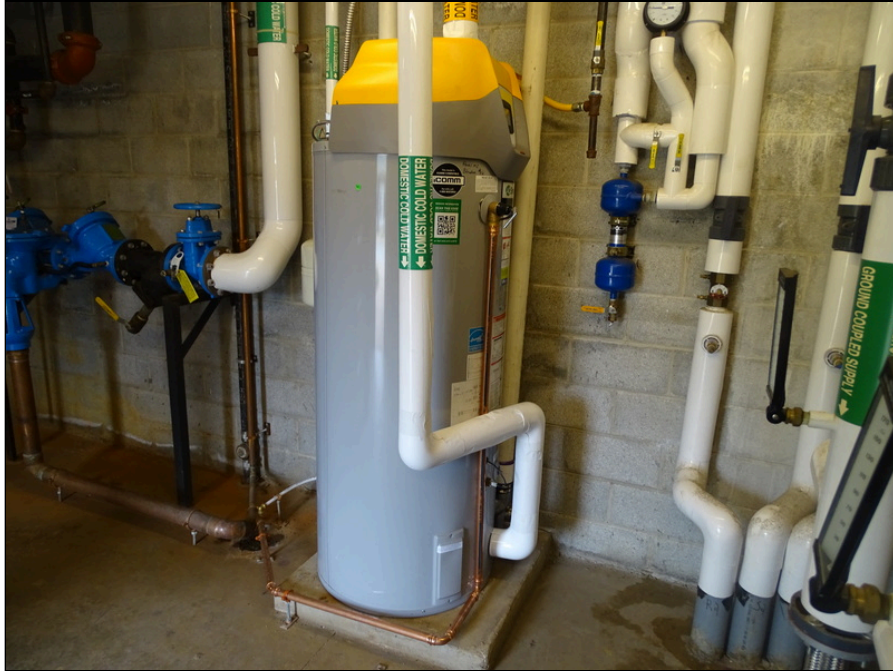
37 - Gas domestic water heater

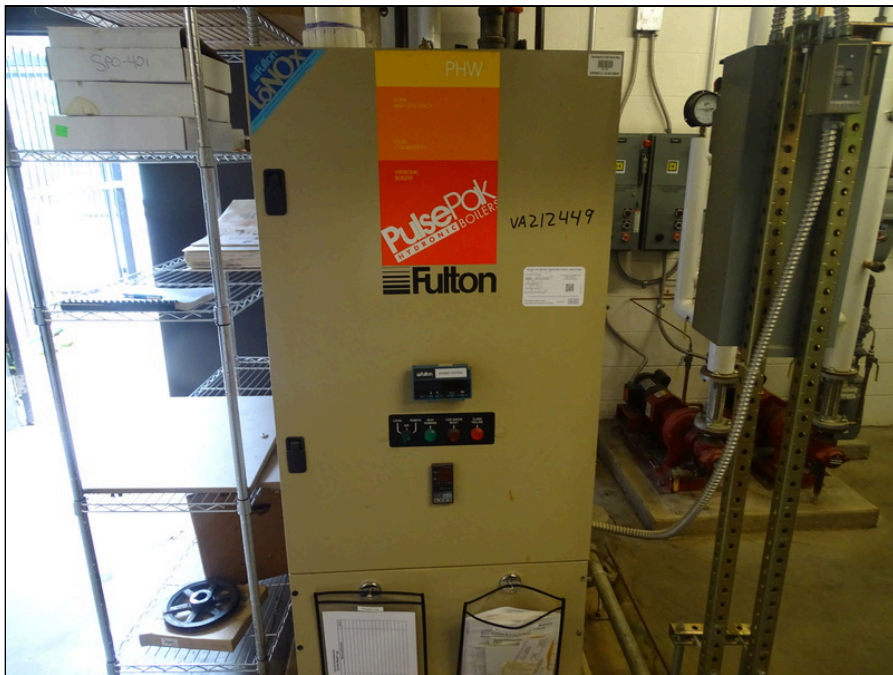
38 - Boiler located in main utility room

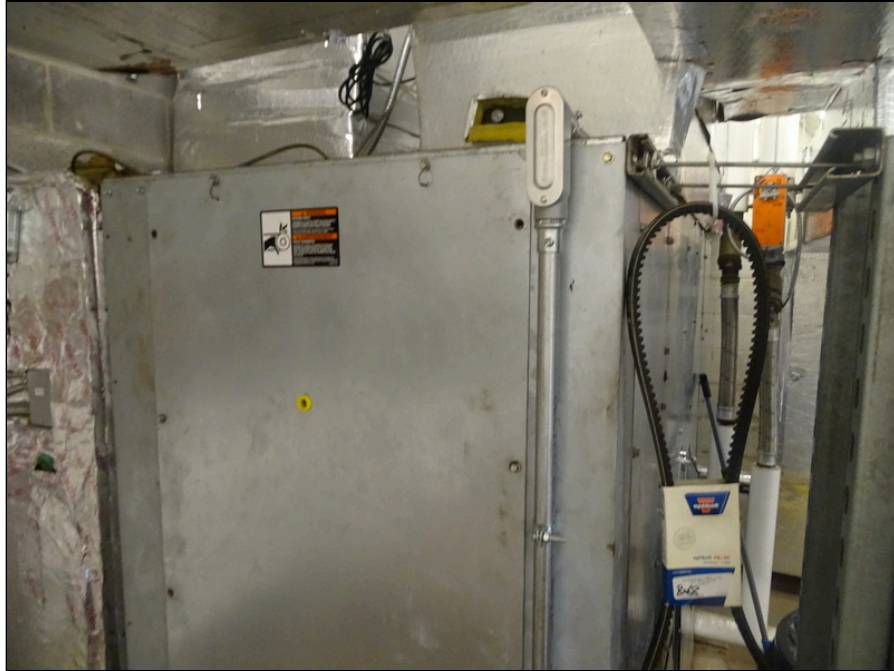
39 - Package air conditioning equipment located in main utility room

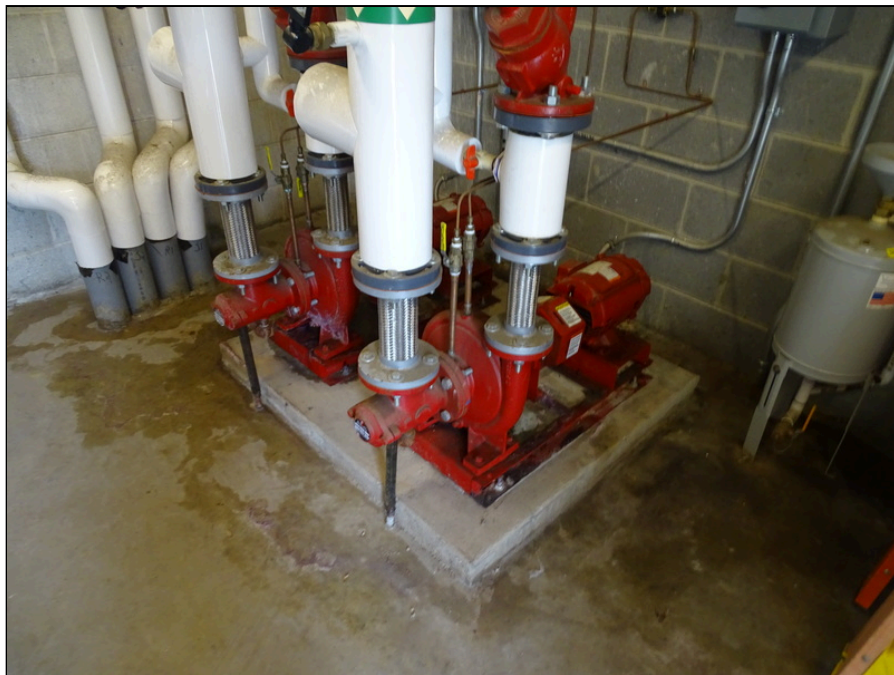
40 - Typical central plant pumps

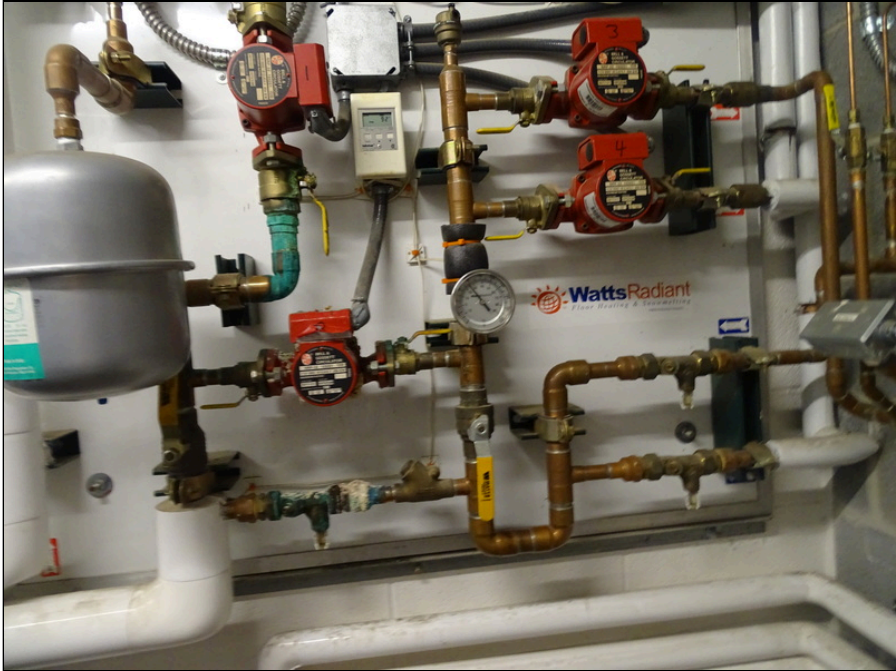
41 - Radiant floor heating system

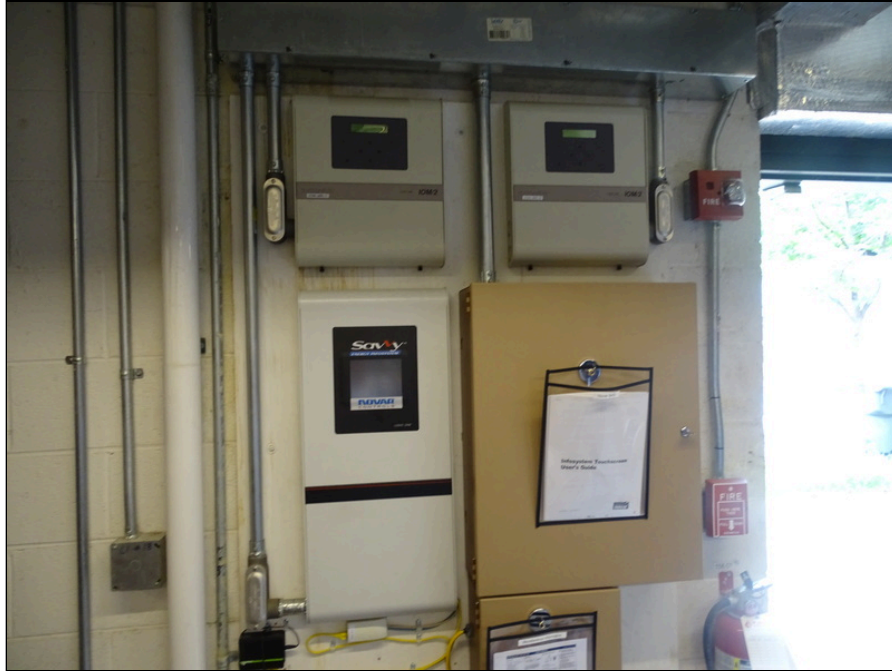
43 - Energy Management System

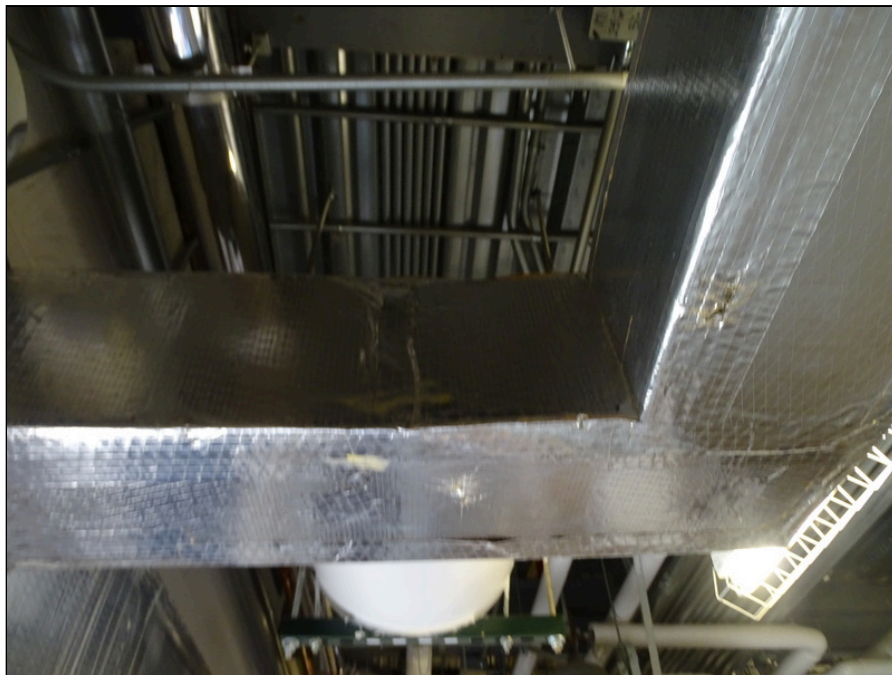
44 - Typical mechanical duct

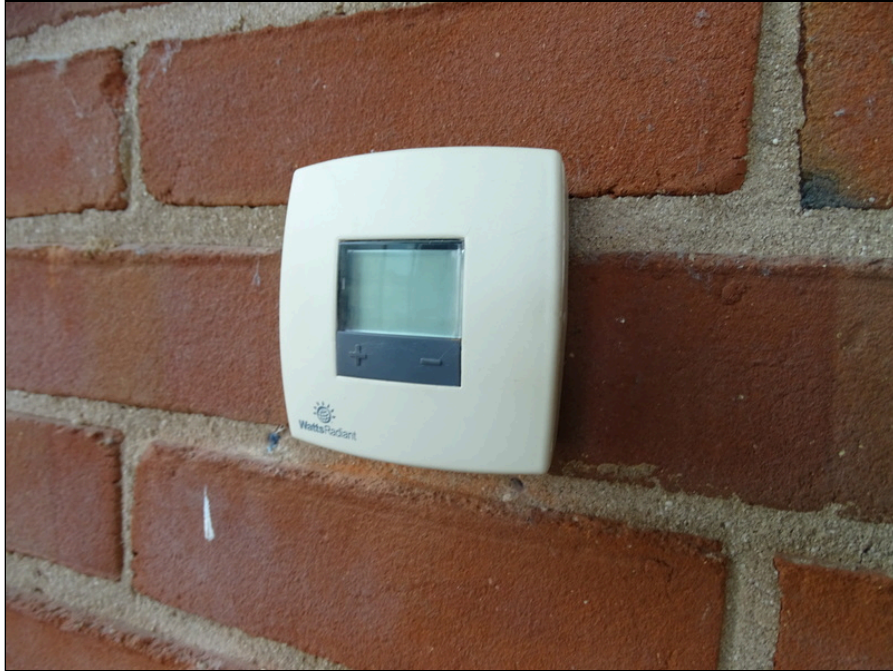
45 - Typical thermostat control

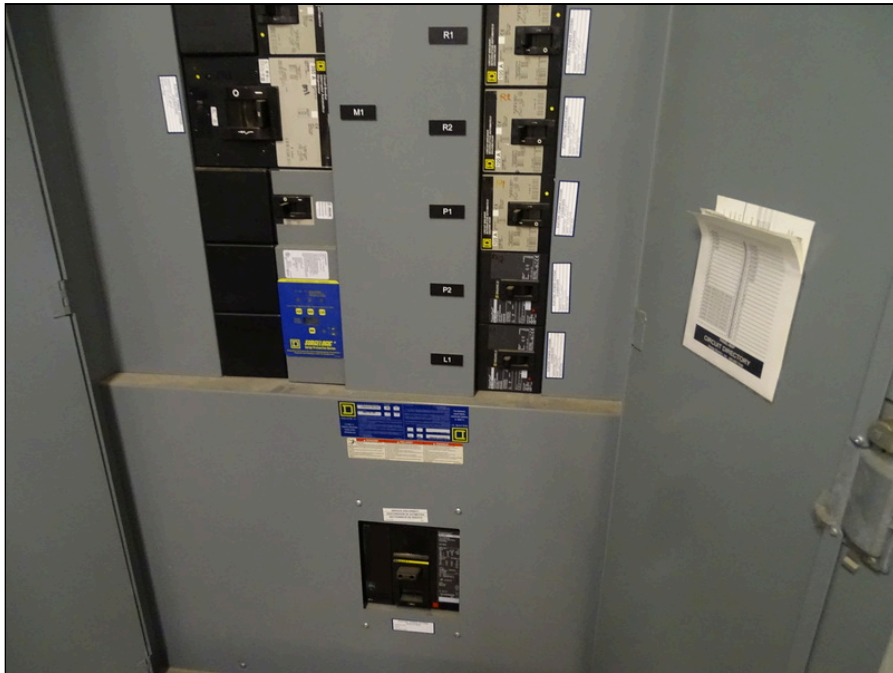
46 - Main electrical switchgear

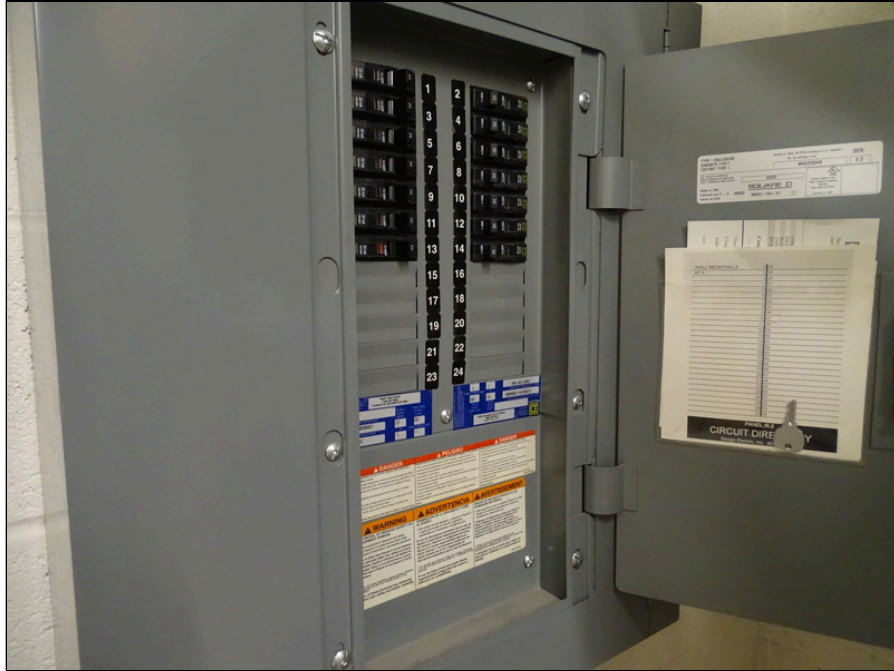
47 - Typical electrical circuit breaker panel

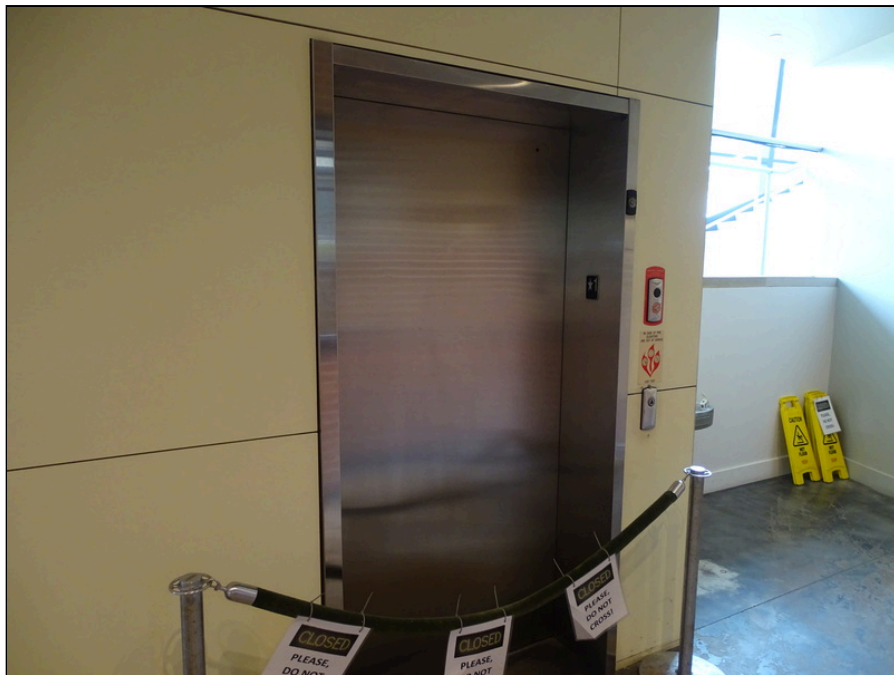
48 - Elevator system

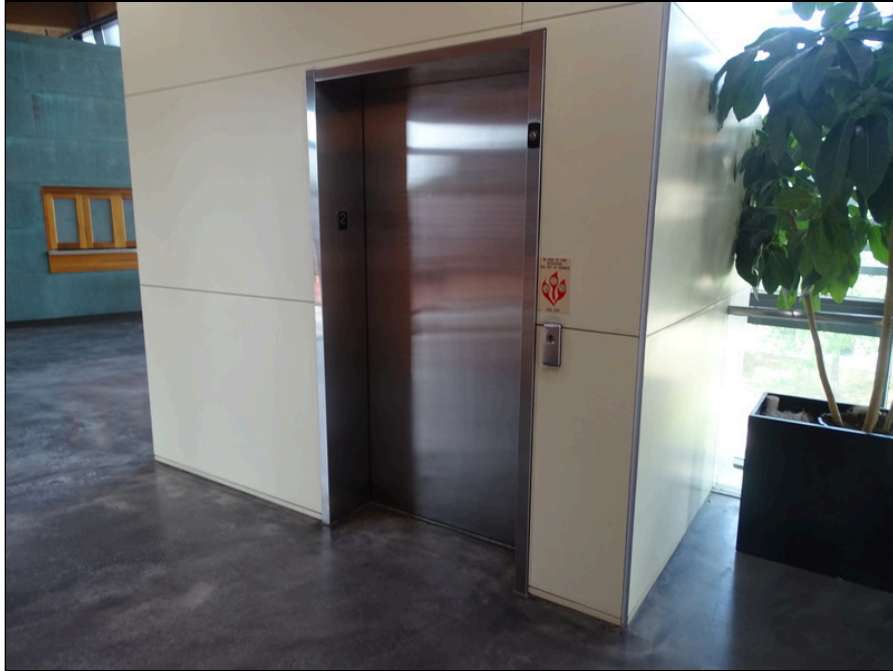
49 - Elevator system

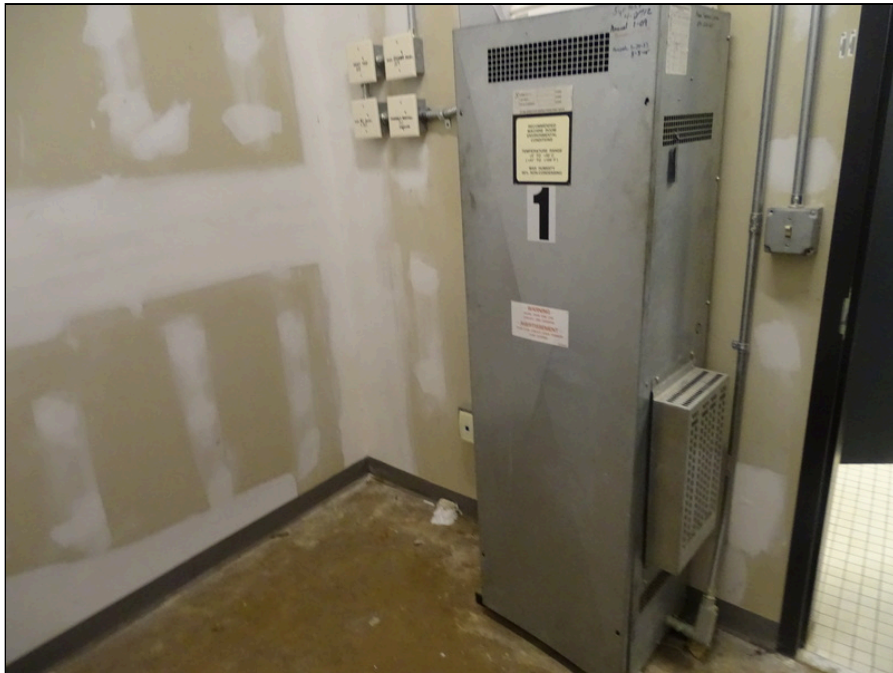
50 - Elevator machine and controls

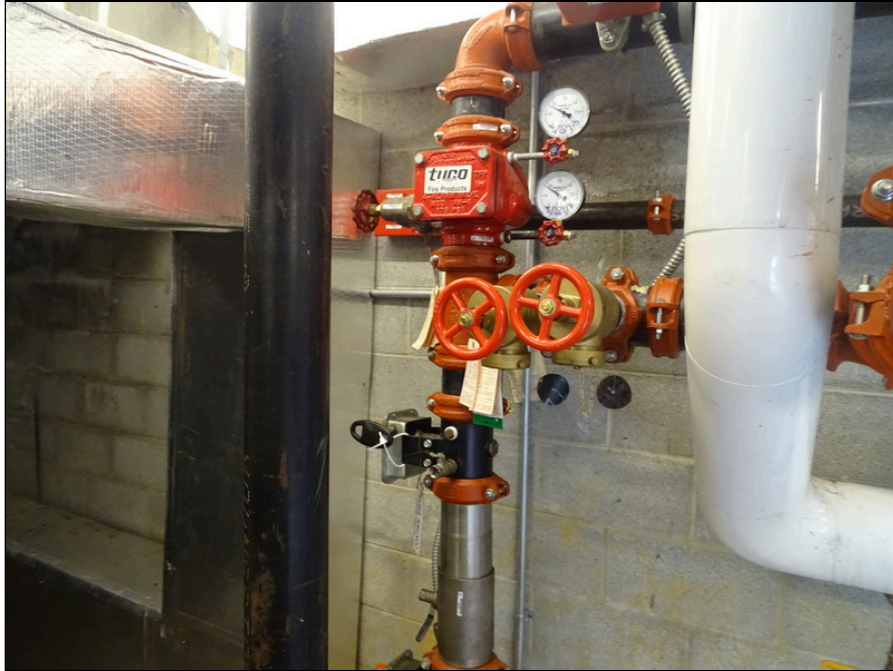
51 - Fire sprinkler system

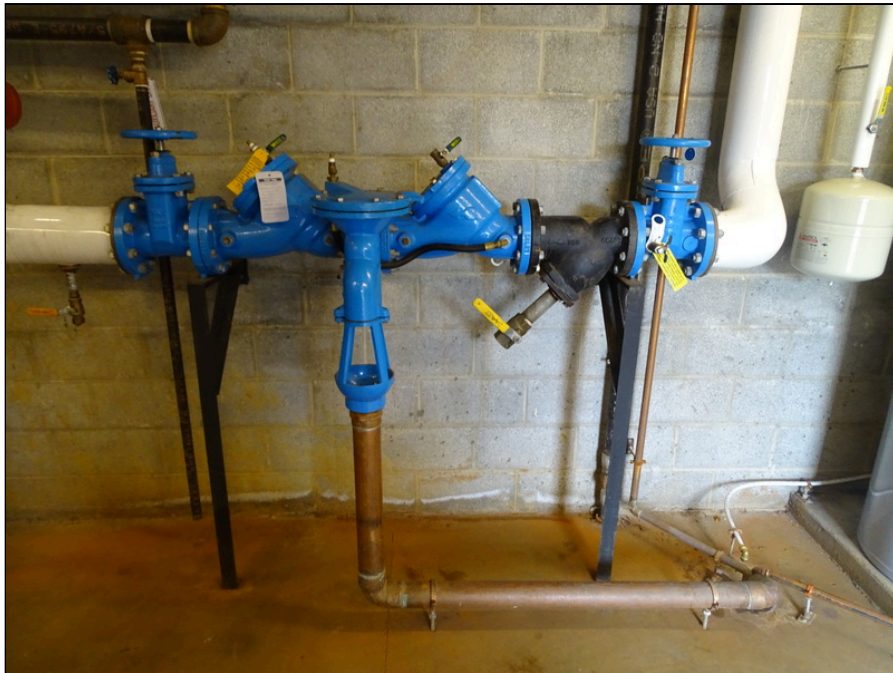
52 - Reduced Pressure Backflow Preventer

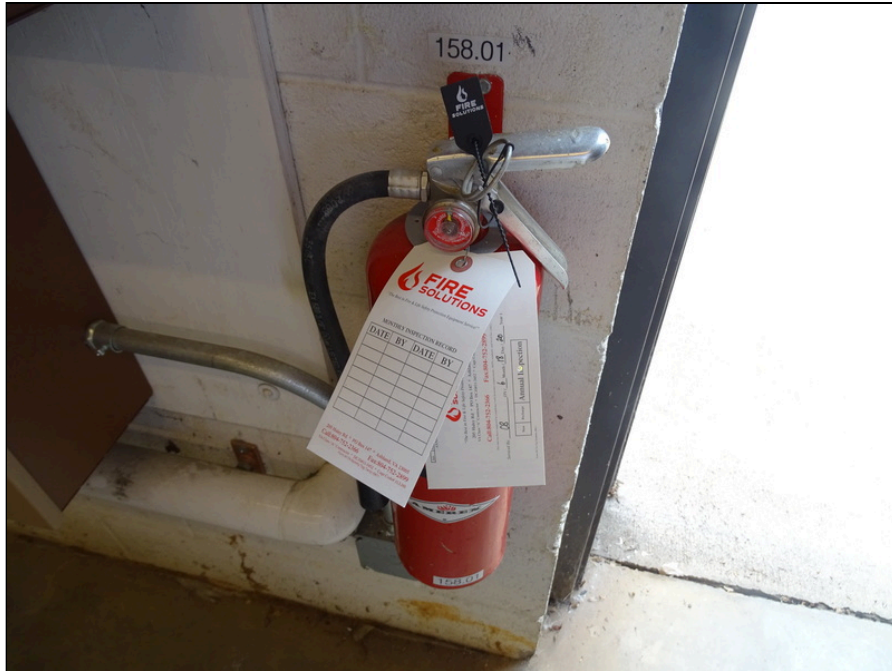
53 - Typical fire extinguisher

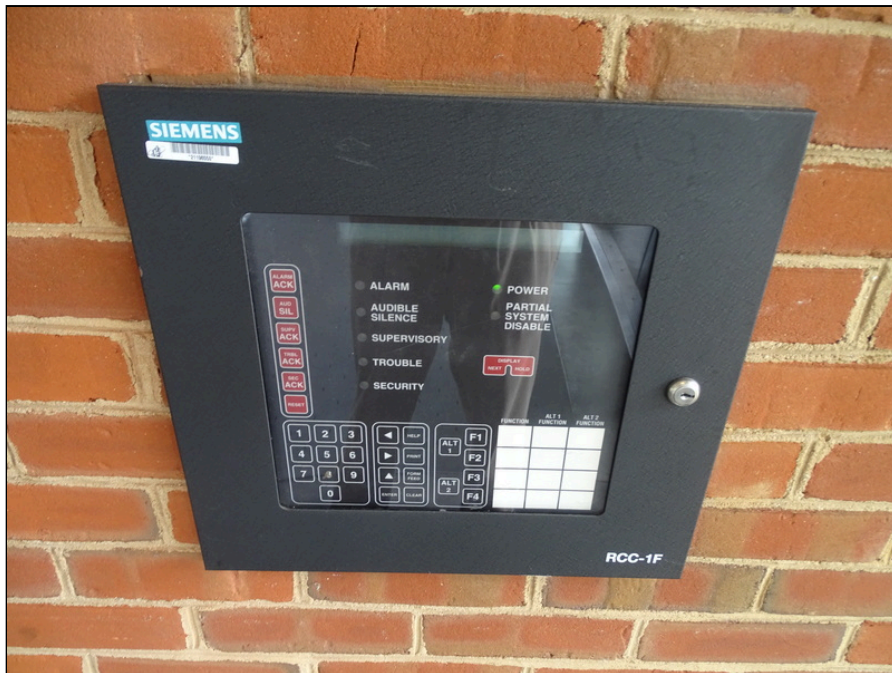
54 - Fire alarm annunciator

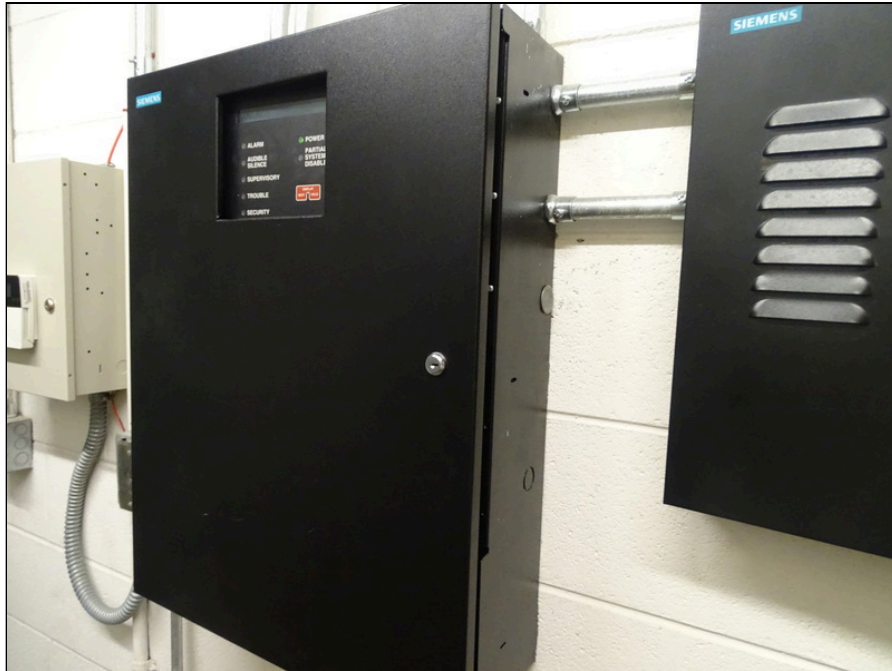
55 - Fire Alarm control panel

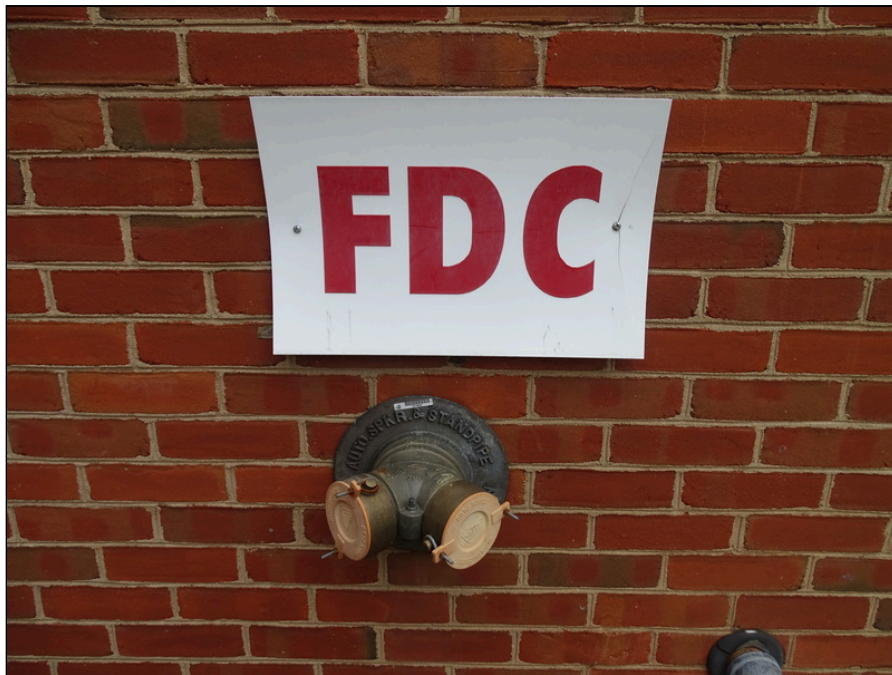
56 - Fire Department connections

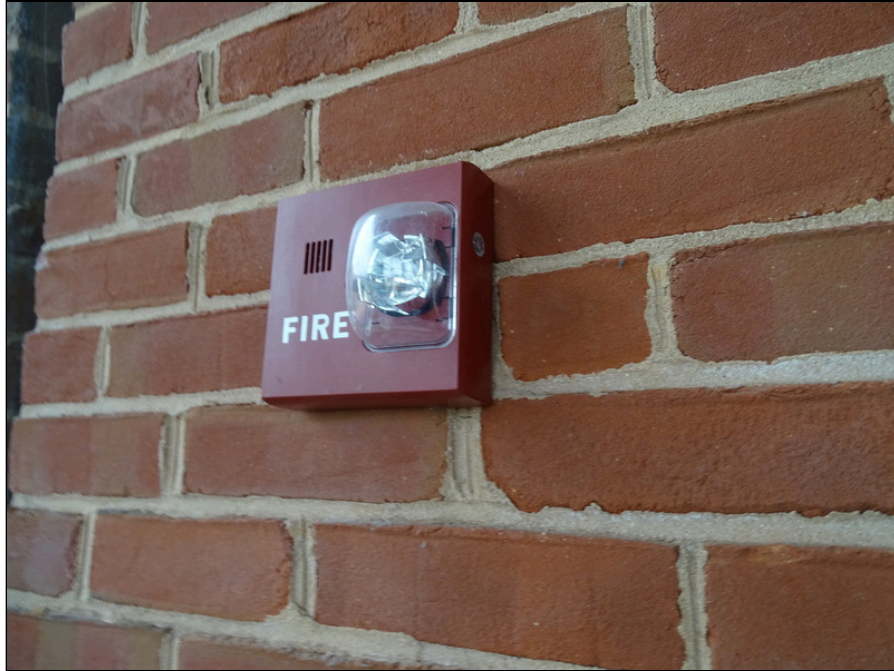
57 - Typical fire alarm bell and strobe

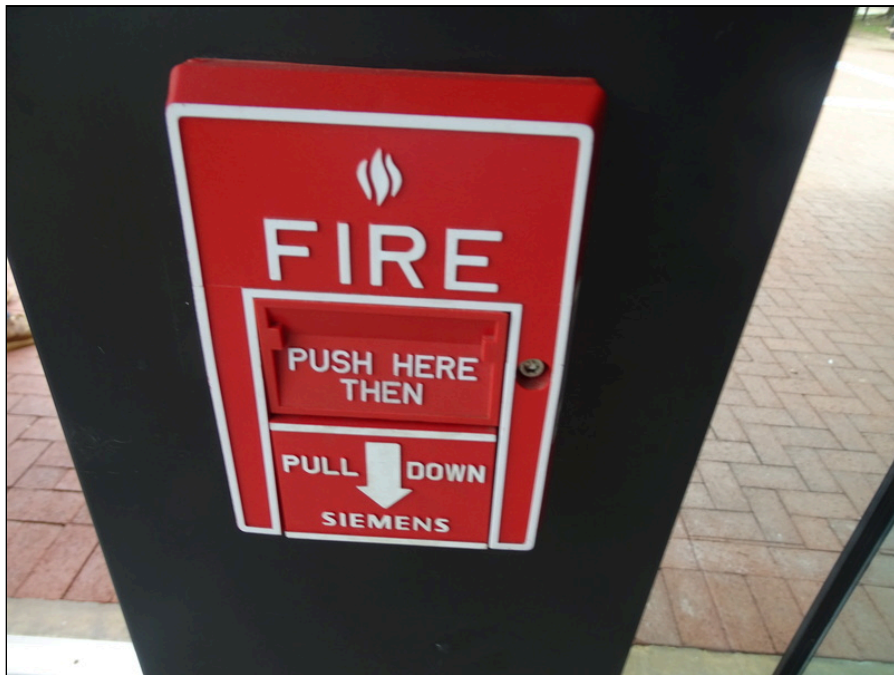
58 - Typical fire alarm pull station

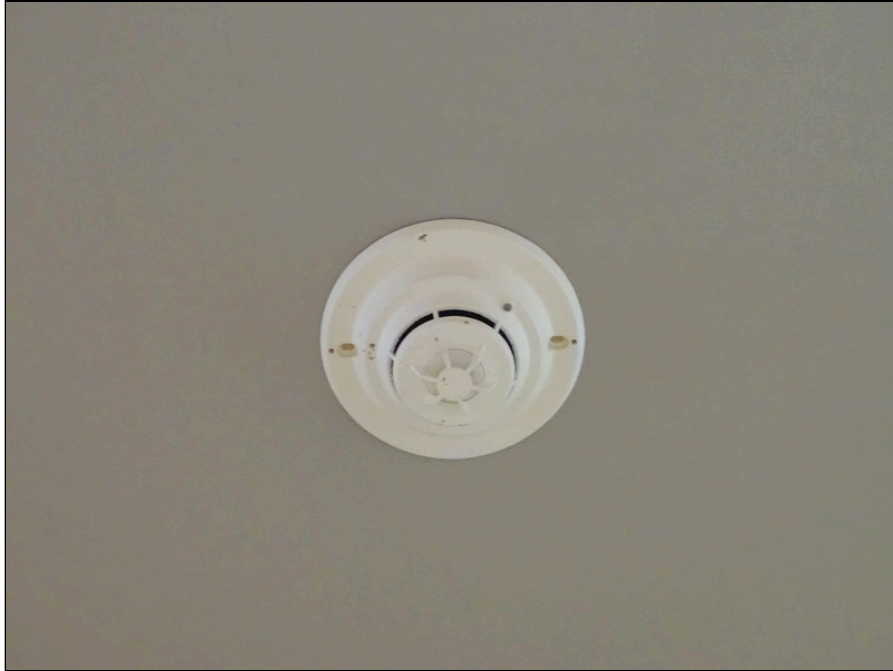
59 - Typical smoke detector

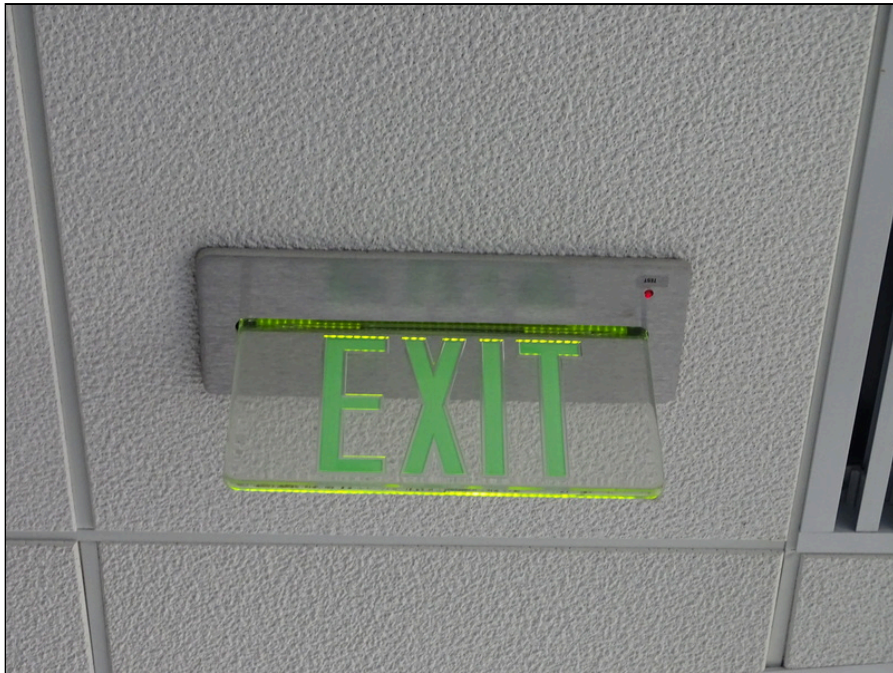
60 - Typical exit sign

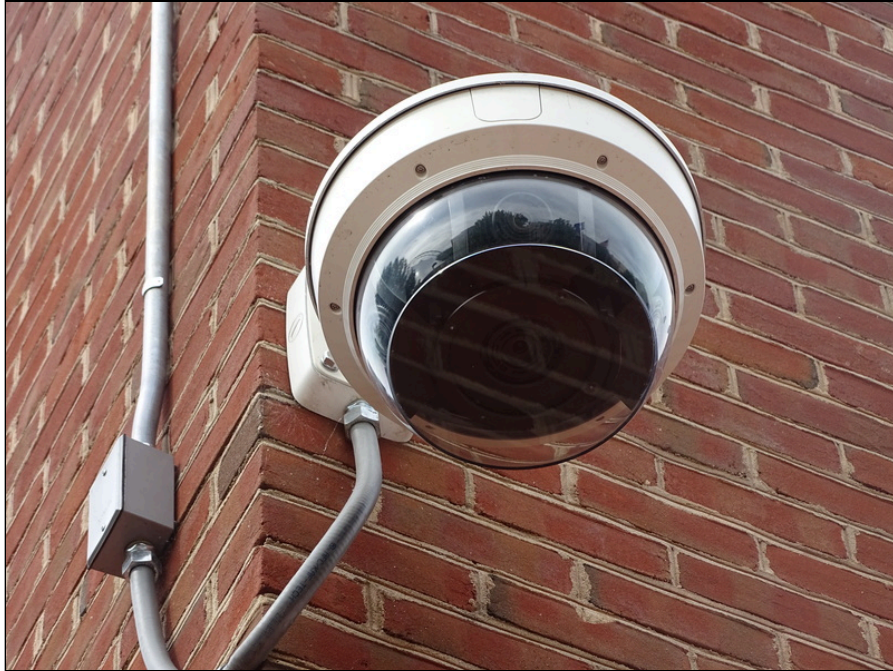
61 - Typical security camera

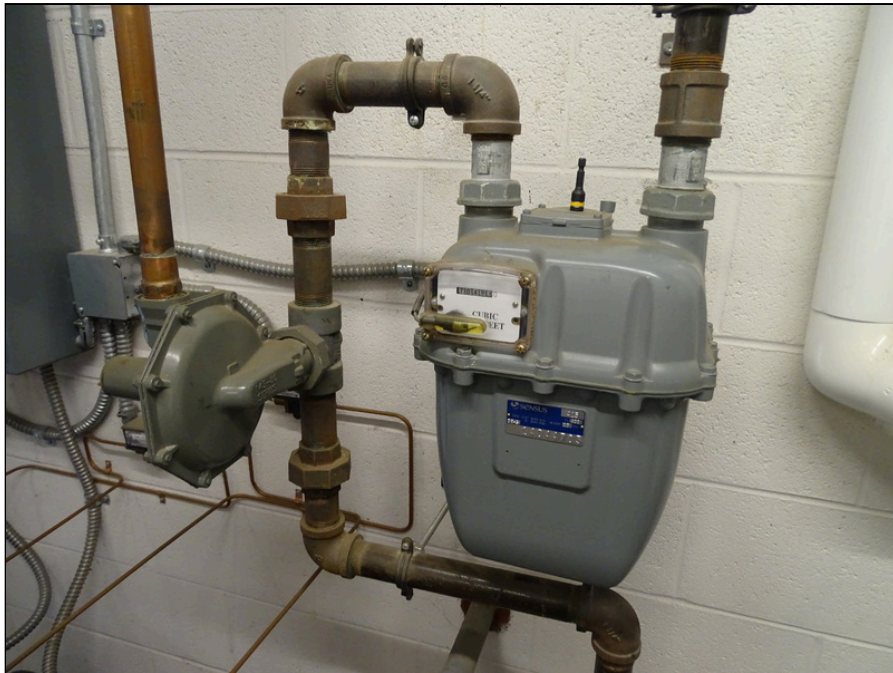
62 - Typical gas meter

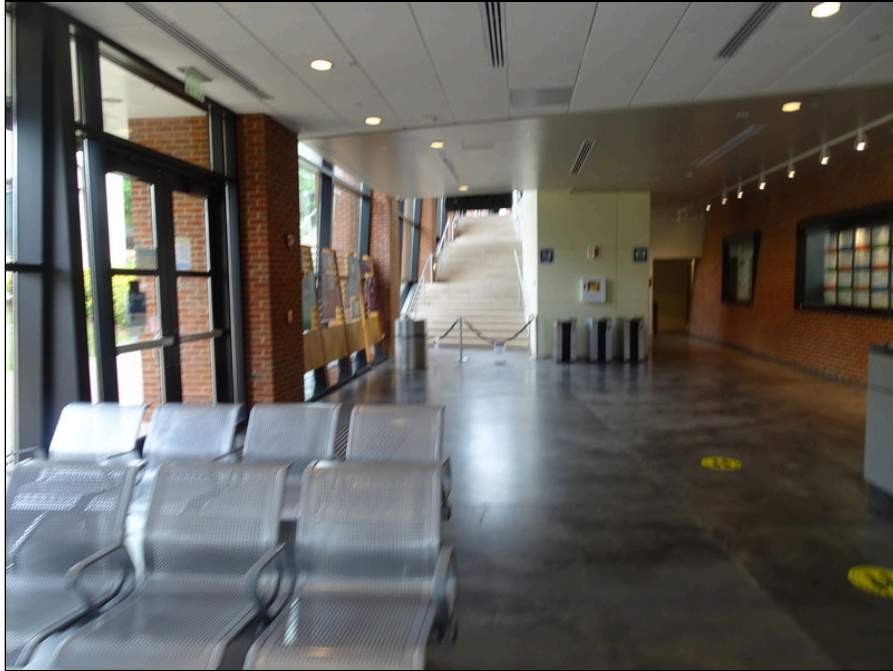
63 - Interior finishes public waiting and assembly area

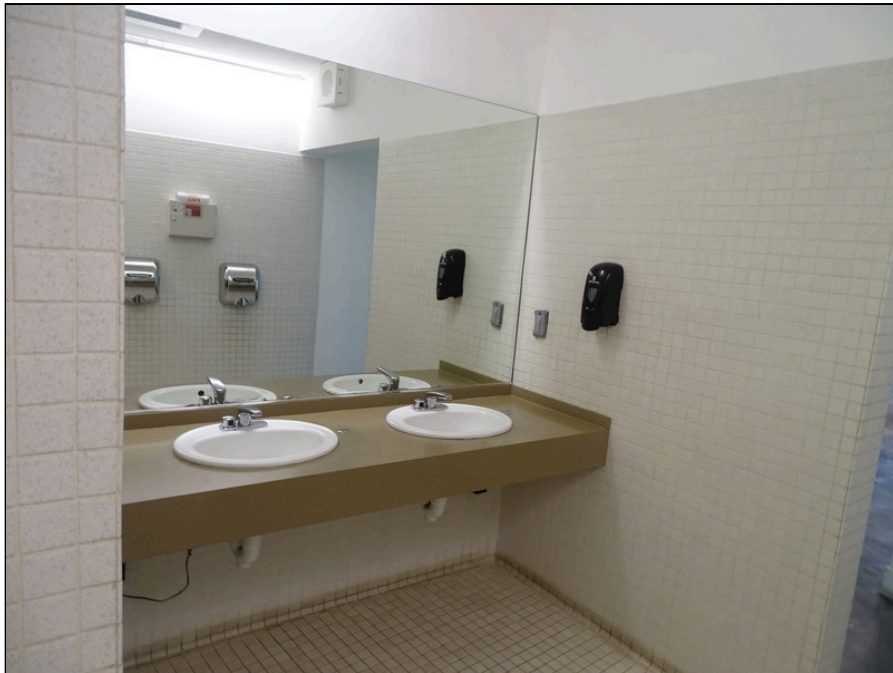
64 - Interior finishes restroom area

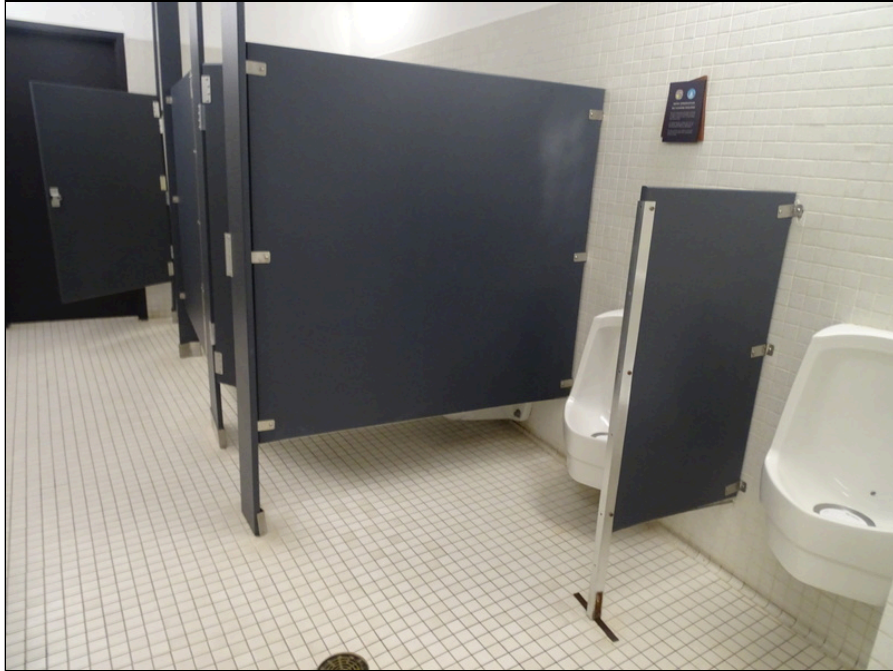
65 - Interior finishes restroom area

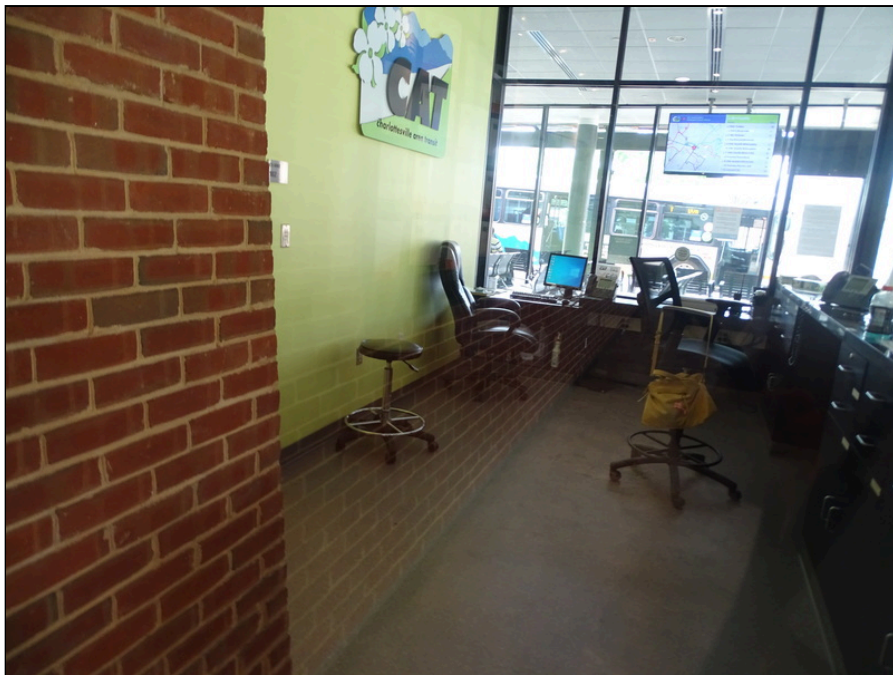
66 - Interior finishes Transit office area

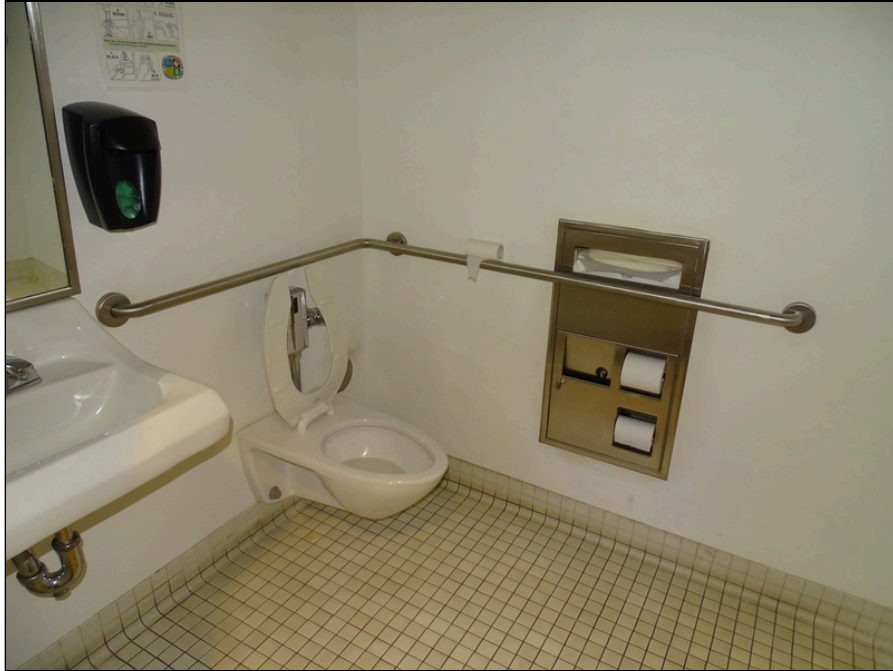
67 - Interior finishes tenant space restroom area

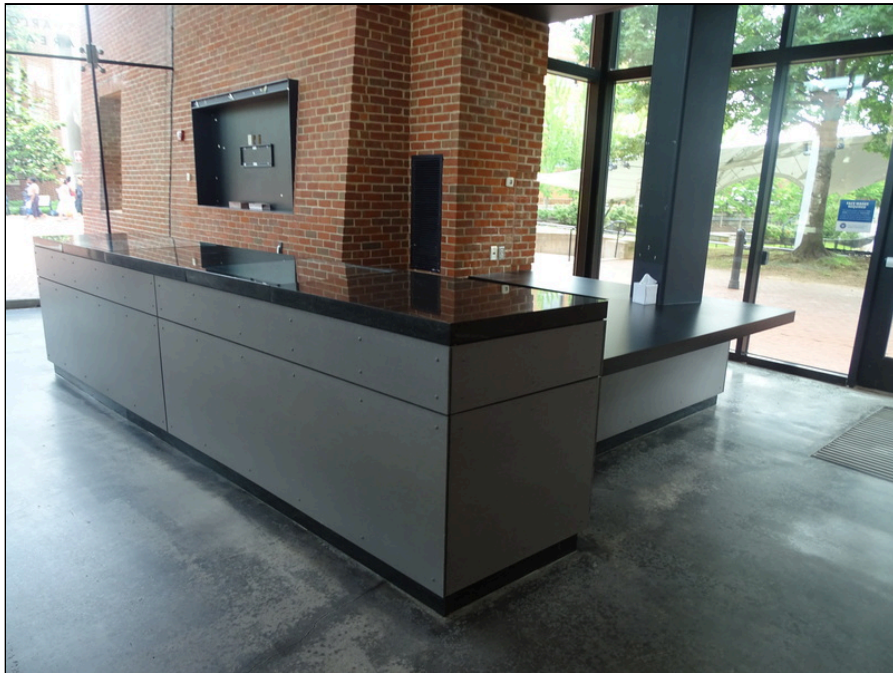
68 - Interior finishes Lobby area

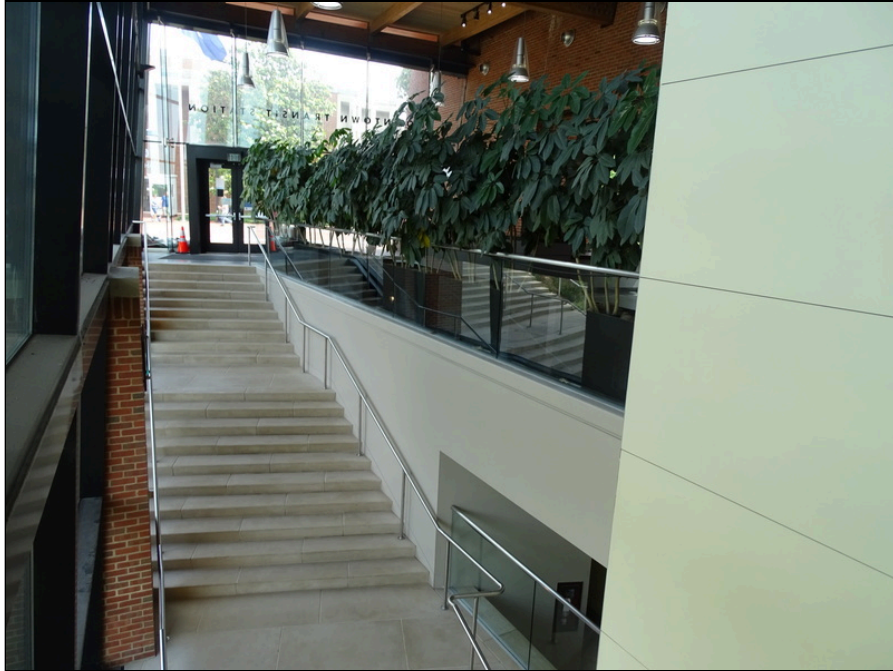
69 - Interior finishes stairs area

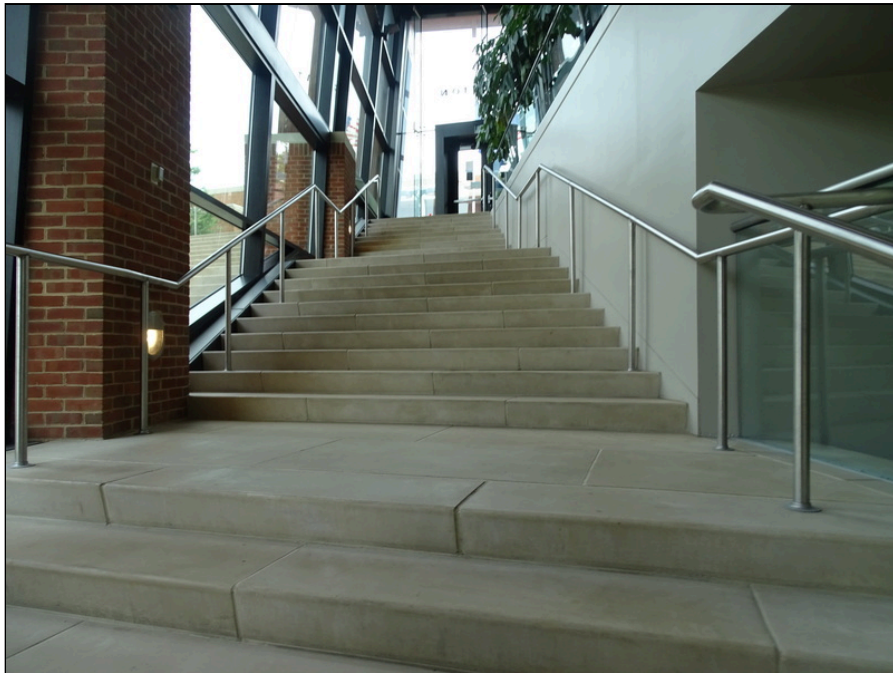
70 - Interior finishes stairs area

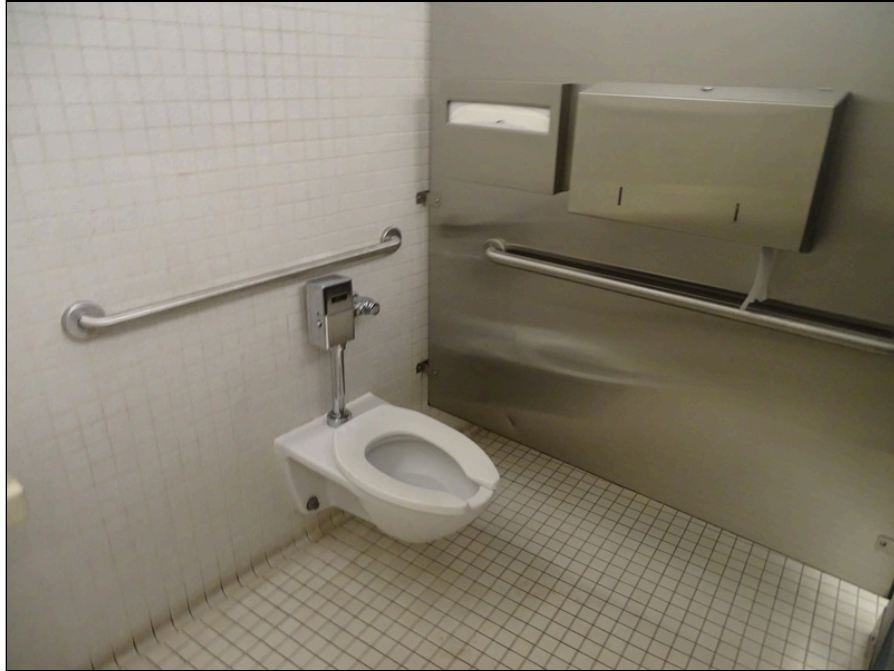
71 - Accessible toilet

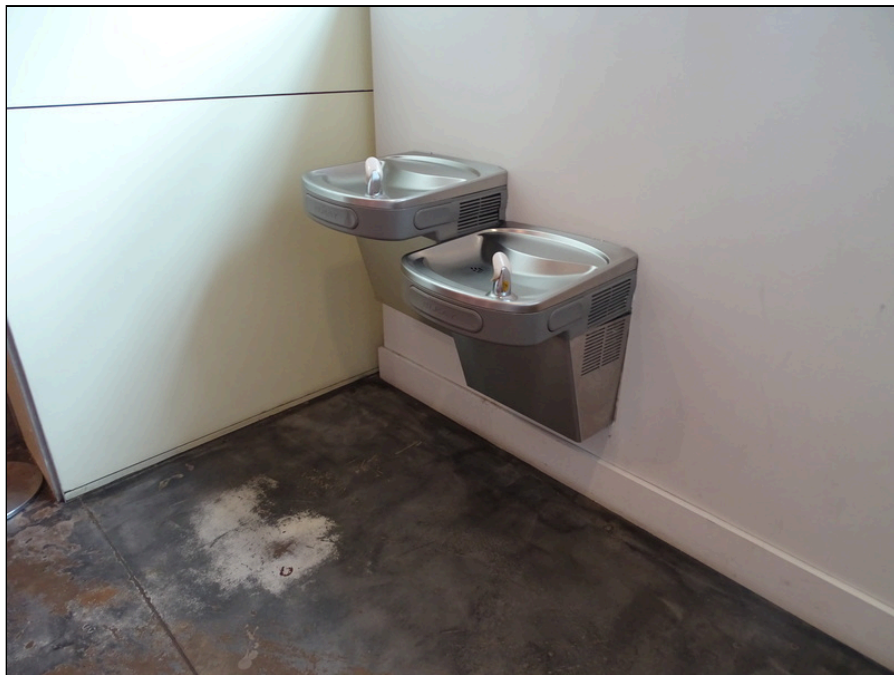
72 - Accessible drinking fountains
