DOWNTOWN TRANSIT CENTER
615 WATER STREET
CHARLOTTESVILLE, VIRGINIA

ECS PROJECT NO. 46:6713

CITY OF CHARLOTTESVILLE - FACILITIES DEVELOPMENT

Reference: Facility Condition Assessment Report for Downtown Transit Center, 615 Water Street,
Charlottesville, Virginia

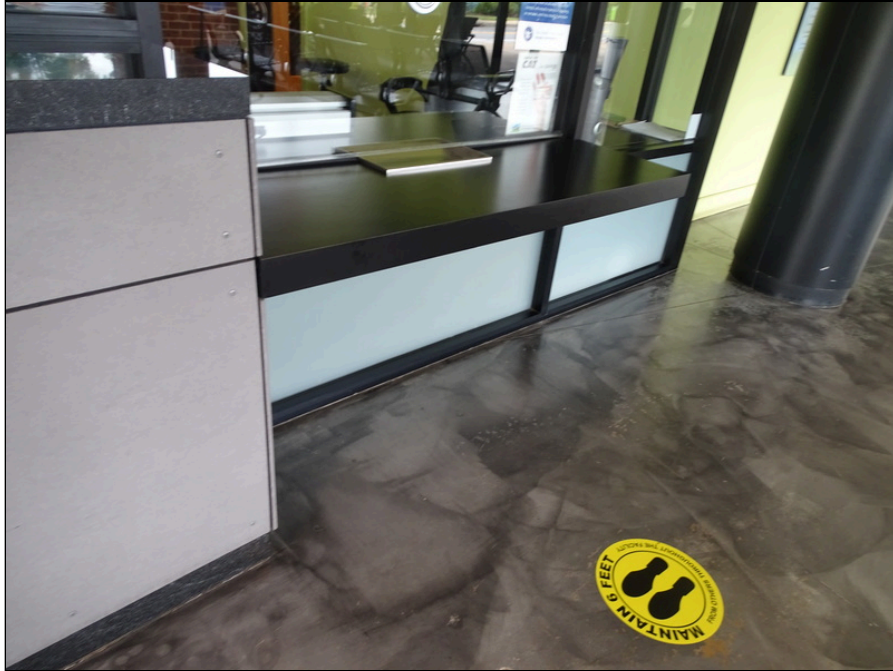
73 - Accessible counter for commercial transactions
