CAT OPERATIONS CENTER  
1545 AVON STREET EXT  
CHARLOTTESVILLE, VIRGINIA

ECS PROJECT NO. 46:6713

CITY OF CHARLOTTESVILLE - FACILITIES DEVELOPMENT

Reference: Facility Condition Assessment Report for CAT Operations Center, 1545 Avon Street Ext,  
Charlottesville, Virginia

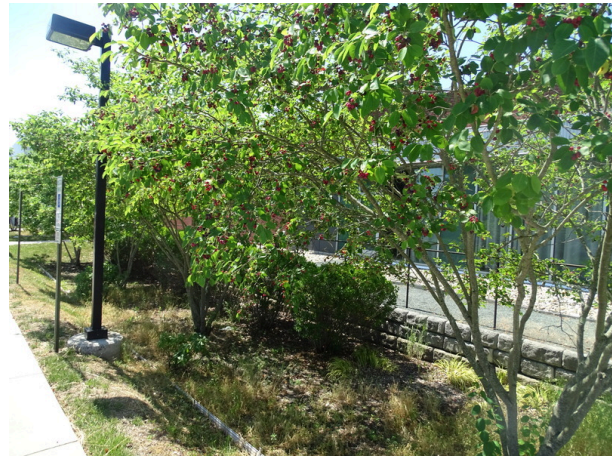
Typical landscaping

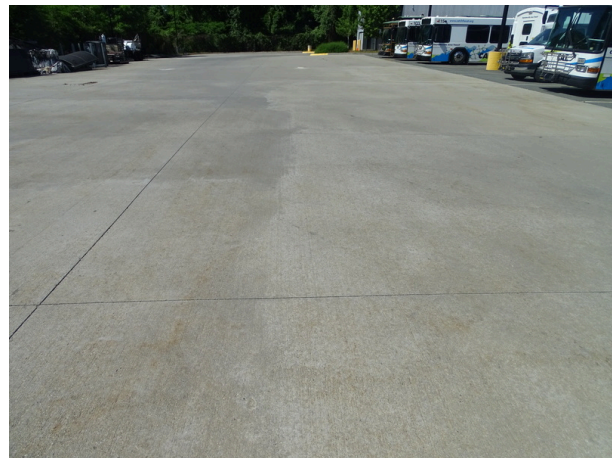
Concrete pavement at center of the site

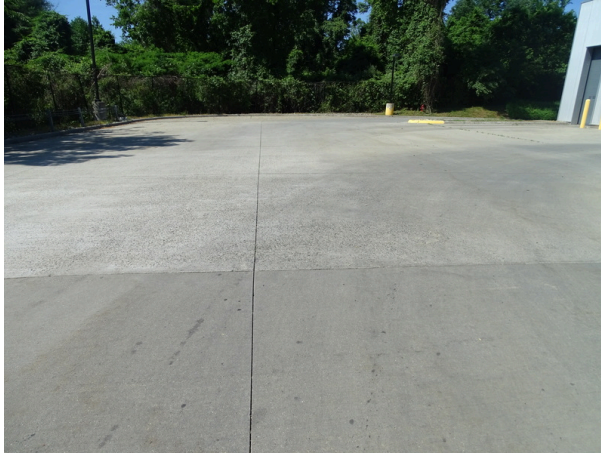
Concrete pavement at east side of the site

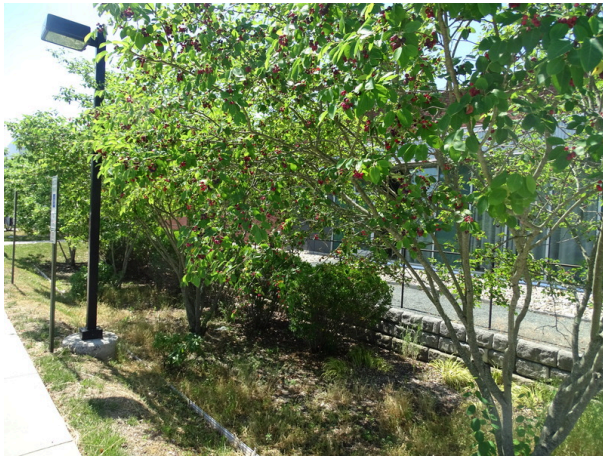
The landscaping consists of mature and sapling trees, small shrubs, and grassed areas around the site. The landscaping and bioretention areas were observed to be in generally good condition. Small landscaping retaining walls were located around Building A and appeared to be in good condition. A large retaining wall was located along the north side of the property and was in good condition. The fence on the east side of the bus parking area was observed to be in good condition.

Typical landscaping

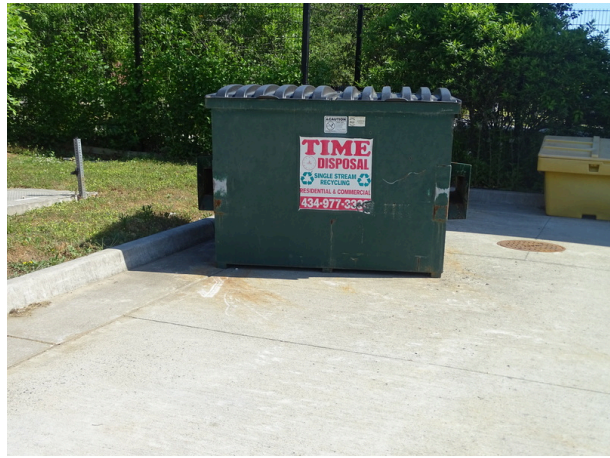
Dumpster area

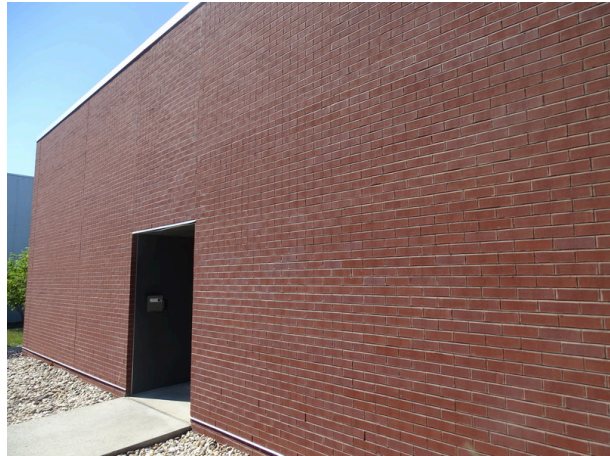
Building exteriors at Building A

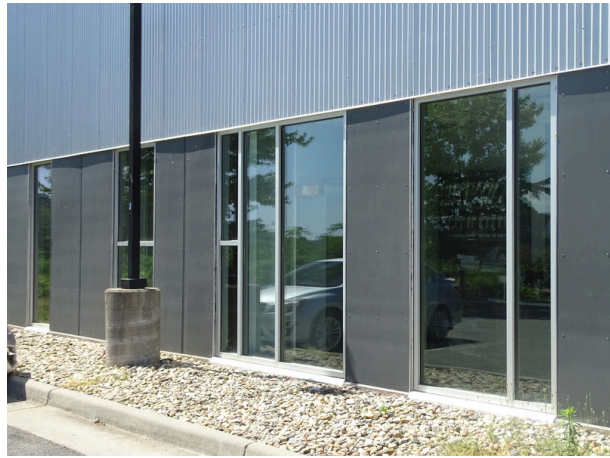
Building exteriors at Building B

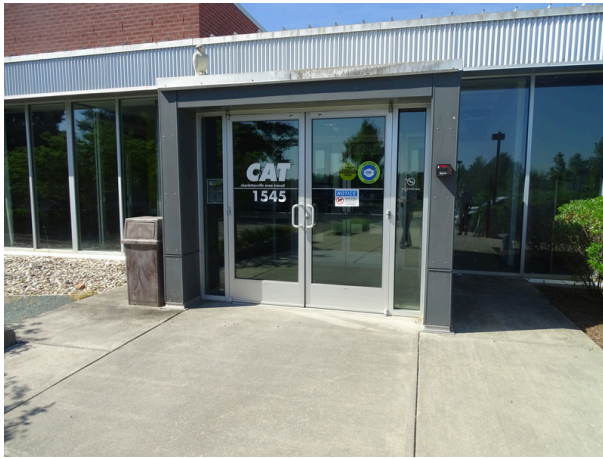
Entrance to Building A

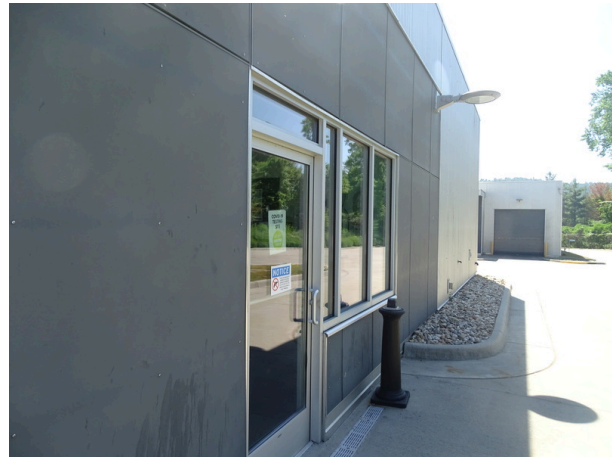
Entrance to Building C

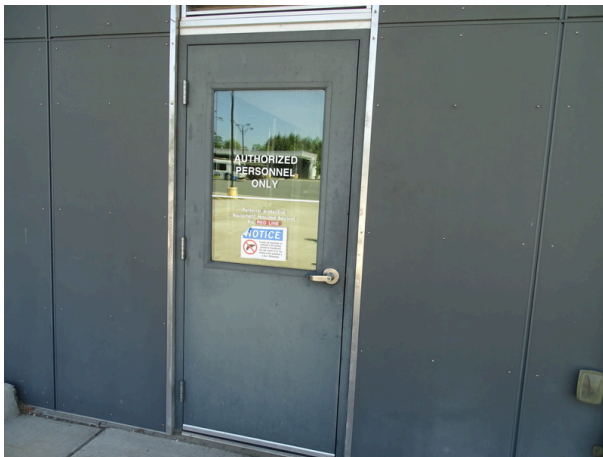
Personal door

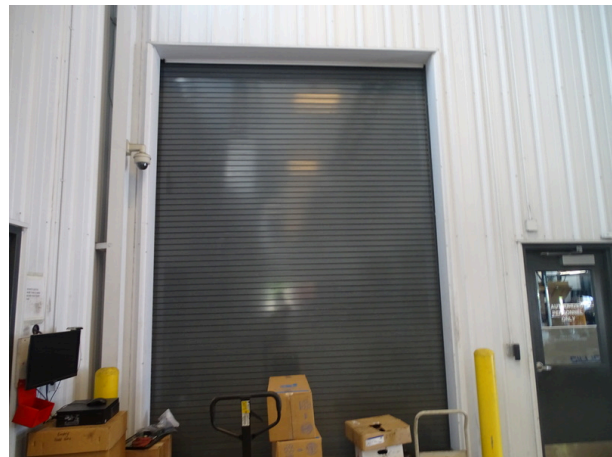
Overhead doors are located at Buildings B and D. The operation of the overhead doors was observed to be working well and were generally in good condition.

Overhead door

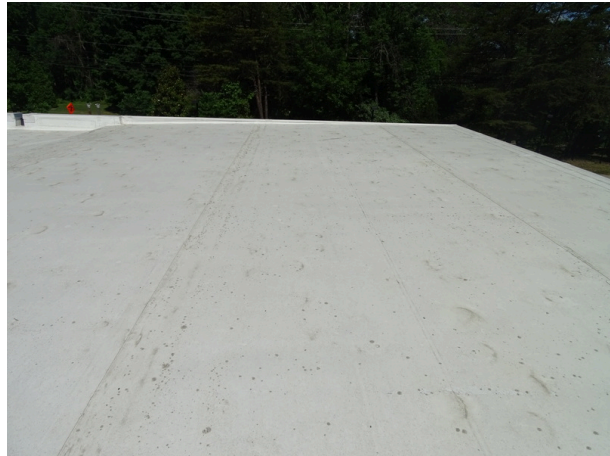
Building C roof

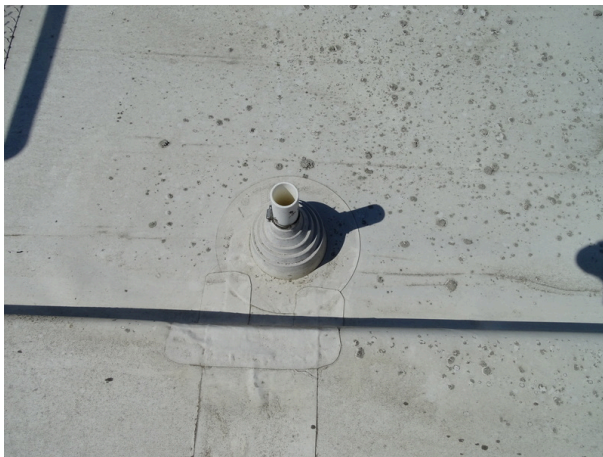
Building C roof - plumbing penetration

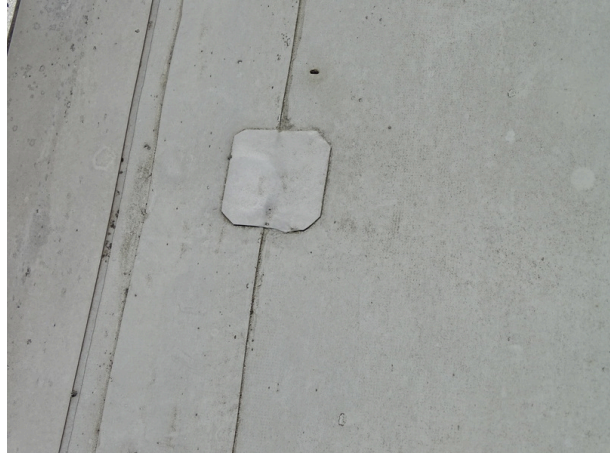
Building C roof - patching

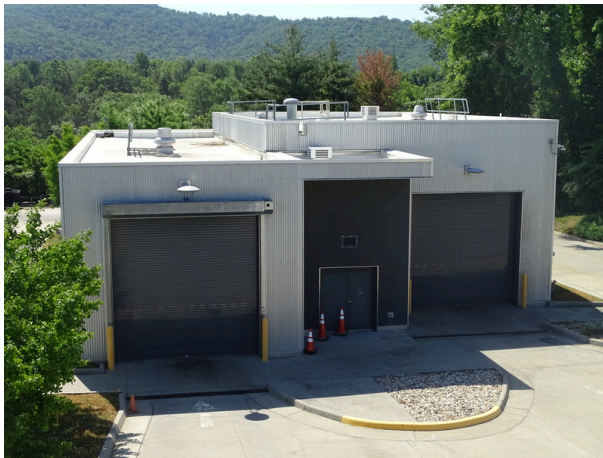
Building D roof

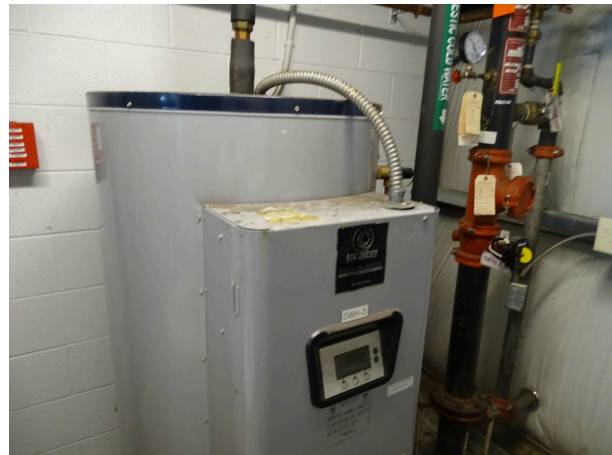
Building B water heater

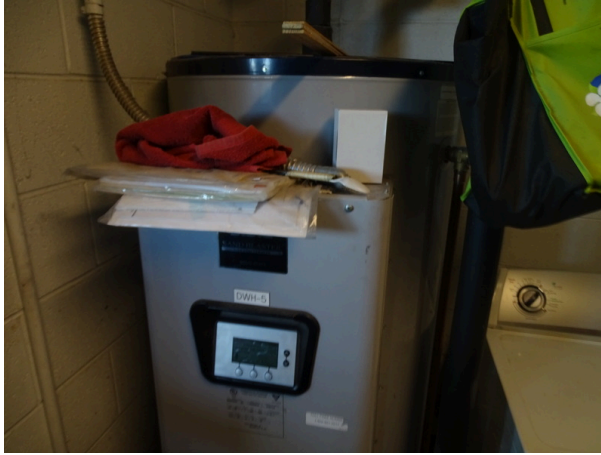
Building C water heater

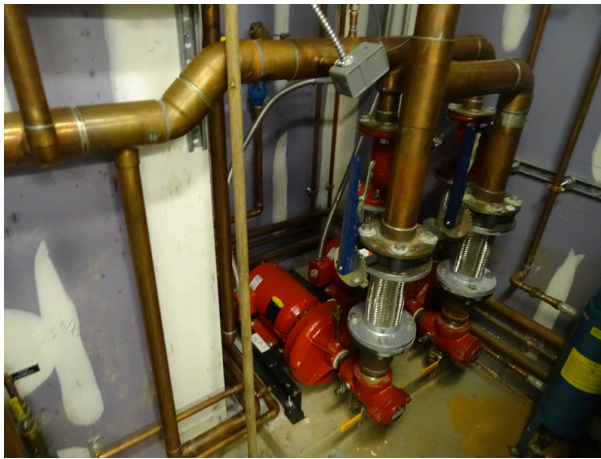
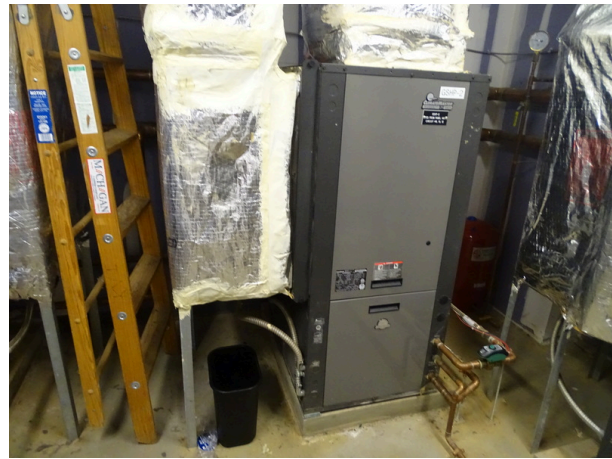
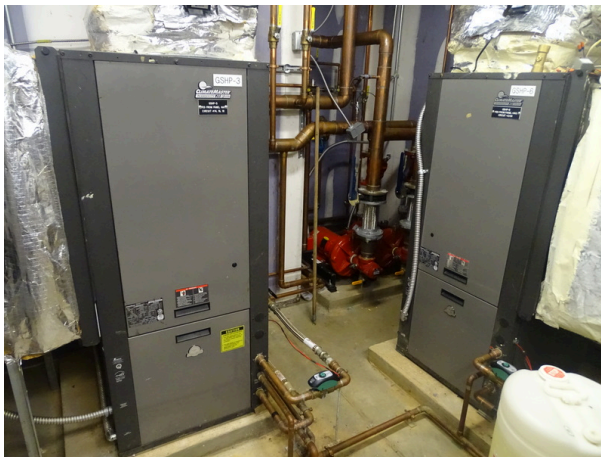
Building A geothermal heat pump

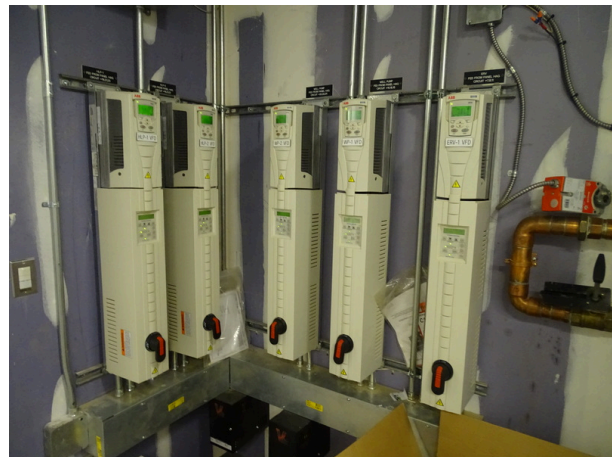
Building A VFDs

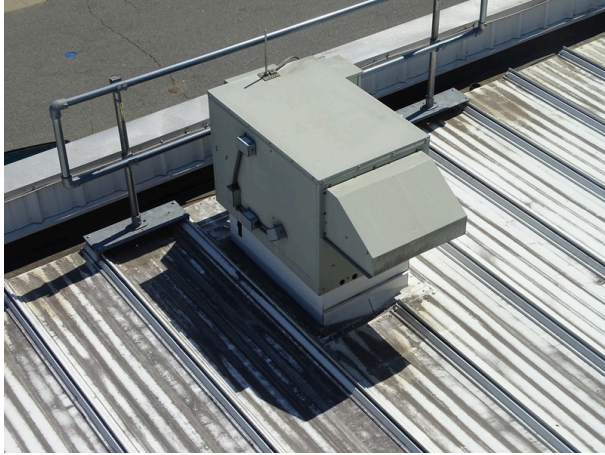
Building B energy recovery system

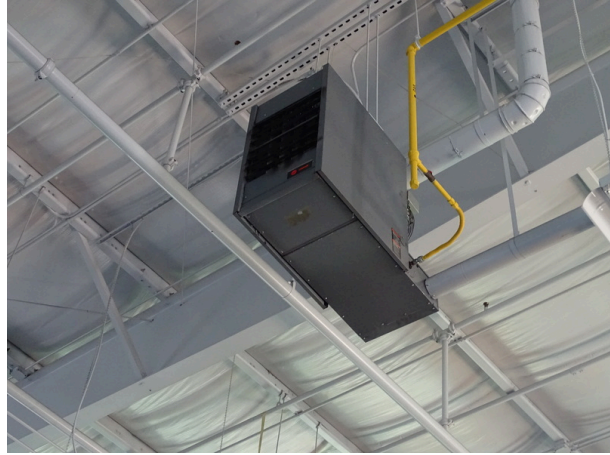
Building B unit heater

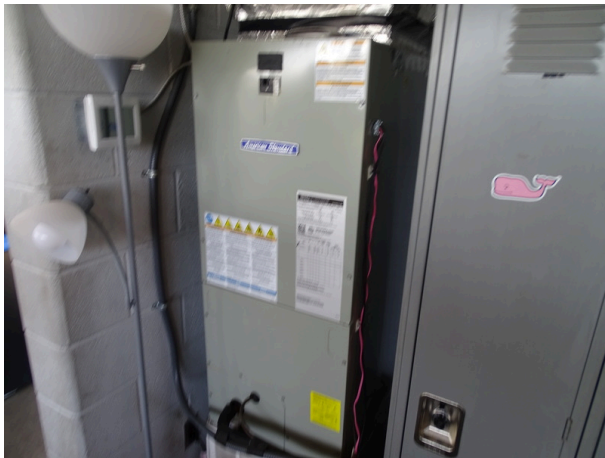
Building C electric heater and thermostat

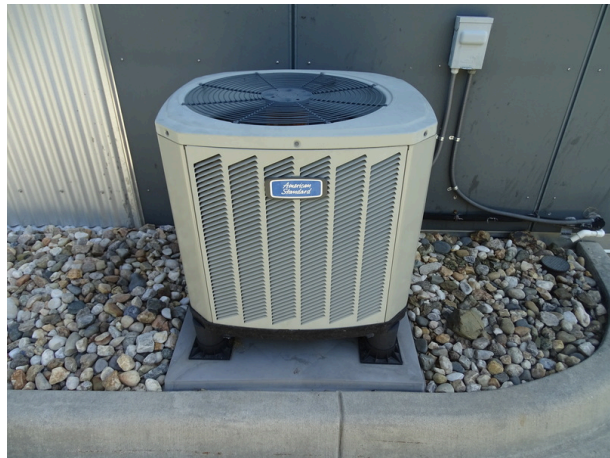
Building C condenser

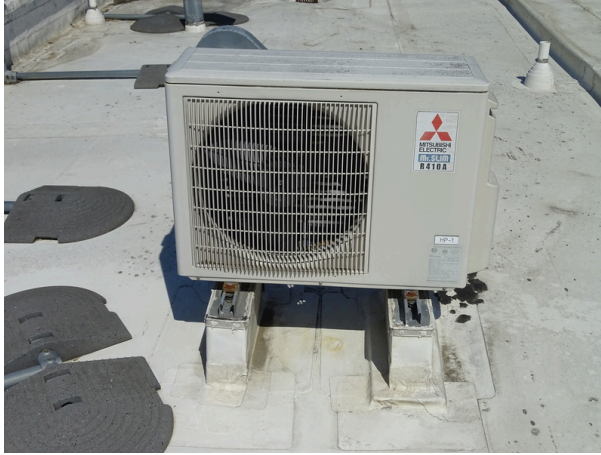
Building C split system

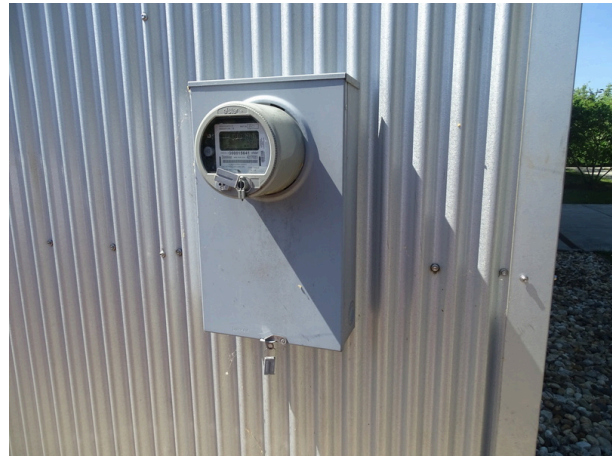
Electric meter

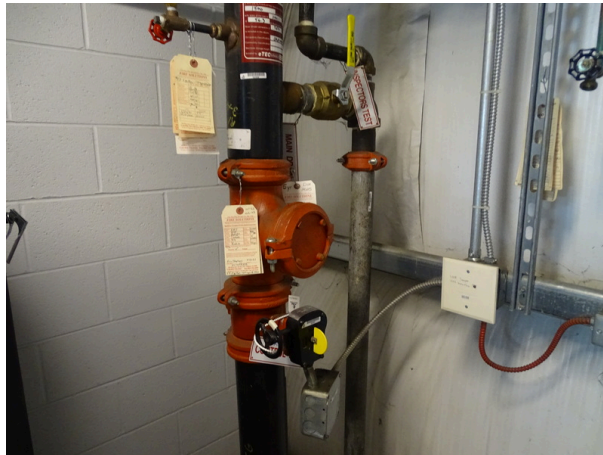
Building B sprinkler riser

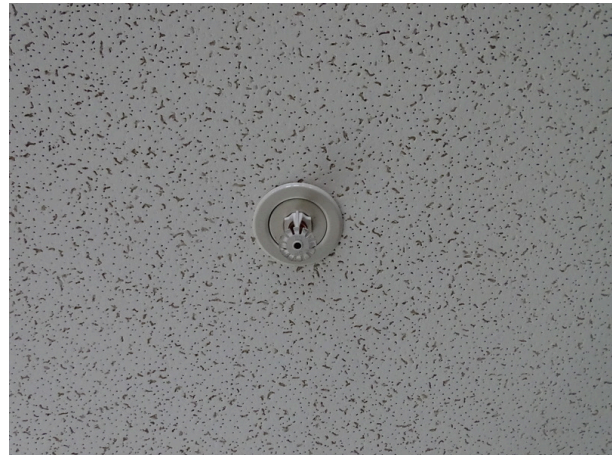
Sprinkler head

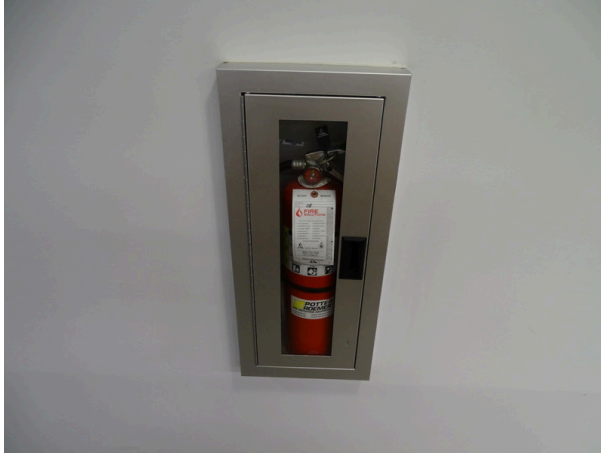
Building A fire extinguisher

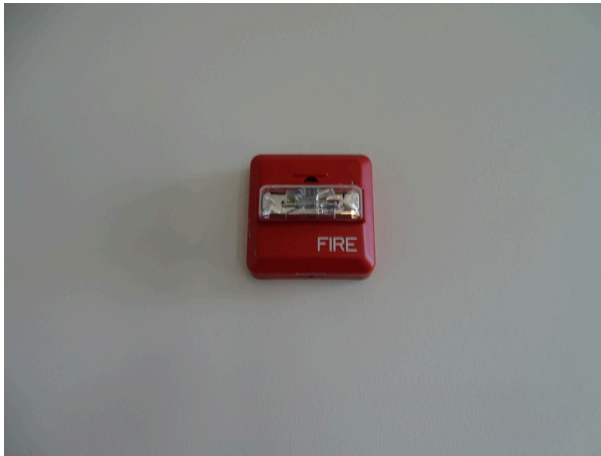
Building A strobe

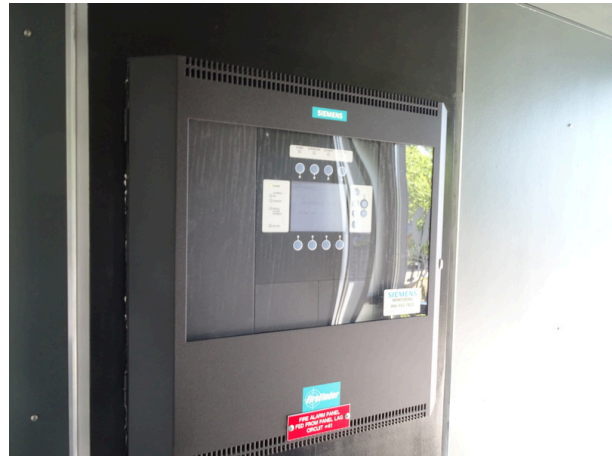
Building A alarm panel

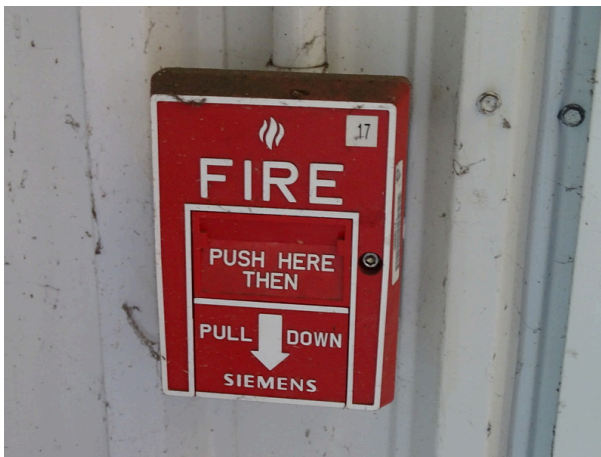
Building B pull station

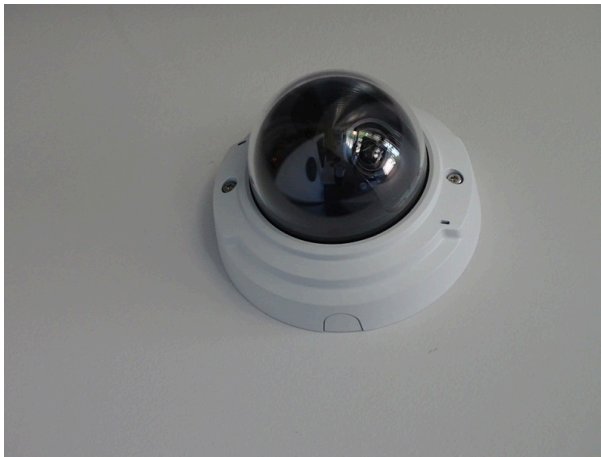
Building A interior security camera

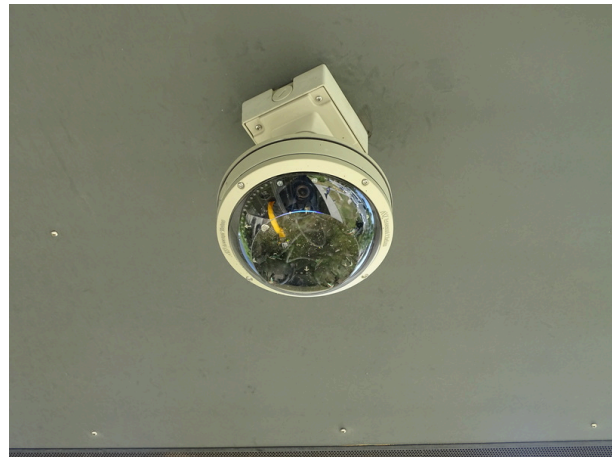
Building interior security camera

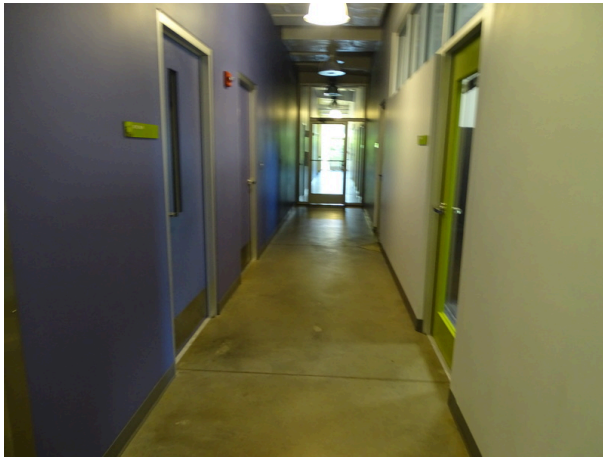
Building A corridor

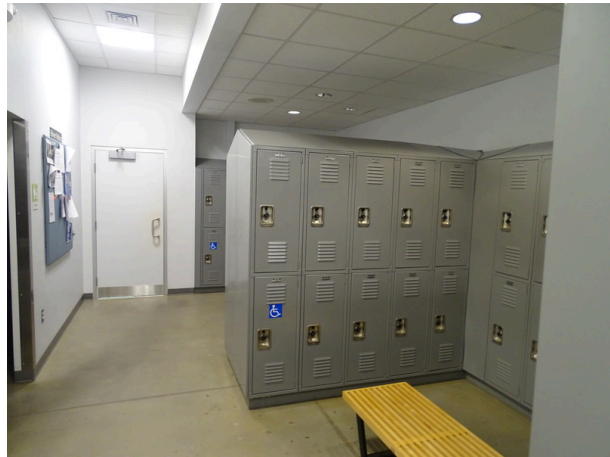
Building A lockers

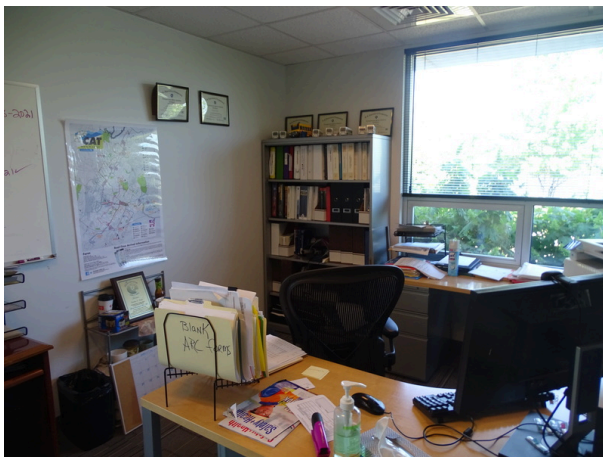
Building A office

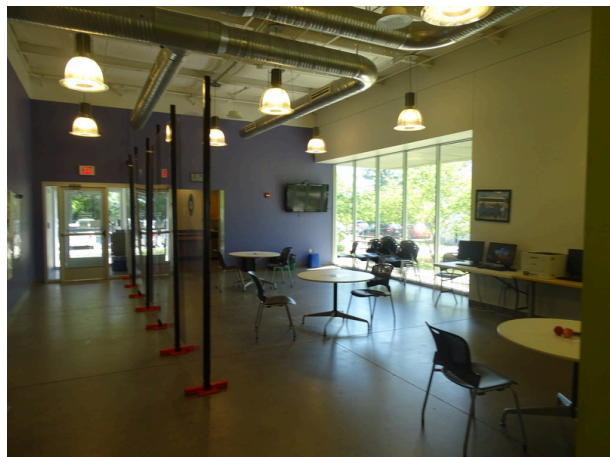
Building A interior

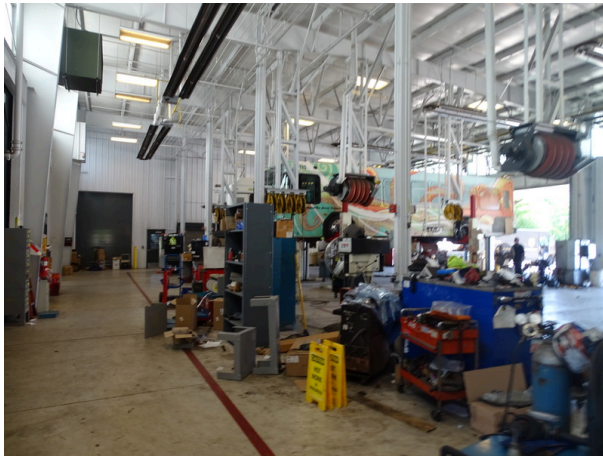
The main shop area generally did not have any finishes. The shop area has unfinished concrete floors, painted metal walls, and painted roof deck ceiling. The shop area was generally in good condition.

Building B shop area

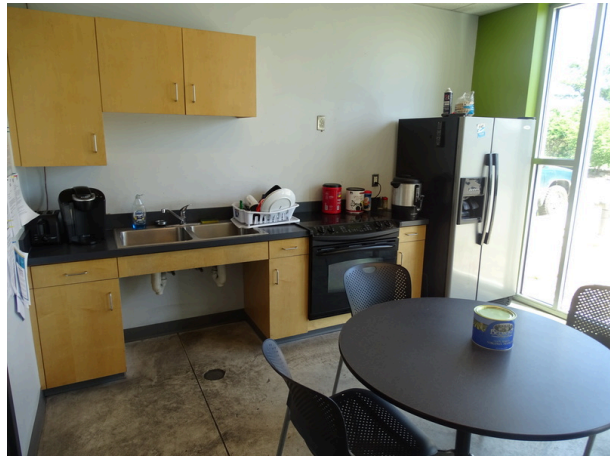
The finishes in the kitchenette include unfinished concrete floors, painted gypsum board walls and suspended acoustical tile ceilings. The finishes in the kitchens were observed to be in generally good condition.

Building B kitchenette

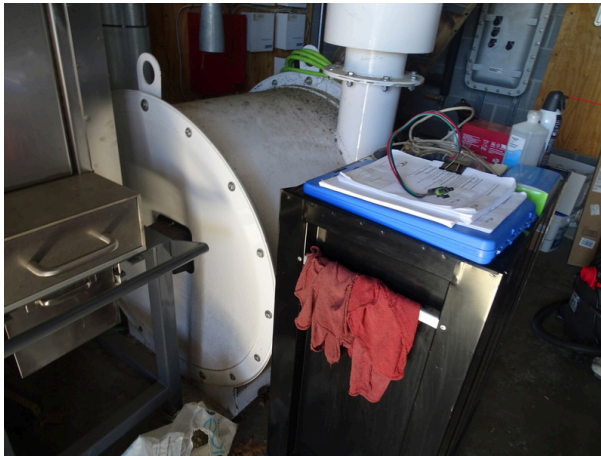
Building D was generally unfinished; the bus bays had painted CMU walls and a painted metal roof deck, and the floor was unfinished concrete. There were no finishes in the storage area or the electric room.

Building D storage room

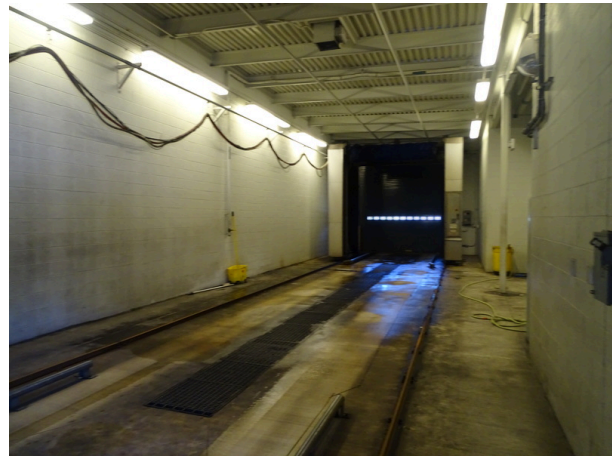
Building D bus bay

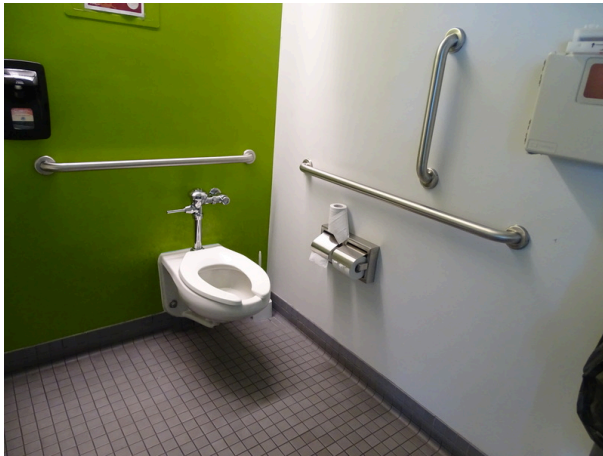
Building A accessible restroom

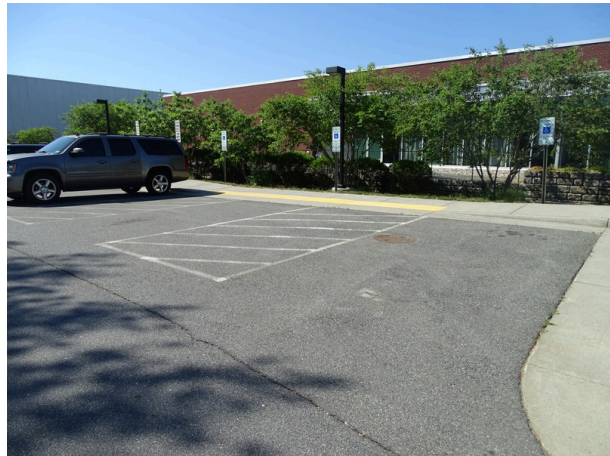
The parking area serving the property has a total of approximately 59 parking spaces. Of the parking spaces, Three are accessible with Two being van accessible. Accessibility requires that 3 accessible parking spaces be provided in parking areas with a total of 51 to 75 spaces. One in six of the accessible parking spaces are required to be van accessible. A minimum of a 60-inch wide access aisle is required to be provided for every two accessible parking spaces. Accessible aisles were observed to be provided. The number of parking spaces provided meets accessibility requirements.

Accessible parking

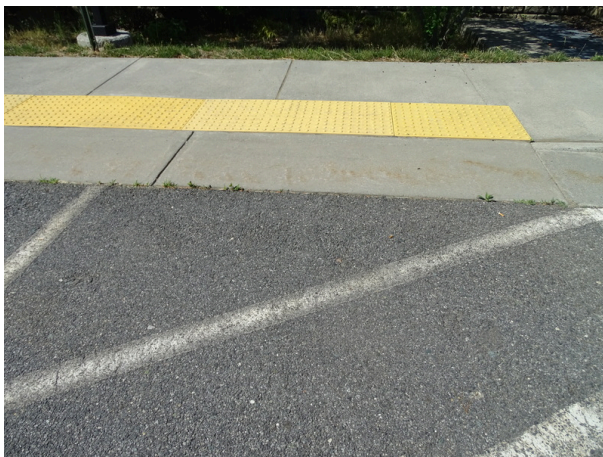
Truncated domes at sidewalk entrance

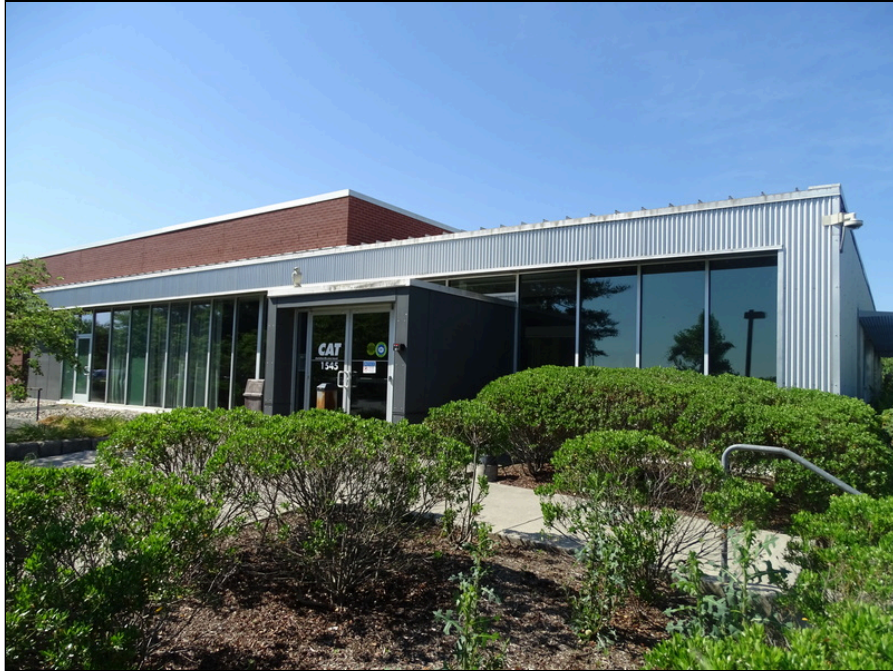
1 - Building A Overview

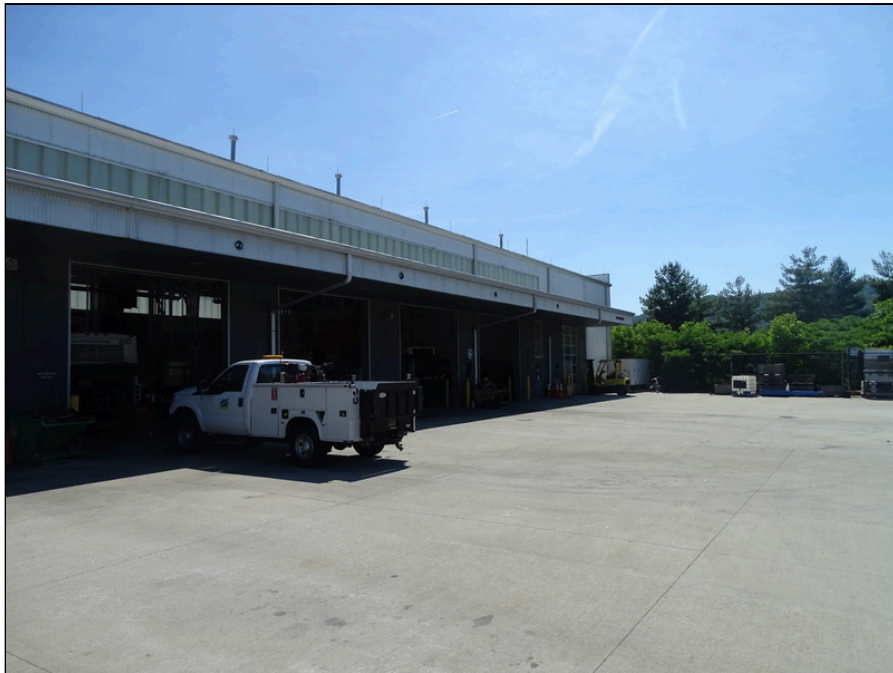
2 - Building B Overview

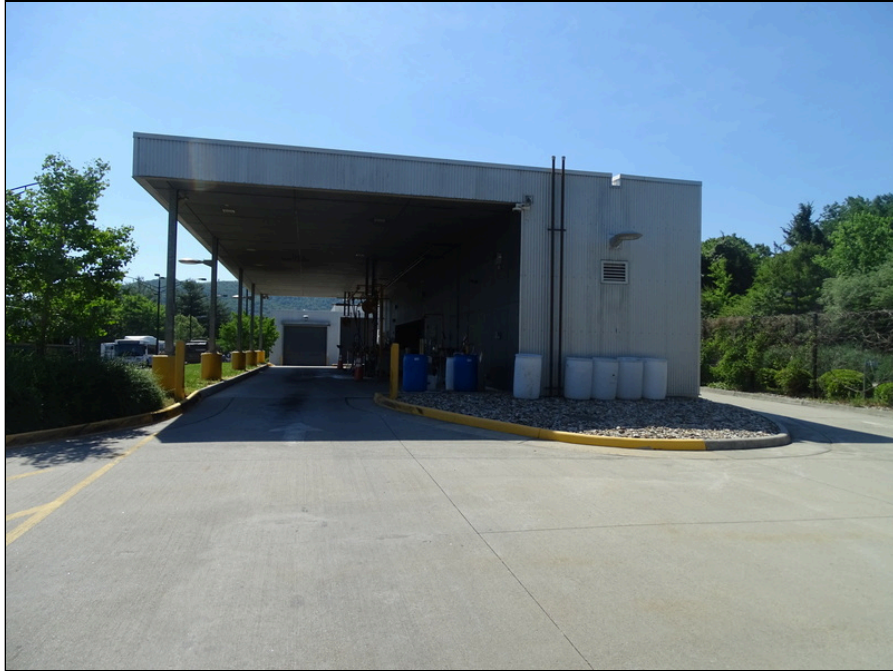
3 - Building C Overview

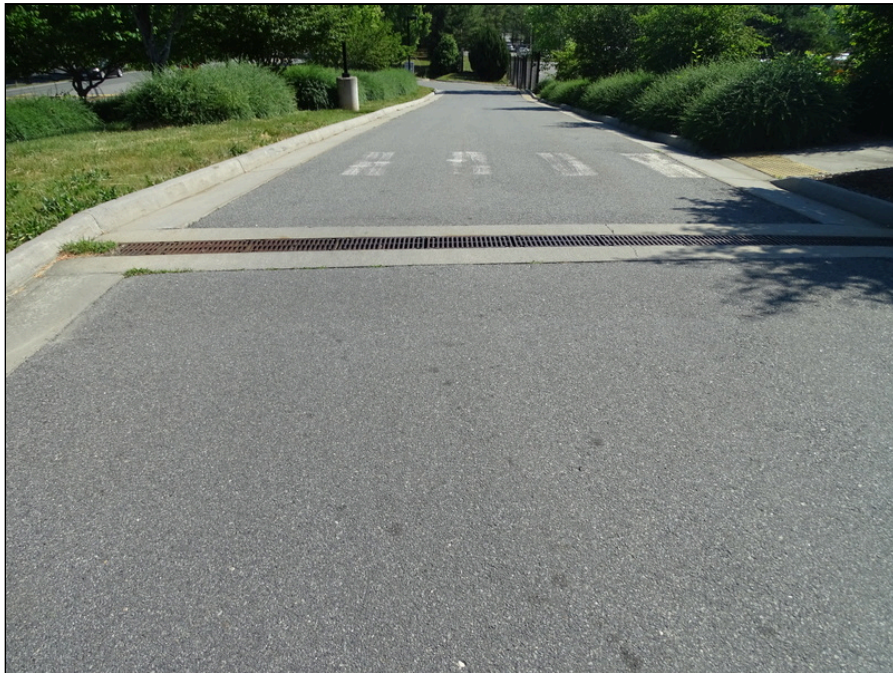
4 - Asphalt pavement north side of site at entrance

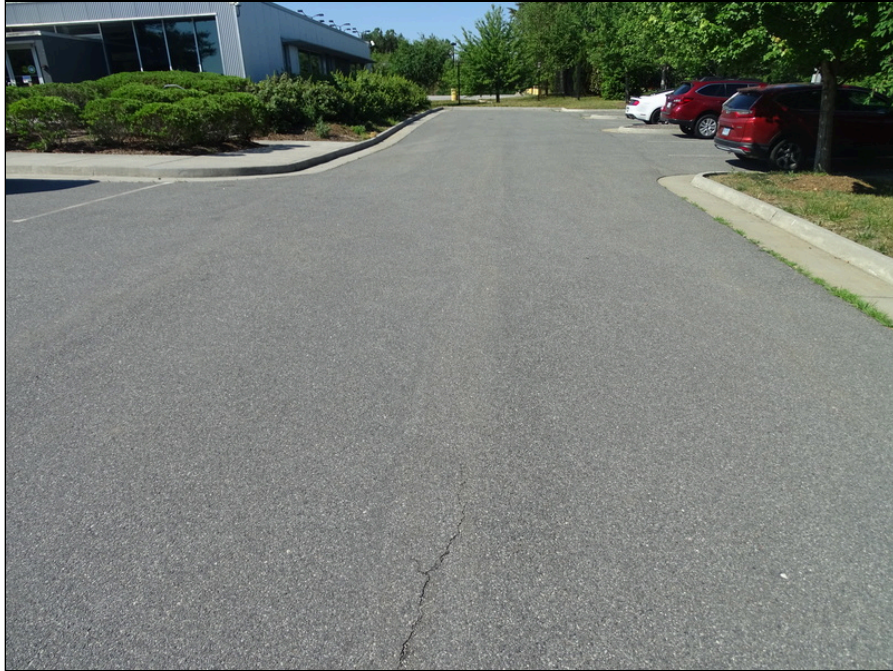
5 - Asphalt pavement north side of site

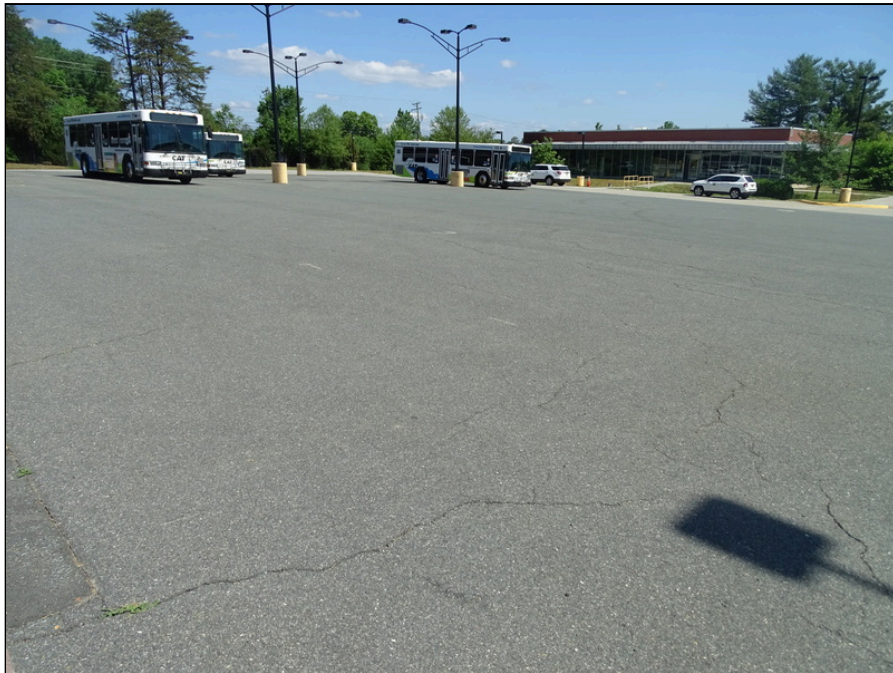
6 - Asphalt pavement at bus parking area

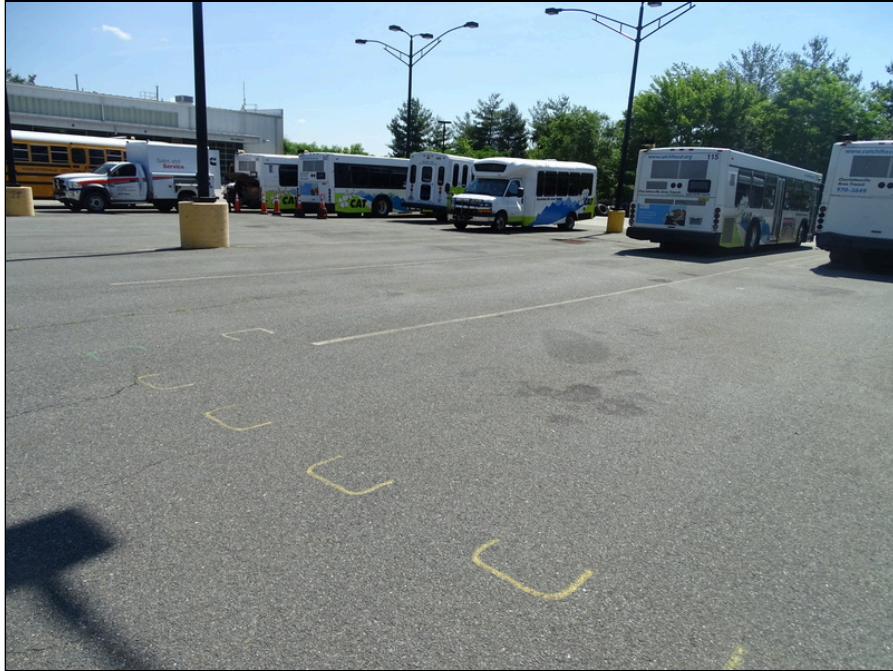
7 - Asphalt pavement at bus parking area

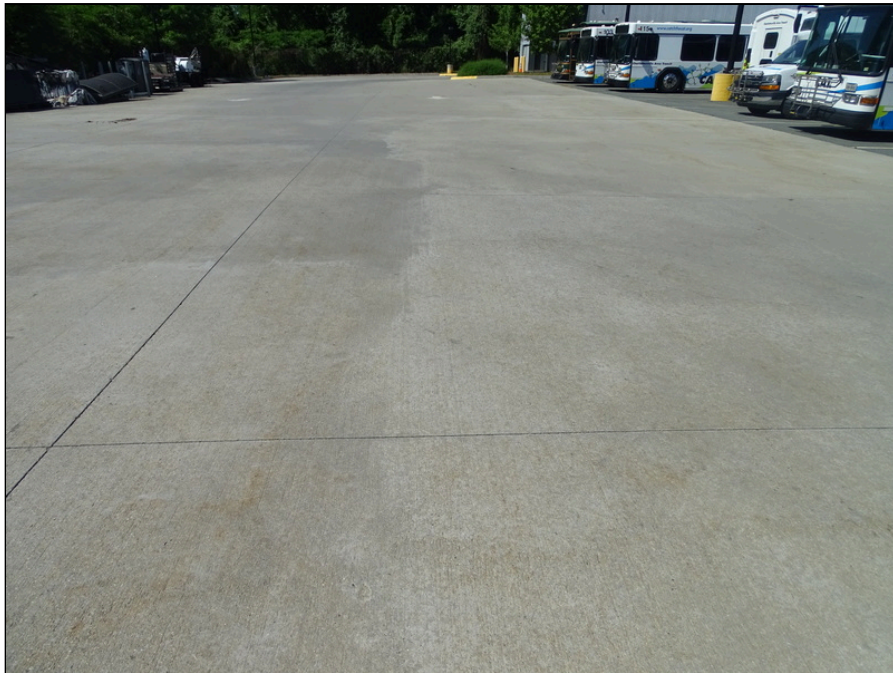
8 - Concrete pavement at center of the site

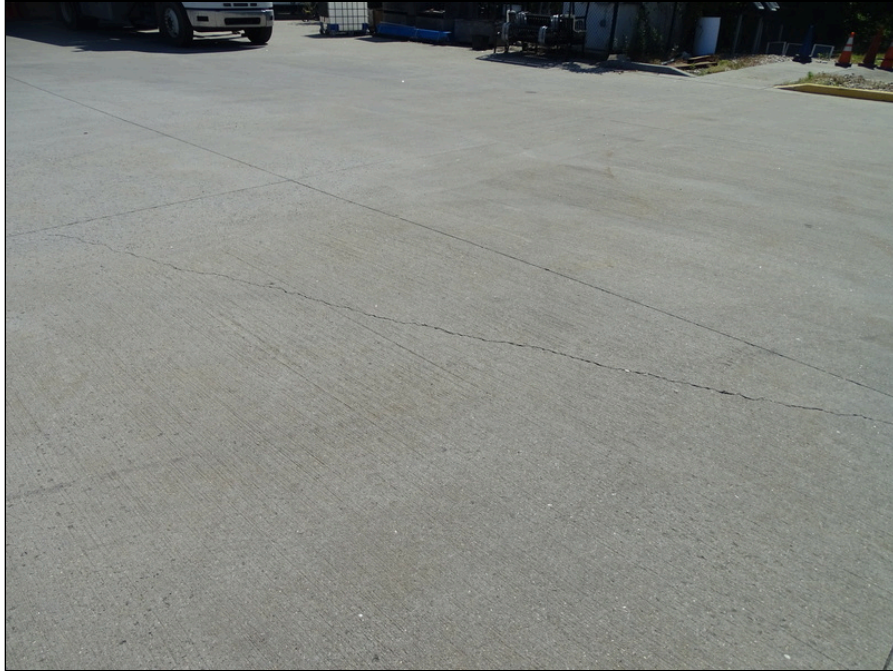
9 - Concrete pavement at center of the site

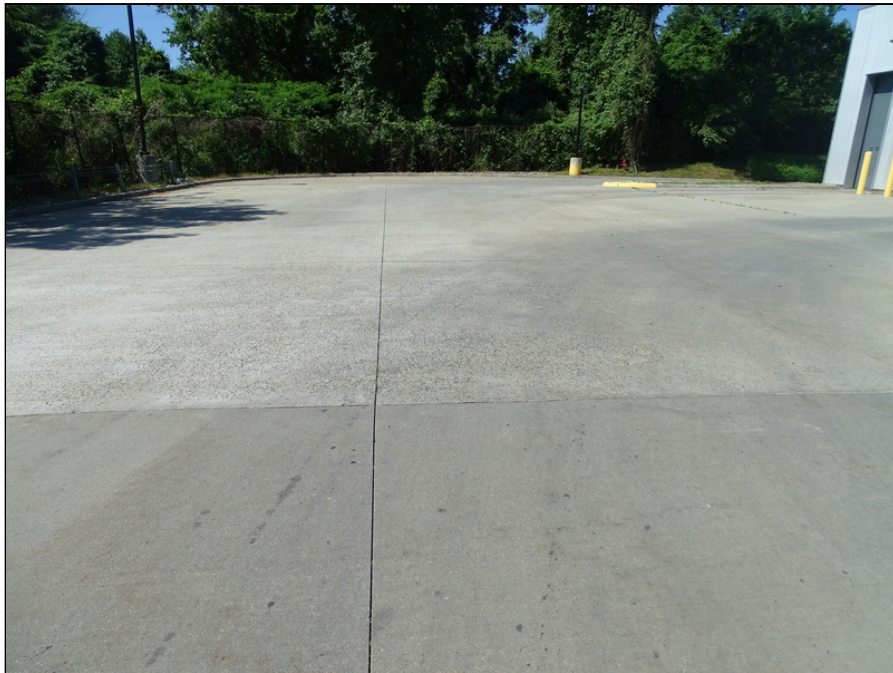
10 - Concrete pavement at east side of the site

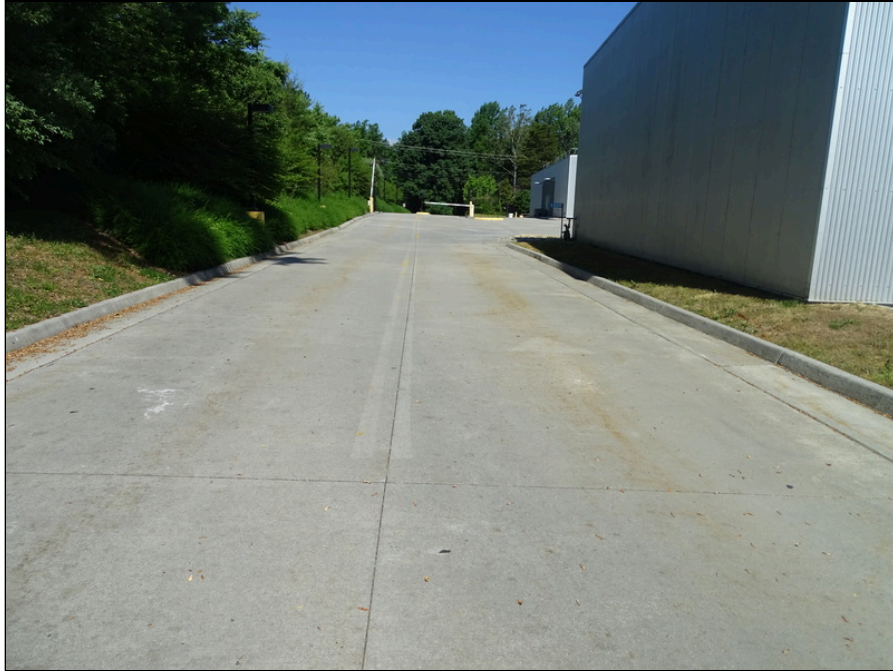
11 - Concrete pavement at south side of the site

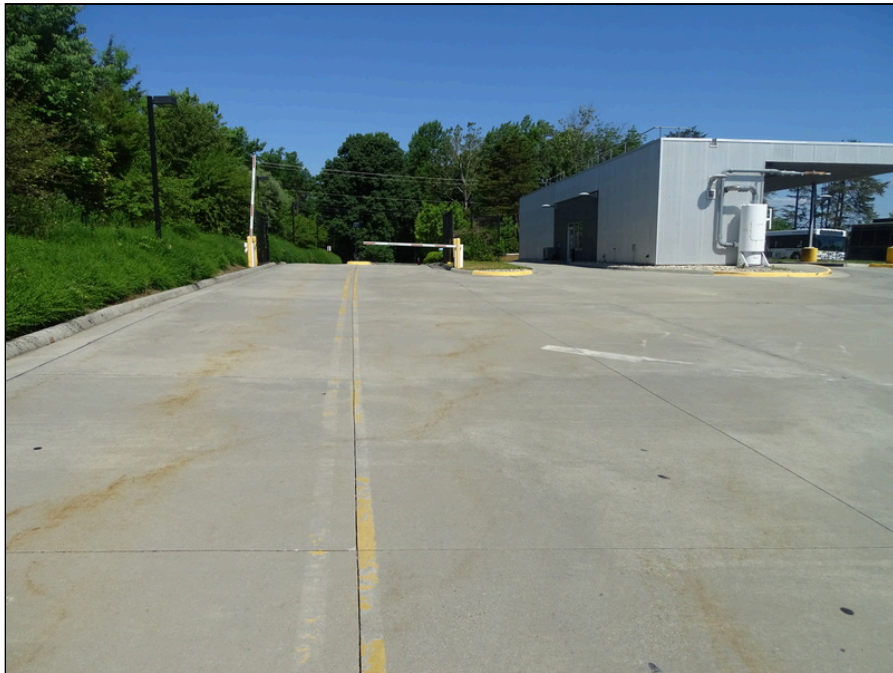
12 - Concrete pavement at west side of the site

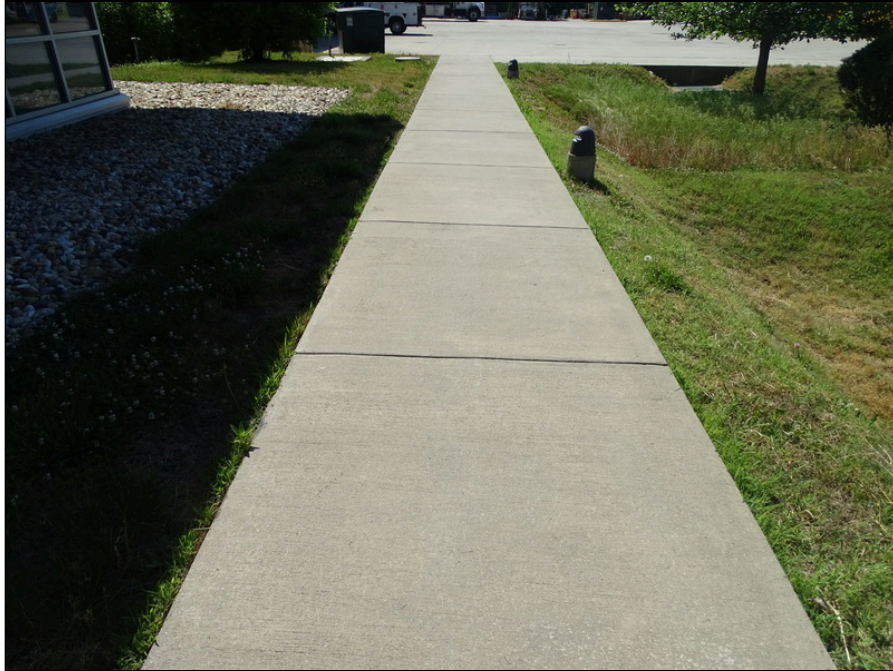
13 - Typical concrete sidewalk

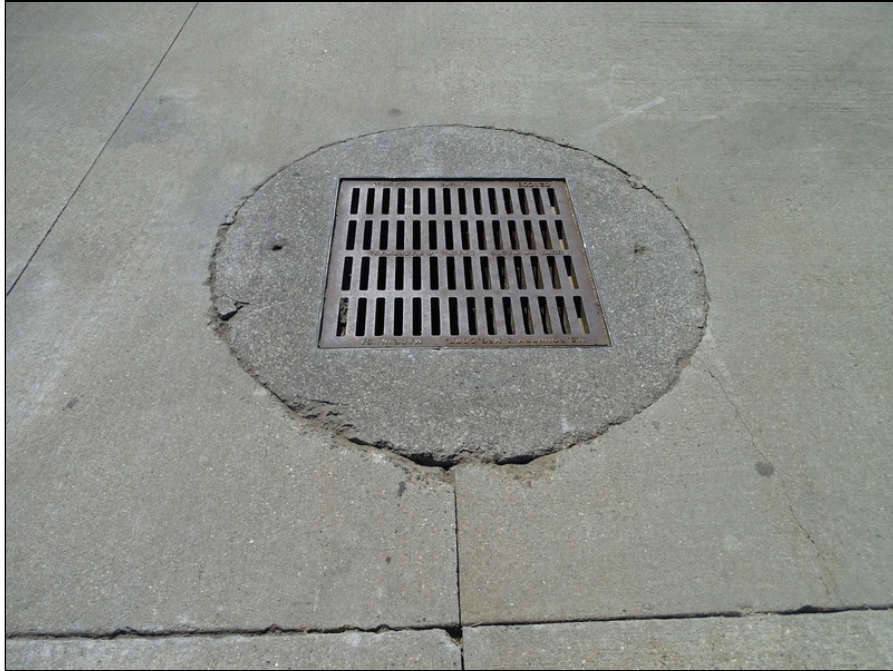
17 - Typical storm sewer drop inlet

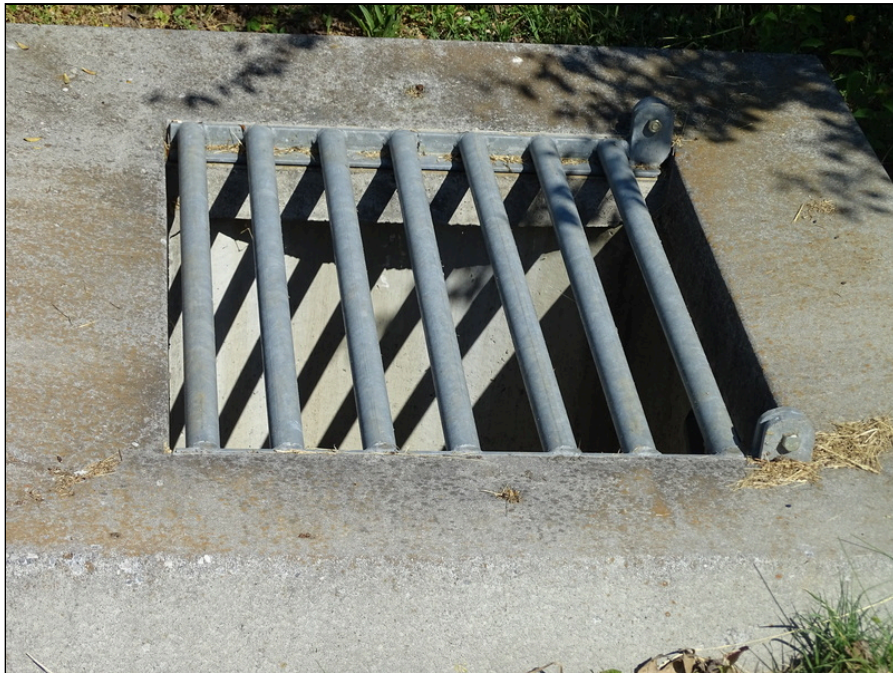
18 - Typical storm sewer drop inlet
