CAT OPERATIONS CENTER  
1545 AVON STREET EXT  
CHARLOTTESVILLE, VIRGINIA

ECS PROJECT NO. 46:6713

CITY OF CHARLOTTESVILLE - FACILITIES DEVELOPMENT

Reference: Facility Condition Assessment Report for CAT Operations Center, 1545 Avon Street Ext,  
Charlottesville, Virginia

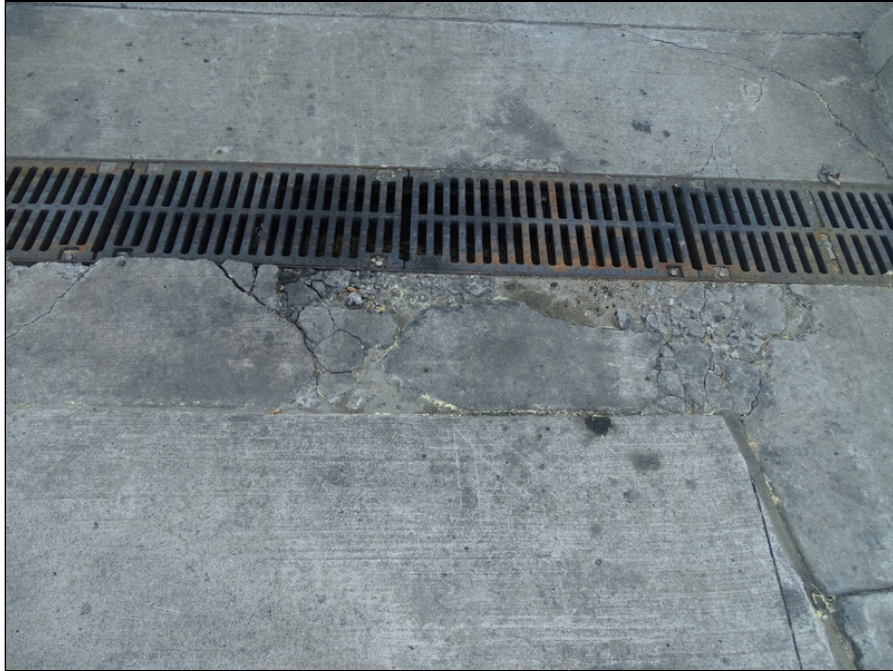
19 - Typical storm sewer drop inlet

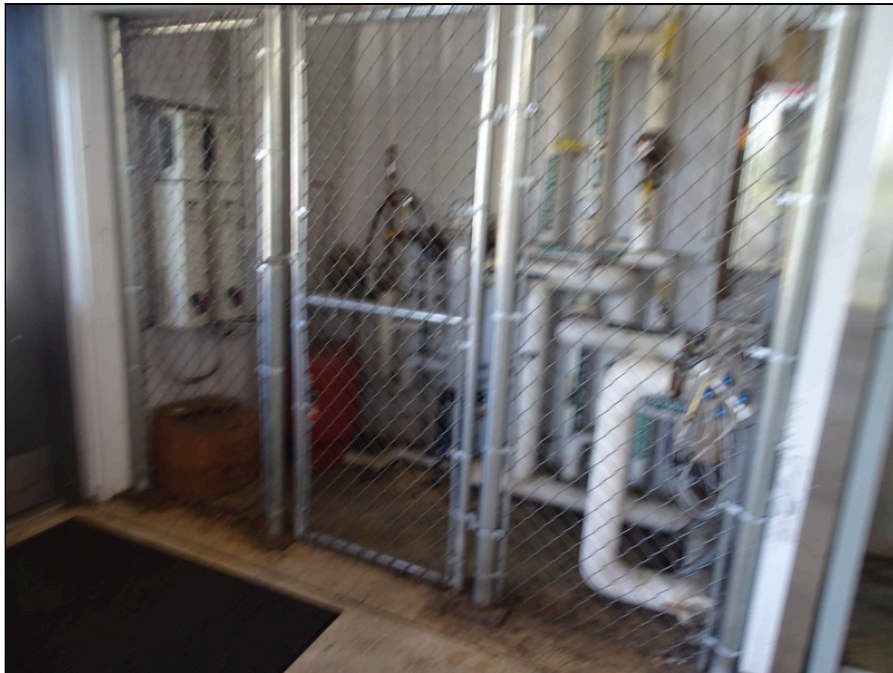
20 - Stormwater management system

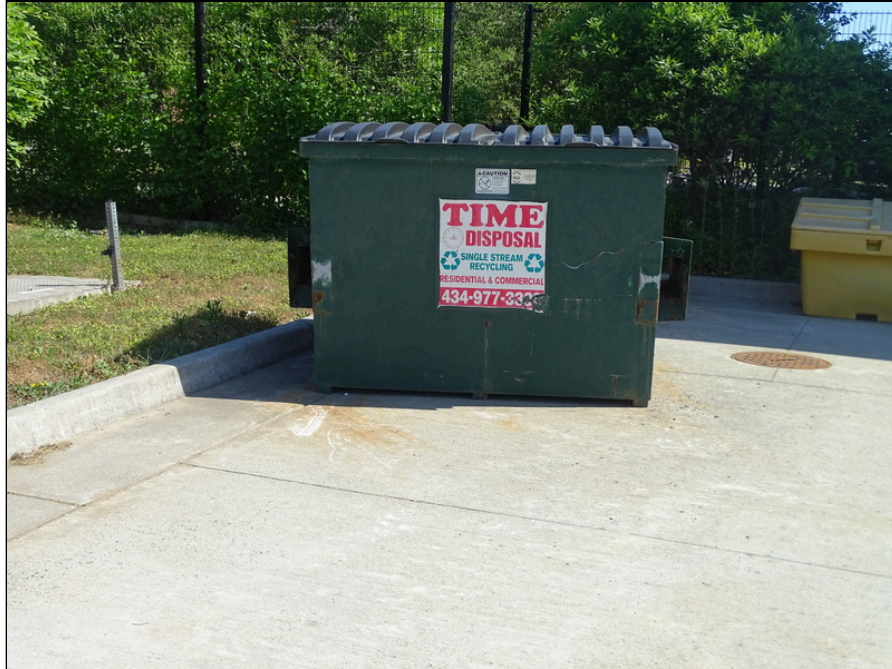
21 - Dumpster area

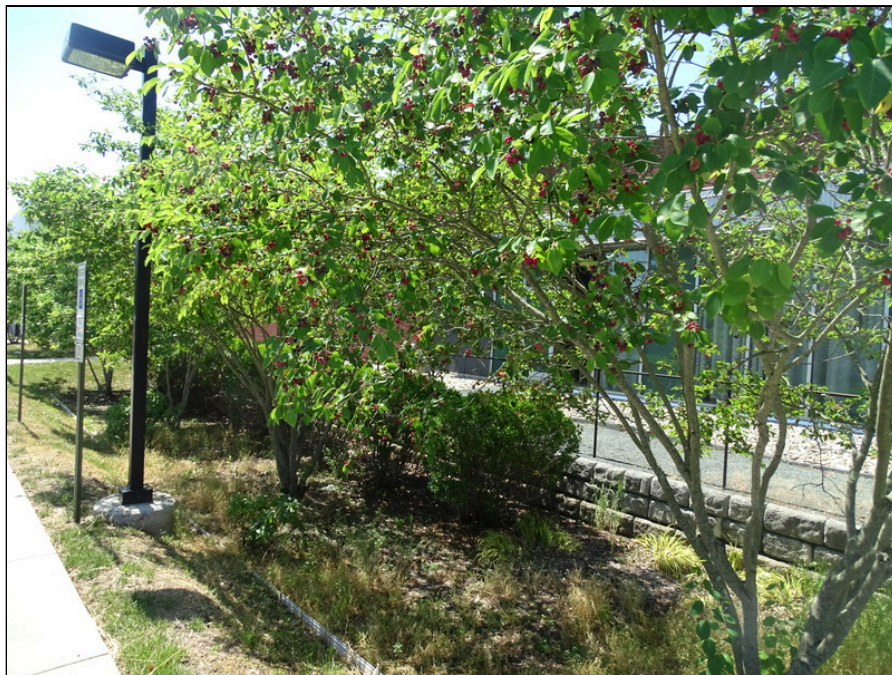
22 - Typical landscaping

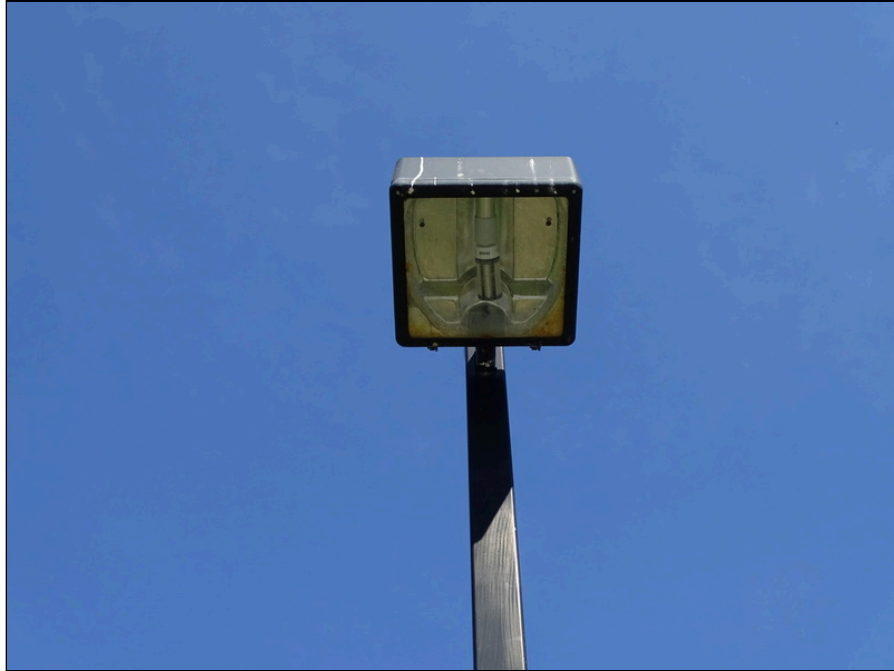
23 - Pole mounted lighting

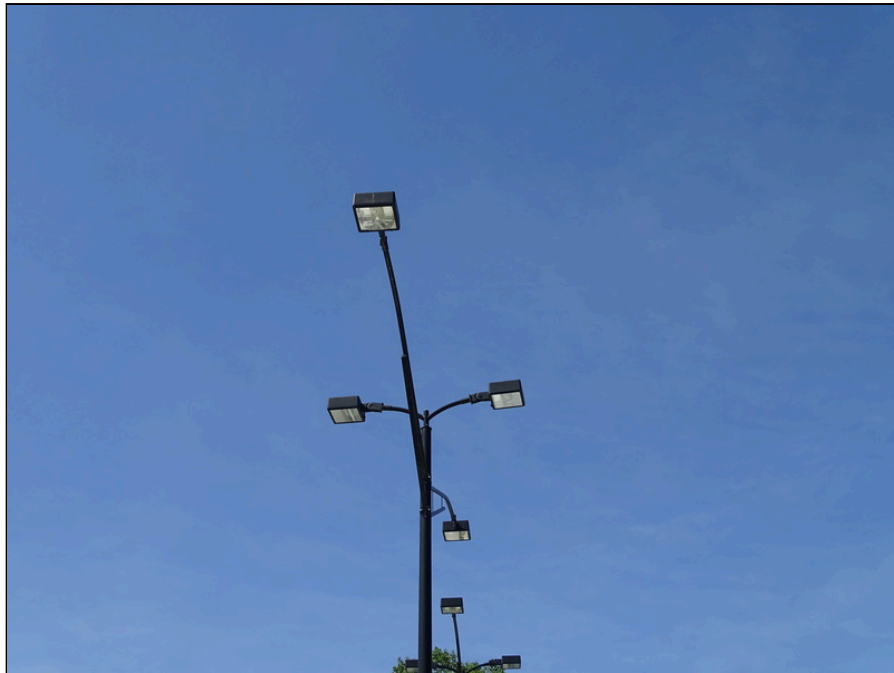
24 - Pole mounted light

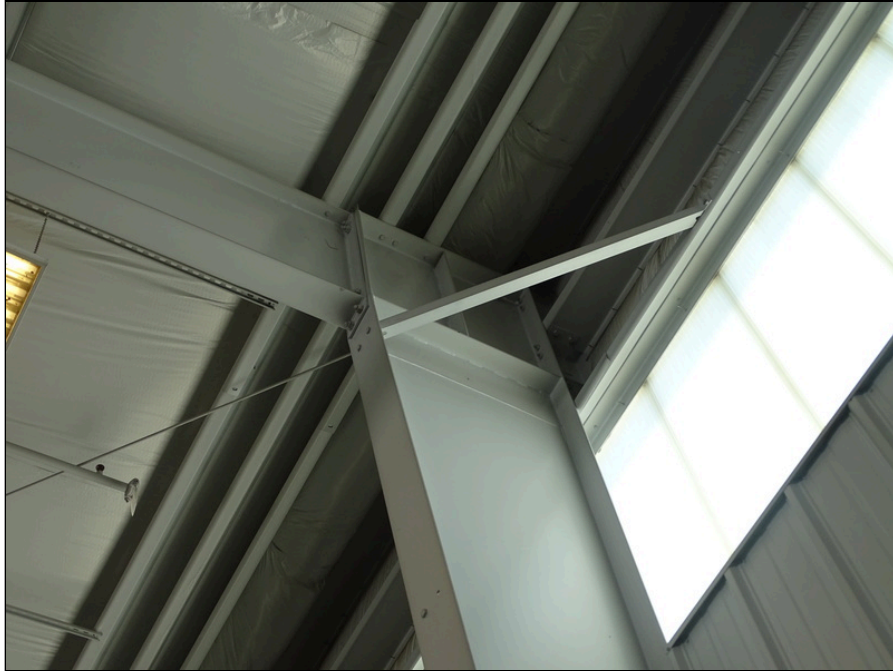
25 - Typical structural framing

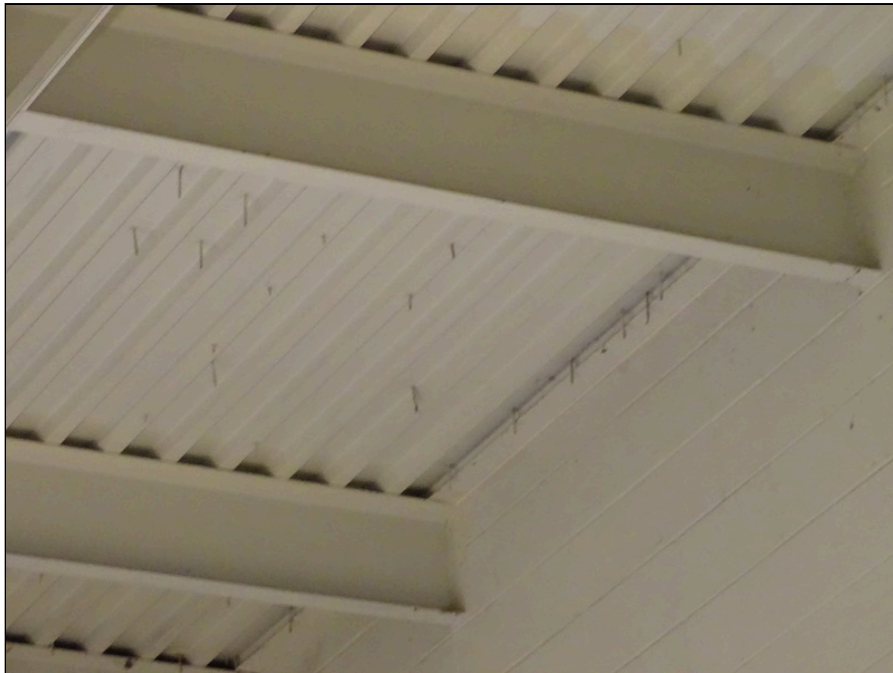
26 - Typical structural framing

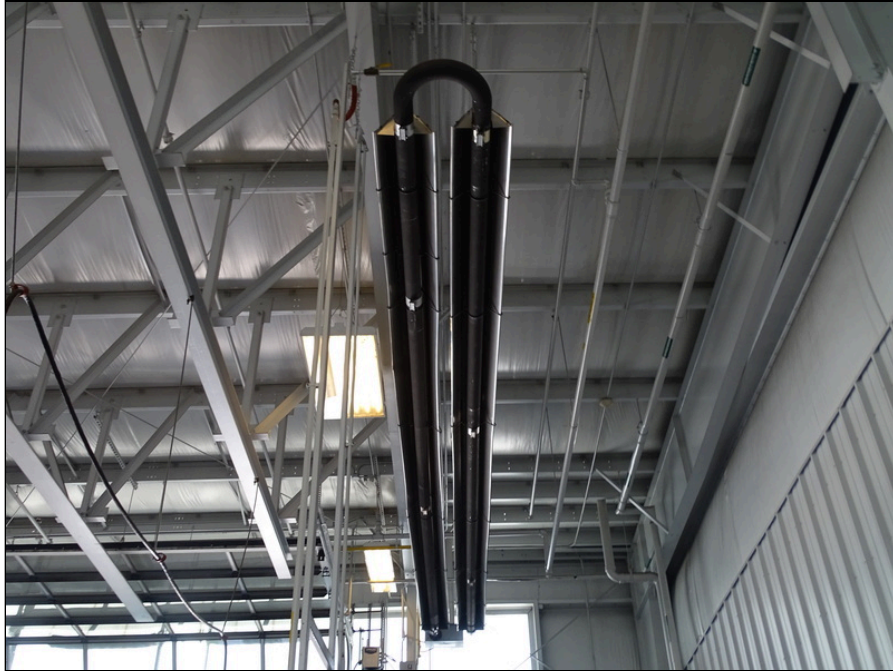
27 - Typical structural framing

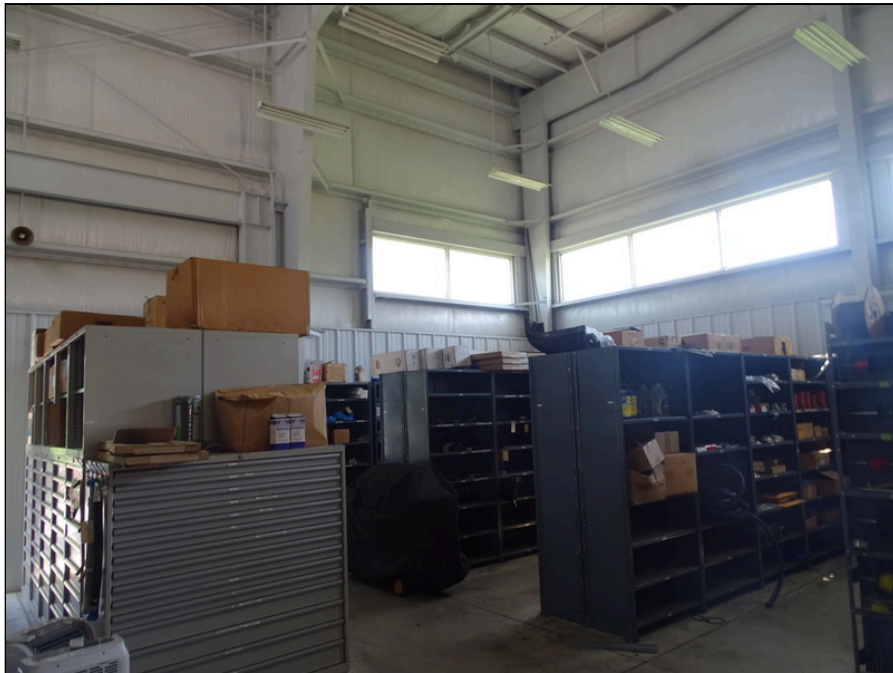
28 - Typical structural framing

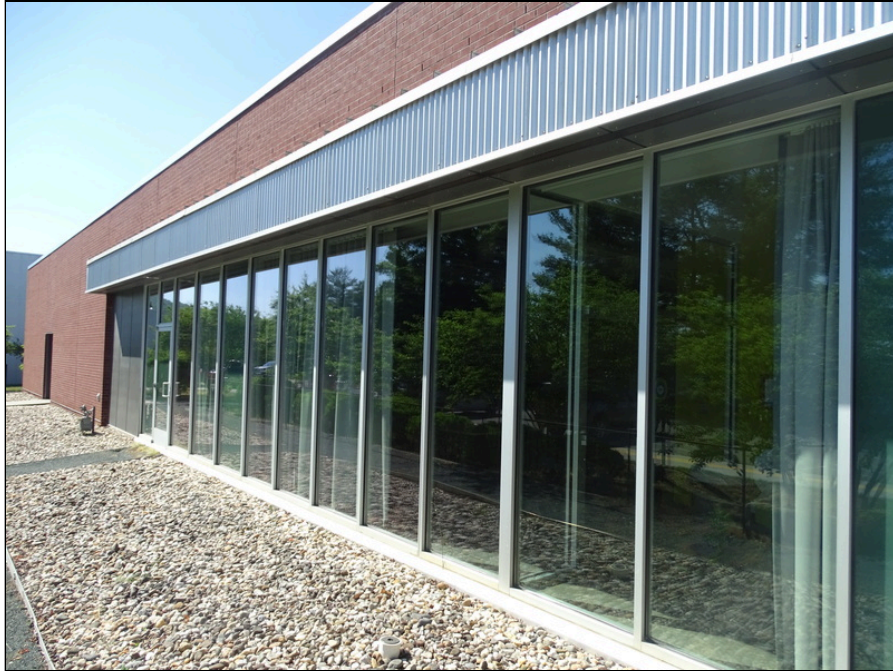
29 - Building exteriors at Building A

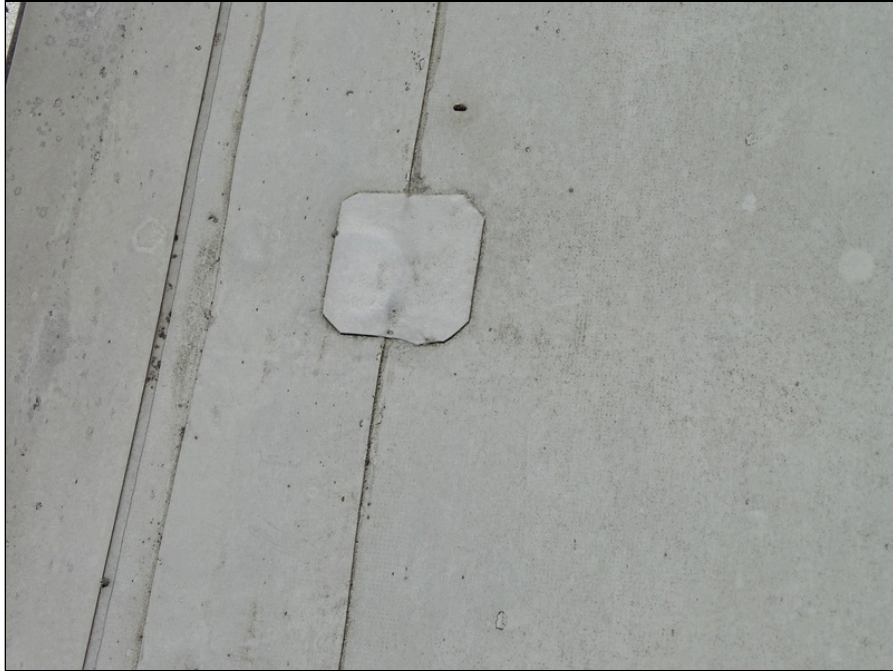
56 - Building C roof - internal drainage

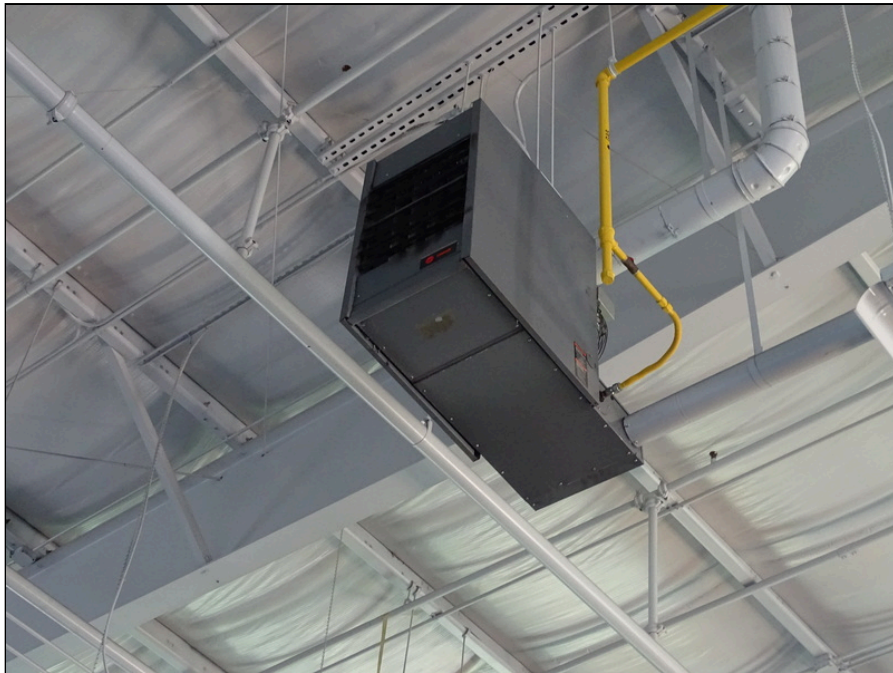
70 - Building B unit heater

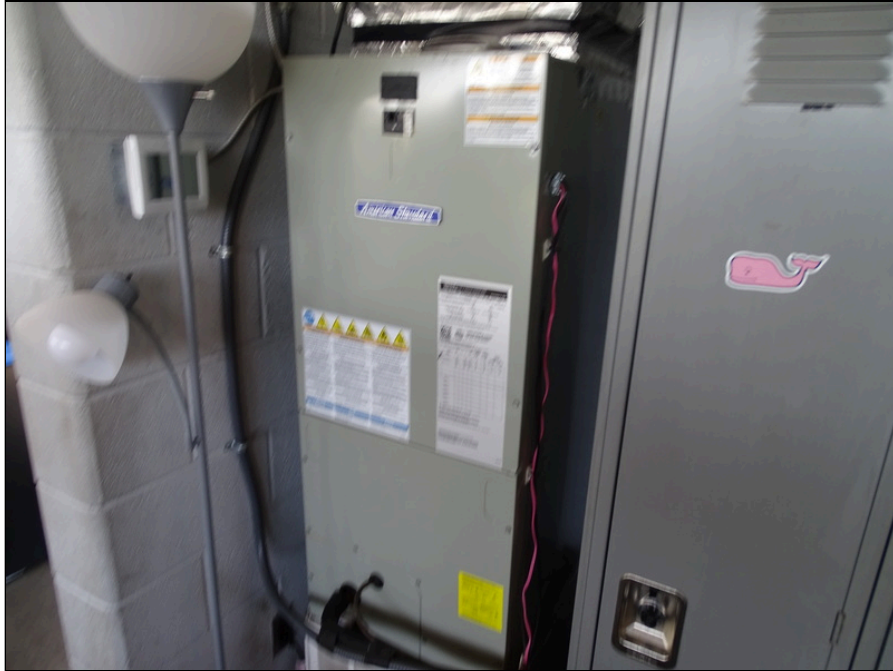
71 - Building C electric heater and thermostat

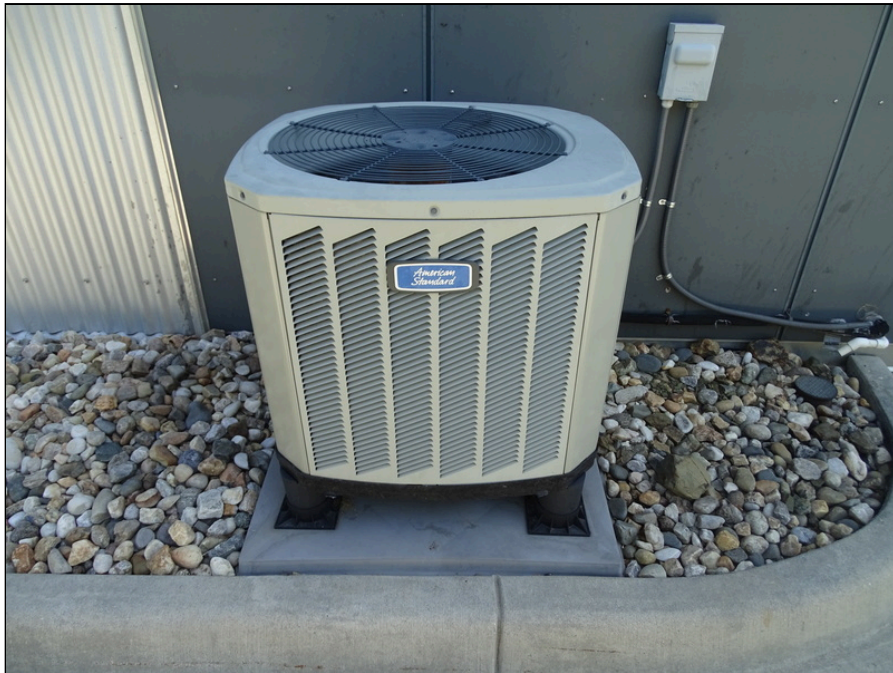
72 - Building C condenser

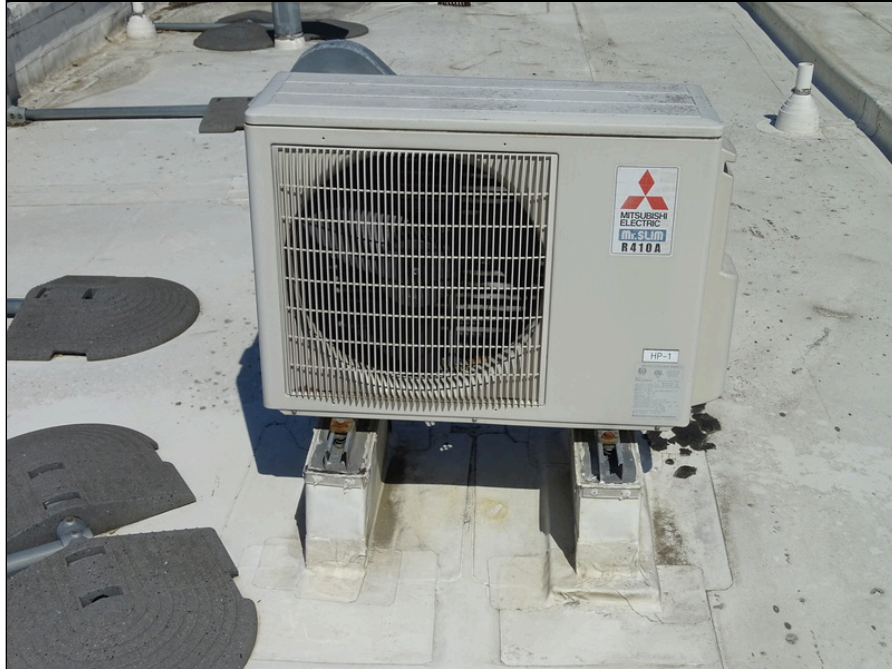
73 - Building C split system

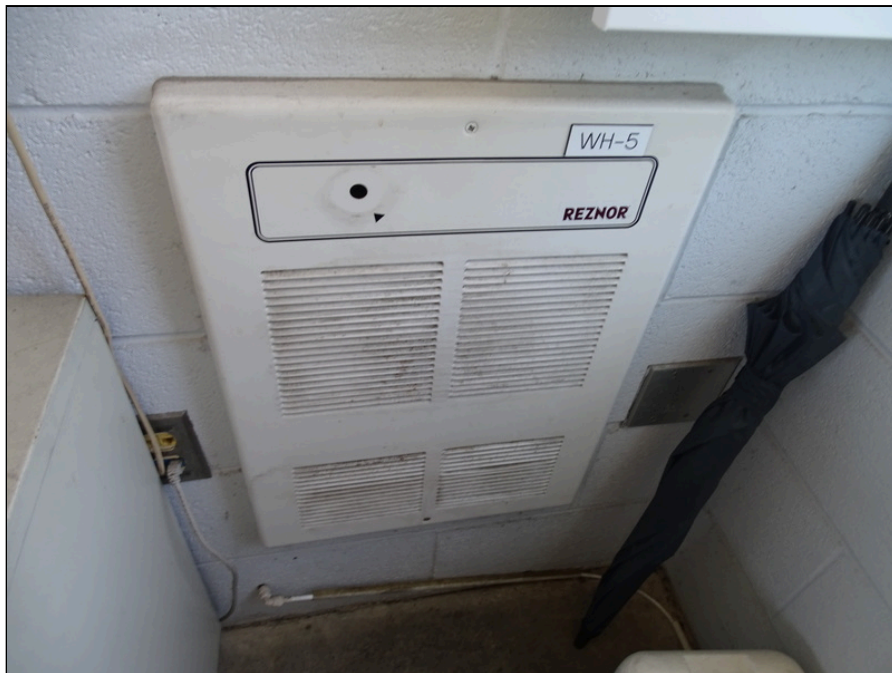
74 - Building C unit heater

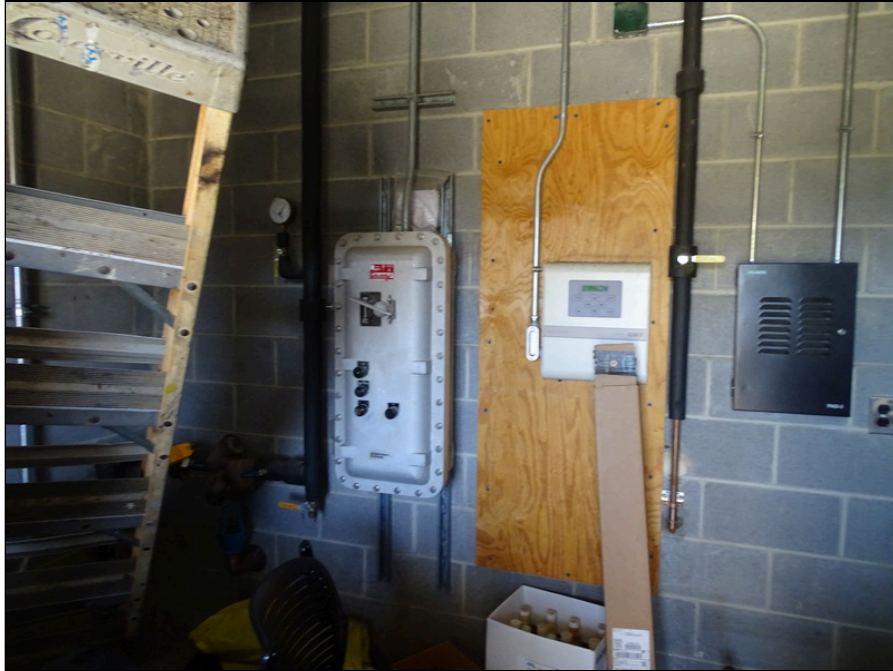
75 - Building D NOVAR BAS

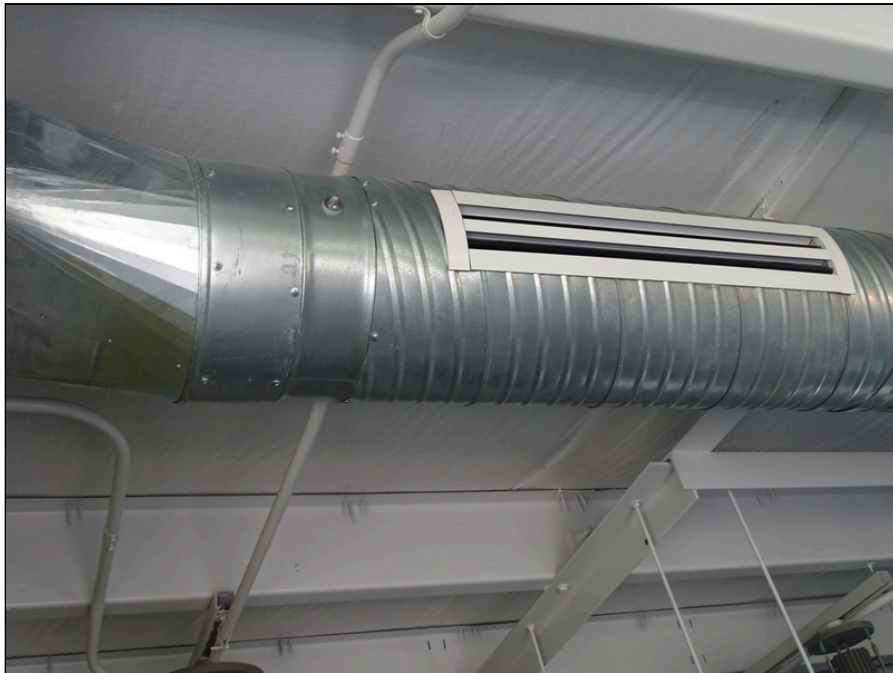
76 - Building A ductwork

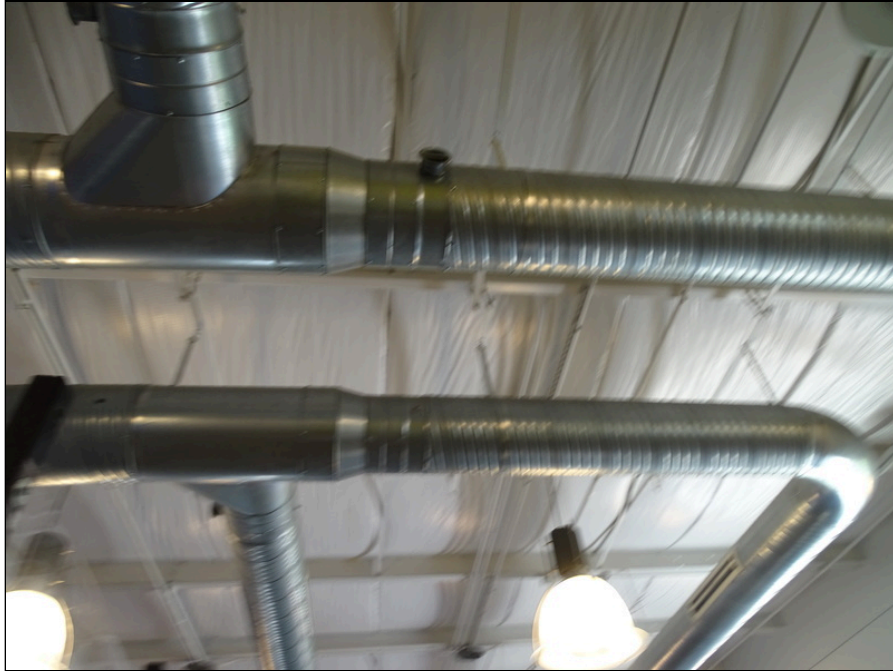
77 - Building B ductwork

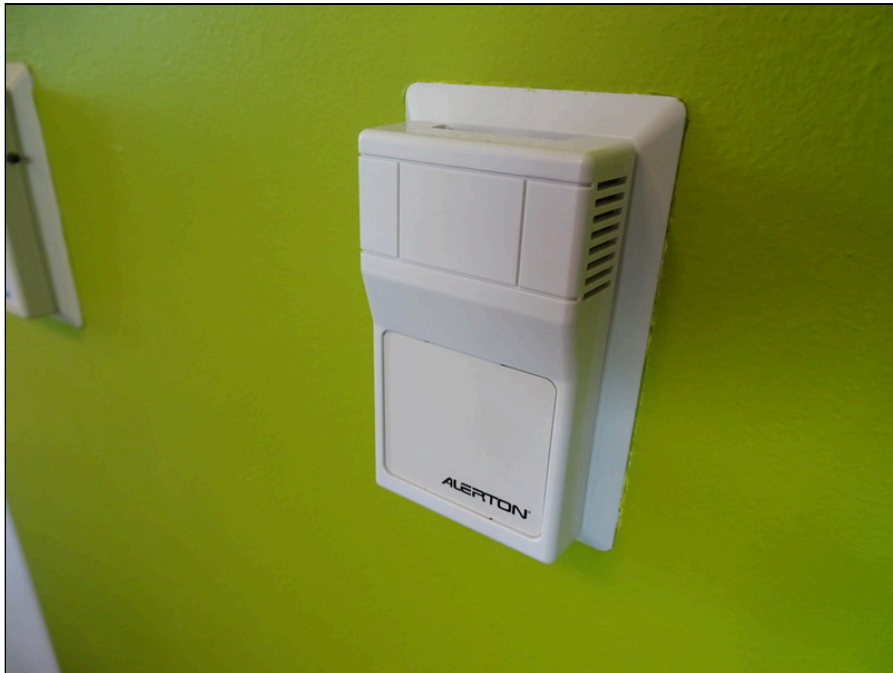
78 - Building A thermostat

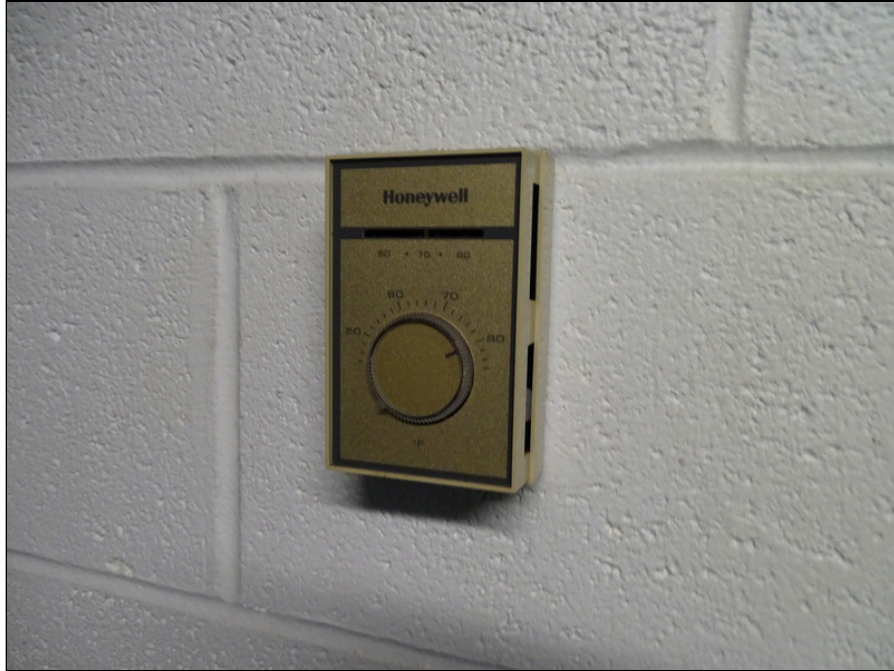
79 - Building B thermostat

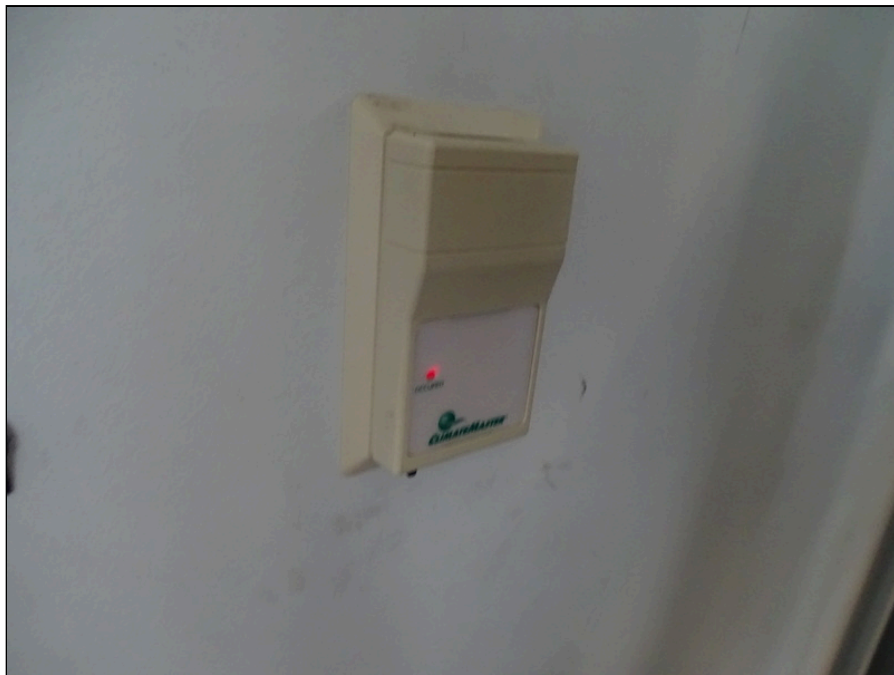
80 - Building C thermostat

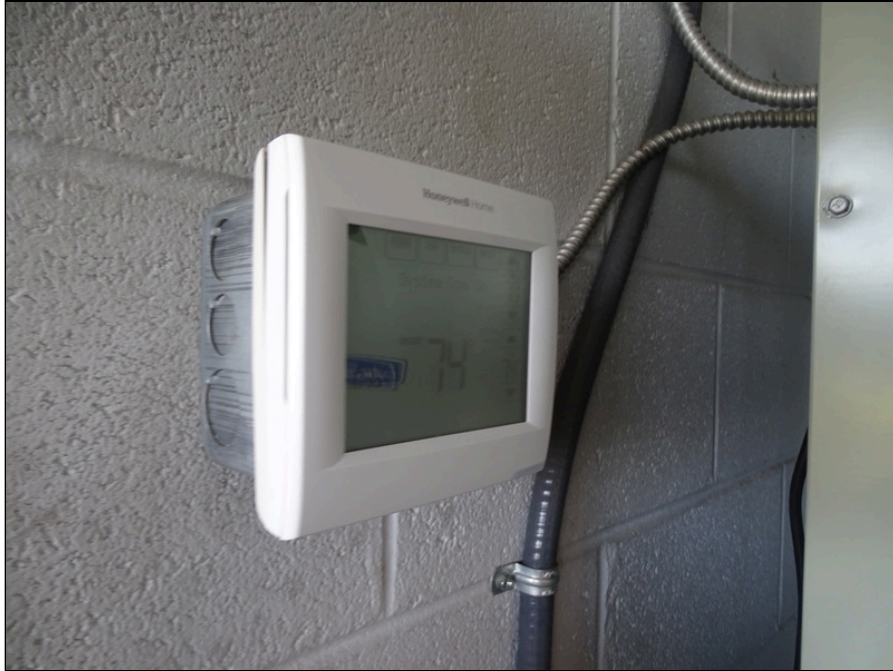
81 - Building D thermostat

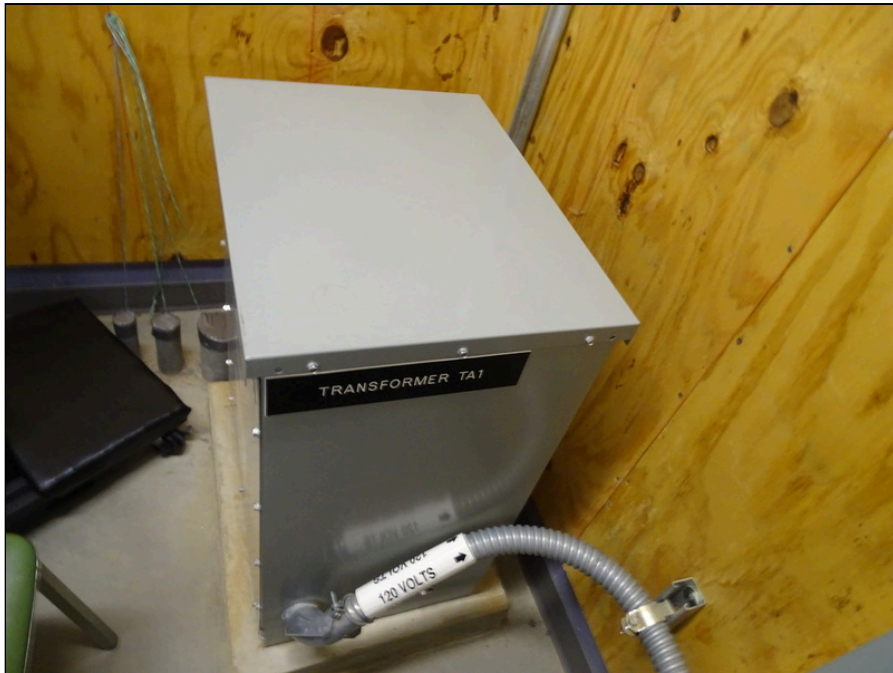
82 - Typical building A transformer

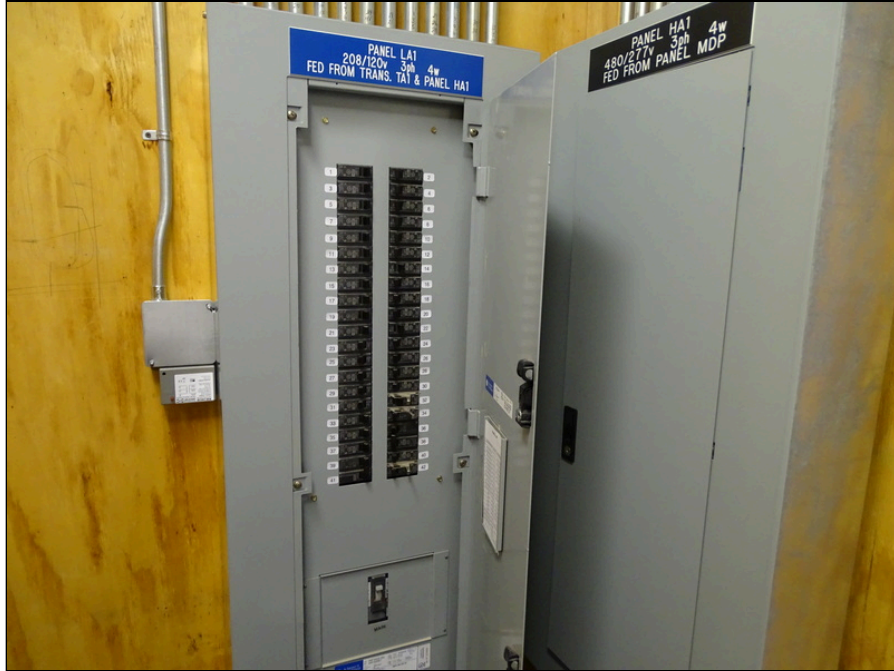
83 - Building A electrical panels

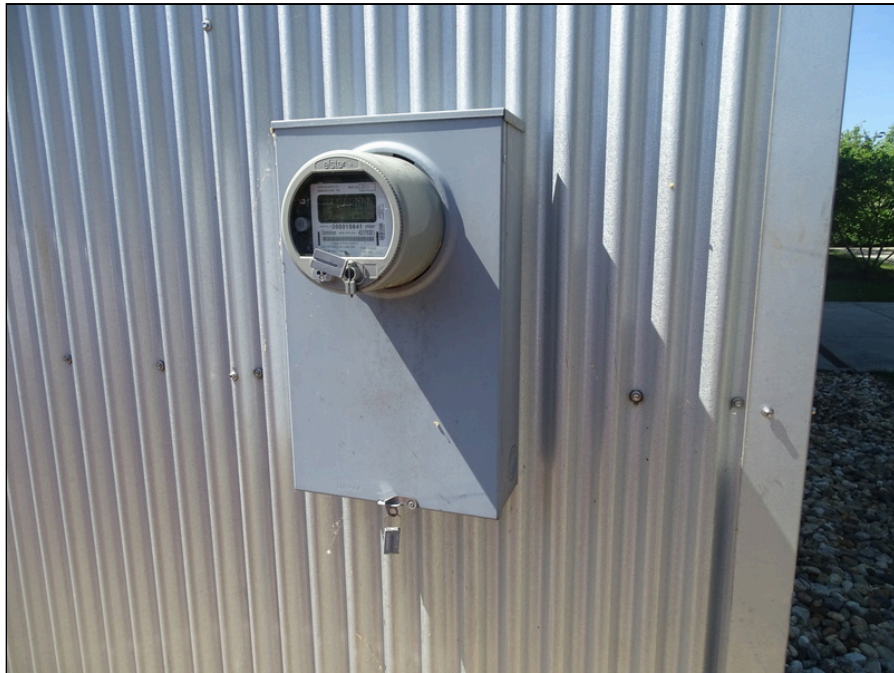
84 - Electric meter

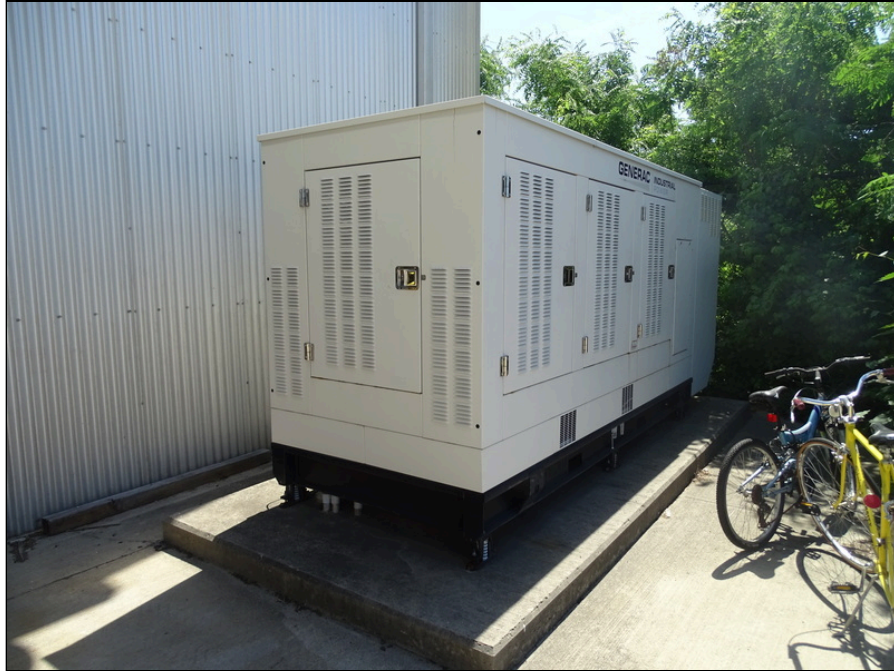
85 - Building B Generator

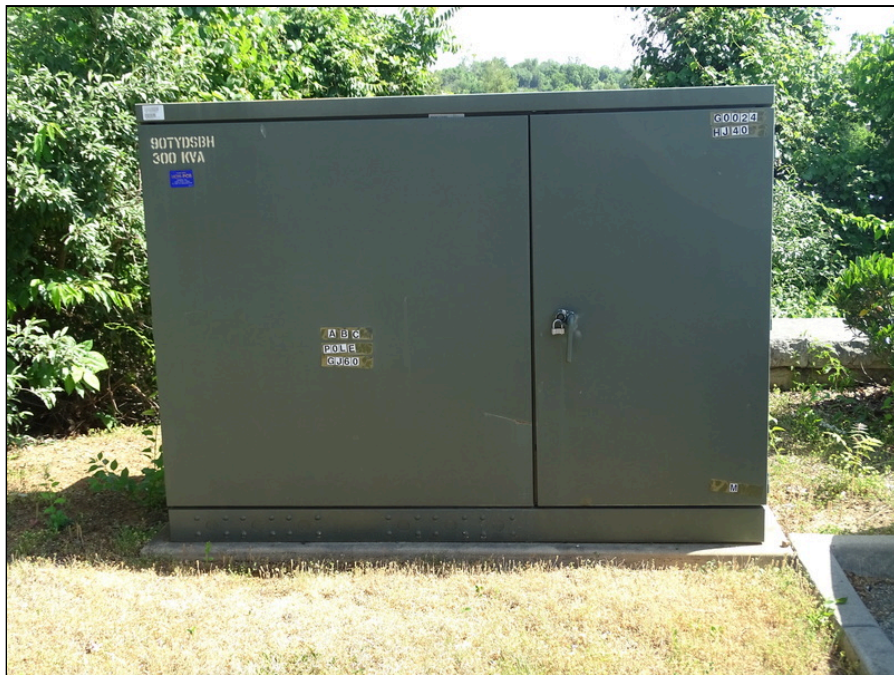
86 - Transformer

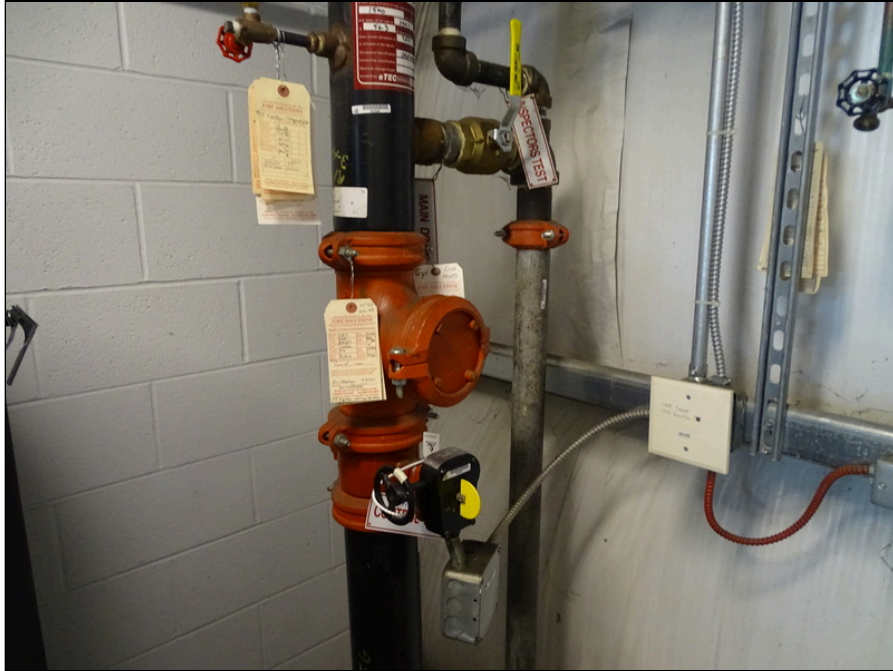
87 - Building B sprinkler riser

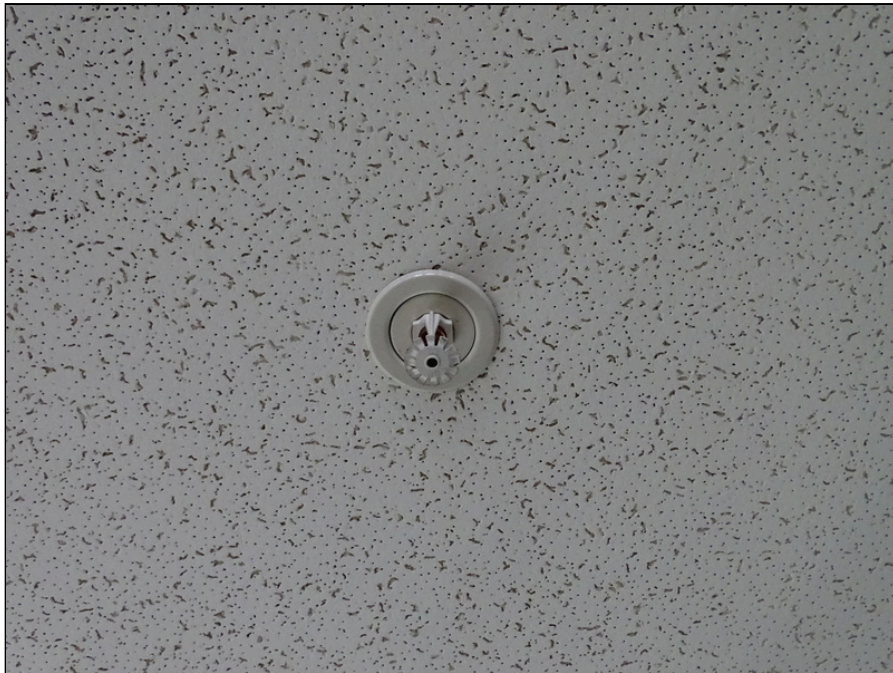
88 - Sprinkler head

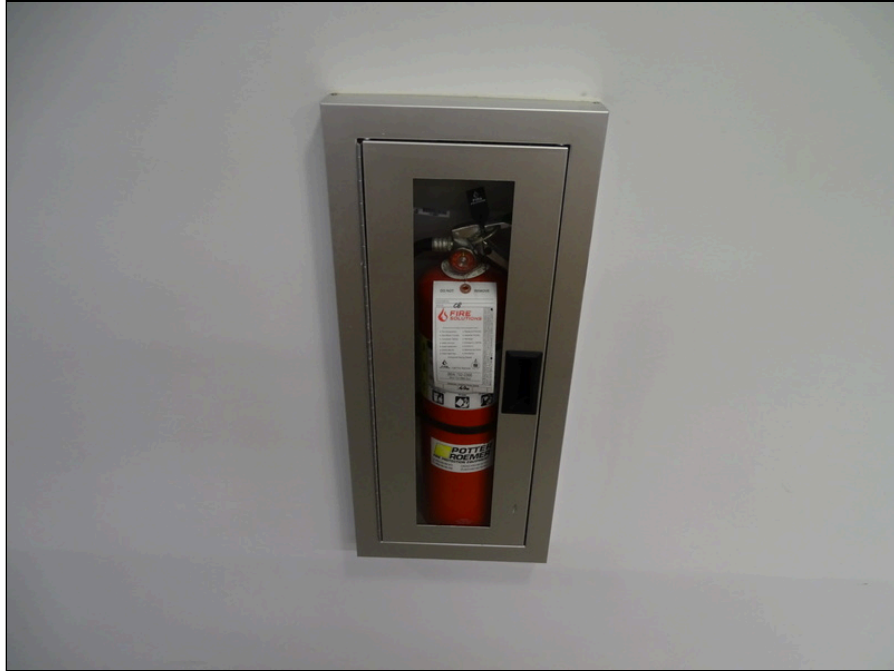
89 - Building A fire extinguisher

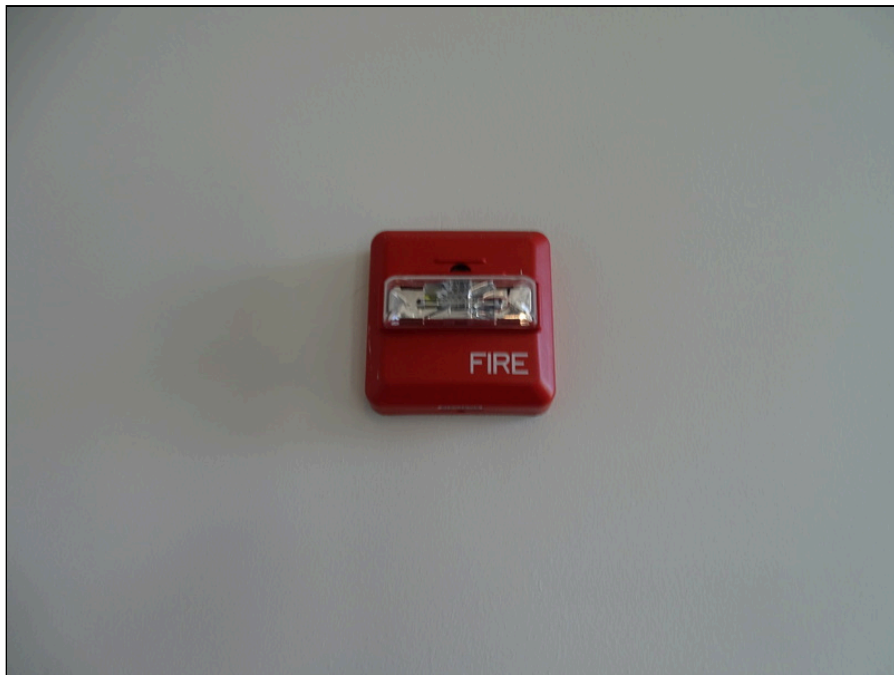
90 - Building A strobe

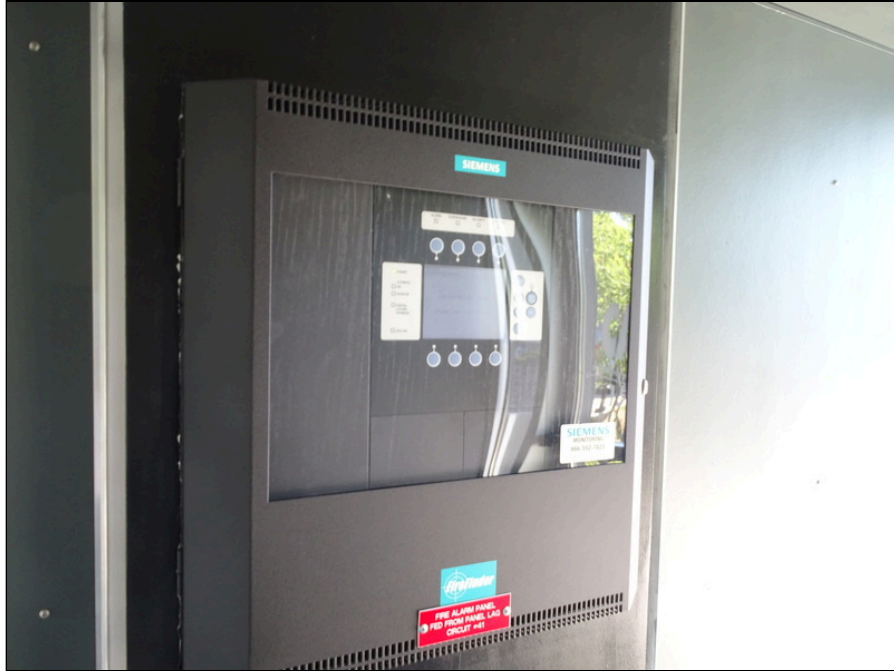
91 - Building A alarm panel

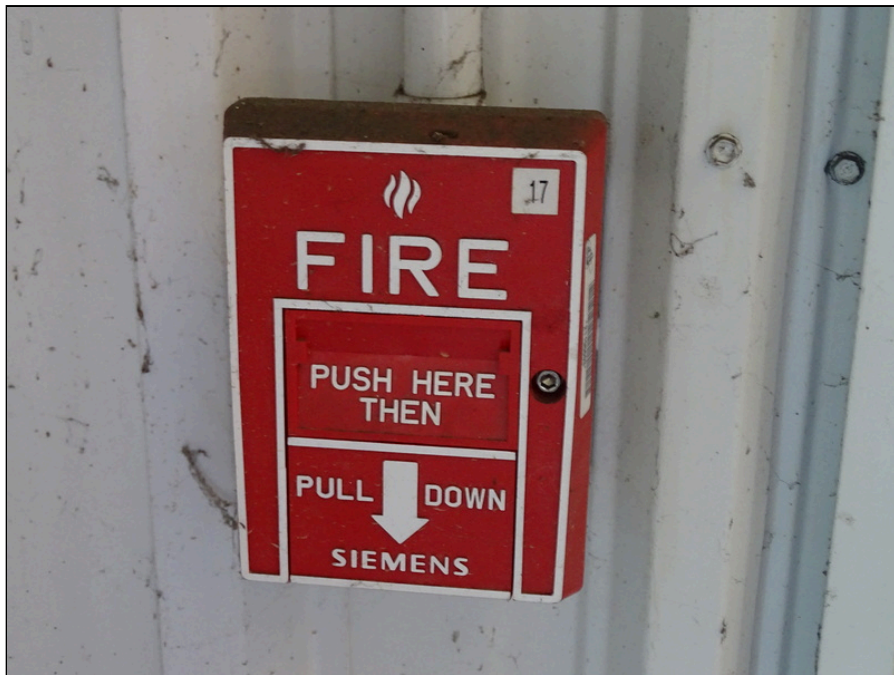
92 - Building B pull station

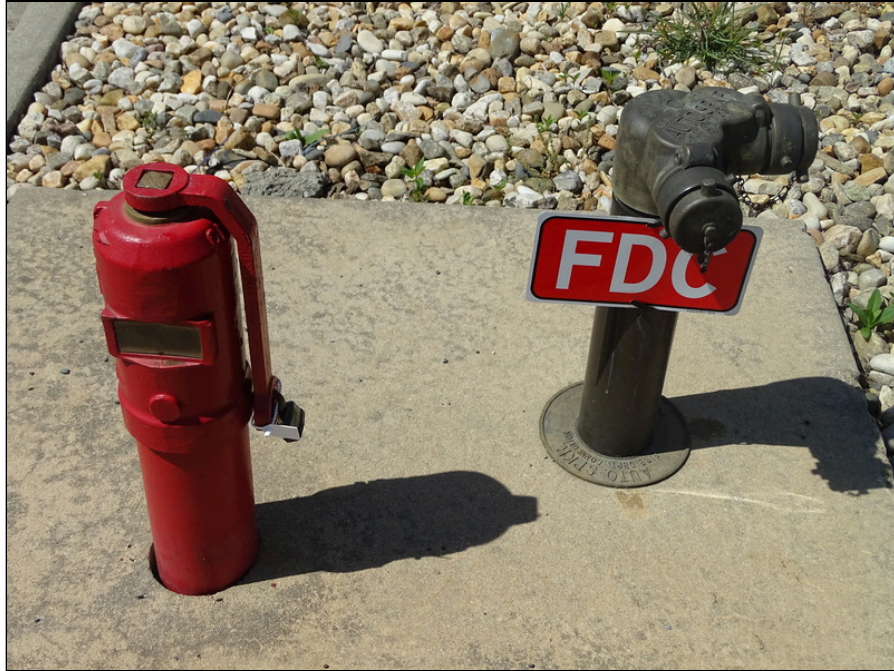
93 - Building B FDC

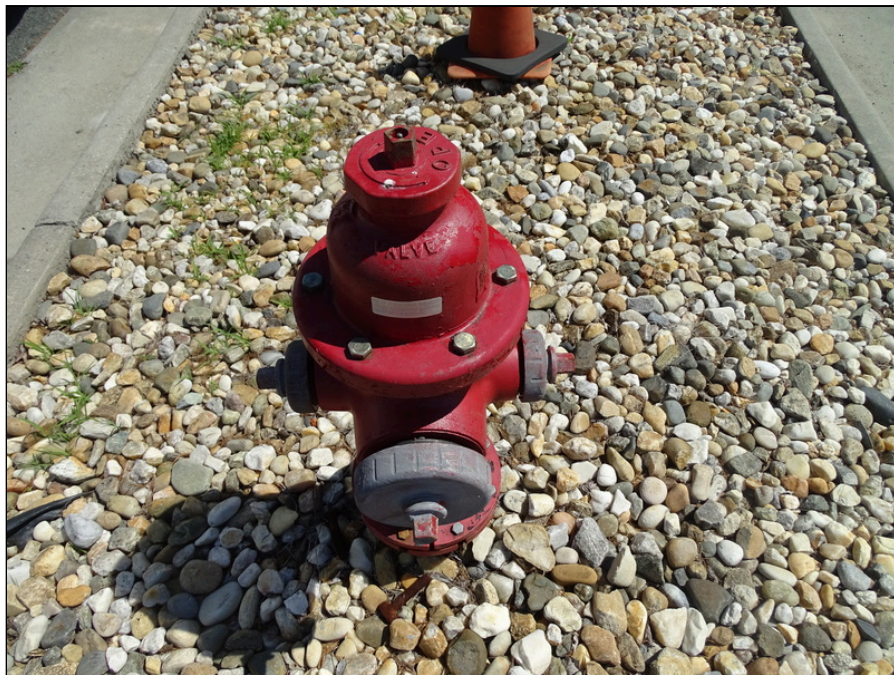
94 - Building C fire hydrant

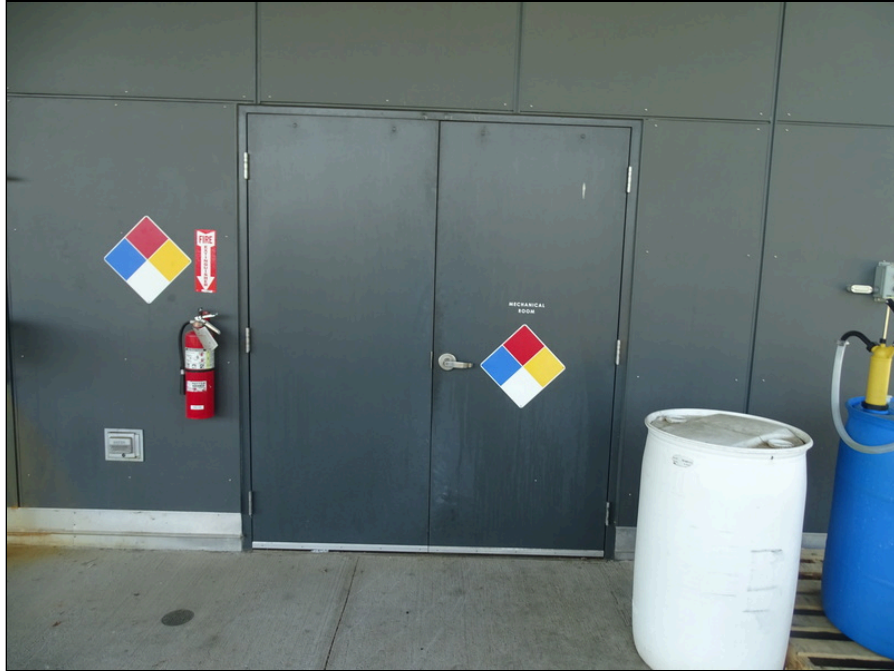
95 - Building C fire extinguisher
