CAT OPERATIONS CENTER  
1545 AVON STREET EXT  
CHARLOTTESVILLE, VIRGINIA

ECS PROJECT NO. 46:6713

CITY OF CHARLOTTESVILLE - FACILITIES DEVELOPMENT

Reference: Facility Condition Assessment Report for CAT Operations Center, 1545 Avon Street Ext,  
Charlottesville, Virginia

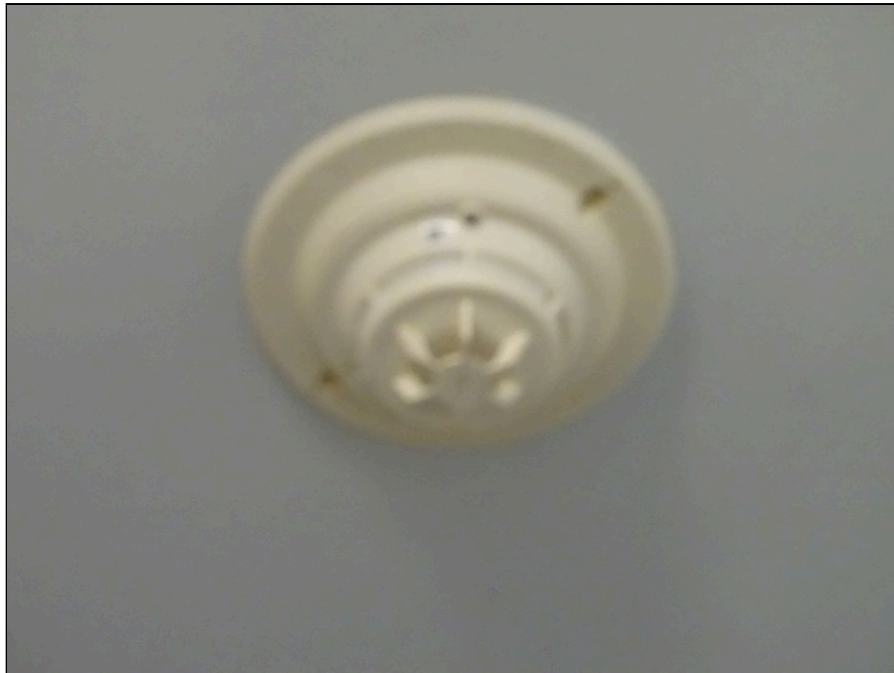
96 - Typical smoke detector

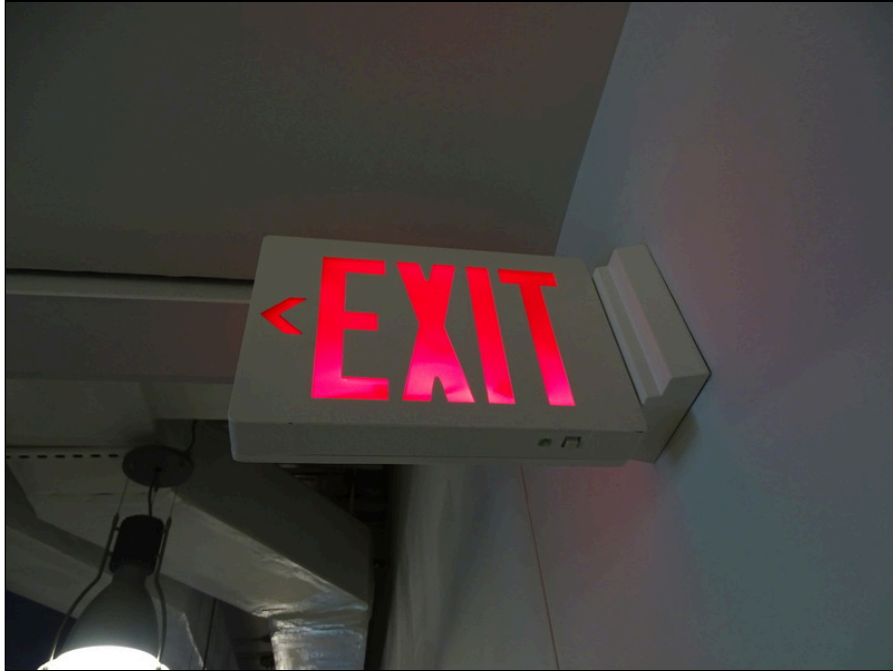
97 - Typical exit sign

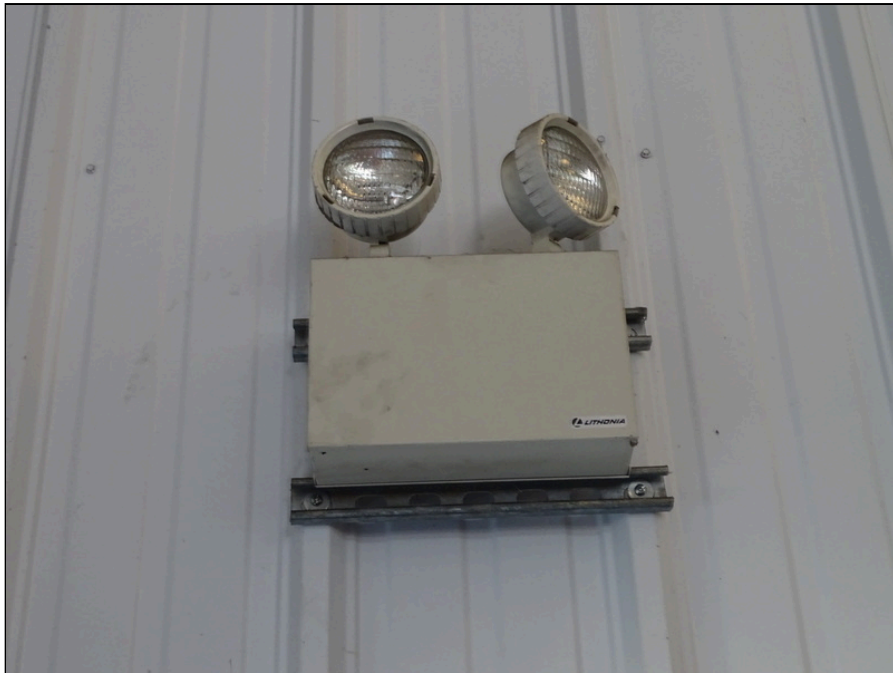
98 - Typical emergency light

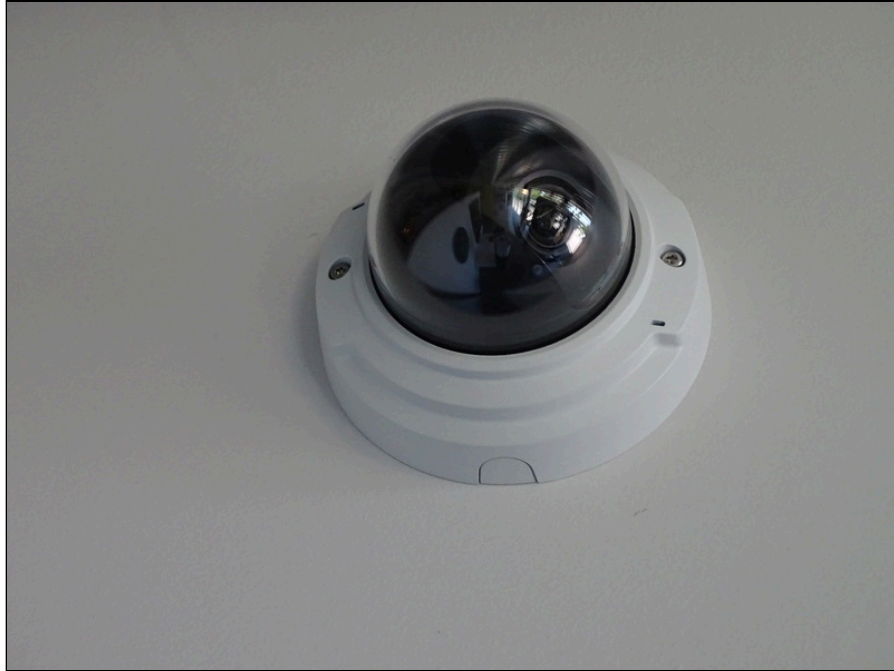
99 - Building A interior security camera

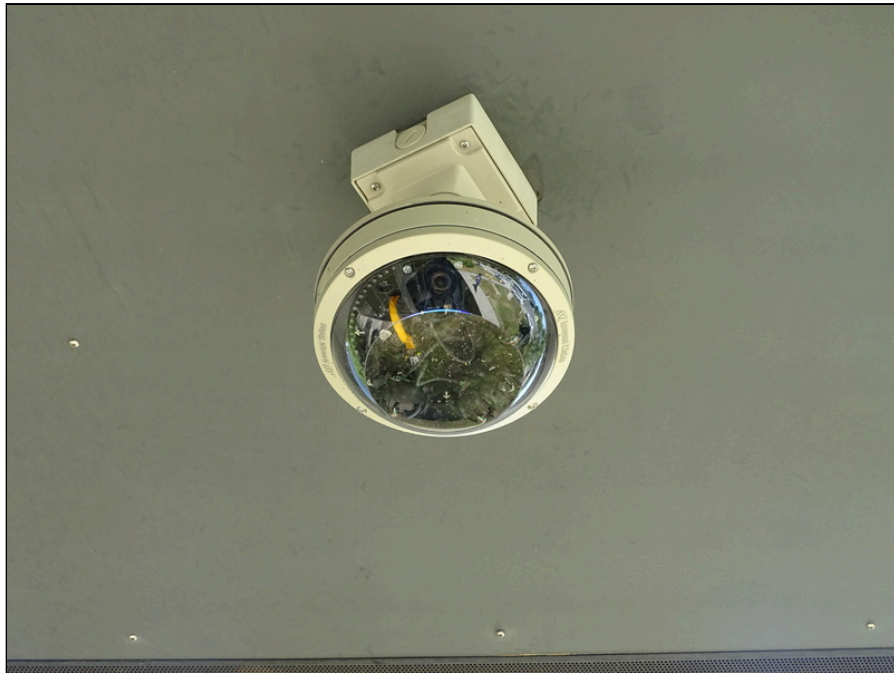
100 - Building interior security camera

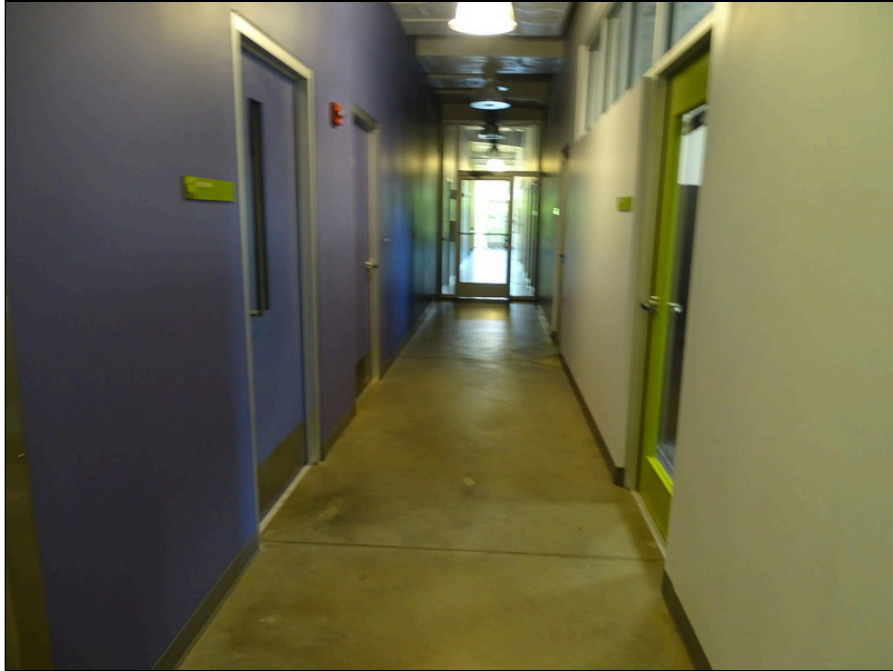
101 - Building A corridor

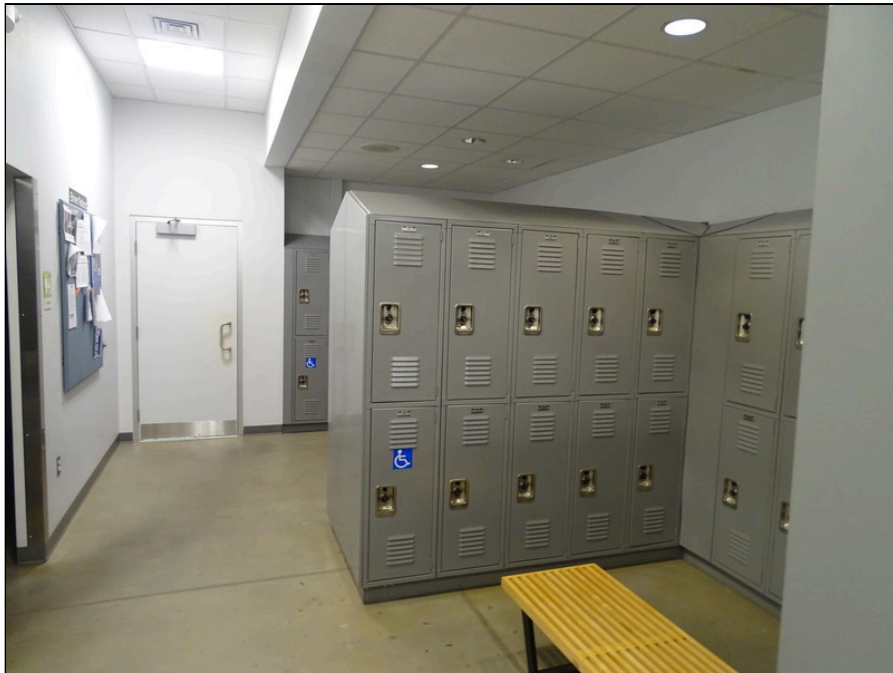
102 - Building A lockers

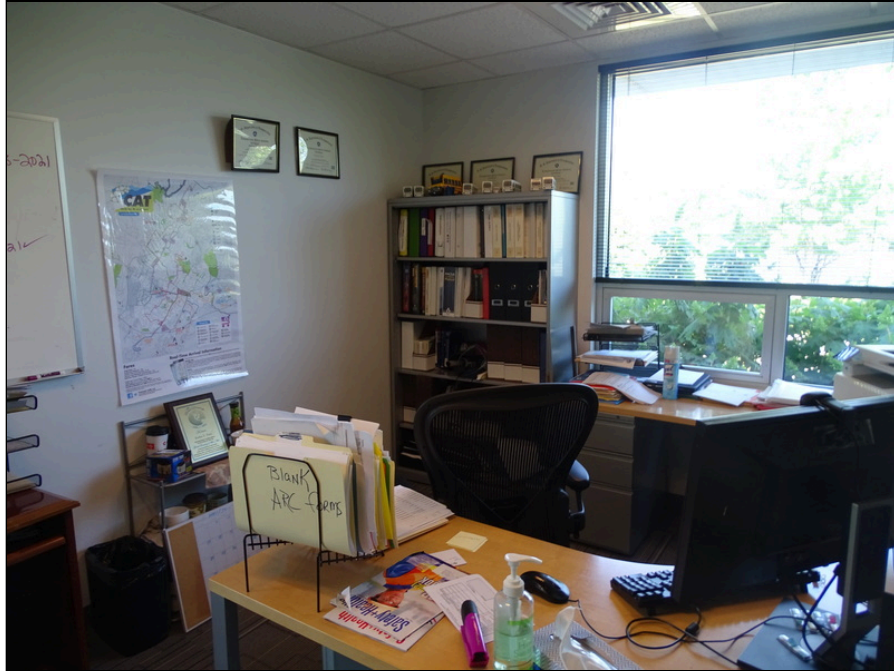
103 - Building A office

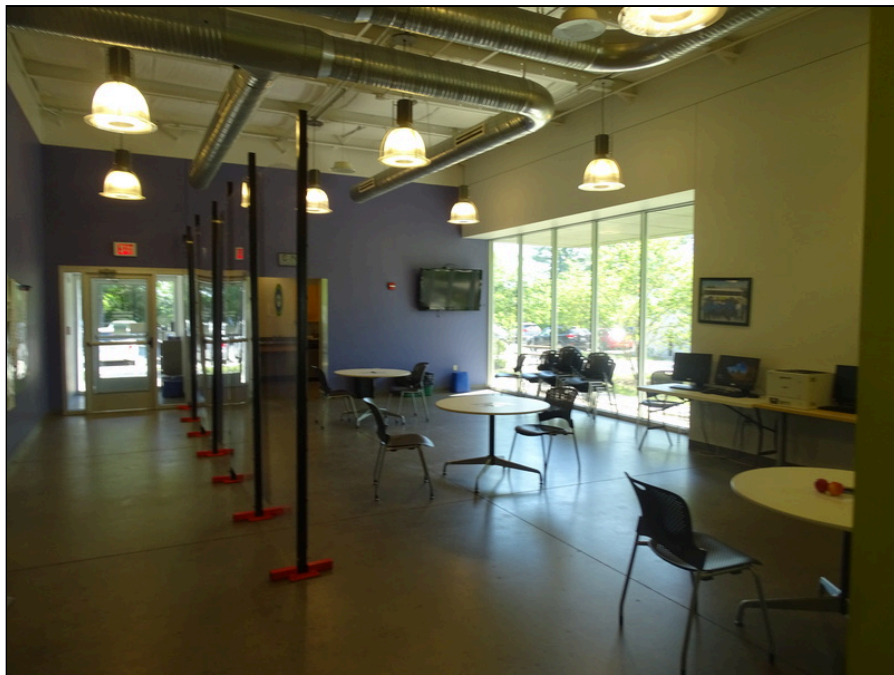
104 - Building A interior

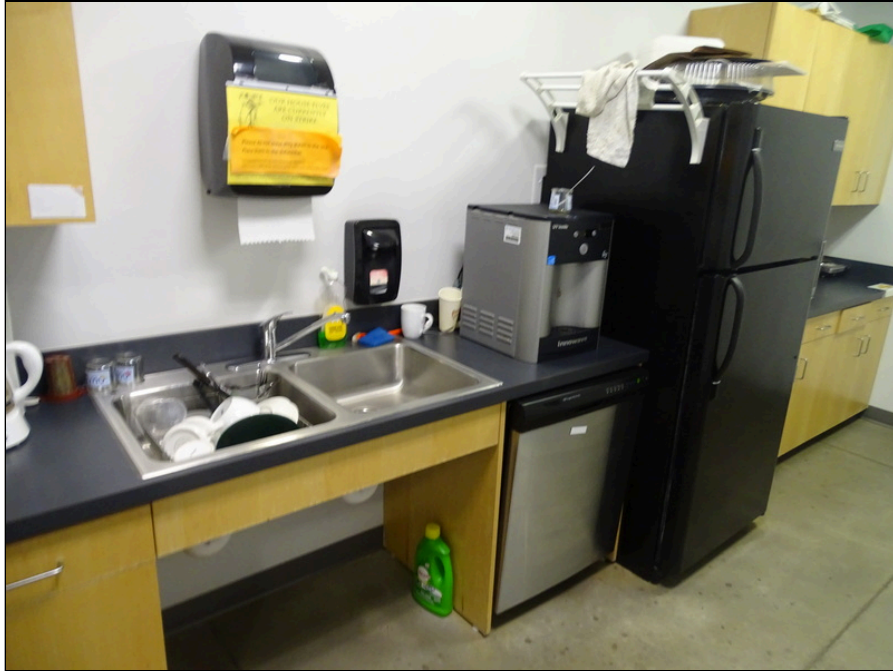
105 - Building A kitchenette

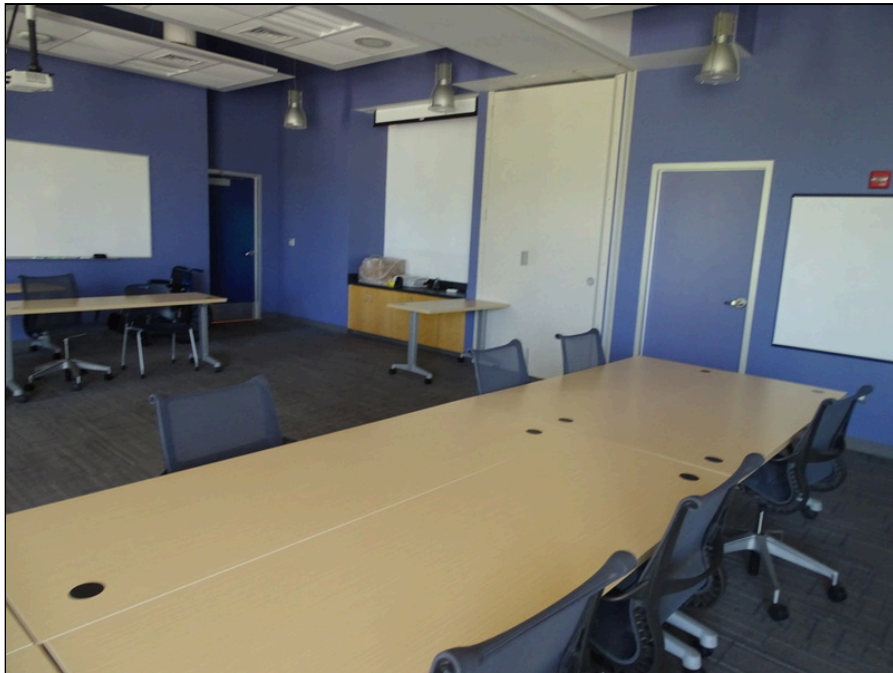
106 - Building A meeting room

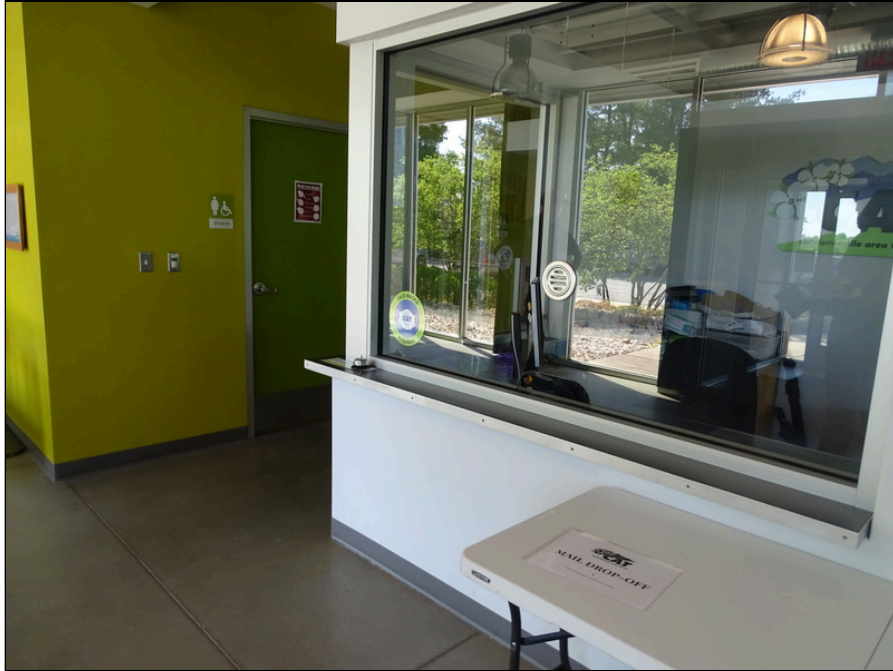
107 - Building A lobby

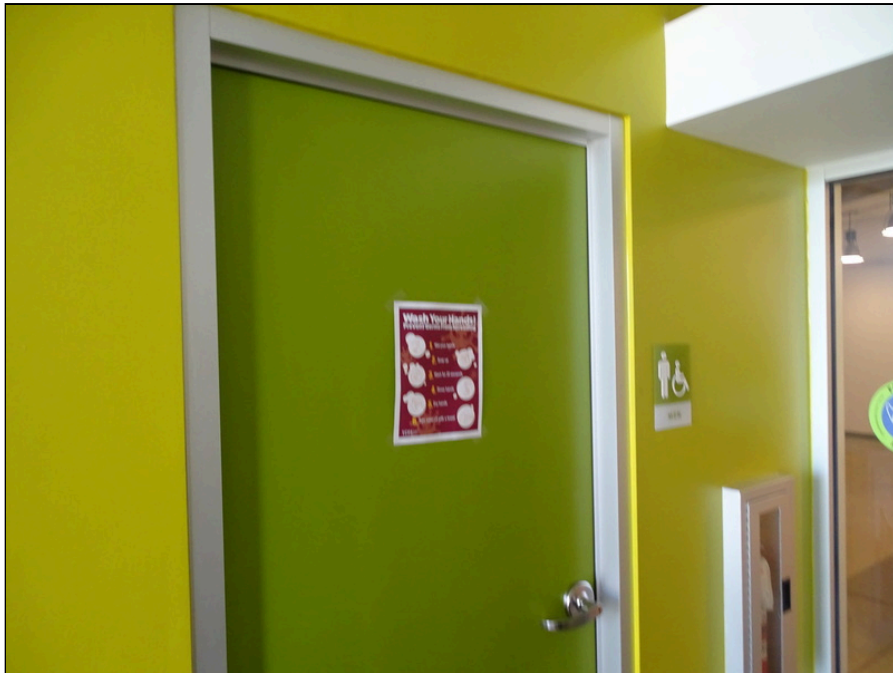
108 - Building A restroom

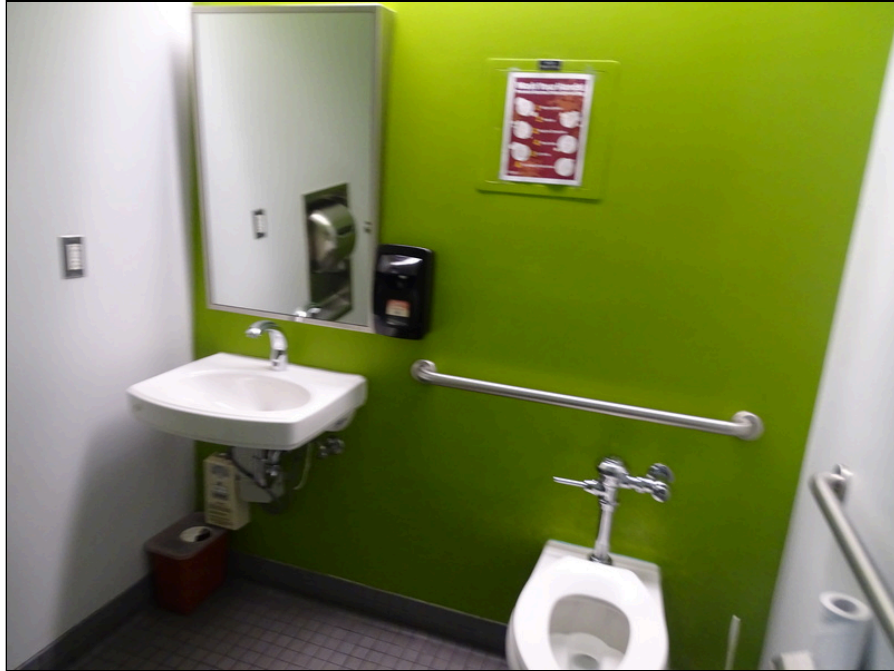
109 - Building A restroom

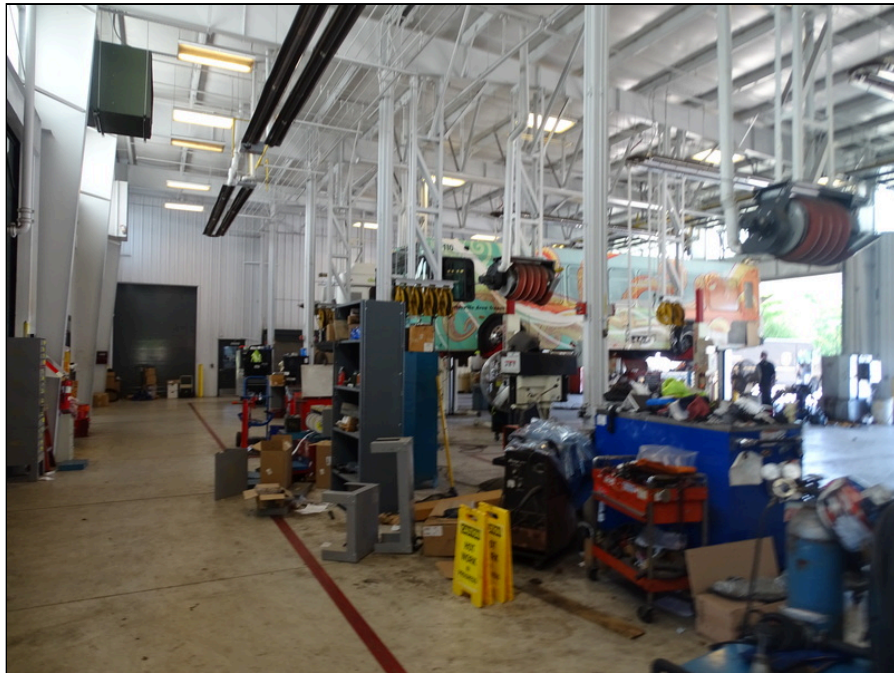
110 - Building B shop area

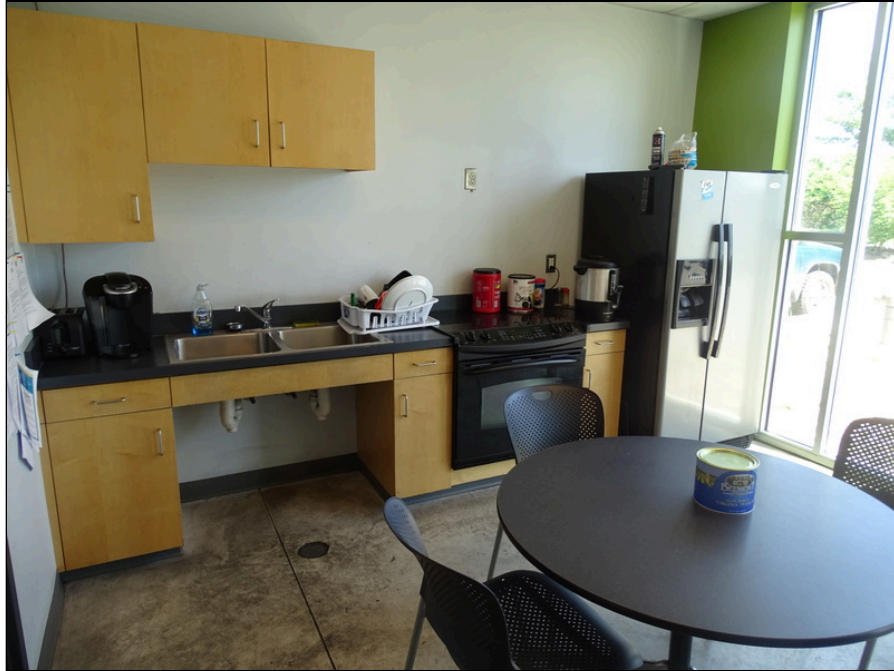
111 - Building B kitchenette

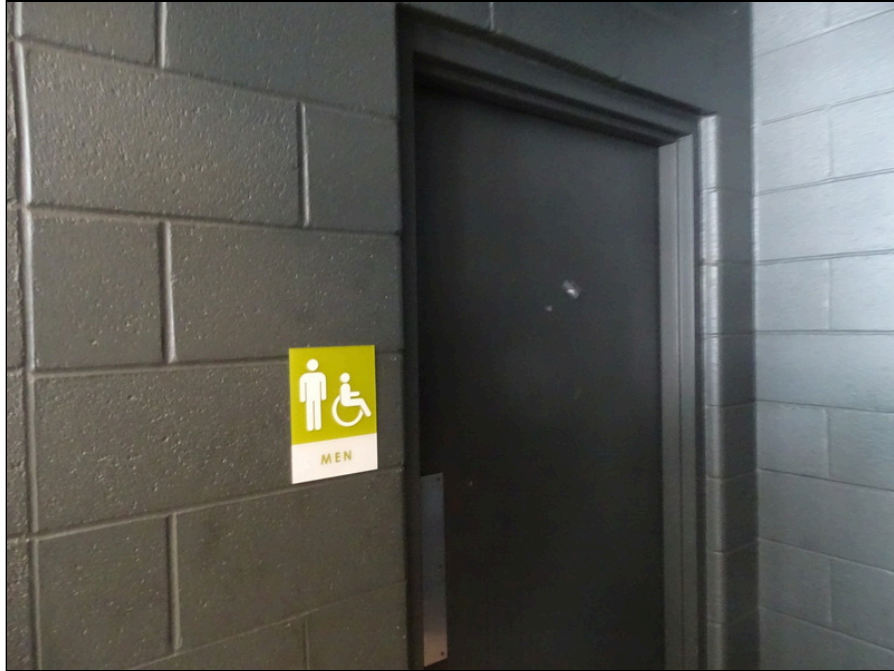
113 - Building B lobby area

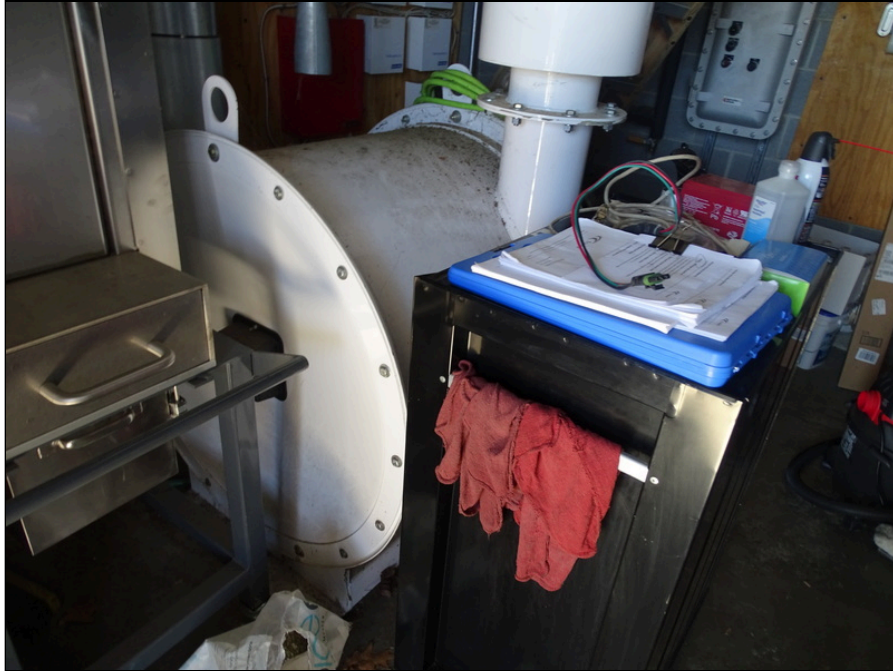
115 - Building D storage room

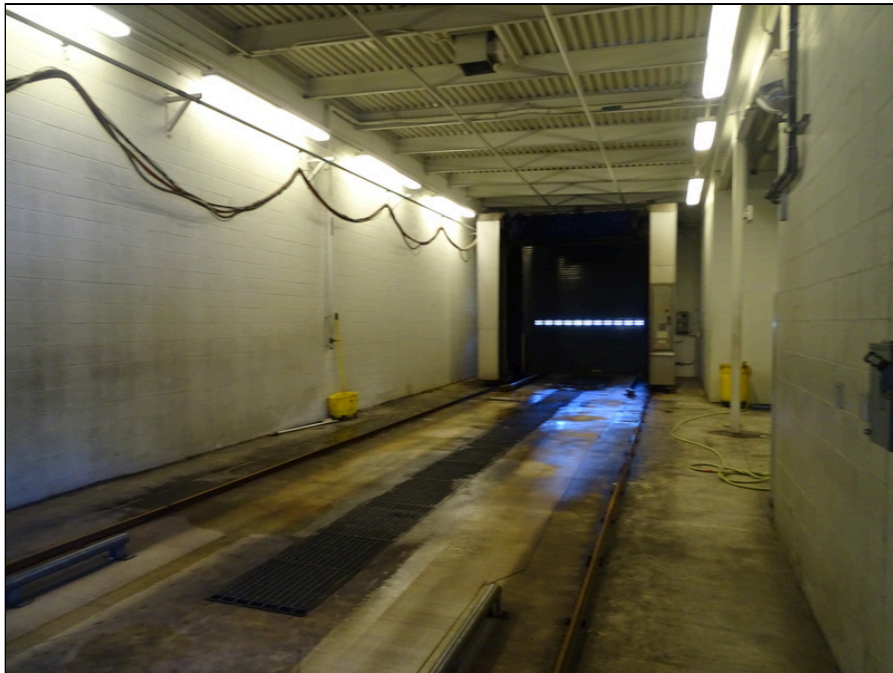
116 - Building D bus bay

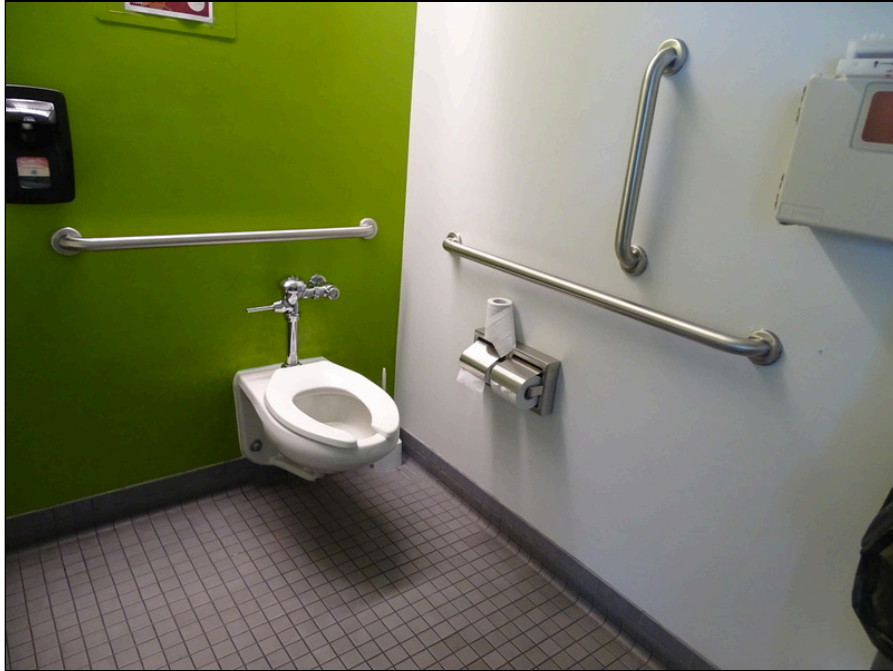
117 - Building A accessible restroom

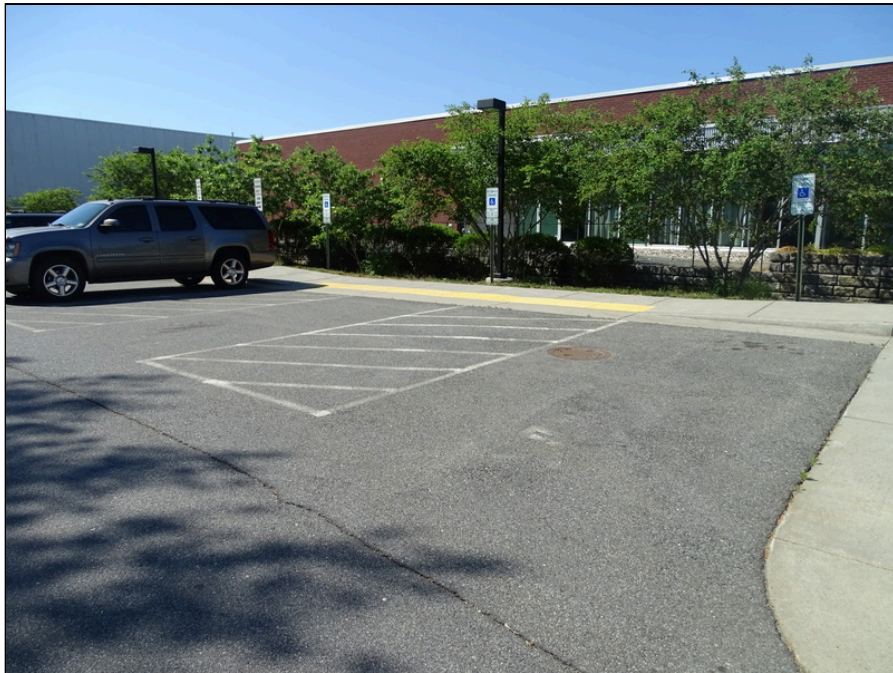
118 - Accessible parking

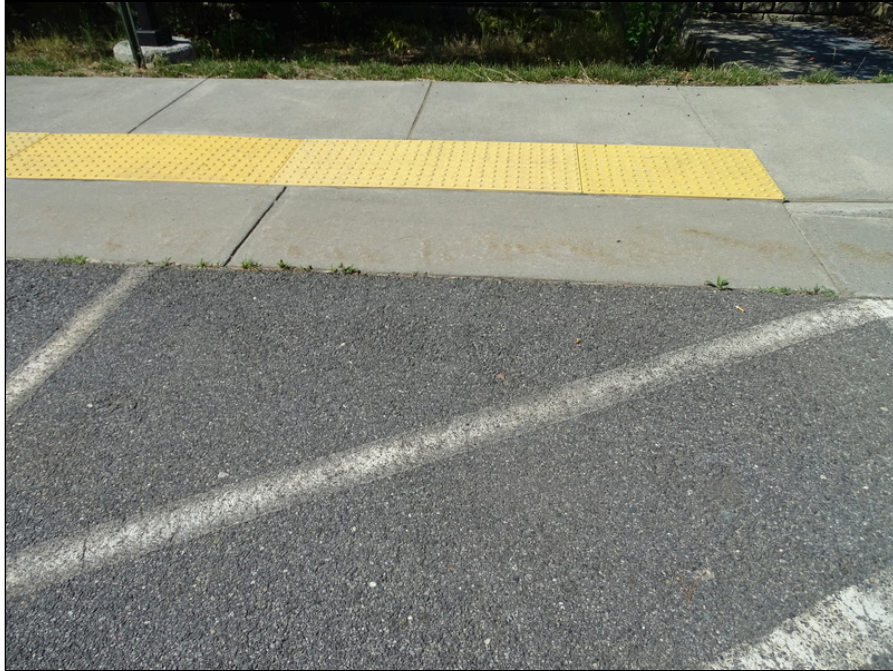
119 - Truncated domes at sidewalk entrance
