CATEC
1000 RIO ROAD EAST
CHARLOTTESVILLE, VIRGINIA

ECS PROJECT NO. 46:6713

CITY OF CHARLOTTESVILLE - FACILITIES DEVELOPMENT

Reference: Facility Condition Assessment Report for CATEC, 1000 Rio Road East, Charlottesville, Virginia

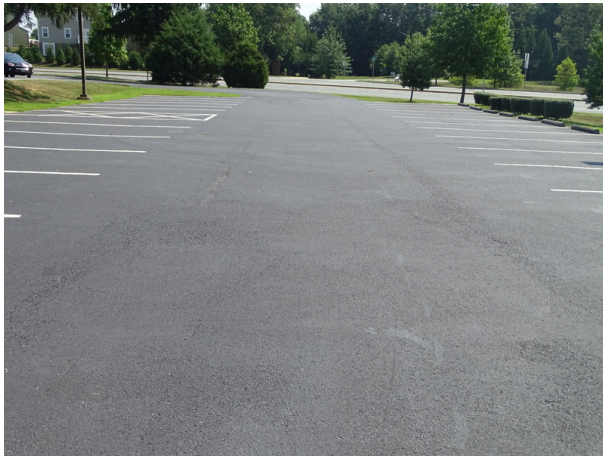
Asphalt-paved drive lanes and parking areas are located on the east and south side of the site which also provides access to the site. Additional parking is provided along the southeast end of the site. The asphalt pavement was observed to be in generally fair condition with alligator cracks observed on the pavement. Striping was in fair condition. The asphalt pavements were reportedly recently repaired. The expected useful life of asphalt pavement is 20 years. We have provided allowances to repair the cracked areas of asphalt pavement based on need over the report period.

Asphalt pavement south parking area

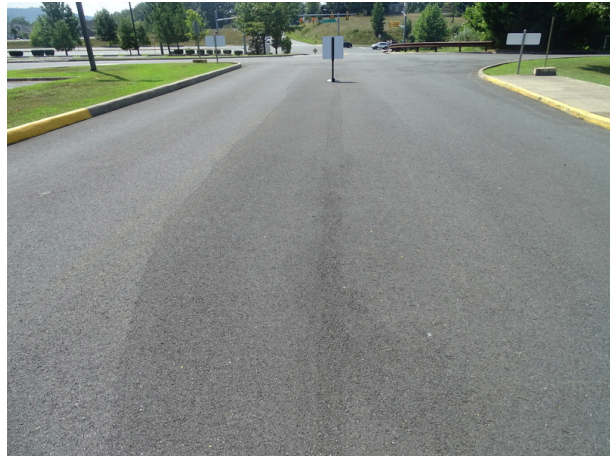
Asphalt pavement west drive lane looking north

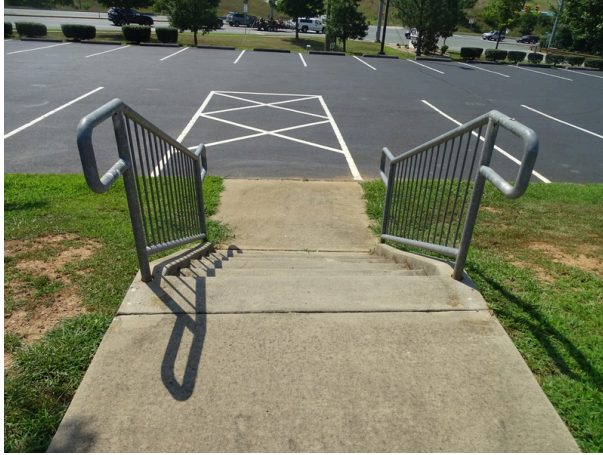
Typical concrete steps

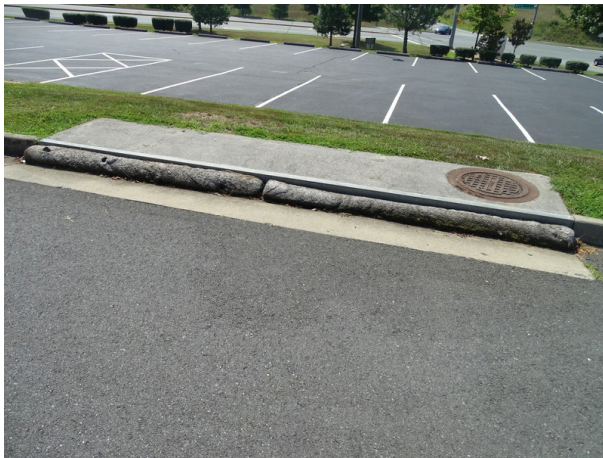
Typical concrete curb

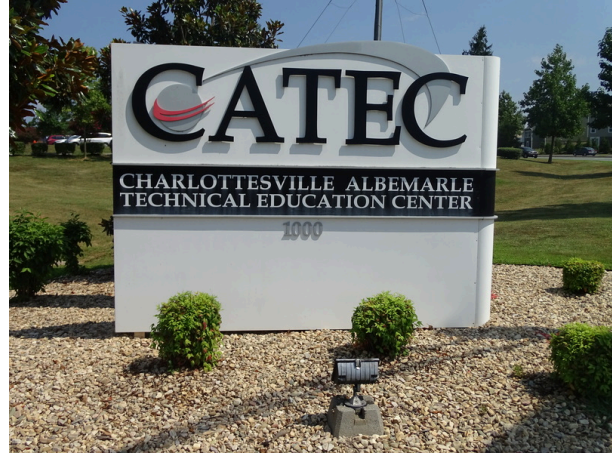
A sign is located at the south entrance. The sign was generally in good condition.

Monument sign at south entrance

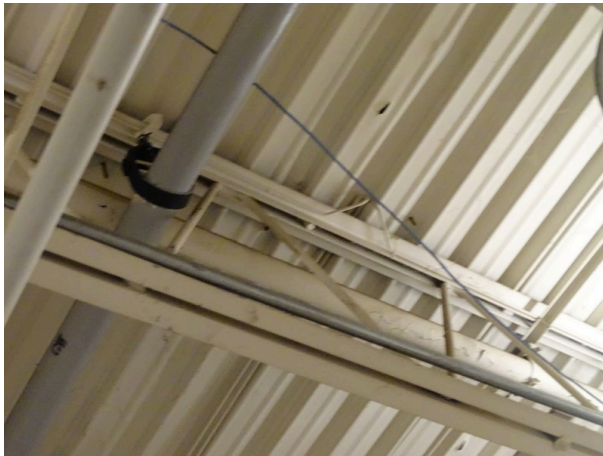
The structure of the building consists of Masonry bearing walls with steel interior columns. The structural frame of the building was generally in good condition.

Structural framing

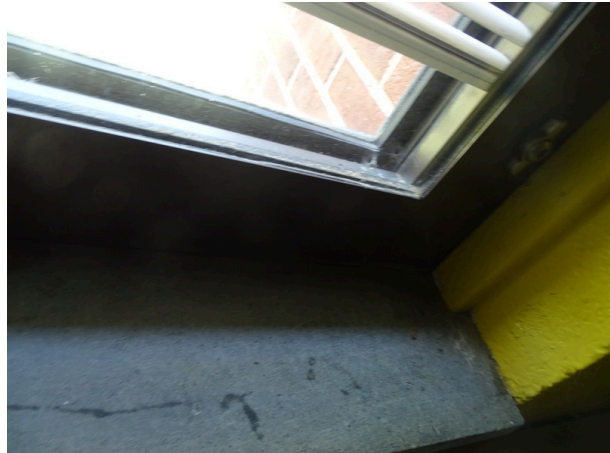
Typical exterior windows - note fog inside the glass

The window system for the building primarily consists of metal frame double-pane window units. Metal frame double-pane windows have a typical expected useful life of 25 years. The windows were generally in good condition. The metal frame of the windows were being refurbished during our site visit in 2016. The exterior windows were fogged and/or gaskets were deteriorated at various locations. We recommend replacing fogged windows and/or exterior window gaskets as needed.

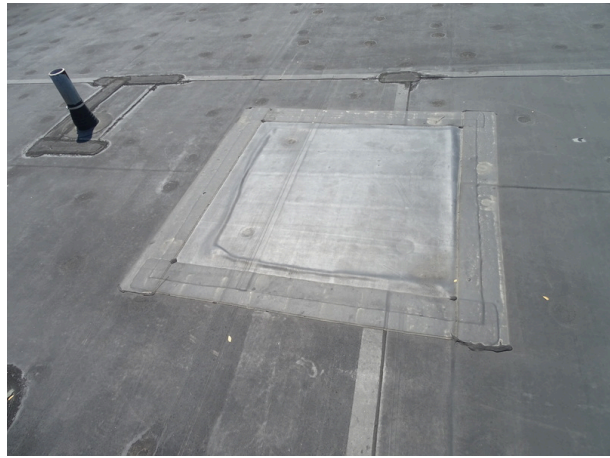
Single-ply membrane roofing system - note patching

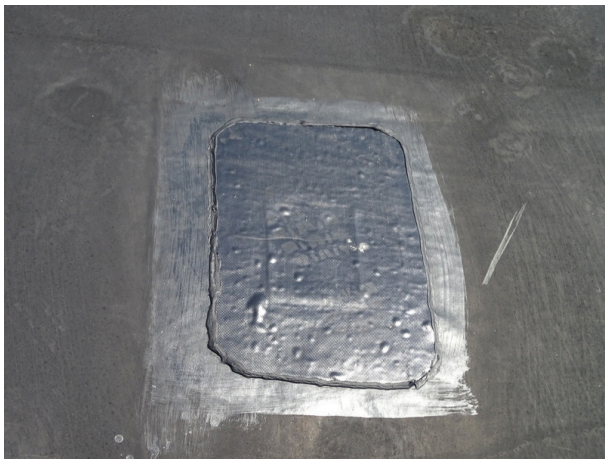
Single-ply membrane roofing system - note patching

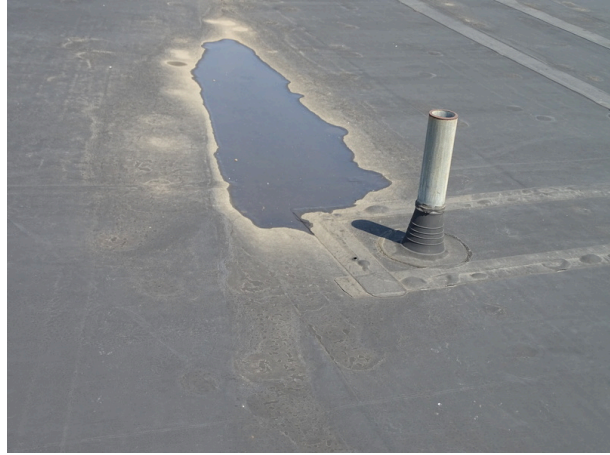
Typical area of ponding

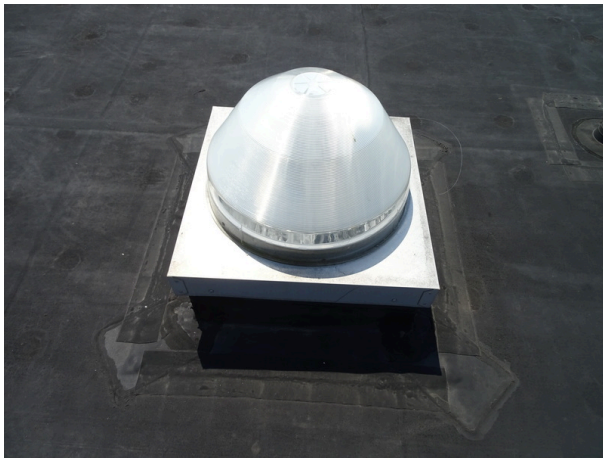
There are five skylights on the north side of the building. The skylights framing was rusted and were generally in fair condition. We recommend the skylights be replaced during roof replacement.

Typical skylight

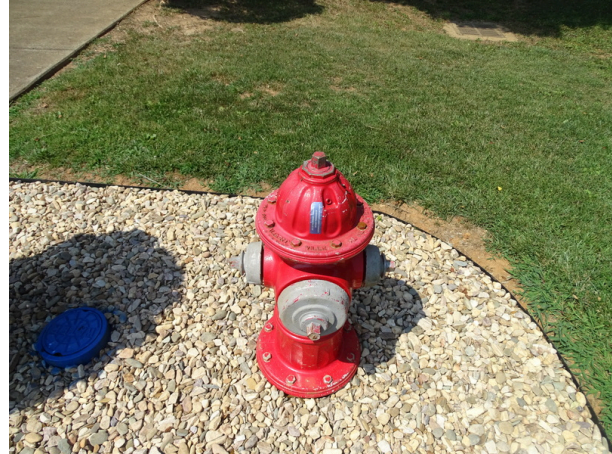
Fire hydrants are located at the building exterior. The fire hydrants were observed to be in good condition.

Typical fire hydrant

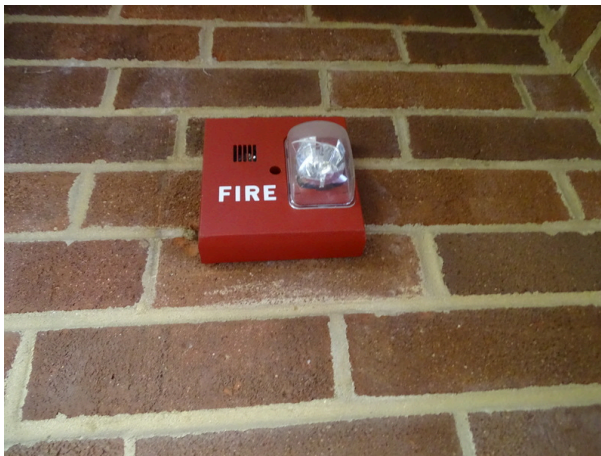
Typical fire alarm bell and strobe

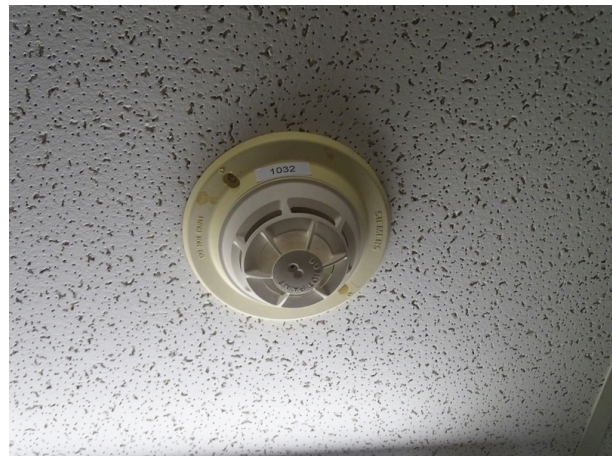
Typical smoke detector

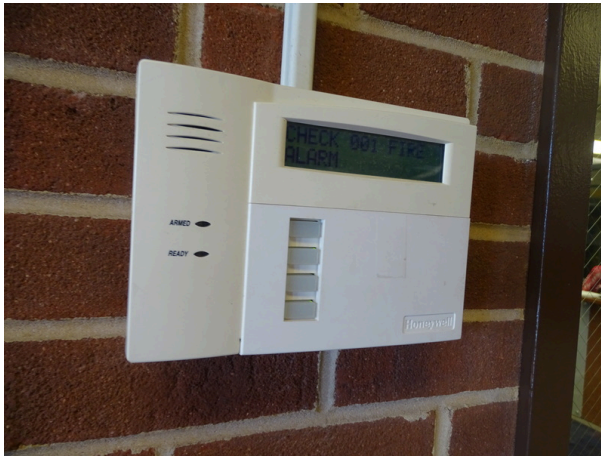
Security system electronic controls

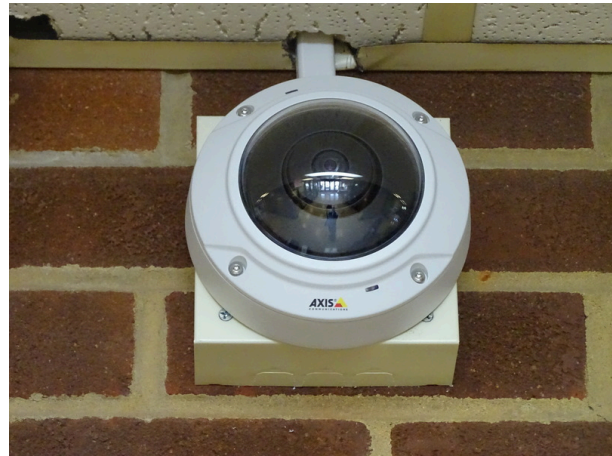
Typical security camera

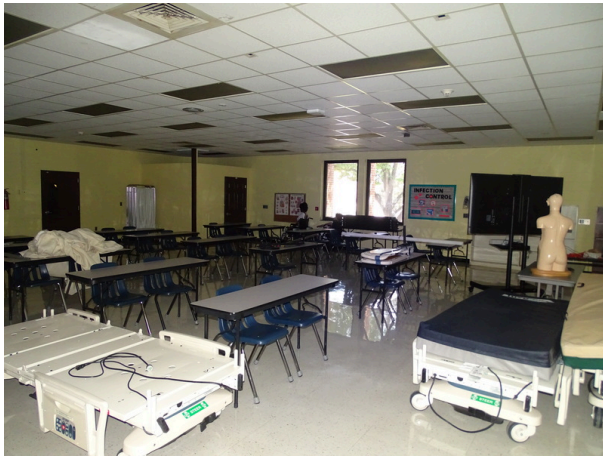
The classrooms consist of vinyl tile flooring, painted CMU walls, and suspended acoustical tile ceilings. The finishes were generally in good condition.

Interior finishes of classroom area

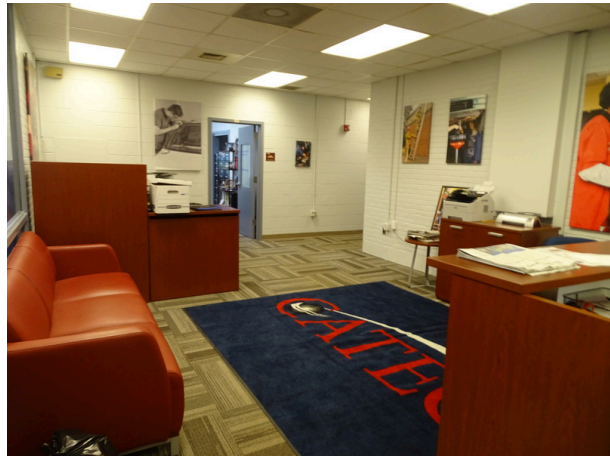
The finishes in the main office include carpet and vinyl floors, painted CMU and gypsum board walls, and suspended acoustical tile ceilings. A glass wall and door assembly was installed at the office entrance. The finishes in the main office were observed to be in generally good condition.

Interior finishes of main office and entrance
area

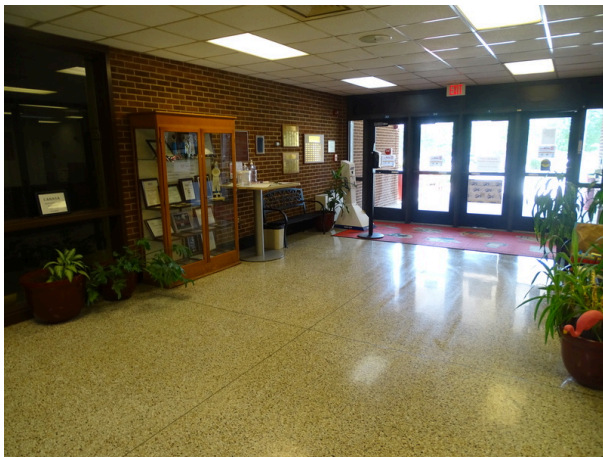
The finishes in the corridors include terrazzo floors, painted CMU and exposed brick walls, and suspended acoustical tile ceilings. The finishes in the corridors were observed to be in generally good condition.

Interior finishes of corridor area

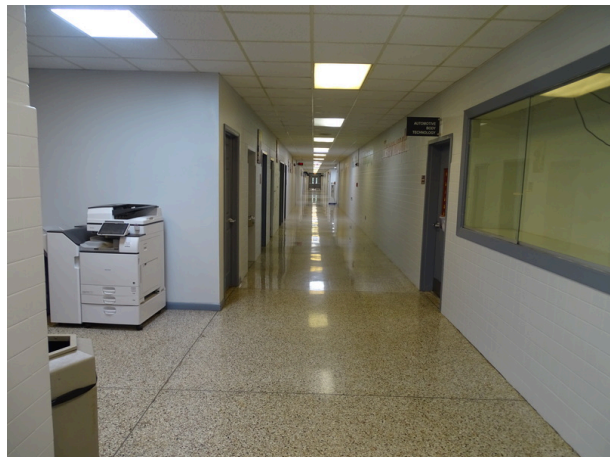
Interior finishes of corridor area

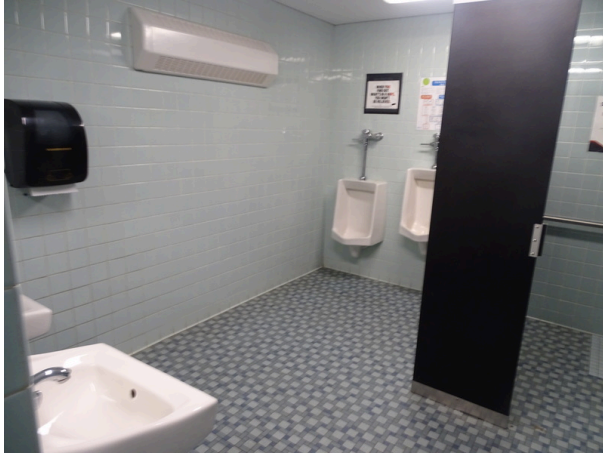
Restrooms are located throughout the building as accessed from corridors. The finishes in the restrooms include ceramic tile floors, ceramic tile walls, and painted gypsum board ceilings. The restrooms were observed to be in generally good condition.

Interior finishes of restroom area

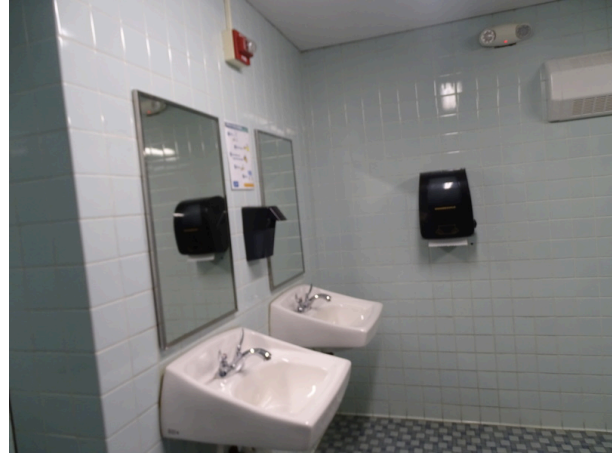
Interior finishes of restroom area

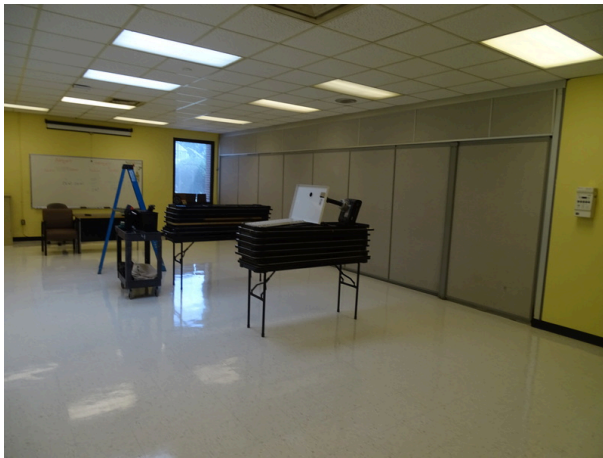
Interior finishes of classroom area

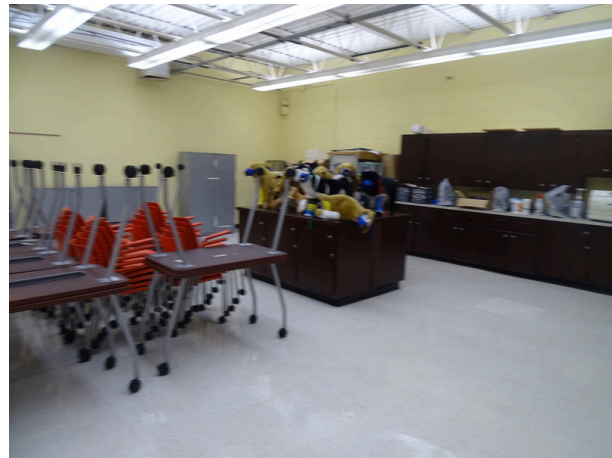
The finishes in the cafeteria area consisted of vinyl tile flooring, painted CMU walls, and unfinished ceiling. The finishes were generally in good condition.

Interior finishes of cafeteria area

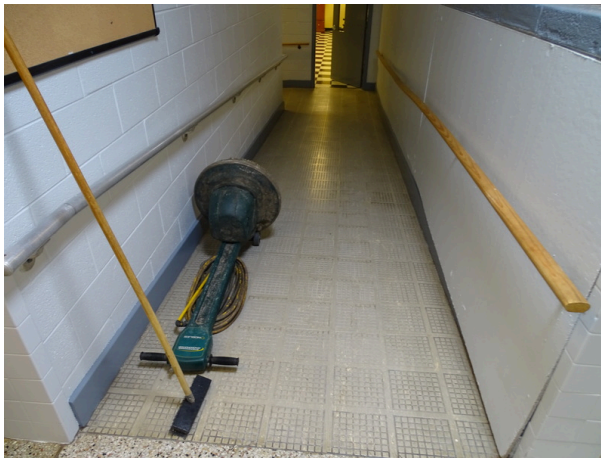
Accessible interior ramp

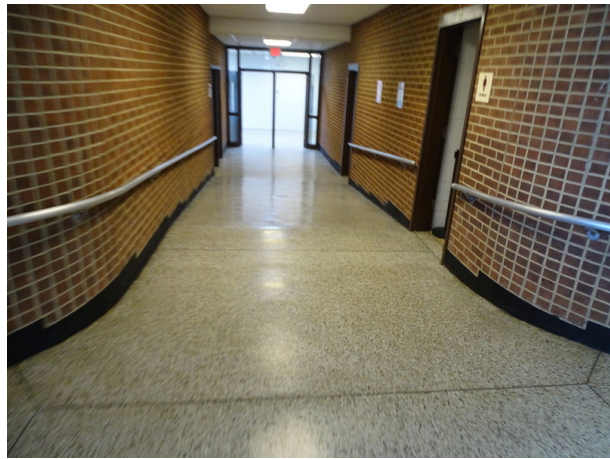
Accessible interior ramp

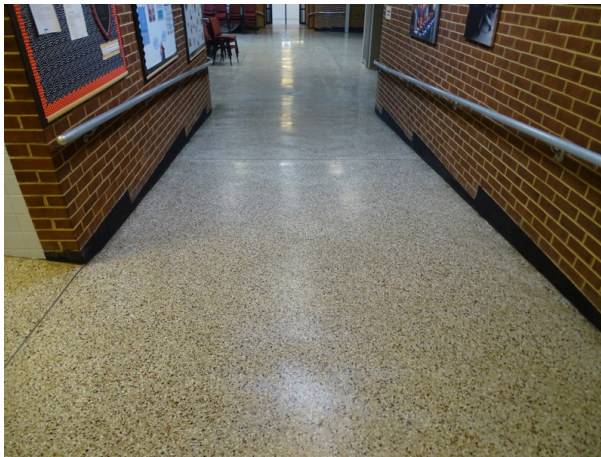
Accessible interior ramp

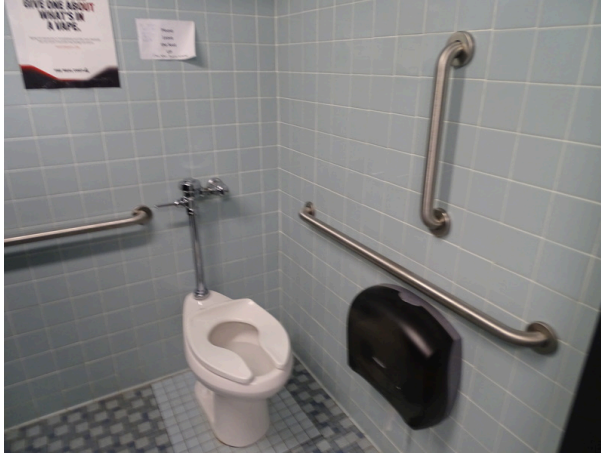
Accessible toilet

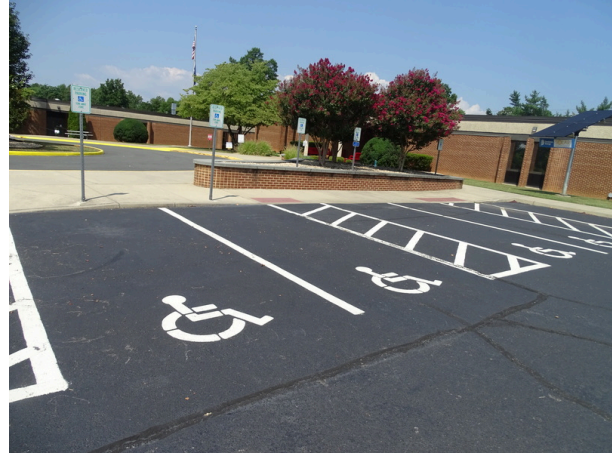
The parking area serving the property has a total of approximately 120 parking spaces. Of the parking spaces, Five are accessible with Four being van accessible. Accessibility requires that five accessible parking spaces be provided in parking areas with a total of 101 to 150 spaces. One in six of the accessible parking spaces are required to be van accessible. A minimum of a 60-inch wide access aisle is required to be provided for every two accessible parking spaces. Accessible aisles were observed to be provided. The number of parking spaces provided does meet accessibility requirements.

Accessible parking spaces

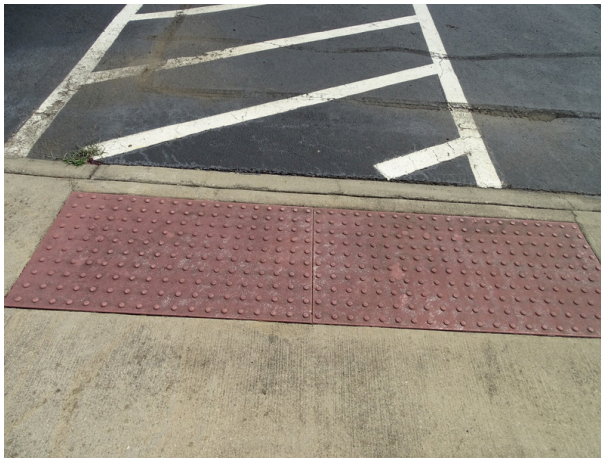
Accessible curb ramp with truncated domes

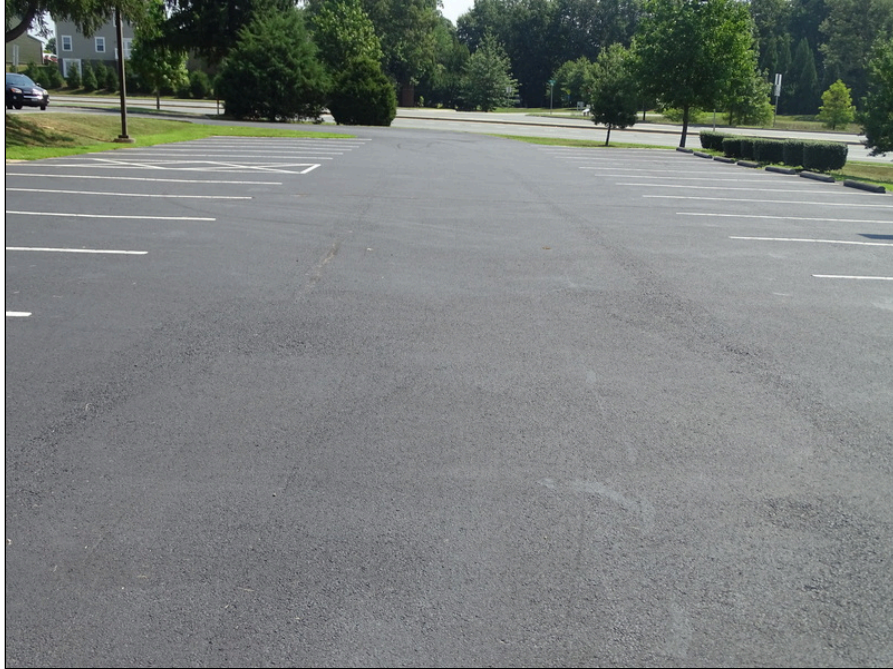
1 - Asphalt pavement south parking area

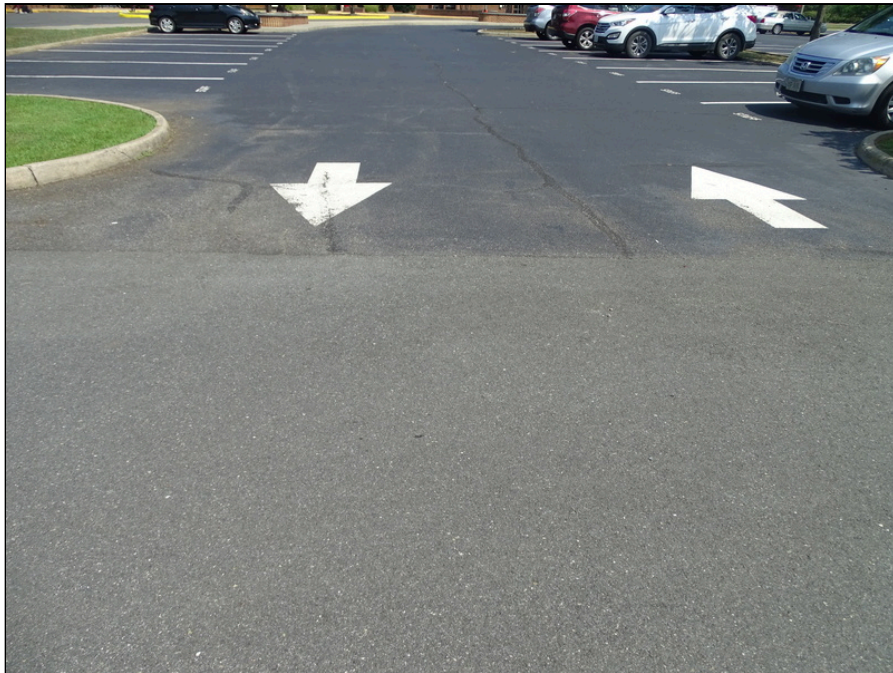
2 - Asphalt pavement center drive lane looking north - note previous repair

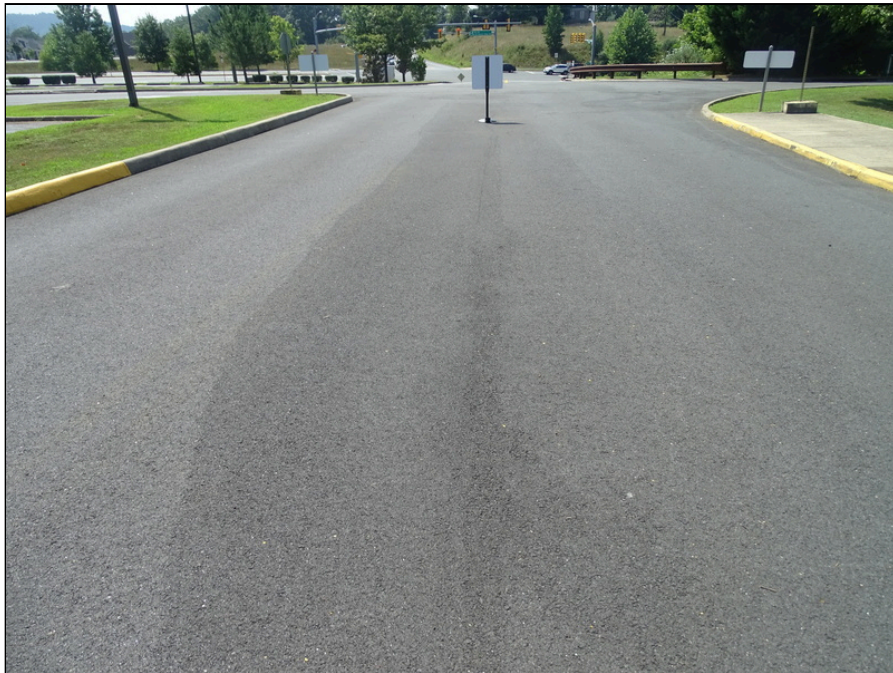
4 - Asphalt pavement west drive lane looking north

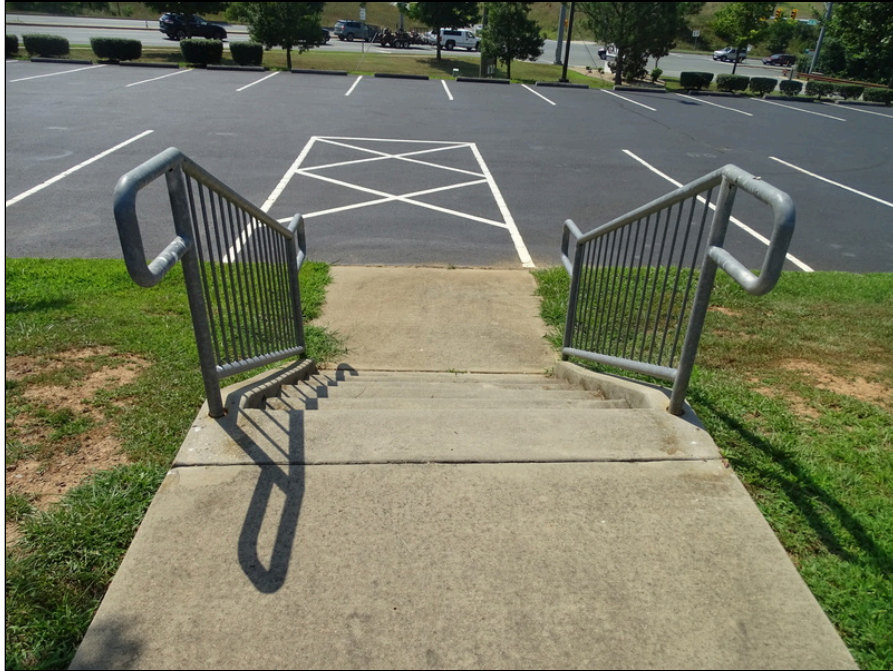
7 - Typical concrete steps

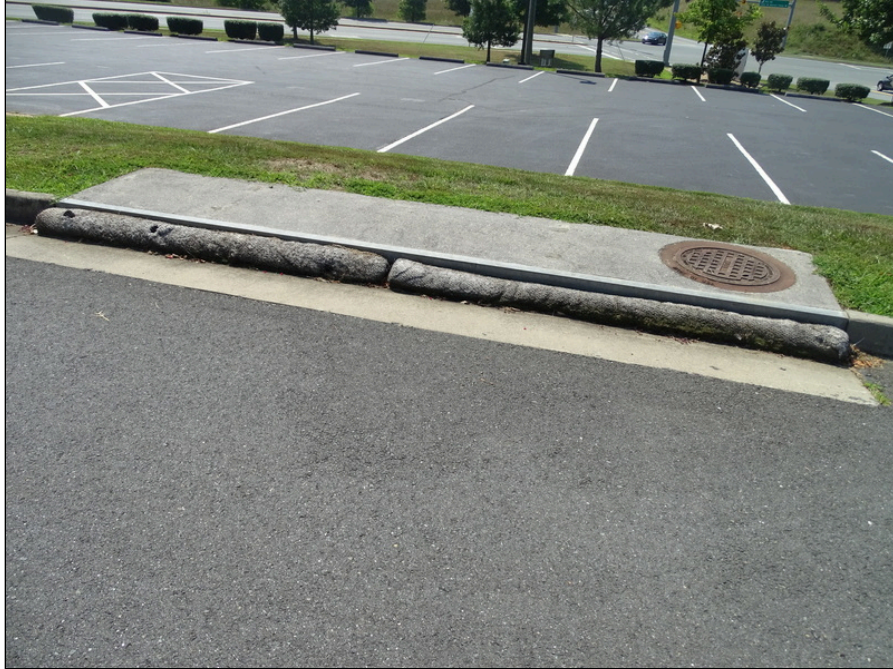
9 - Typical concrete curb

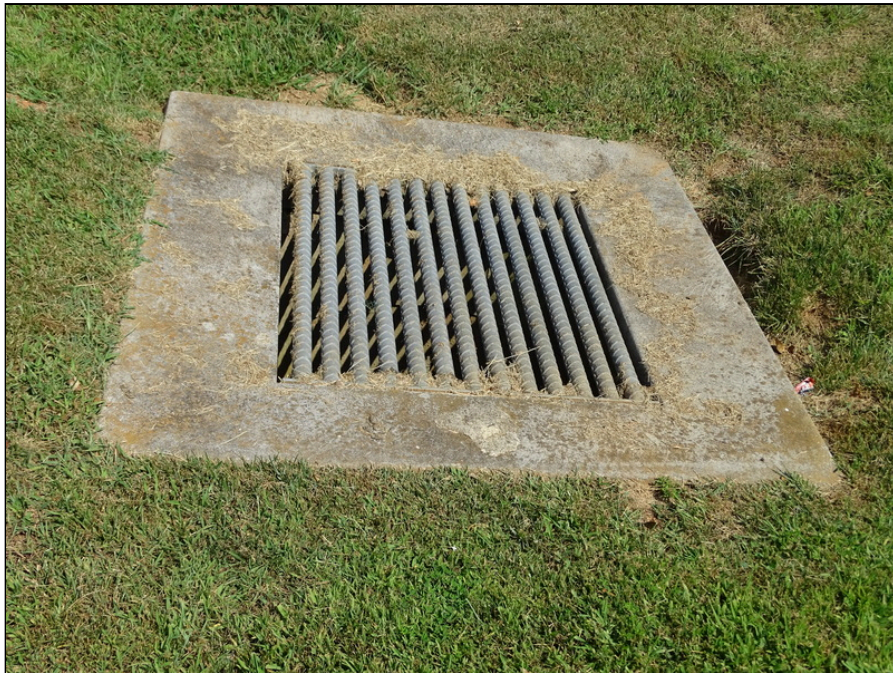
10 - Typical storm water drainage

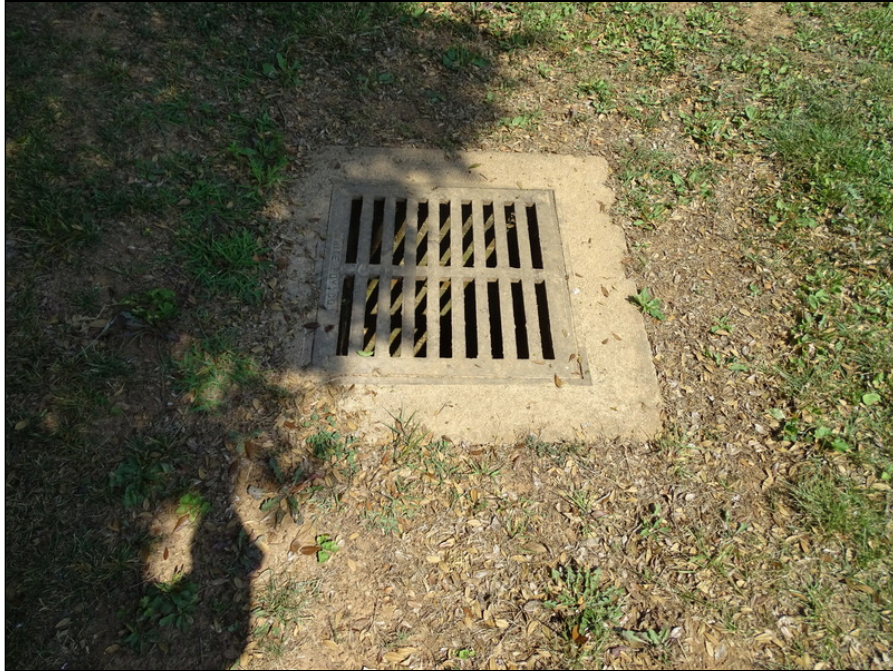
11 - Typical storm water drainage

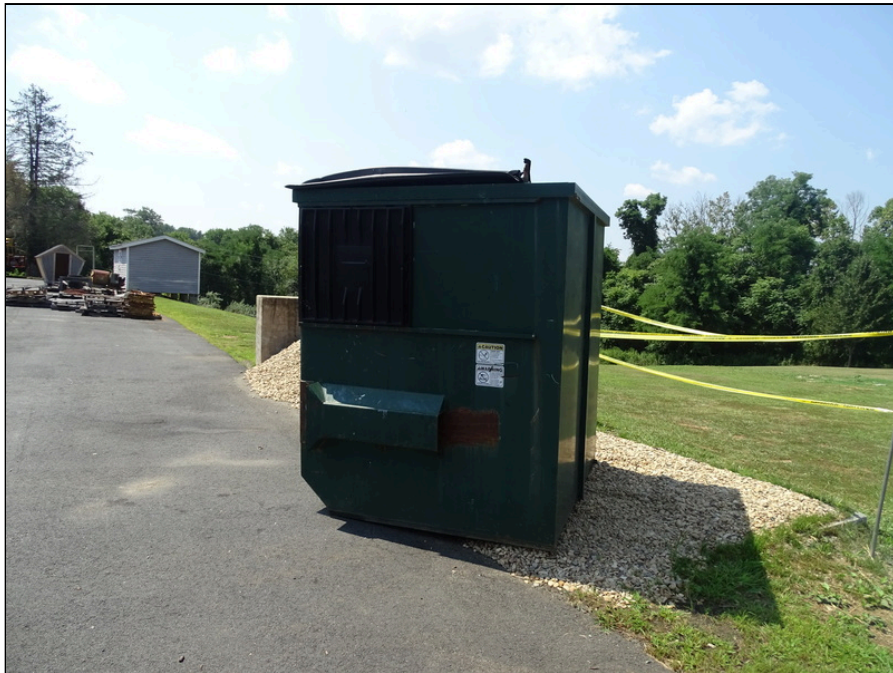
12 - Typical dumpster

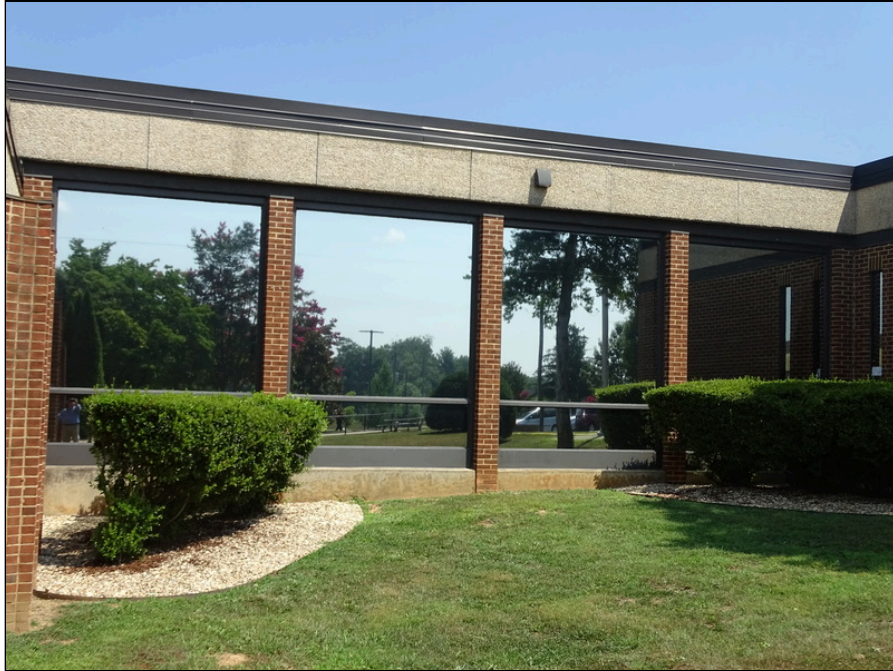
13 - Typical landscaping

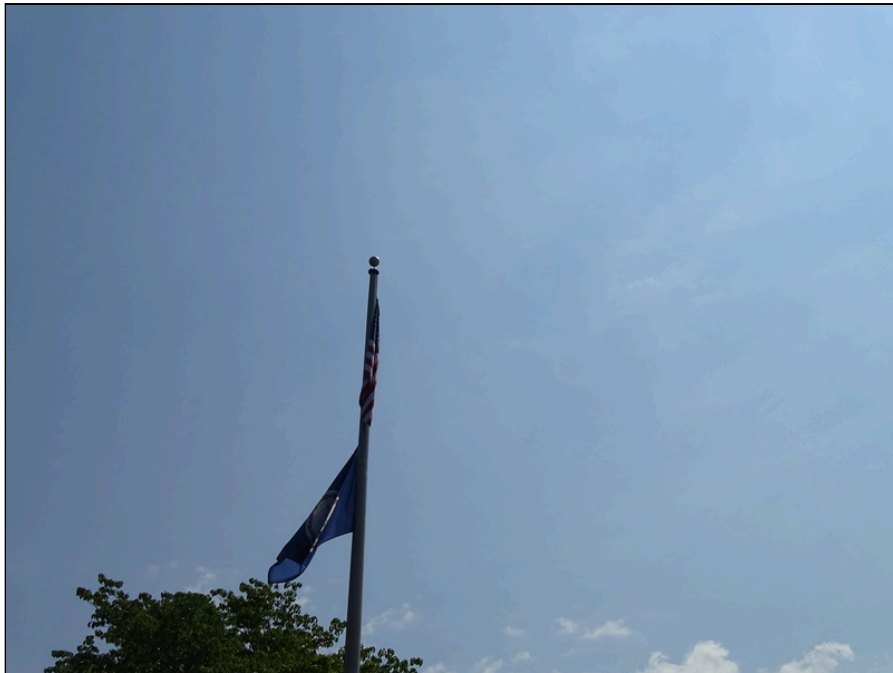
14 - Typical landscape - note flag pole

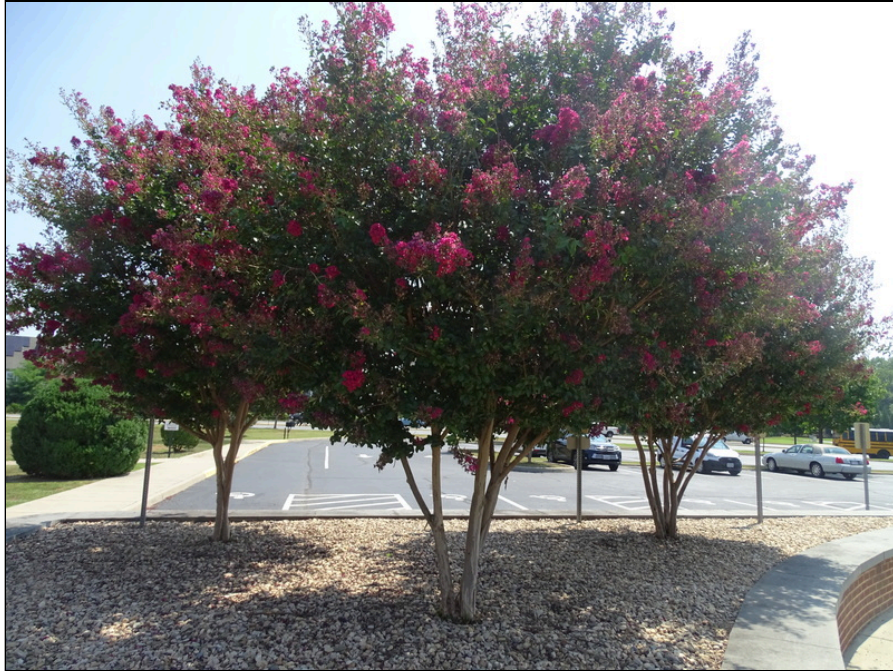
15 - Typical landscaping

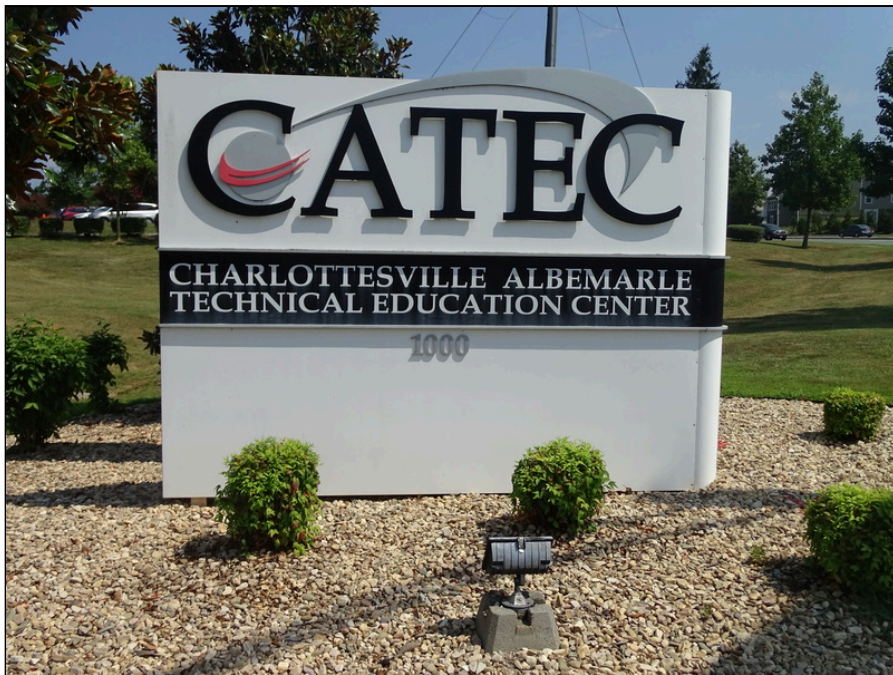
16 - Monument sign at south entrance

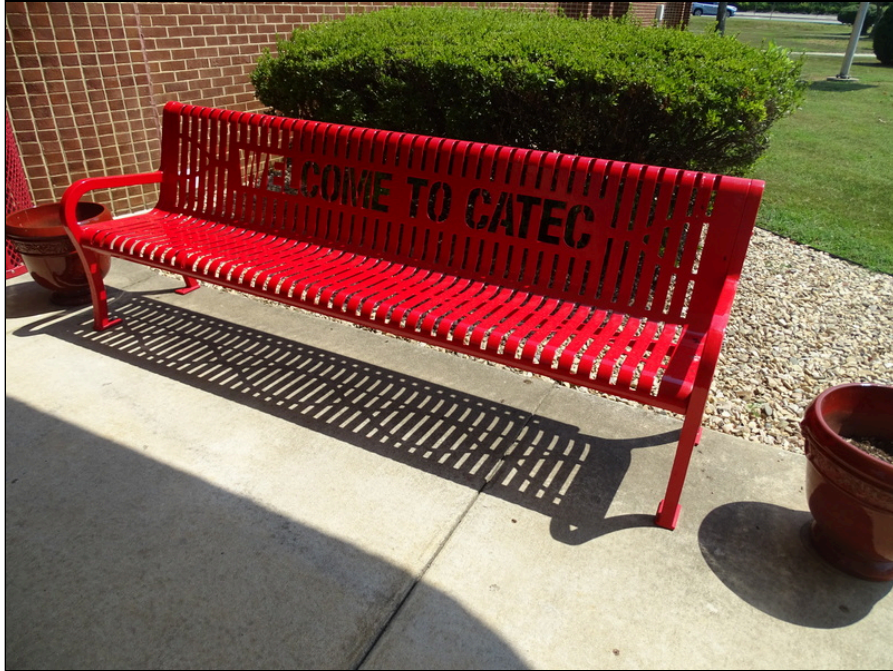
17 - Typical landscaping

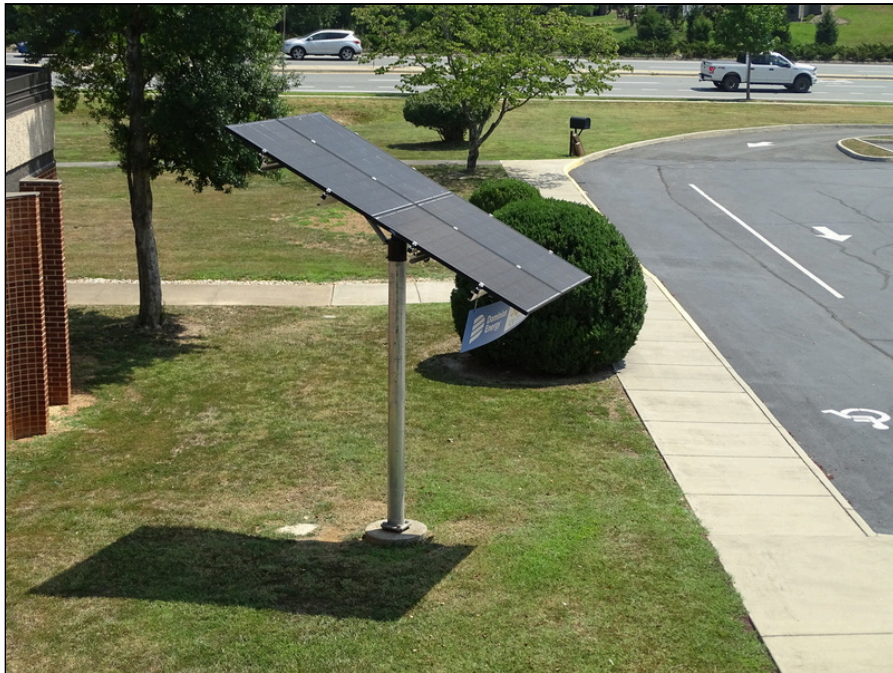
18 - Typical landscaping

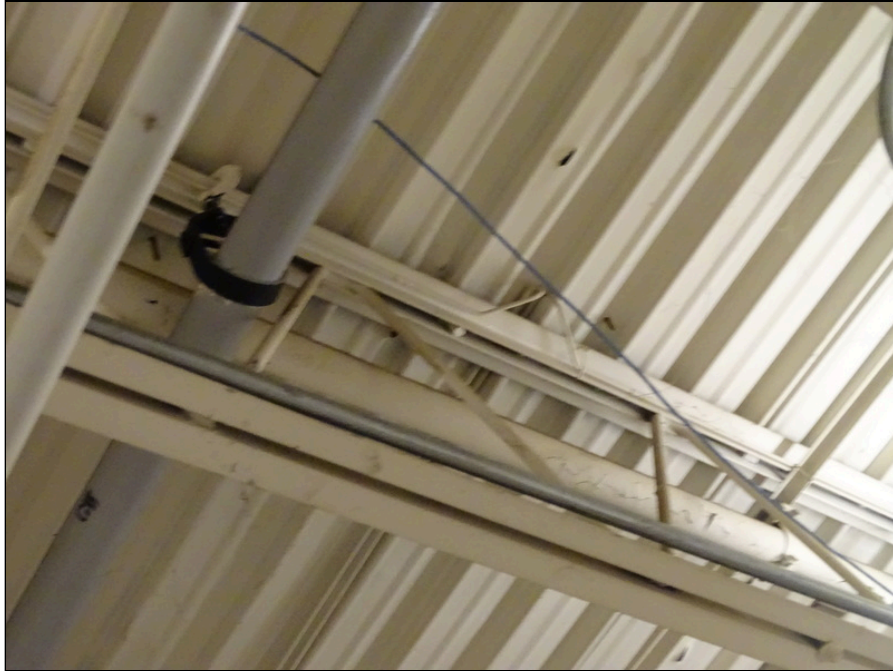
19 - Structural framing

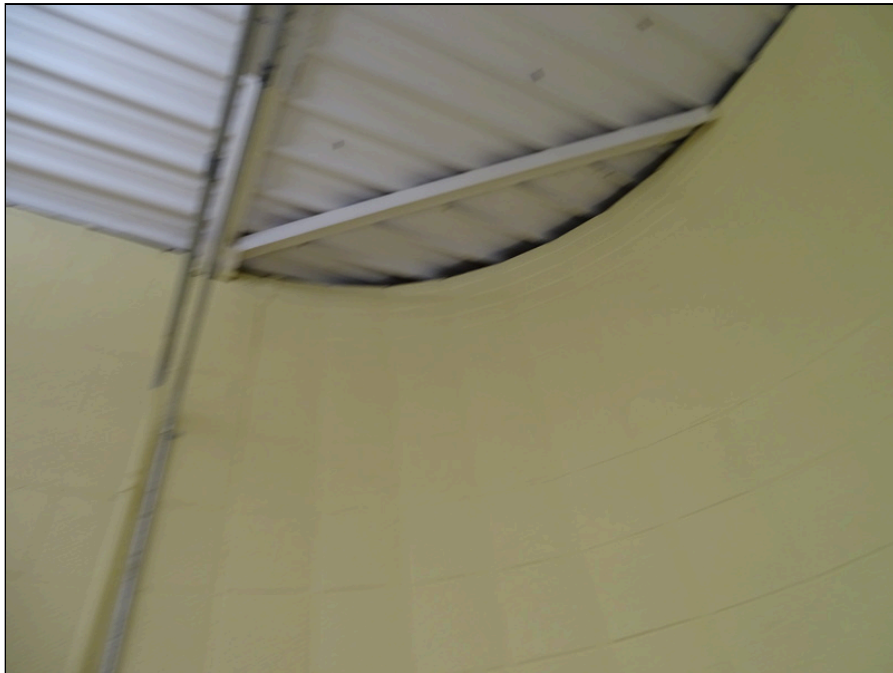
20 - Structural framing

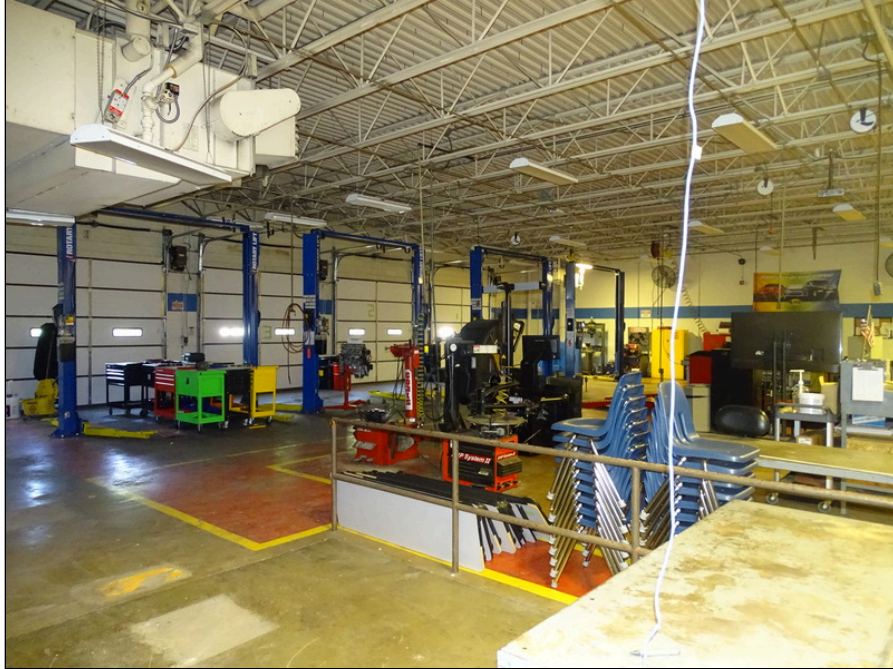
21 - Structural framing

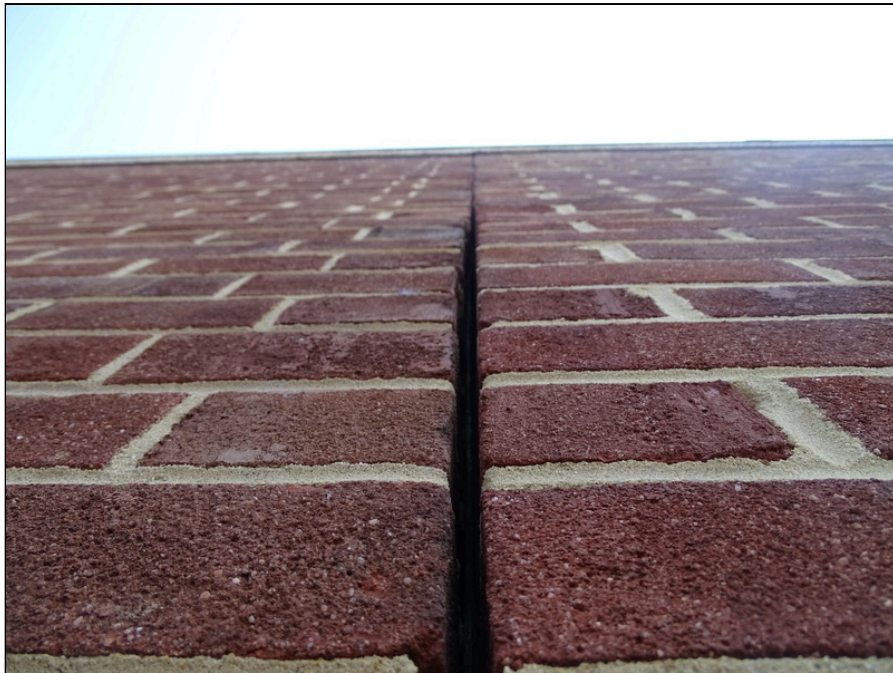
22 - Building exterior northwest side of the building

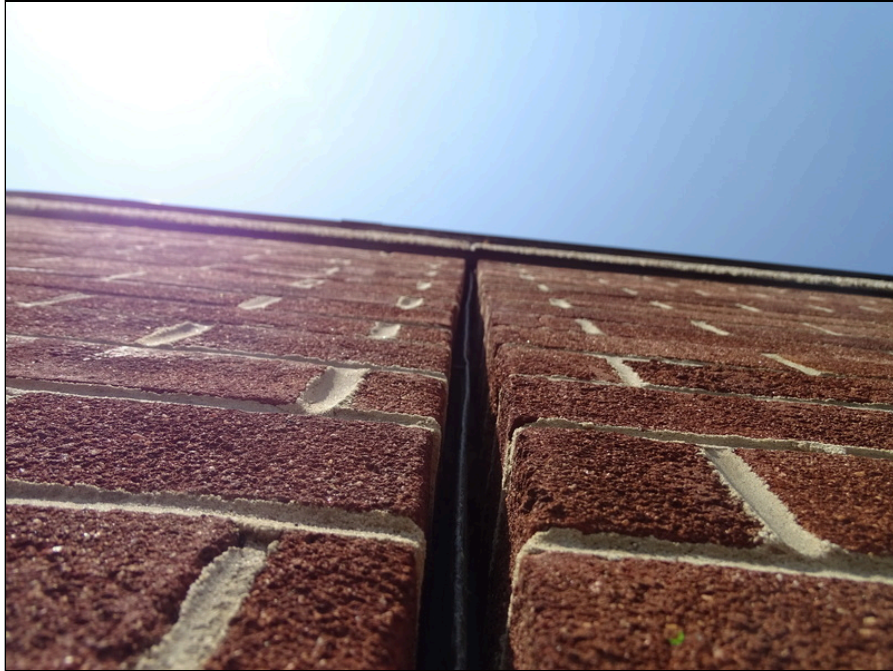
23 - Building exterior northwest side of the building

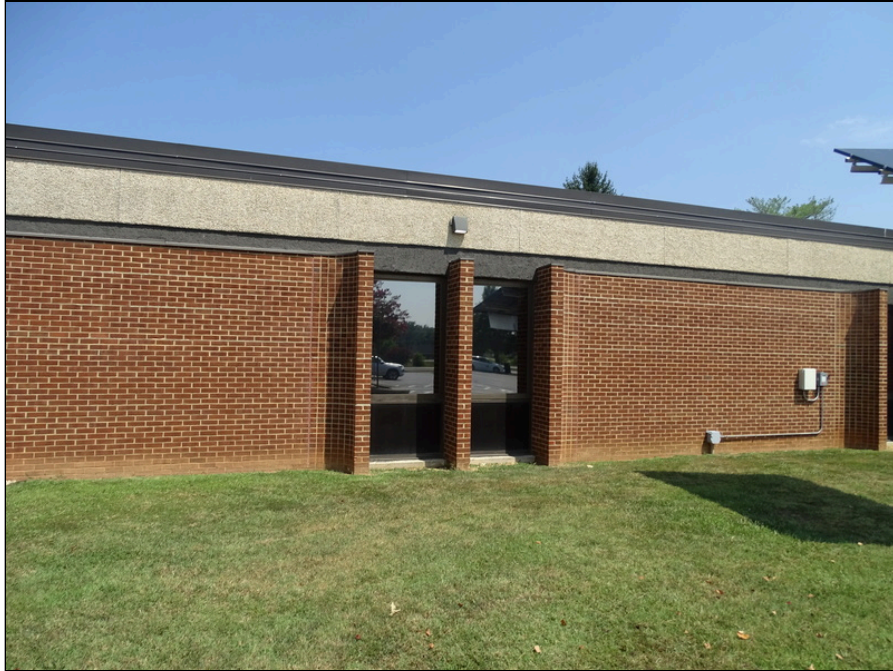
25 - Building exterior southeast side of the building

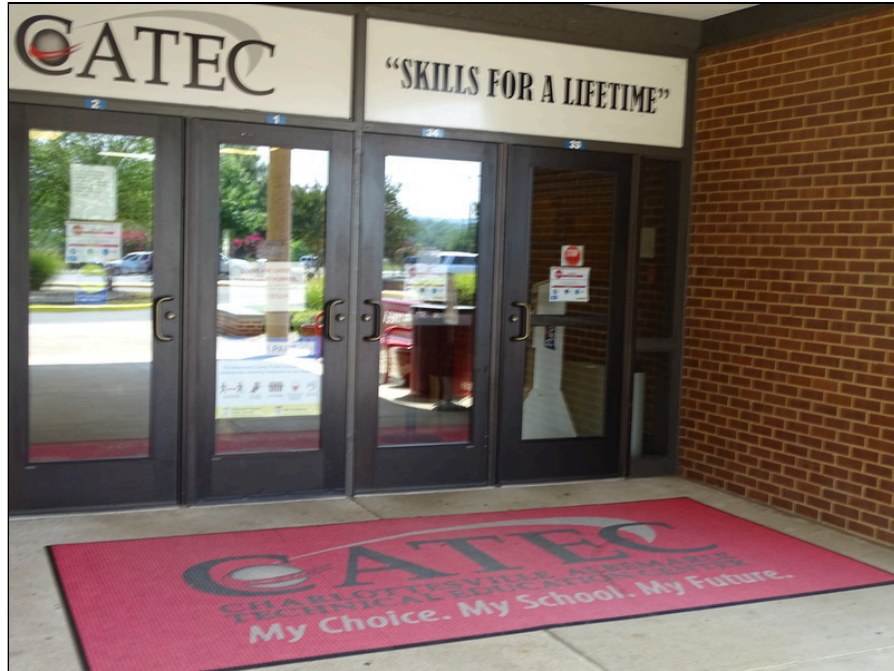
29 - Main entrance exterior doors

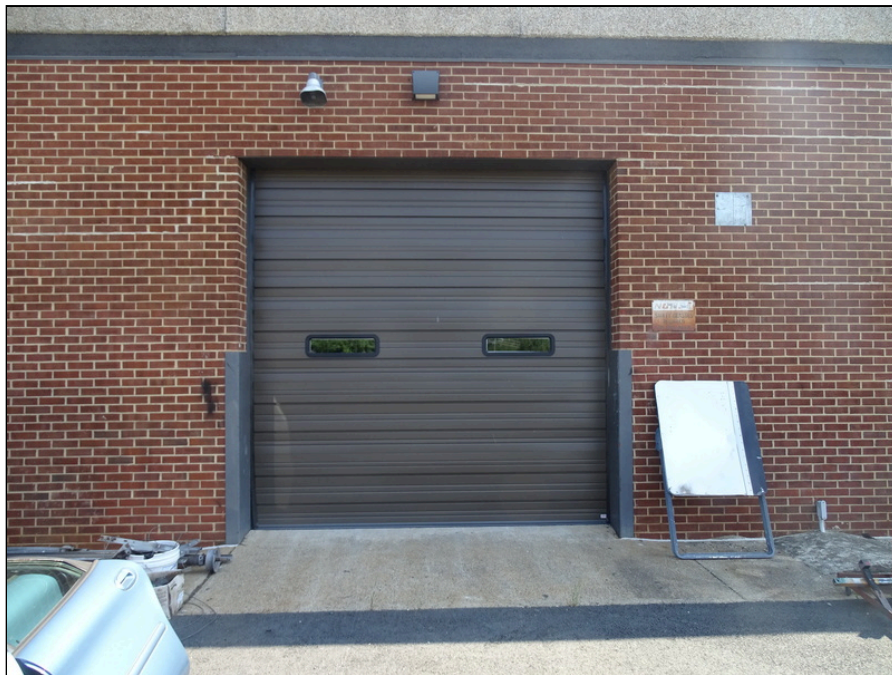
30 - Typical overhead doors
