CATEC
1000 RIO ROAD EAST
CHARLOTTESVILLE, VIRGINIA

ECS PROJECT NO. 46:6713

CITY OF CHARLOTTESVILLE - FACILITIES DEVELOPMENT

Reference: Facility Condition Assessment Report for CATEC, 1000 Rio Road East, Charlottesville, Virginia

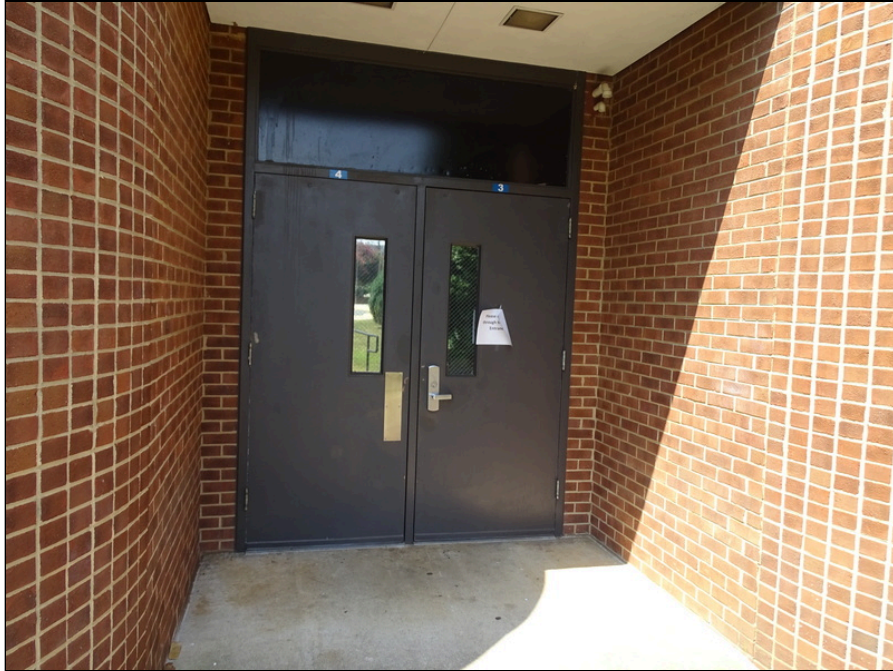
31 - Typical personnel doors

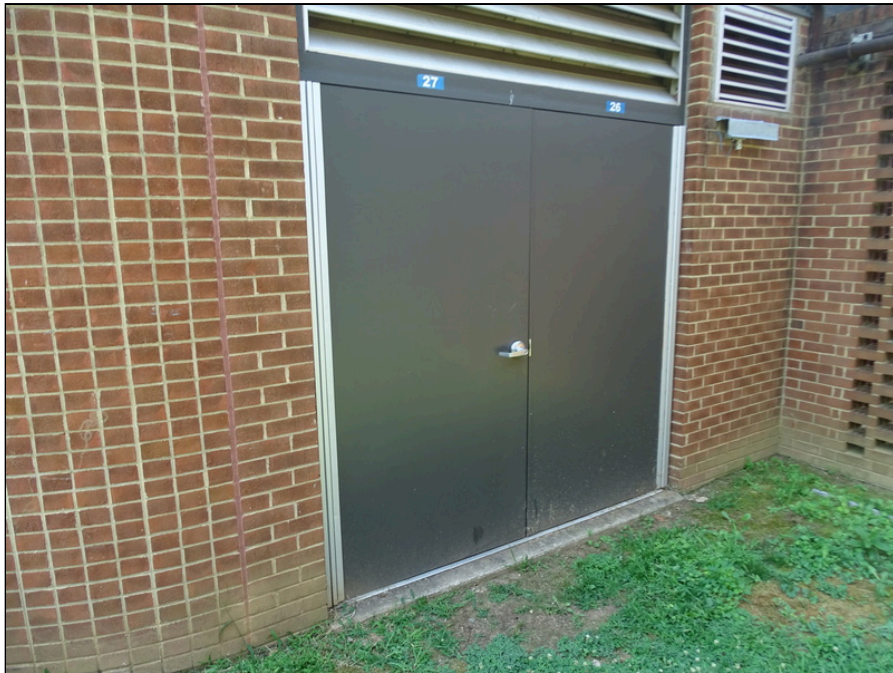
32 - Typical personnel doors

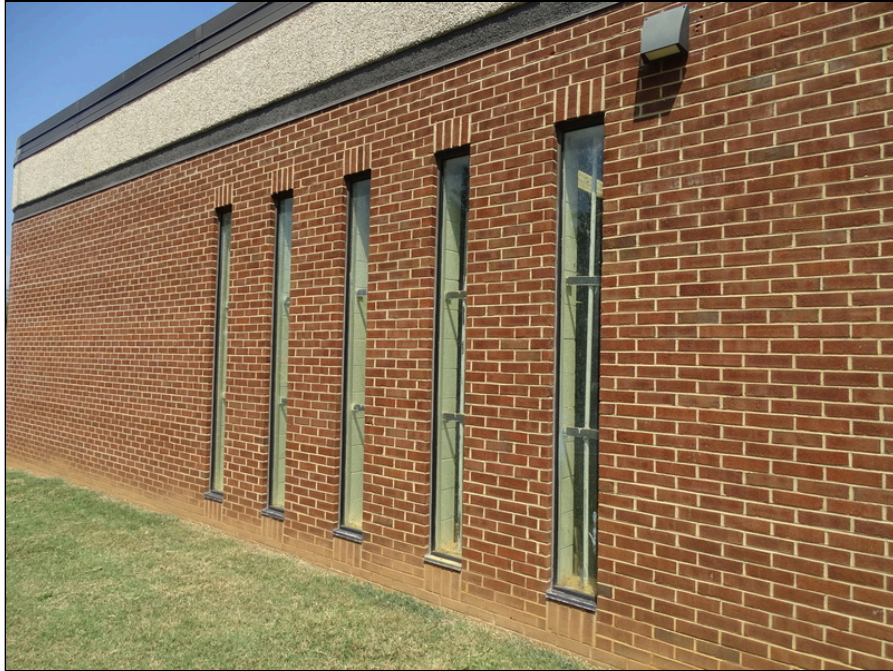
33 - Typical exterior windows

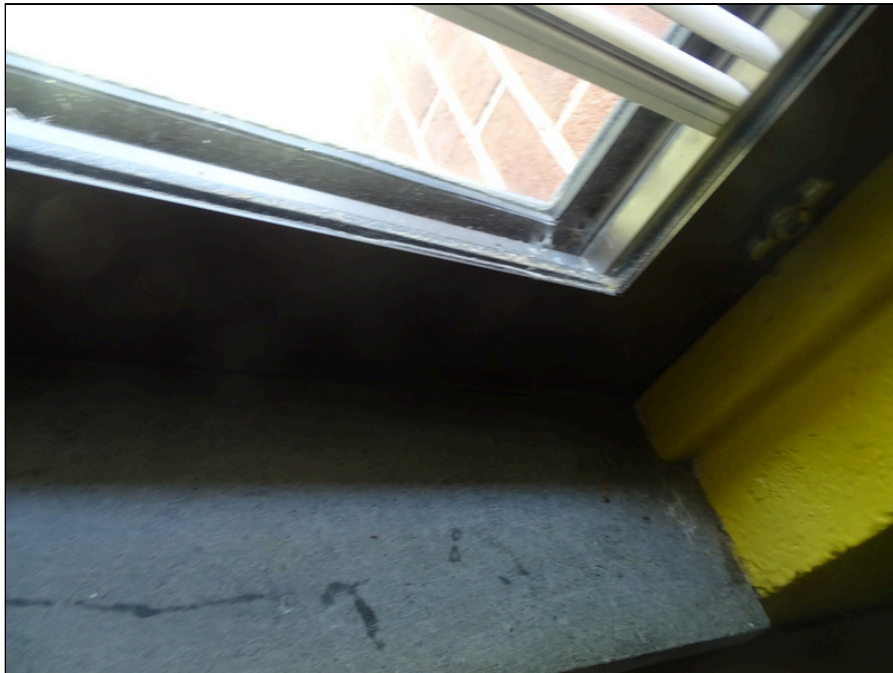
34 - Typical exterior windows - note fog inside the glass

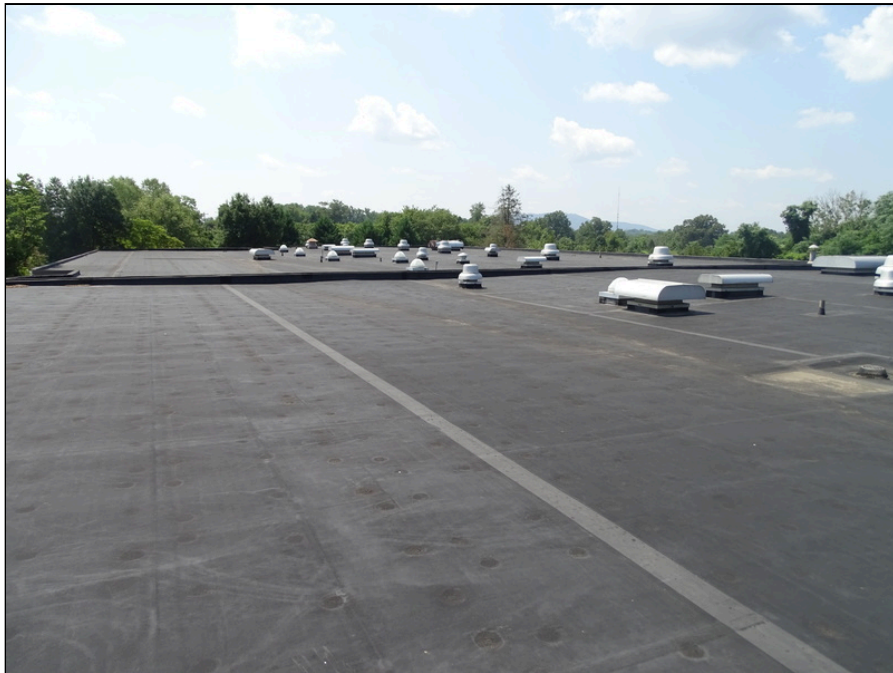
38 - Single-ply membrane roofing system looking south

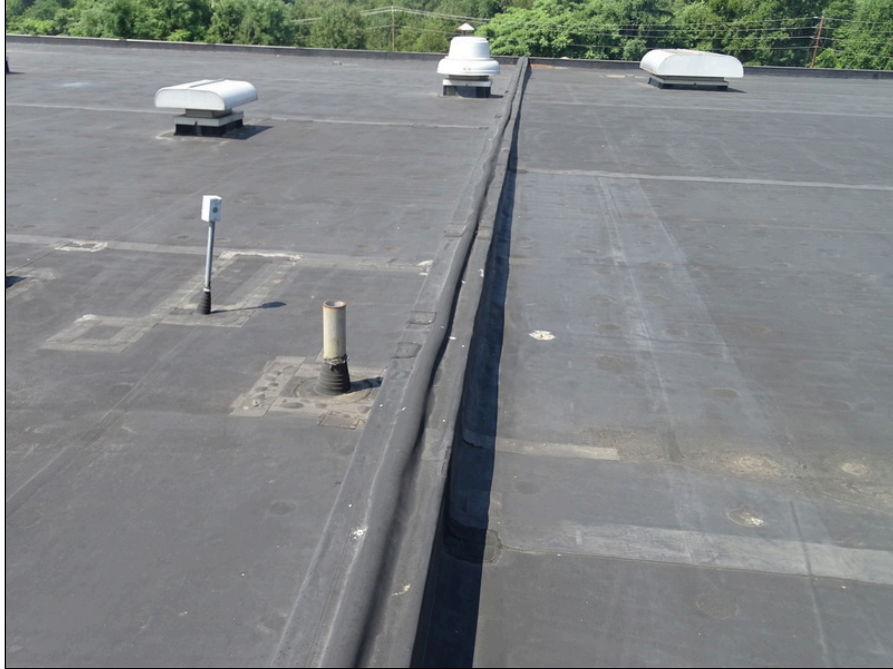
39 - Single-ply membrane roofing system looking south

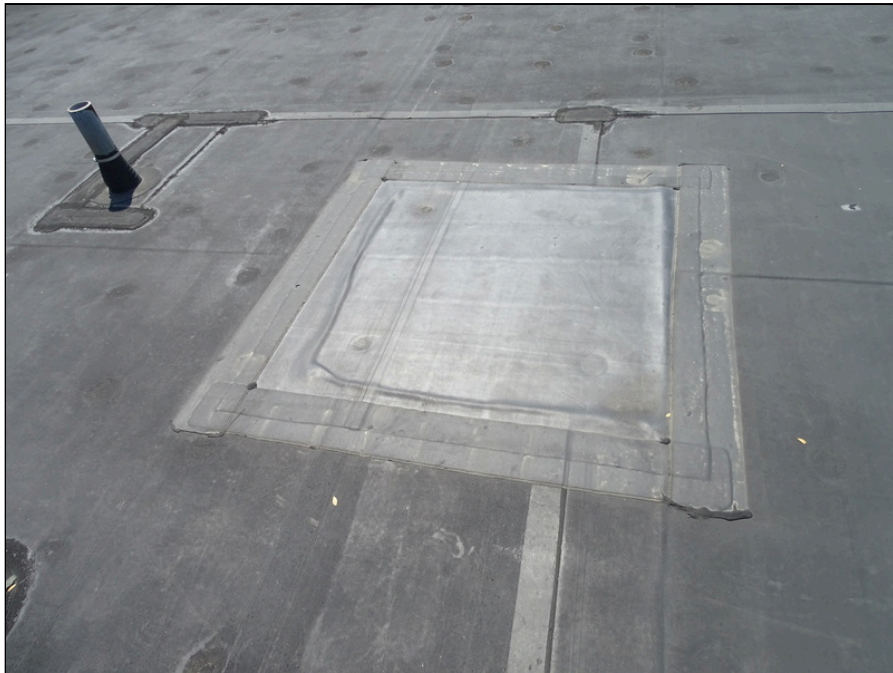
40 - Single-ply membrane roofing system - note patching

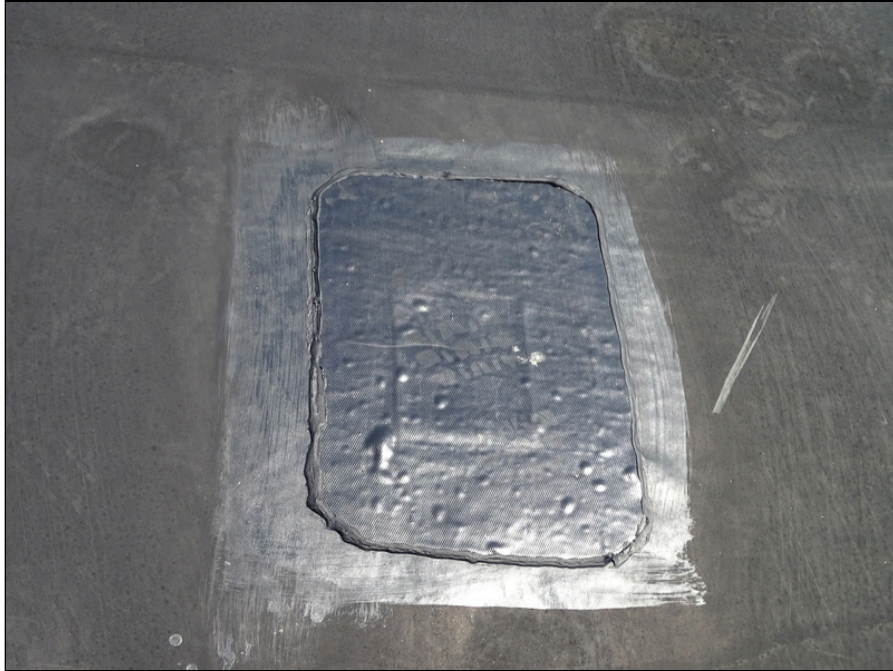
41 - Single-ply membrane roofing system - note patching

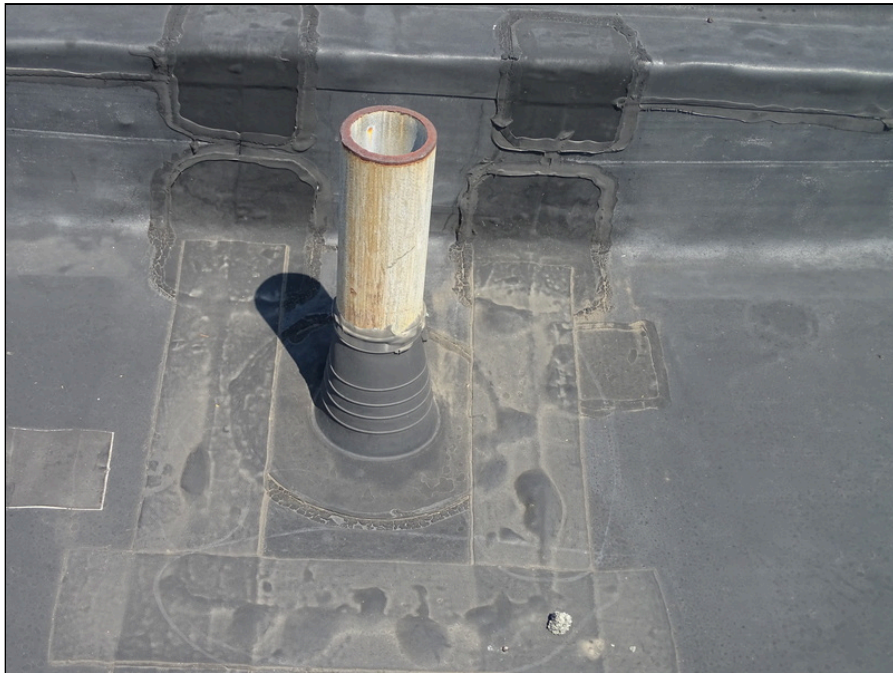
42 - Typical plumbing penetration

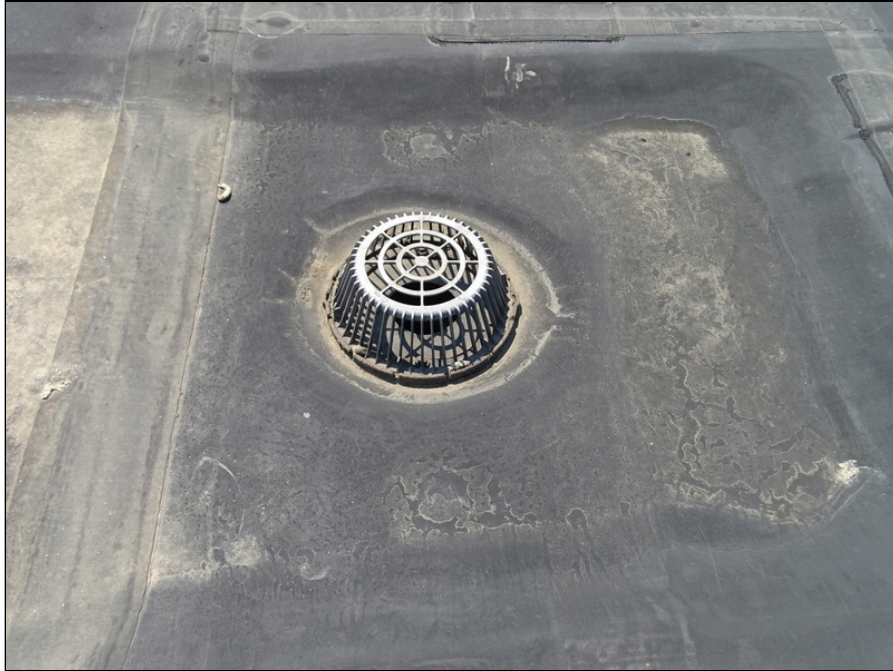
43 - Typical internal drain

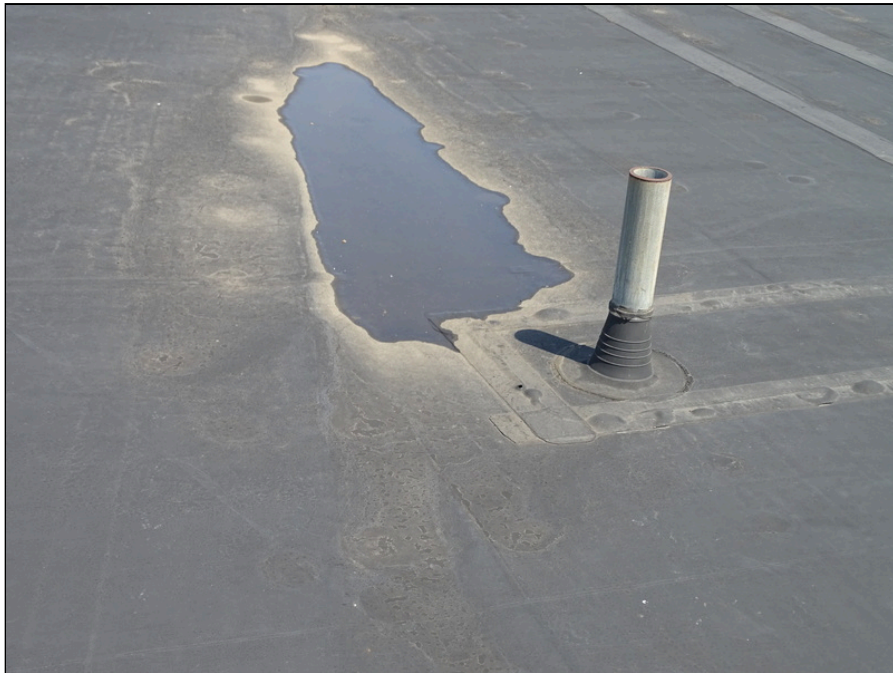
44 - Typical area of ponding

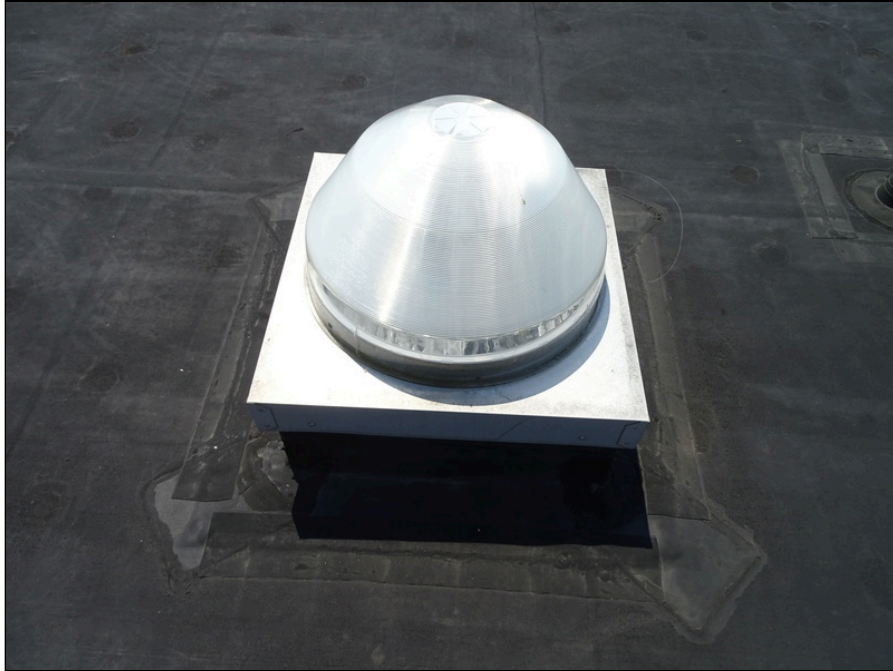
45 - Typical skylight

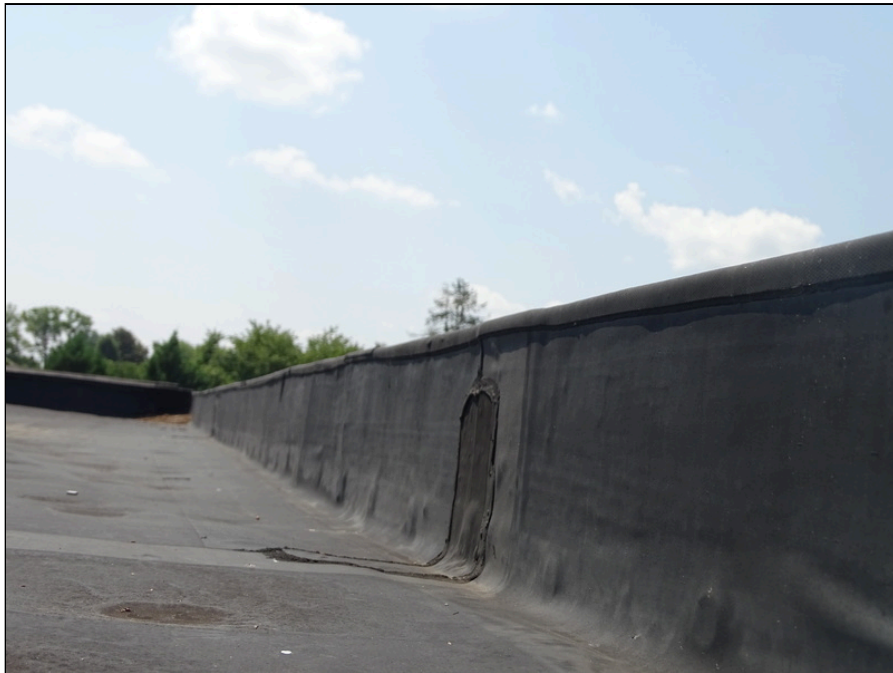
46 - Single-ply membrane roofing system - note patching

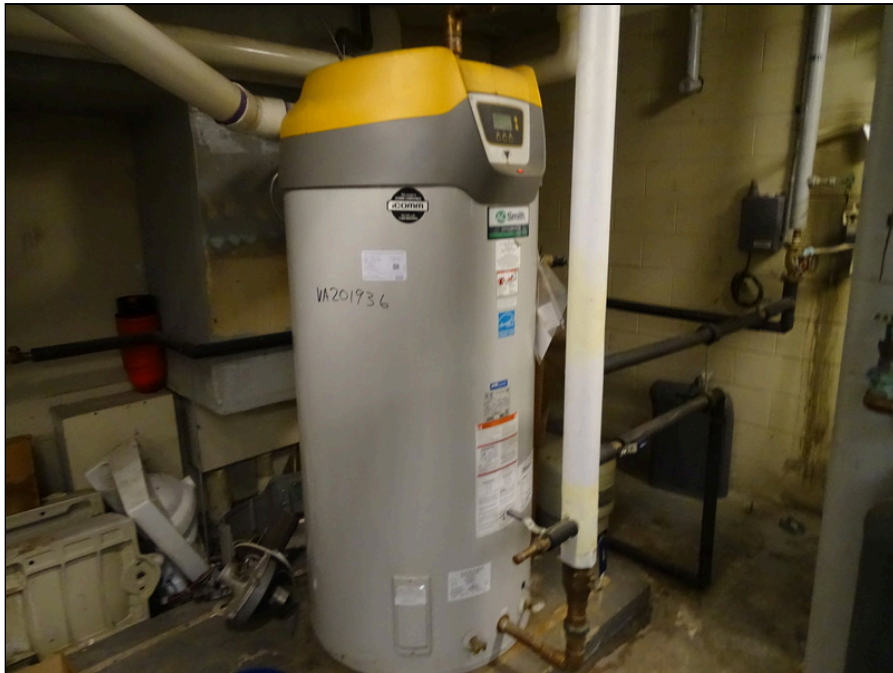
48 - Gas water heater located in main utility room

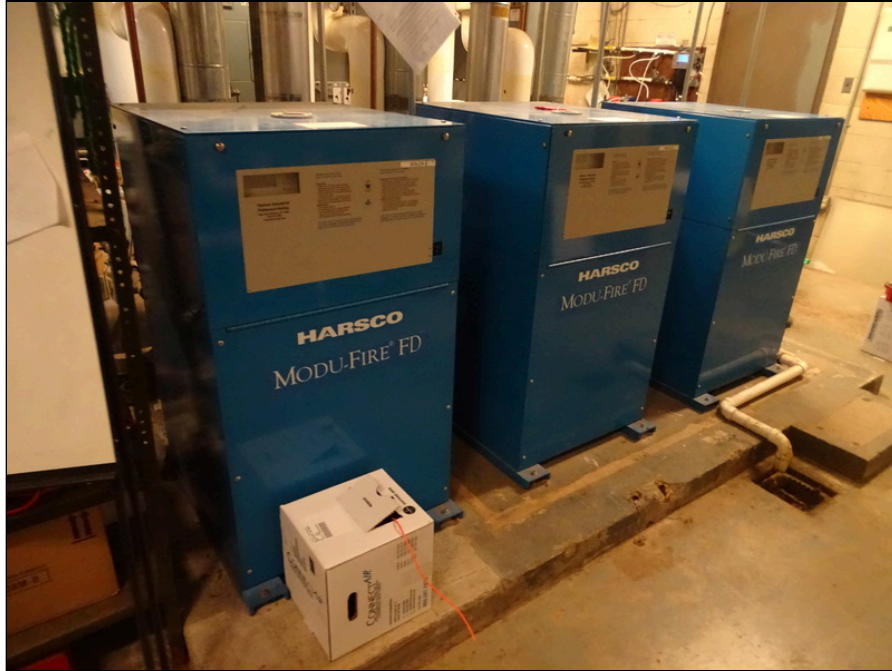
49 - Boilers located in main utility room

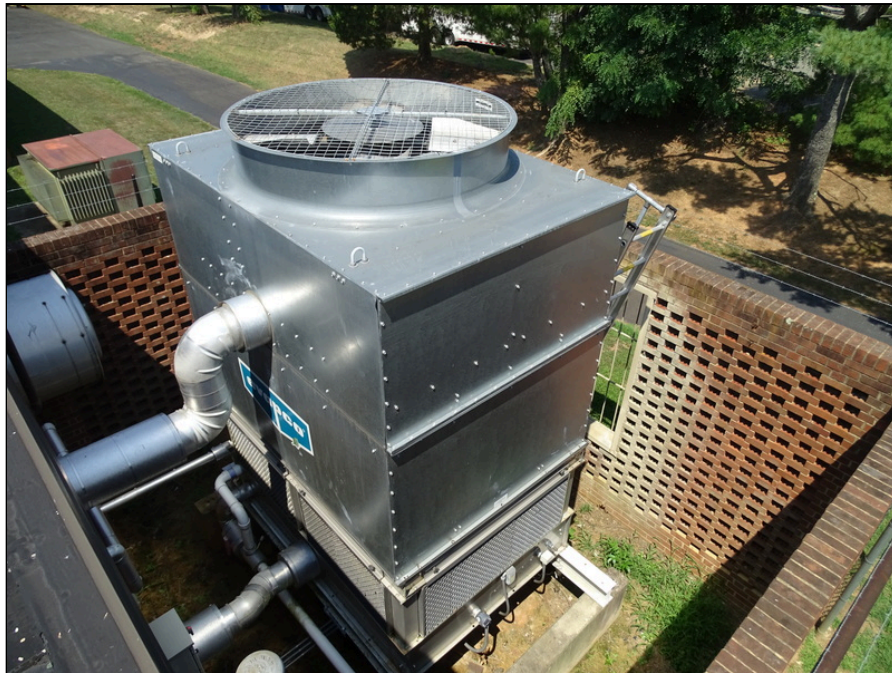
50 - Cooling Tower located on the north side of the building

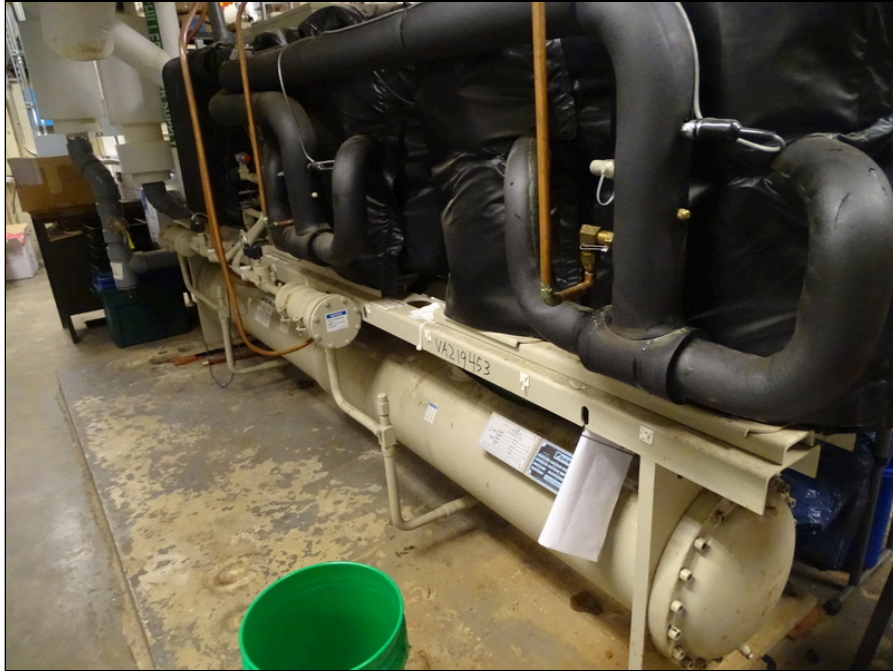
51 - Chiller located in main utility room

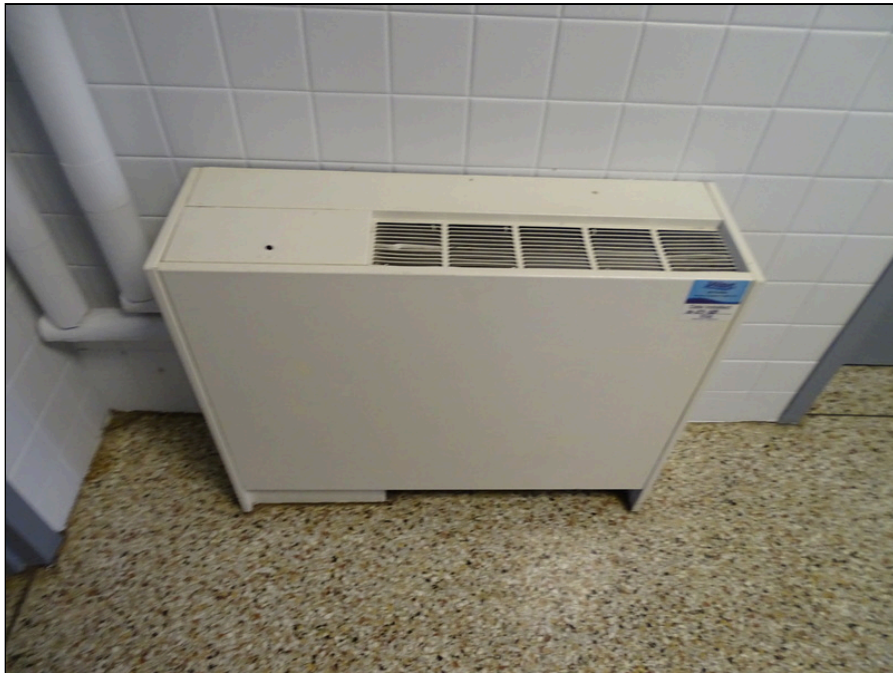
52 - Typical Fan Coil Unit

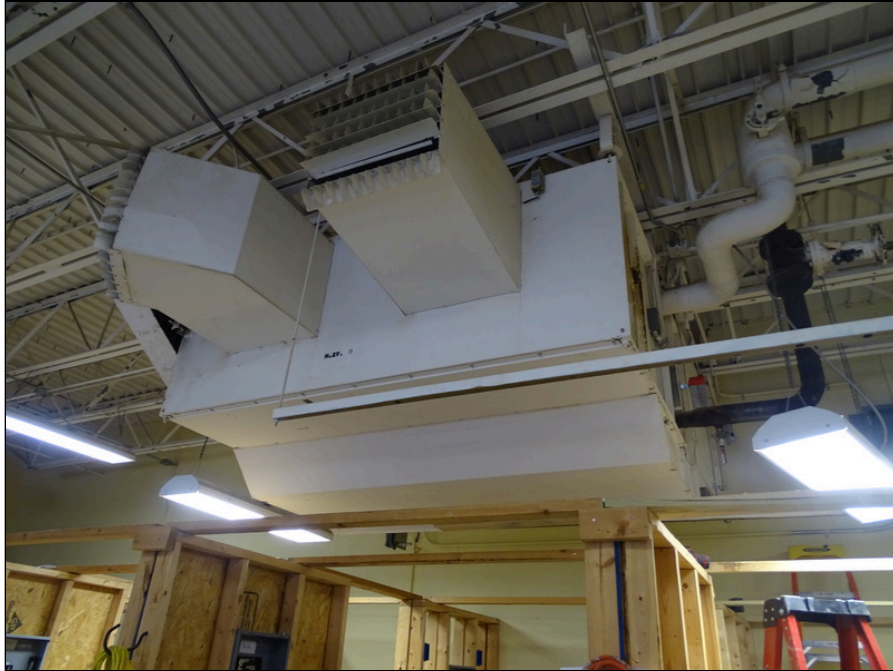
53 - Typical Unit Ventilator

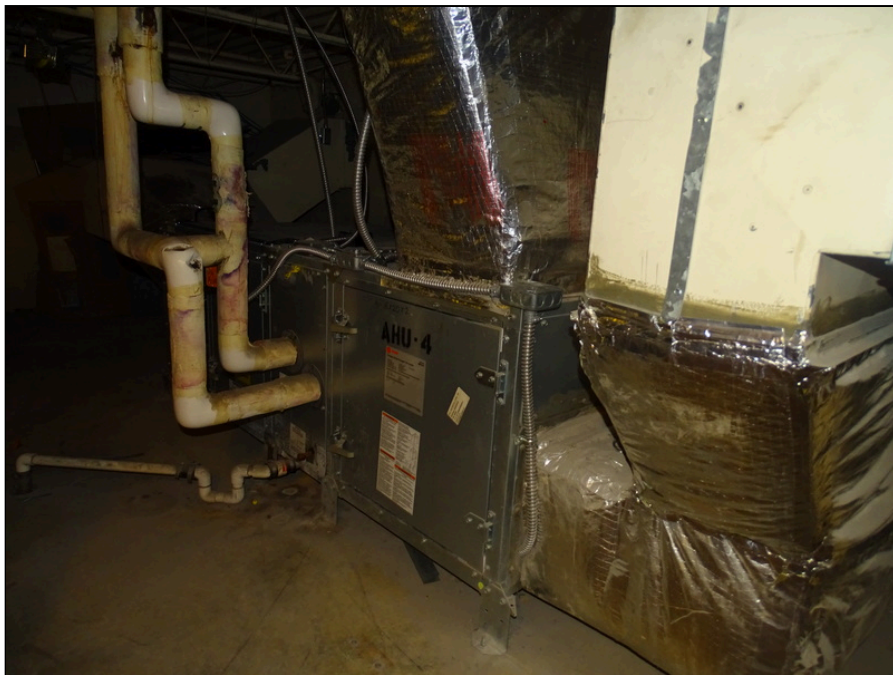
54 - Typical Air Handler Unit

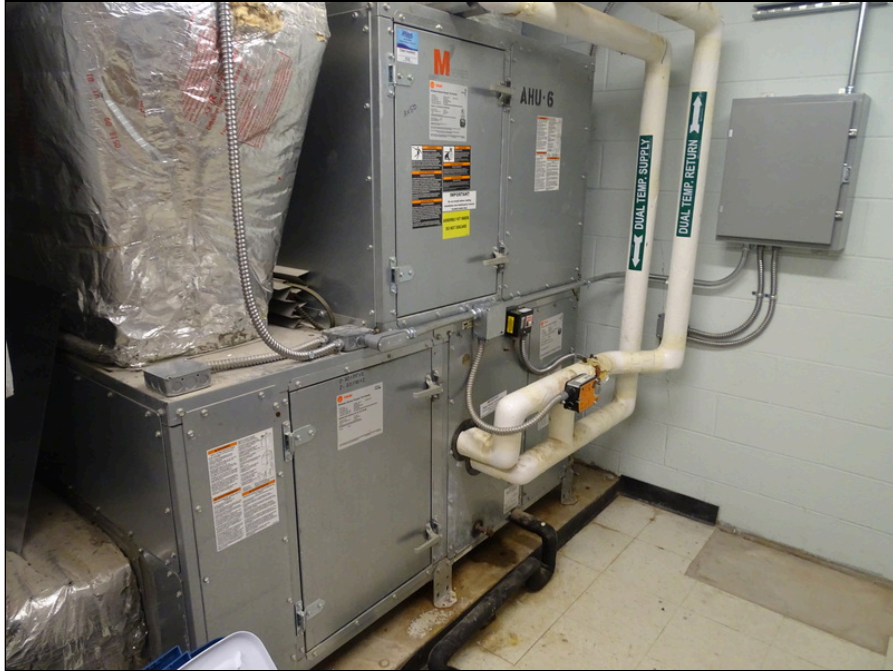
55 - Typical Air Handler Unit

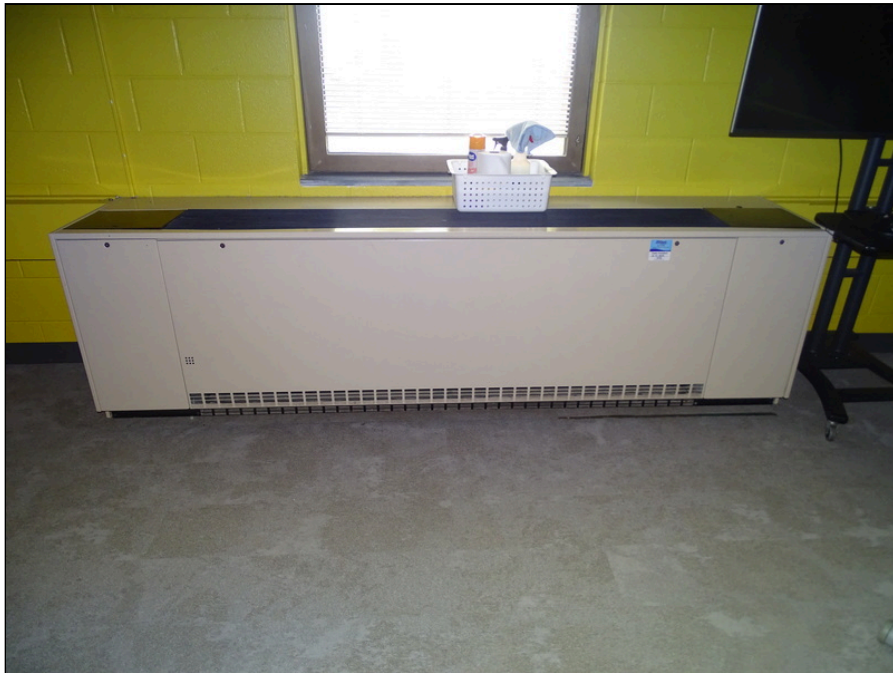
56 - Typical larger Fan Coil Unit

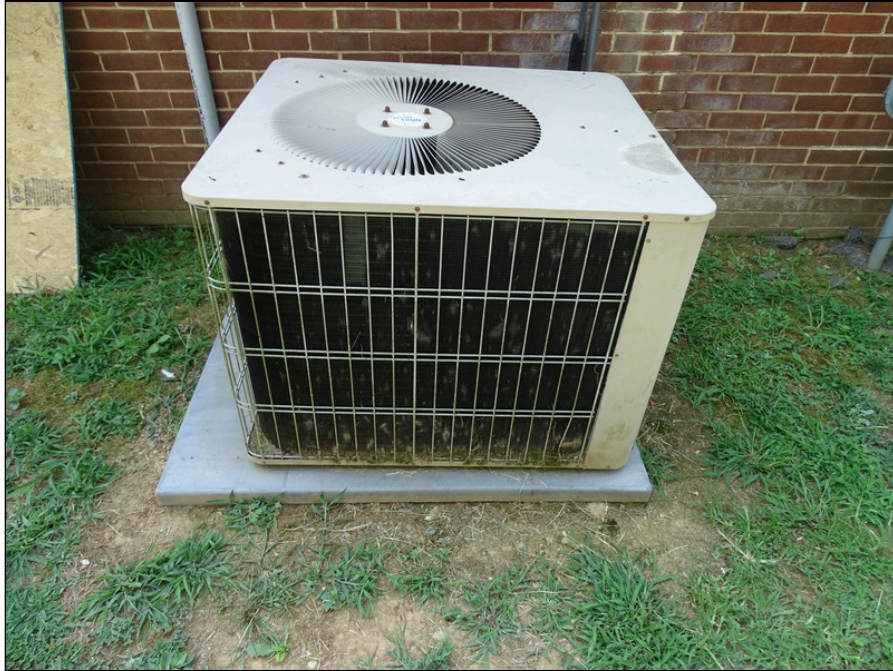
57 - Typical Condenser Unit

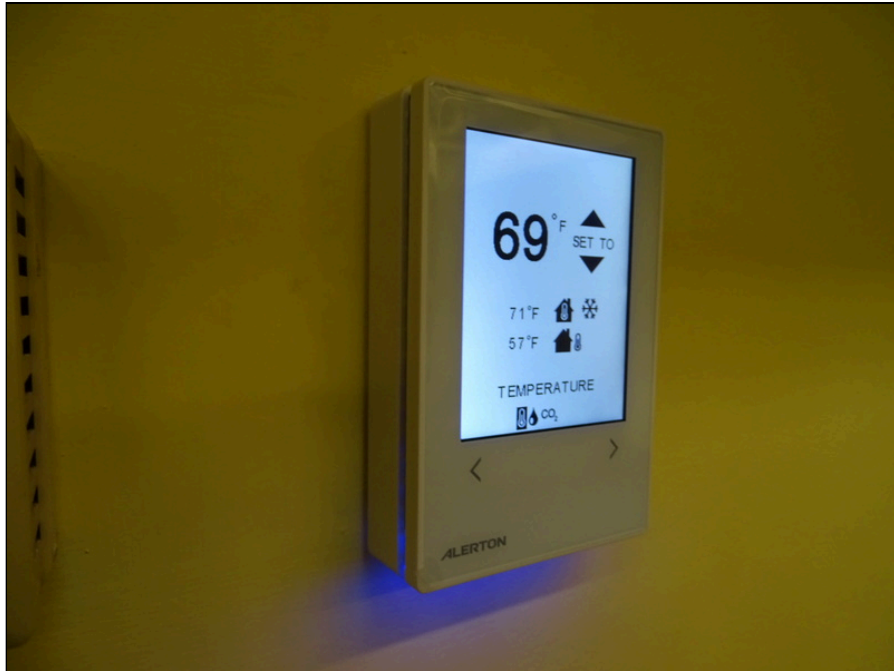
59 - Thermostat

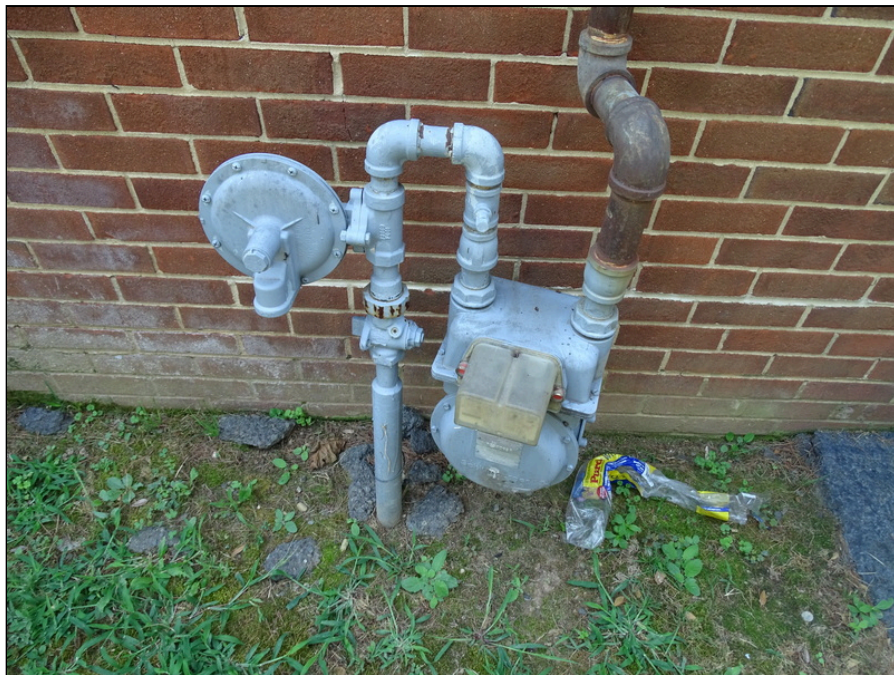
60 - Typical gas meter

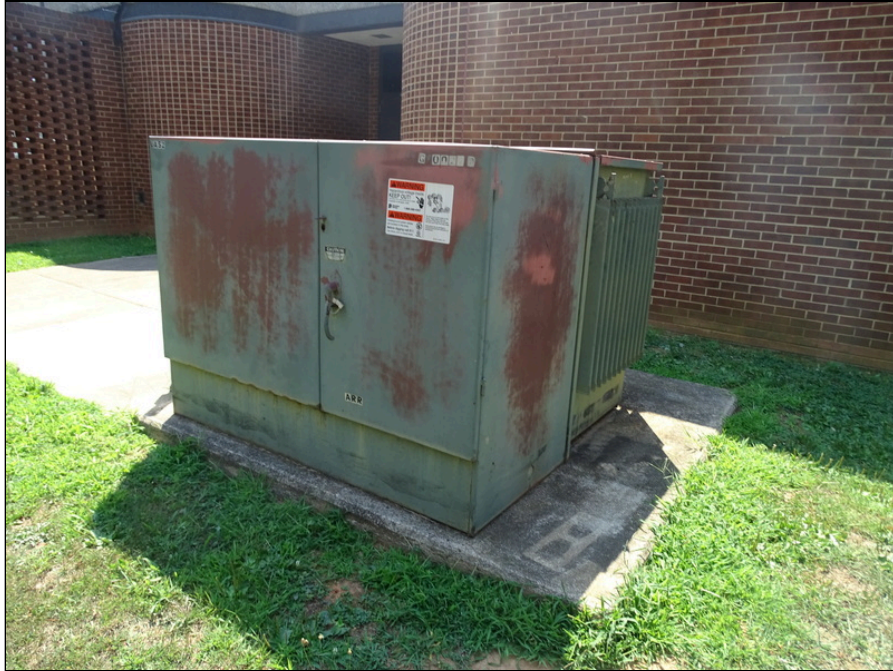
61 - Utility electrical transformer

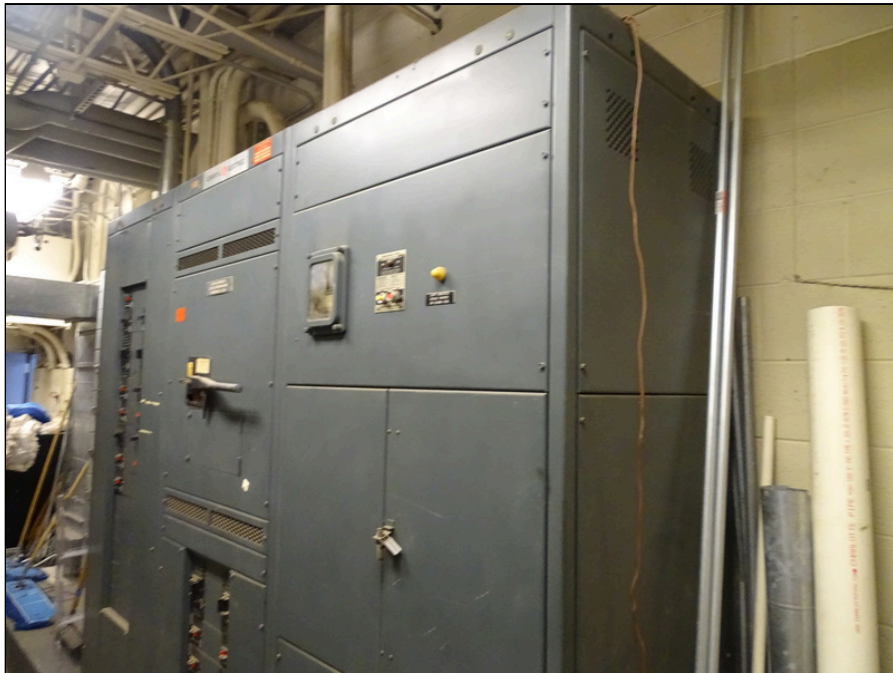
62 - Main electrical switchgear

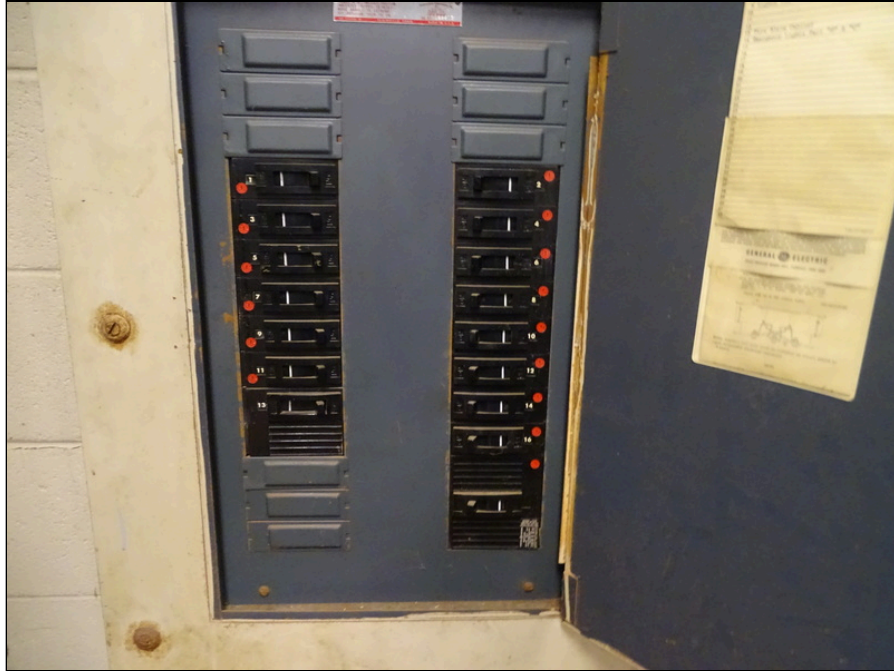
63 - Typical electrical circuit breaker panel

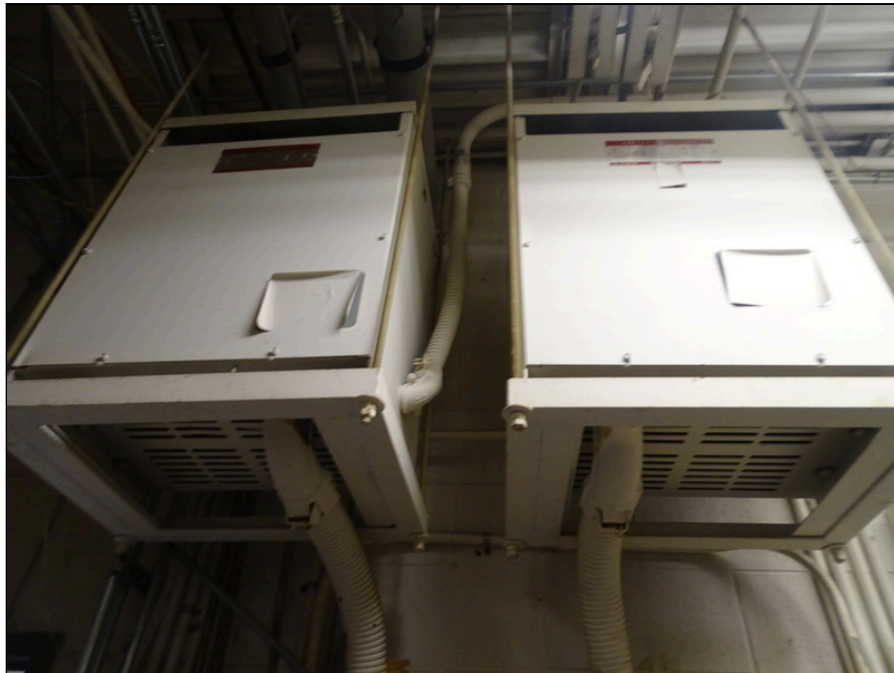
64 - Typical building transformer

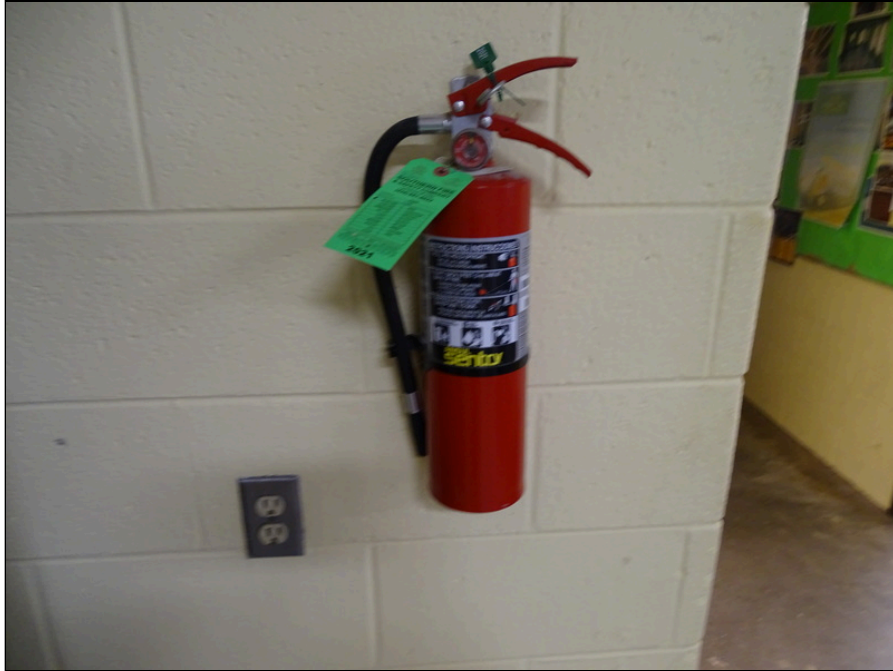
65 - Typical fire extinguisher

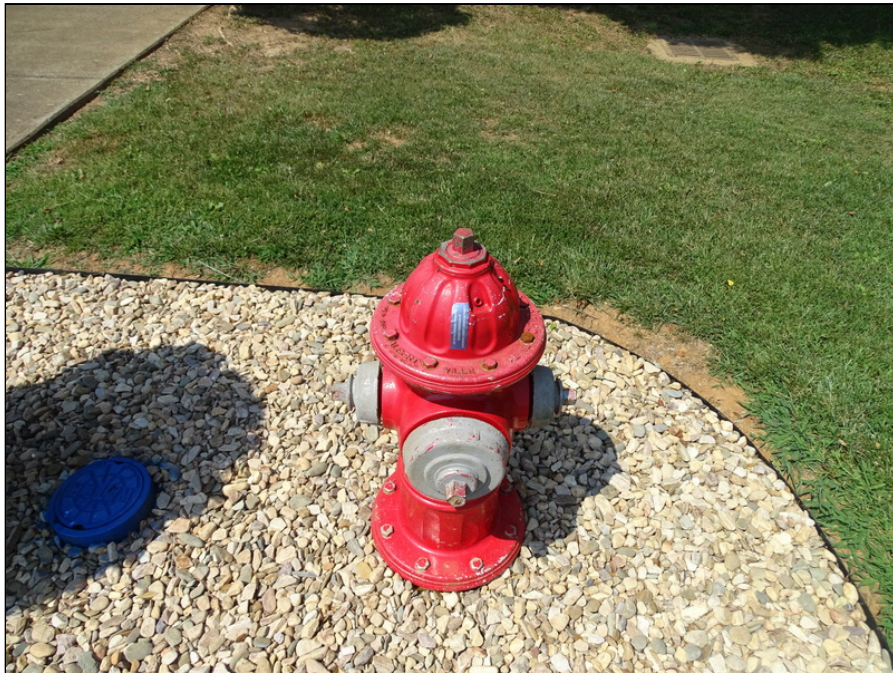
66 - Typical fire hydrant

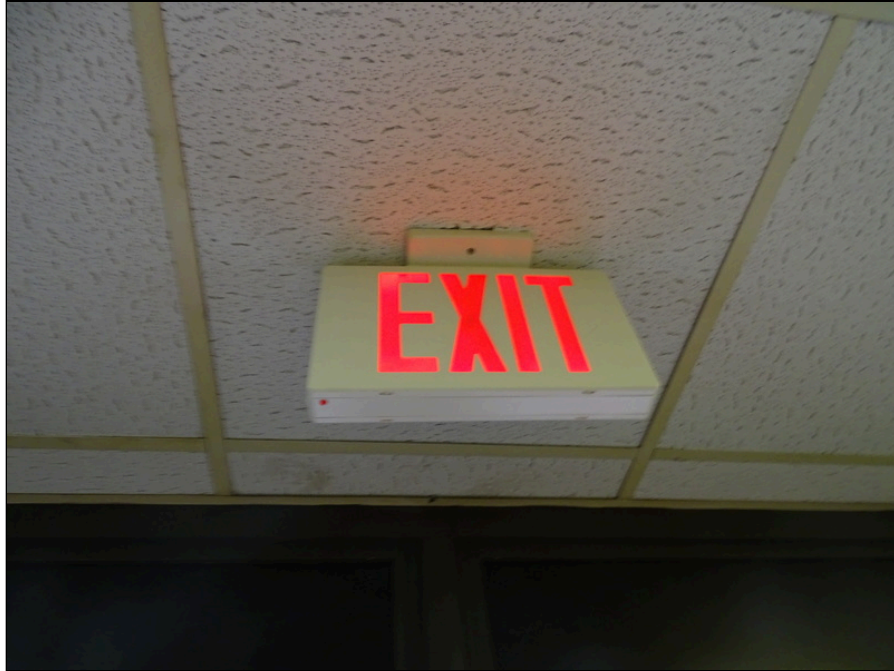
67 - Typical exit sign

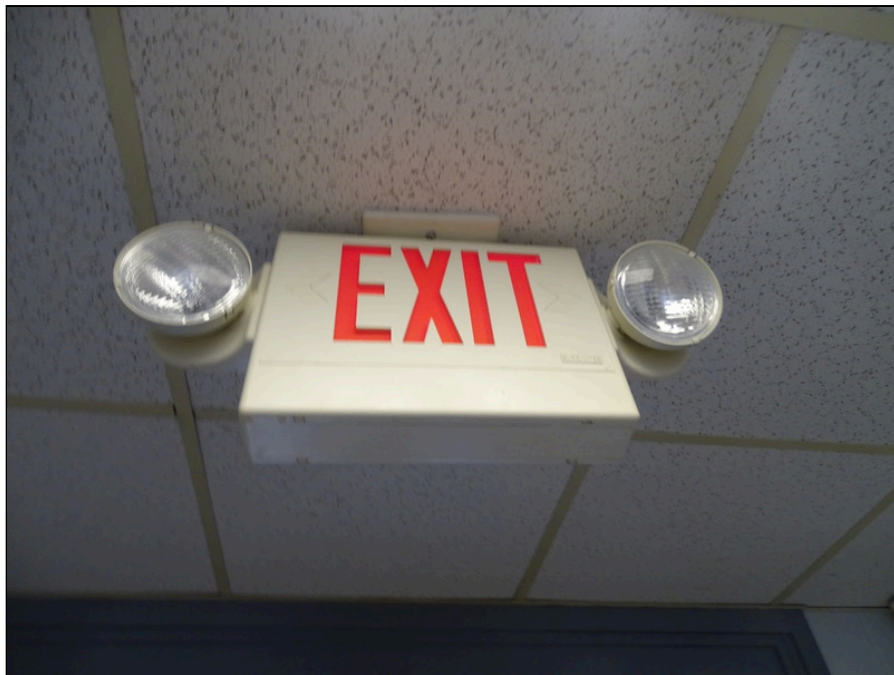
68 - Typical exit sign and emergency light

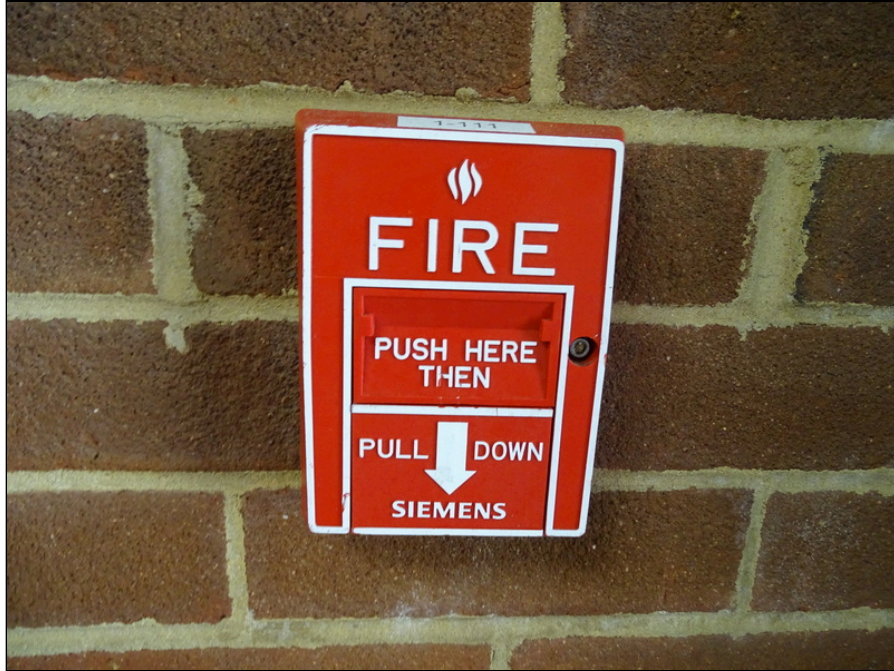
69 - Typical fire alarm pull station

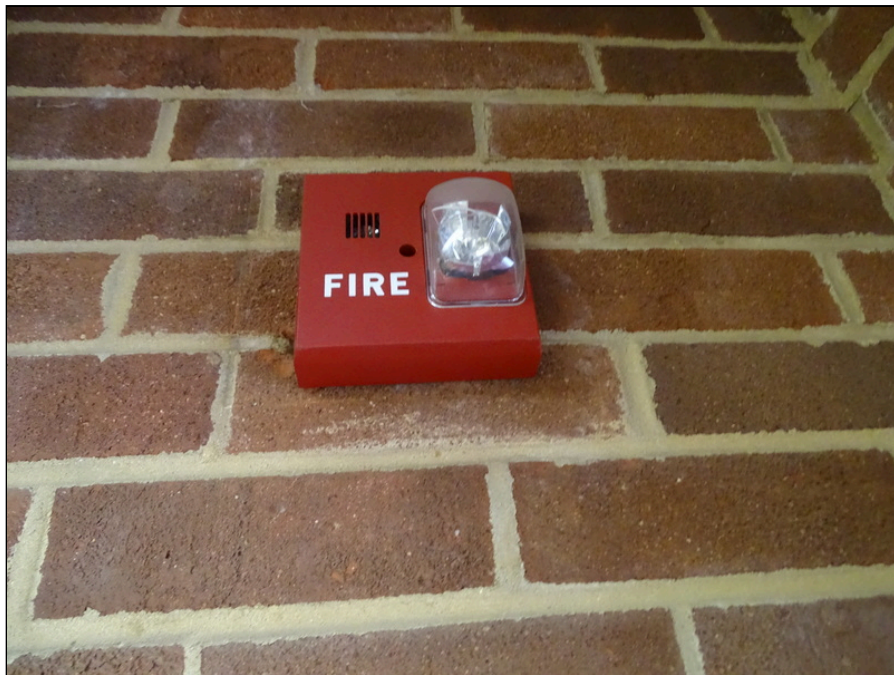
70 - Typical fire alarm bell and strobe

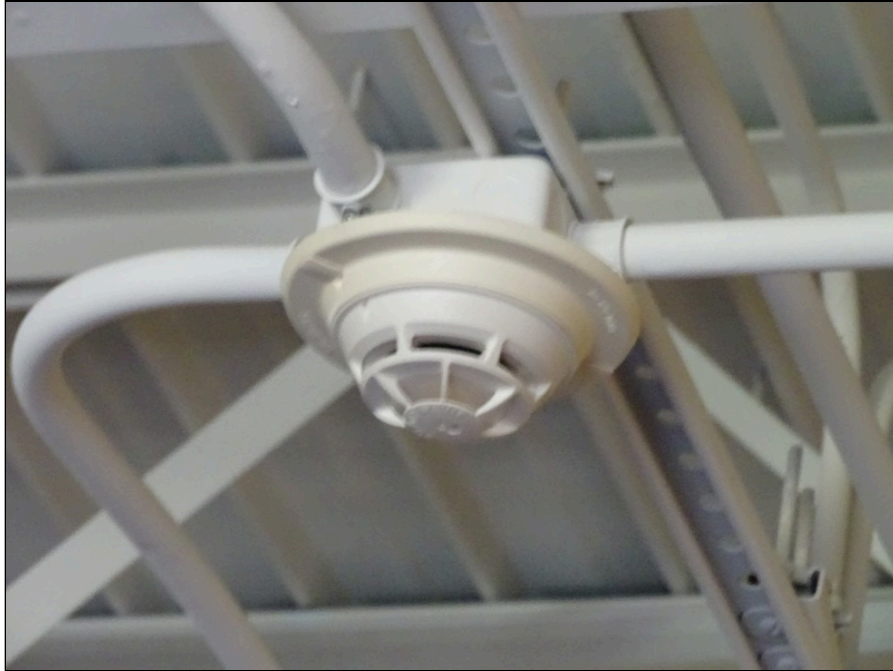
71 - Typical smoke detector

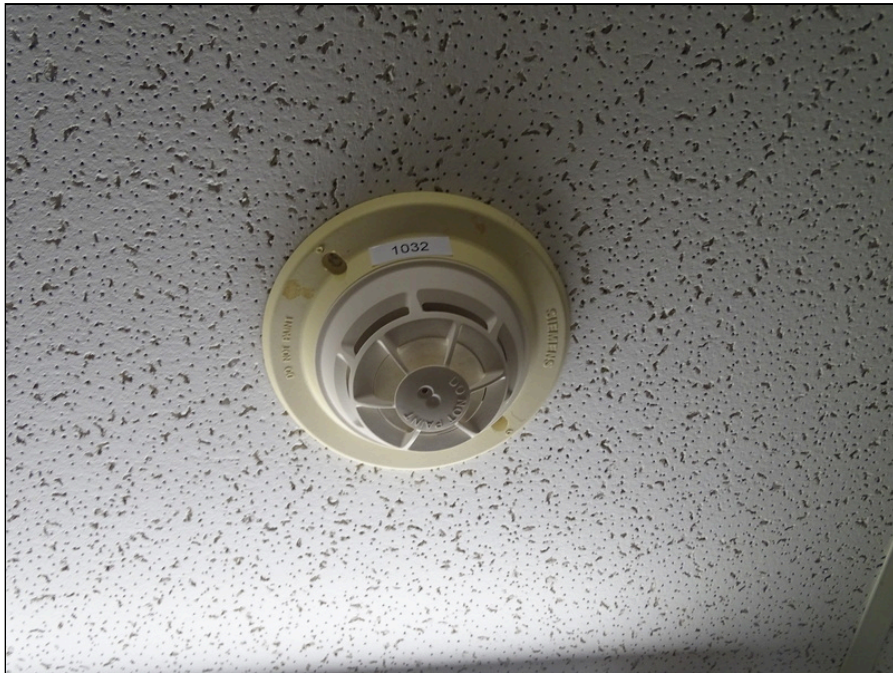
72 - Typical smoke detector

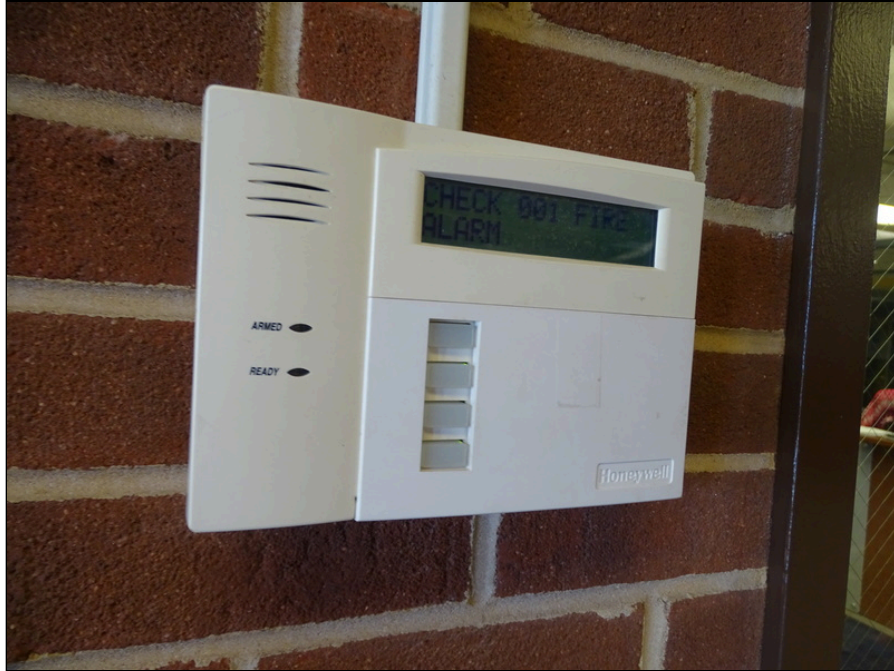
73 - Security system electronic controls
