CATEC
1000 RIO ROAD EAST
CHARLOTTESVILLE, VIRGINIA

ECS PROJECT NO. 46:6713

CITY OF CHARLOTTESVILLE - FACILITIES DEVELOPMENT

Reference: Facility Condition Assessment Report for CATEC, 1000 Rio Road East, Charlottesville, Virginia

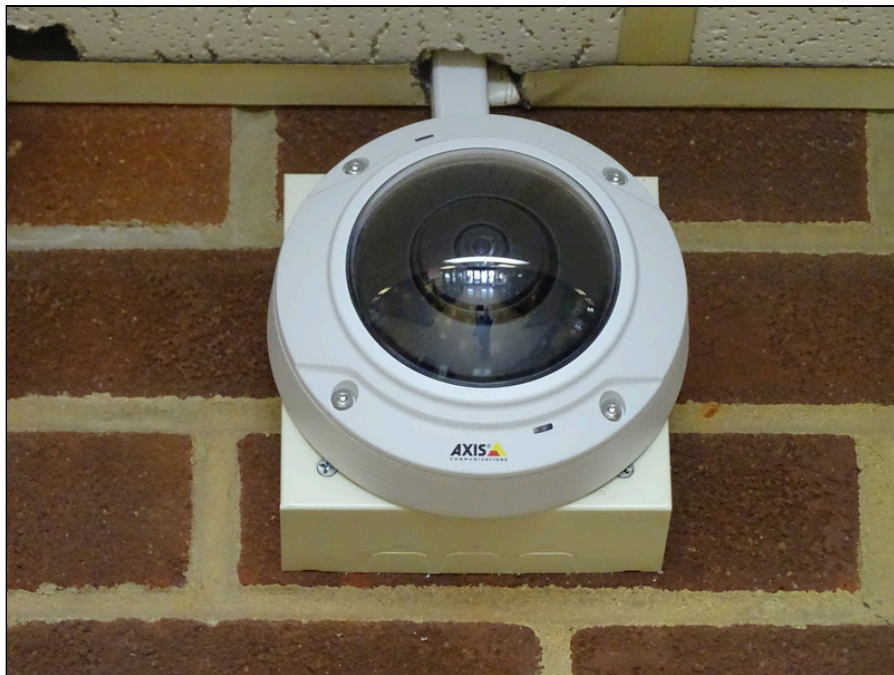
74 - Typical security camera

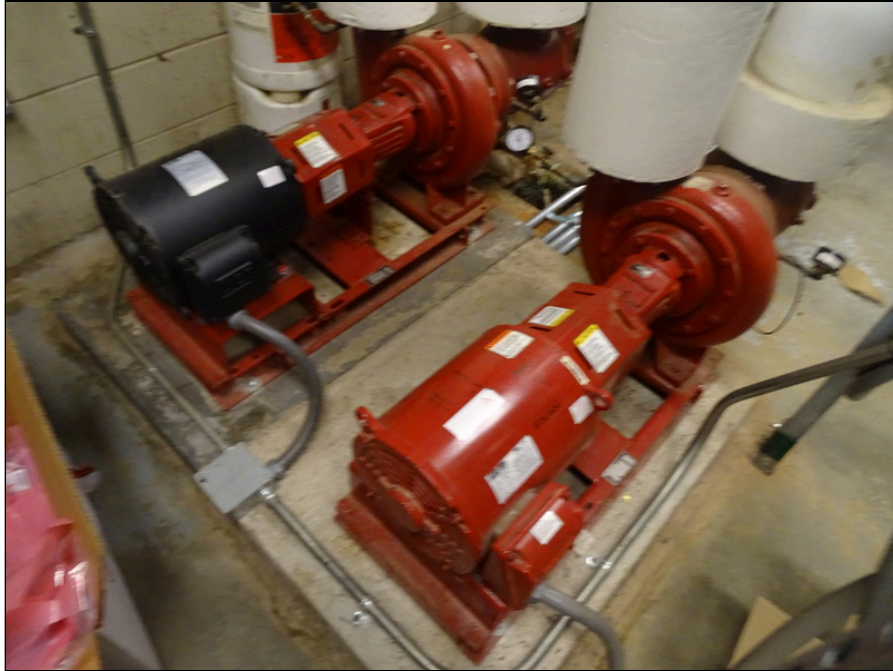
75 - Interior finishes of mechanical-utility room area

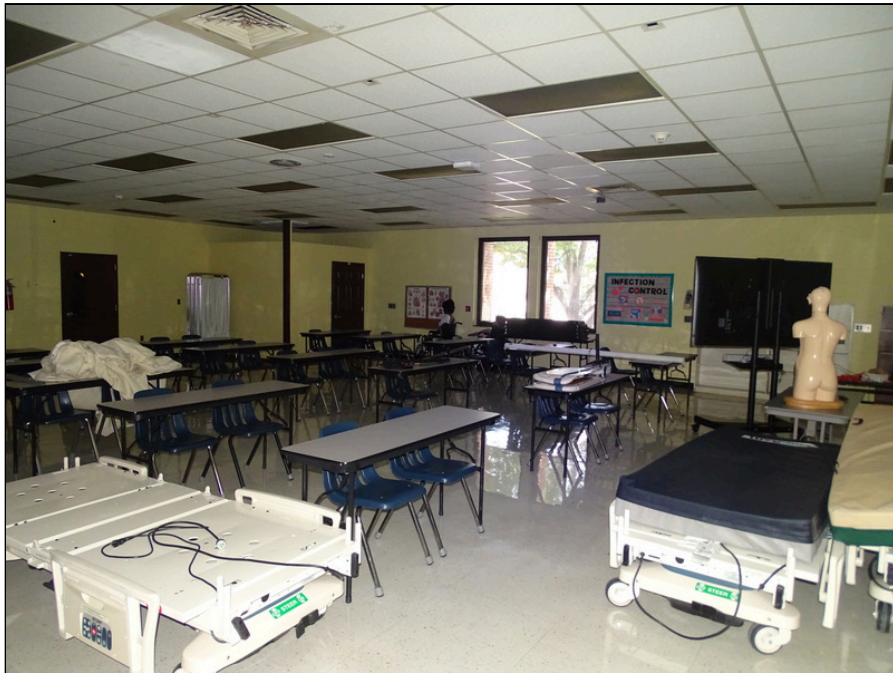
76 - Interior finishes of classroom area

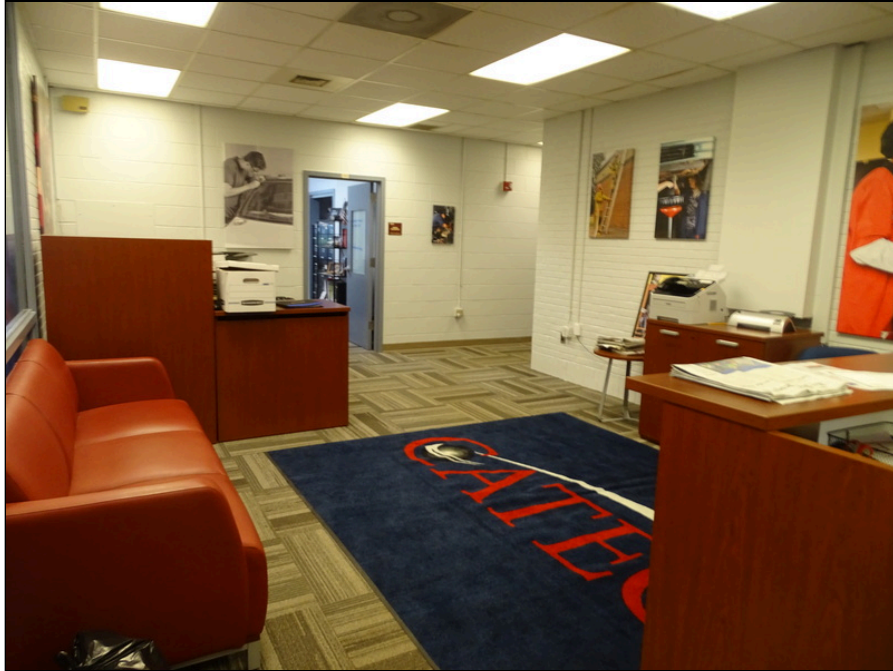
77 - Interior finishes of main office and entrance area

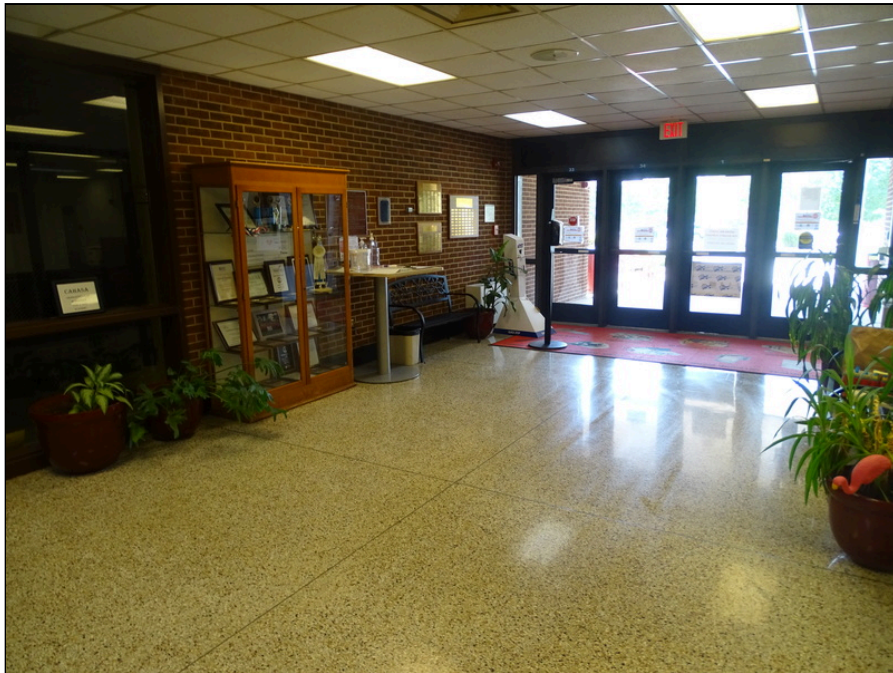
78 - Interior finishes of corridor area

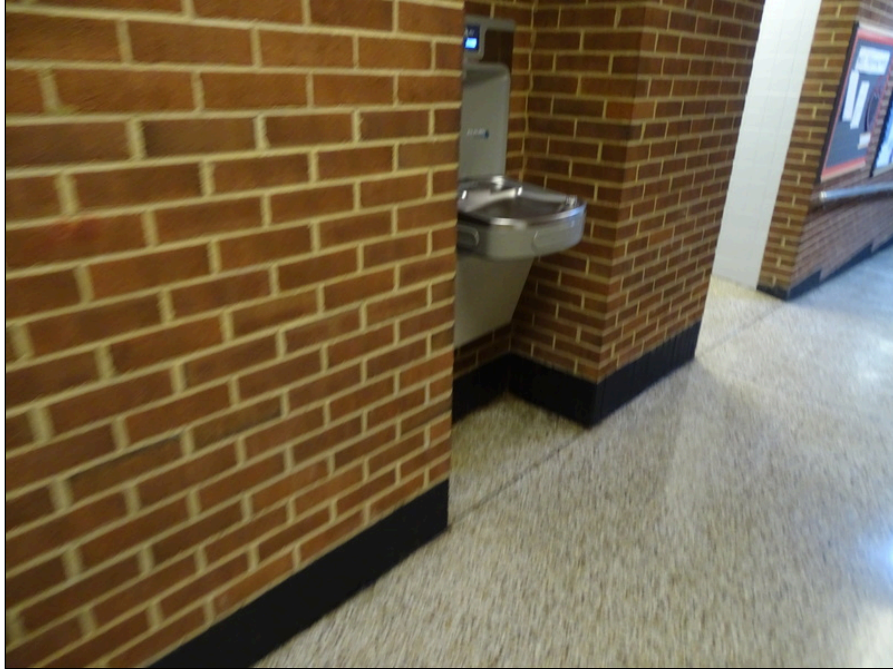
79 - Typical water fountain

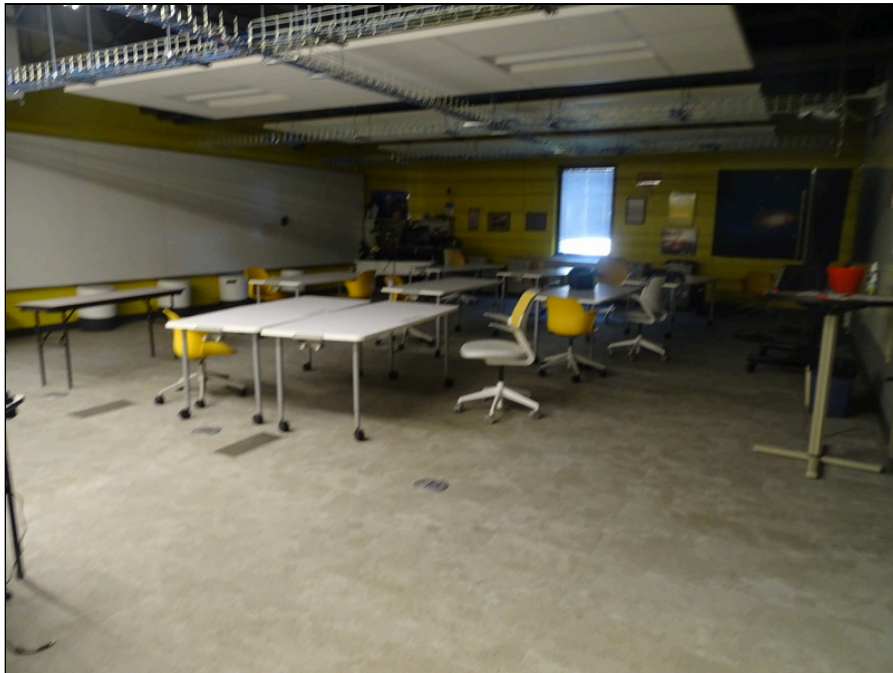
80 - Interior finishes of classroom area

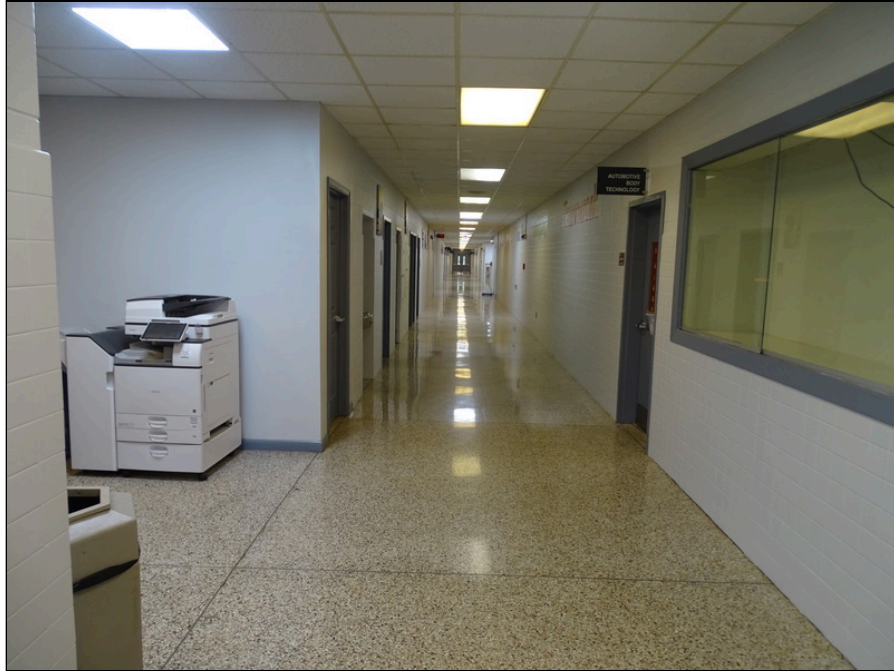
81 - Interior finishes of corridor area

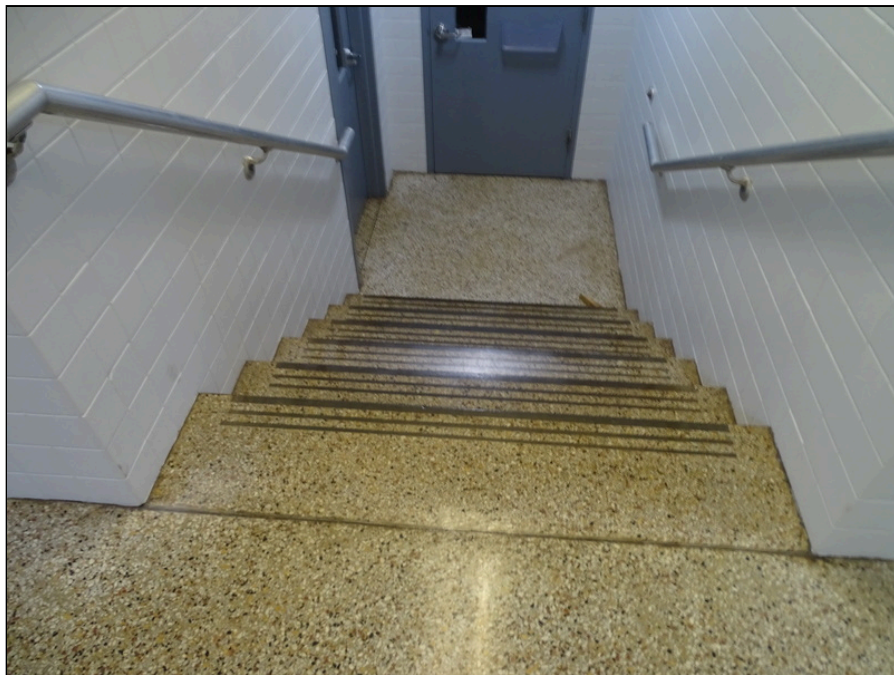
82 - Interior finishes of stair

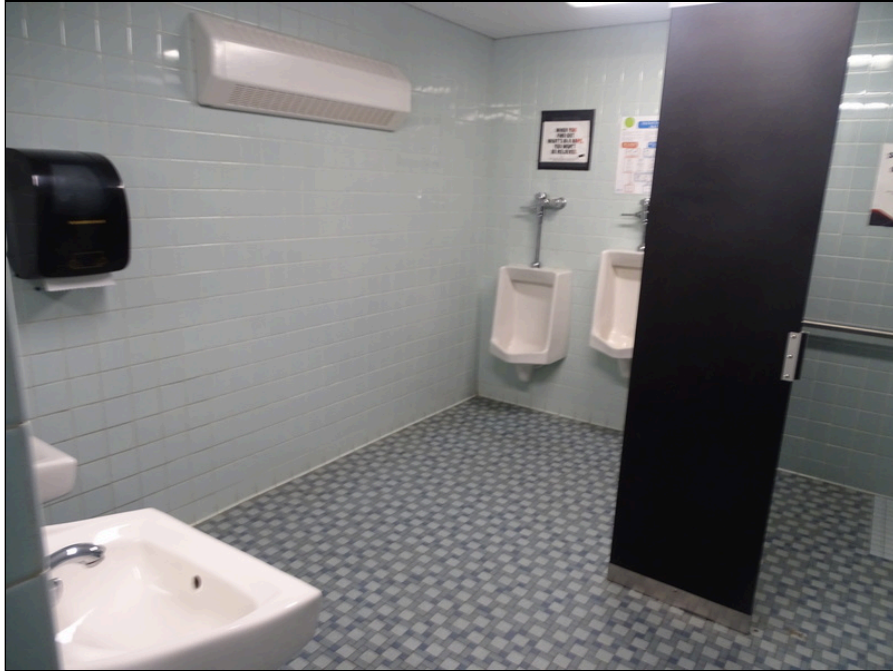
83 - Interior finishes of restroom area

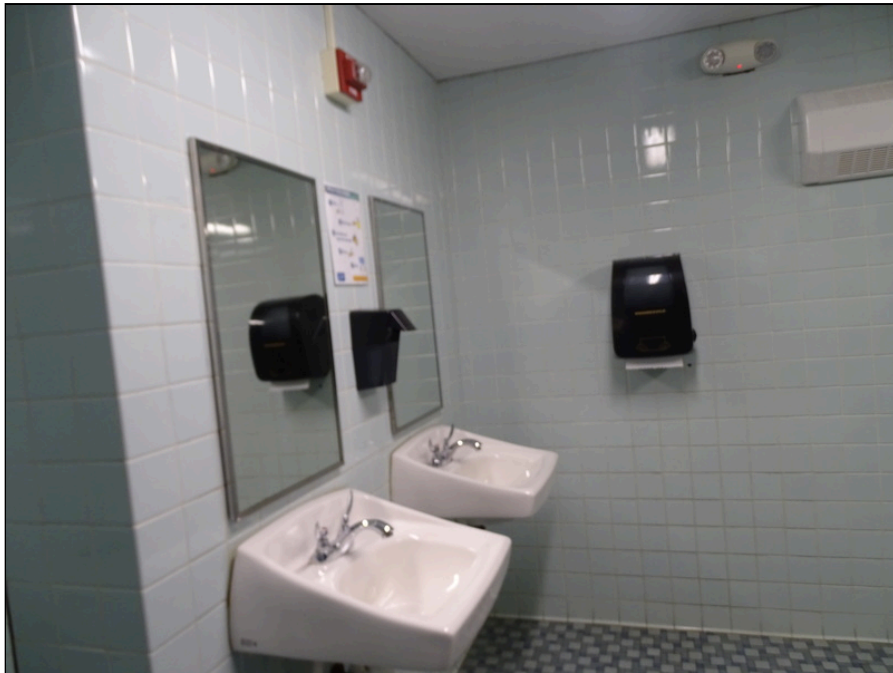
84 - Interior finishes of restroom area

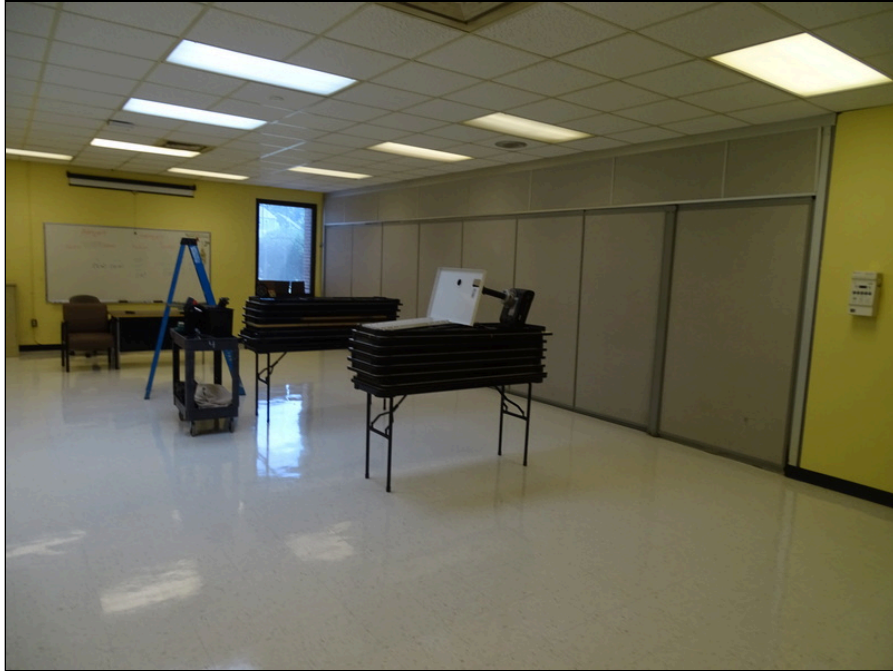
85 - Interior finishes of classroom area

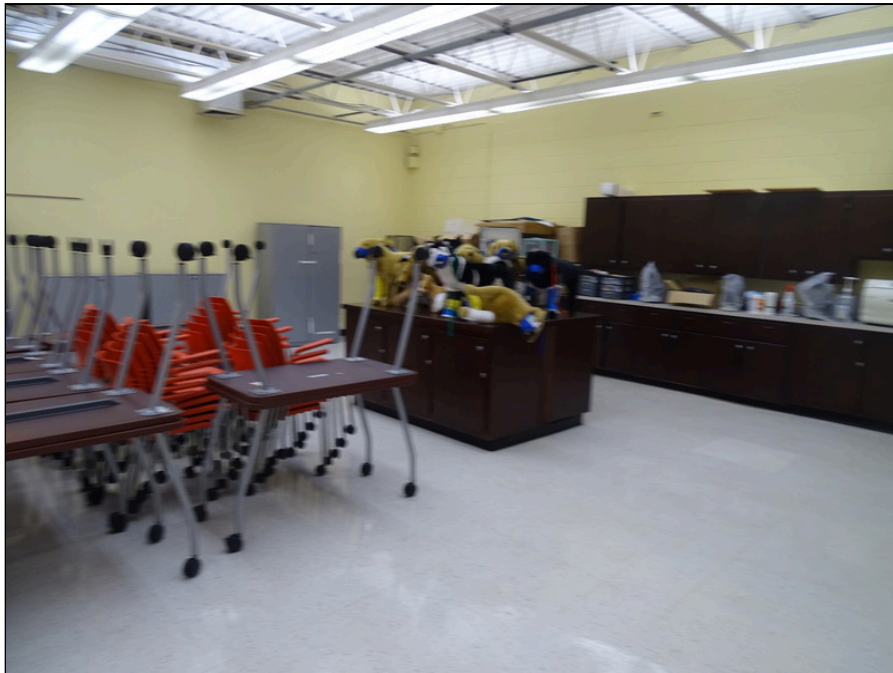
86 - Interior finishes of cafeteria area

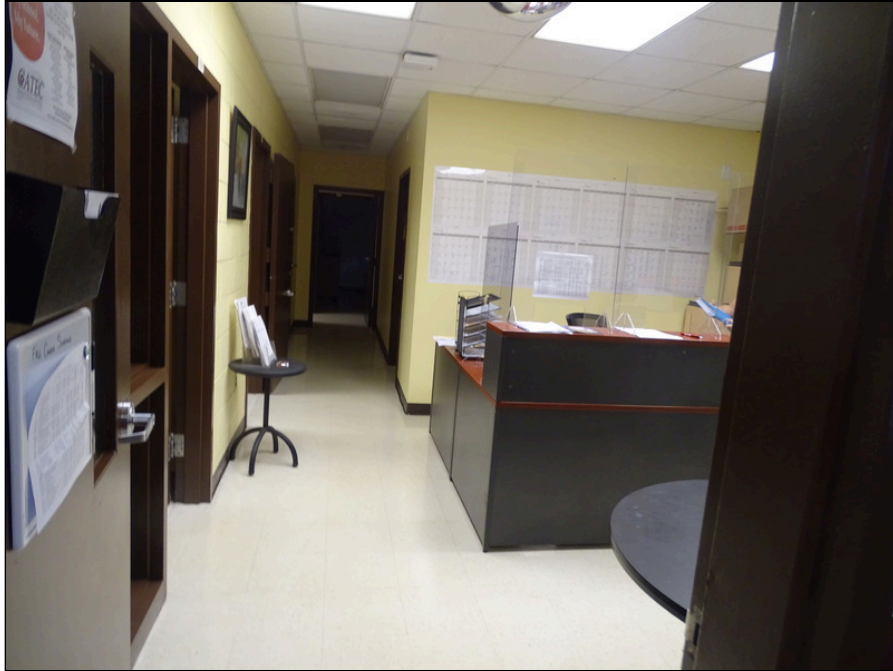
87 - Interior finishes of corridor area

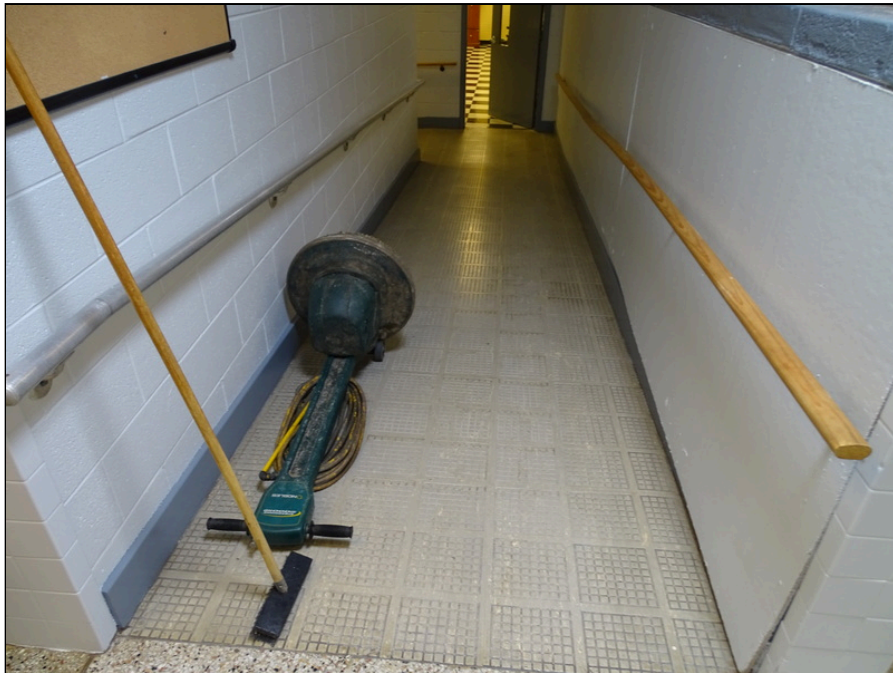
88 - Accessible interior ramp

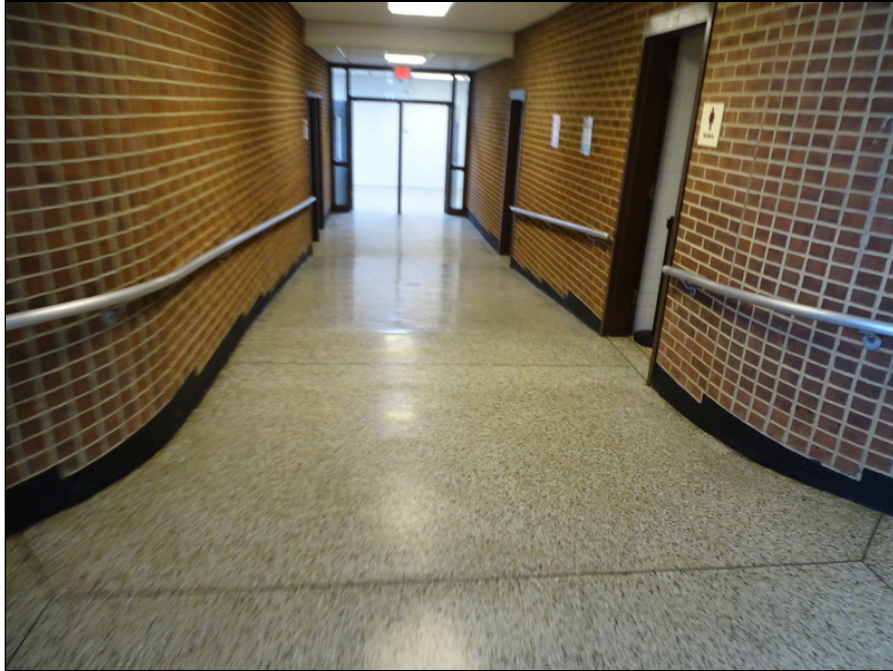
89 - Accessible interior ramp

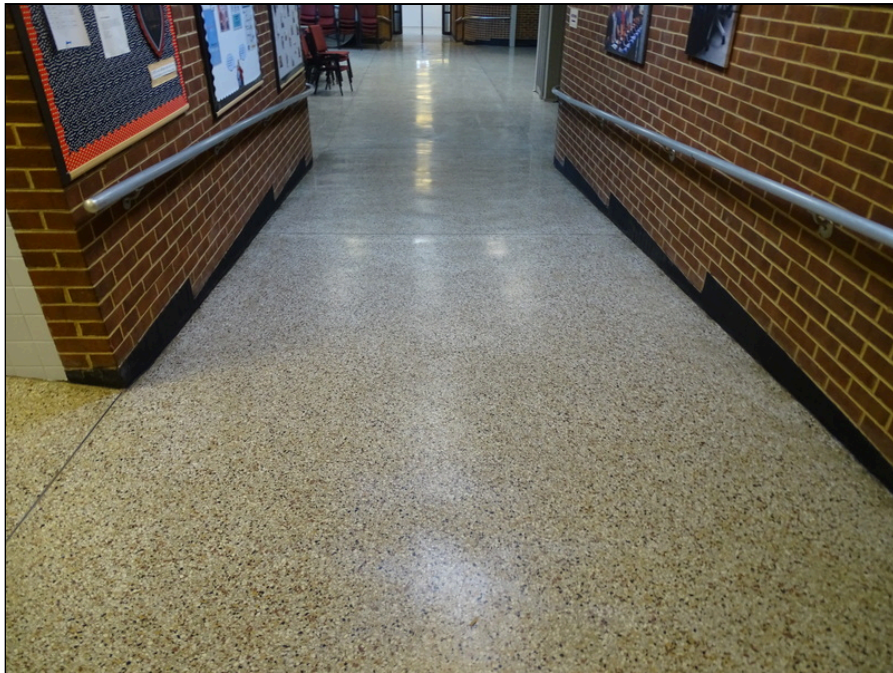
90 - Accessible interior ramp

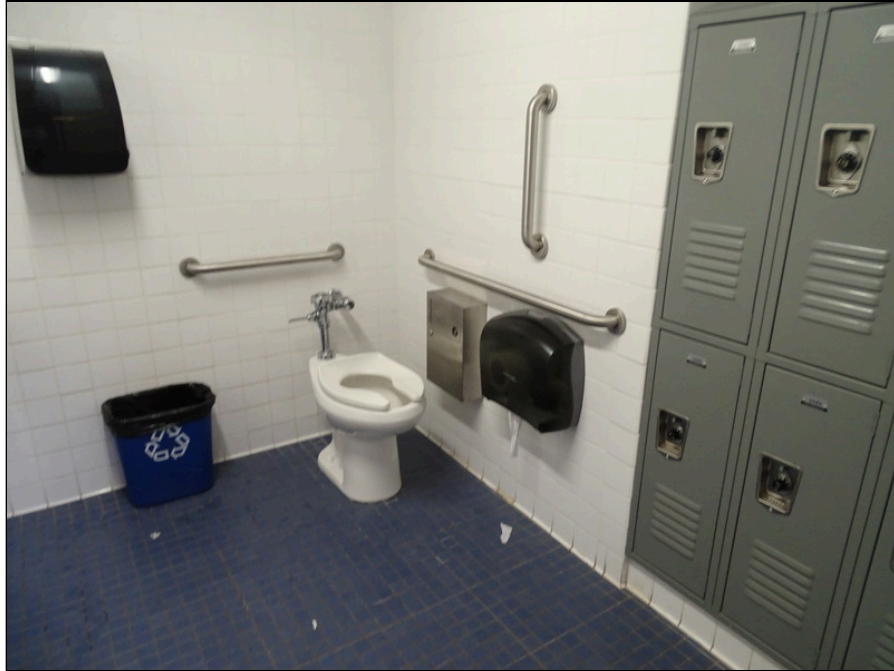
91 - Accessible toilet

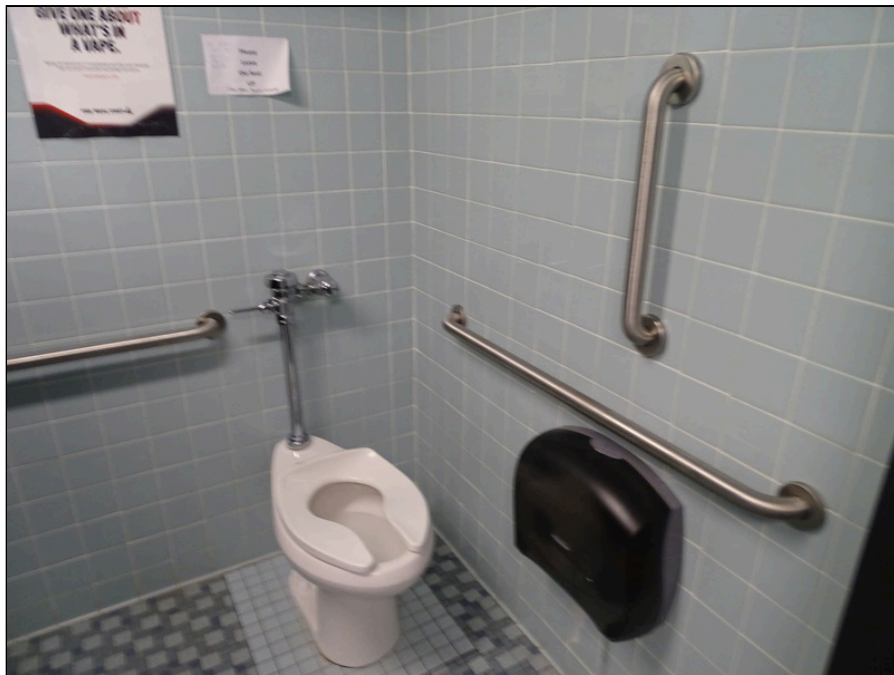
92 - Accessible toilet

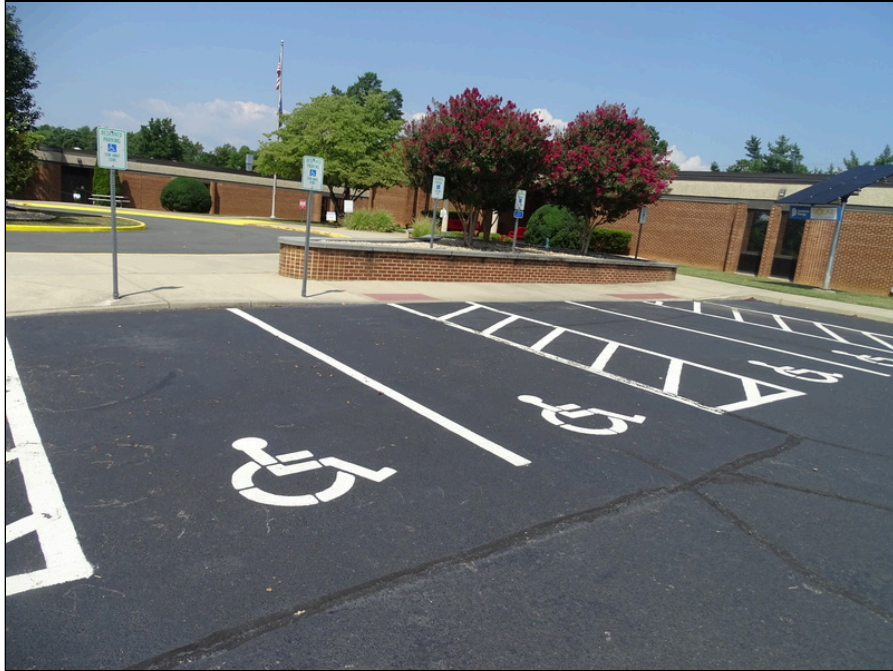
93 - Accessible parking spaces

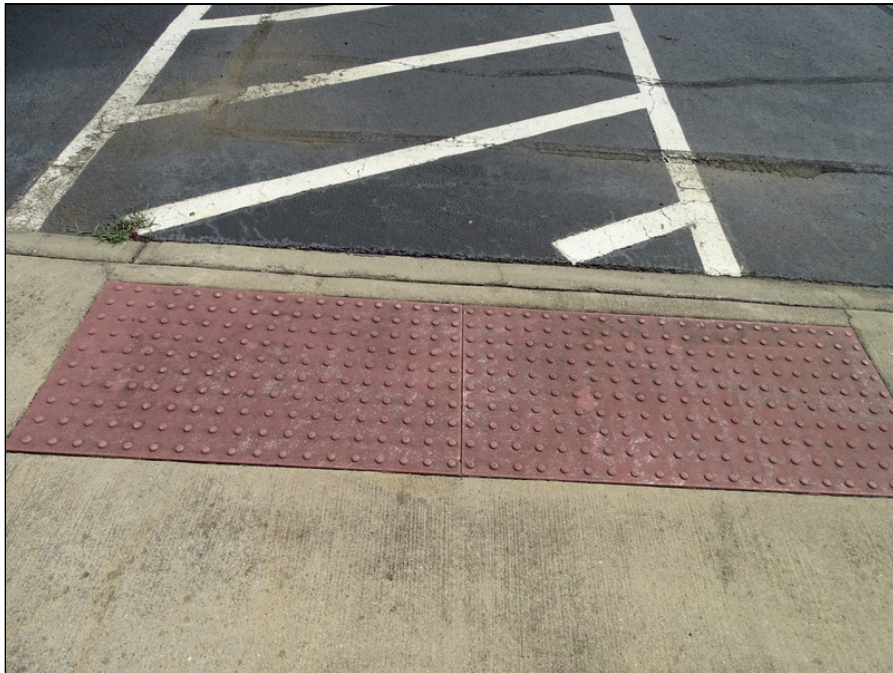
94 - Accessible curb ramp with truncated domes
