CHARLOTTESVILLE HIGH SCHOOL STADIUM FIELD HOUSE
1401 MELBOURNE ROAD
CHARLOTTESVILLE, VIRGINIA

ECS PROJECT NO. 46:6713

CITY OF CHARLOTTESVILLE - FACILITIES DEVELOPMENT

Reference: Facility Condition Assessment Report for Charlottesville High School Stadium Field House,
1401 Melbourne Road, Charlottesville, Virginia

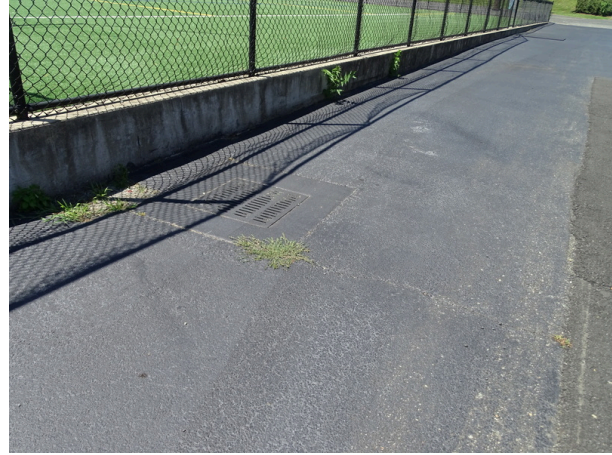
Typical yard inlet

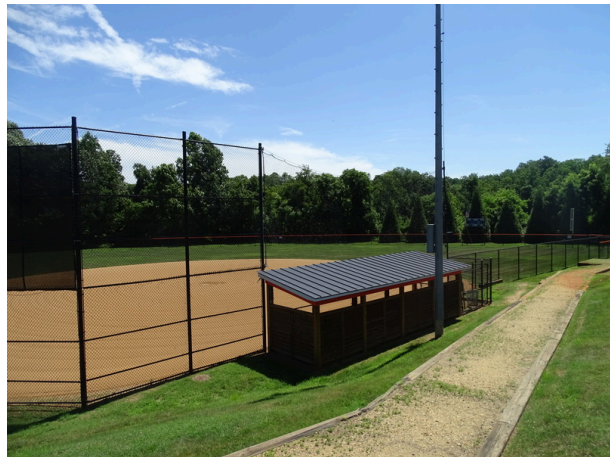
Baseball field at the northeast side of the site

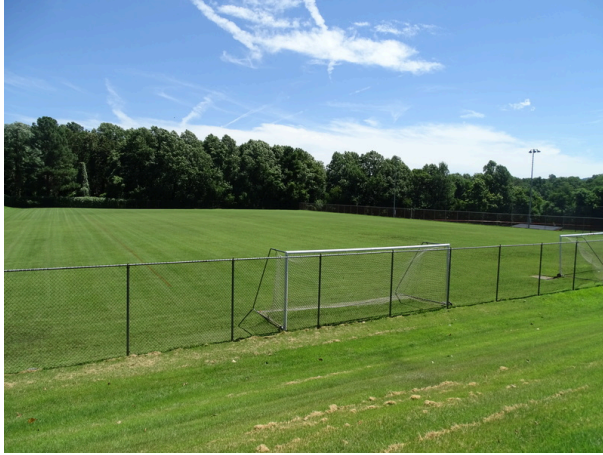
Football field at the center of the site

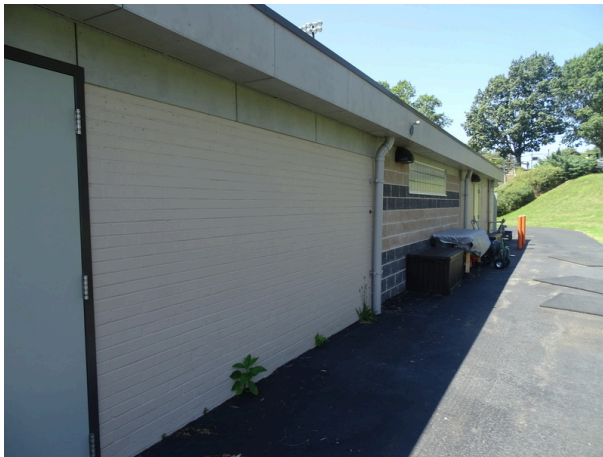
Building exterior of field house

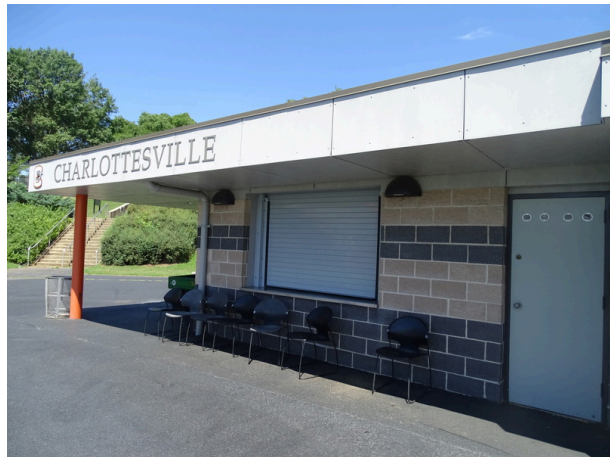
Typical building exterior of field house

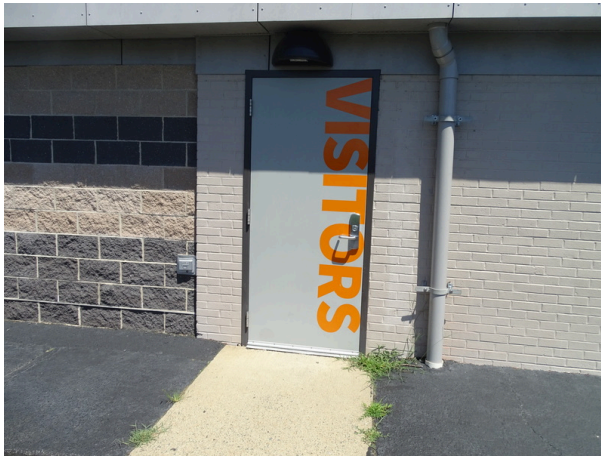
Typical exterior door

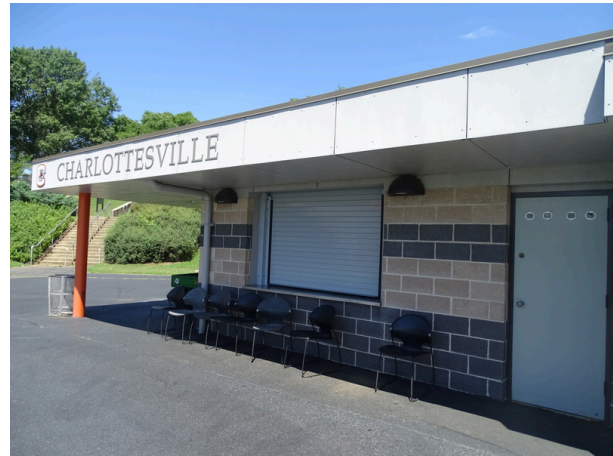
Typical building exterior of field house

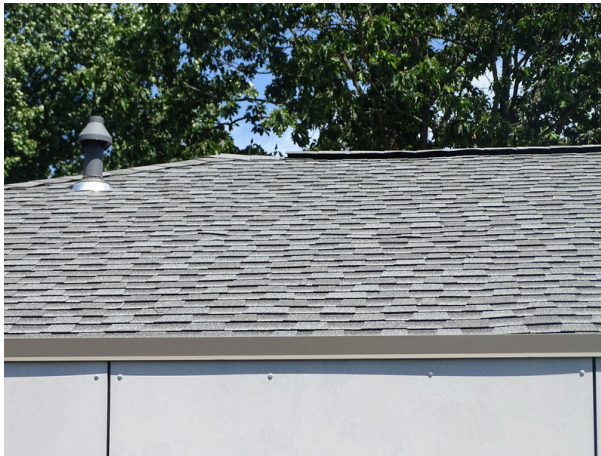
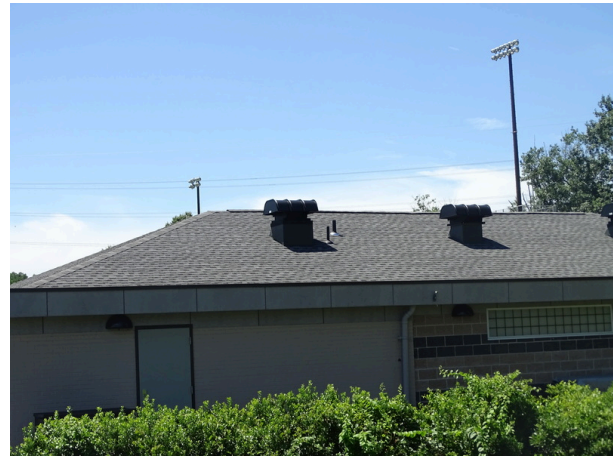
Drainage for the roofing systems is provided by gutters and PVC downspouts. The gutters and downspouts were in good condition.

Asphalt shingle roofing system located at Field House Building

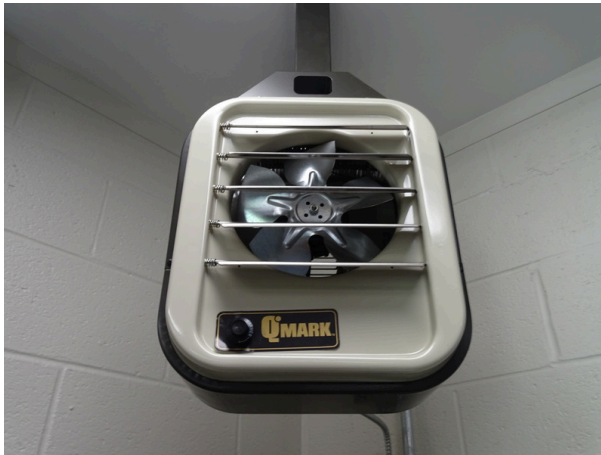
Typical space heater

3.4.2.1 Equipment																													
REPLACE SPACE HEATERS	15	2	13	5	EA	\$1,000.00	\$5,000	100%													\$5,000								\$5,000

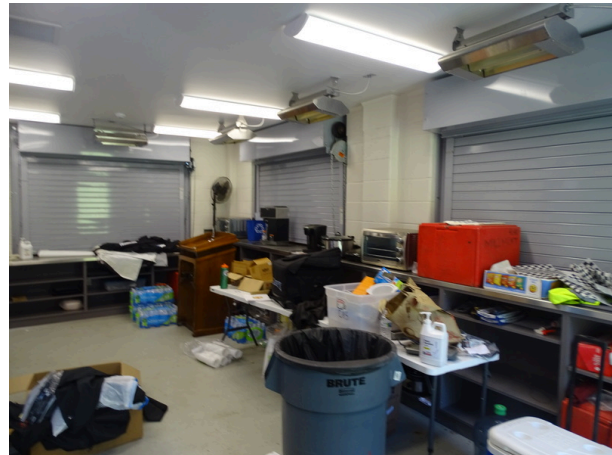
Interior finishes concession area

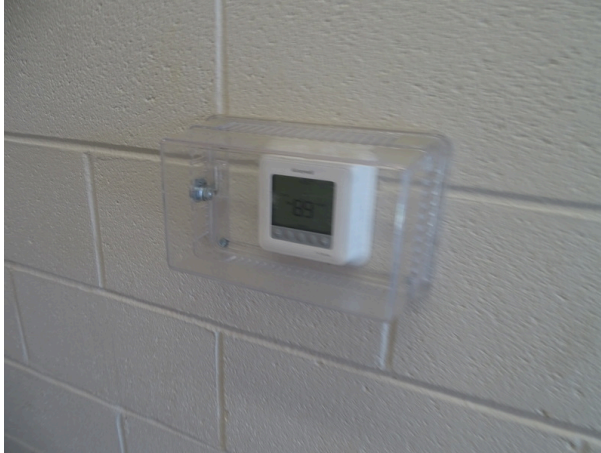
Typical thermostat

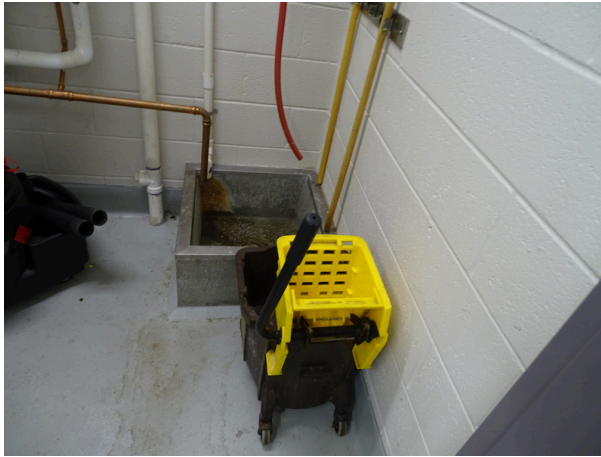
Utility room

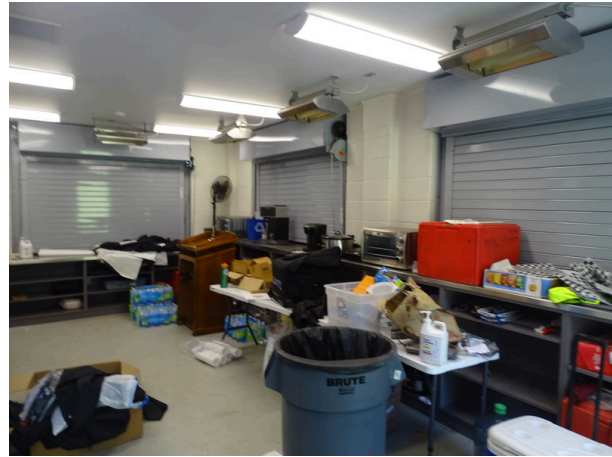
The concession area finishes include coated concrete floors, painted CMU walls, and painted gypsum board ceilings. The finishes in the concession area were observed to be in generally good condition.

Interior finishes concession area

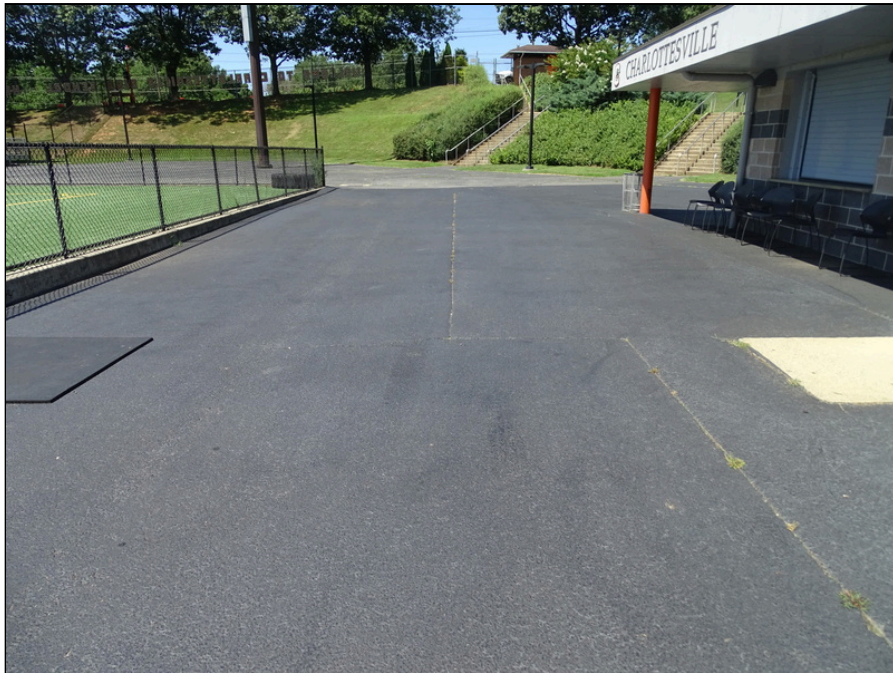
8 - Asphalt pavement in field House Building

3.2.4 Paving, Curbing, and Parking																													
REPAIR ASPHALT PAVEMENTS AS NEEDED	20	15	5	1	LS	\$9,000.00	\$9,000	100%					\$3,000					\$3,000					\$3,000						\$9,000

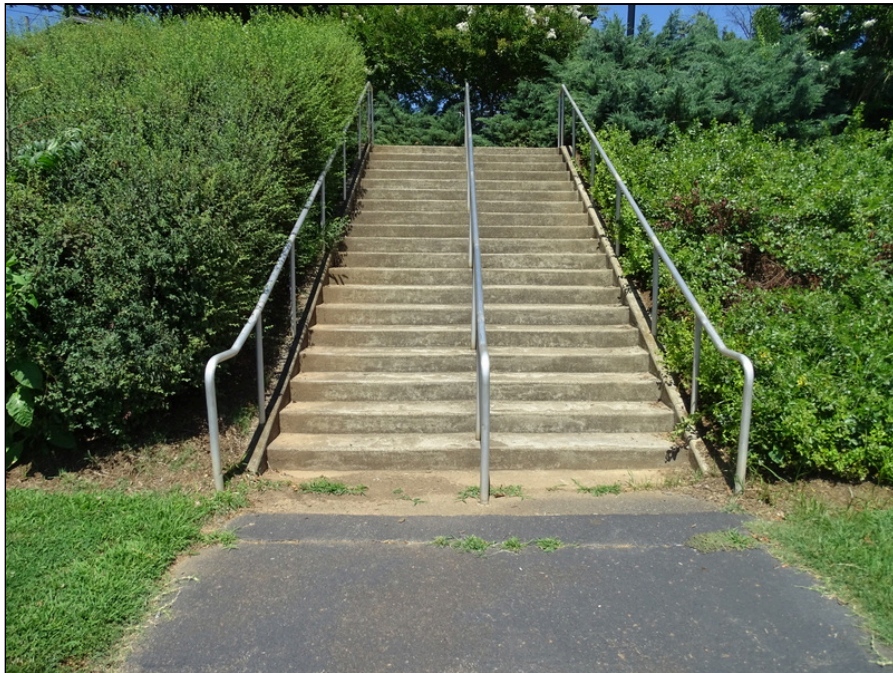
10 - Concrete stair at north end of the site

3.2.5 Flatwork																													
REPAIR ASPHALT WALKWAY AS NEEDED	20	15	5	1	LS	\$5,000.00	\$5,000	100%					\$2,500					\$2,500											\$5,000
REPAIR CONCRETE SIDEWALK AND STEPS AS NEEDED	20	15	5	1	LS	\$5,000.00	\$5,000	100%					\$2,500									\$2,500							\$5,000

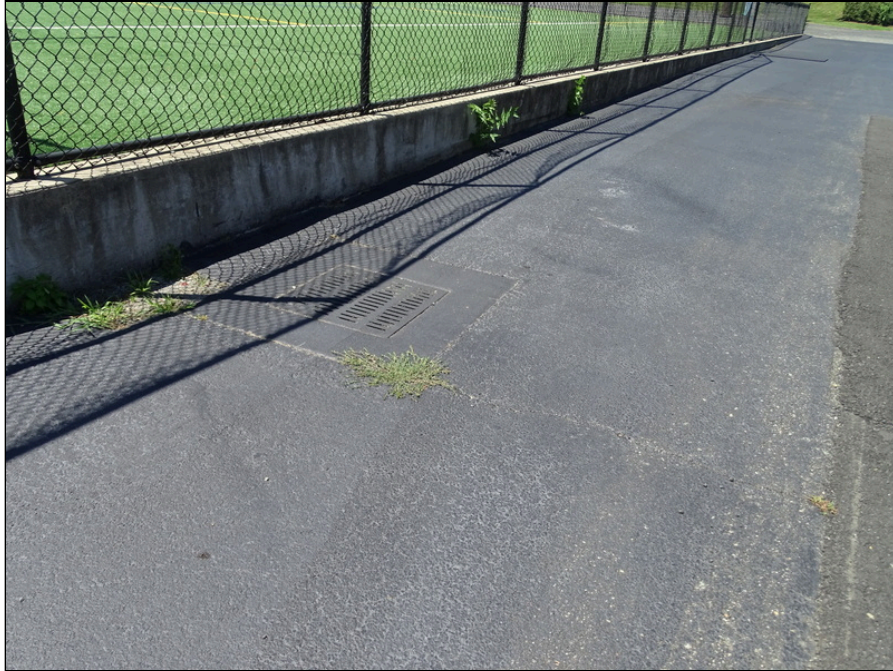
11 - Typical yard inlet

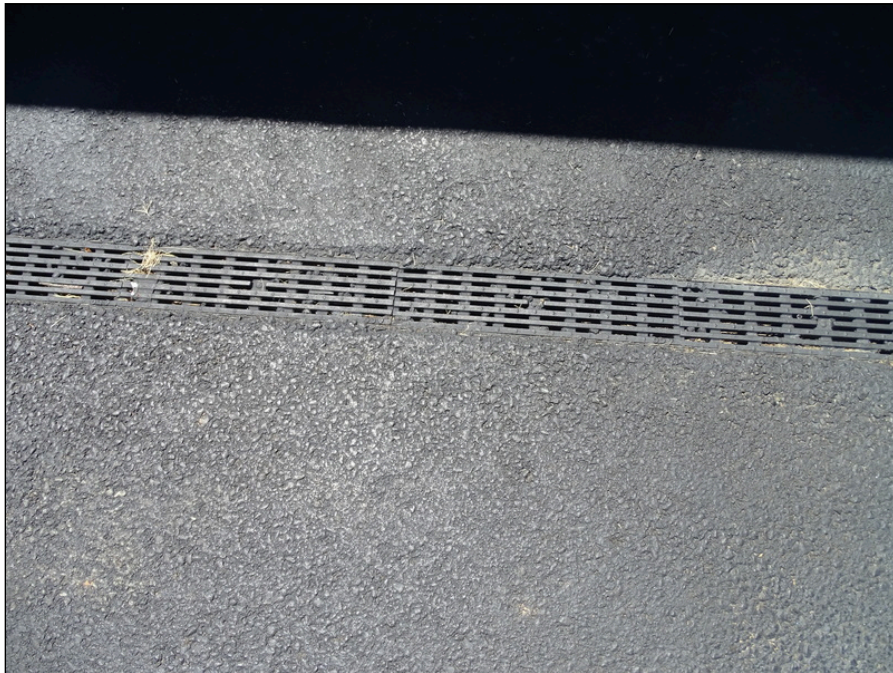
12 - Typical water storm drainage

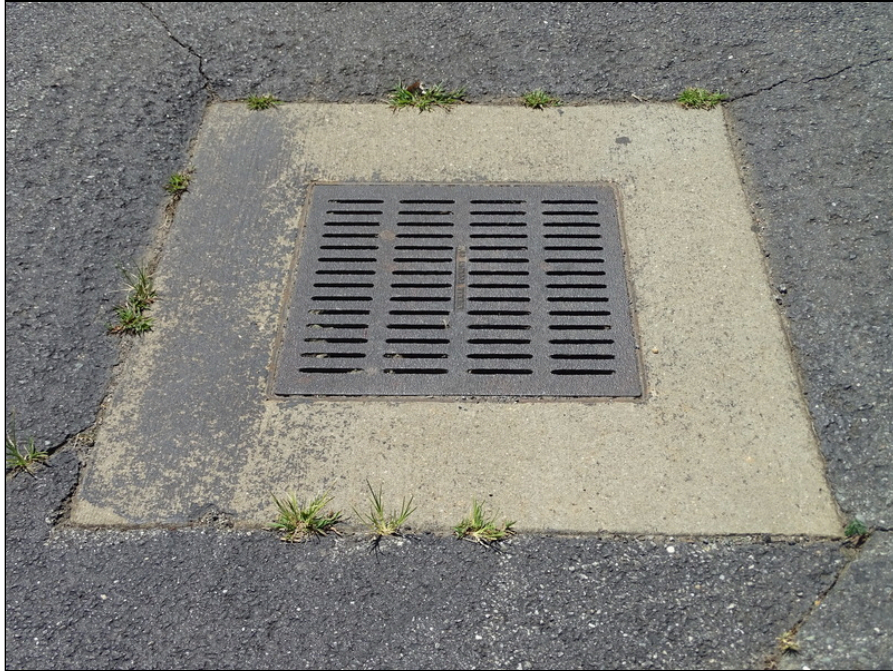
13 - Typical water storm drainage

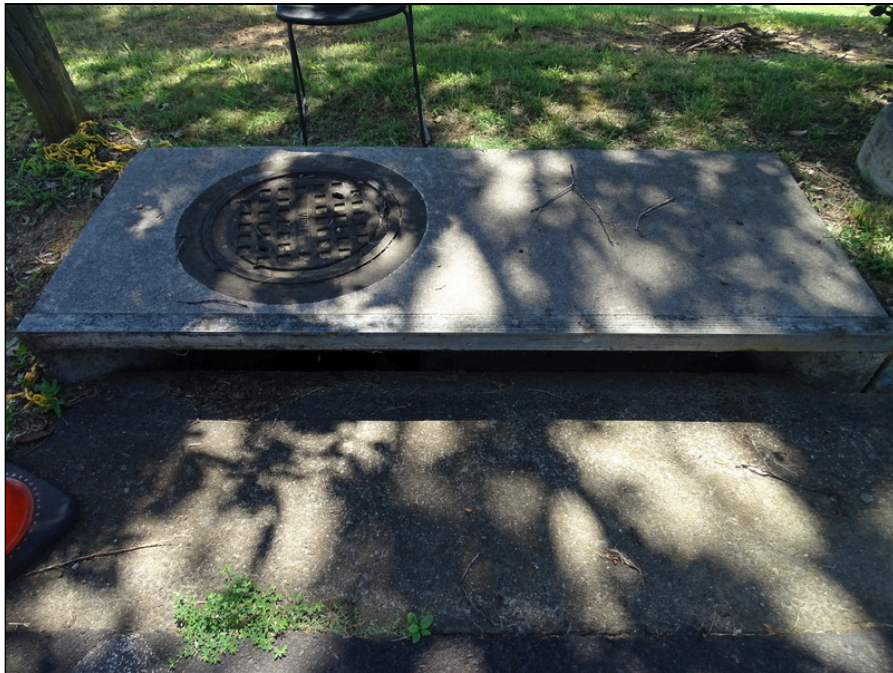
14 - Typical water storm drainage

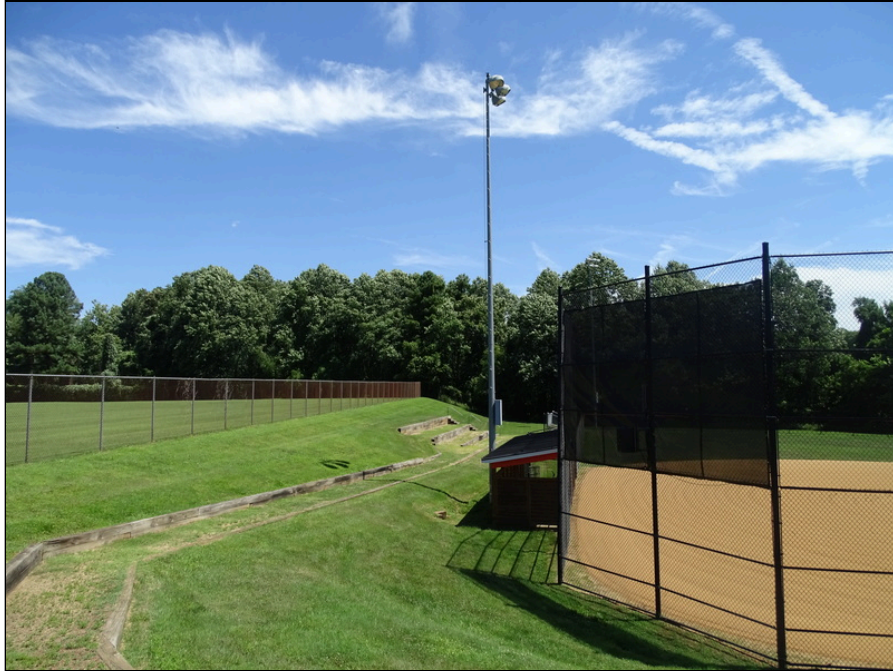
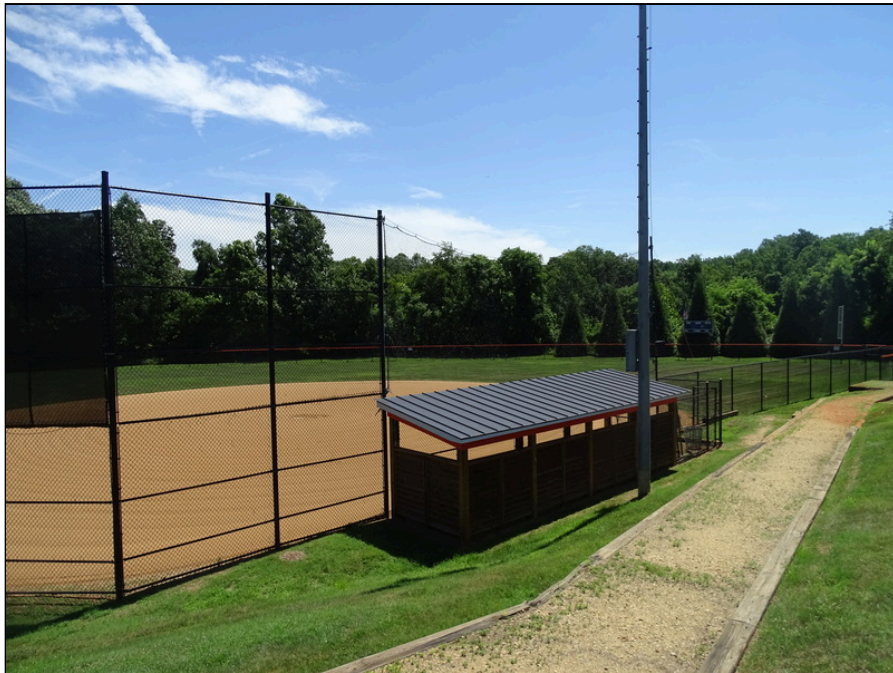
15 - Baseball field at the northeast side of the site

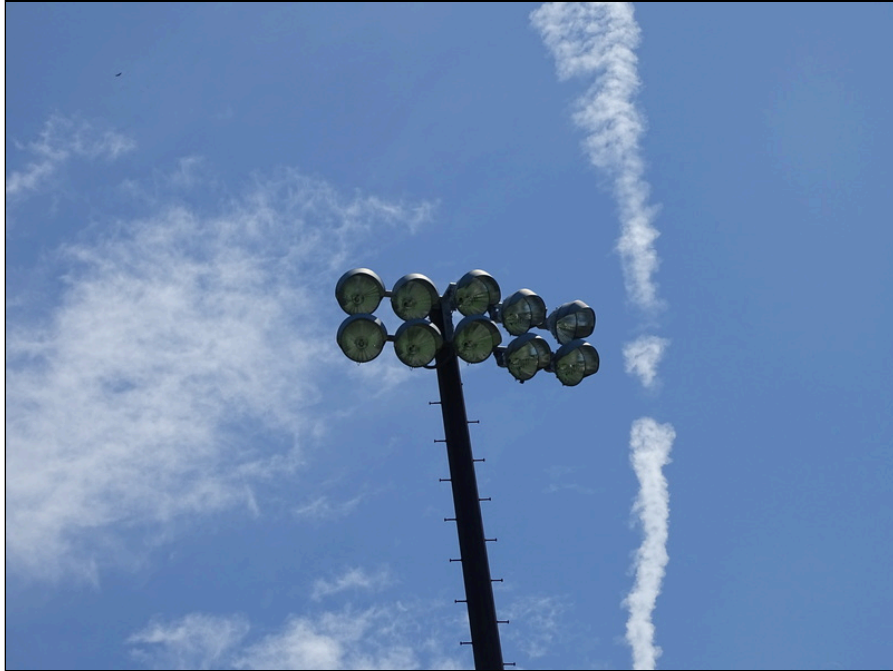
17 - Pole mounted lighting

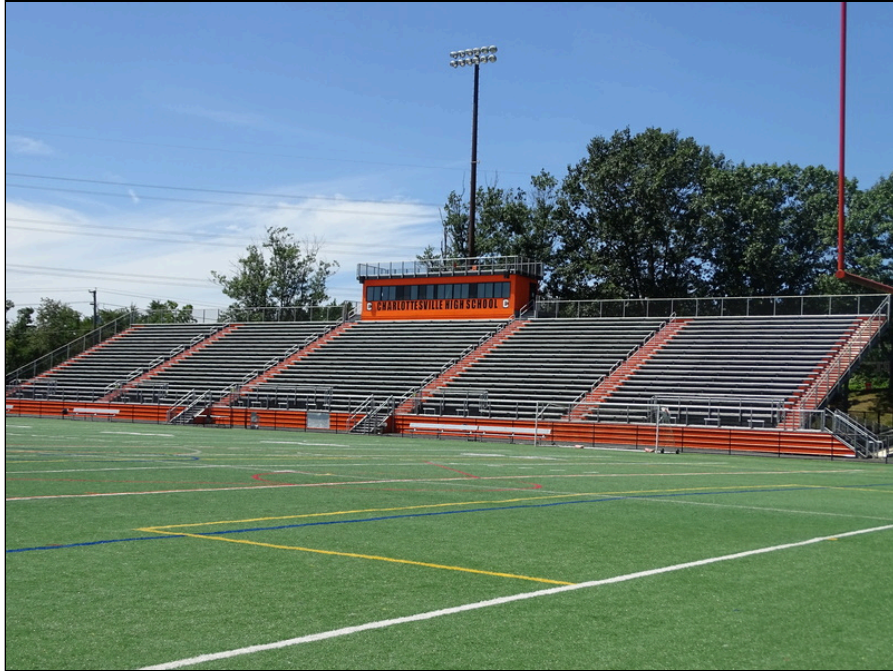
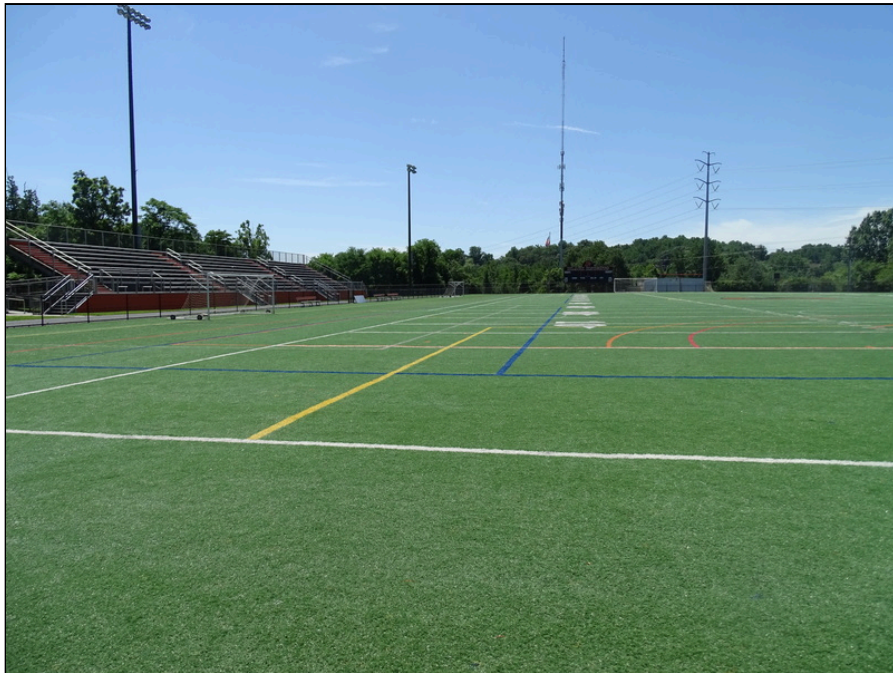
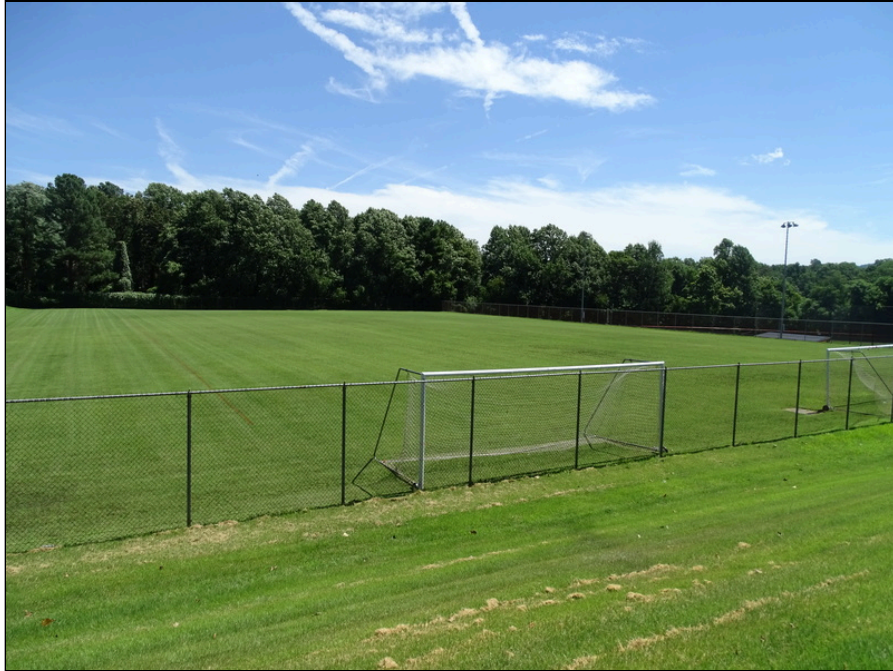
19 - Football field at the center of the site

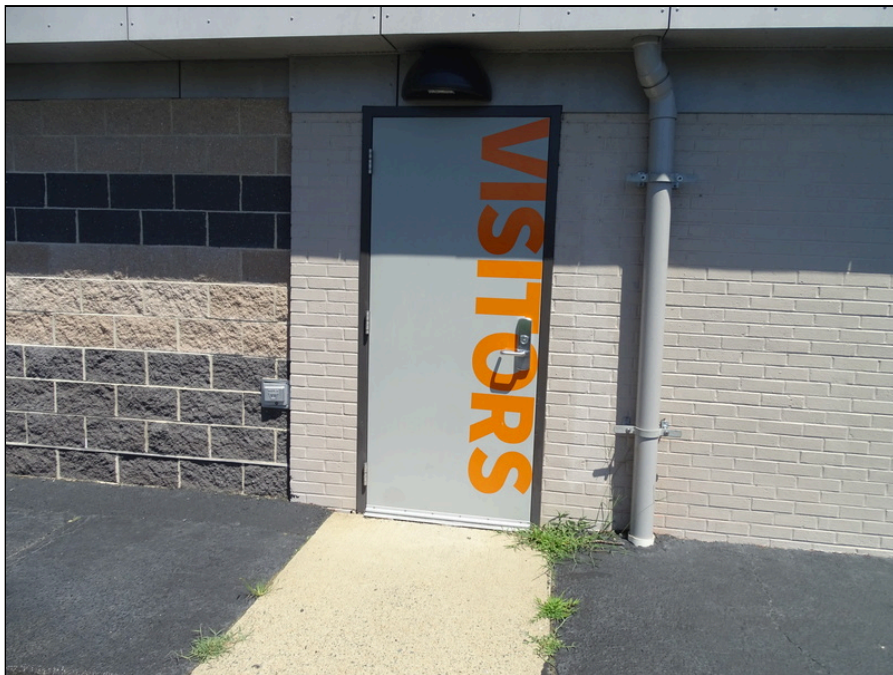
22 - Typical exterior door

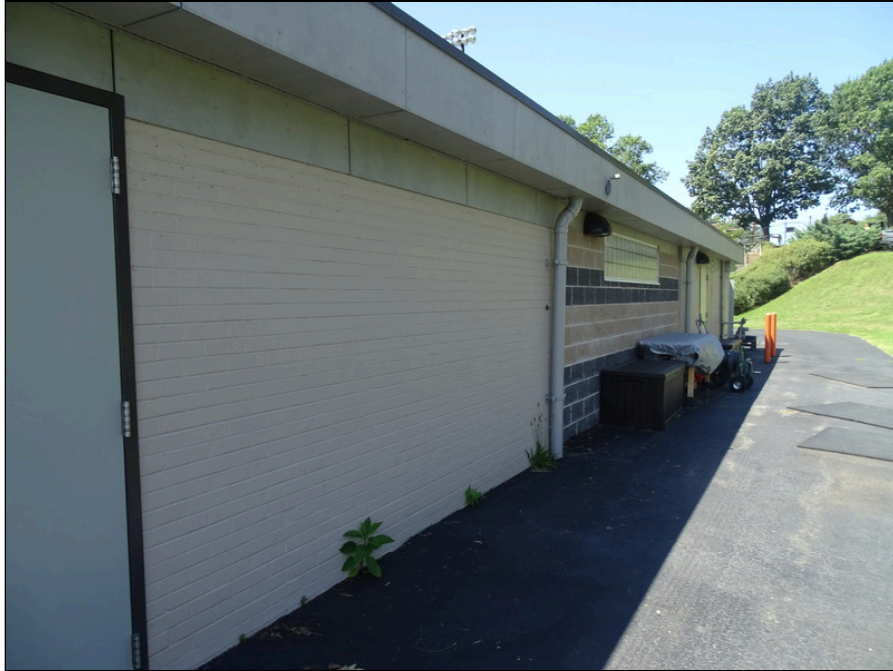
23 - Building exterior of field house

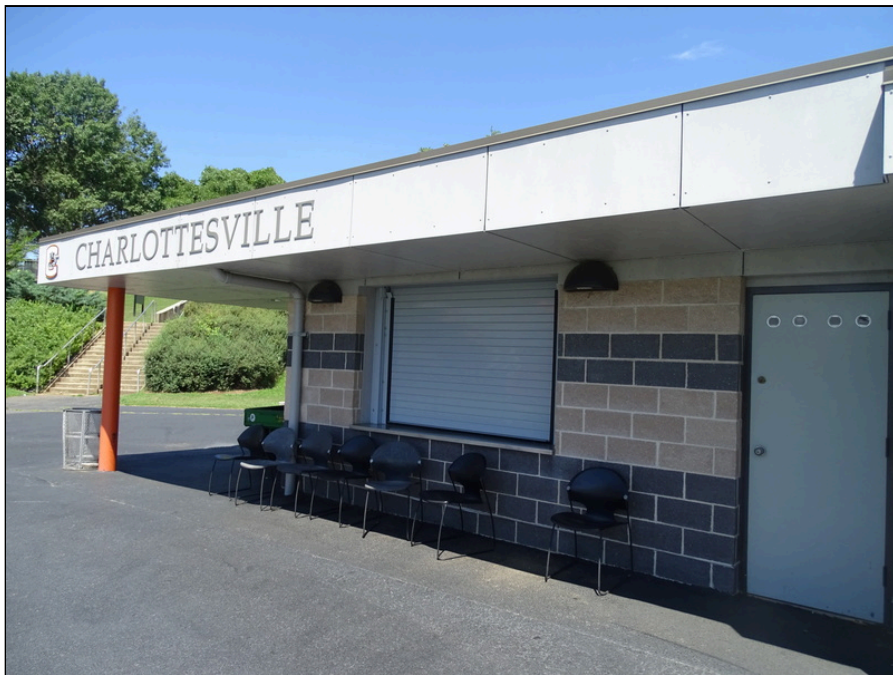
24 - Typical building exterior of field house

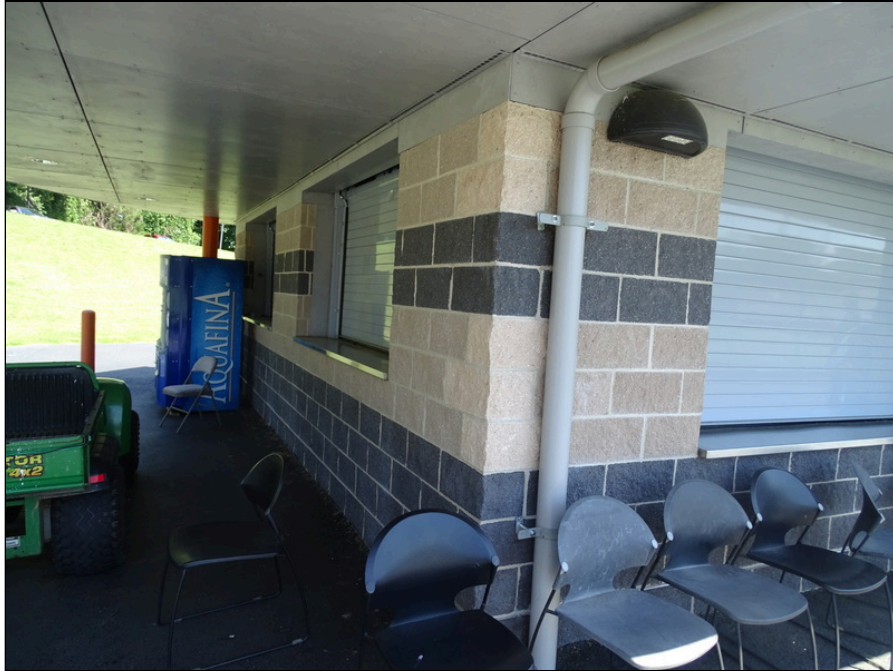
25 - Typical patio of field house

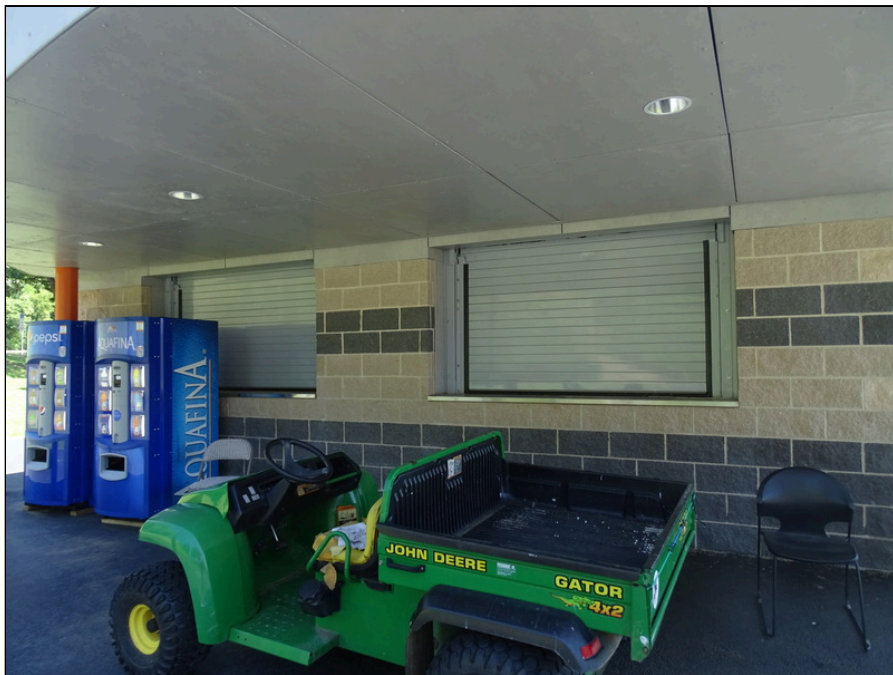
26 - Roll up windows

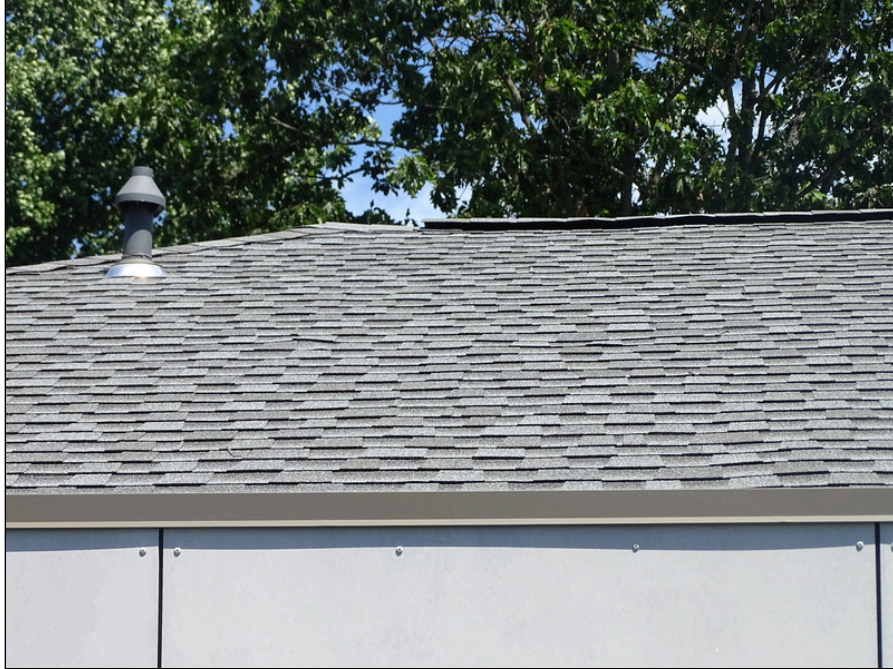
29 - Asphalt shingle roofing system located at Field House Building

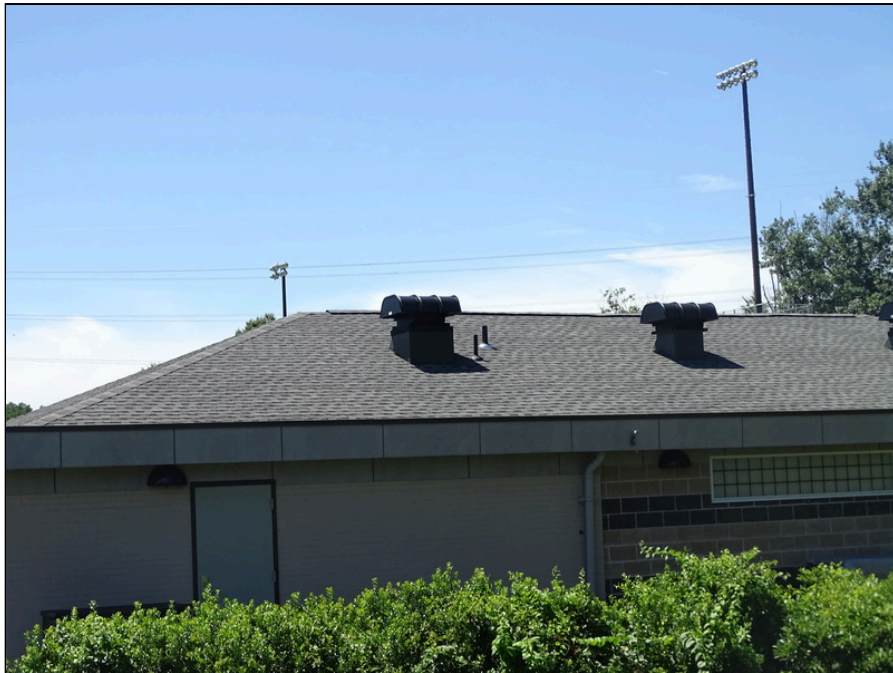
30 - Asphalt shingle roofing system located at Field House Building

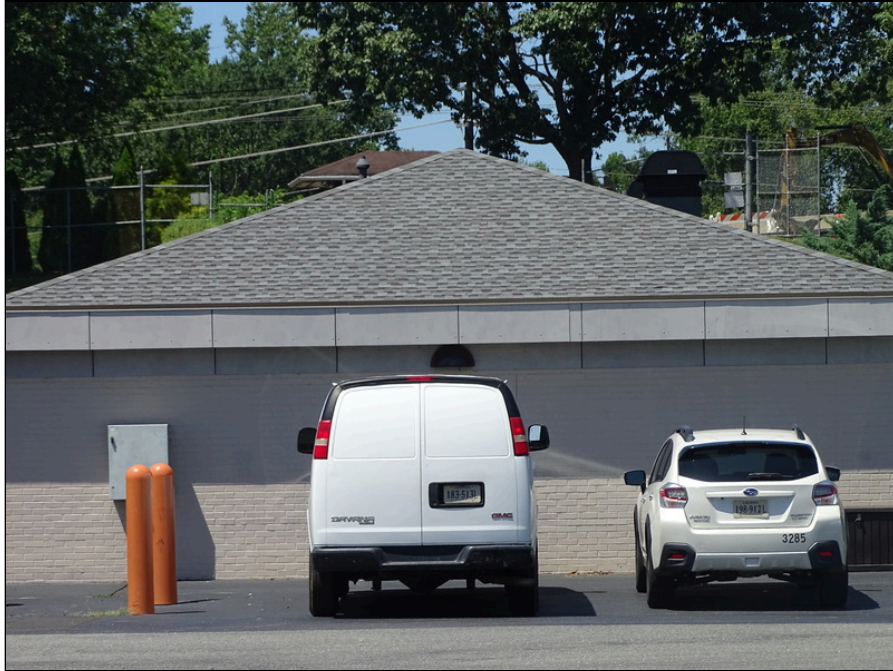
31 - Asphalt shingle roofing system located at Field House Building

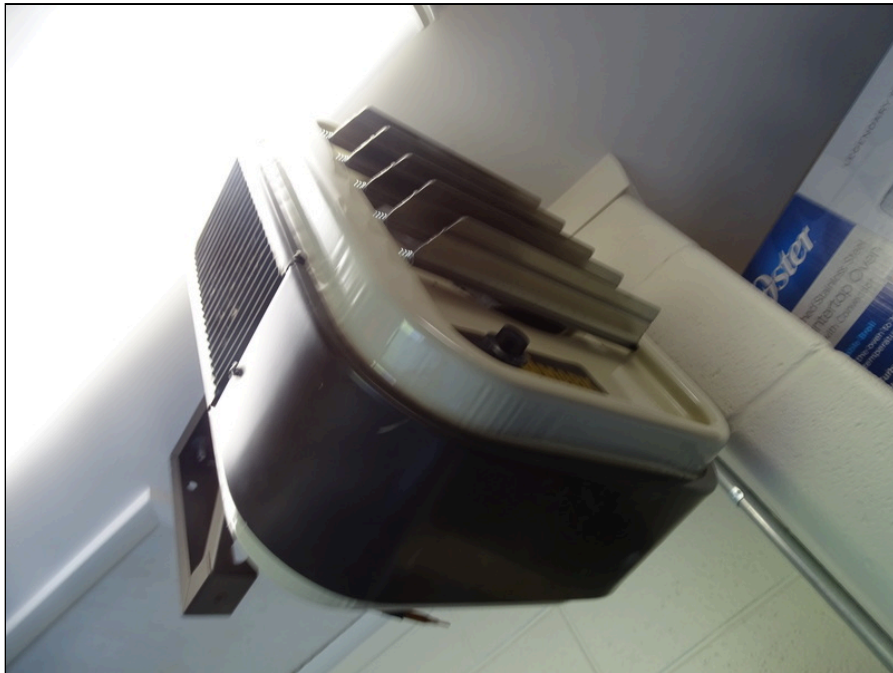
32 - Typical space heater

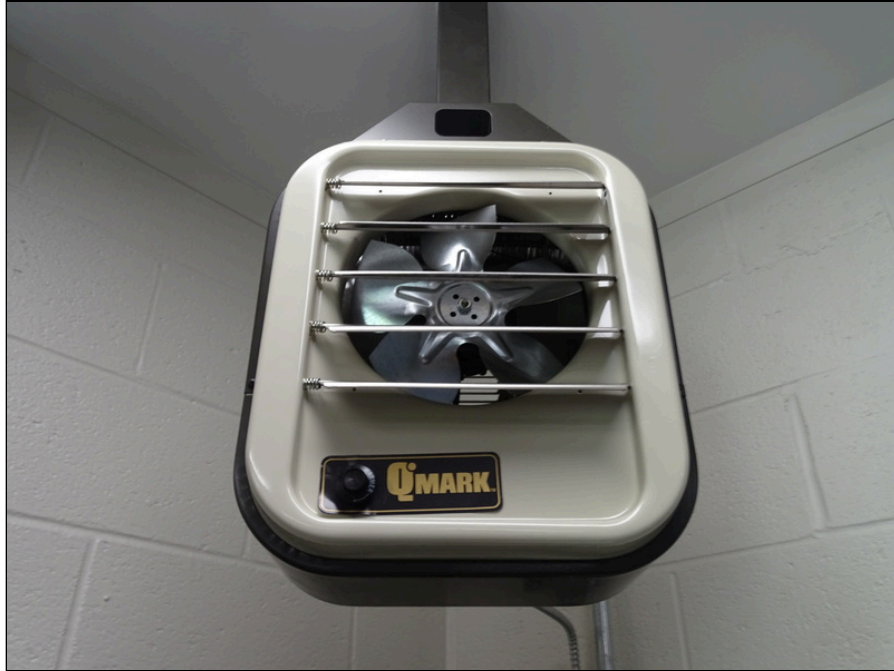
33 - Typical space heater

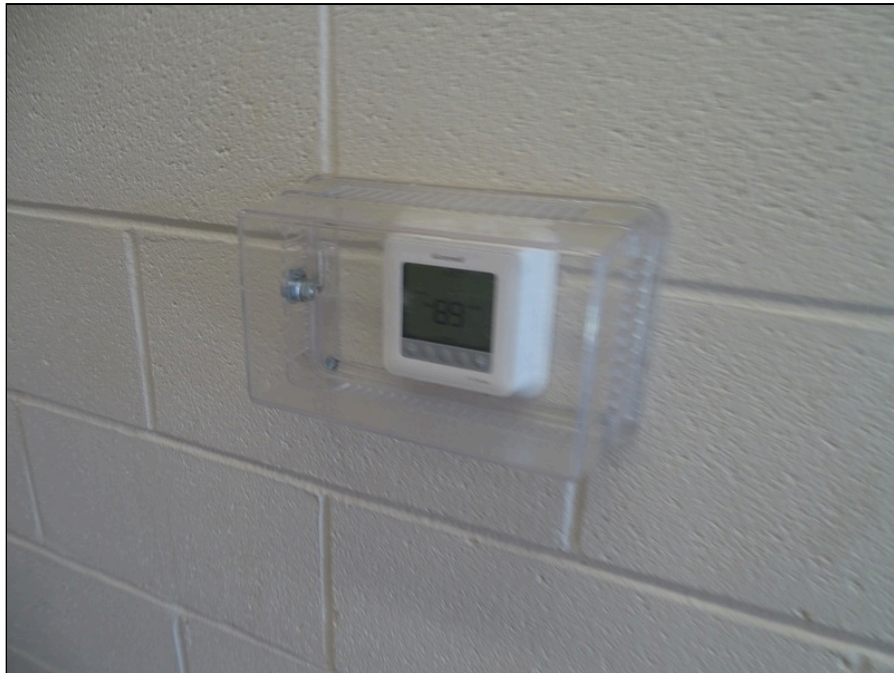
34 - Typical thermostat

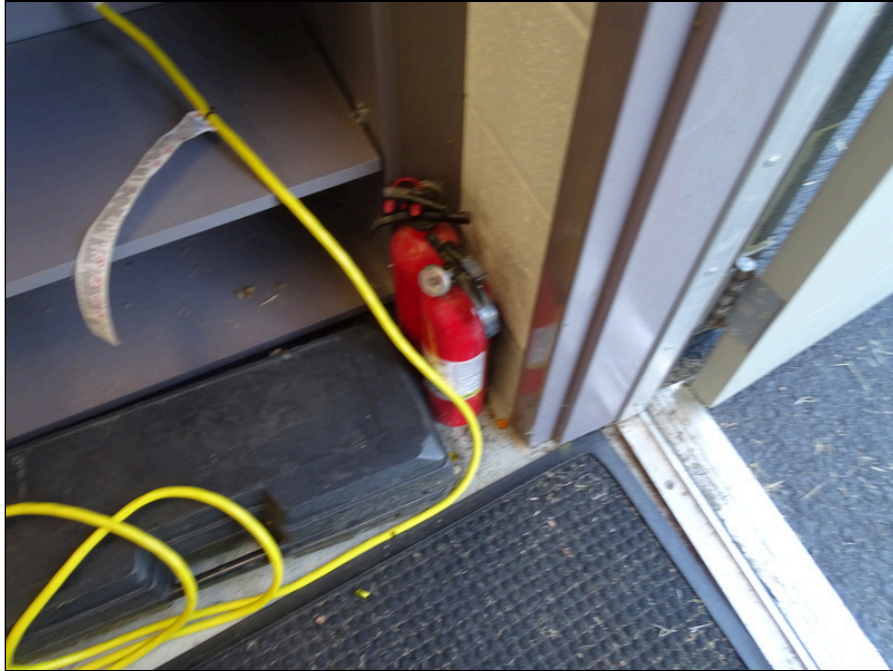
35 - Typical fire extinguisher

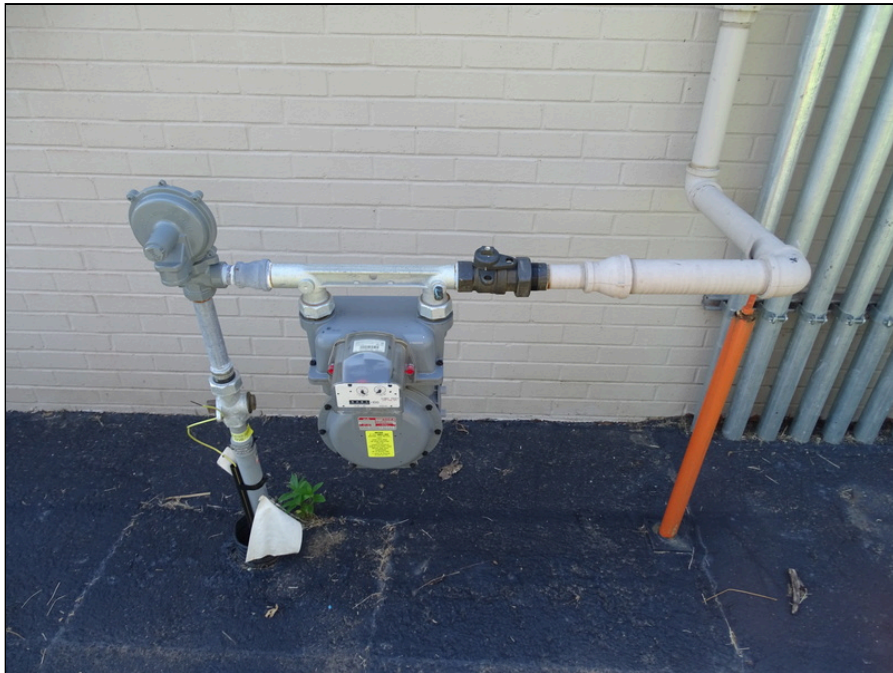
36 - Typical gas meter

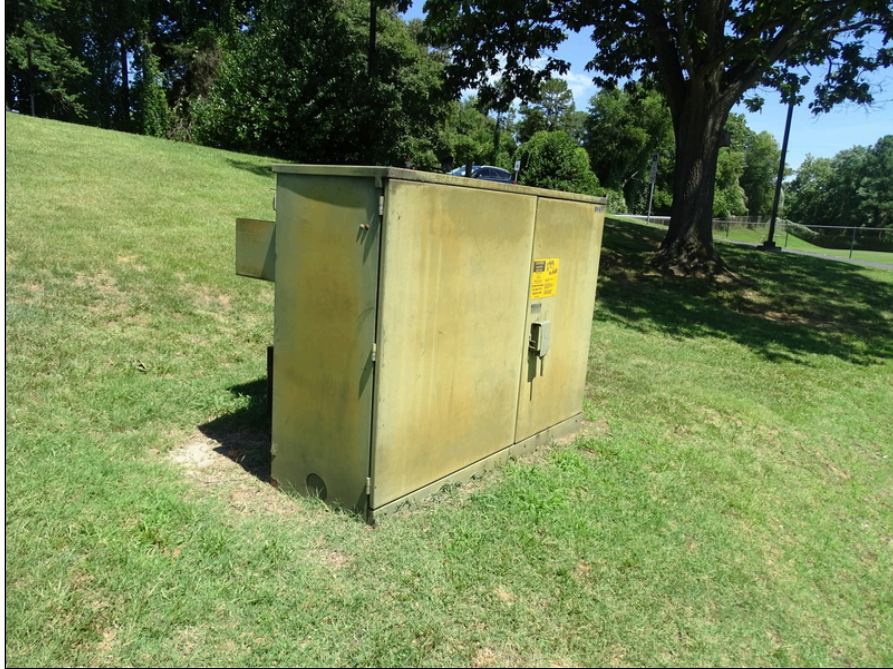
37 - Pad mounted electrical utility transformer servicing Field House Building

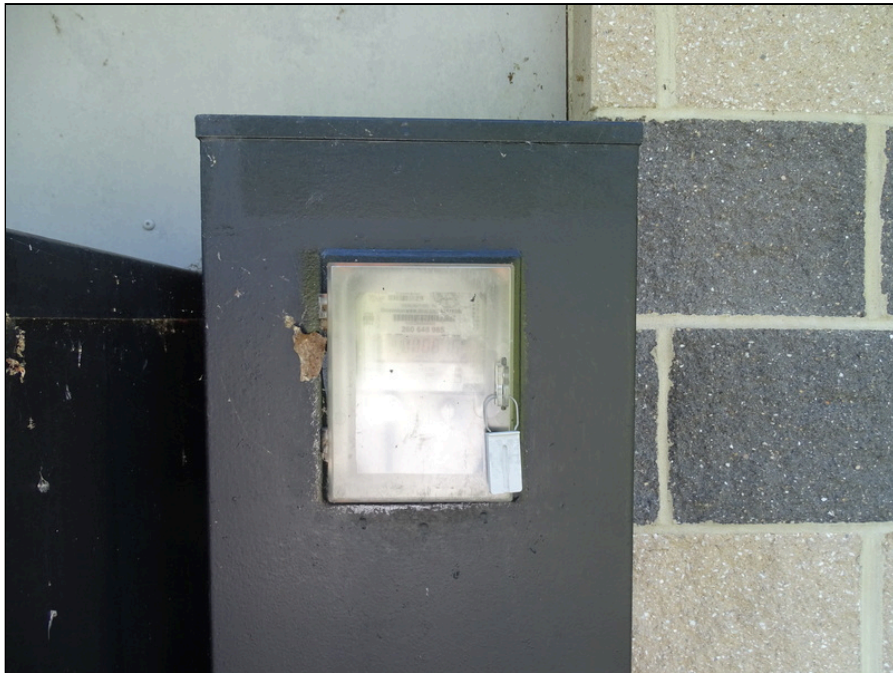
38 - Electrical utility meter

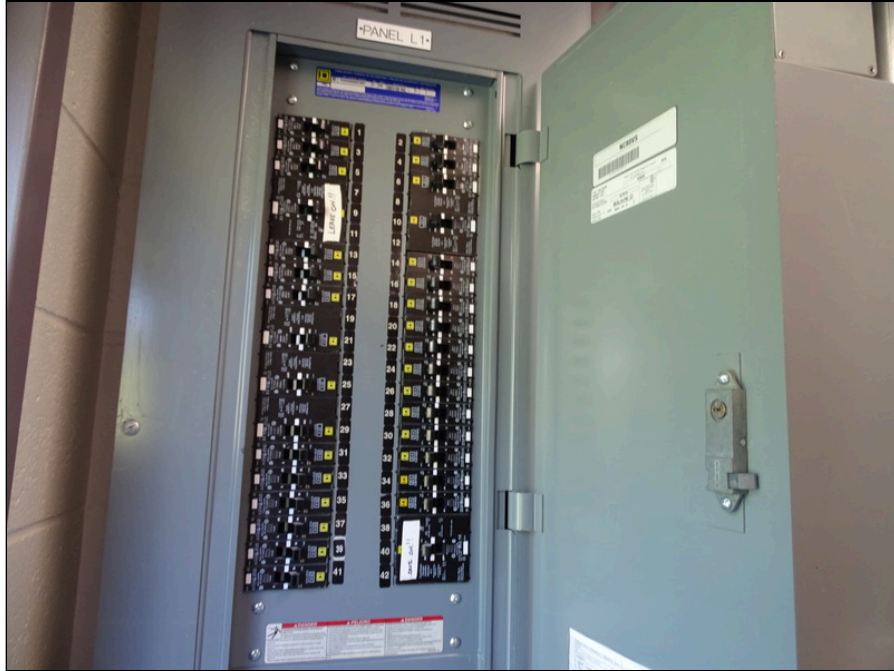
39 - Main electrical disconnect and circuit breaker panel at Maintenance Building

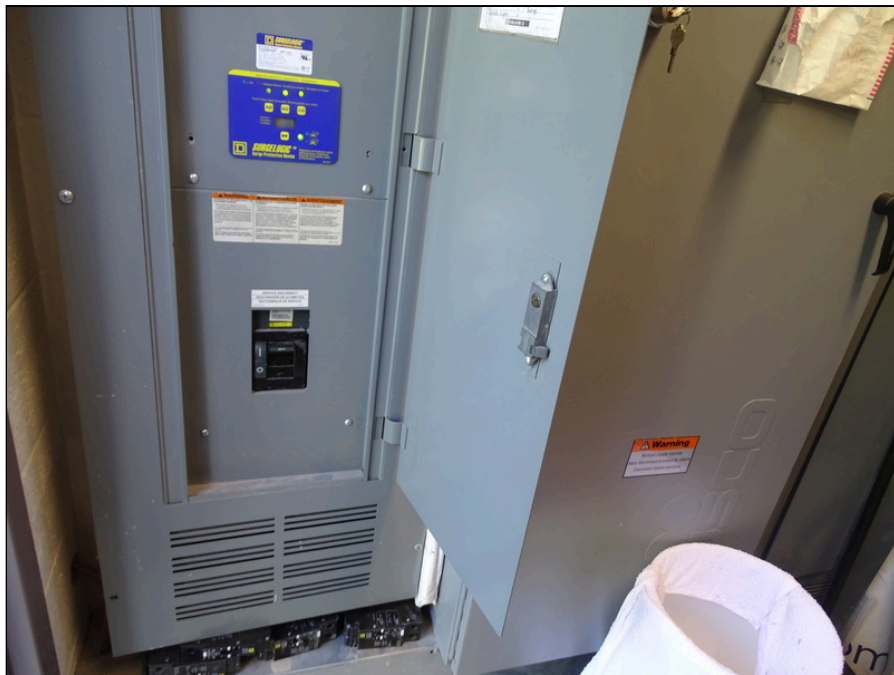
40 - Main switch disconnect

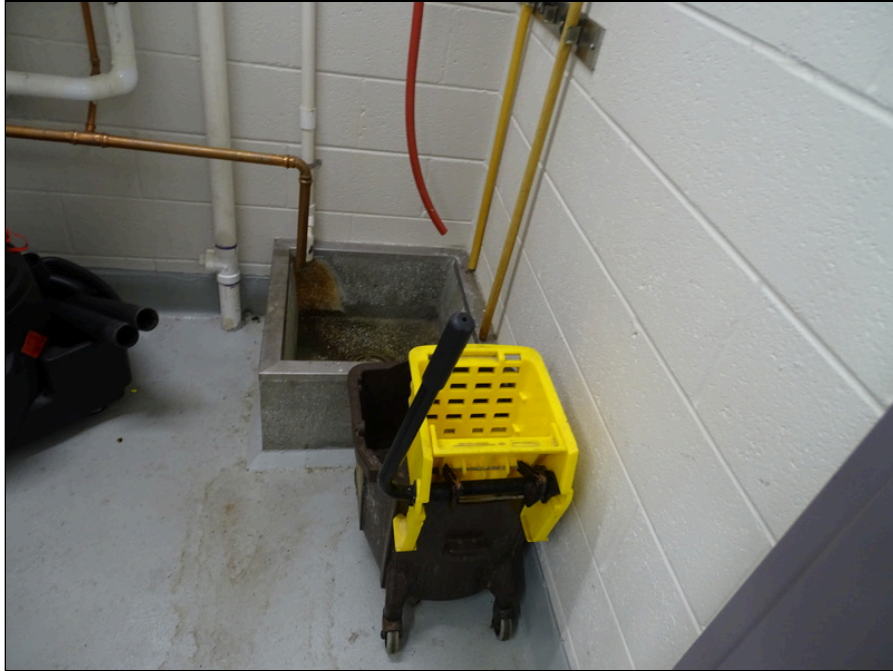
41 - Utility room

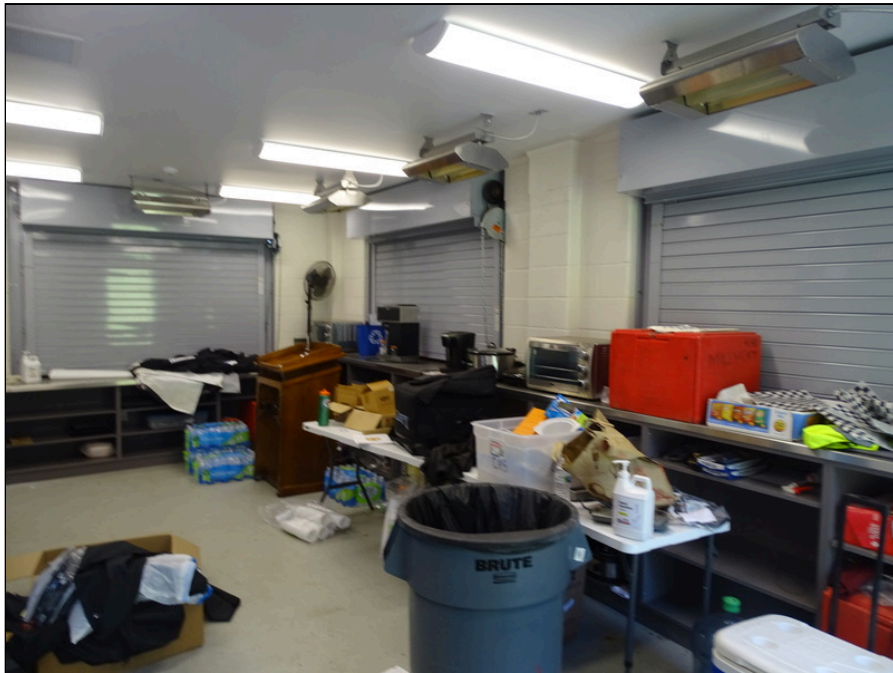
42 - Interior finishes concession area
