CHARLOTTESVILLE HIGH SCHOOL STADIUM FIELD HOUSE
1401 MELBOURNE ROAD
CHARLOTTESVILLE, VIRGINIA

ECS PROJECT NO. 46:6713

CITY OF CHARLOTTESVILLE - FACILITIES DEVELOPMENT

Reference: Facility Condition Assessment Report for Charlottesville High School Stadium Field House,
1401 Melbourne Road, Charlottesville, Virginia

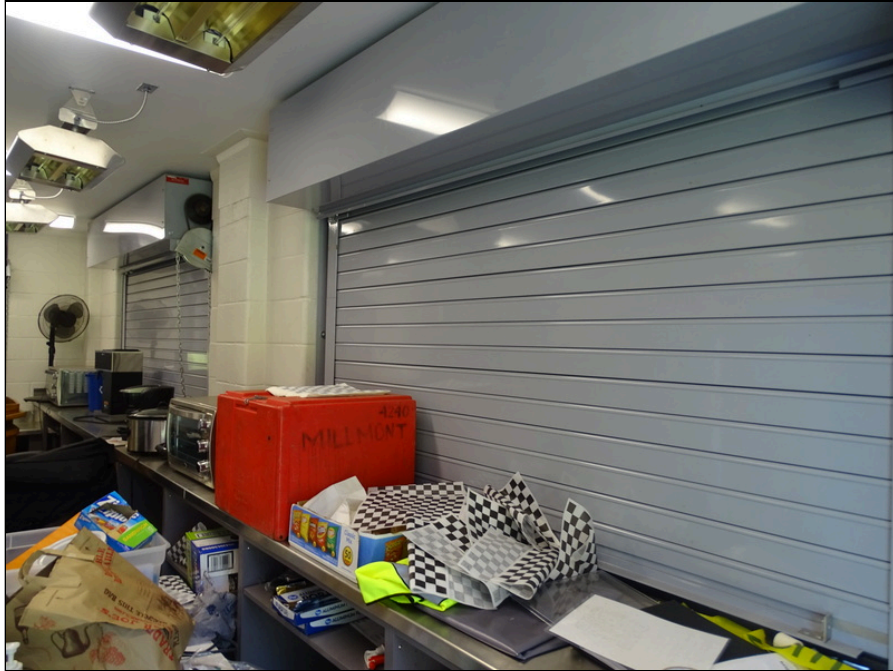
43 - Interior finishes concession area

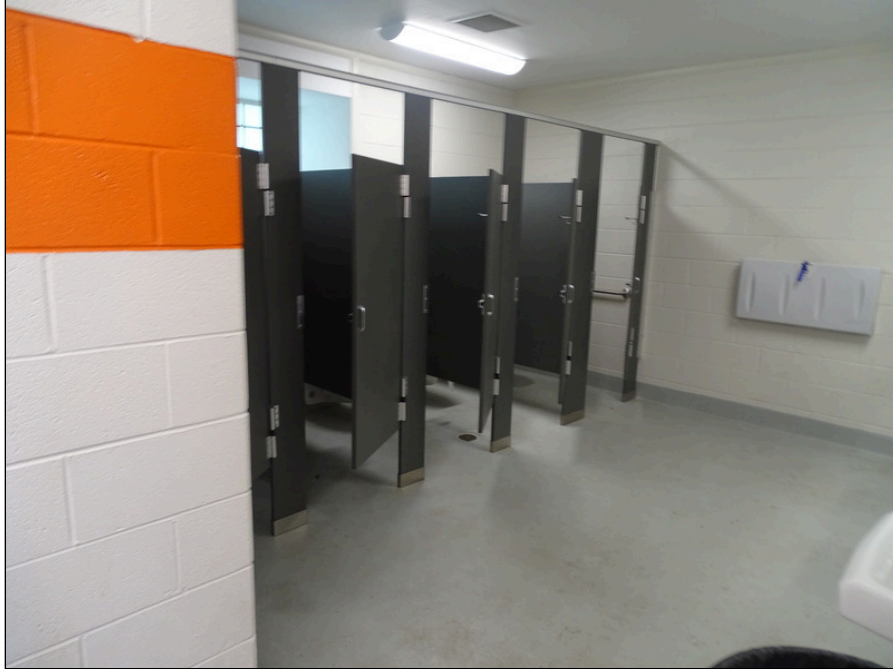
45 - Typical restroom

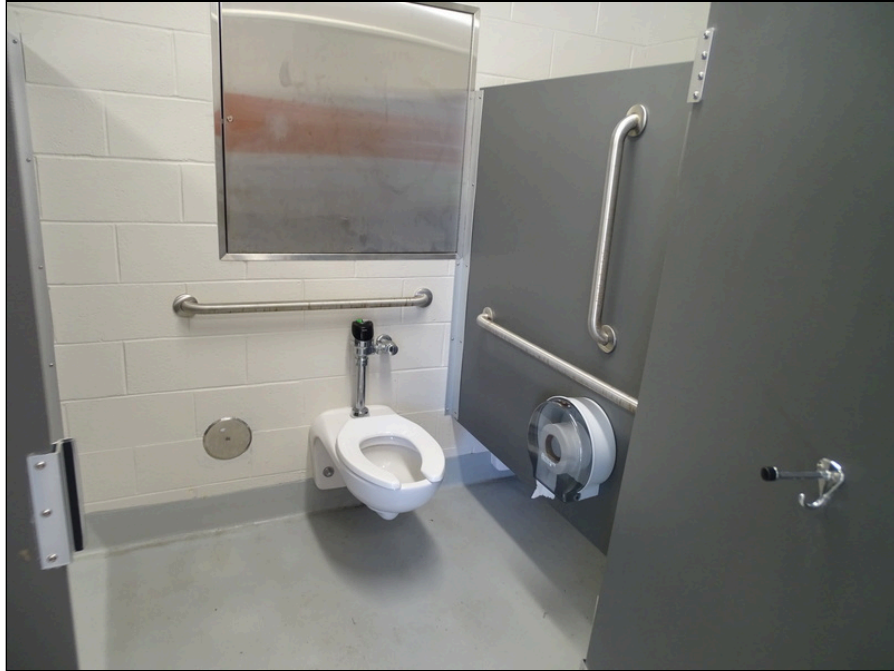
47 - Accessible toilet

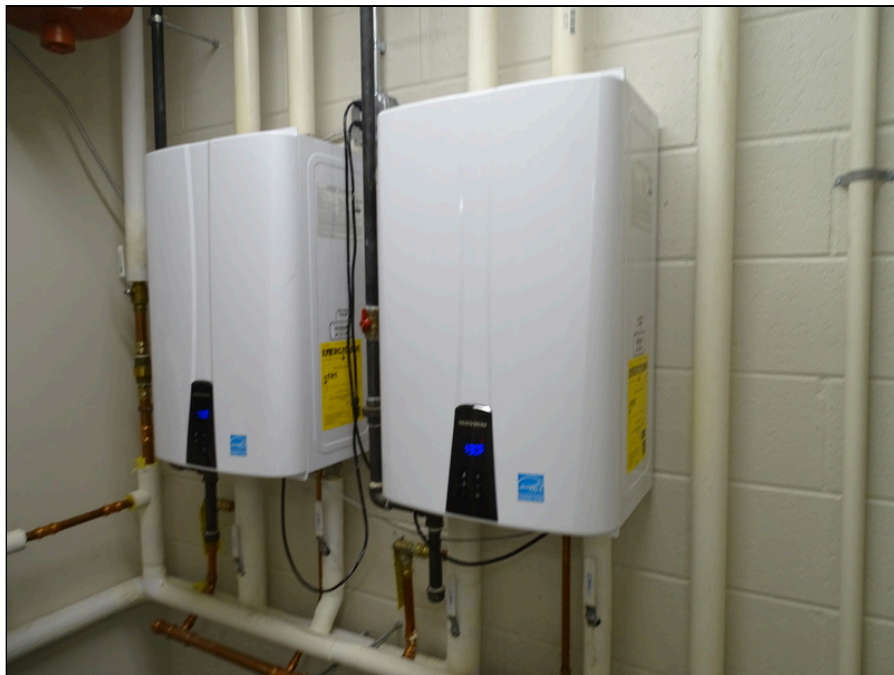
48 - Tankless water heaters
