FACILITY CONDITION ASSESSMENT

CENTRAL LIBRARY
201 E MARKET STREET
CHARLOTTESVILLE, VIRGINIA

ECS PROJECT NO. 46:6713

NOVEMBER 2, 2021

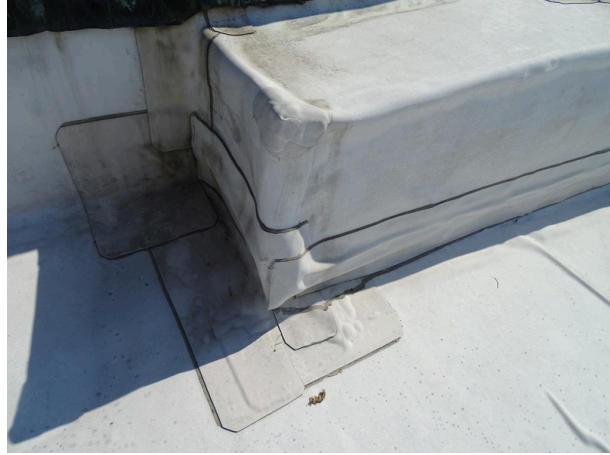
Typical parapet wall - note patching

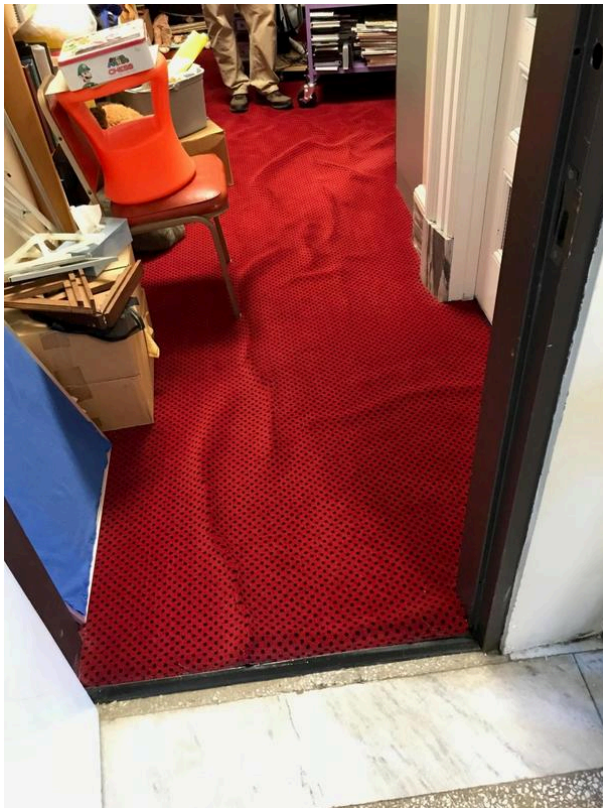
Third Floor Carpet

Immediate Repair Cost					
Item	Quantity	Unit	Unit Cost	Replacement Percent	Immediate Total
3.7.1 Interior Finishes of Common Areas					
REPAIR/REPLACE CARPET ON STAIRS AND THIRD FLOOR	1	EA	\$1,500.00	100%	\$1,500
Total Repair Cost					\$1,500.00

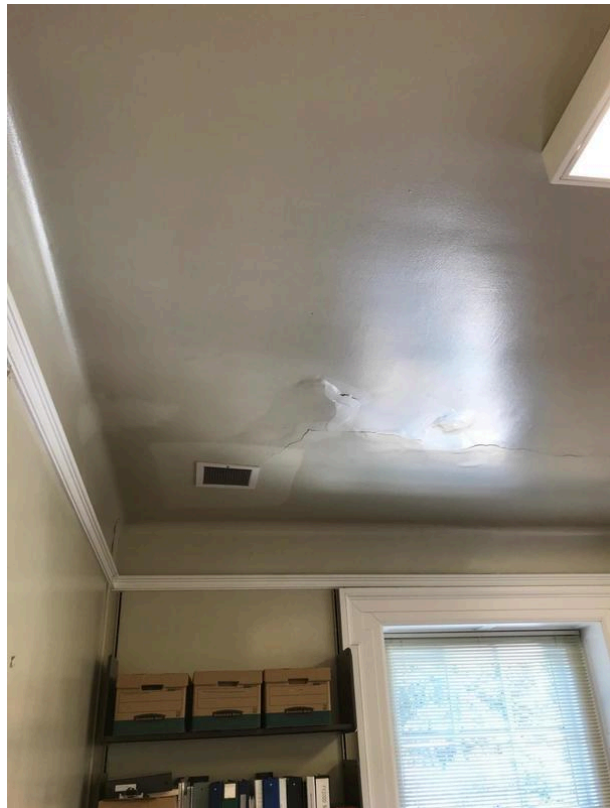
Third Floor Ceiling

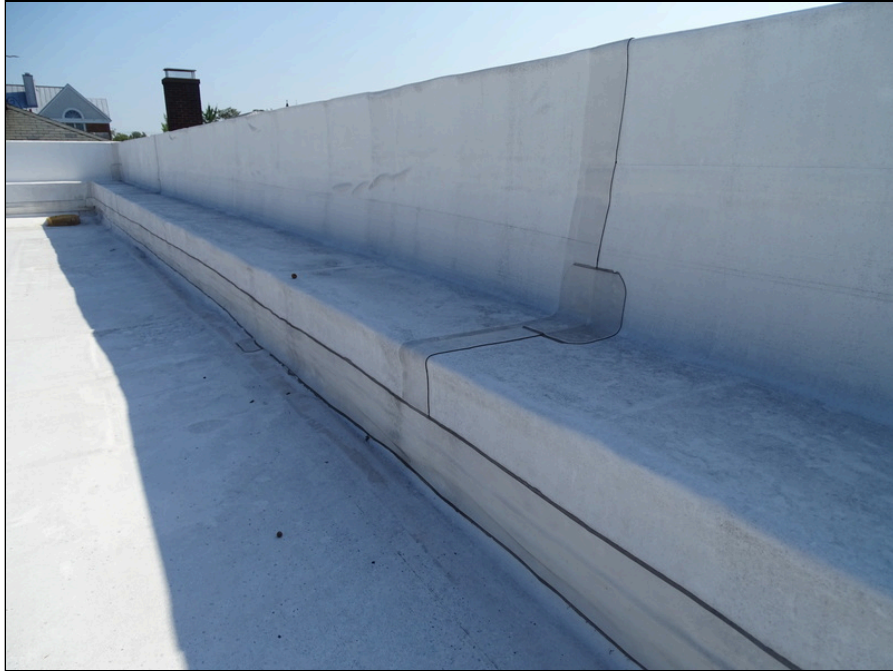
21 - Typical parapet wall - note patching

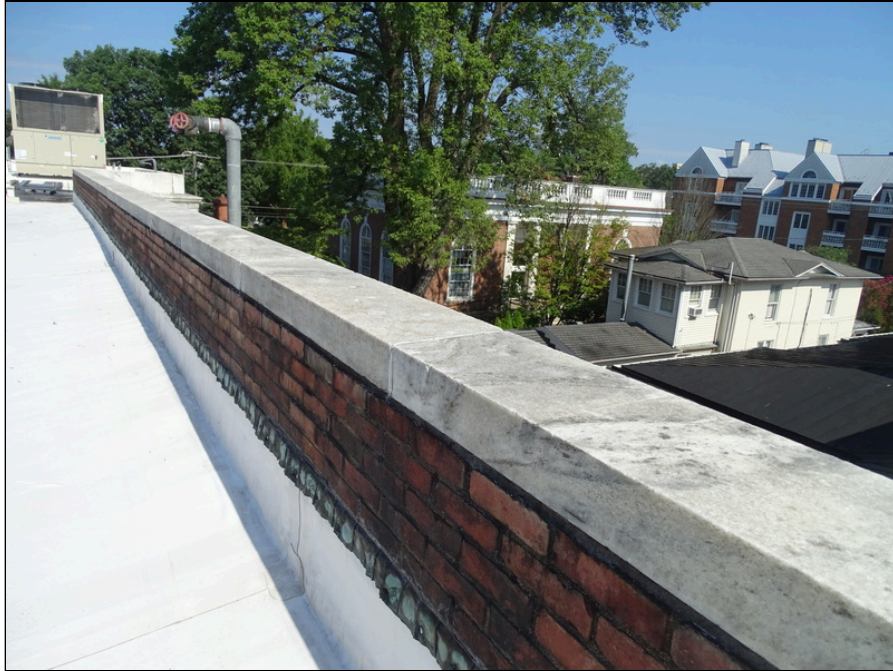
23 - Typical parapet wall - note patching

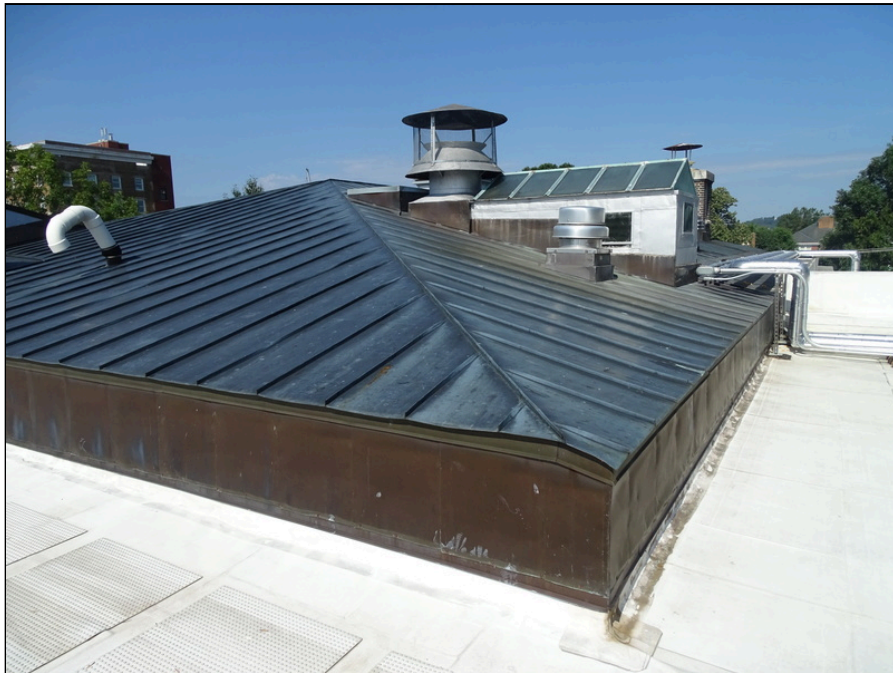
26 - Metal roofing system located at the southwest side of the building

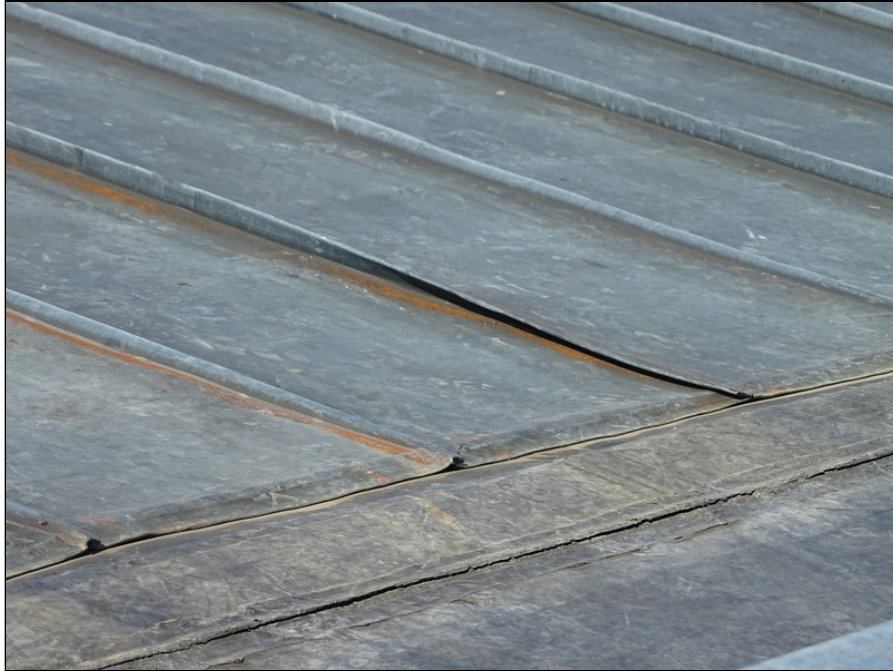
27 - Metal roofing system located at the southwest side of the building

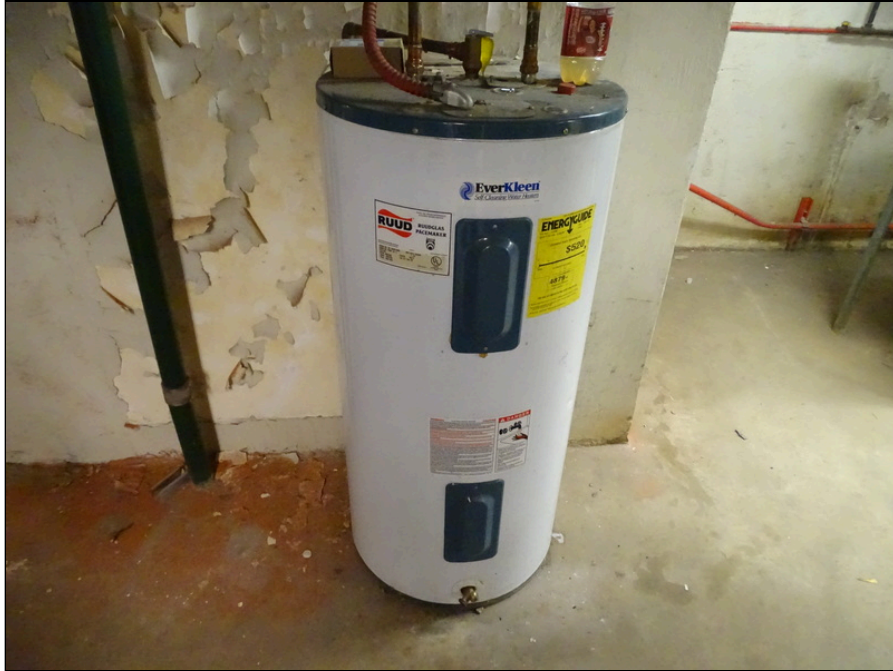
29 - Electric domestic water heater

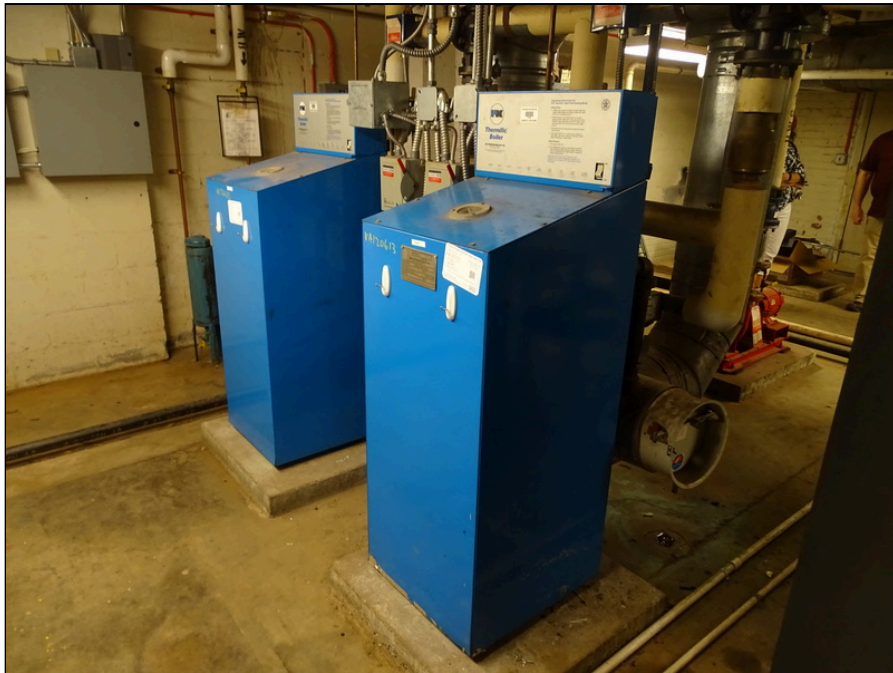
30 - Boilers located in main utility room

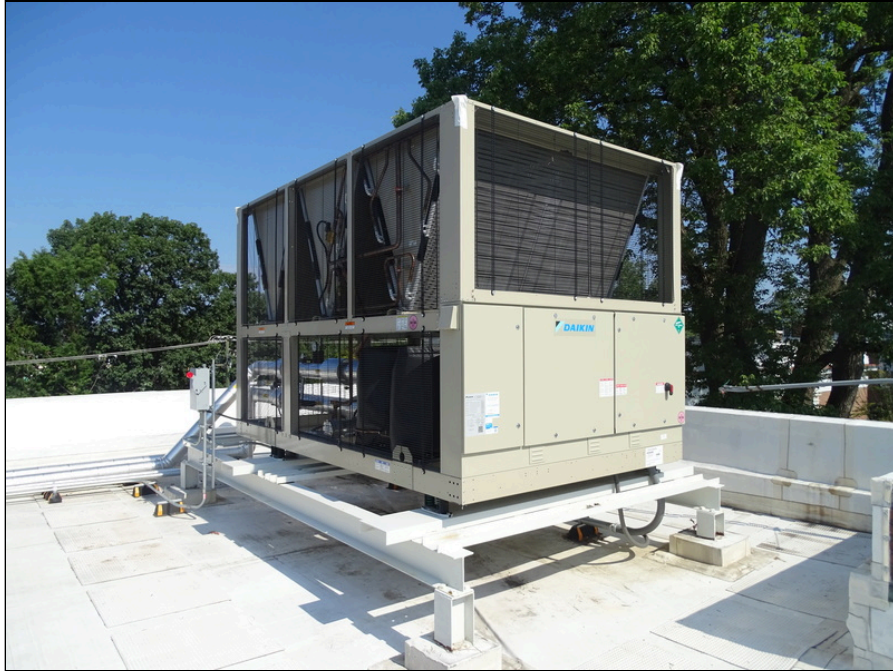
31 - Condenser Unit located on roof

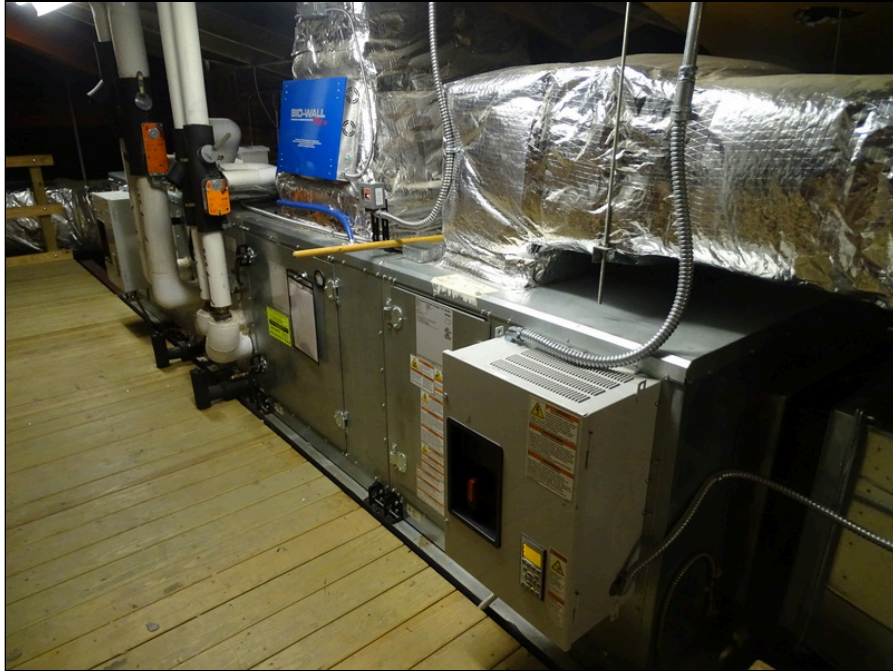
33 - Air Handler Unit located in attic

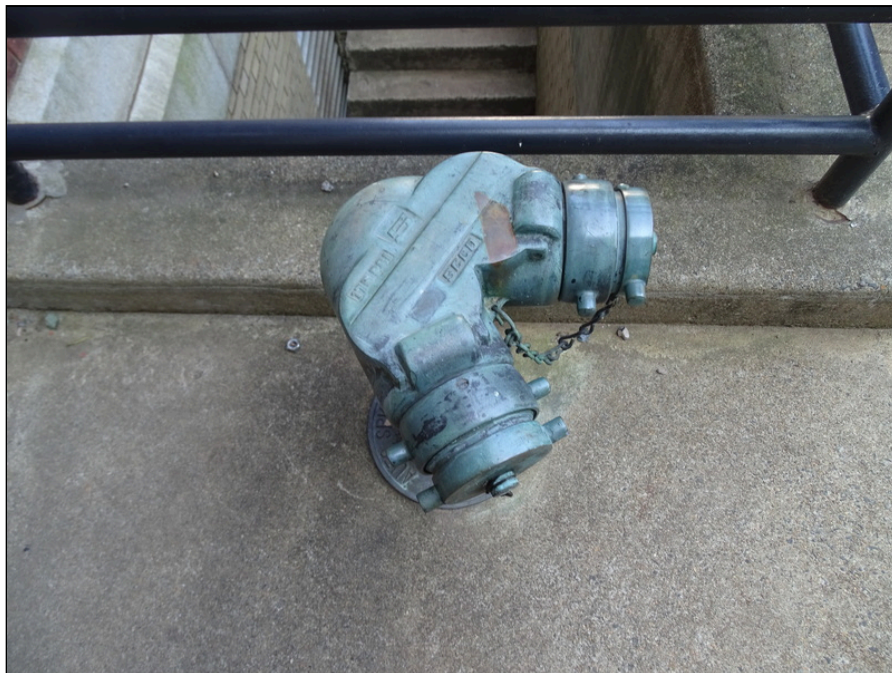
48 - Fire Department connections

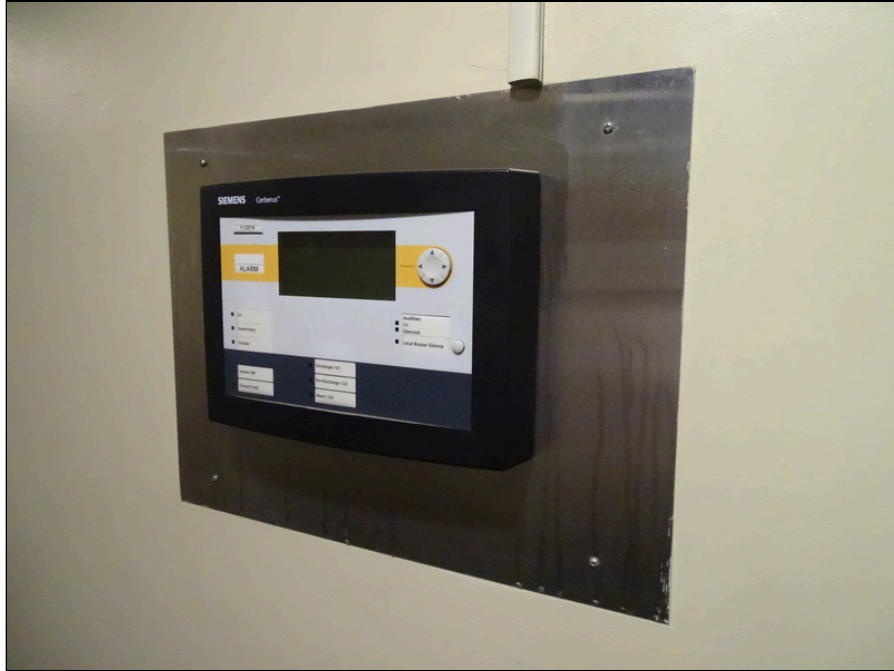
49 - Fire alarm control panel

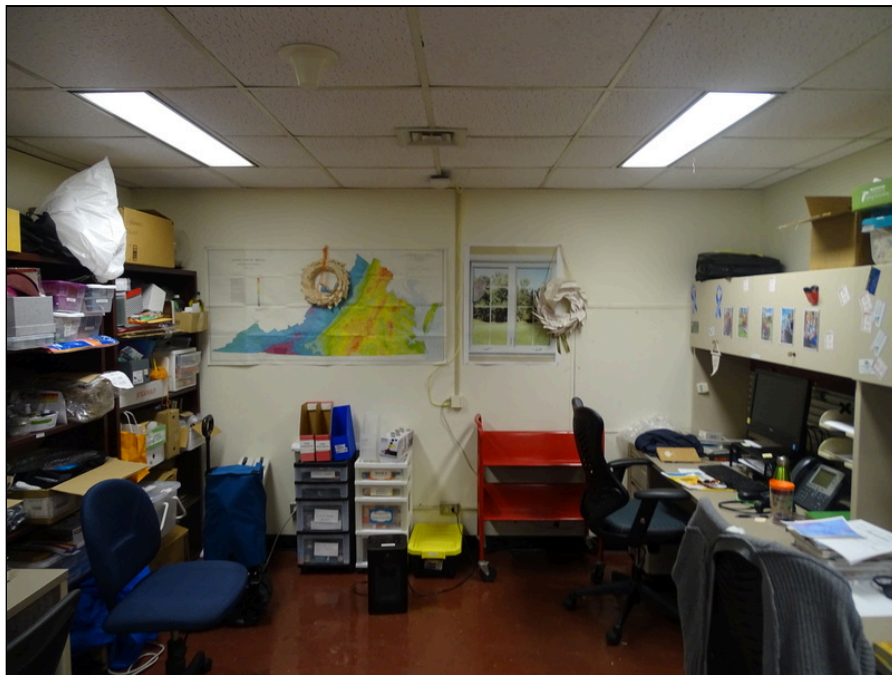
68 - Interior finishes office area

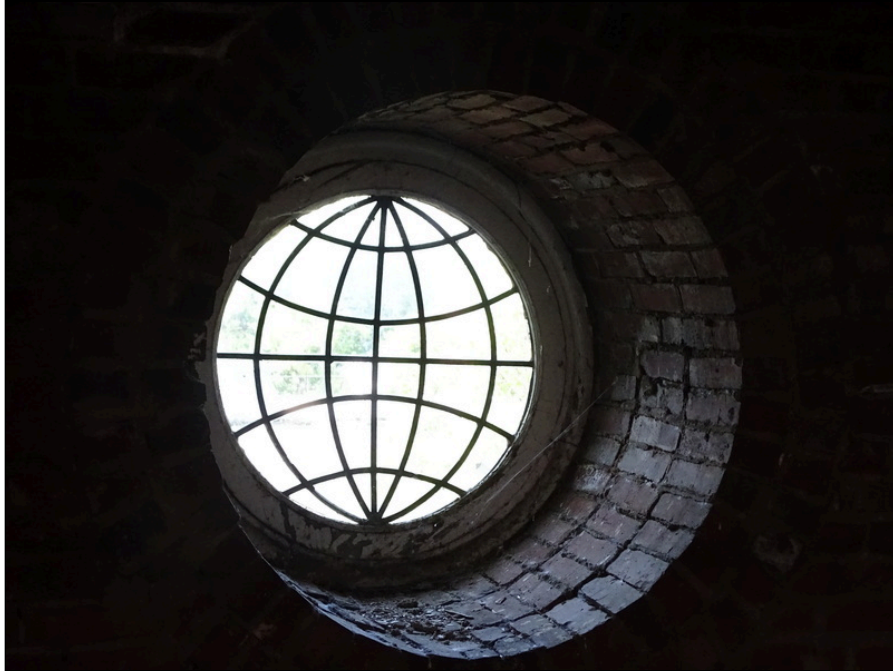
69 - Typical skylight

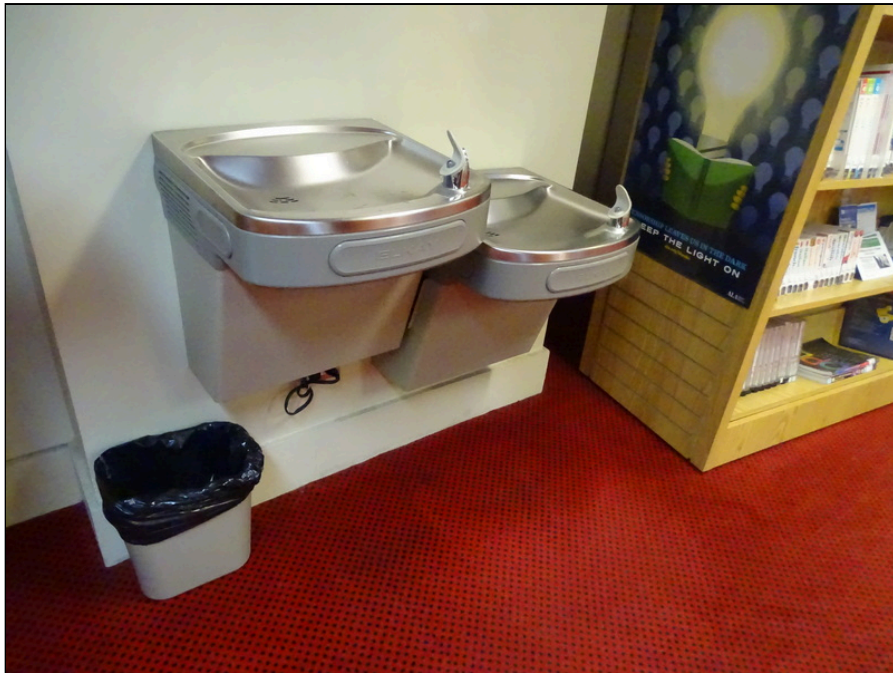
70 - Typical water fountain

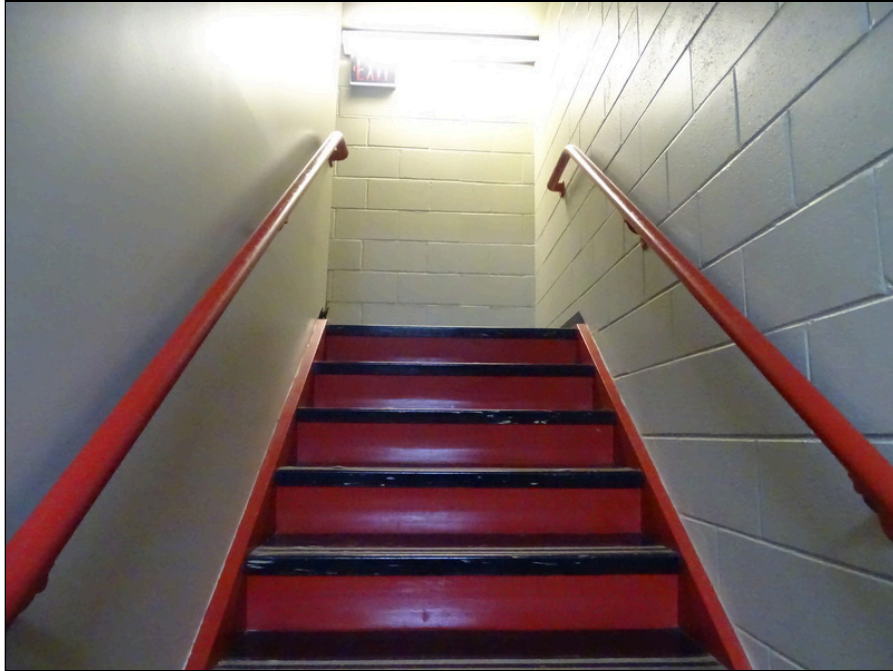
71 - Typical steps interior

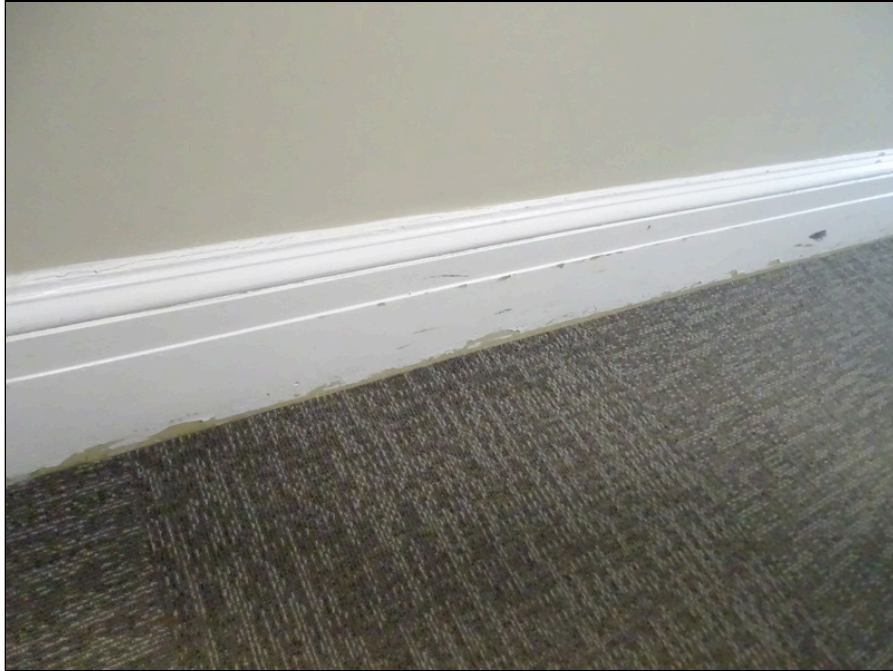
73 - Typical interior - note peeling paint

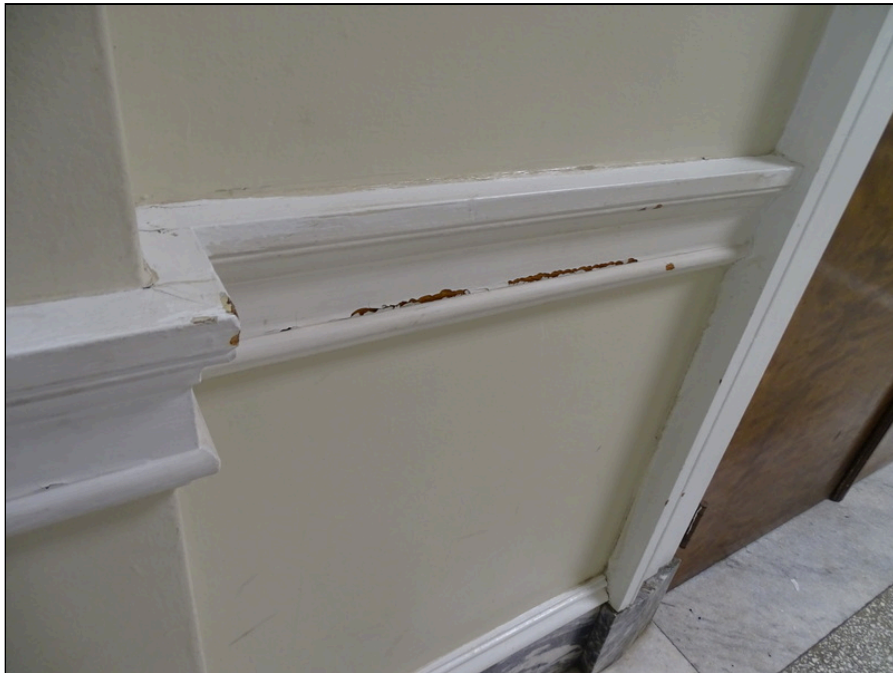
74 - Typical interior - note peeling paint

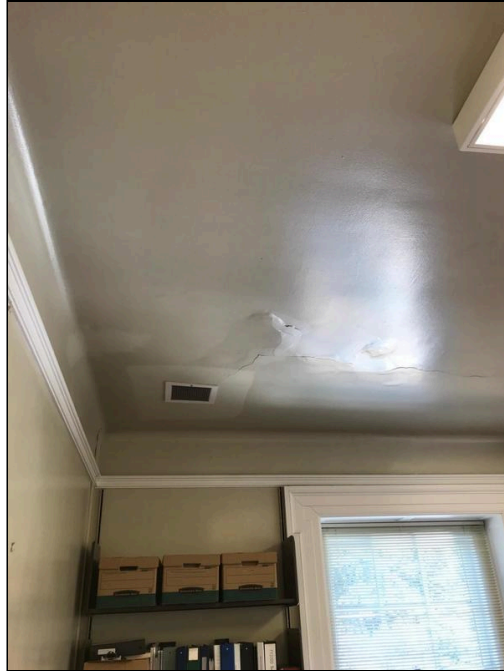
77 - Third Floor Ceiling

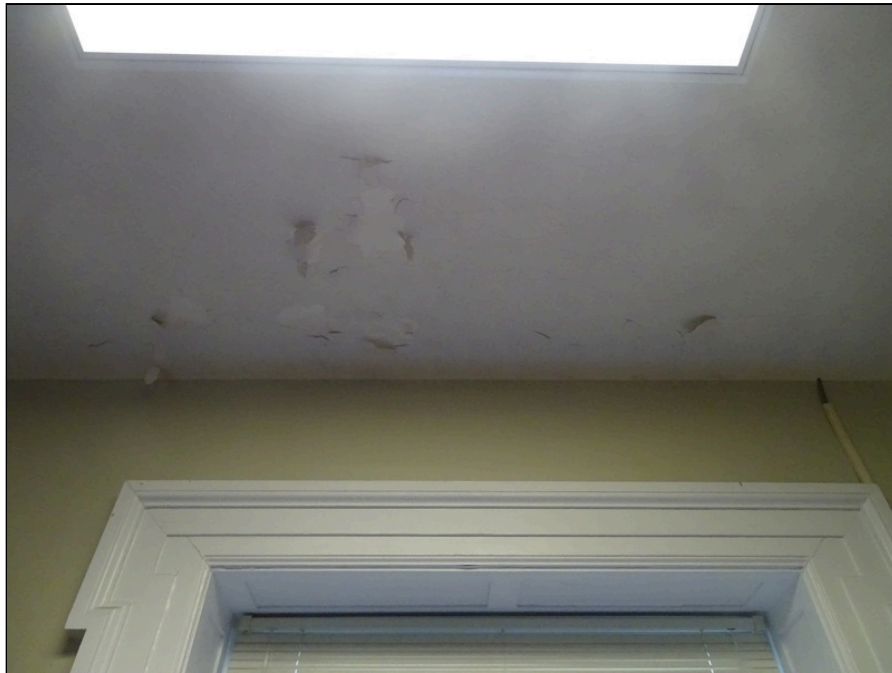
78 - Typical interior - note peeling paint

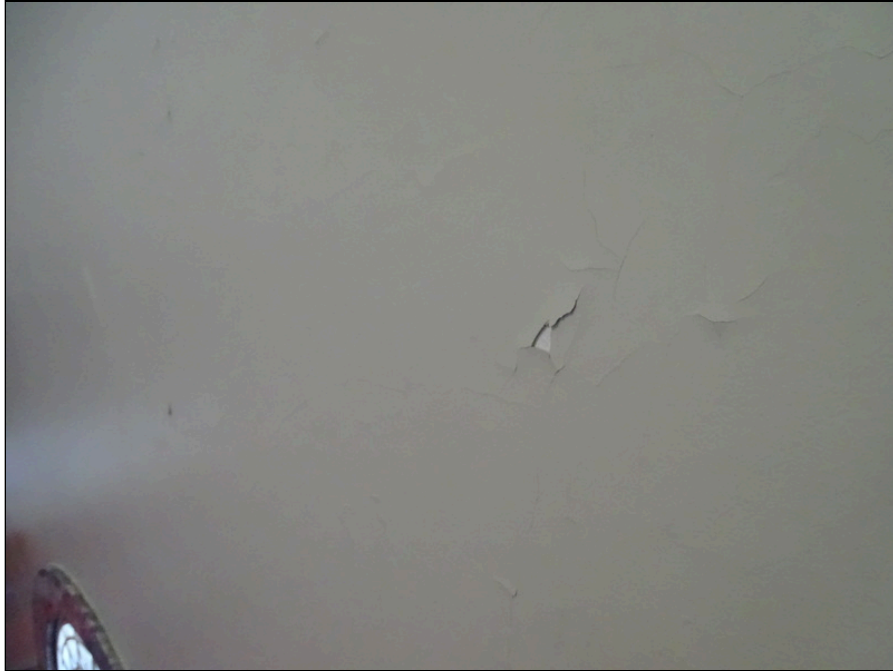
79 - Typical interior - note peeling paint

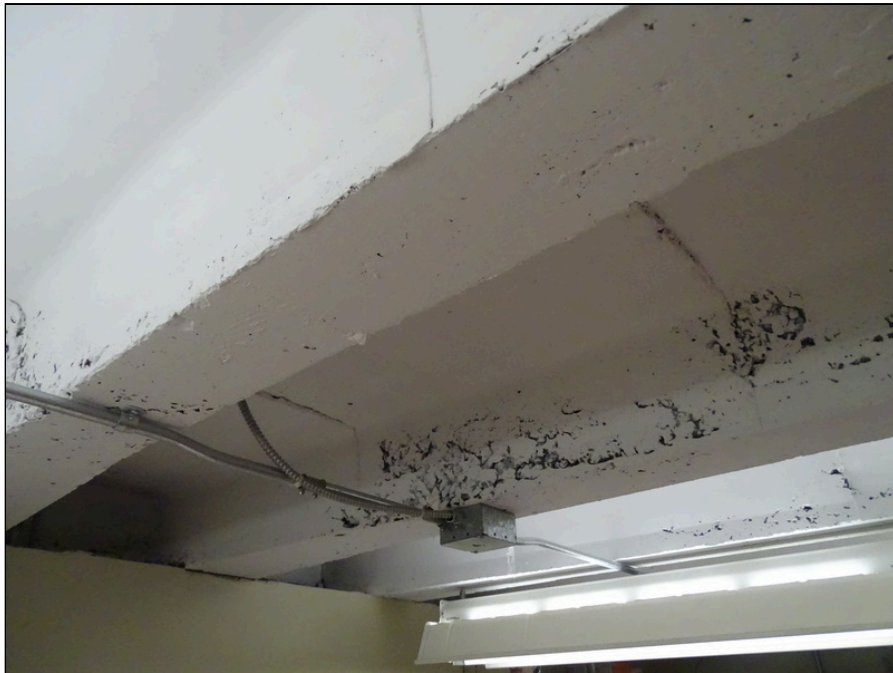
80 - Typical interior - note peeling paint
