CIRCUIT COURT
315-317 EAST HIGH STREET
CHARLOTTESVILLE, VIRGINIA

ECS PROJECT NO. 46:6713

CITY OF CHARLOTTESVILLE - FACILITIES DEVELOPMENT

Reference: Facility Condition Assessment Report for Circuit Court, 315-317 East High Street,
Charlottesville, Virginia

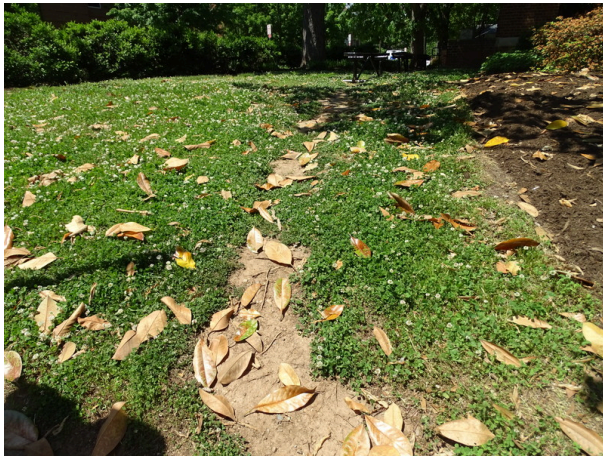
Typical landscaping

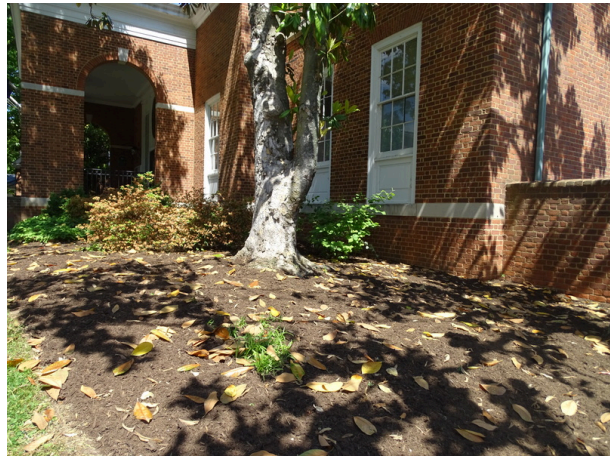
Typical landscaping

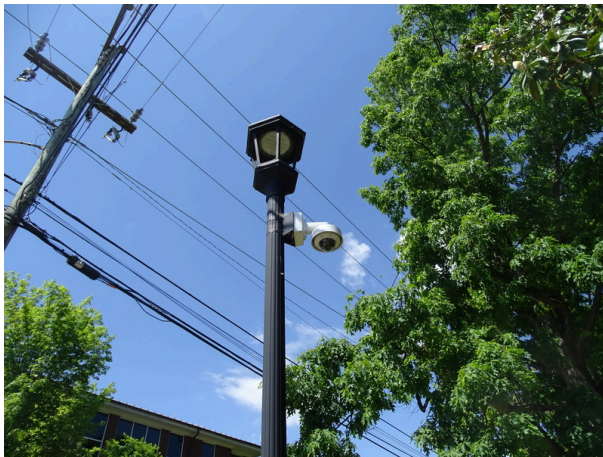
Typical pole mounted light and security camera

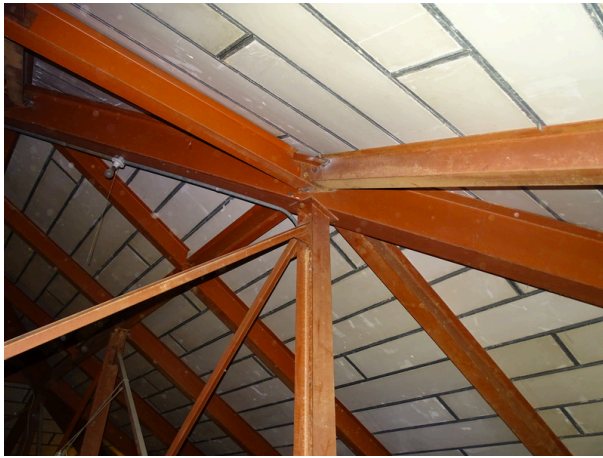
The structure of the building consists of Concrete masonry unit bearing walls with structural steel framing and concrete topped metal decks. The structural frame of the building was generally in good condition.

Structural framing

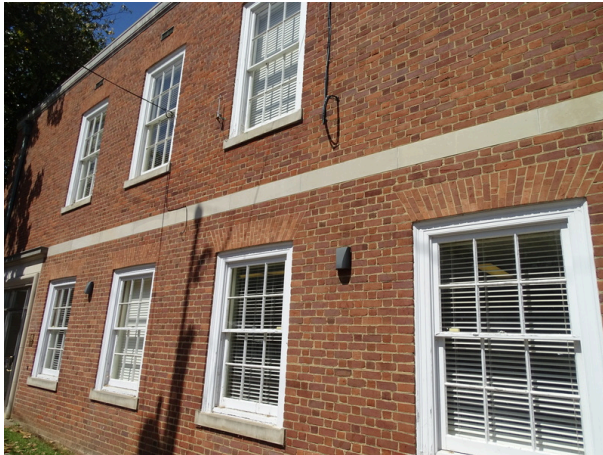
Typical exterior window overview

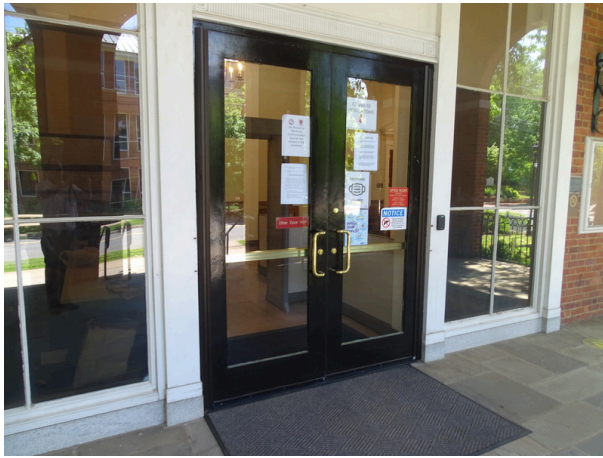
Main entrance at south side of the building

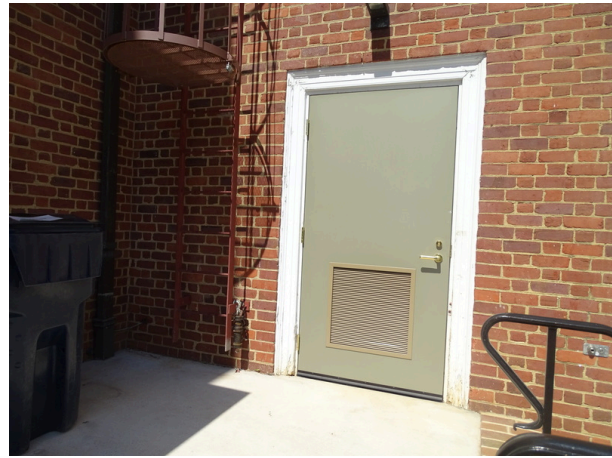
Exterior steel door

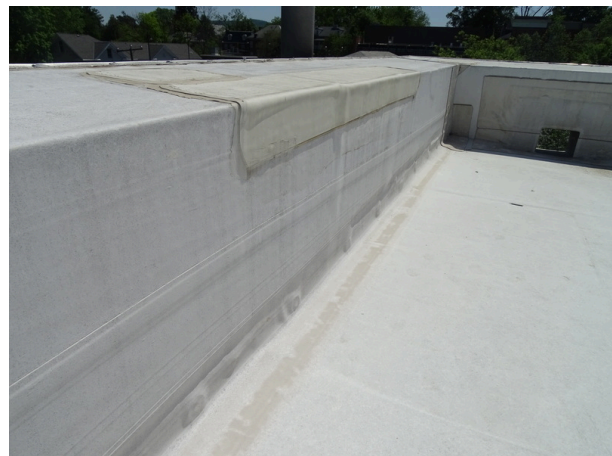
Single-ply membrane roofing system at parapet wall - note patching

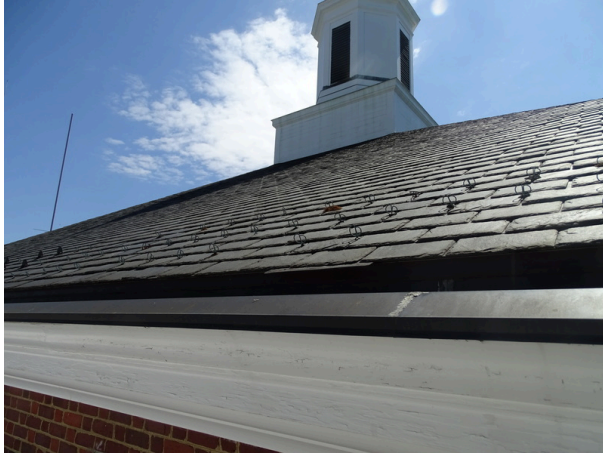
Slate roofing system

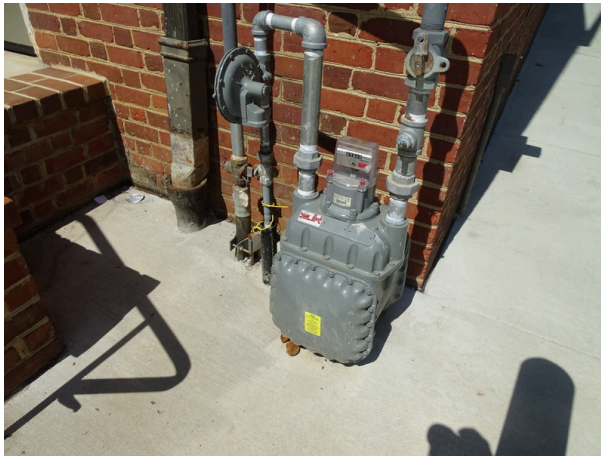
Typical gas meter

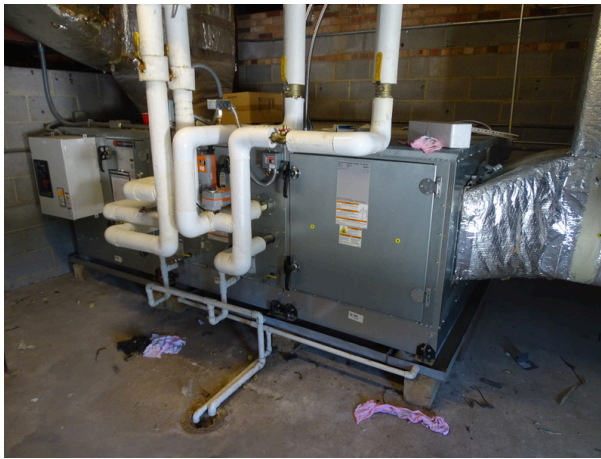
Air Handler Unit located in attic space

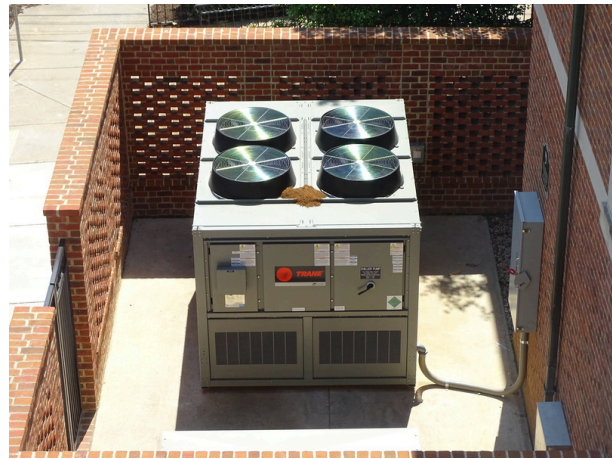
Chiller located outside ground level northwest side of the building

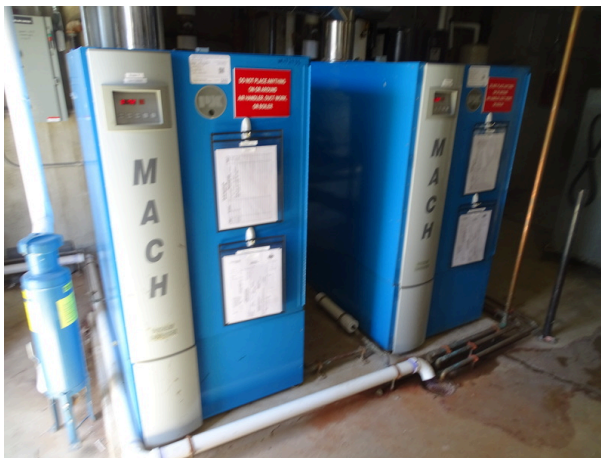
Boilers located in main utility room

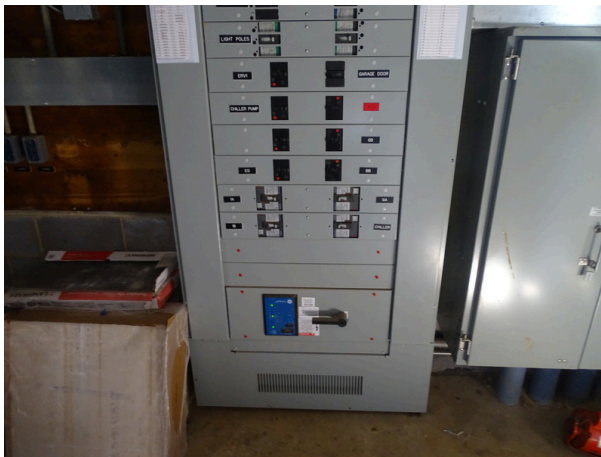
Main electrical switchgear

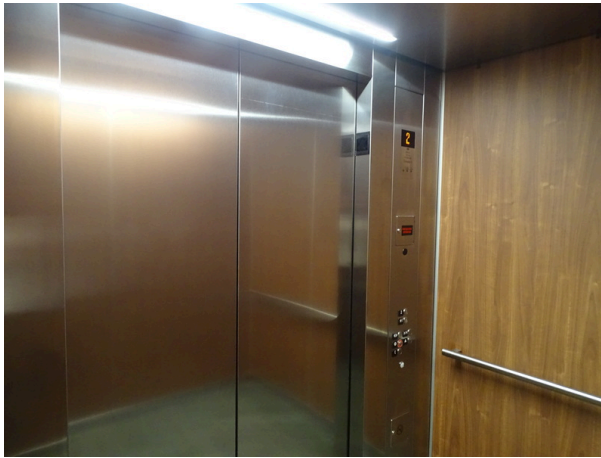
The building contains a hydraulic passenger elevator. It is understood recent renovations included the installation of the passenger hydraulic elevator system manufactured by KONE. Routine maintenance is considered adequate to keep the elevator system in good condition during the projection period of this report.

Elevator interior cab

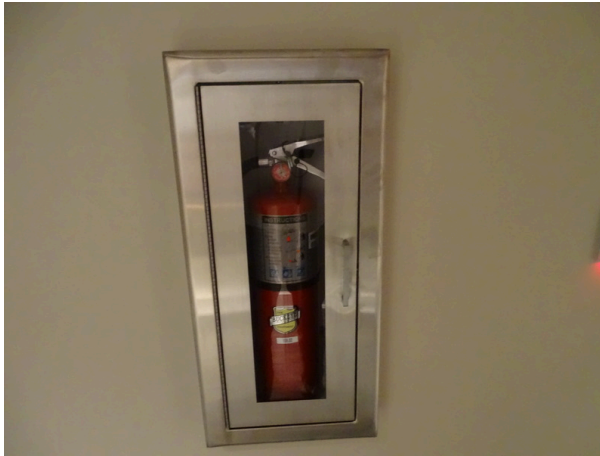
Typical fire extinguisher

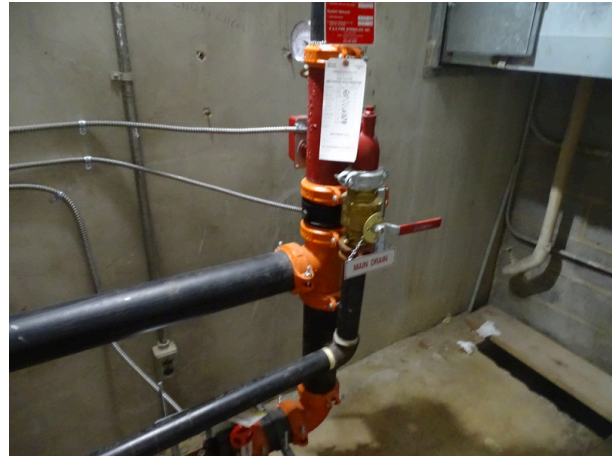
Sprinkler system

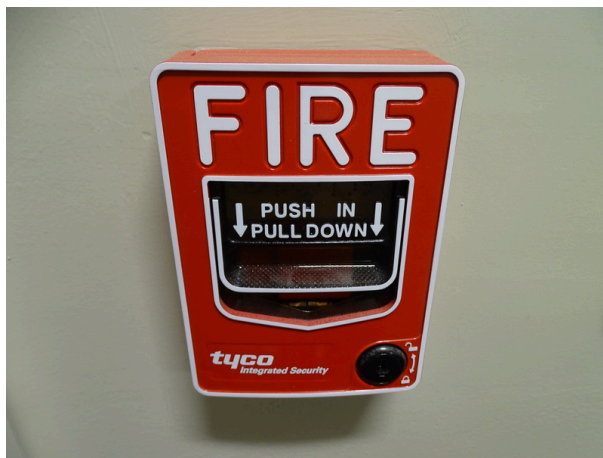
Typical pull down station

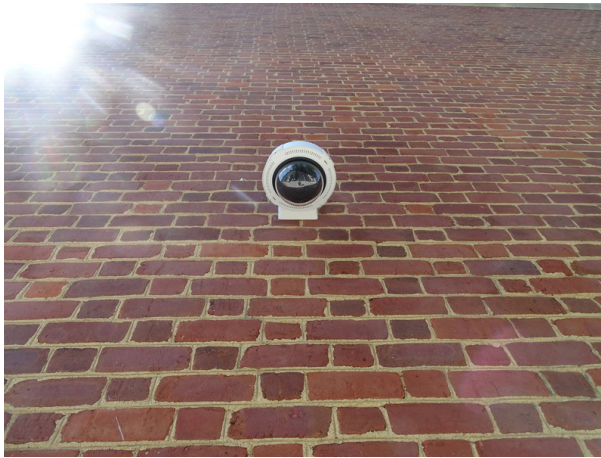
The building is monitored 24-hours a day by a computerized security system with cameras. Security cameras were observed at locations at the building interior and exterior. The security system was generally in good condition. The building security for prisoner transportation reportedly was improved with recent renovations.

Typical security camera

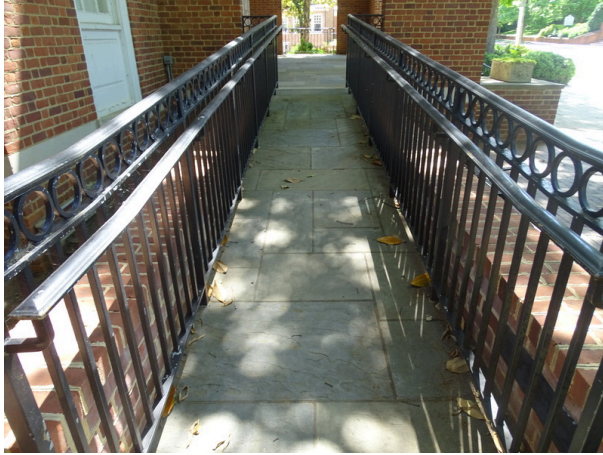
Ramps at southwest side of site

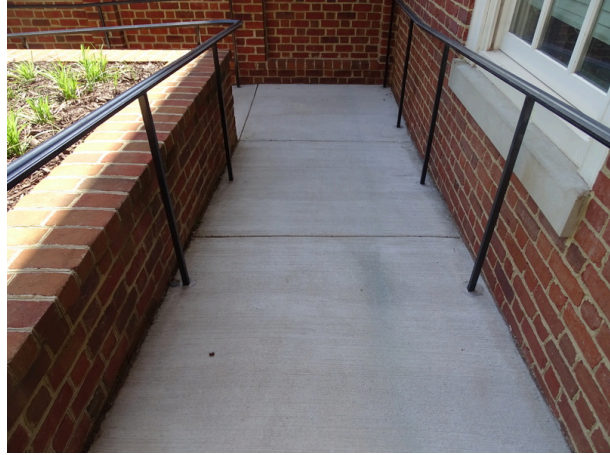
Typical accessible ramp

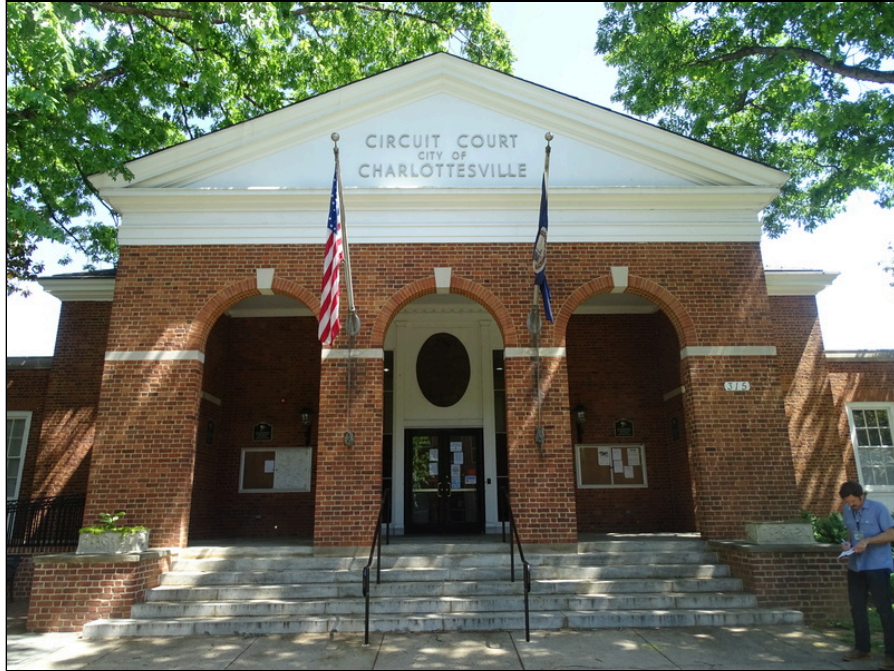
1 - Circuit Court

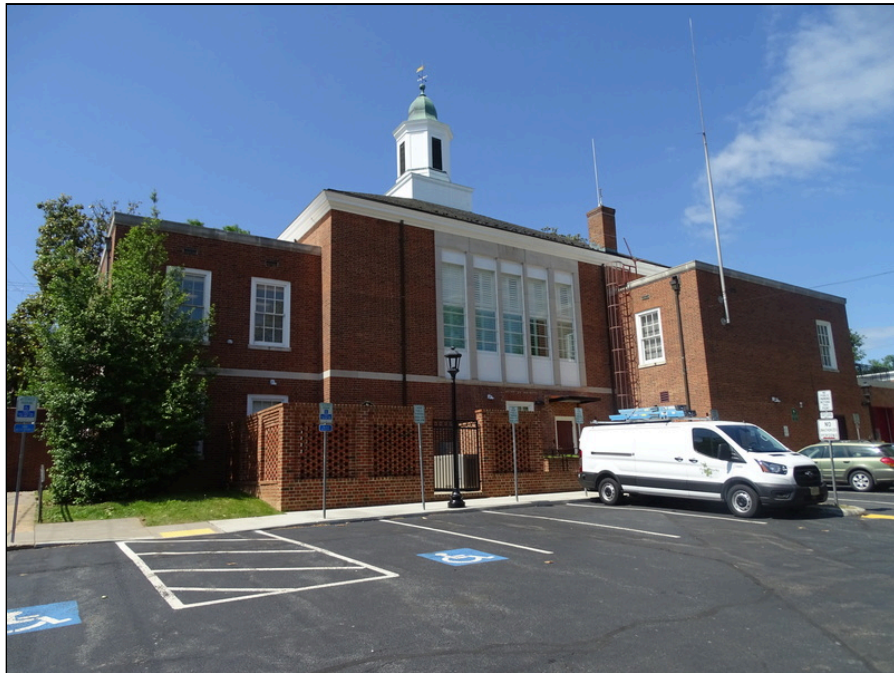
2 - Circuit Court northeast elevation of the building

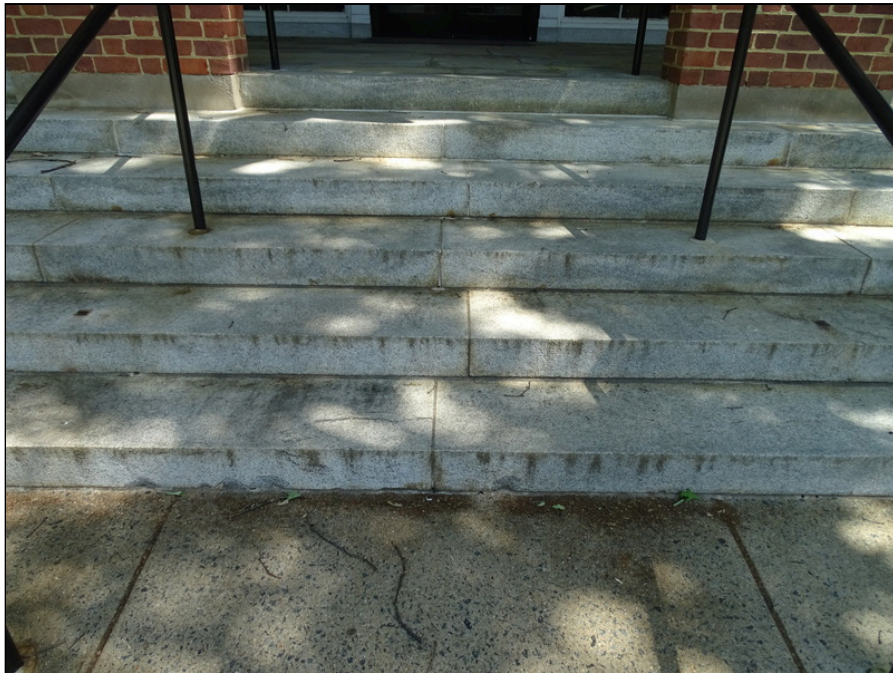
6 - Concrete stair at south side of site

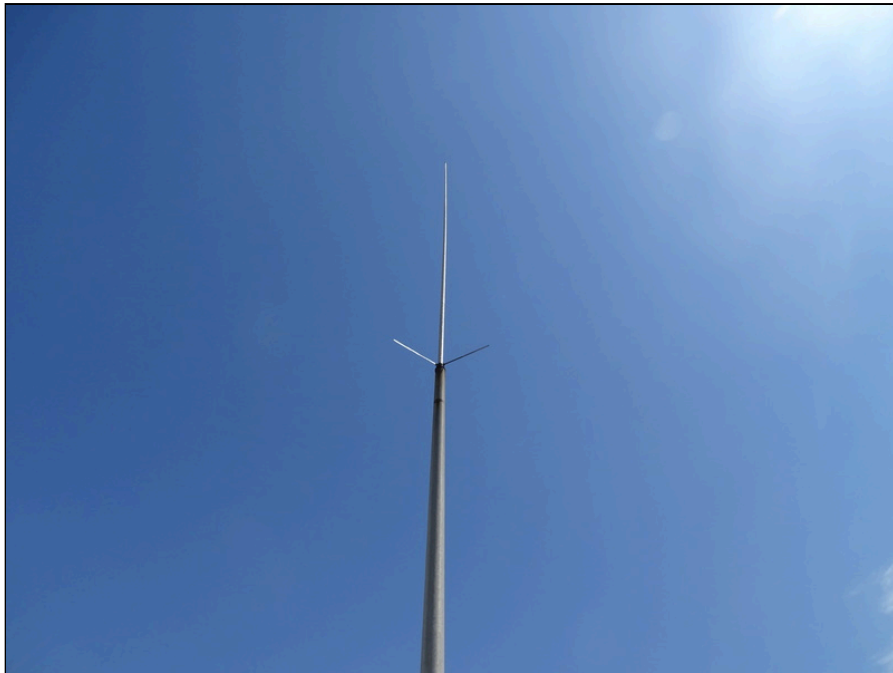
12 - Lightning protection

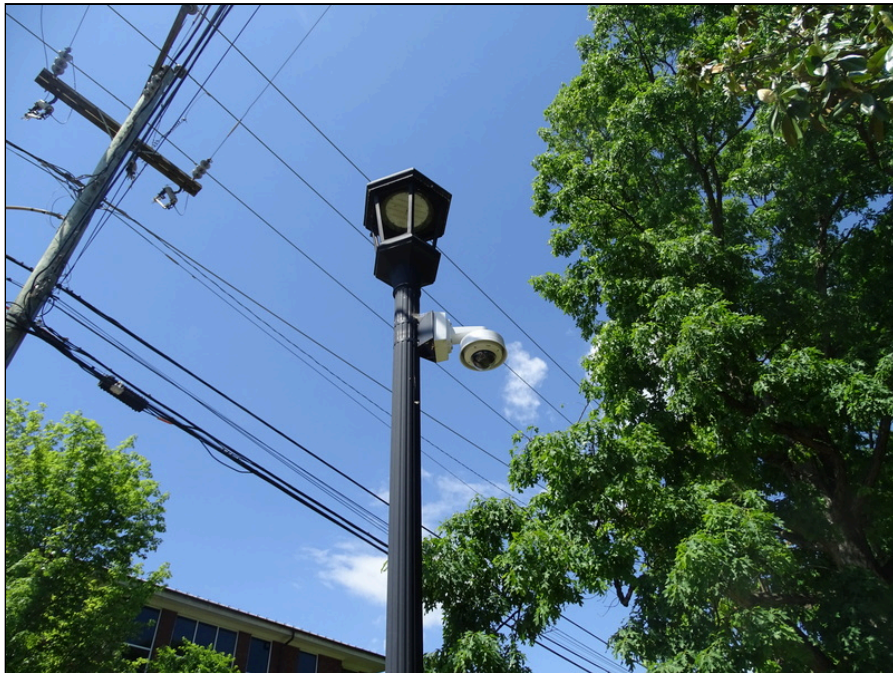
14 - Typical pole mounted light and security camera

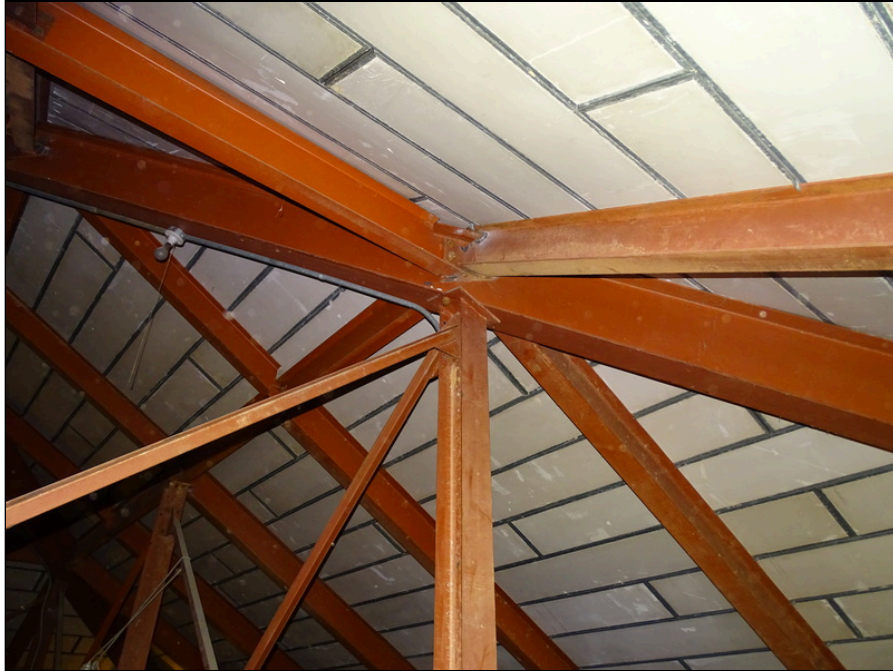
15 - Structural framing

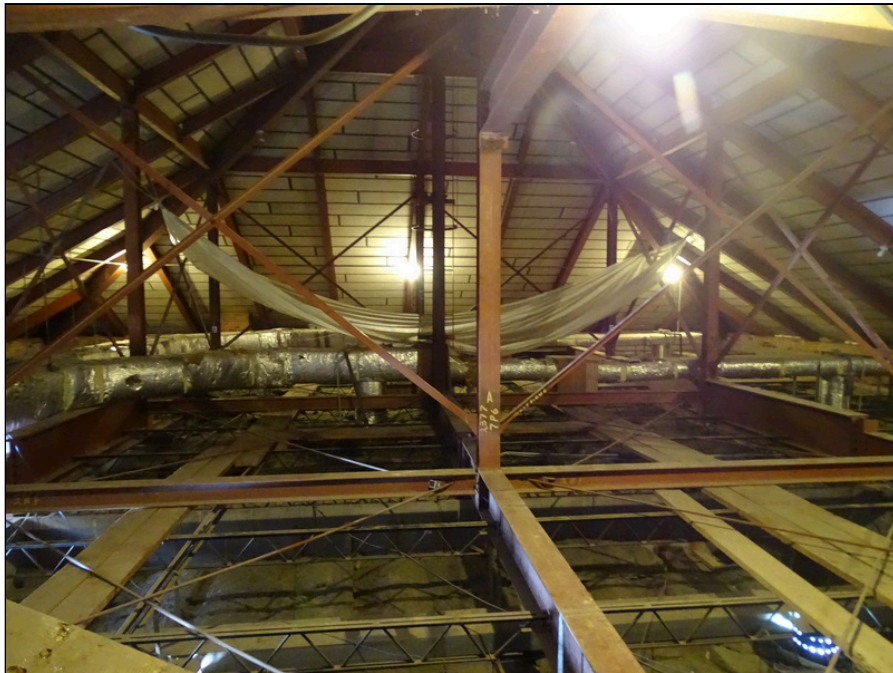
16 - Structural framing

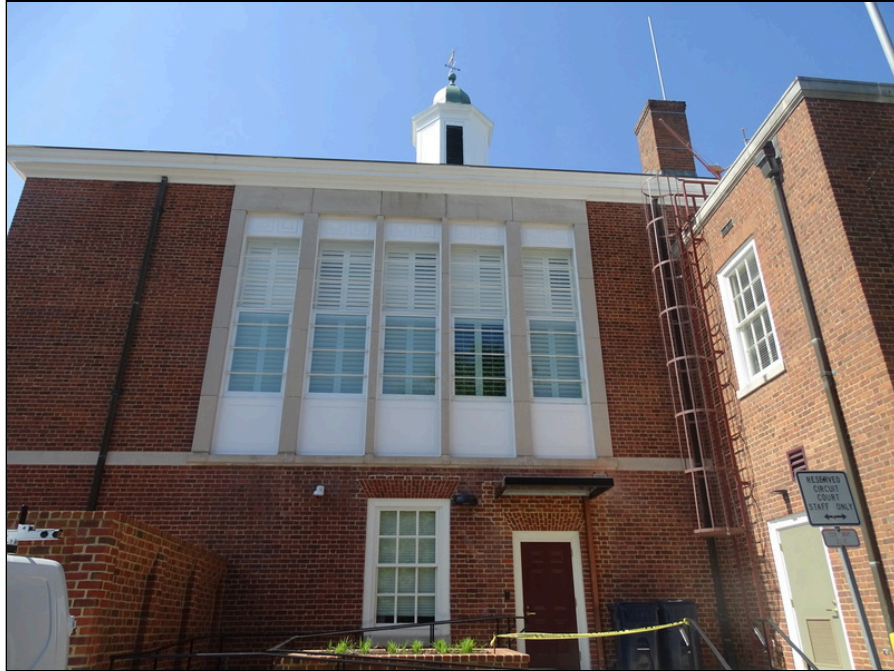
17 - Exterior building elevation at northwest side

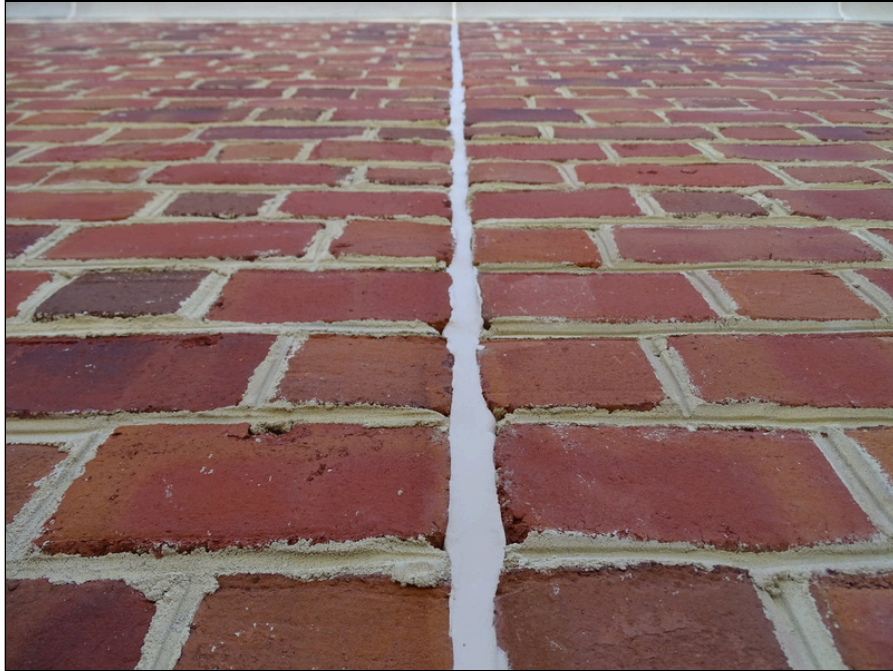
19 - Building exterior vertical joint

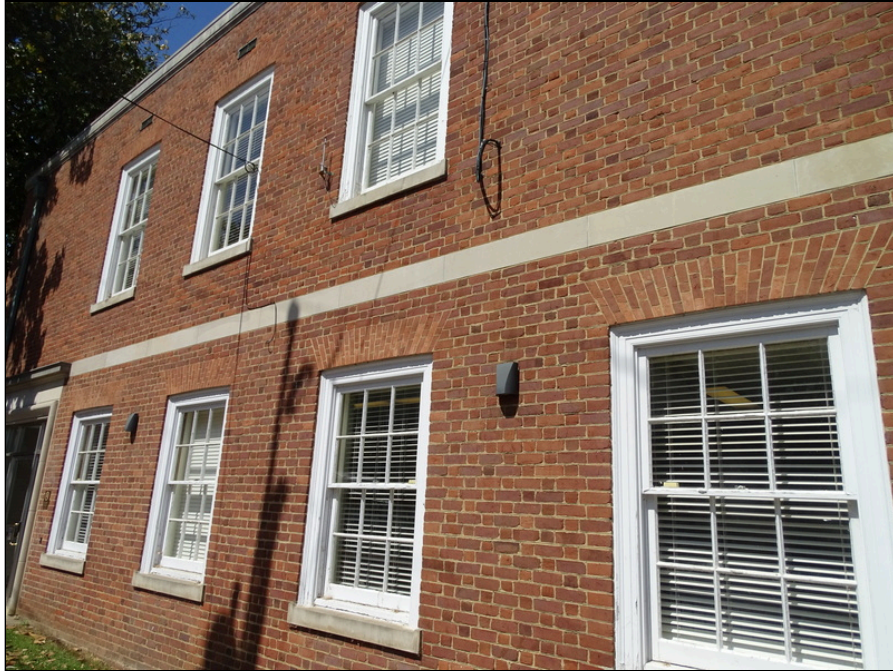
21 - Typical exterior window overview

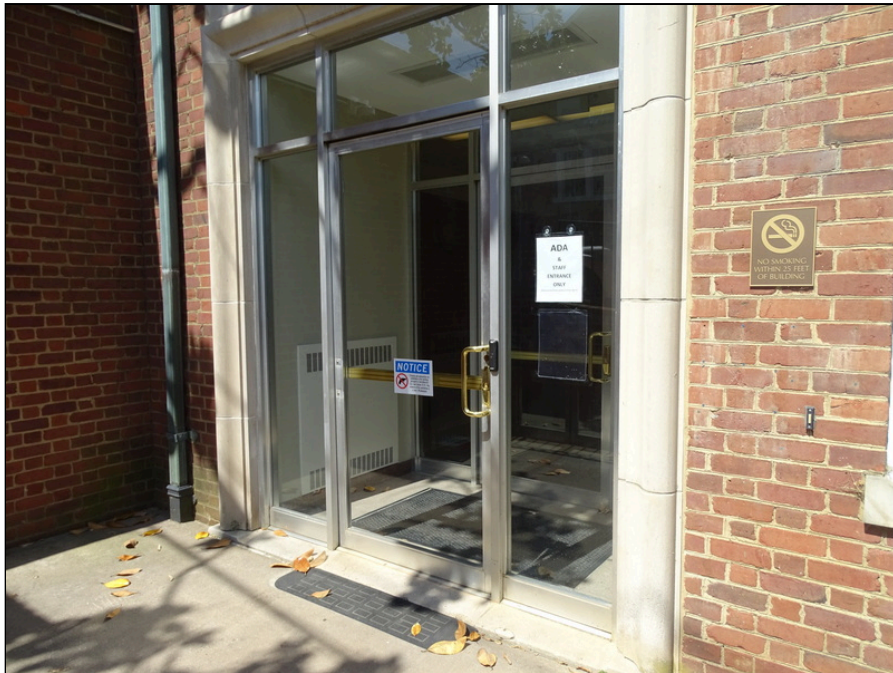
24 - Exterior door at east entrance of the building lower level

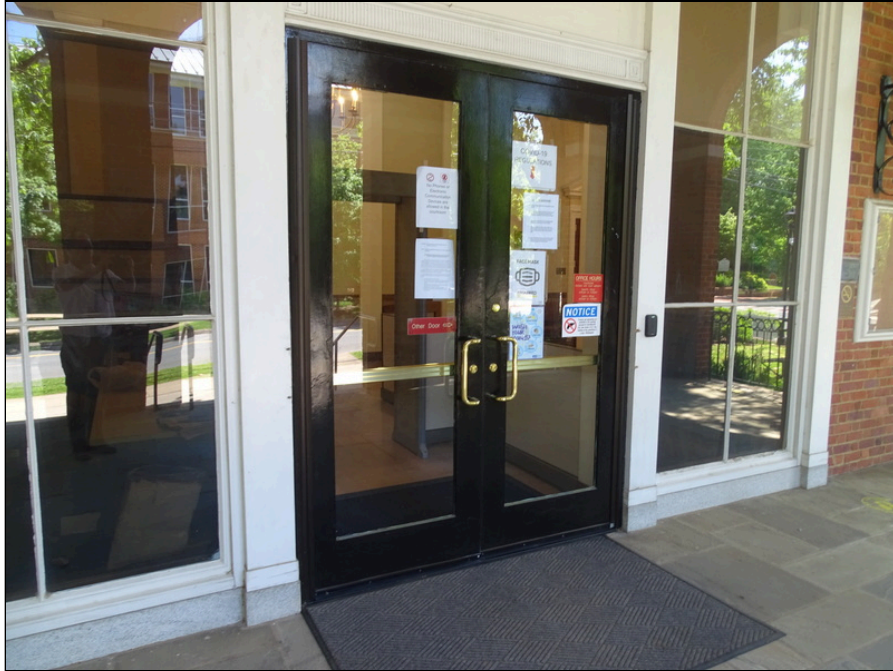
25 - Main entrance at south side of the building

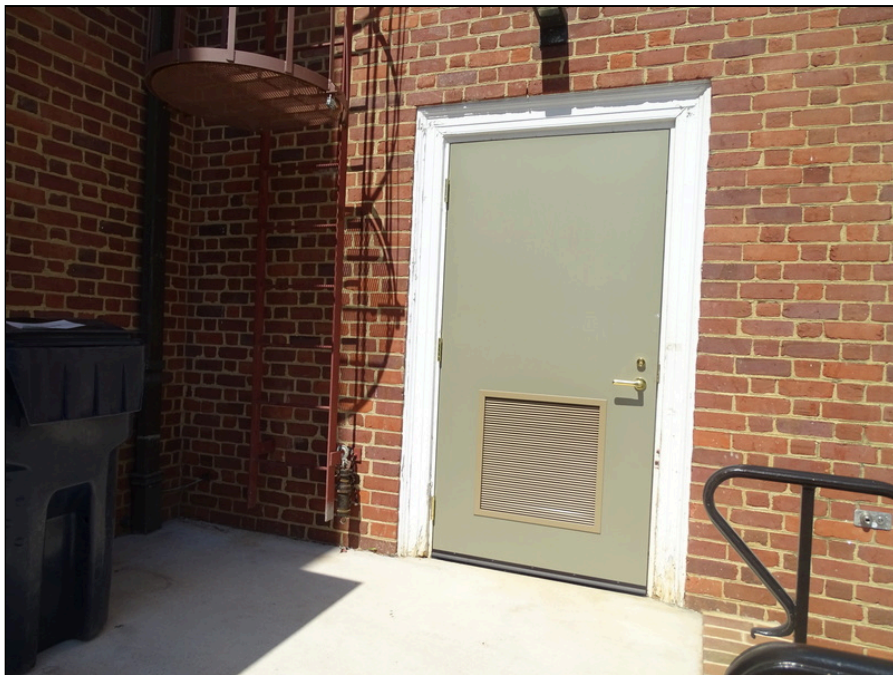
26 - Exterior steel door

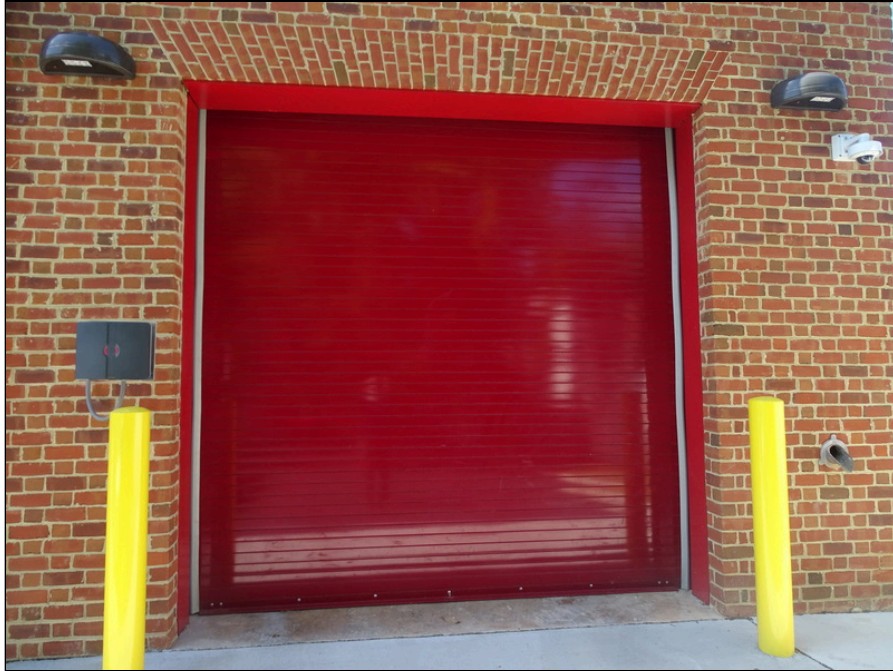
27 - Typical overhead door

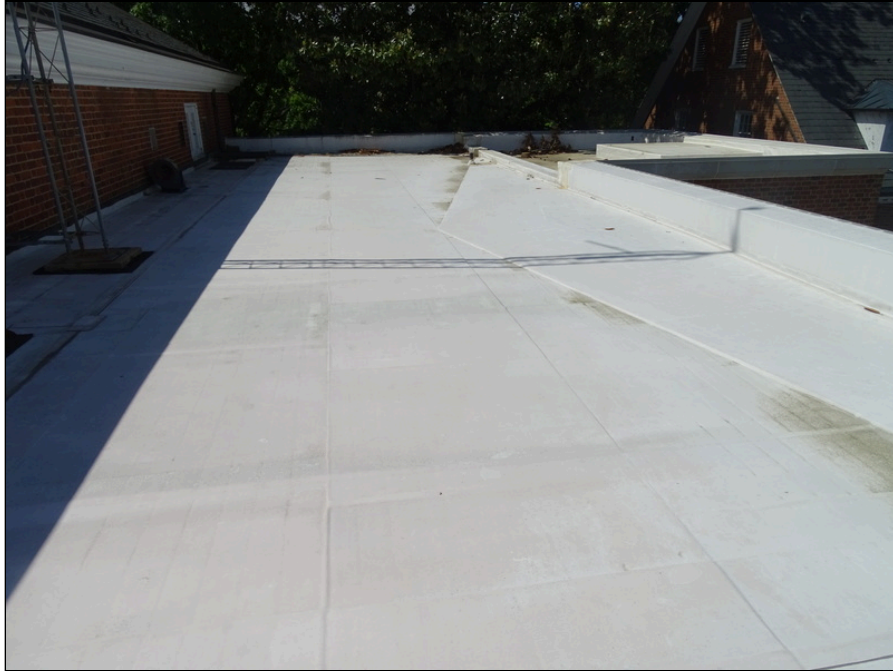
31 - Single-ply membrane roofing system

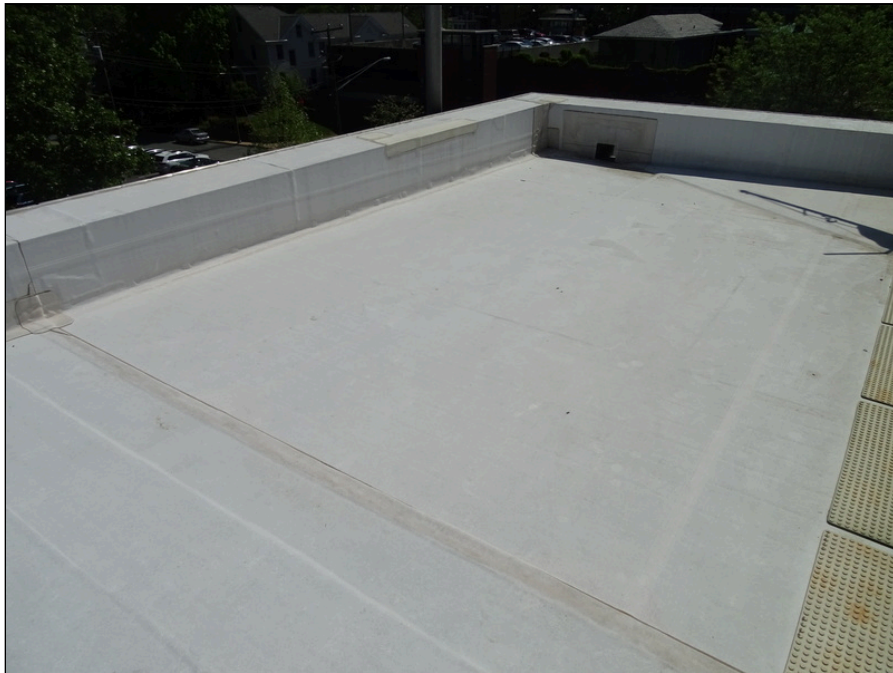
32 - Typical parapet wall and through-wall scupper drain

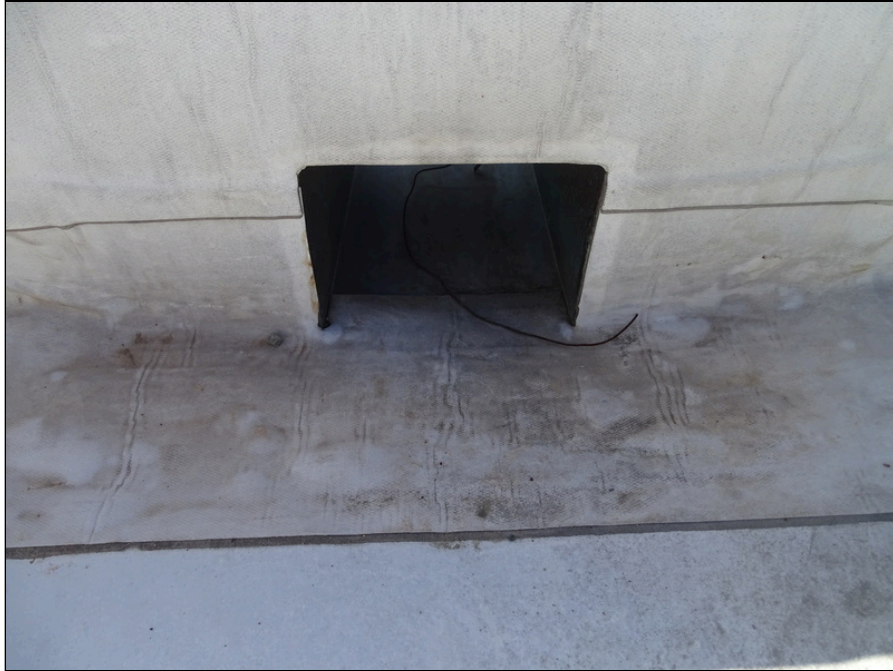
33 - Typical parapet wall and through-wall scupper drain

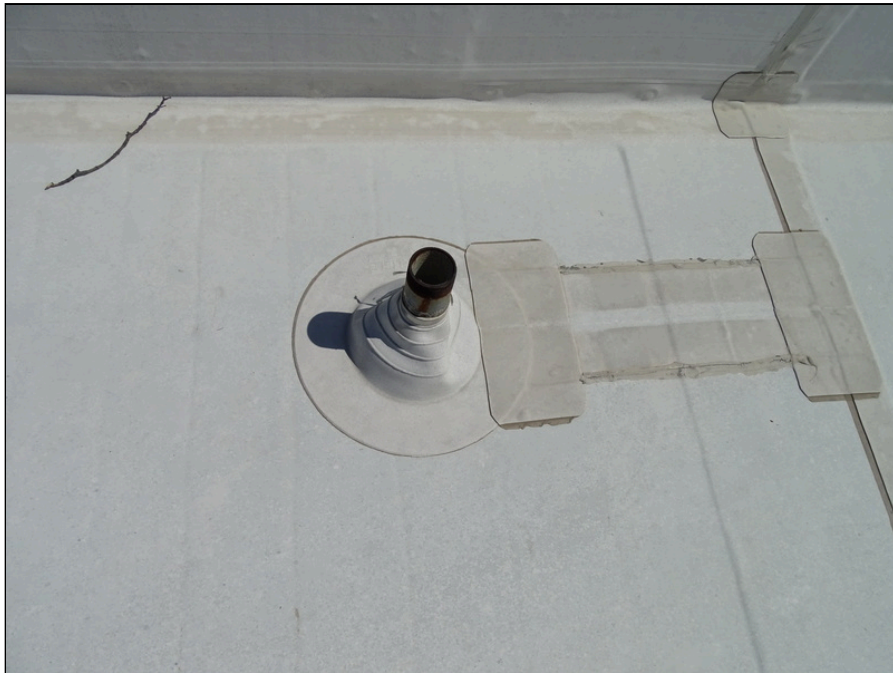
34 - Typical plumbing penetration

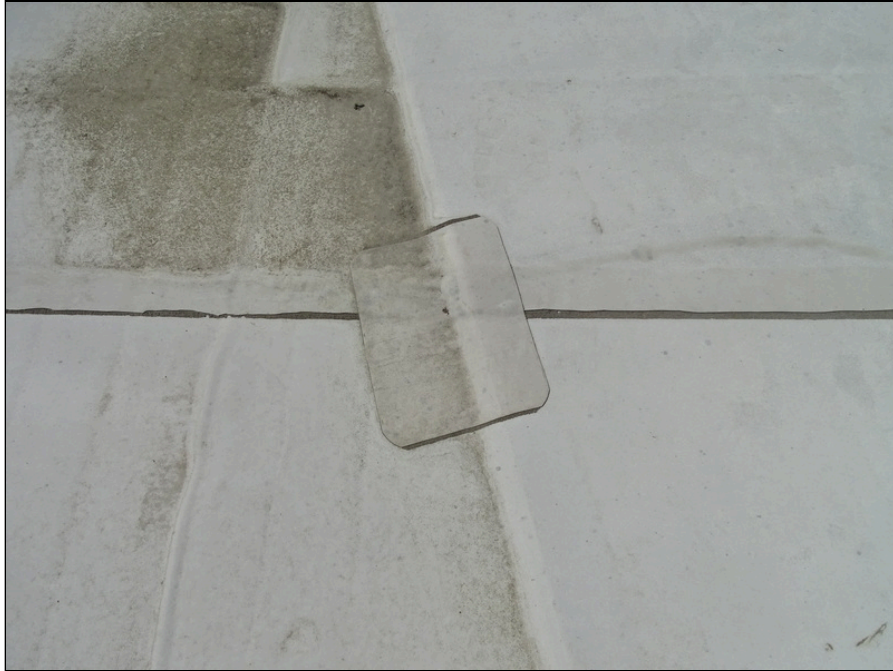
35 - Single-ply membrane roofing system at parapet wall - note patching

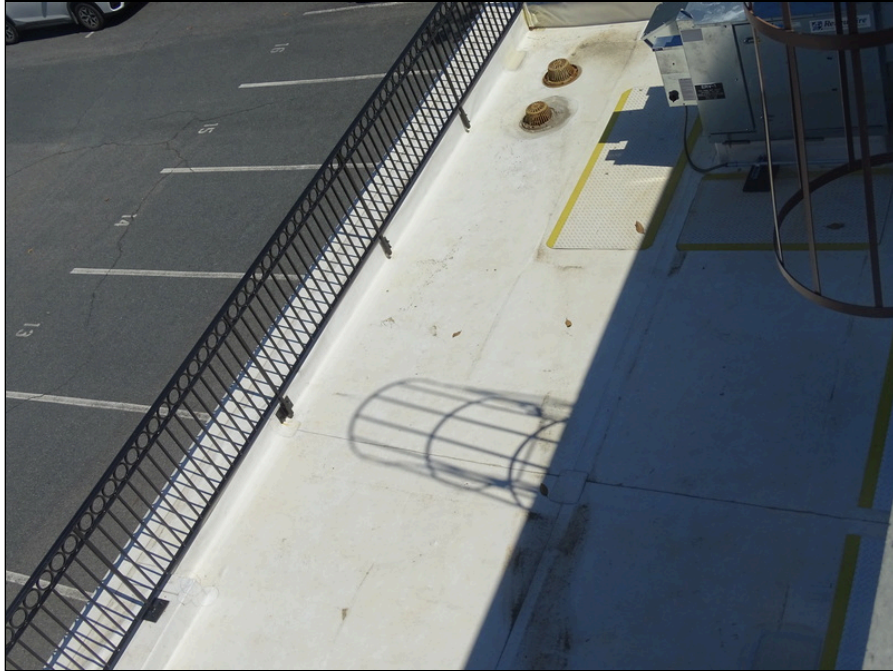
37 - Single-ply membrane roofing system

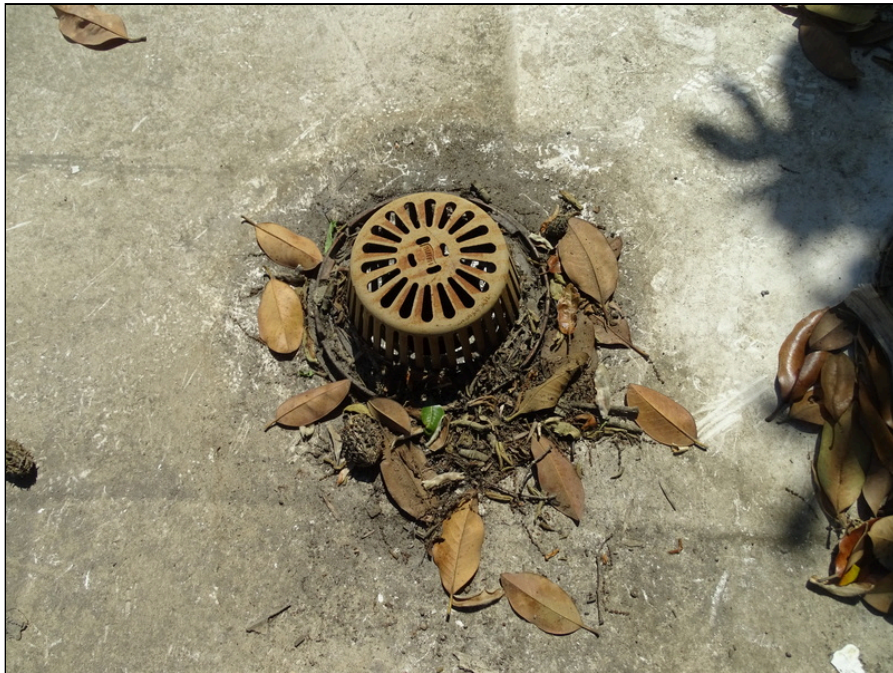
38 - Typical internal drain

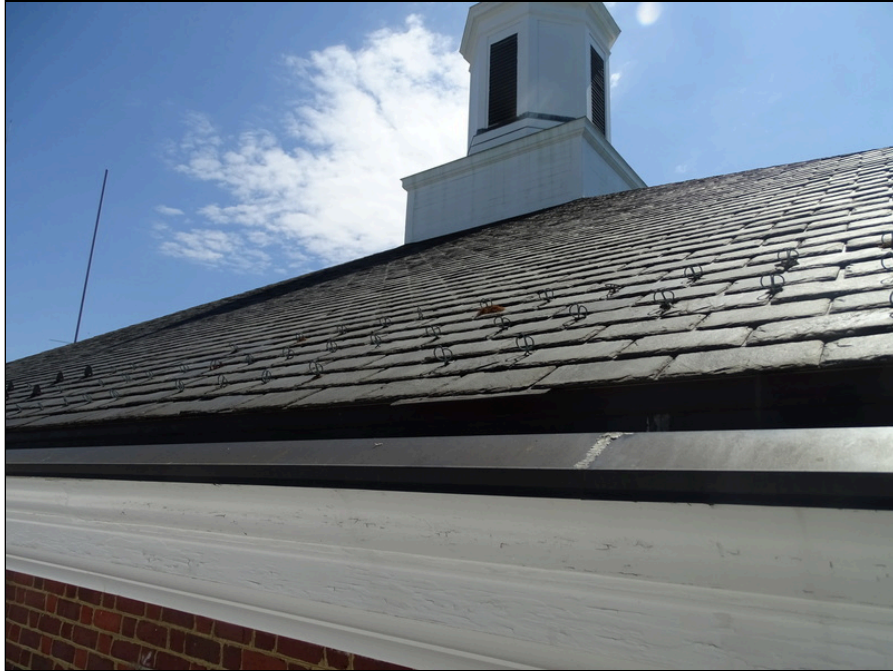
39 - Slate roofing system

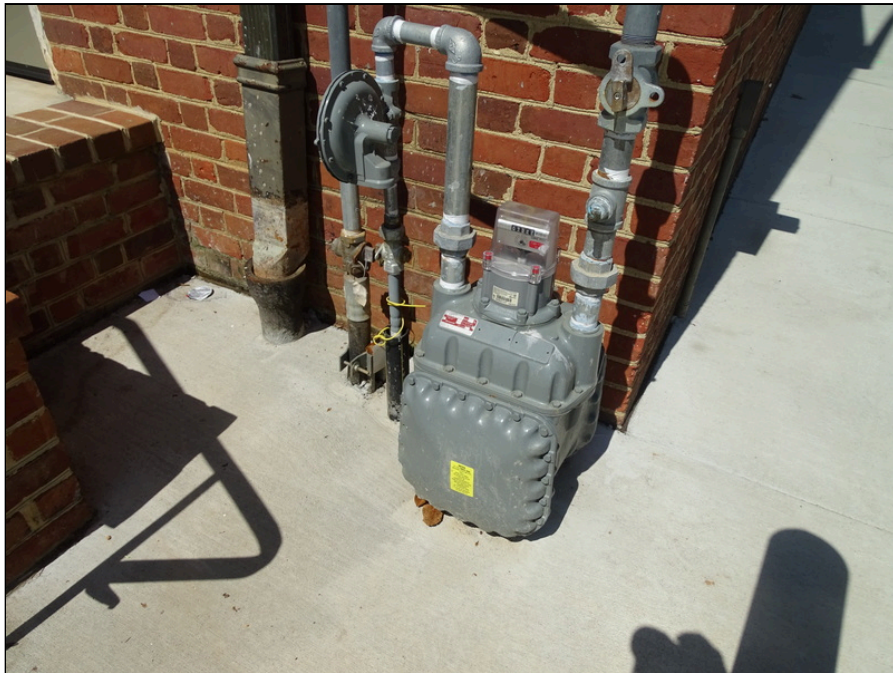
42 - Typical gas meter

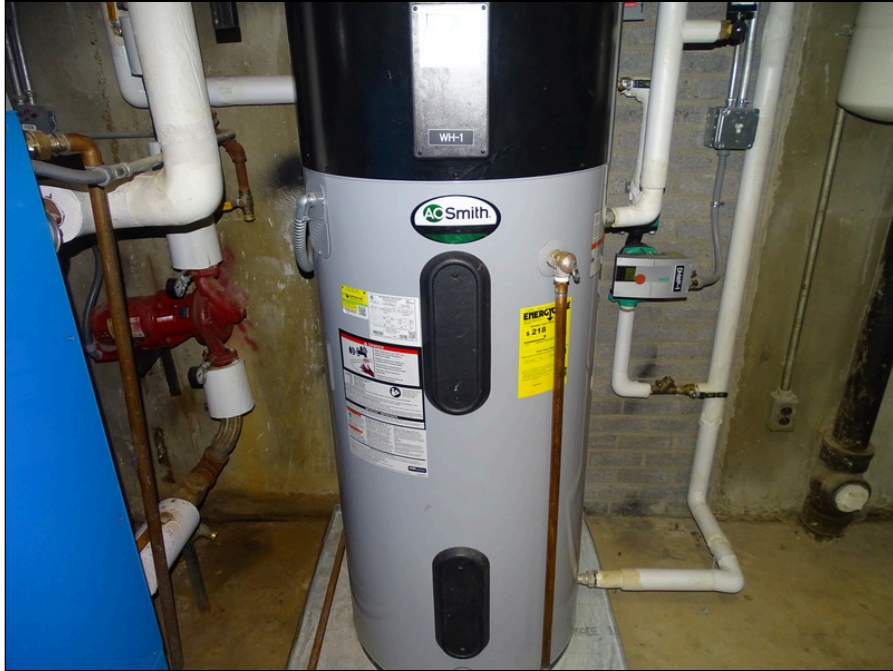
43 - Electric water heater

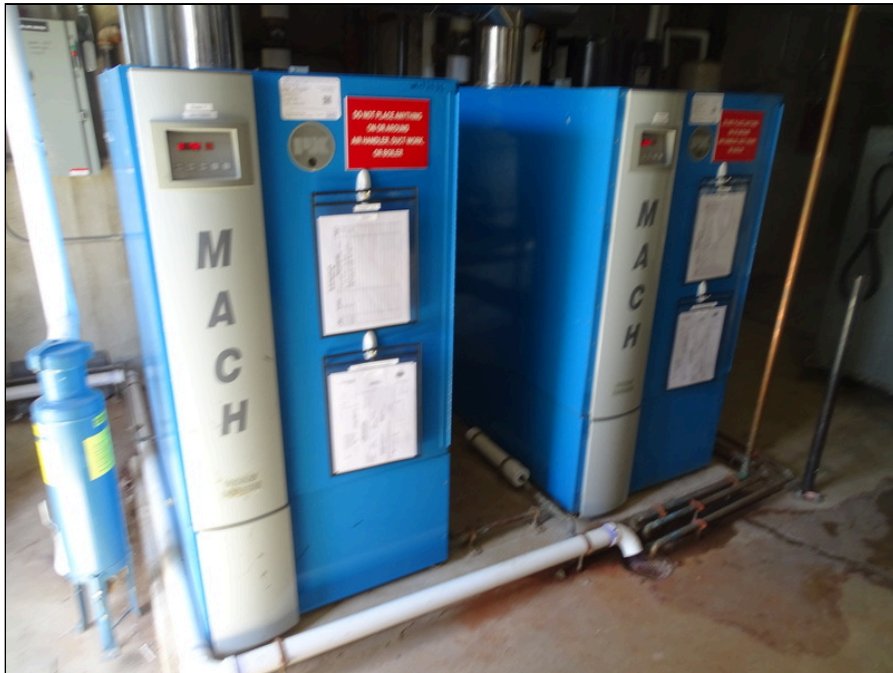
44 - Boilers located in main utility room

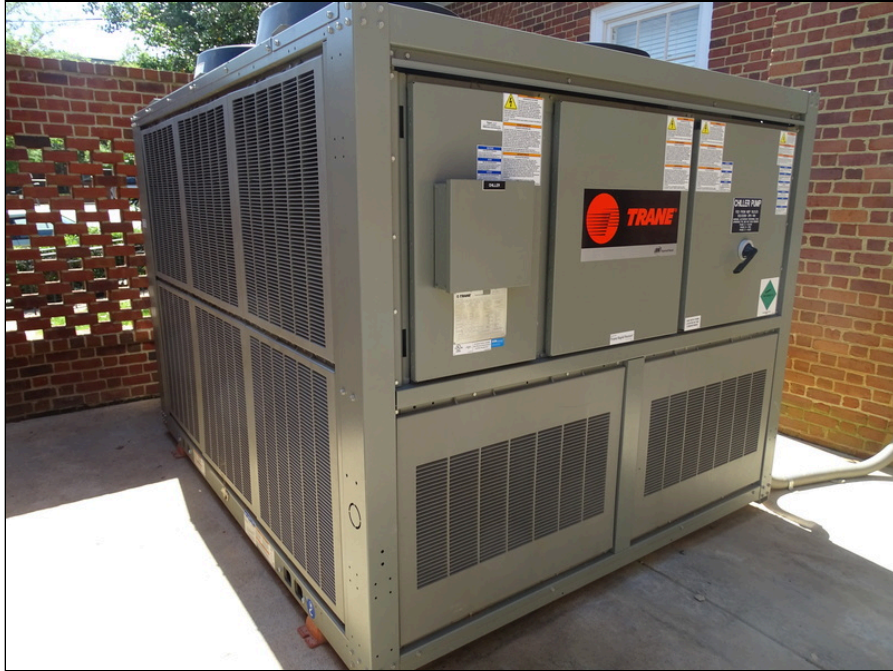
45 - Chiller located outside ground level northwest side of the building

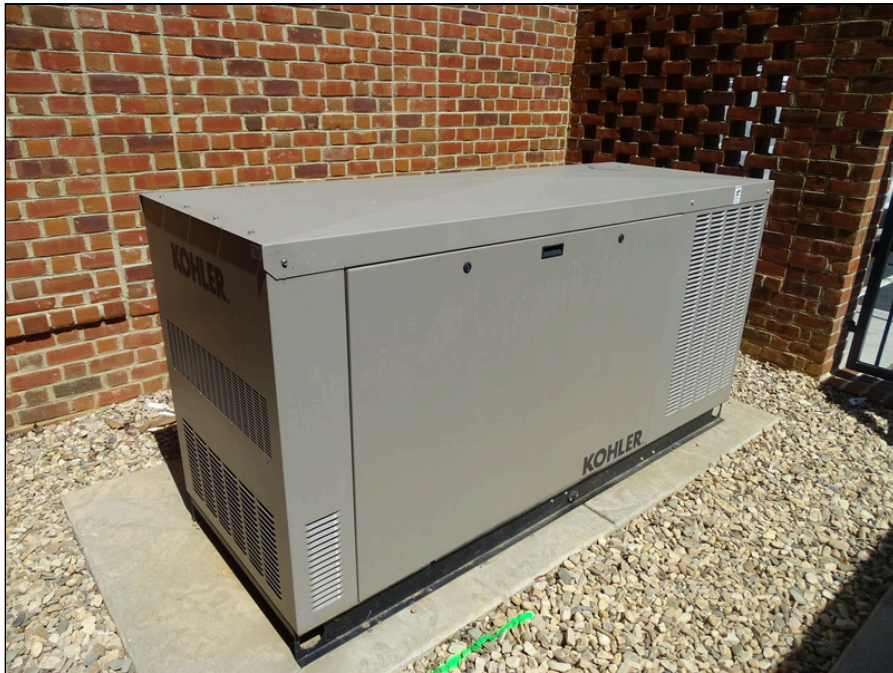
46 - Typical emergency generator
