CIRCUIT COURT
315-317 EAST HIGH STREET
CHARLOTTESVILLE, VIRGINIA

ECS PROJECT NO. 46:6713

CITY OF CHARLOTTESVILLE - FACILITIES DEVELOPMENT

Reference: Facility Condition Assessment Report for Circuit Court, 315-317 East High Street,
Charlottesville, Virginia

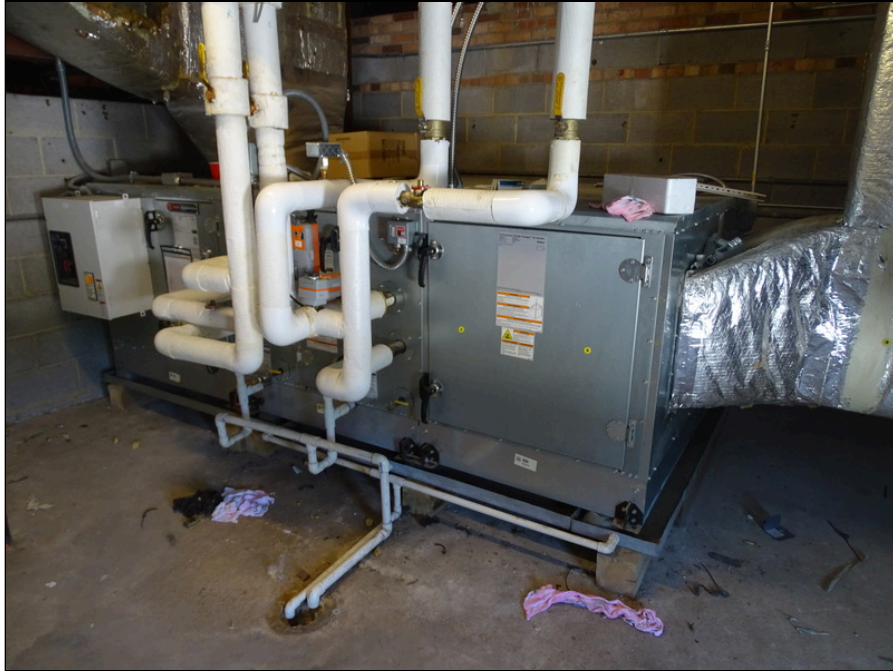
47 - Air Handler Unit located in attic space

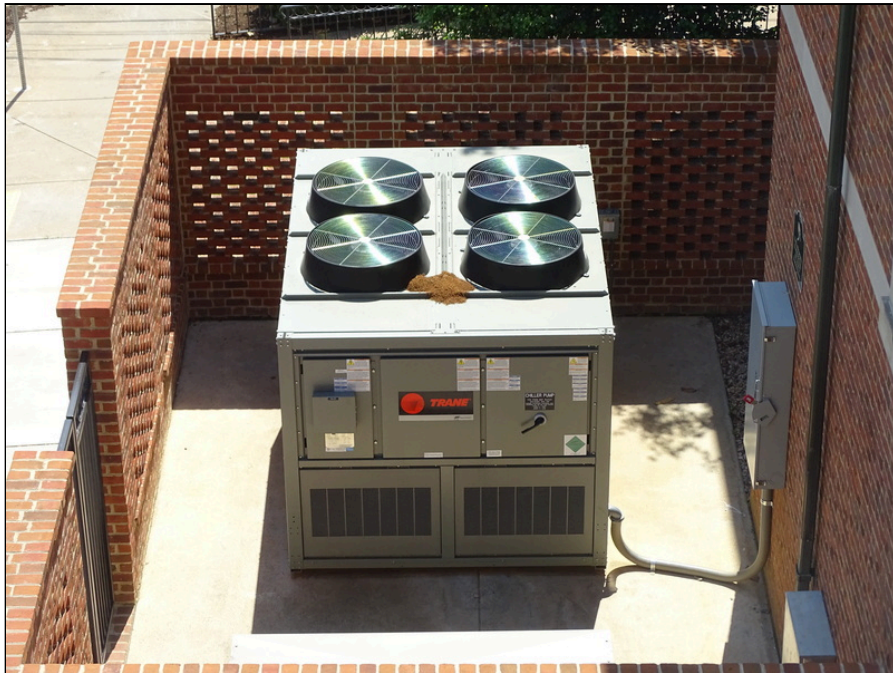
48 - Chiller located outside ground level northwest side of the building

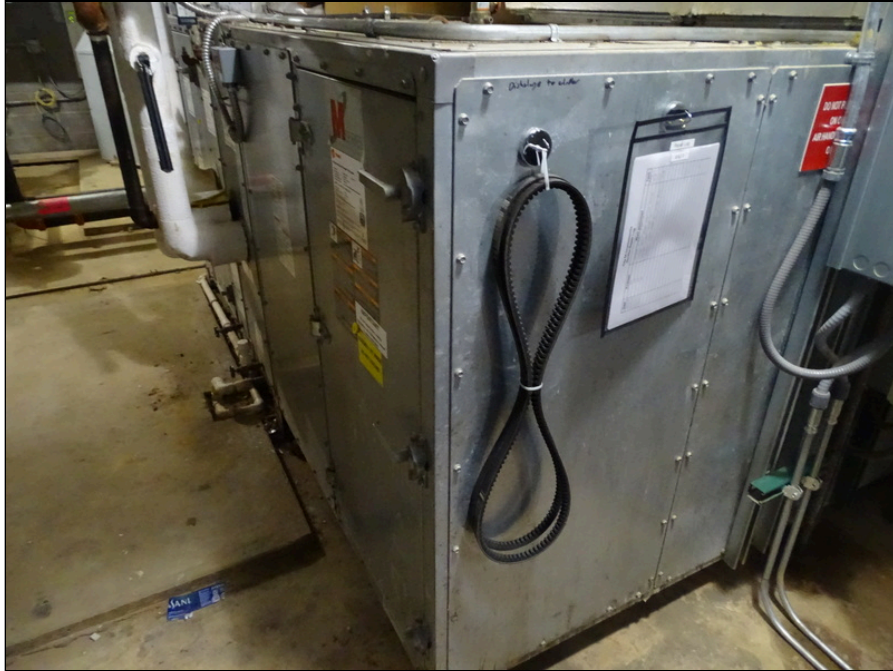
49 - Air Handler Unit located in attic space

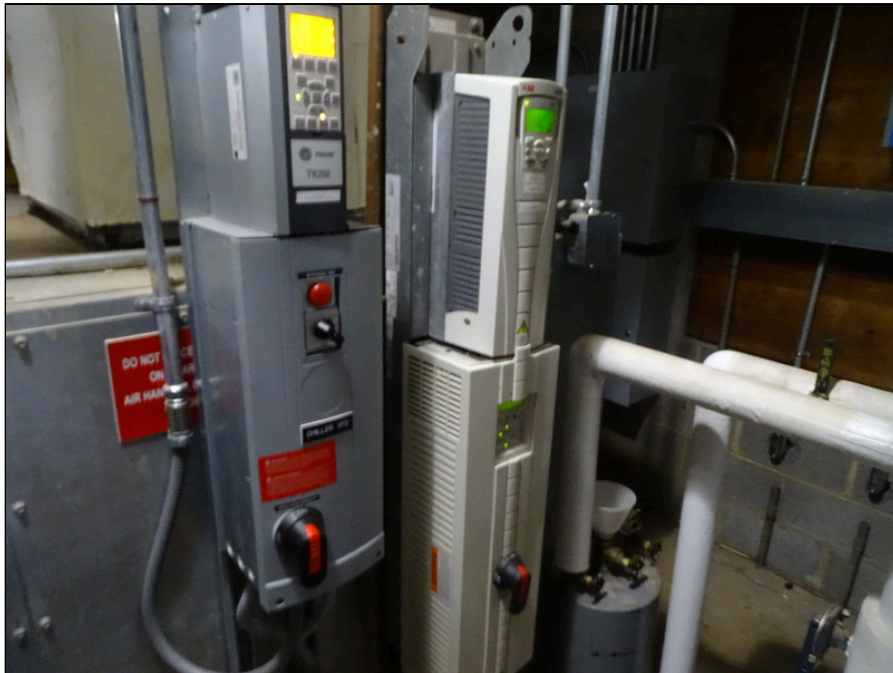
50 - Variable frequency drive system

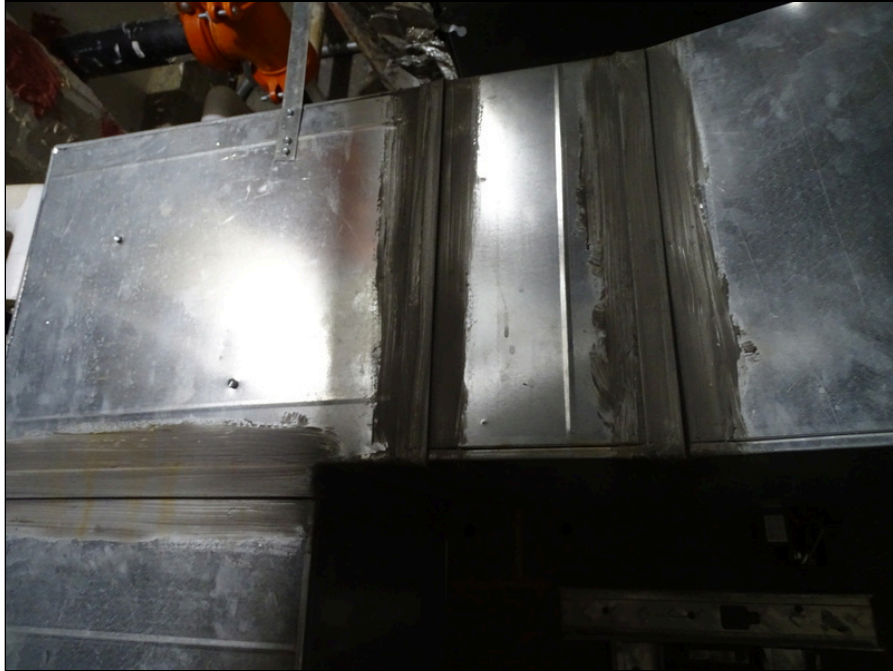
51 - Typical mechanical duct

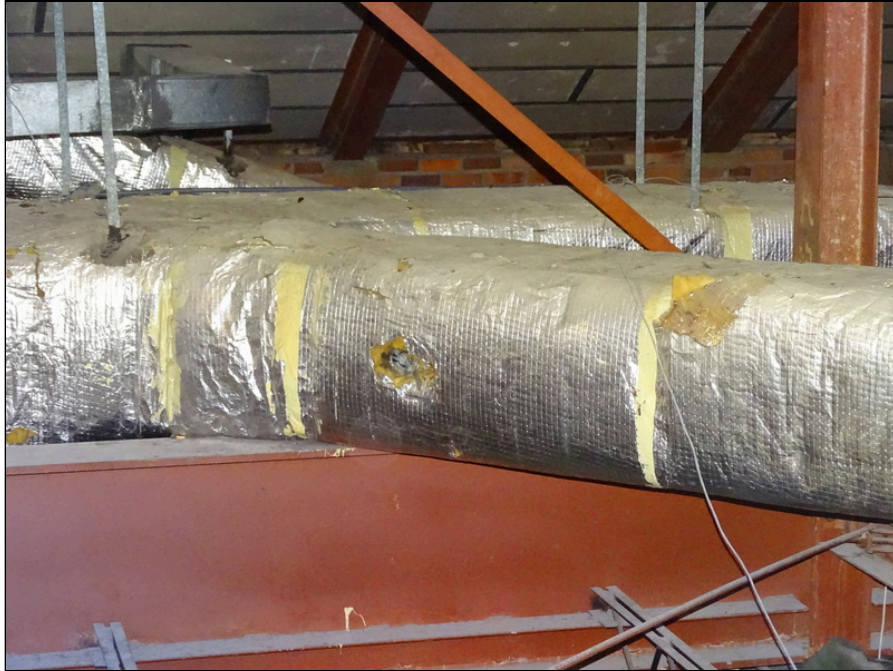
53 - Typical mechanical duct

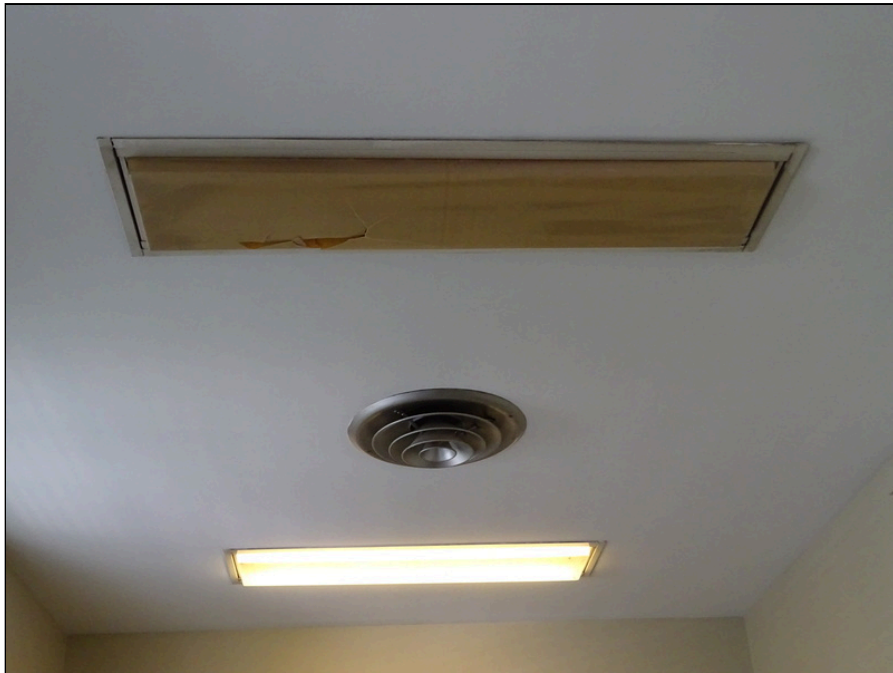
54 - Typical ducted supply

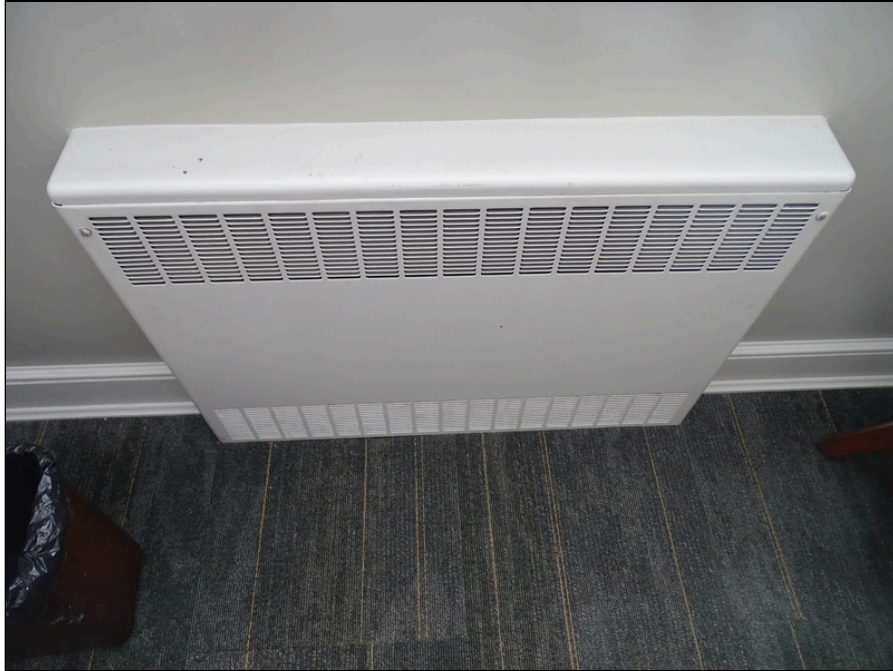
55 - Typical water source heat pump

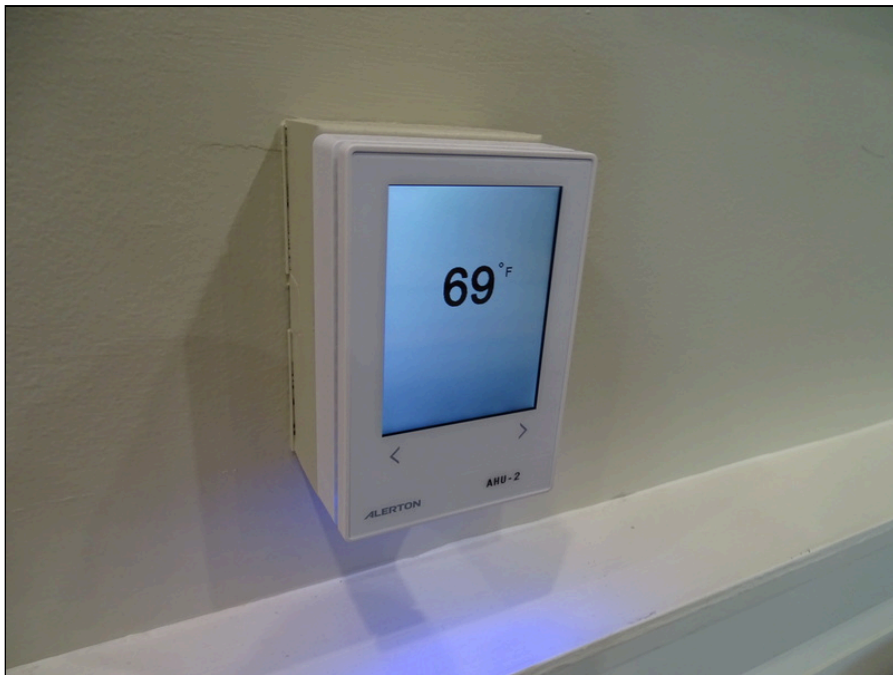
56 - Typical thermostat control

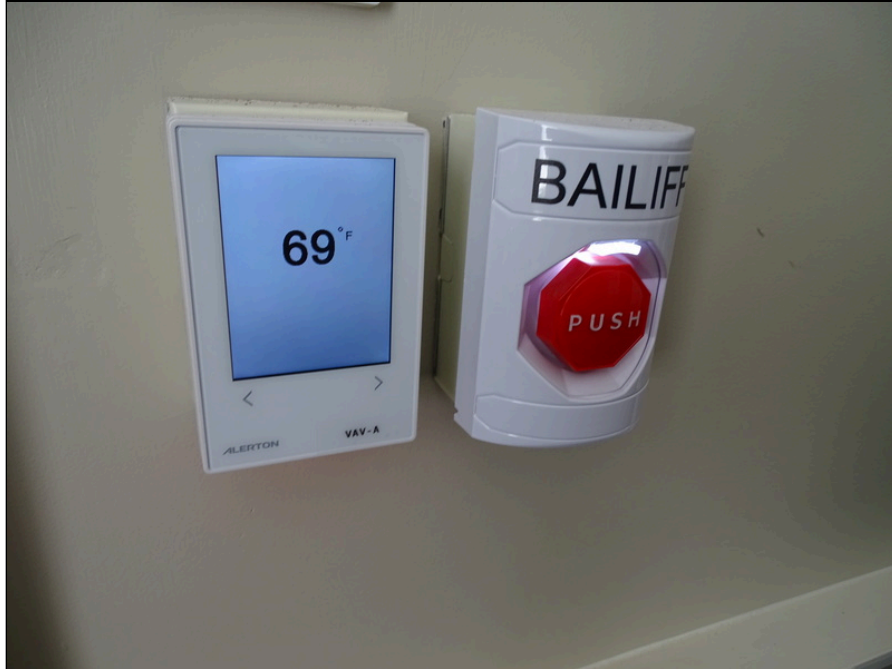
57 - Mechanical system thermostat controls

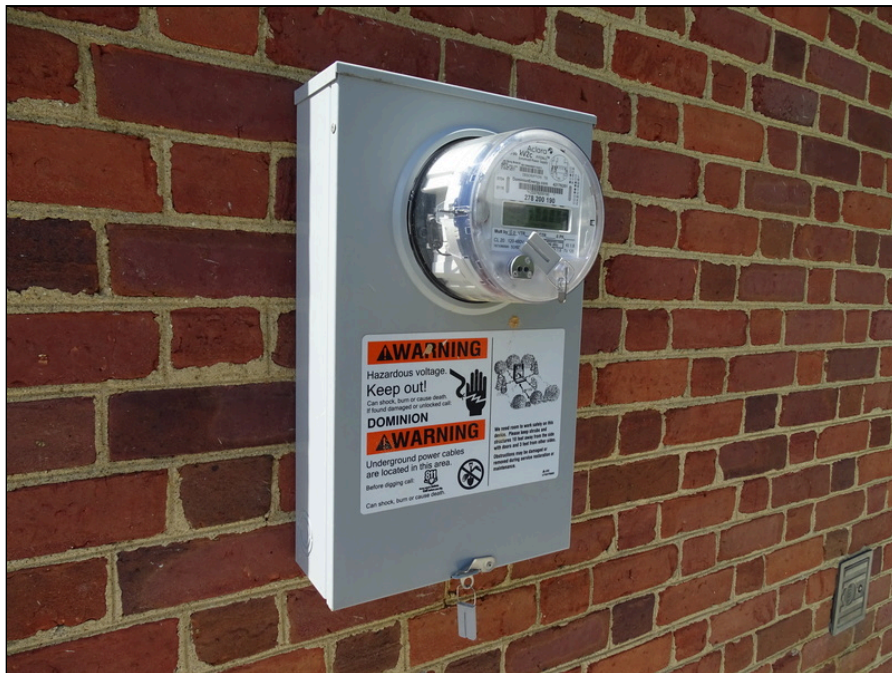
58 - Electric utility meter

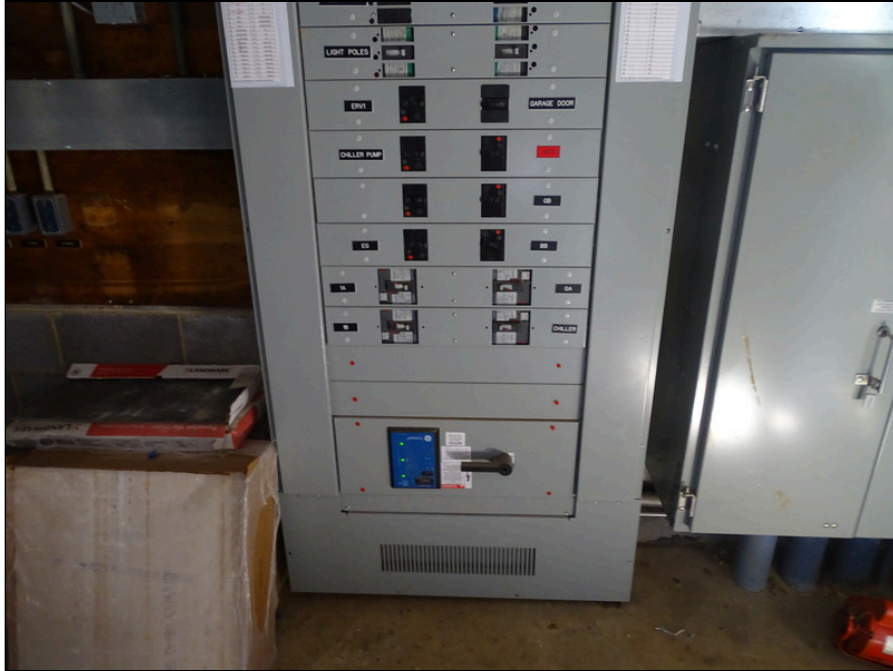
59 - Main electrical switchgear

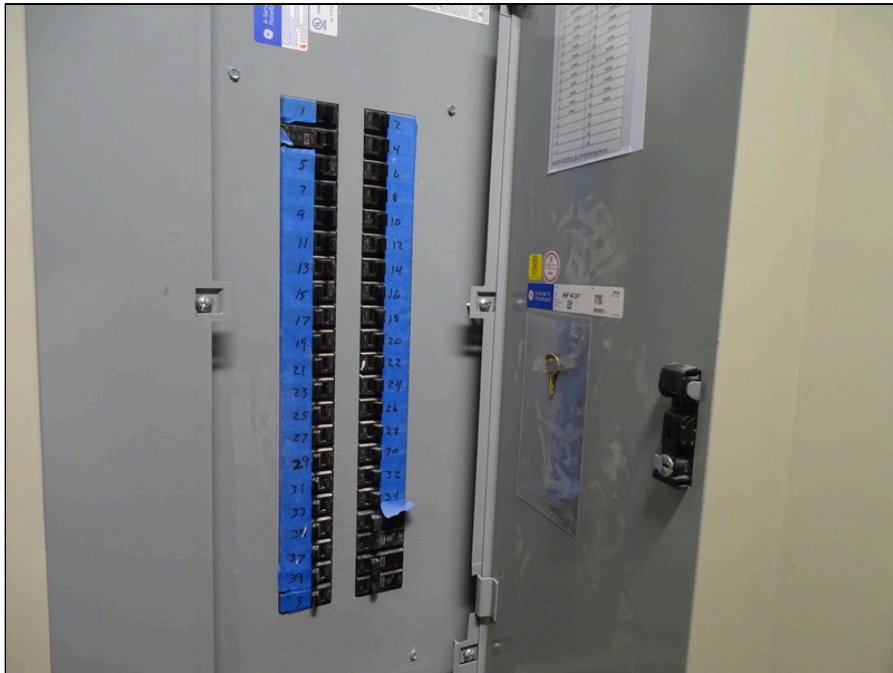
60 - Typical electrical circuit breaker panel

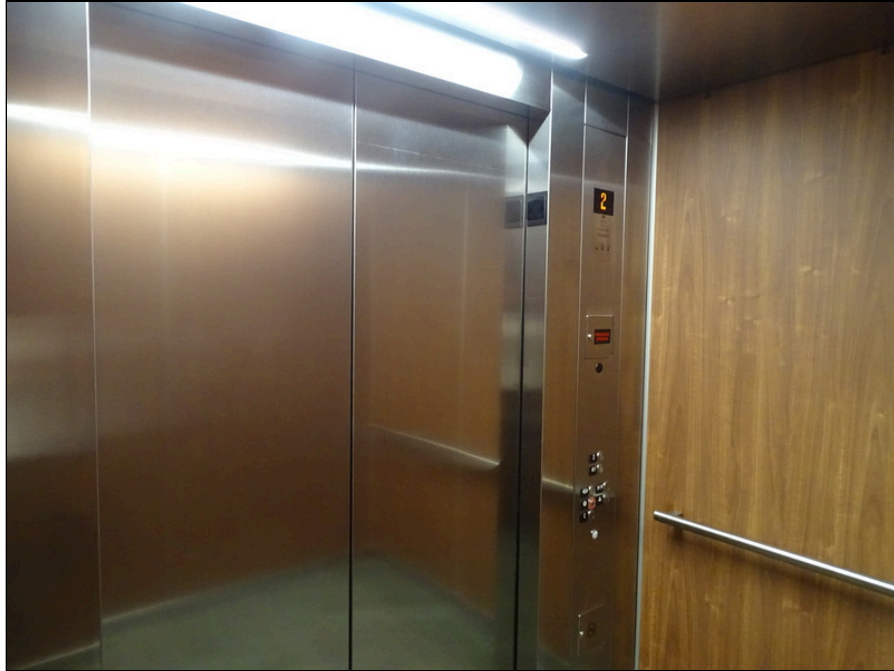
61 - Elevator interior cab

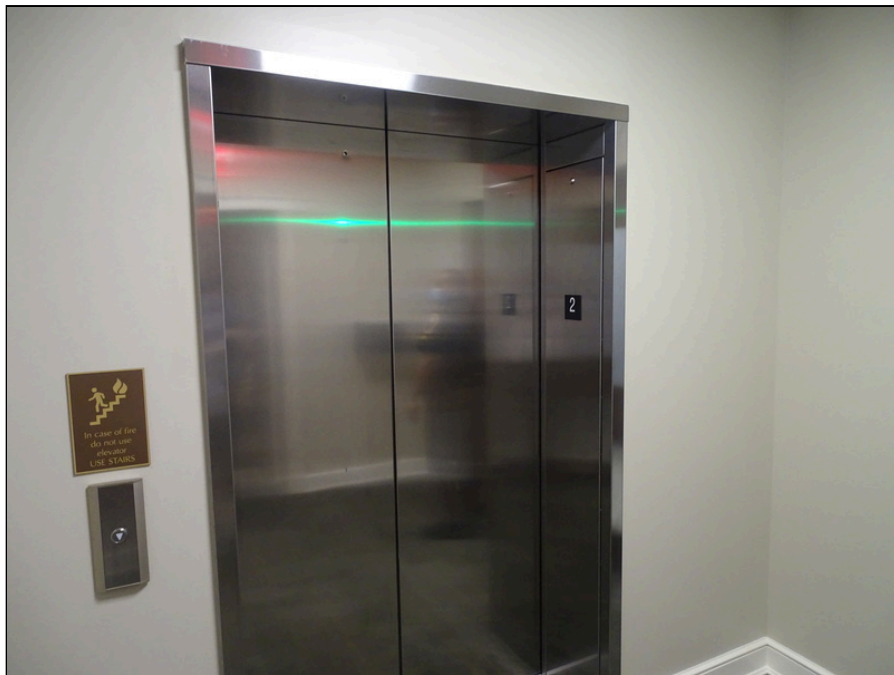
62 - Elevator at second level

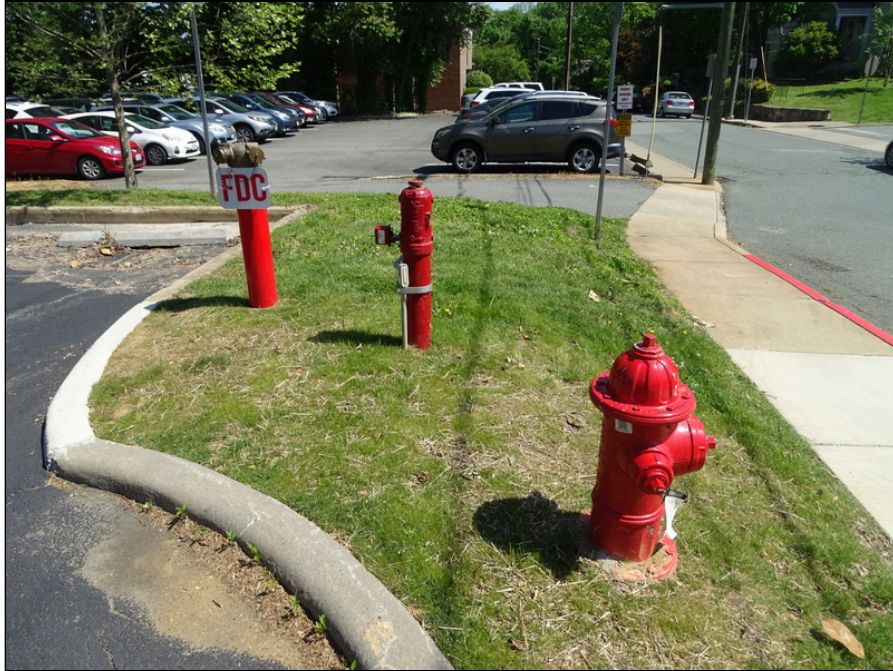
63 - Typical fire hydrant

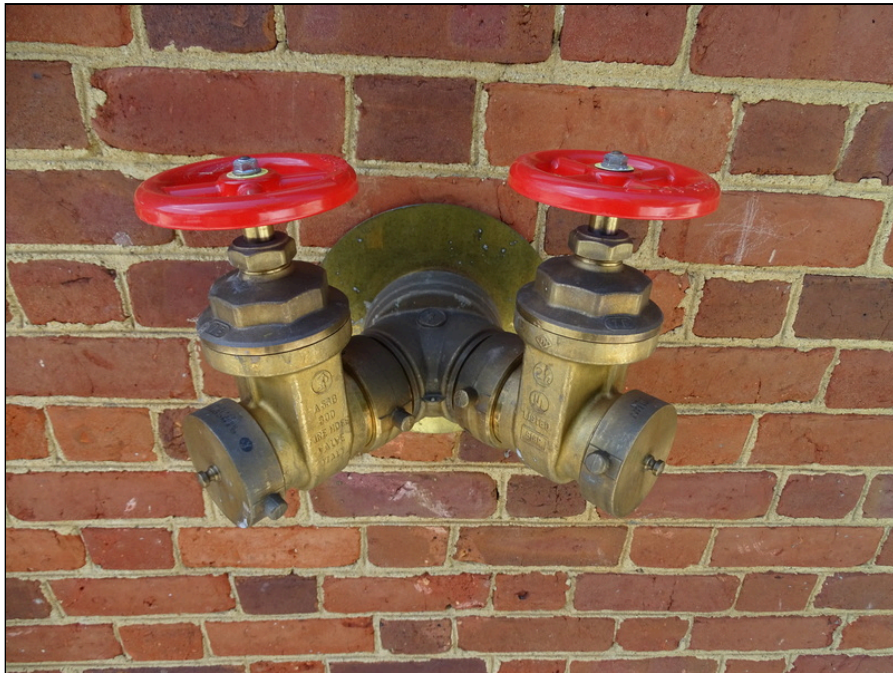
64 - Fire Department Connection

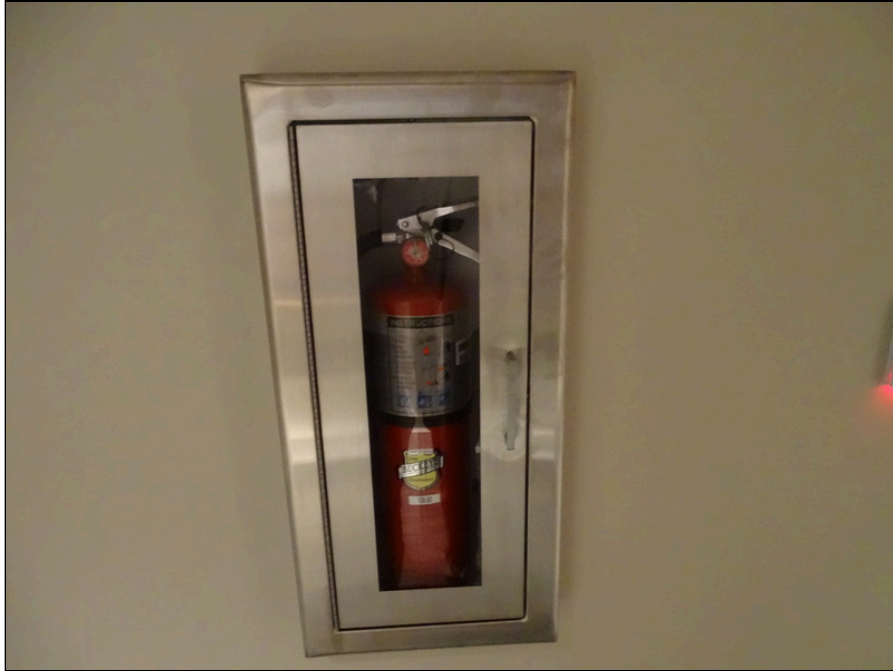
65 - Typical fire extinguisher

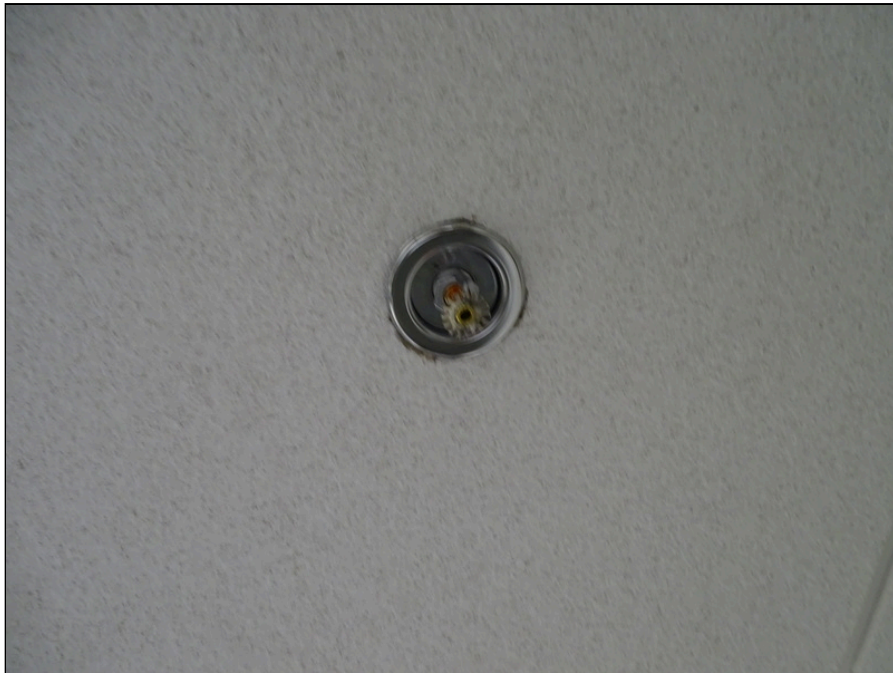
66 - Typical fire sprinkler head

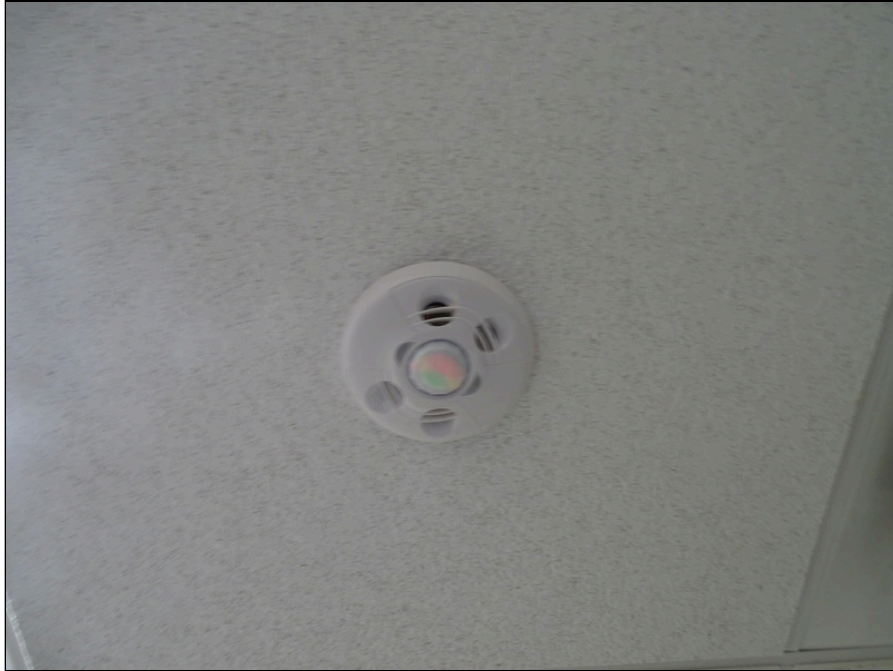
67 - Typical smoke detector

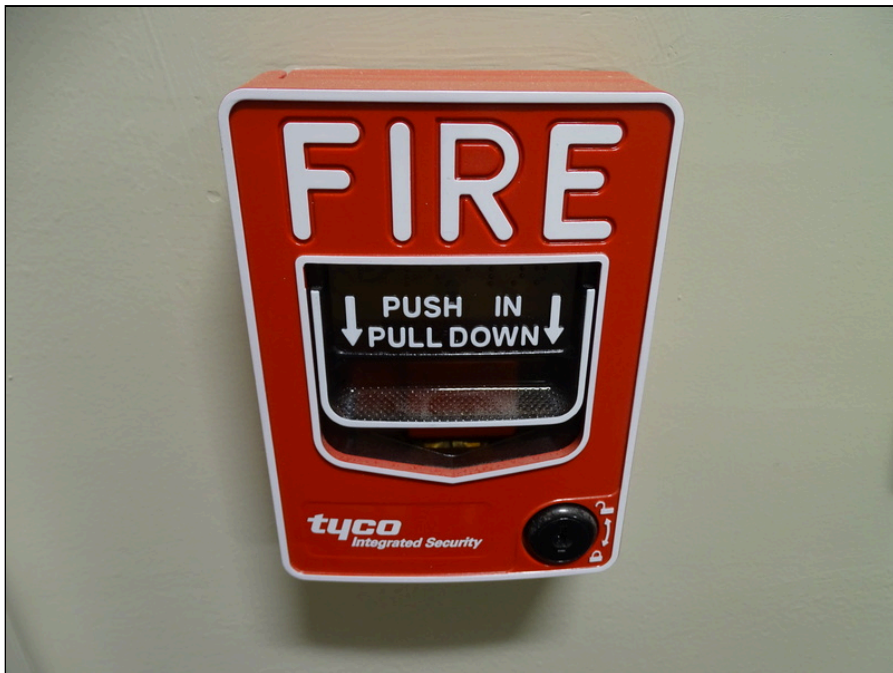
68 - Typical pull down station

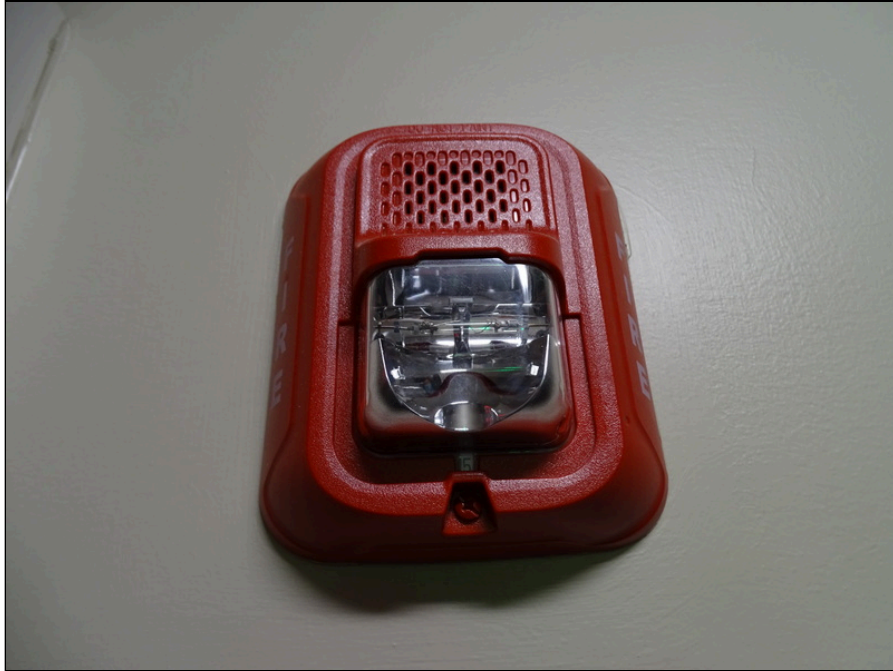
69 - Typical fire alarm, bell, and strobe

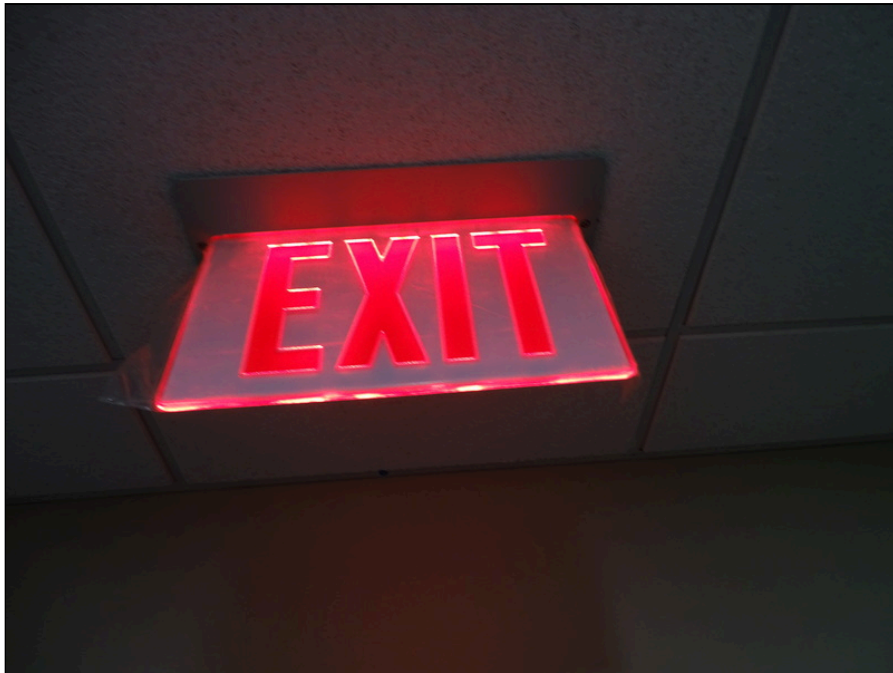
70 - Typical exit sign

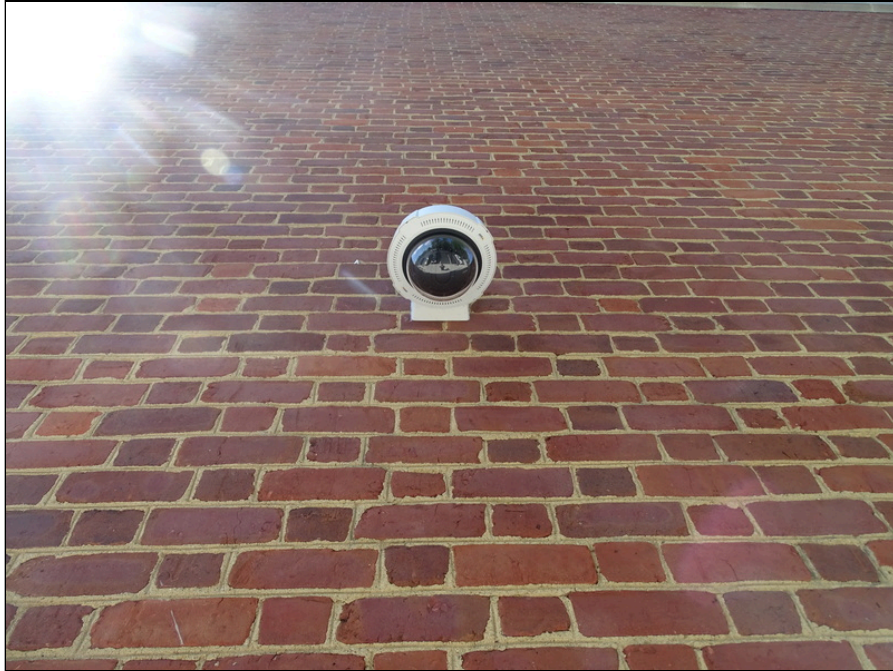
71 - Typical security camera

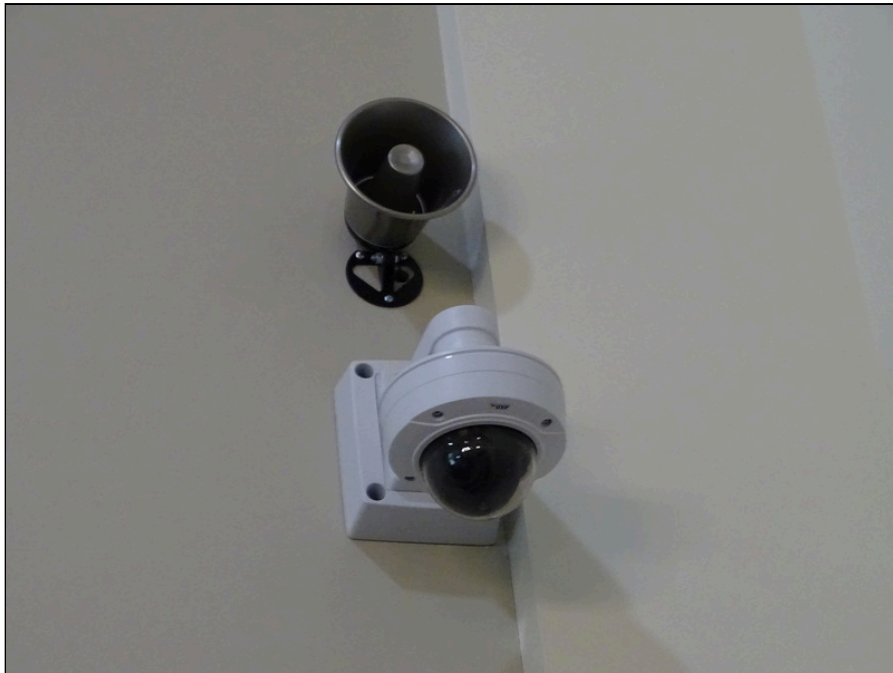
72 - Typical security camera

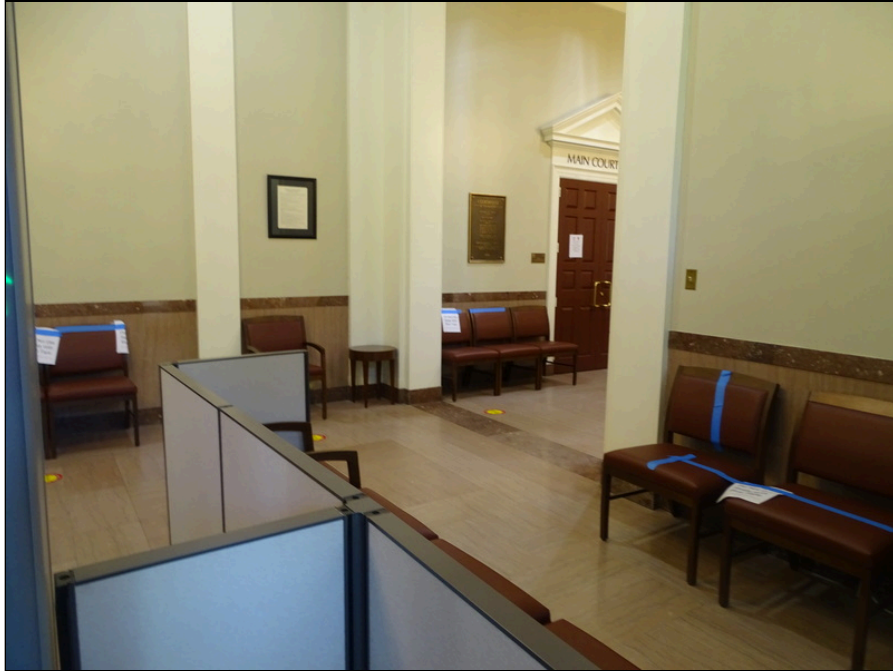
73 - Lobby lower level interior finishes

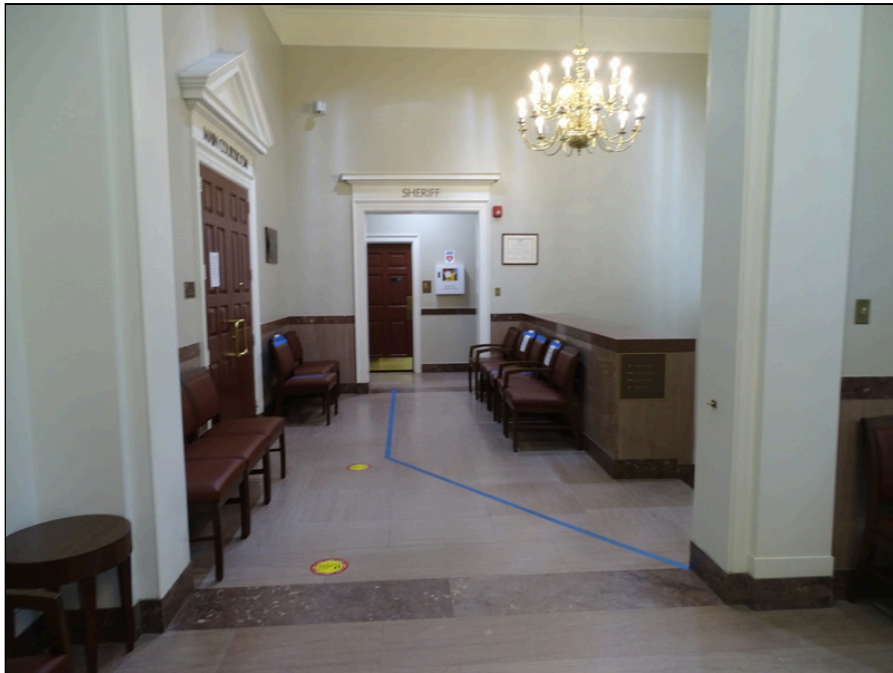
74 - Lobby area interior

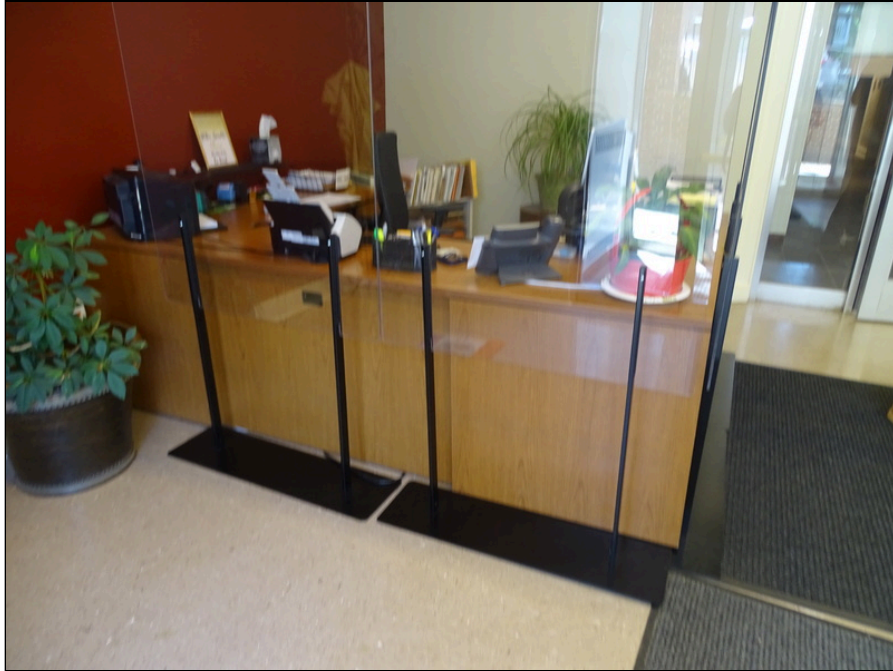
75 - Lobby area interior

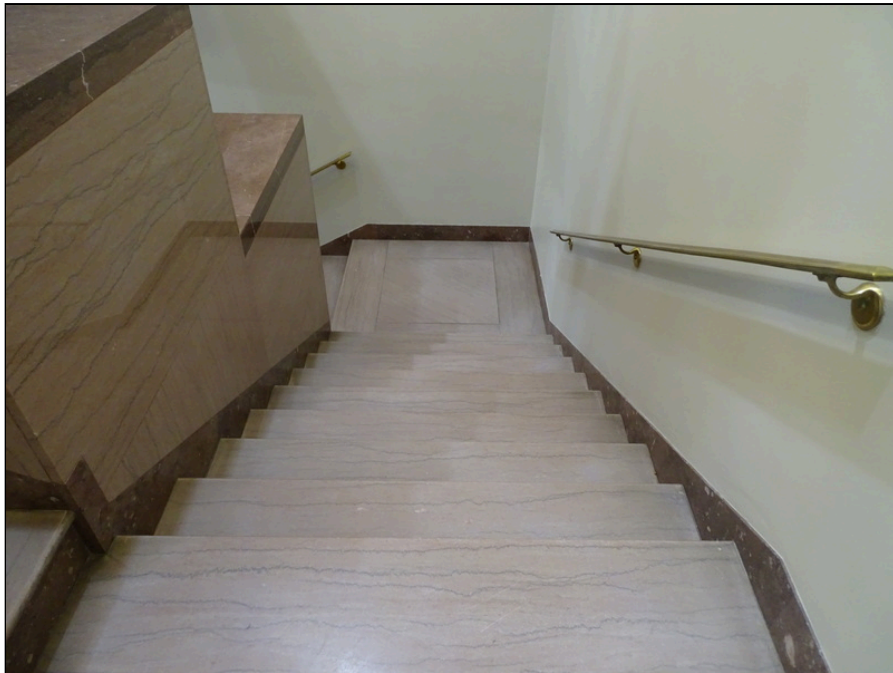
76 - Stairwell at southwest side of the building

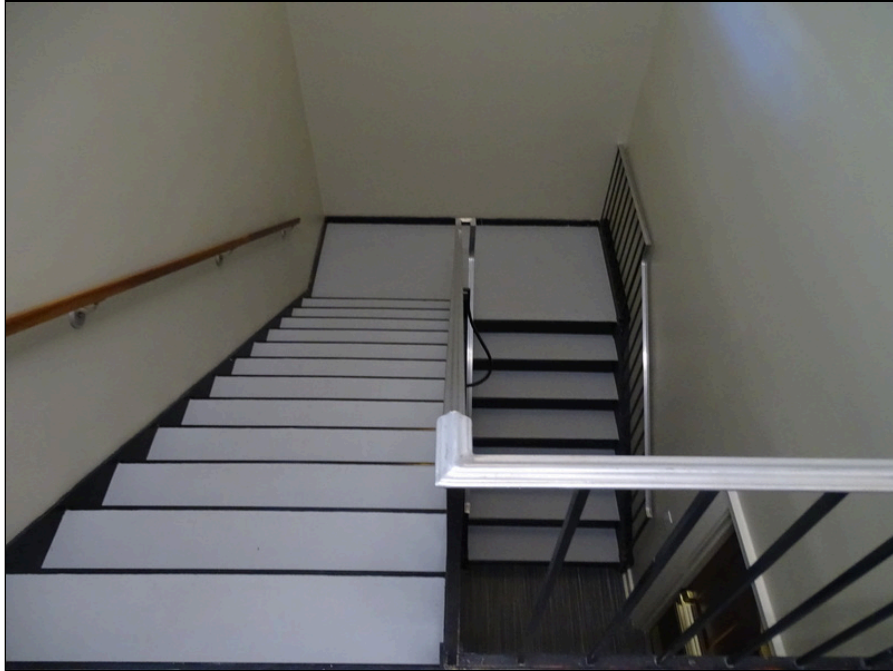
77 - Stairwell at southwest side of the building

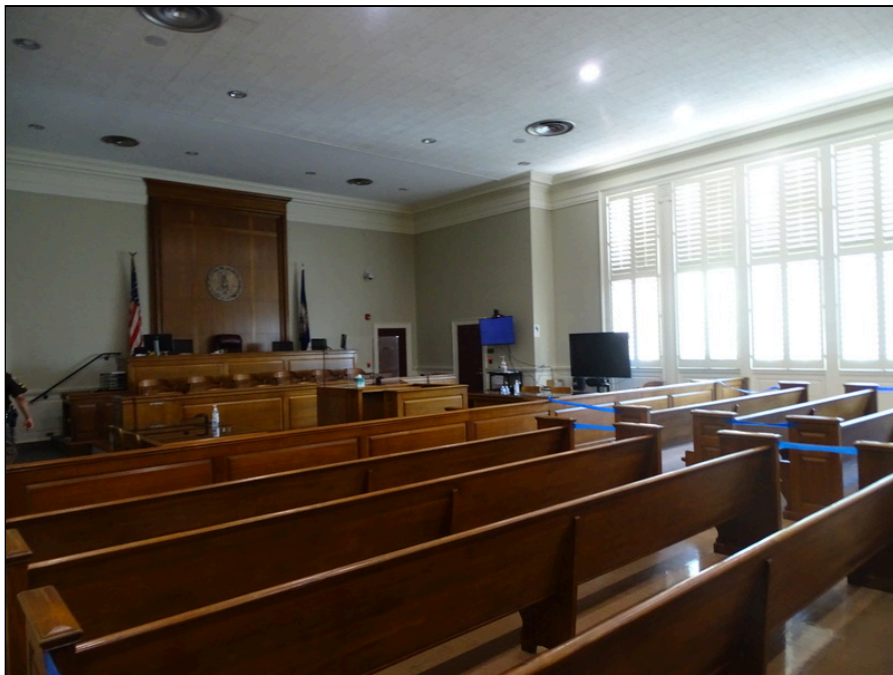
78 - Courtroom interior area

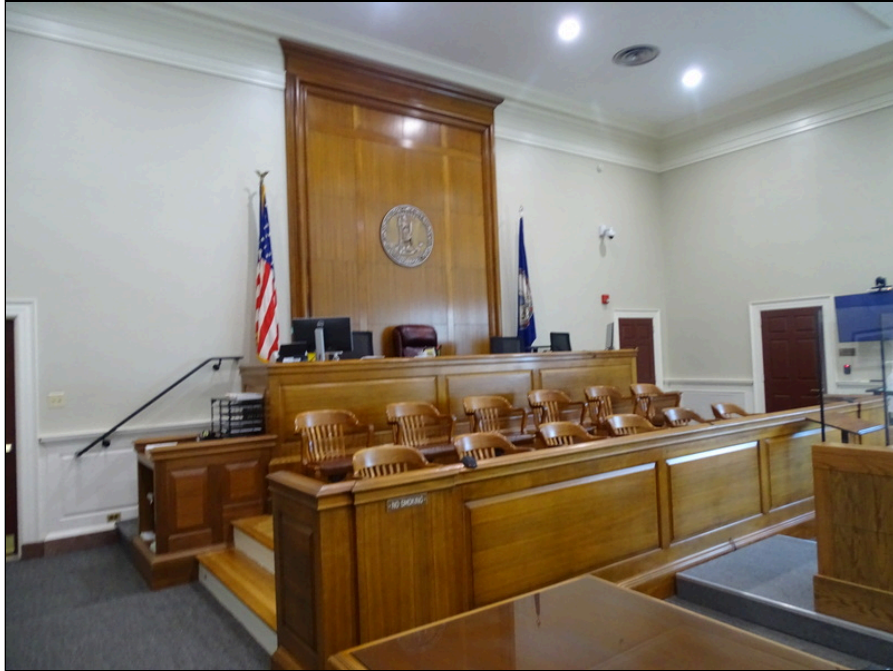
79 - Courtroom interior area

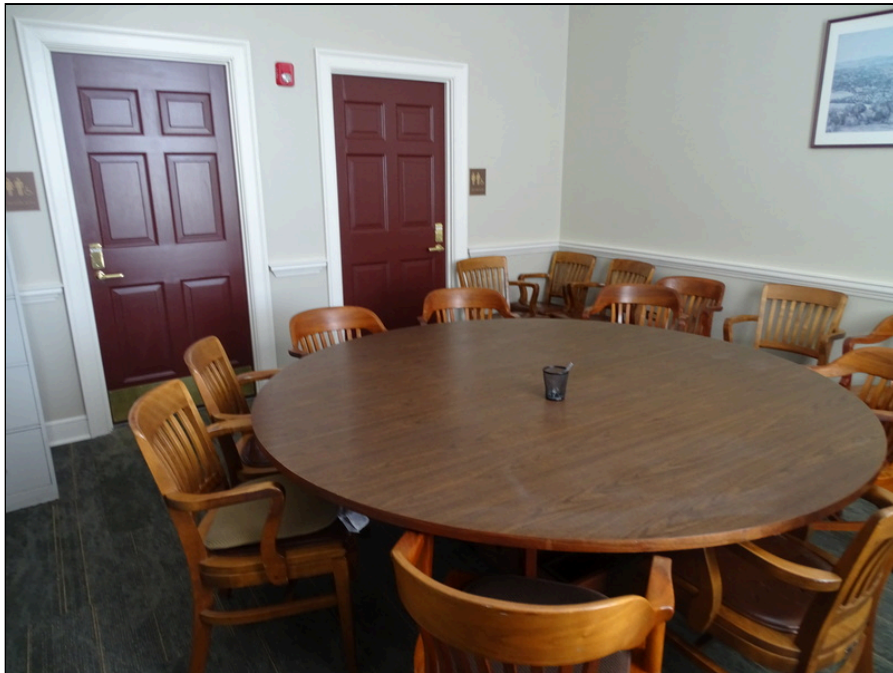
80 - Lobby area interior

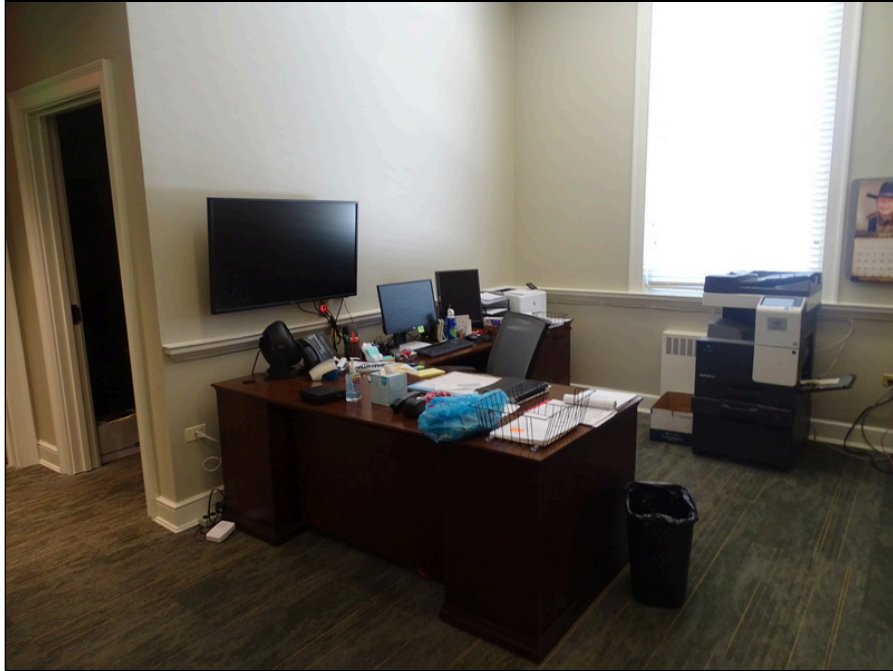
81 - Typical office interior

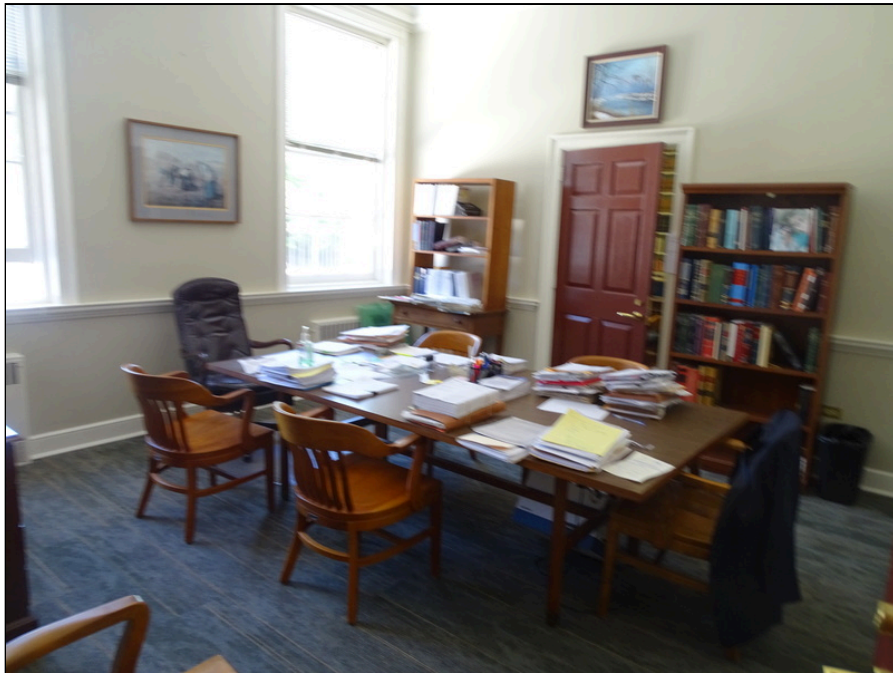
82 - Typical office interior

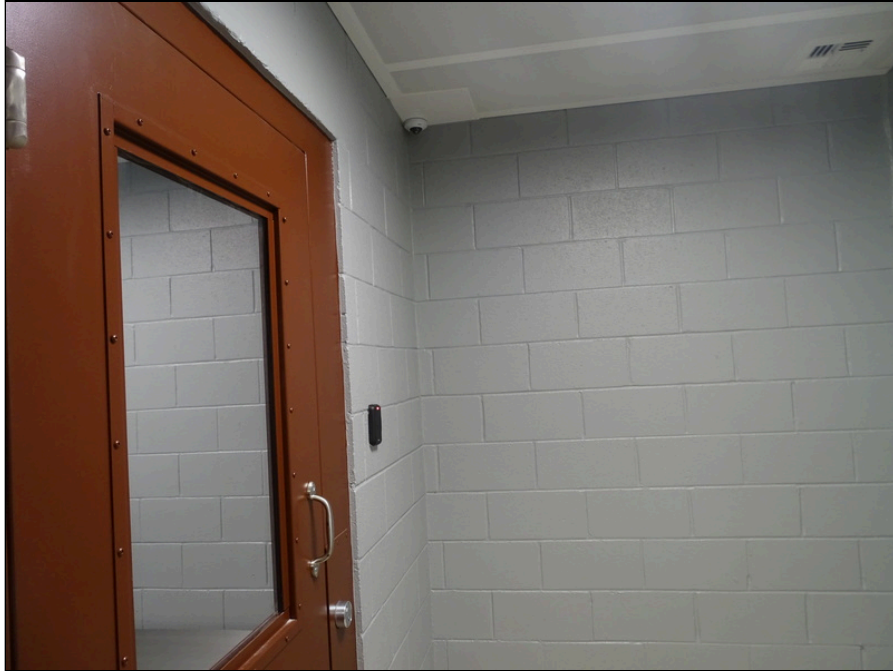
83 - Typical cell interior139

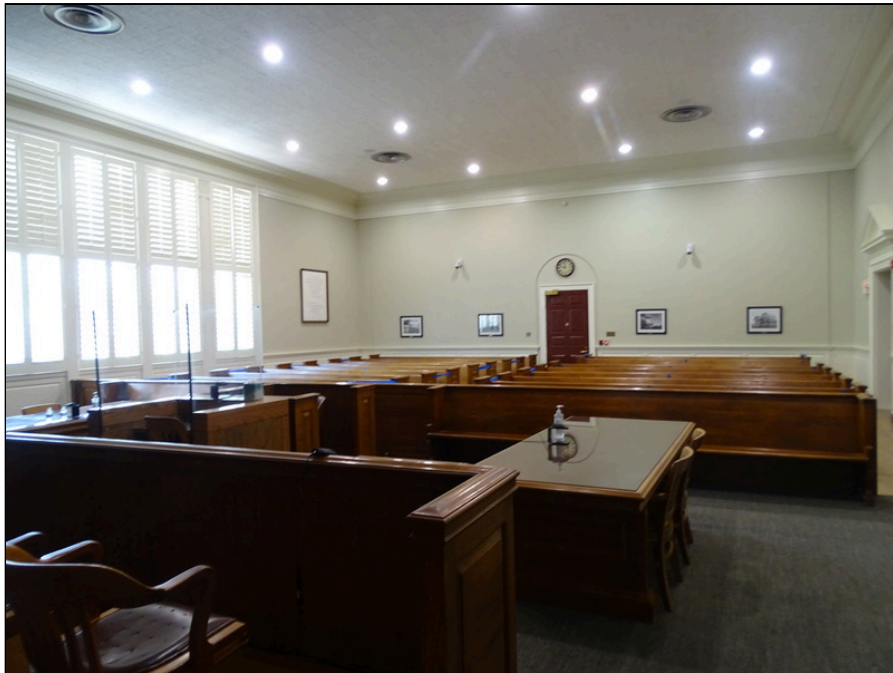
84 - Courtroom interior area

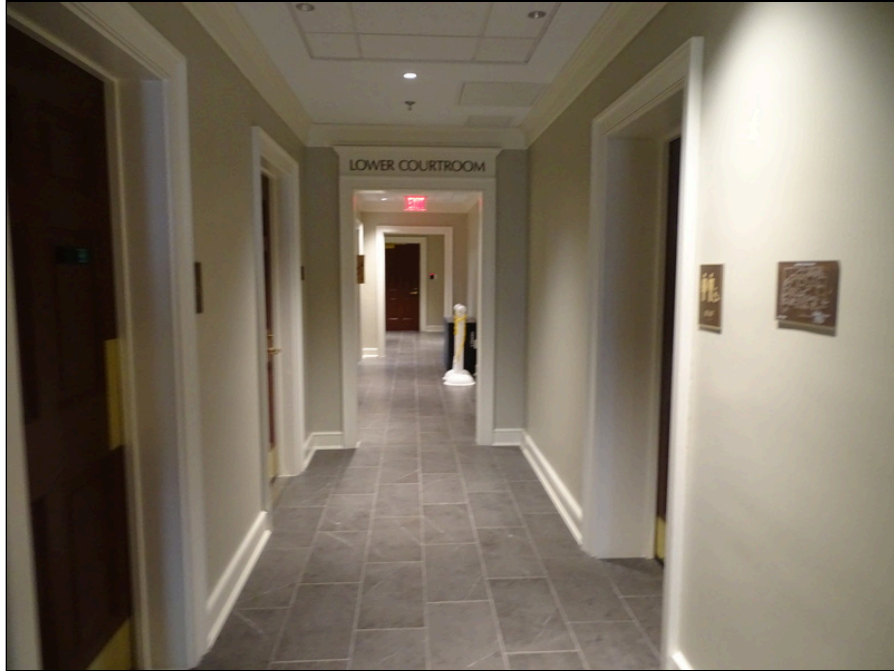
85 - Corridor area interior finishes
