CIRCUIT COURT
315-317 EAST HIGH STREET
CHARLOTTESVILLE, VIRGINIA

ECS PROJECT NO. 46:6713

CITY OF CHARLOTTESVILLE - FACILITIES DEVELOPMENT

Reference: Facility Condition Assessment Report for Circuit Court, 315-317 East High Street,
Charlottesville, Virginia

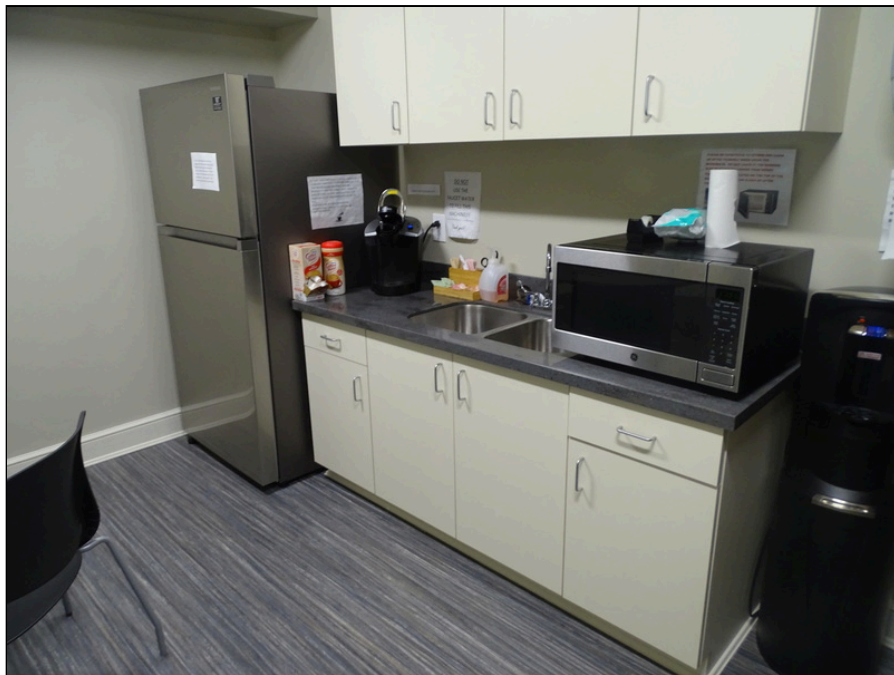
86 - Kitchen interior finishes

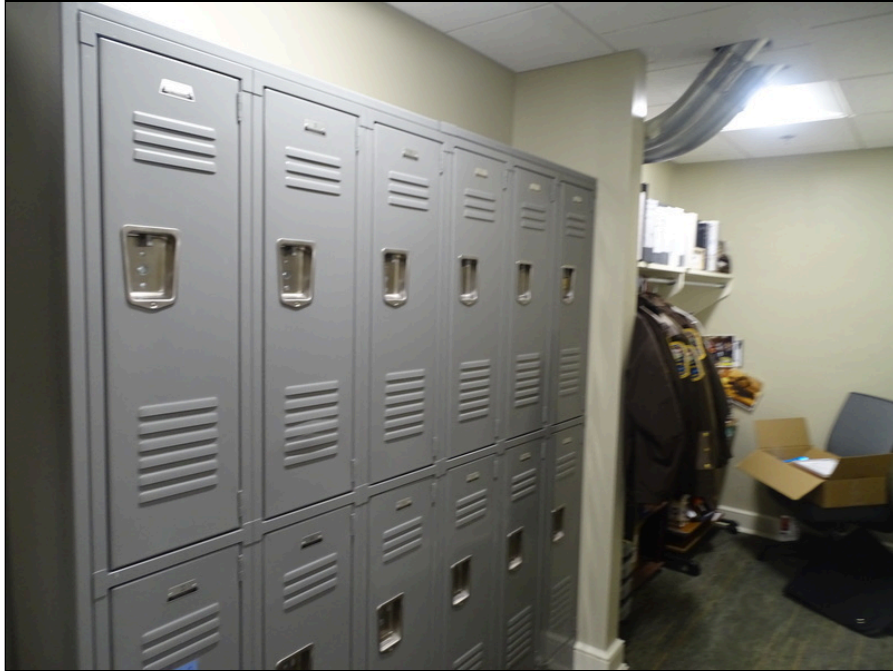
87 - Typical locker area interior

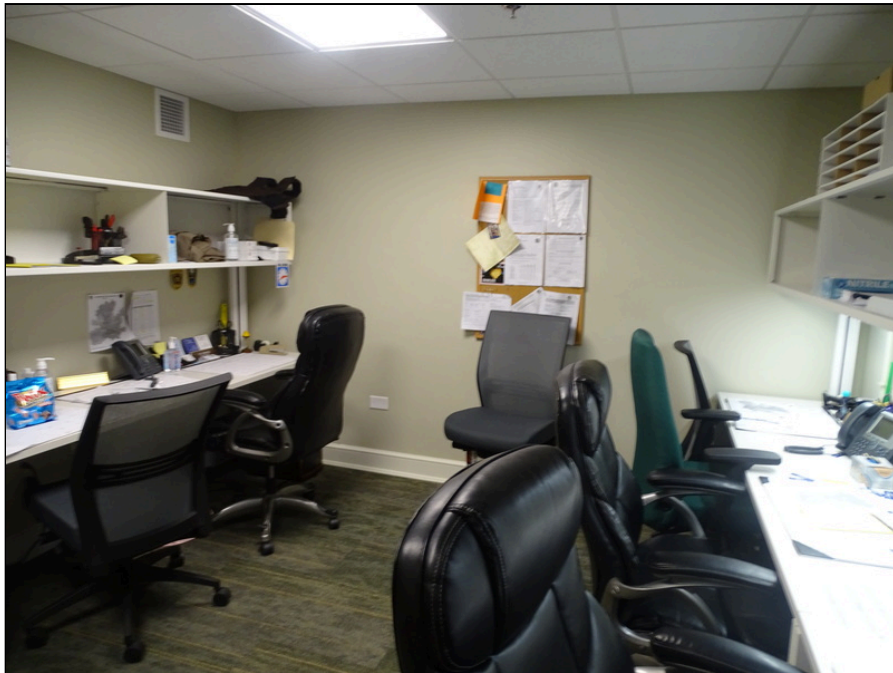
88 - Typical interior office area

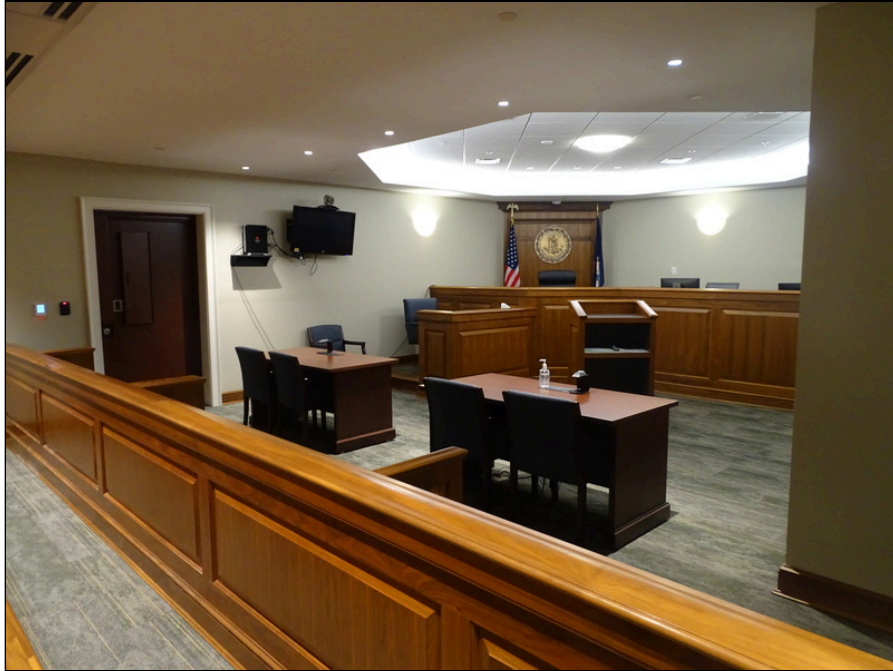
89 - Courtroom interior area

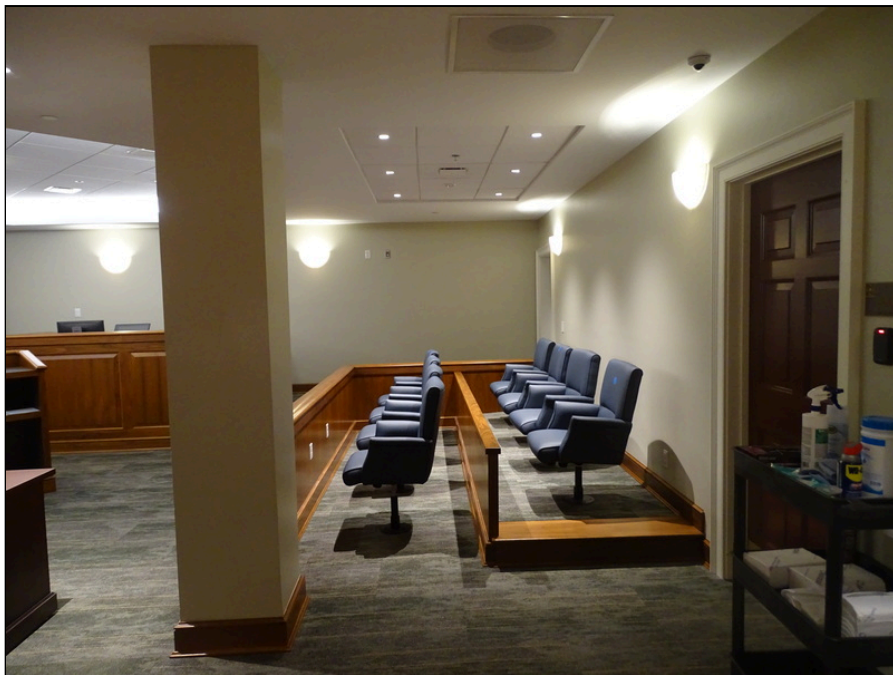
90 - Courtroom interior area

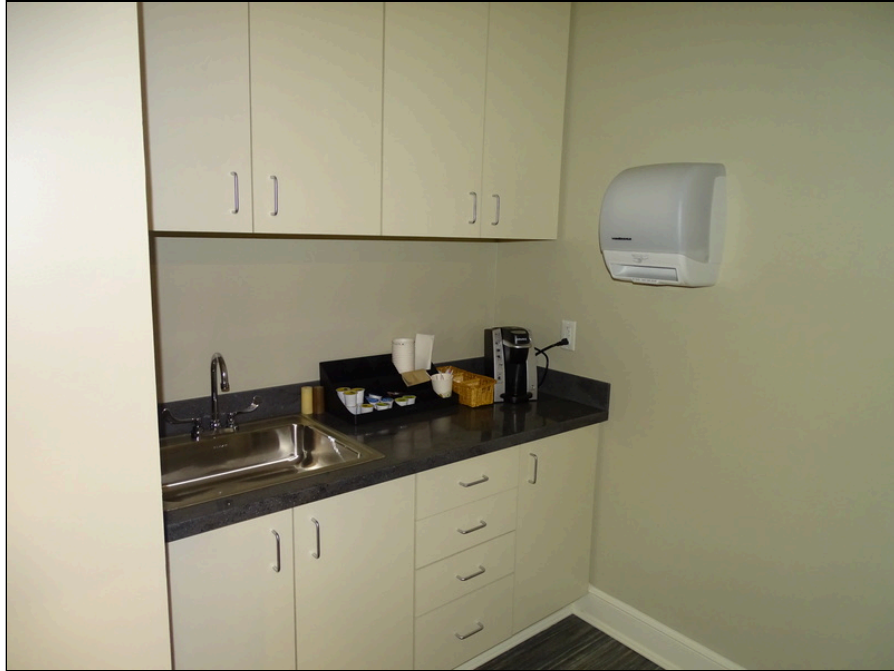
91 - Kitchen interior finishes

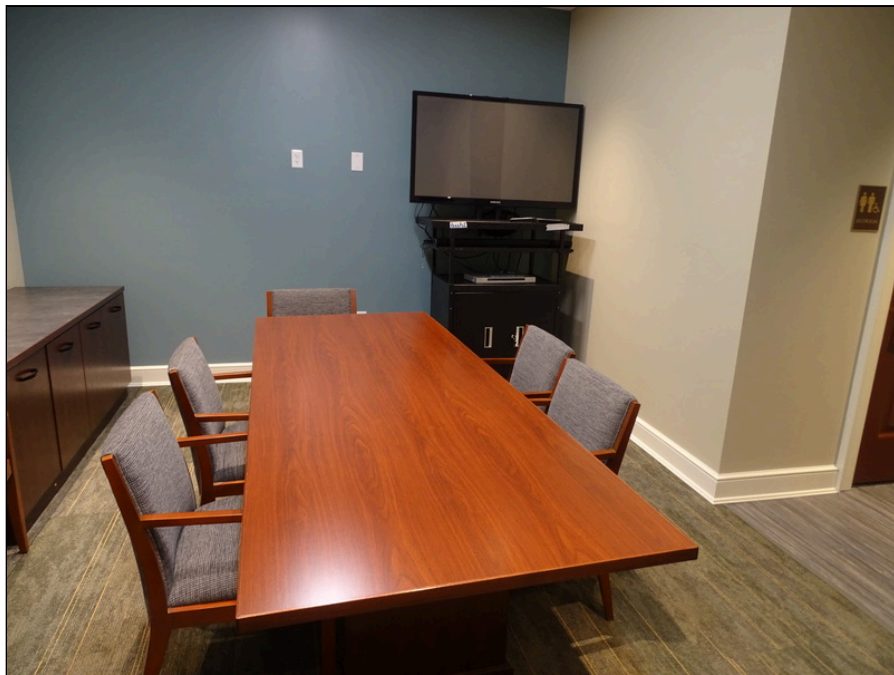
92 - Conference area interior finishes

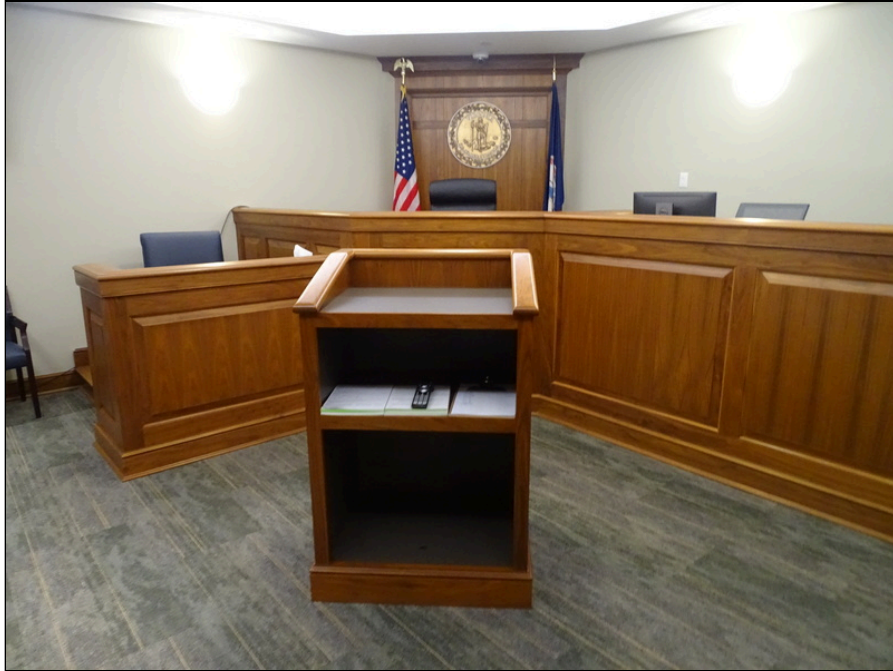
93 - Courtroom interior area

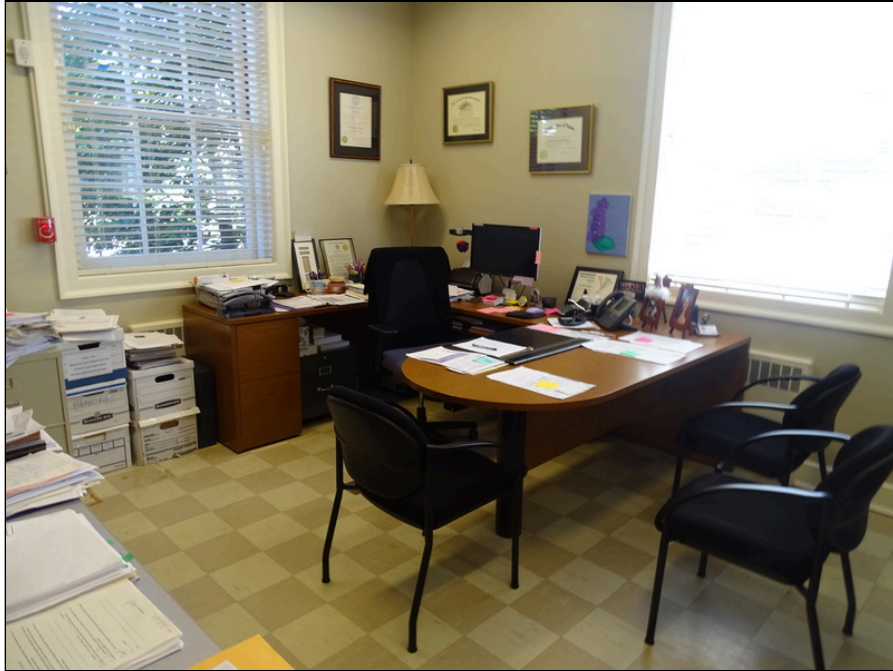
95 - Typical office area interior

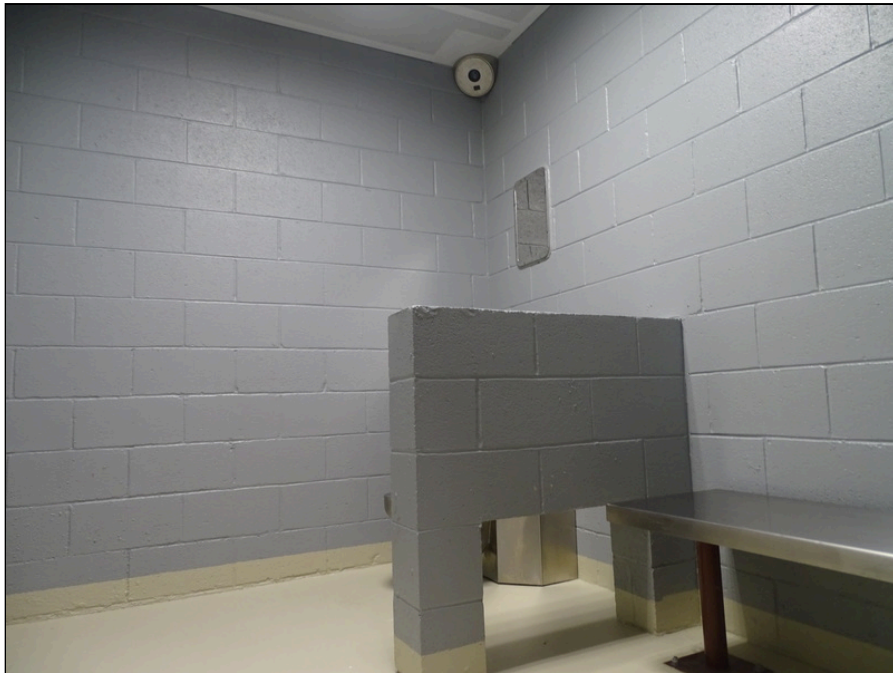
96 - Typical cell interior

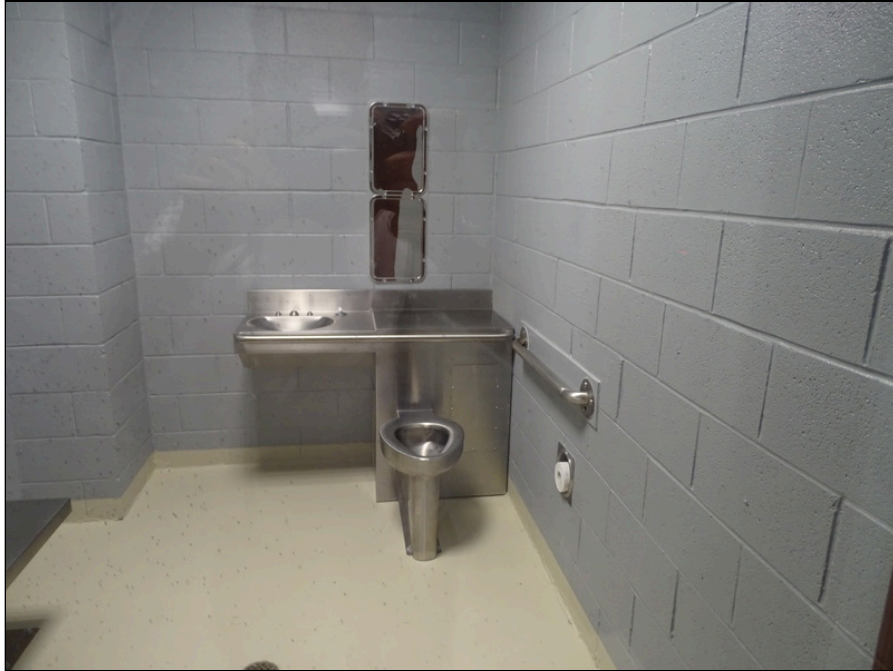
97 - Typical cell interior

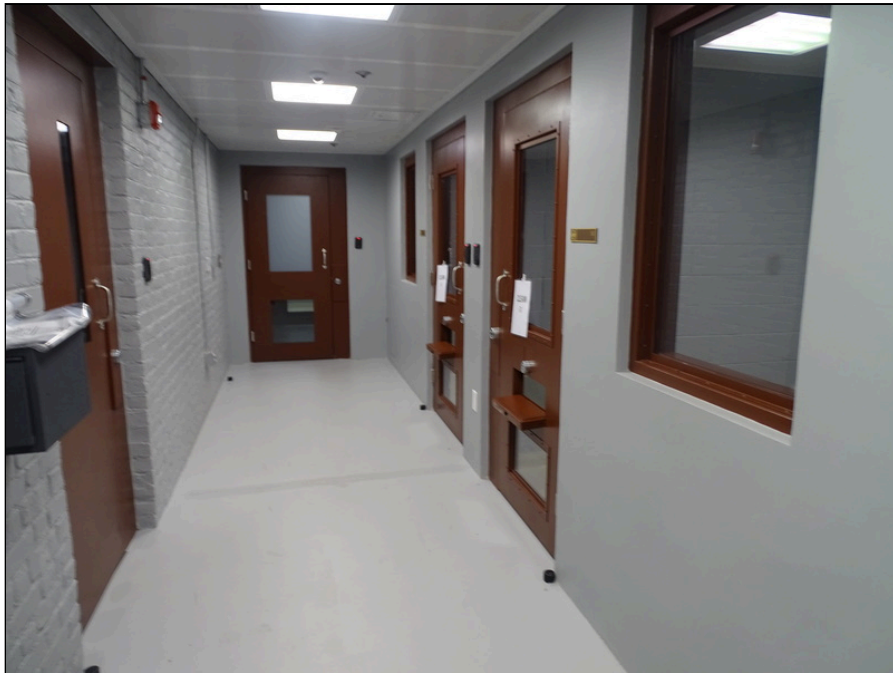
98 - Typical cell corridor

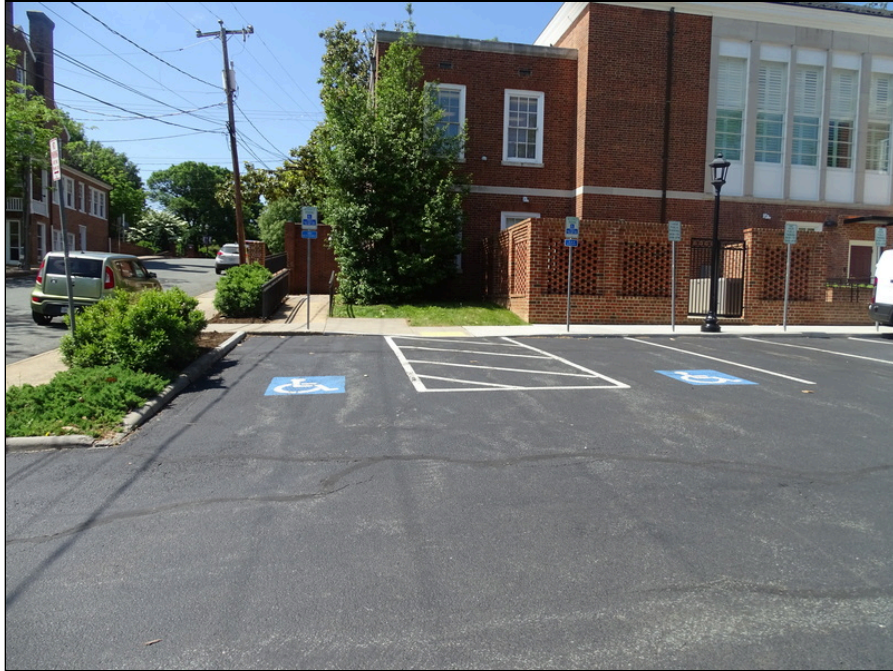
99 - Accessible parking spaces, aisle, and truncated domes

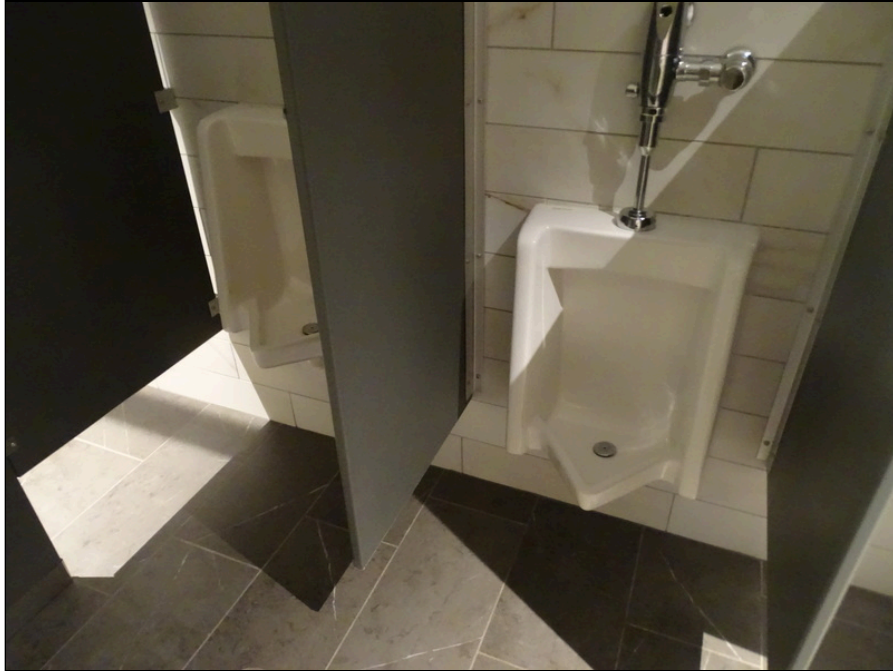
101 - Accessible restroom interiors

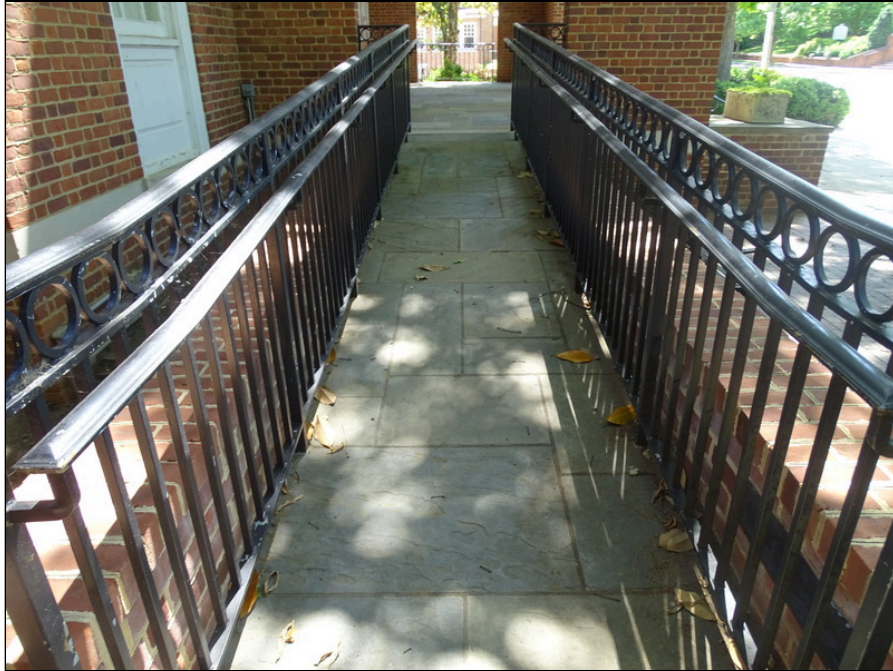
103 - Ramps at southwest side of site

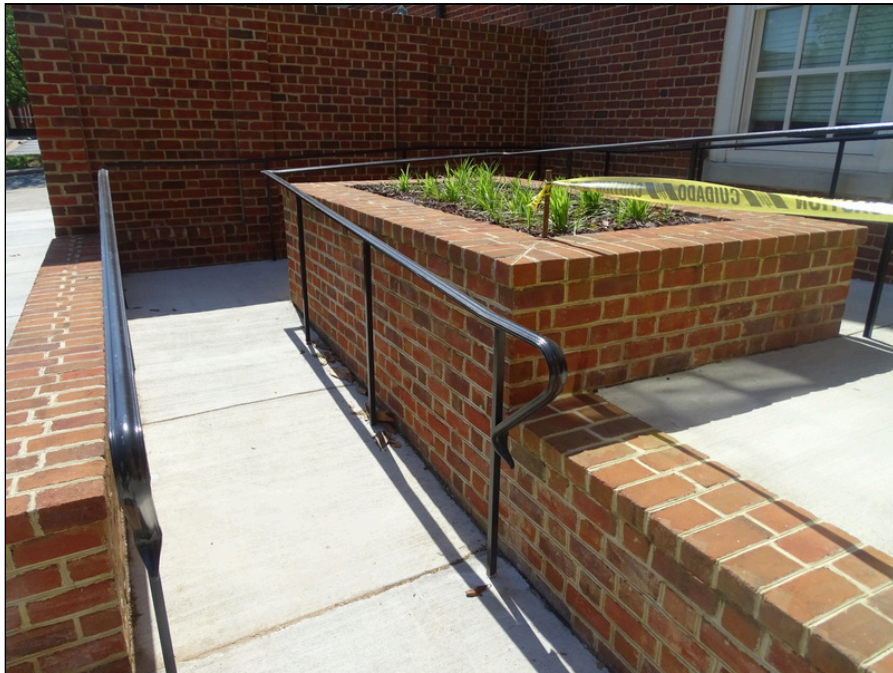
104 - Typical accessible ramp

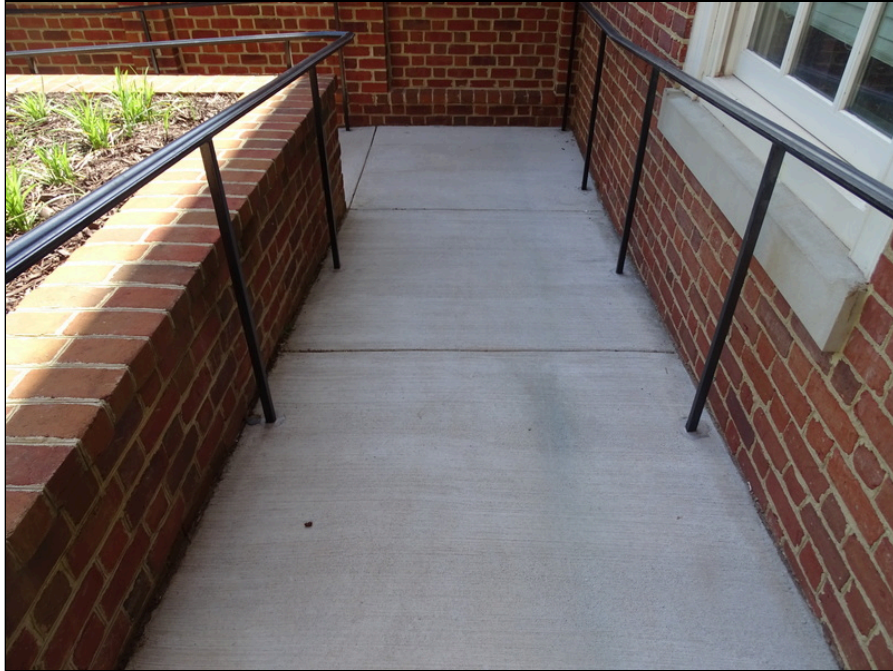
105 - Typical accessible ramp

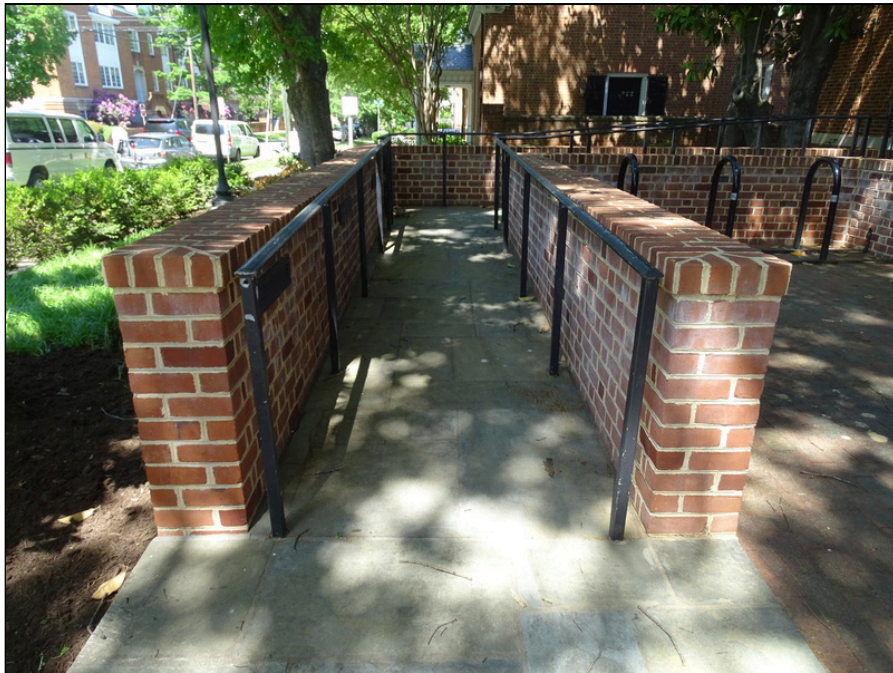
106 - Typical accessible ramp

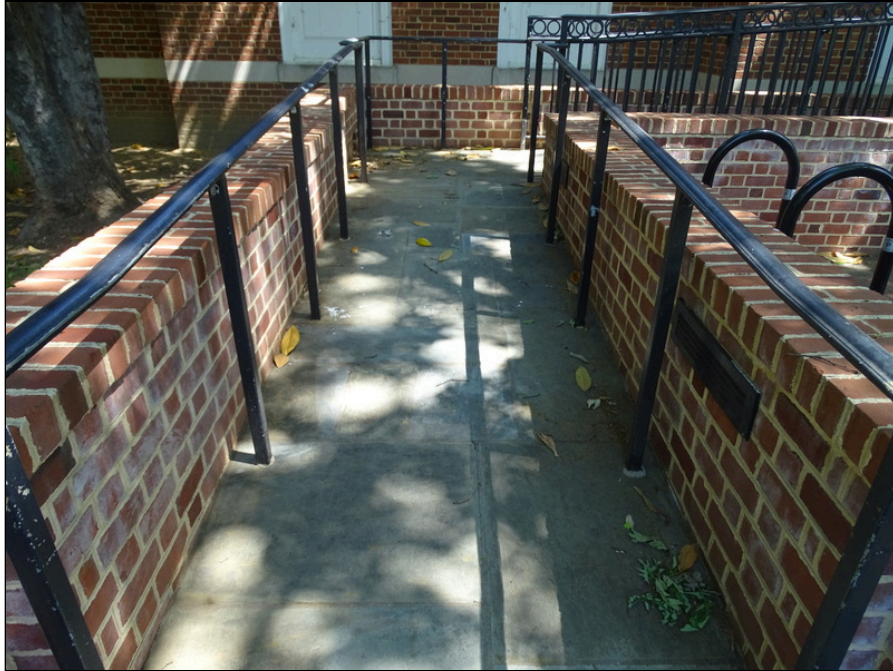
107 - Typical accessible ramp

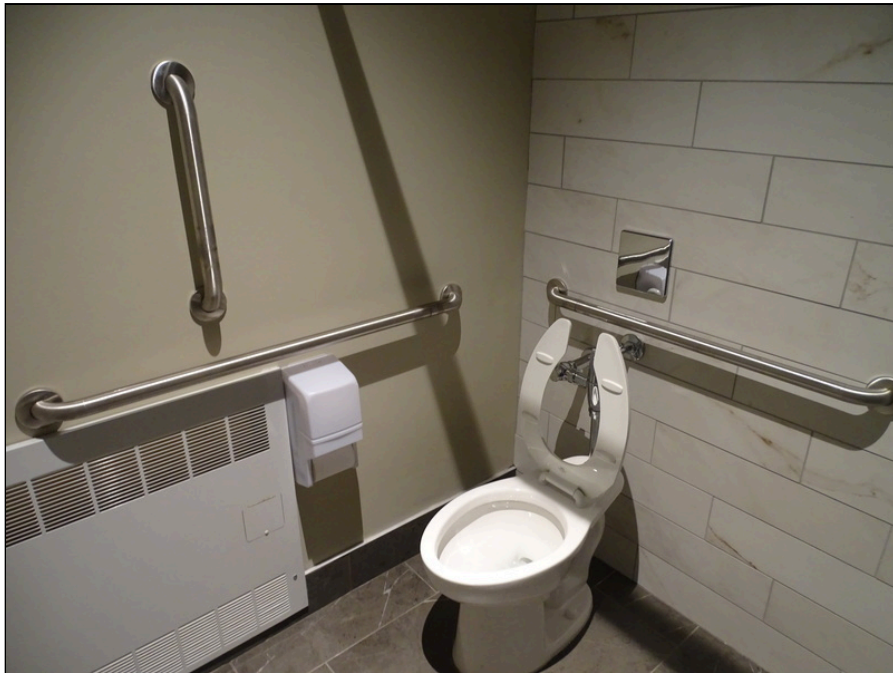
108 - Accessible restroom interiors

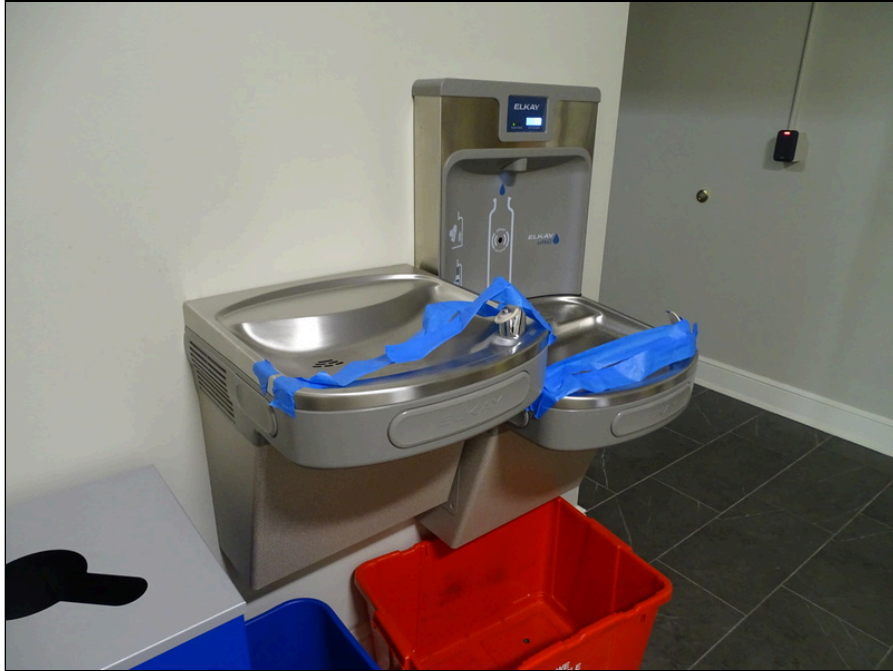
109 - Accessible drinking fountain
