CITY HALL
605 EAST MAIN STREET
CHARLOTTESVILLE, VIRGINIA

ECS PROJECT NO. 46:6713

CITY OF CHARLOTTESVILLE - FACILITIES DEVELOPMENT

Reference: Facility Condition Assessment Report for City Hall, 605 East Main Street, Charlottesville, Virginia

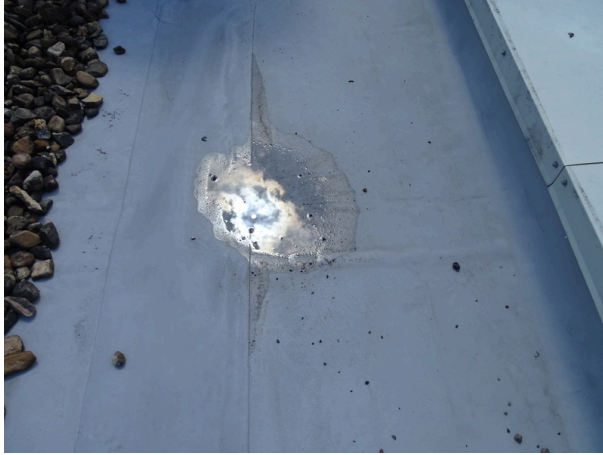
single-ply roofing system west side of the
building - note ponding

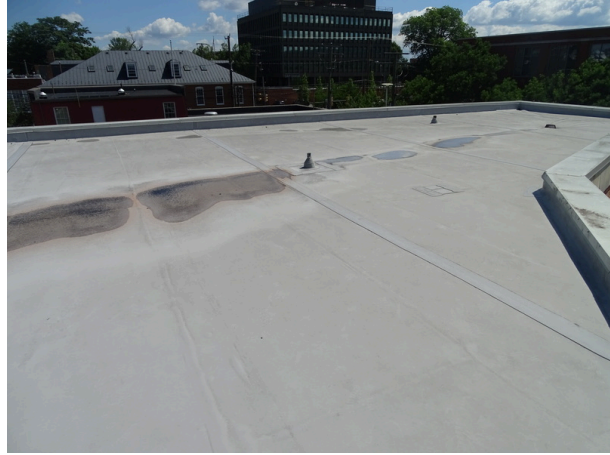
Single-ply roofing system east side of the
building - note ponding

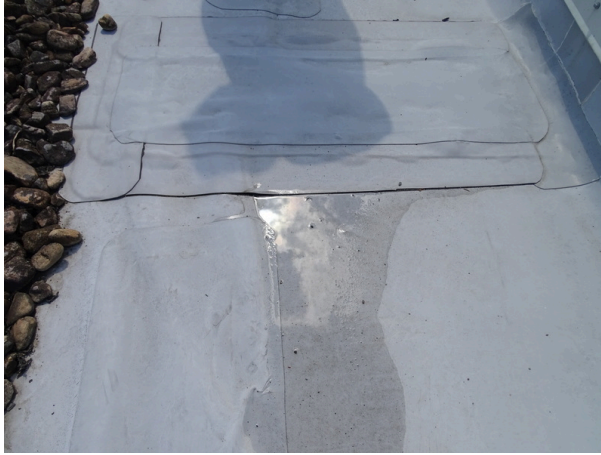
Typical patching

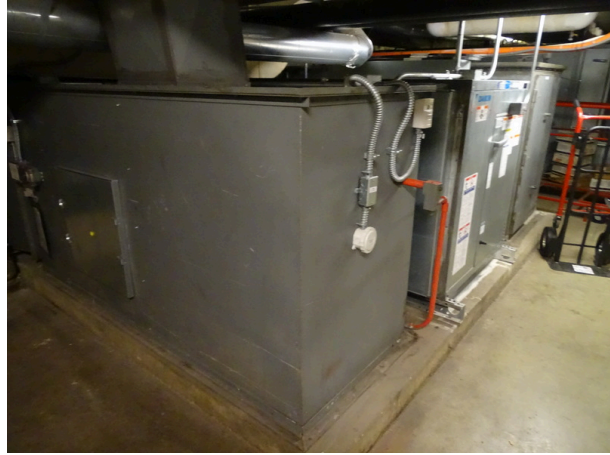
Typical older Air Handler Unit located in the City Hall Building

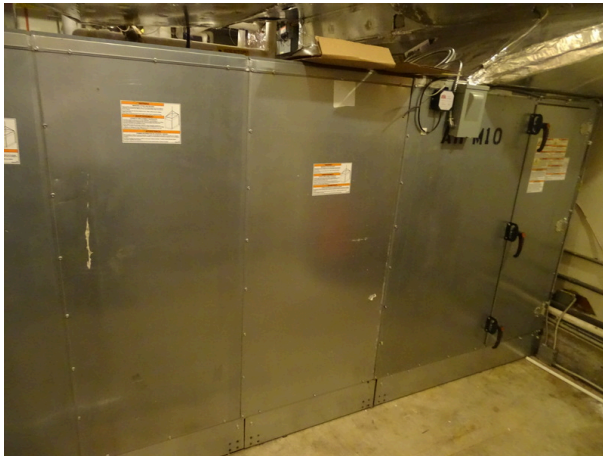
Typical older Air Handler Unit located in the City Hall Building

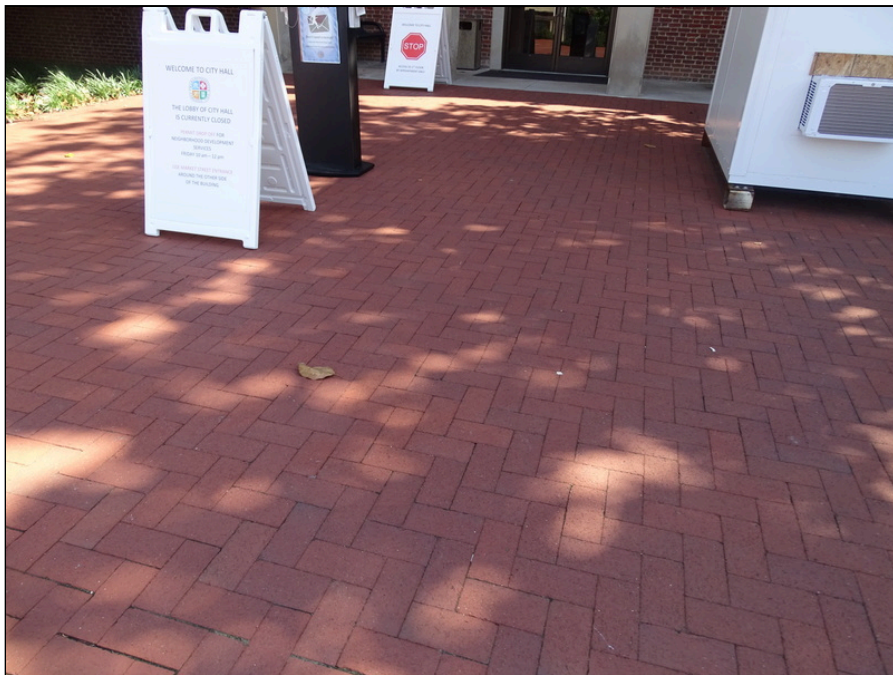
2 - Typical brick sidewalk

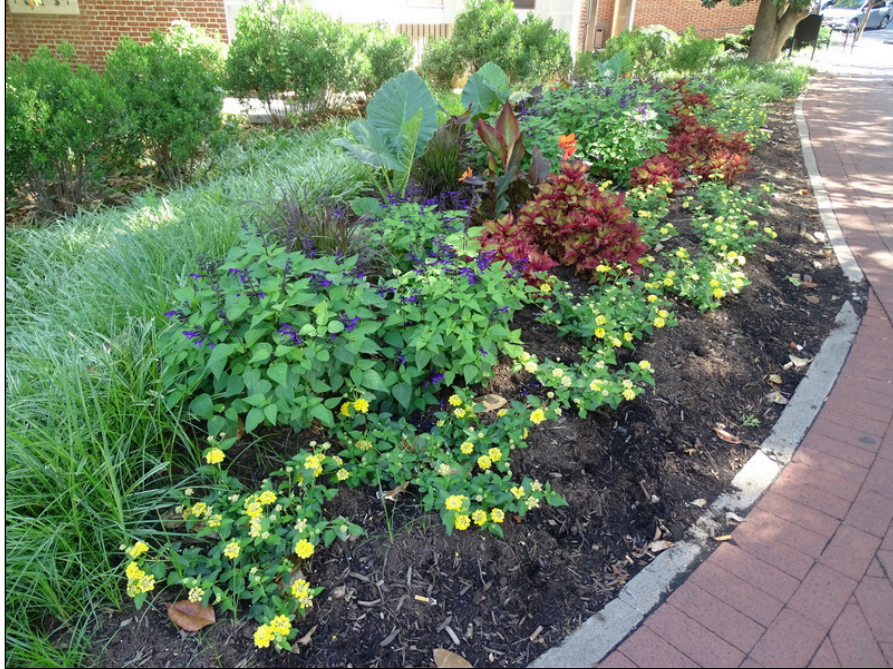
3 - Typical landscaping

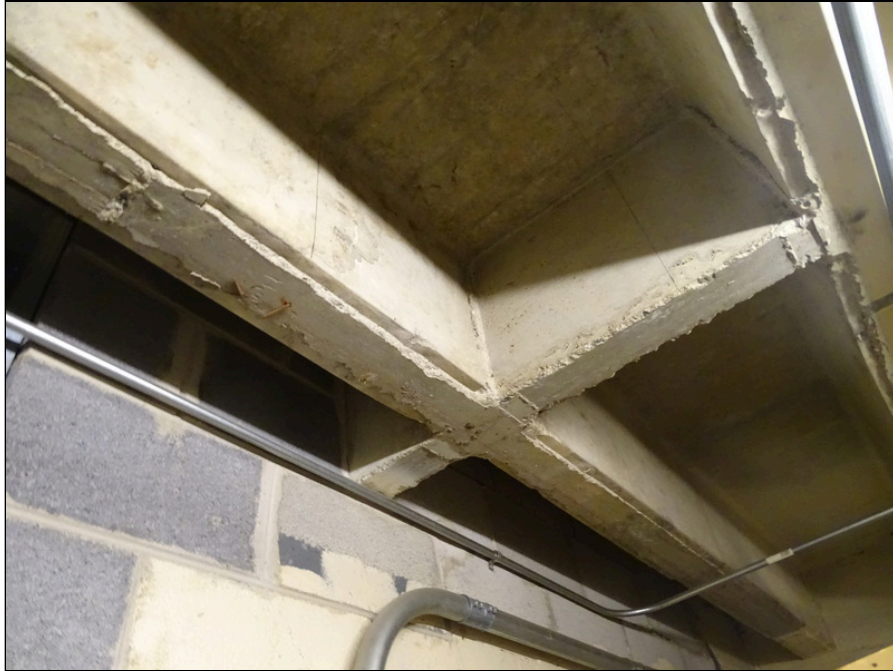
5 - Structural framing lower level

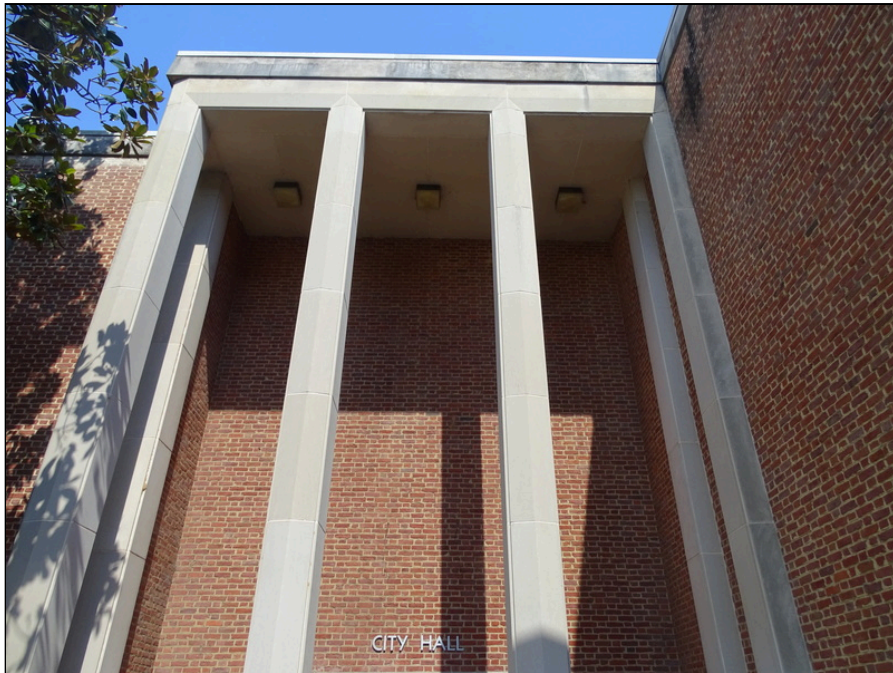
6 - City Hall building south entrance

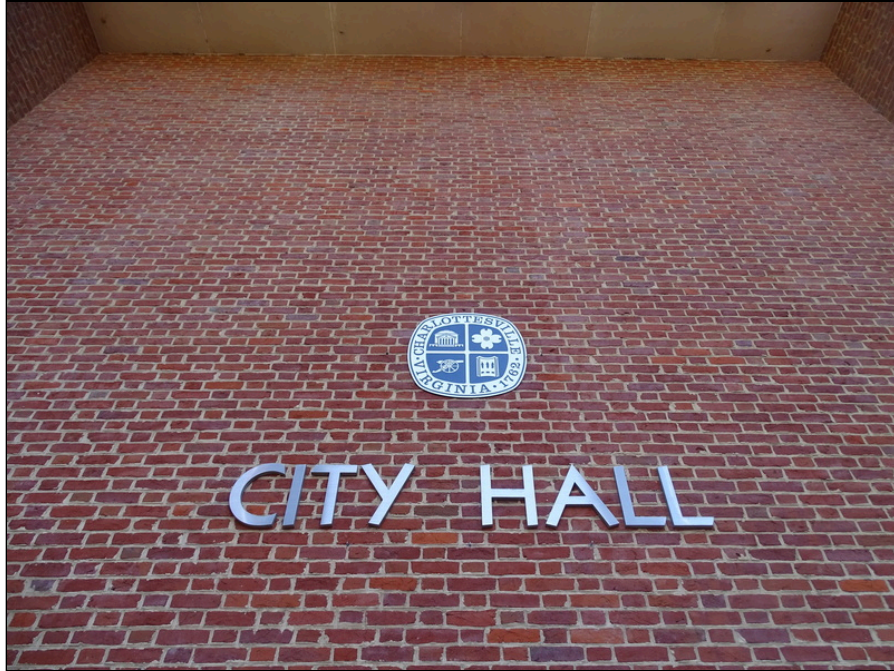
7 - Building exterior west side of the building

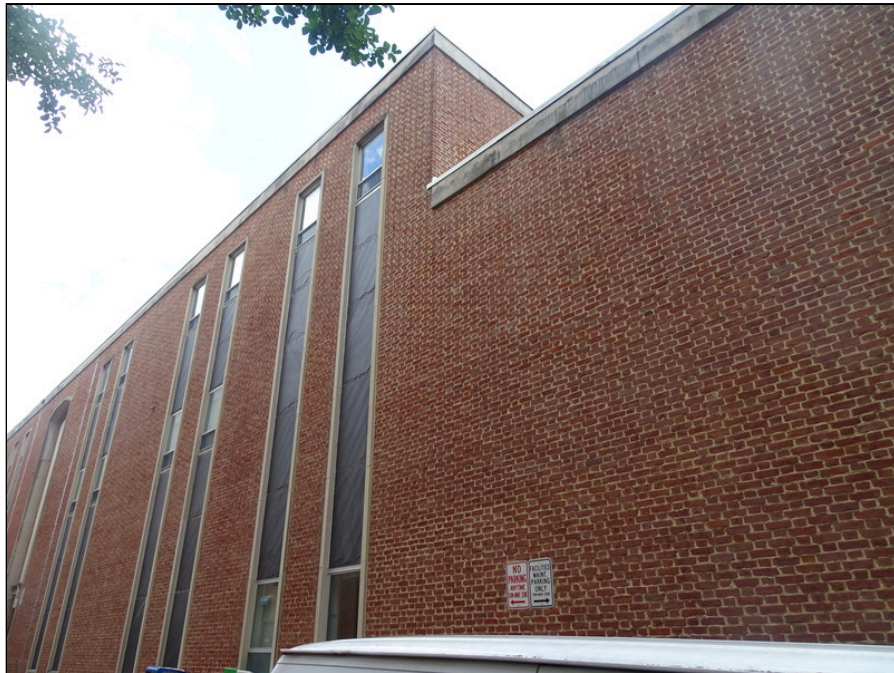
8 - Building exterior west side of the building

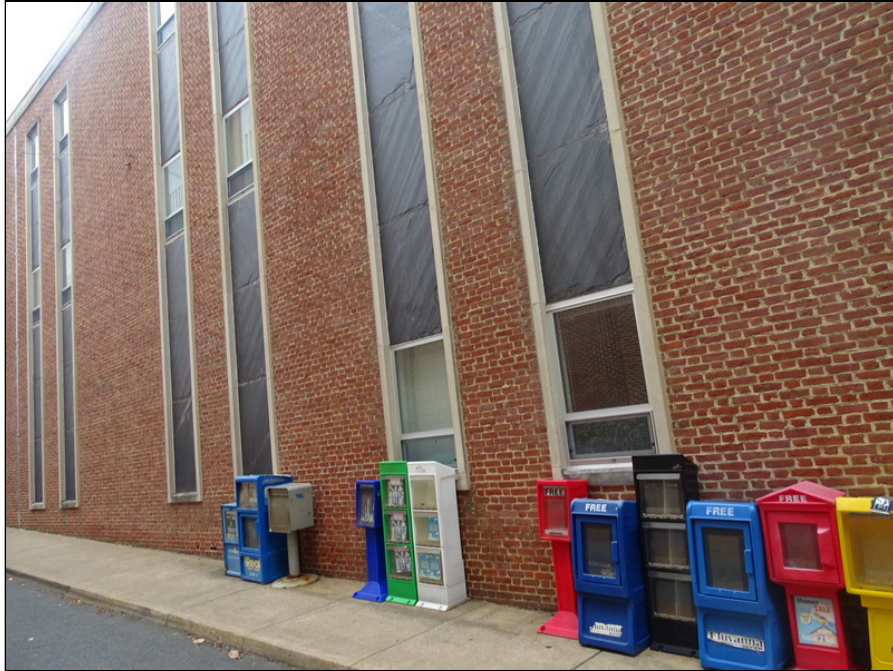
9 - Building exterior west side of the building

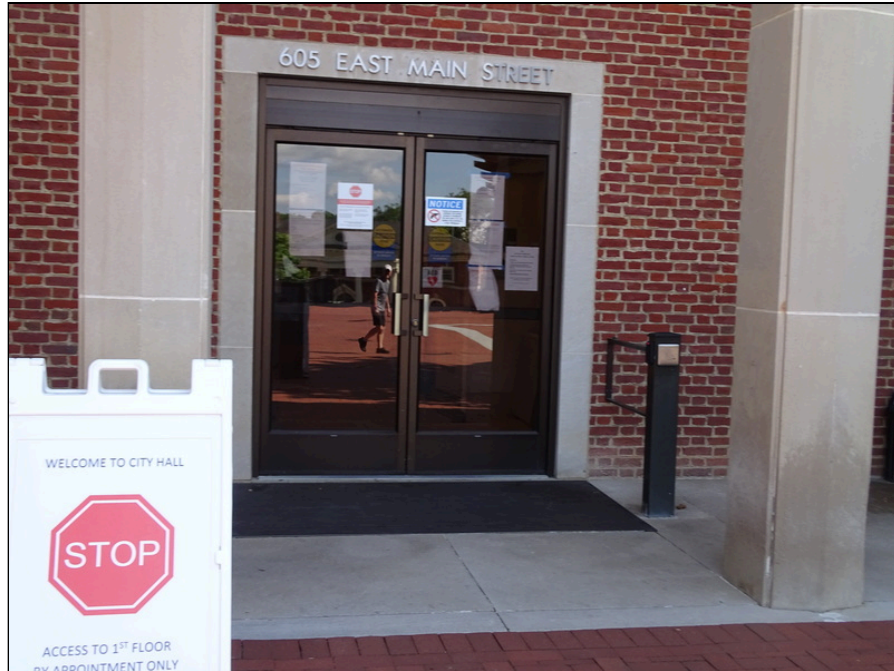
15 - Main entrance doors

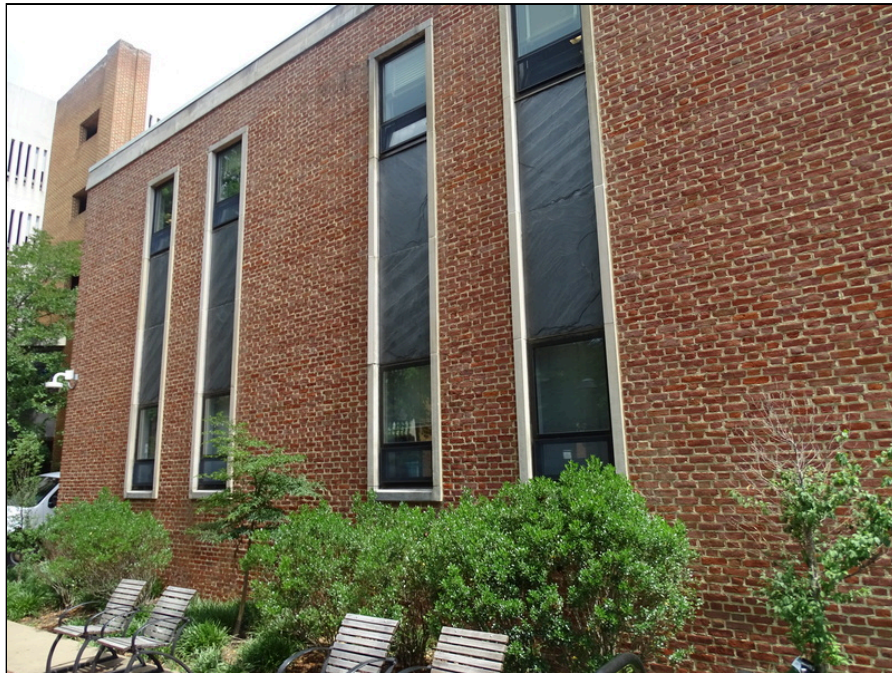
16 - Typical exterior window

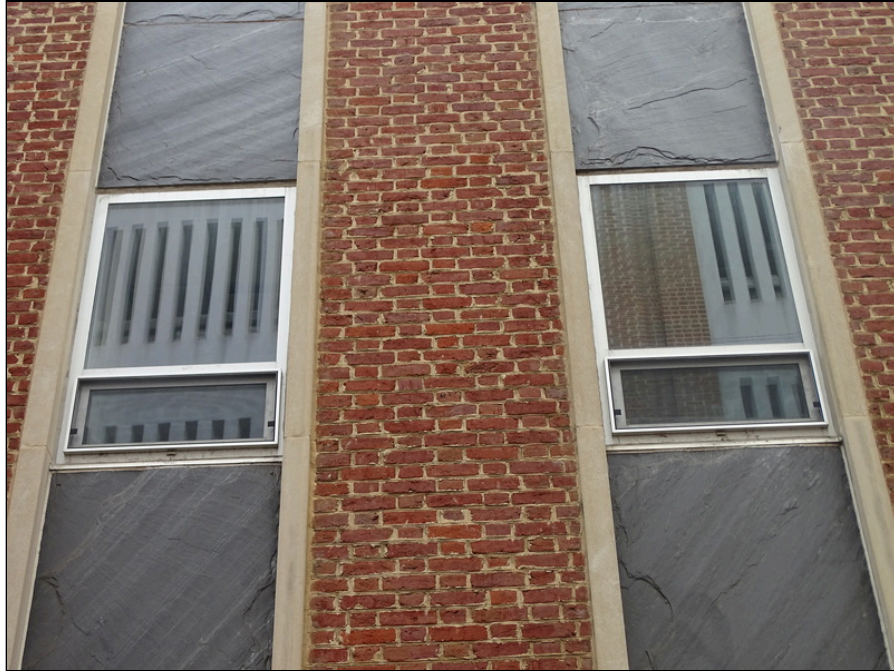
17 - Typical exterior window

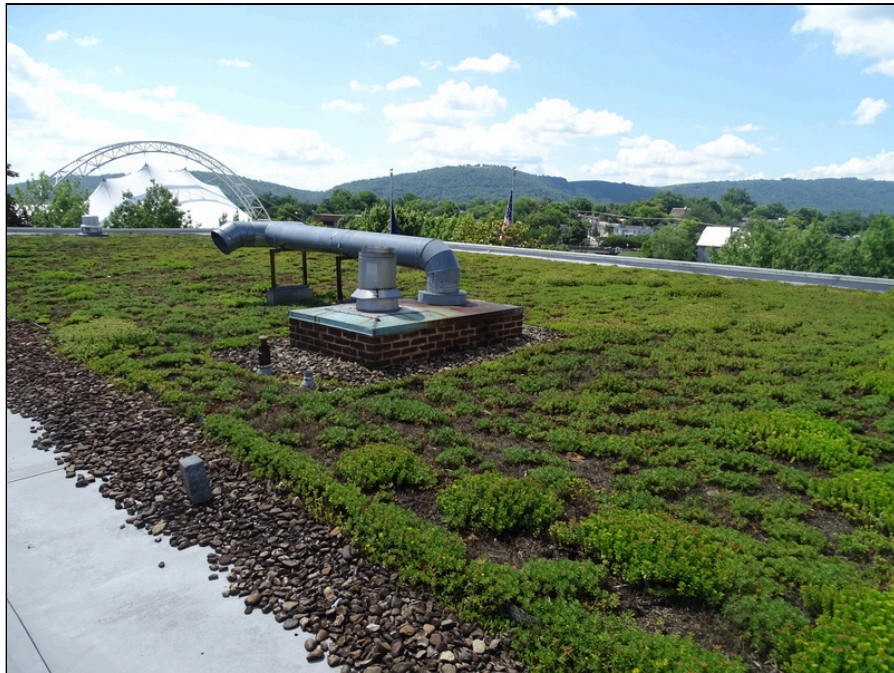
18 - Green Roofing System west side of the building

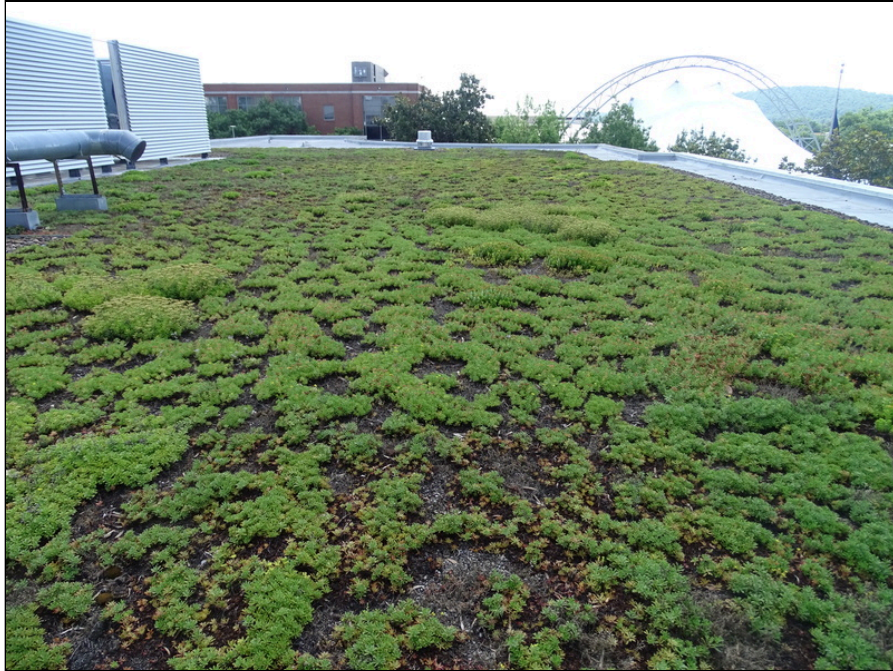
19 - Green Roofing System west side of the building

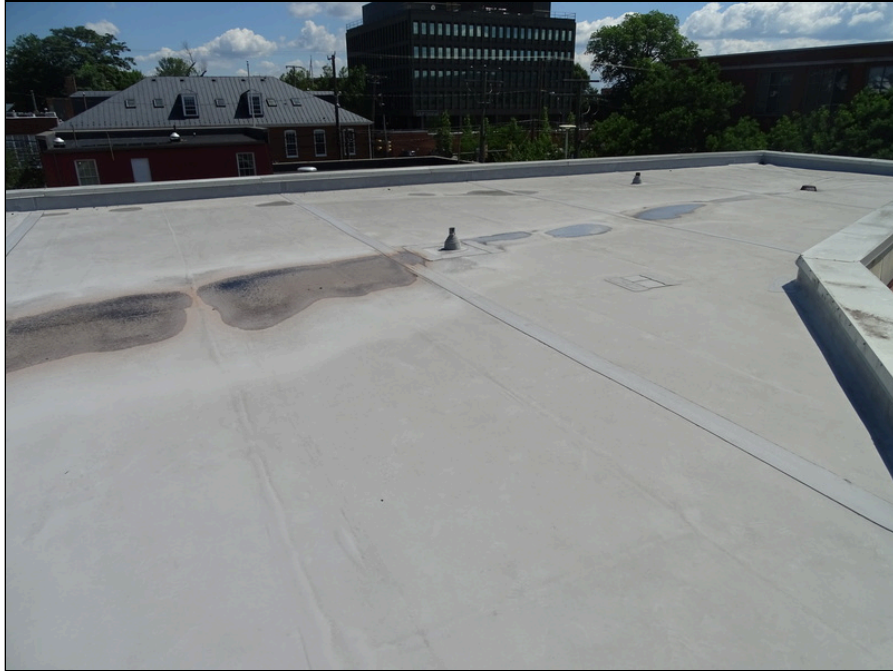
21 - Single-ply roofing system east side of the building - note ponding

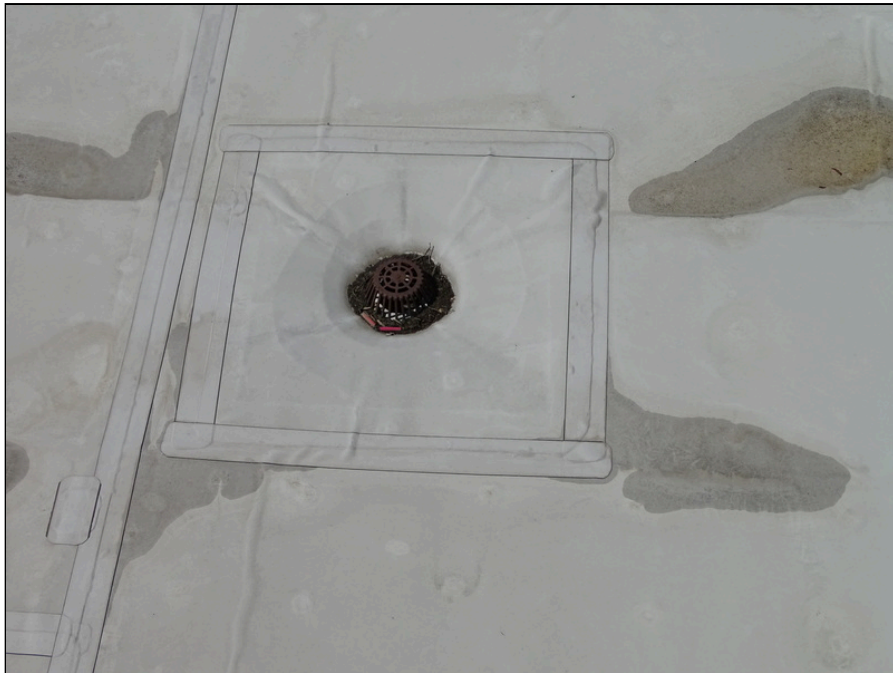
22 - Typical internal drain

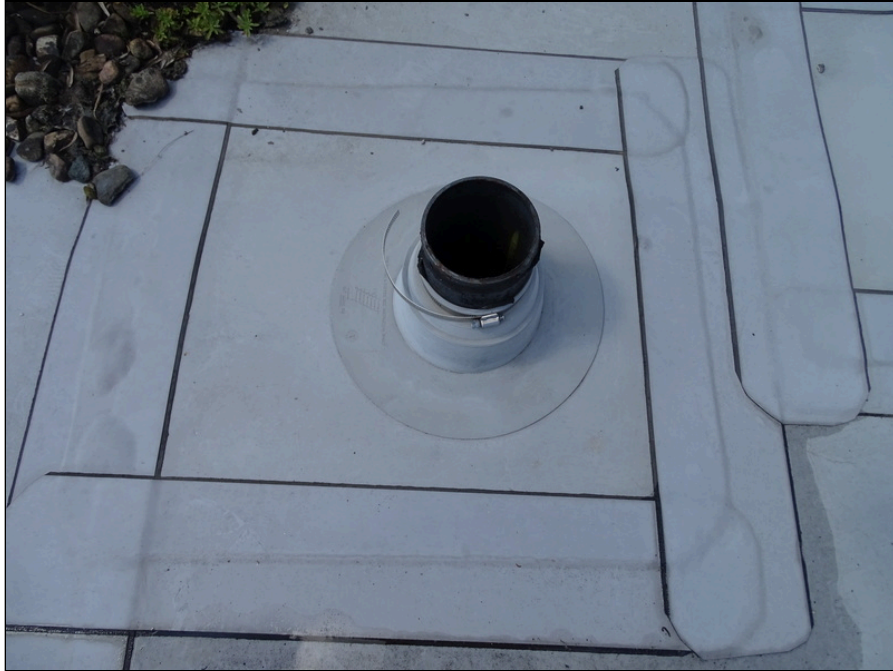
23 - Typical plumbing penetration

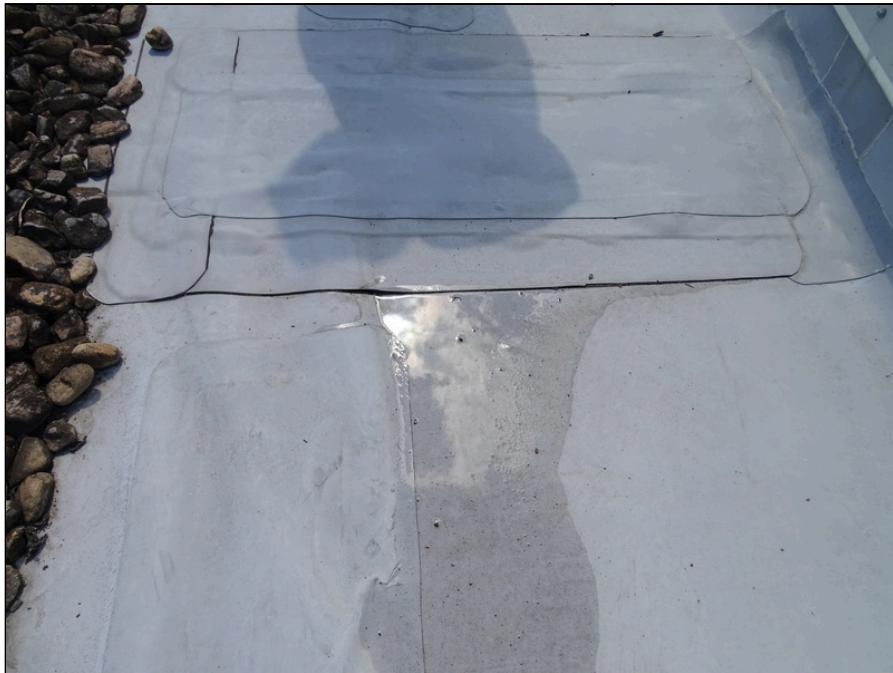
24 - Typical patching

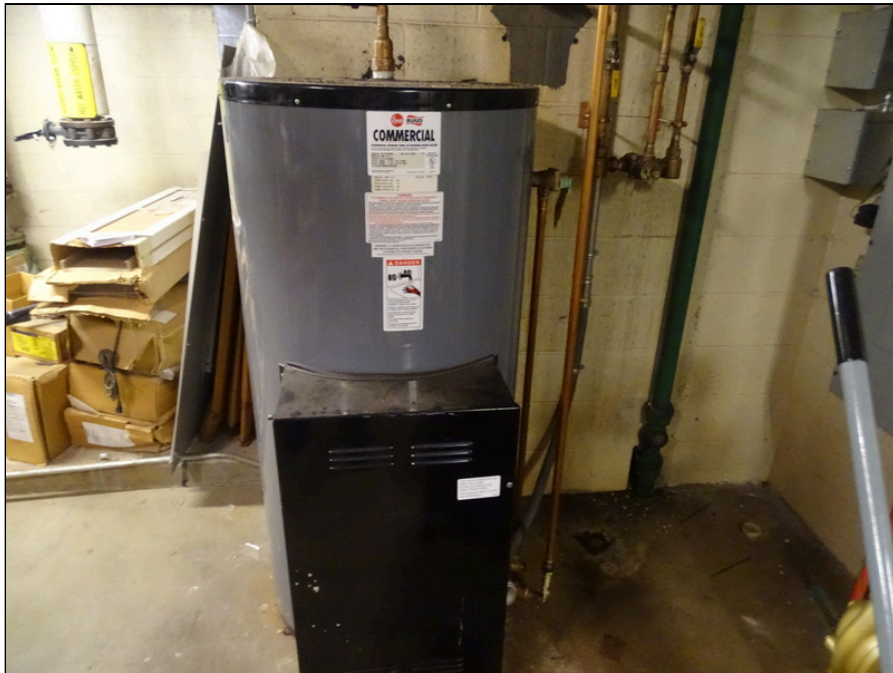
26 - Electric water heater located in main utility room

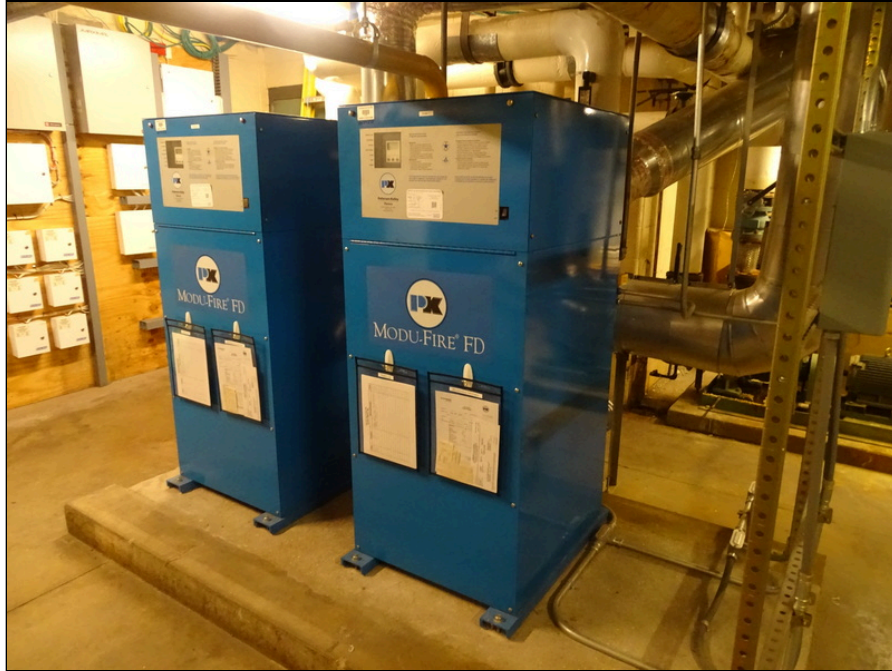
27 - Boilers located in the City Hall Building

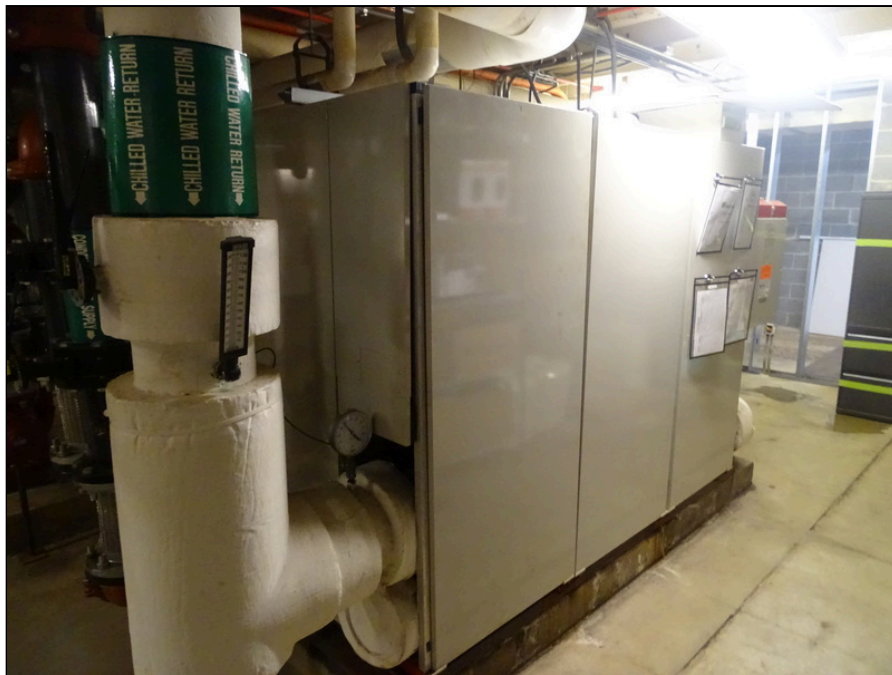
28 - Chiller located in the City Hall Building

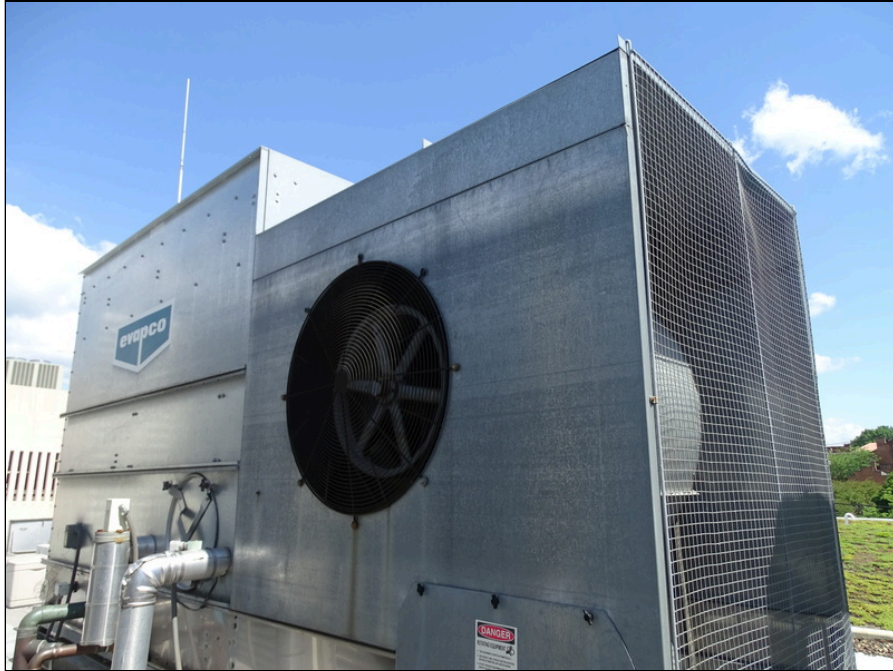
29 - Cooling Towers located on the roof of City Hall Building

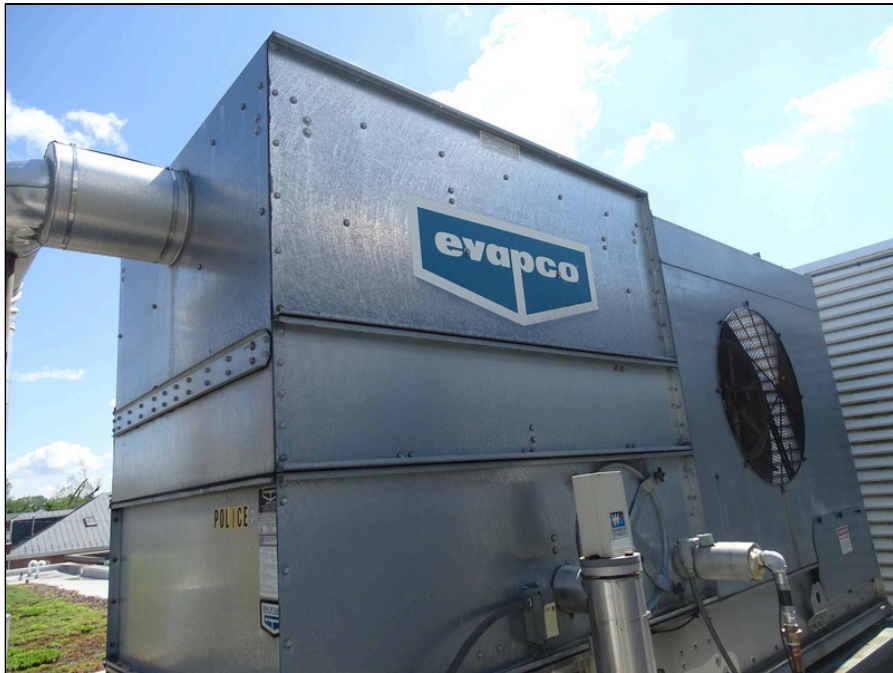
30 - Cooling Towers located on the roof of City Hall Building

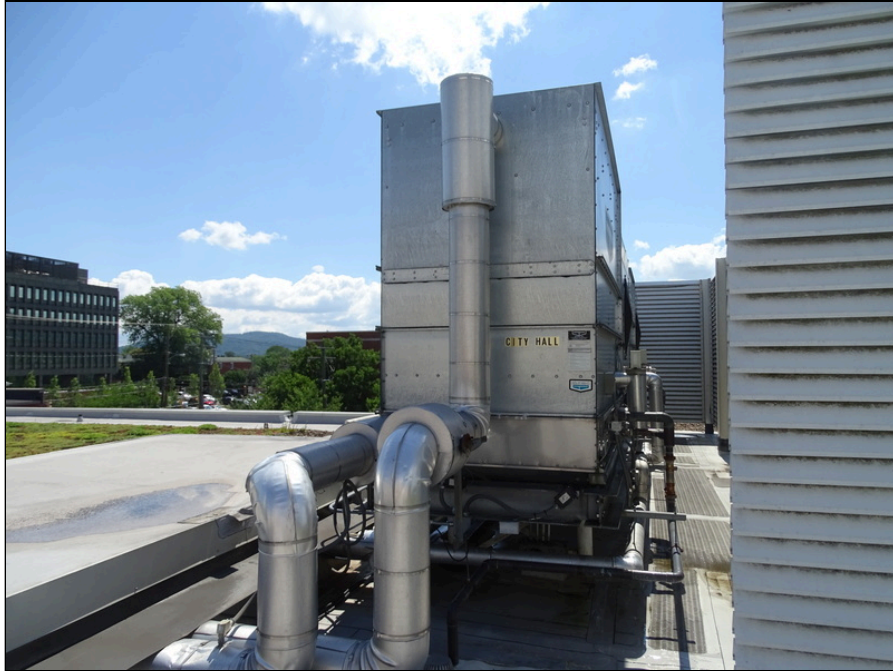
31 - Cooling Towers located on the roof of City Hall Building

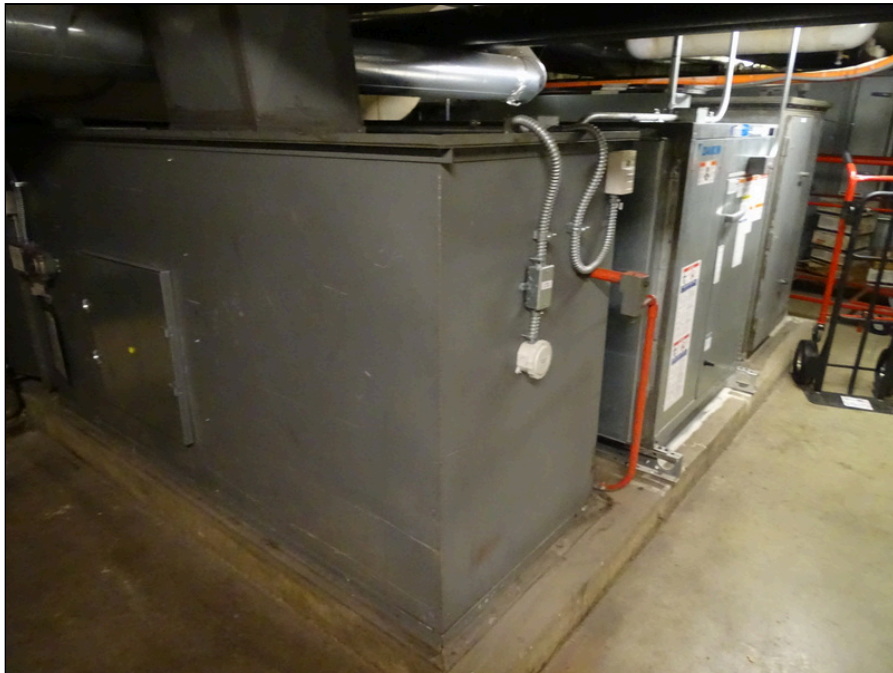
32 - Typical older Air Handler Unit located in the City Hall Building

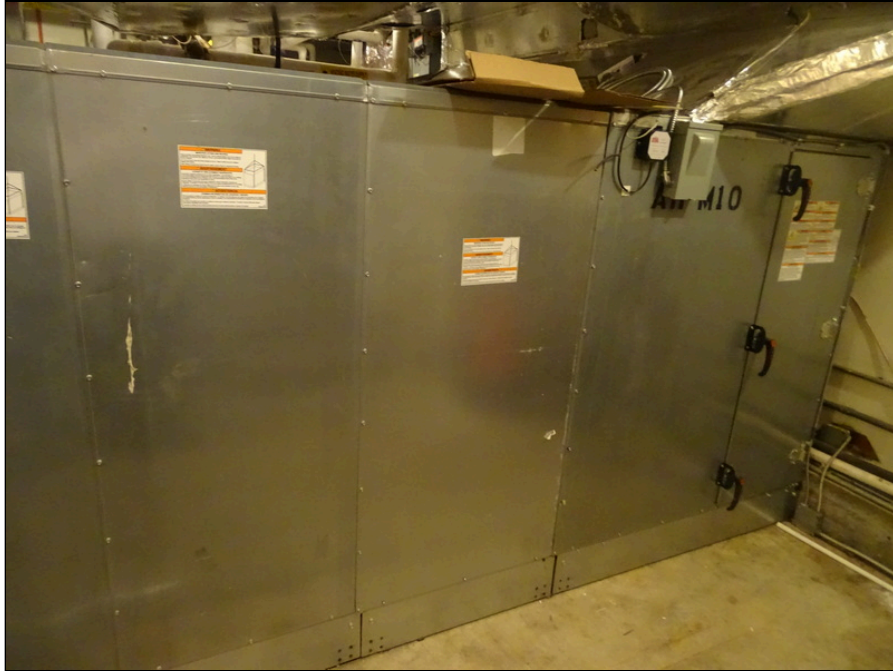
33 - Typical older Air Handler Unit located in the City Hall Building

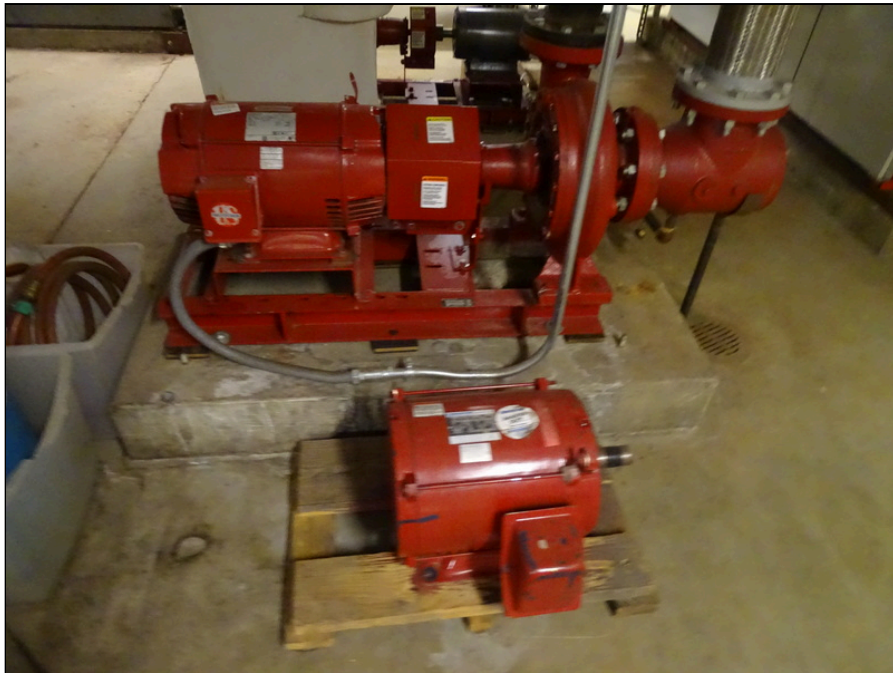
34 - Typical Central Plant Pumps located in the City Hall Building

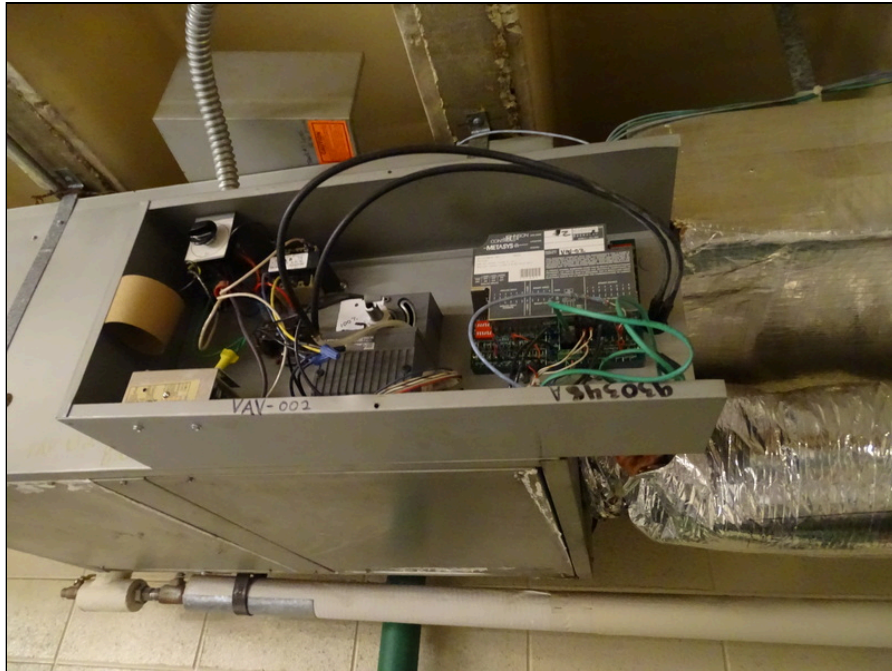
35 - Typical VAV Box

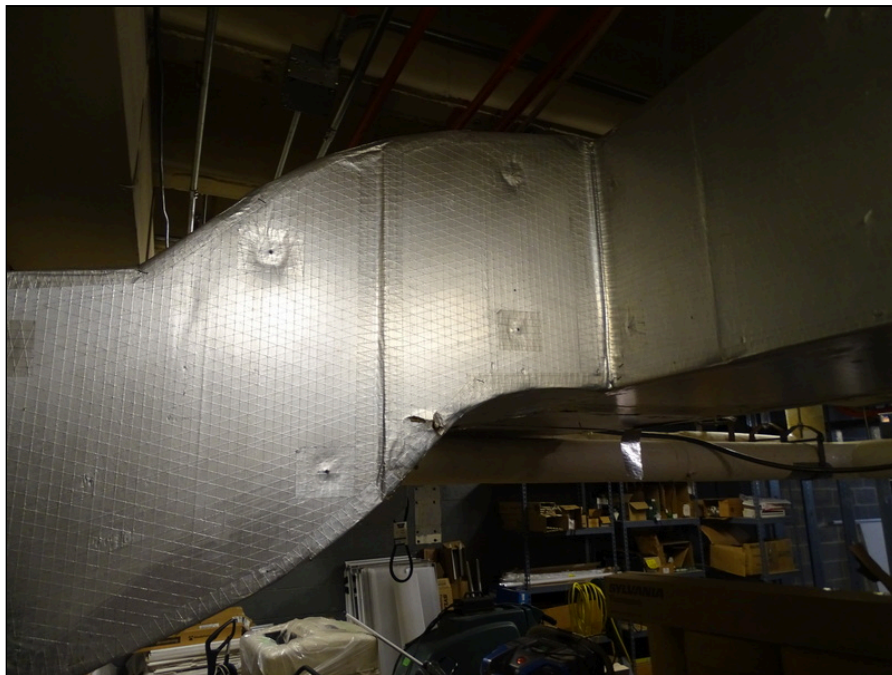
36 - Typical mechanical duct

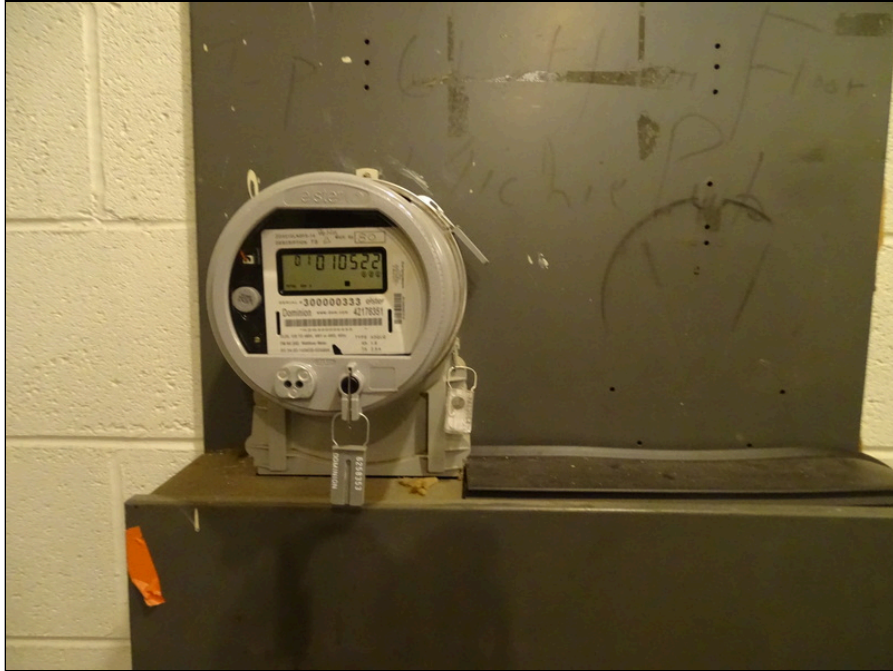
37 - Typical meter

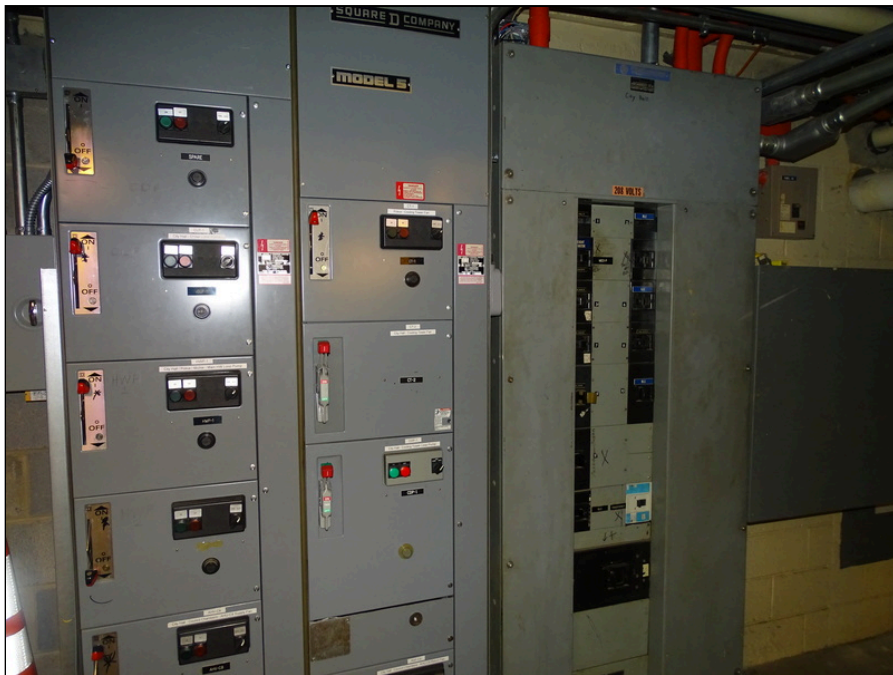
38 - Main electrical switchgear

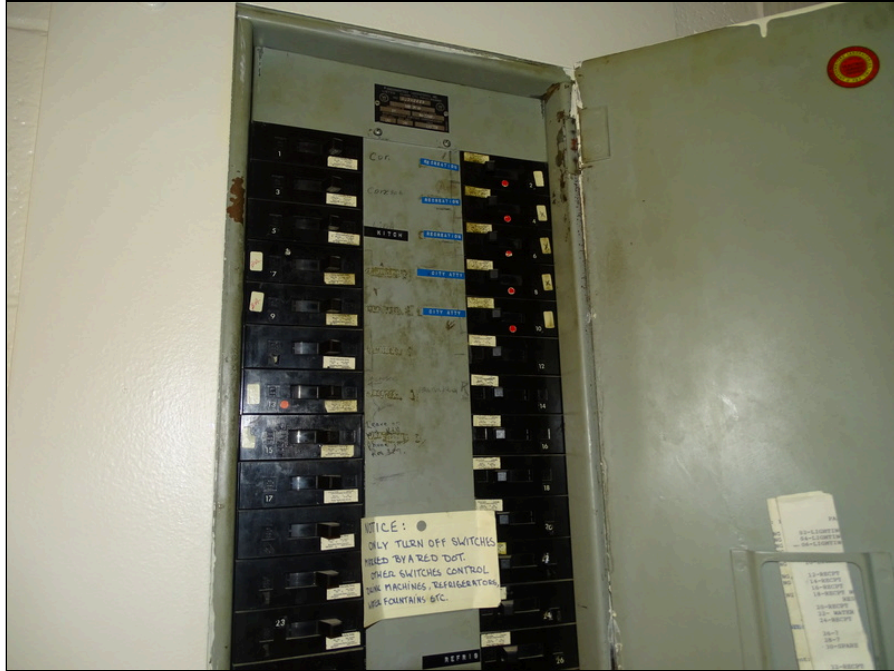
39 - Typical electrical circuit breaker panel

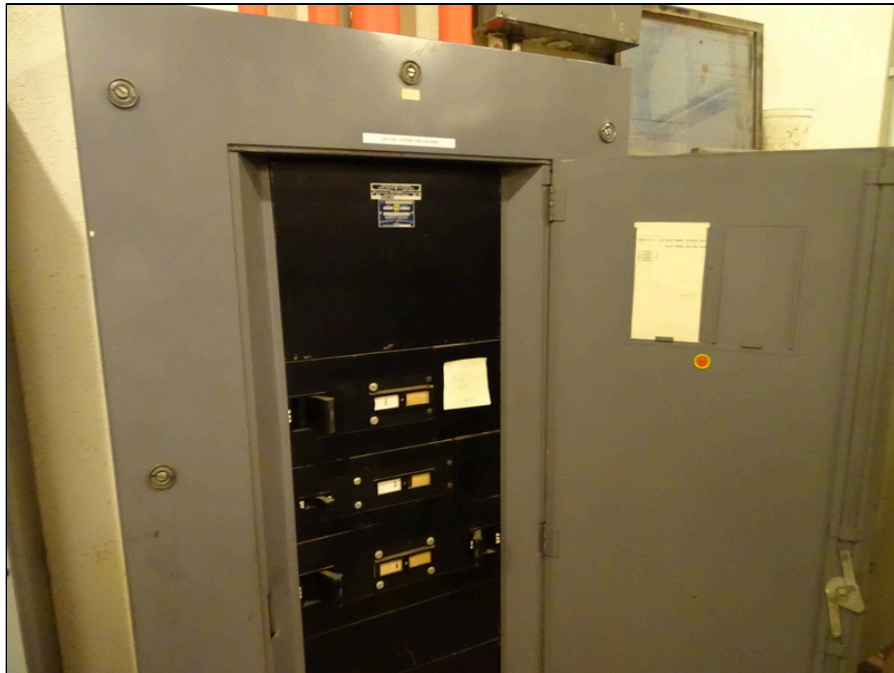
40 - Electric panel

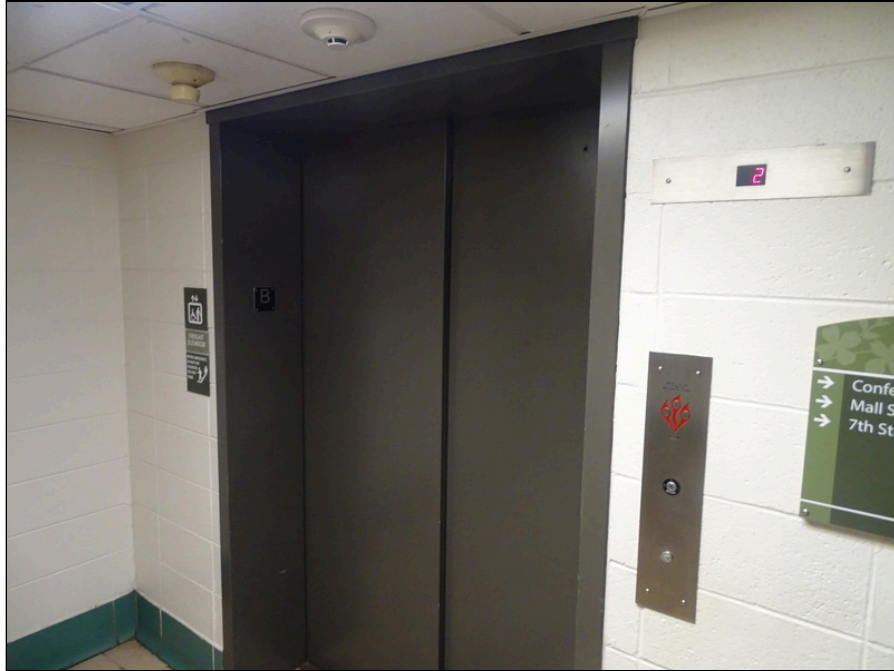
41 - Freight elevator system

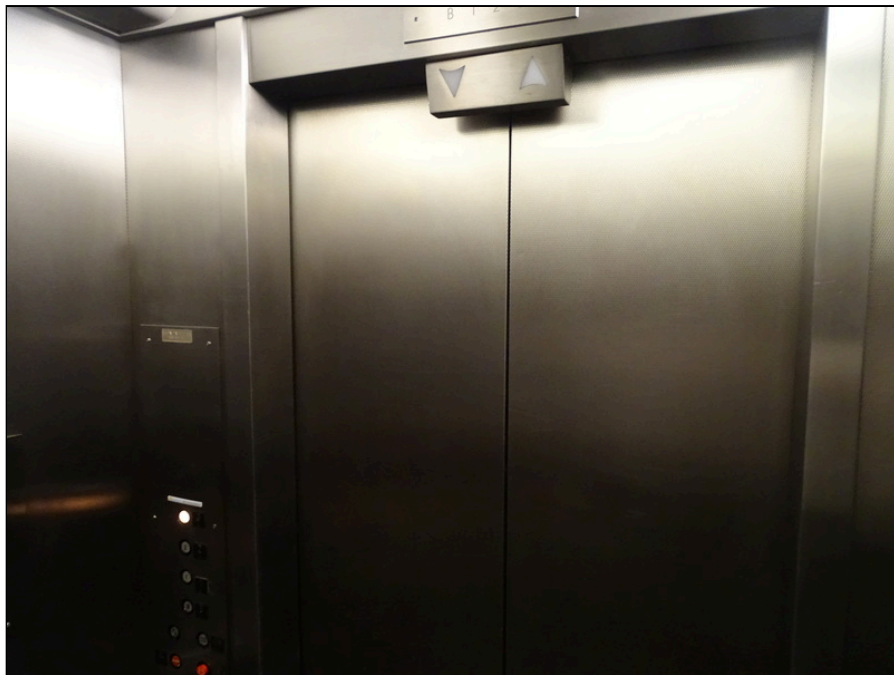
42 - Passenger elevator cab finishes

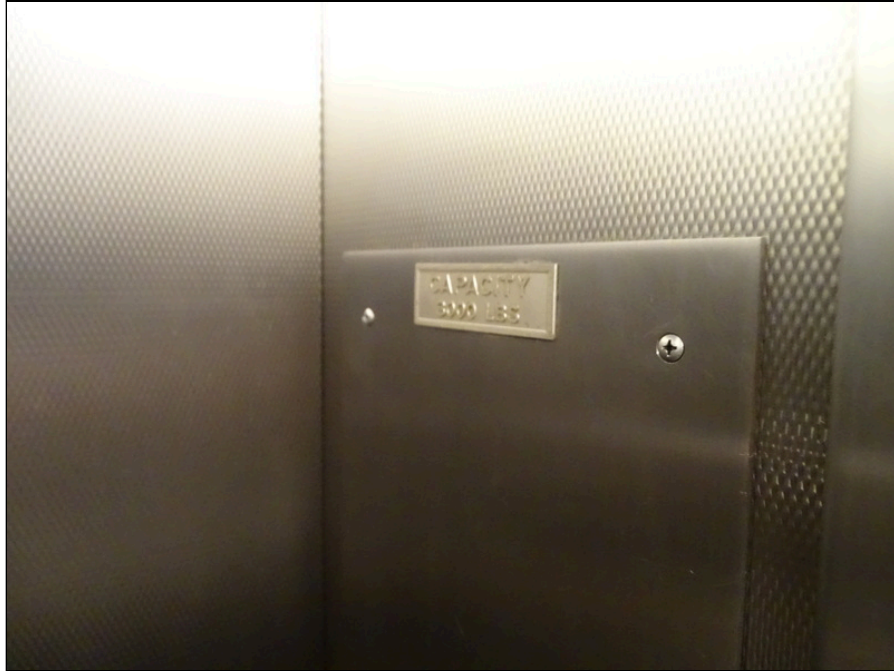
43 - Passenger elevator cab finishes

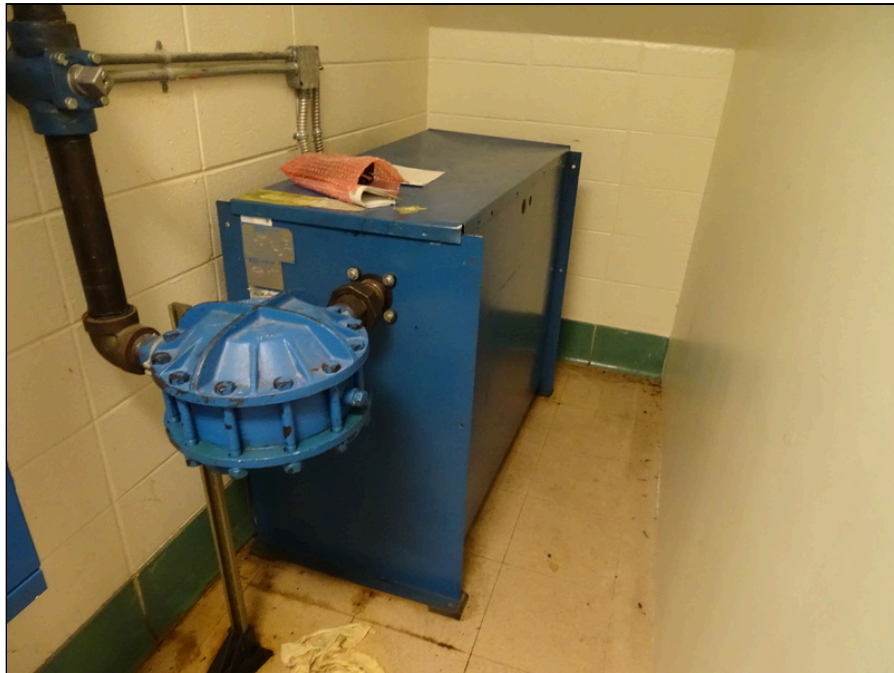
44 - Passenger elevator machine
