CITY HALL
605 EAST MAIN STREET
CHARLOTTESVILLE, VIRGINIA

ECS PROJECT NO. 46:6713

CITY OF CHARLOTTESVILLE - FACILITIES DEVELOPMENT

Reference: Facility Condition Assessment Report for City Hall, 605 East Main Street, Charlottesville, Virginia

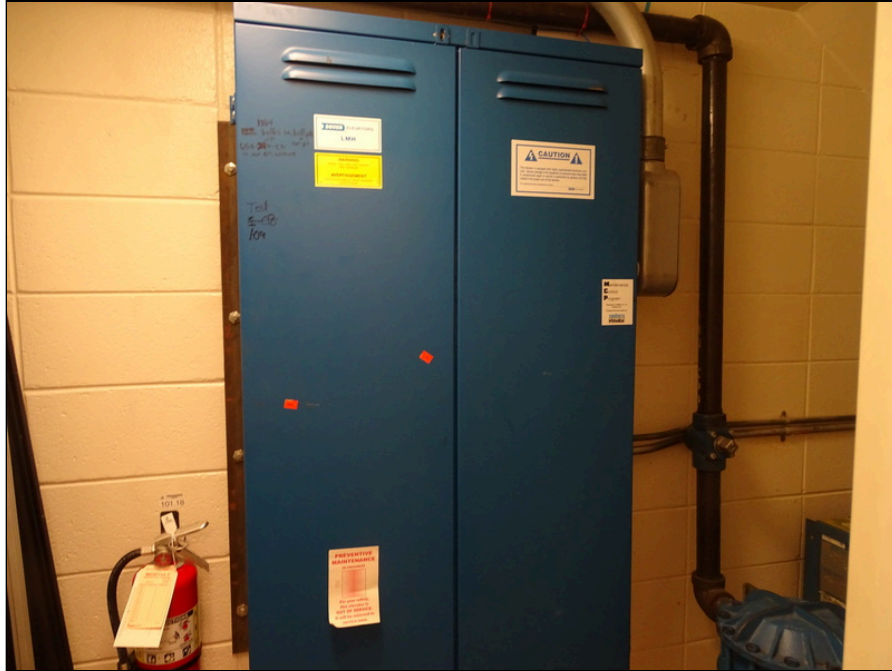
45 - Passenger elevator controls

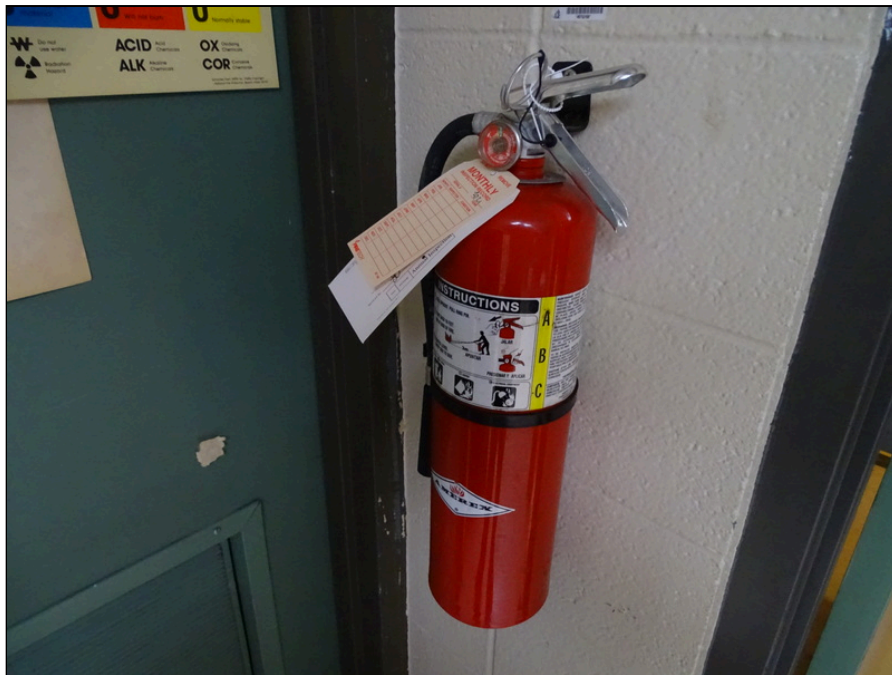
46 - Typical fire extinguisher

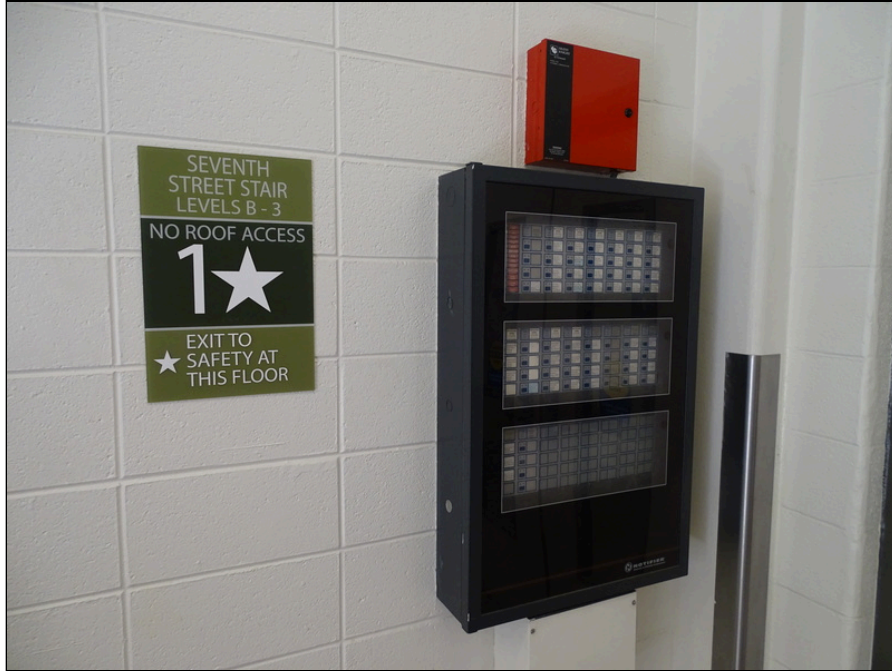
47 - Fire alarm annunciator and control panel

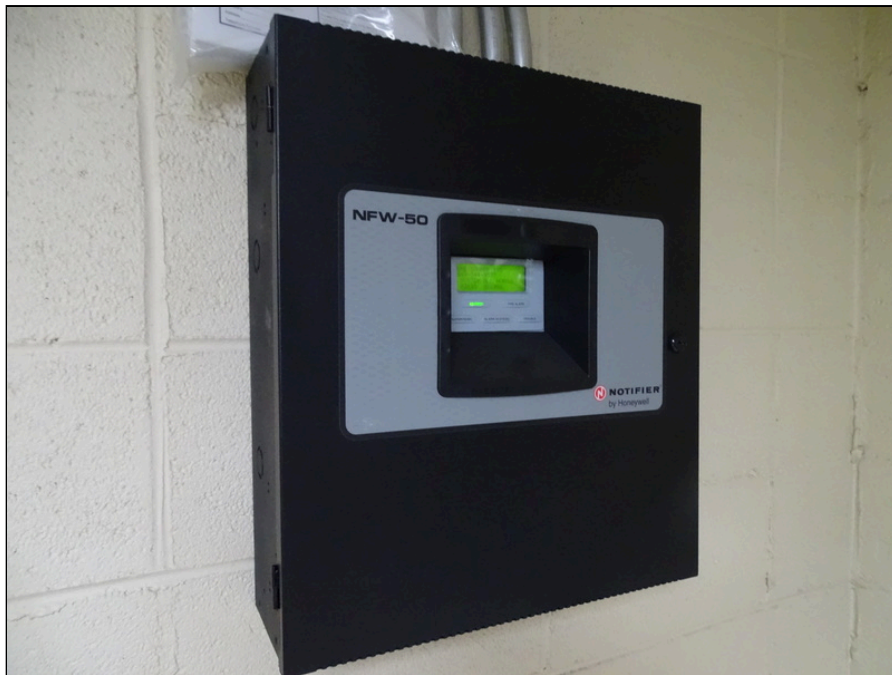
48 - Fire alarm notifier electronics

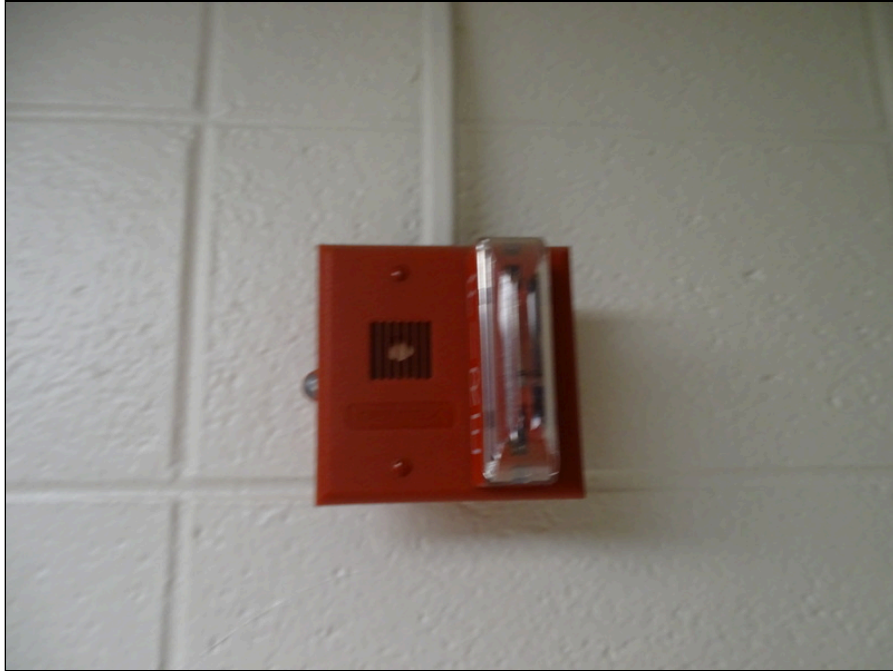
49 - Typical fire alarm bell and strobe

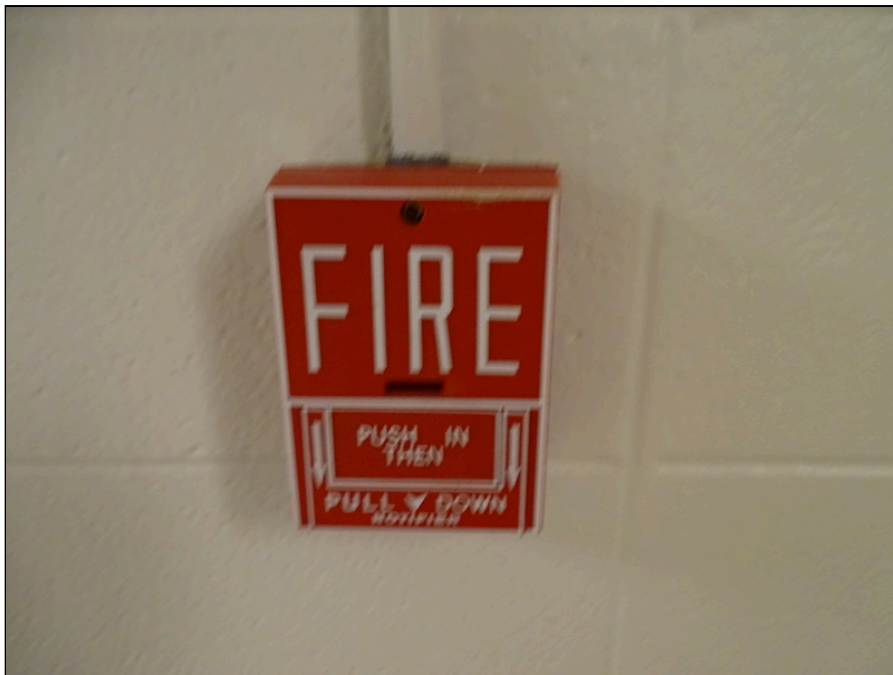
50 - Typical fire alarm pull station

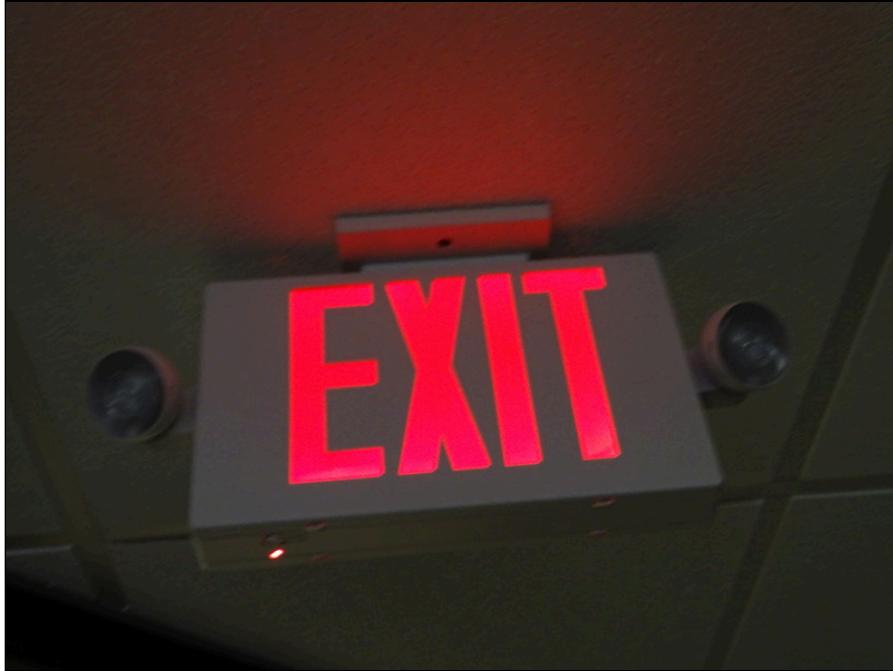
51 - Typical exit sign

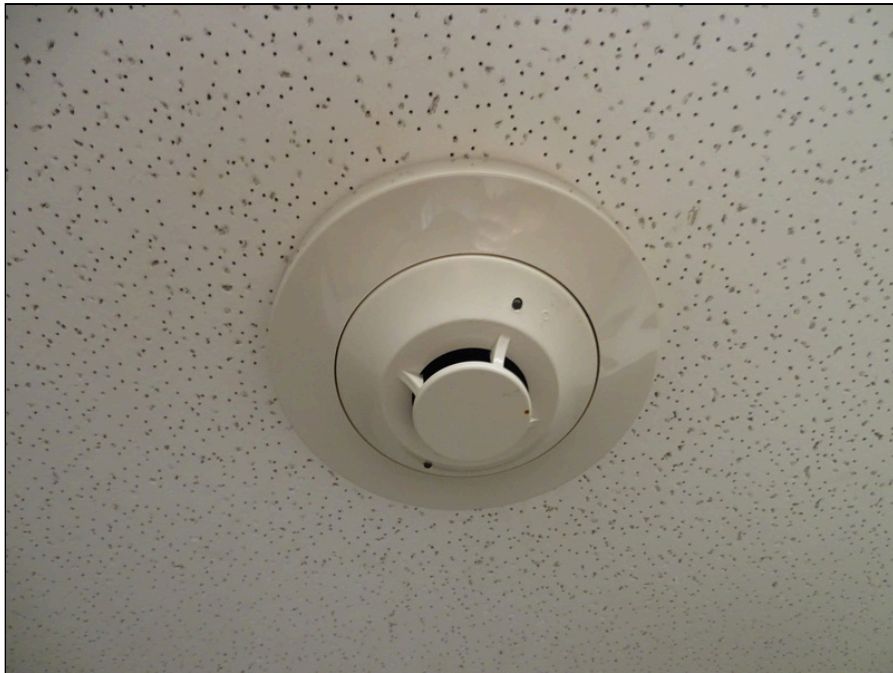
52 - Typical smoke detector

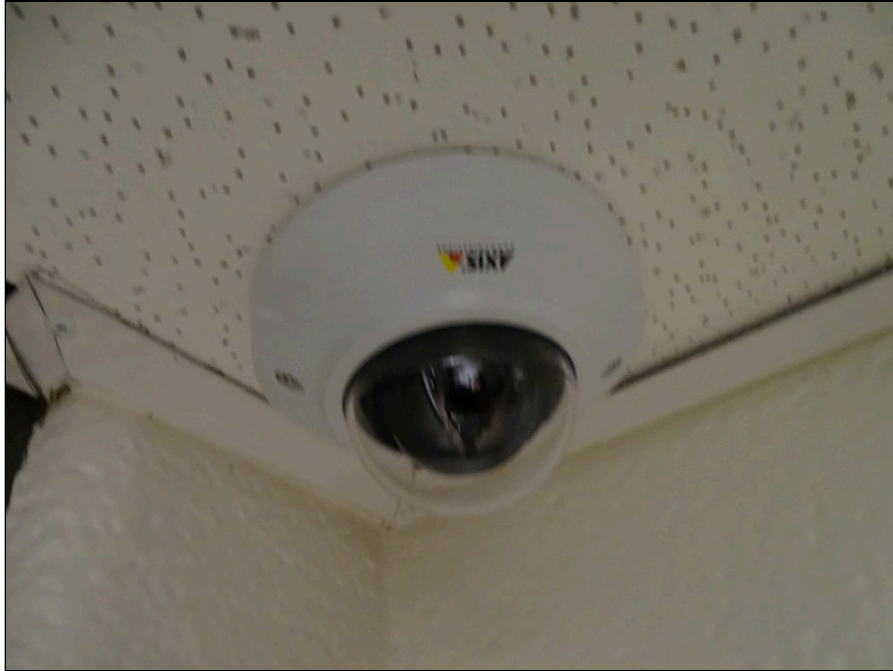
53 - Typical security camera

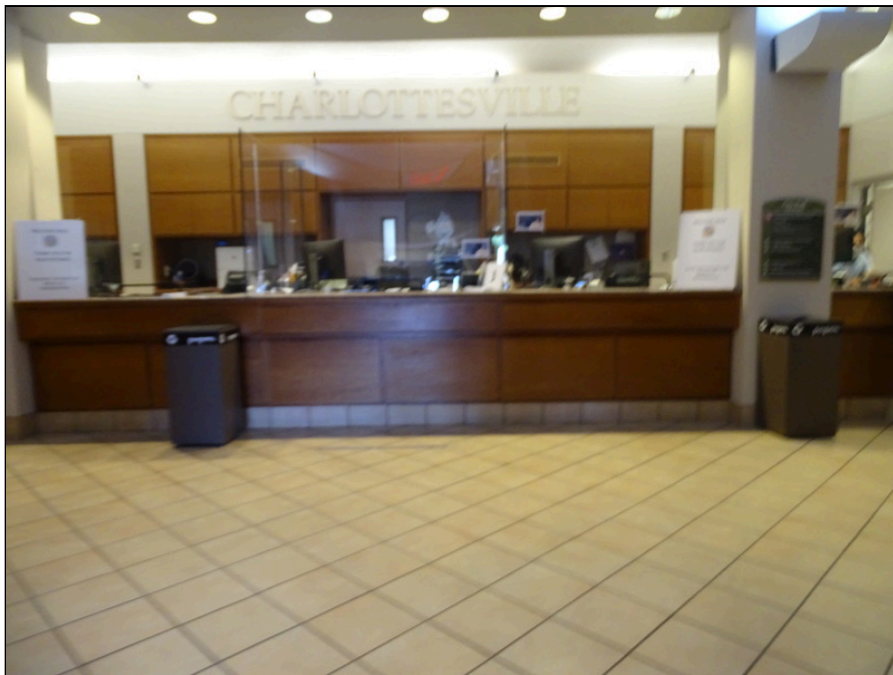
54 - Interior finishes entrance area

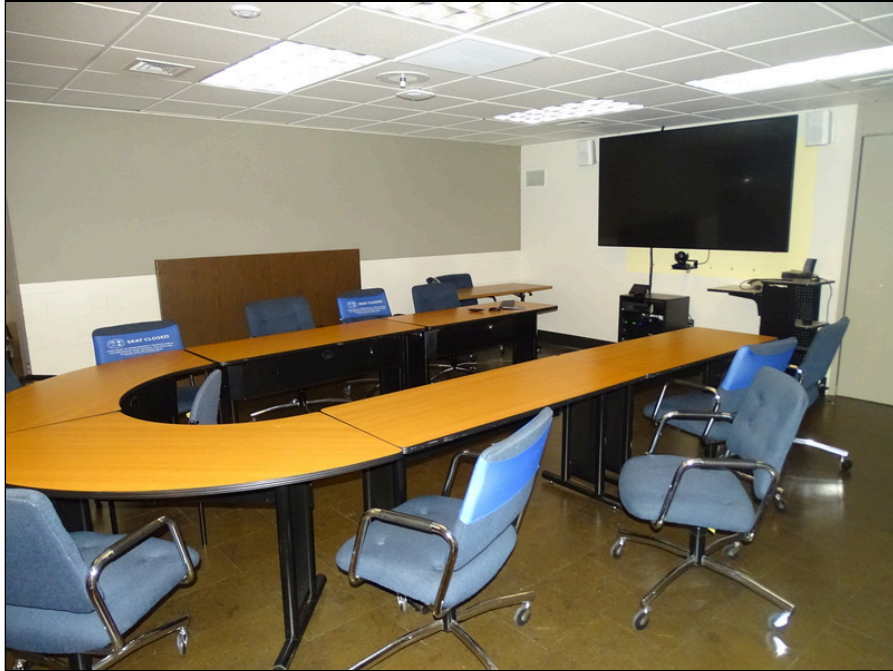
55 - Interior finishes office area

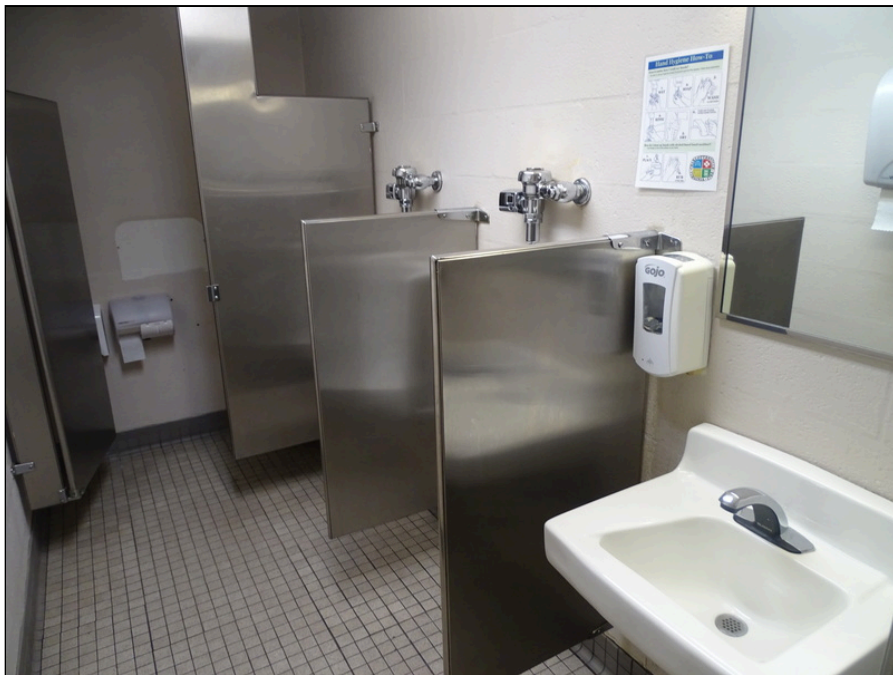
56 - Interior finishes restroom area

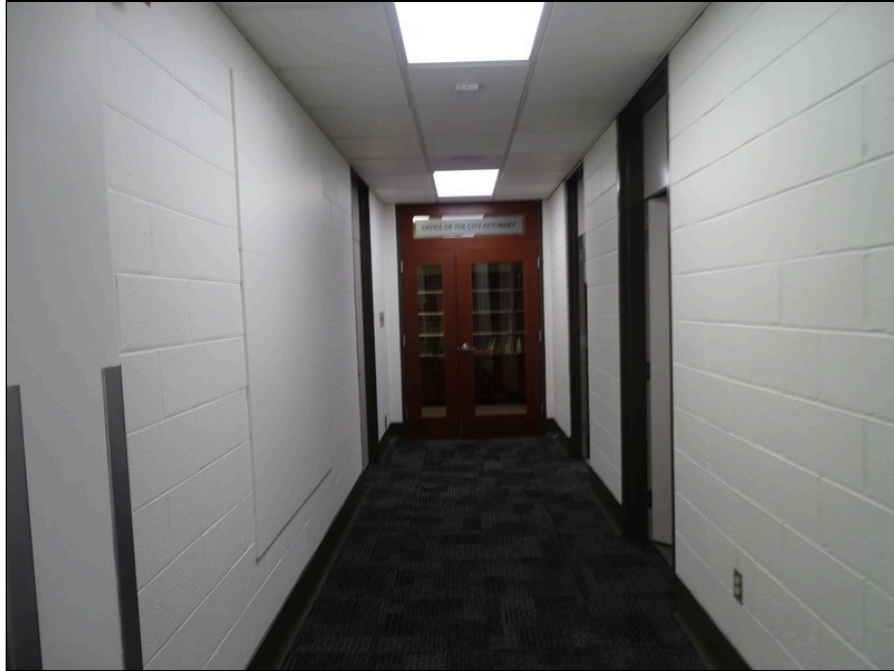
57 - Interior finishes corridor area

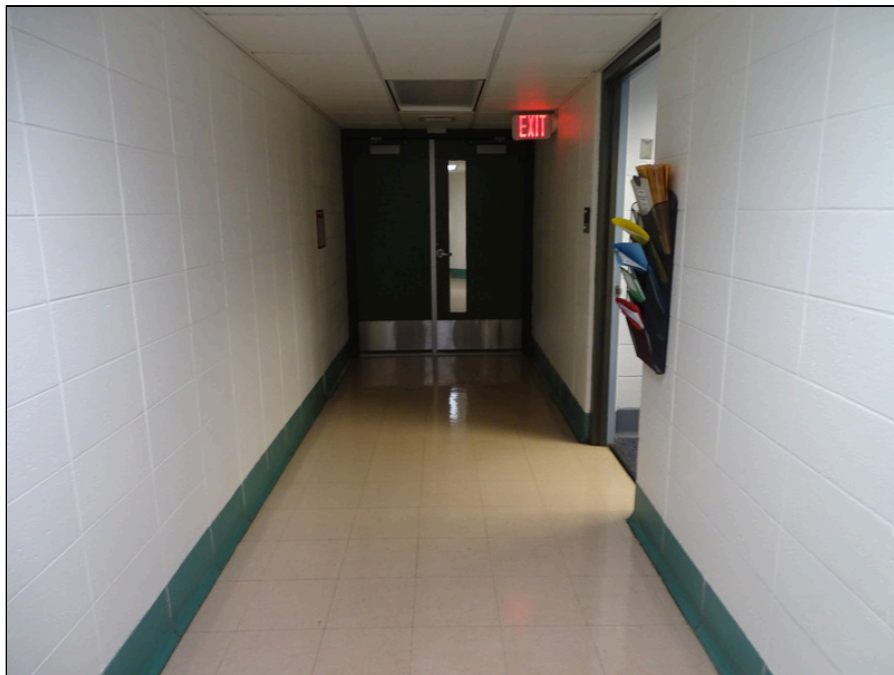
58 - Interior finishes corridor area

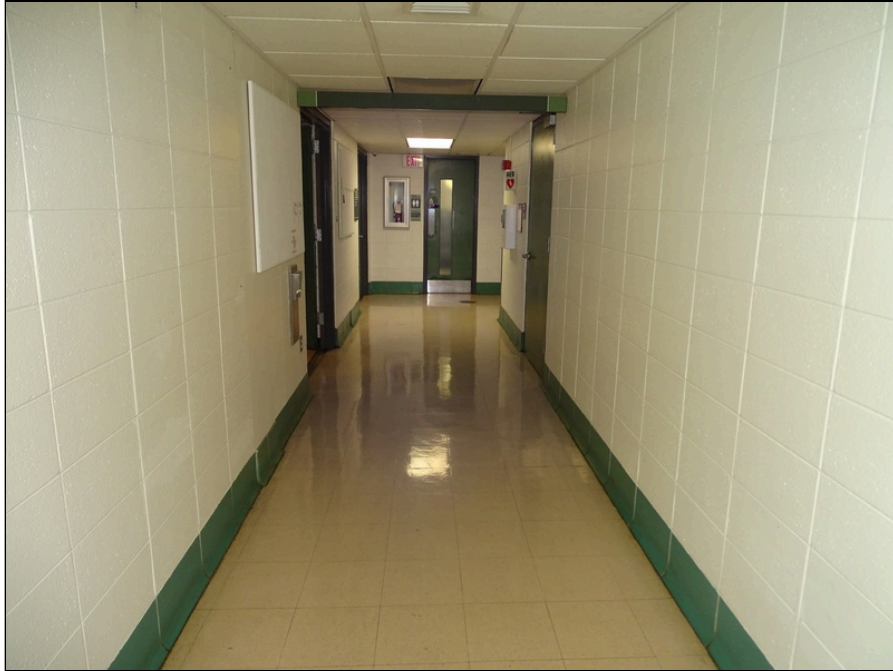
59 - Interior finishes corridor area

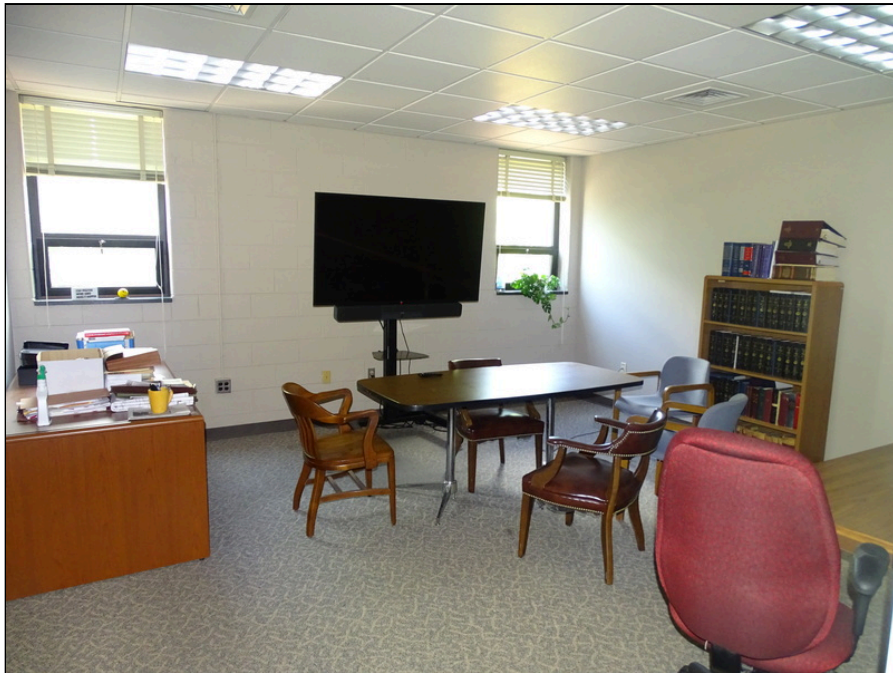
60 - Interior finishes office area

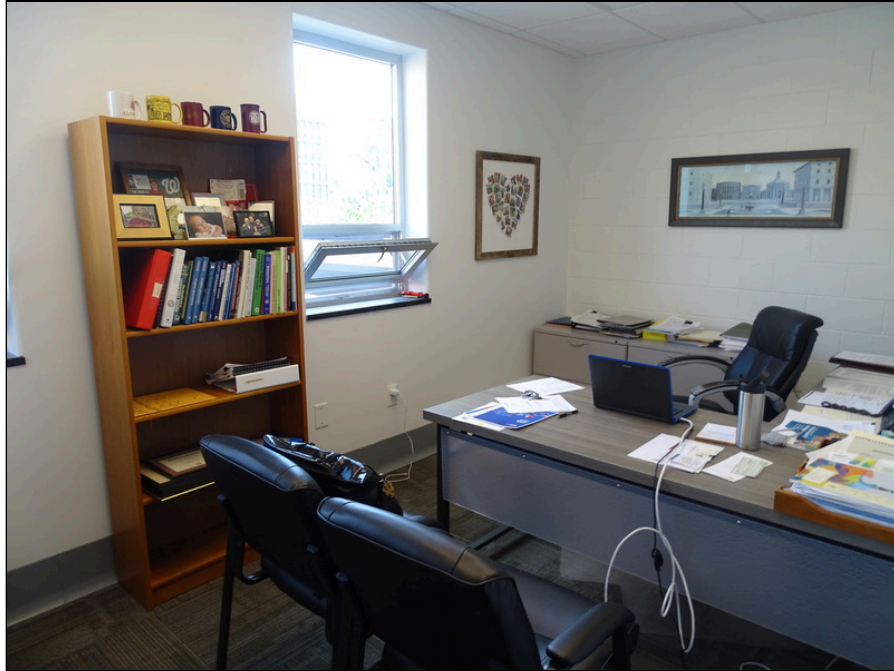
61 - Interior finishes office area

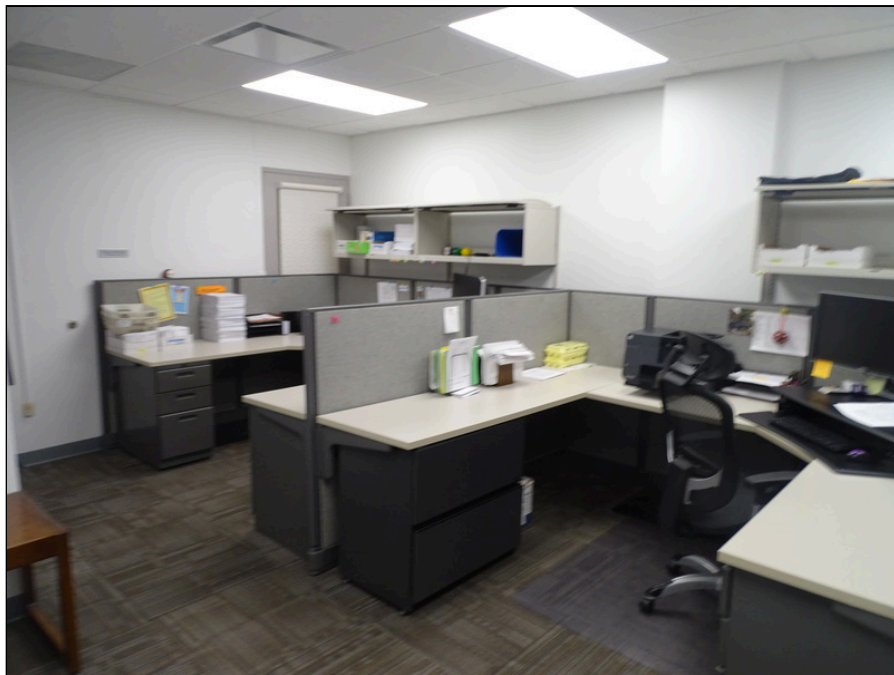
62 - Interior finishes office area

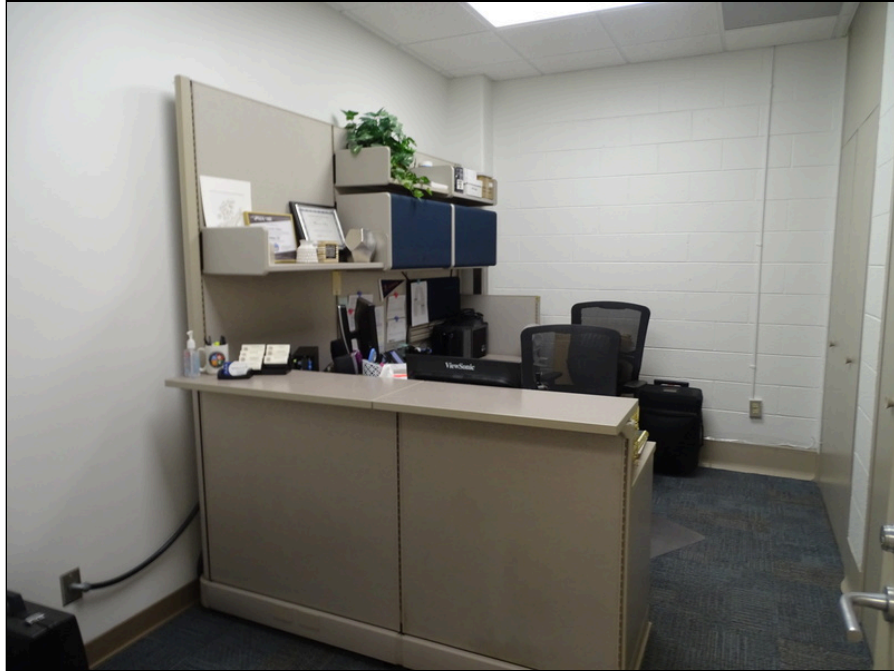
63 - Interior finishes office area

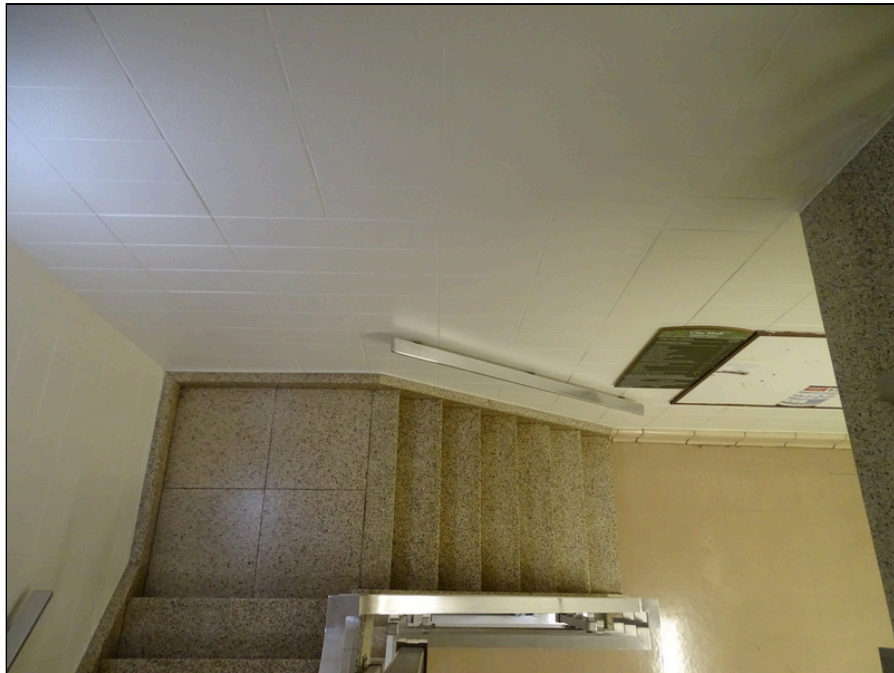
64 - Interior finishes stair area

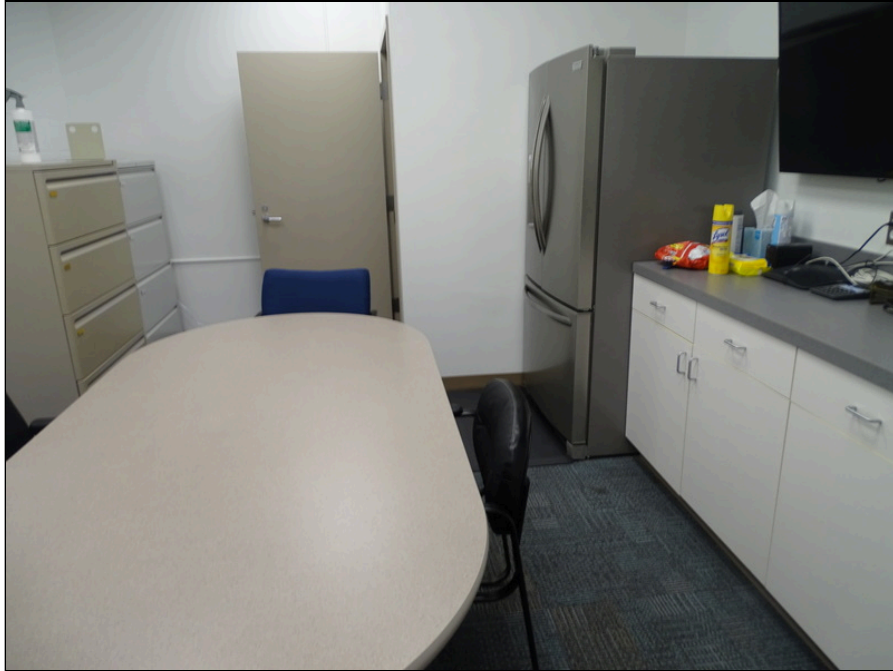
65 - Interior finishes kitchen area

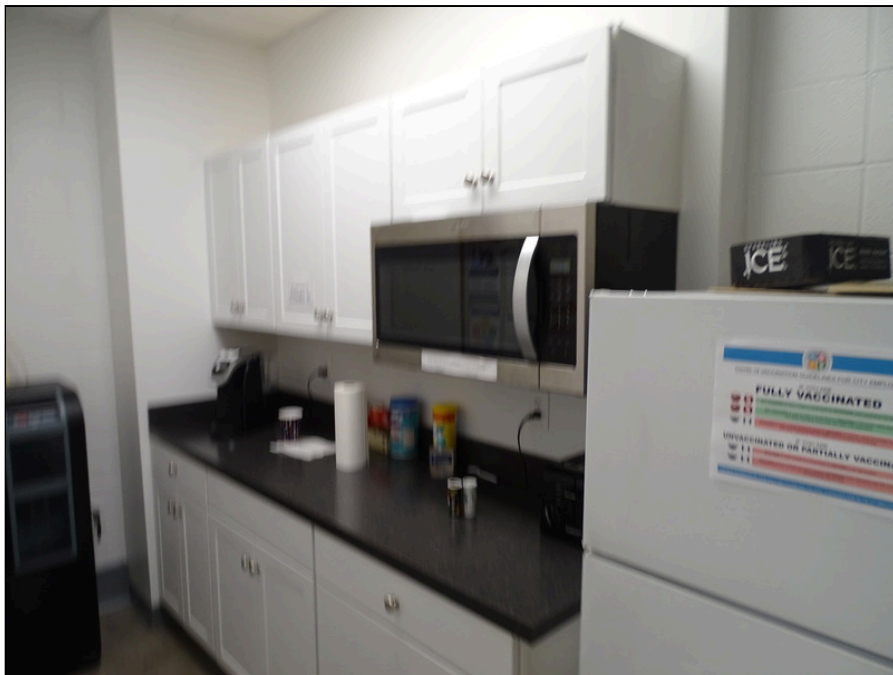
66 - Interior finishes kitchen area

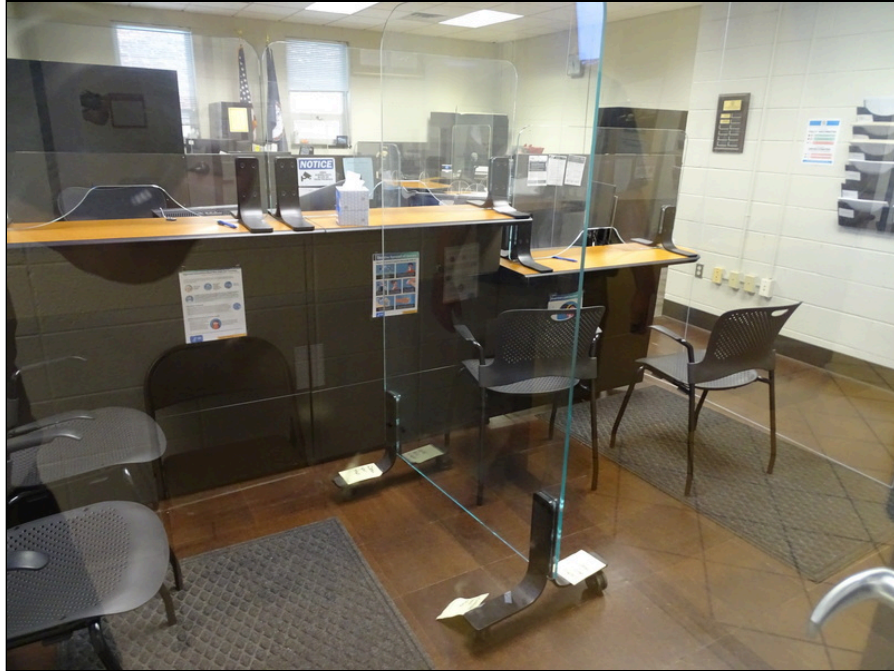
67 - Interior finishes reception area

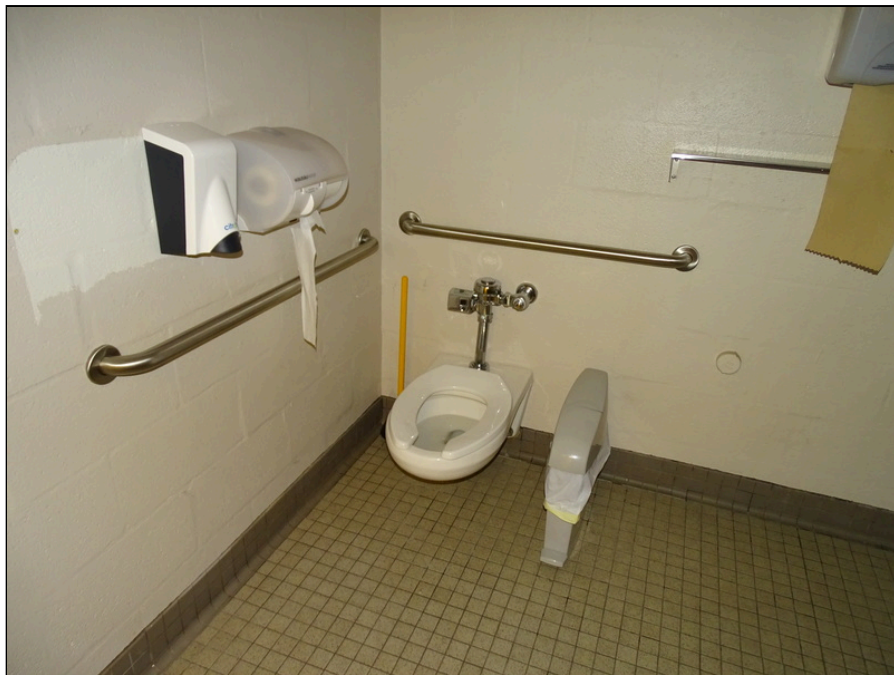
68 - Accessible restroom

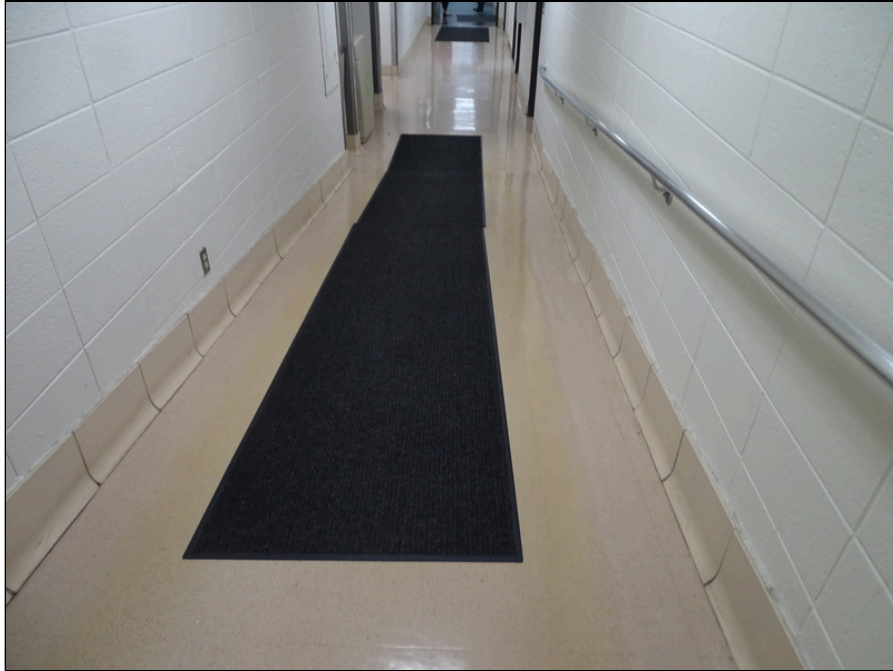
69 - Accessible interior ramp

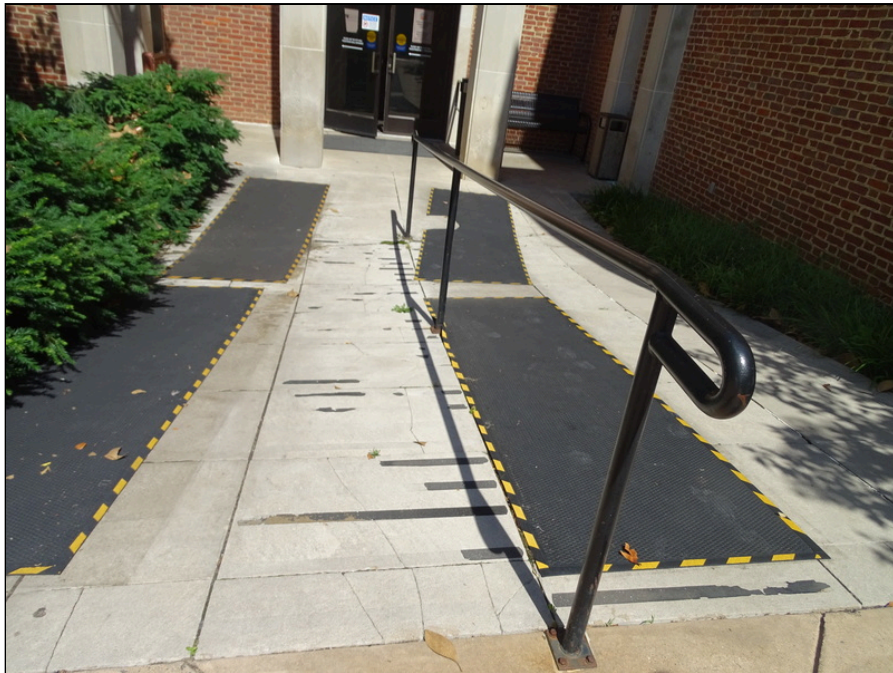
70 - Accessible exterior ramp
