CITY HALL ANNEX
120 7TH STREET NE
CHARLOTTESVILLE, VIRGINIA

ECS PROJECT NO. 46:6713

CITY OF CHARLOTTESVILLE - FACILITIES DEVELOPMENT

Reference: Facility Condition Assessment Report for City Hall Annex, 120 7th Street NE, Charlottesville, Virginia

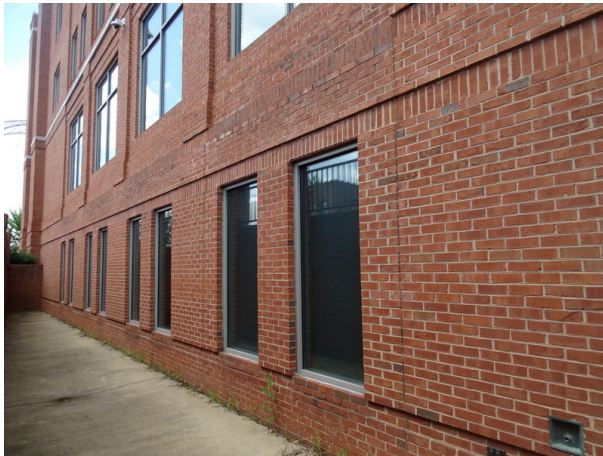
Exterior east elevation

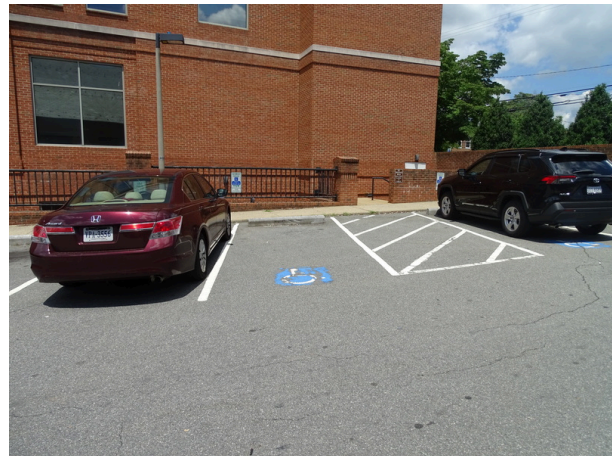
Typical accessible parking

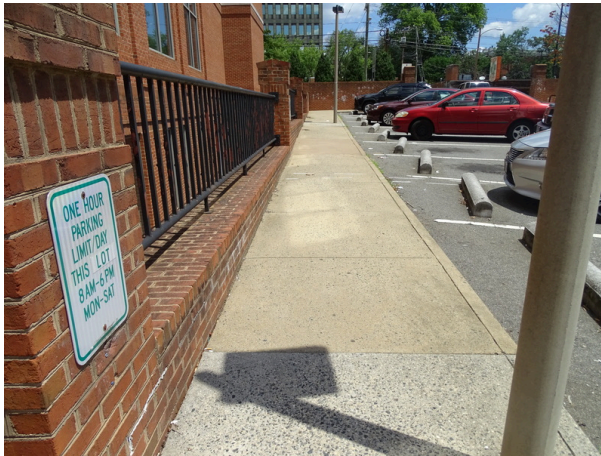
Typical concrete sidewalk

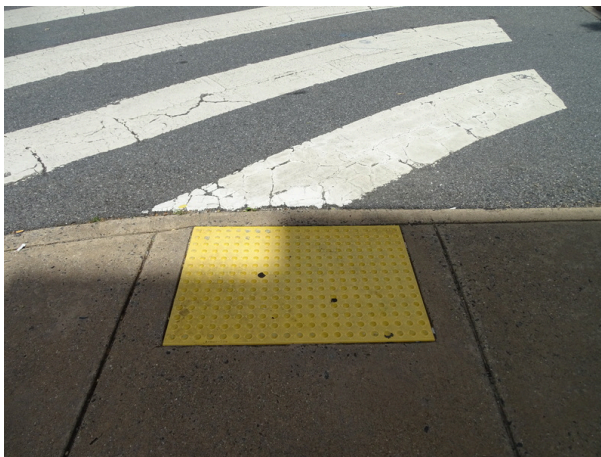
Typical truncated Domes

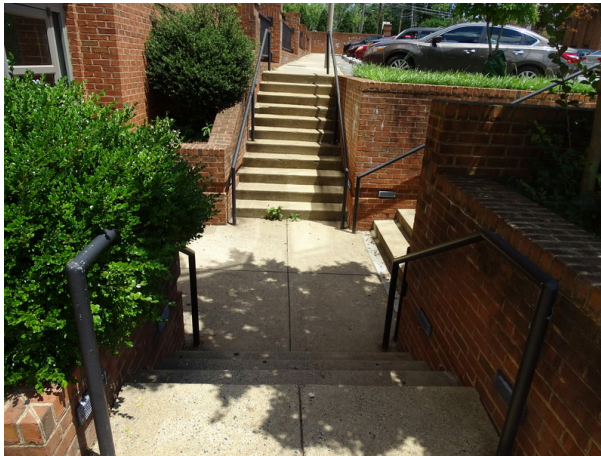
The brick landscaping retaining walls and brick fencing were generally in fair condition, although efflorescence and deteriorated mortar joints were observed in various locations throughout. The dumpster enclosure also had efflorescence staining throughout the surface. Cleaning and minor repairs should be completed as a maintenance item.

Typical landscaping

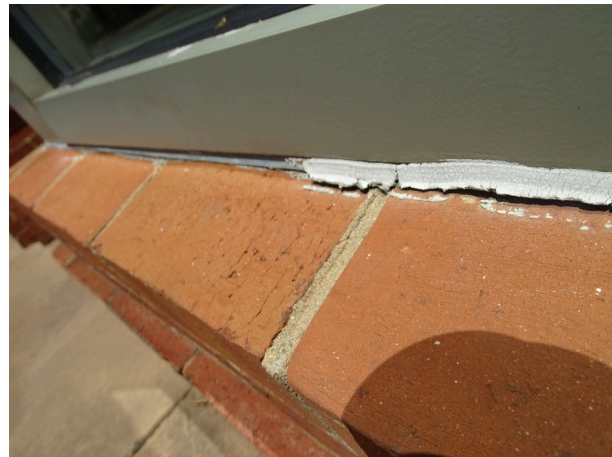
Typical window - note window perimeter sealant

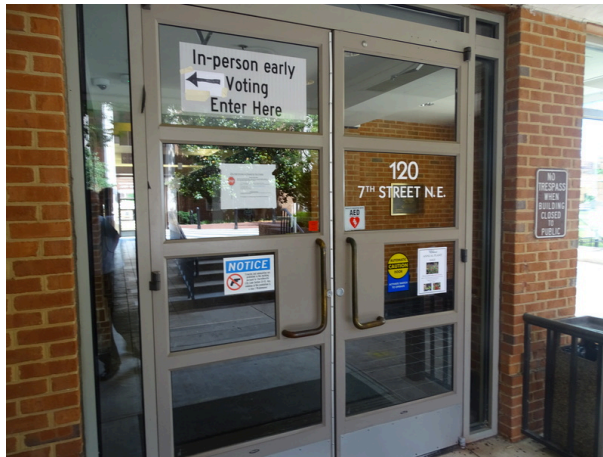
Storefront entrance

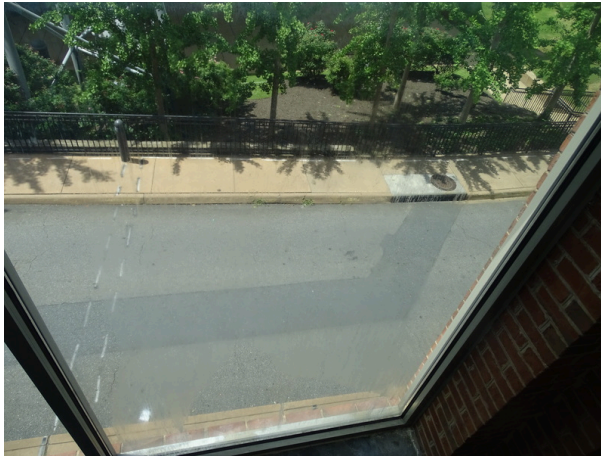
Fogged window

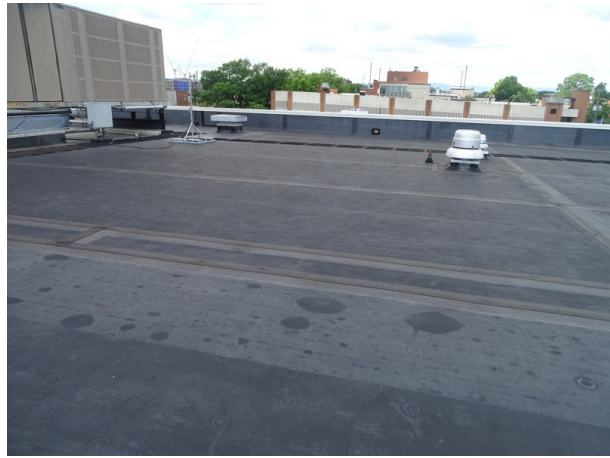
Typical equipment flashing

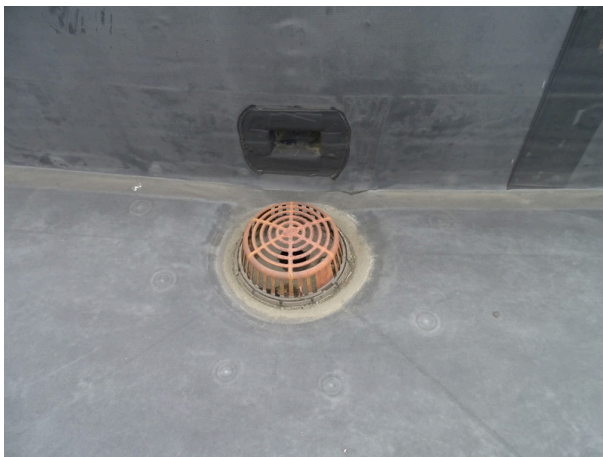
Roof drain and overflow scupper

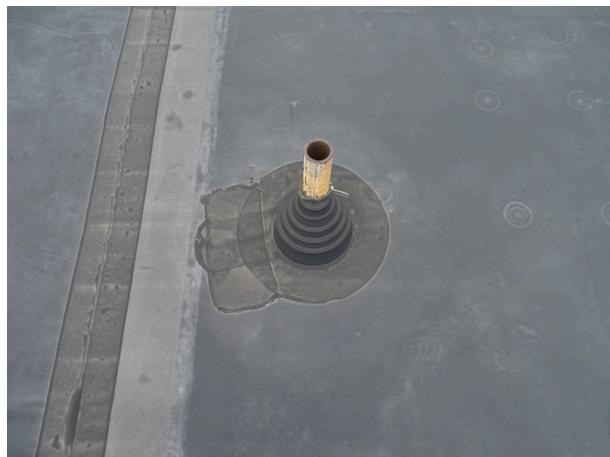
Typical pipe flashing

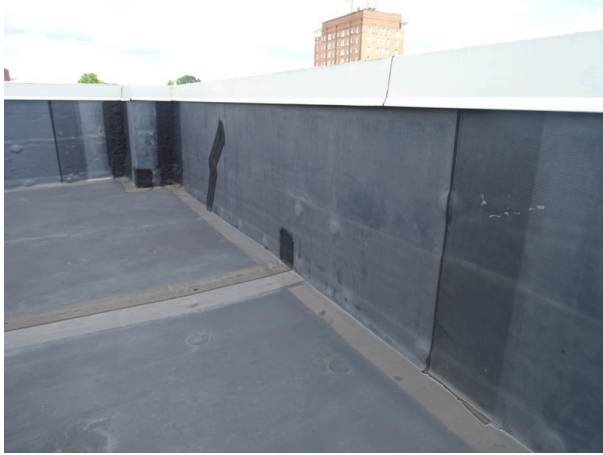
Roof parapet wall

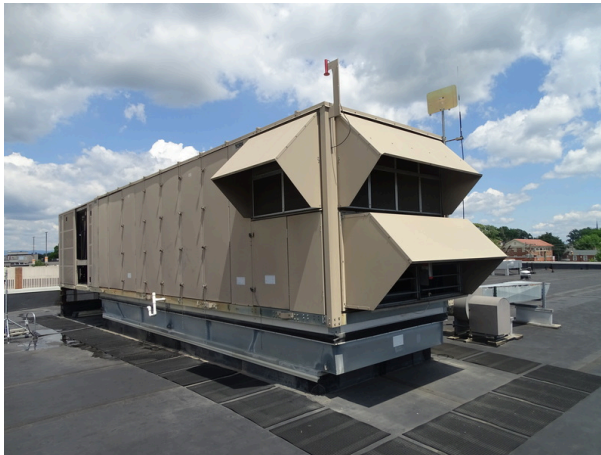
York Air Handler

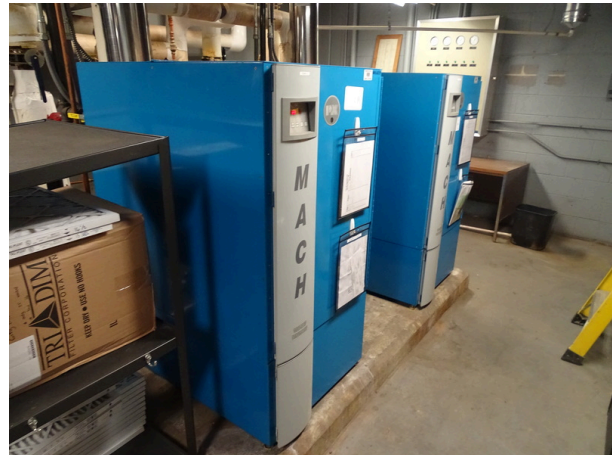
Boiler manufacturer data

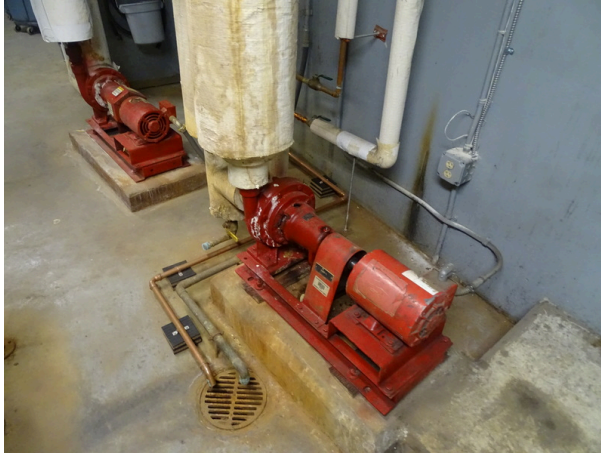
Typical pump

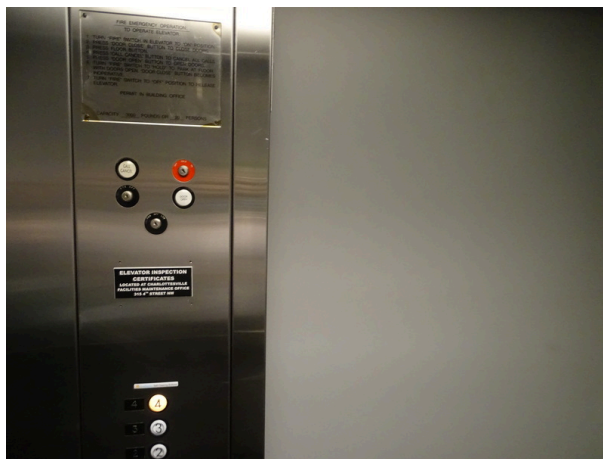
Typical elevator

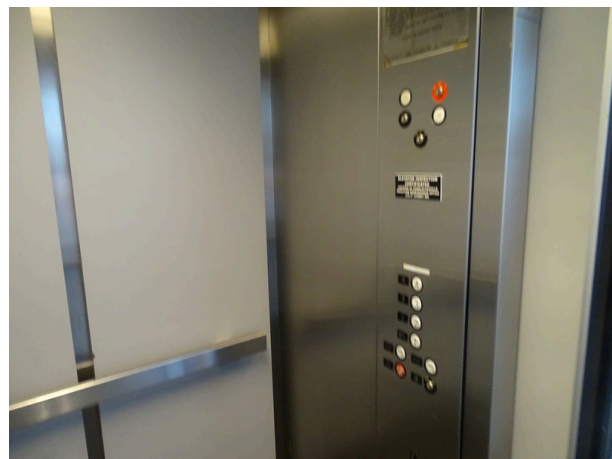
Typical elevator interior

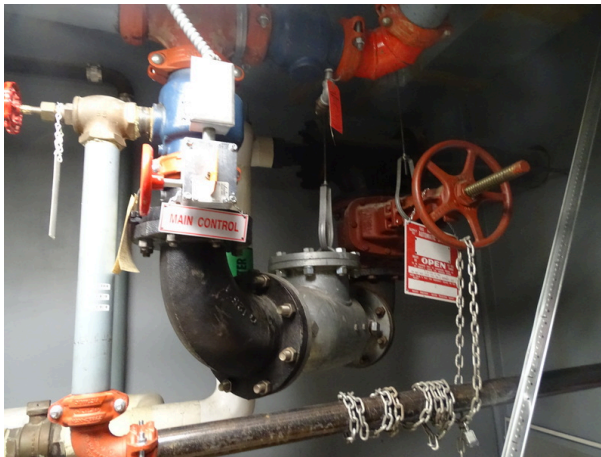
Sprinkler system

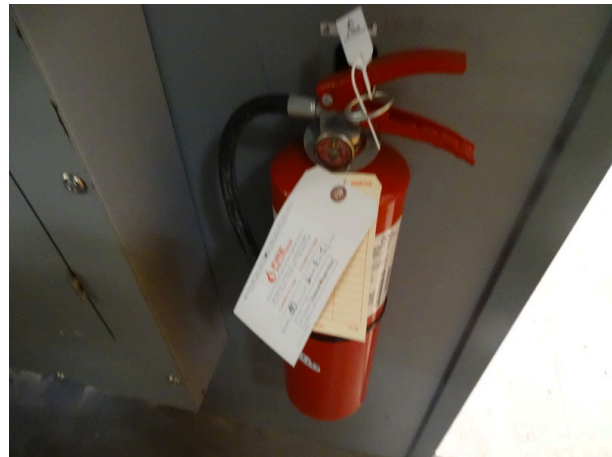
Fire extinguisher

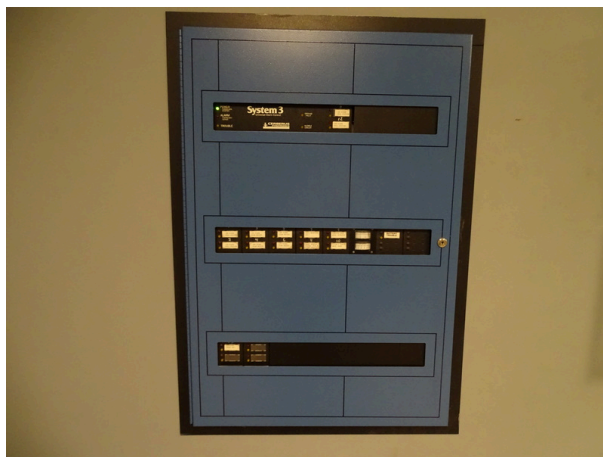
Fire alarm panel

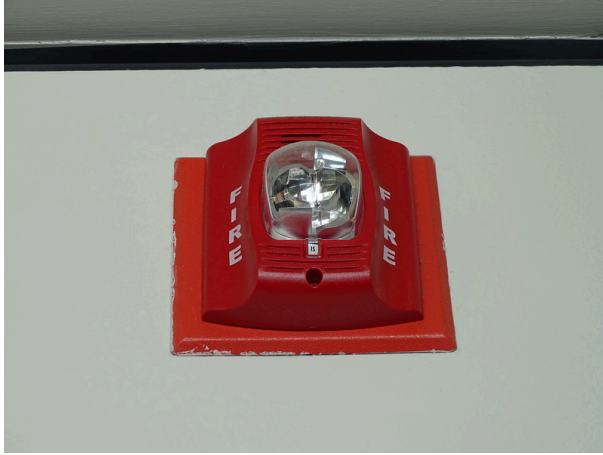
Fire strobe and alarm

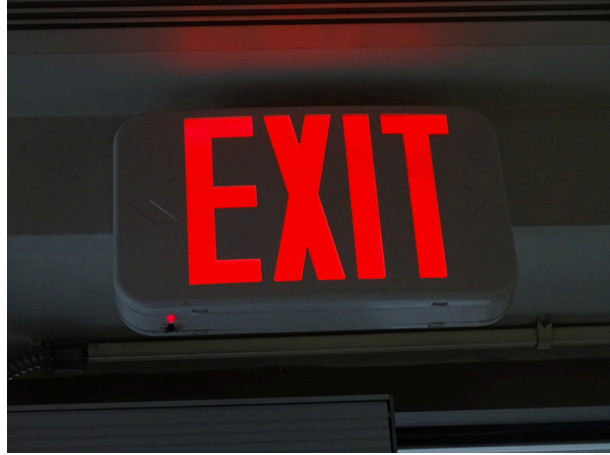
Typical exit sign

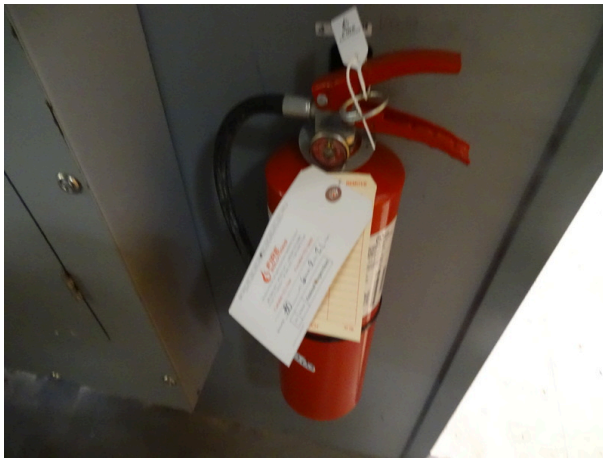
Fire extinguisher

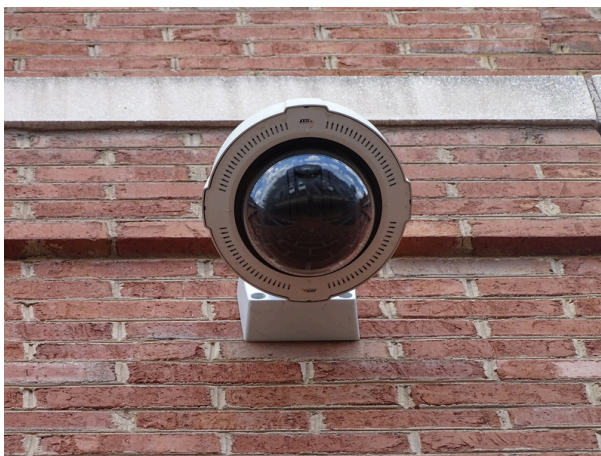
Security camera

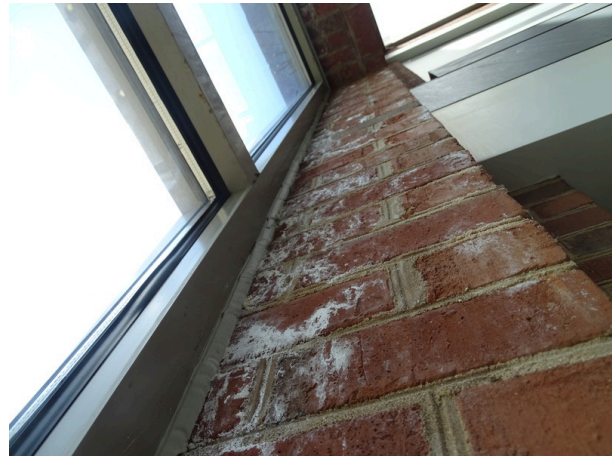
Efflorescence and soiled interior

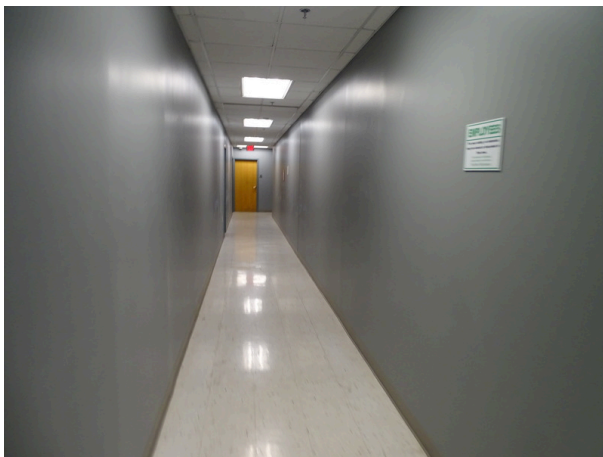
Typical corridor

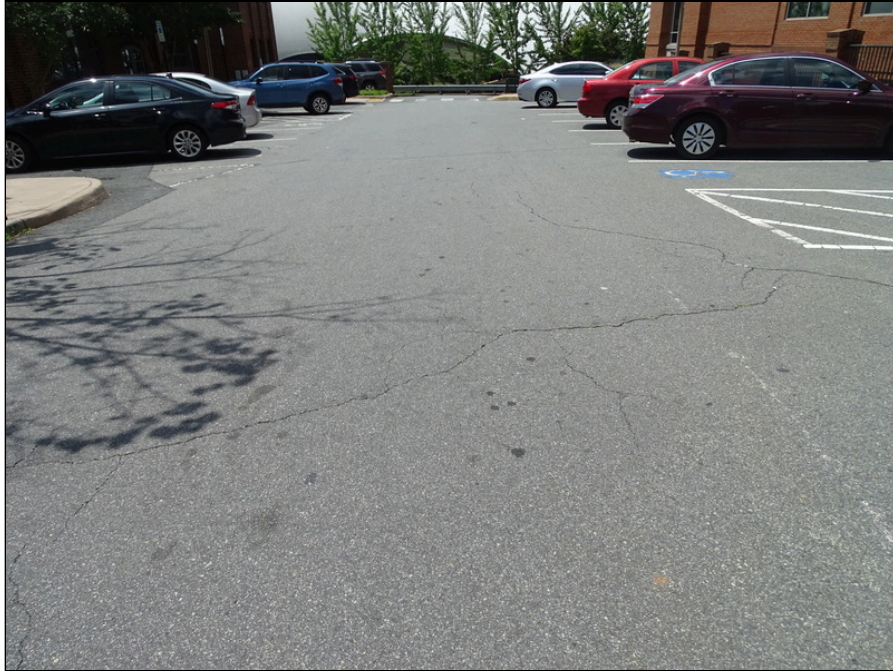
3 - Parking area on east side of building

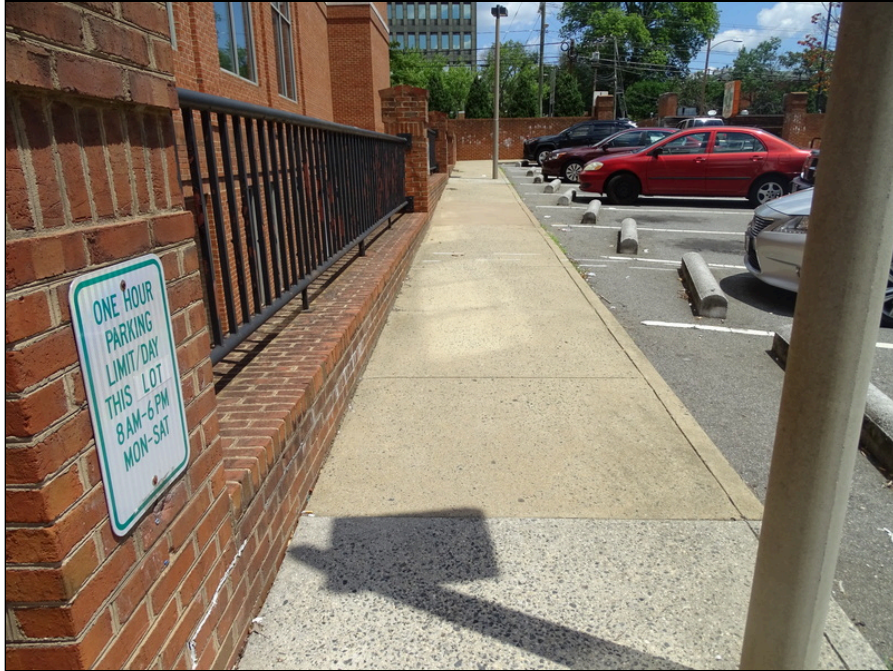
5 - Typical concrete sidewalk

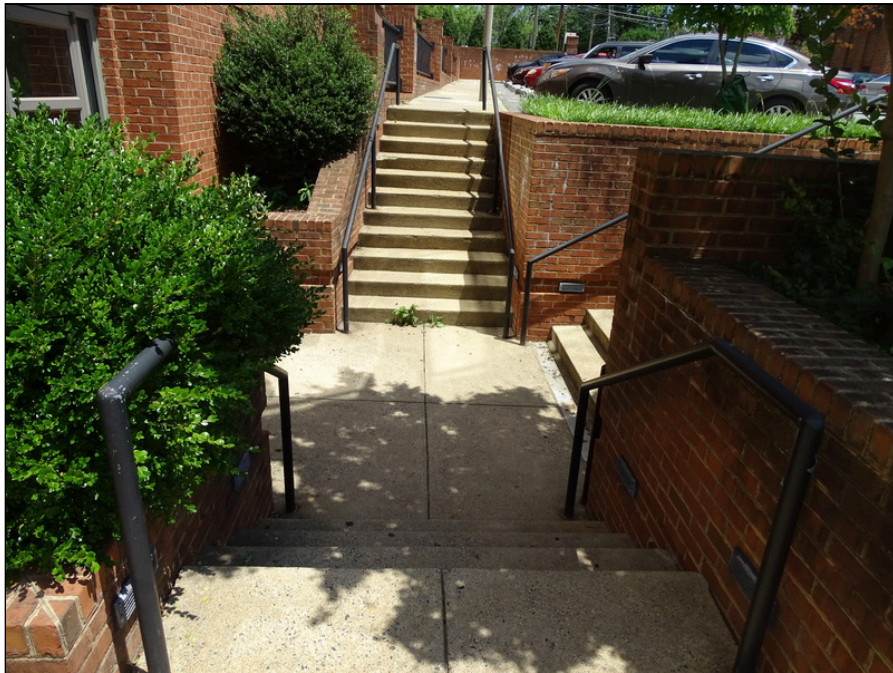
6 - Typical concrete stairs

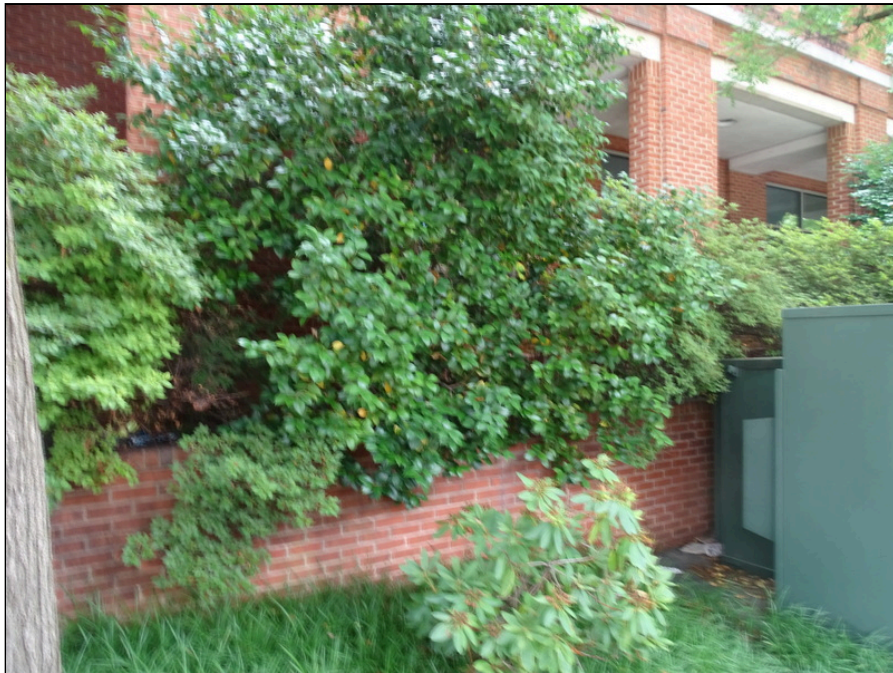
8 - Typical landscape

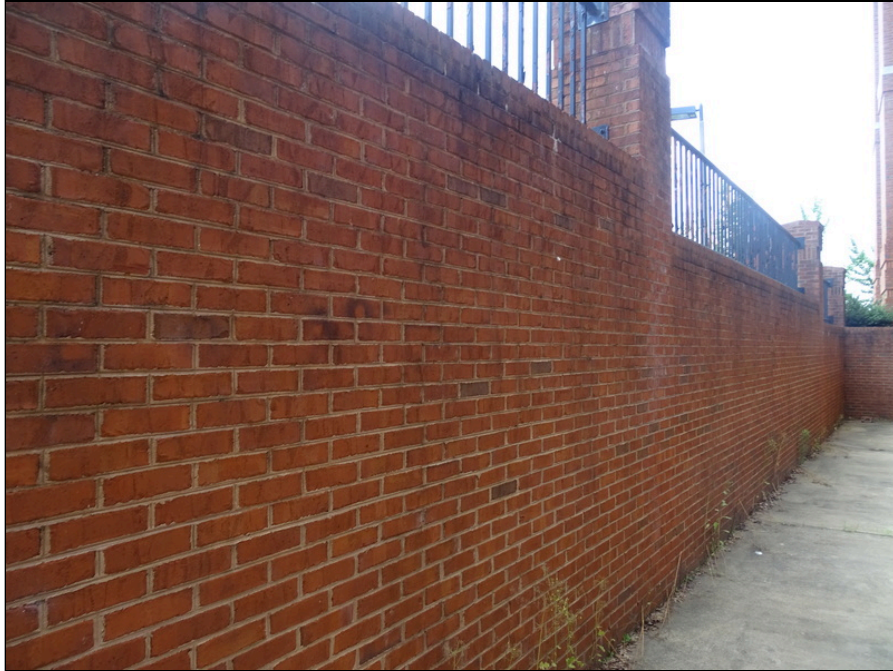
9 - Typical retaining wall

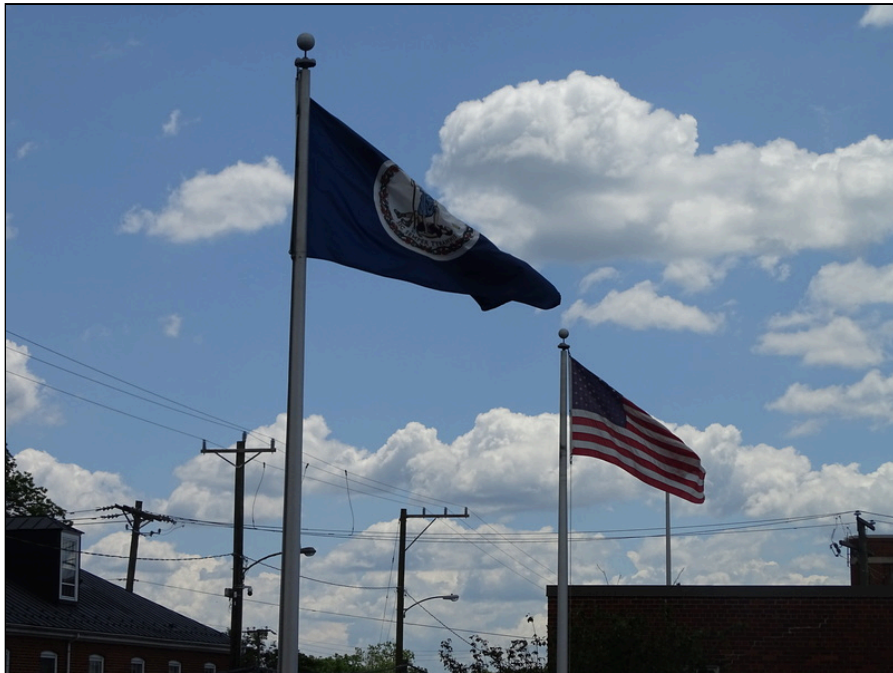
10 - Flag pole

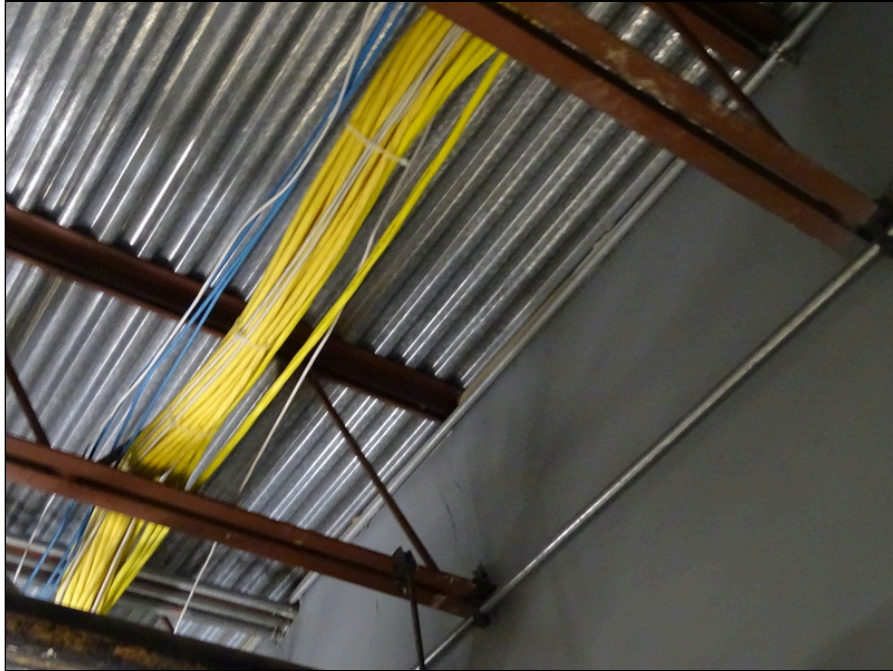
11 - Metal deck supporting an elevated level

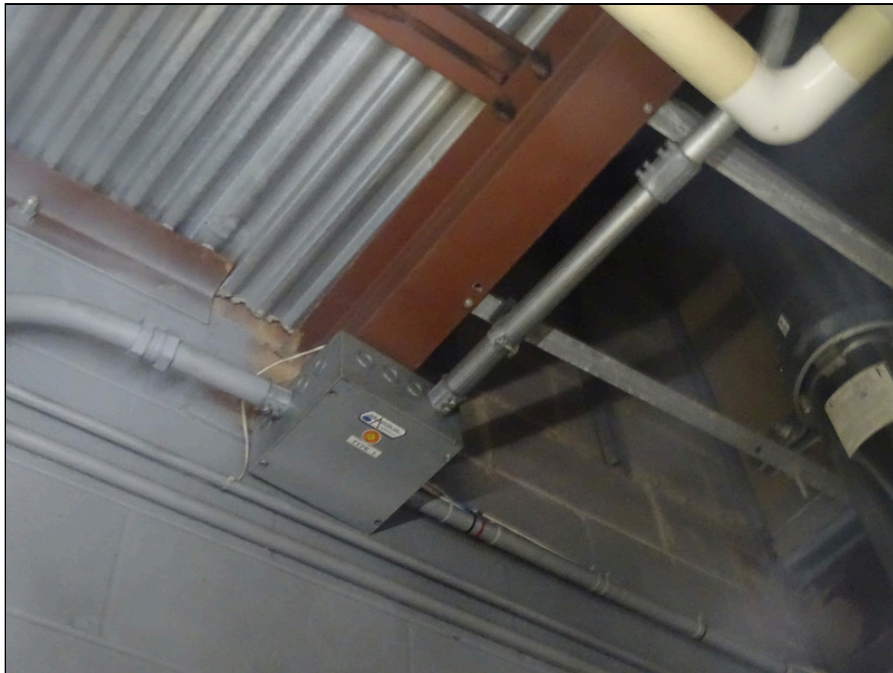
12 - Metal deck supporting an elevated level

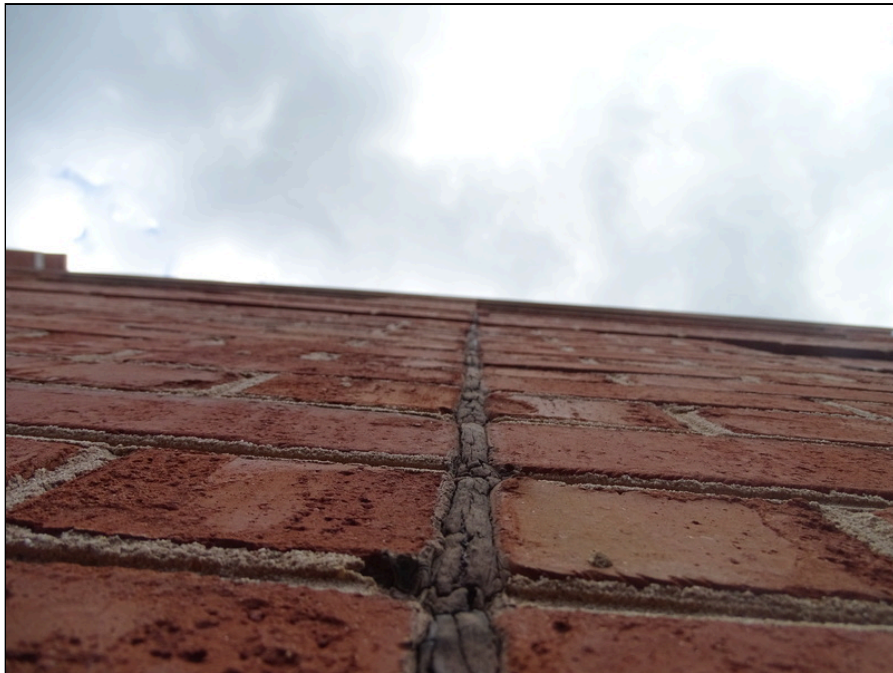
20 - Typical exterior - note vertical joint sealant

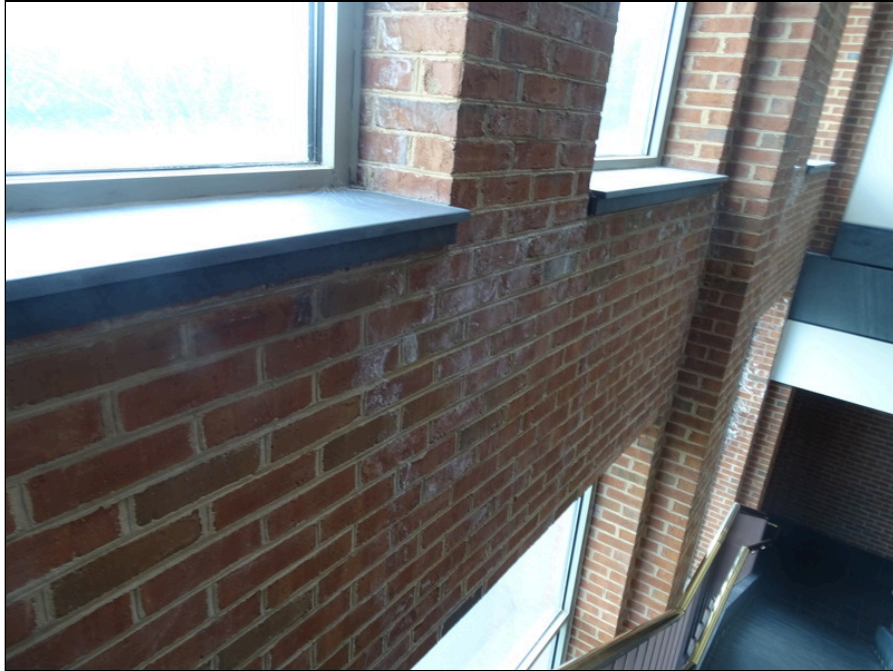
25 - Efflorescence and soiled interior

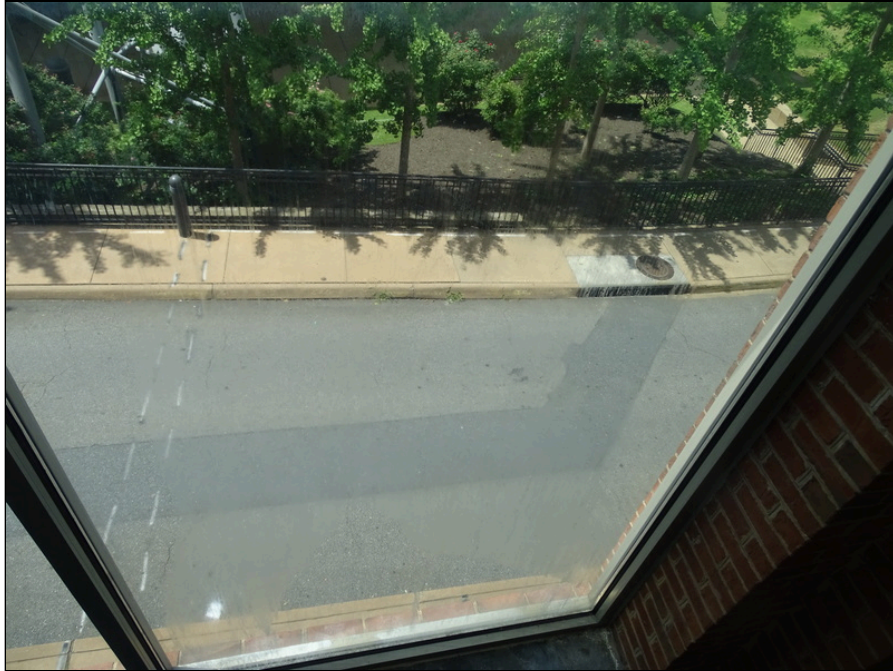
27 - Typical window - note fogged glass

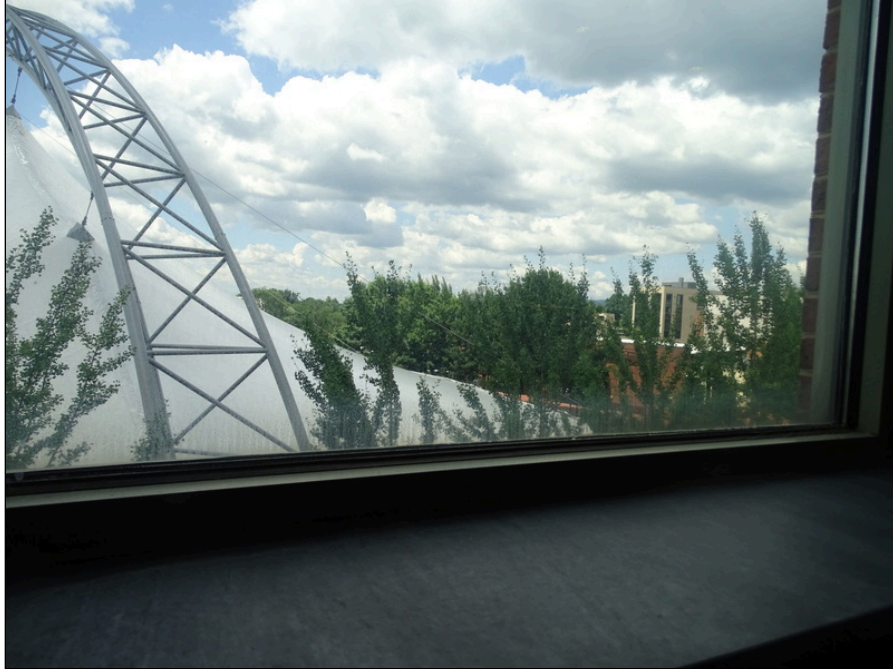
29 - Typical window - note fogged glass

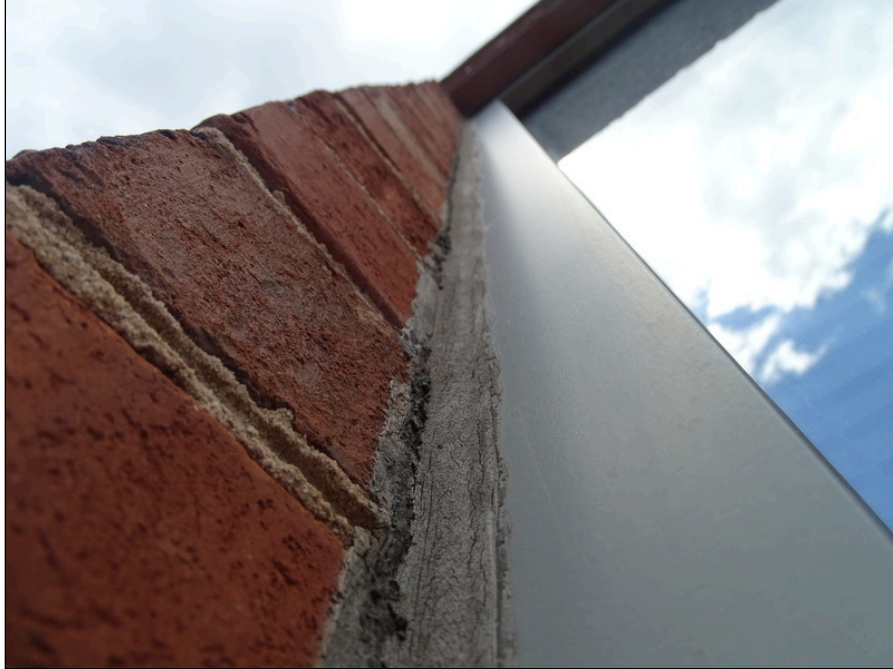
31 - Window perimeter sealant

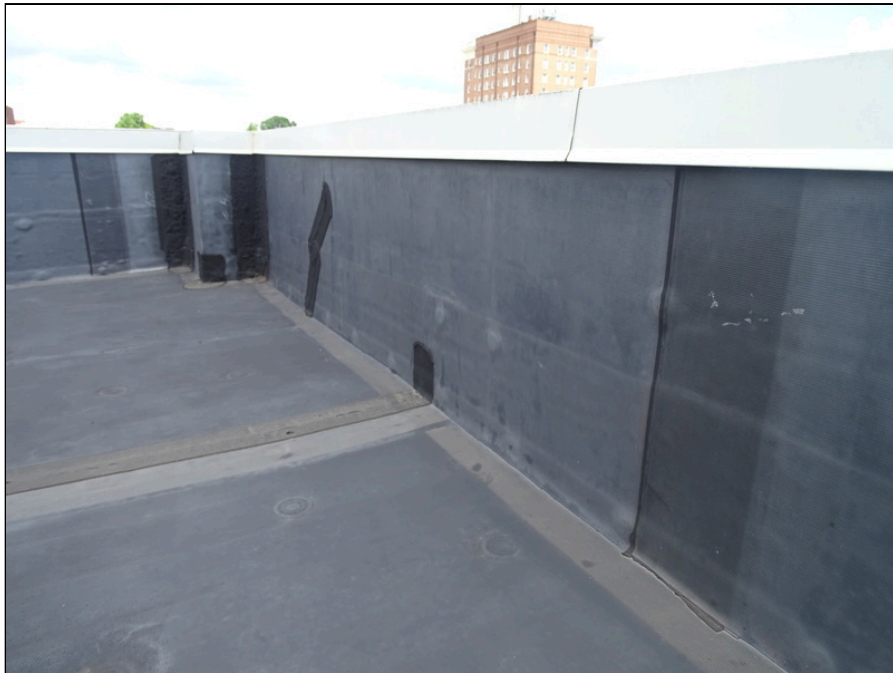
34 - Roof parapet wall

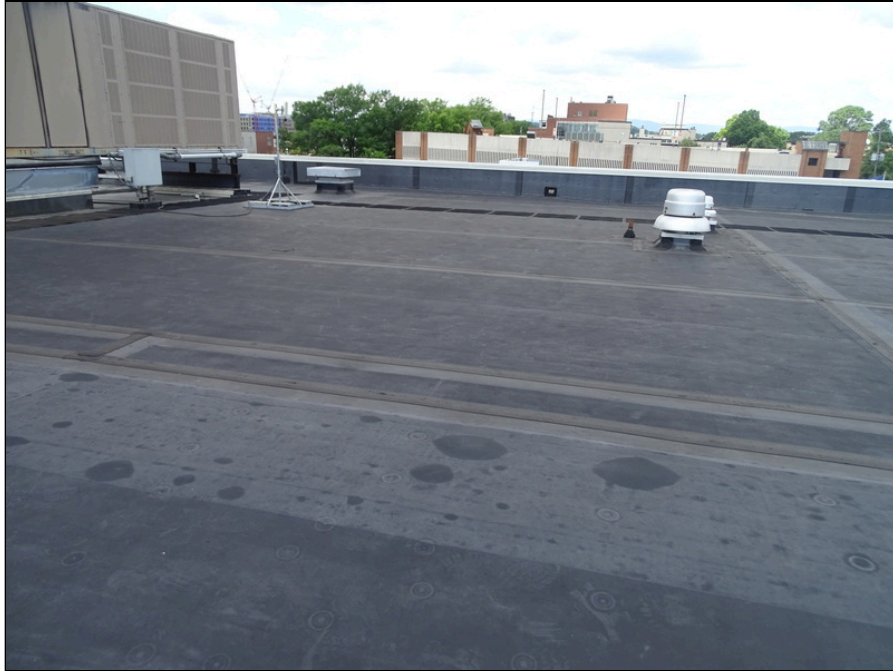
35 - Typical equipment flashing

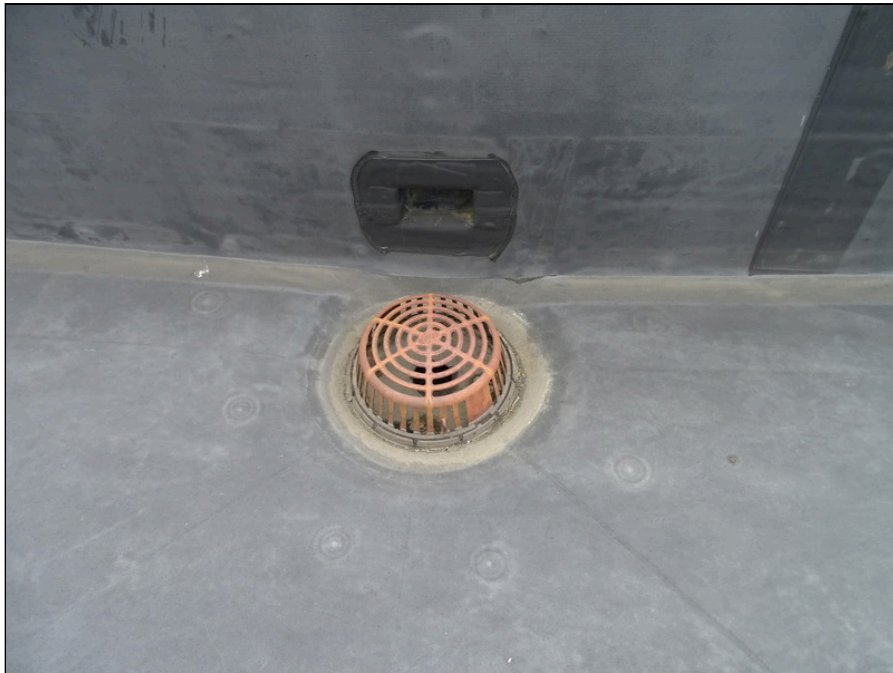
36 - Roof drain and overflow scupper

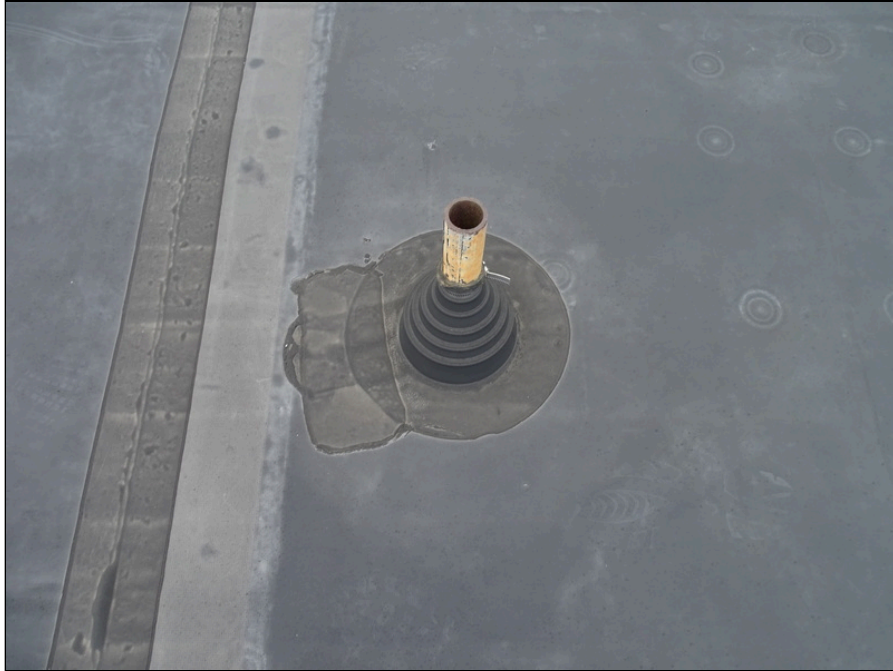
37 - Typical pipe flashing

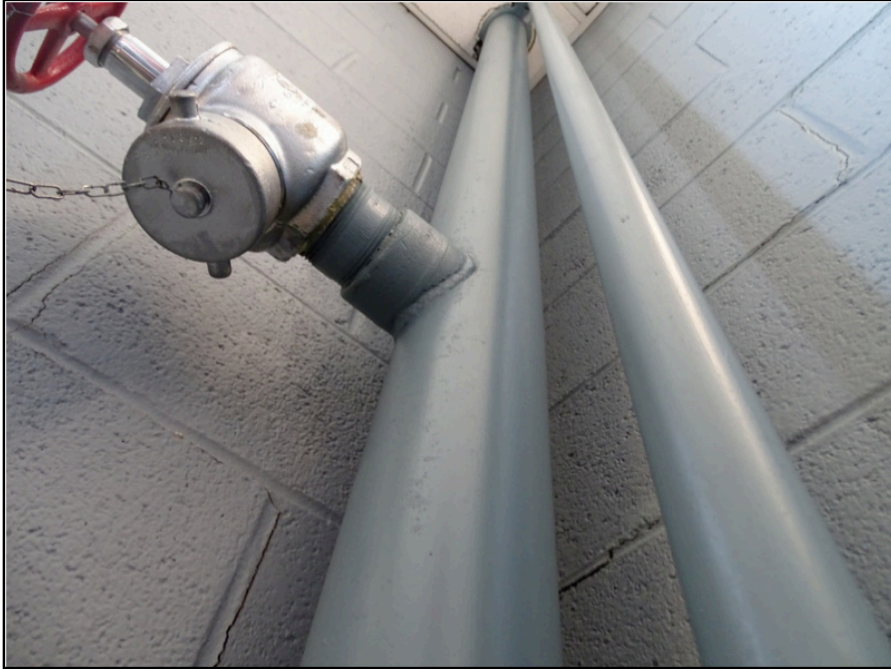
57 - Sprinkler standpipe

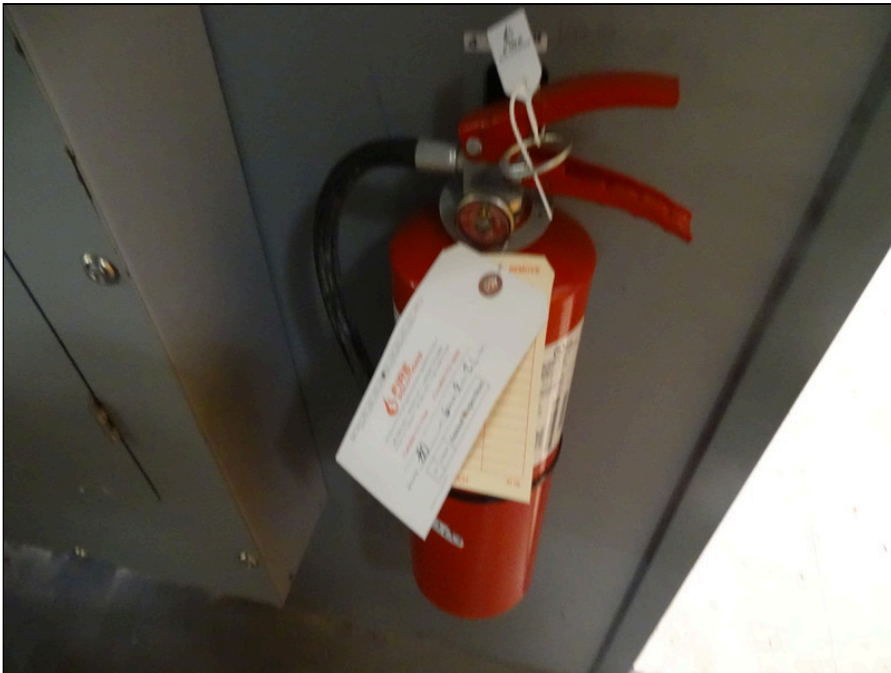
58 - Fire extinguisher

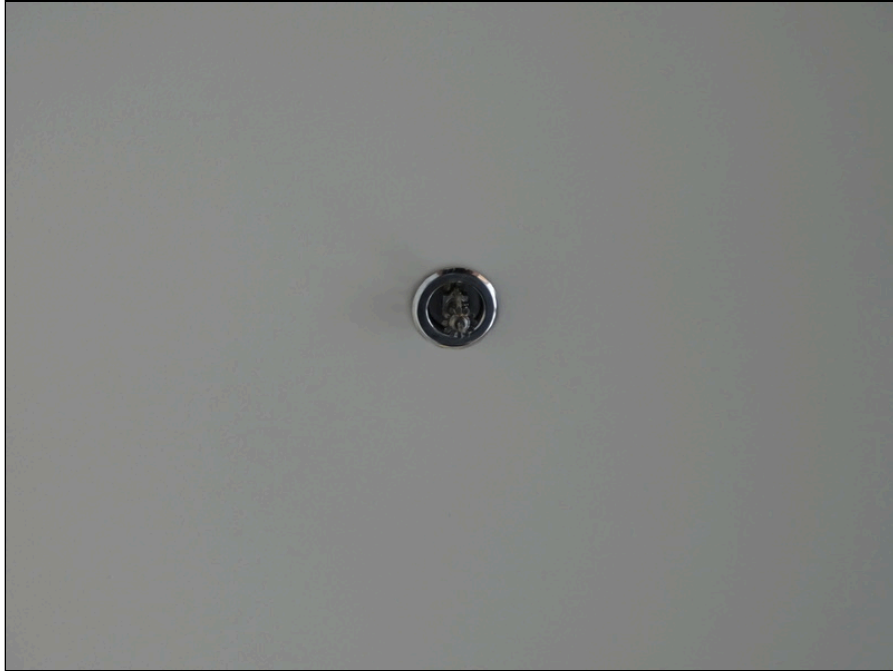
59 - Sprinkler head

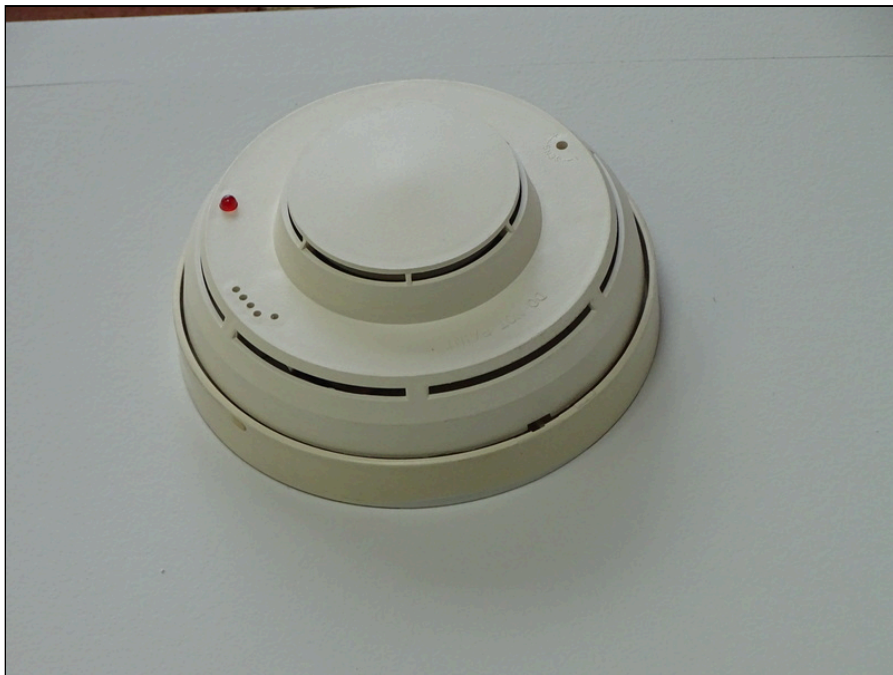
60 - Typical smoke detector

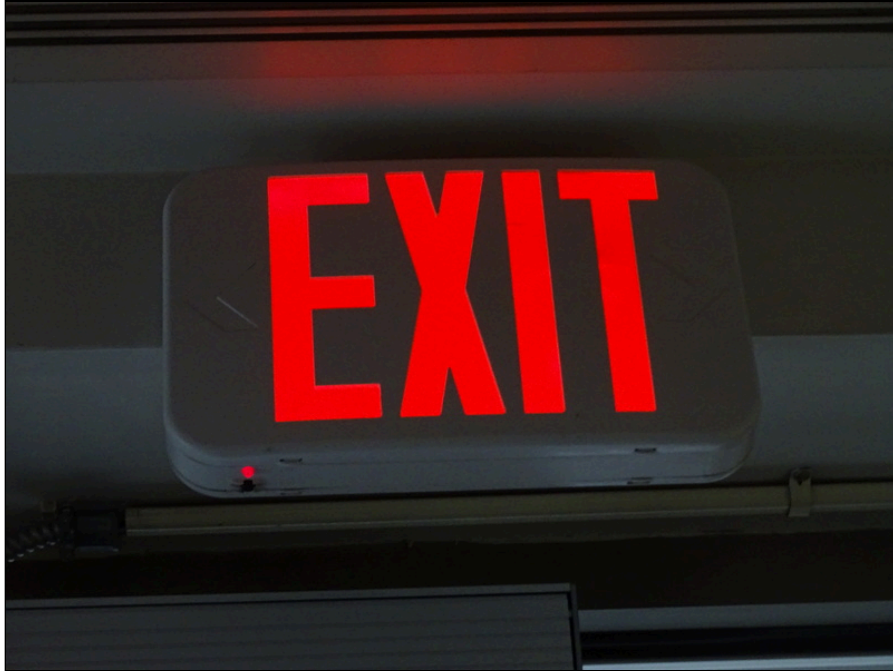
61 - Typical exit sign

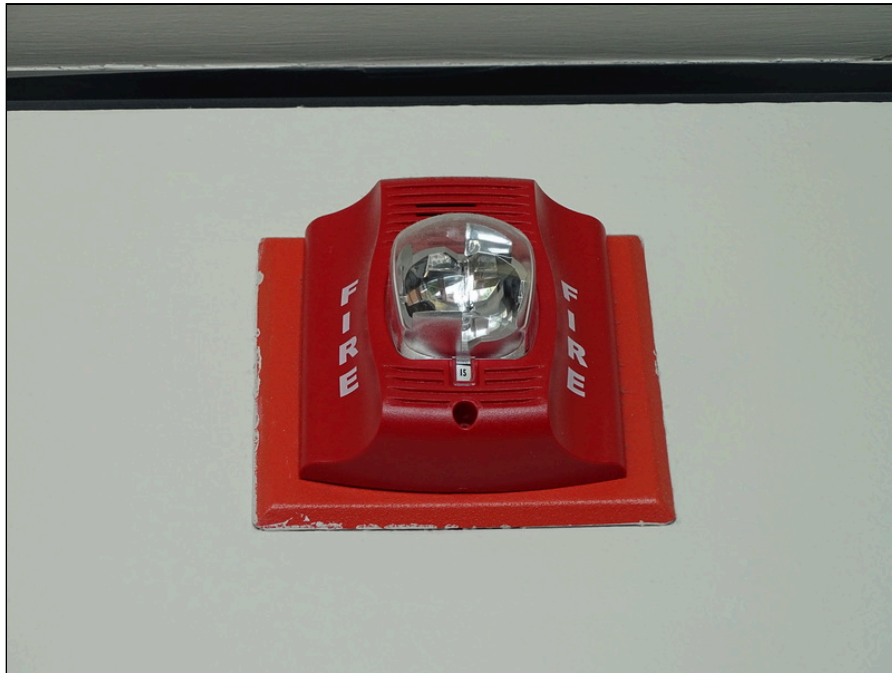
64 - Fire strobe and alarm

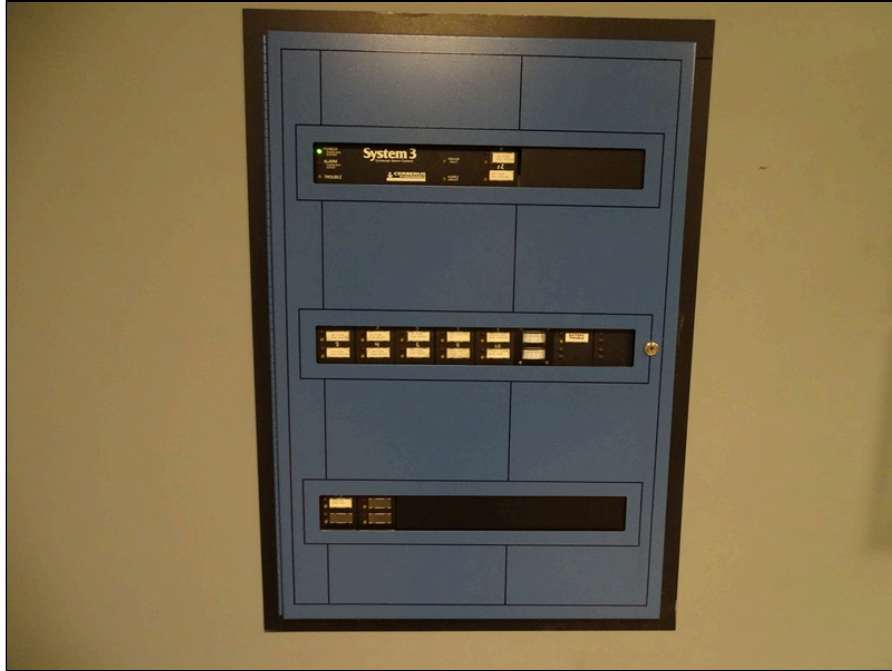
65 - Fire alarm panel

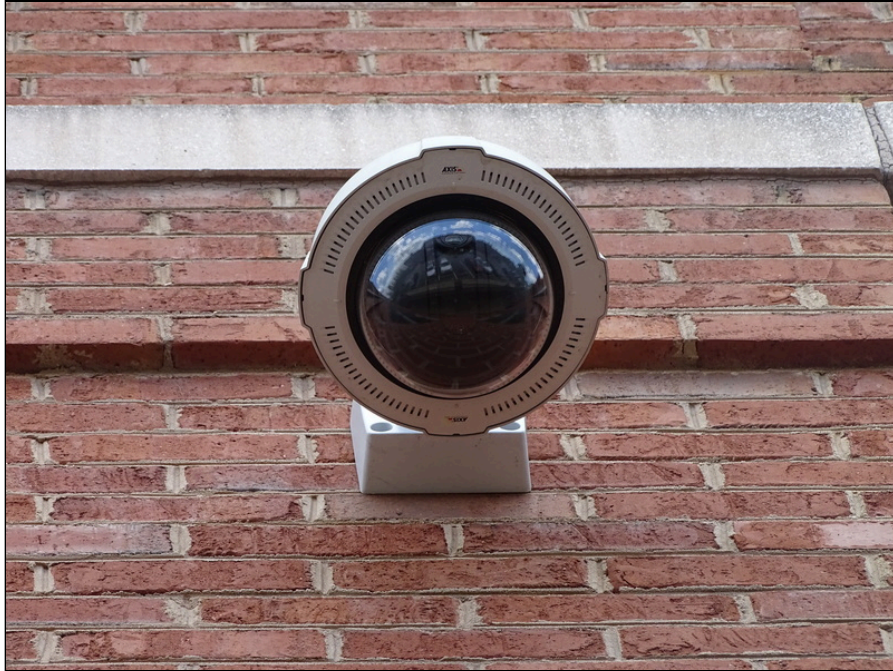
67 - Security camera

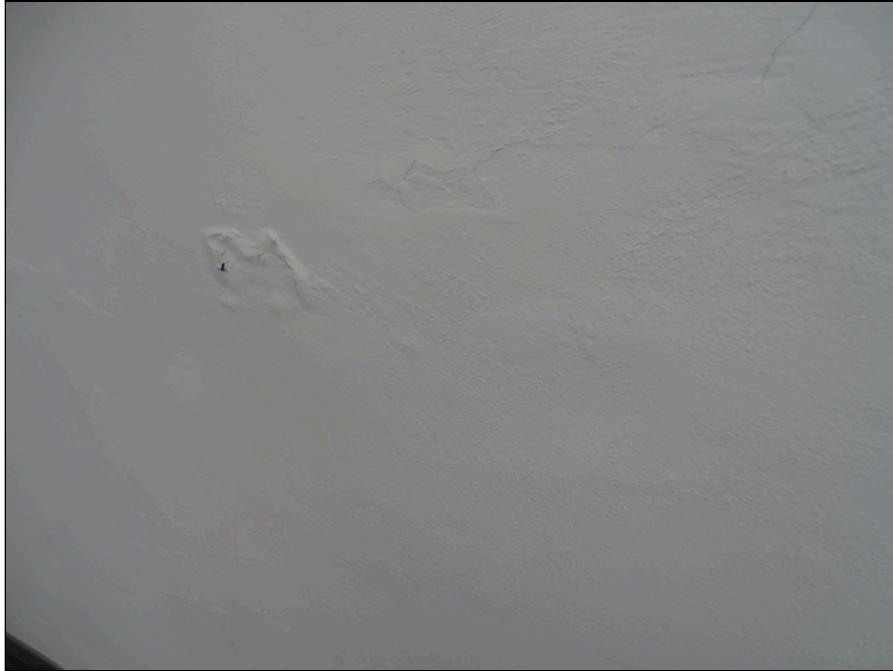
69 - Interior Paint condition
