CITY HALL ANNEX
120 7TH STREET NE
CHARLOTTESVILLE, VIRGINIA

ECS PROJECT NO. 46:6713

CITY OF CHARLOTTESVILLE - FACILITIES DEVELOPMENT

Reference: Facility Condition Assessment Report for City Hall Annex, 120 7th Street NE, Charlottesville, Virginia

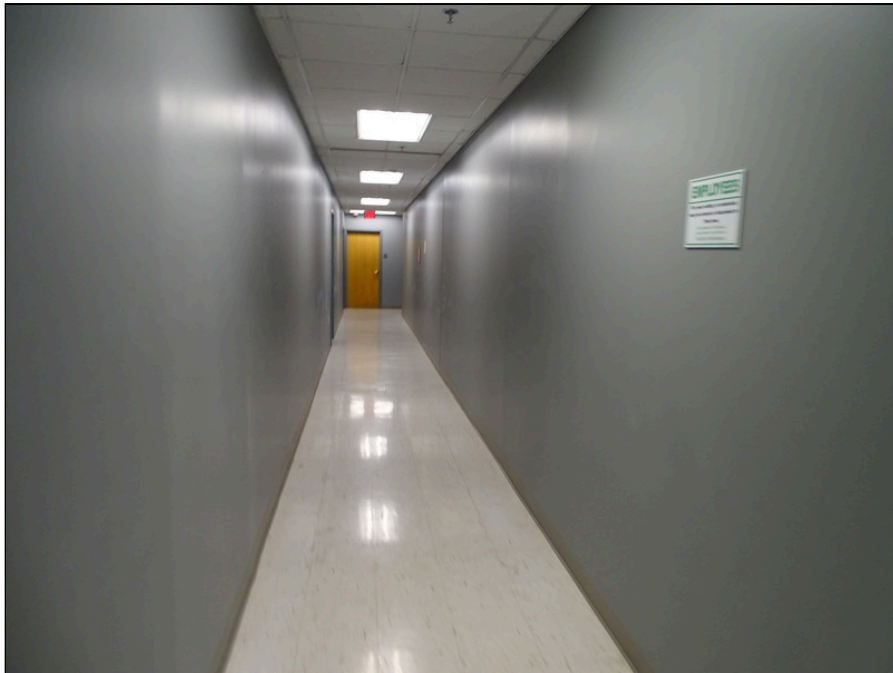
70 - Typical corridor

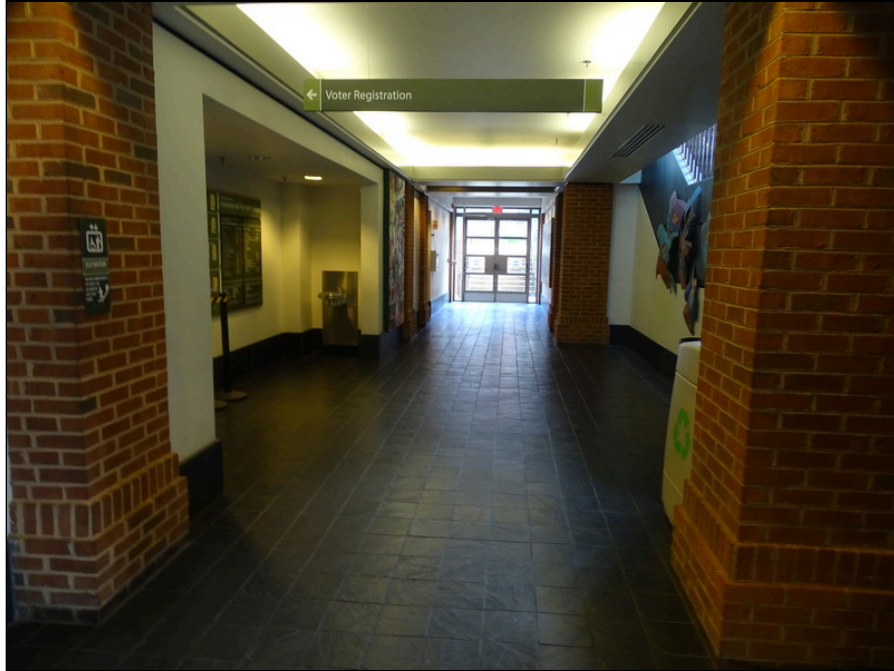
71 - Main entrance area

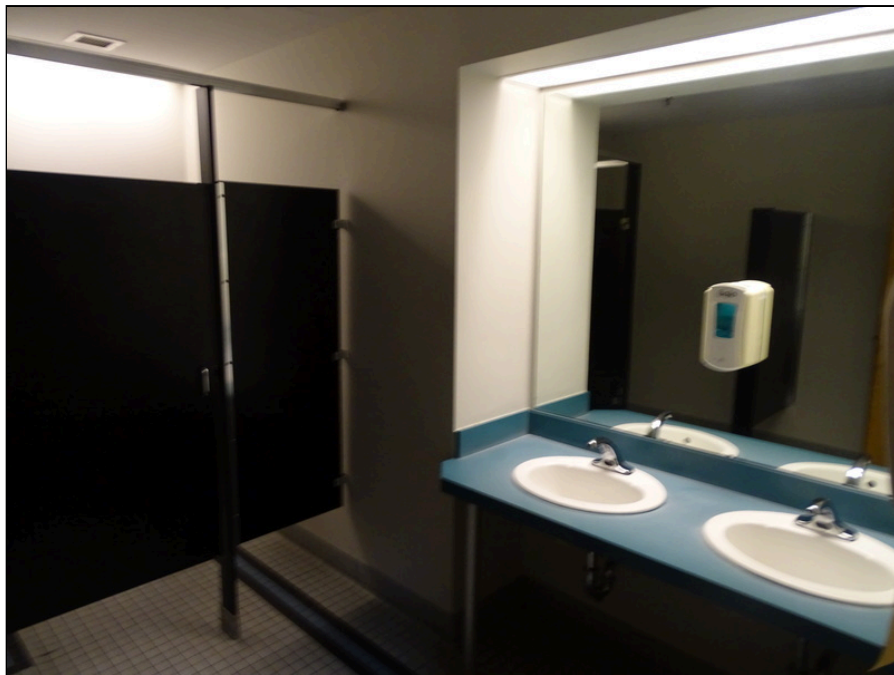
72 - Typical Accessible restroom

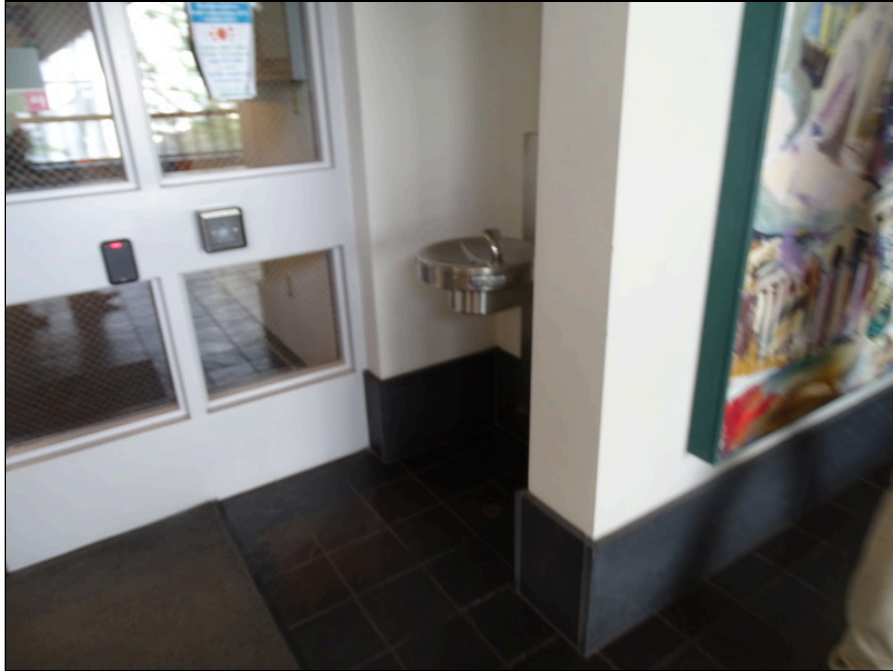
73 - Drinking fountain

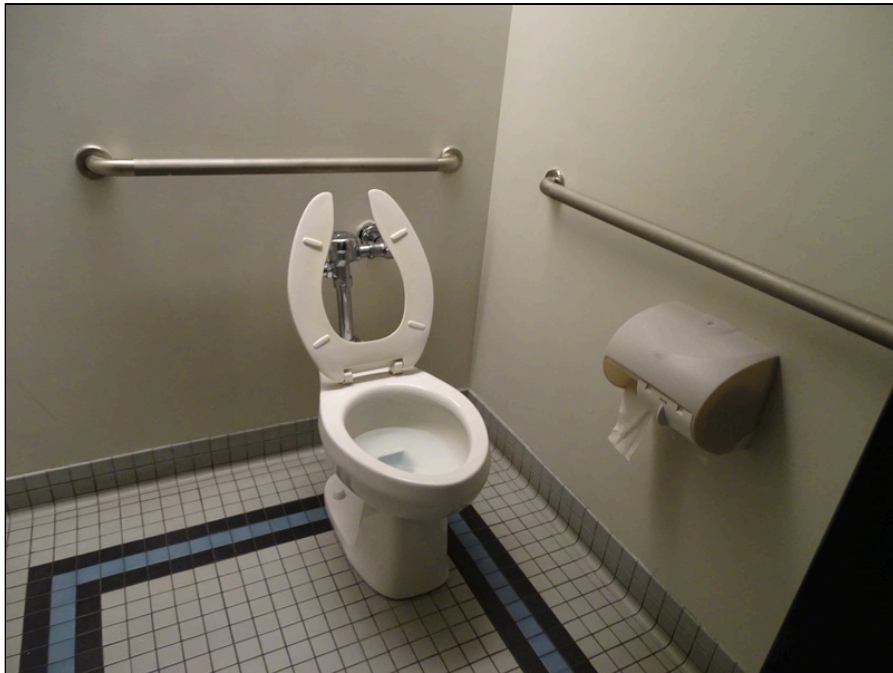
74 - Typical toilet

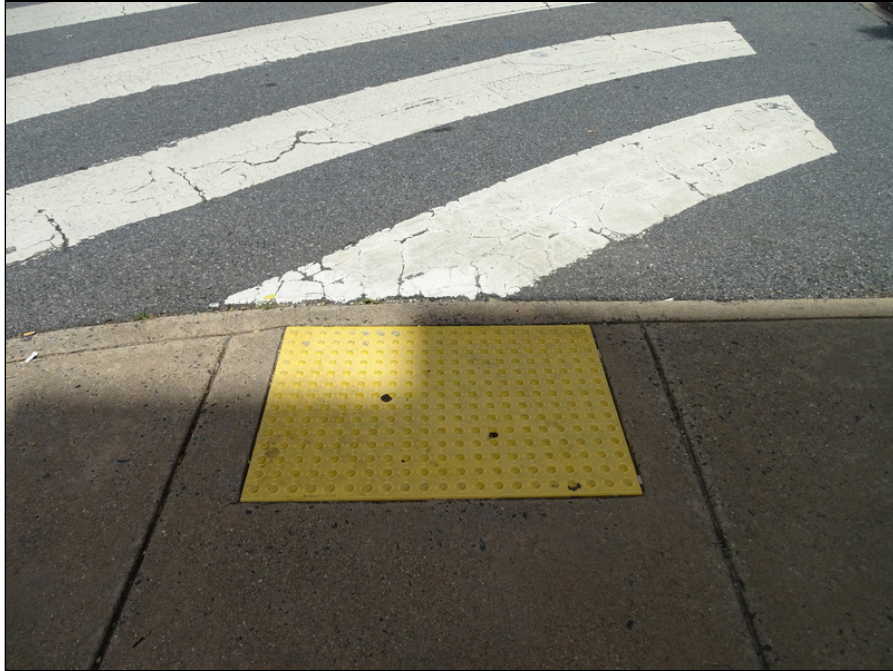
75 - Typical truncated Domes

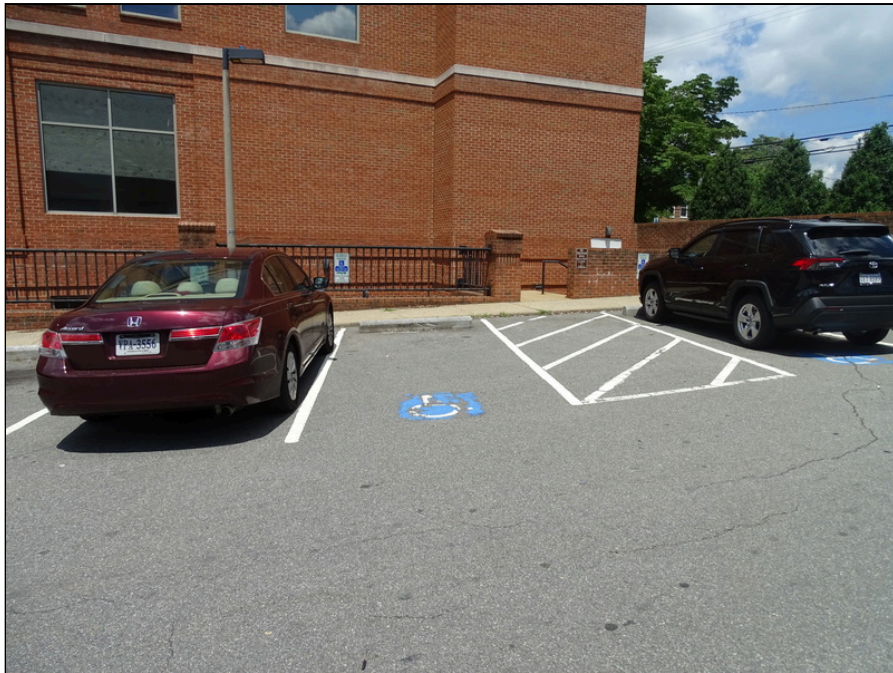
76 - Typical accessible parking
