FACILITIES WAREHOUSE - FLEET BUILDING
325 4TH STREET NW
CHARLOTTESVILLE, VIRGINIA

ECS PROJECT NO. 46:6713

CITY OF CHARLOTTESVILLE - FACILITIES DEVELOPMENT

Reference: Facility Condition Assessment Report for Facilities Warehouse - Fleet Building, 325 4th Street NW, Charlottesville, Virginia

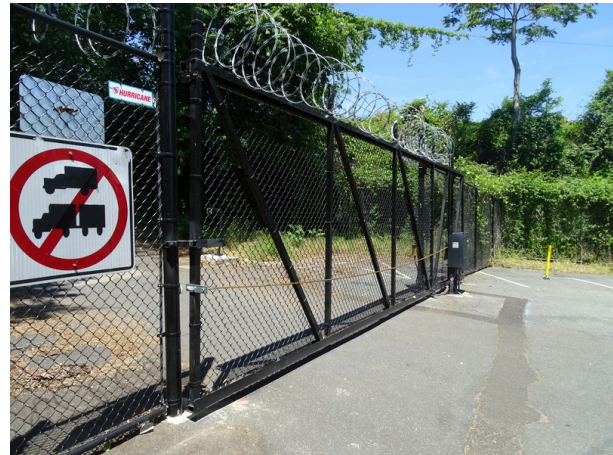
Typical chain link metal gate and fence

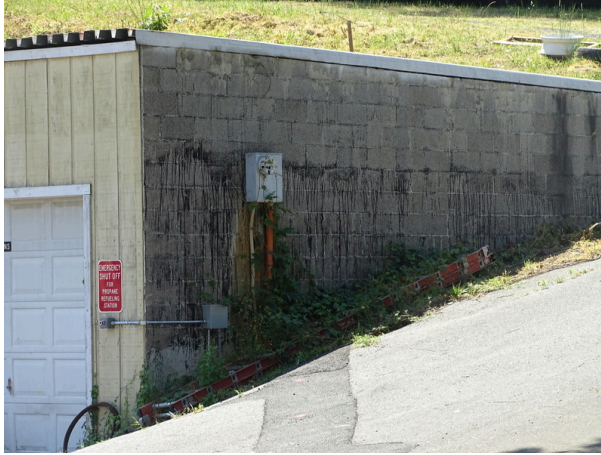
Adjacent garage wall - note efflorescence

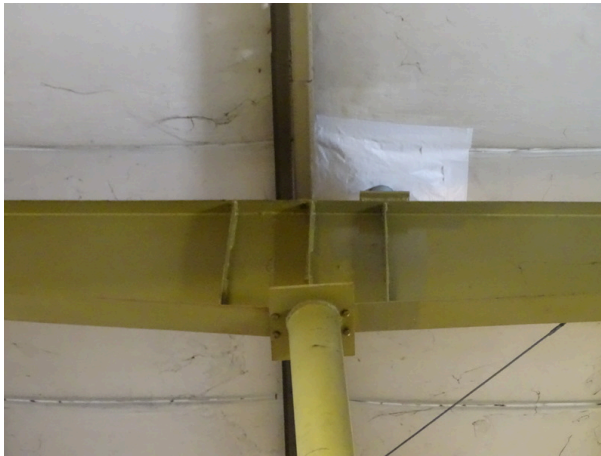
The structure of the building consists of Structural steel. The structural frame of the building was generally in good condition.

Structural framing

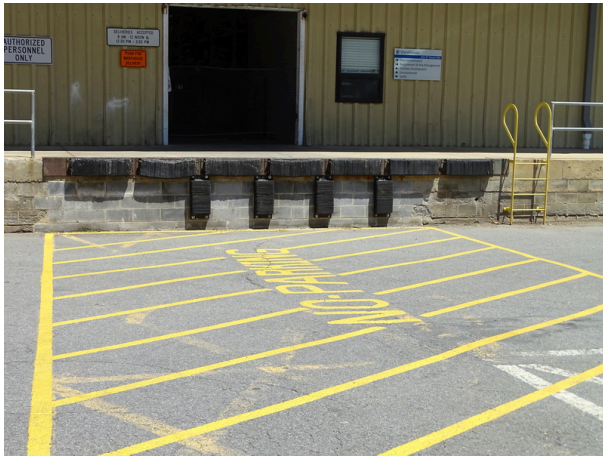
The primary exterior of the building consists of Metal. The metal siding was physically damaged and deteriorated at various locations. The building exteriors were generally in fair condition. The expected useful life of metal siding is approximately 50 years. We recommend that the metal siding be replaced.

Typical building exterior in loading dock area

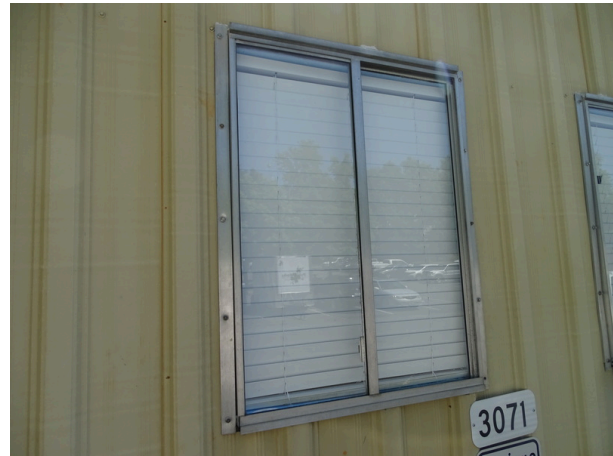
The window system for the building primarily consists of Aluminum frame double pane window units. There are older window units and newer window units that were generally in fair and good condition, respectively. The expected useful life of gaskets is typically 20 years. We recommend replacing the older window units.

Typical older exterior window unit

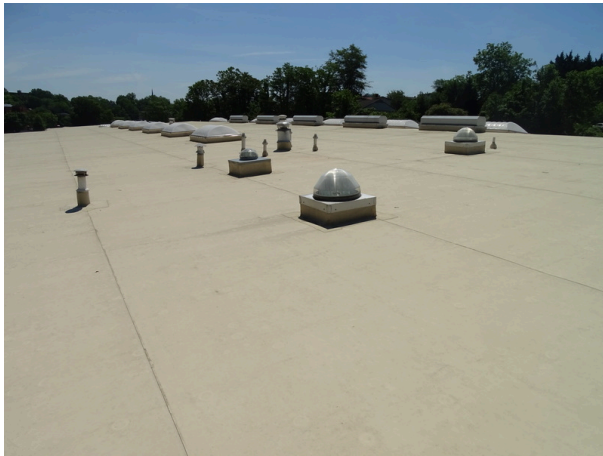
The main roofing system consists of single-ply sheet membrane roofing system. The roofing system was reportedly replaced in 2015. Drainage for the roofing system is provided by both gutters and downspouts and internal drains. The drainage was observed to be in generally good condition. The expected useful life of the roofing systems is generally 15 years. Based on the reported age of the roofing system, we recommend scheduled replacement during the end of the study period.

Roofing system looking east side of the building
looking east

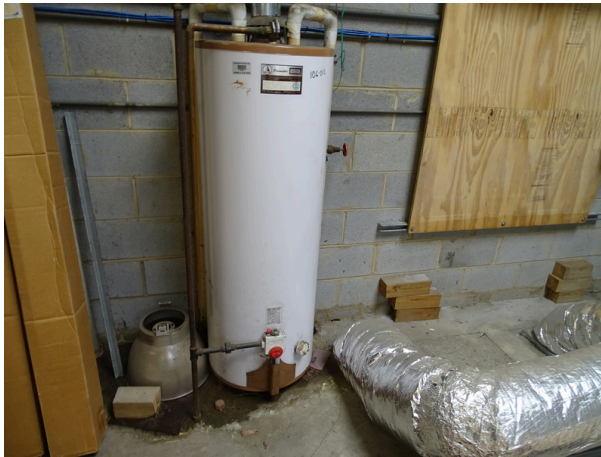
Domestic hot water to the building is provided by 2 Gas domestic water heaters. The Gas domestic water heaters were installed in 1999 and in 2011. The expected useful life of a Gas domestic water heater is approximately 12 to 15 years. We recommend replacing the Gas domestic water heaters during the report period.

Typical water heater

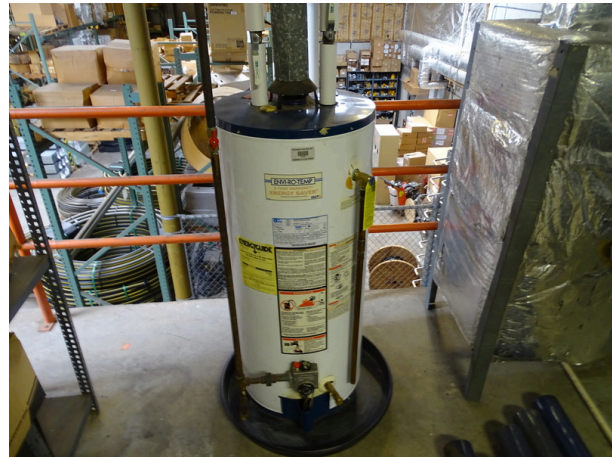
Typical water heater

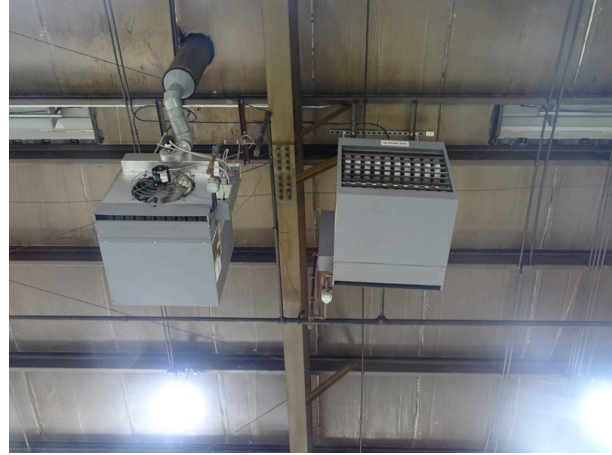
Eight ceiling mounted space heaters are located in the garage and warehouse areas. The space heaters were manufactured by Trane and Sterling in 1975 and 2007, respectively. The expected useful life of space heaters is approximately 20 years. The space heaters were generally in fair condition. We recommend replacing the space heaters based on their age during the report period.

Typical space Heaters

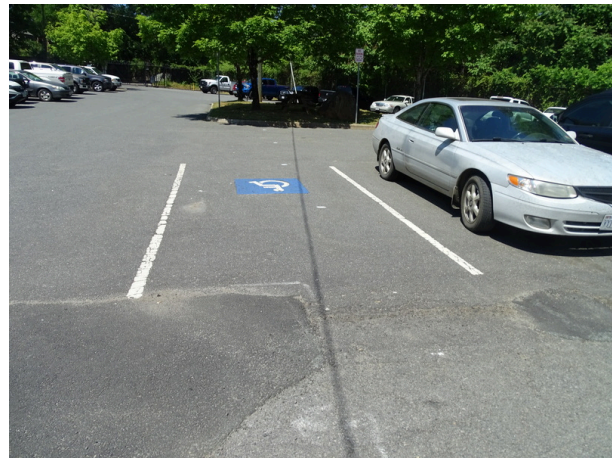
The parking area serving the property has a total of approximately 181 parking spaces. Of the parking spaces, Three are accessible with None being van accessible. Accessibility requires that six accessible parking space be provided in parking areas with a total of 151 to 200 spaces. One in six of the accessible parking spaces are required to be van accessible. A minimum of a 60-inch wide access aisle is required to be provided for every two accessible parking spaces. Accessible aisles were not provided. The number of parking spaces provided does not meet accessibility requirements. We recommend installing three more additional accessible spaces with one being van accessible.

Accessible parking space - note striping faded

Cost Recommendation	EUL	EFF AGE	RUL	Year	Cost
INSTALL THREE ADDITIONAL ACCESSIBLE PARKING SPACES (ONE VAN ACCESSIBLE)	1	1	0	Immediate	\$1,500
Total					\$1,500

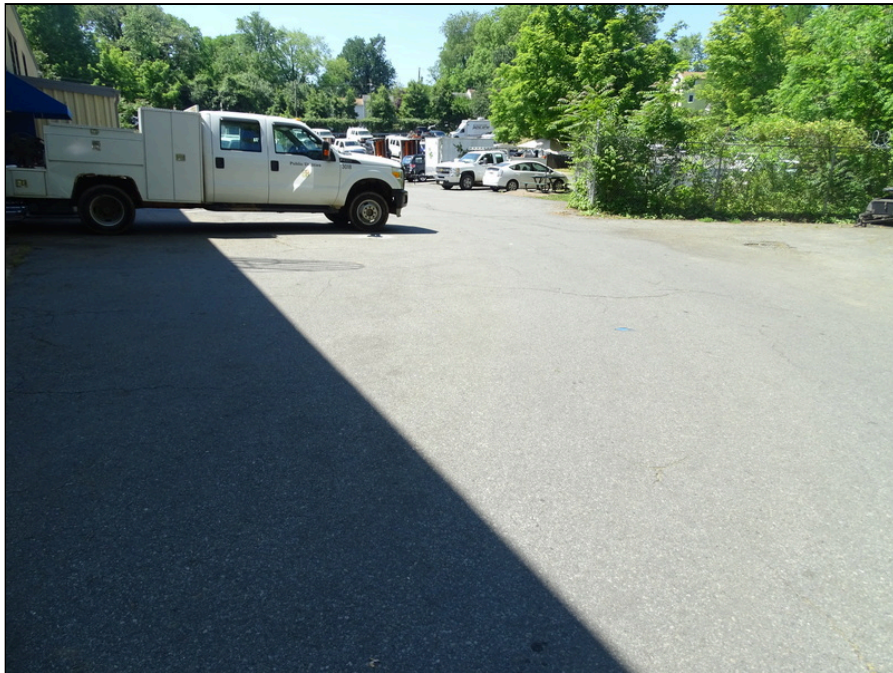
2 - Asphalt pavement west side of the site

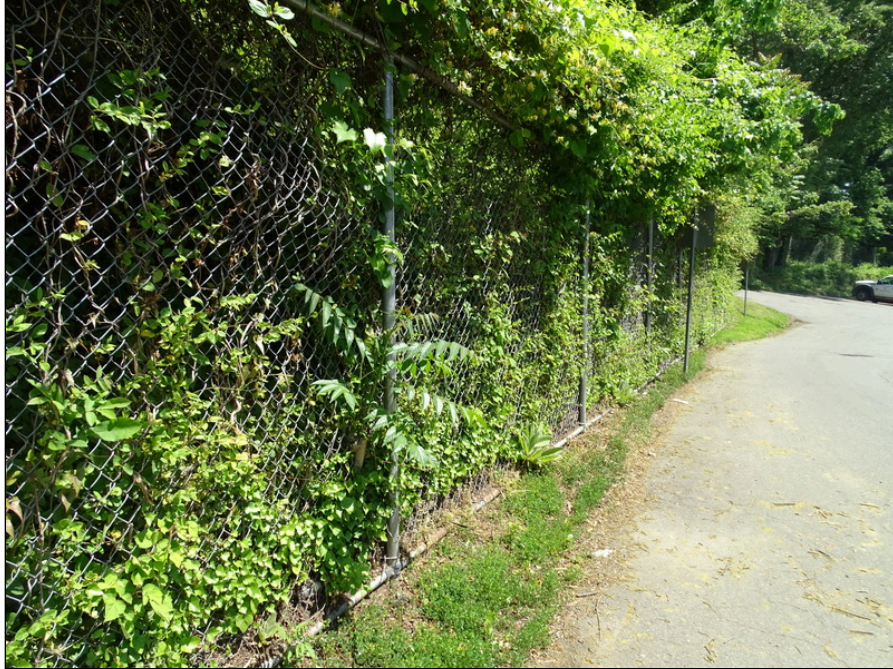
21 - Typical chain link fence note deterioration

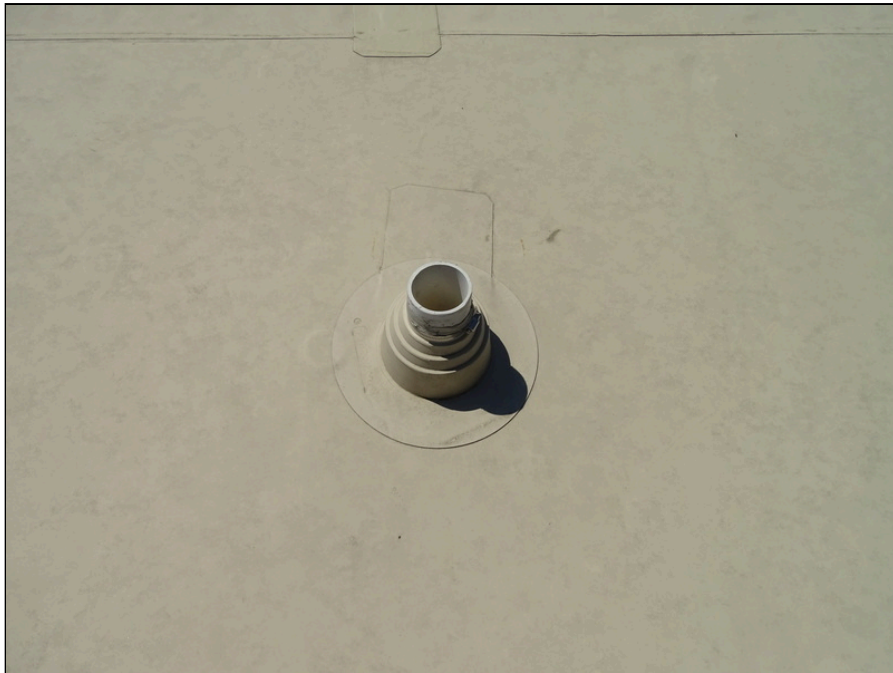
46 - Typical plumbing penetration

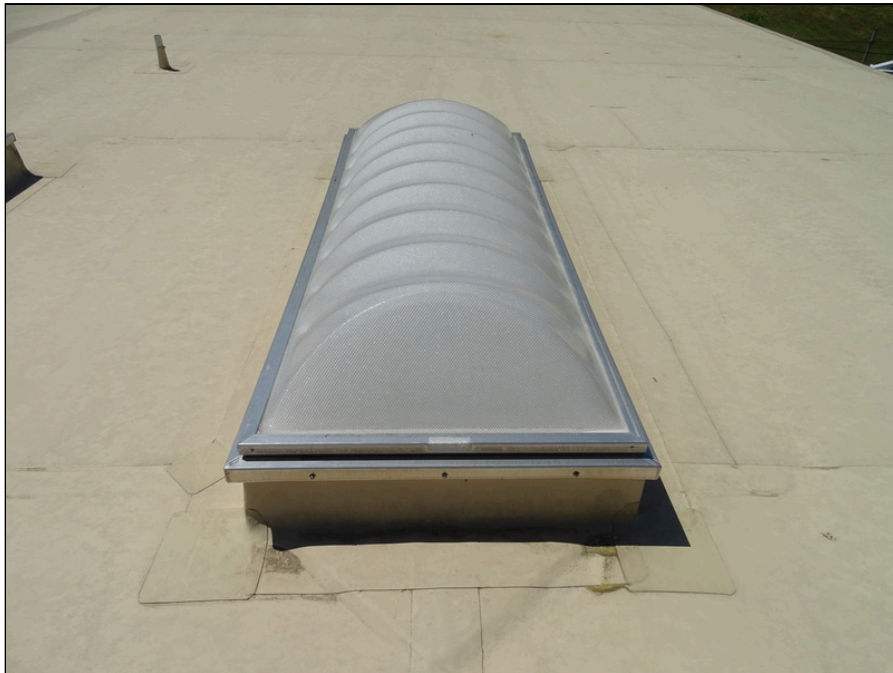
48 - Typical larger skylights

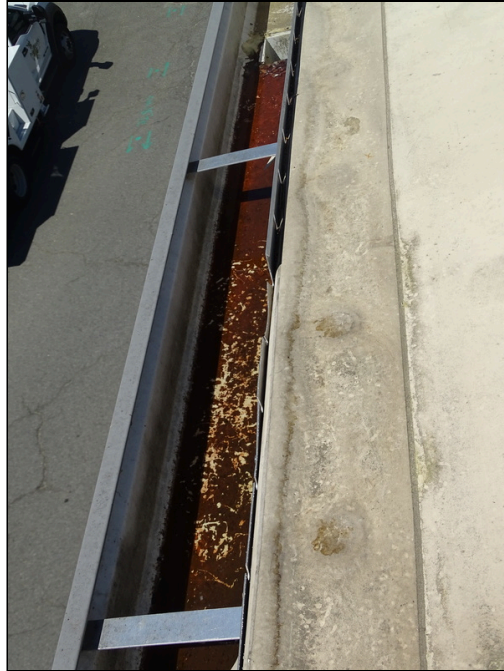
49 - Typical gutter and downspout

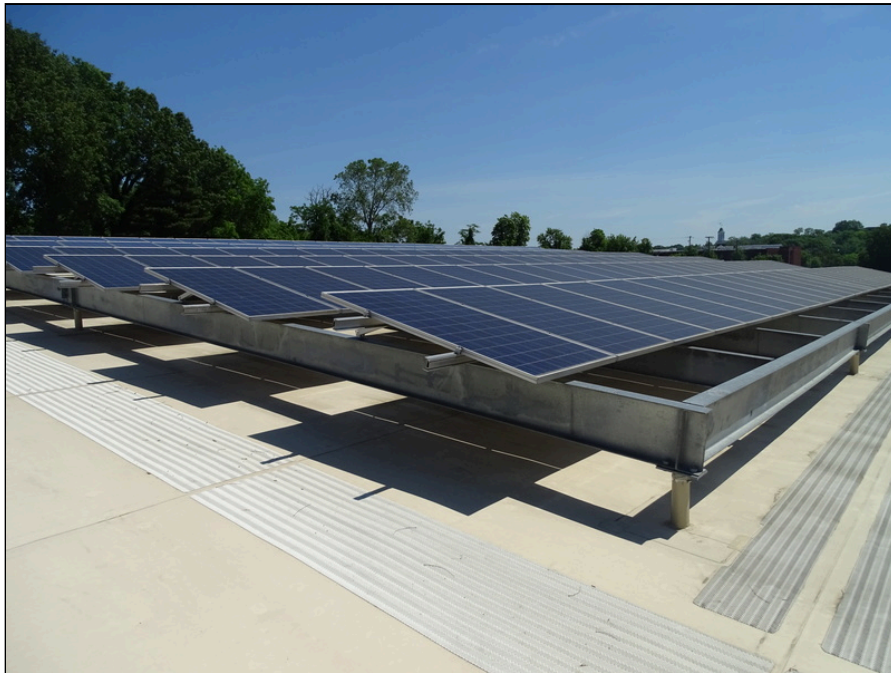
50 - Solar Power System located on roof

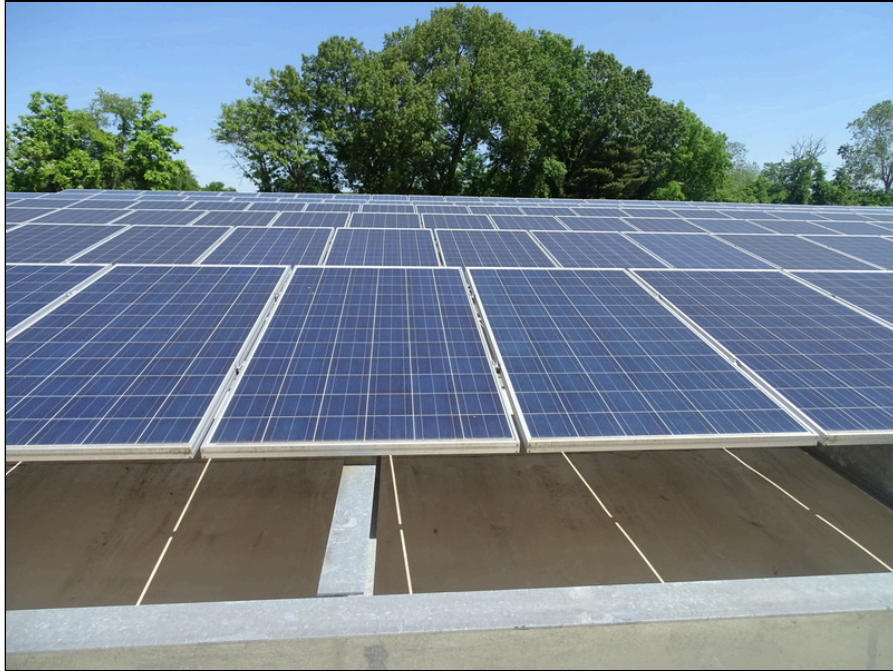
51 - Solar Power System located on roof

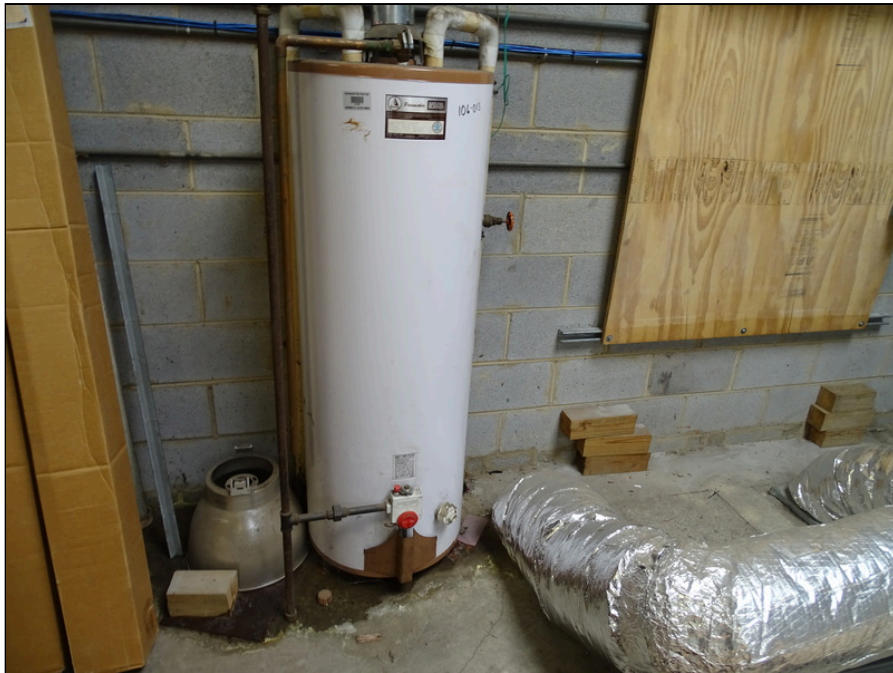
52 - Typical water heater

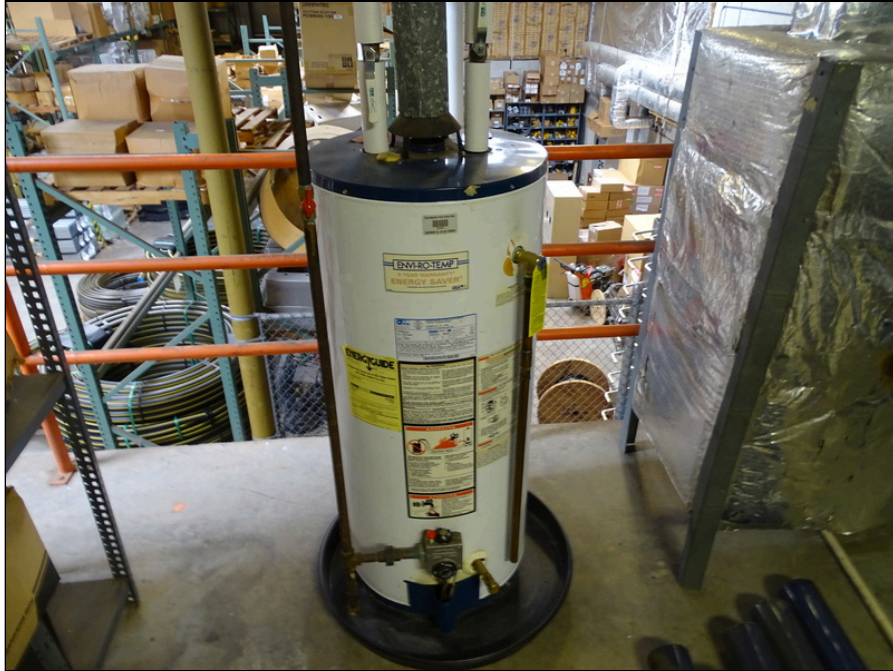
53 - Typical water heater

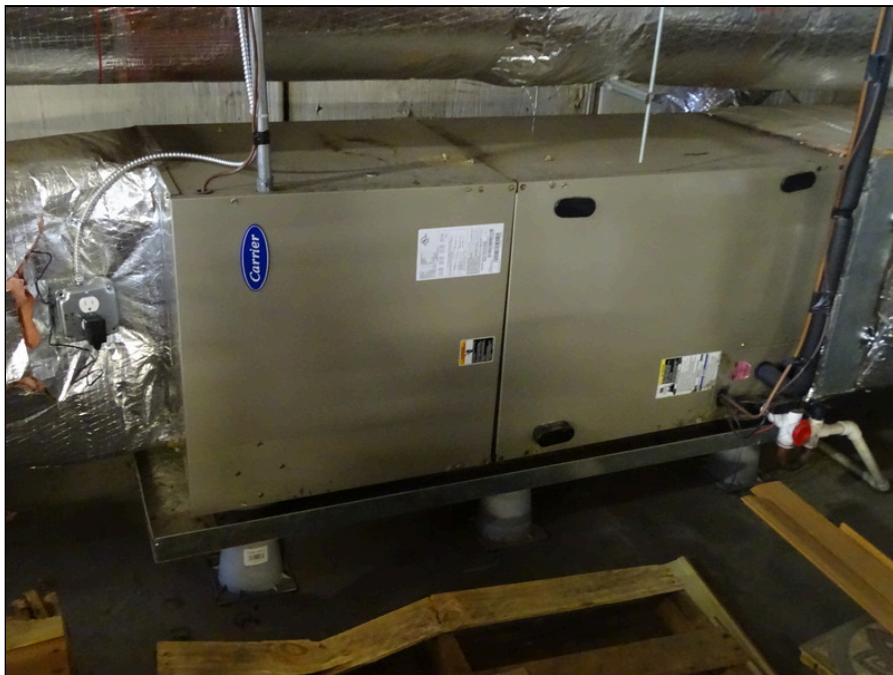
54 - Typical air handler unit located in attic area

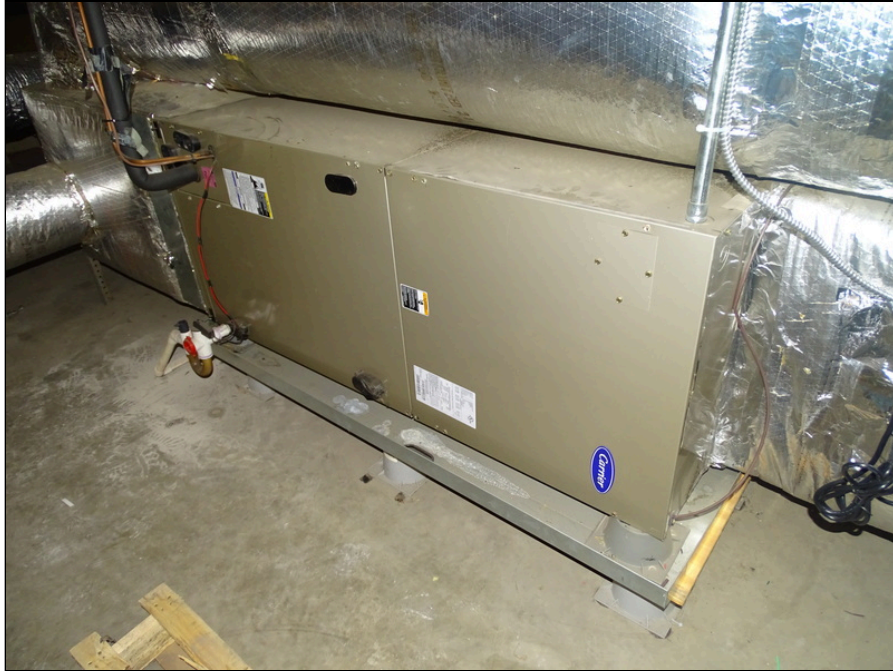
55 - Typical air handler unit located in attic area

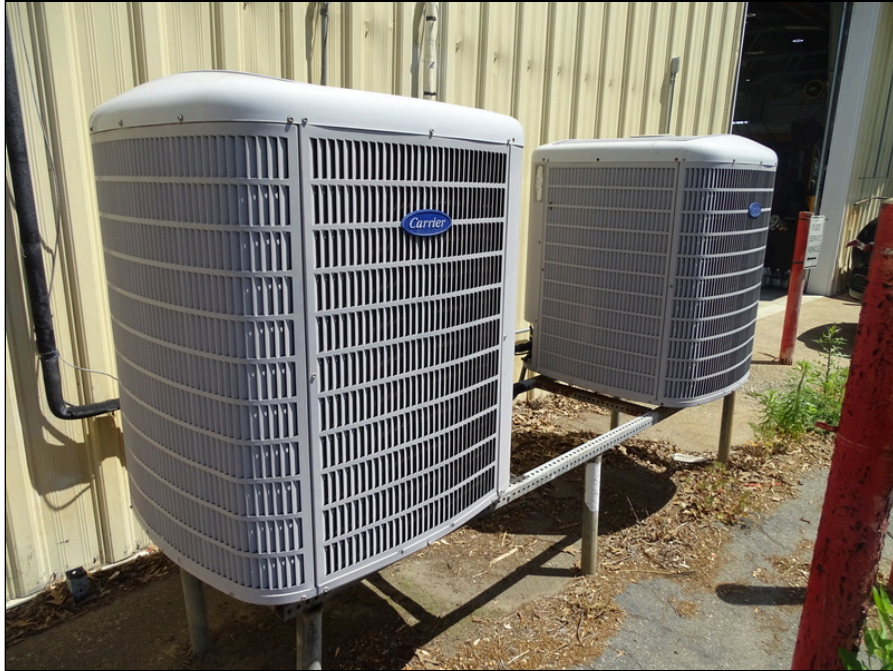
57 - Condenser Units

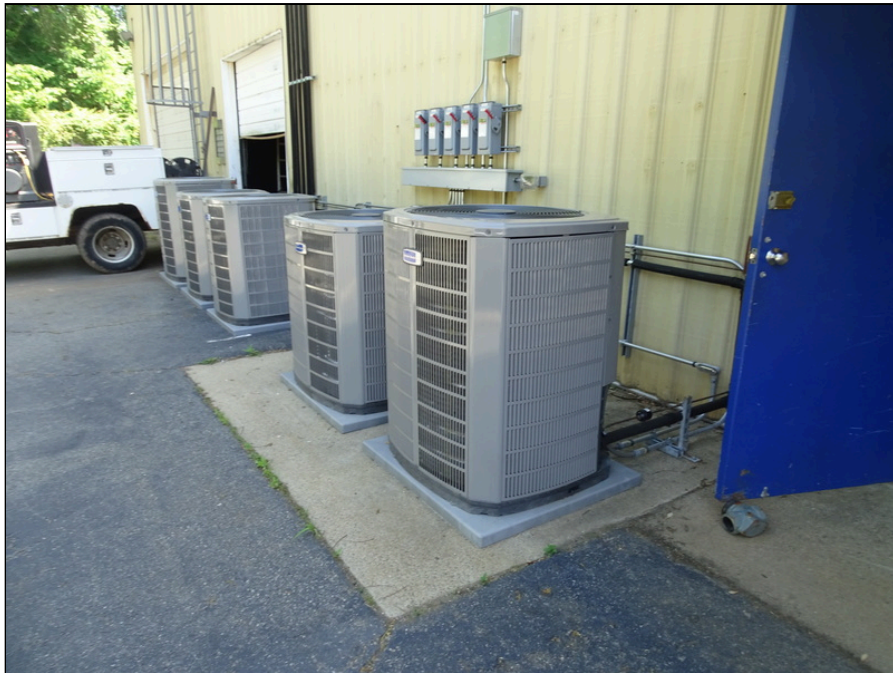
58 - Condenser Units

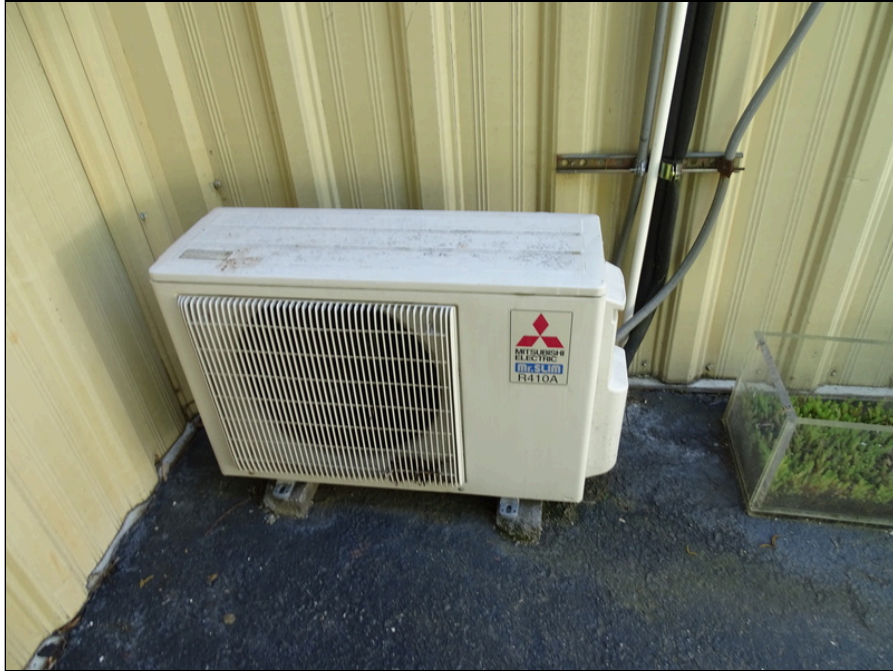
59 - Ductless Split System

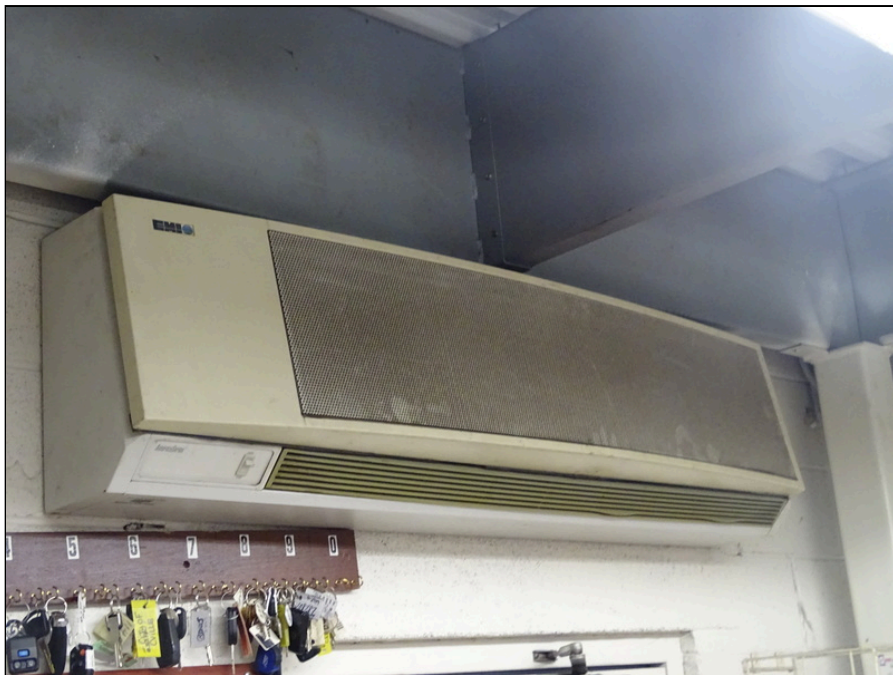
60 - Ductless Split System Wall Mounted Unit

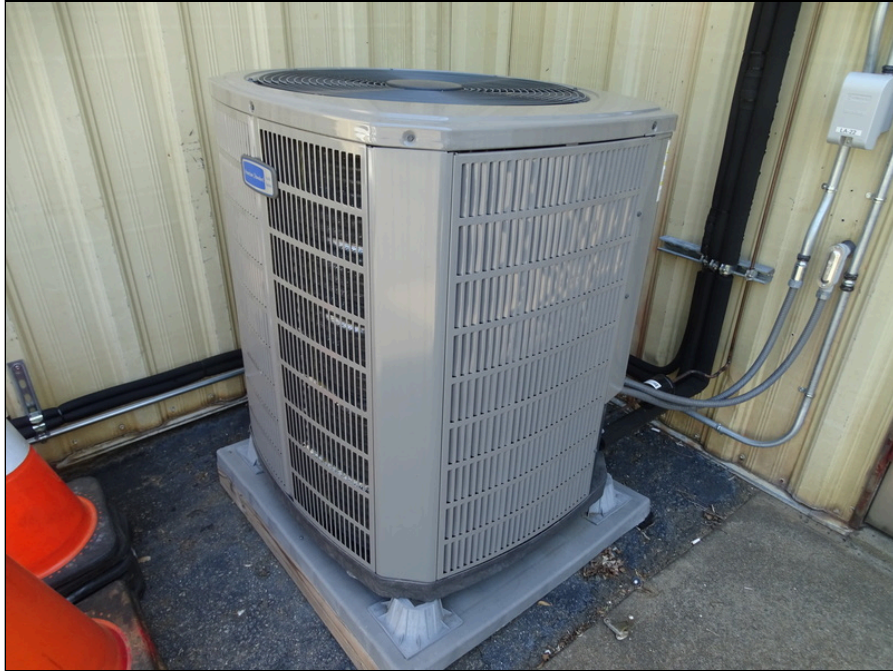
61 - Heat Pump

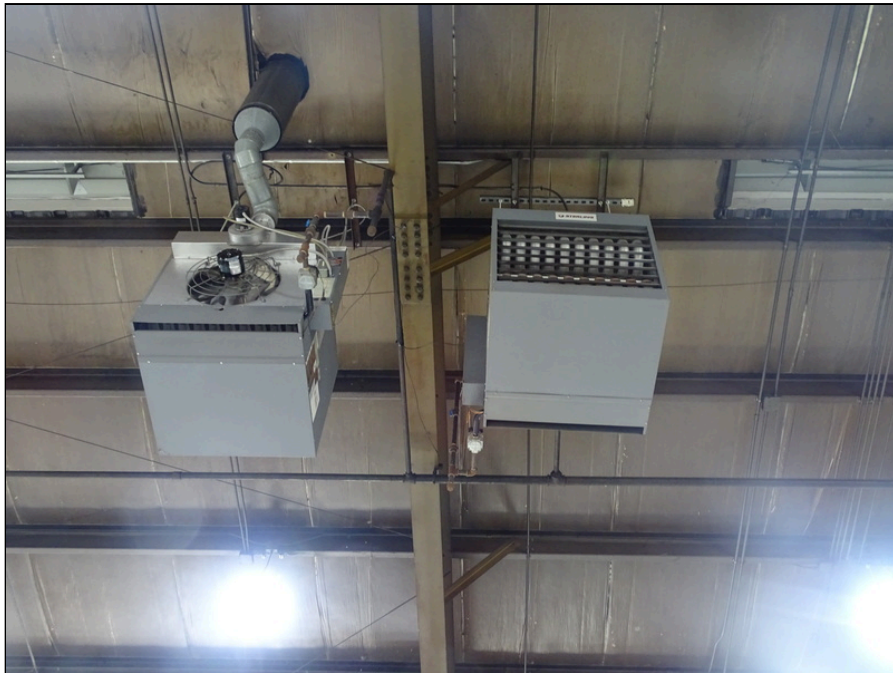
62 - Typical space Heaters

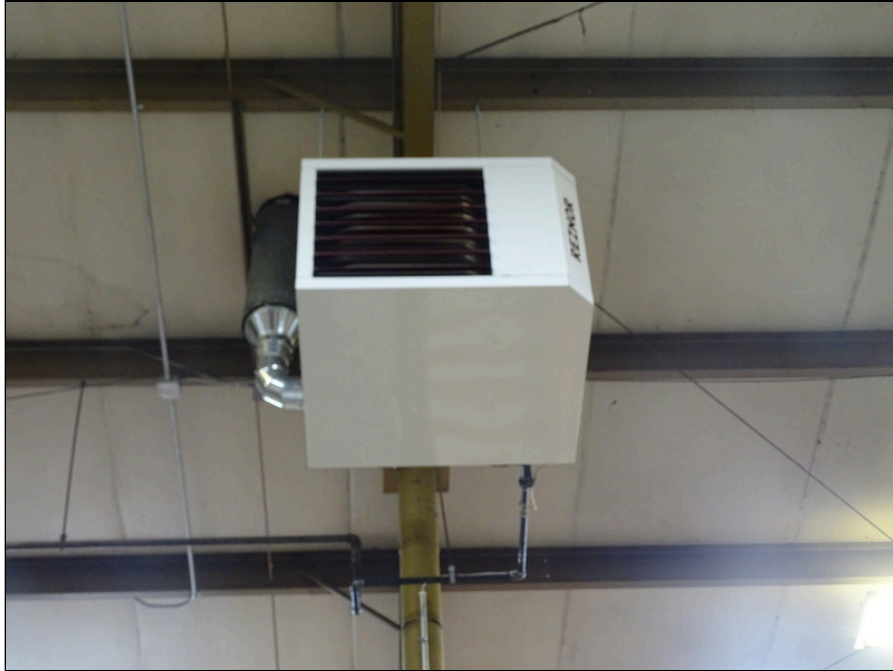
63 - Typical space Heaters

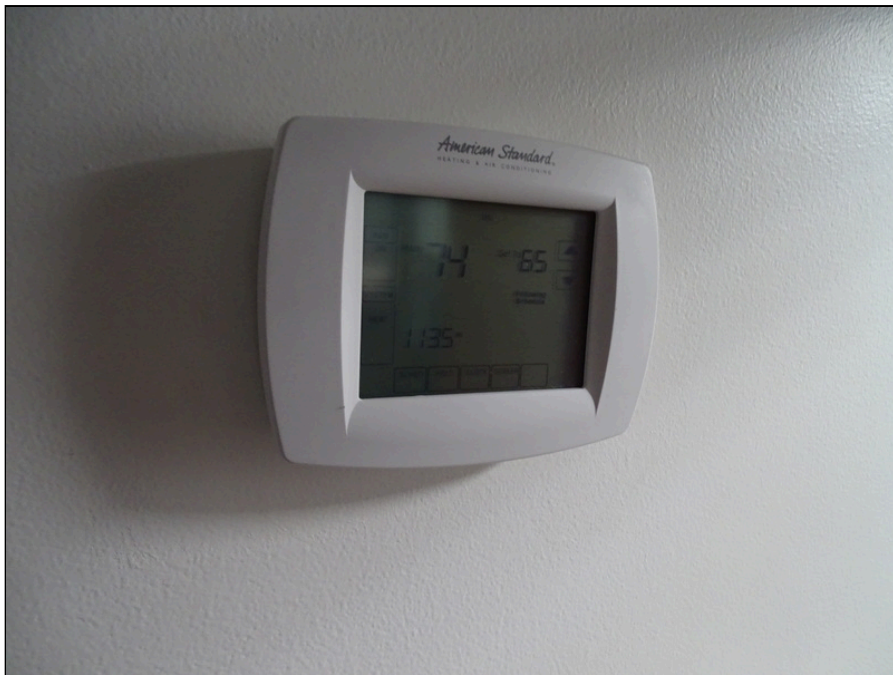
64 - Typical digital thermostat

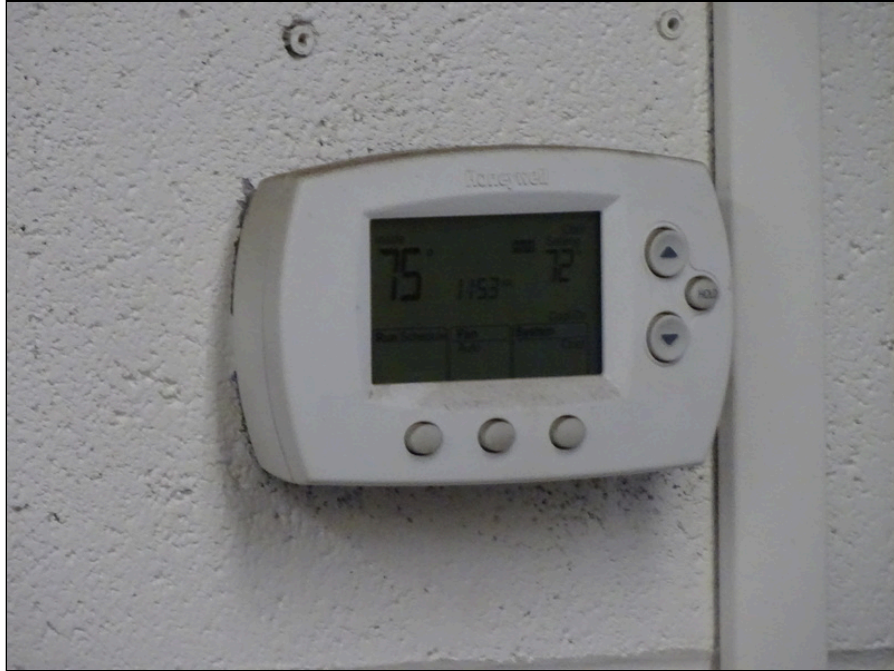
65 - Typical digital thermostat

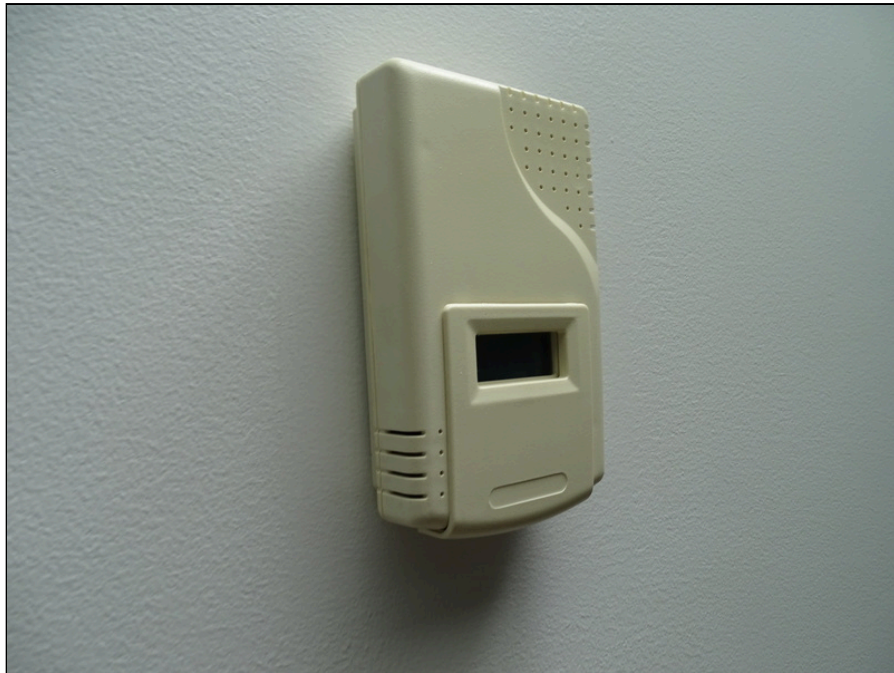
66 - Typical digital thermostat

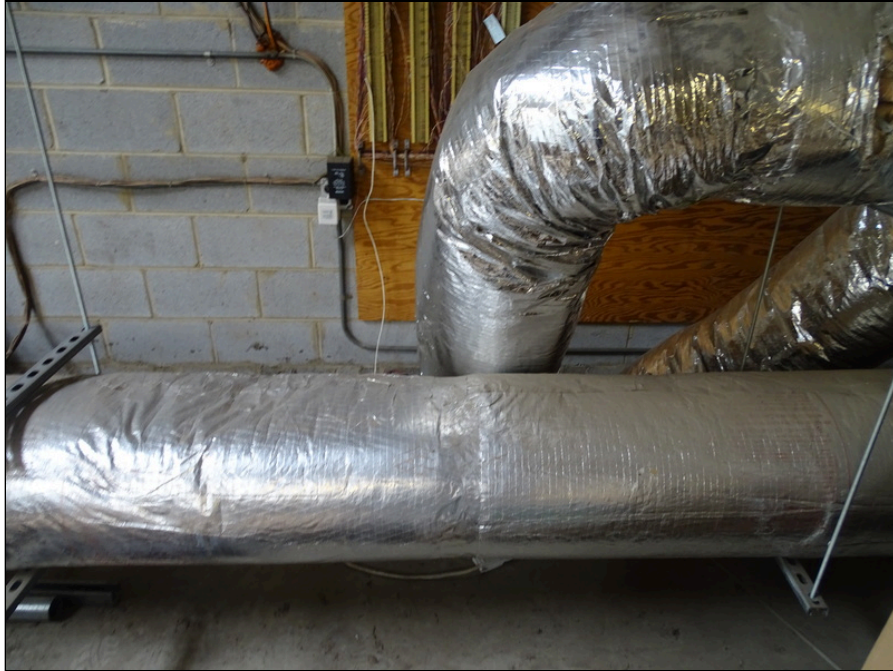
67 - Typical mechanical duct

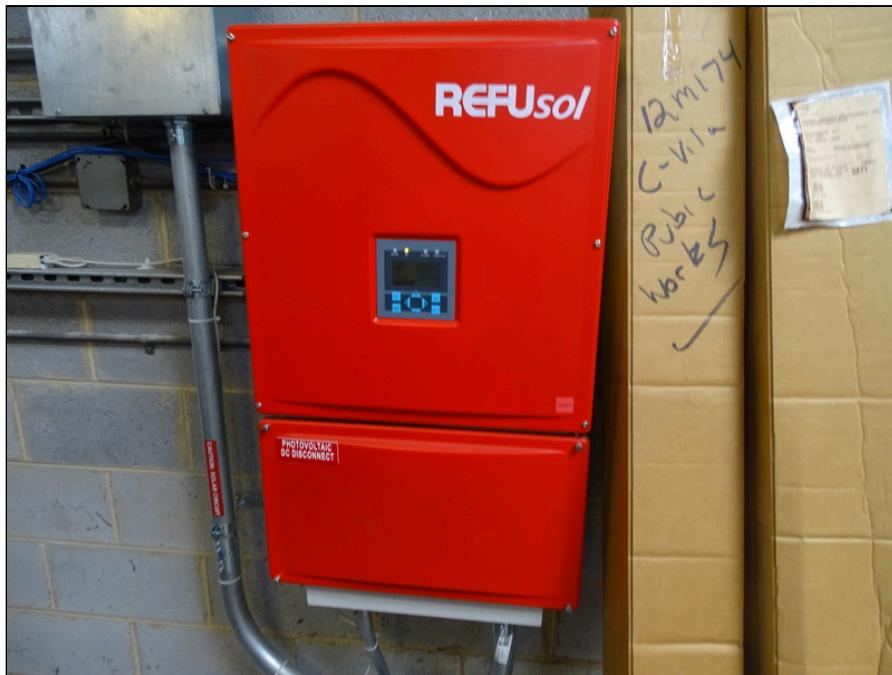
68 - Solar Power system electronics and meter

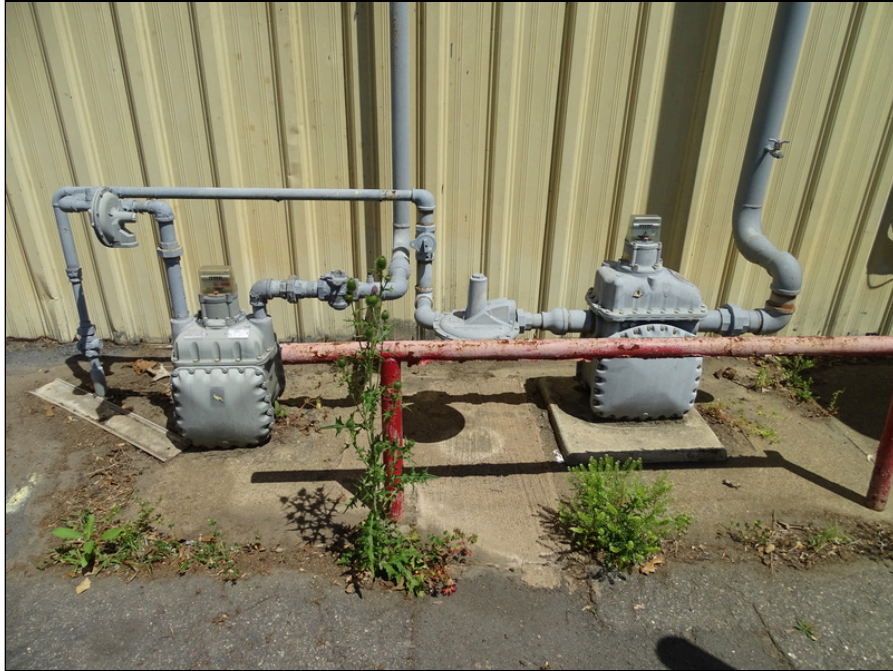
69 - Typical gas meter

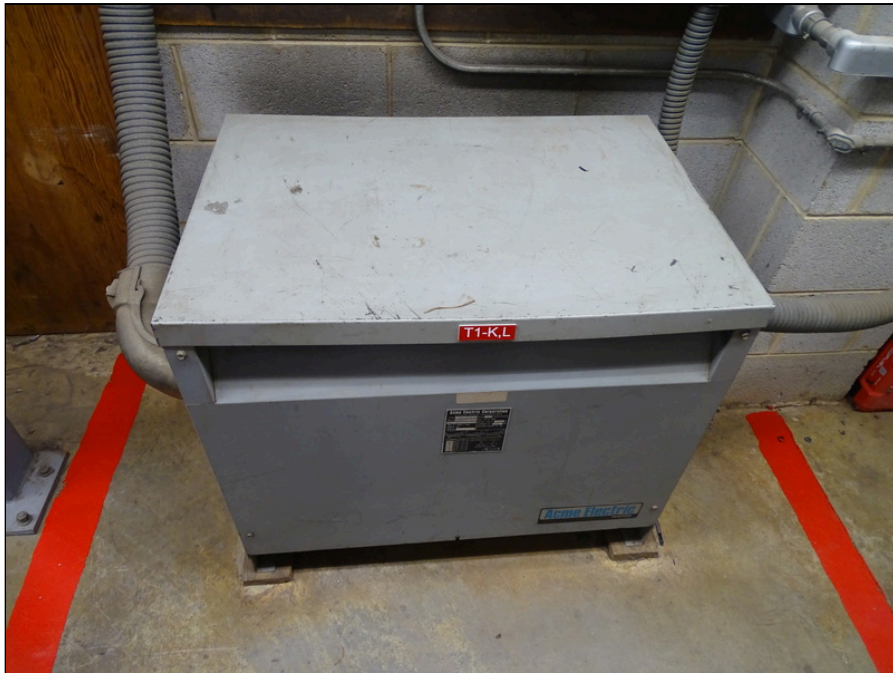
70 - Typical building transformer

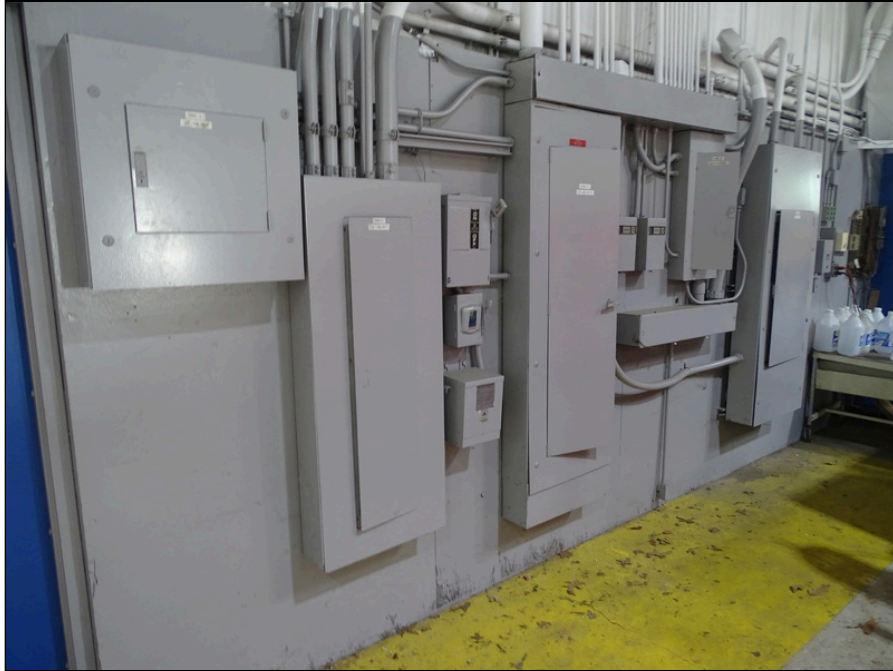
71 - Main electrical disconnect, utility meter, and emergency transfer switch

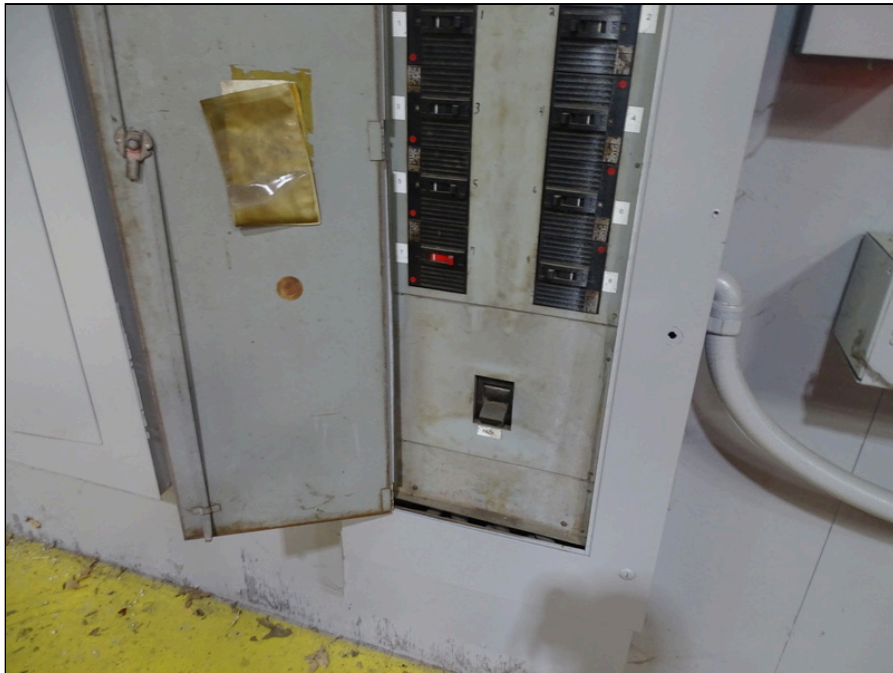
72 - Main electrical disconnect,

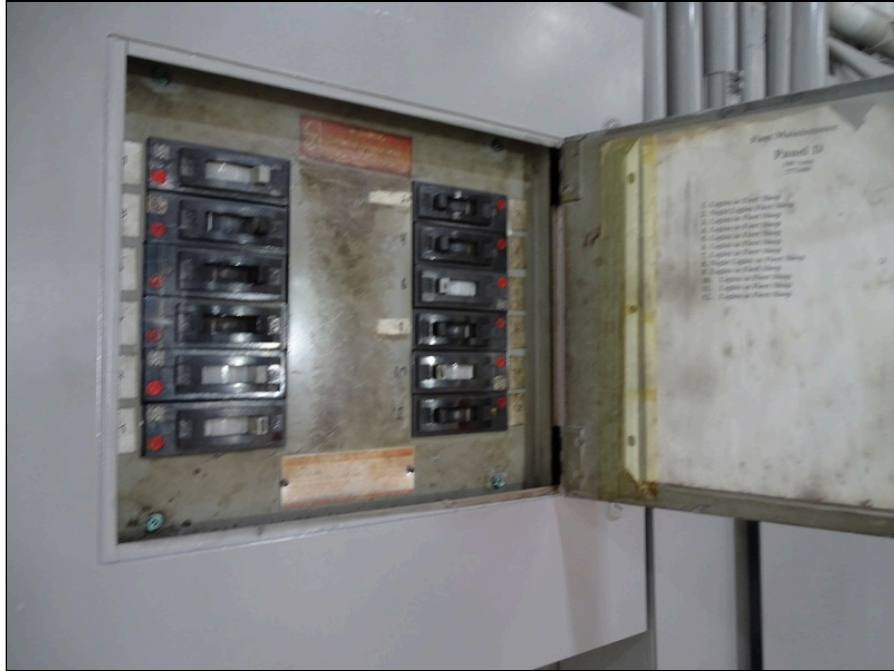
73 - Typical circuit breaker panel

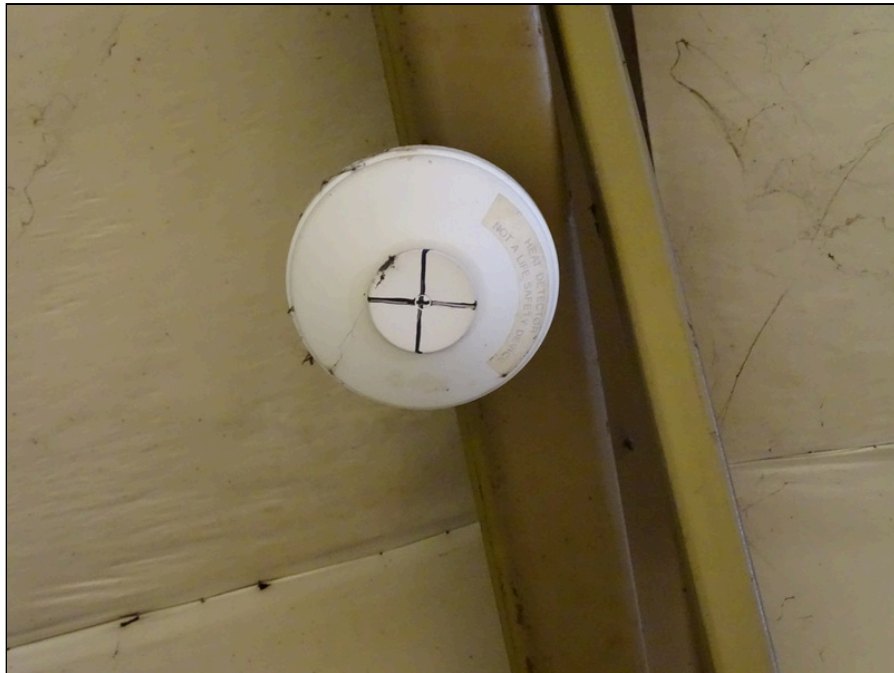
74 - Typical smoke detector

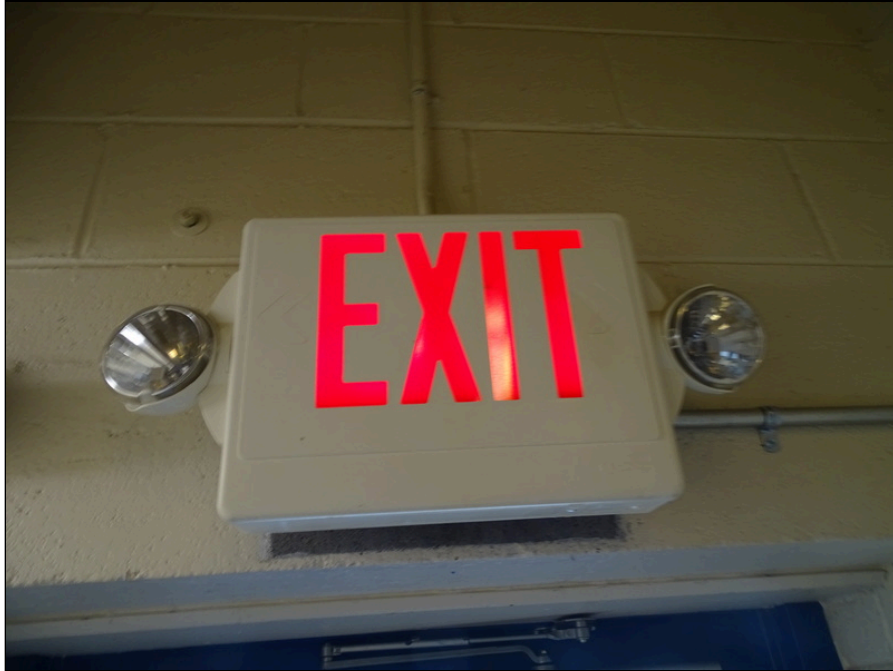
75 - Typical exit sign with emergency lighting

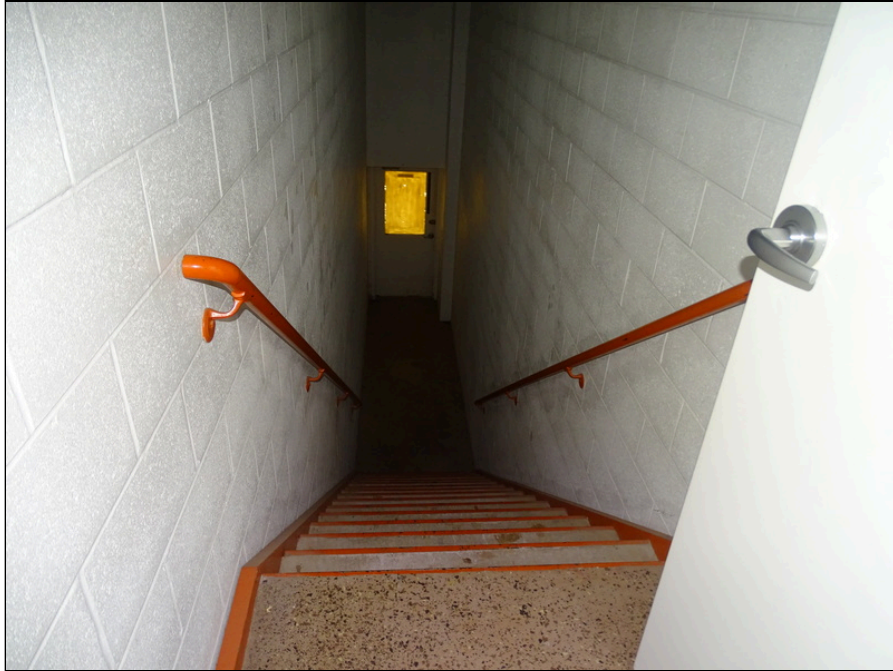
77 - Interior finishes stairway area

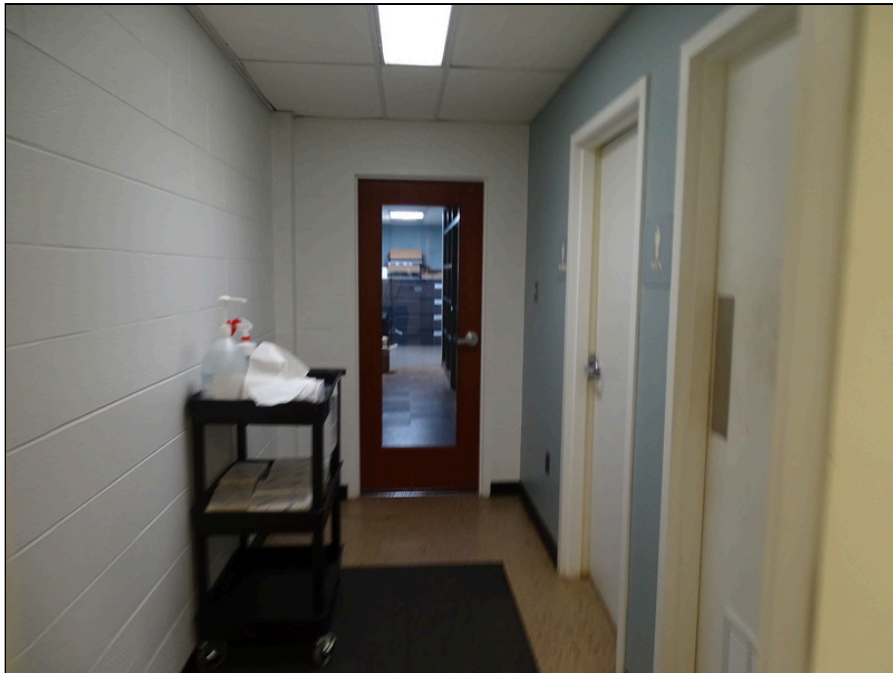
78 - Corridor
