FACILITIES WAREHOUSE - FLEET BUILDING
325 4TH STREET NW
CHARLOTTESVILLE, VIRGINIA

ECS PROJECT NO. 46:6713

CITY OF CHARLOTTESVILLE - FACILITIES DEVELOPMENT

Reference: Facility Condition Assessment Report for Facilities Warehouse - Fleet Building, 325 4th Street NW, Charlottesville, Virginia

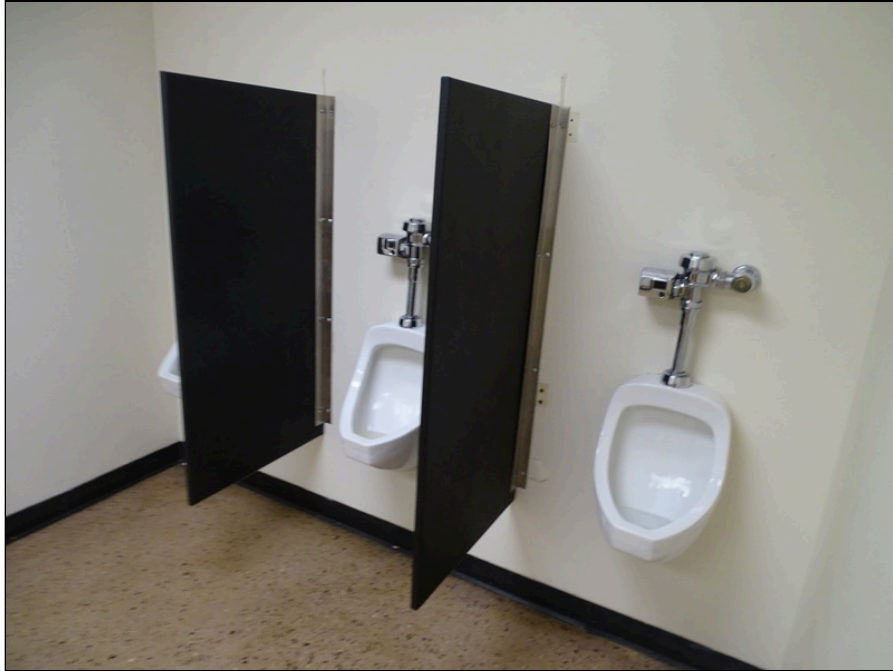
79 - Interior finishes restroom area

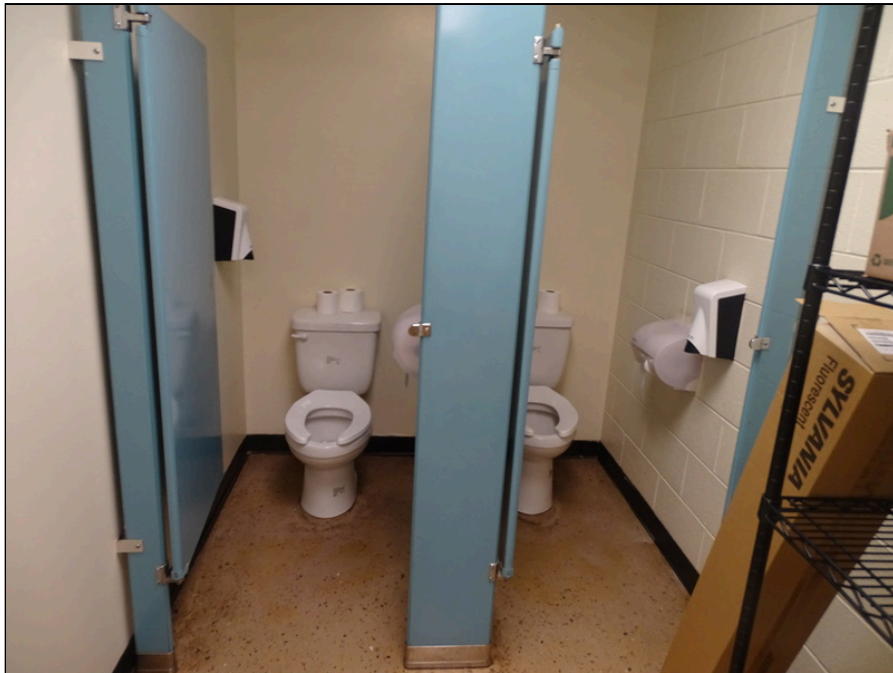
80 - Interior finishes restroom area

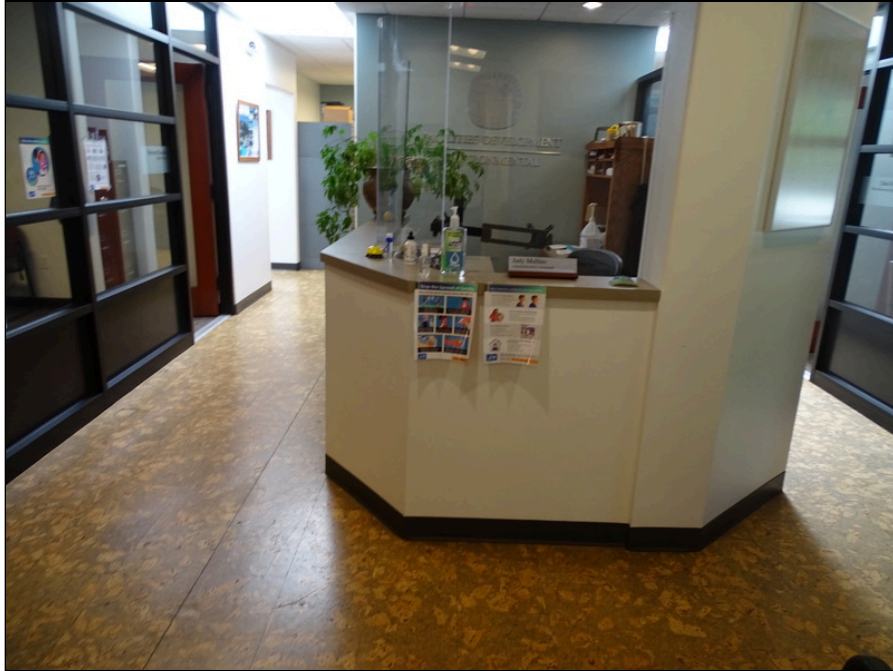
81 - Interior finishes lobby area

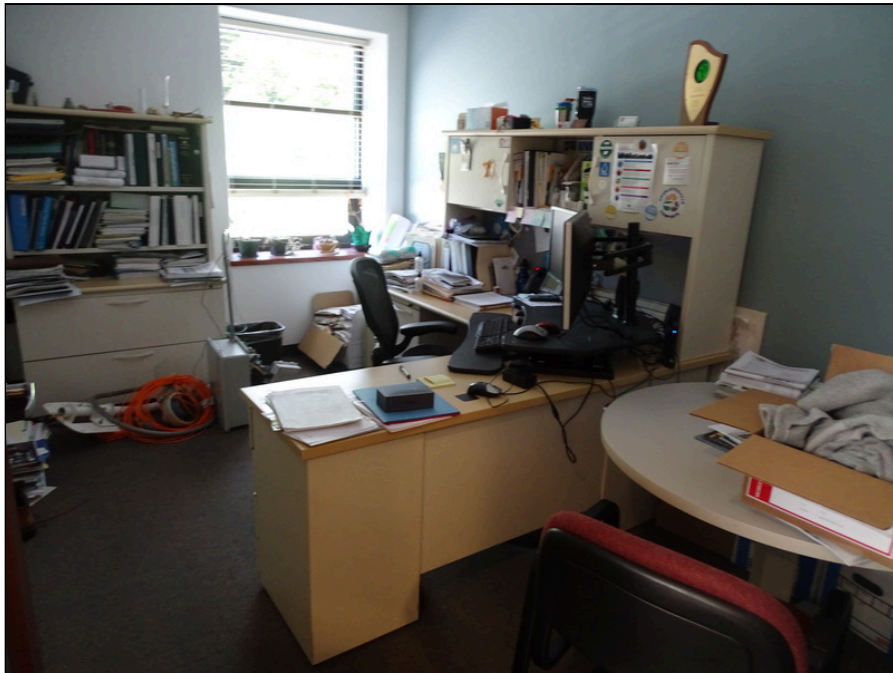
82 - Interior finishes office area

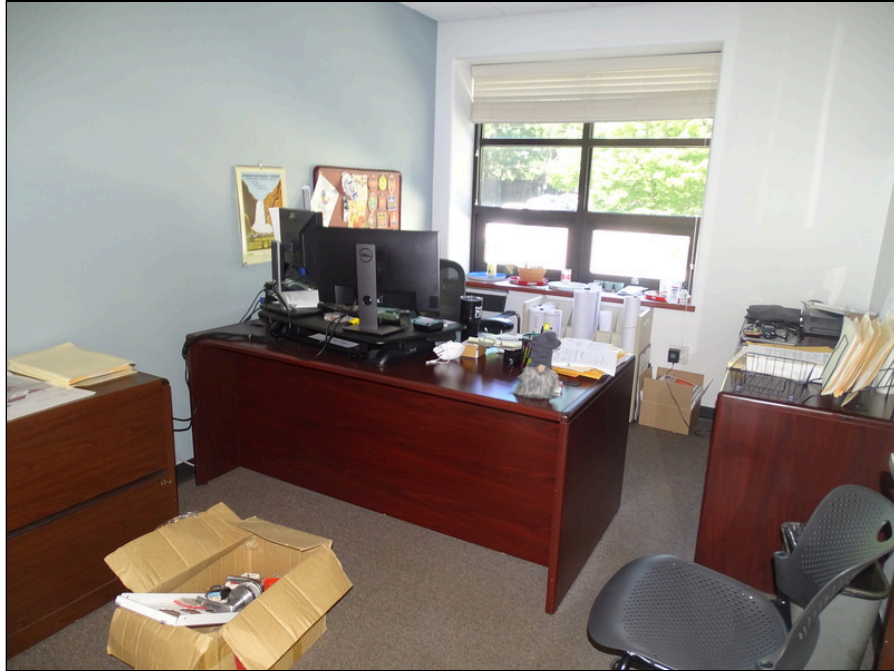
83 - Interior finishes office area

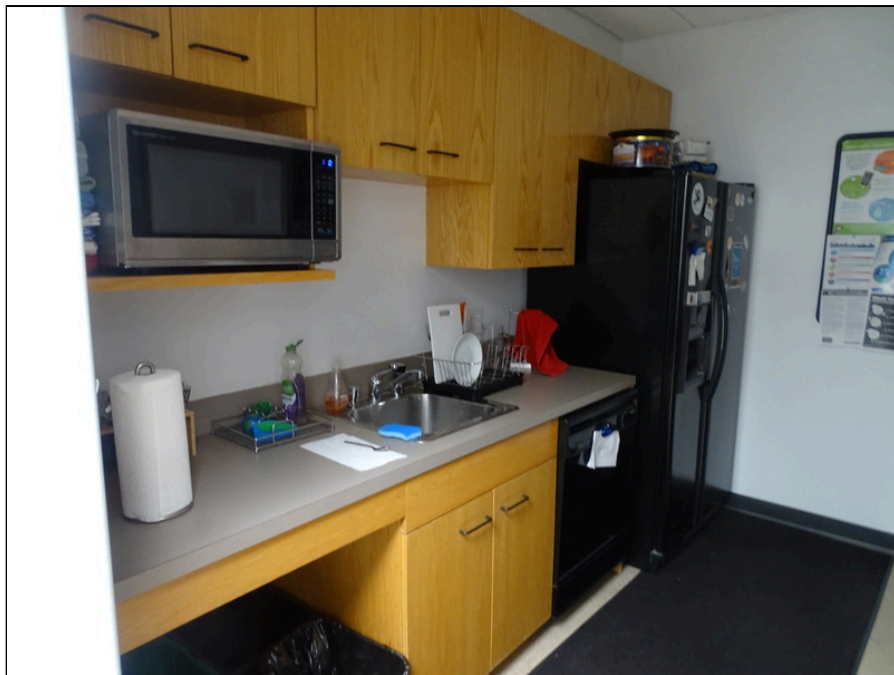
84 - Interior finishes kitchen area

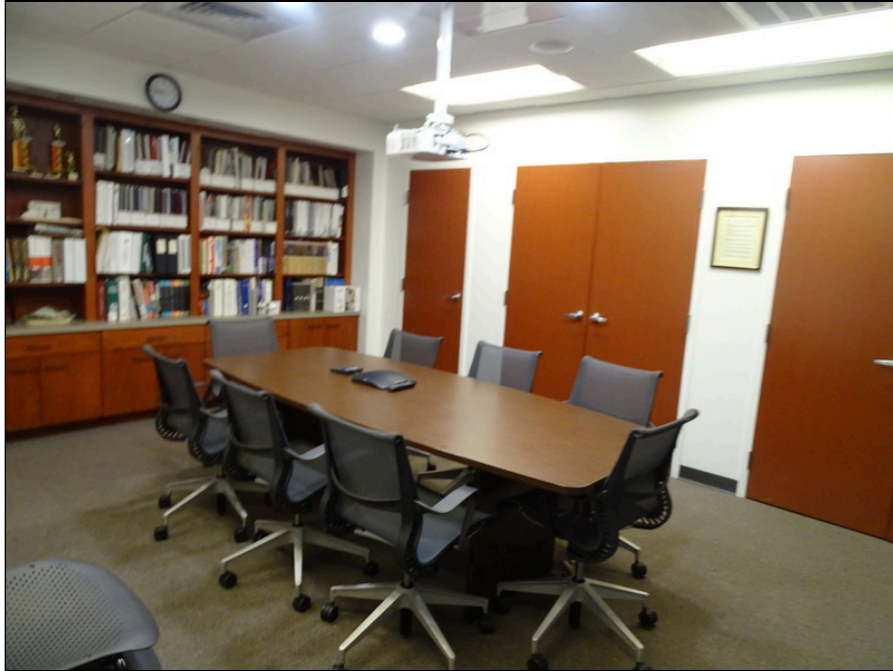
85 - Interior finishes meeting room area

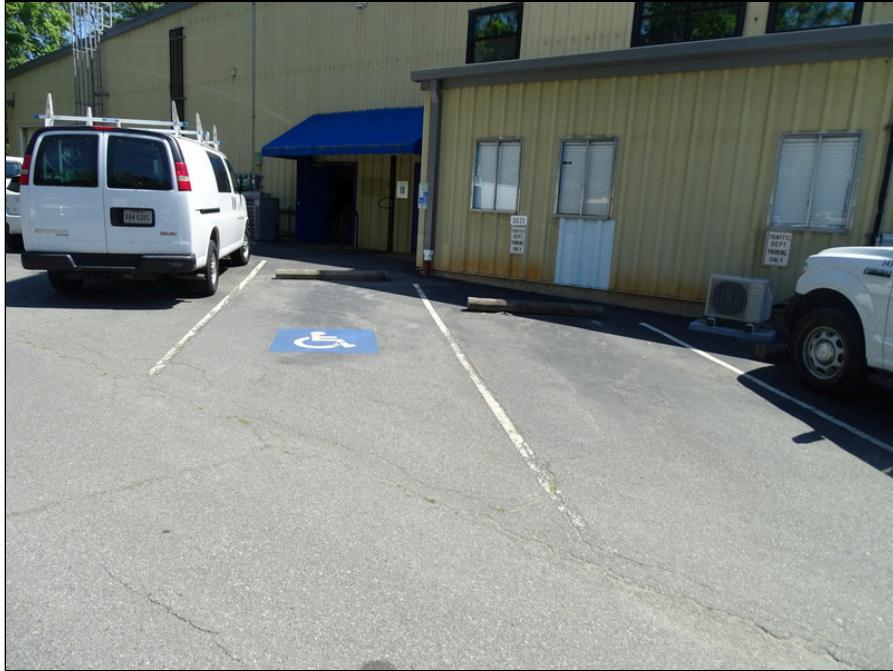
91 - Accessible parking space - note striping faded

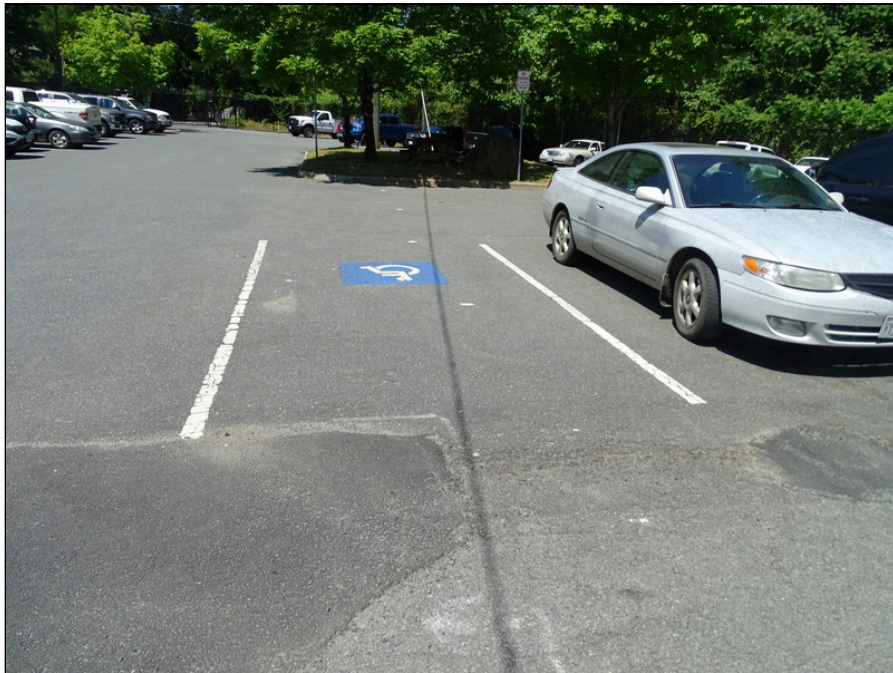
92 - Accessible parking space - note striping faded
