CITY OF PROMISE  
708 PAGE STREET  
CHARLOTTESVILLE, VIRGINIA

ECS PROJECT NO. 46:6713

CITY OF CHARLOTTESVILLE - FACILITIES DEVELOPMENT

Reference: Facility Condition Assessment Report for City of Promise, 708 Page Street, Charlottesville, Virginia

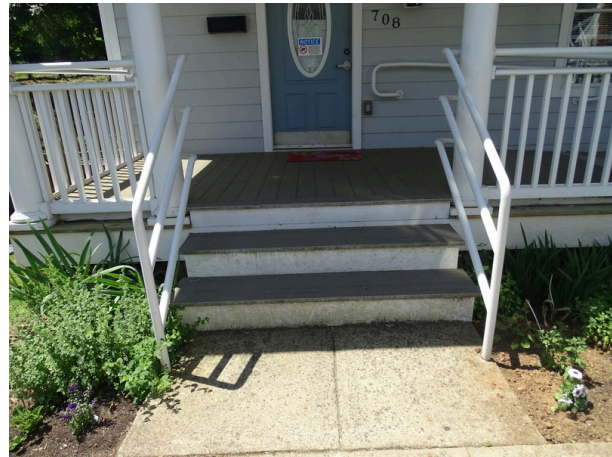
Concrete sidewalk at north side of site

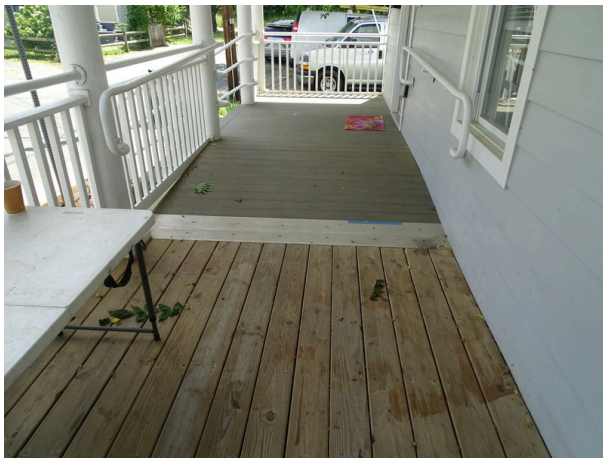
Typical patio

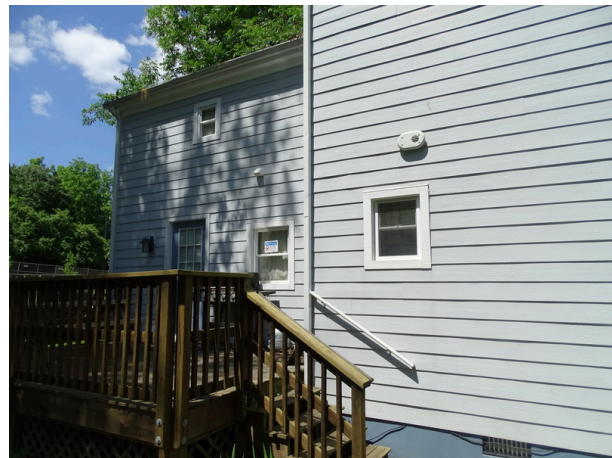
Typical wooden deck

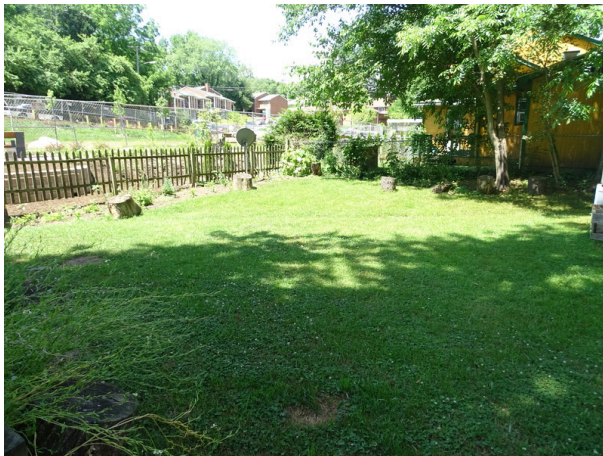
Landscaping and wood fence at south side of  
site

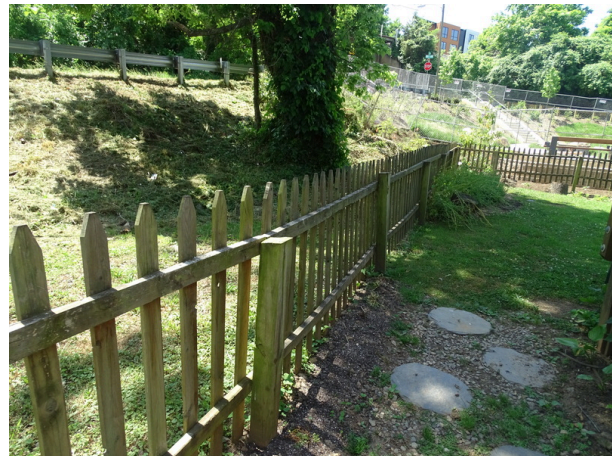
Landscaping and wood fence at south side of  
site

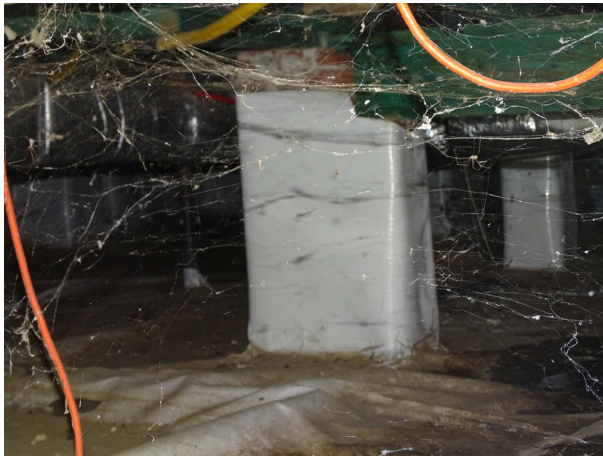
The structure of the building consists of Brick pier columns with wood framing for flooring and roofing. The structural frame of the building was generally in good condition.

Structural framing

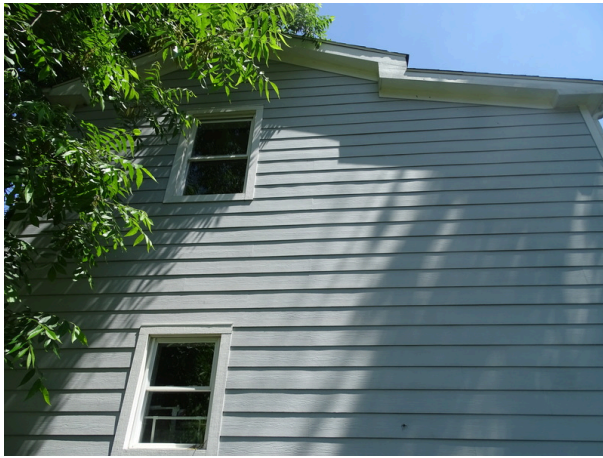
Exterior at south side of the building

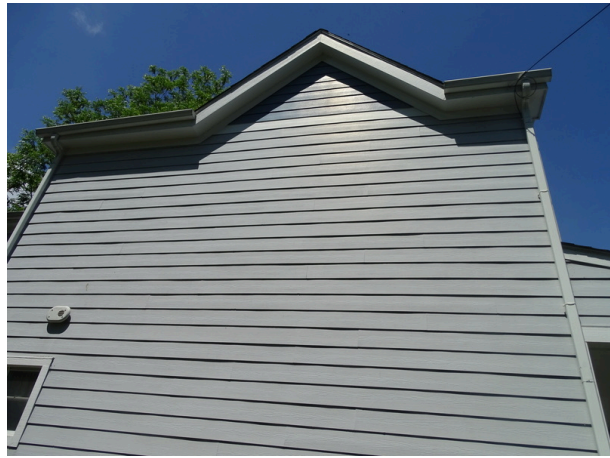
Exterior at west side of the building

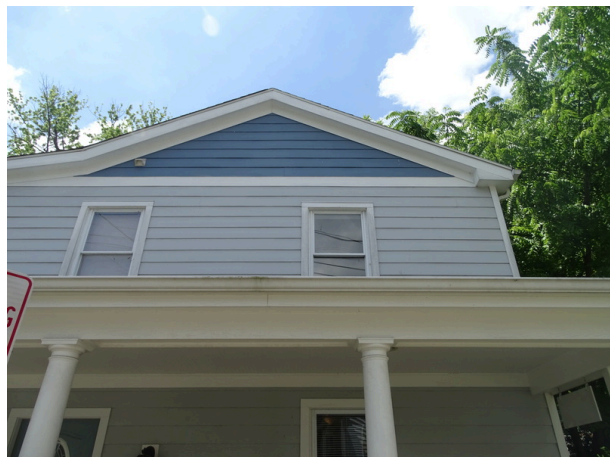
Exterior at north side of the building

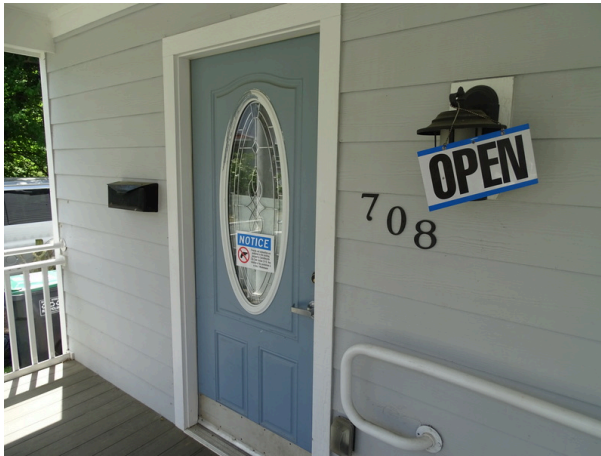
The main entrance is Wood door with glass. The main entrance door was generally in good condition. Exterior doors typically have an expected useful life of 20 to 30 years.

Main entrance door

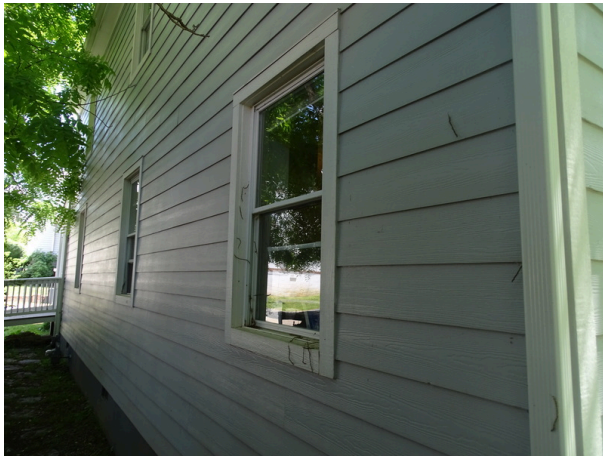
Typical exterior window

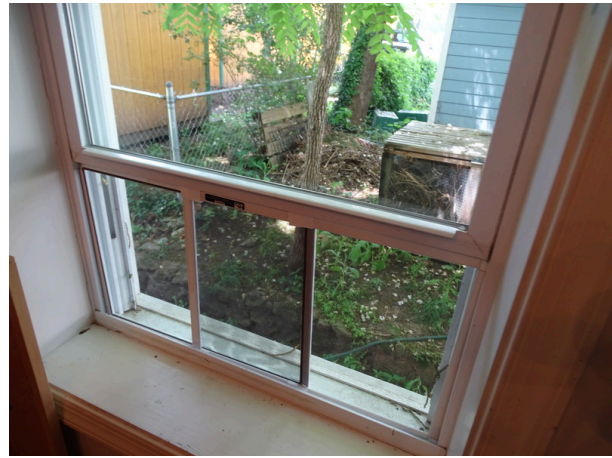
Typical exterior window

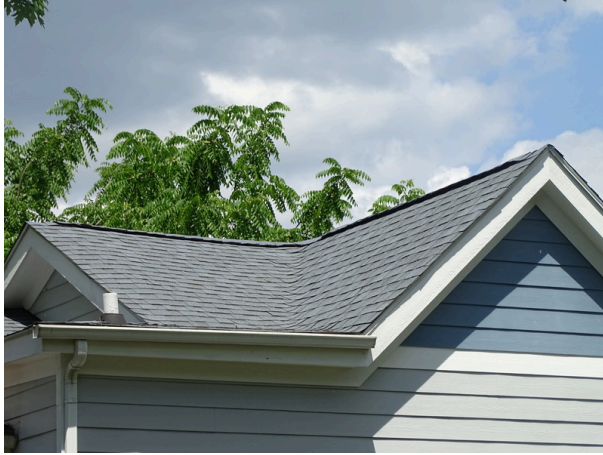
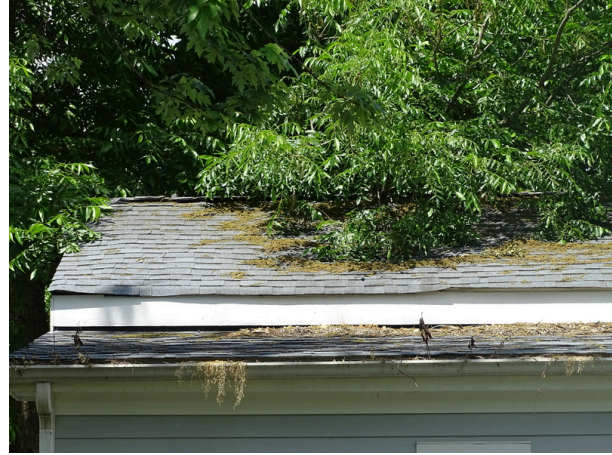
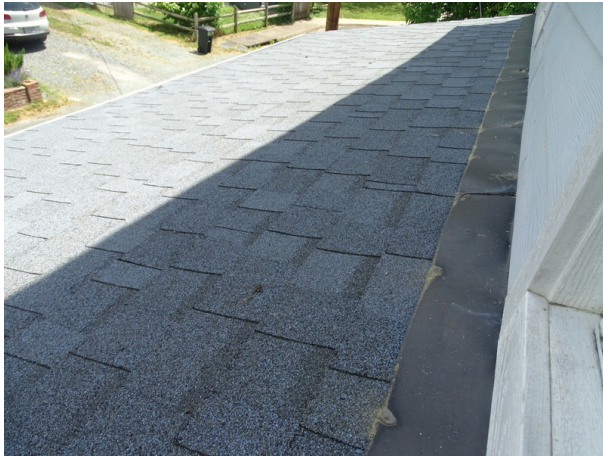
Drainage for the roofing system is provided by gutters and downspouts. The gutters and downspouts were observed to be in good condition. Vegetation was observed overflowing or growing from the gutter. We recommend regular cleaning of the gutters as a maintenance item.

Asphalt shingle roofing system

3.3.6 Roofing Systems																														
REPLACE ASPHALT SHINGLED ROOFING SYSTEM	20	10	10	1,000	SF	\$5.00	\$5,000	100%										\$5,000												\$5,000

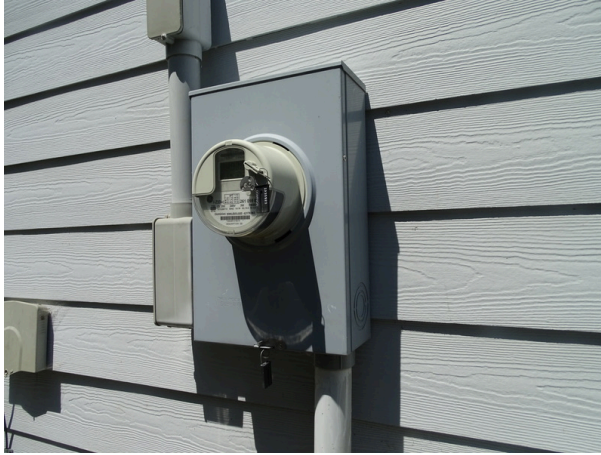
Electricity is provided to the building by Dominion Virginia Power through a pole-mounted transformer located on Albemarle Street. The main electrical entrance is located on the east side of the building and provides single-phase 3-wire 200 amps service.

Electrical meter

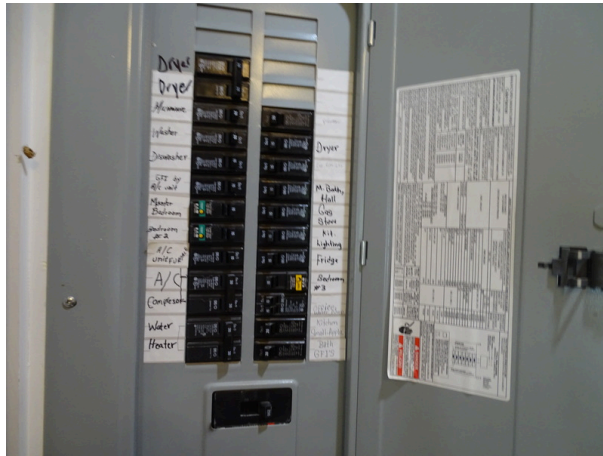
Power is distributed by copper wire from a circuit breaker panel located in the building. The circuit breaker panel was observed to be in generally good condition.

Electrical main disconnect and breaker panel

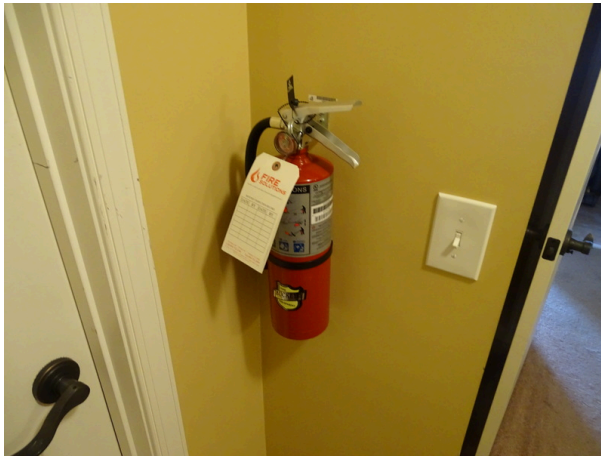
Fire extinguishers were observed throughout the building. The fire extinguishers were observed to have recent inspection tags issued by Fire Solutions in June 2021. These devices are required to be inspected annually. Replacement of the fire extinguishers is considered routine maintenance.

Typical fire extinguisher

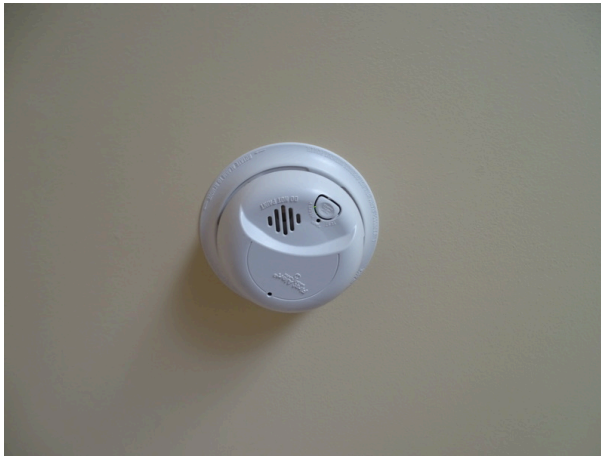
Typical smoke detector

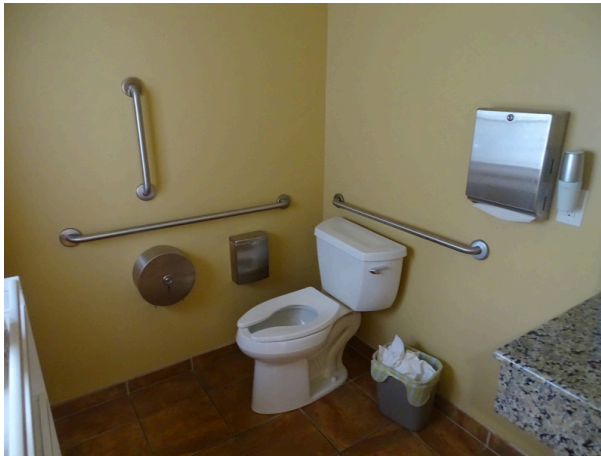
Accessible restroom

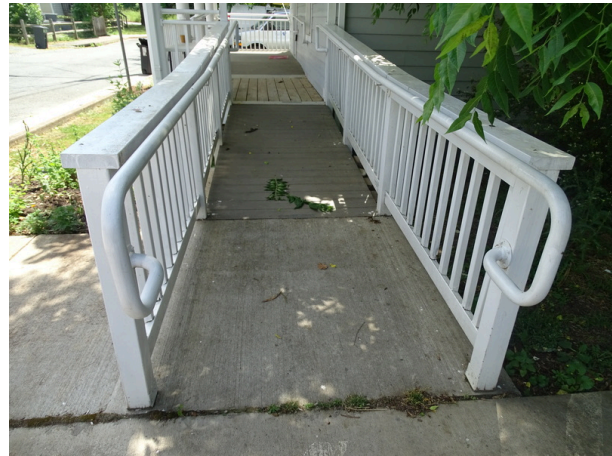
Accessible ramp

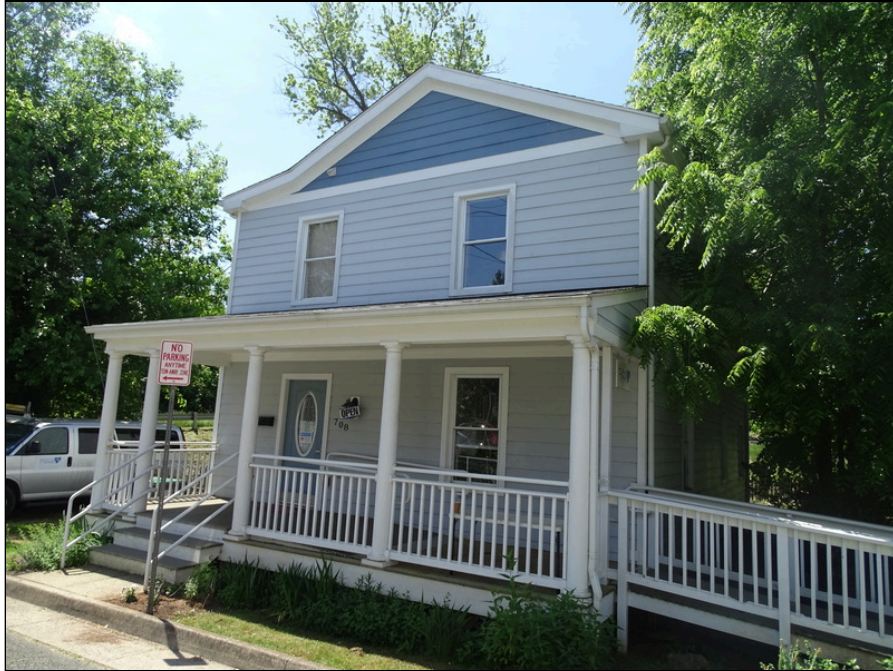
1 - City of Promise

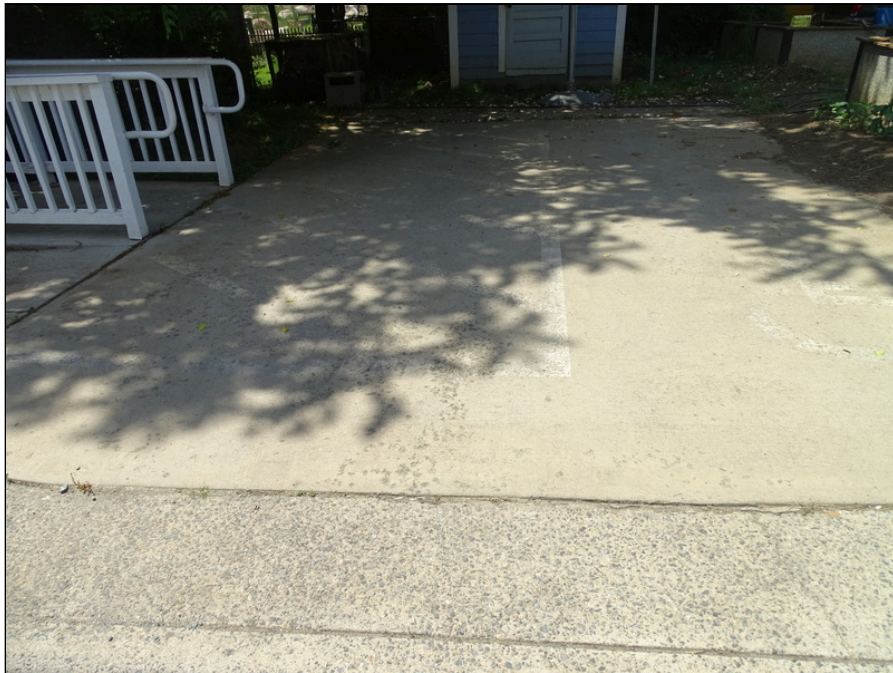
2 - Concrete pavement at west side of site

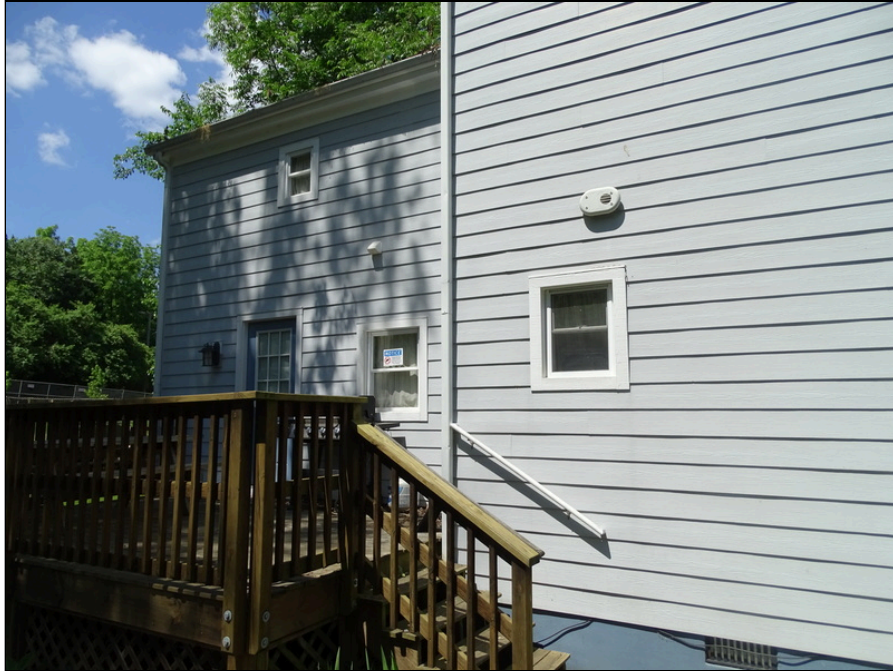
7 - Typical wooden deck

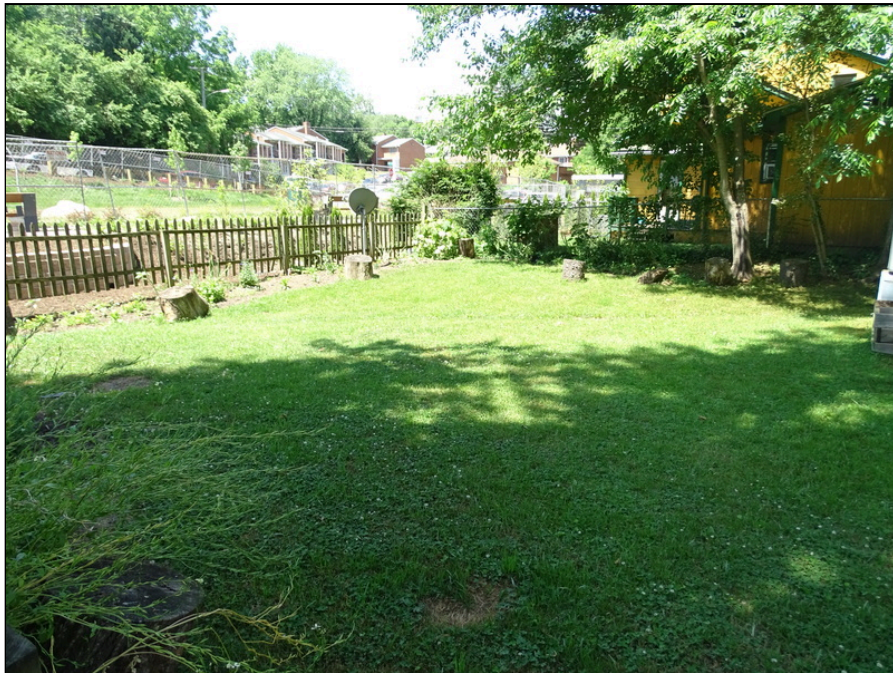
8 - Landscaping and wood fence at south side of site

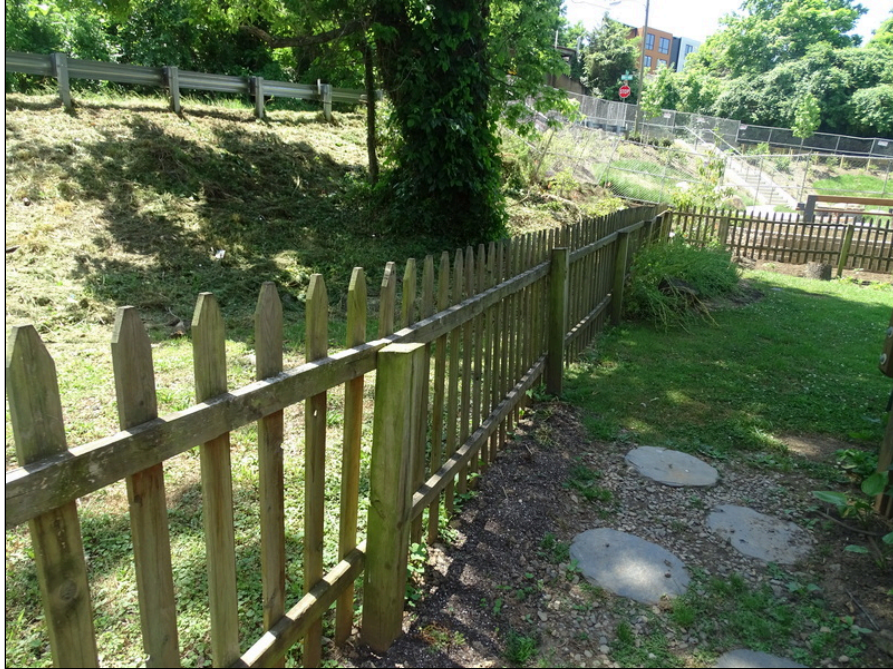
9 - Landscaping and wood fence at south side of site

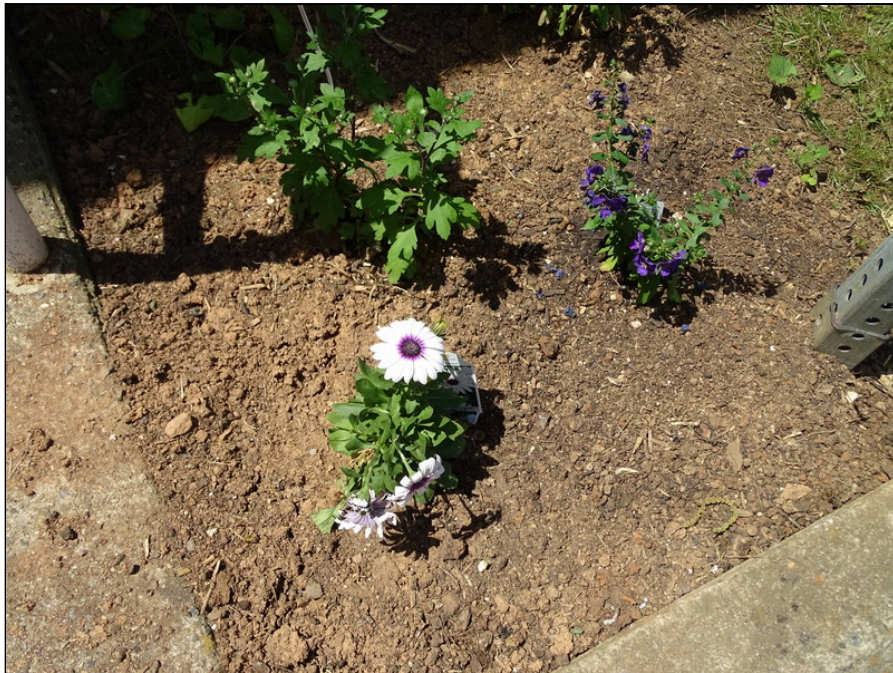
10 - Typical landscape

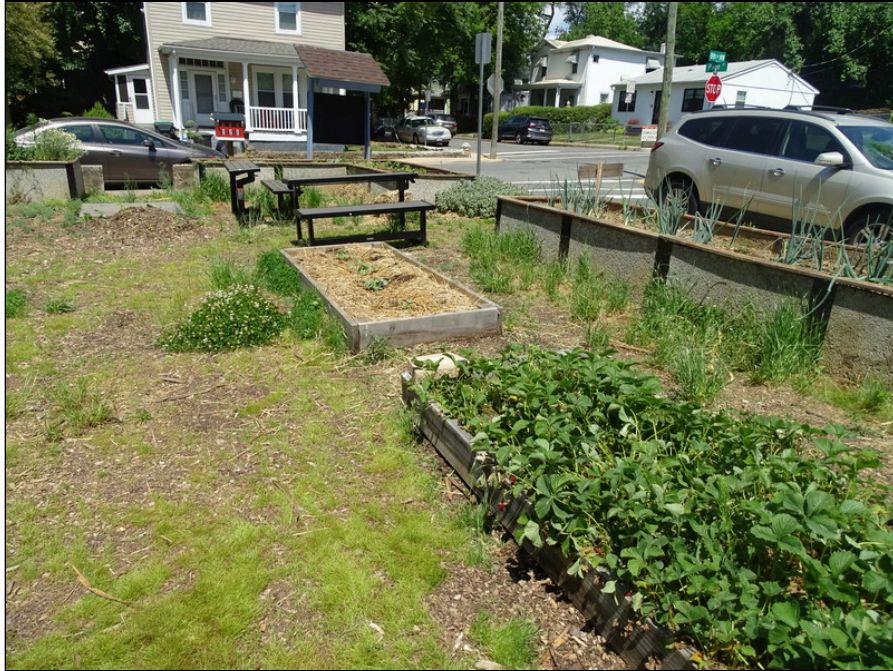
11 - Typical landscape

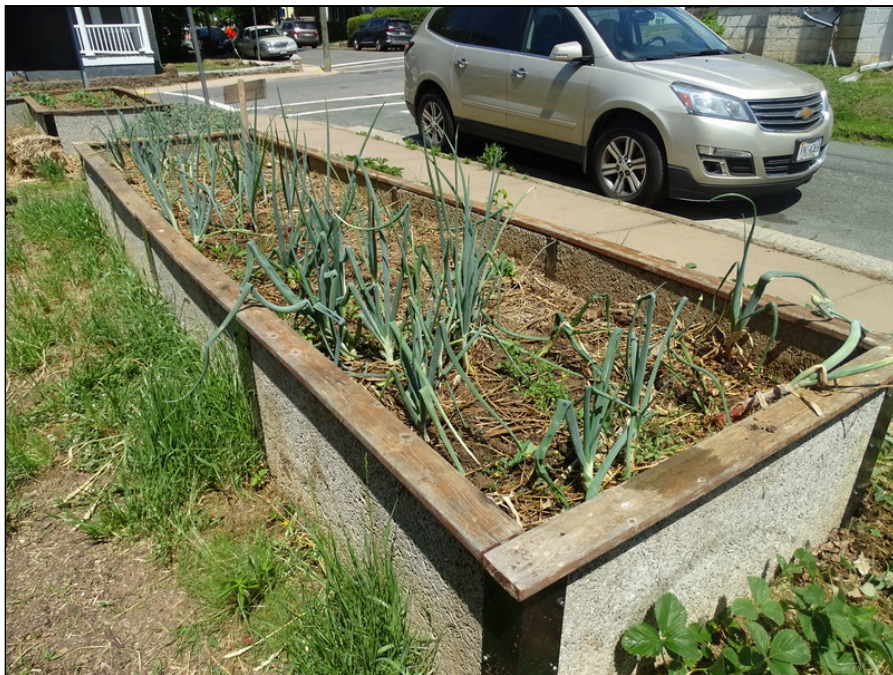
12 - Typical landscape

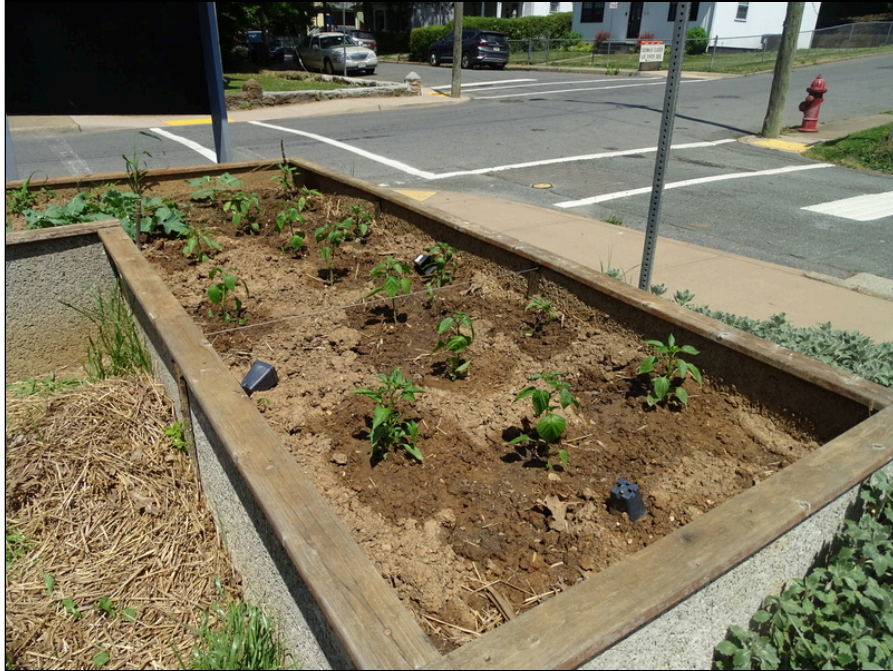
13 - Typical landscape

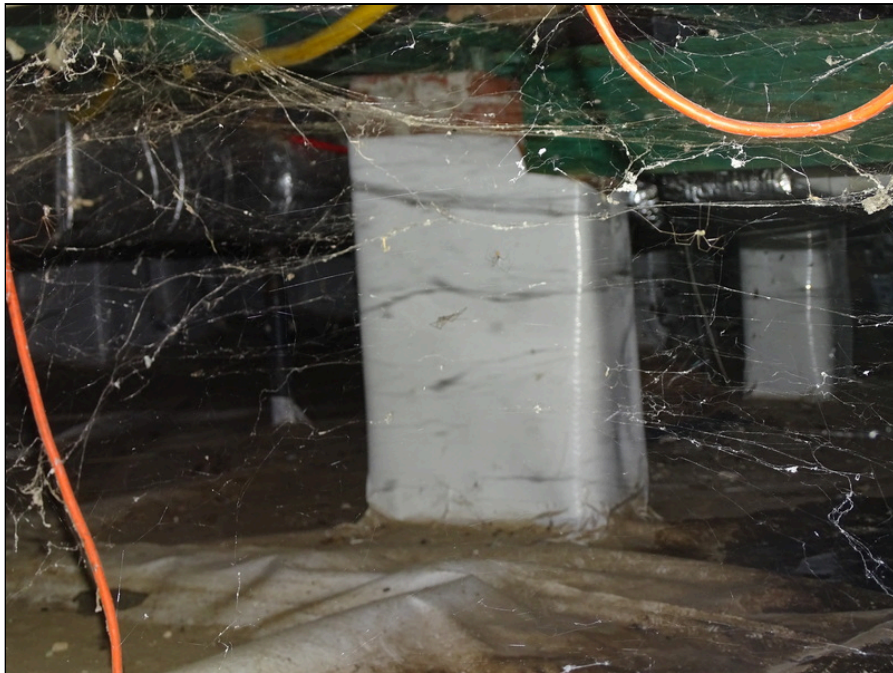
14 - Structural framing

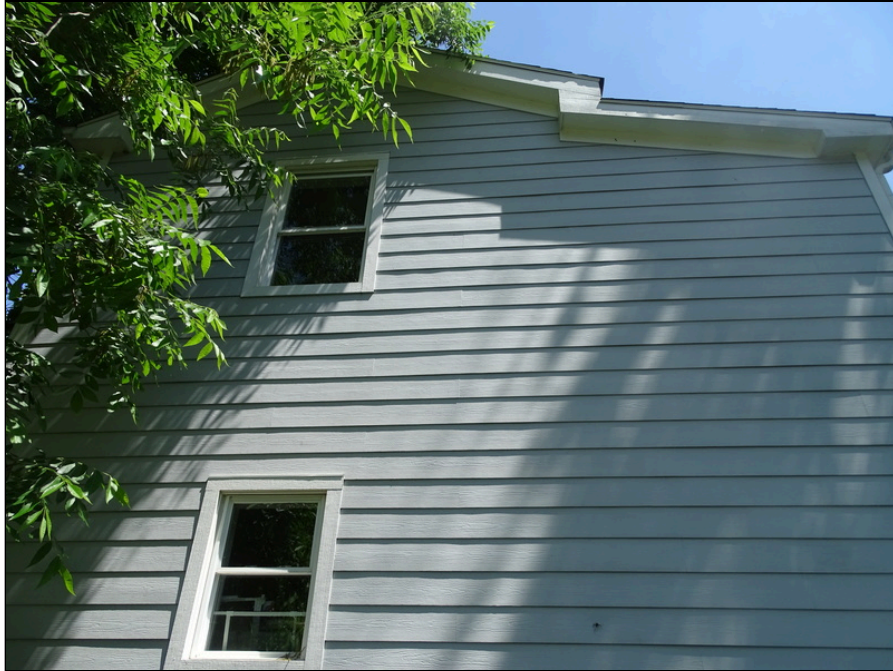
15 - Exterior at south side of the building

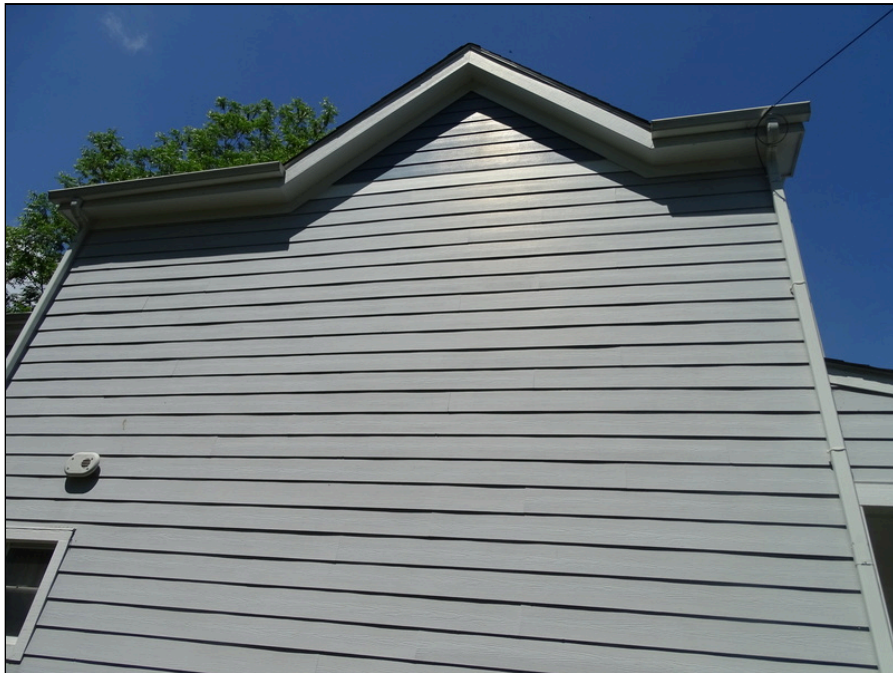
16 - Exterior at west side of the building

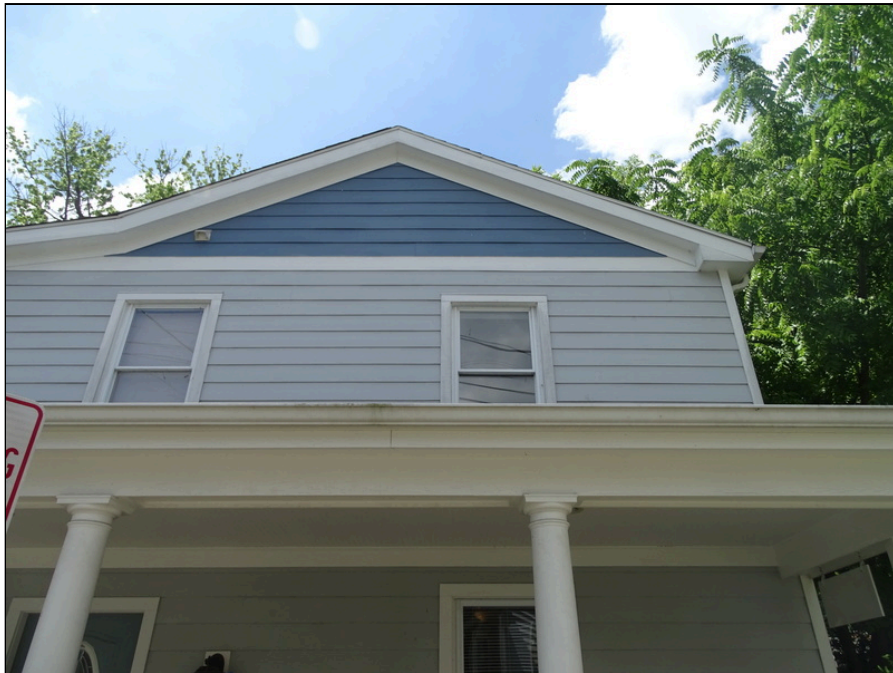
18 - Exterior at north side of the building

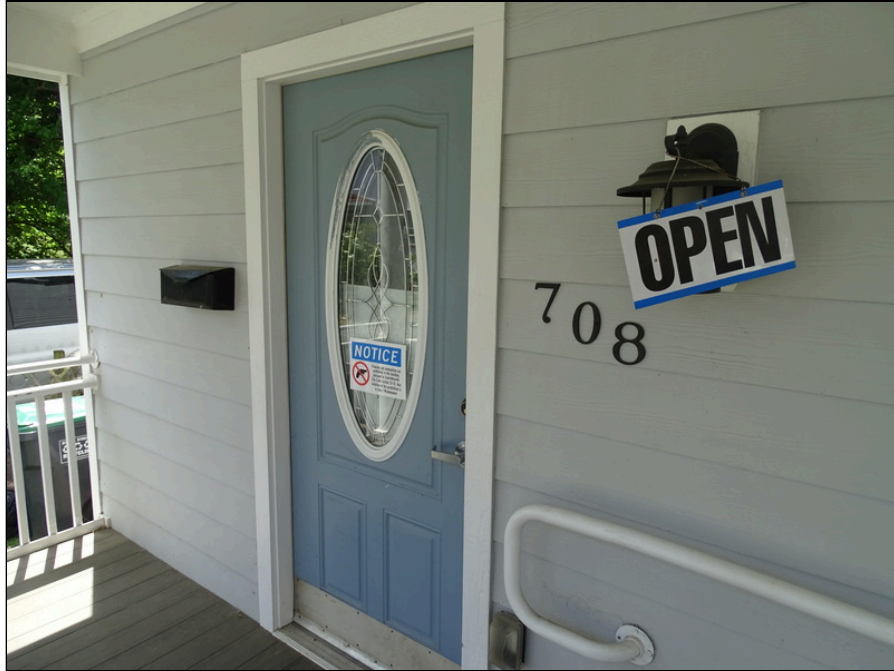
19 - Main entrance door

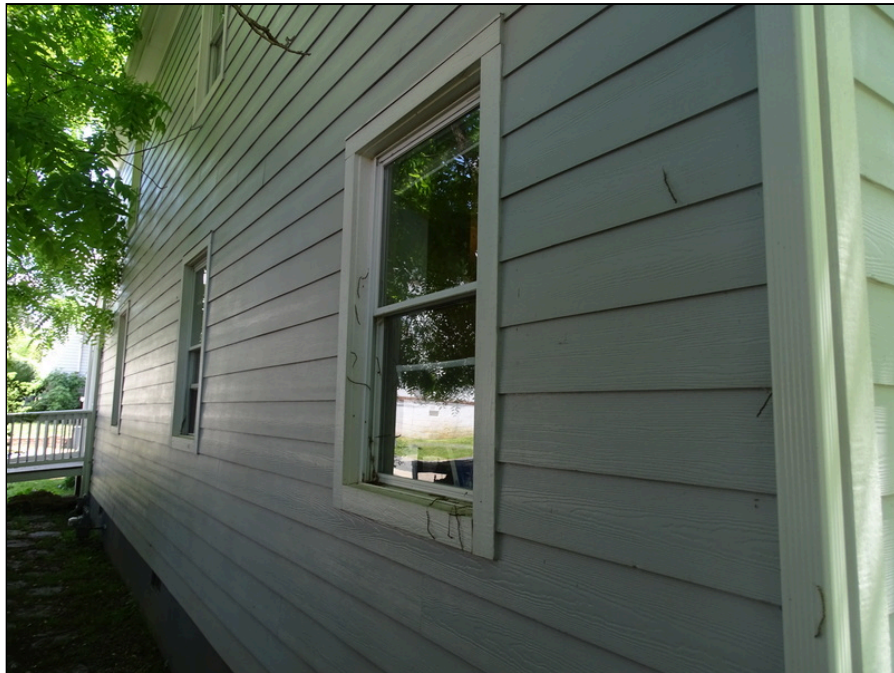
20 - Typical exterior window

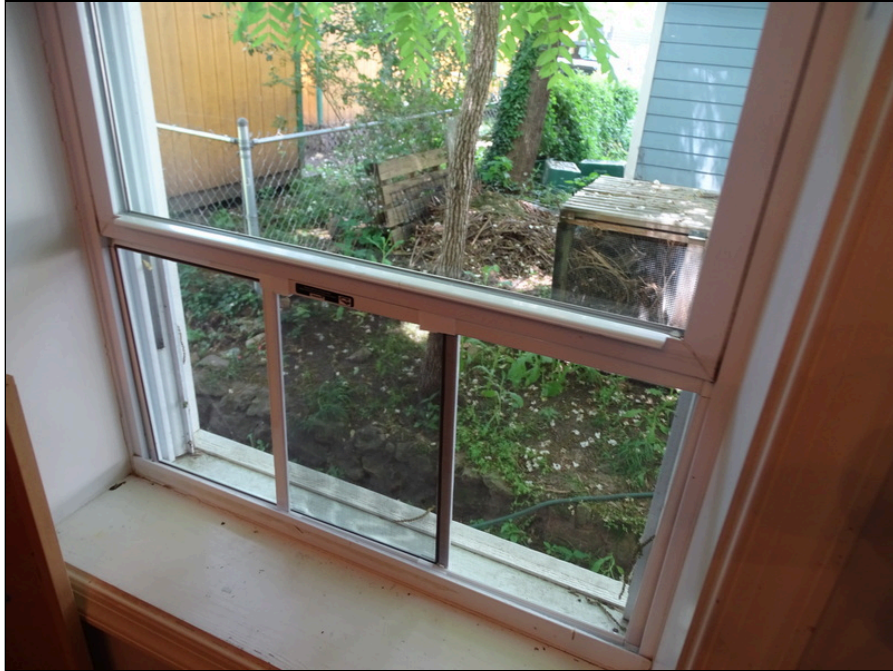
21 - Typical exterior window

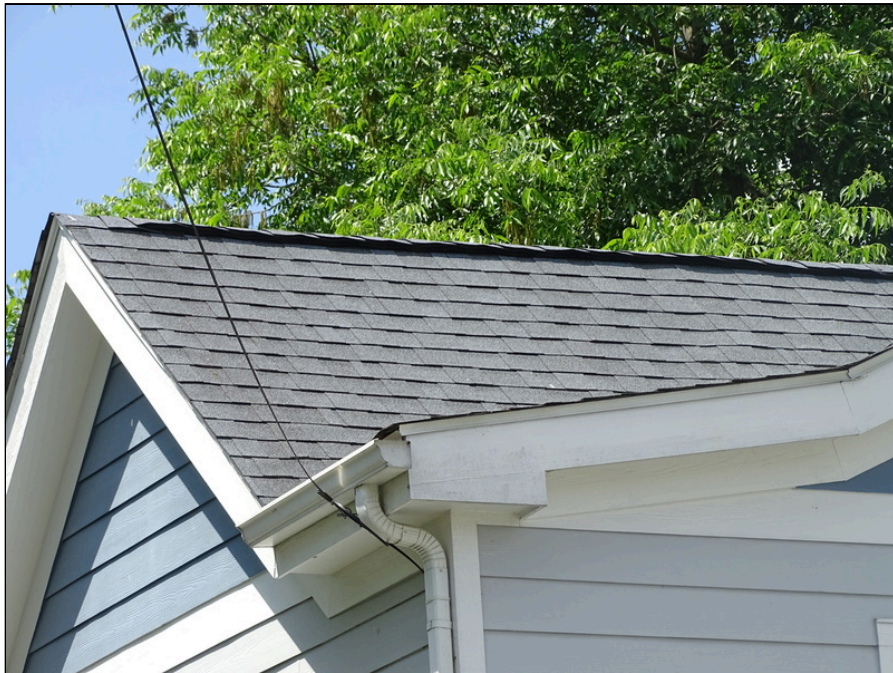
22 - Asphalt shingle roofing system

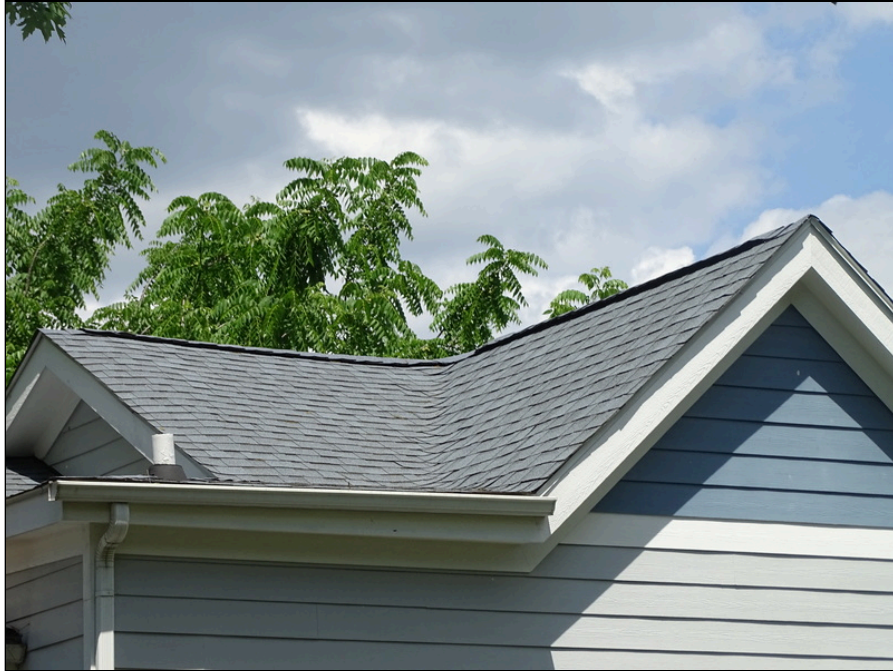
23 - Asphalt shingle roofing system

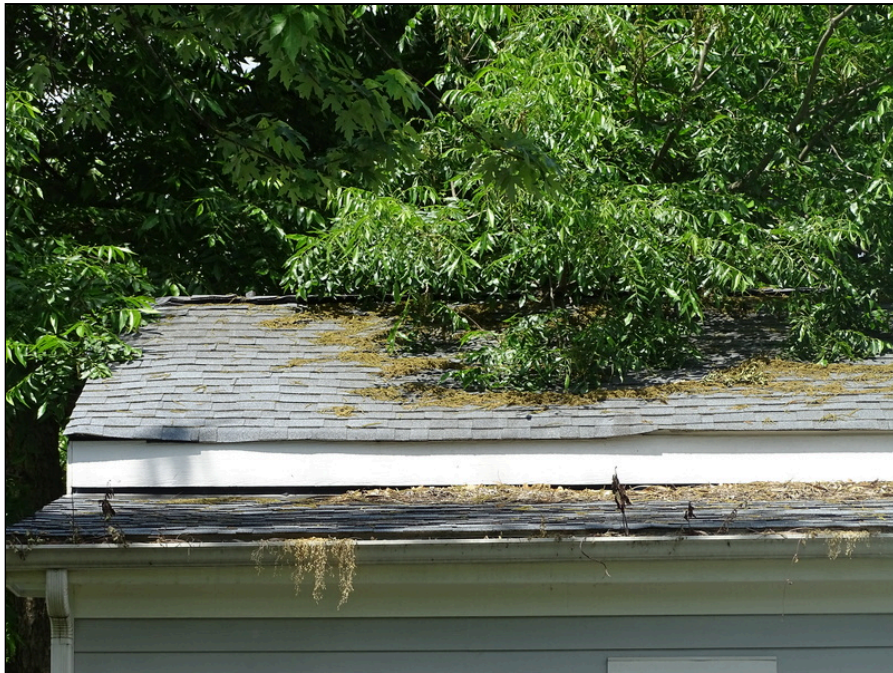
24 - Asphalt shingle roofing system

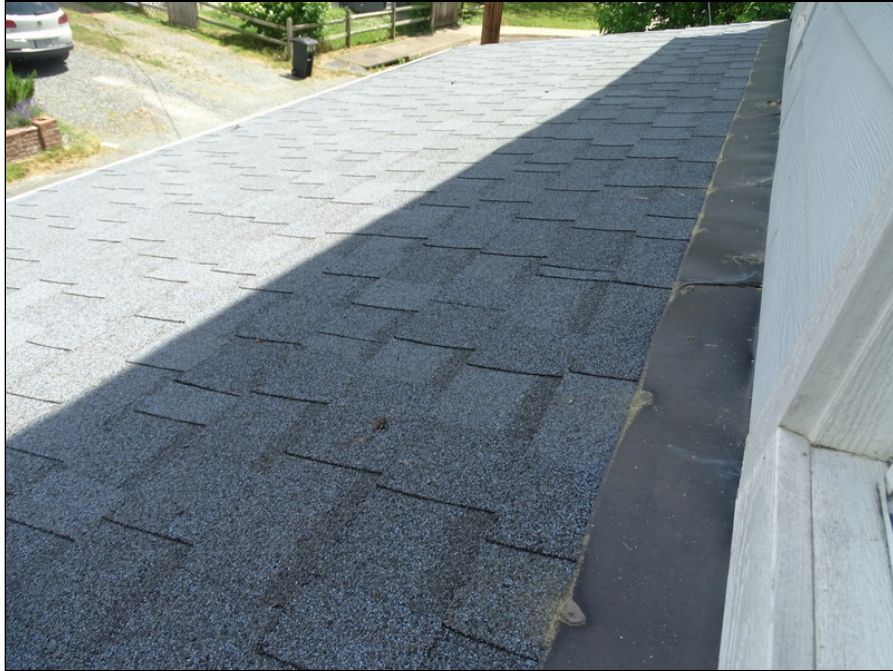
25 - Asphalt shingle roofing system

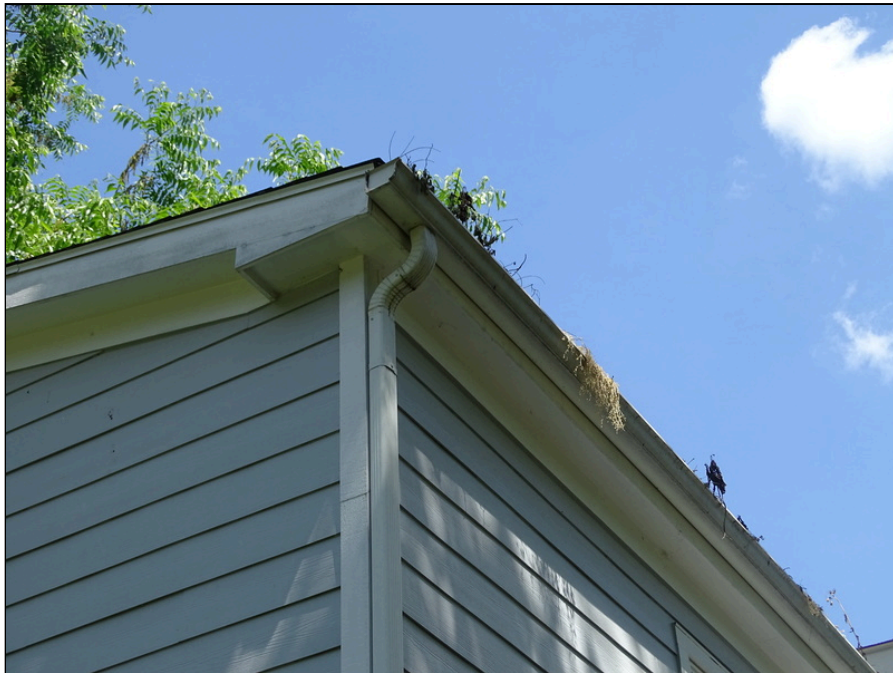
26 - Typical gutter and downspout

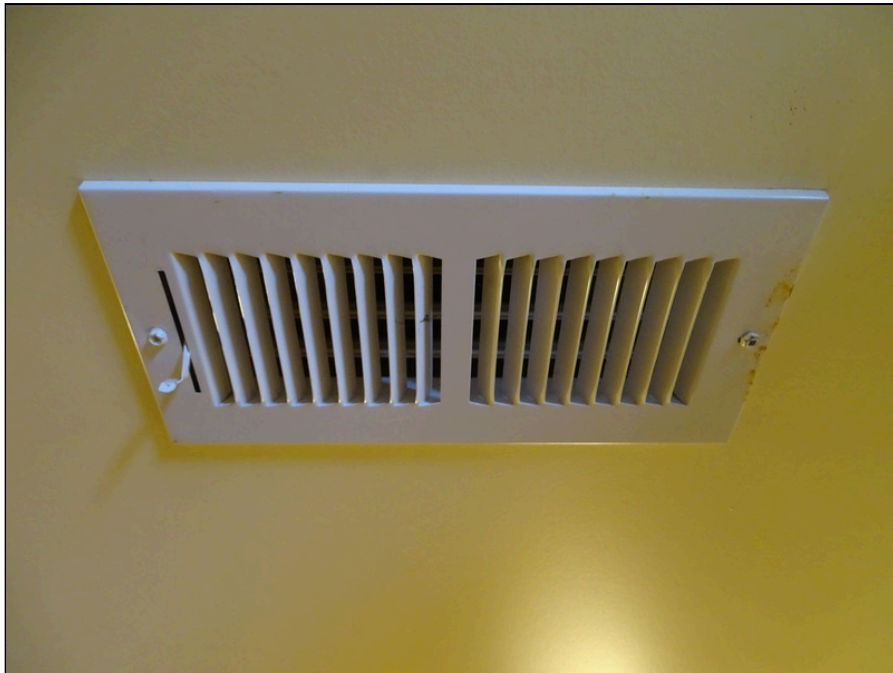
30 - Typical ceiling air vent

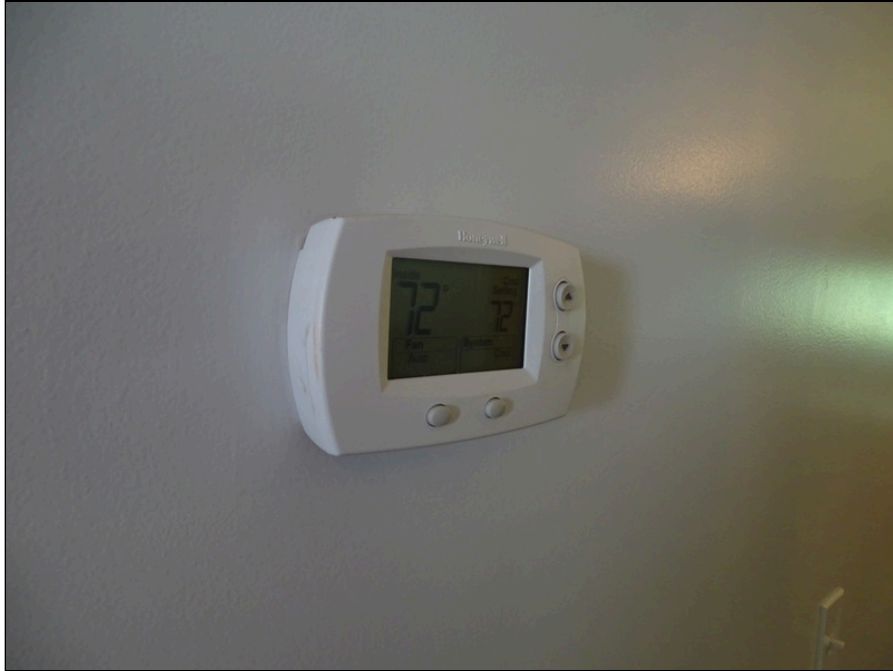
31 - Digital thermostat

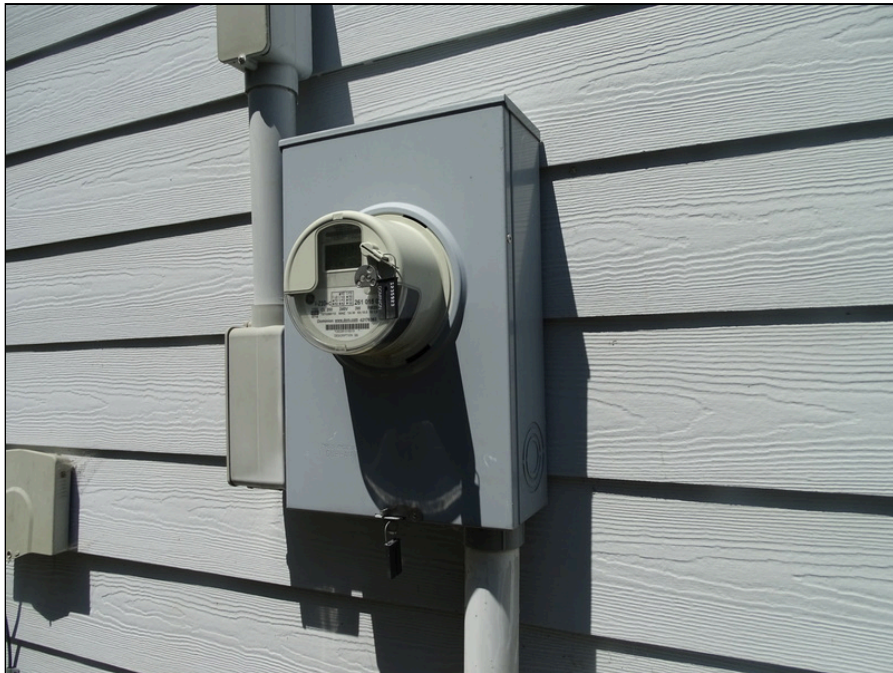
32 - Electrical meter

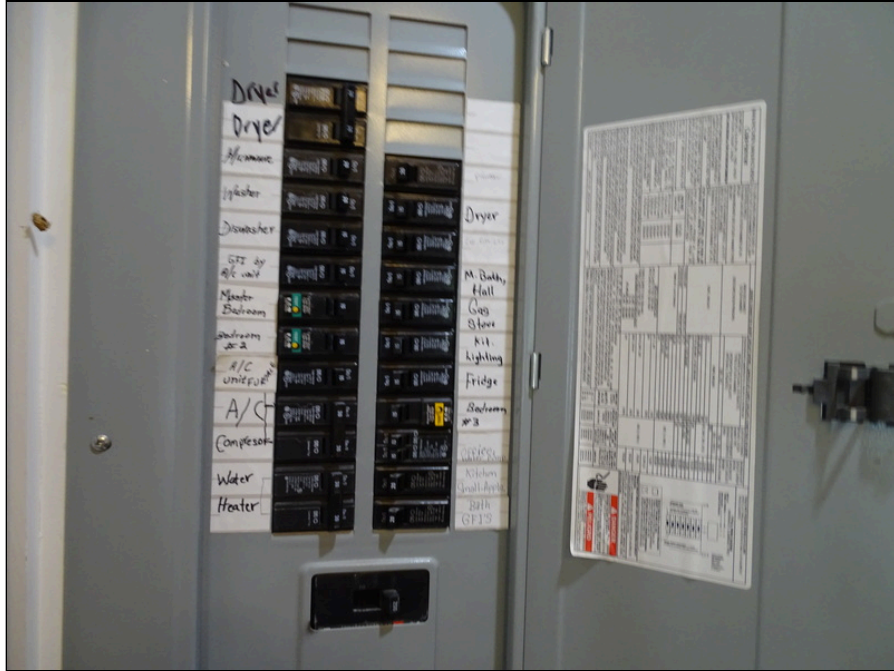
33 - Electrical main disconnect and breaker panel

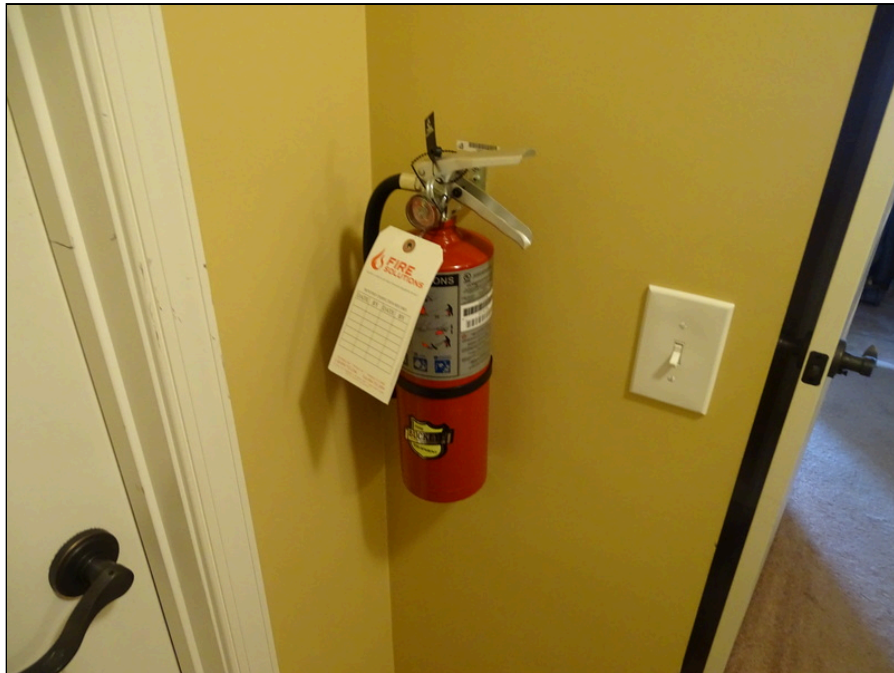
34 - Typical fire extinguisher

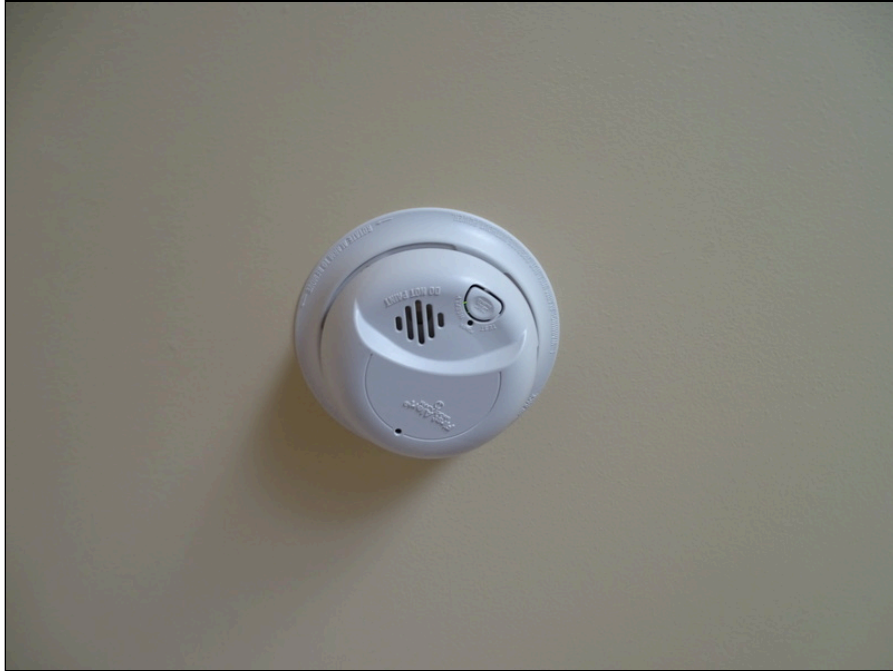
35 - Typical smoke detector
