CITY OF PROMISE  
708 PAGE STREET  
CHARLOTTESVILLE, VIRGINIA

ECS PROJECT NO. 46:6713

CITY OF CHARLOTTESVILLE - FACILITIES DEVELOPMENT

Reference: Facility Condition Assessment Report for City of Promise, 708 Page Street, Charlottesville, Virginia

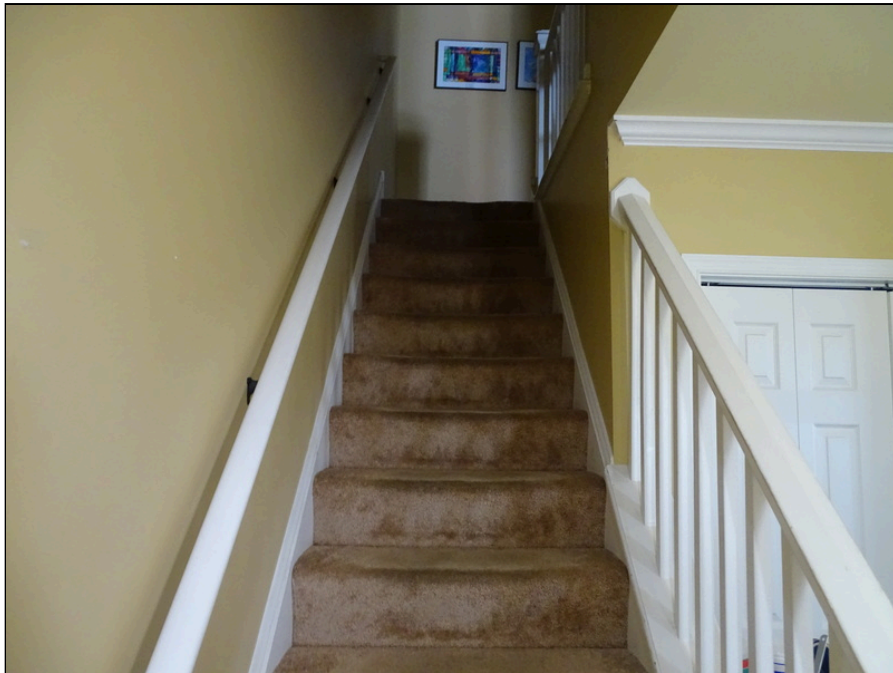
36 - Reception area interior finishes

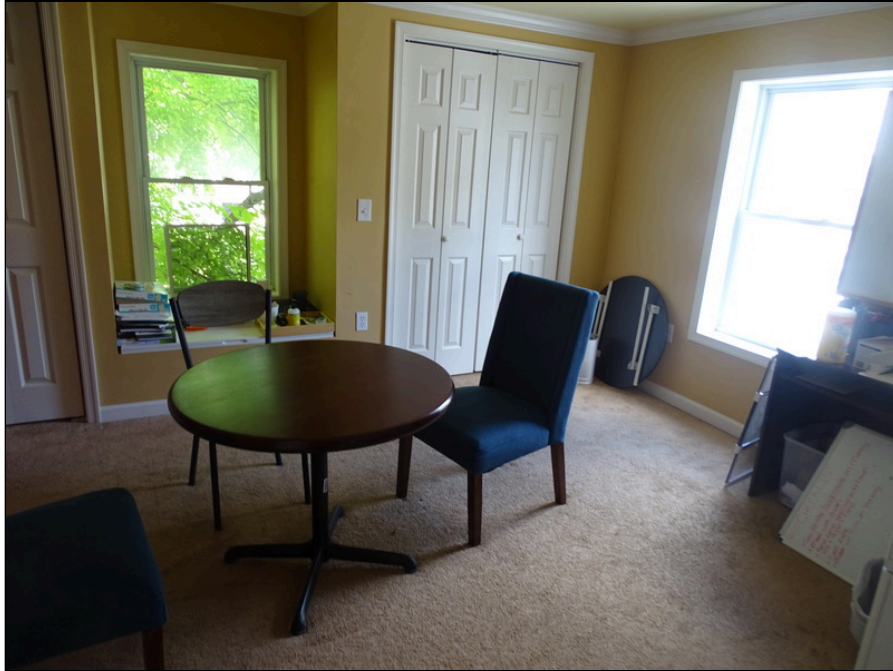
37 - Office area interior finishes

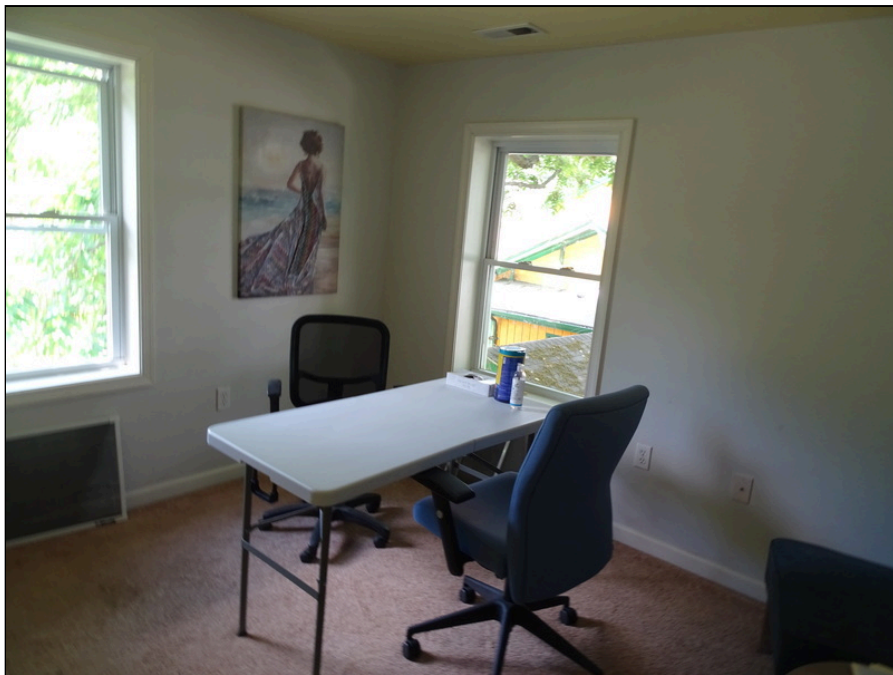
38 - Office area interior finishes

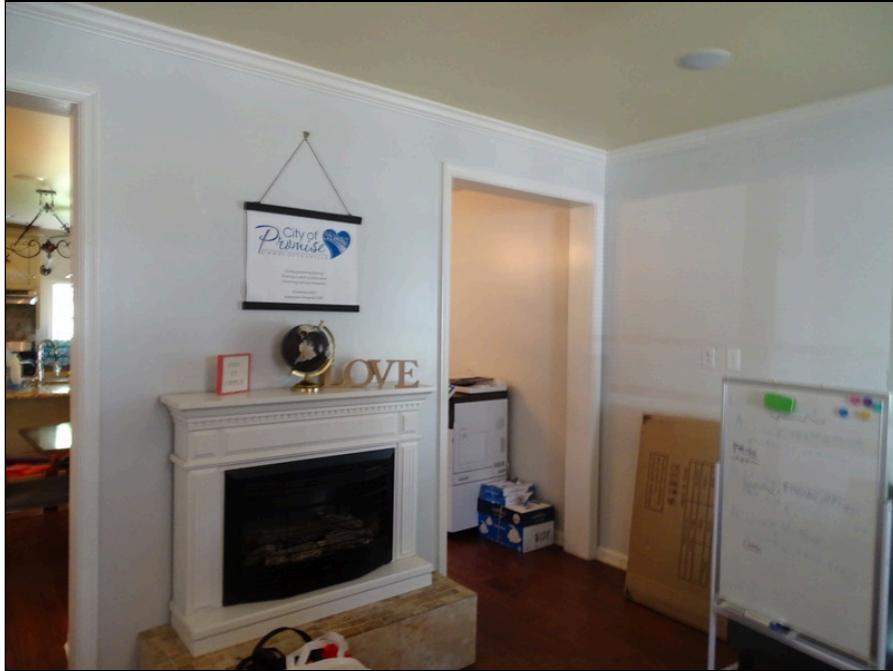
39 - Typical fire place

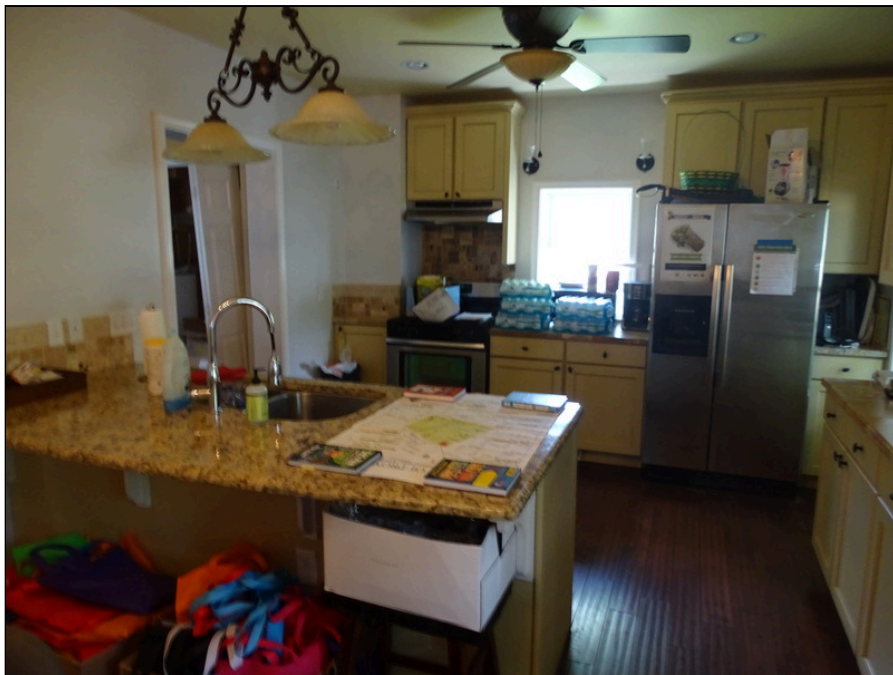
40 - Kitchen

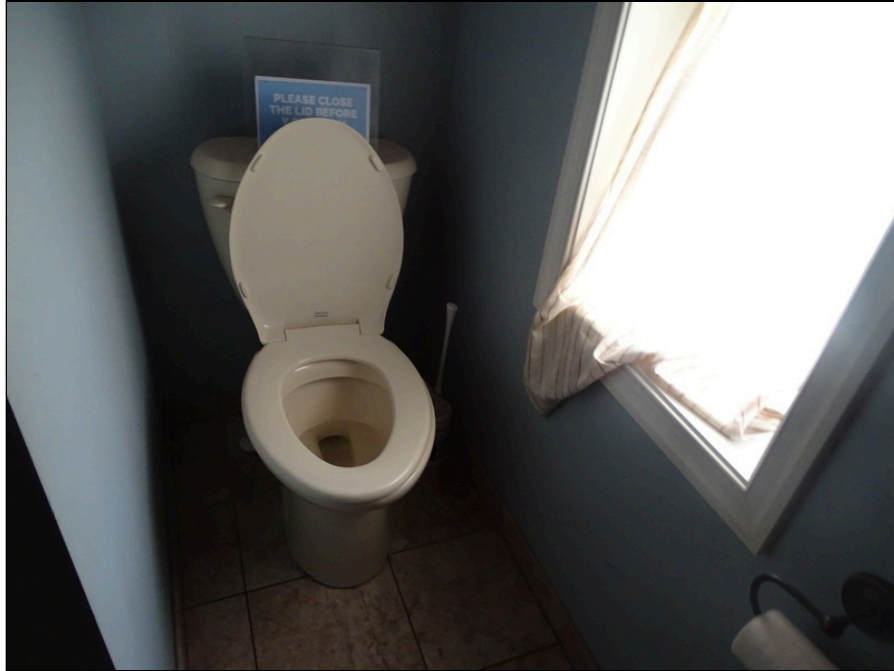
41 - Typical restroom

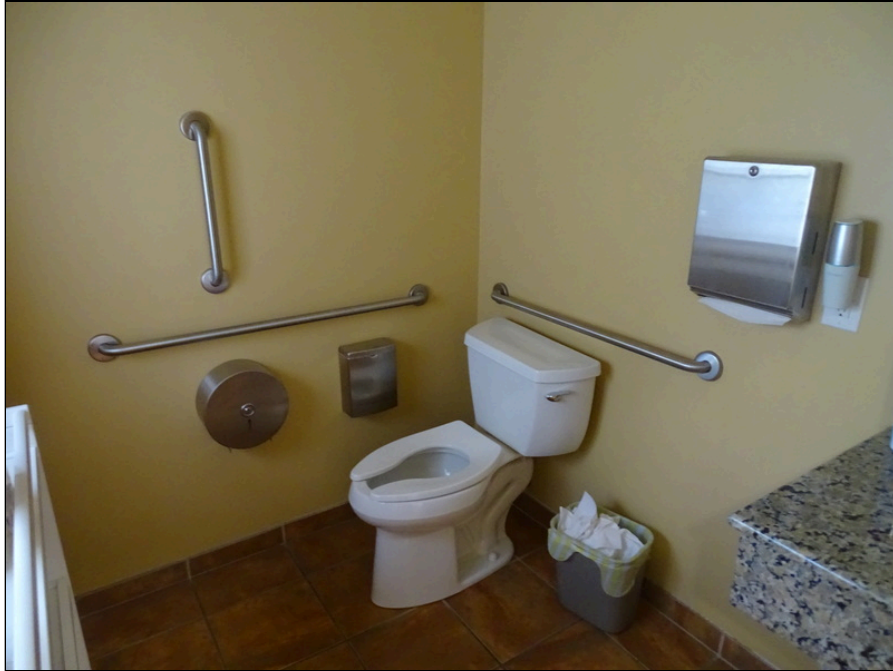
43 - Accessible restroom

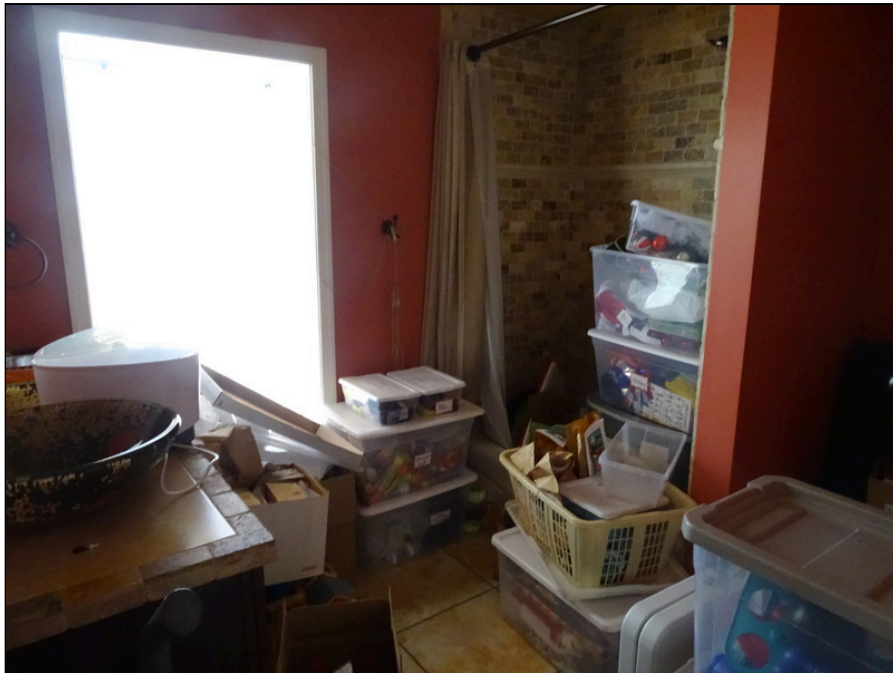
44 - Typical restroom

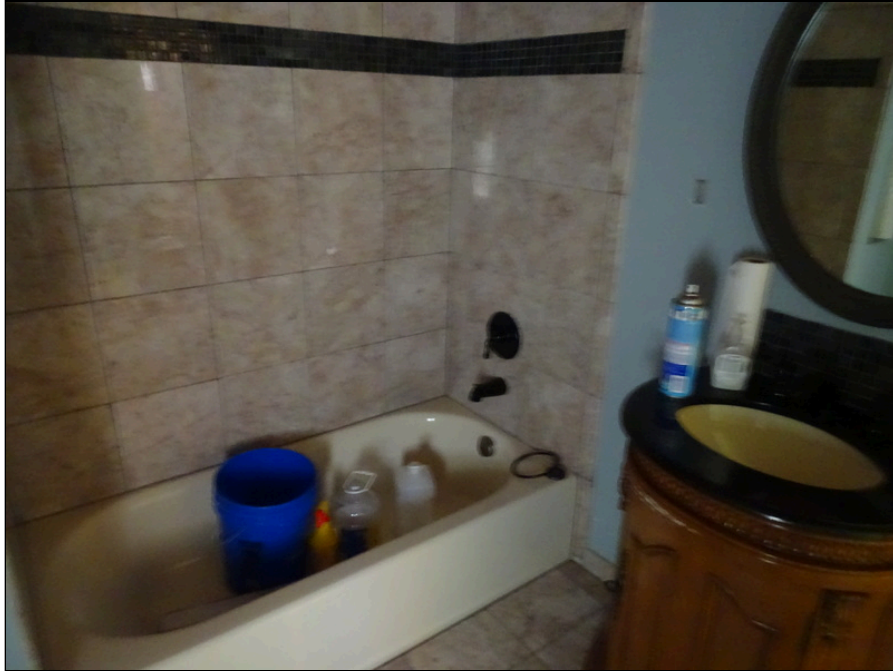
45 - Typical restroom

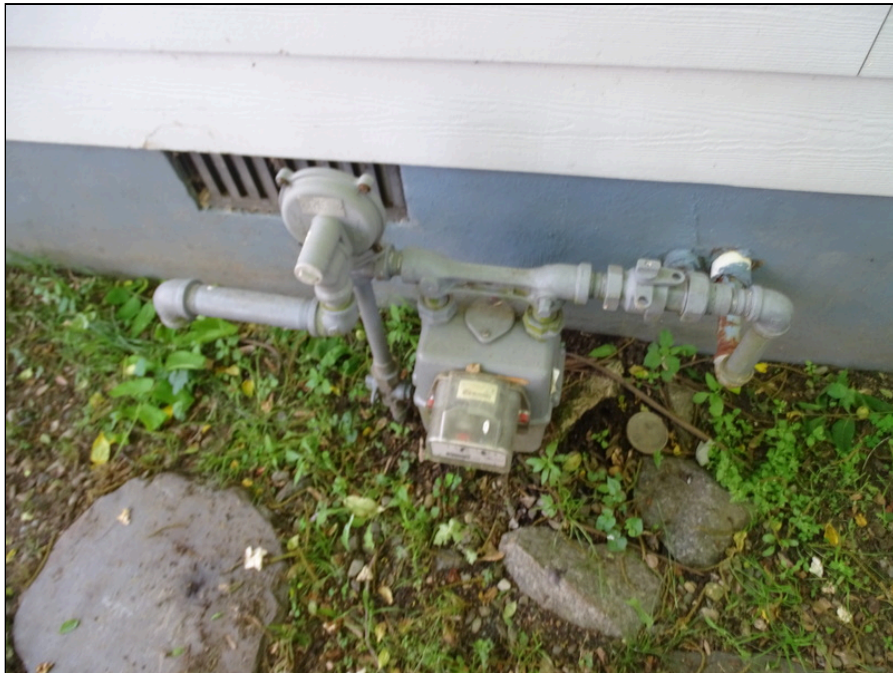
46 - Typical meter

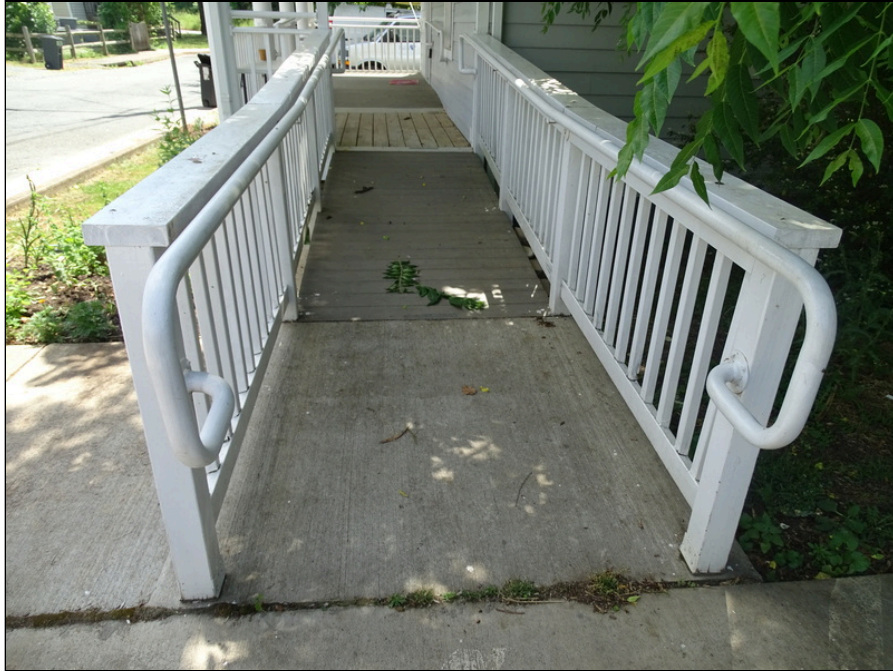
47 - Accessible ramp

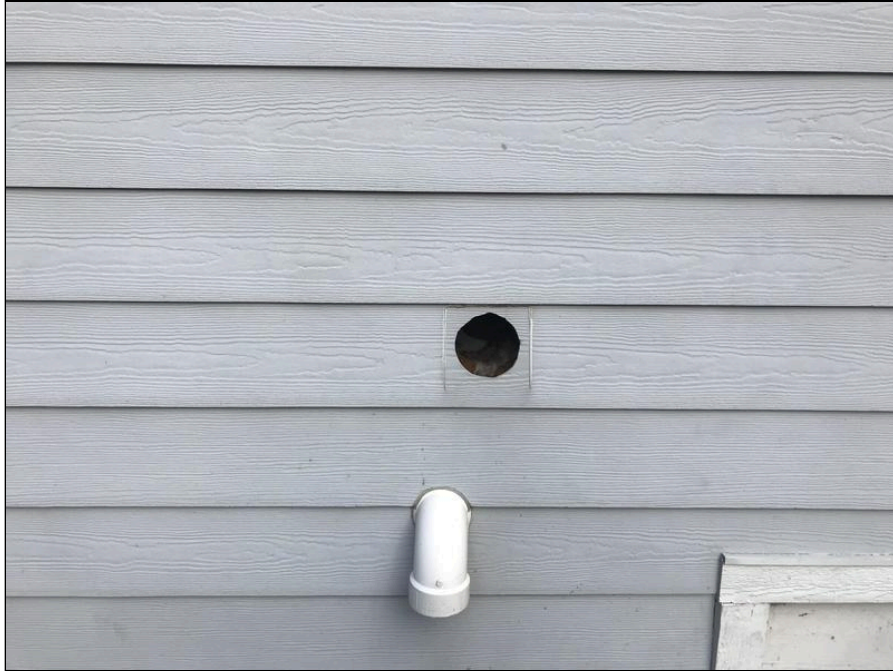
49 - Hole in Siding
