CLARK ELEMENTARY SCHOOL
1000 BELMONT AVENUE
CHARLOTTESVILLE, VIRGINIA

ECS PROJECT NO. 46:6713

CITY OF CHARLOTTESVILLE - FACILITIES DEVELOPMENT

Reference: Facility Condition Assessment Report for Clark Elementary School, 1000 Belmont Avenue,
Charlottesville, Virginia

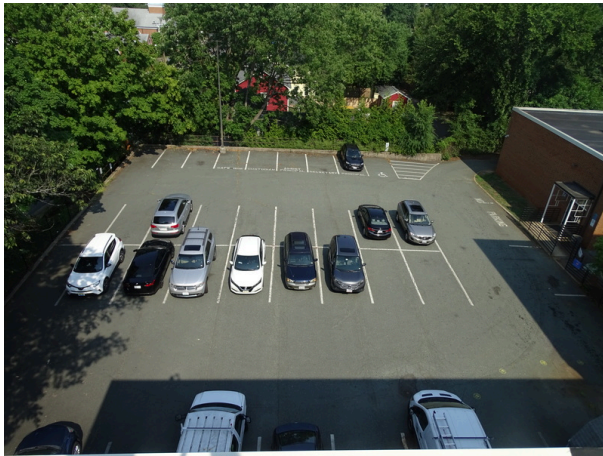
Asphalt-paved drive lanes and parking areas are located on the southwest side of the site which also provides access to the site. The asphalt pavement was observed to be in generally fair condition with minor cracks observed on the pavement. Striping was in fair condition. The expected useful life of asphalt pavement is 20 years. We have provided allowances to repair the cracked areas of asphalt pavement.

Asphalt parking located at southwest end of site

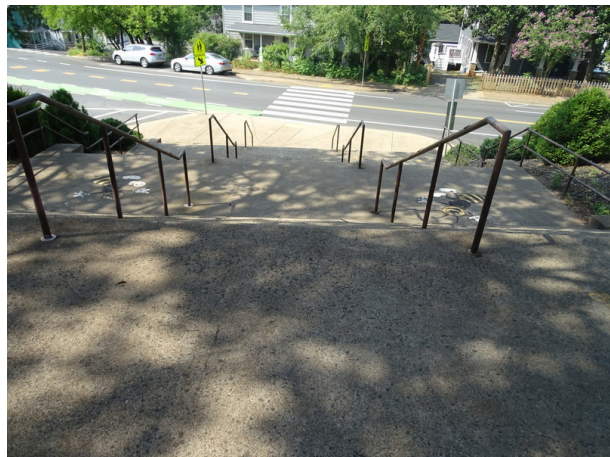
Typical concrete steps

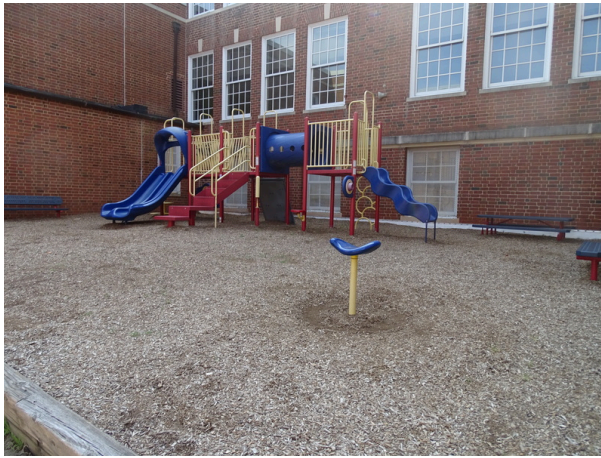
Playground area at center of building

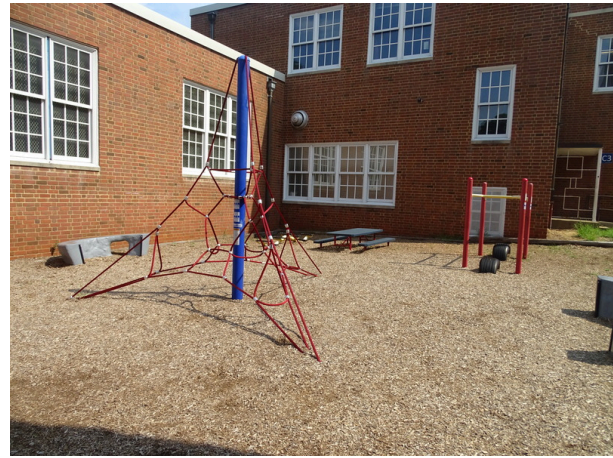
Playground area at center of building

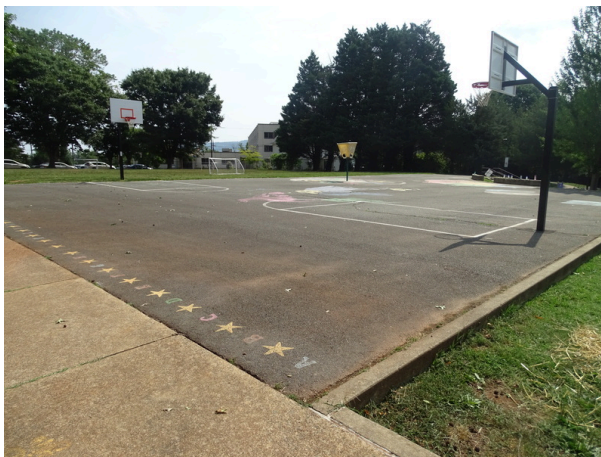
The softball is located at the east side of the property. The softball field was in good condition.

Basketball court and softball field at east side of
the property

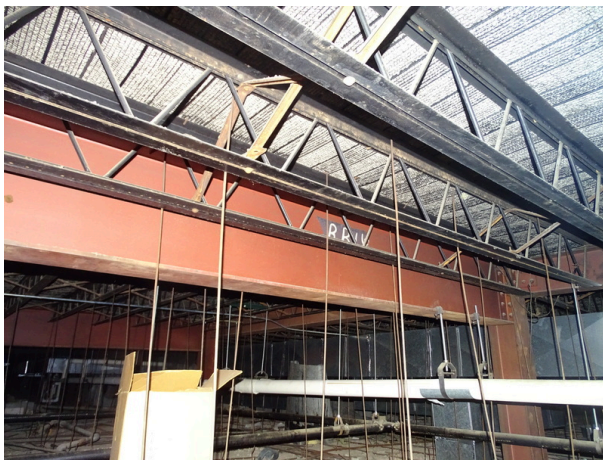
The structure of the building consists of brick masonry and concrete masonry unit bearing walls. There are interior steel columns supporting structural steel and metal diaphragm roof framing for the low slope roofing system. The structural frame of the building was generally in good condition.

Structure framing

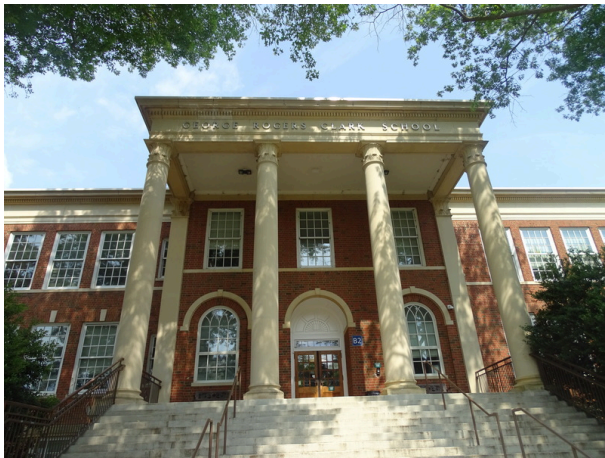
Concrete steps east side of the building

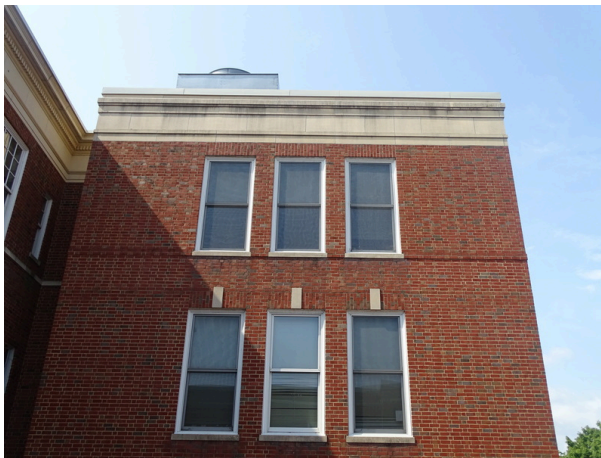
The window system for the building primarily consists of wood framed single-pane operable window units. Some of the older window units were observed to be damaged and it was reported that the windows were drafty and caused temperature control issues in some of the classrooms. The windows have a typical expected useful life of 25 years. Replacement of windows has been included in the study period.

Typical exterior window

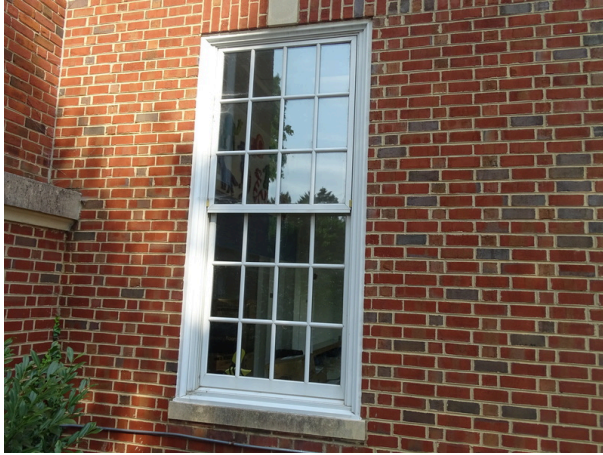
Typical exterior window

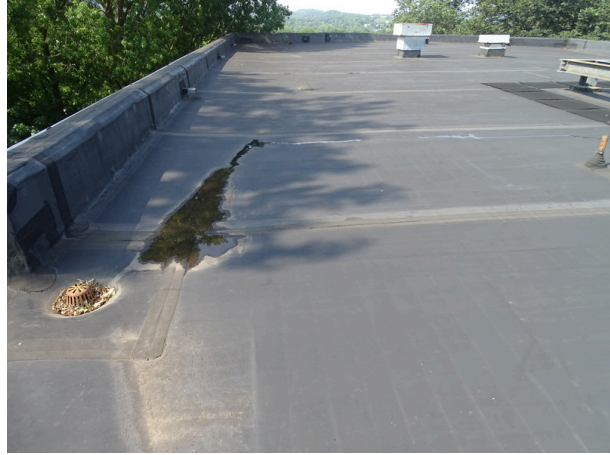
Single-ply membrane roofing system - note
ponding

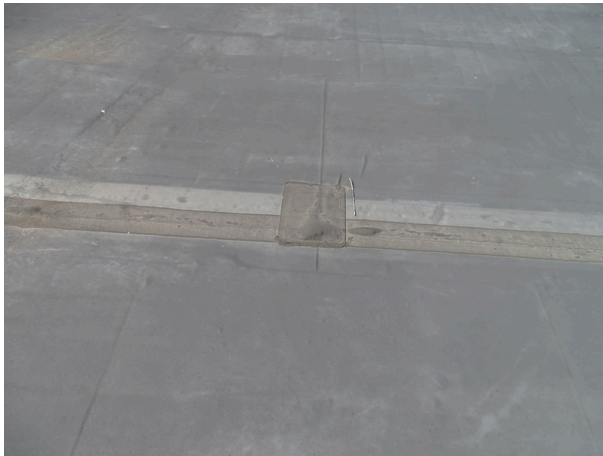
Single-ply membrane roofing system addition -
note patching

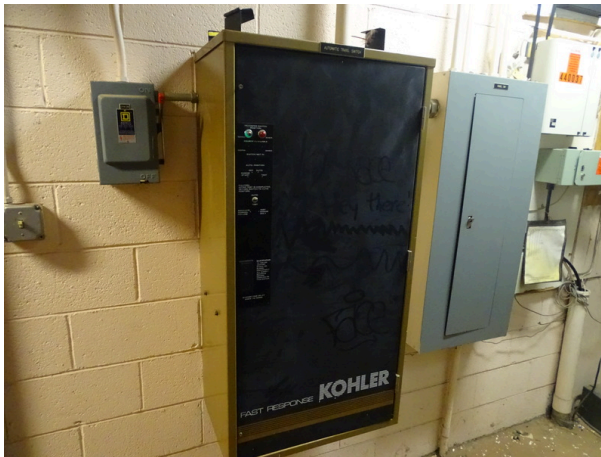
The emergency back up power generator transfer switch was manufactured by Kohler and is located in the main mechanical room. The transfer switch installation date was unknown with an expected useful life of 25 years with proper maintenance. The transfer switch should be replaced in conjunction with the generator.

Emergency power transfer switch

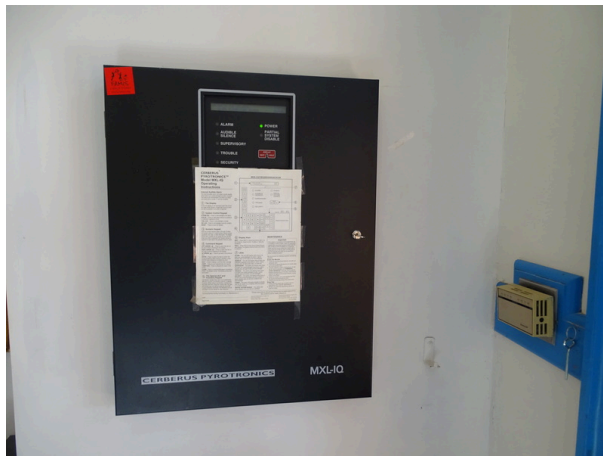
The fire alarm system was observed but not tested. A fire control pane is located in the Main Office. The fire control panel was observed to be in good condition. Emergency exit signs and lighting, pull stations, fire extinguishers, smoke detectors, and alarm bells and strobes are located throughout the building.

Fire alarm control panel

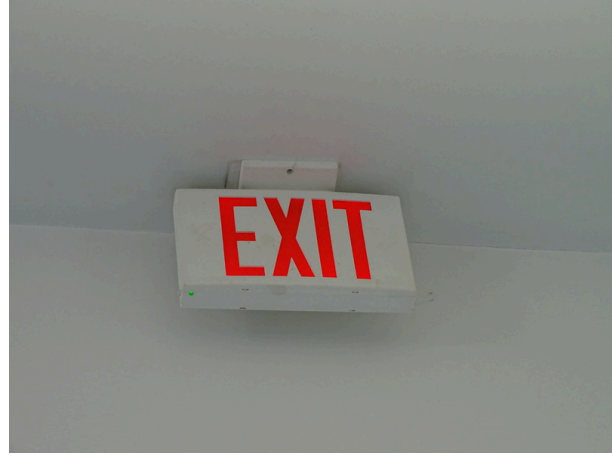
Typical exit sign

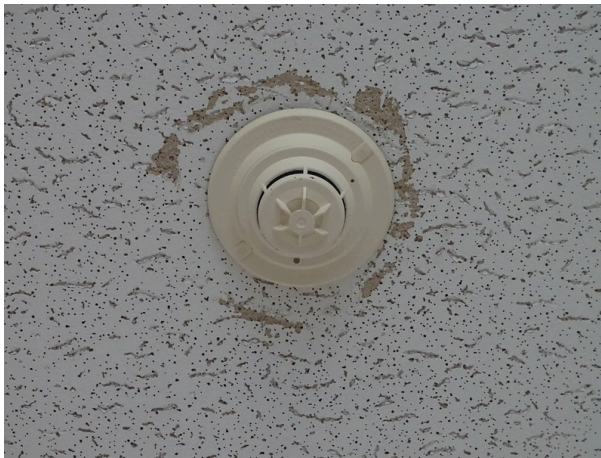
Typical smoke detector

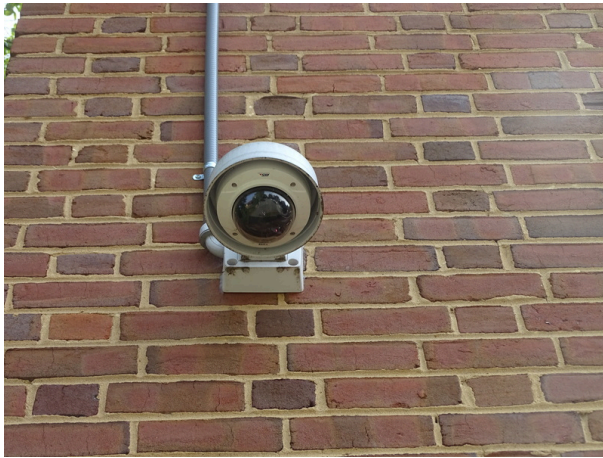
Security camera

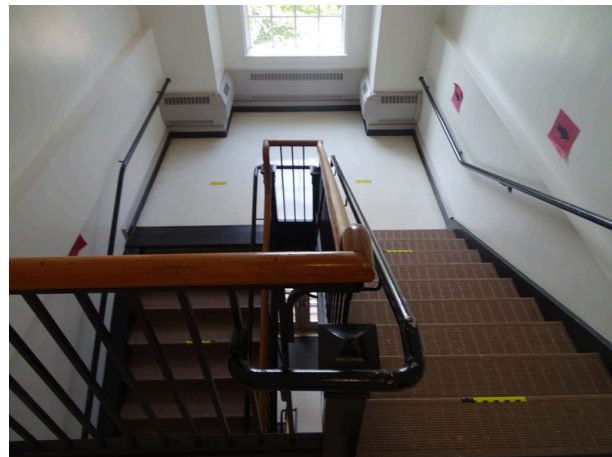
Interior finishes of stair area

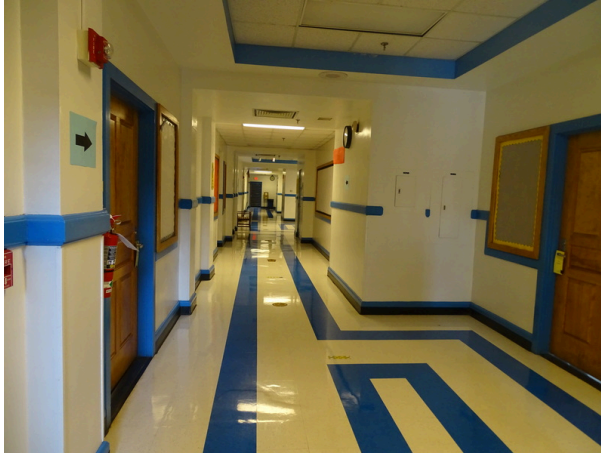
The finishes in the corridors include vinyl tile floors, painted plaster and/or gypsum board walls, and painted plaster and/or gypsum board and suspended acoustical ceiling tile ceilings. The finishes in the corridors were observed to be in generally good condition.

Interior finishes of corridor area

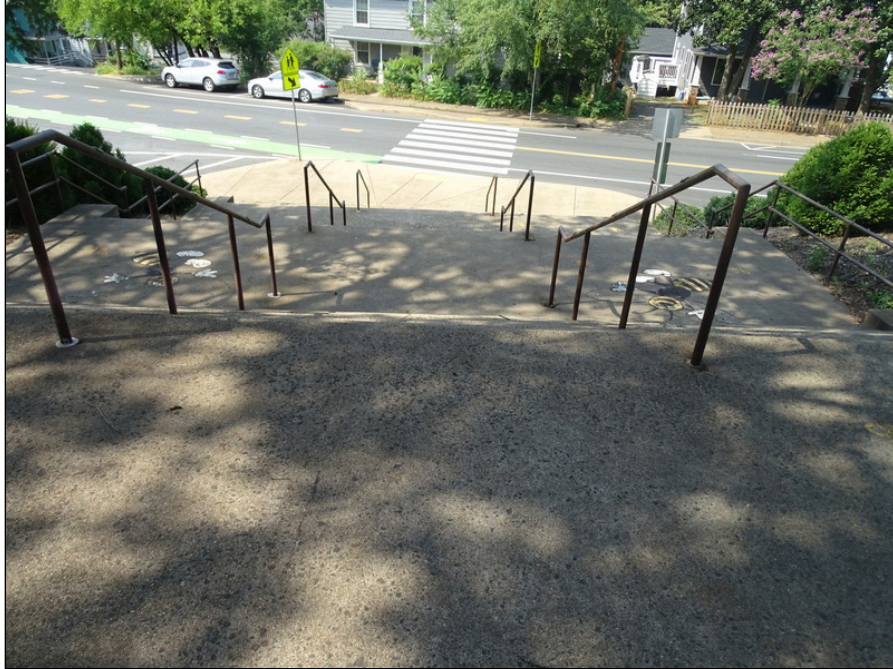
13 - Typical concrete steps

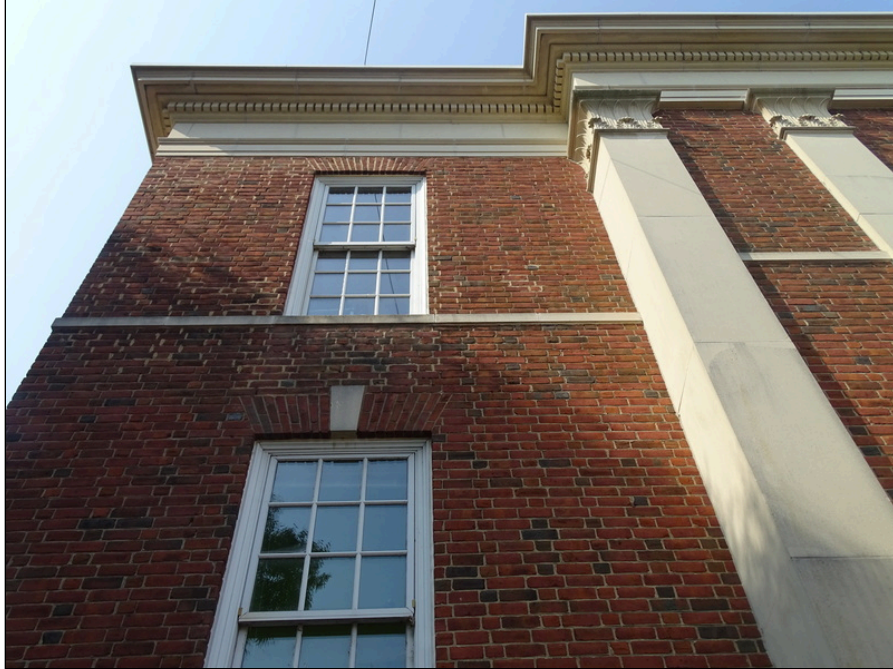
31 - Building exterior north side of the

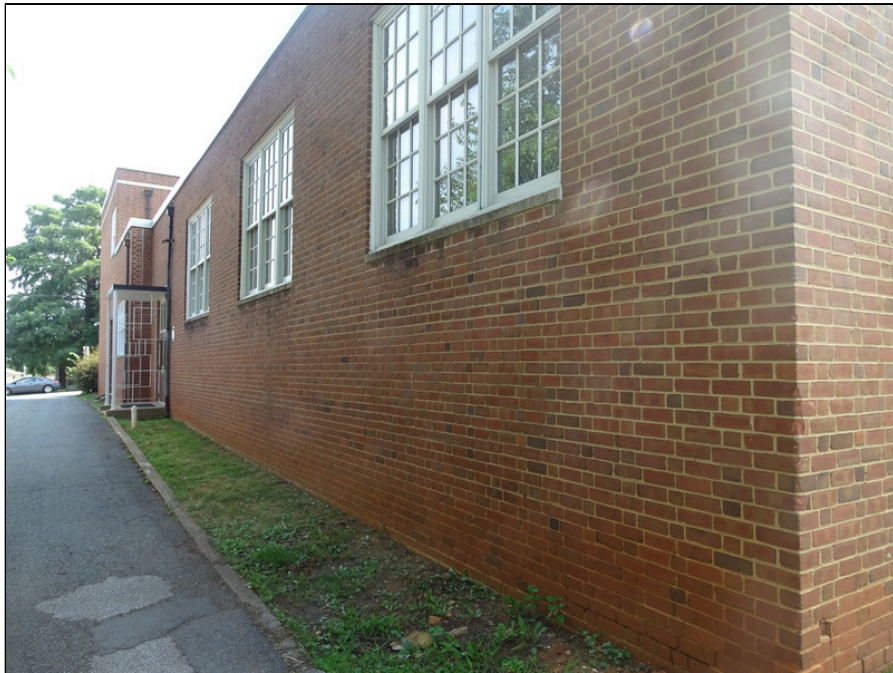
32 - Building exterior - note efflorescence

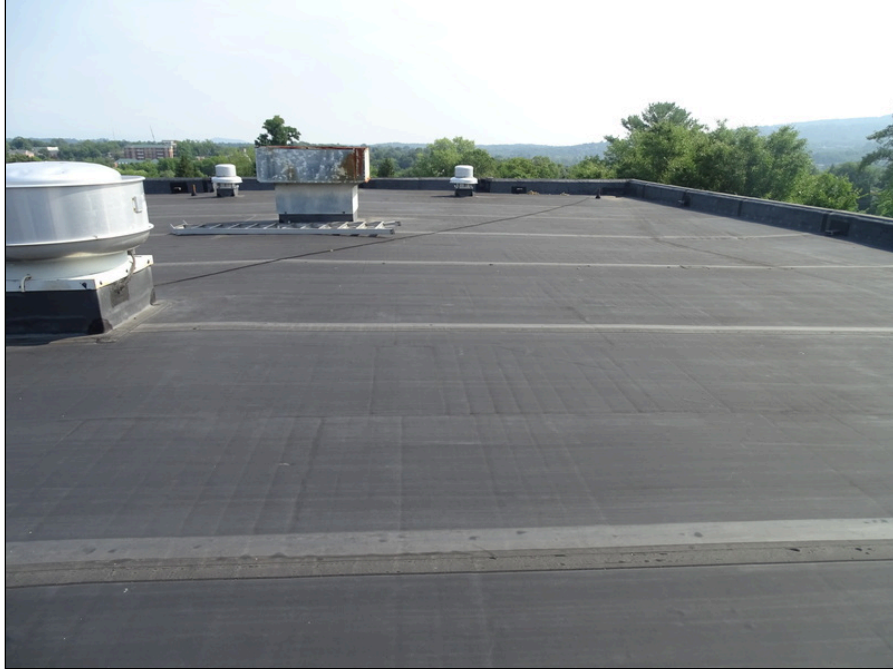
49 - Single-ply membrane roofing system looking north

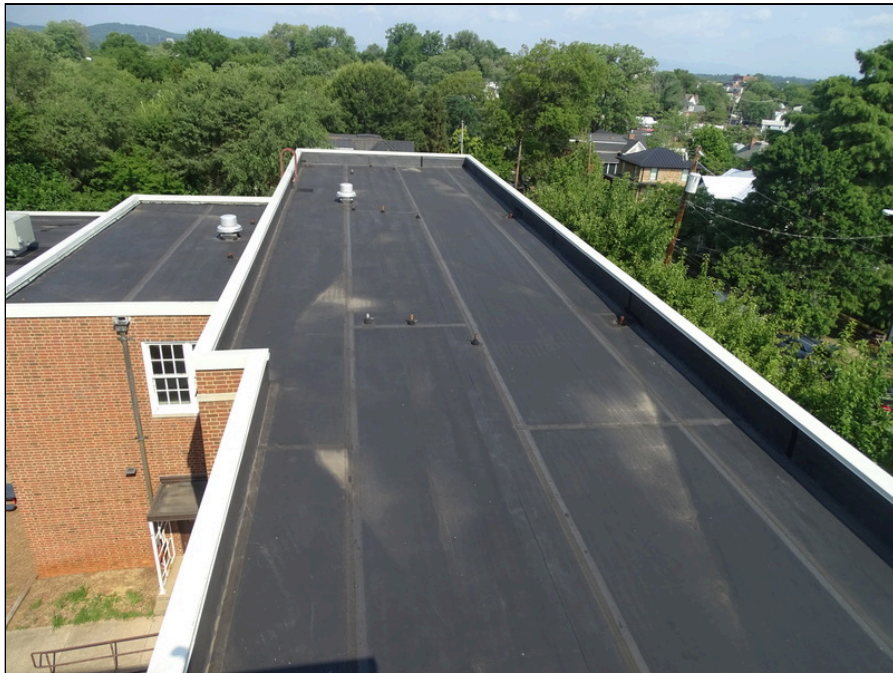
50 - Single-ply membrane roofing system addition

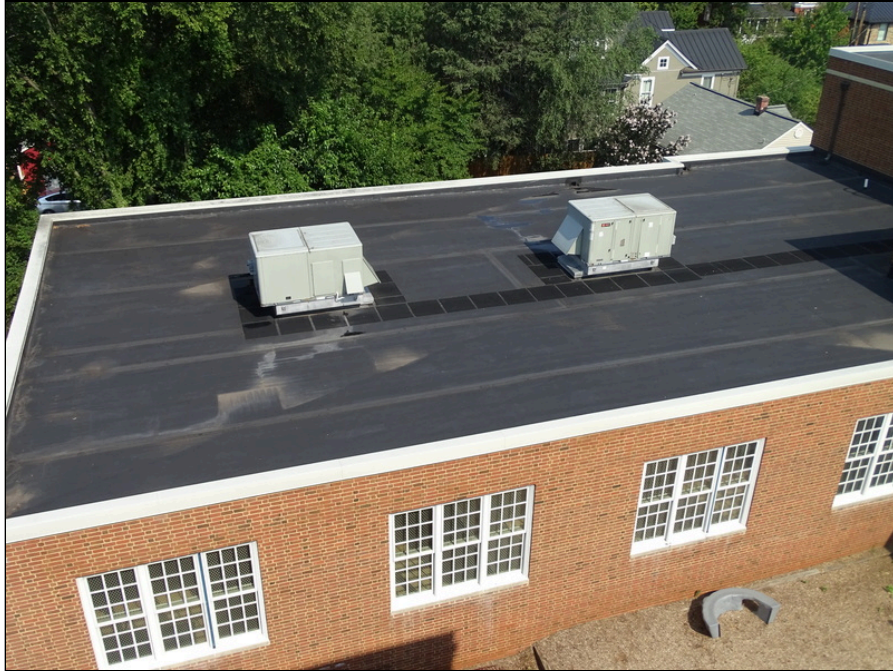
51 - Roofing metal coping

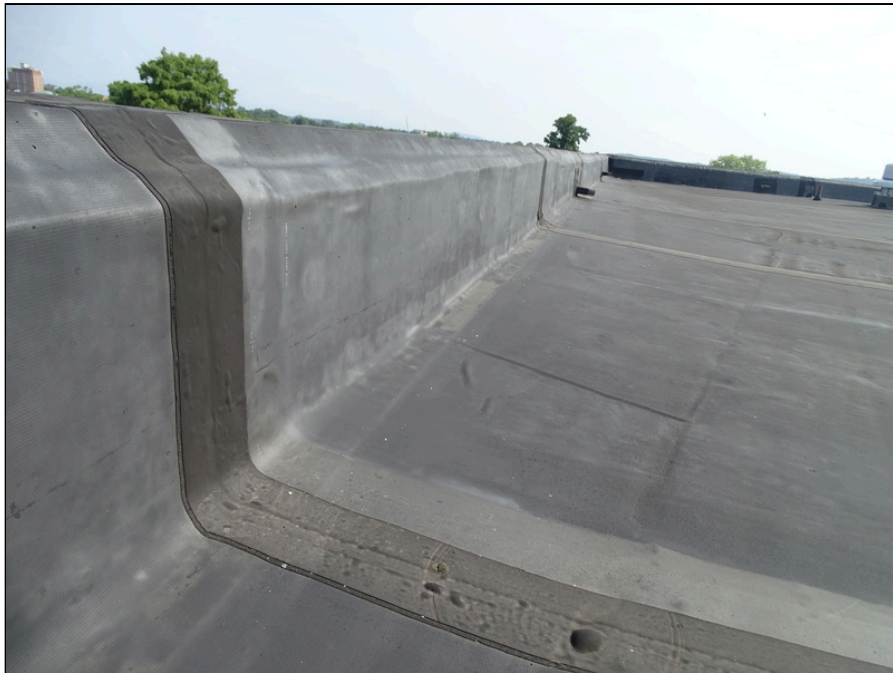
52 - Typical parapet wall

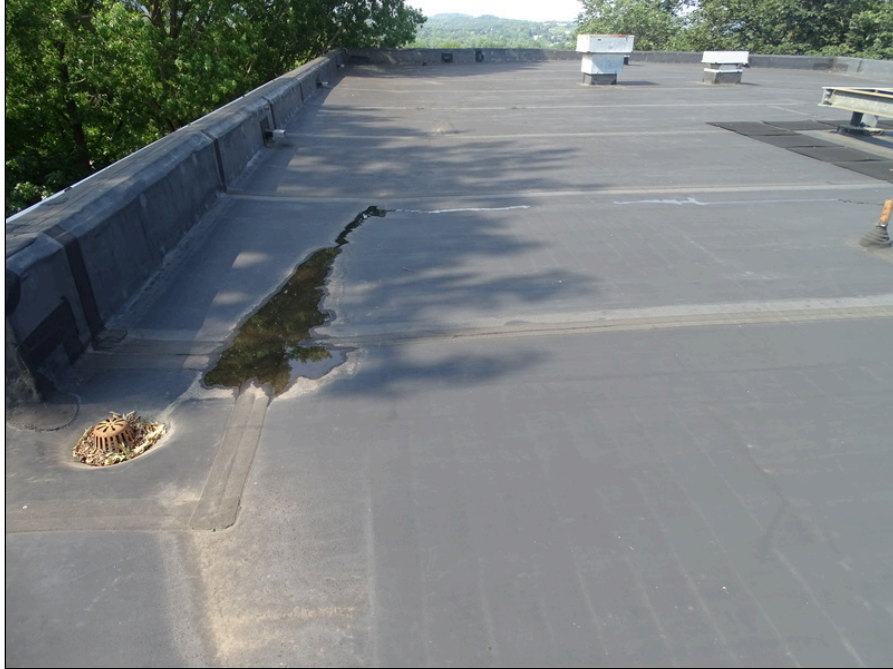
53 - Single-ply membrane roofing system - note ponding

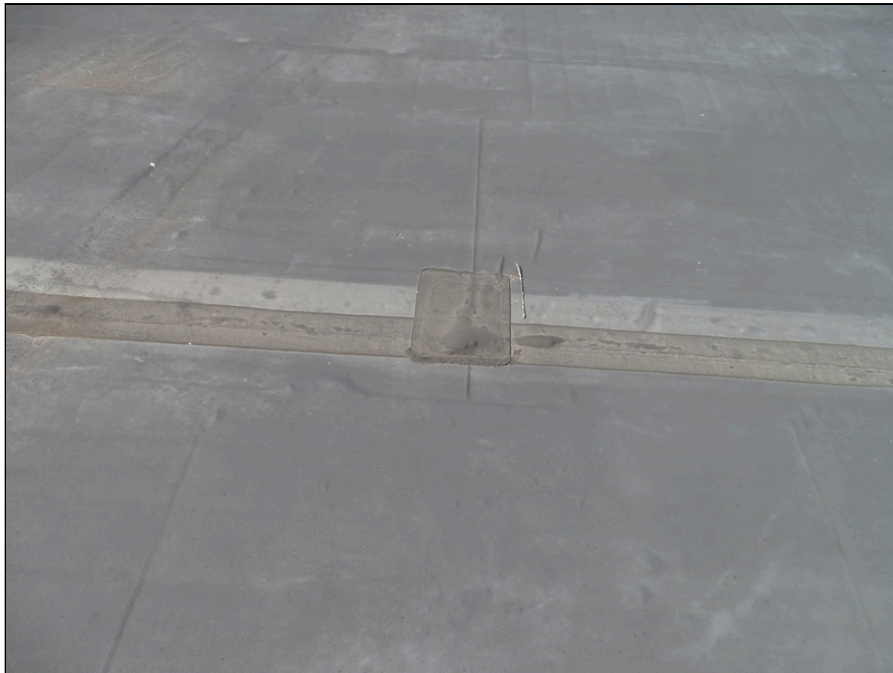
54 - Single-ply membrane roofing system addition - note patching

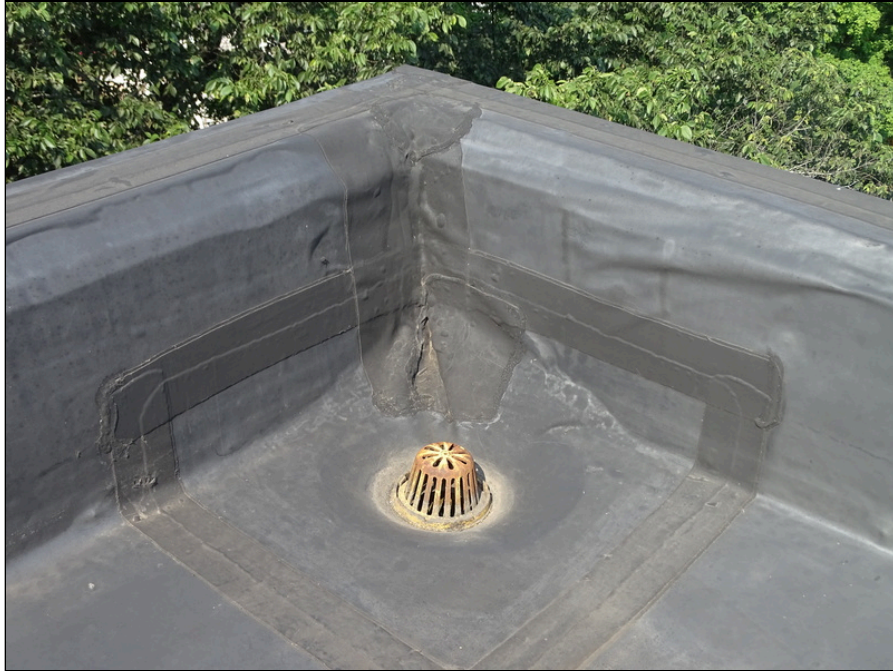
55 - Typical internal drain

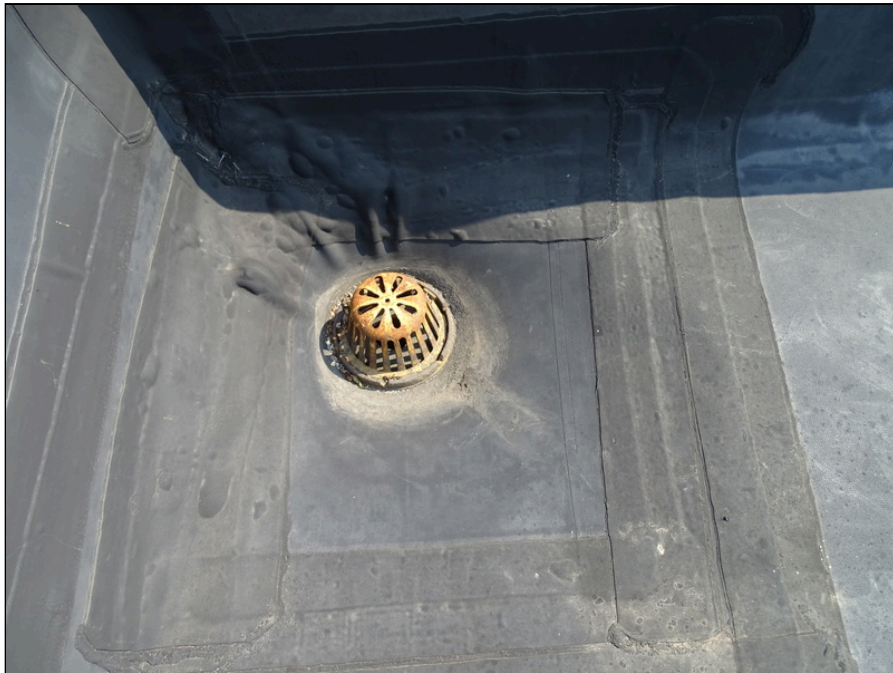
56 - Typical internal drain

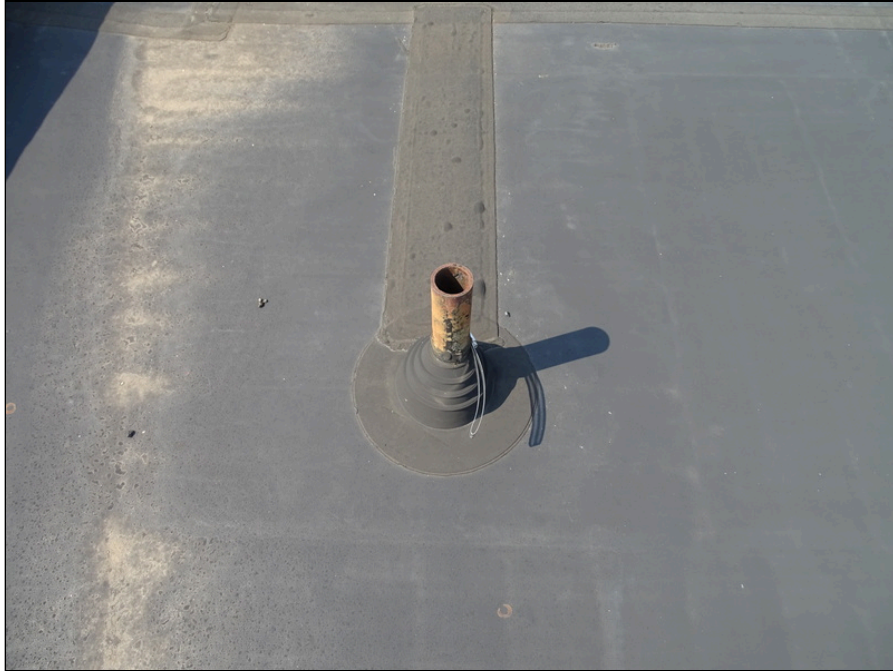
57 - Typical plumbing penetration

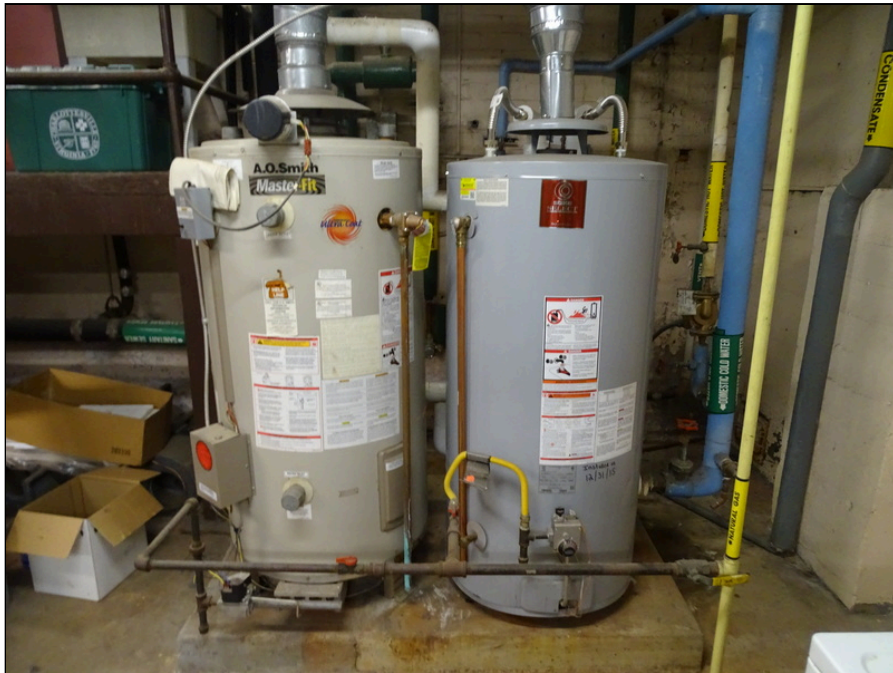
58 - Gas domestic water heaters

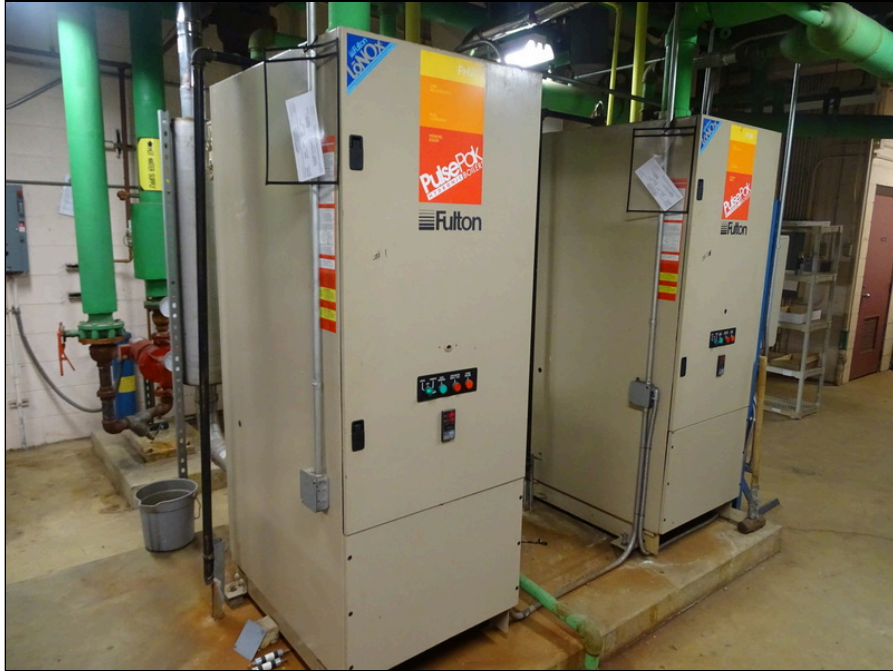
59 - Boilers located in mechanical room

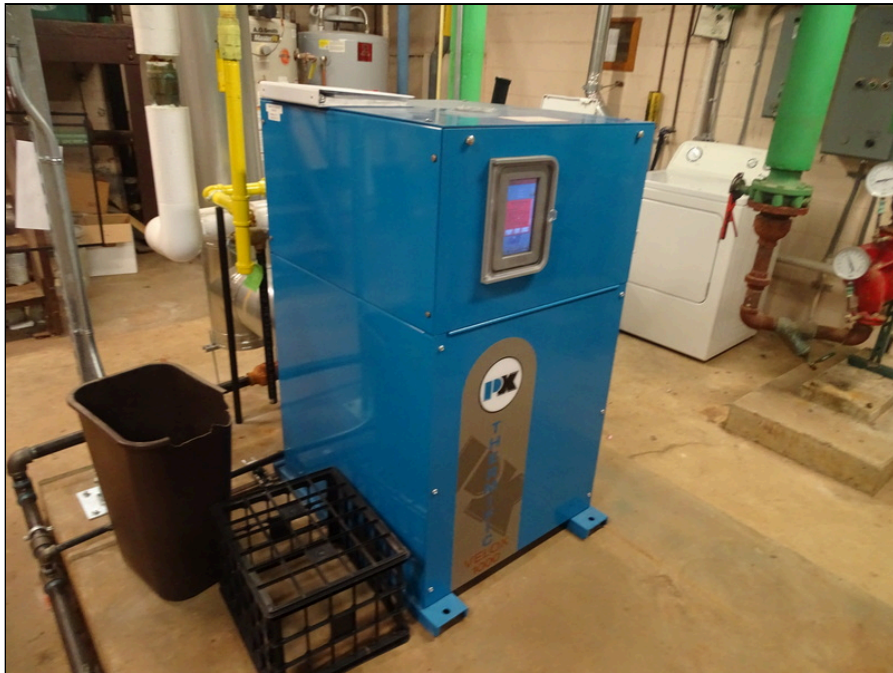
60 - Boiler located in mechanical room

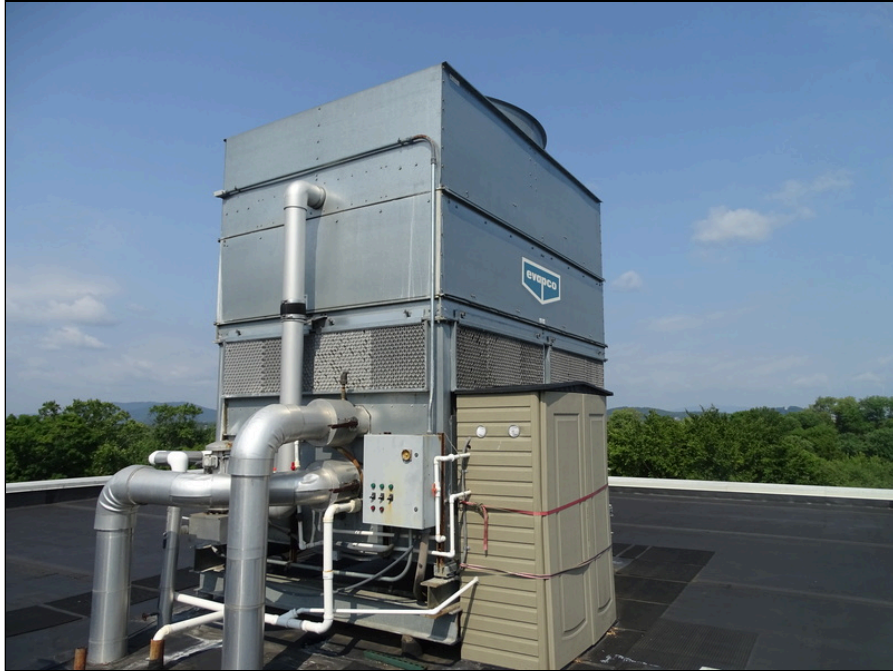
61 - Cooling tower located on roof

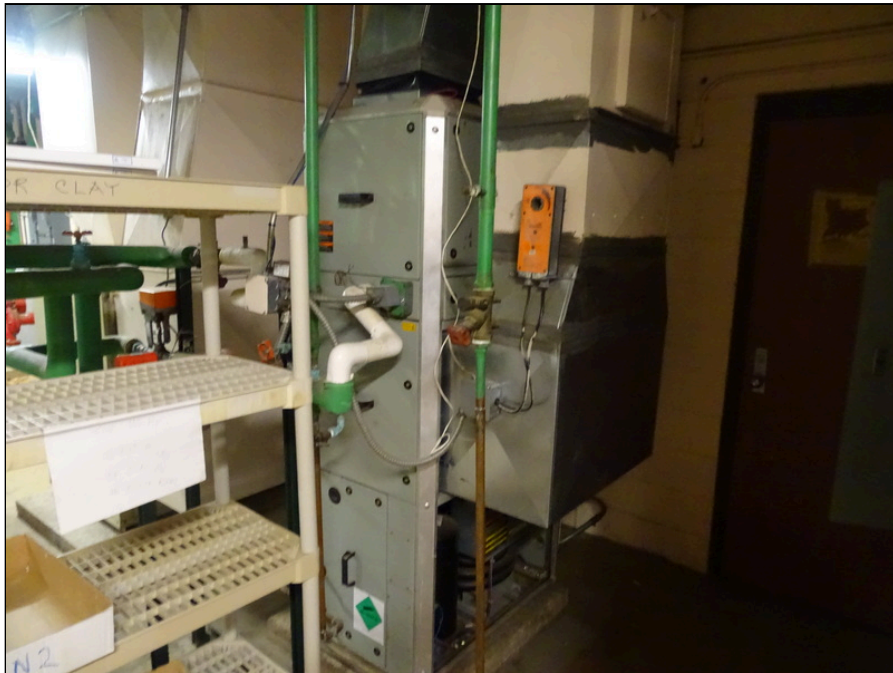
62 - Typical air handler

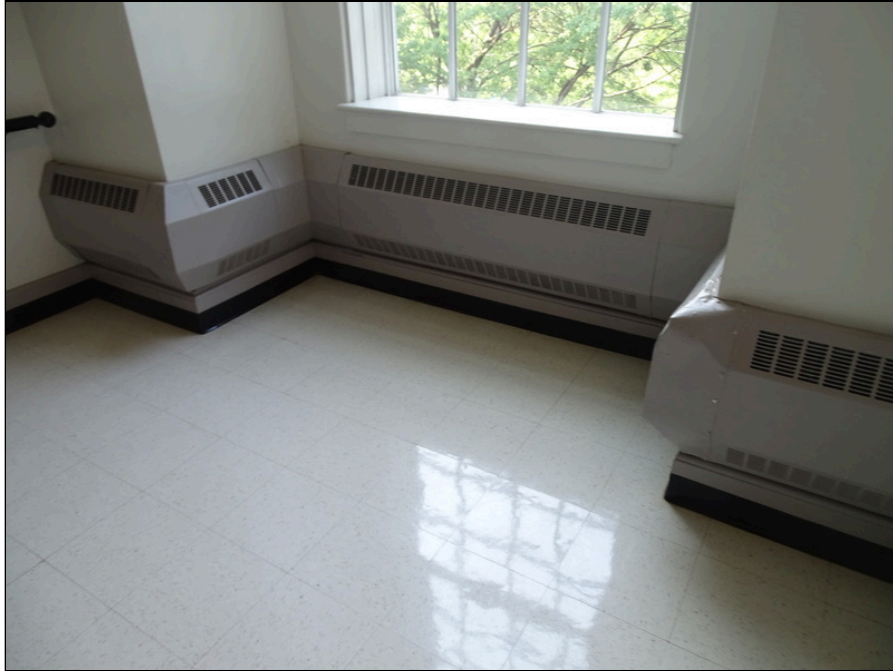
63 - Typical water source heat pump

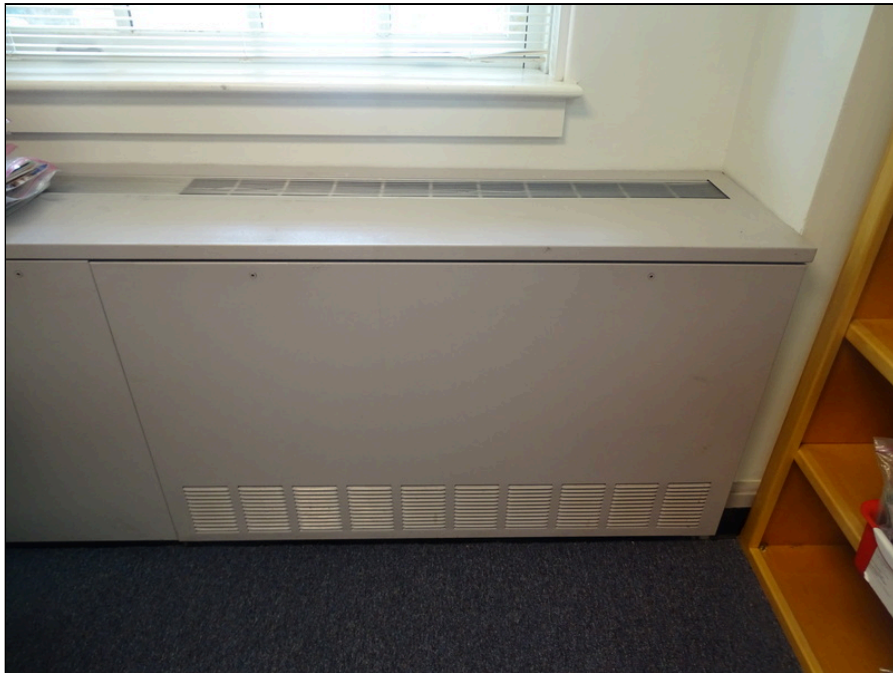
64 - Typical water source heat pump

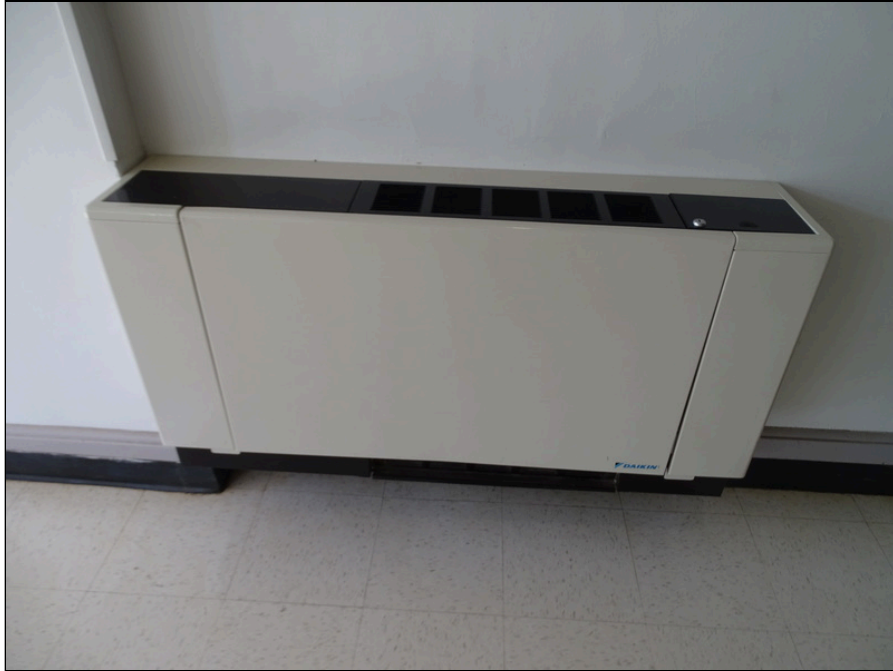
65 - Typical water source heat pump

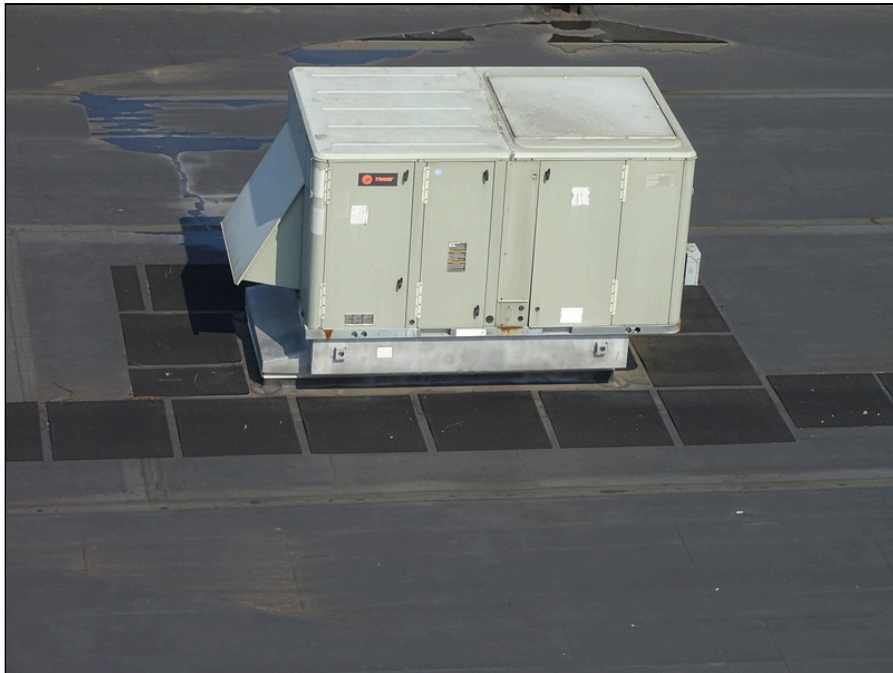
66 - Typical package unit

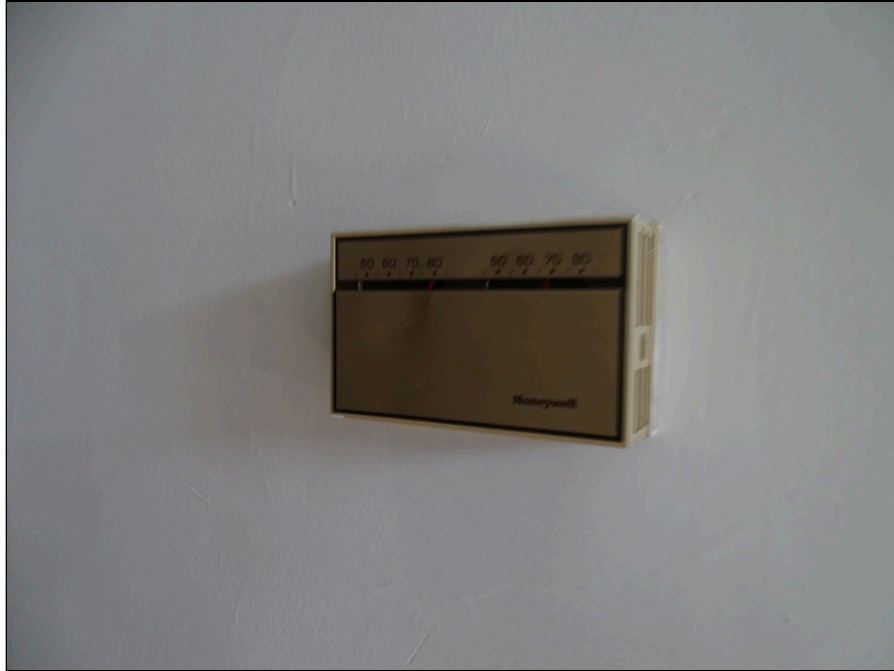
67 - Typical thermostat

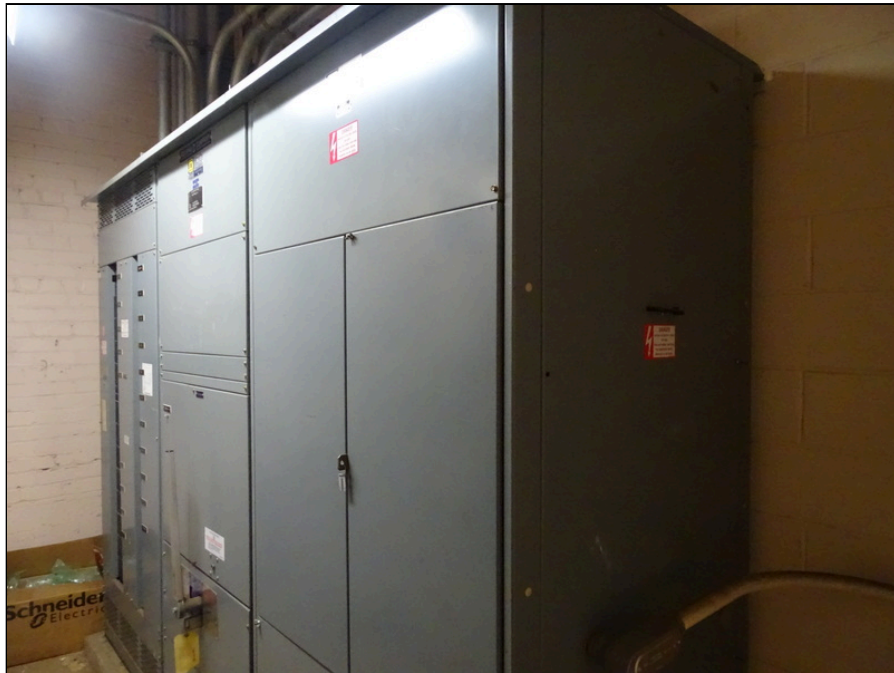
68 - Electrical main switchgear

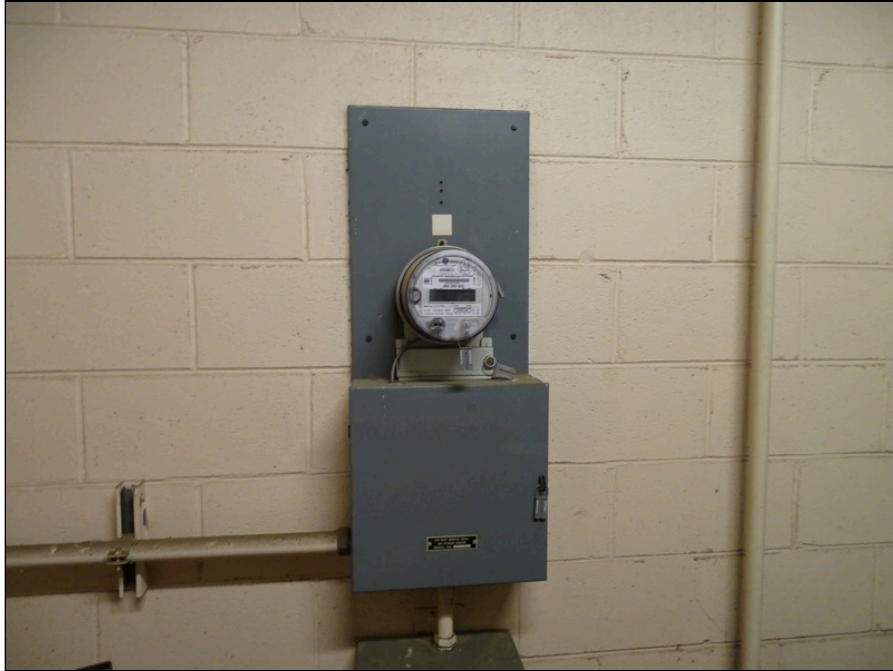
69 - Electrical meter located in main utility room

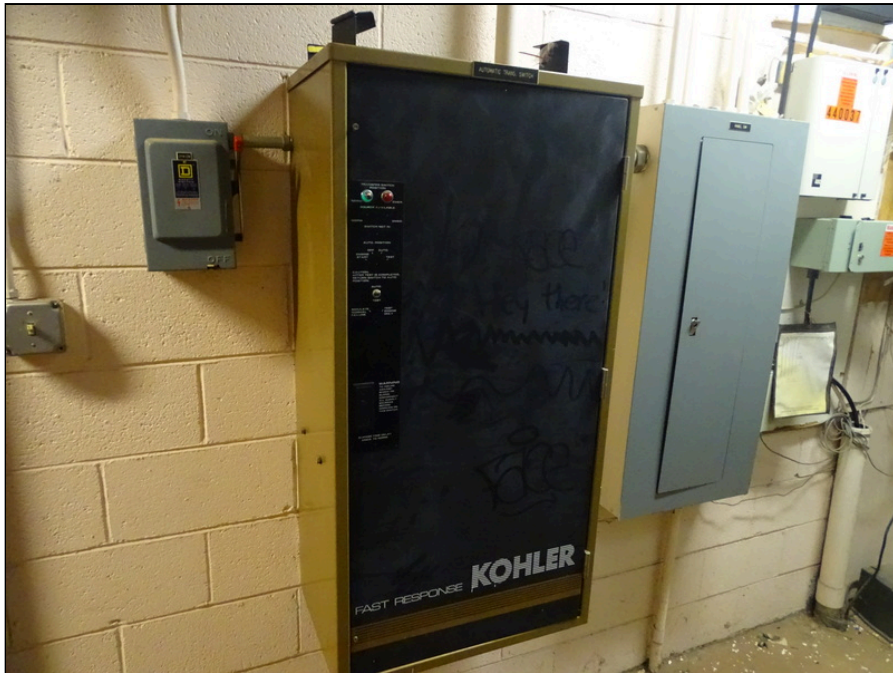
70 - Emergency power transfer switch

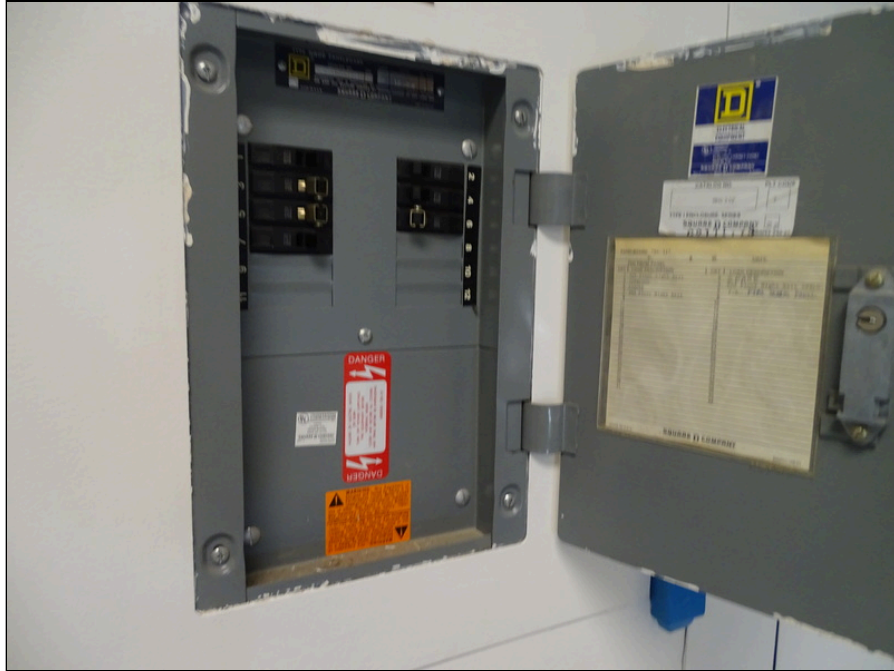
71 - Typical electrical panel

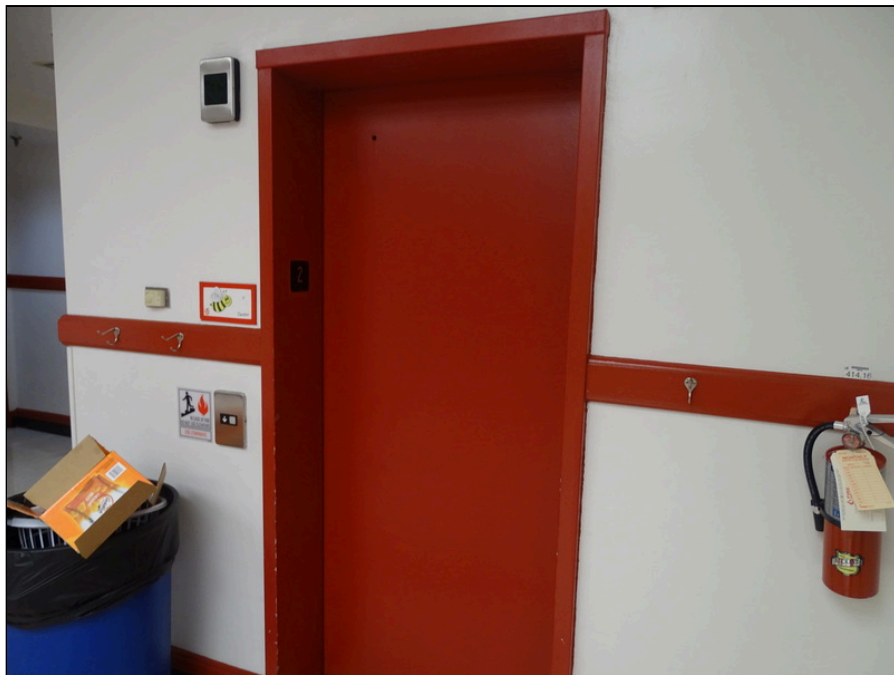
72 - Elevator at north side of the building

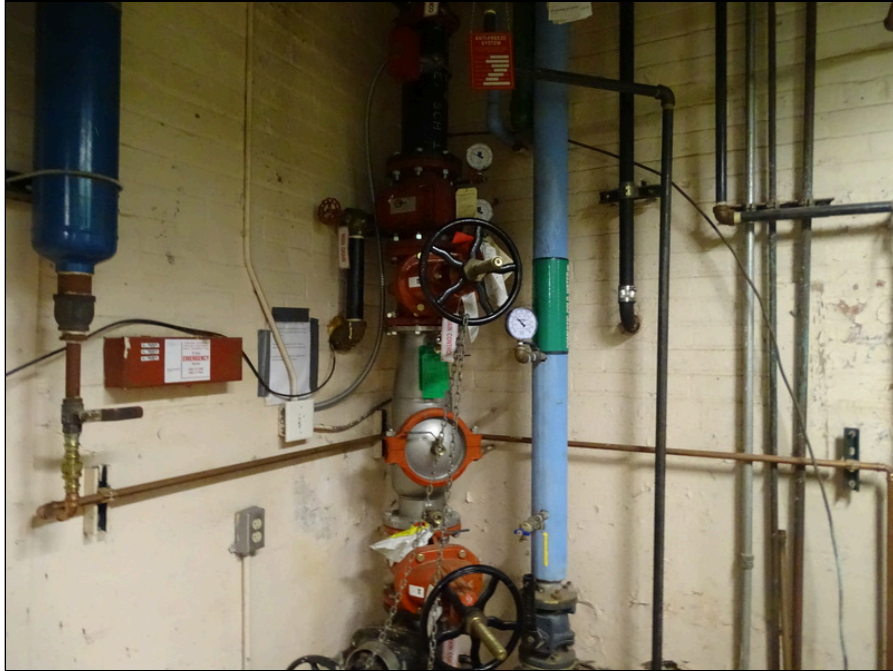
73 - Fire sprinkler system located in main utility room
