CLARK ELEMENTARY SCHOOL
1000 BELMONT AVENUE
CHARLOTTESVILLE, VIRGINIA

ECS PROJECT NO. 46:6713

CITY OF CHARLOTTESVILLE - FACILITIES DEVELOPMENT

Reference: Facility Condition Assessment Report for Clark Elementary School, 1000 Belmont Avenue,
Charlottesville, Virginia

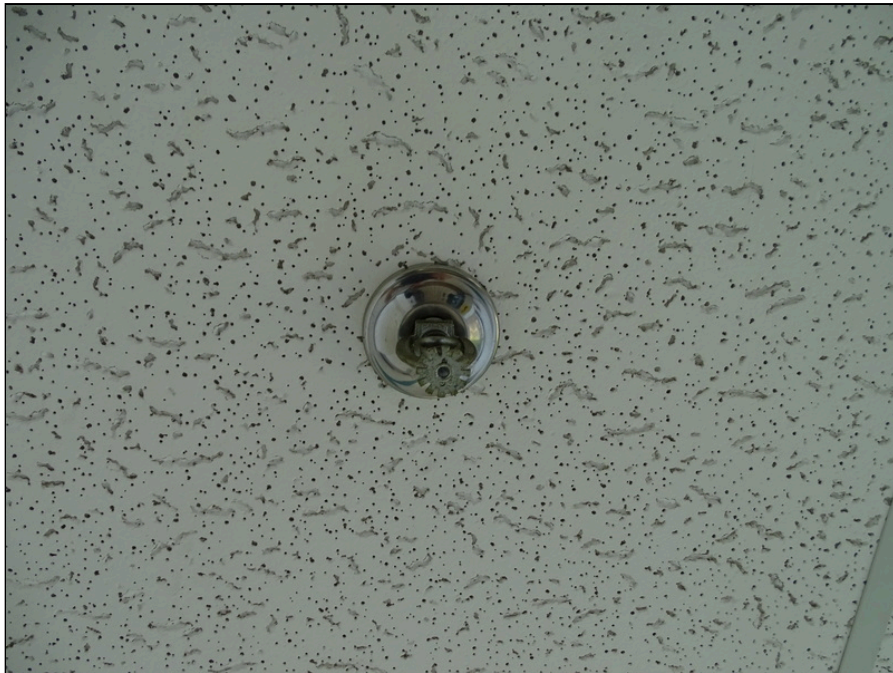
74 - Typical fire sprinkler head

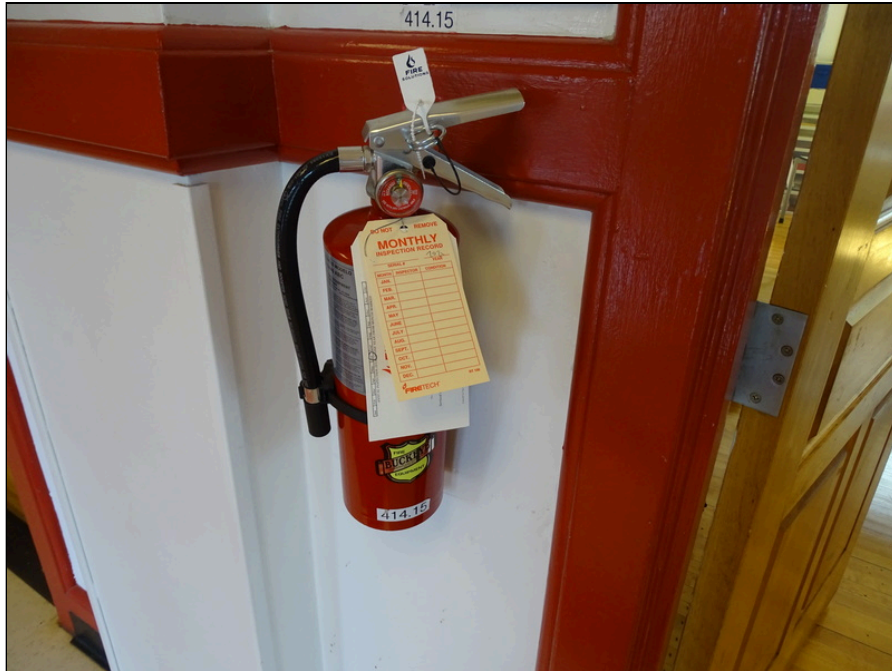
75 - Typical fire extinguisher

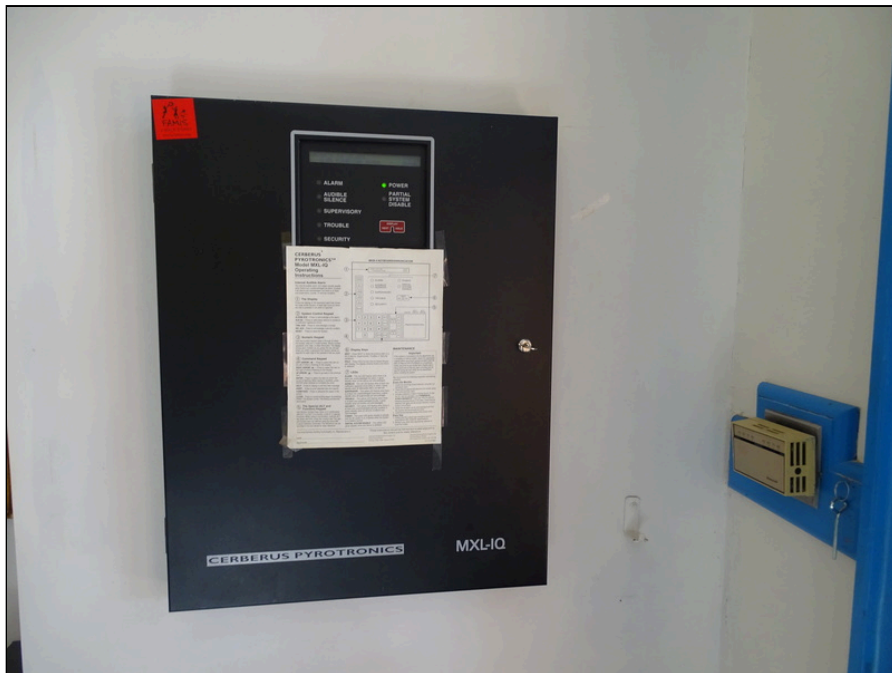
76 - Fire alarm control panel

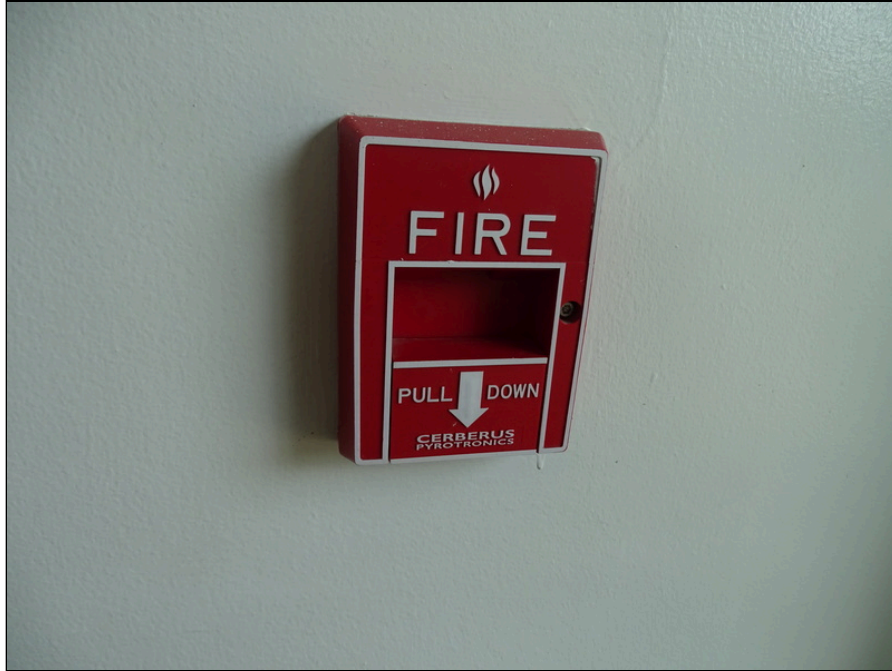
77 - Typical fire alarm pull station

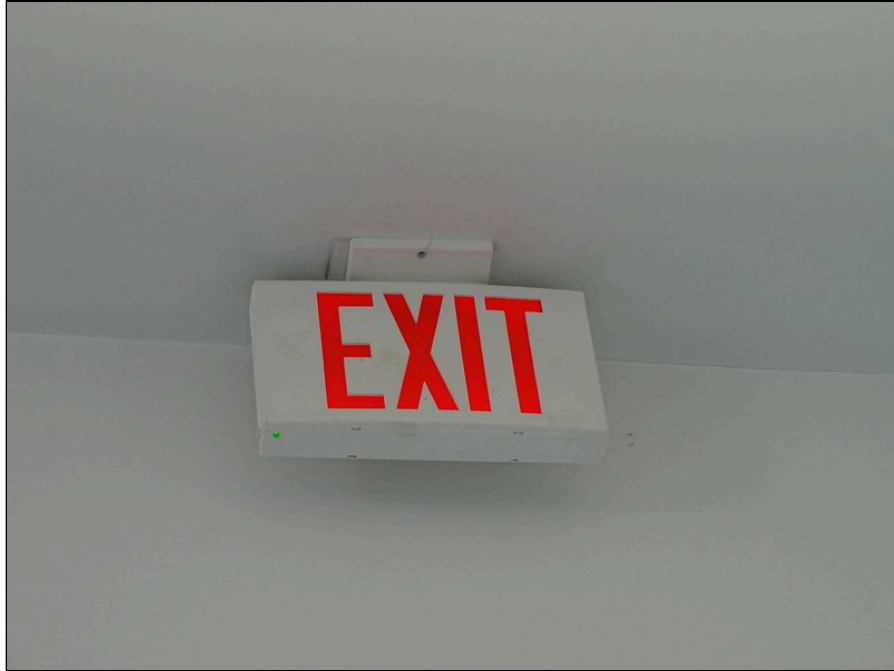
79 - Typical exit sign

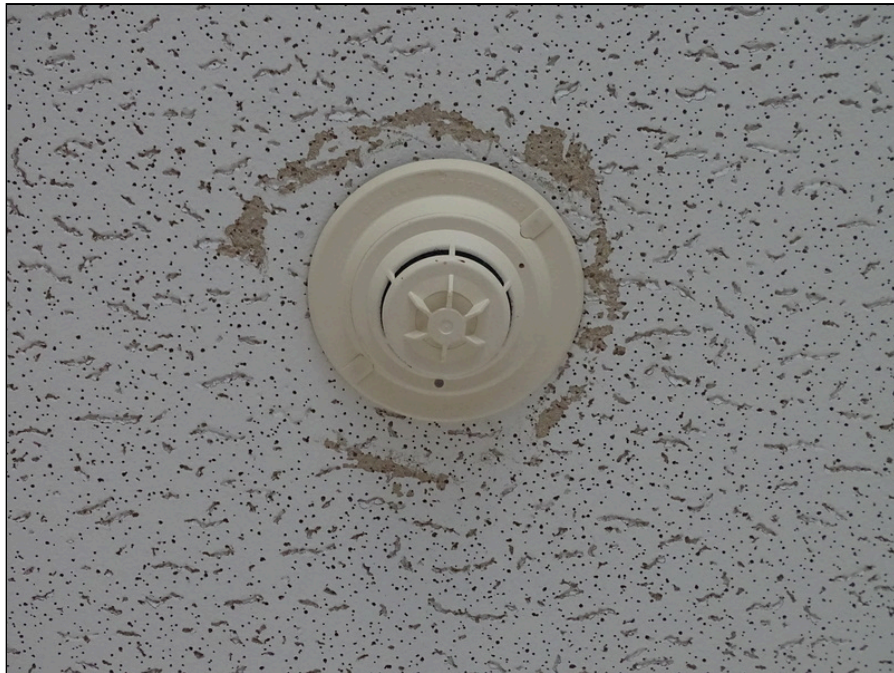
80 - Typical smoke detector

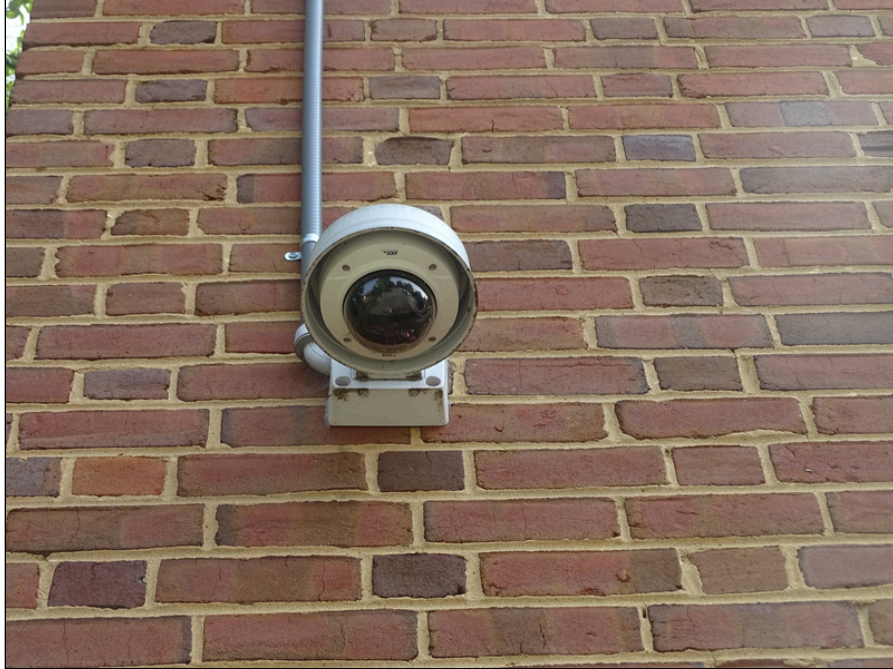
81 - Security camera

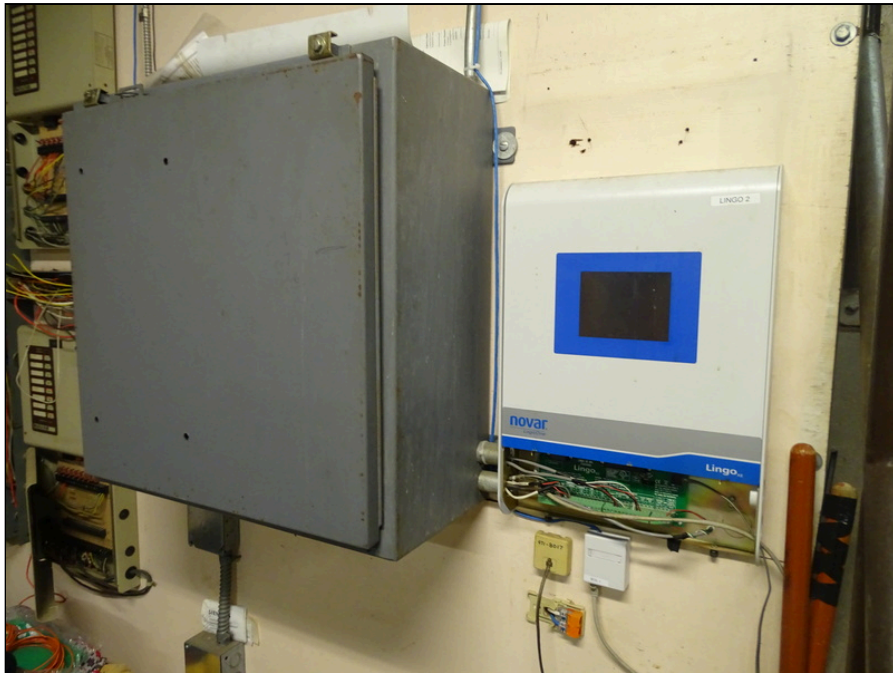
82 - Security alarm

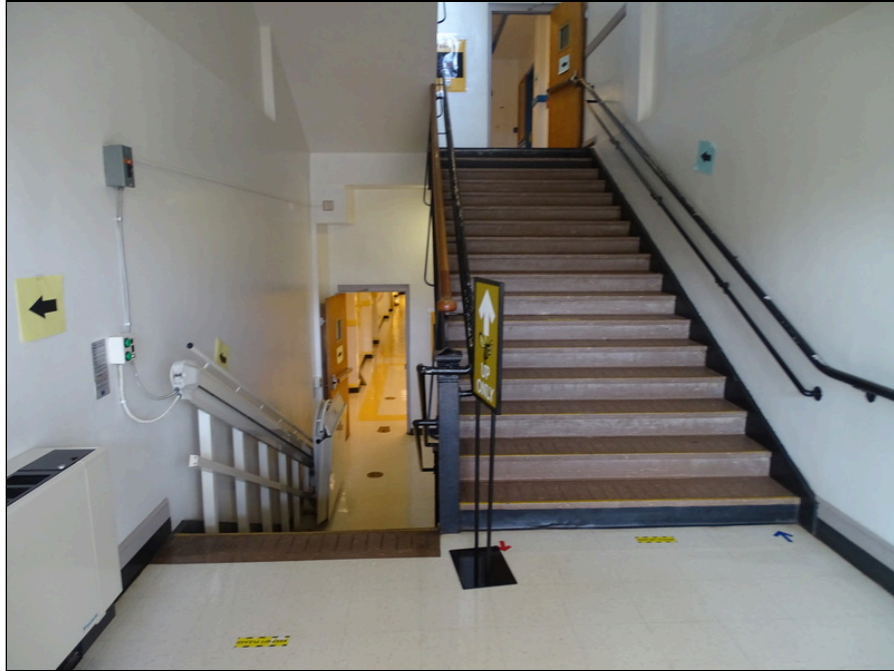
83 - Interior finishes of stair area

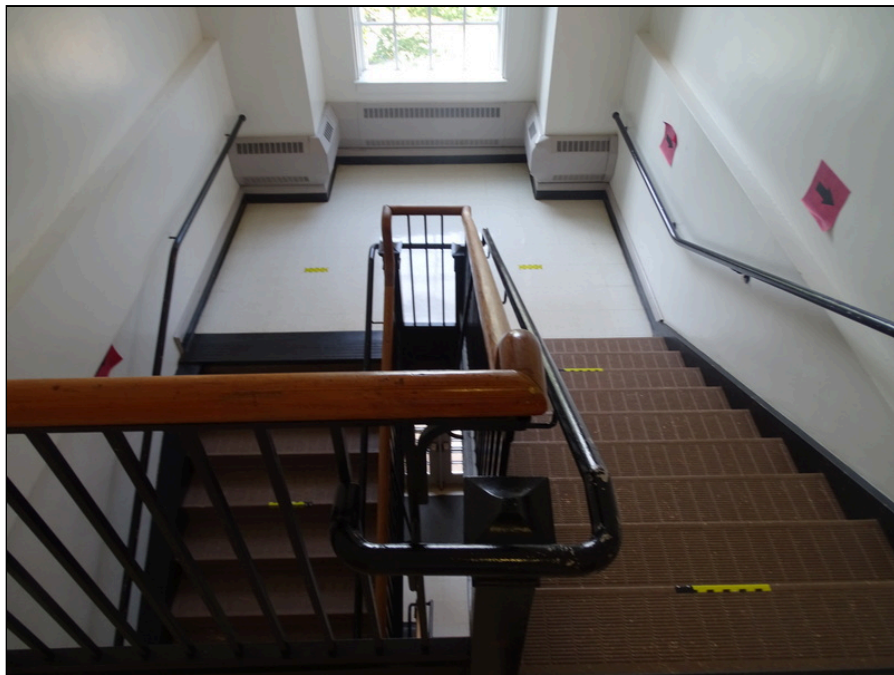
84 - Interior finishes of stair area

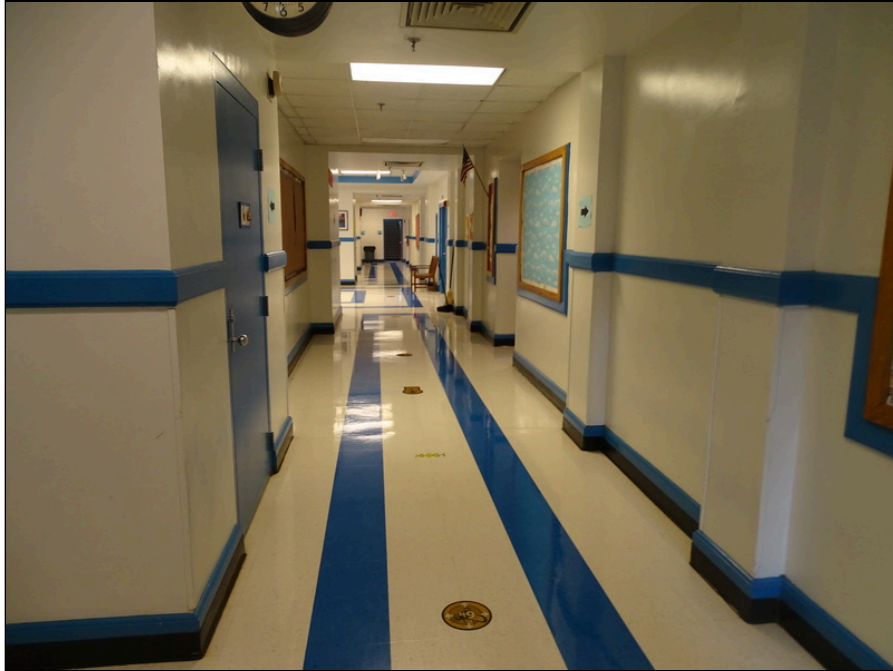
85 - Interior finishes of corridor area

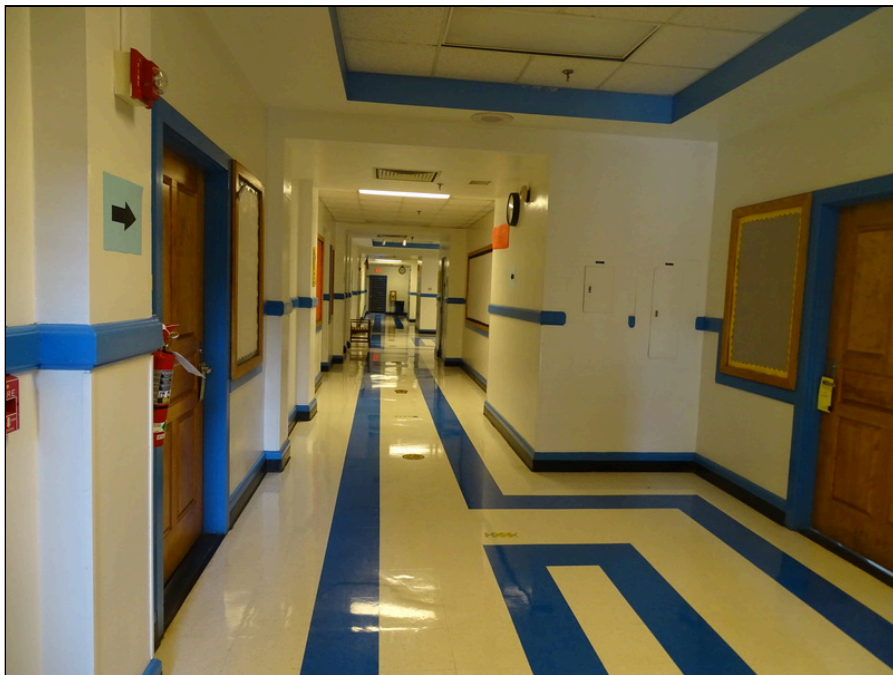
86 - Interior finishes of corridor area

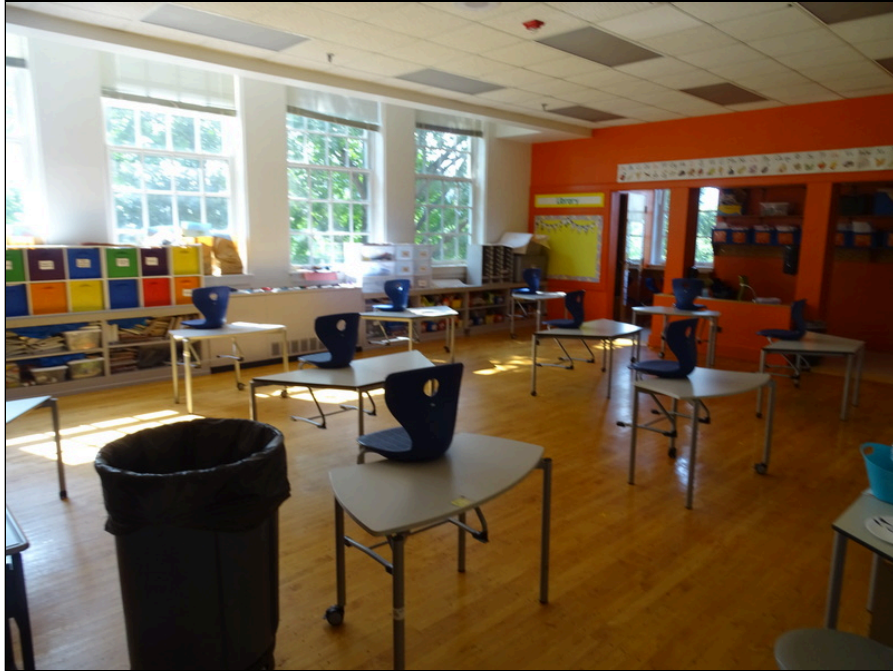
87 - Interior finishes of library area

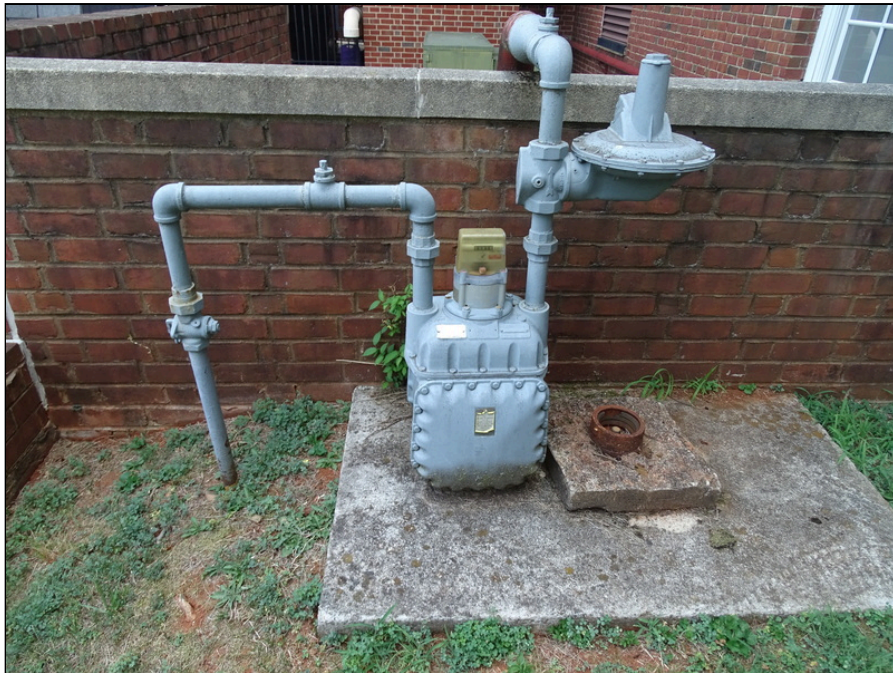
90 - Typical gas meter

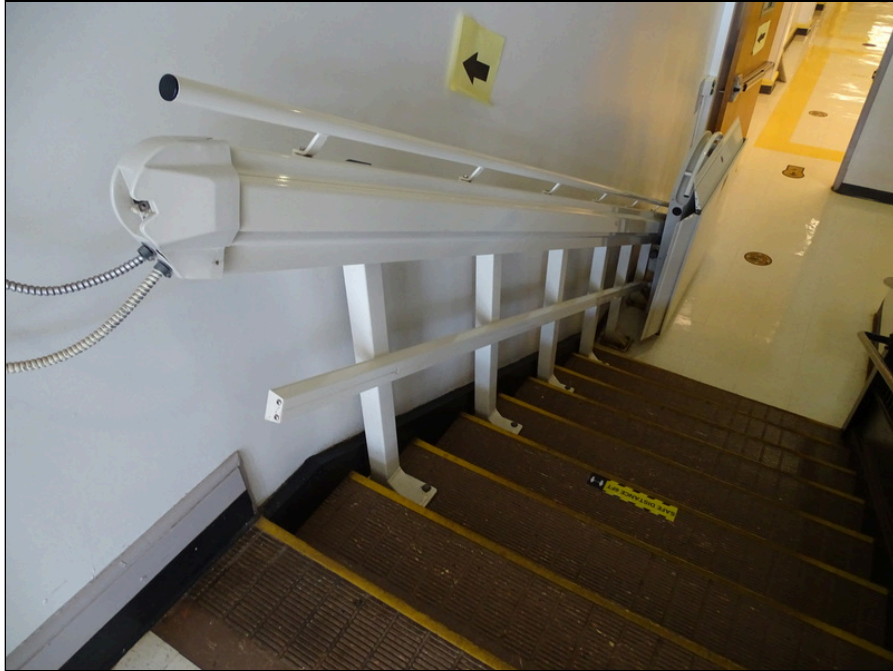
91 - Accessible chair lift

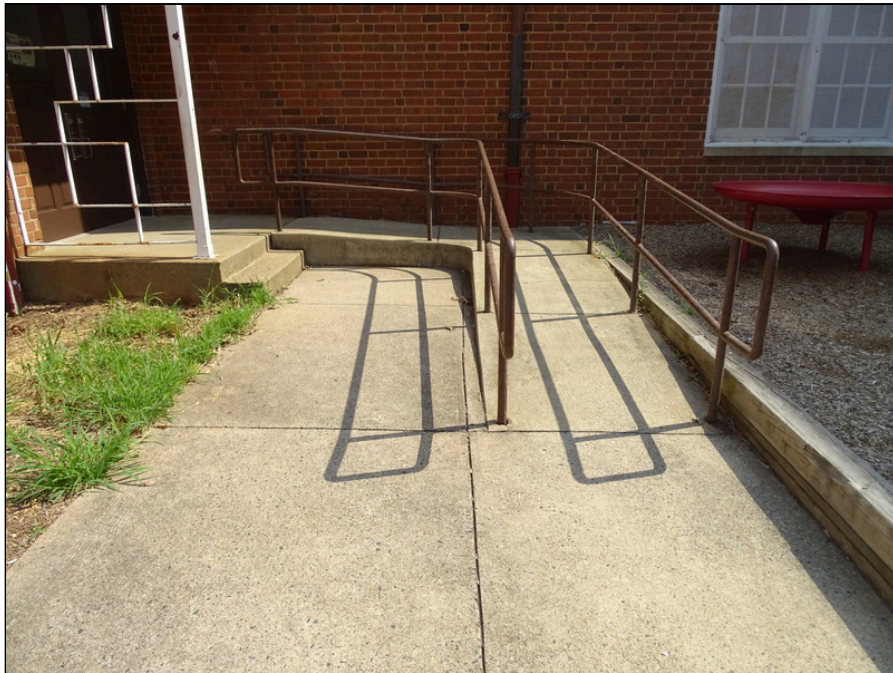
92 - Accessible ramp

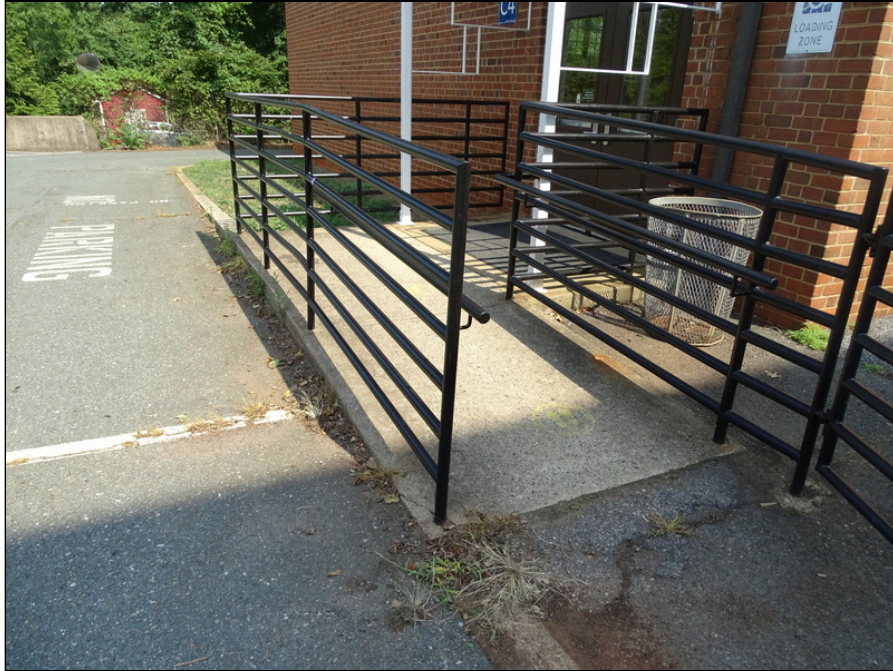
93 - Accessible ramp

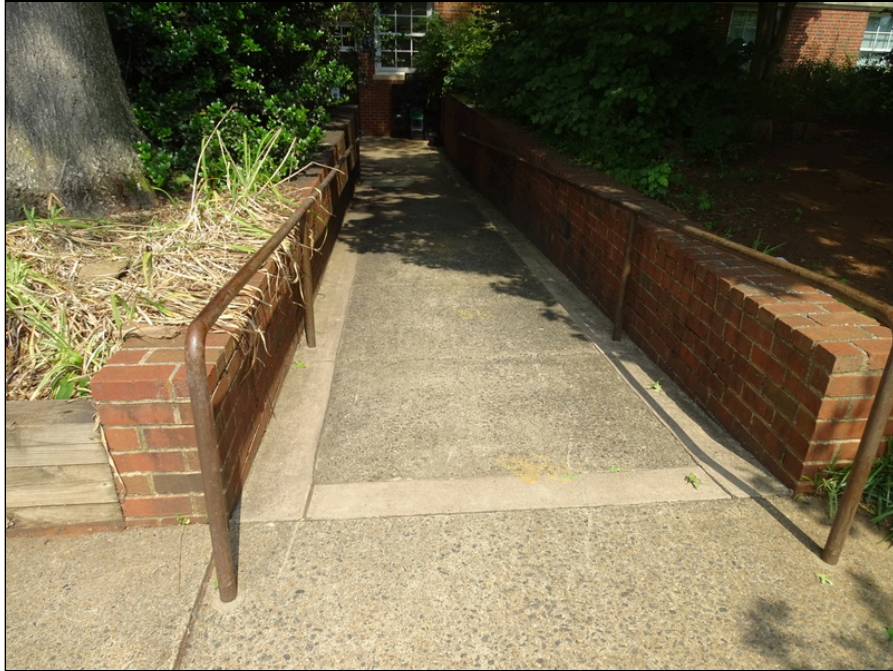
95 - Accessible ramp

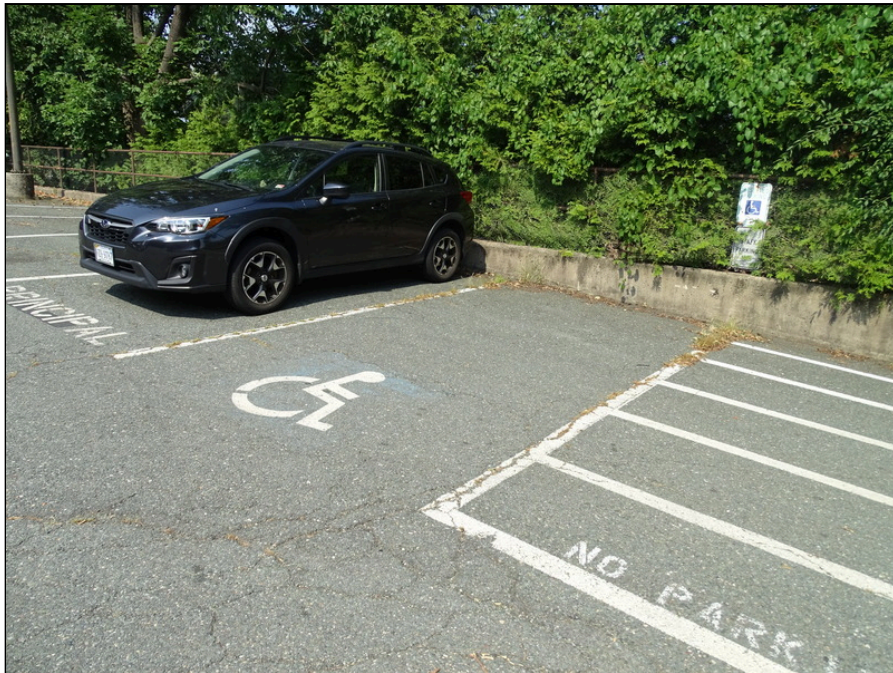
96 - Accessible parking space

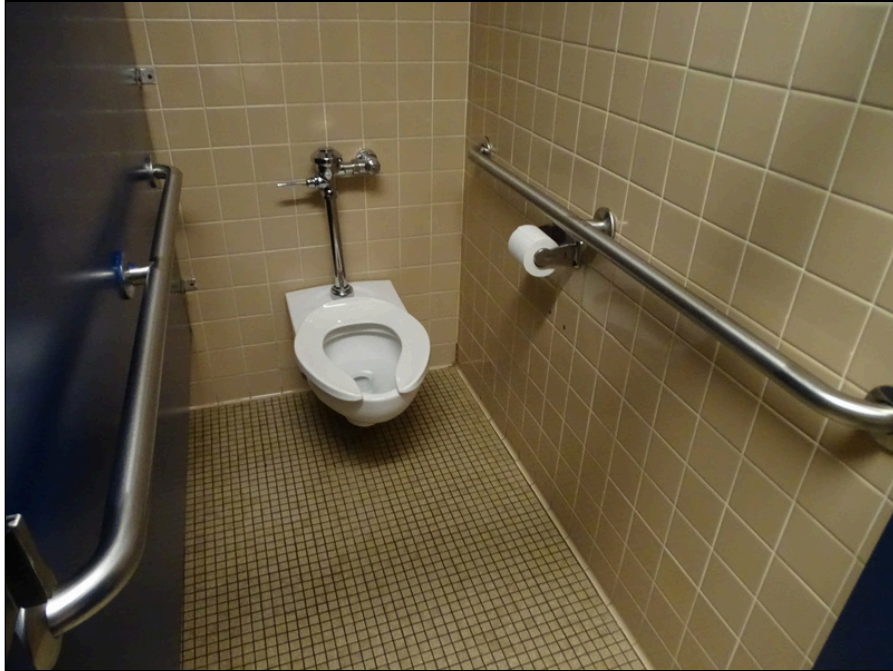
97 - Accessible restroom
