DISCOVERY MUSEUM
524 EAST MAIN STREET
CHARLOTTESVILLE, VIRGINIA

ECS PROJECT NO. 46:6713

CITY OF CHARLOTTESVILLE - FACILITIES DEVELOPMENT

Reference: Facility Condition Assessment Report for Discovery Museum, 524 East Main Street,
Charlottesville, Virginia

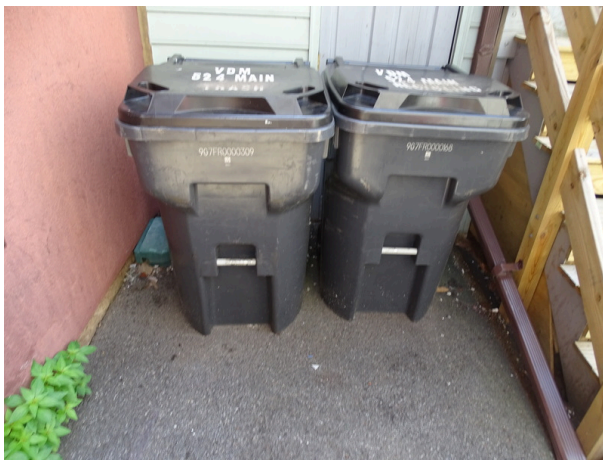
Trash container pad

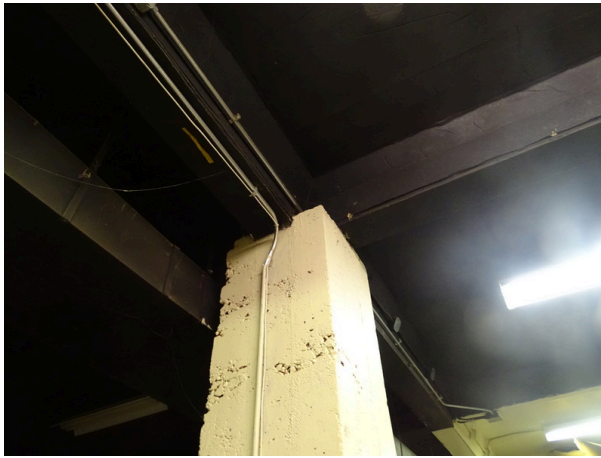
The structure of the building consists of Brick masonry bearing walls with steel framing and concrete topped metal decks for upper levels with concrete columns in the basement and wood framing at the ground level. The structural frame of the building was generally in good condition.

Structural framing at first level

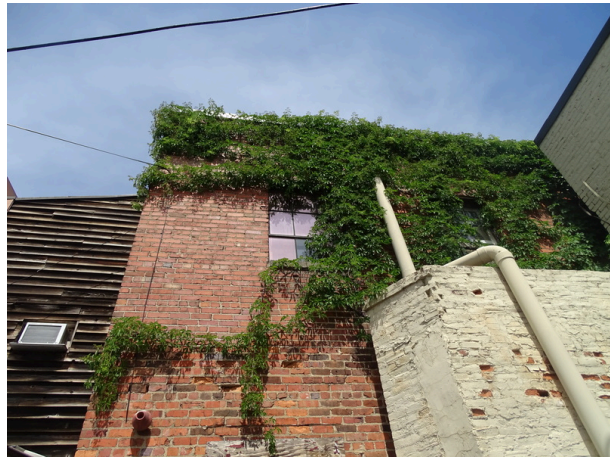
Typical exterior wall

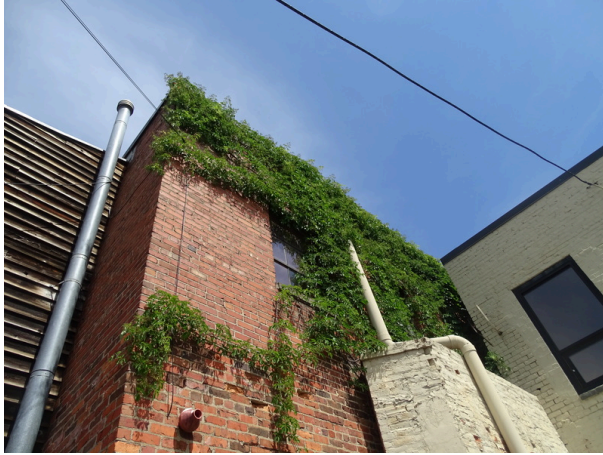
Typical exterior wall

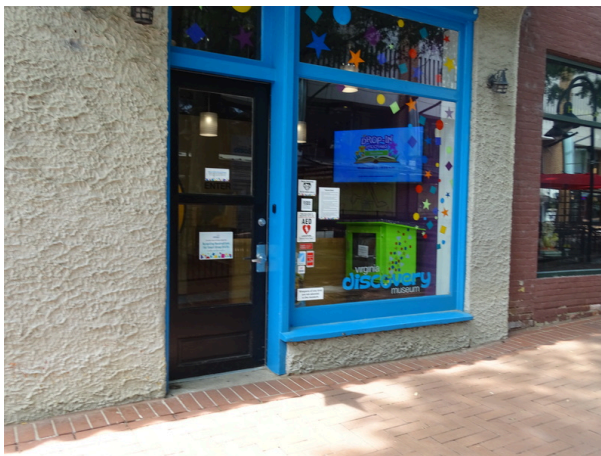
Main entrance door and window on north side of building

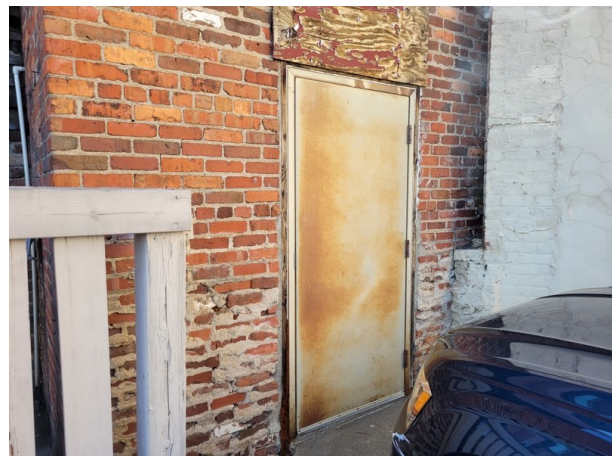
A steel personnel door is located at the south end, east side of the building. The personnel door was generally in poor condition with noticeable deterioration of the door slab and surrounding wood elements. A piece of plywood covers a former transom over the door and was also deteriorated. We recommend re-pointing the brick opening, replacing the wood infill, replacing the door and frame, and replacing or infilling the transom.

Rear entrance

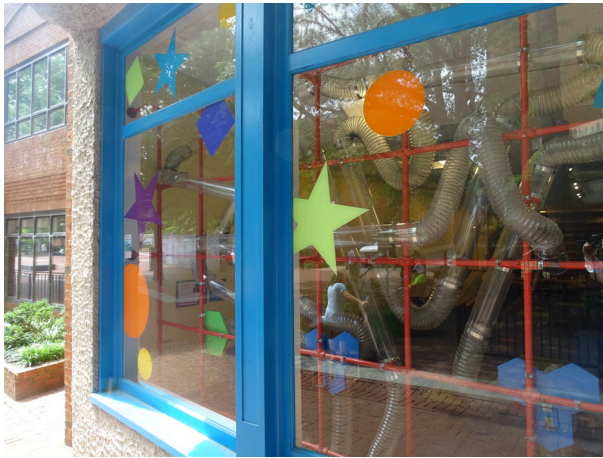
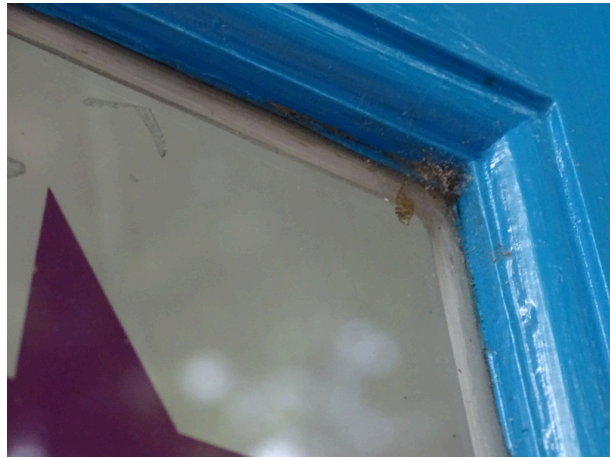
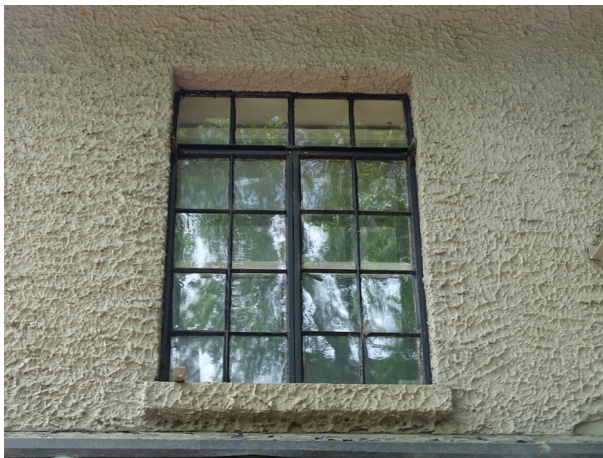
The window system for the building primarily consists of Wood-frame double-pane window units at the ground level with metal frame single pane - operable window units located on the second level. The windows can be considered historical in nature. Based on the historical requirements, we recommend repair and/or replacement of the window units as needed.

Typical exterior window on north side of the building

3.3.5 Exterior Windows																													
REPAIR WINDOWS AS NEEDED	30	25	5	1	LS	\$10,000.00	\$10,000	100%					\$10,000																\$10,000

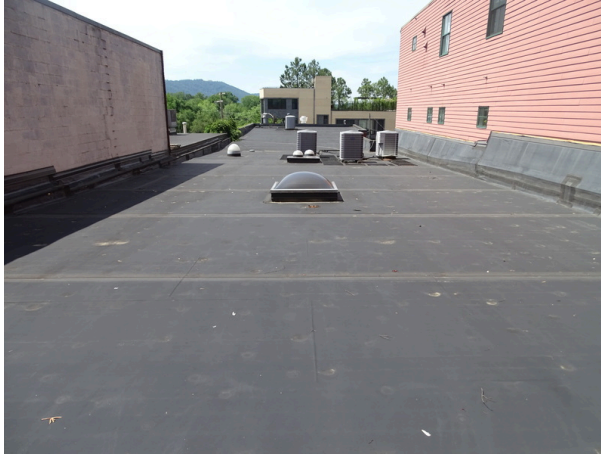
Roofing system looking south

3.3.6 Roofing Systems																													
REPLACE SINGLE-PLY ROOFING SYSTEM	20	18	2	6,500	SF	\$14.00	\$91,000	100%		\$91,000																			\$91,000

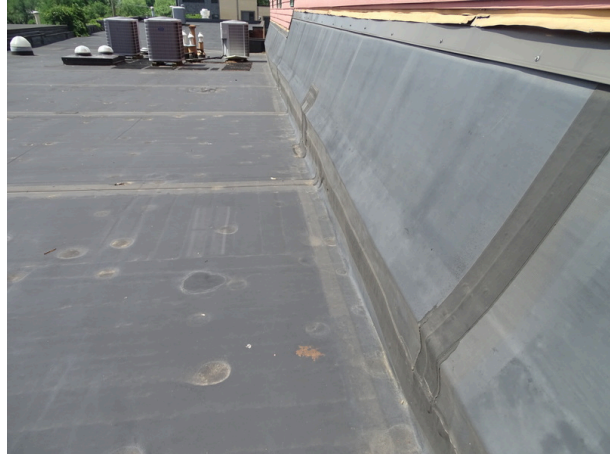
Roofing system parapet walls

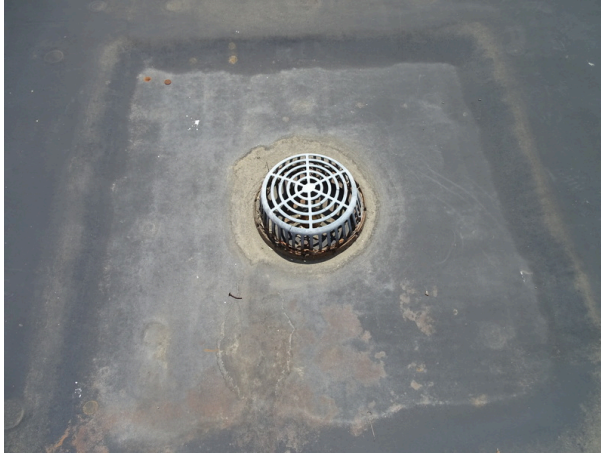
Typical interior drain

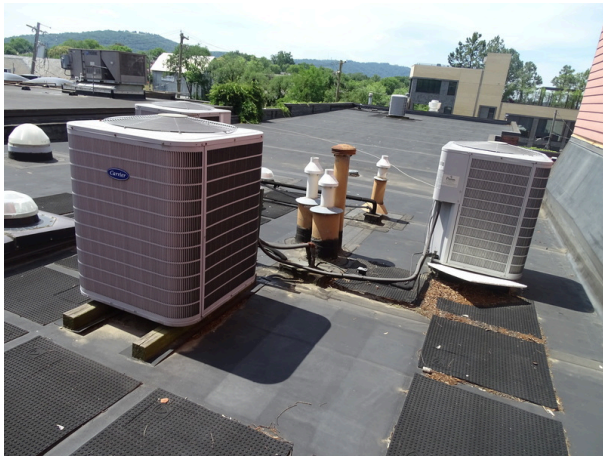
Typical condenser unit

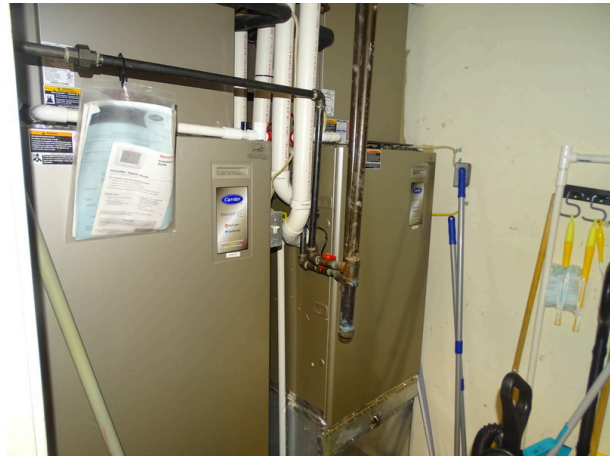
Typical gas furnace and air handler units

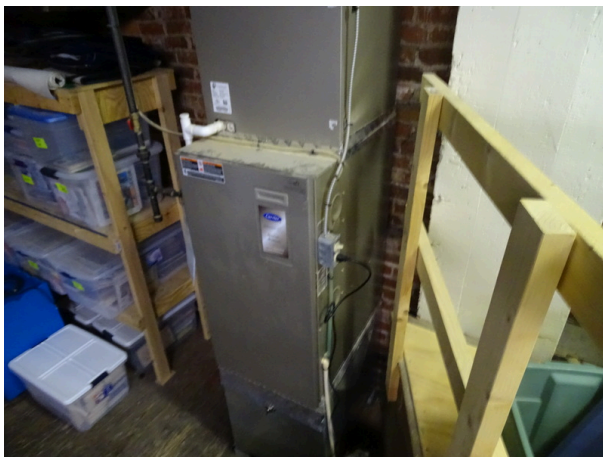
Typical air handler unit

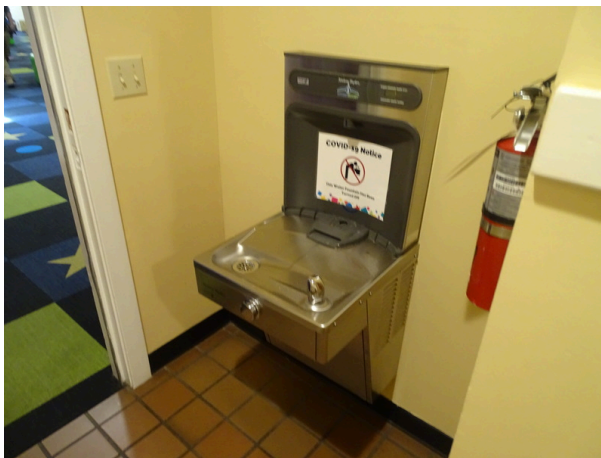
Typical water fountain

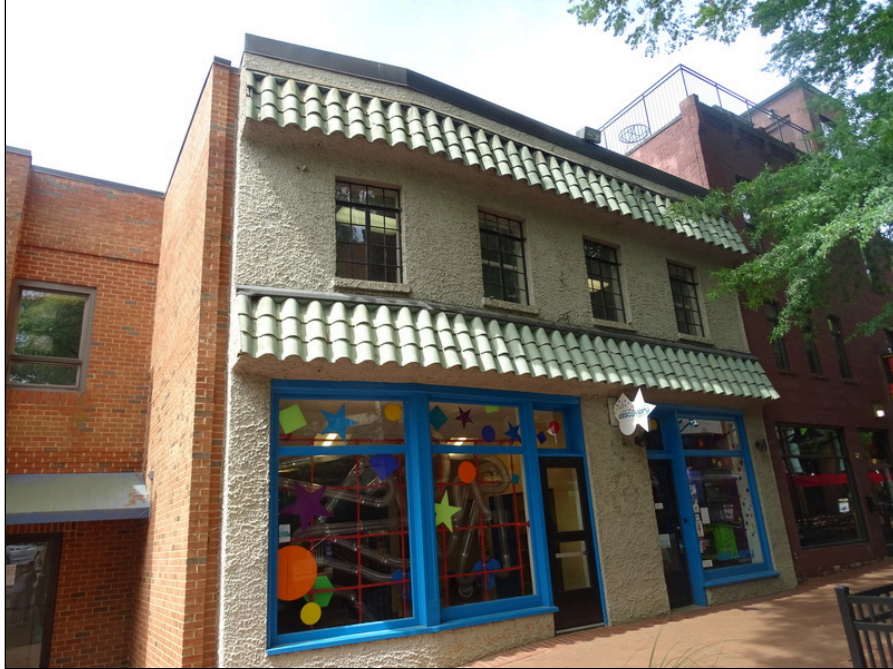
1 - Discovery Museum

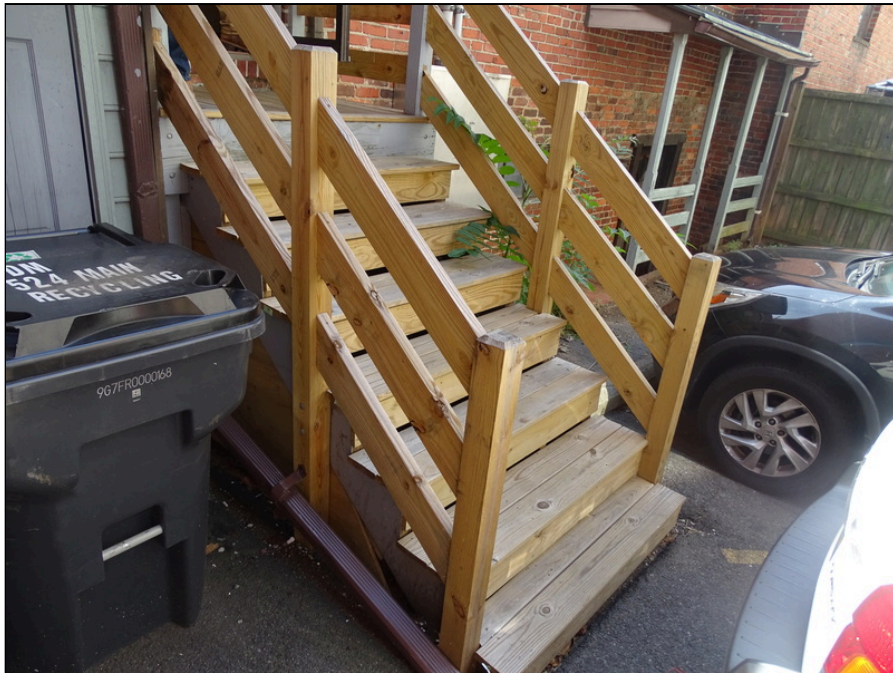
2 - Exterior wood stair

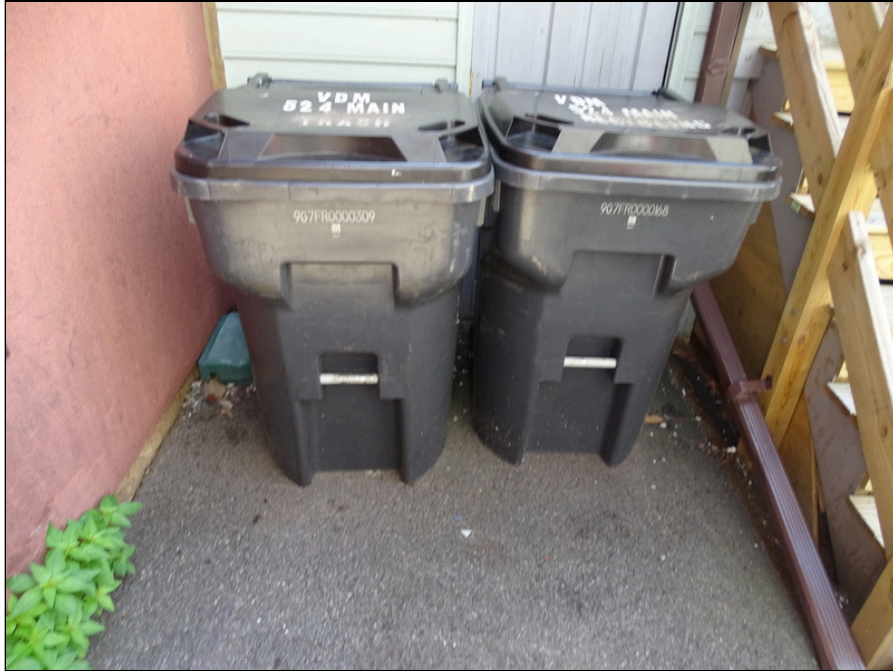
3 - Trash container pad

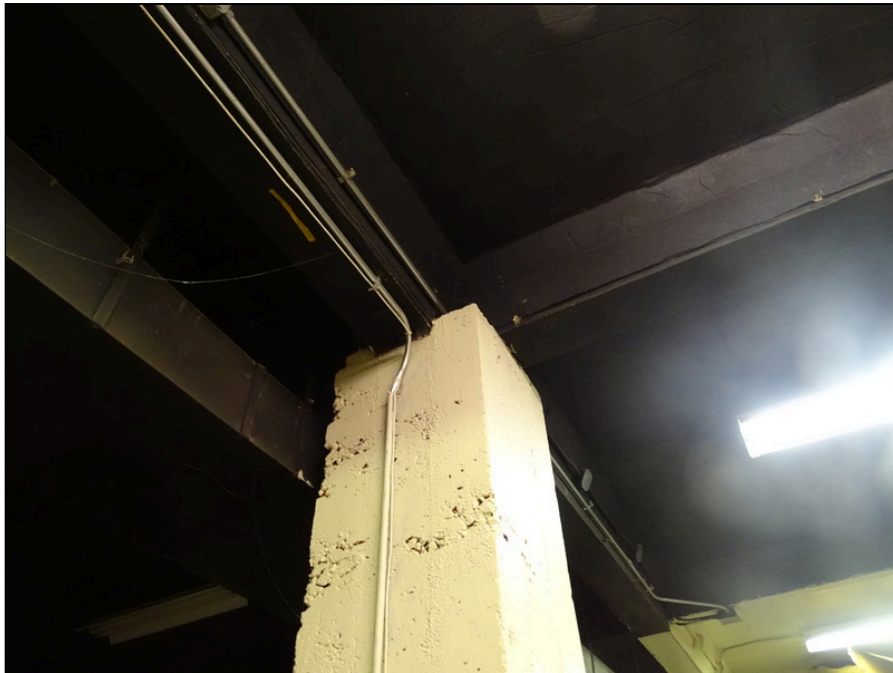
4 - Structural framing at first level

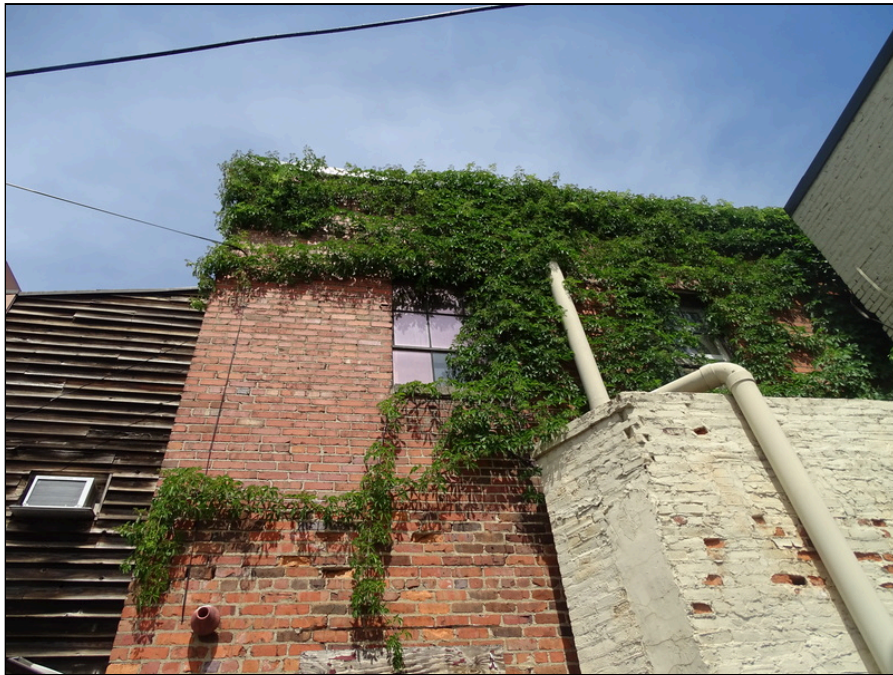
8 - Typical exterior wall

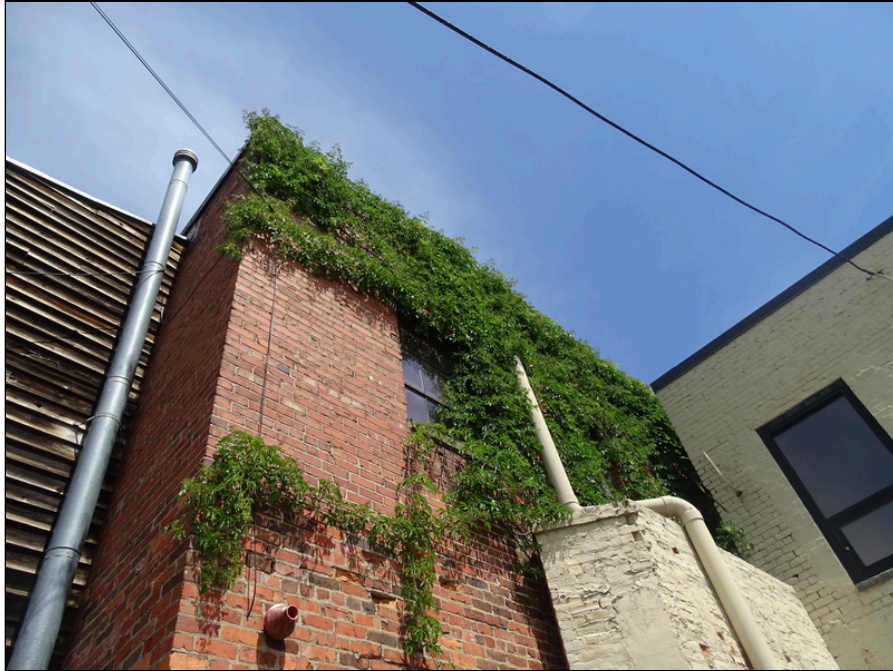
9 - Typical exterior wall

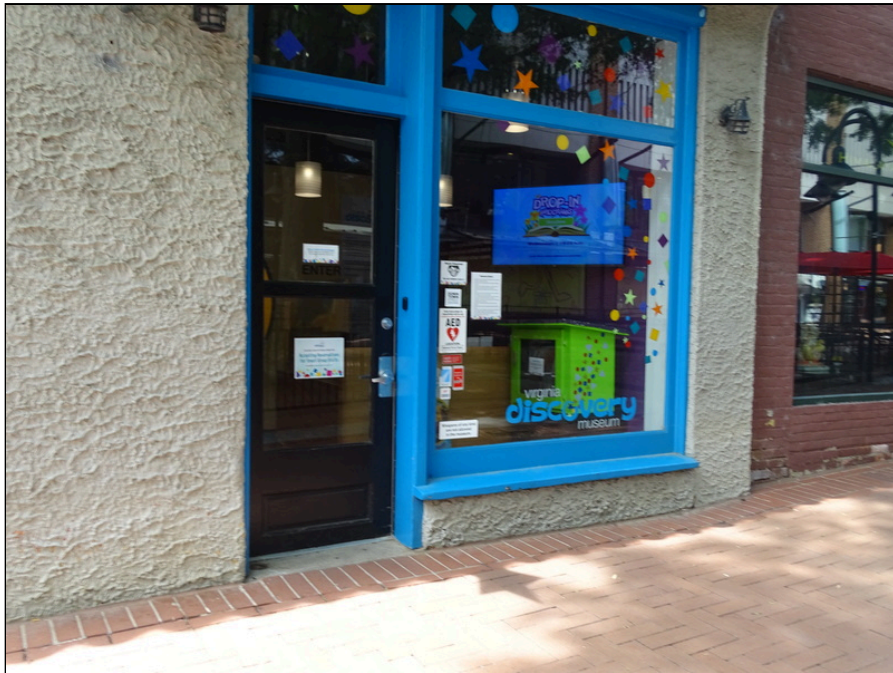
14 - Main entrance door and window on north side of building

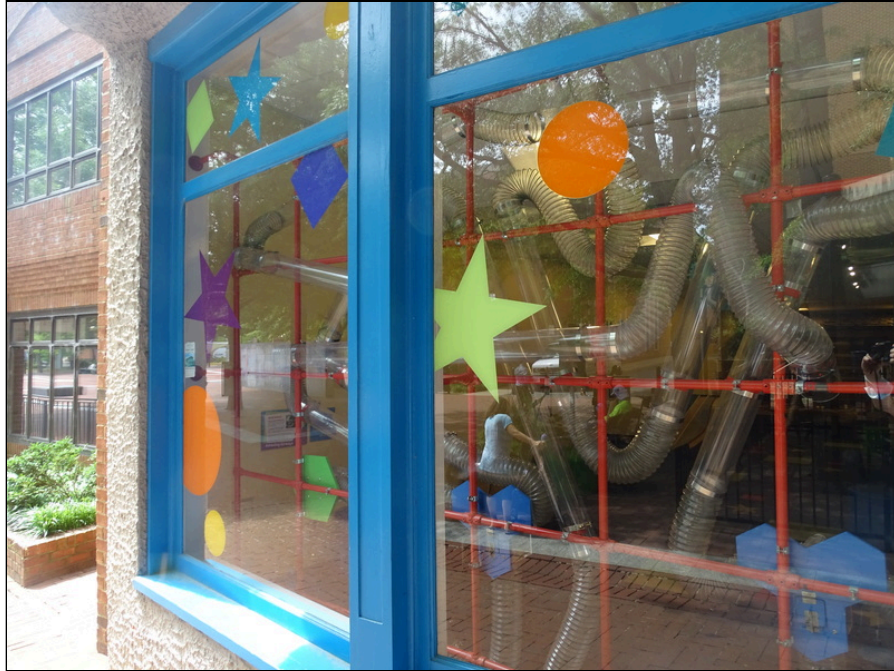
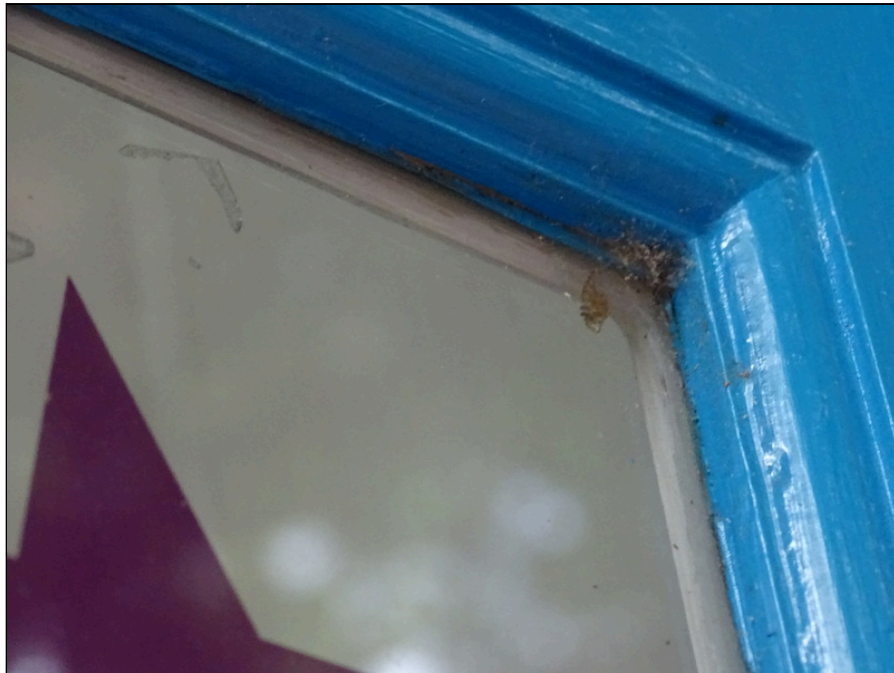
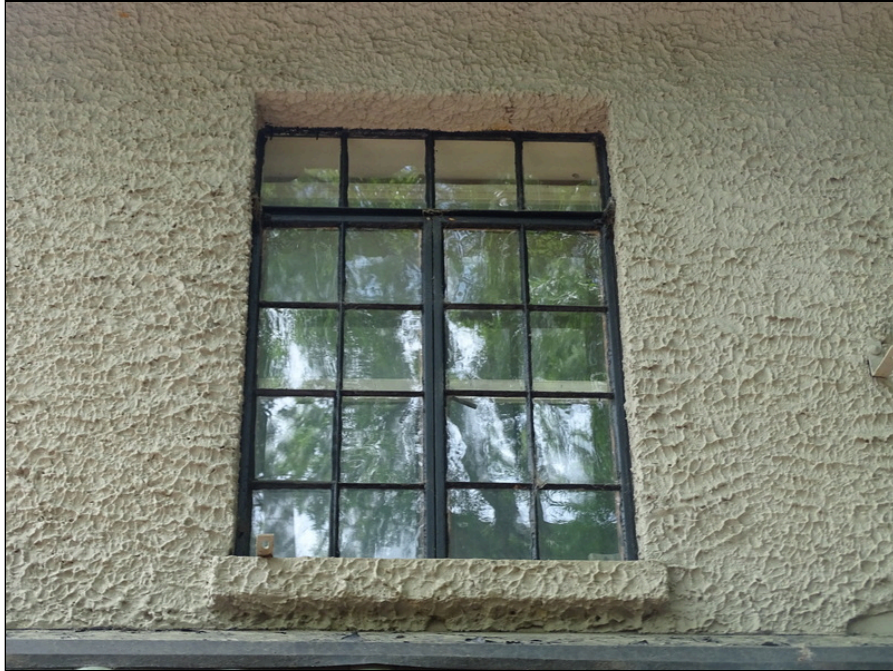
15 - Typical exterior window on north side of the building

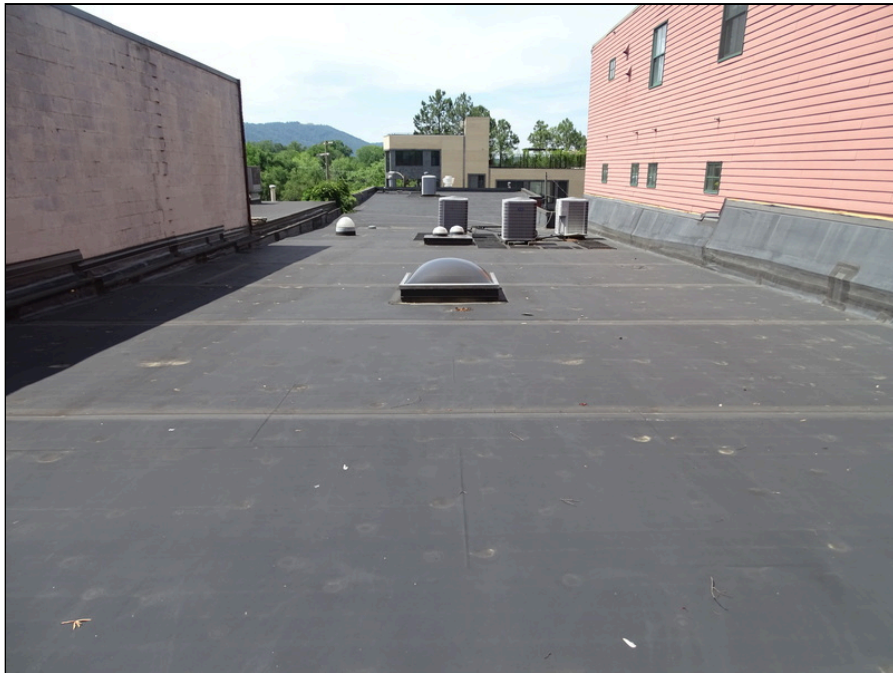
18 - Roofing system looking south

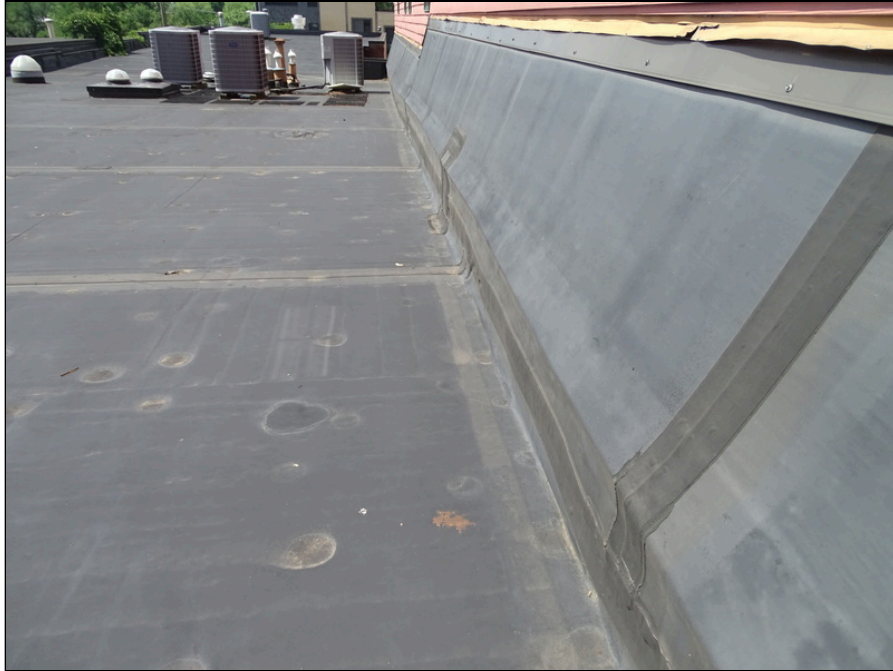
19 - Roofing system parapet walls

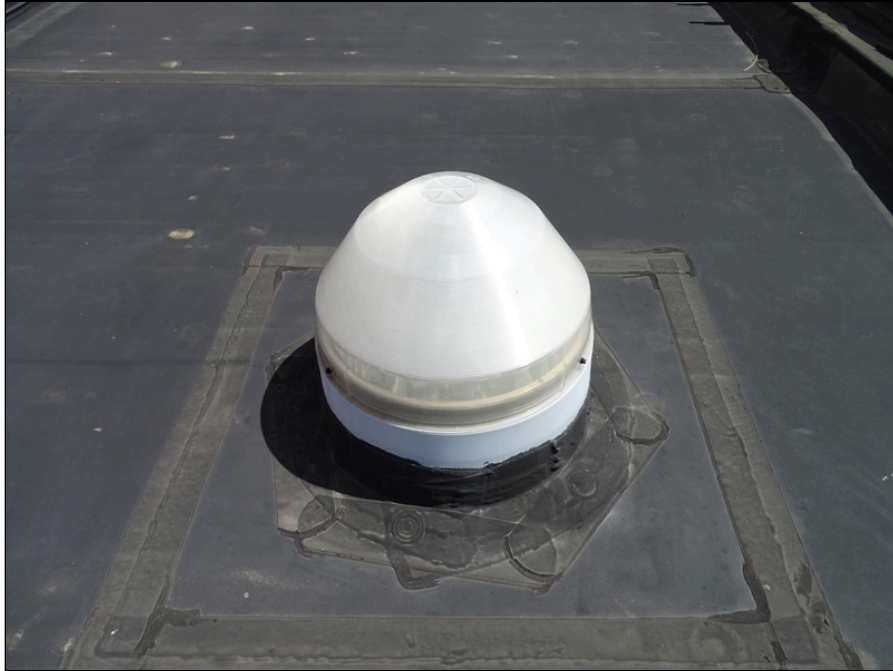
20 - Typical skylight

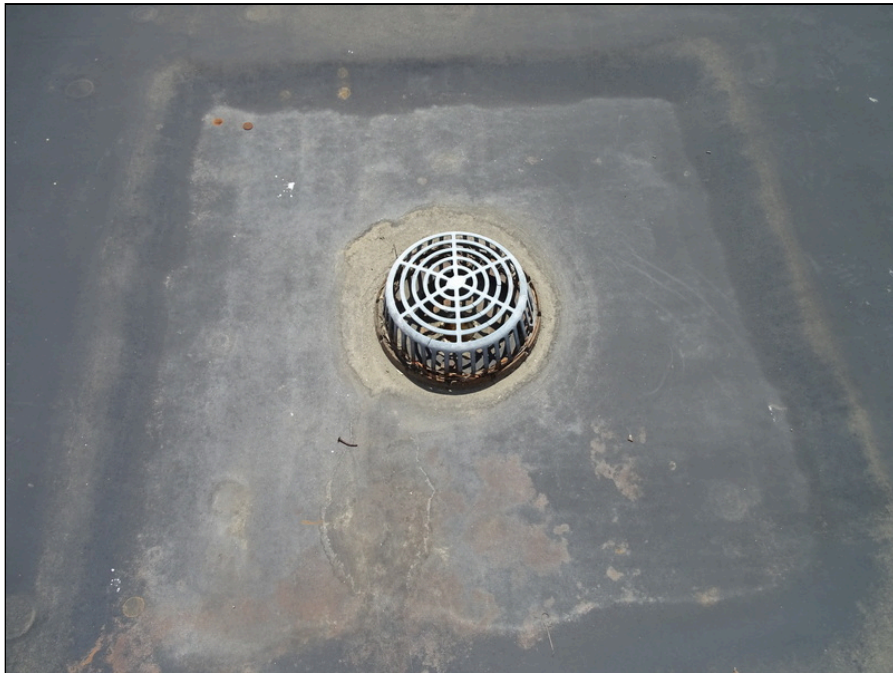
22 - Typical interior drain

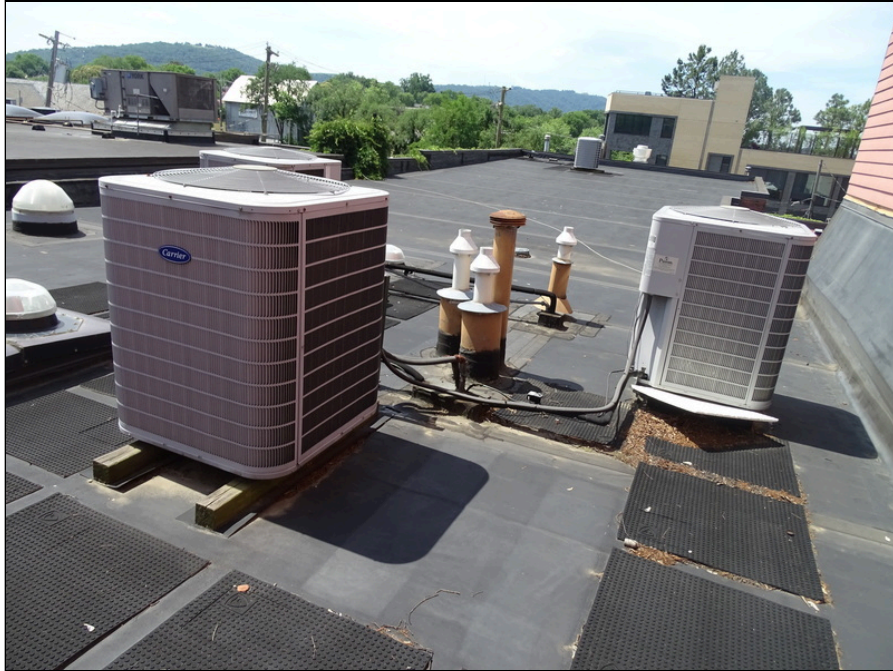
27 - Typical condenser unit

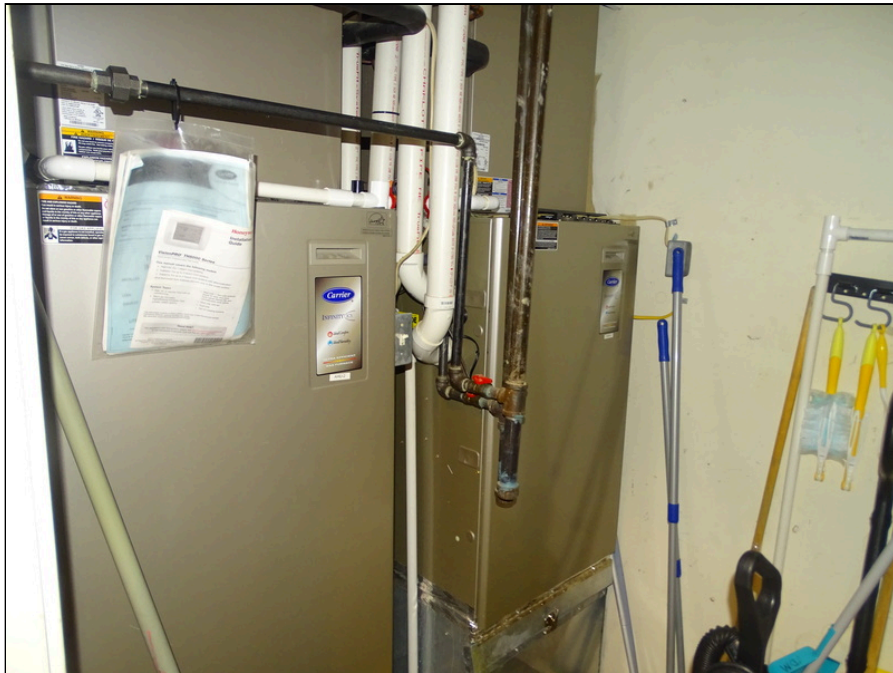
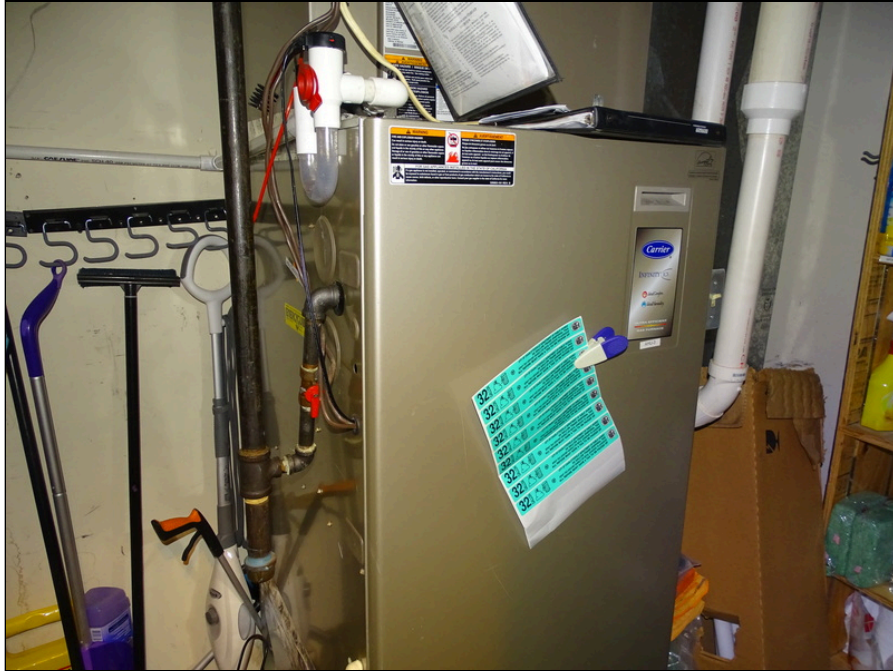
28 - Typical gas furnace and air handler units

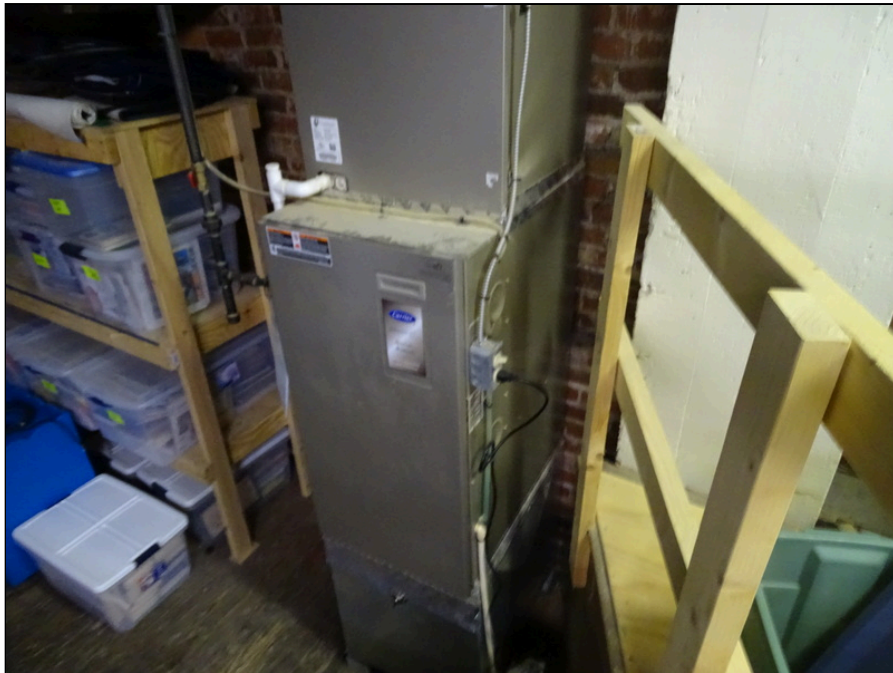
30 - Air handler

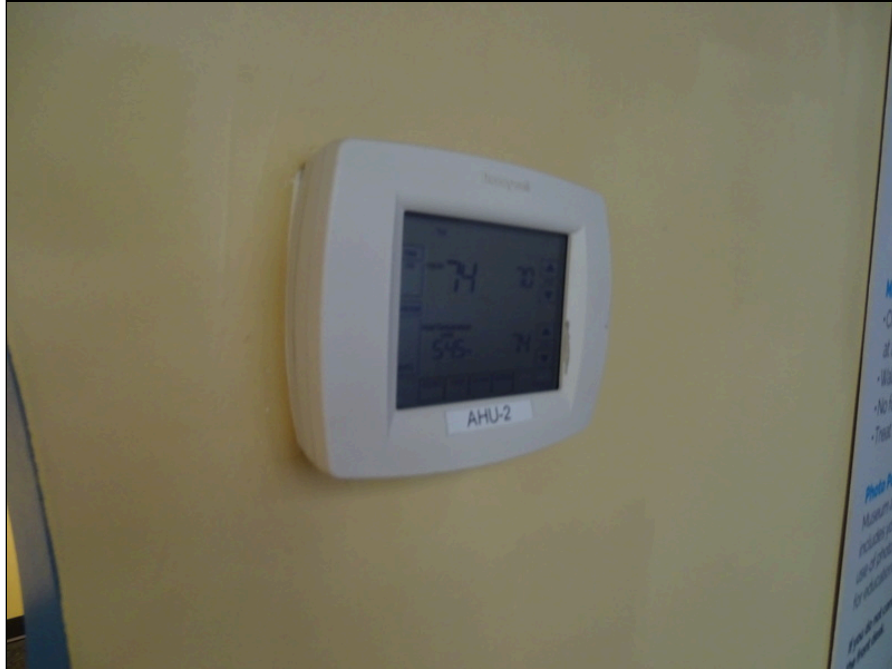
31 - Typical digital thermostat

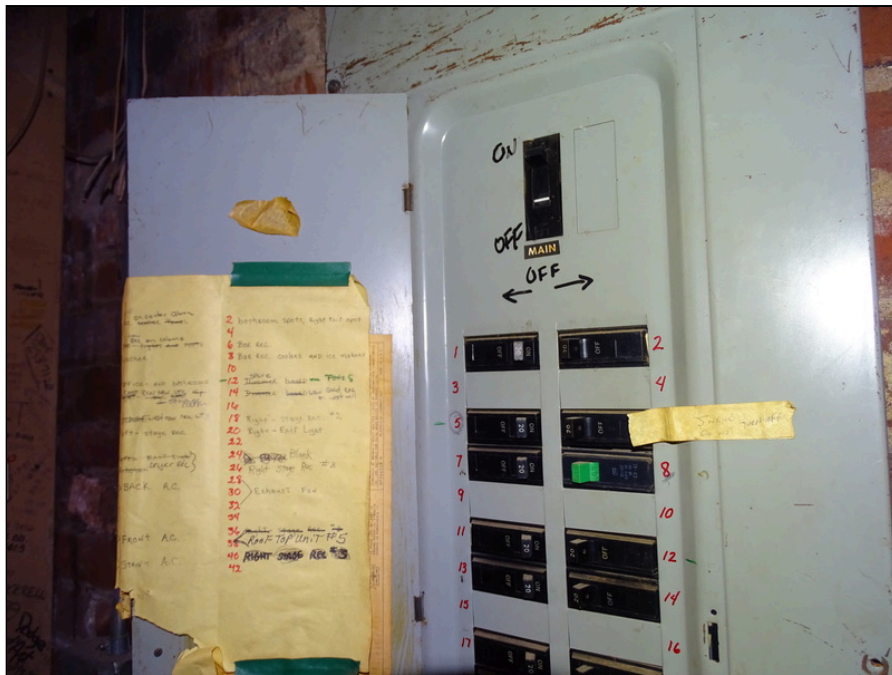
32 - Electric main disconnect panel

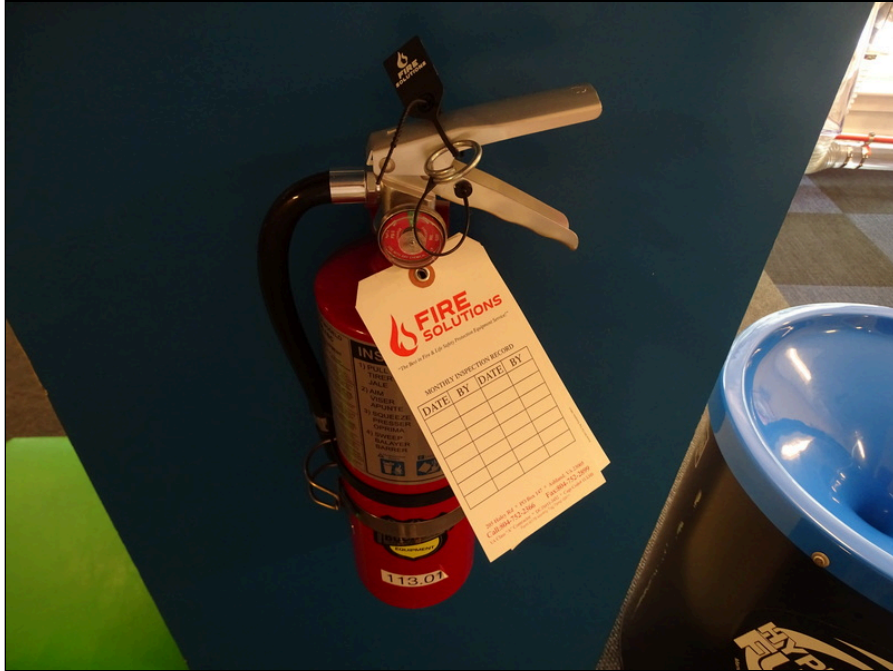
33 - Typical fire extinguisher

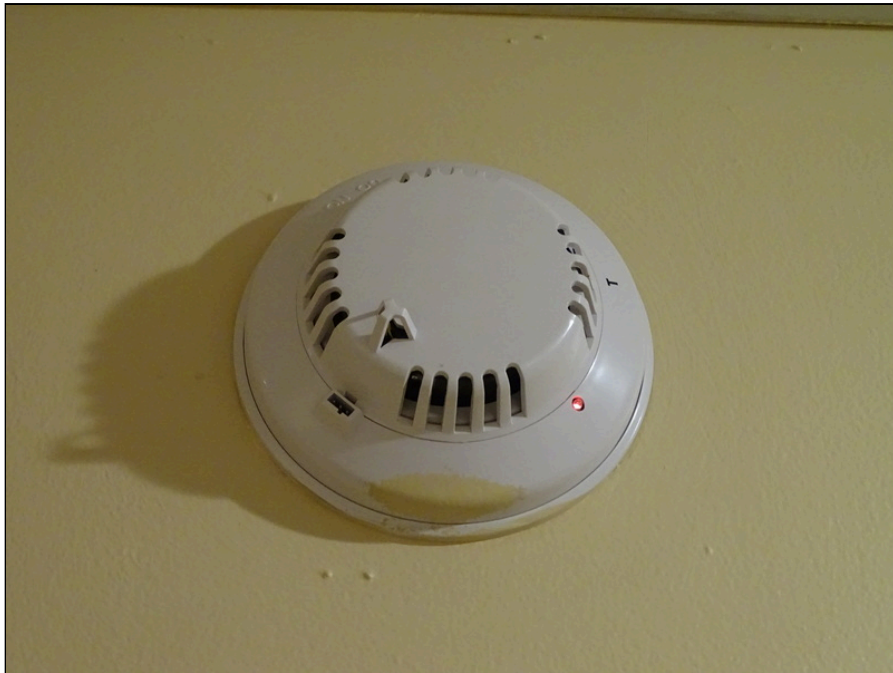
34 - Typical smoke detector

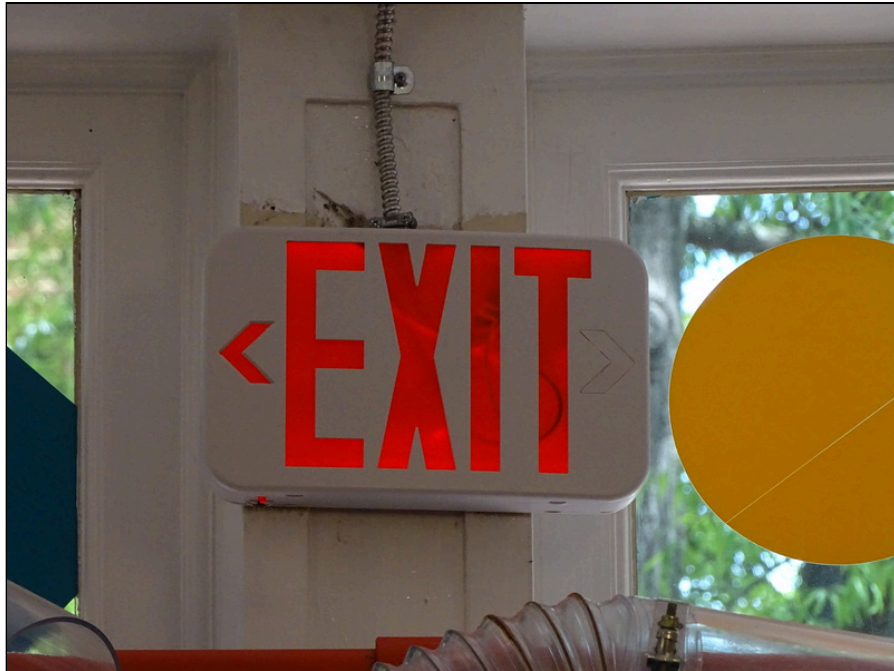
35 - Typical exit sign

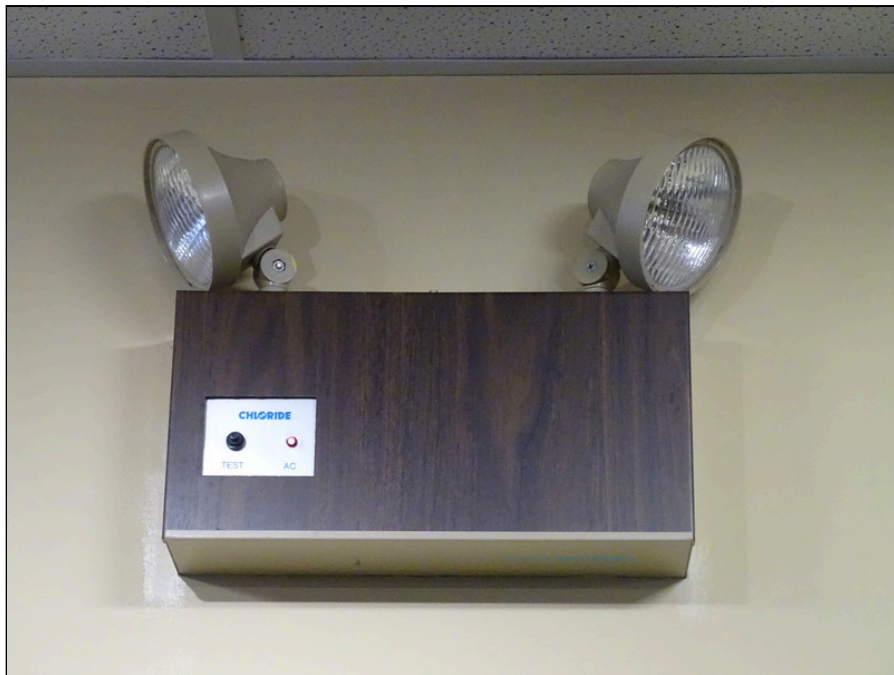
36 - Typical emergency lighting

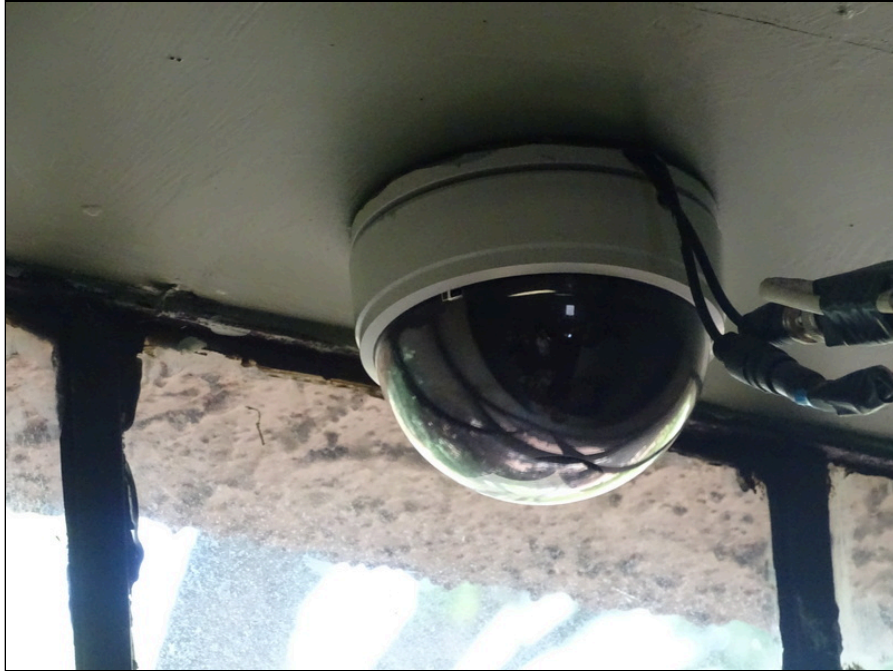
37 - Typical security camera

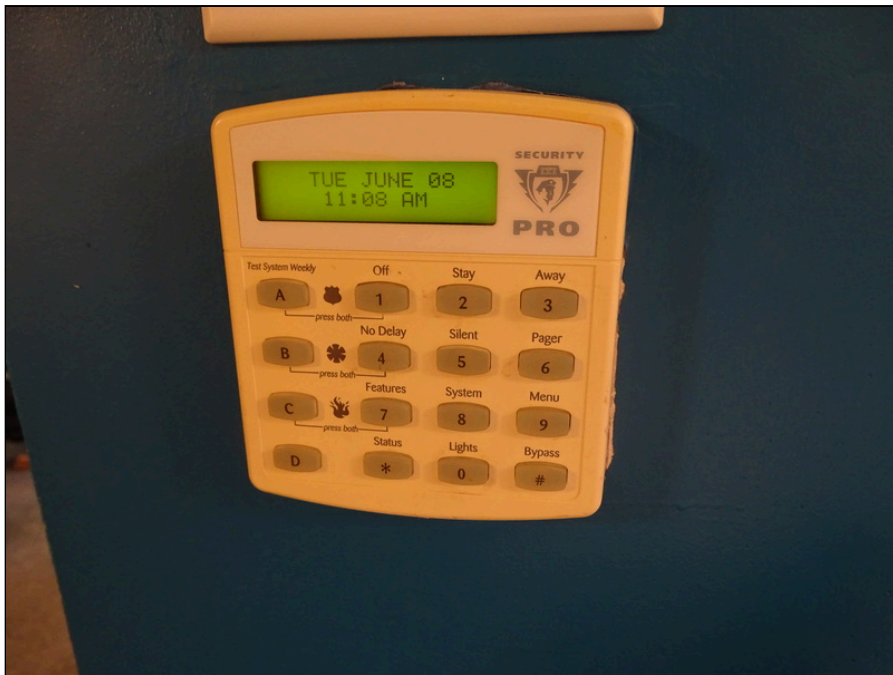
38 - Security alarm system keypad

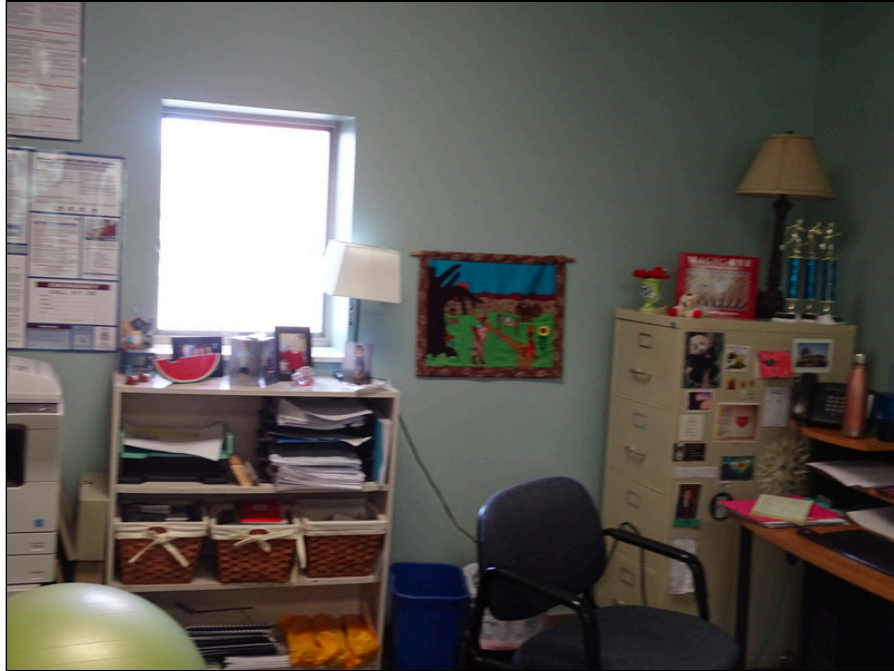
39 - Typical interior of second floor office area

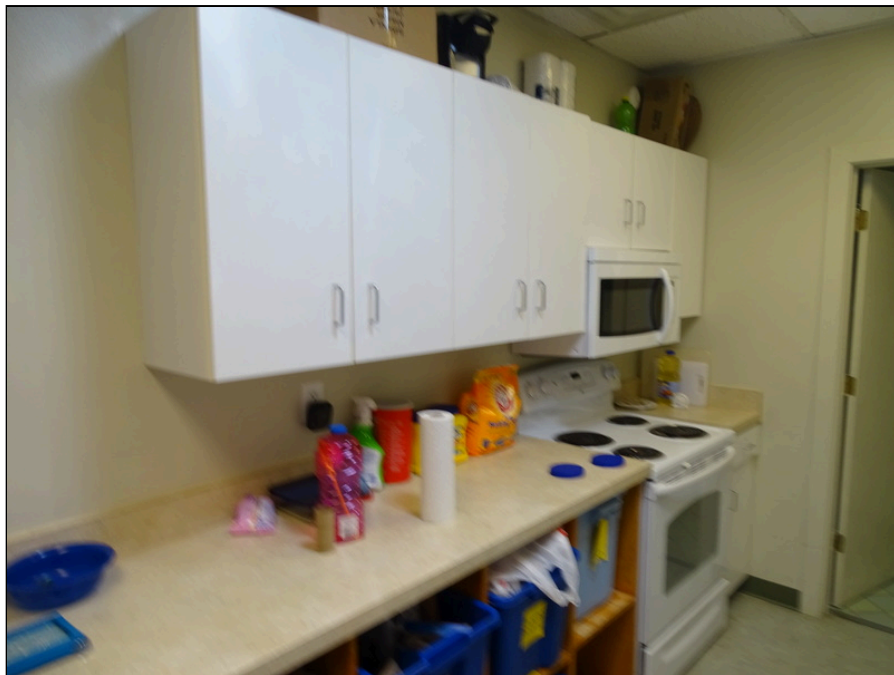
40 - Interior finishes of kitchen area

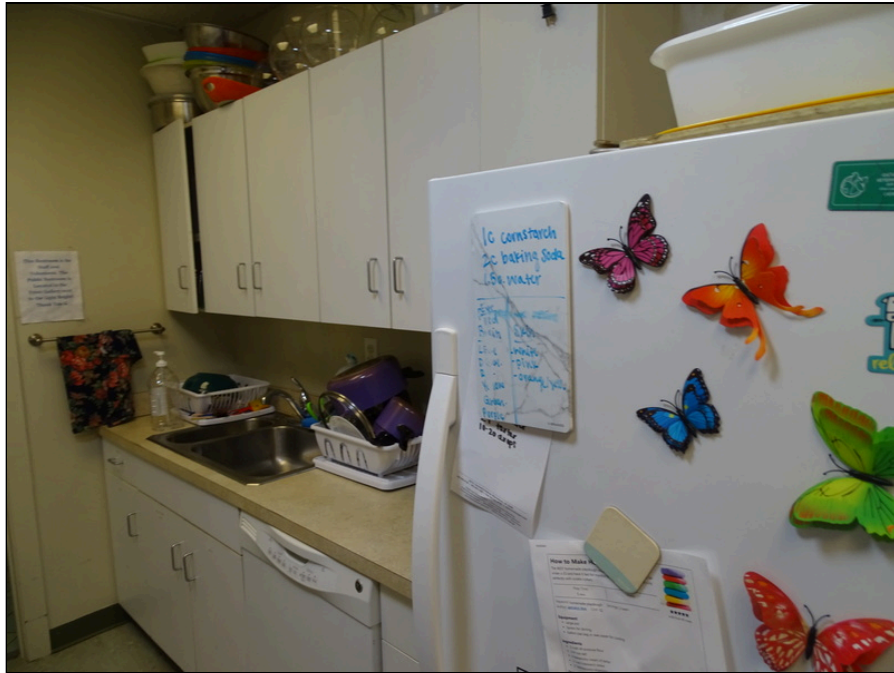
41 - Interior finishes of kitchen area

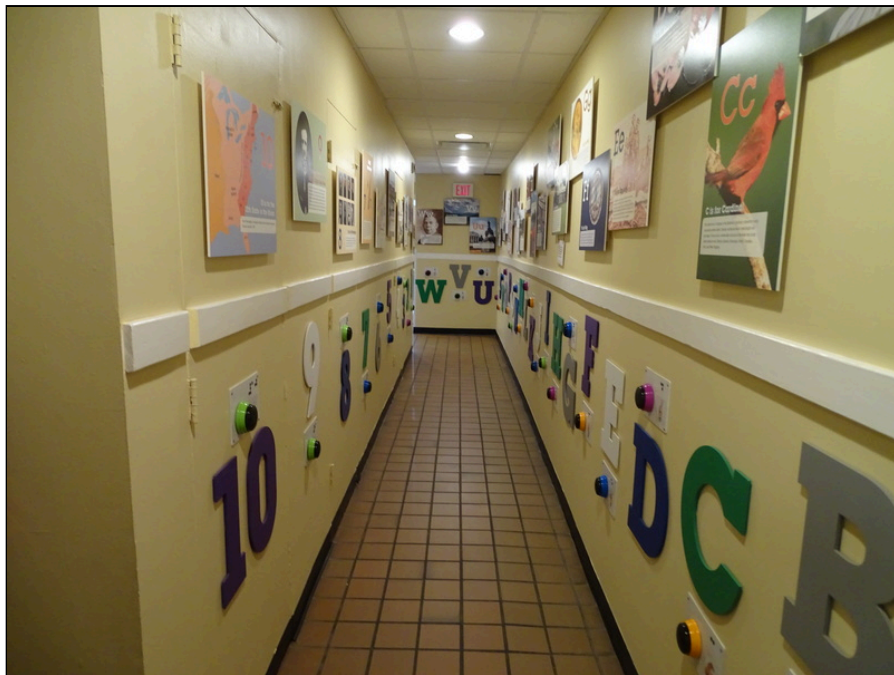
42 - Interior finishes of corridor area
