DISCOVERY MUSEUM
524 EAST MAIN STREET
CHARLOTTESVILLE, VIRGINIA

ECS PROJECT NO. 46:6713

CITY OF CHARLOTTESVILLE - FACILITIES DEVELOPMENT

Reference: Facility Condition Assessment Report for Discovery Museum, 524 East Main Street,
Charlottesville, Virginia

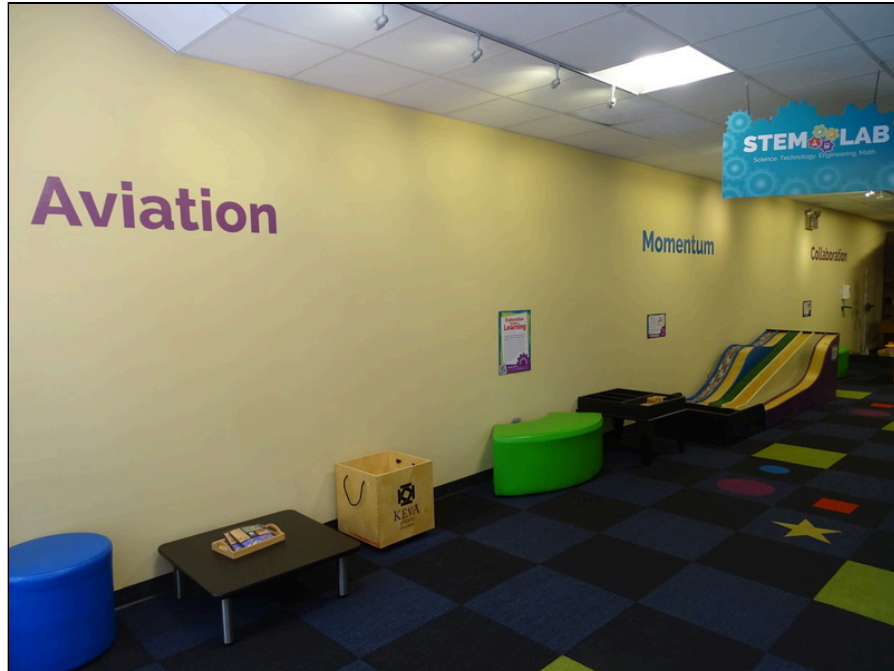
43 - Interior finishes

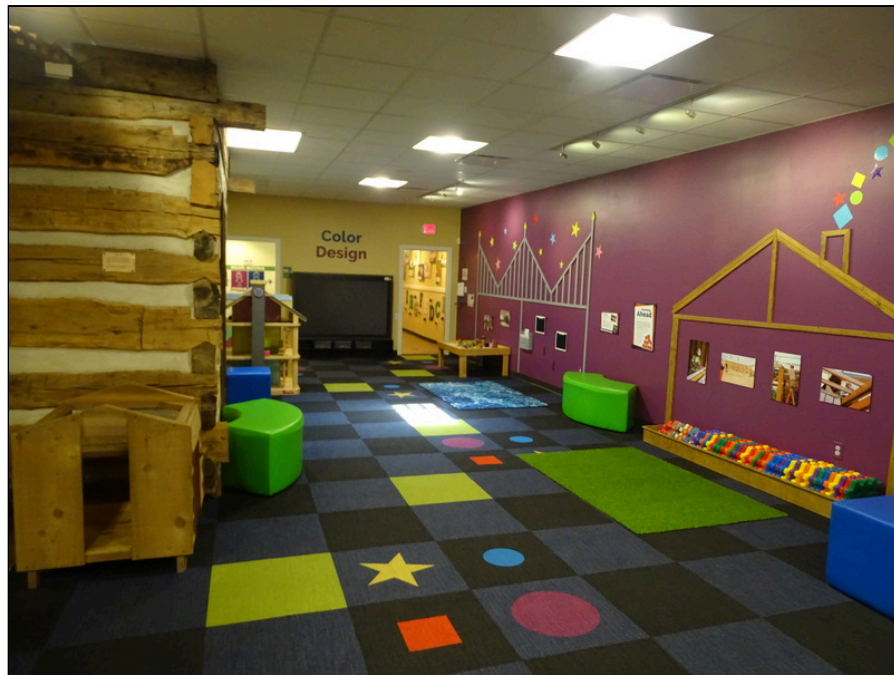
44 - Interior finishes

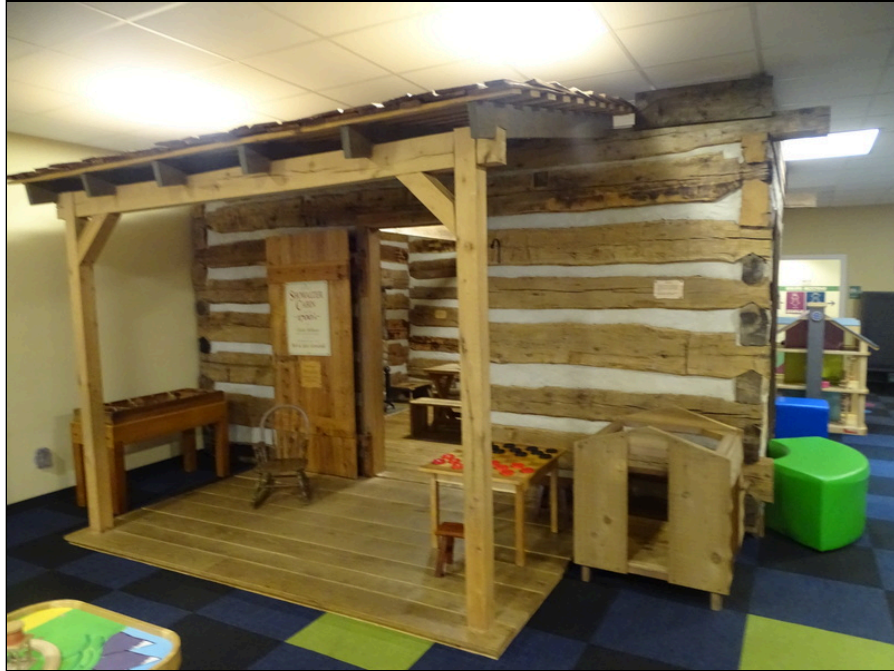
45 - Interior finishes

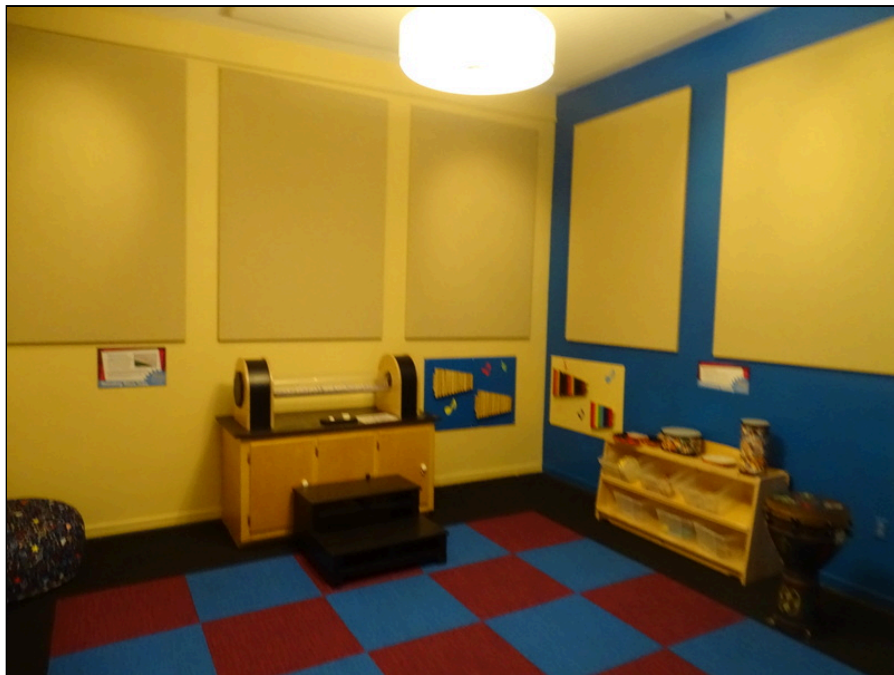
46 - Interior finishes

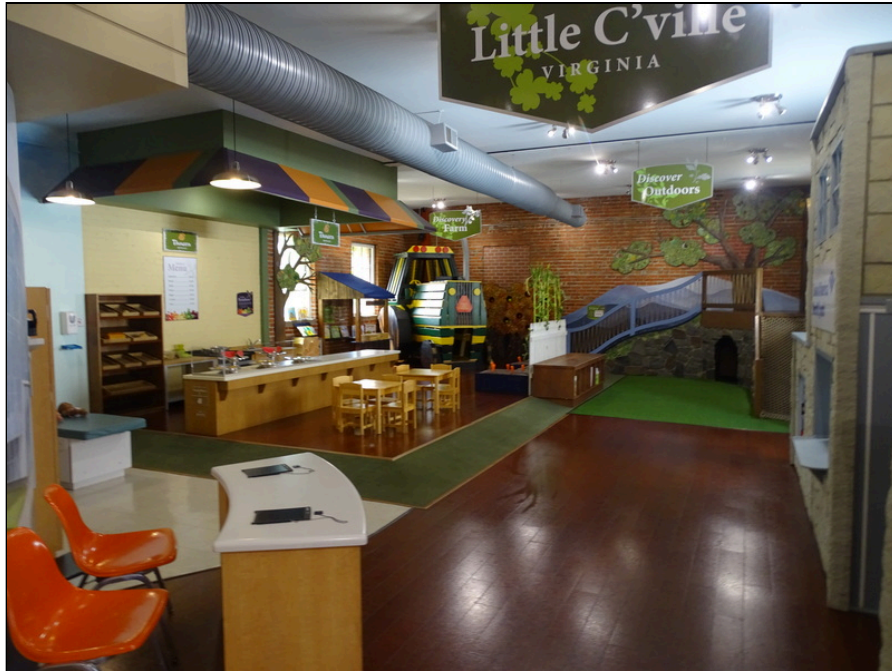
47 - Interior finishes

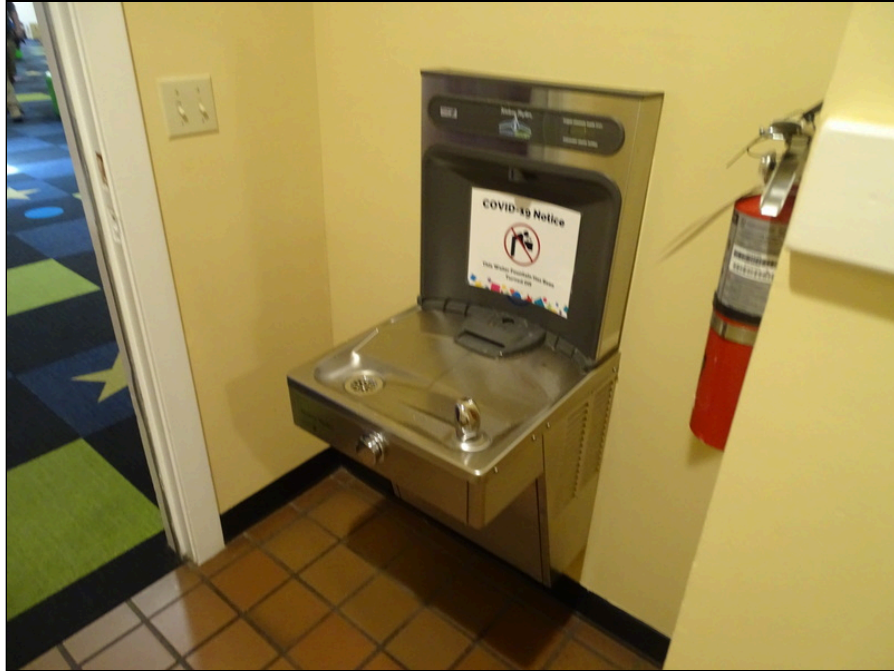
49 - Typical water fountain

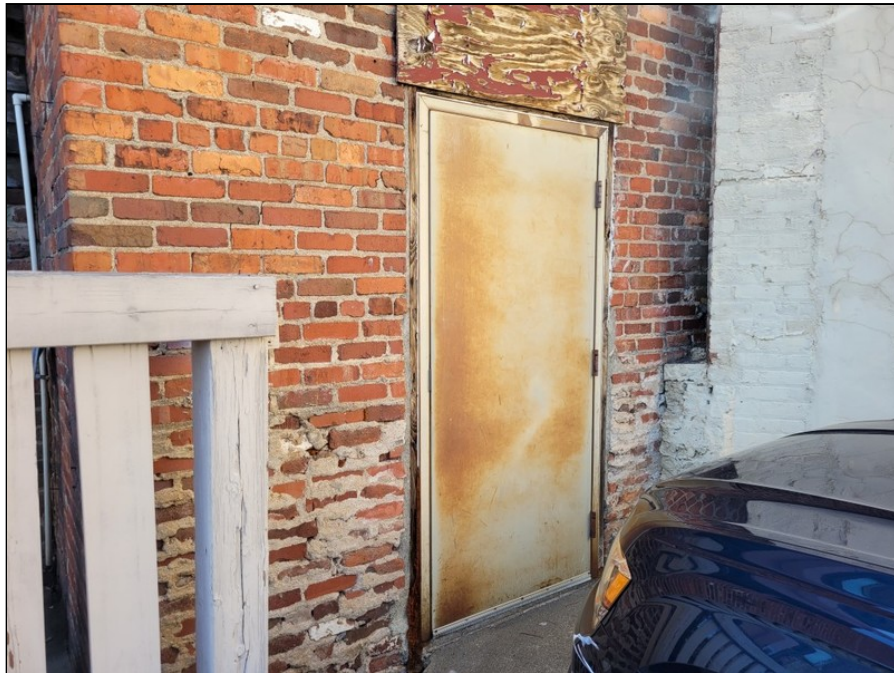
50 - Rear entrance

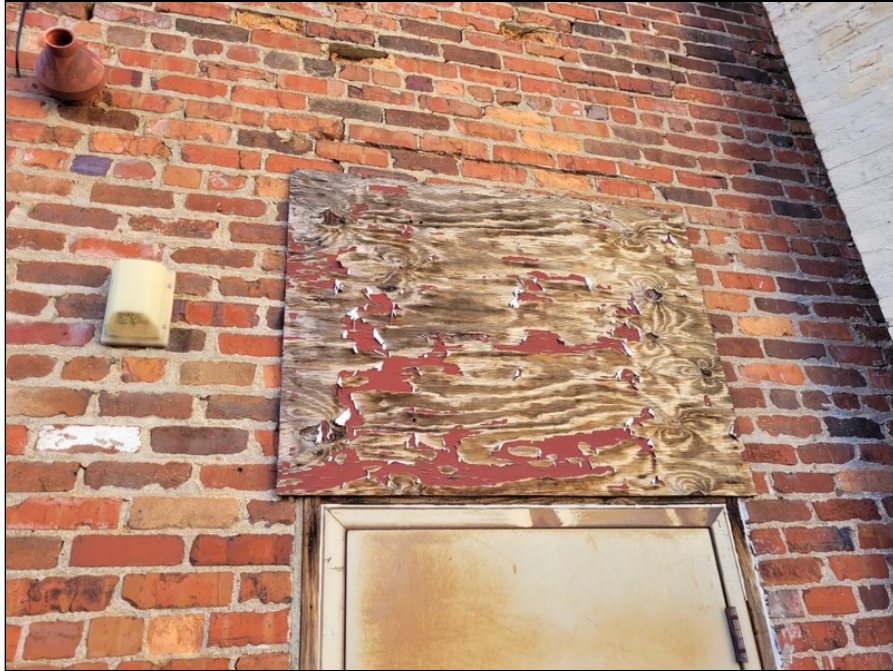
51 - Transom cover
