FONTAINE AVENUE FIRE STATION  
2420 FONTAINE AVENUE  
CHARLOTTESVILLE, VIRGINIA

ECS PROJECT NO. 46:6713

CITY OF CHARLOTTESVILLE - FACILITIES DEVELOPMENT

Reference: Facility Condition Assessment Report for Fontaine Avenue Fire Station, 2420 Fontaine Avenue, Charlottesville, Virginia

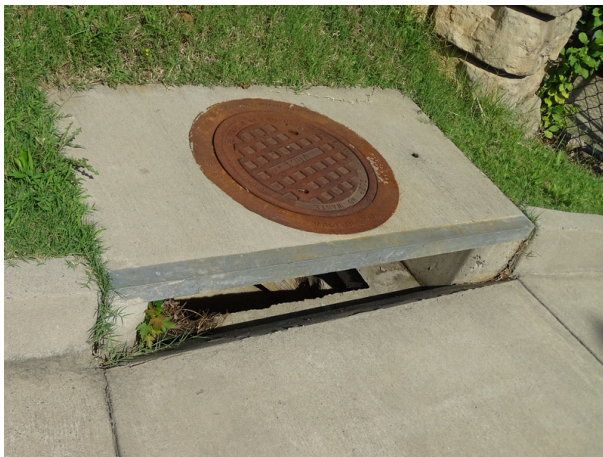
Typical storm water drainage

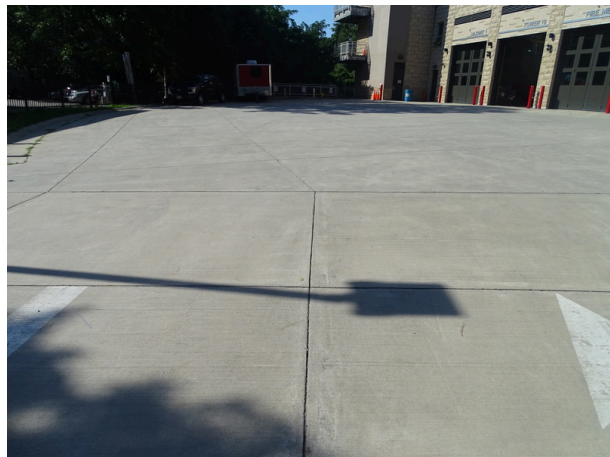
Concrete pavement

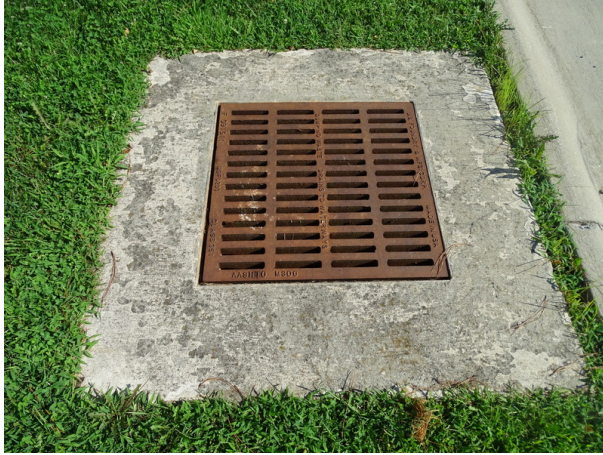
Typical yard inlet

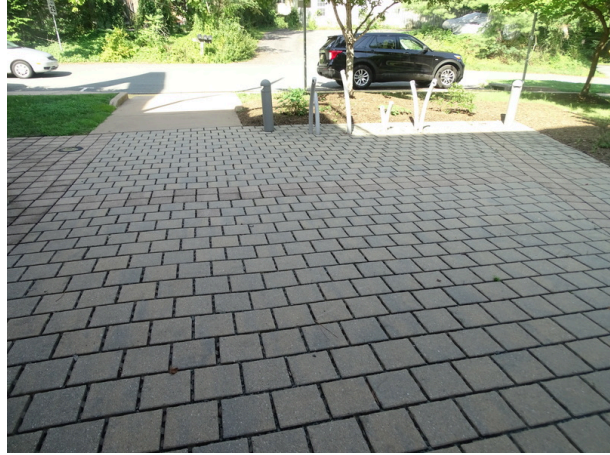
Typical brick pavement

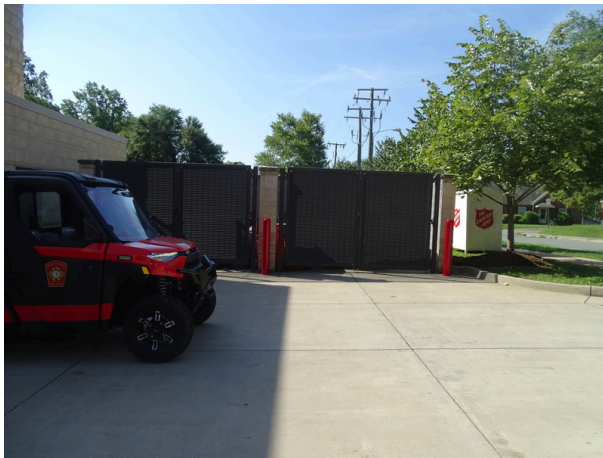
Dumpster pad

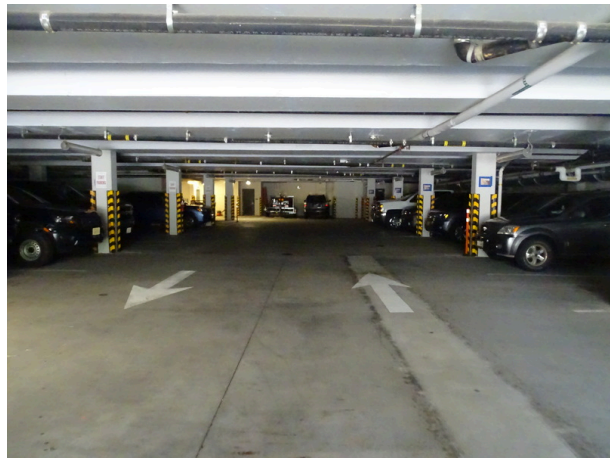
Parking garage area

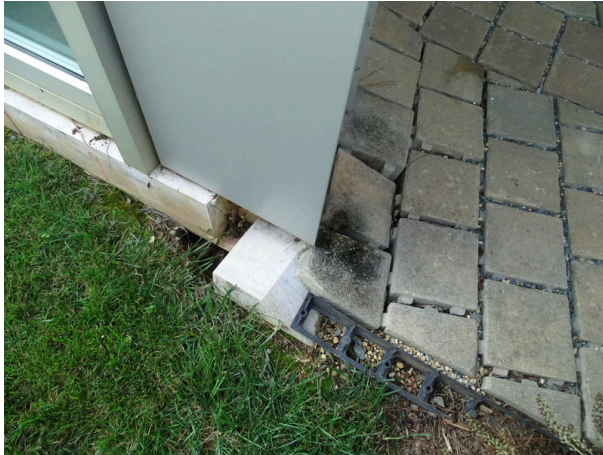
At the north and west of the building Concrete sidewalks of undetermined thickness were provided. Regularly spaced control joints were observed. The Concrete sidewalks were generally in good condition. A brick paver patio was located at the northwest entrance of the building. The brick paver patio was settled in one area and generally in fair condition. We recommend repairing the brick paver patio as a maintenance item.

Typical brick sidewalk condition

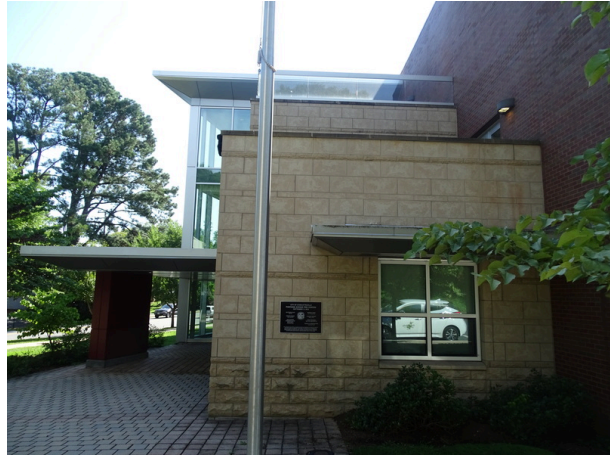
Typical sidewalk

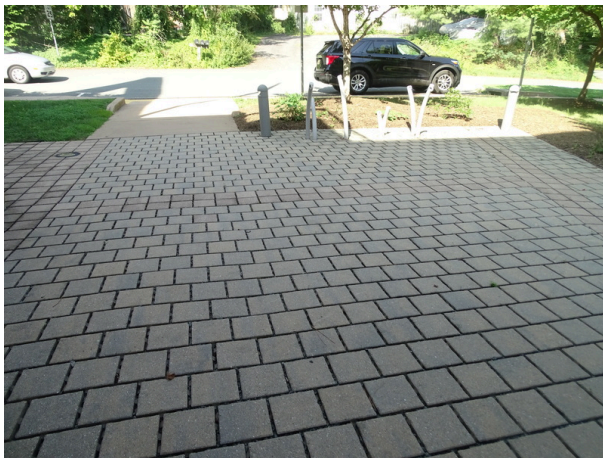
Typical brick pavement

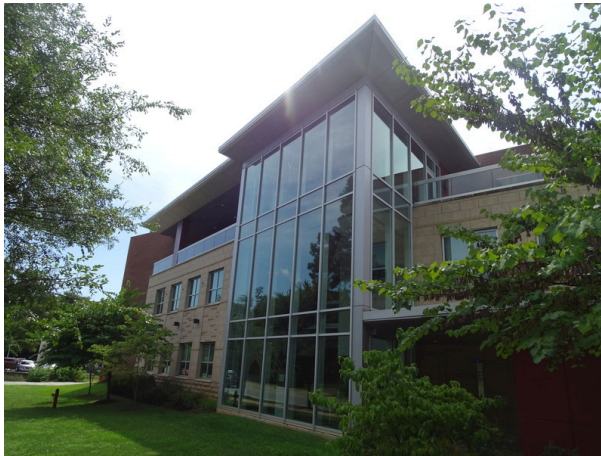
The landscaping consists generally of young sapling trees, small shrubs, and grassed areas around the site. The landscaping was observed to be in generally good condition. A segmental stone retaining wall is located around the emergency generators and another at the SE side of the building. The walls were in generally good condition.

Typical landscaping overview

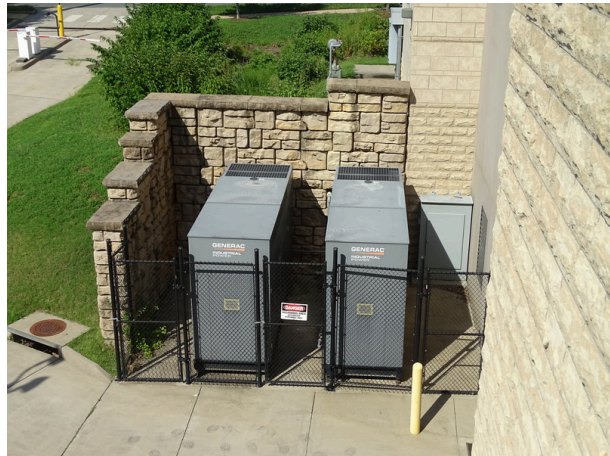
Typical Generator

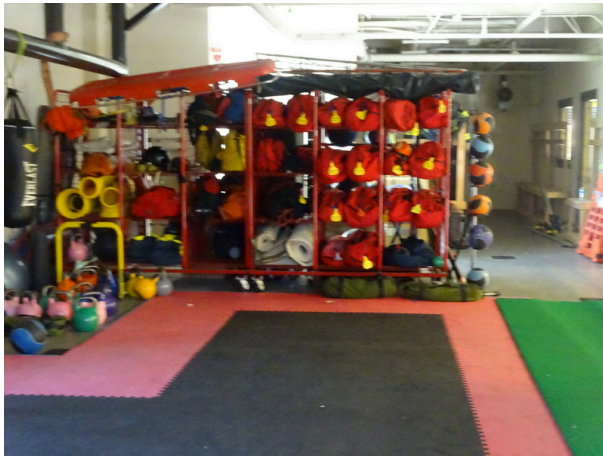
A fitness center is located on the second floor of the building. No unusual problems or concerns were observed or reported with the fitness center

Fitness center interior

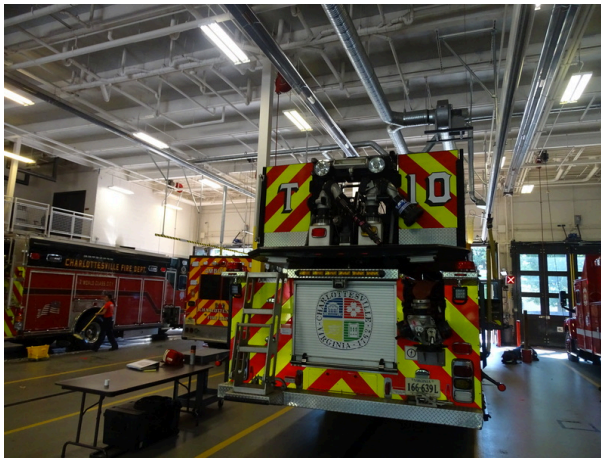
Bay area interior structure

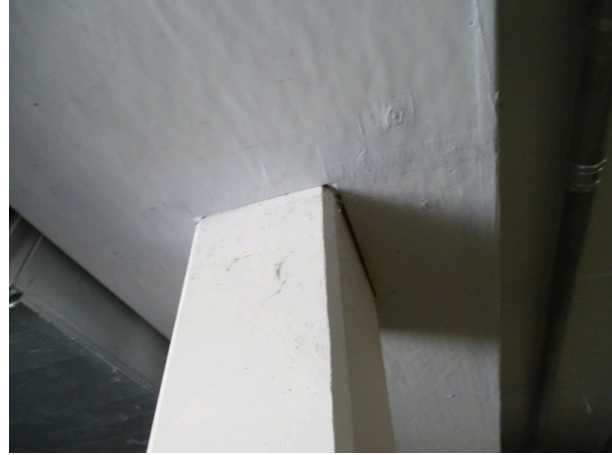
Garage structure framing

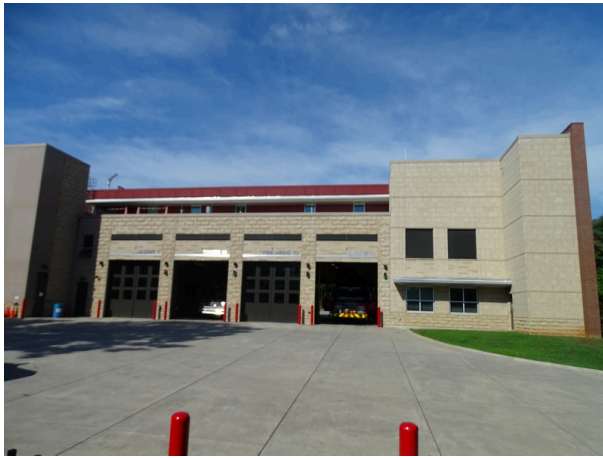
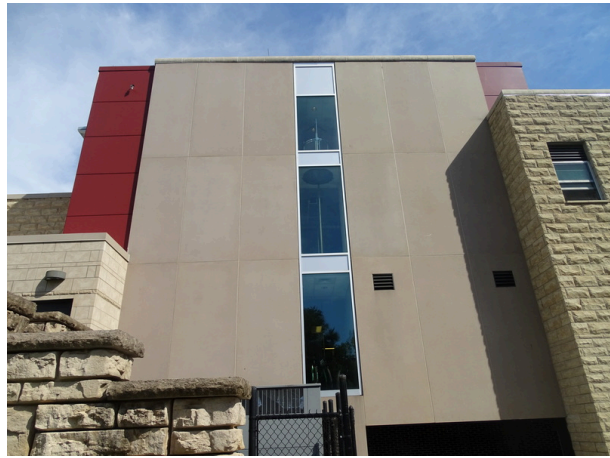
Exterior sealants are located around the window and door frames, composite metal panels, horizontal joints, and vertical joints in the brick veneer. The expected useful life of exterior sealants is approximately 10 to 12 years before replacement is needed. The exterior sealants were generally in fair condition. We recommend that the exterior sealants be replaced during the report period.

Fountain fire station south elevation overview

Building exterior overview

Exterior wall siding overview

3.3.3 Building Exteriors																														
REPLACE SEALANTS	12	8	4	1	LS	\$15,000.00	\$15,000	100%				\$15,000																	\$15,000	
3.3.4 Exterior Doors																														
REPAIR OVERHEAD DOOR BRACING AS NEEDED	20	19	1	1	LS	\$5,000.00	\$5,000	100%	\$5,000																				\$5,000

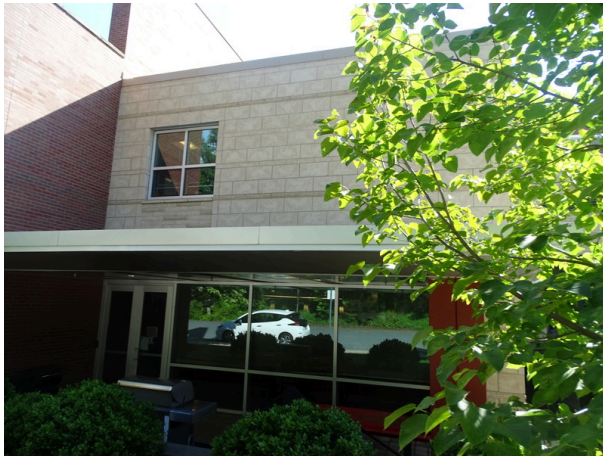
Storefront door

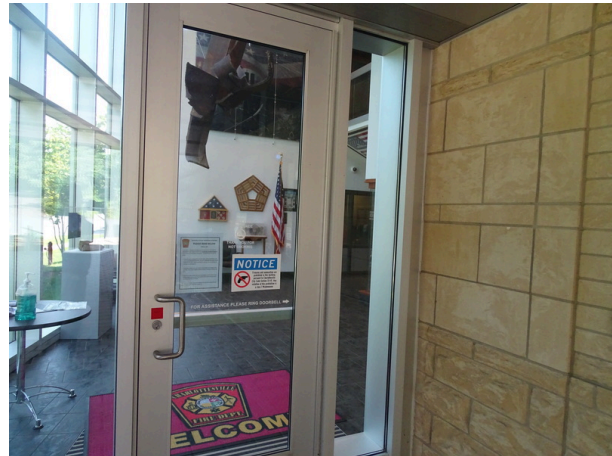
Typical exterior door

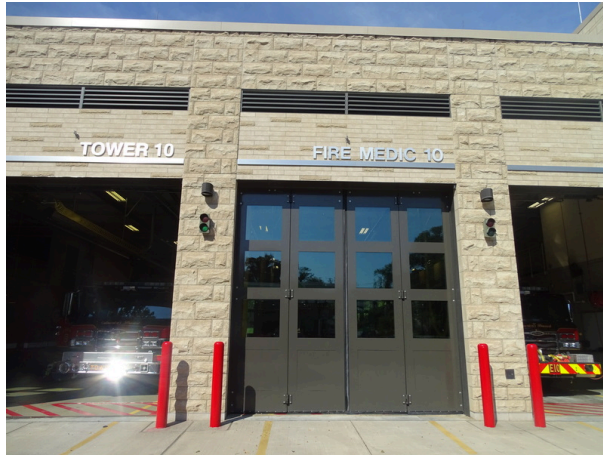
Folding bay doors are located on the east and west sides of the building. The bay doors were reportedly having problems with bracing and generally in good to fair condition. We recommend repairing the overhead door bracing as needed.

Typical bay - Overhead door

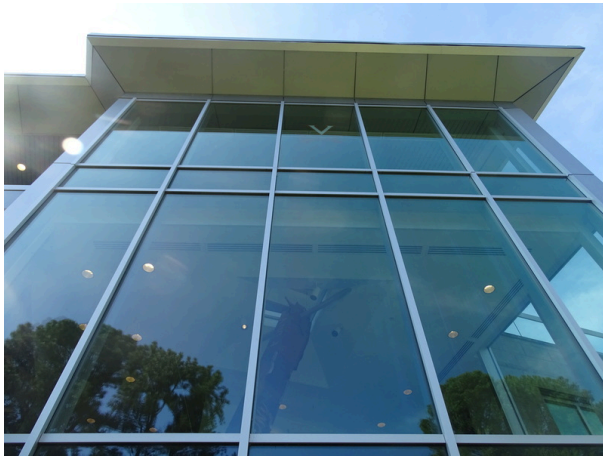
Glass curtain wall exterior window

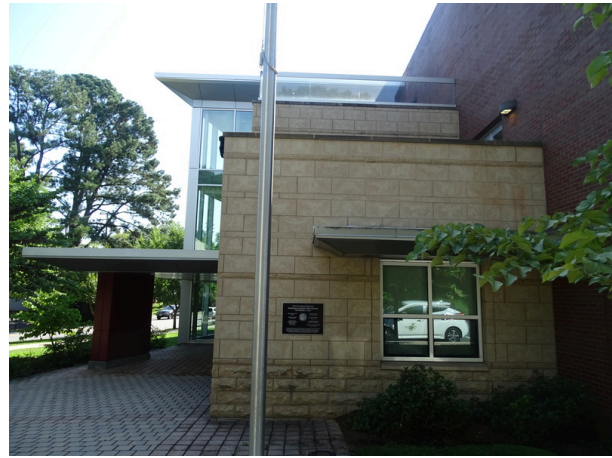
The window system for the building consists of Aluminum frame double pane window units. The expected useful life of windows is typically 30 years. The windows were generally in good condition.

Typical exterior window

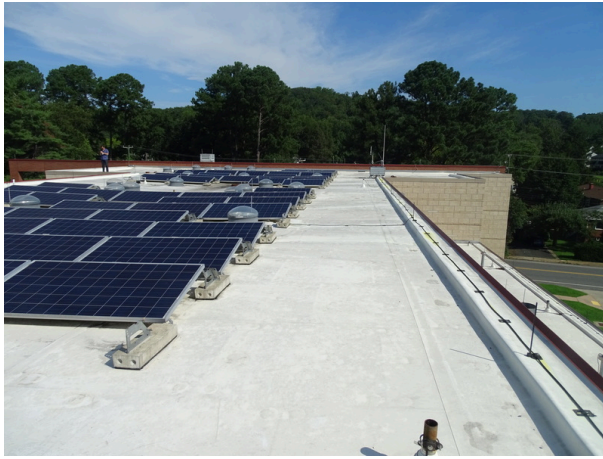
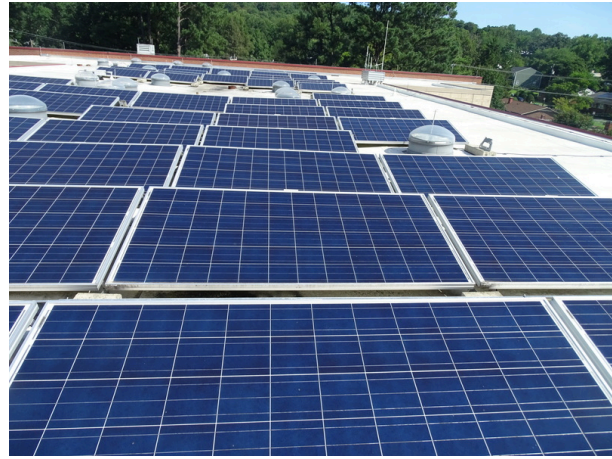
Typical solar PV system overview

3.2.8 Special Utility Systems																														
REPLACE SOLAR PANELS AS NEEDED	20	5	15	55	EA	\$2,500.00	\$137,500	100%															\$137,500						\$137,500

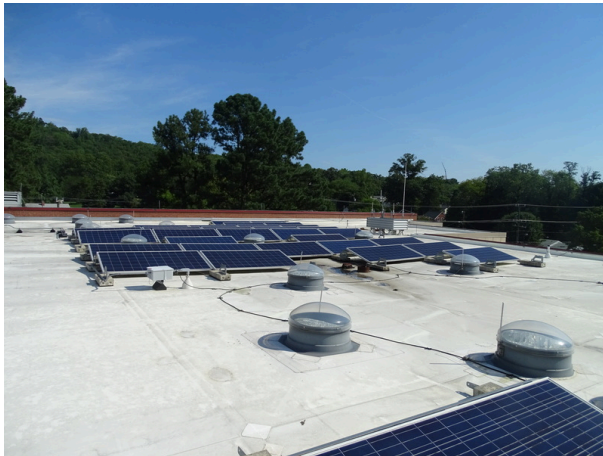
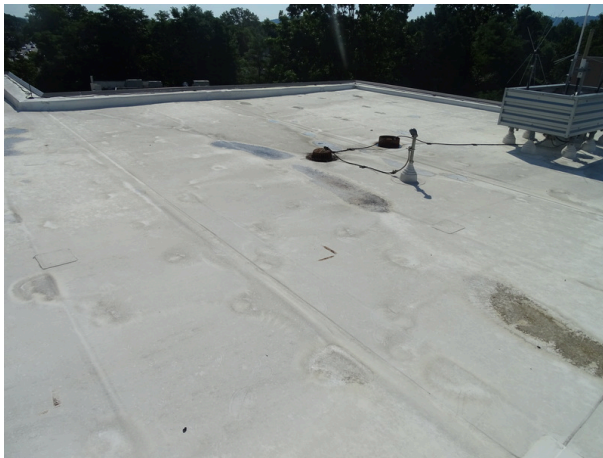
The roofing system consists of a Single-ply sheet membrane roofing system. The roofing was in generally good to fair condition with some patching and ponding noted. Reported leakage was noted during our site visit with repairs made as needed. The roofing system age is 8 years in age from original construction. The expected useful life of a single-ply roofing system is 20 years with proper maintenance. We recommend an allowance for continued roofing repairs as needed until recommended replacement later in the report period.

Single-ply roofing system overview

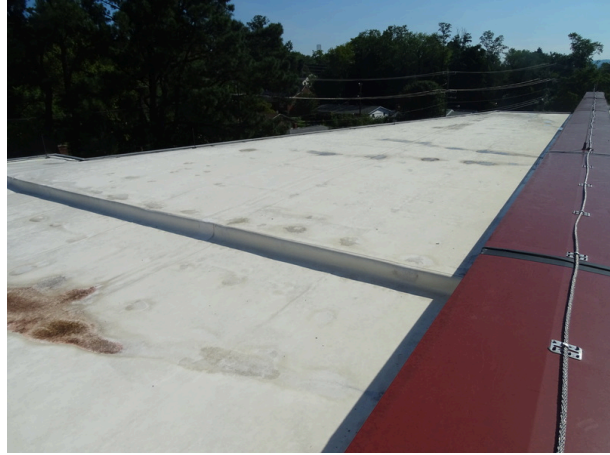
Metal coping overview

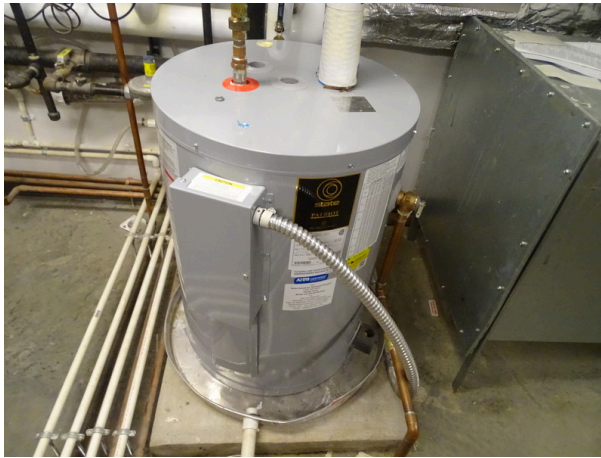
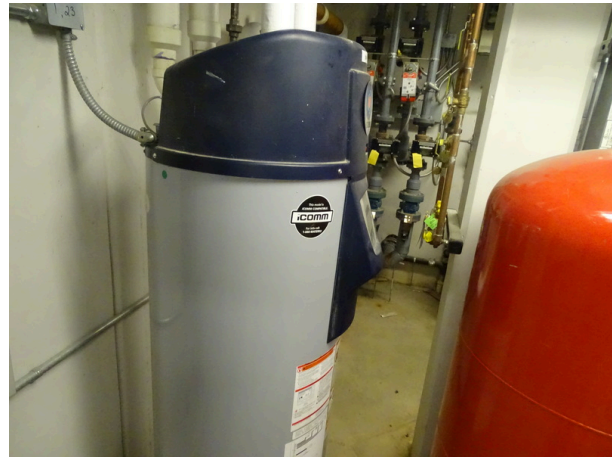
Domestic hot water to the building is provided by Electric water heater and tankless water heaters . The expected useful life of Electric water heater and tankless water heaters is approximately 12-15 years. We recommend replacing the Electric water heater and tankless water heaters during the report period.

Domestic water heater

water heater

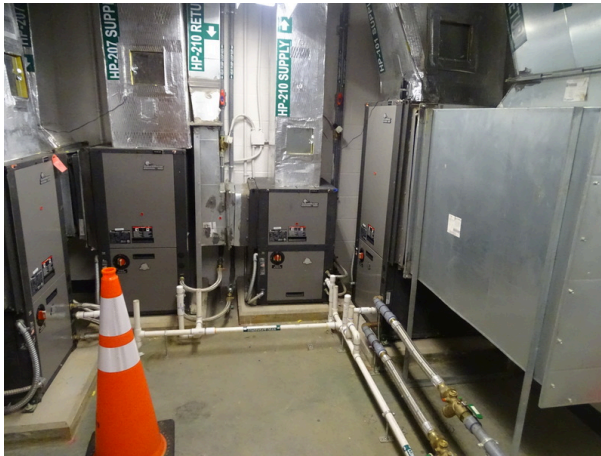
Geothermal Heat Pump Vertical Package Unit

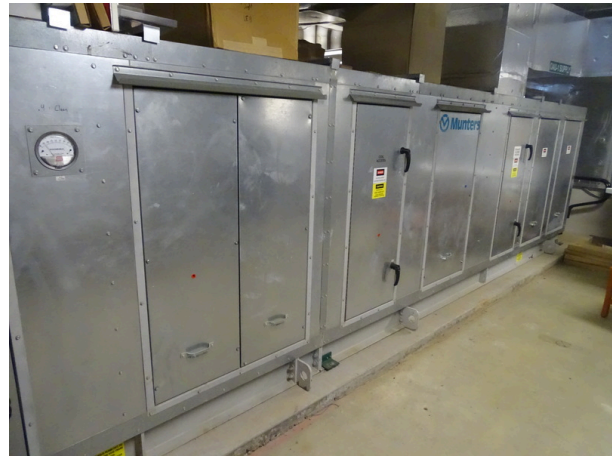
Dehumidifier Unit

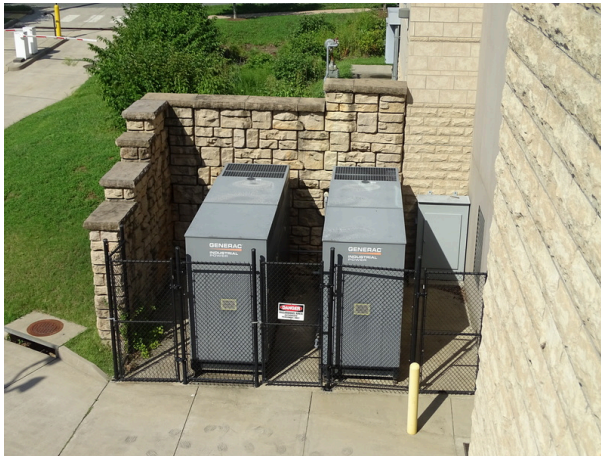
Two emergency generators, manufactured by Generac, were located on the south side of the building. The emergency generators are reportedly tested on a weekly basis. The expected useful life of an emergency generator is 25 years with proper maintenance. The emergency generators were observed to be in good condition. Based on the age of the generator, we recommend replacement during the report period.

Typical Generator

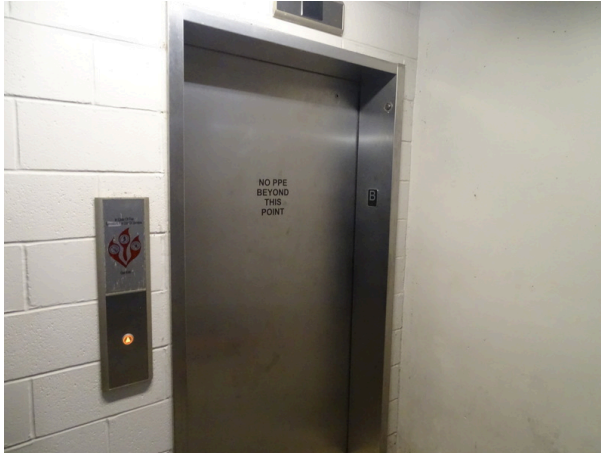
The building is served by one passenger elevator. The elevator was manufactured by Kone. Kone currently has the maintenance contract for the elevators. The expected useful life of the elevator controls is 30 to 40 years with proper maintenance. Routine maintenance is considered adequate to keep the elevator system in good condition during the projection period of this report. The elevator was inspected on March 18, 2021.

Typical elevator

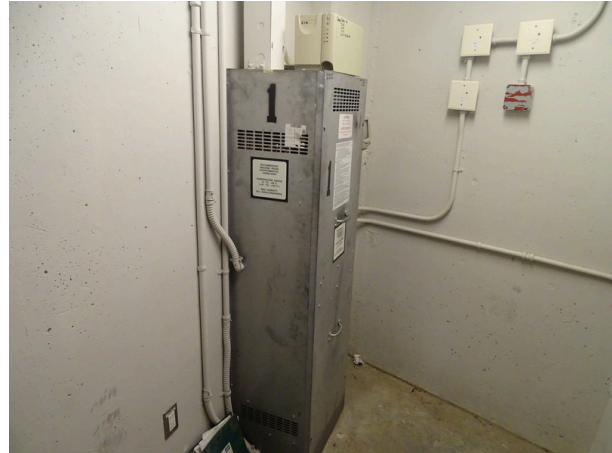
Elevator equipment

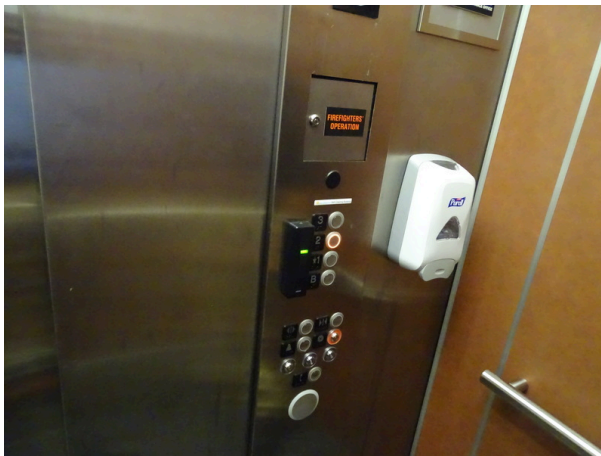
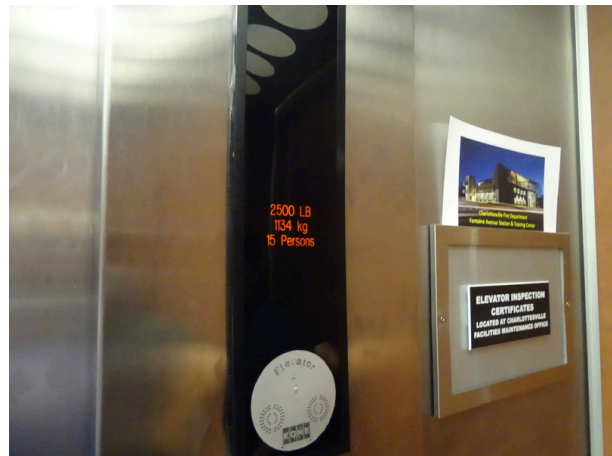
Elevator cab overview

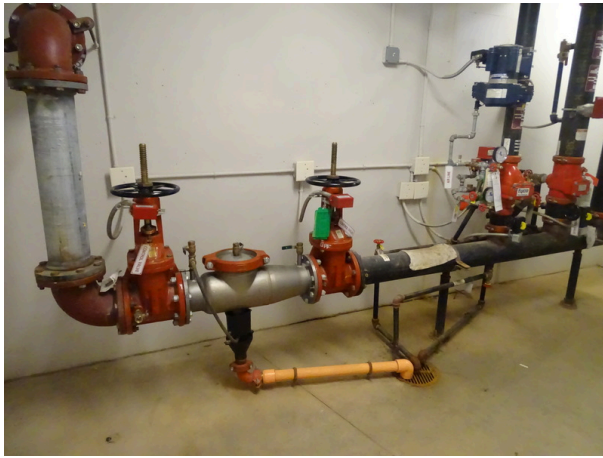
Typical sprinkler system piping

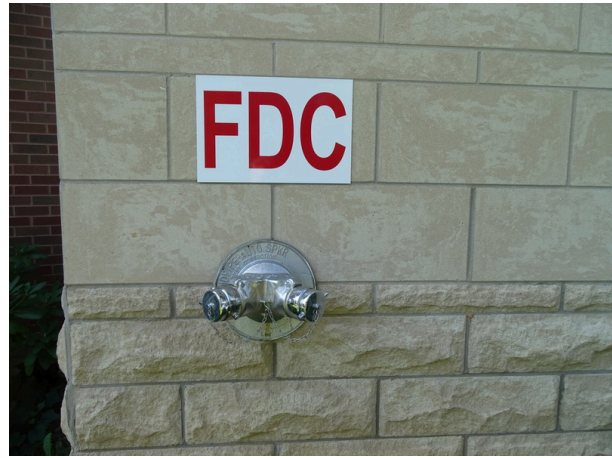
Typical Fire Department Connection

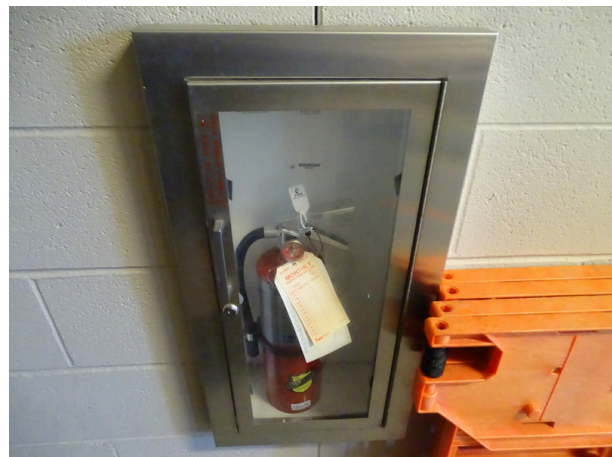
Fire extinguisher

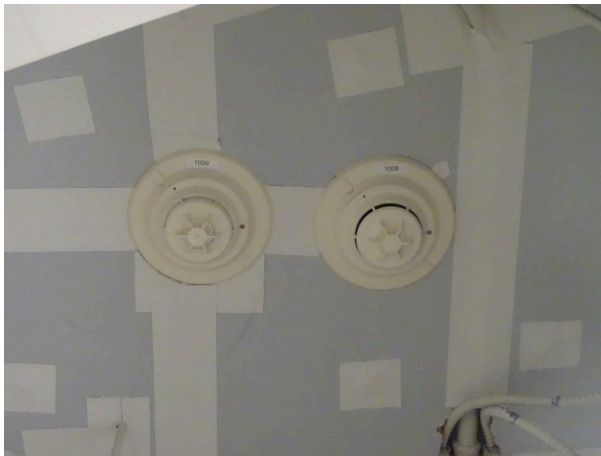
Typical smoke detector

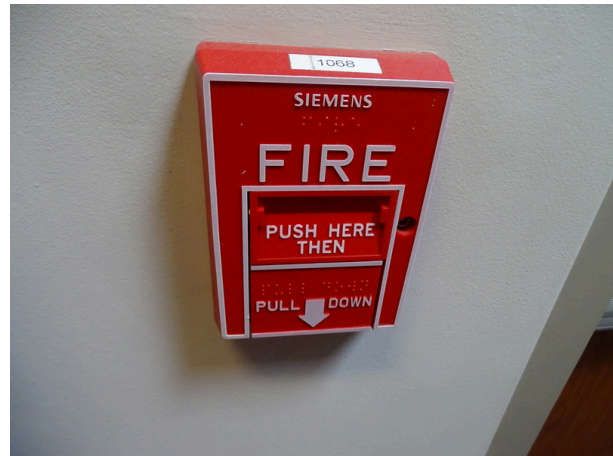
Typical pull down station

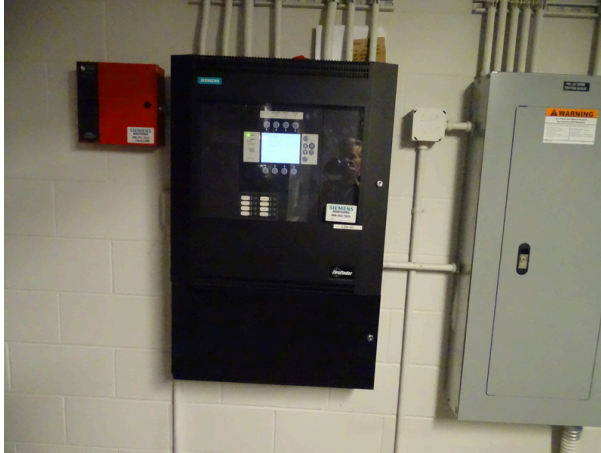
The fire alarm system was observed but not tested. The fire alarm panel was observed to be in good condition.

Fire alarm panel

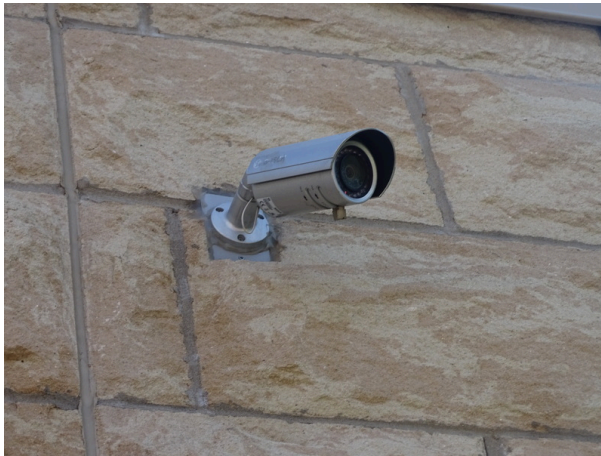
The building is monitored by a computerized security system with cameras. Security cameras were observed at locations at the building interiors and exteriors. The security system was generally in good condition.

Typical security camera

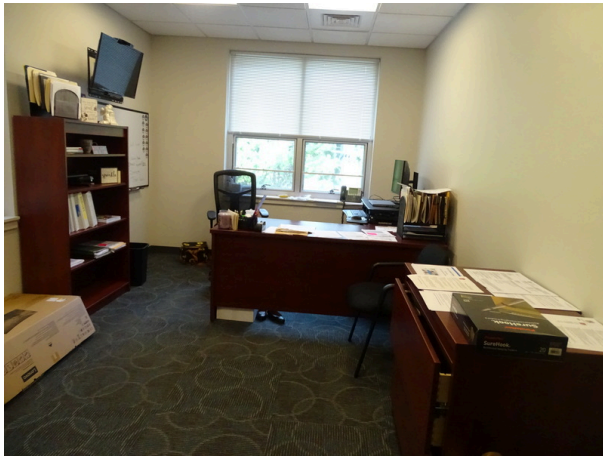
Typical office interior

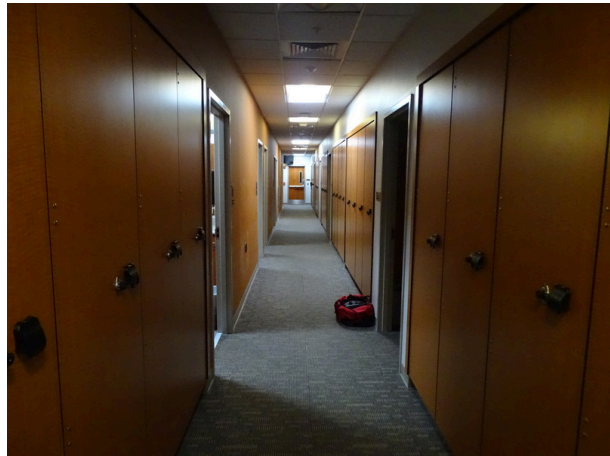
Typical corridor interior

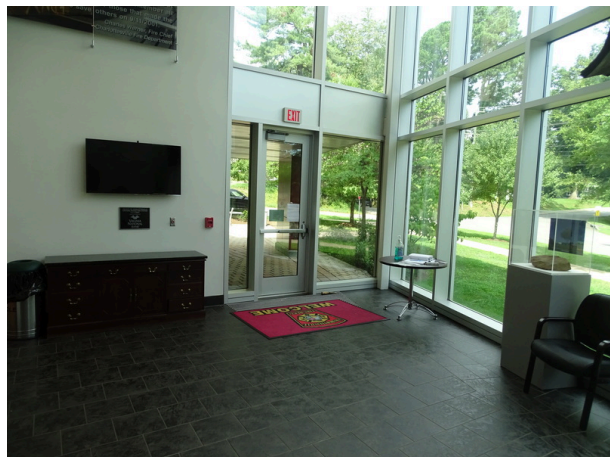
Typical interior hall overview

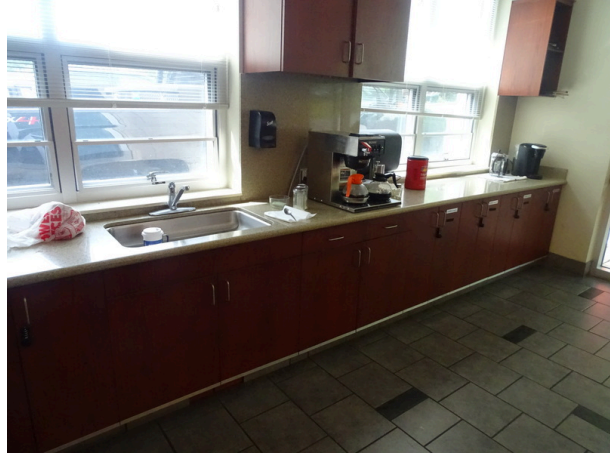
Typical kitchen cabinet

Based on the fair condition of the interior finishes at the kitchen, we recommend the kitchen interiors be renovated.

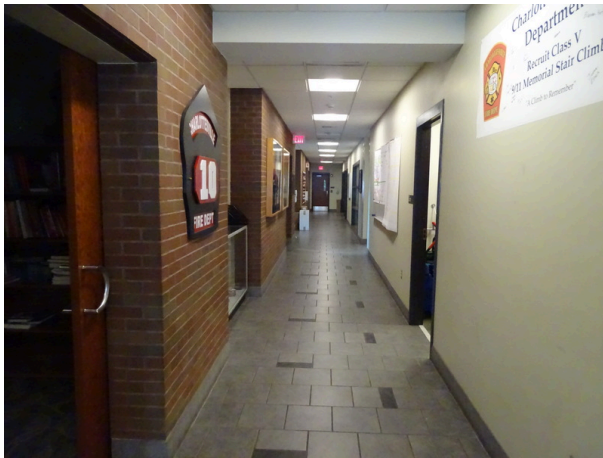
Typical corridor area interior

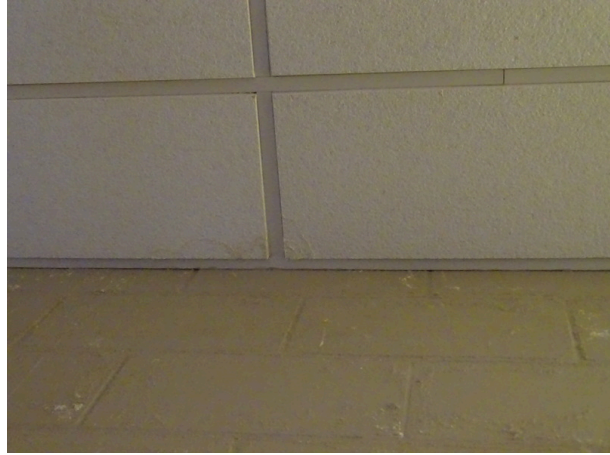
The stair finishes include painted CMU walls, painted steel stringers and handrails, and vinyl treads. The walls are experiencing a fair degree of efflorescence from a possible leak. We recommend a focused investigation of the area to determine the cause.

Efflorescence interior

Cost Recommendation	EUL	EFF AGE	RUL	Year	Cost
RENOVATE COMMERCIAL KITCHEN AND REPLACE APPLIANCES	10	8	2	2	\$50,000
FOCUSED LEAK INVESTIGATION	-	-	0	Immediate	\$1,000
Total					\$51,000

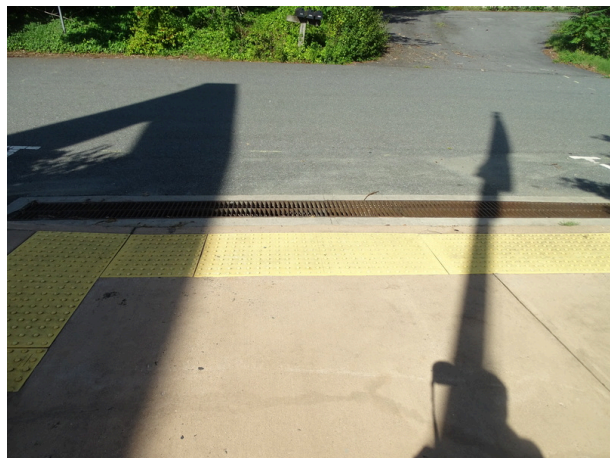
Typical truncated Domes

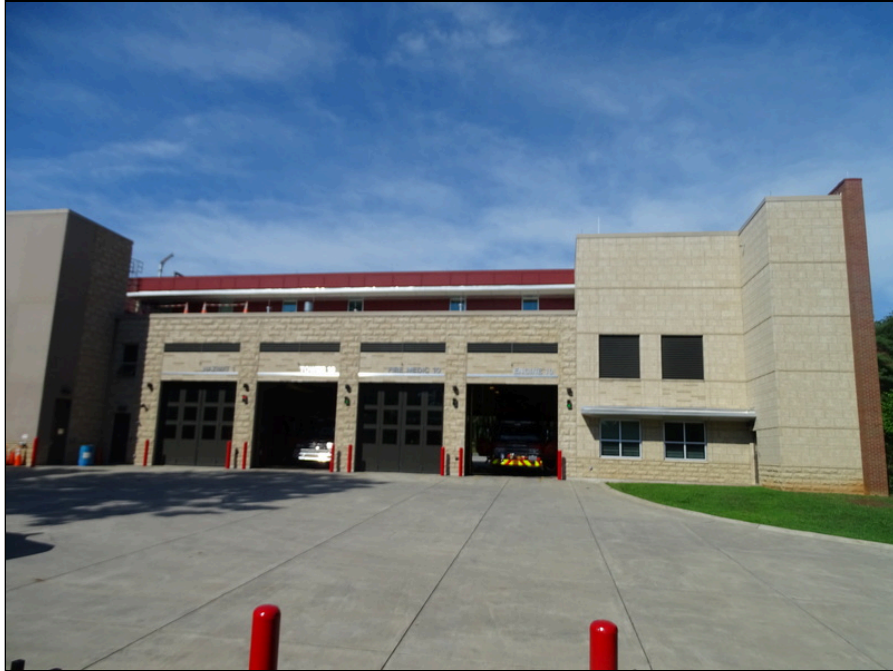
1 - Fountain fire station south elevation overview

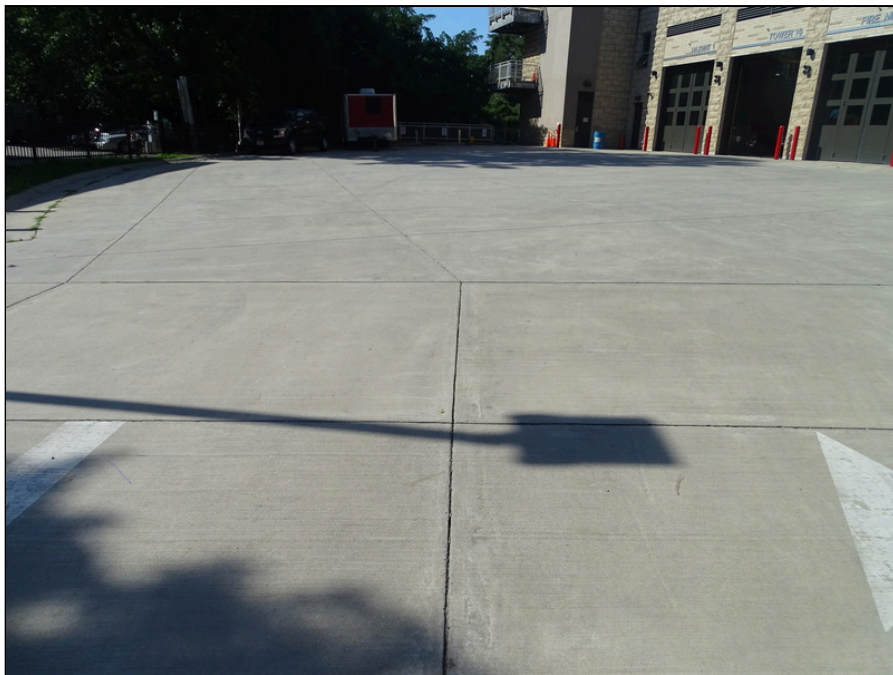
2 - Concrete pavement

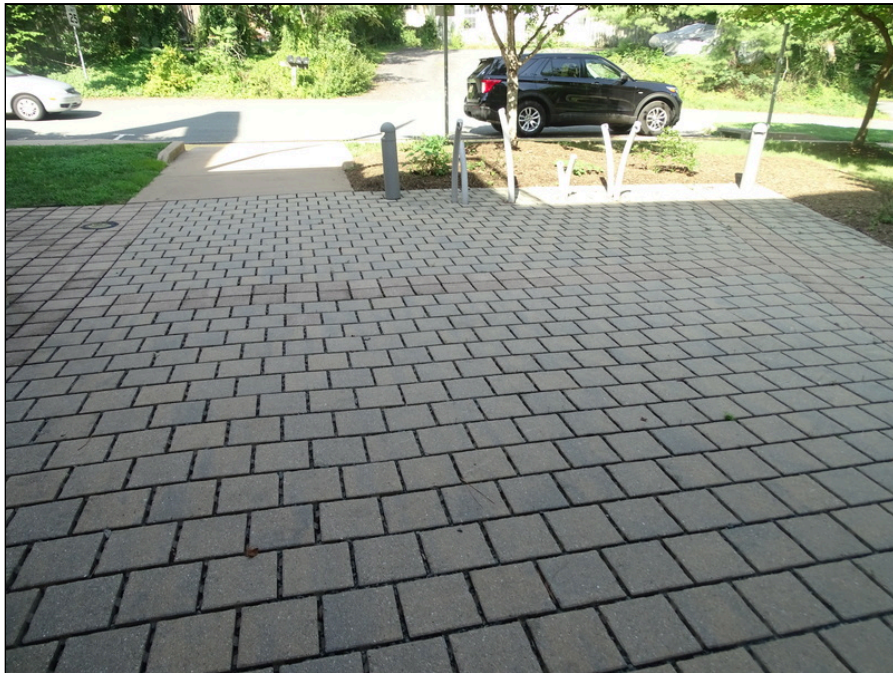
4 - Typical brick pavement

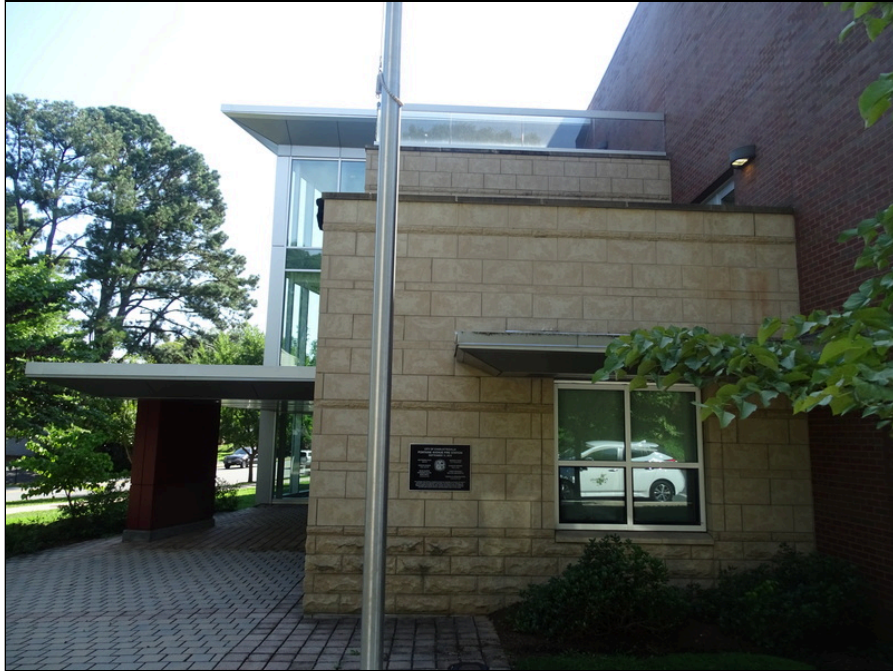
5 - Typical sidewalk

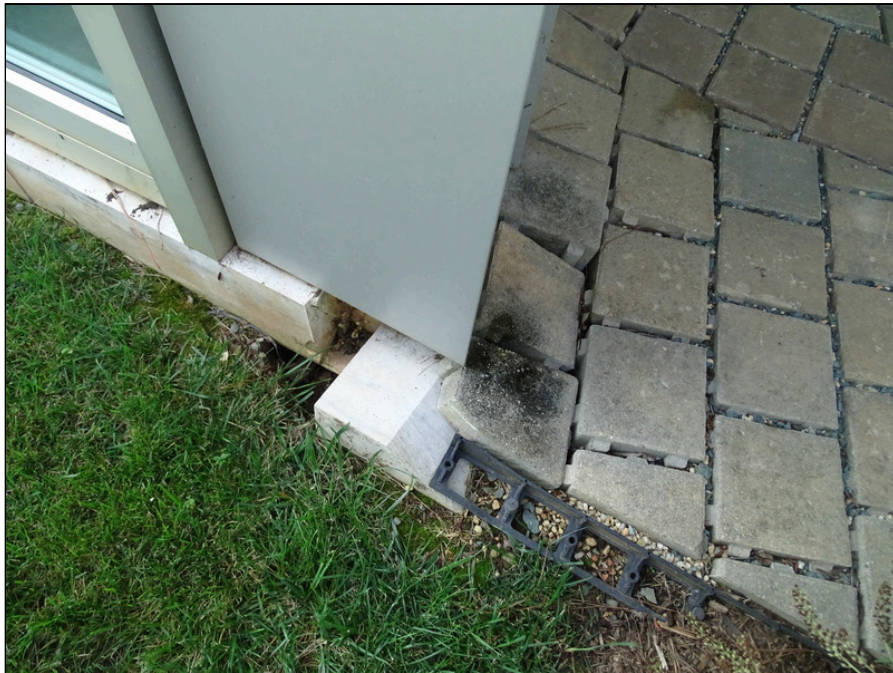
6 - Typical brick sidewalk condition

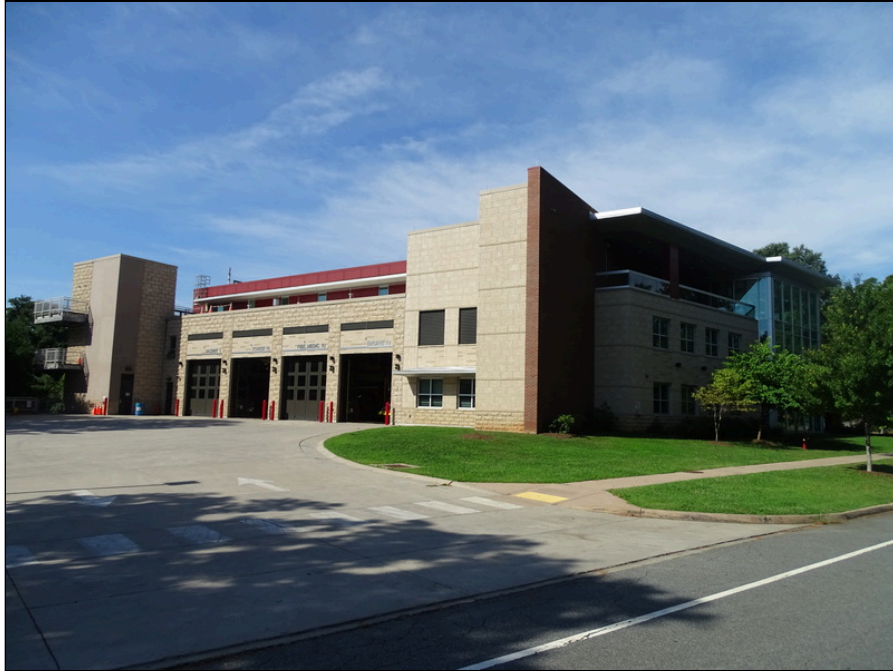
7 - Vehicle concrete access

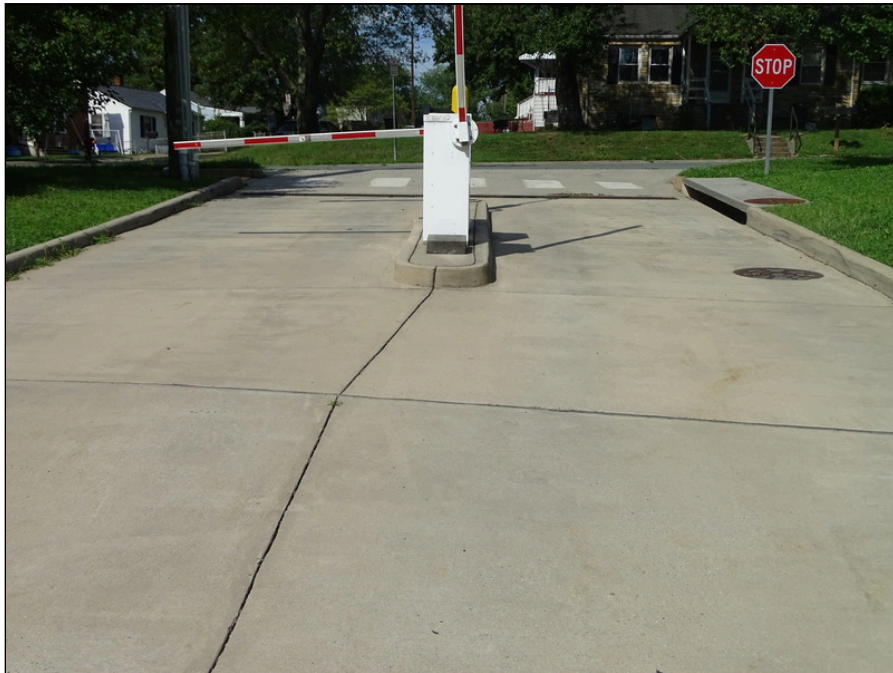
8 - Vehicle access

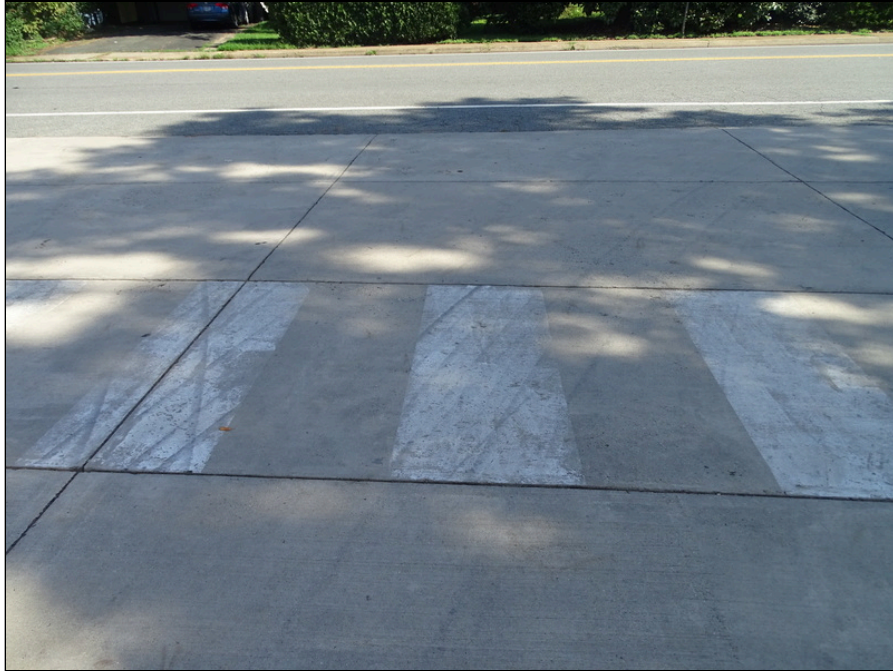
9 - Striping condition

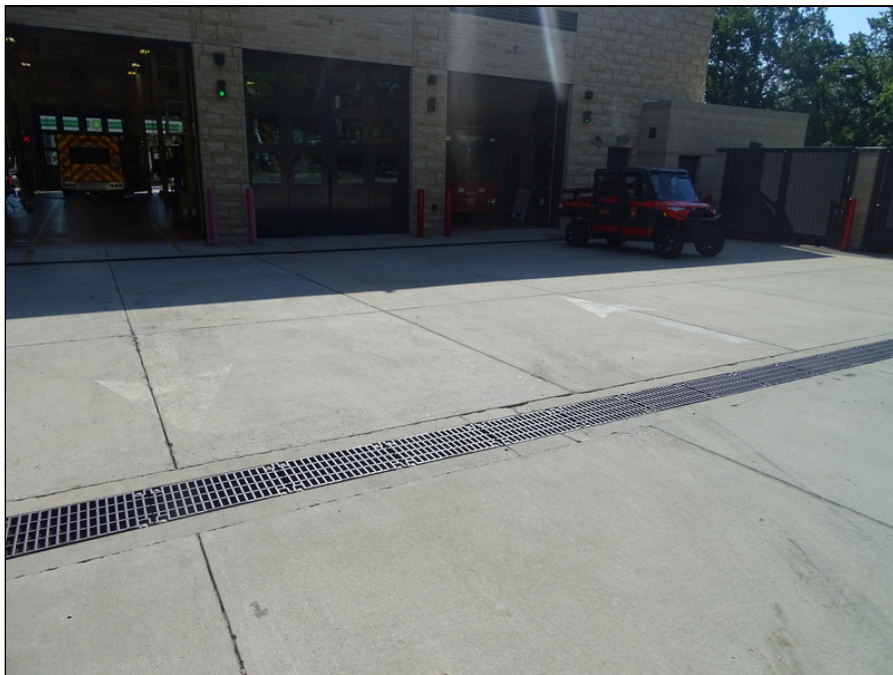
10 - Typical storm water drainage

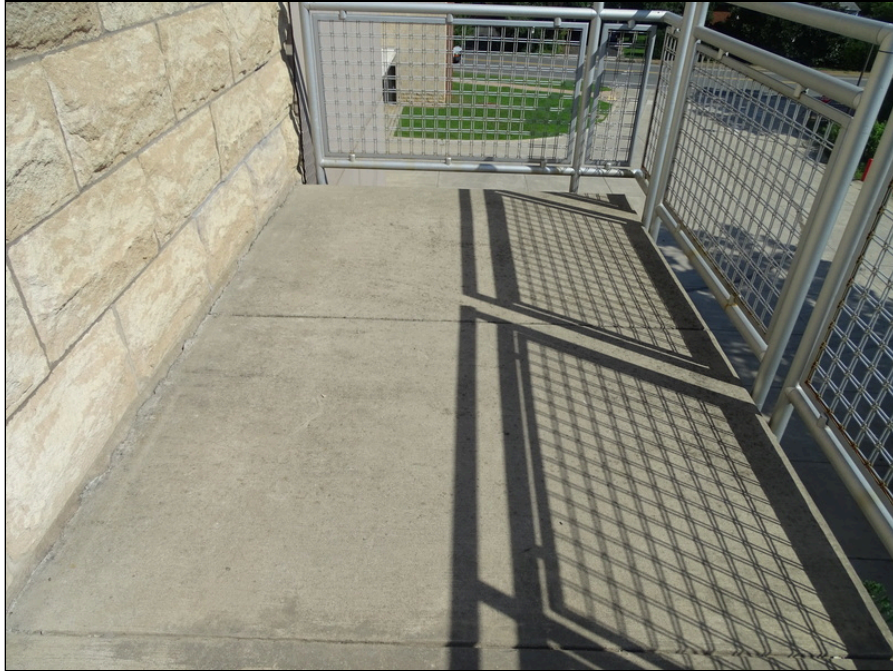
11 - Sidewalk - note concrete separated from wall

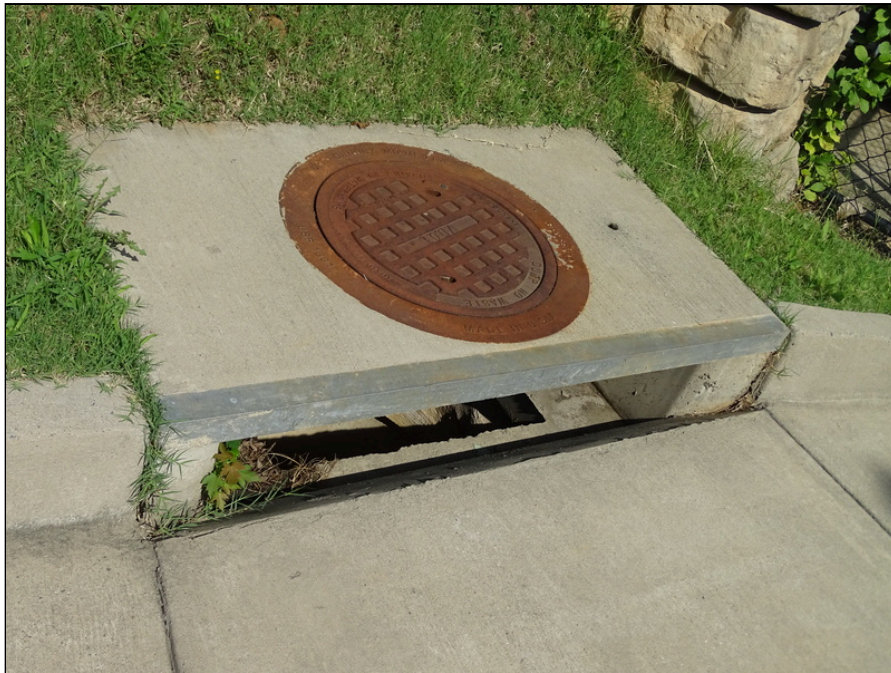
14 - Typical storm water drainage

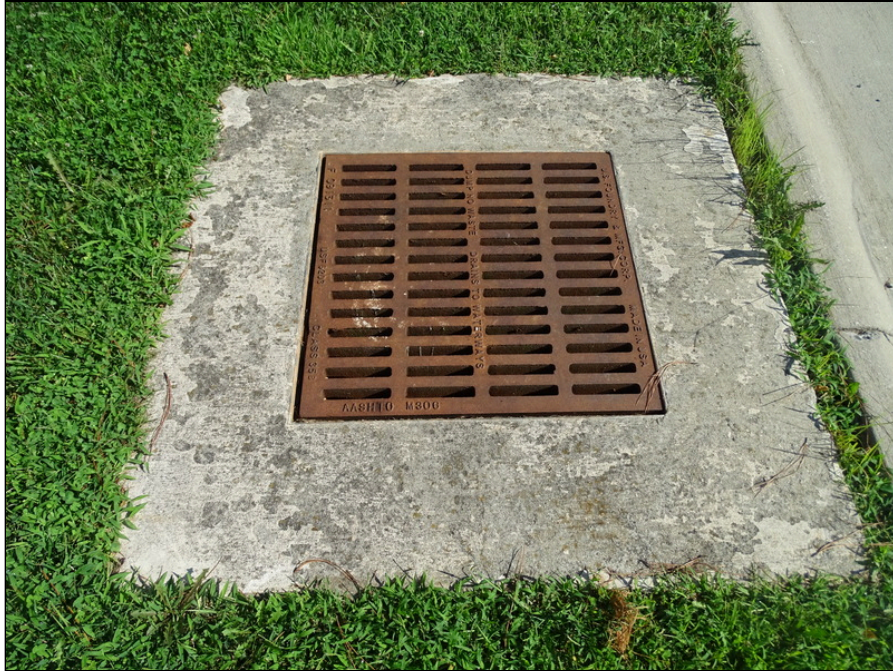
15 - Typical yard inlet

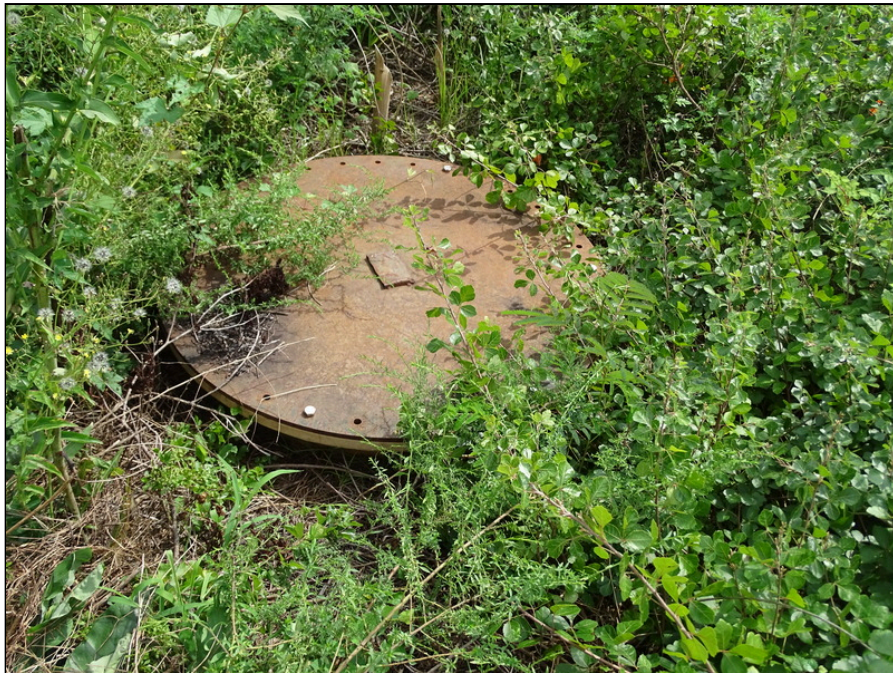
16 - Typical yard inlet
