FONTAINE AVENUE FIRE STATION  
2420 FONTAINE AVENUE  
CHARLOTTESVILLE, VIRGINIA

ECS PROJECT NO. 46:6713

CITY OF CHARLOTTESVILLE - FACILITIES DEVELOPMENT

Reference: Facility Condition Assessment Report for Fontaine Avenue Fire Station, 2420 Fontaine Avenue, Charlottesville, Virginia

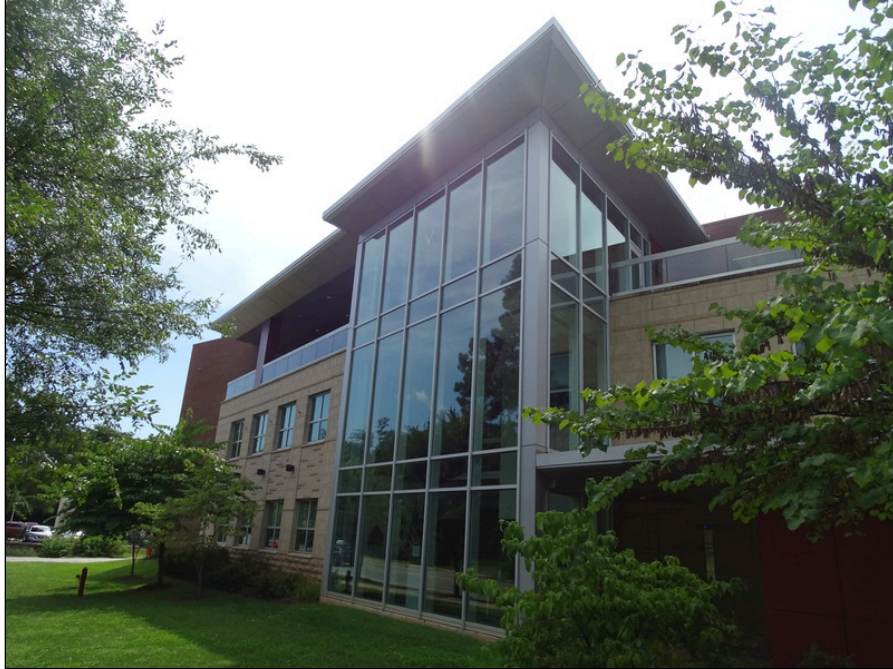
17 - Typical landscaping overview

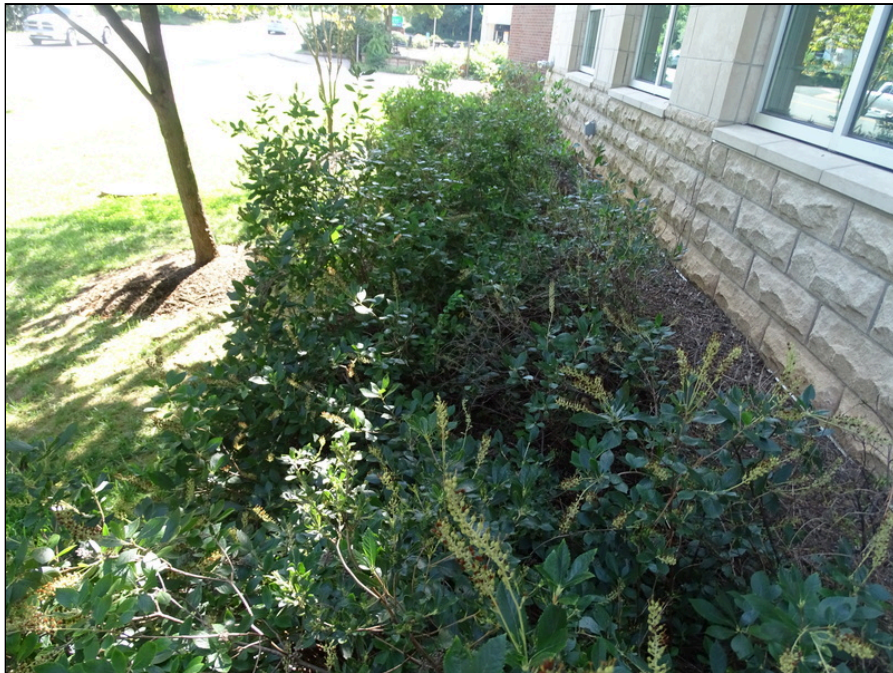
18 - Typical landscape

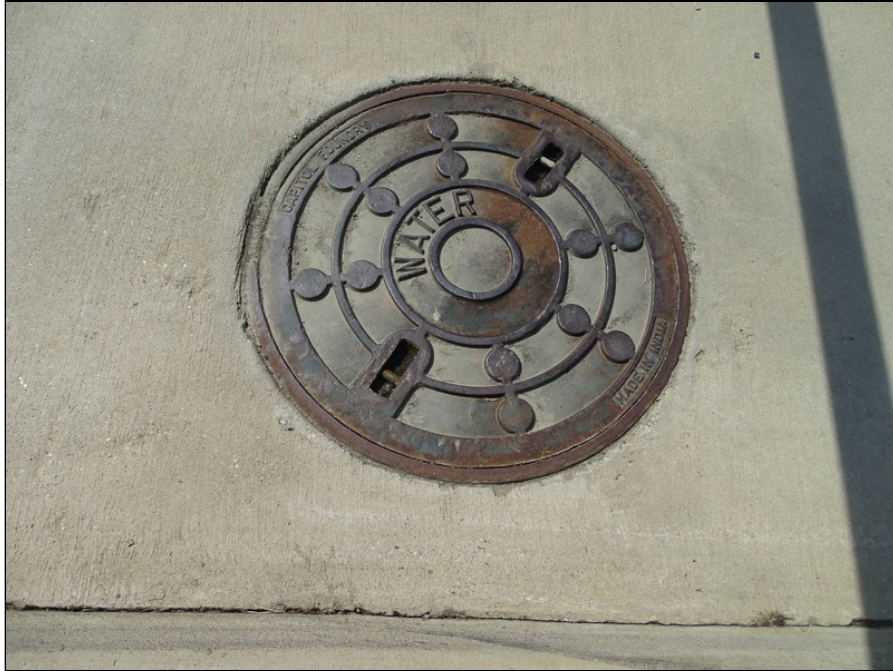
19 - Typical water area

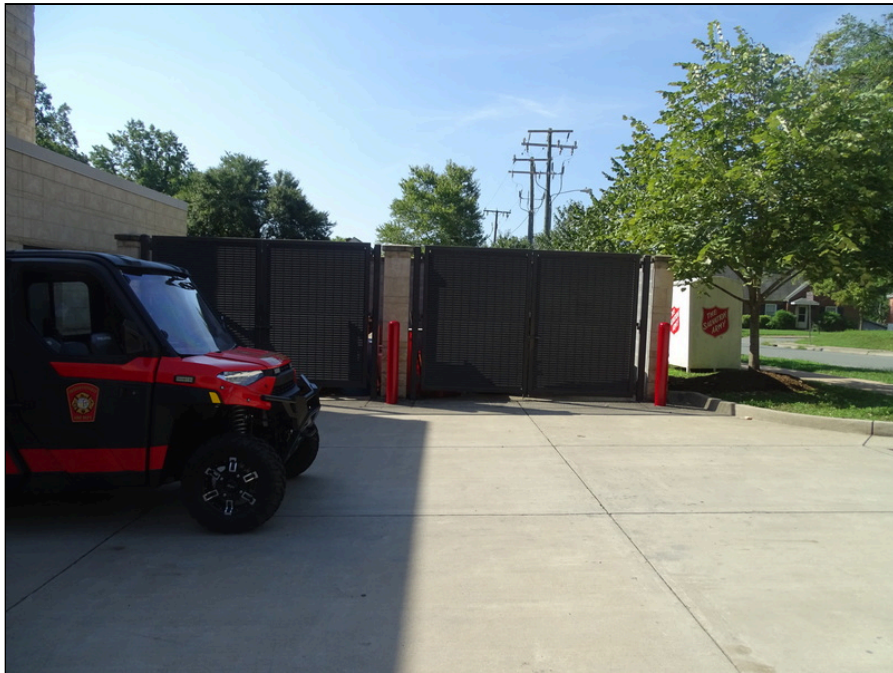
20 - Dumpster pad

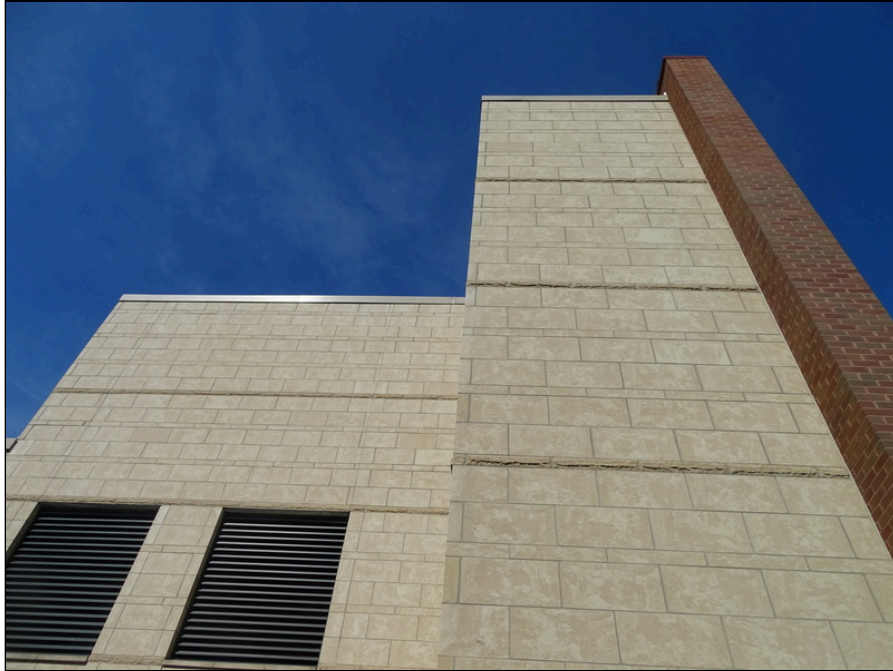
21 - Building south exterior

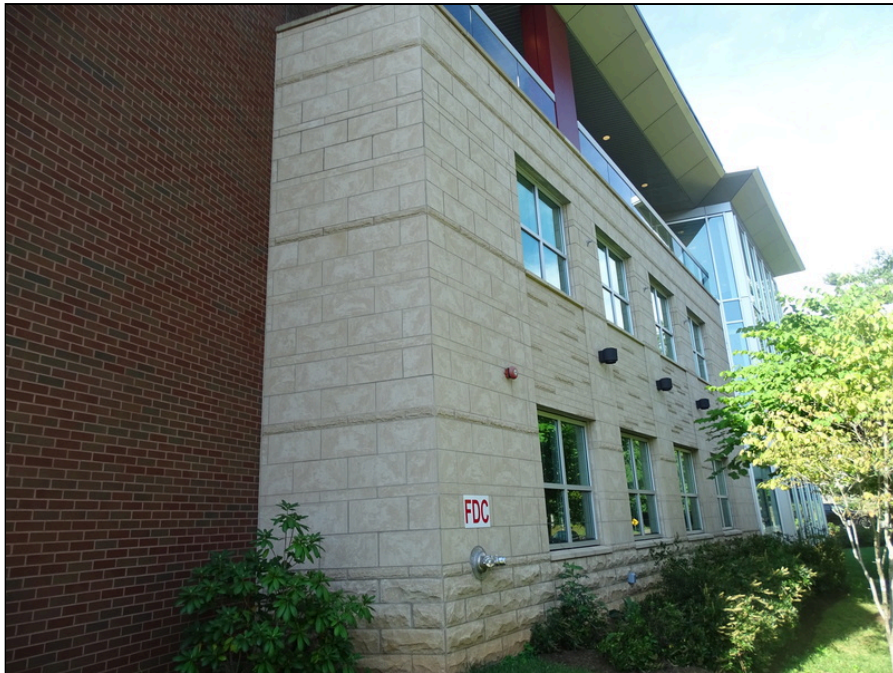
22 - Building north exterior

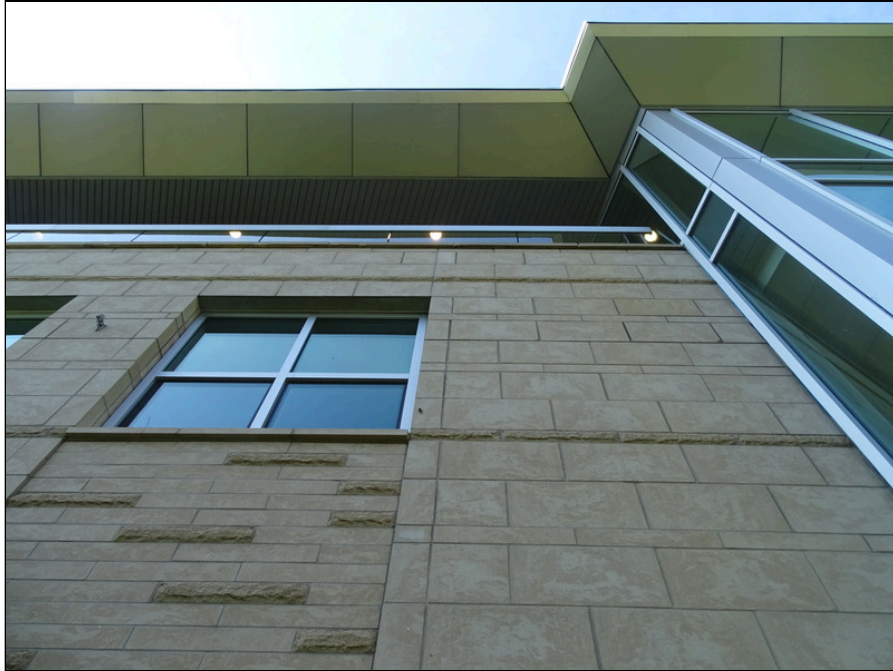
23 - Building north exterior

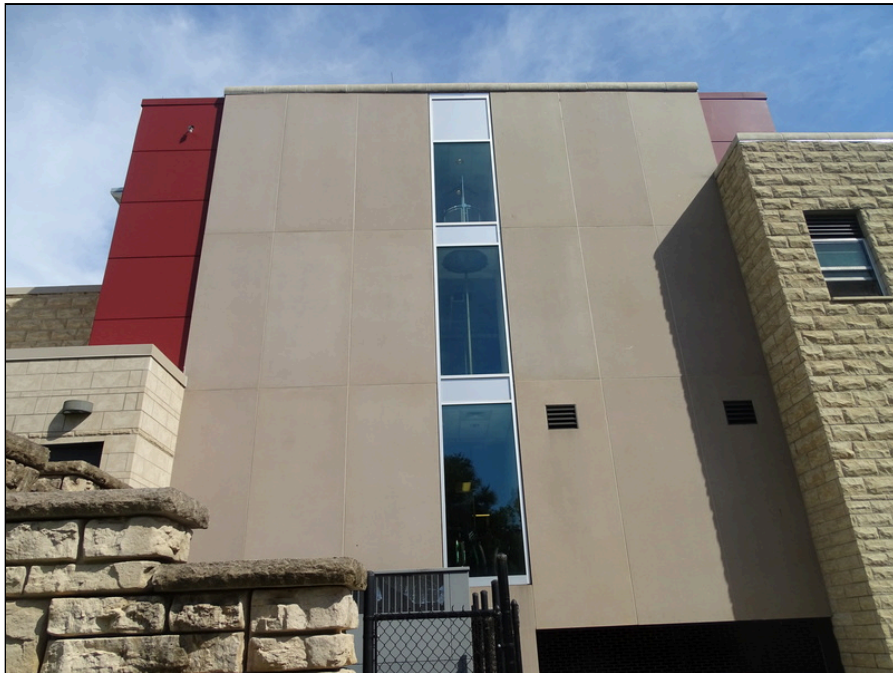
24 - Building exterior overview

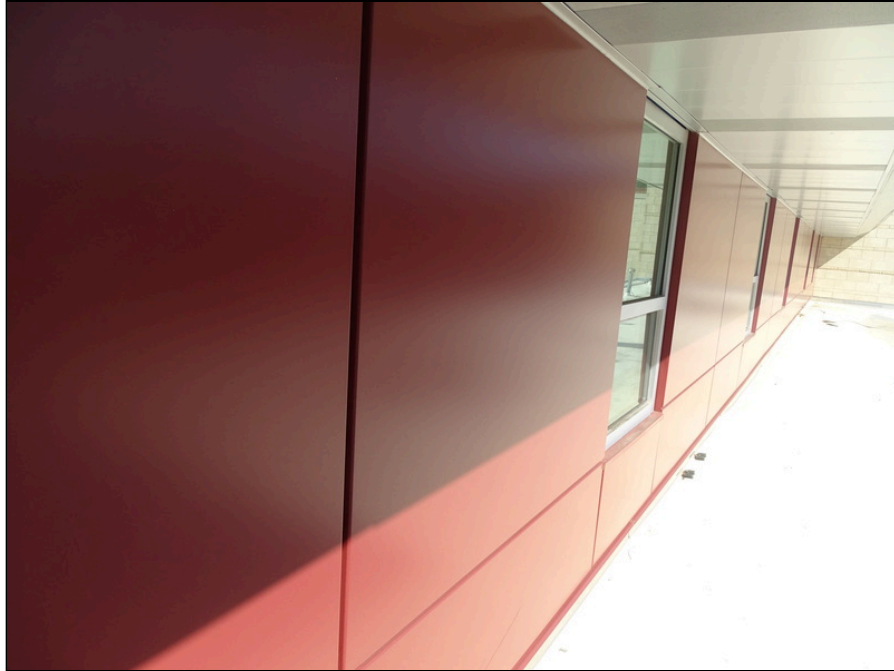
27 - Exterior wall siding overview

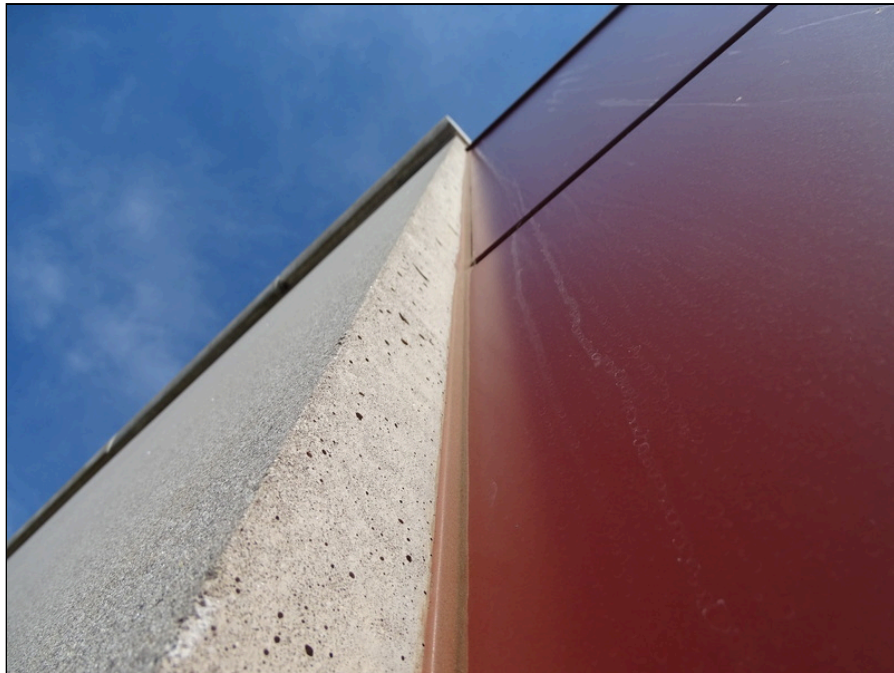
28 - Exterior wall condition

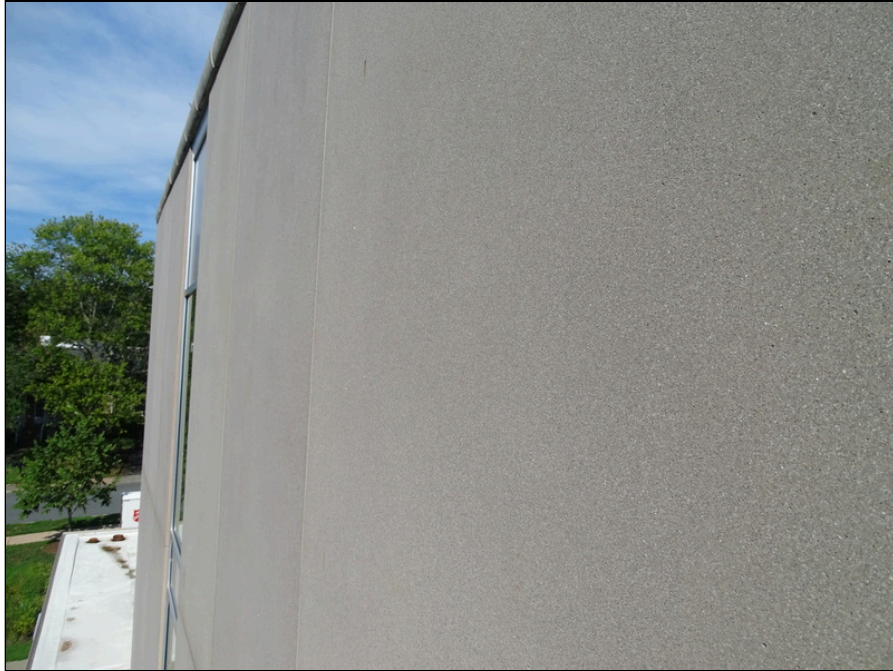
29 - Unfinished exterior wall overview

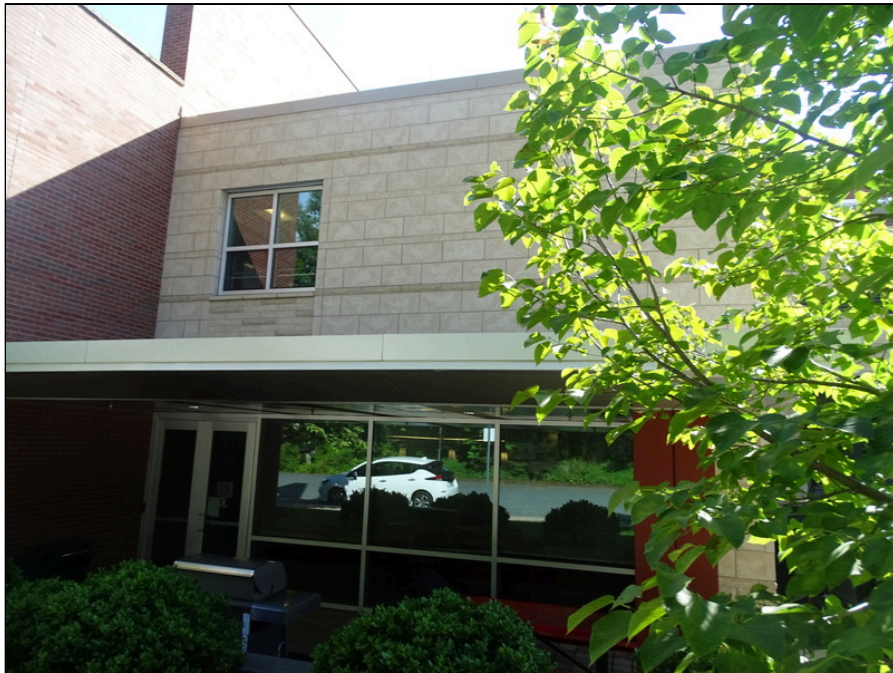
30 - Storefront door

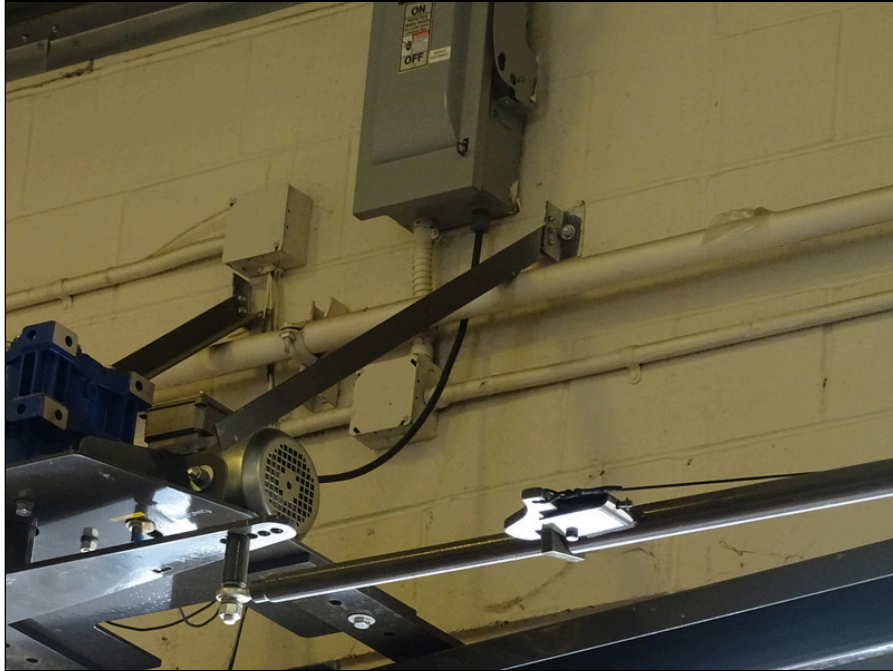
31 - Overhead doors with reported problems with bracing

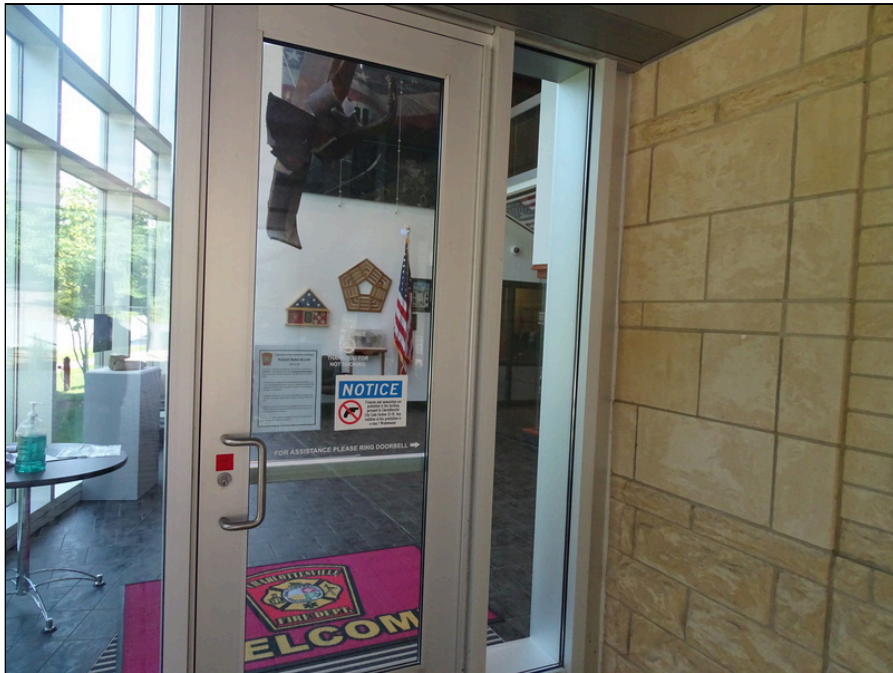
32 - Typical exterior door

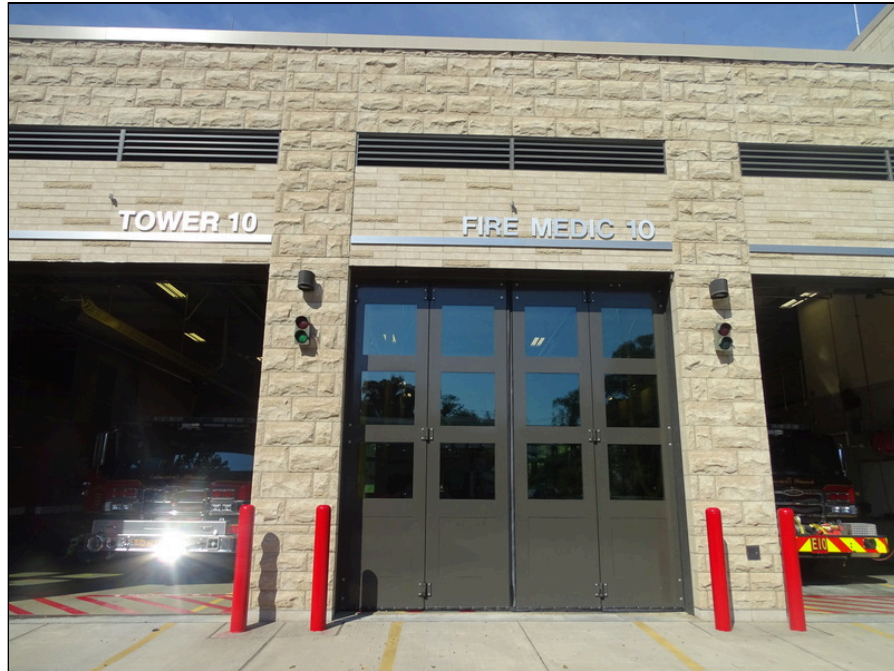
33 - Typical bay door

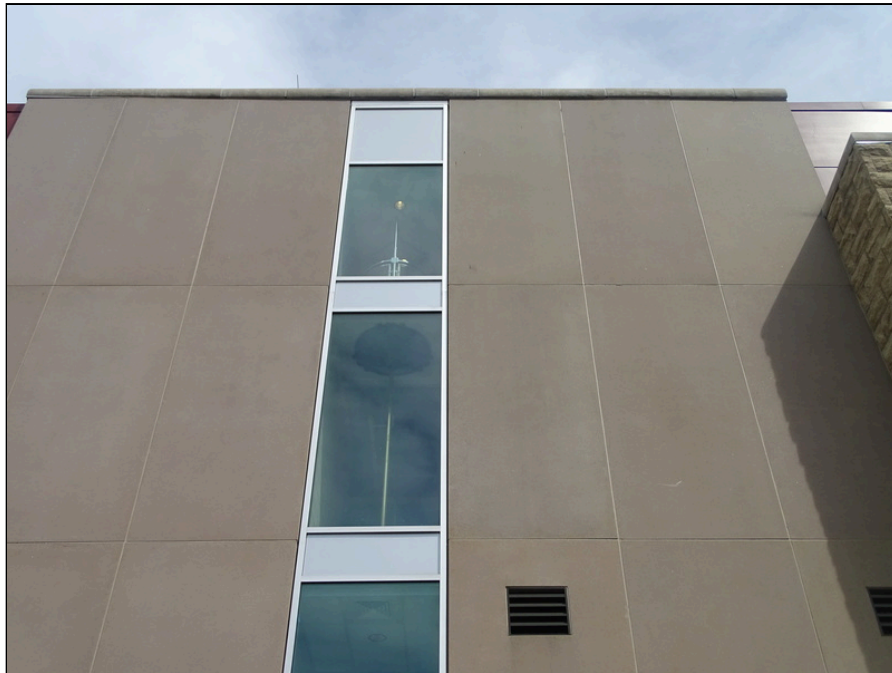
34 - Typical window

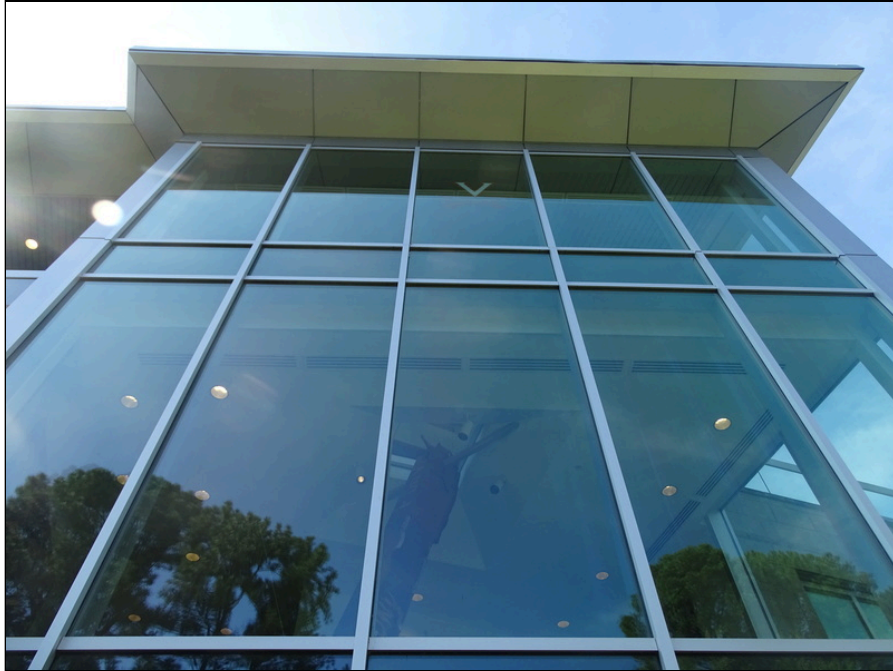
35 - Glass curtain wall exterior window

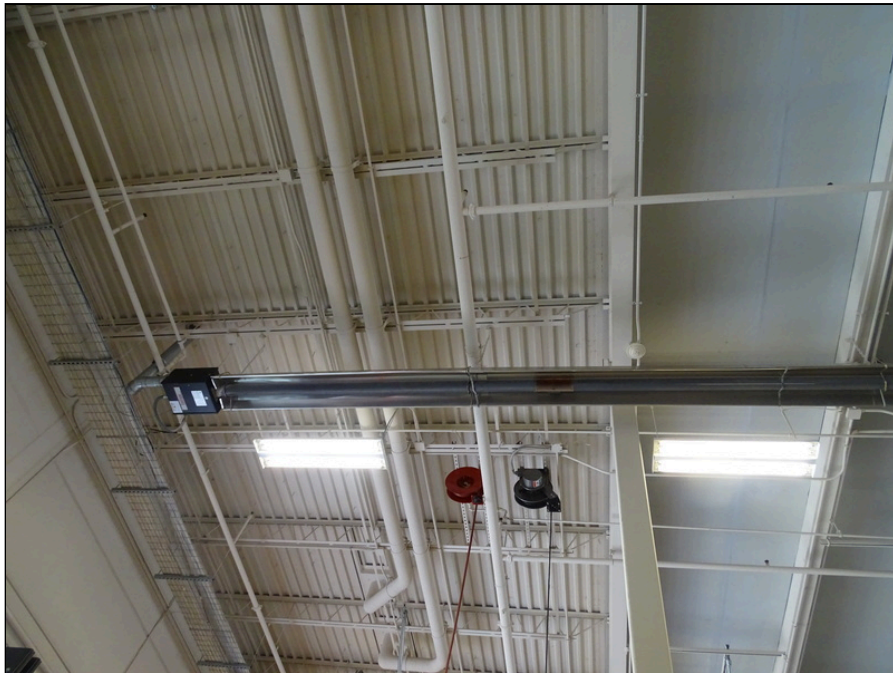
36 - Metal deck supporting an elevated level

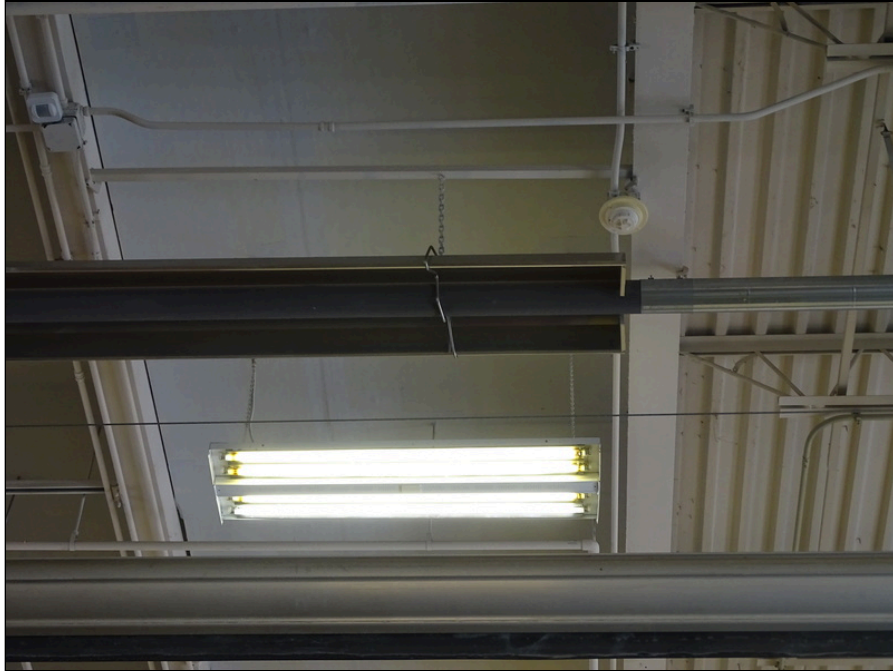
37 - Metal deck supporting an elevated level

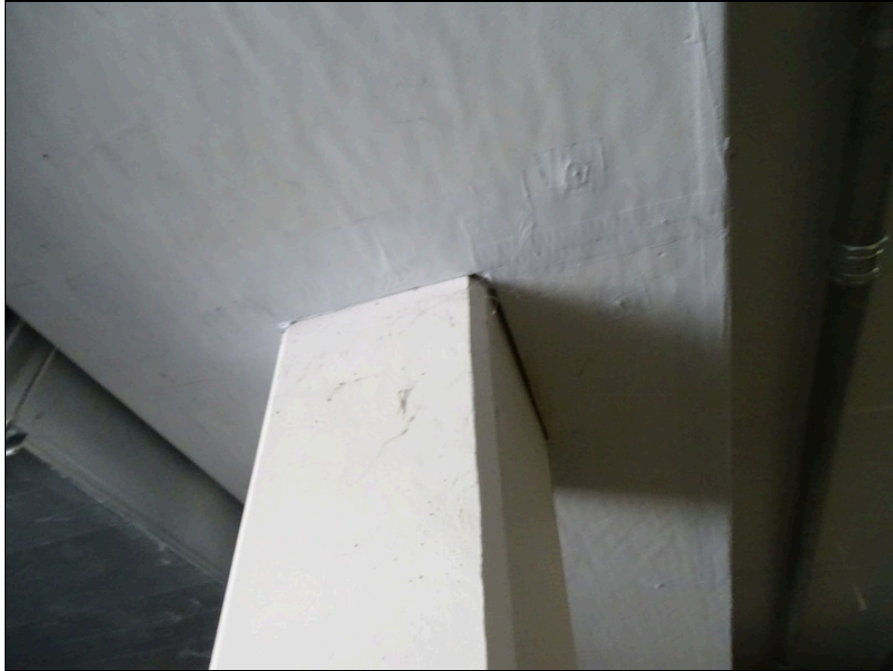
39 - Garage structure framing

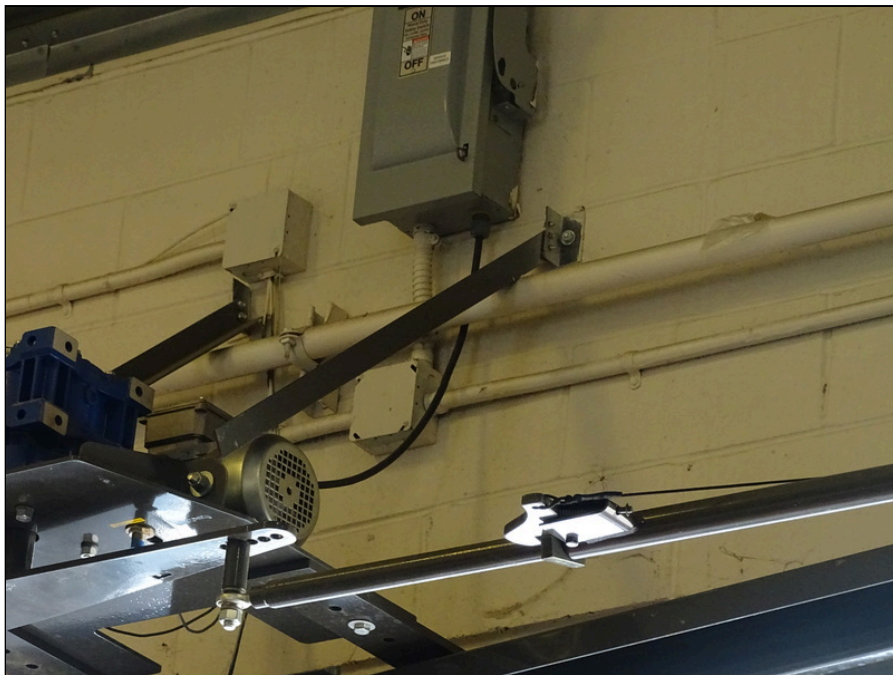
40 - CMU wall overview

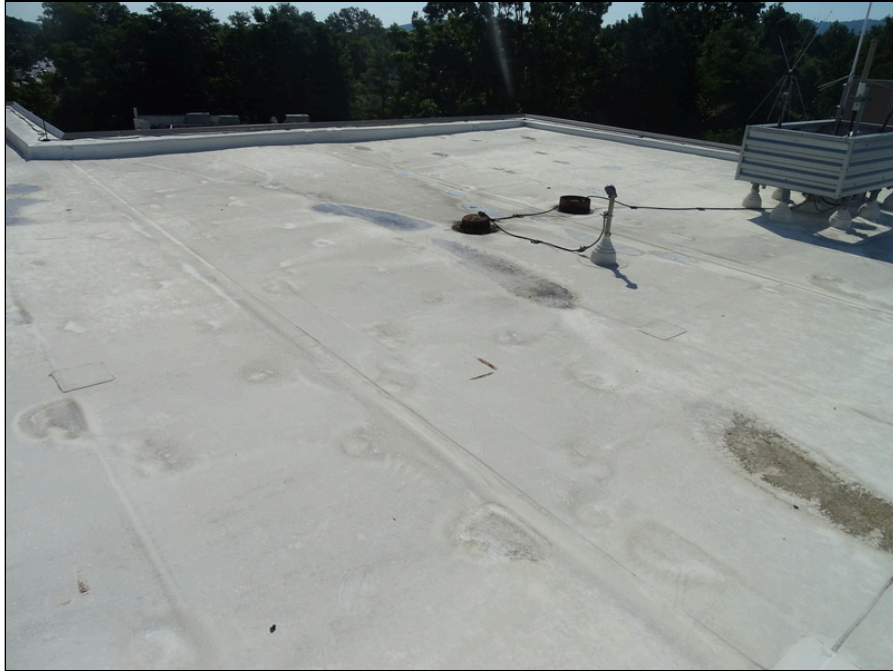
41 - Single-ply roofing system overview

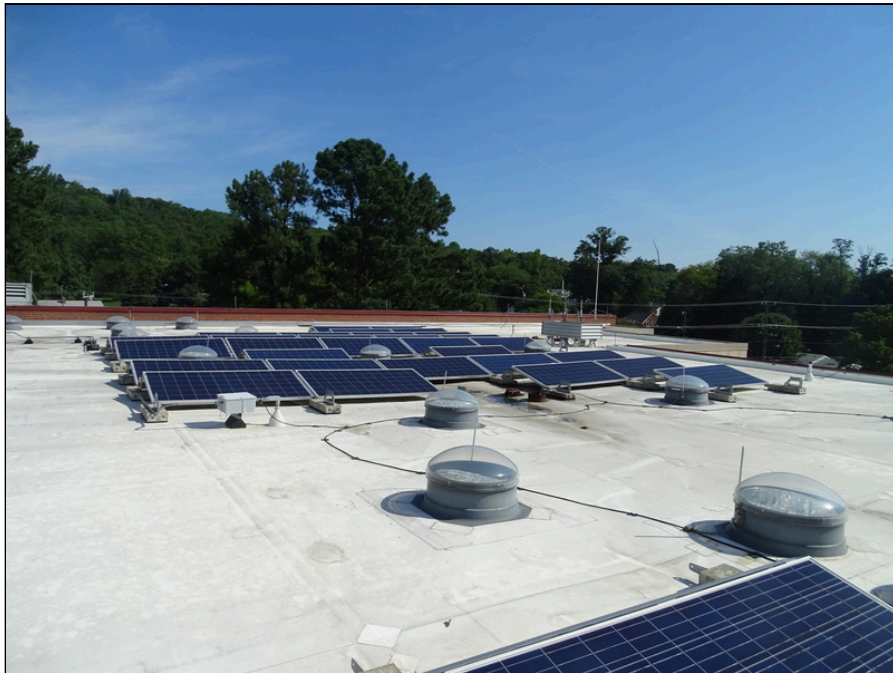
46 - Single-ply roofing system overview

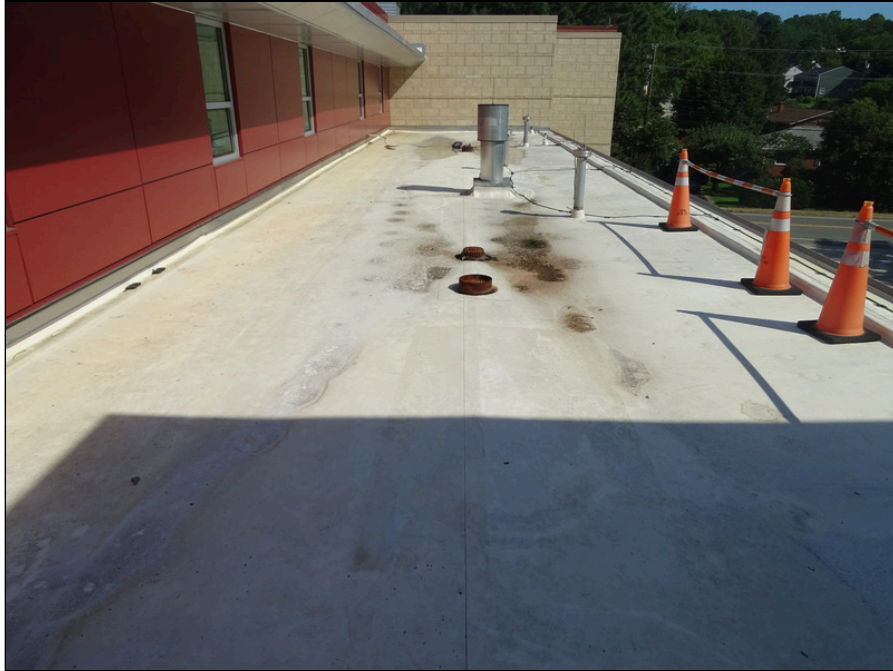
47 - Low level roof condition

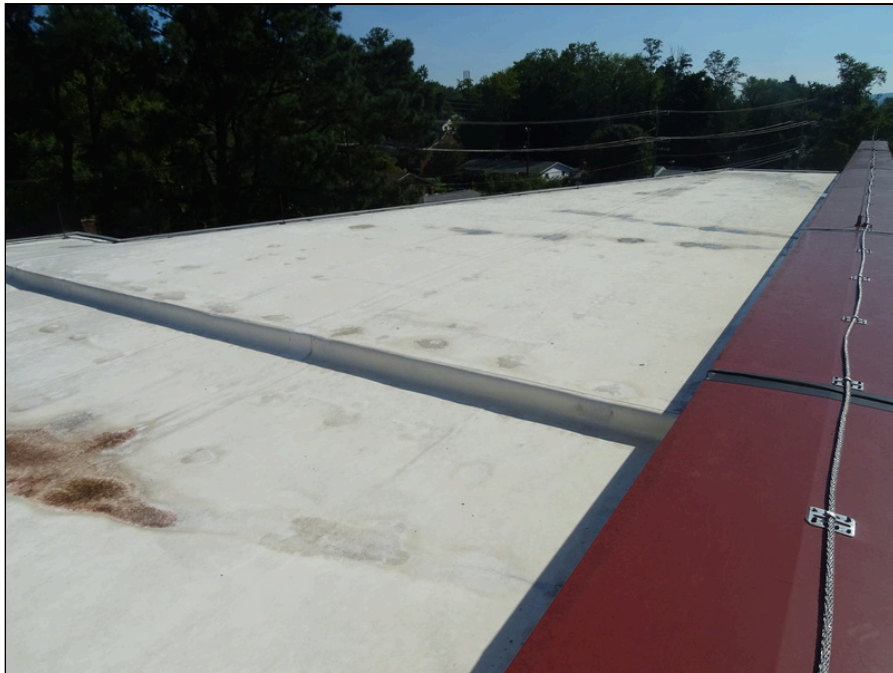
48 - Metal coping overview

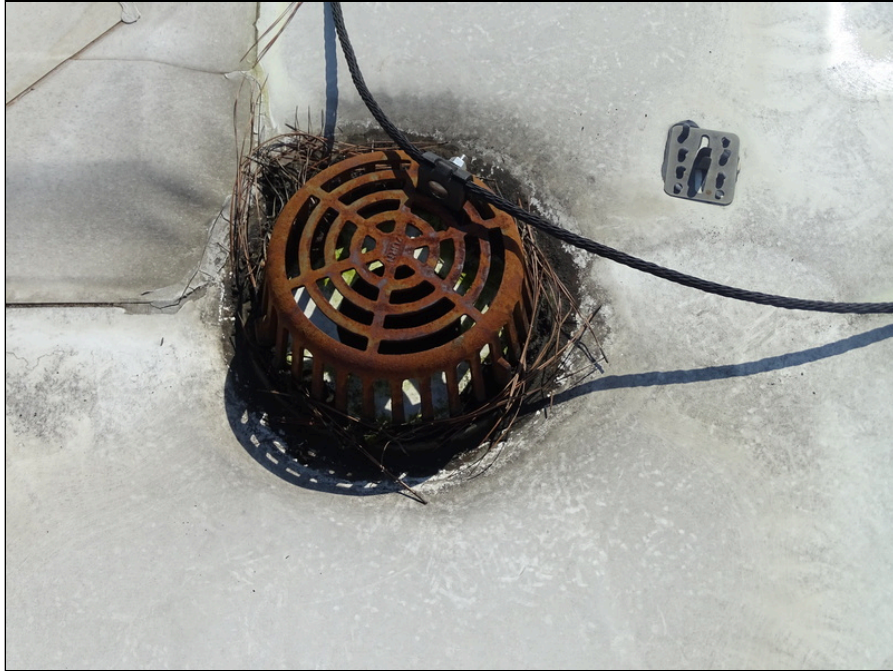
49 - Typical internal drain

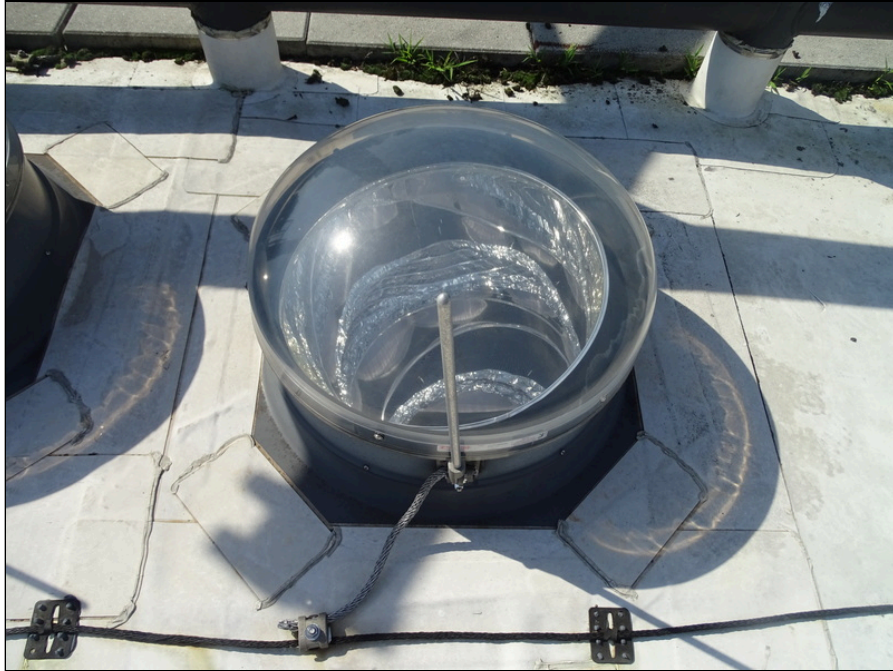
51 - Typical skylight

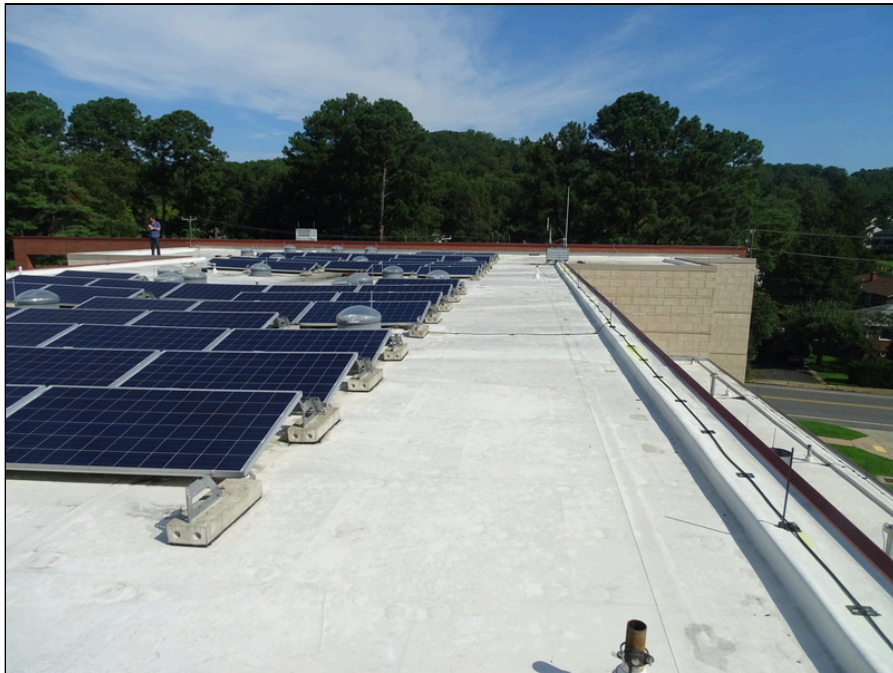
52 - Typical solar PV system overview

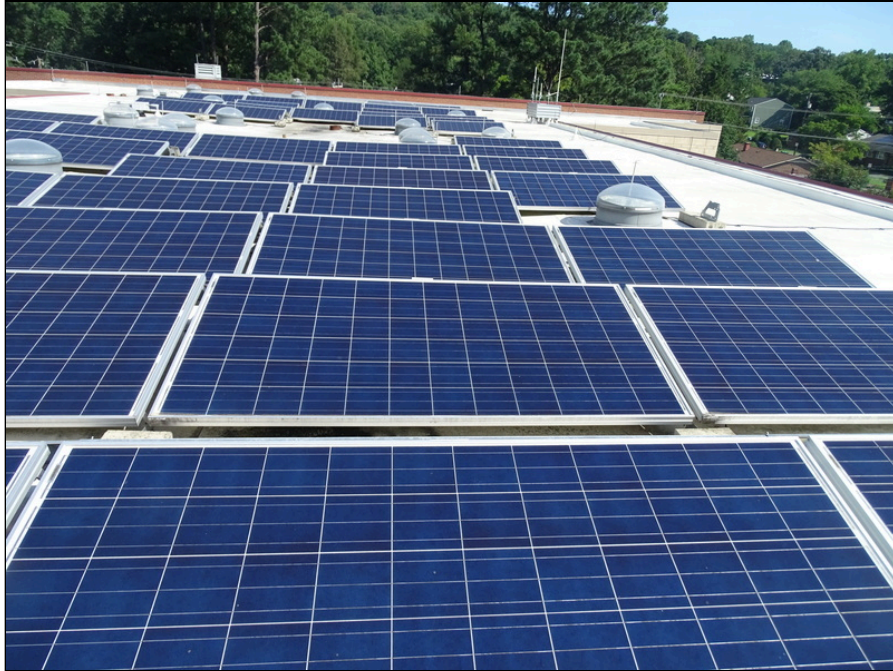
53 - Typical solar PV system overview

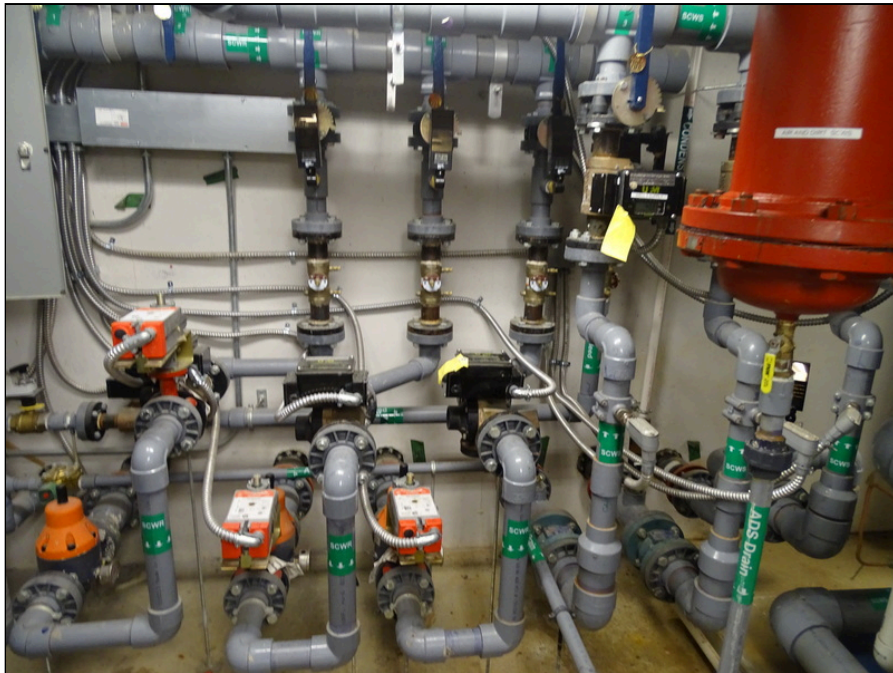
54 - Plumbing system

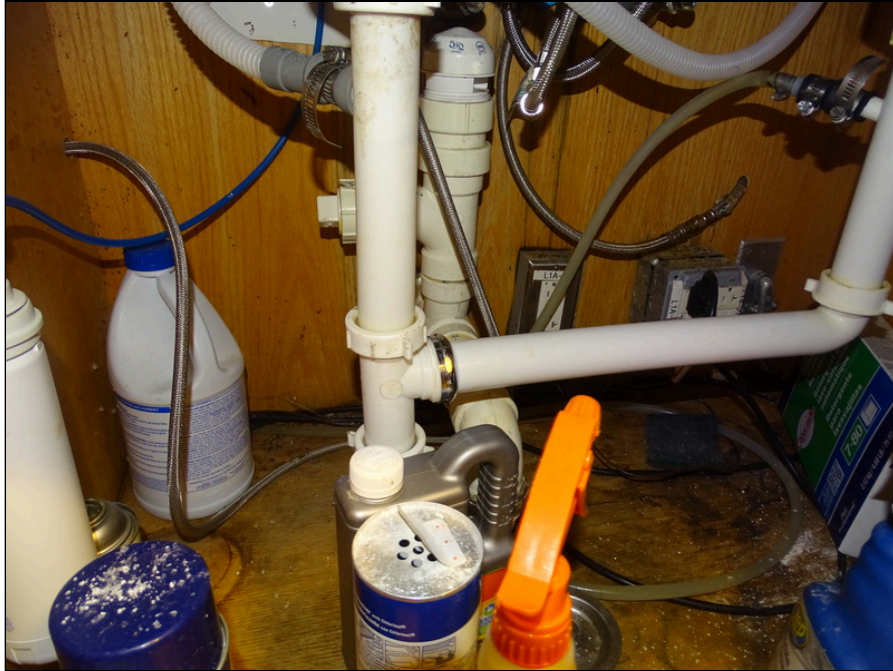
55 - PVC piping overview

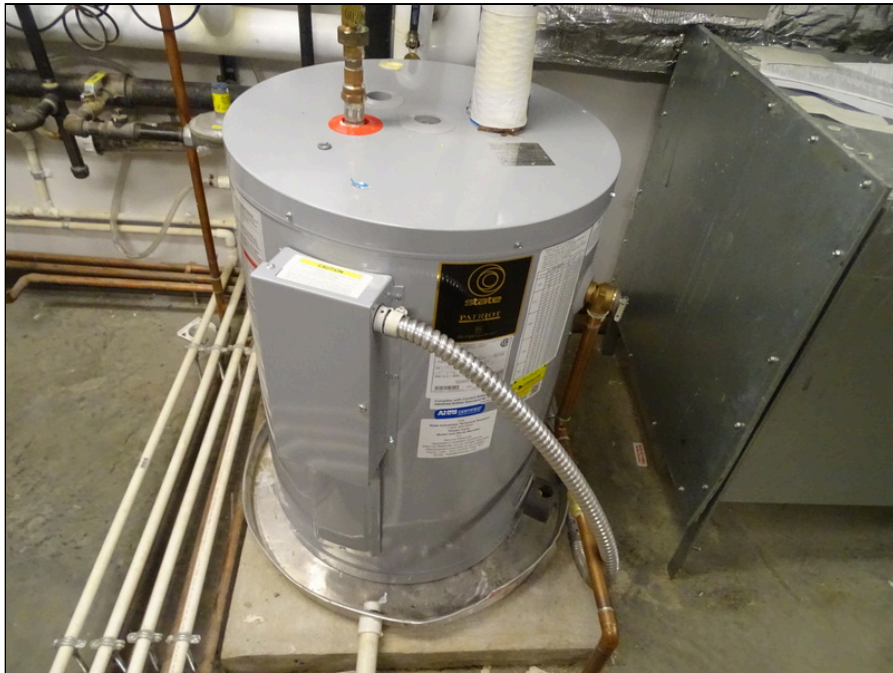
56 - Domestic water heater

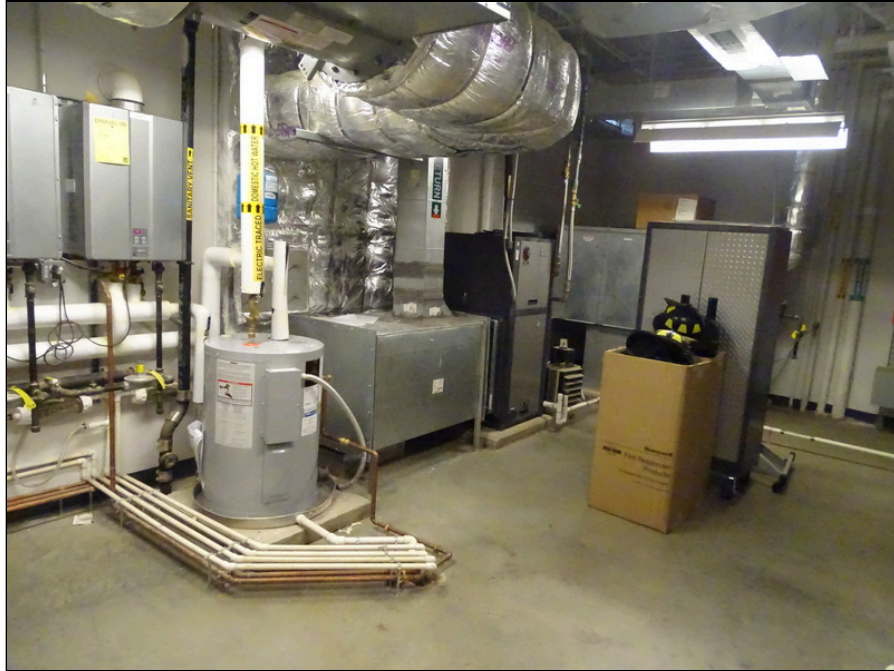
57 - Domestic water piping

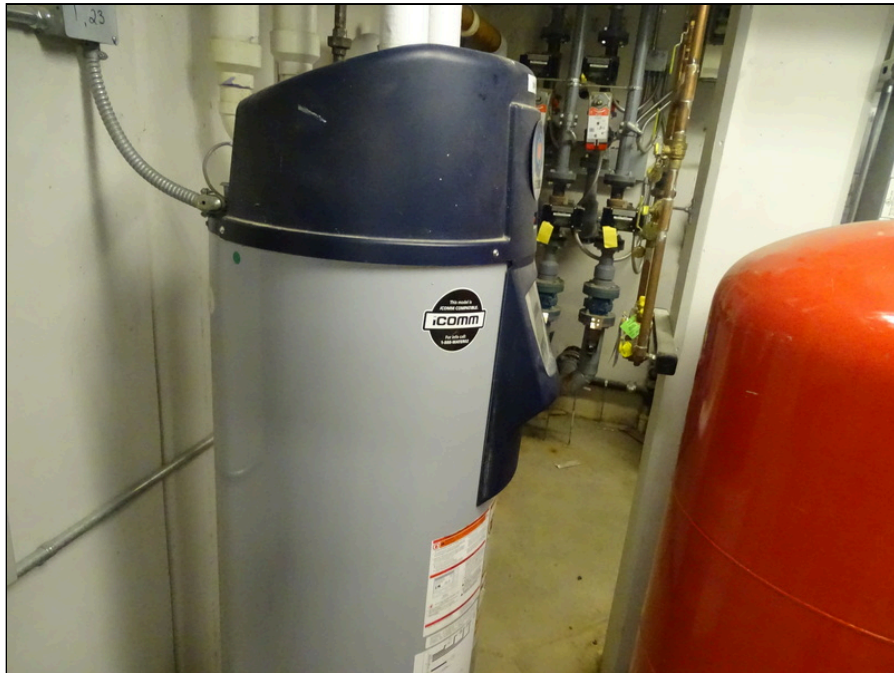
58 - water heater

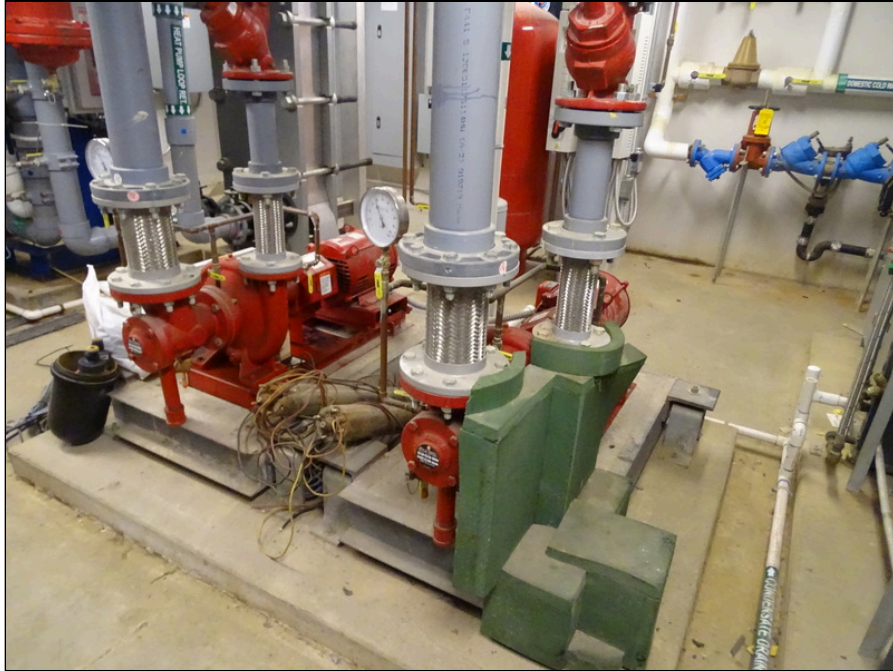
59 - Hot water piping system

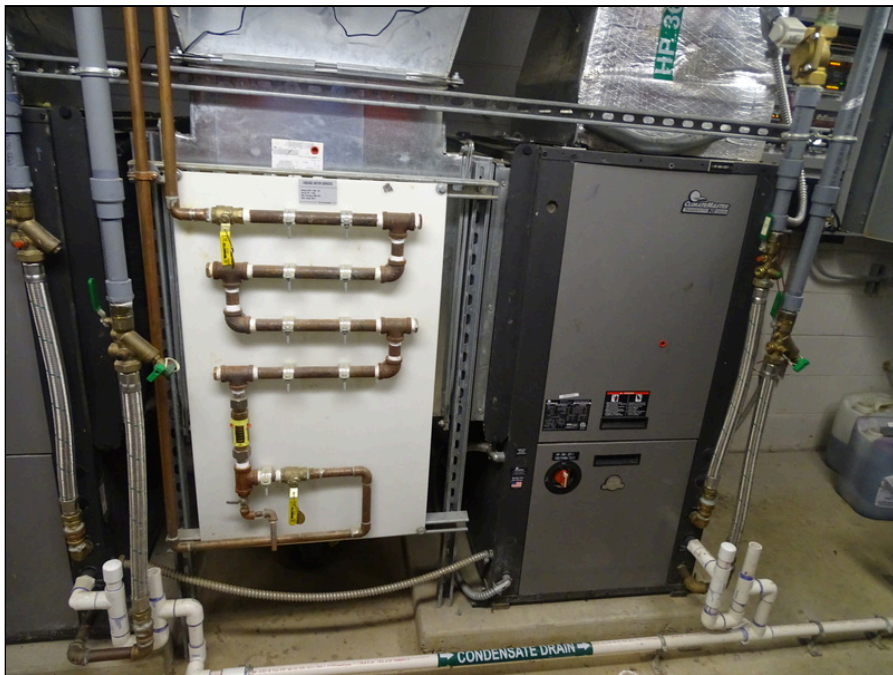
60 - Geothermal Heat Pump Vertical Package Unit

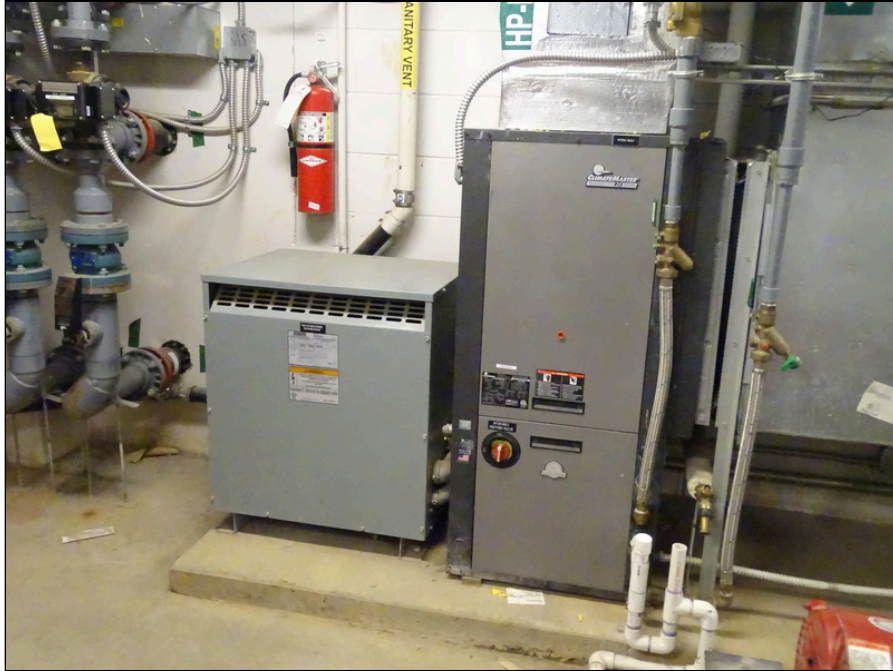
61 - Geothermal Heat Pump Vertical Package Unit

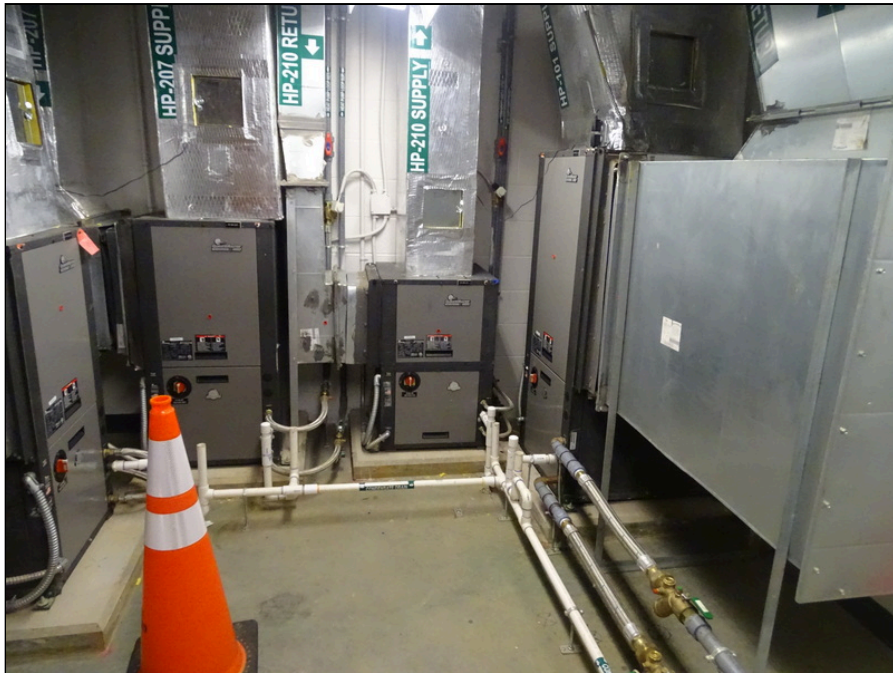
62 - Geothermal Heat Pump Vertical Package Unit
