FONTAINE AVENUE FIRE STATION  
2420 FONTAINE AVENUE  
CHARLOTTESVILLE, VIRGINIA

ECS PROJECT NO. 46:6713

CITY OF CHARLOTTESVILLE - FACILITIES DEVELOPMENT

Reference: Facility Condition Assessment Report for Fontaine Avenue Fire Station, 2420 Fontaine Avenue, Charlottesville, Virginia

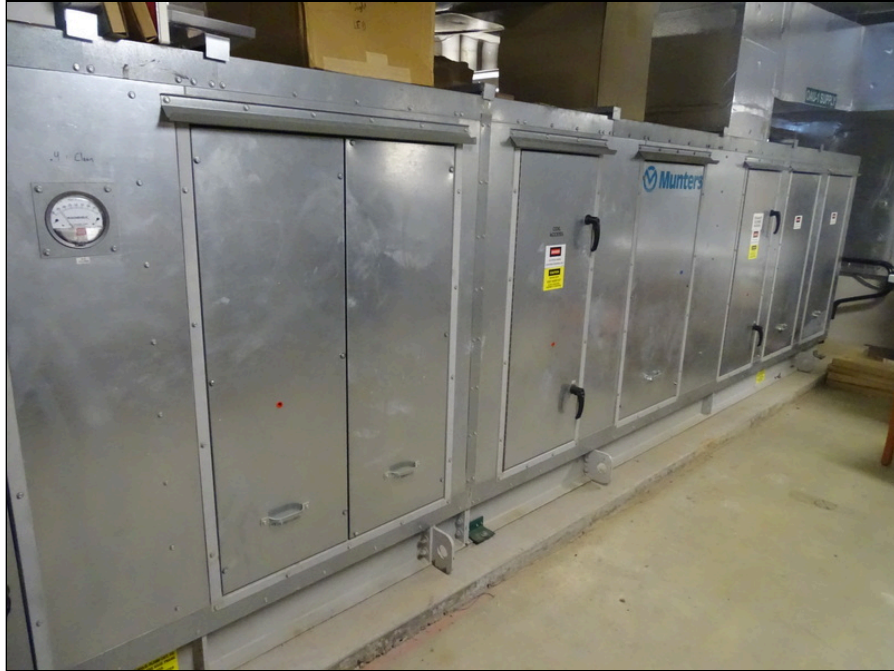
63 - Dehumidifier Unit

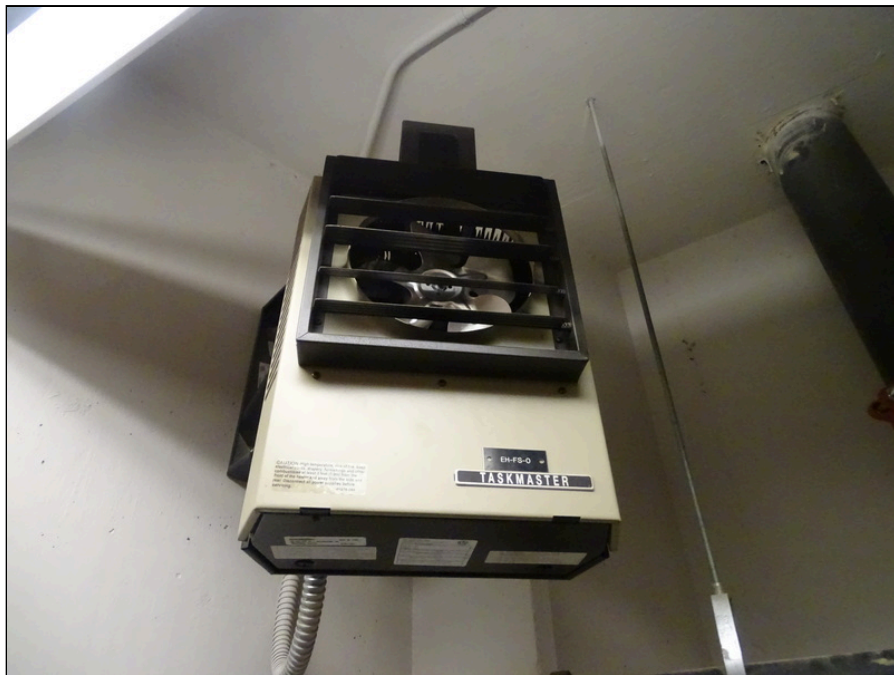
64 - Typical space heater

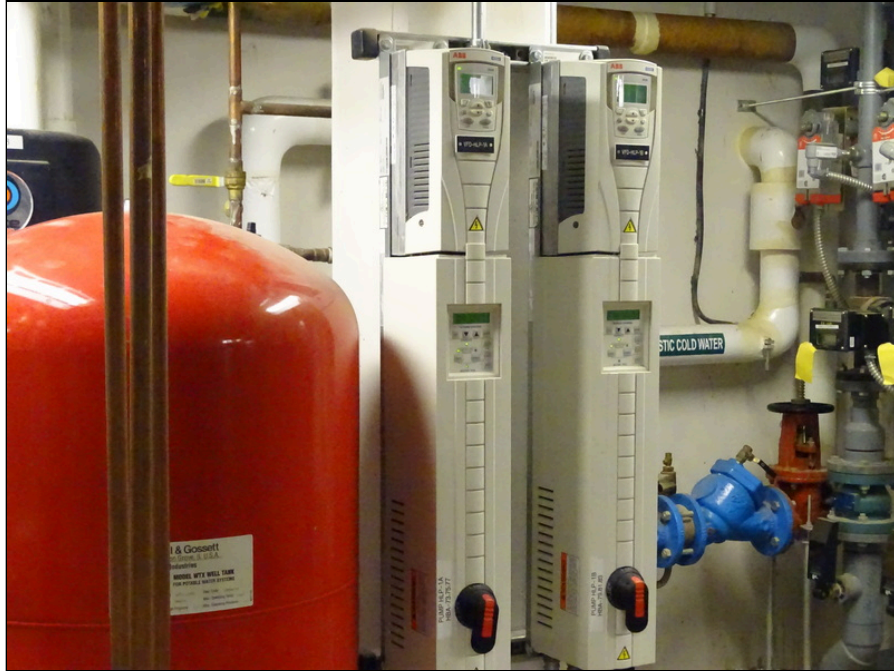
65 - Variable frequency drive mechanical controls

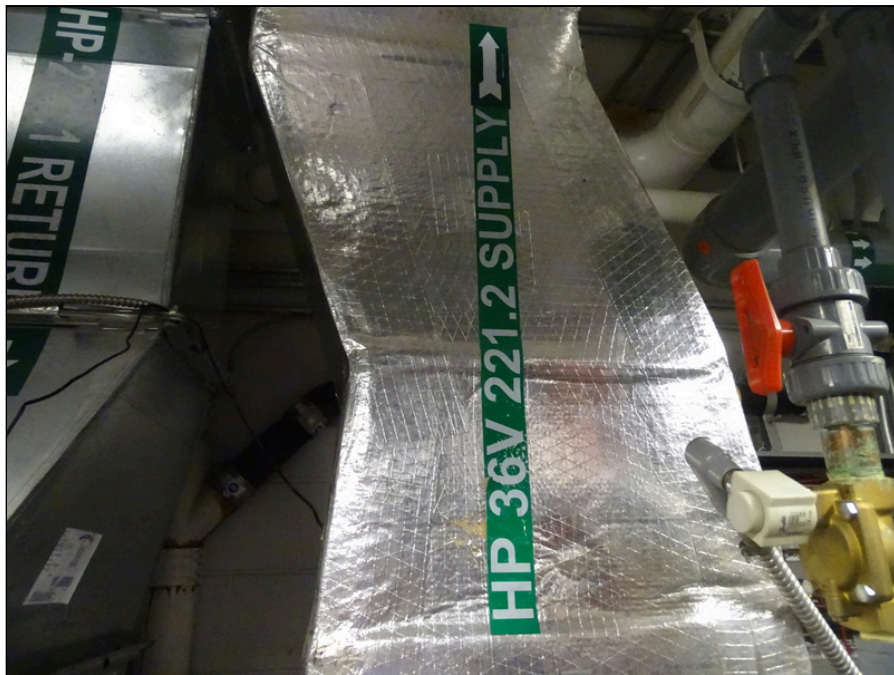
66 - duct work

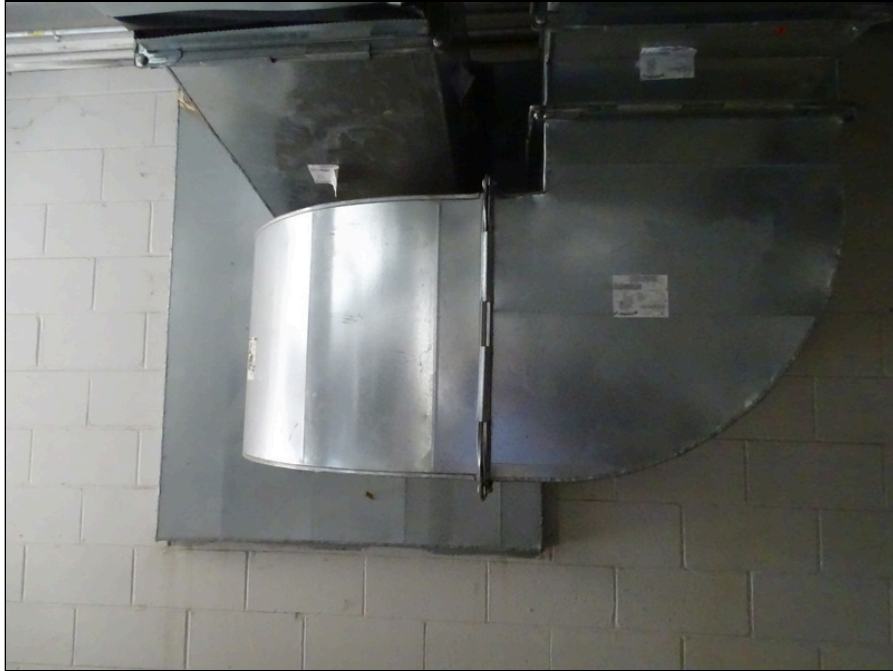
67 - Typical mechanical ductwork

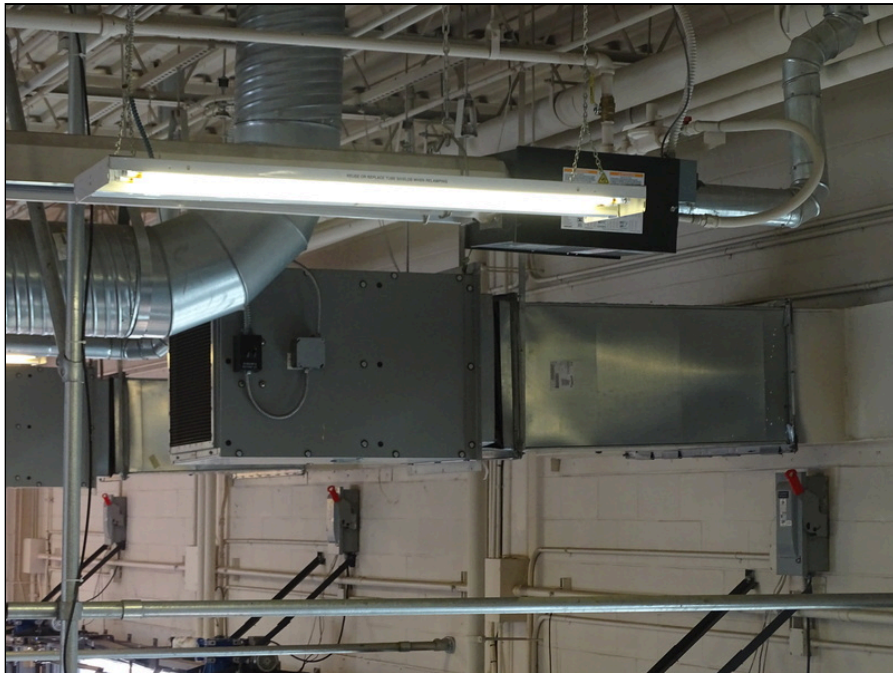
68 - Typical mechanical duct

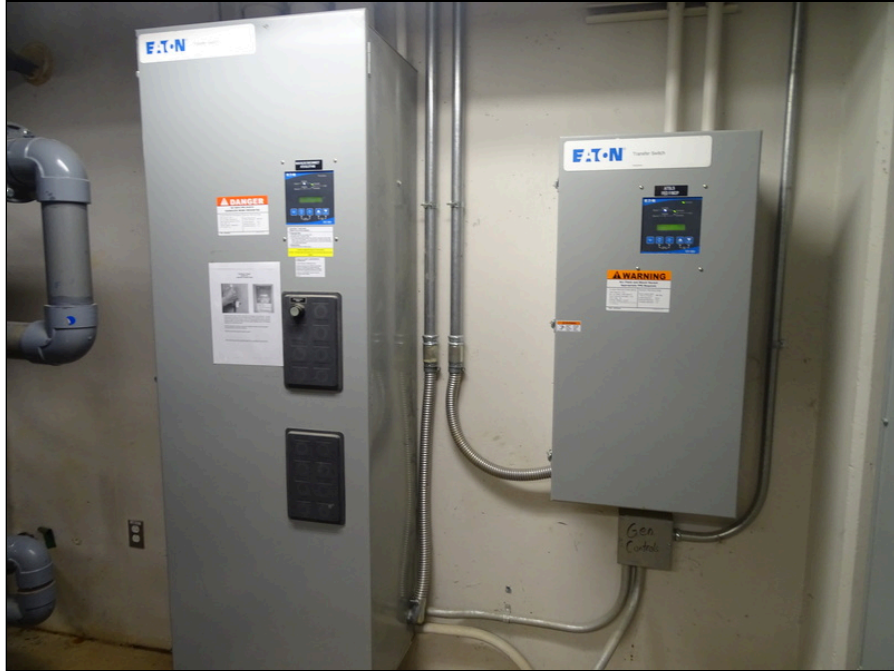
74 - Electrical panel

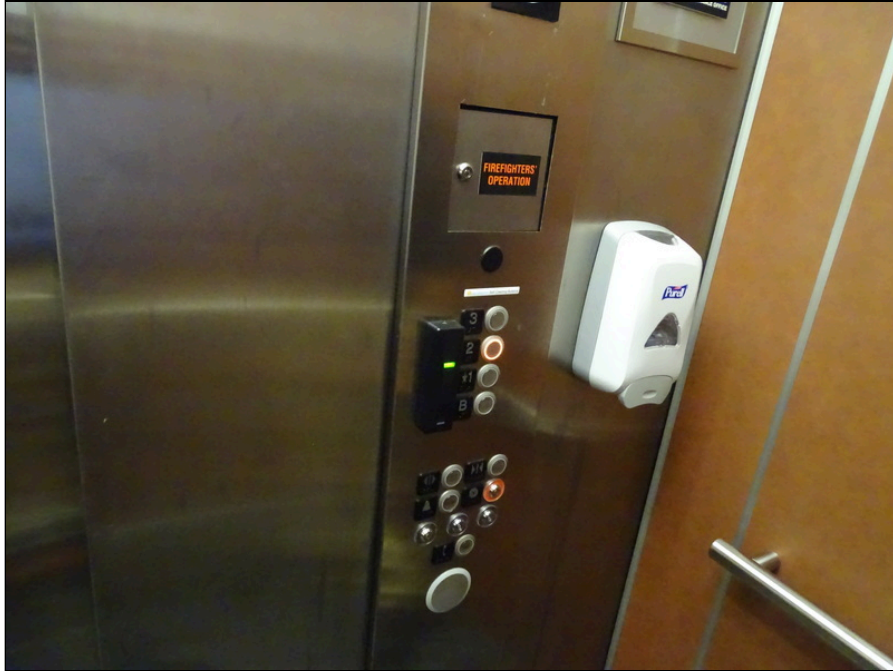
90 - Elevator equipment

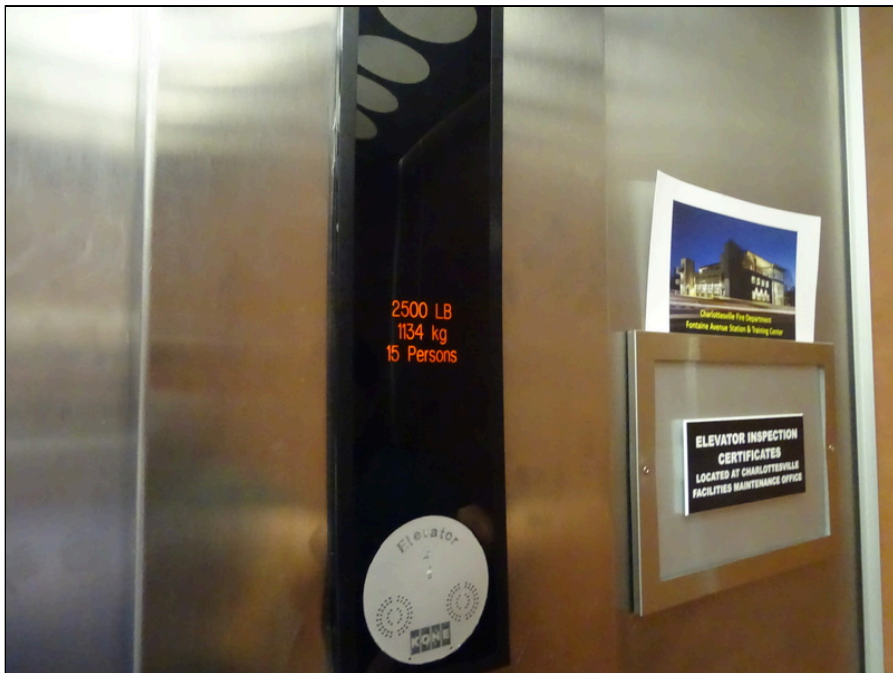
91 - Elevator cab overview

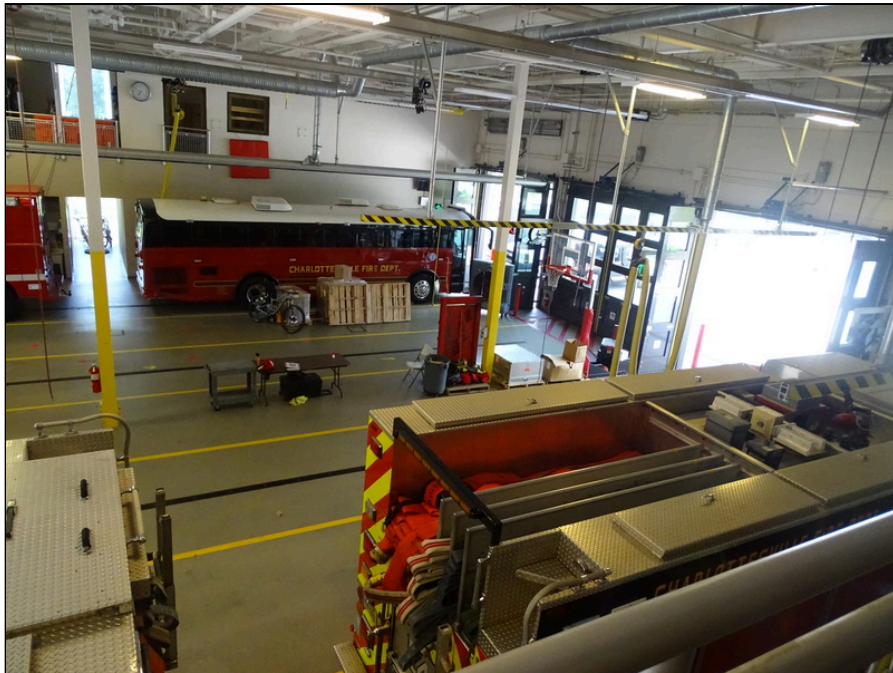
93 - Bay area interior finishes

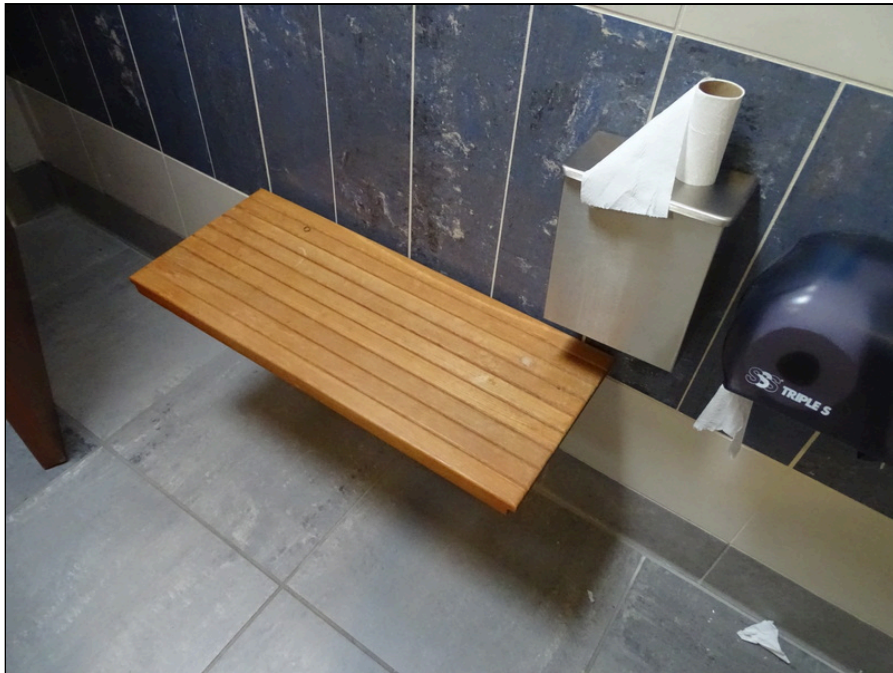
103 - Dorm area- interior finishes

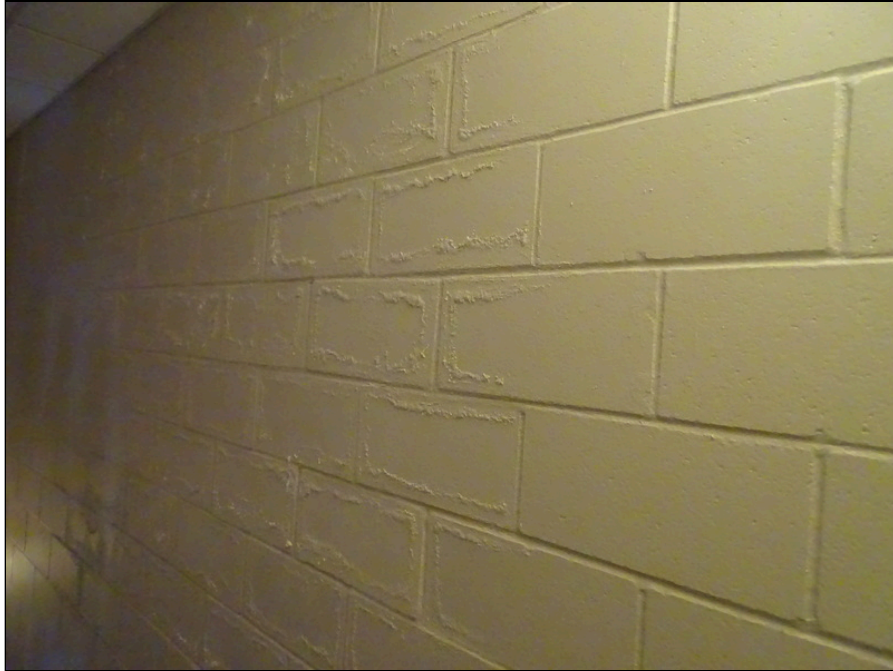
104 - Disable rest room interior

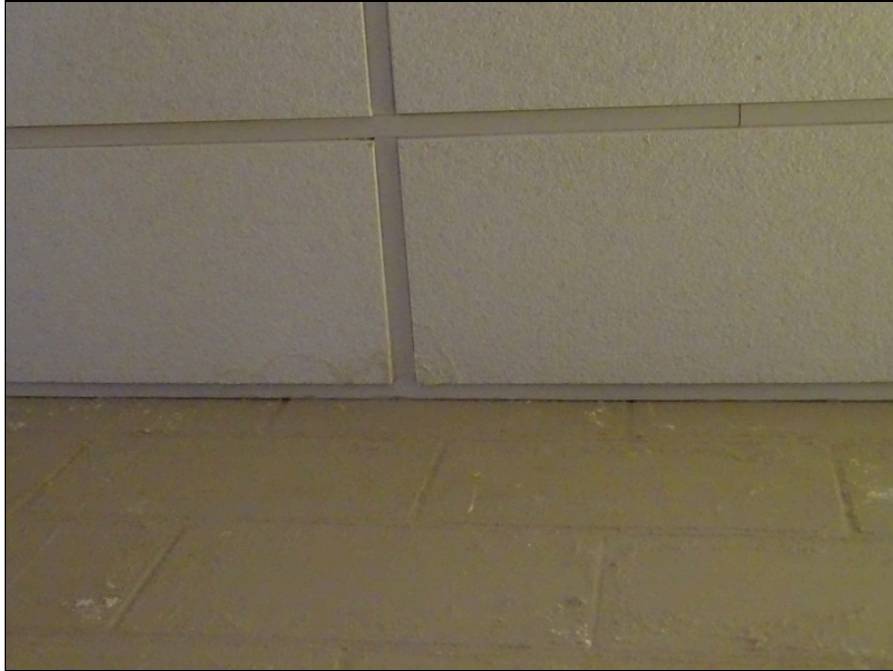
106 - Efflorescence stair interior

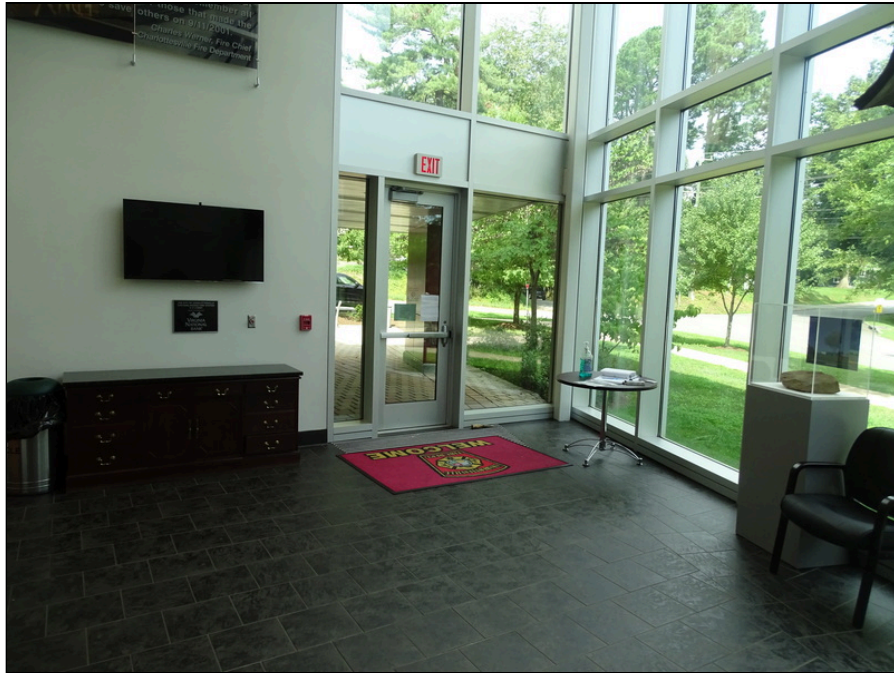
111 - Typical interior hall overview

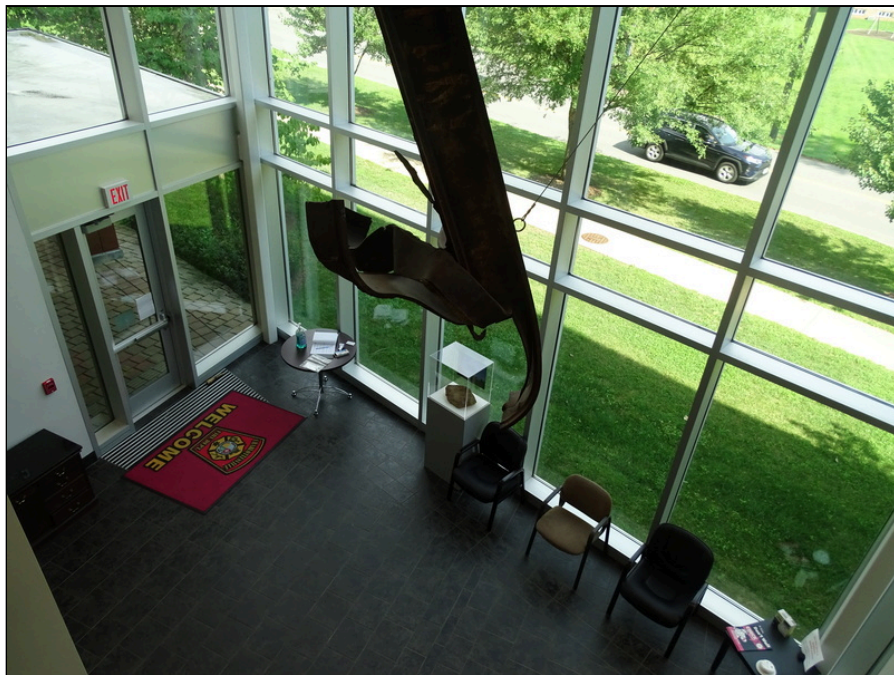
112 - Typical hall interior overview

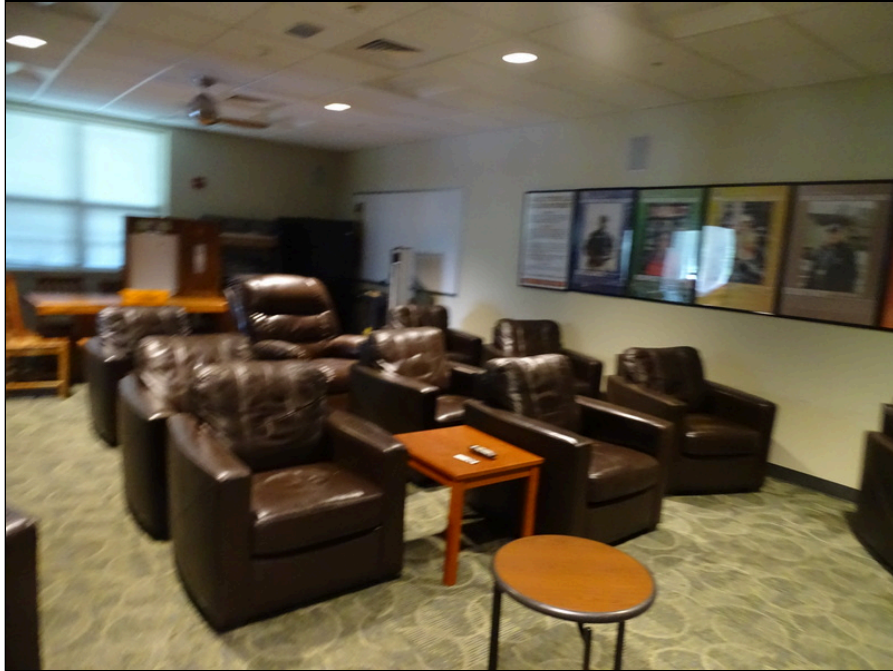
113 - Typical setting area overview

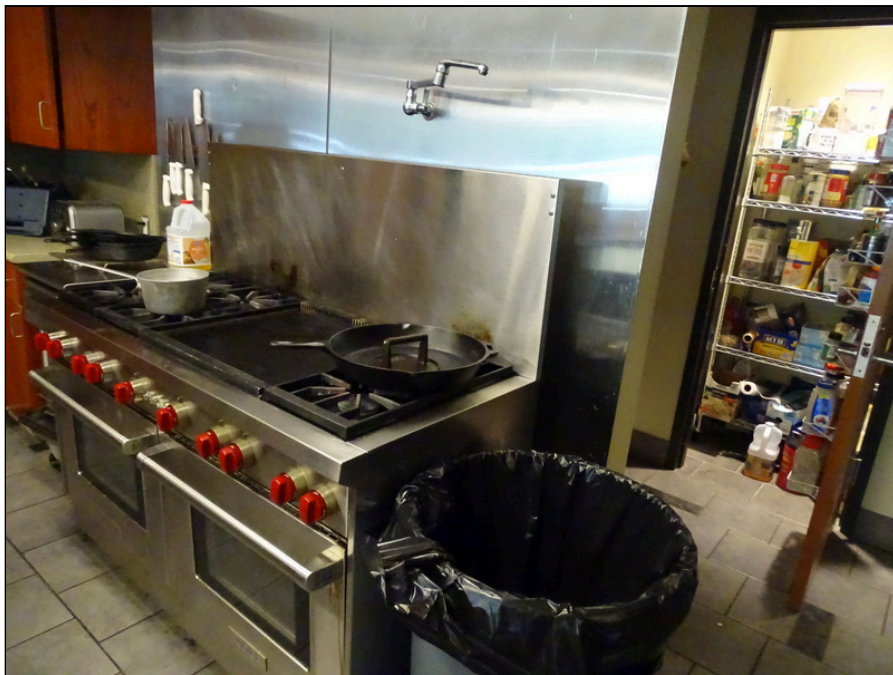
114 - Typical Kitchen overview

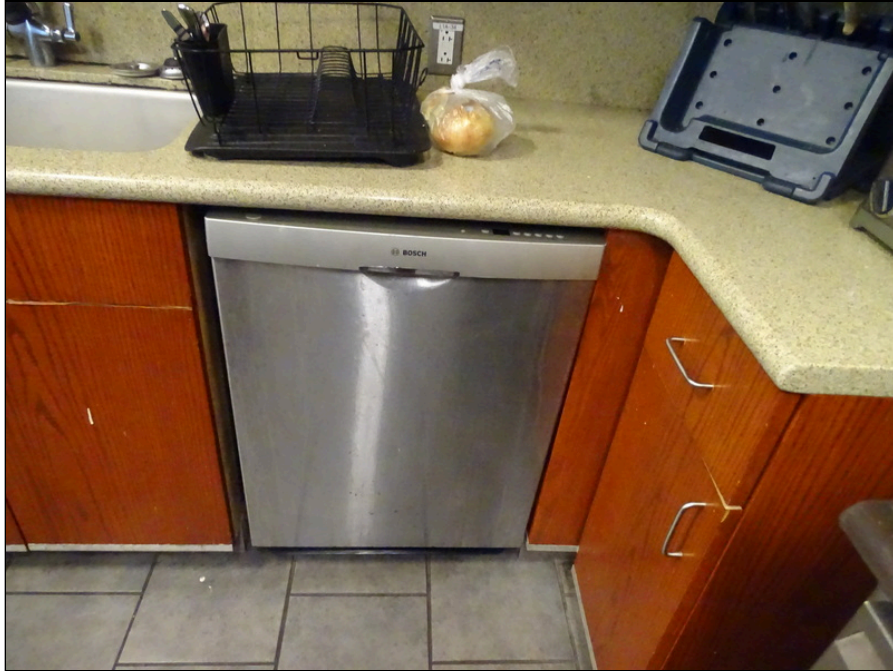
115 - Typical dishwasher

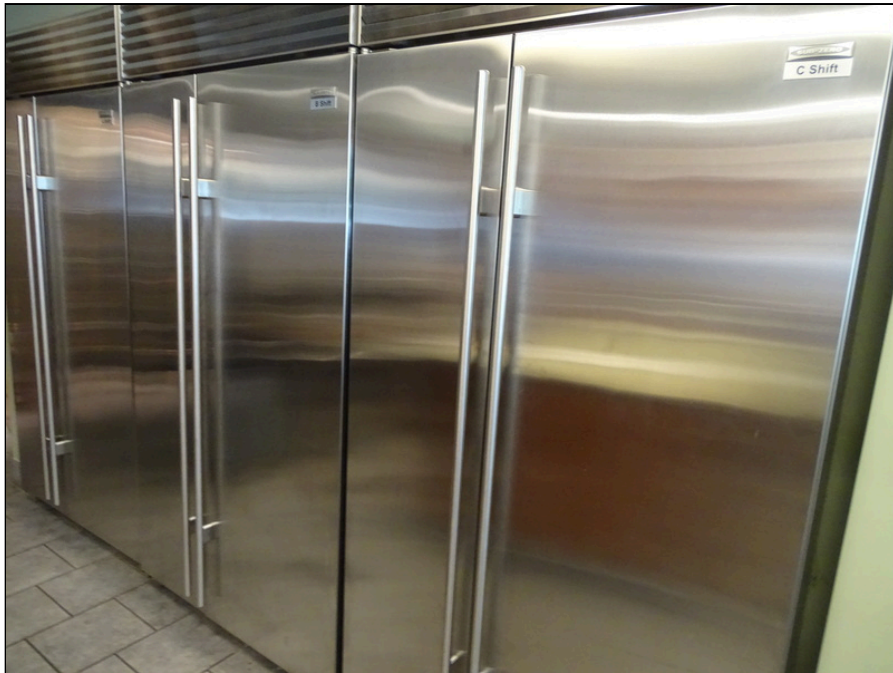
116 - Typical refrigerator

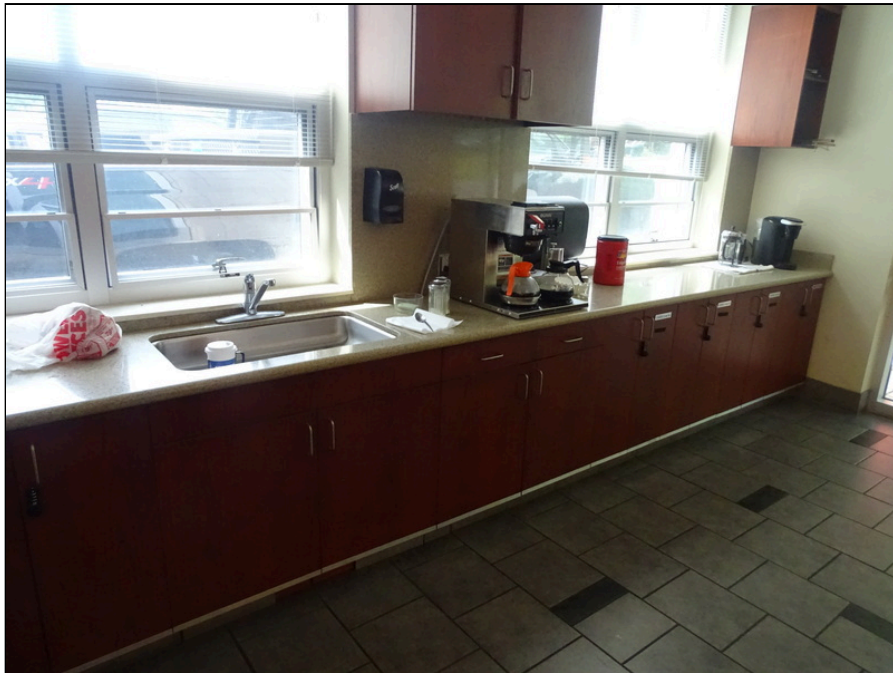
120 - Typical kitchen cabinet

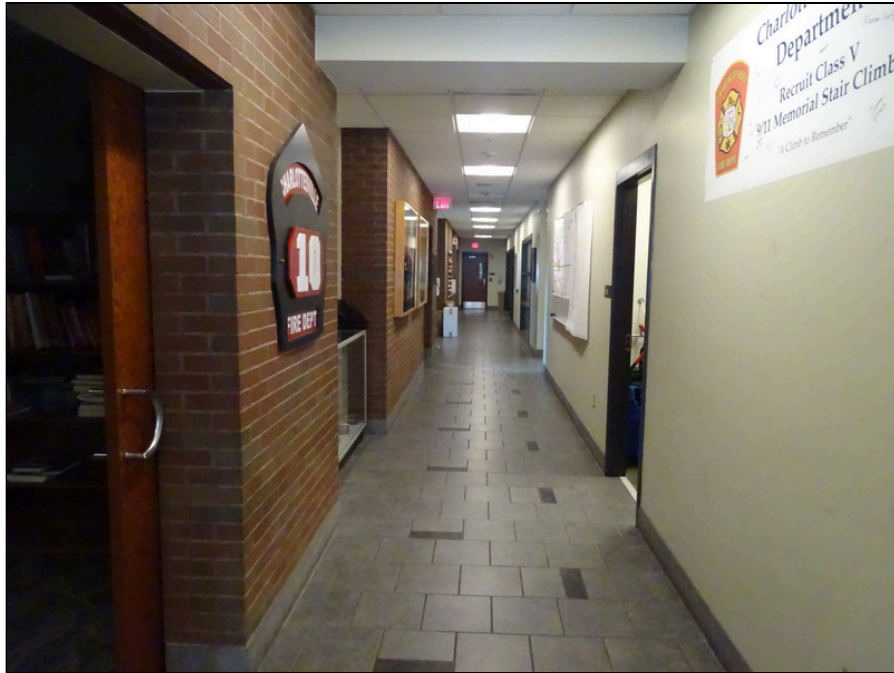
121 - Typical corridor area interior

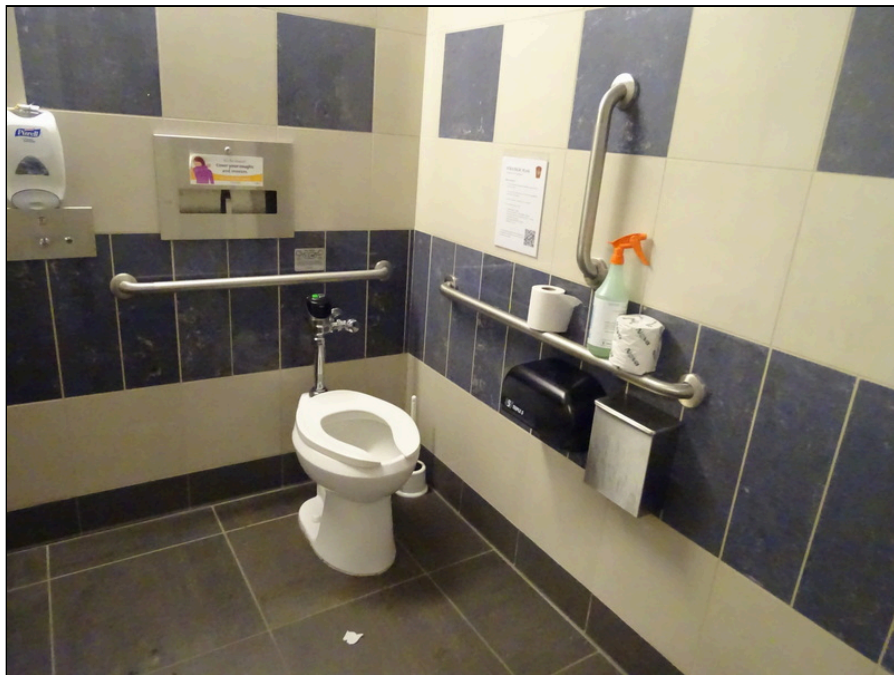
122 - Accessible Toilet

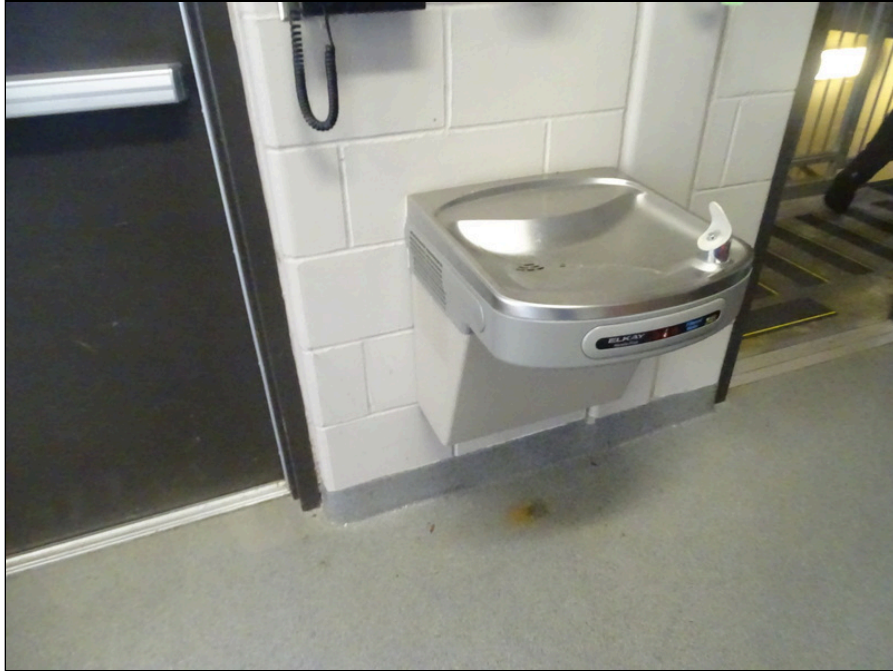
123 - Typical drinking water fountain

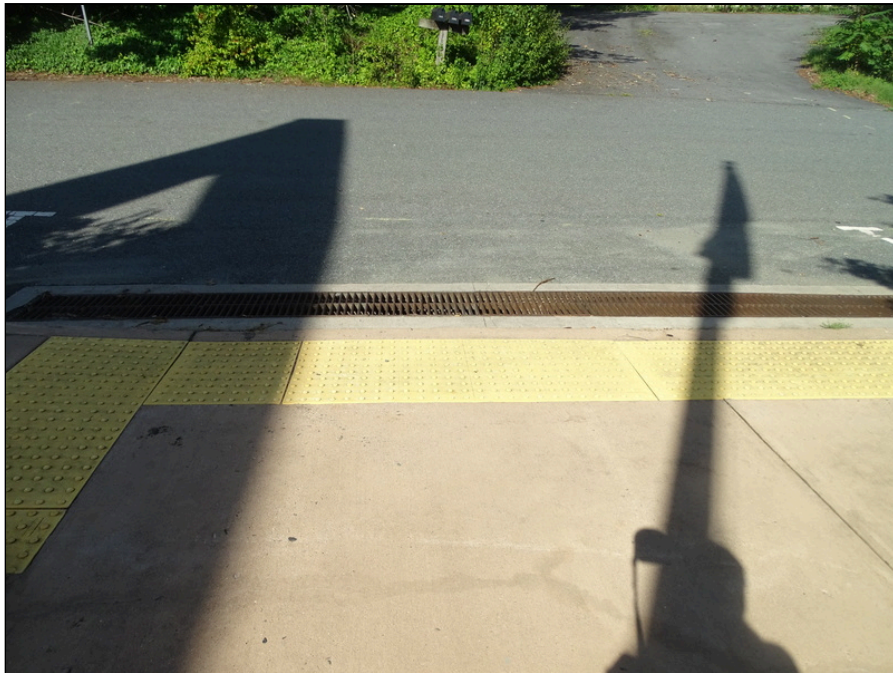
124 - Typical truncated Domes

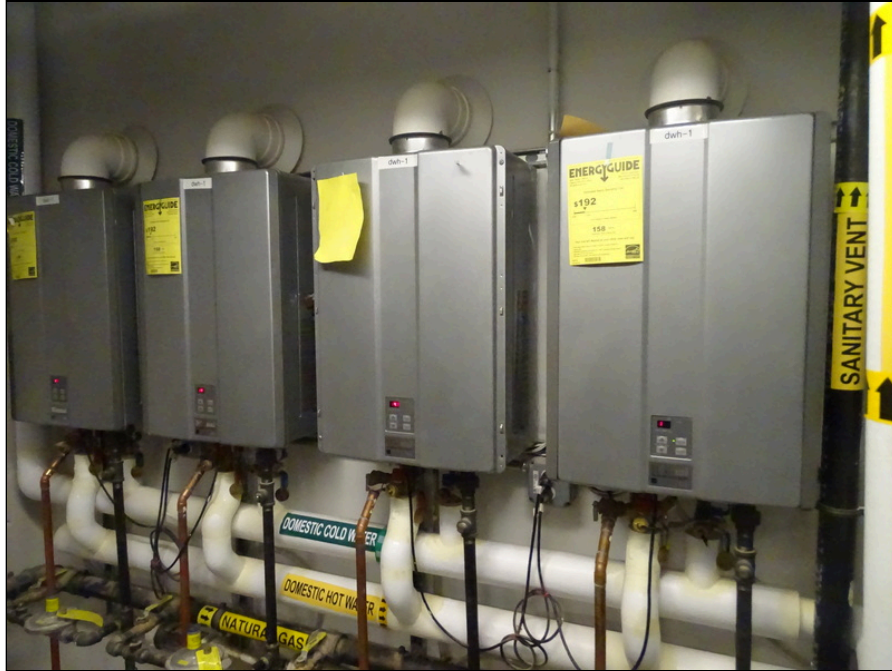
125 - Tankless domestic water heaters
