RIDGE STREET FIRE STATION & HOSE TOWER  
203 RIDGE STREET  
CHARLOTTESVILLE, VIRGINIA

ECS PROJECT NO. 46:6713

SEPTEMBER 14, 2021

Reference: Facility Condition Assessment Report for Ridge Street Fire Station & Hose Tower, 203 Ridge Street, Charlottesville, Virginia

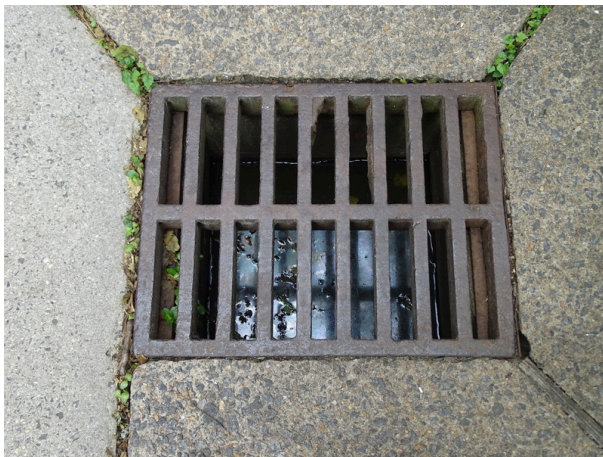
Typical yard inlet drain

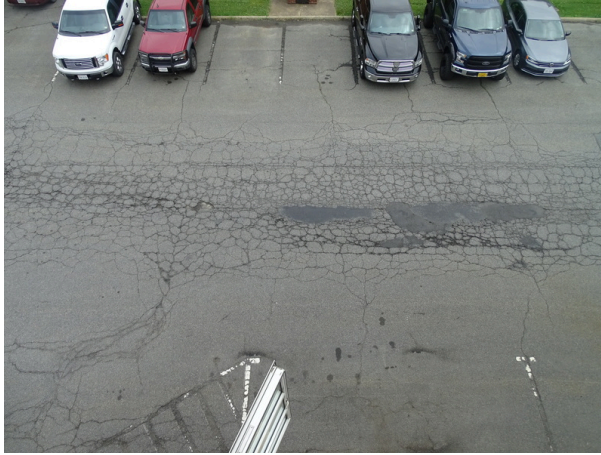
Asphalt paving drive lane and parking northwest side of the building - note alligator cracking

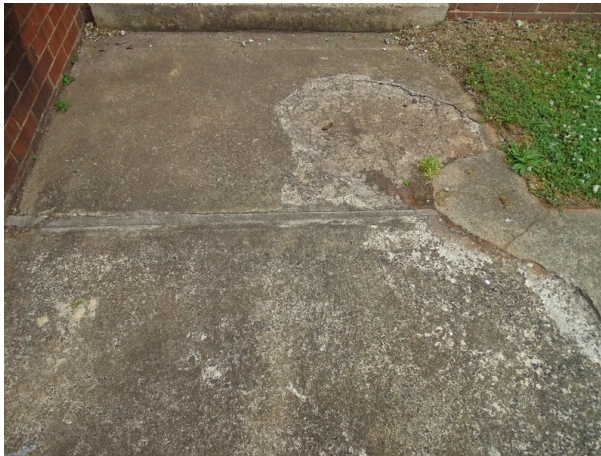
There are Concrete sidewalks of undetermined thickness provided on the east side and south side of the building. Regularly spaced control joints were observed. Several sections of the Concrete sidewalks were observed to be deteriorated. We recommend that the deteriorated sections of Concrete sidewalks be replaced

Concrete sidewalk south side - note deterioration

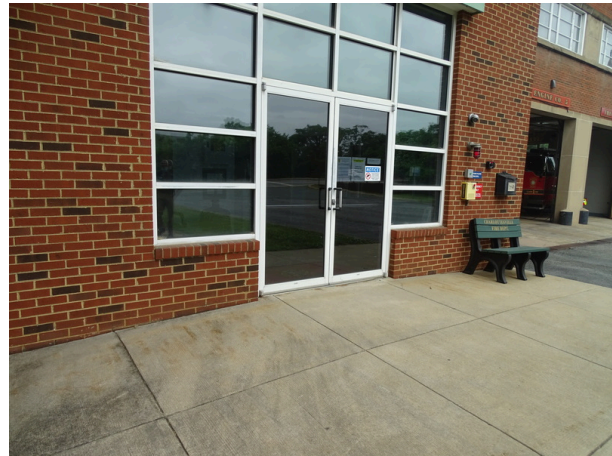
Concrete sidewalk east side

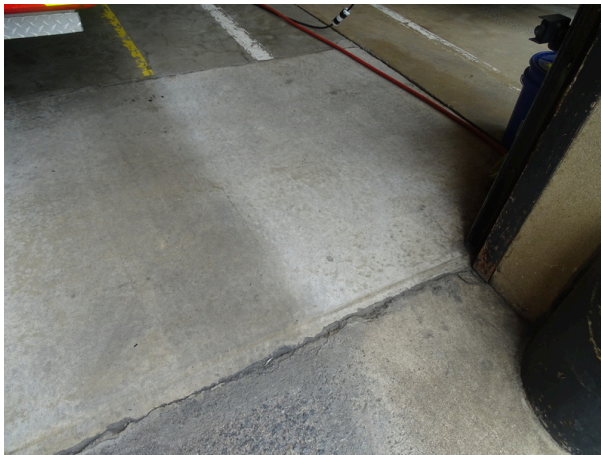
The structure of the building consists of Concrete masonry unit bearing walls with interior steel columns. The structural frame of the building was generally in good to fair condition. Recent renovations indicated repairs to previously noted interior CMU wall cracking that did not pose an imminent danger. The bay number nine concrete slab-on-grade area was cracked. In addition, the area reportedly yields when fire truck engines load the slab area. We recommend removing the cracked concrete area and re-establishing a solid subgrade after removal of soft yielding subgrade material.

Slab on grade at east bay area - note cracking and settlement

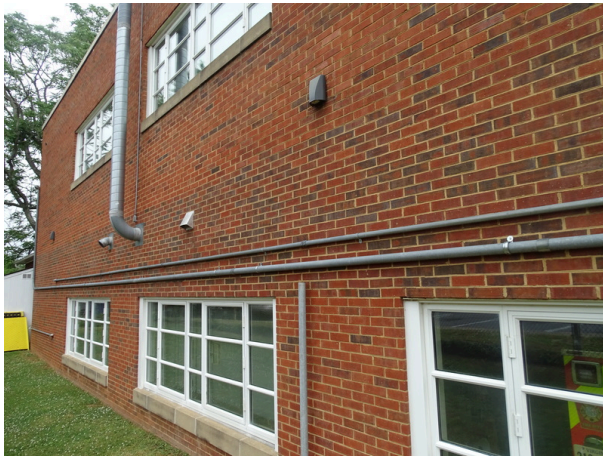
Building exterior north wall

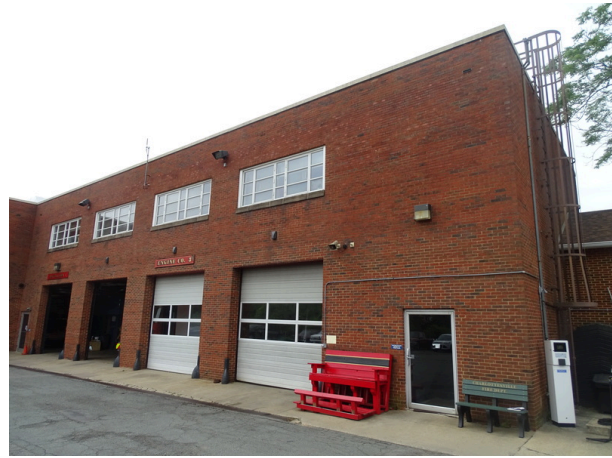
Building exterior north side of the west bay area

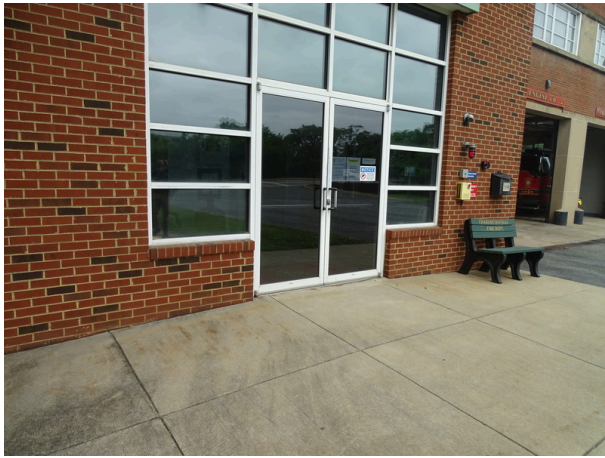
Storefront entrance at west addition

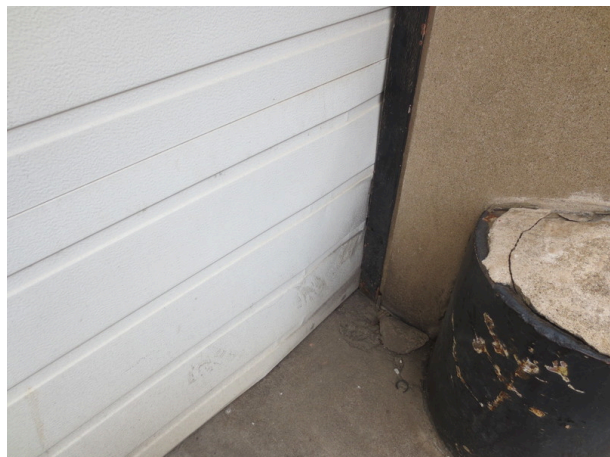
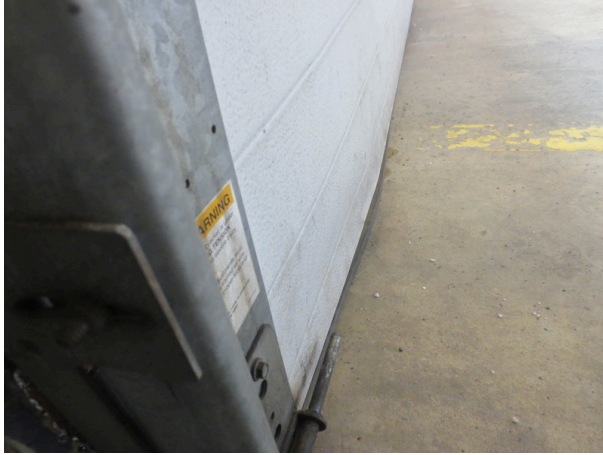
Overhead doors are located at north side of the west bay area and the east and west sides of the east bay area. The overhead doors on the north and west sides were generally in good condition. The three overhead doors on the east side of the building were damaged and in need of replacement.

Overhead door east

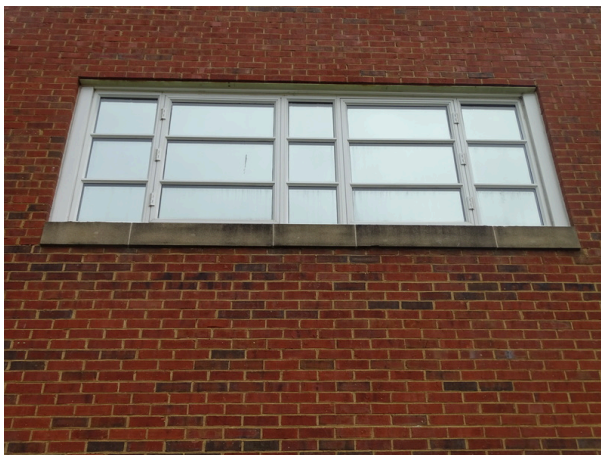
The window system for the building primarily consists of Cluminum frame double pane - operable window units with aluminum frame double pane window units located around the building. The gaskets in the windows were generally in fair condition. The expected useful life of gaskets is typically 20 years. Fogged windows were observed at the west exterior walls of the east bay area on the second level. There was also reported leakage for windows on the north wall of the west end of the building on the second level. The window replacement parts for the operable components were reportedly difficult to replenish from the window manufacturer and/or other suppliers. We recommend the windows be replaced during the report period.

Typical operable exterior window

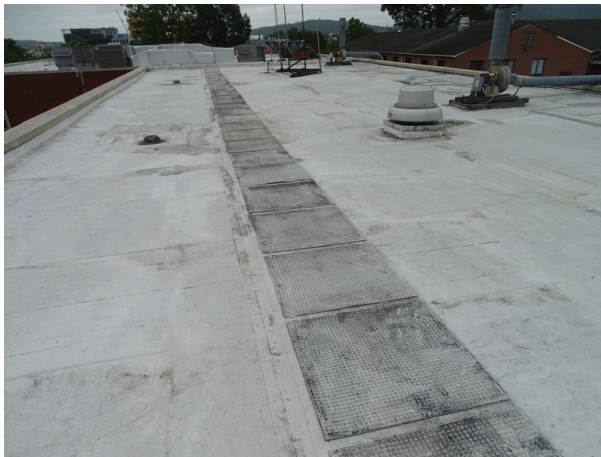
Single-ply membrane roofing system over main building area

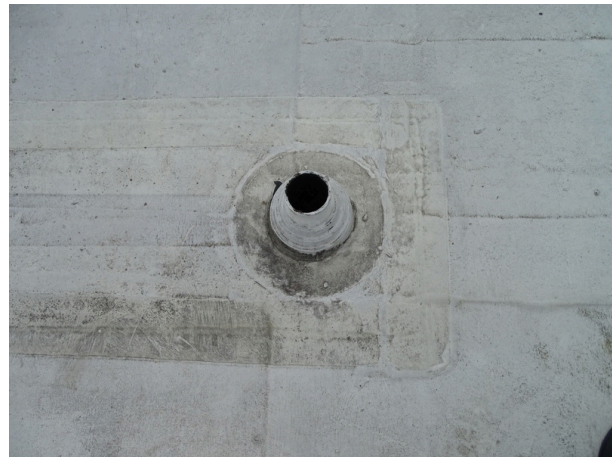
Typical plumbing penetration for main roofing system

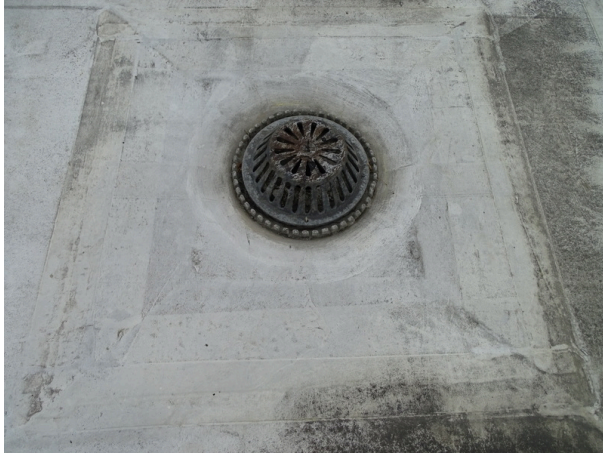
Typical internal drain for main roofing system

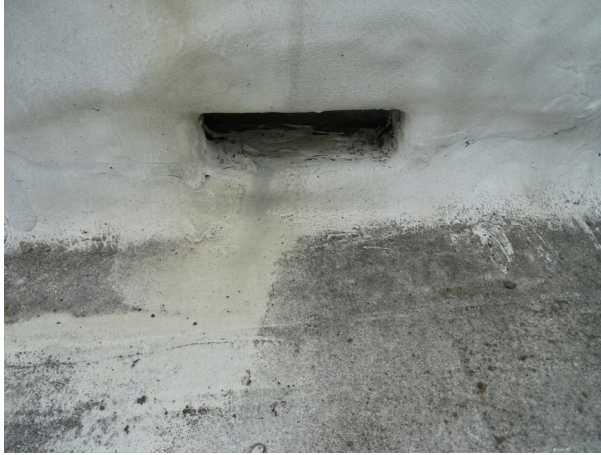
Typical parapet wall and through wall scupper drain of main roofing system

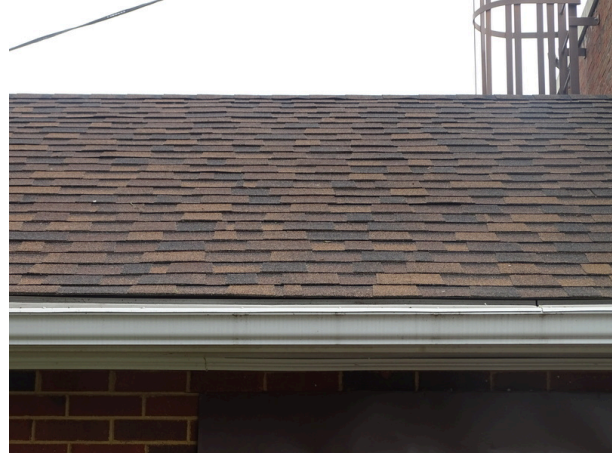
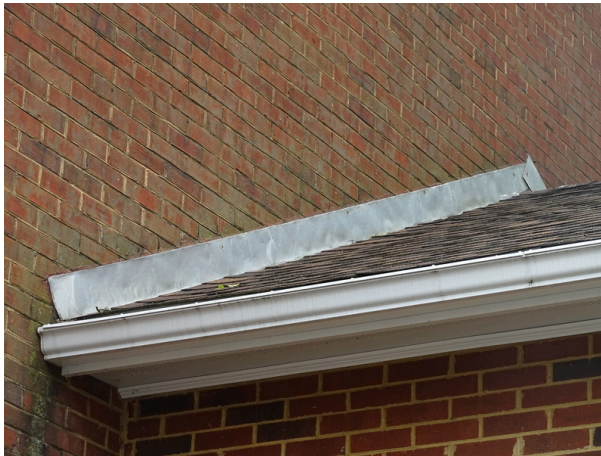
Asphalt shingle roofing system over west addition - note recent replacement

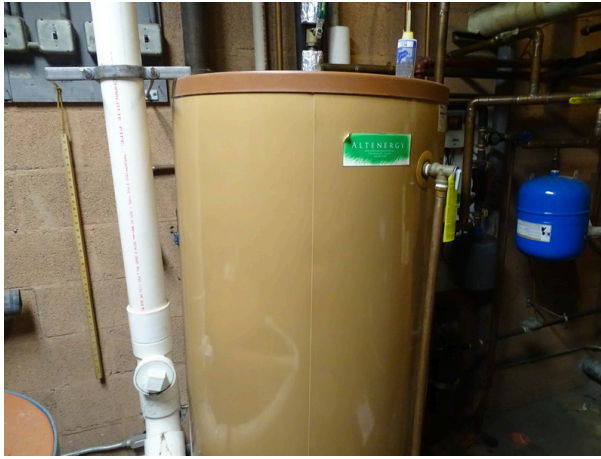
Domestic hot water storage tank

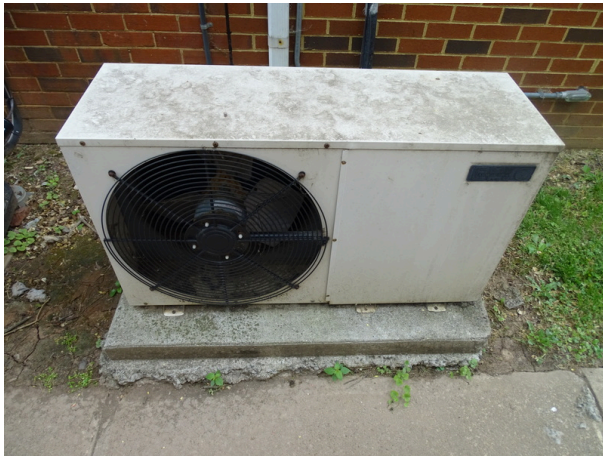
Condenser located on grade - manufactured by  
Enviromaster International in 1996

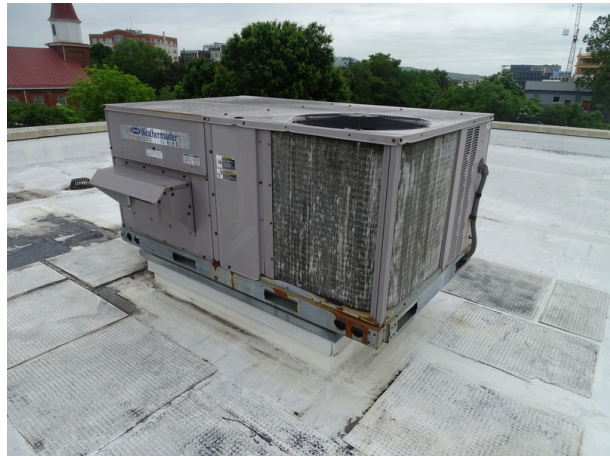
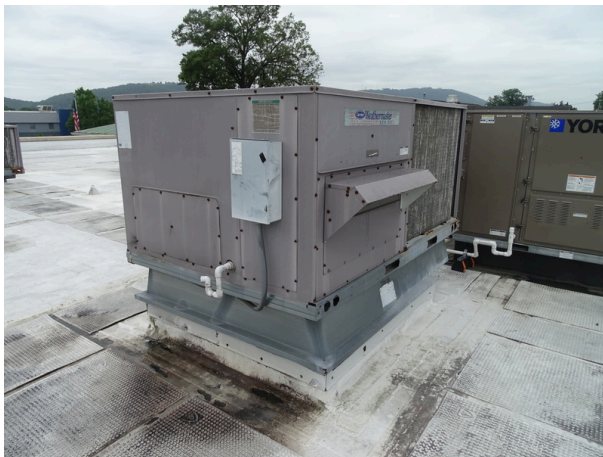
Condenser located on roof - manufactured by  
Carrier in 2006

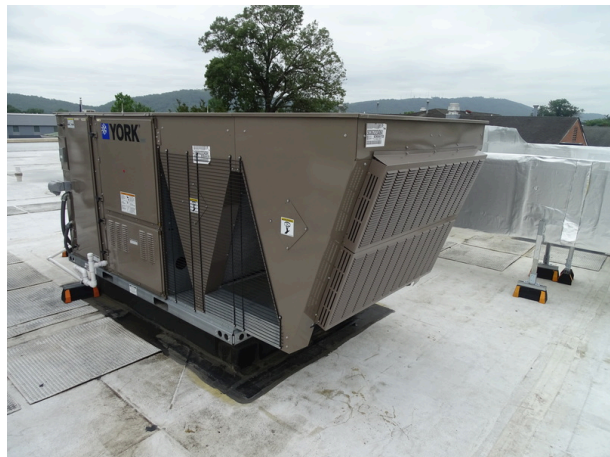
Condenser located on roof - manufactured by  
York

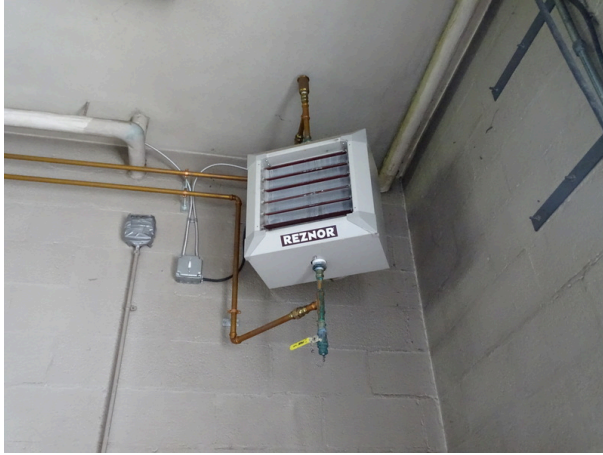
Ceiling mounted hot water heating units

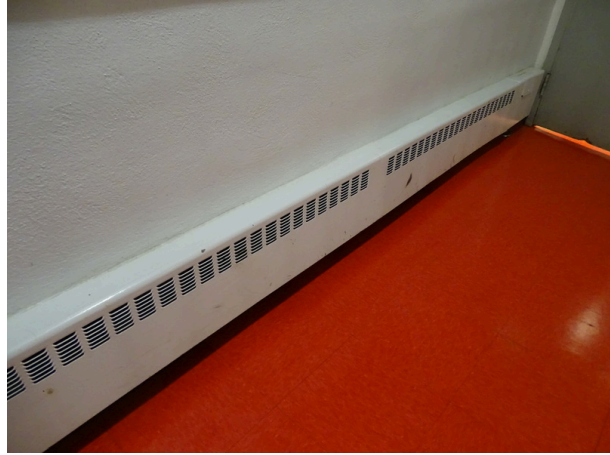
Typical hot water baseboard heater unit

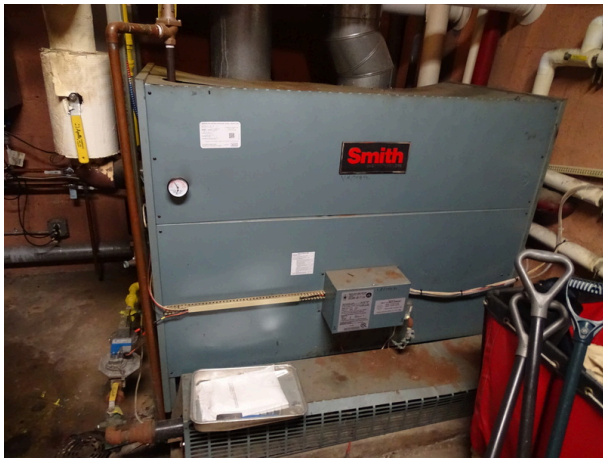
Boiler located in main utility room

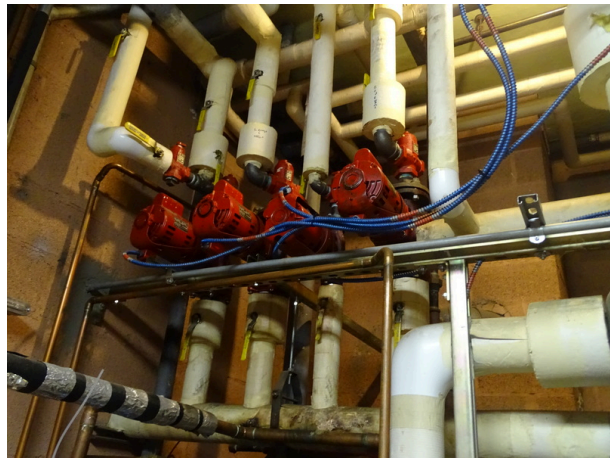
Typical hot water piping system

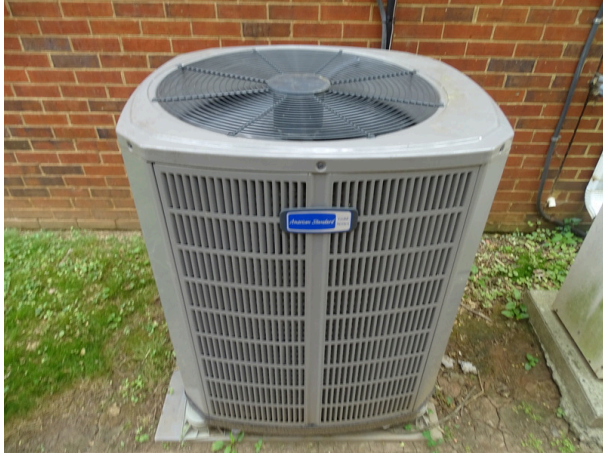
Condenser located on grade - manufactured by  
American Standard in 2017

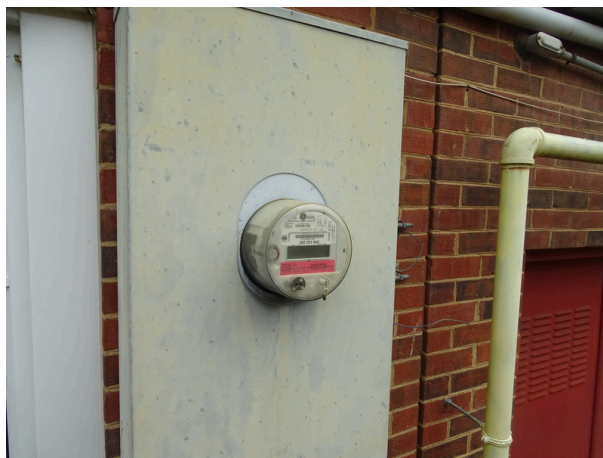
Typical electric meter

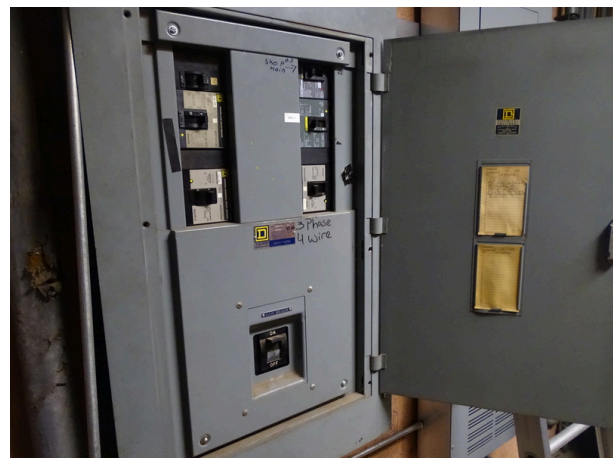
Main electrical switch gear

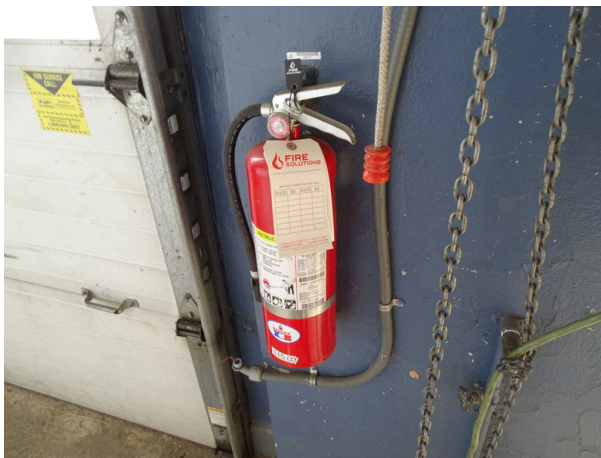
Typical fire extinguisher

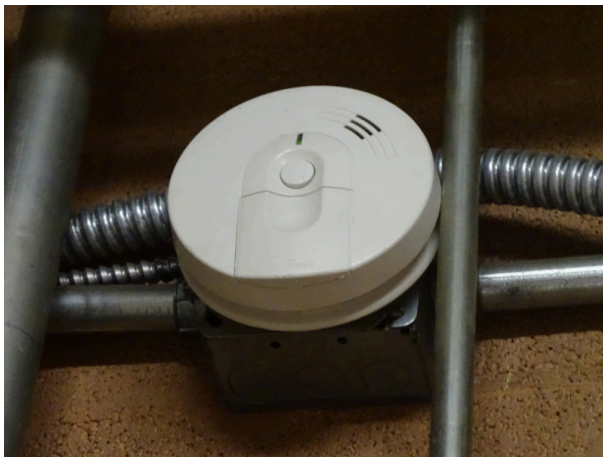
Typical smoke detector

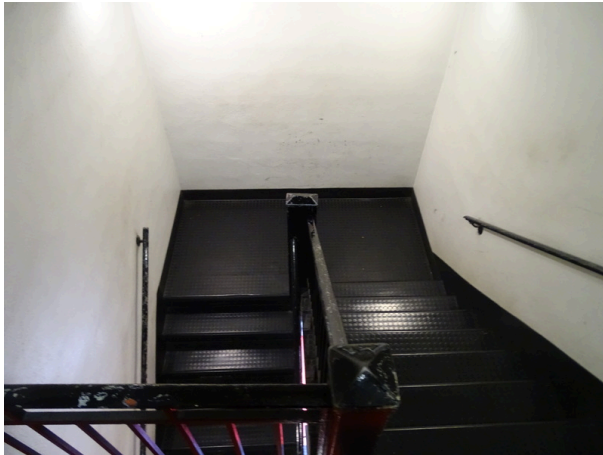
Typical stair area interior

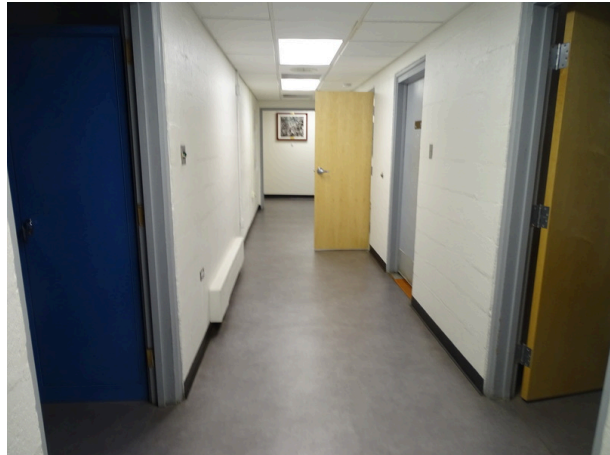
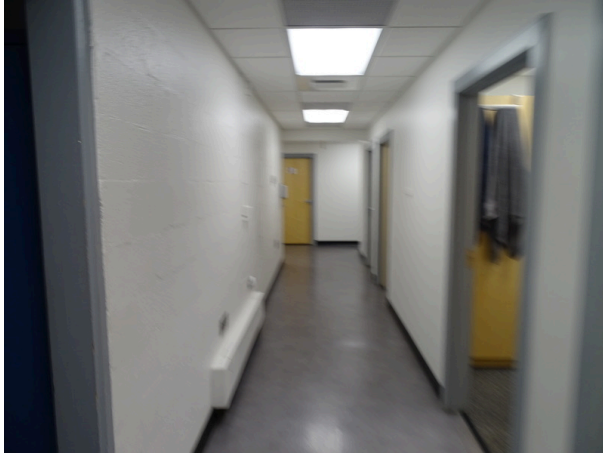
Typical corridor area interior

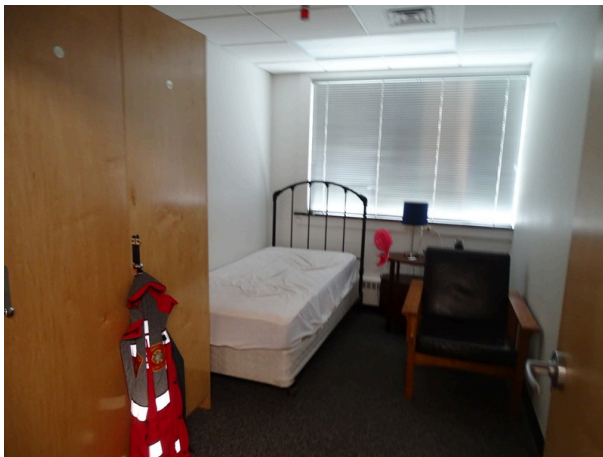
Typical dorm room interior

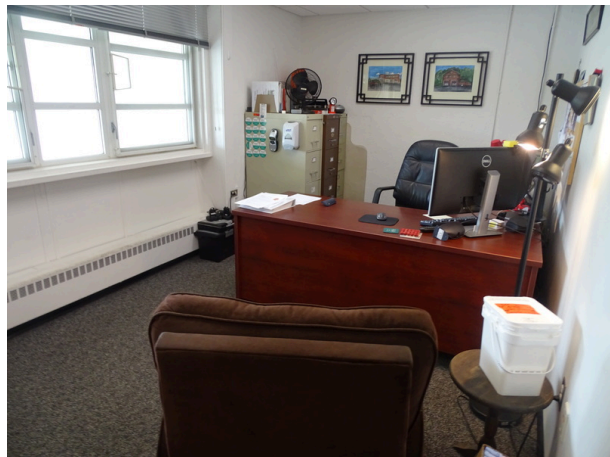
Typical interior of office areas

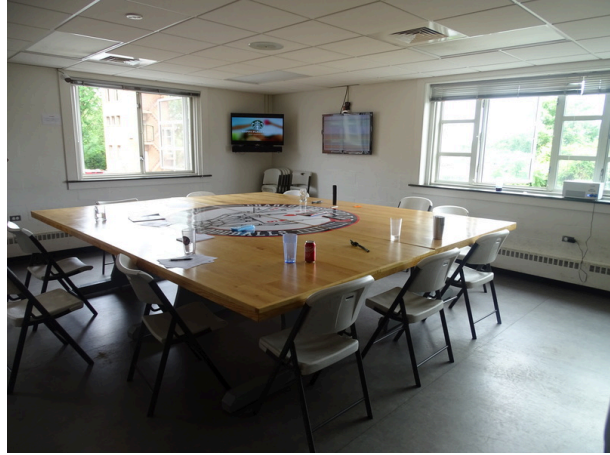
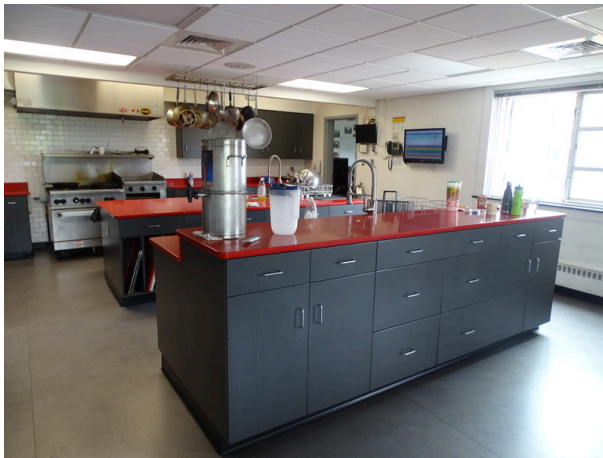
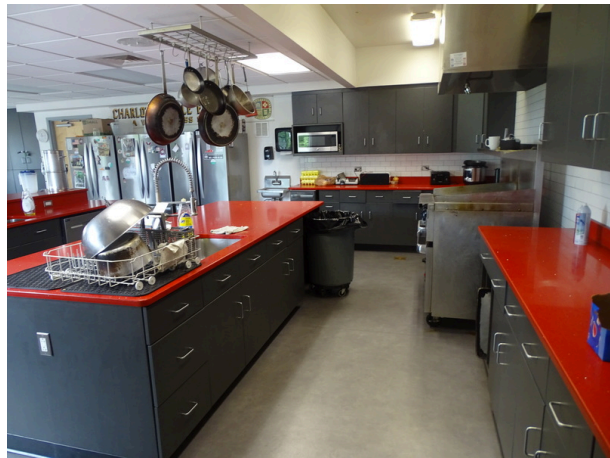
Typical kitchen area interiors

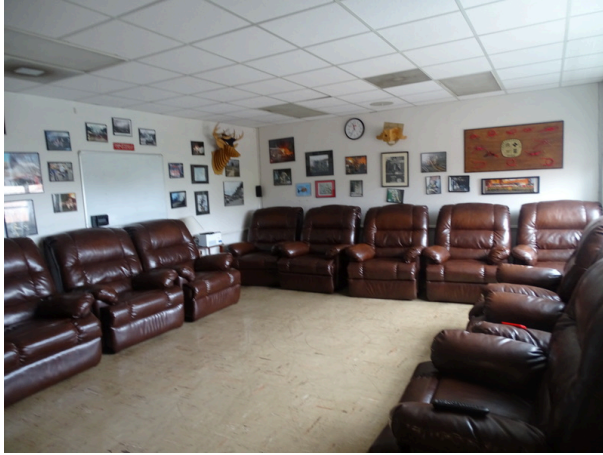
Typical meeting room area interior

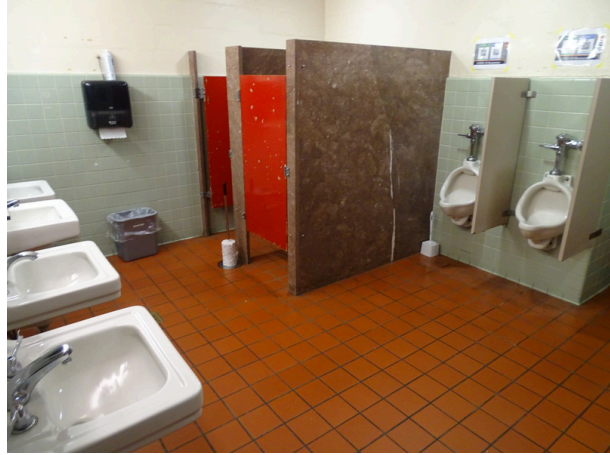
Typical restroom interiors

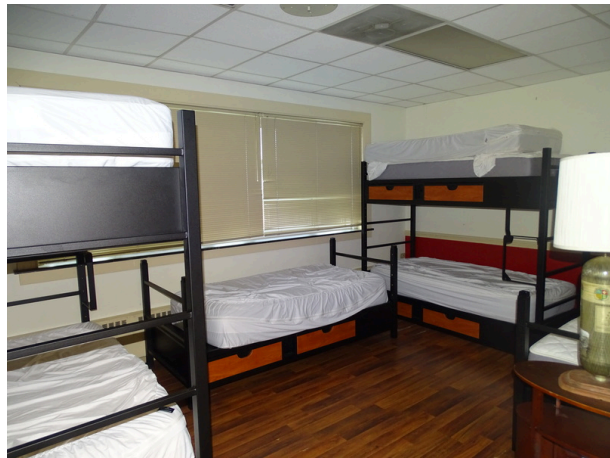
Typical dorm room interior

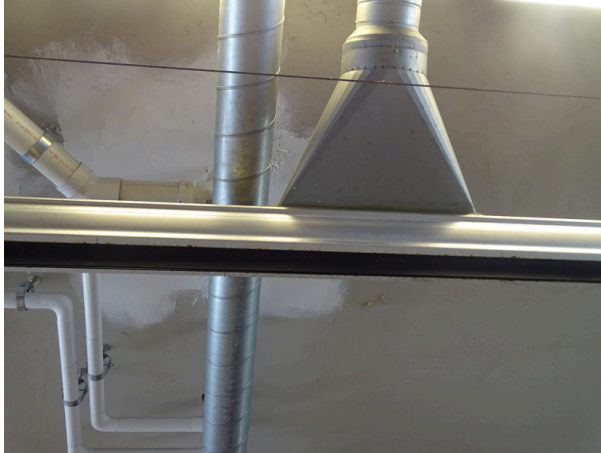
Typical interior of bay area - note peeling paint  
on ceiling

Cost Recommendation	EUL	EFF AGE	RUL	Year	Cost
PAINT BAY AREAS	7	3	4	4	\$2,500
				11	\$2,500
				18	\$2,500
Total					\$7,500

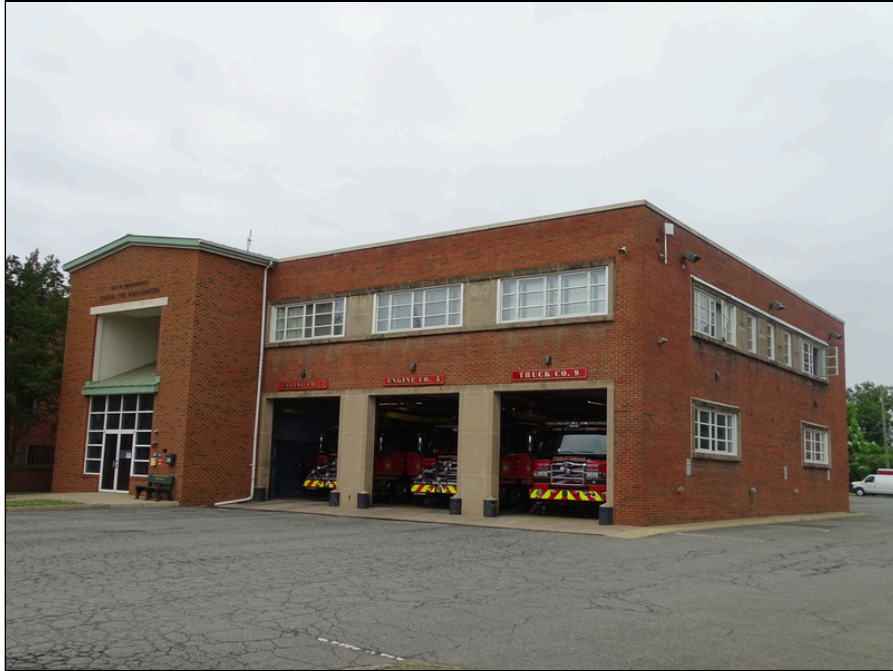
1 - Ridge Street Fire Station & Hose Station

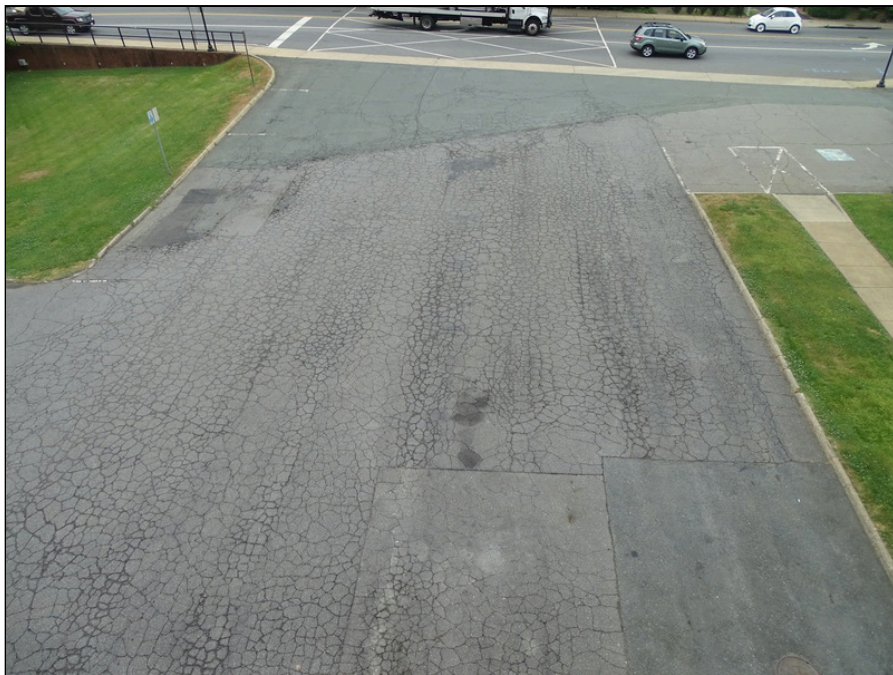
8 - Asphalt paving drive lane at east entrance

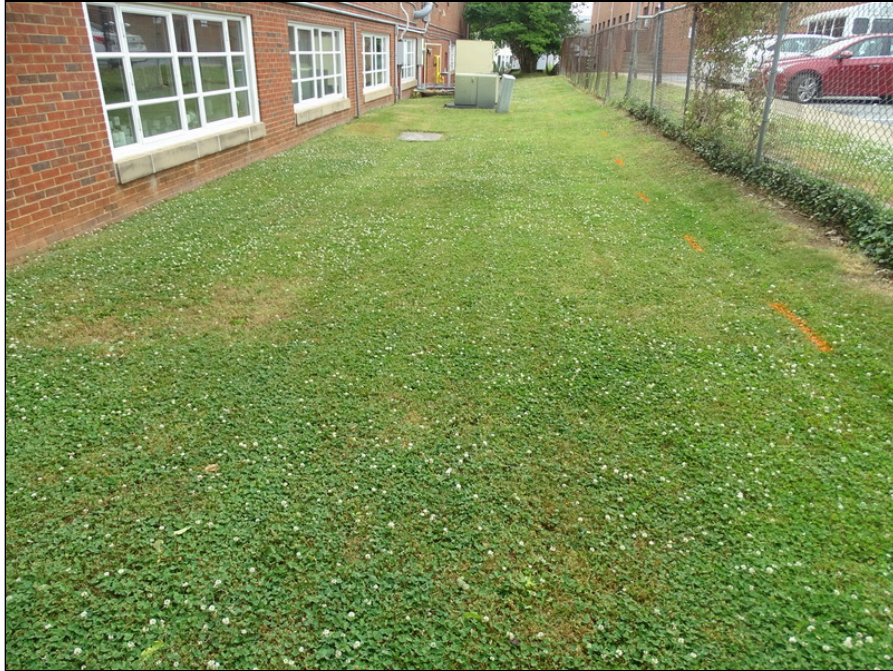
15 - Lawn area

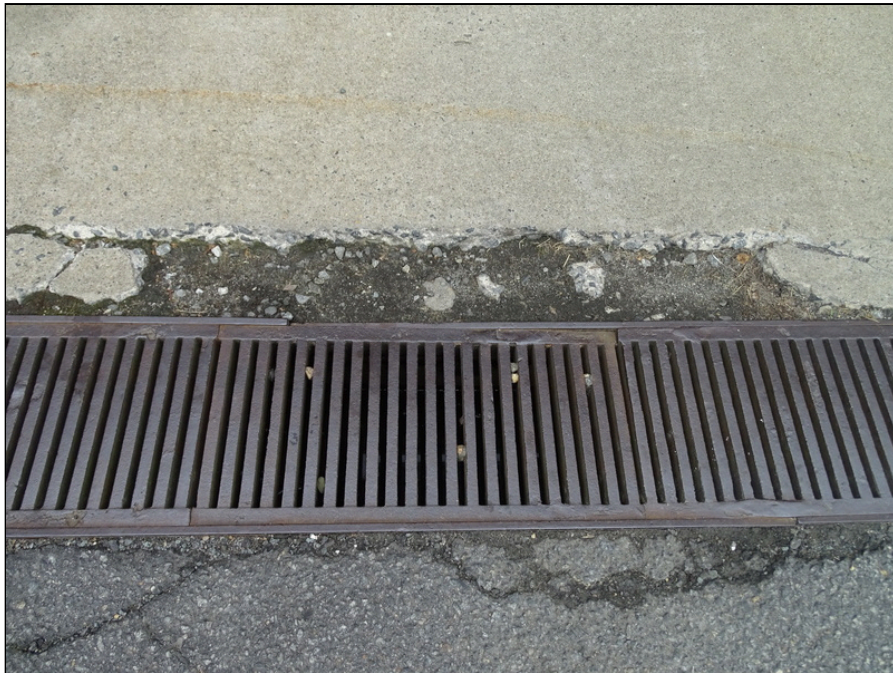
16 - Typical drain

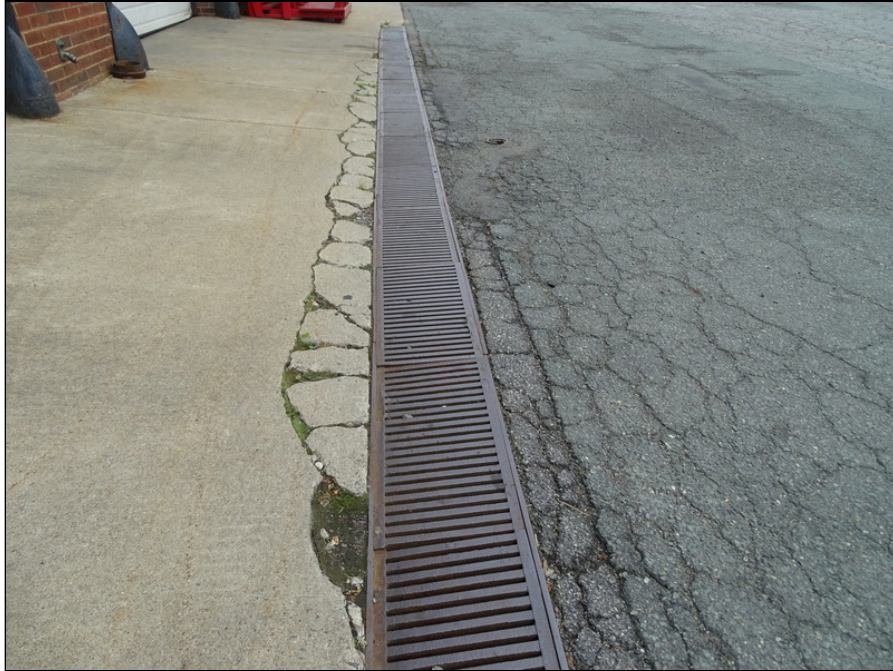
17 - Typical drain

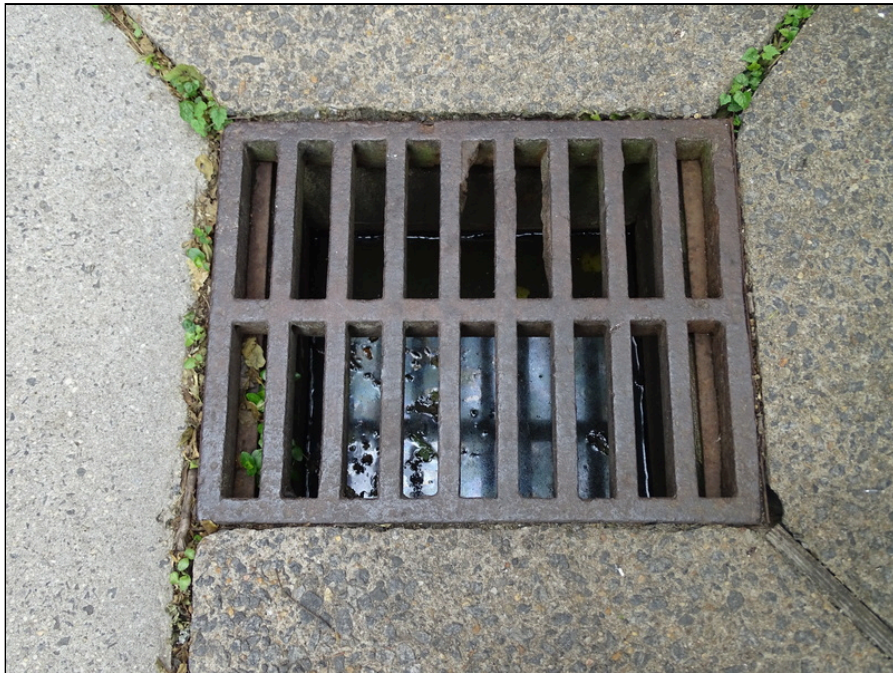
18 - Typical yard inlet drain

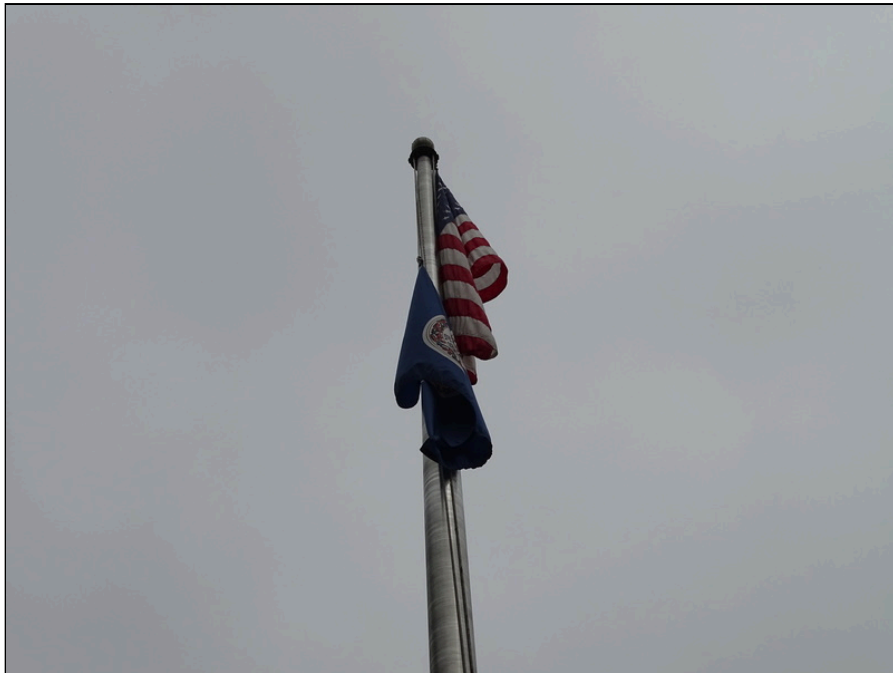
20 - Typical flag pole

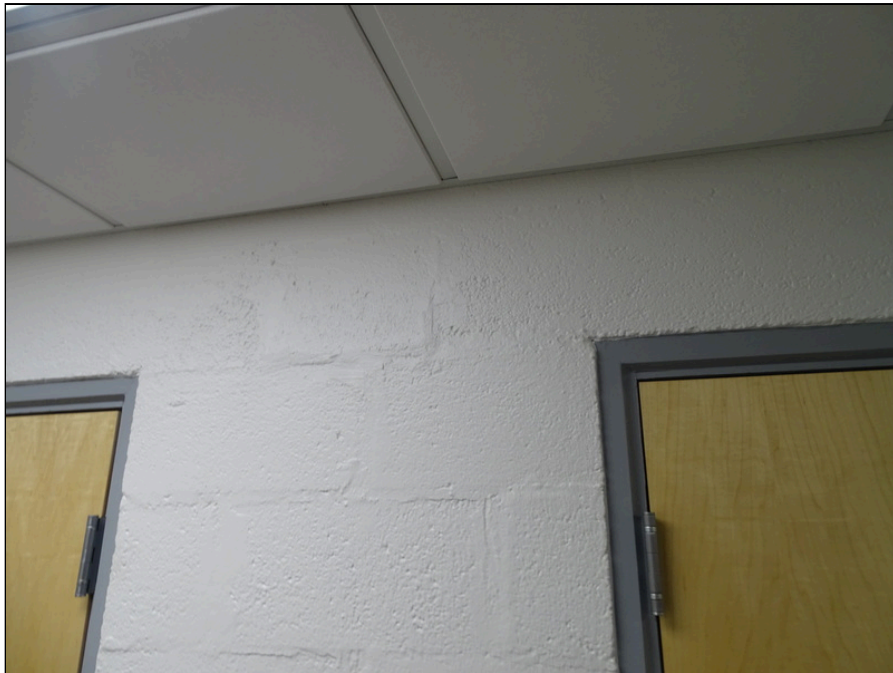
24 - Typical ceiling

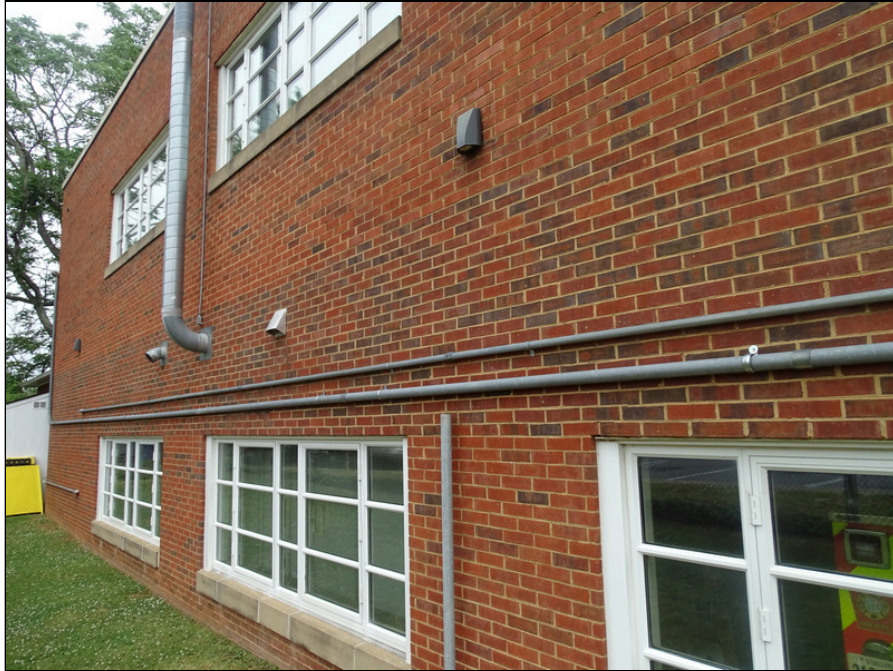
25 - Building exterior north wall

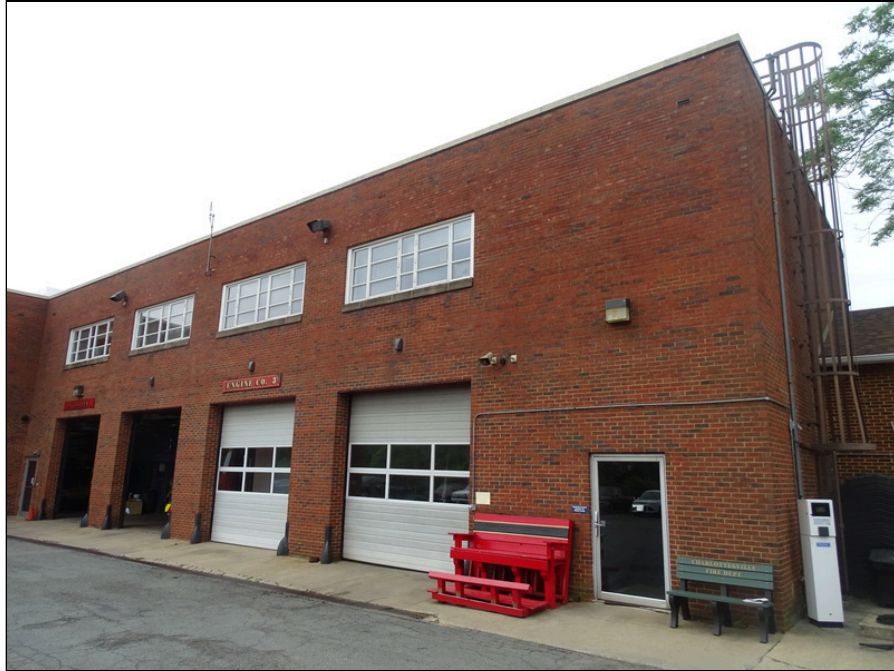
27 - Building exterior north side of the west bay area

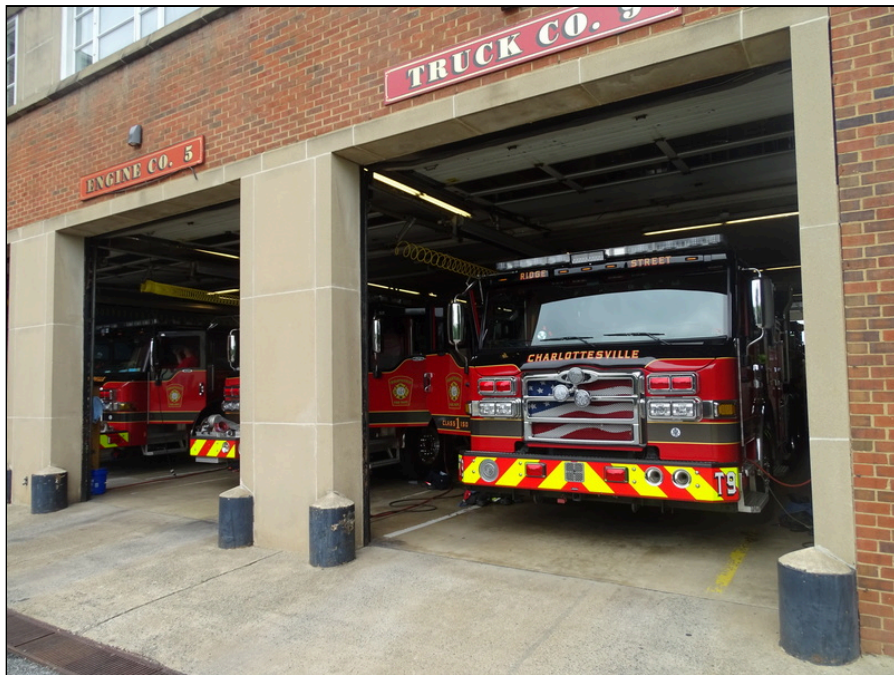
28 - Typical exterior of bay area

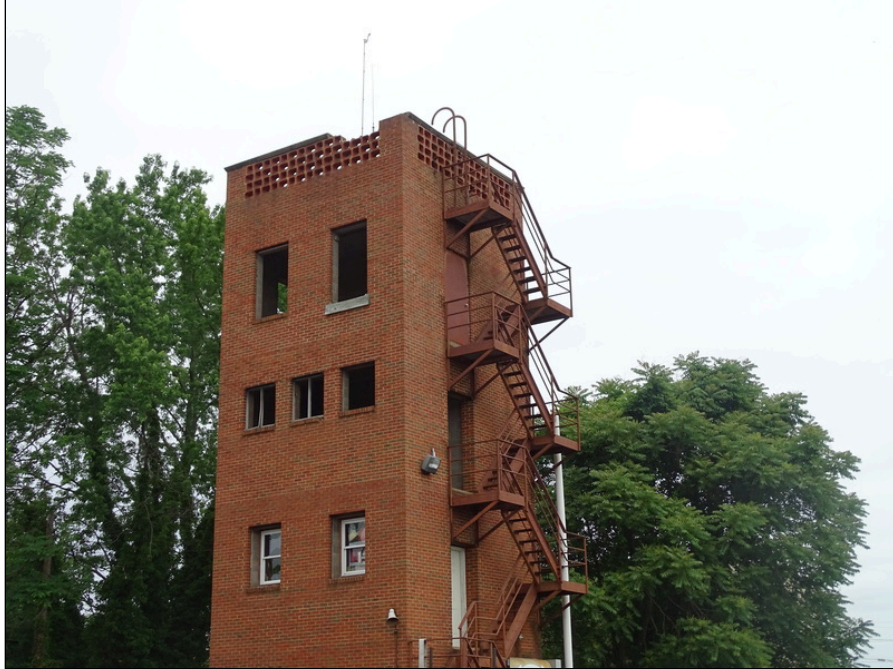
A hose tower is located at the northwest side of the property. The hose tower is constructed of CMU with brick veneer. It was reported the hose tower was not utilized for training purposes, however, hose storage was noted.

29 - Training tower structure

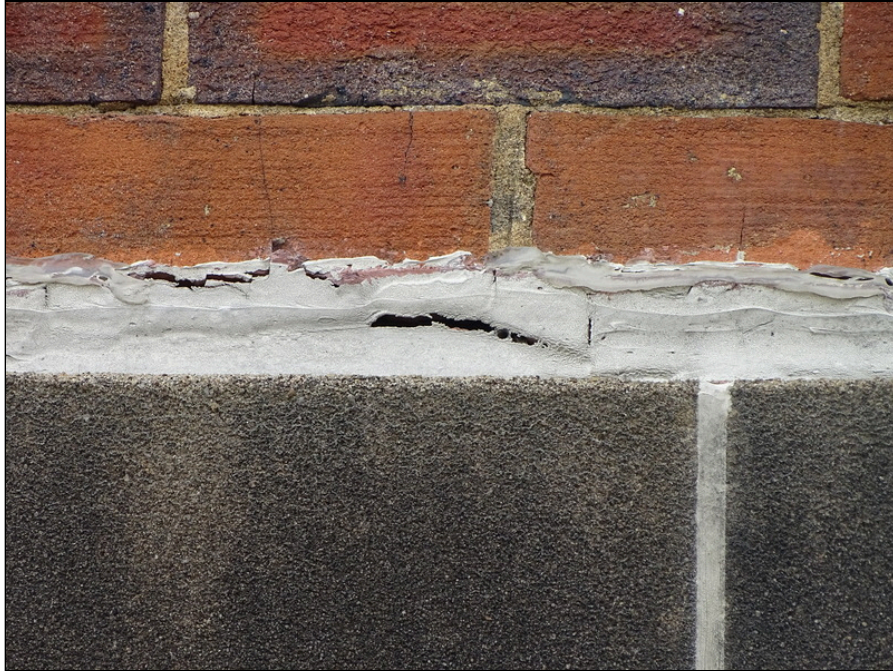
31 - Typical sealant condition

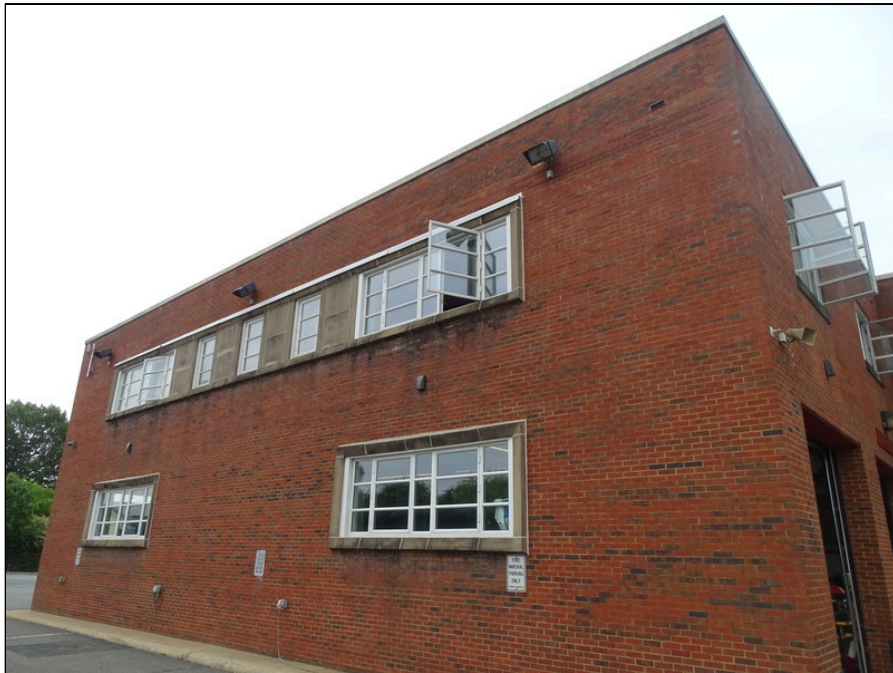
32 - Building exterior north wall

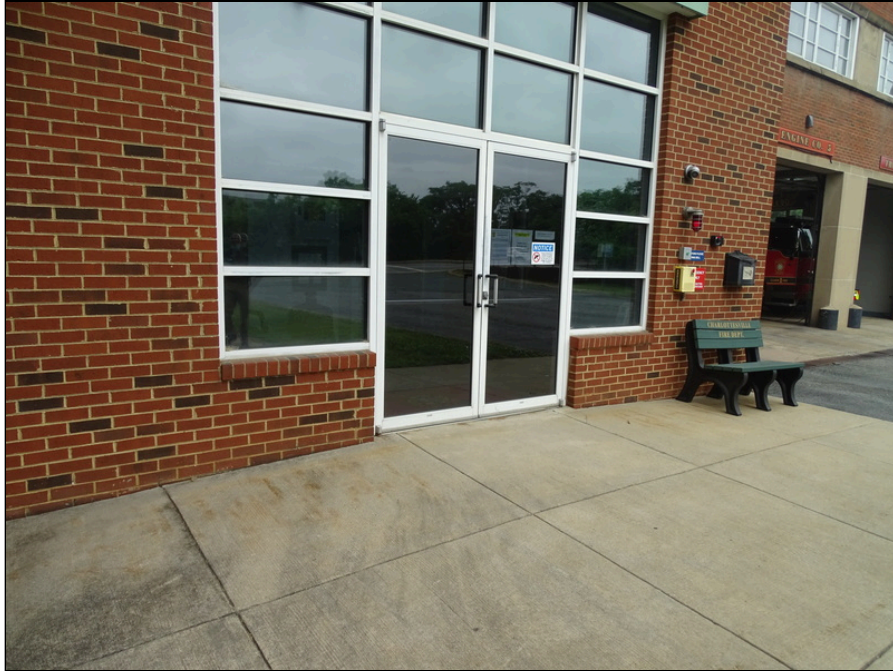
33 - Storefront entrance at west addition

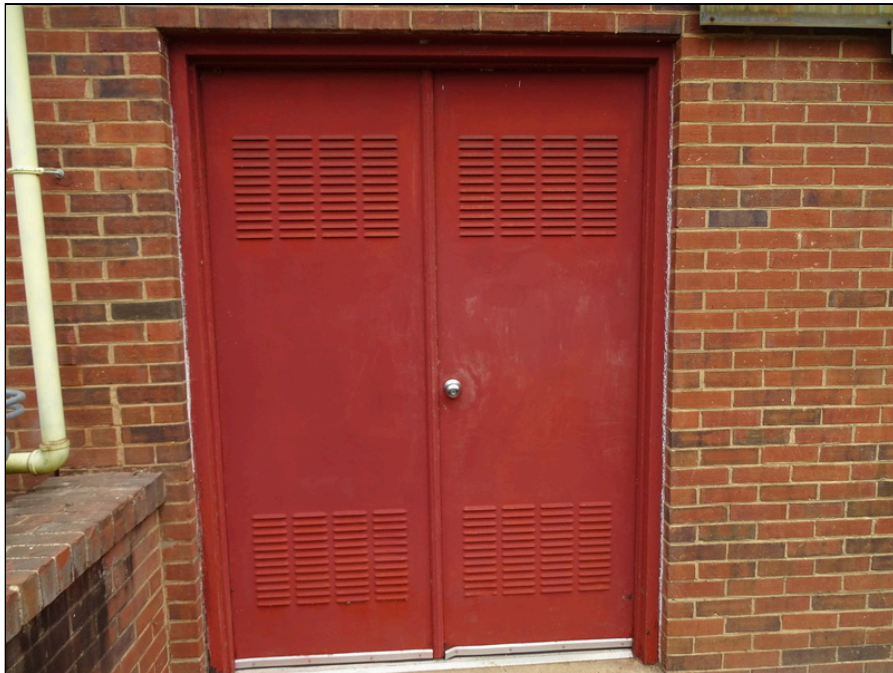
34 - Typical steel personnel door
