RIDGE STREET FIRE STATION & HOSE TOWER  
203 RIDGE STREET  
CHARLOTTESVILLE, VIRGINIA

ECS PROJECT NO. 46:6713

SEPTEMBER 14, 2021

Reference: Facility Condition Assessment Report for Ridge Street Fire Station & Hose Tower, 203 Ridge Street, Charlottesville, Virginia

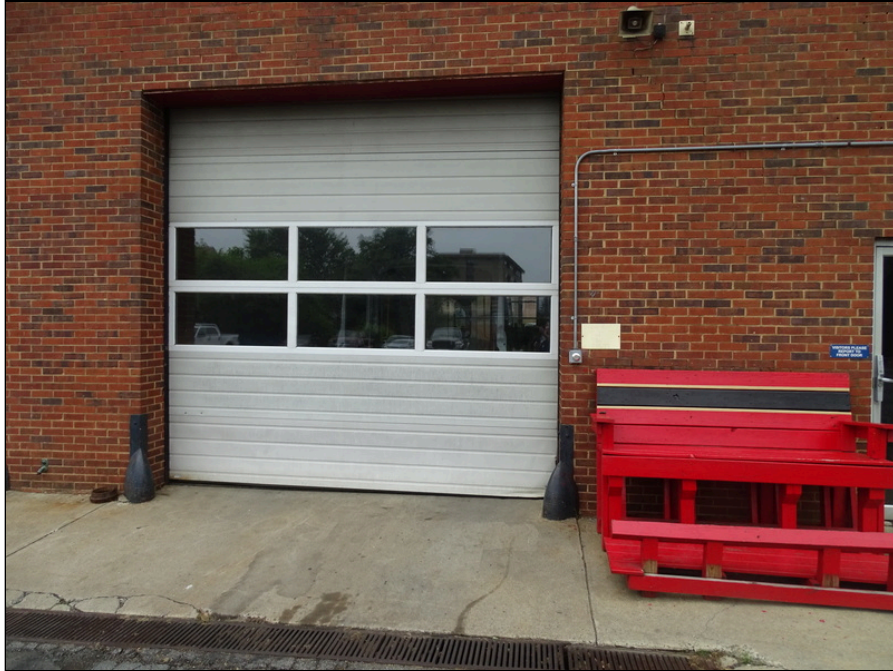
35 - Typical over head door

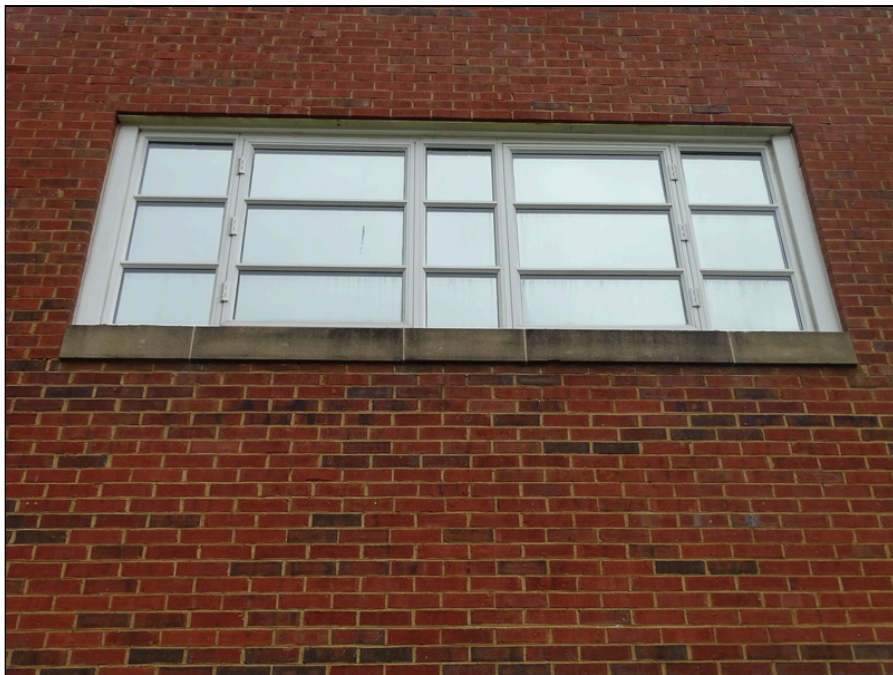
36 - Typical operable exterior window

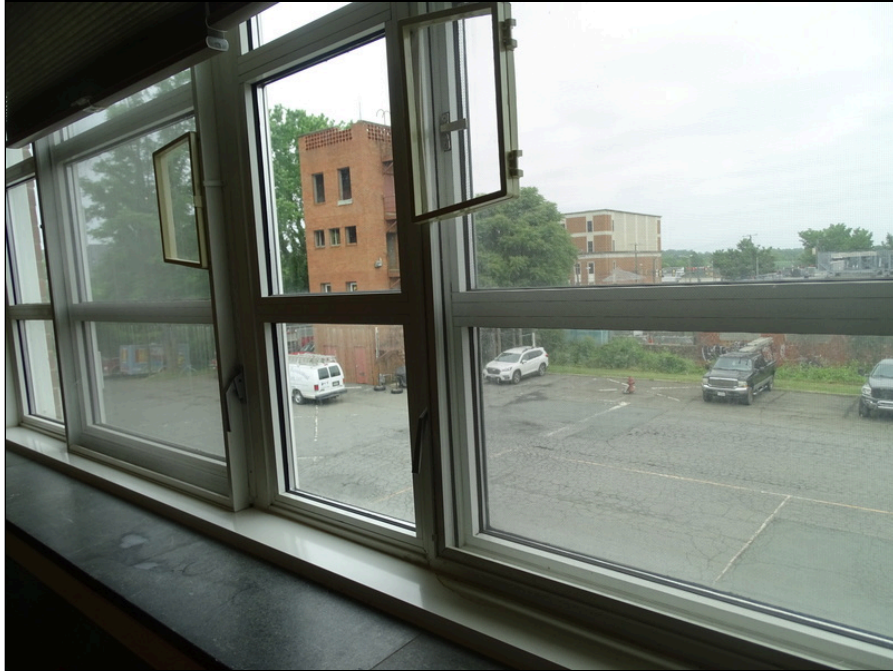
39 - Exterior windows

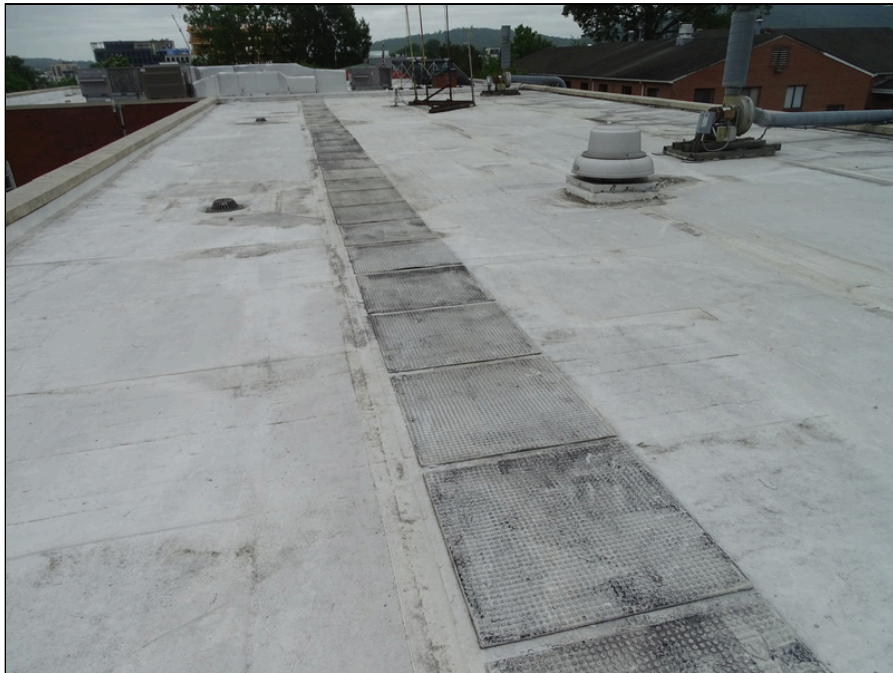
40 - Single-ply membrane roofing system over main building area

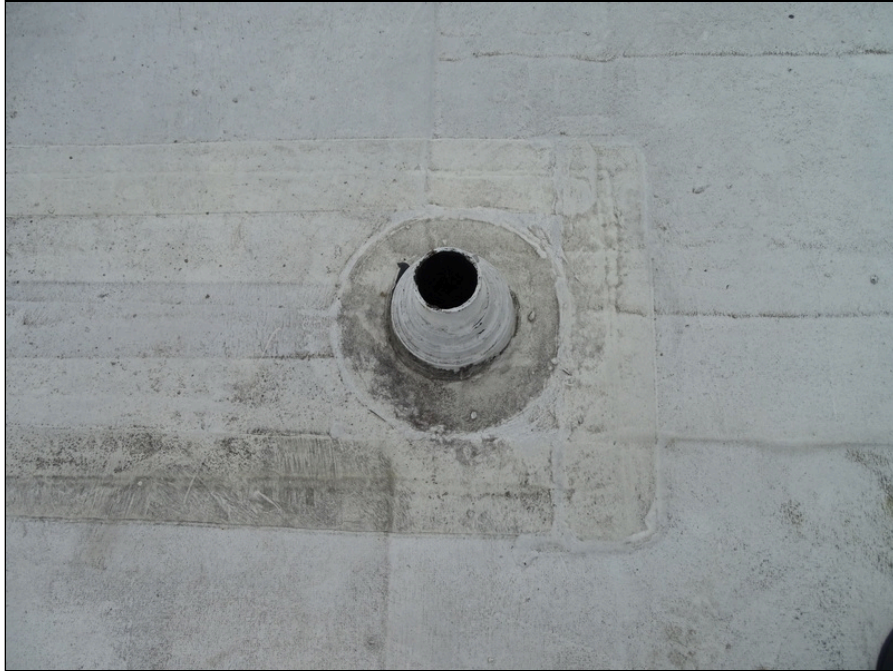
41 - Typical plumbing penetration for main roofing system

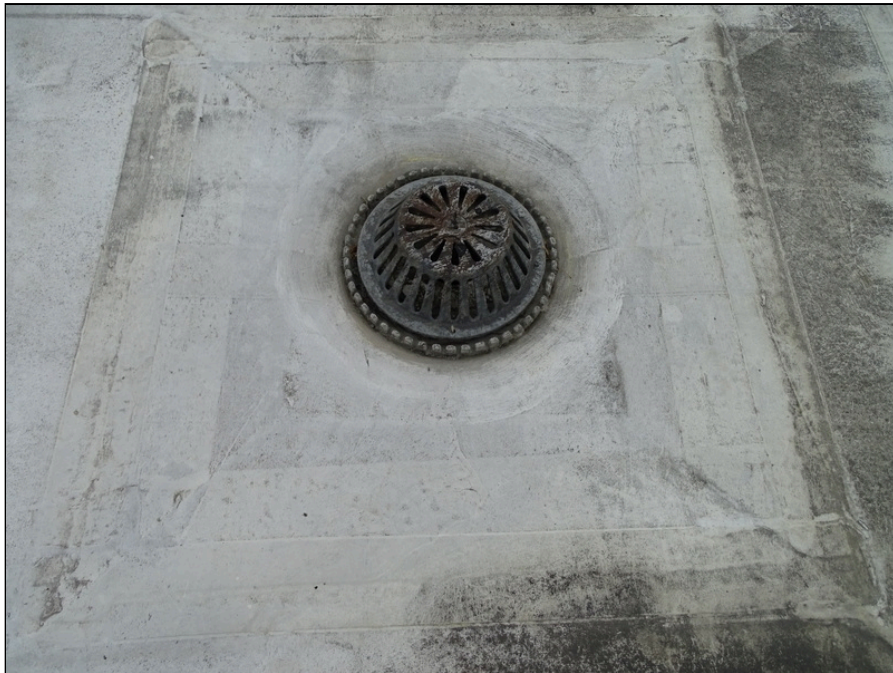
42 - Typical internal drain for main roofing system

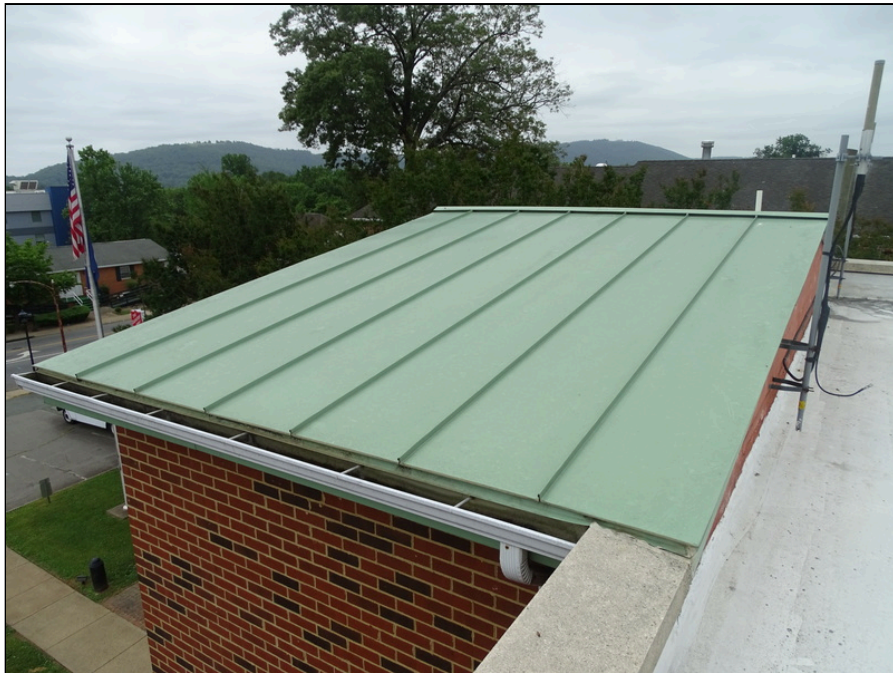
46 - Standing seam metal roofing system over east addition

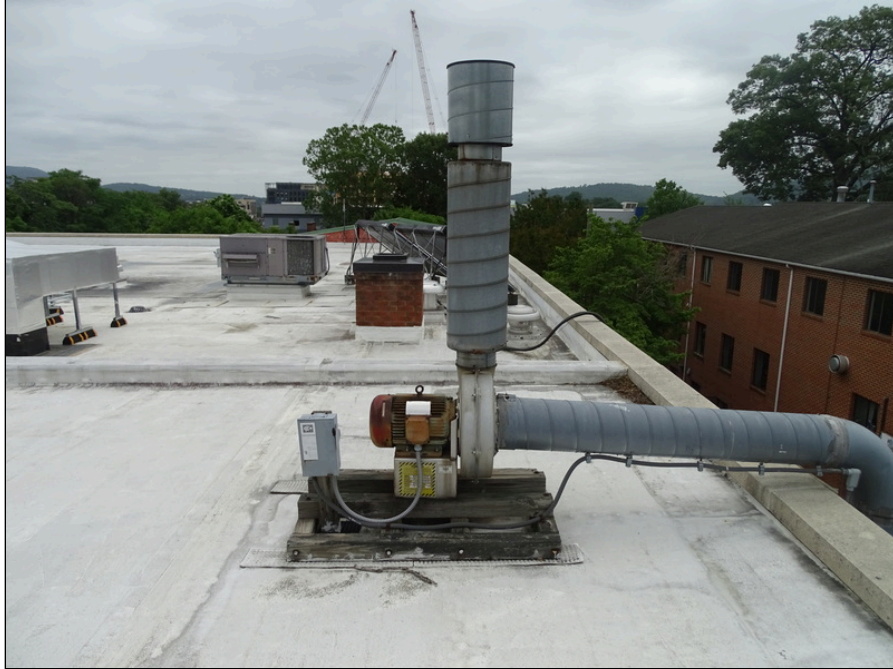
47 - Roofing system

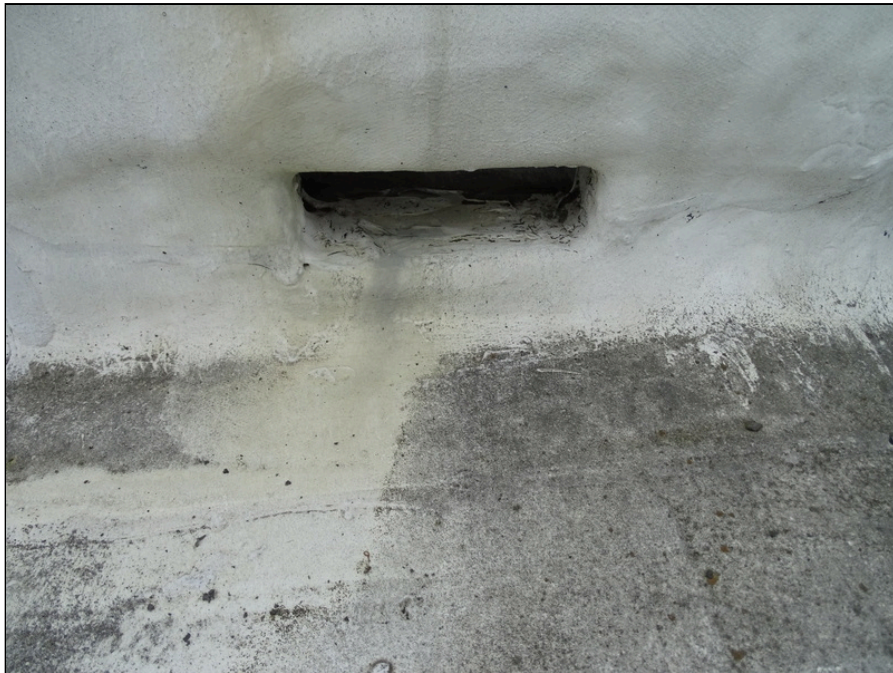
48 - Typical parapet wall and through wall scupper drain of main roofing system

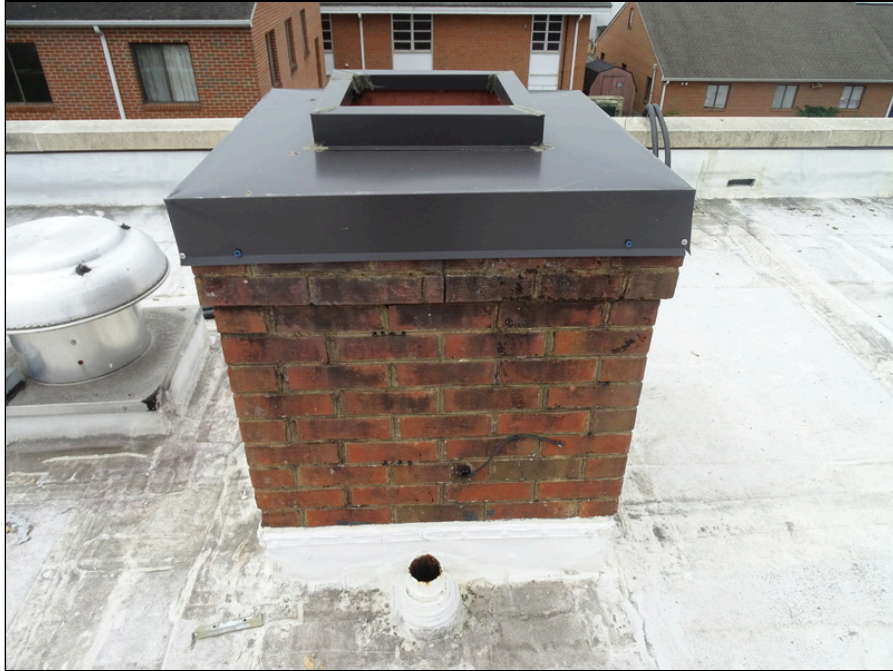
49 - Typical chimneys

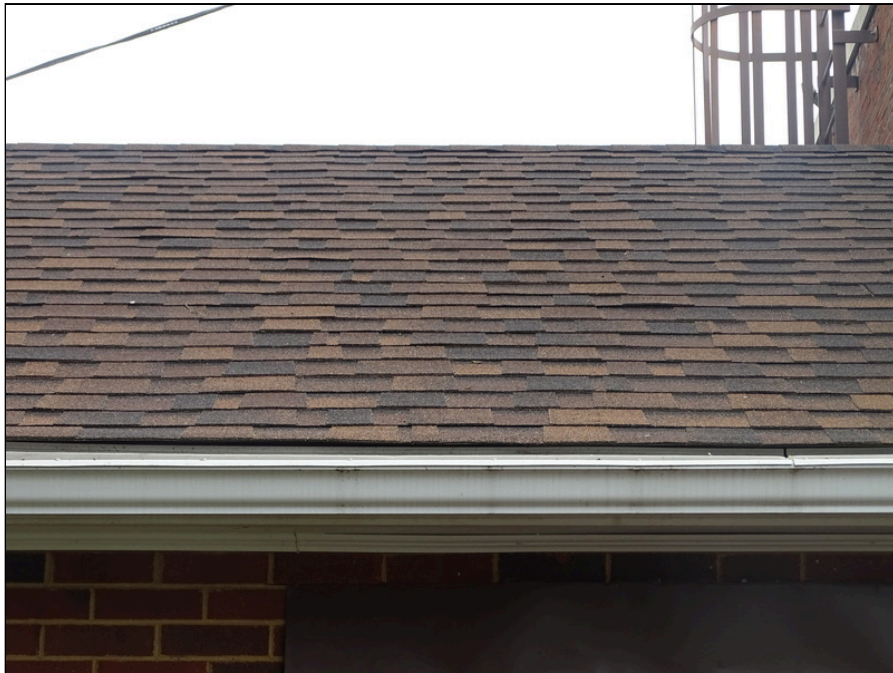
50 - Asphalt shingle roofing system over west addition - note recent replacement

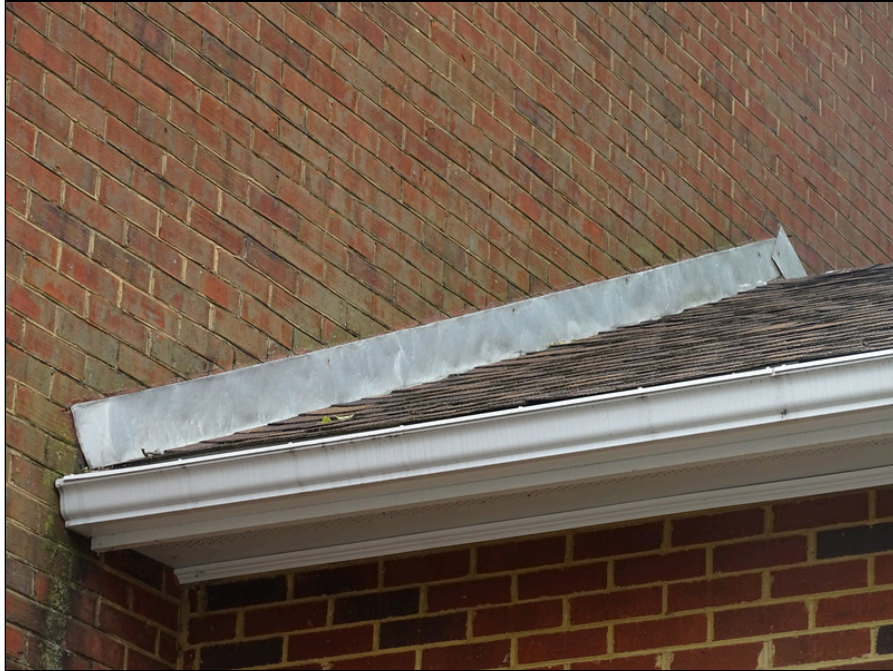
51 - Asphalt shingle roofing system over west addition - note recent replacement

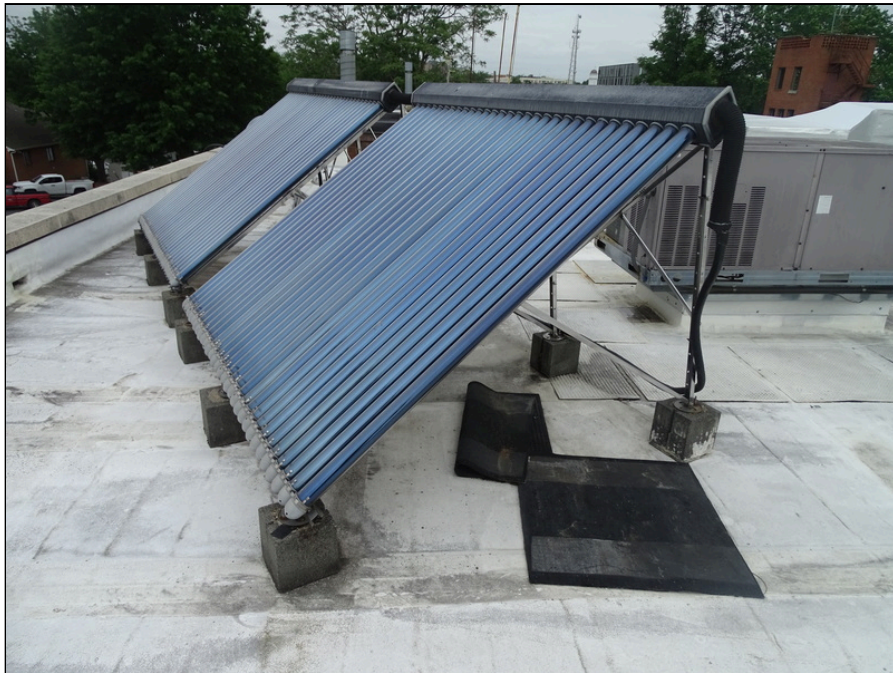
52 - Typical solar panel

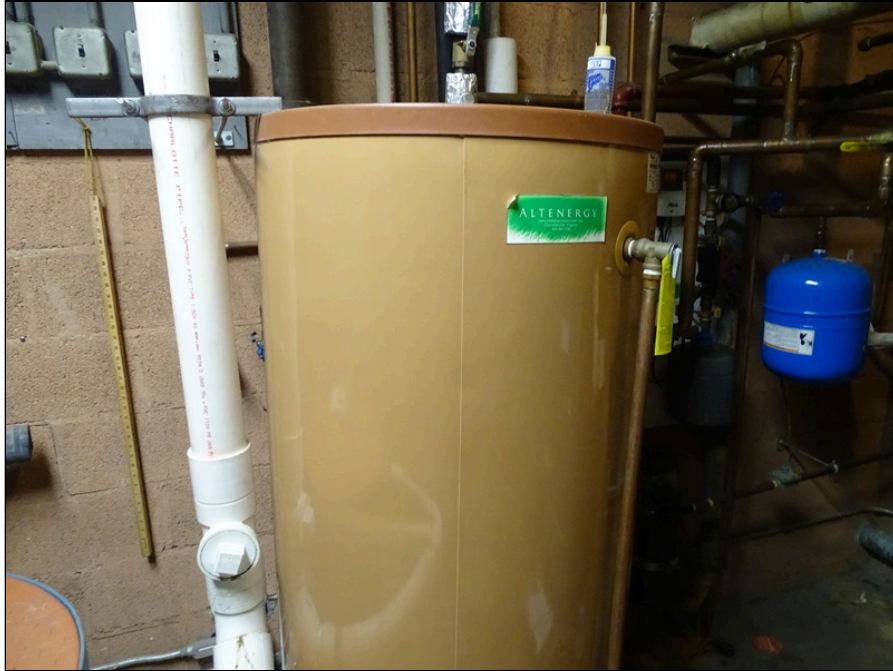
53 - Domestic hot water storage tank

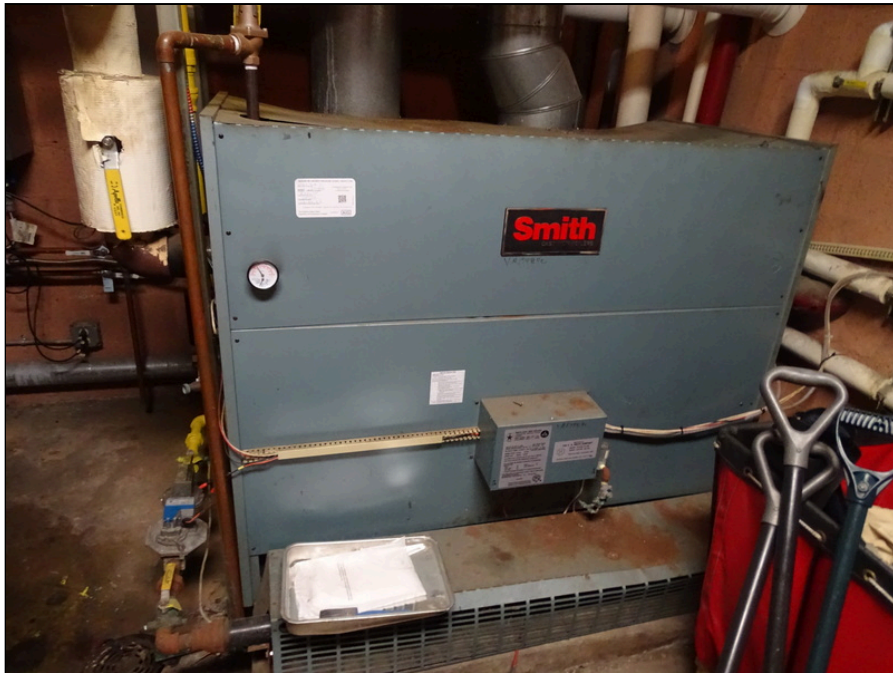
54 - Boiler located in main utility room

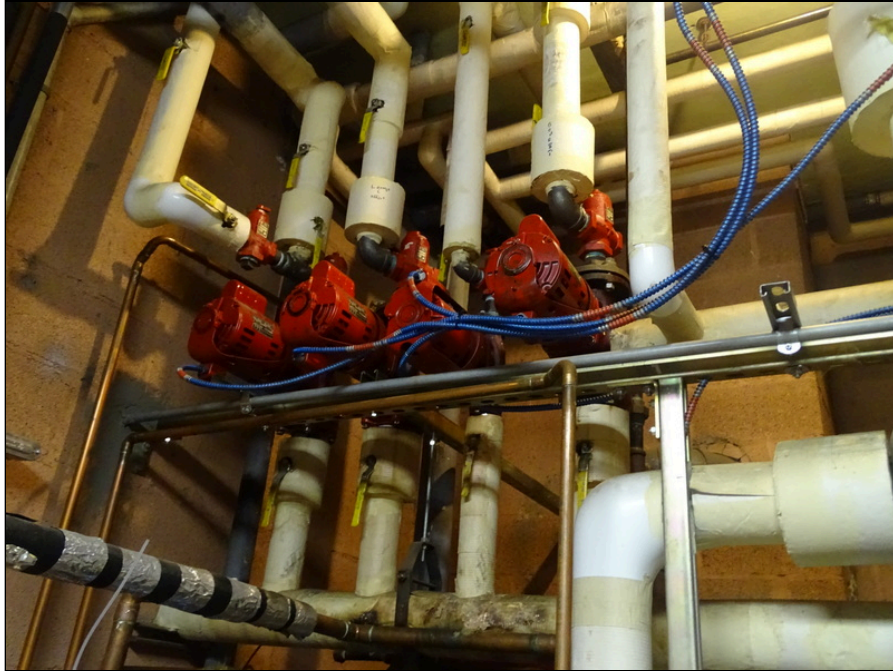
55 - Typical hot water piping system

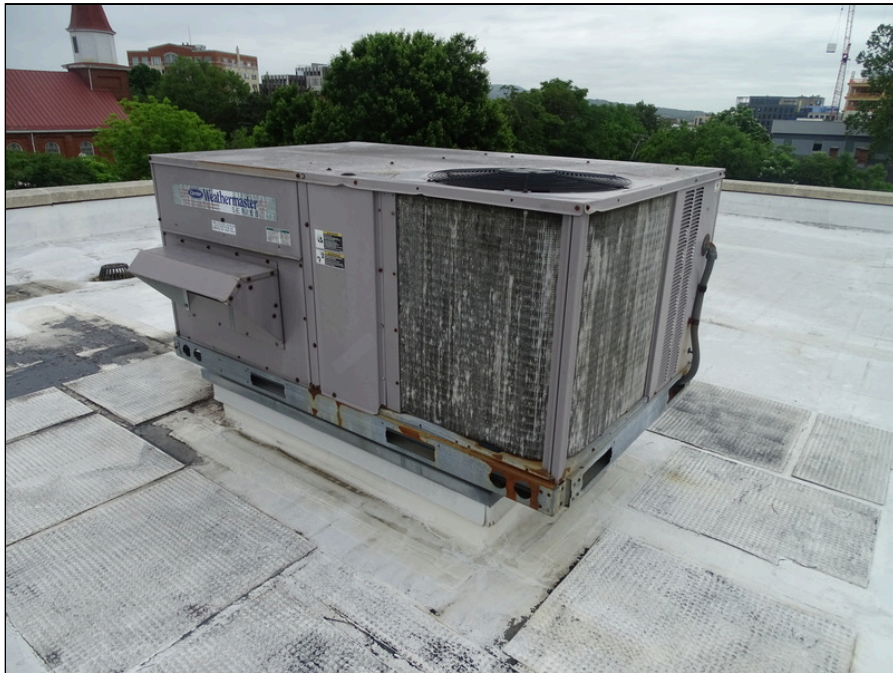
56 - Condenser located on roof - manufactured by Carrier in 2006

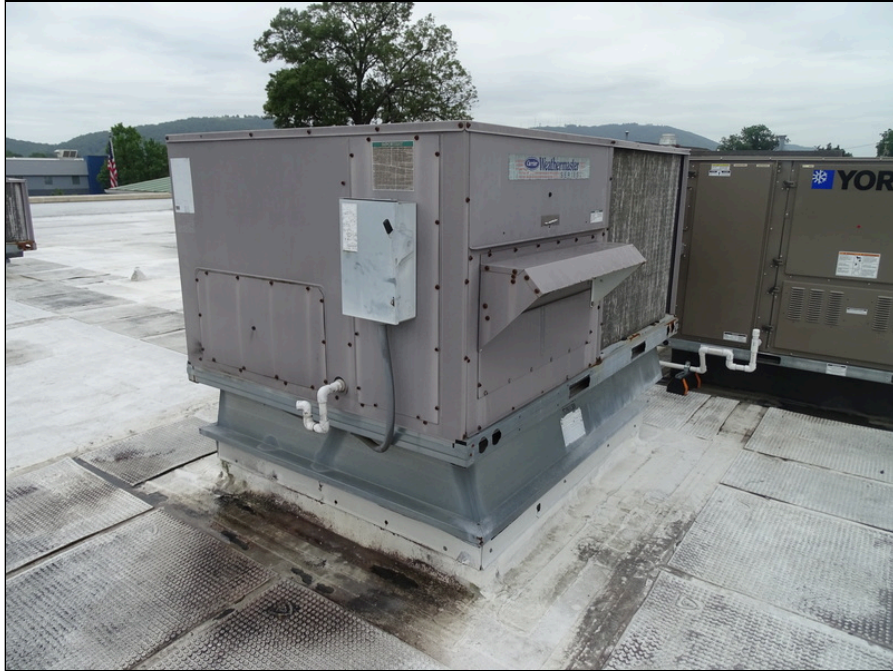
57 - Condenser located on roof - manufactured by Carrier in 2006

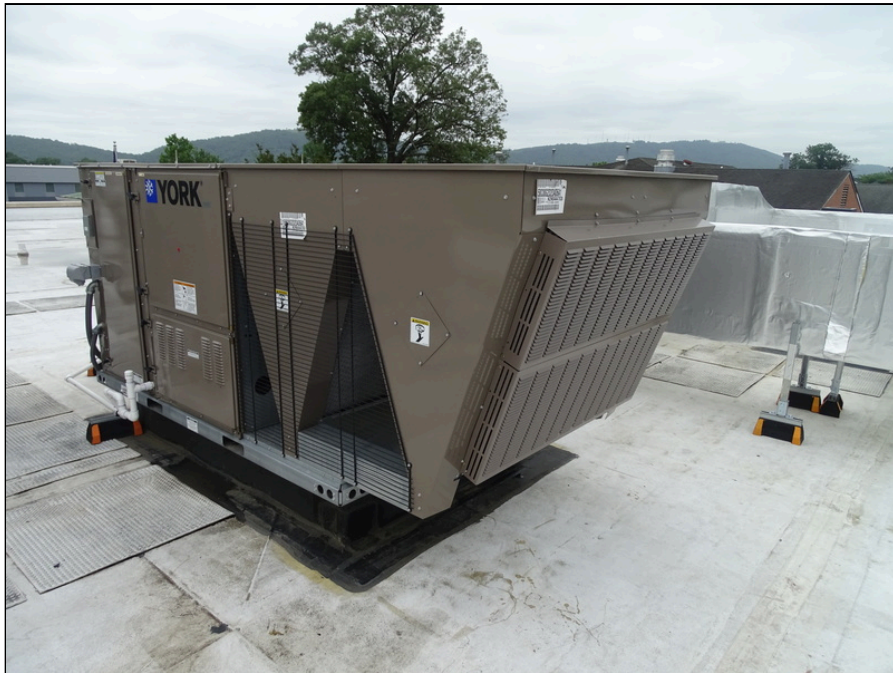
58 - Condenser located on roof - manufactured by York

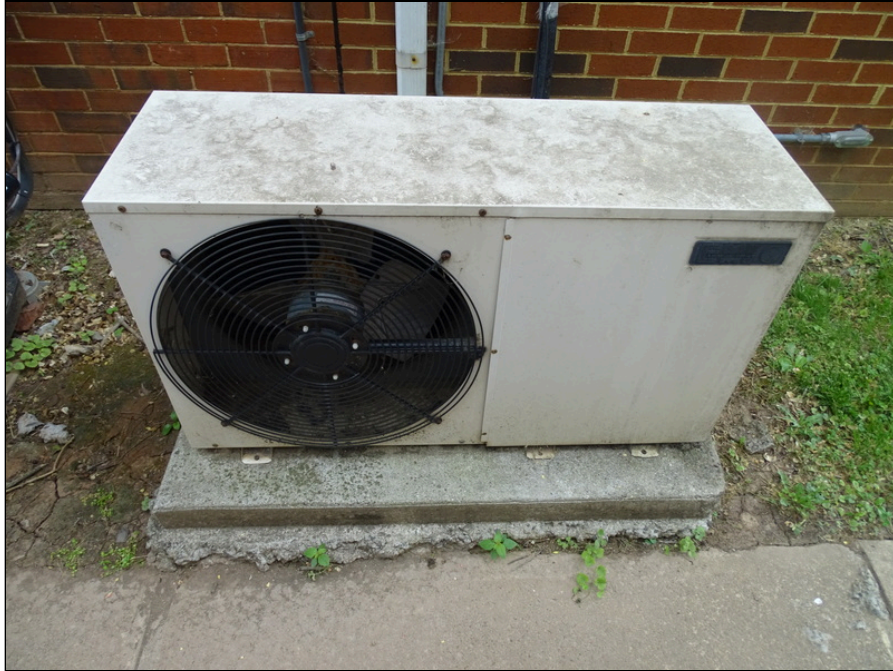
59 - Condenser located on grade - manufactured by Enviromaster International in 1996

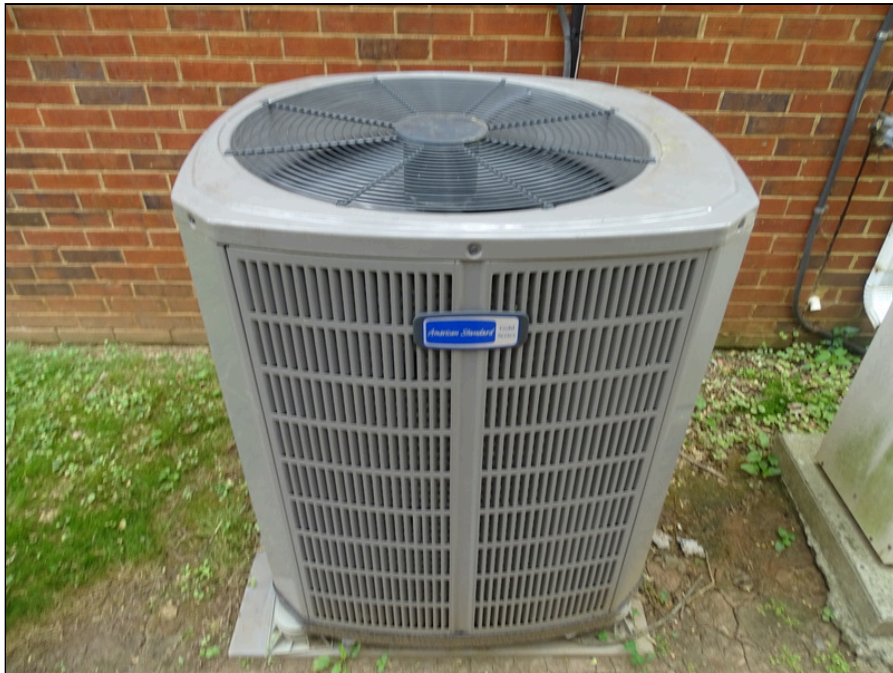
60 - Condenser located on grade - manufactured by American Standard

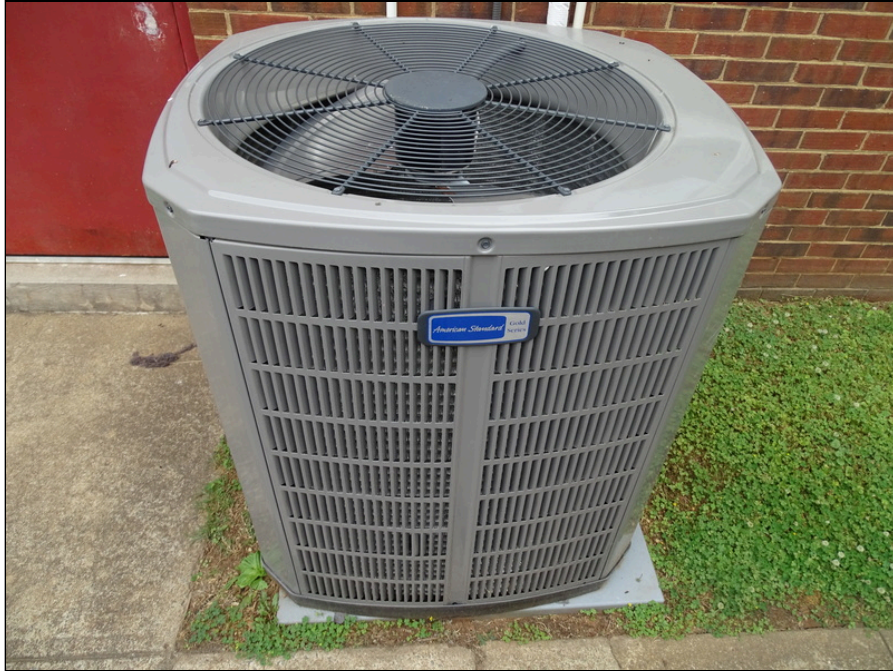
61 - Condenser located on grade - manufactured by American Standard

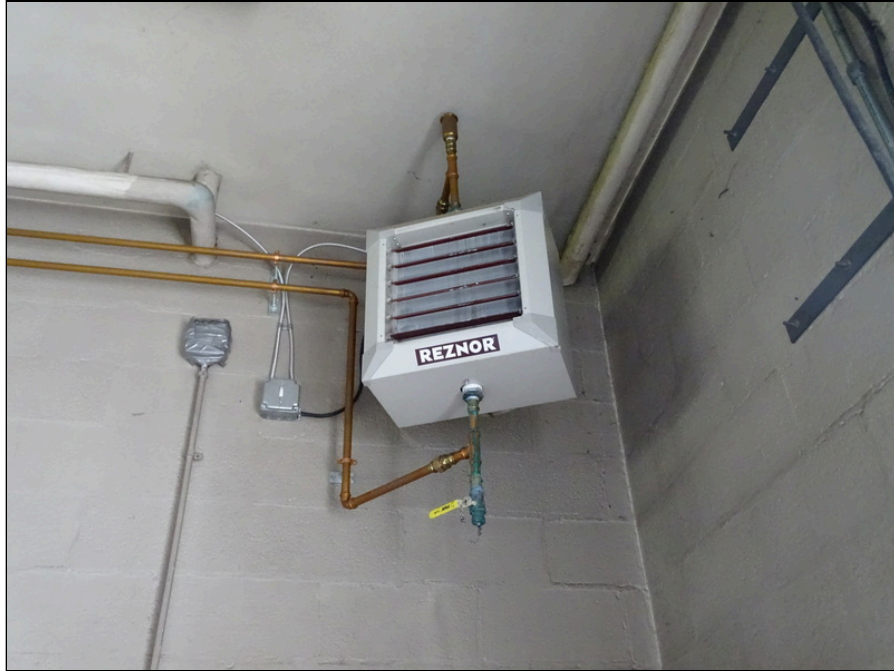
63 - Ceiling mounted hot water heating units

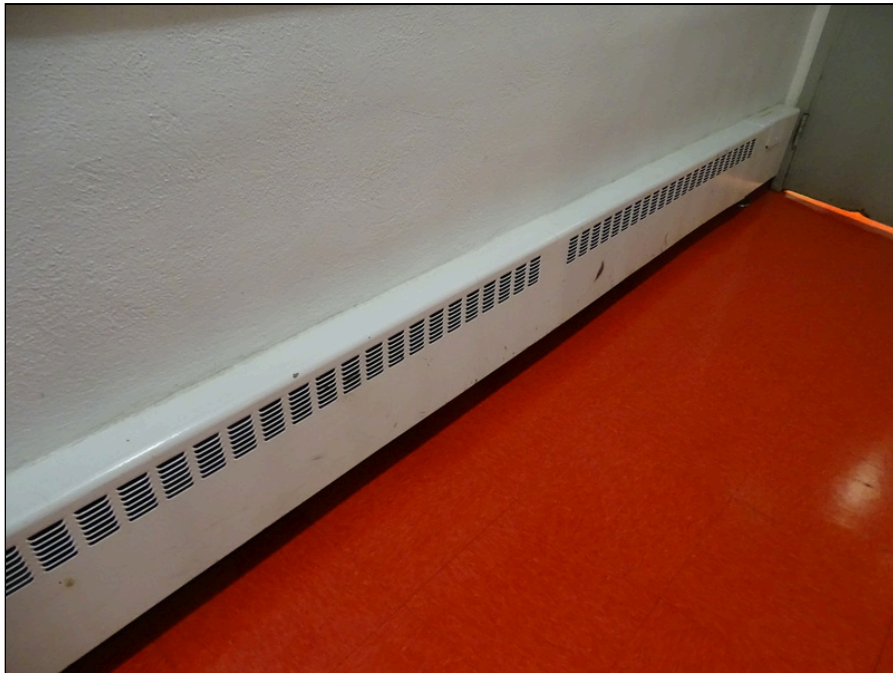
66 - Typical hot water baseboard heater unit

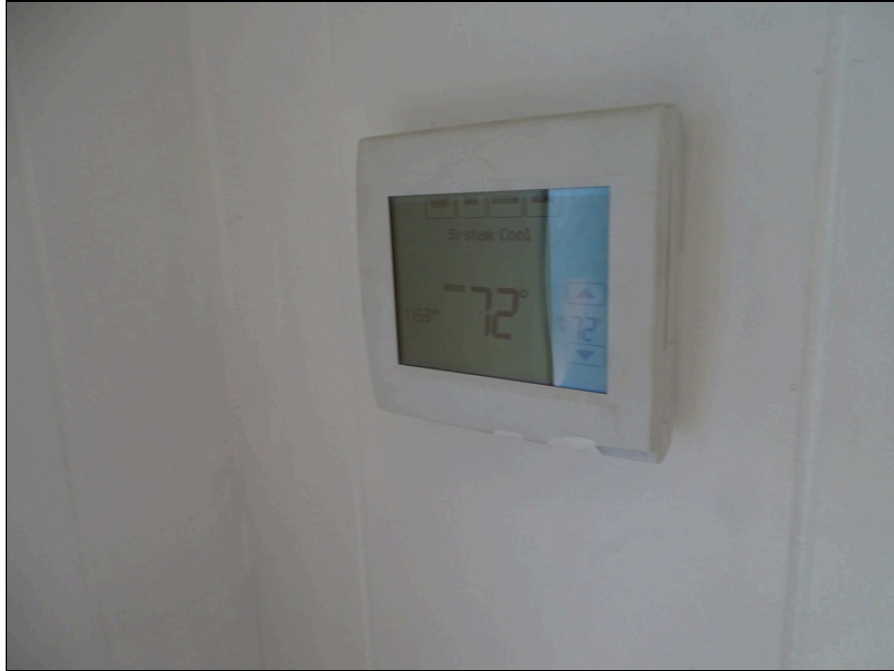
67 - Typical digital thermostat

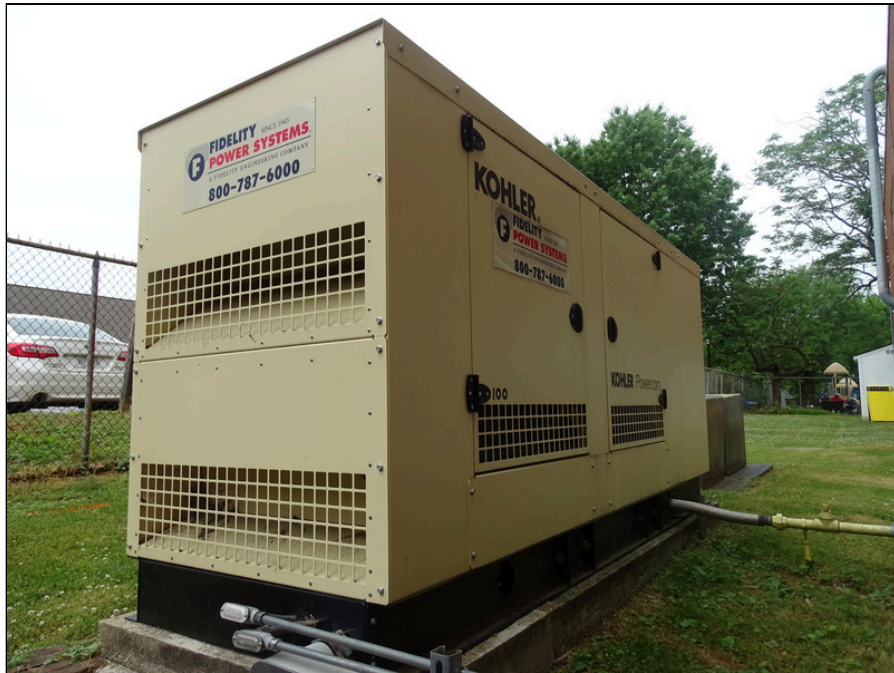
68 - Emergency power supply on south side of the building

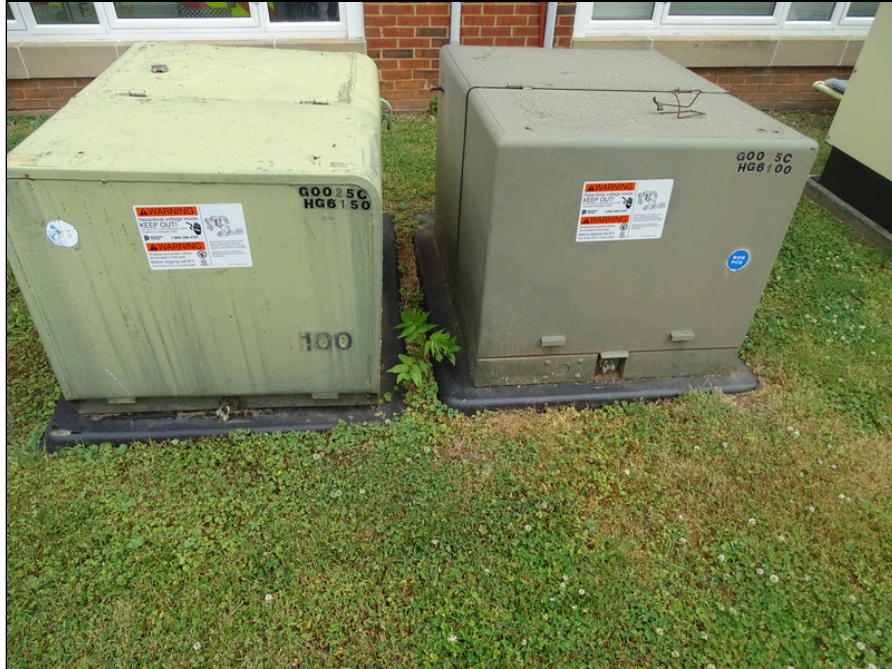
69 - Utility transformers on south side of the building

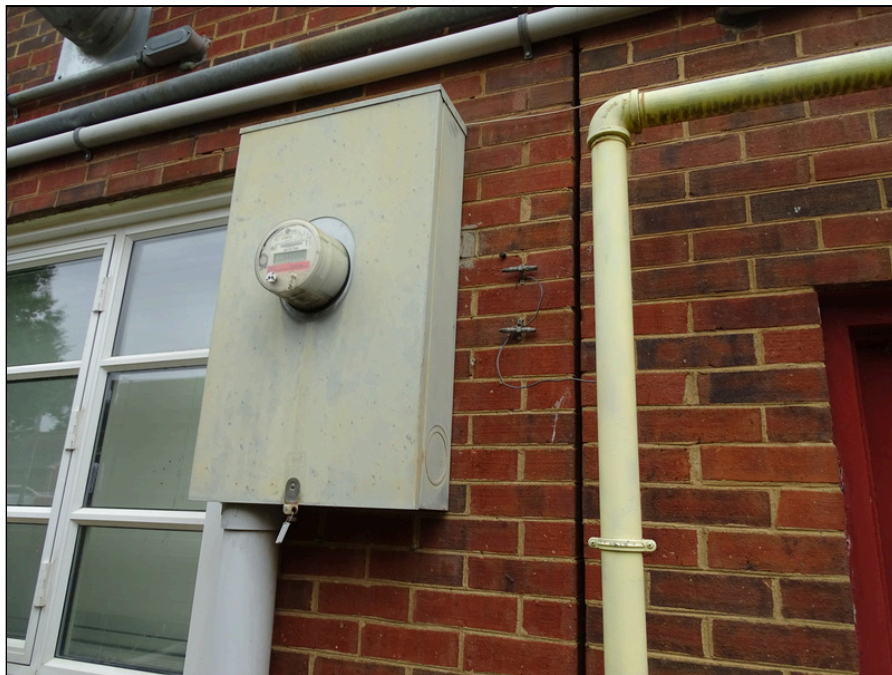
70 - Typical electric meter

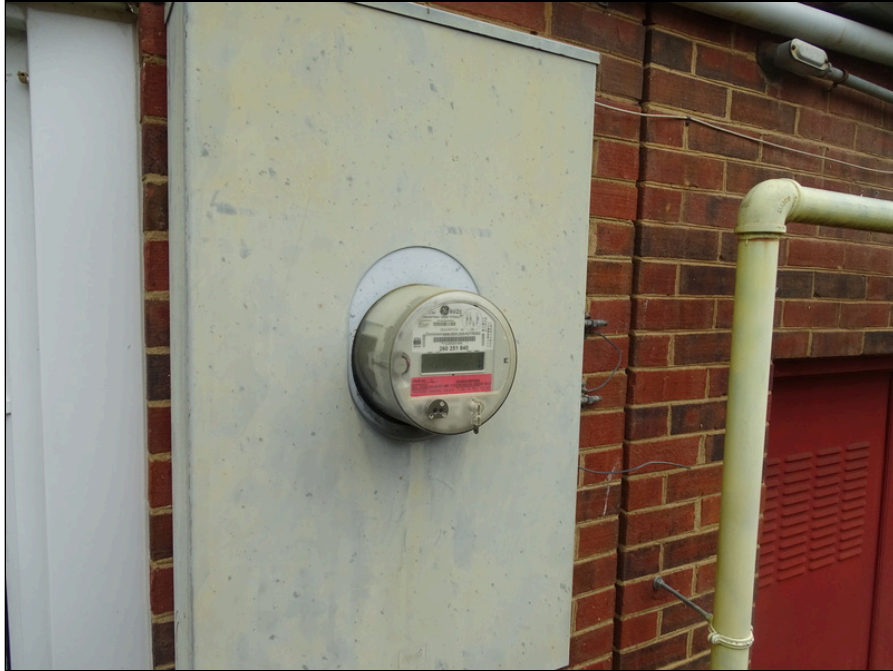
71 - Typical electric meter

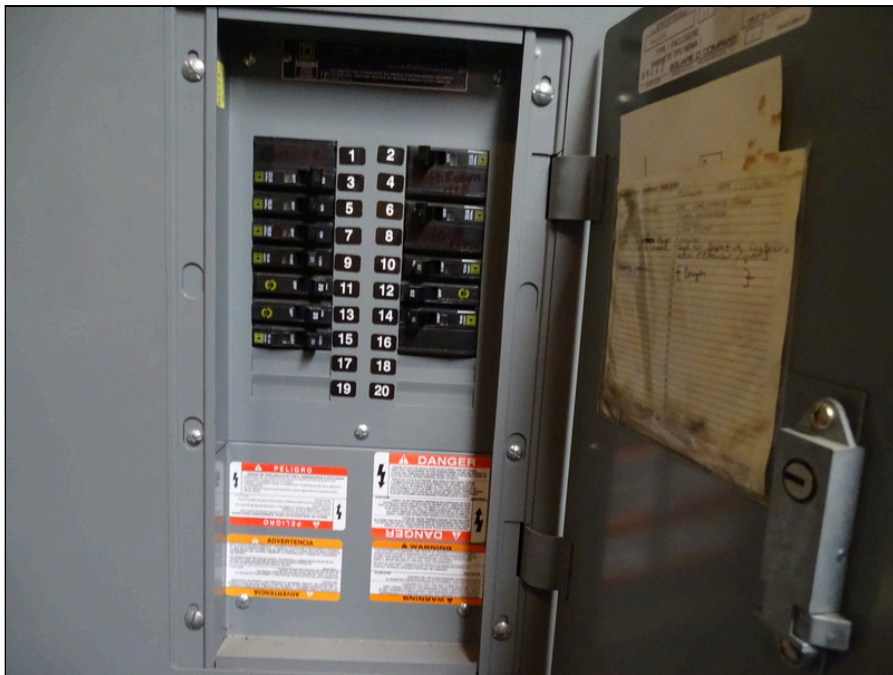
72 - Emergency transfer switch

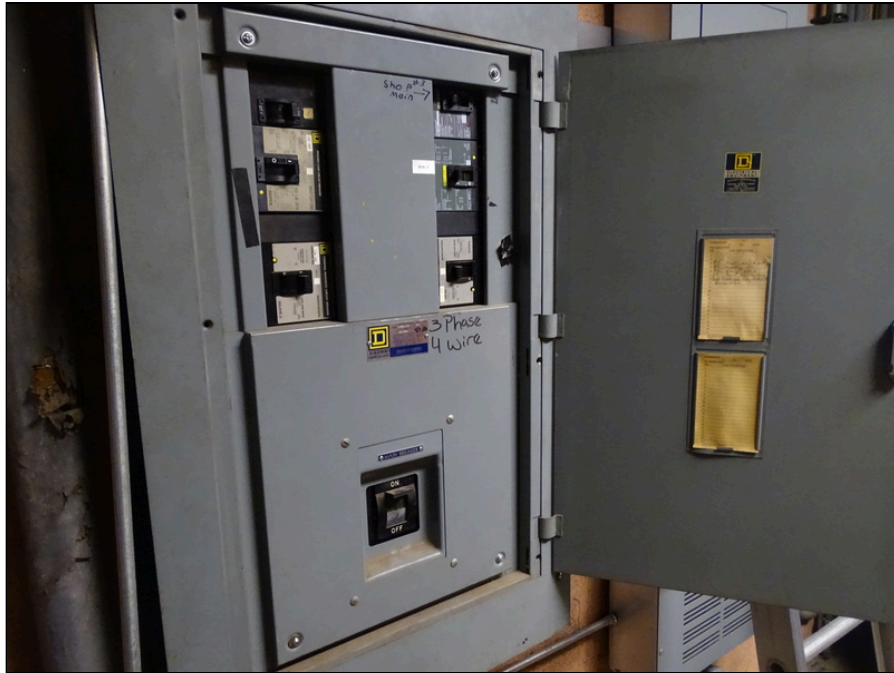
73 - Main electrical switch gear

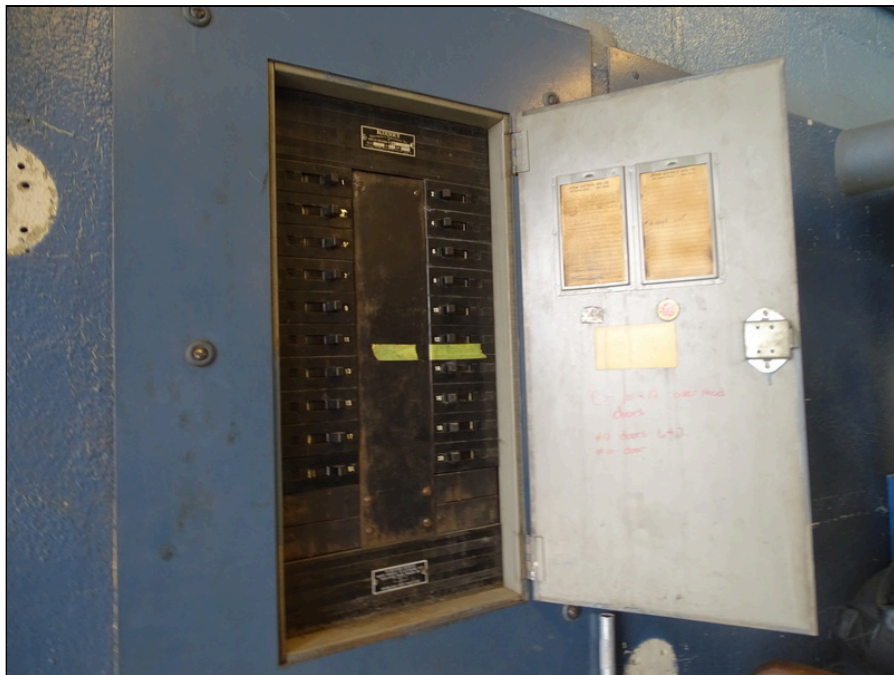
74 - Typical older circuit breaker panel

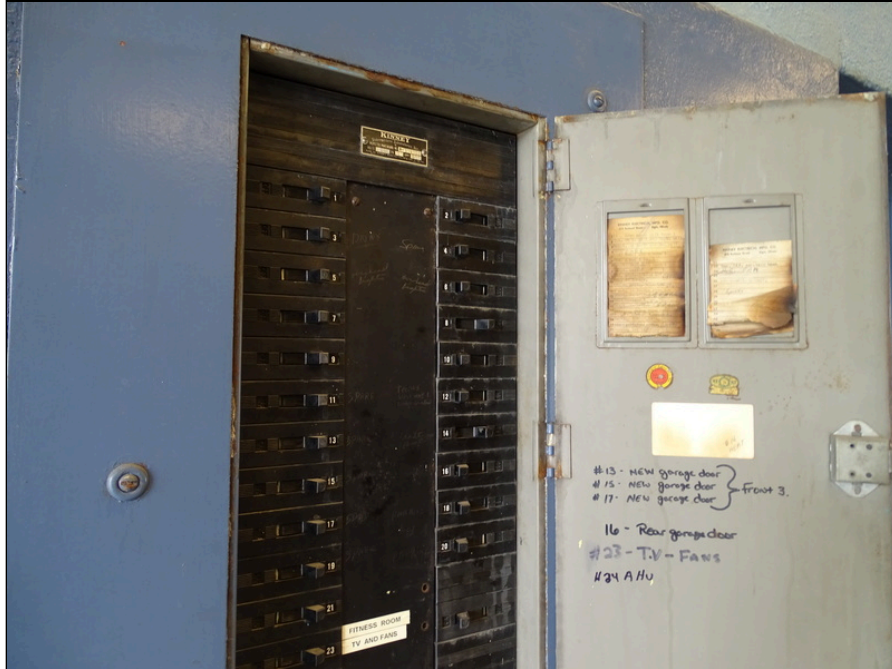
75 - Typical electrical sub panel

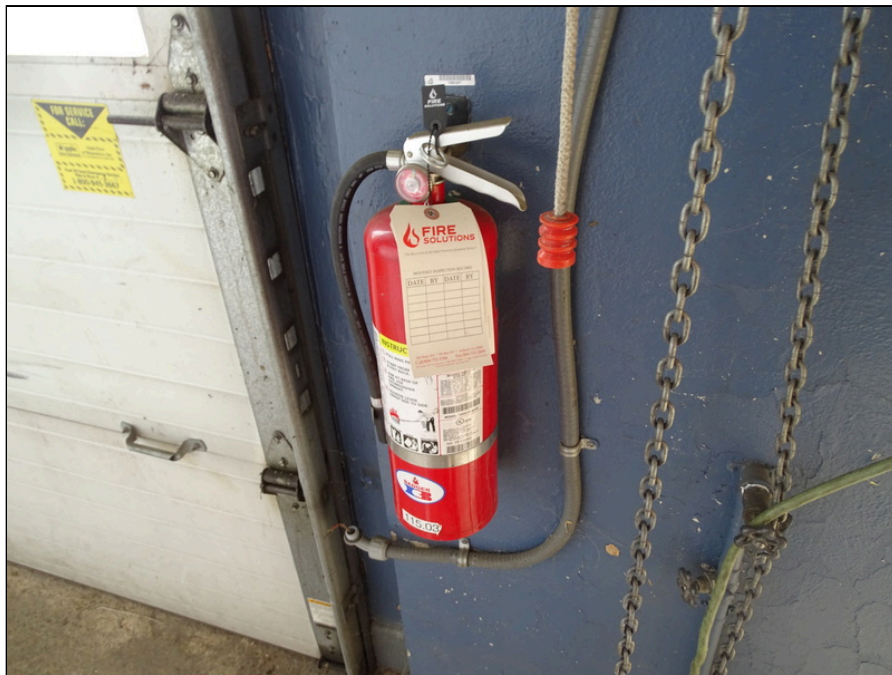
76 - Typical fire extinguisher

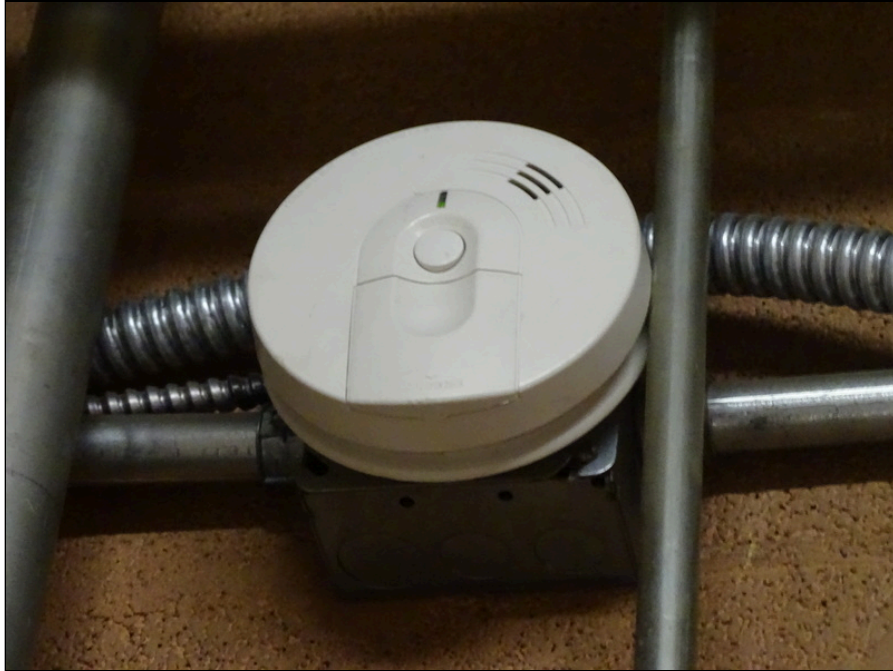
77 - Typical smoke detector

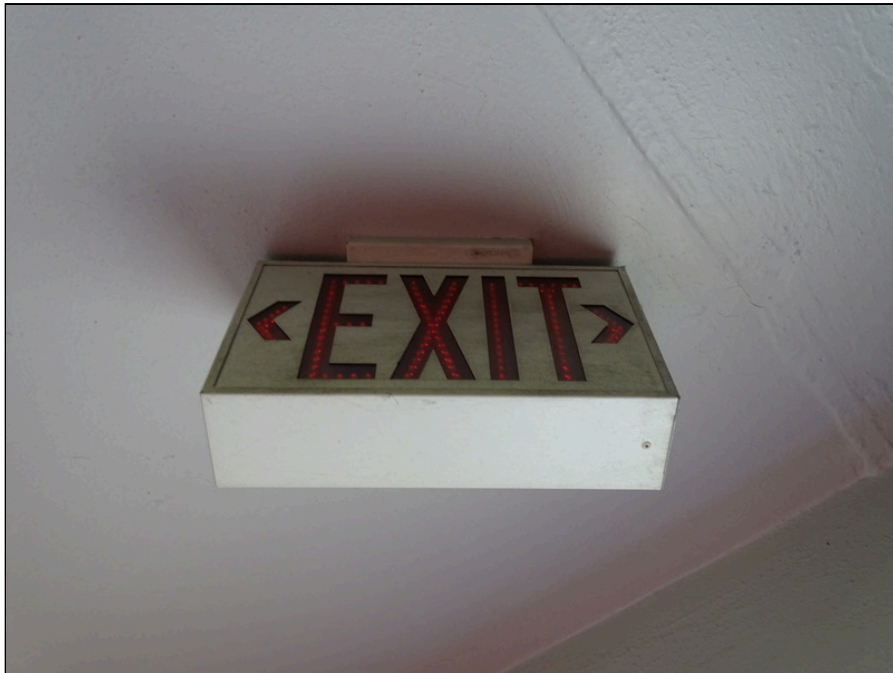
78 - Typical Exit sign

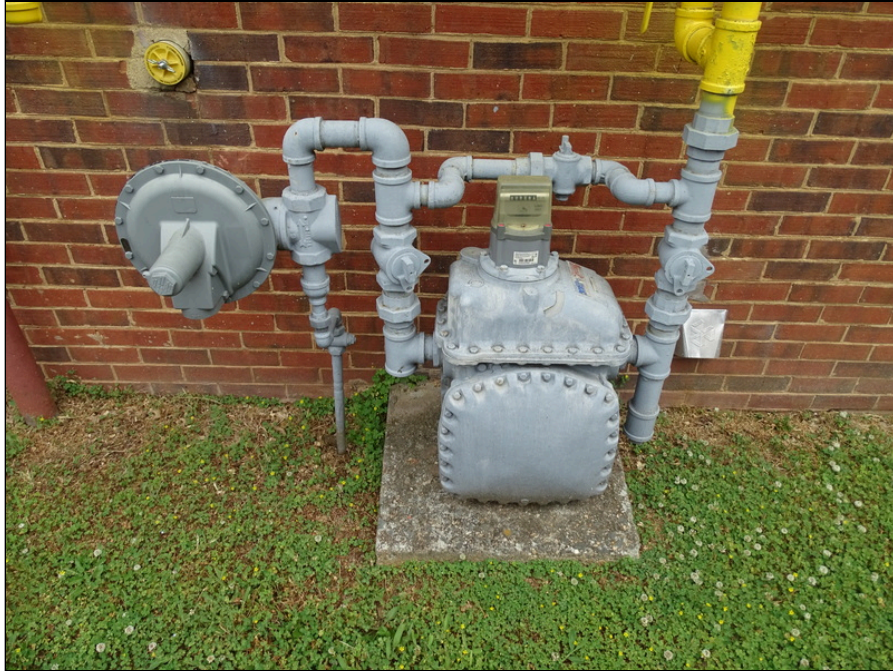
79 - Typical gas meter

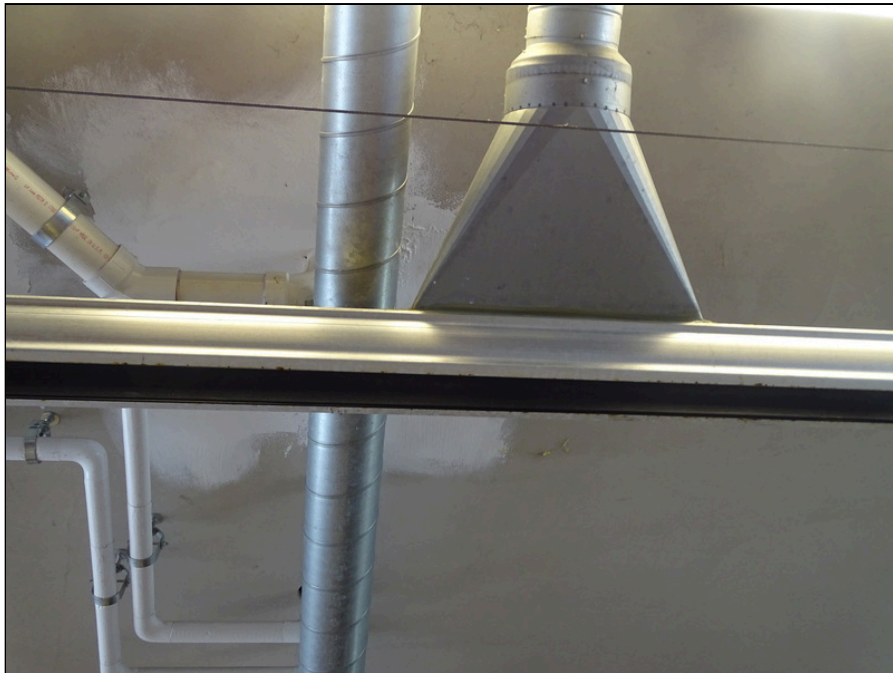
80 - Typical interior of bay area - note peeling paint on ceiling
