RIDGE STREET FIRE STATION & HOSE TOWER  
203 RIDGE STREET  
CHARLOTTESVILLE, VIRGINIA

ECS PROJECT NO. 46:6713

SEPTEMBER 14, 2021

Reference: Facility Condition Assessment Report for Ridge Street Fire Station & Hose Tower, 203 Ridge Street, Charlottesville, Virginia

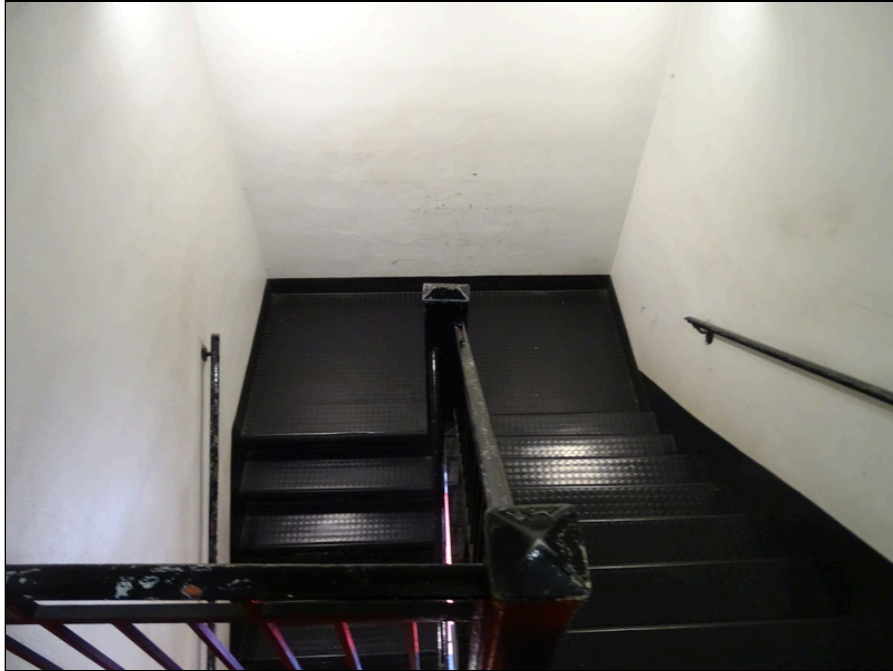
81 - Typical stair area interior

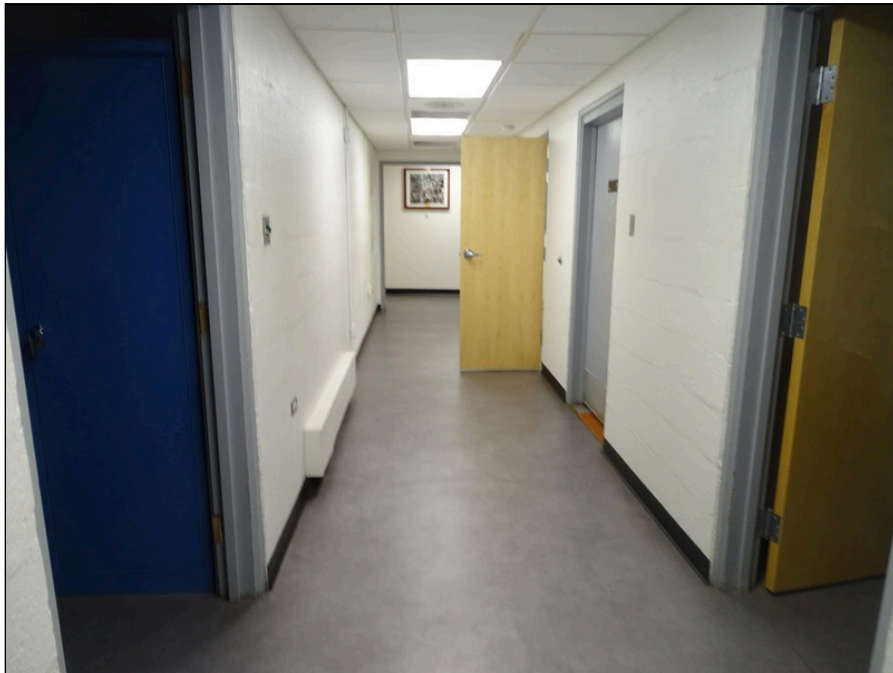
82 - Typical corridor area interior

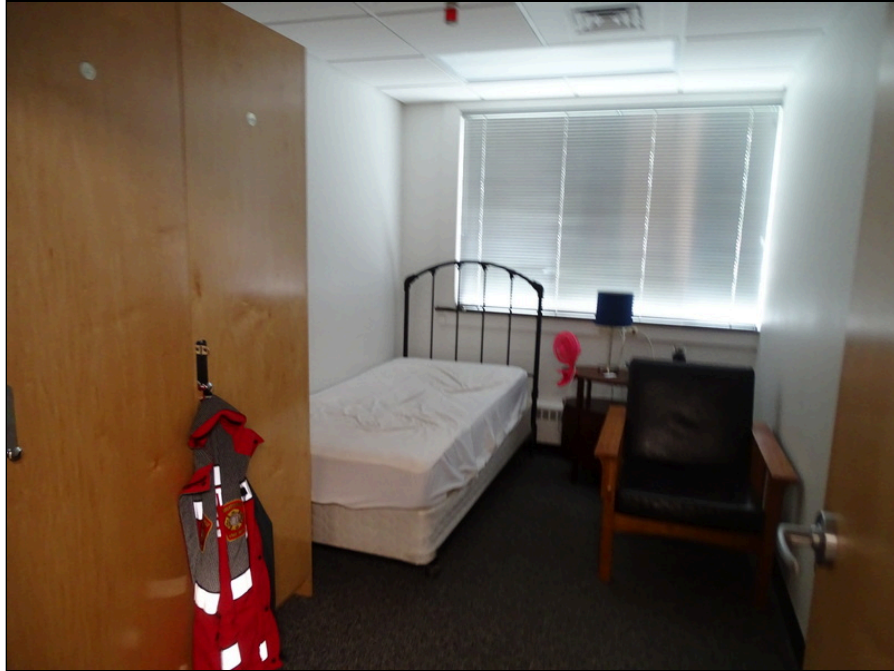
83 - Typical dorm room area interior

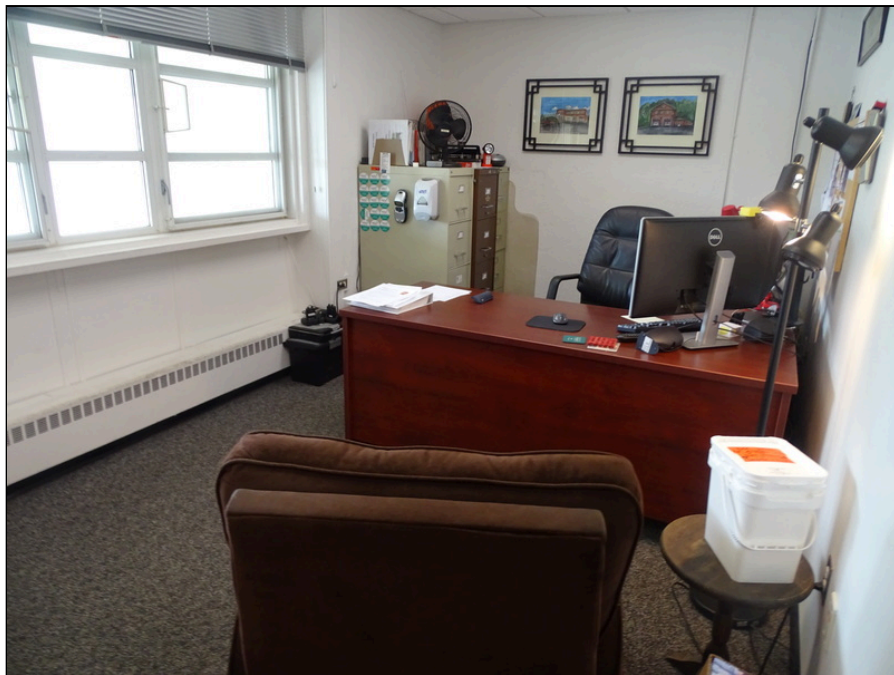
84 - Typical interior of office areas

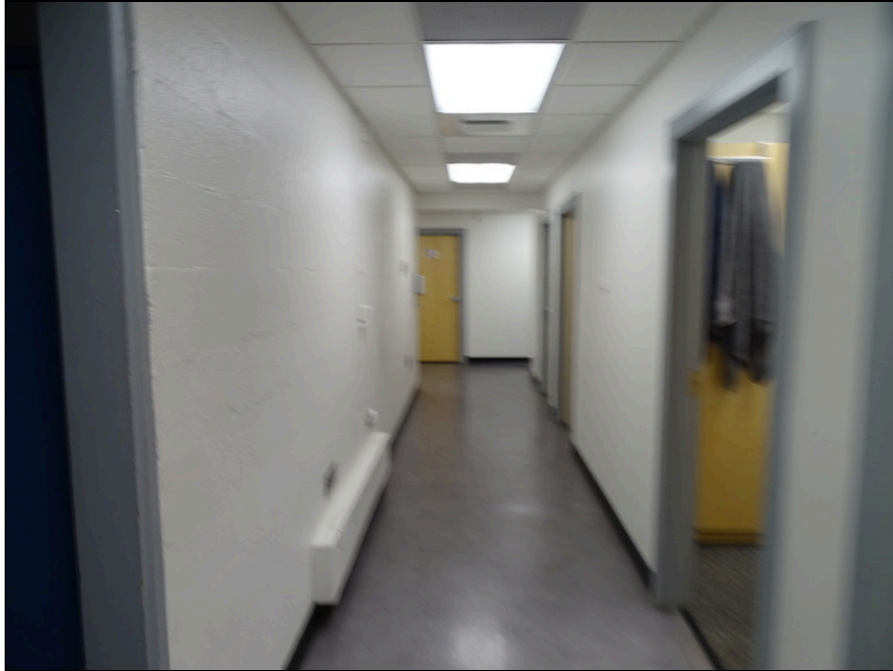
85 - Typical corridor area interior

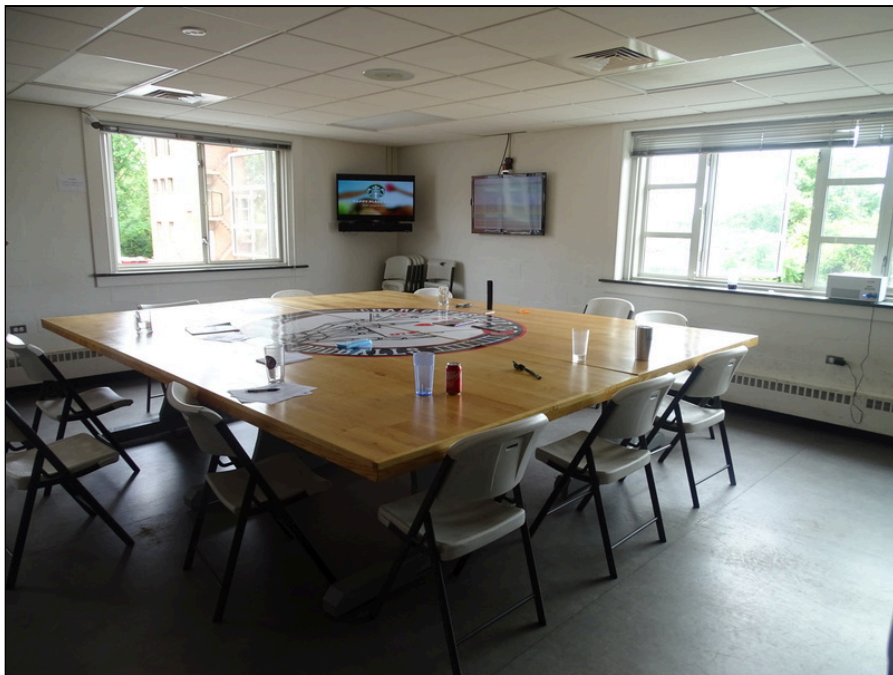
86 - Typical kitchen area interiors

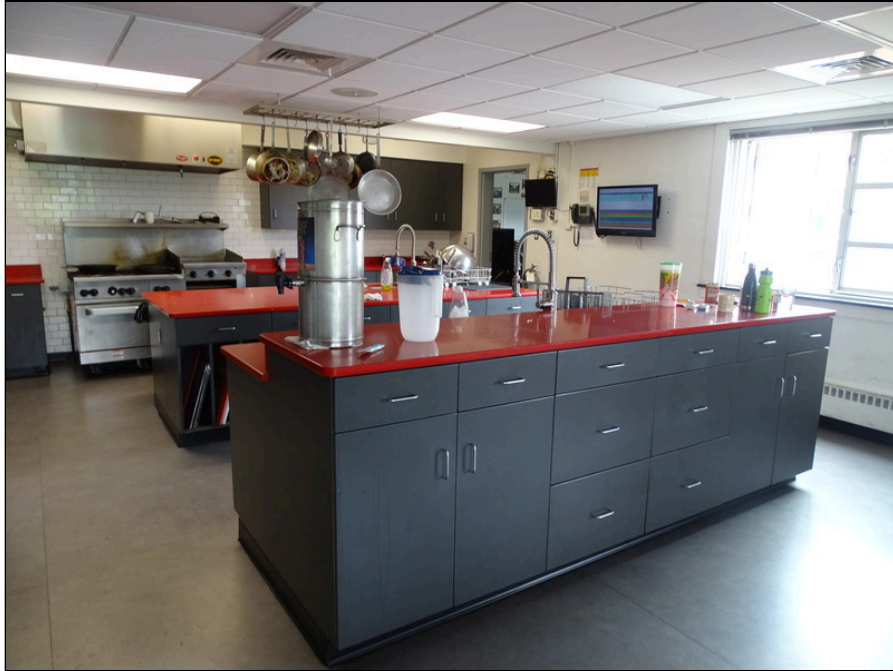
87 - Typical kitchen area interiors

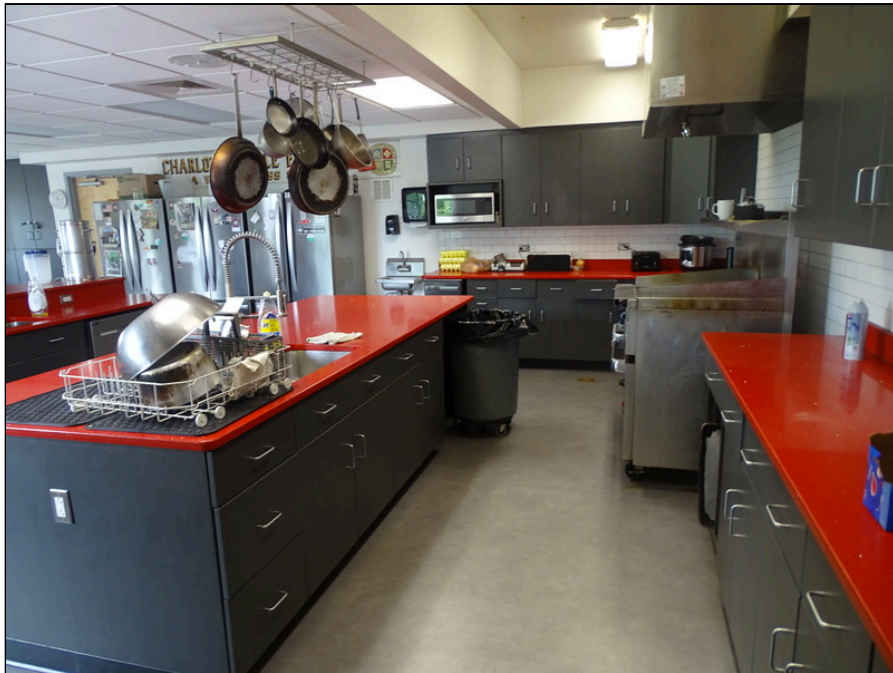
88 - Typical kitchen area interiors

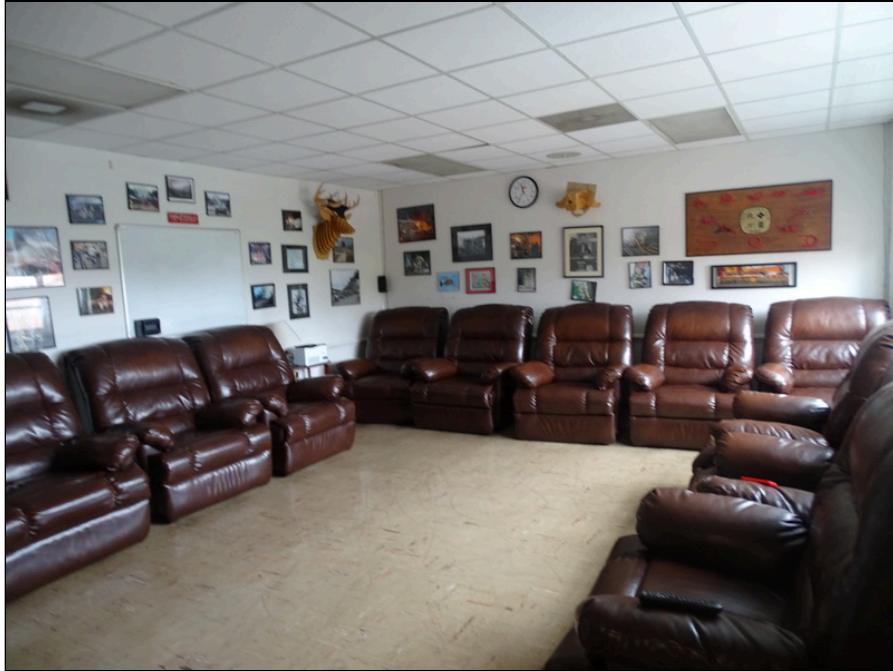
89 - Typical living area interior

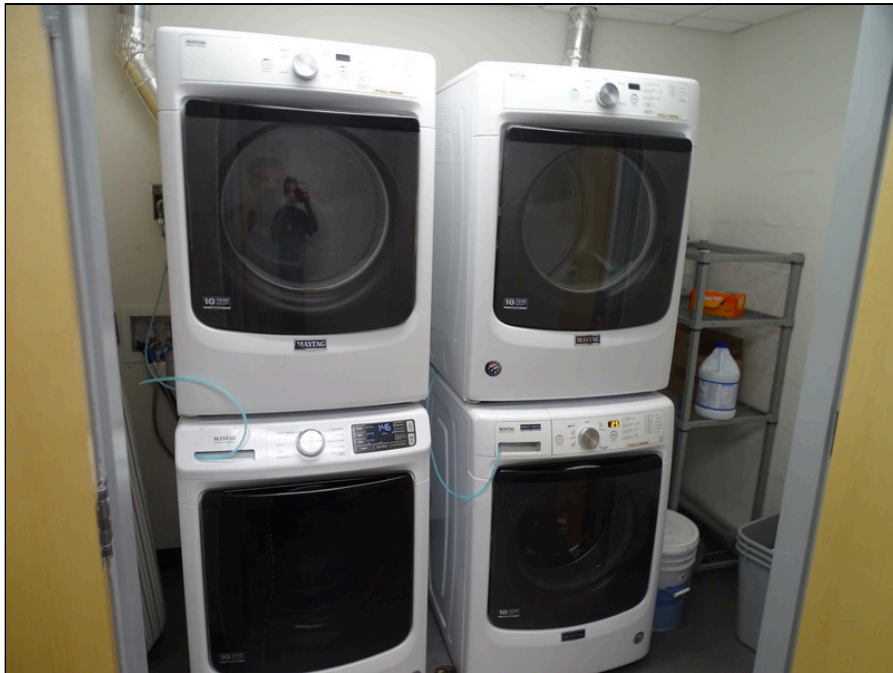
90 - Laundry appliances

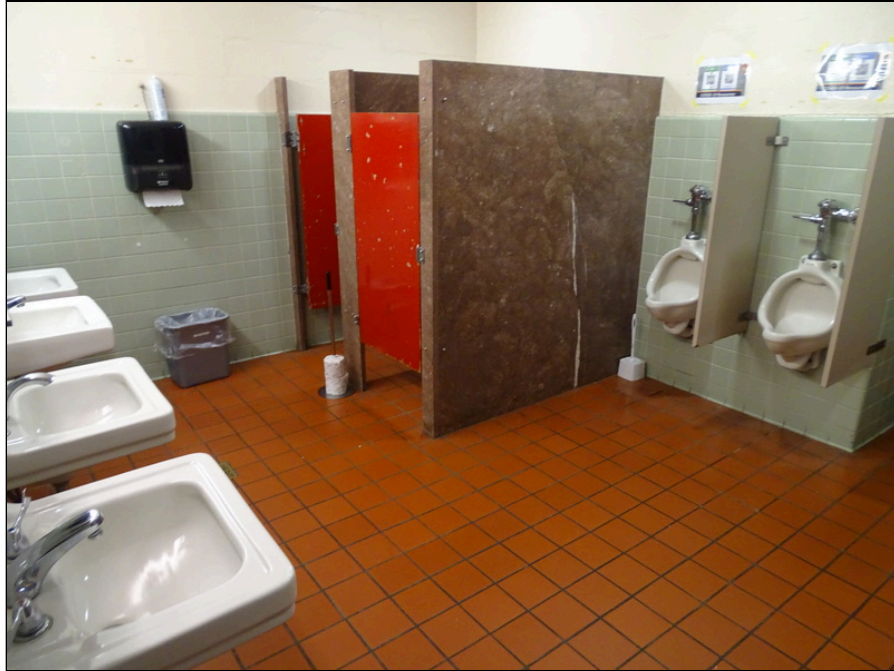
91 - Typical restroom interiors

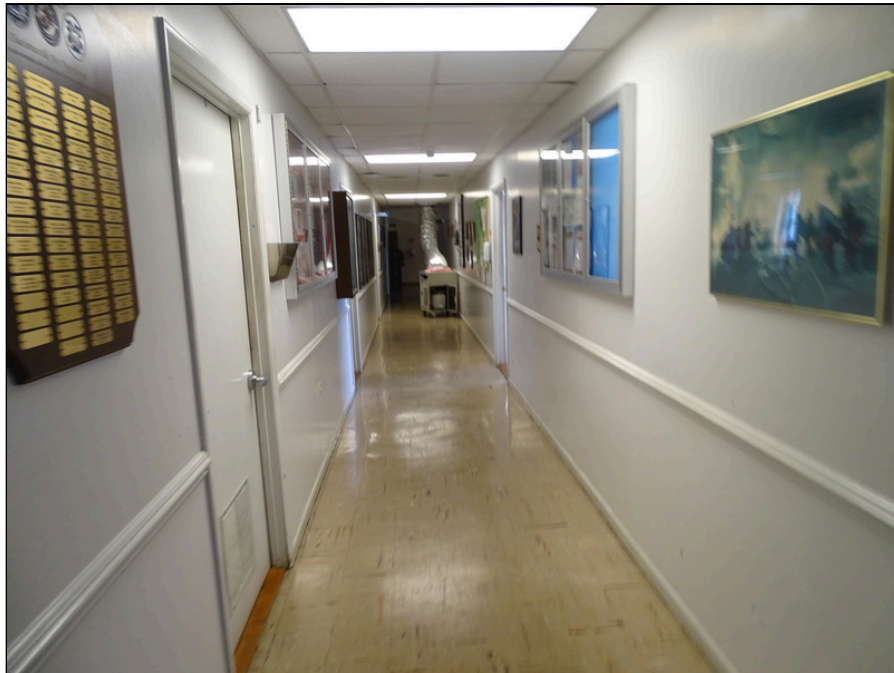
92 - Typical corridor area interiors

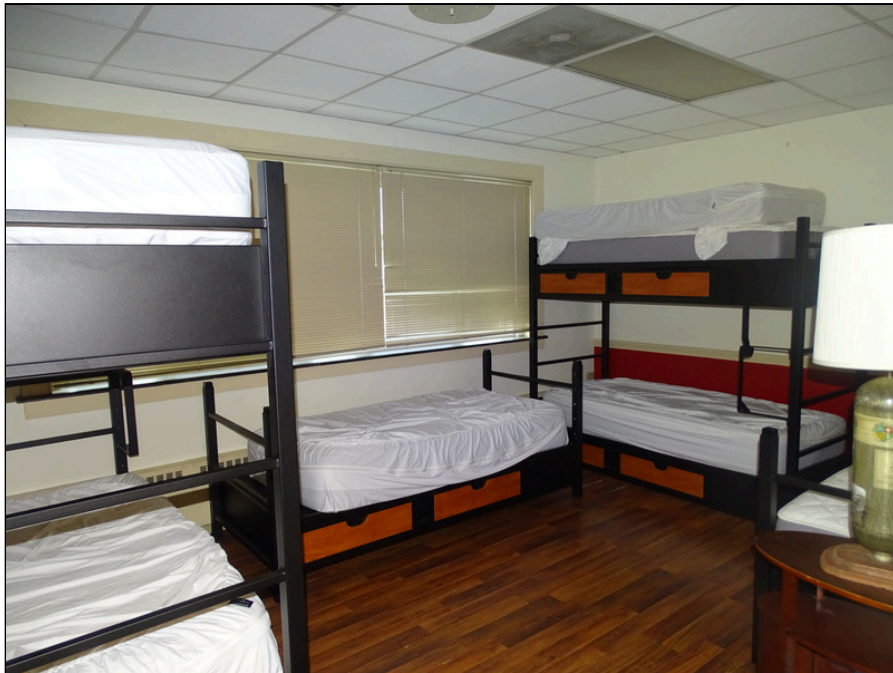
94 - Typical dorm room area interior

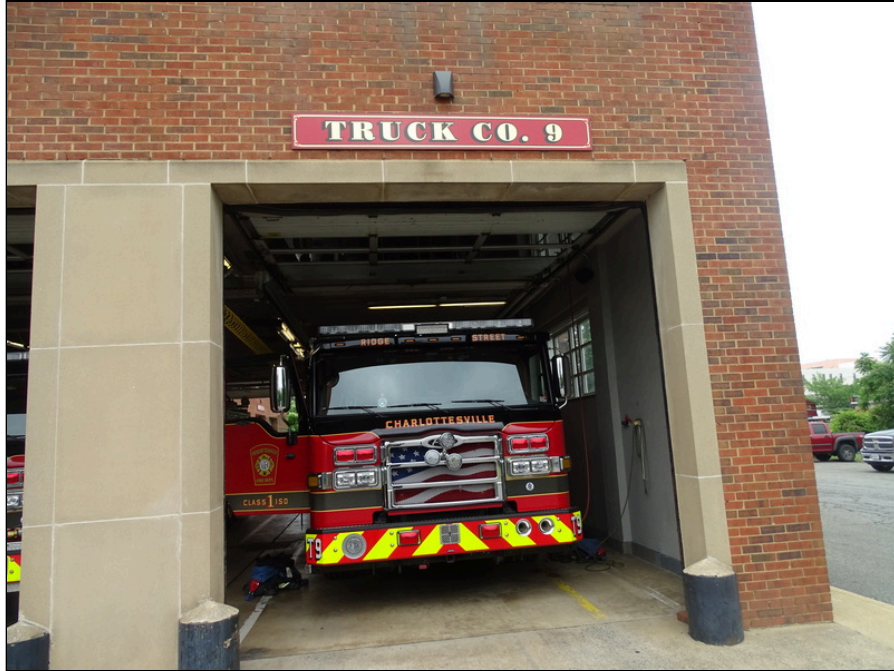
95 - Typical interior of bay area

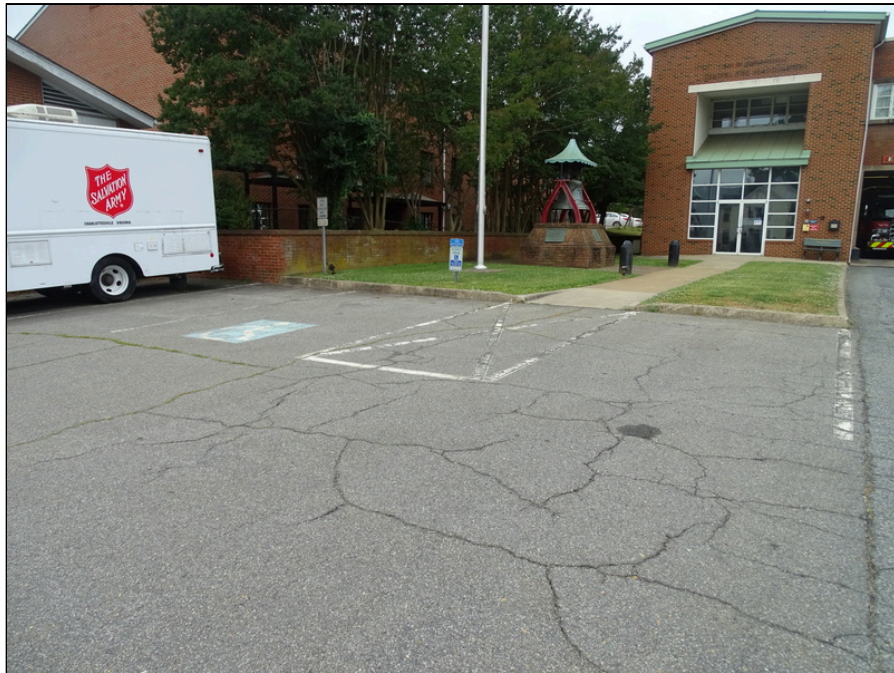
96 - Accessible parking space - note one space provided when two are required

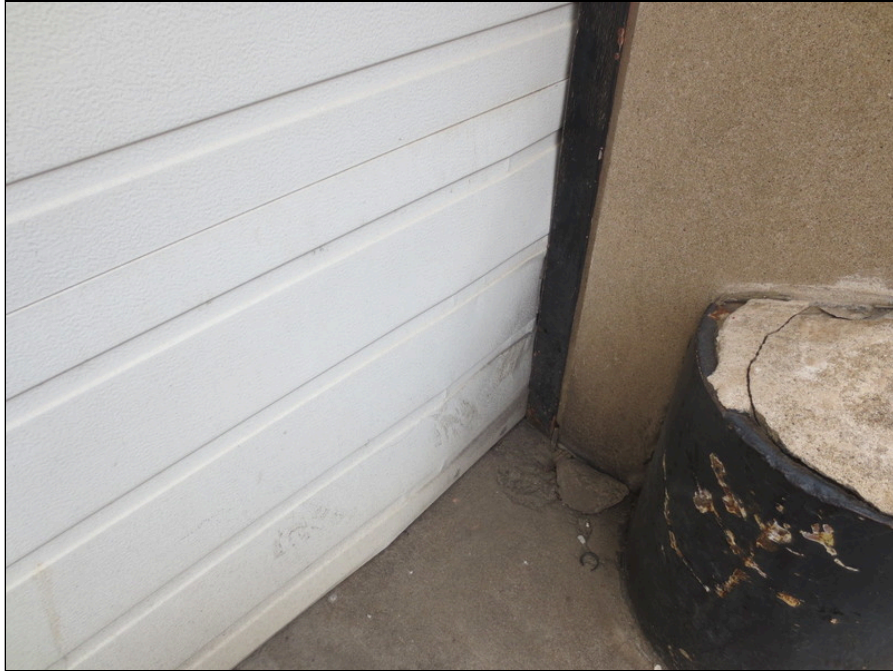
99 - Overhead door east

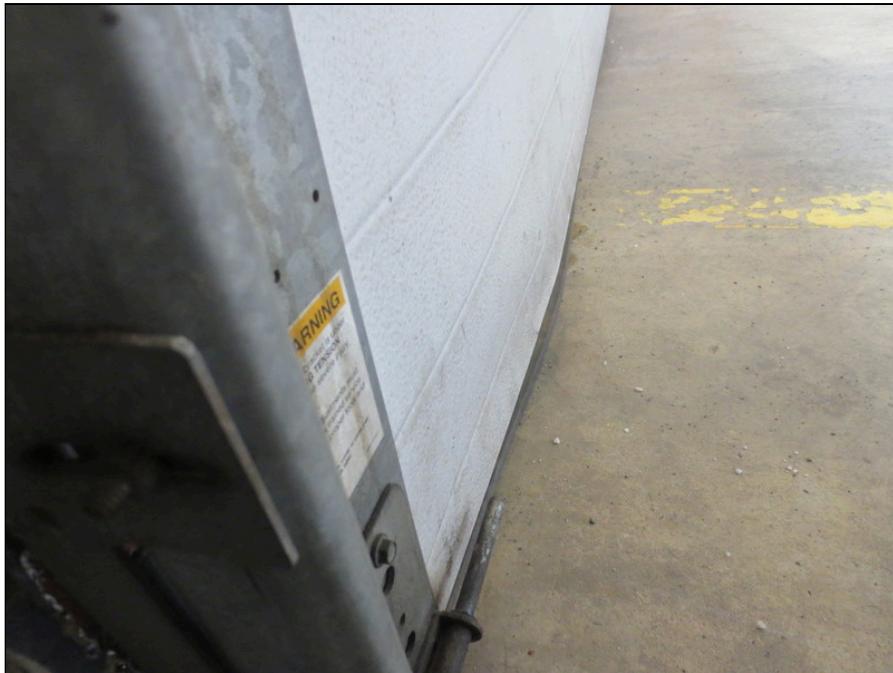
100 - Overhead door east
