FACILITY CONDITION ASSESSMENT

GORDON AVENUE LIBRARY
1500 GORDON AVENUE
CHARLOTTESVILLE, VIRGINIA

ECS PROJECT NO. 46:6713

NOVEMBER 2, 2021

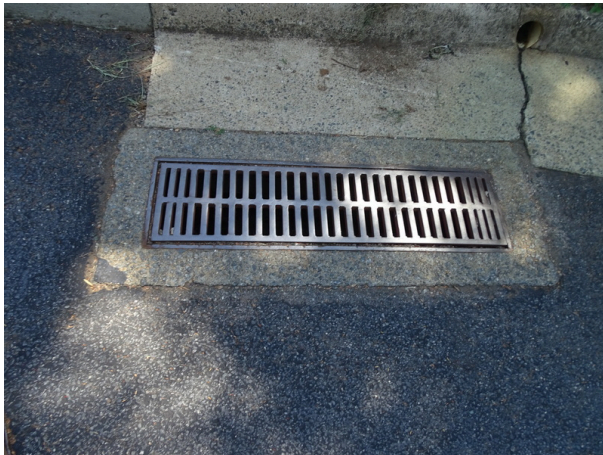
Typical storm drainage

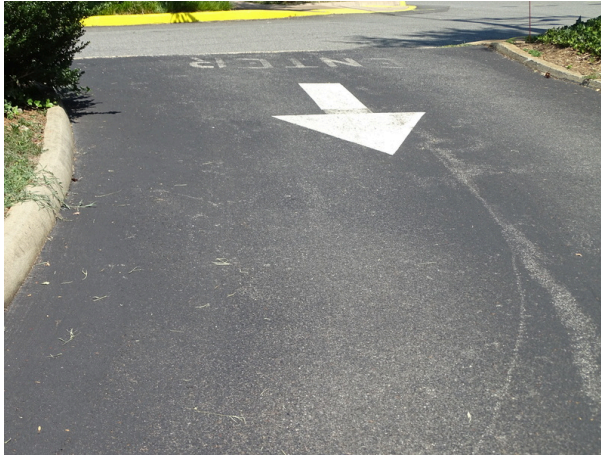
Asphalt-paved drive lanes and parking are located on the north, west, and east sides of the site. The asphalt pavement was observed to be in generally fair condition with cracking observed. The expected useful life of asphalt pavements is generally 20 years. We recommend the asphalt pavements be repaired during the report period.

Asphalt pavement and concrete apron west side of site

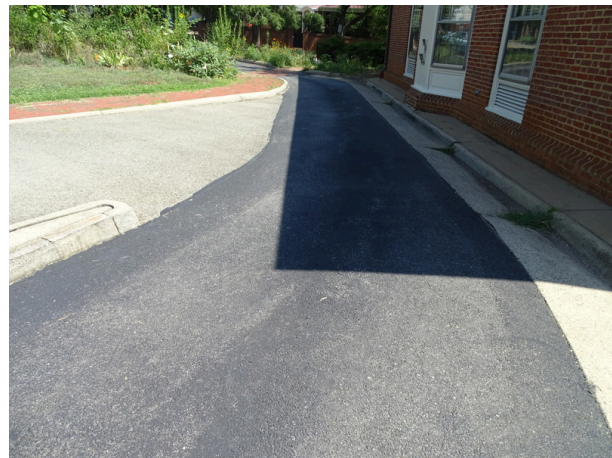
New asphalt pavement installed

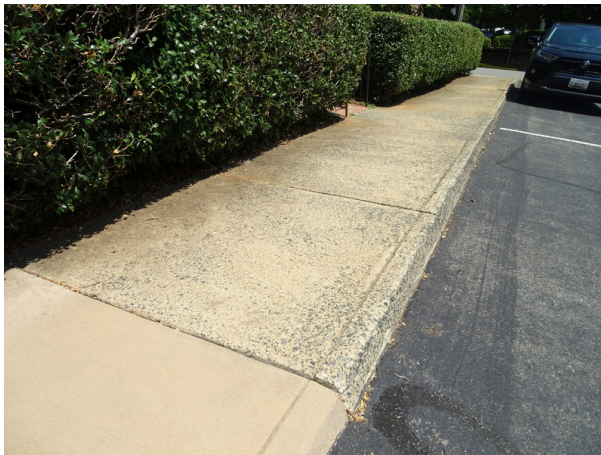
Concrete sidewalk north side of the site

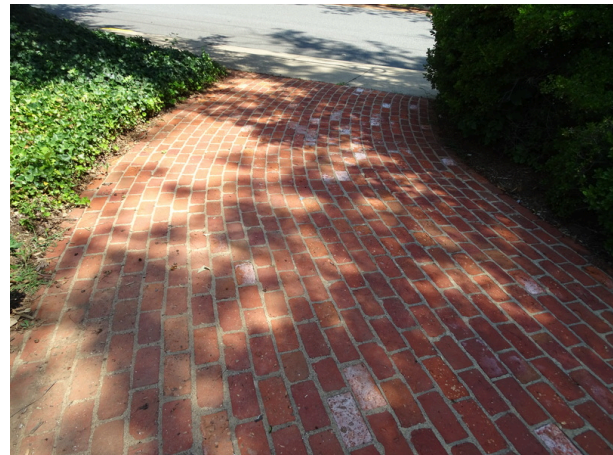
Concrete and brick sidewalks of undetermined thickness are provided at the north side of the site. Regularly spaced control joints were observed. Sections of the brick sidewalks were observed to be refurbished since the last visit.

Brick sidewalk north side of the site

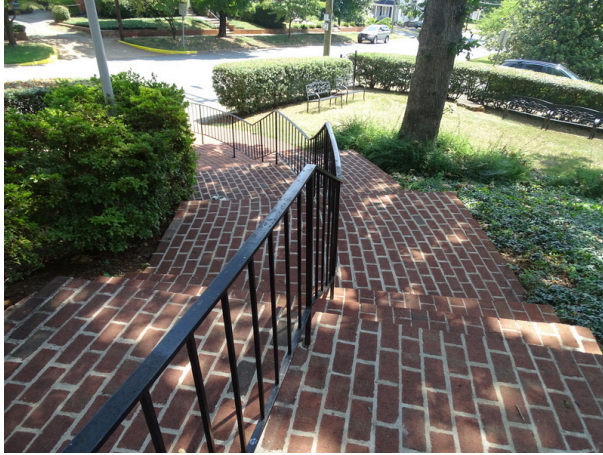
Brick sidewalk and steps east side of the building

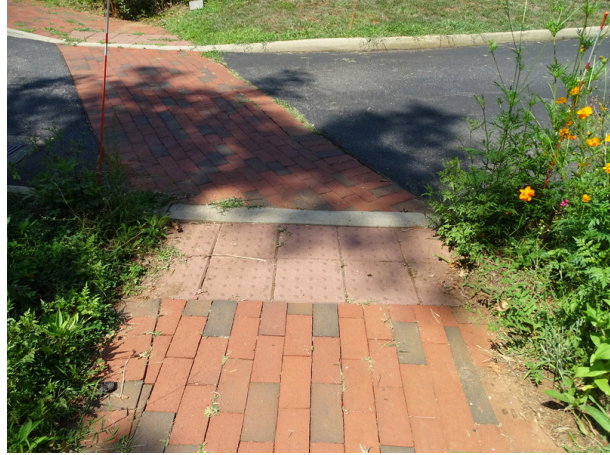
Brick sidewalk with truncated domes

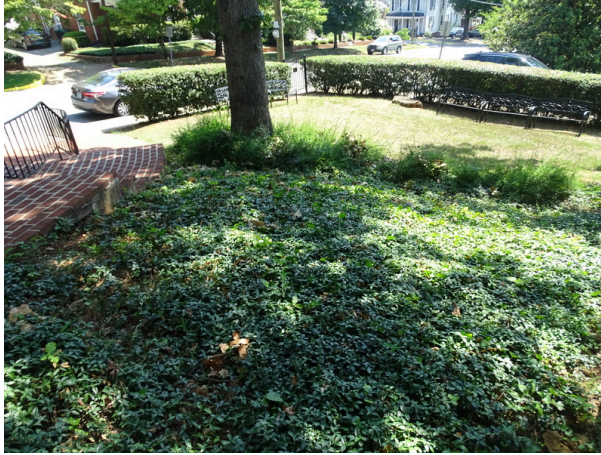
The landscaping consists generally of mature trees, small shrubs, hedges, and grassed areas around the site. The landscaping was observed to be in generally good condition.

Typical landscaping

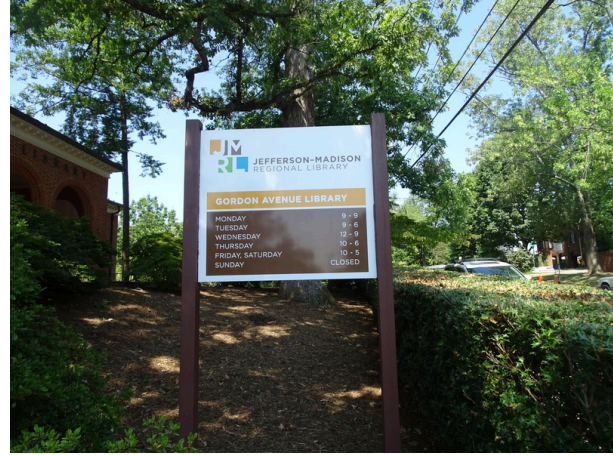
Monument sign

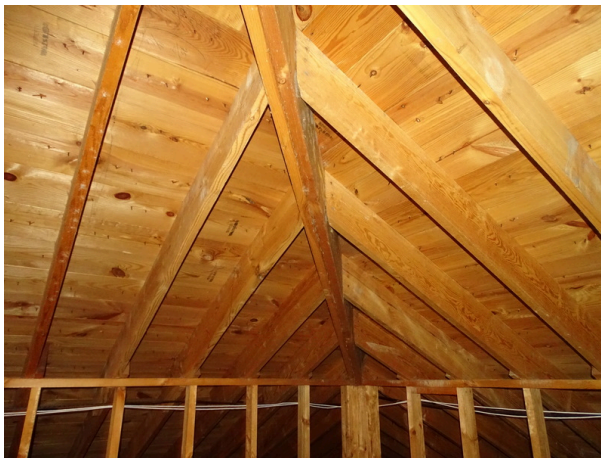
The structure of the building consists of Masonry bearing walls with wood roof framing. The structural frame of the building was generally in good condition.

Structural framing

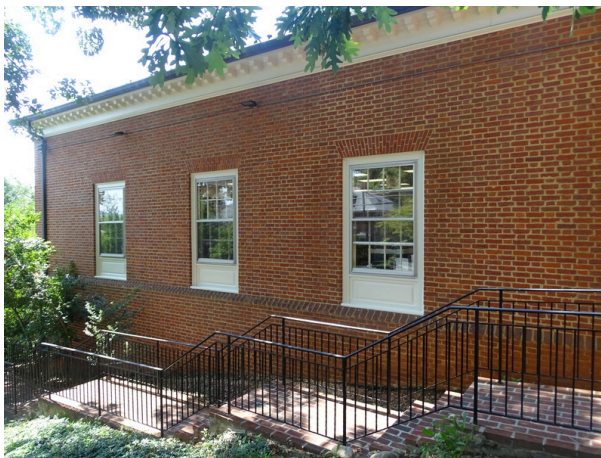
Building exterior west side of the building

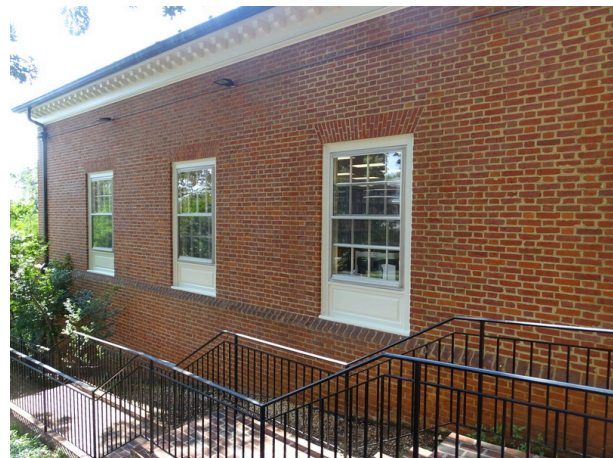
Building exterior north side of the building

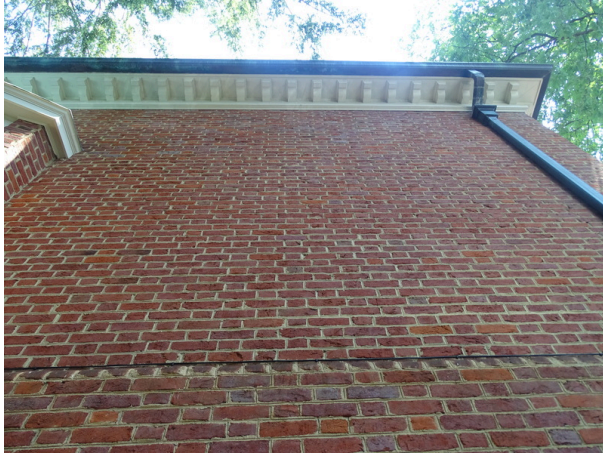
Building exterior south side of the building

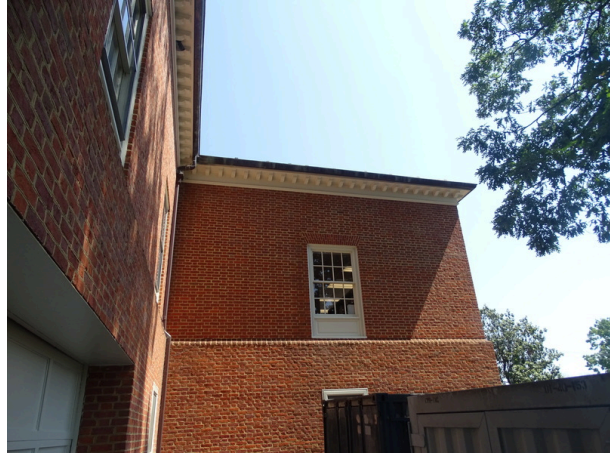
Building exterior east side of the building

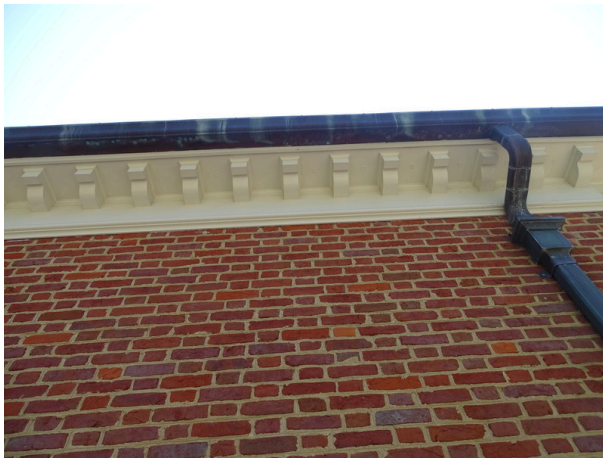
The wood trim and wood cornice are painted. The paint was generally in good to fair condition. Painted exteriors typically have an expected useful life of 5 to 7 years. We recommend the wood trim and cornice be painted during the report period.

Typical wood cornice at building exterior

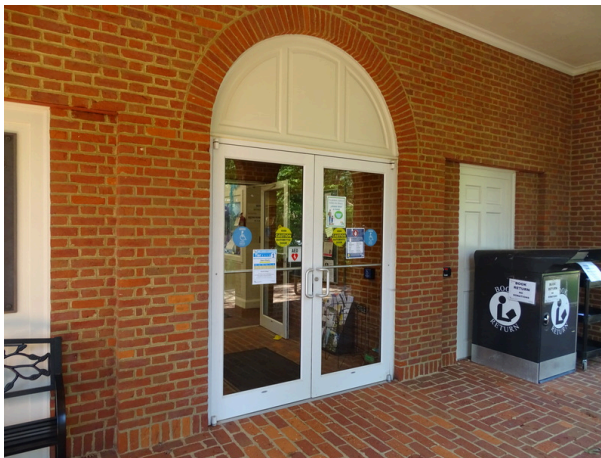
The main entrance is a Storefront entrance. The main entrance doors were generally in good condition. Personnel doors are located around the building. The personnel doors were generally in good condition. Exterior doors typically have an expected useful life of 20 to 30 years.

Main entrance at north side of the building

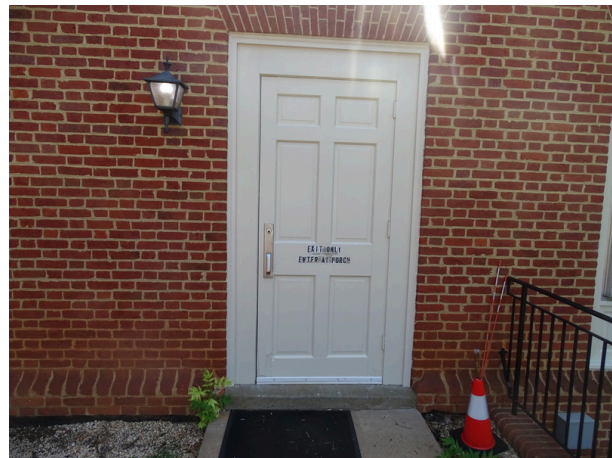
Typical personnel door

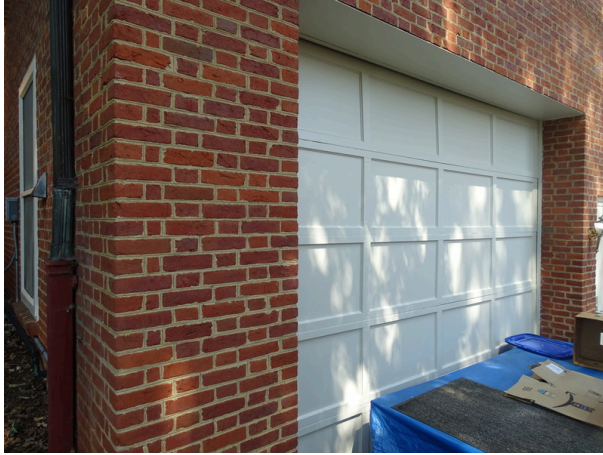
Typical over head door

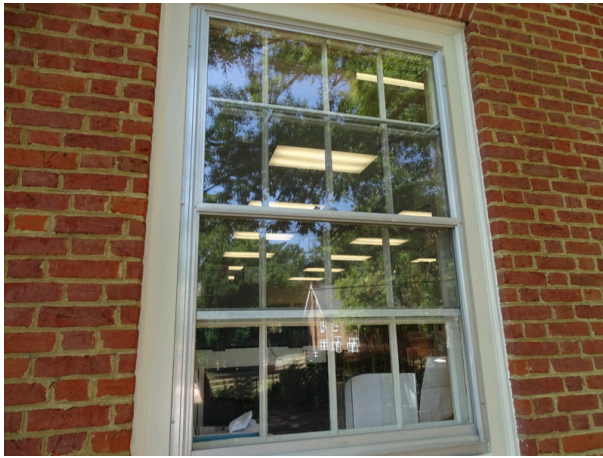
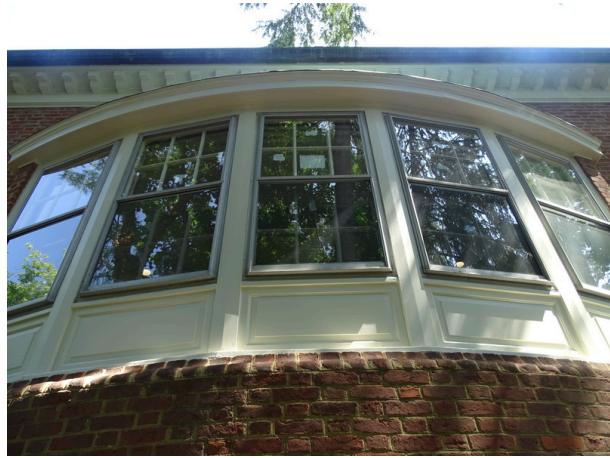
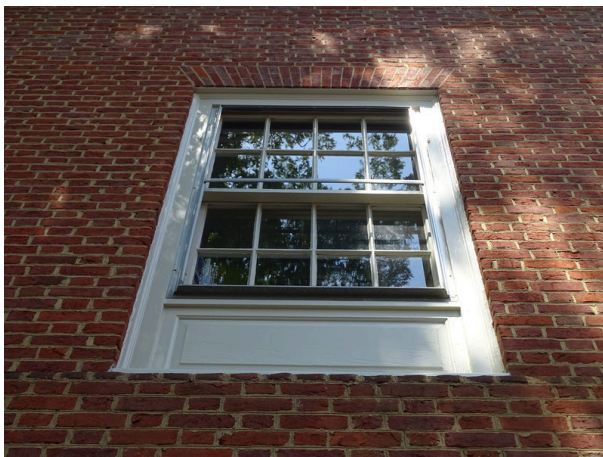
The window system for the building primarily consists of Wood-framed single-pane operable window units with outer storm window units. The window units were generally in good condition. The expected useful life of windows is typically 30 years.

Typical exterior window

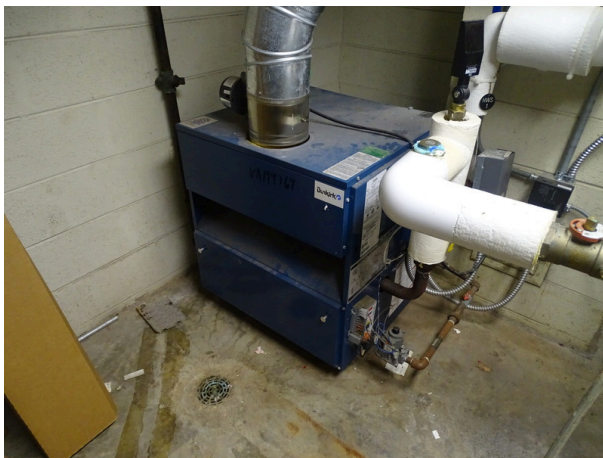
Boiler located in main utility room

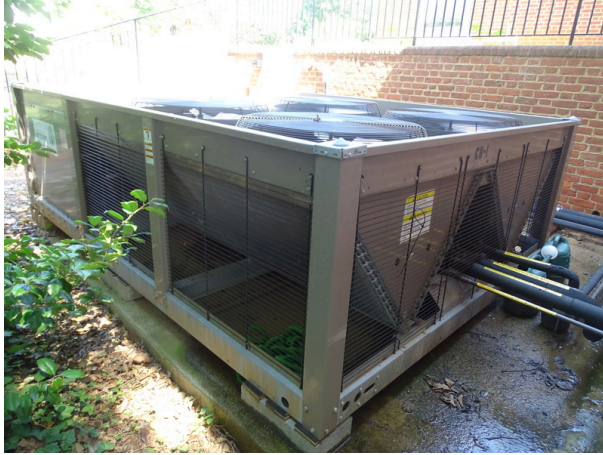
Condenser Unit located at southwest side of the building

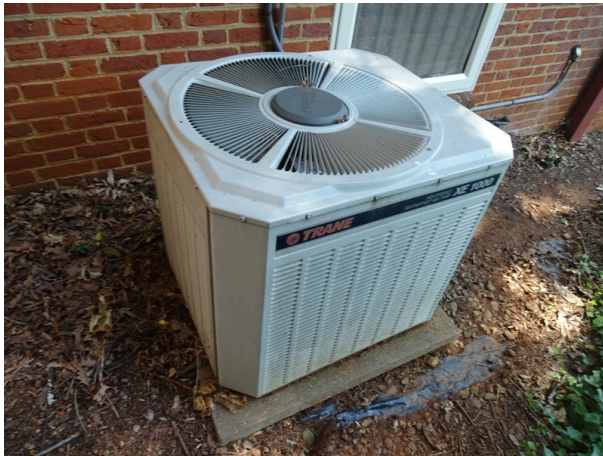
The split system is located at the southeast side of the building and was reportedly manufactured by Trane in 2006. The expected useful life of split systems is generally 15 to 20 years. The split systems were generally in fair condition. We recommend replacing the split systems during the report period.

Split System southeast side of the building

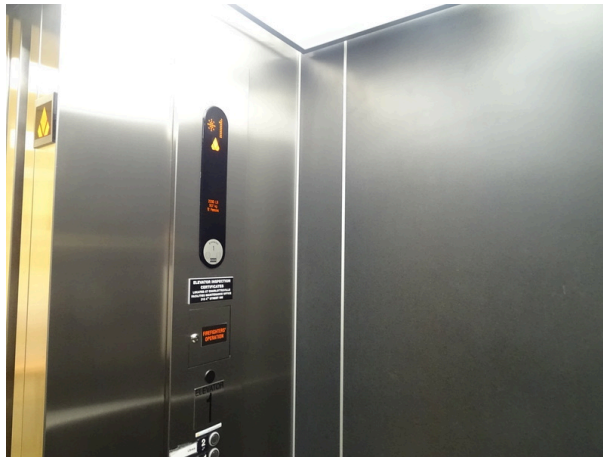
Elevator cab interior finishes

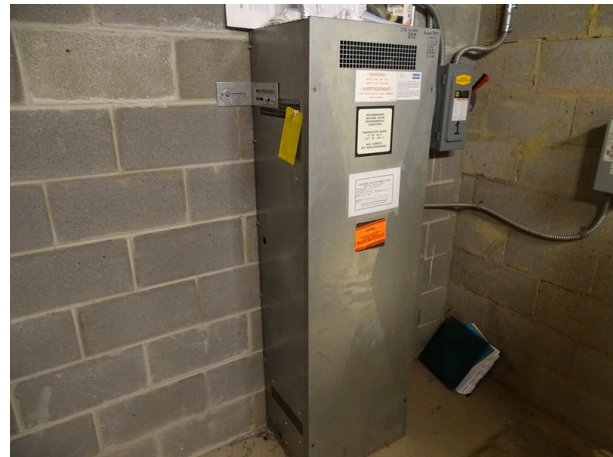
The building is served by one passenger elevator. The elevator was manufactured by KONE. The expected useful life of the elevator controls is 30 to 40 years with proper maintenance. Routine maintenance is considered adequate to keep the elevator system in good condition during the projection period of this report.

Elevator machine and controls

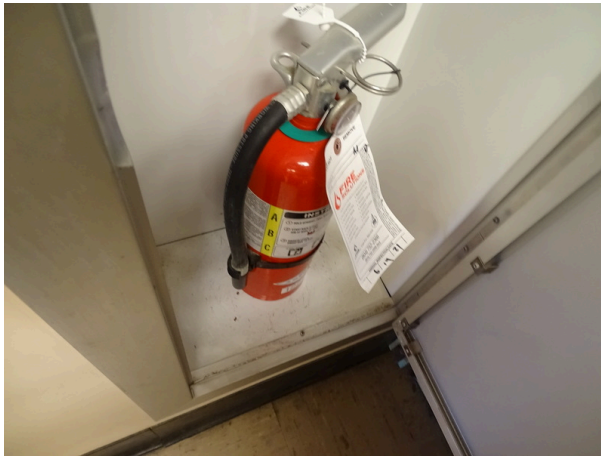
Typical fire extinguisher

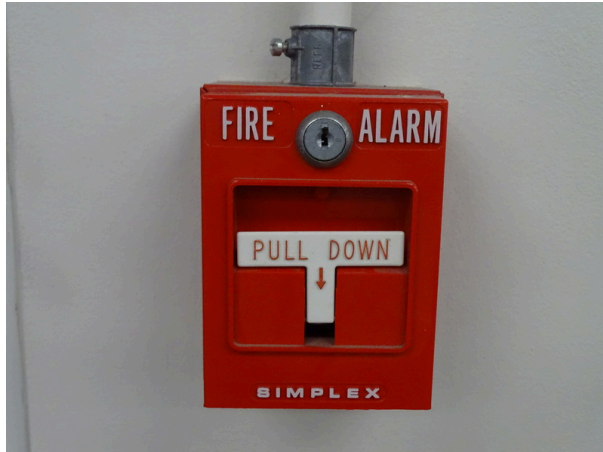
Typical fire alarm pull station

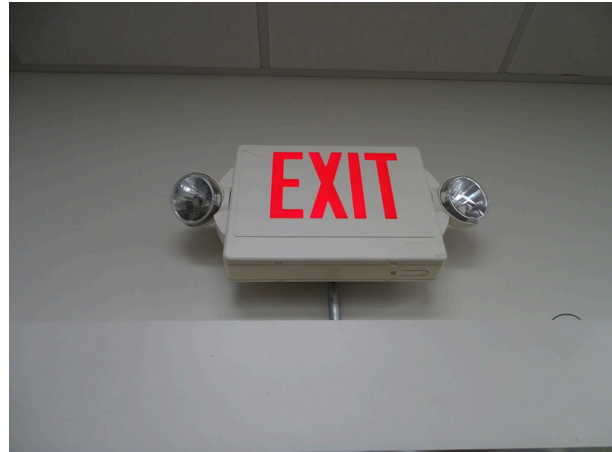
Typical exit sign and emergency lighting

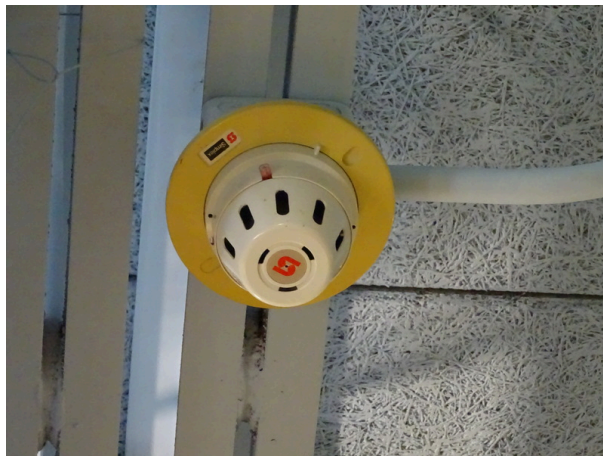
Typical smoke detector

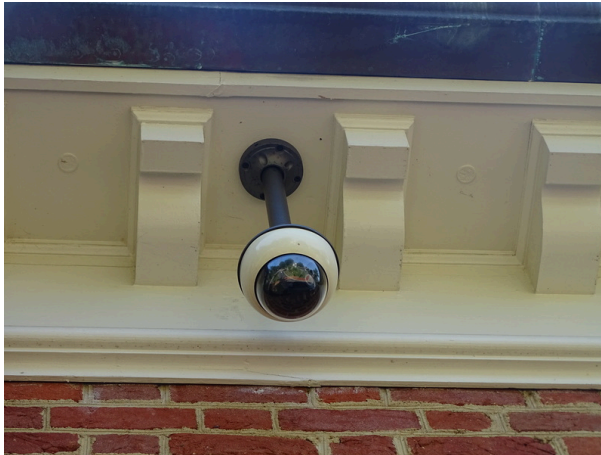
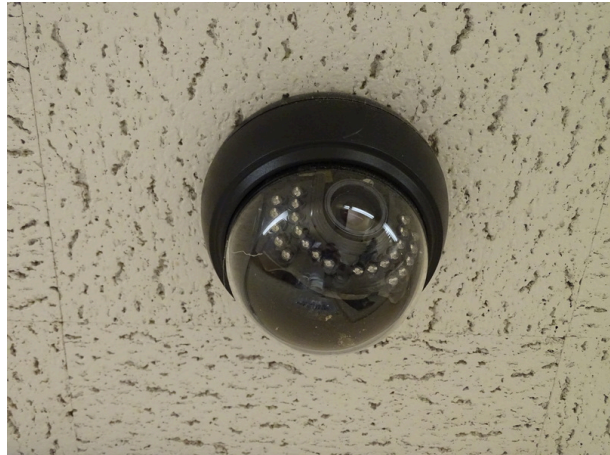
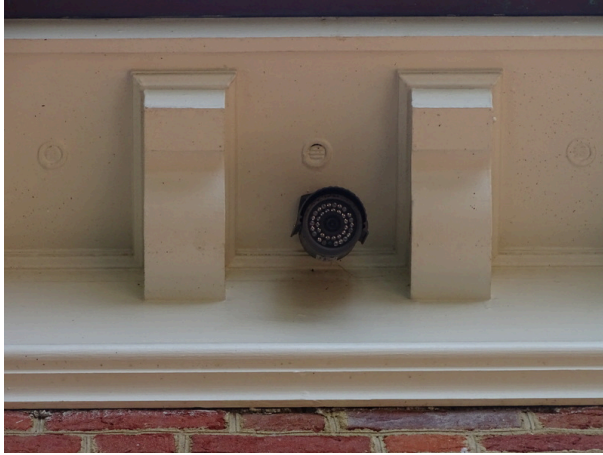
The building is monitored 24-hours a day by a computerized security system with cameras. Security cameras were observed at locations at the building interior and exterior. The security system was generally in good condition.

Typical security camera

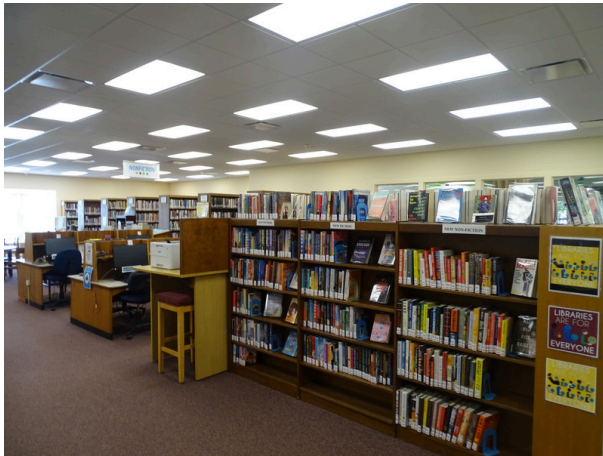
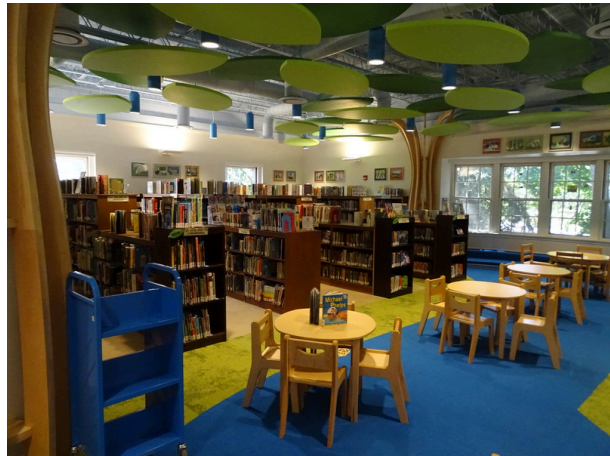
Interior finishes of lobby - library area - note newer suspended acoustical tile ceiling

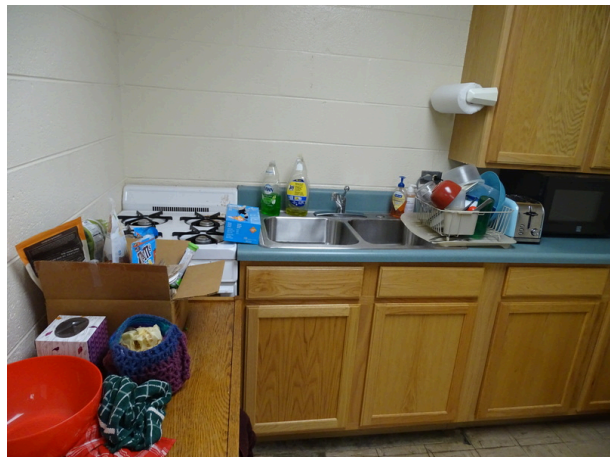
Interior finished of kitchen area

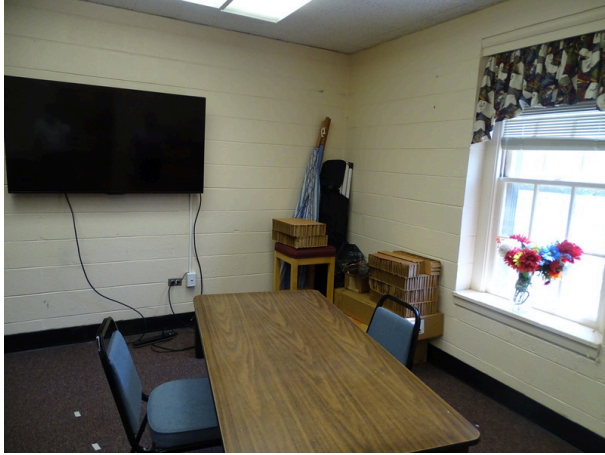
The finishes in the meeting rooms include carpet floors, painted CMU walls, and acoustical tile ceilings. The finishes in the meeting rooms were observed to be in generally good to fair condition. We recommend replacing the older acoustical tile ceilings.

Interior finishes of meeting room area - note
older acoustical tile ceiling

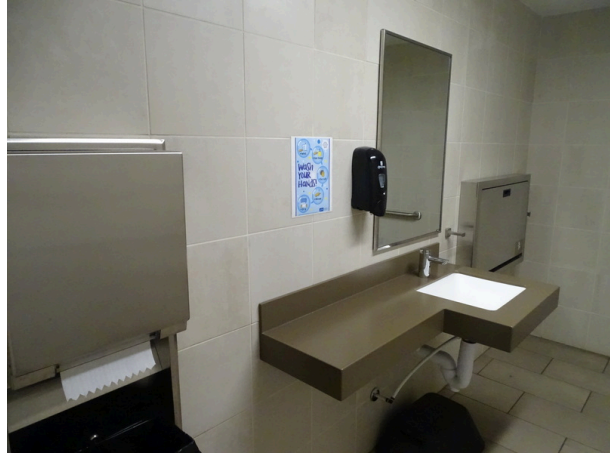
Typical restroom area

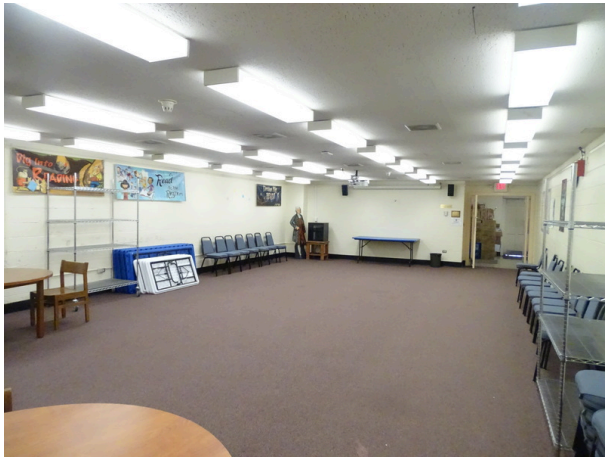
Typical interior

Cost Recommendation	EUL	EFF AGE	RUL	Year	Cost
REPLACE ACOUSTICAL TILE CEILINGS	50	49	1	1	\$15,000
Total					\$15,000

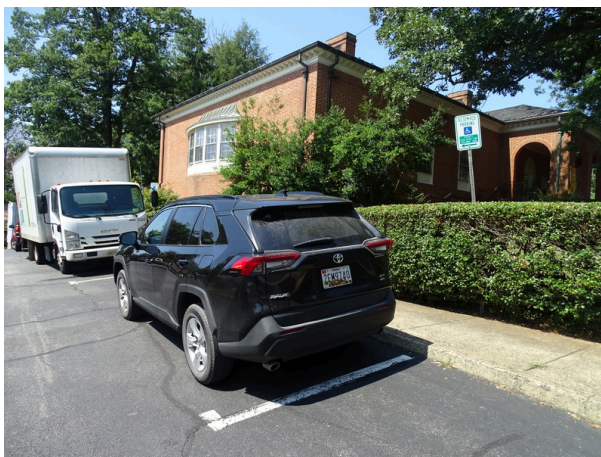
Accessible parking

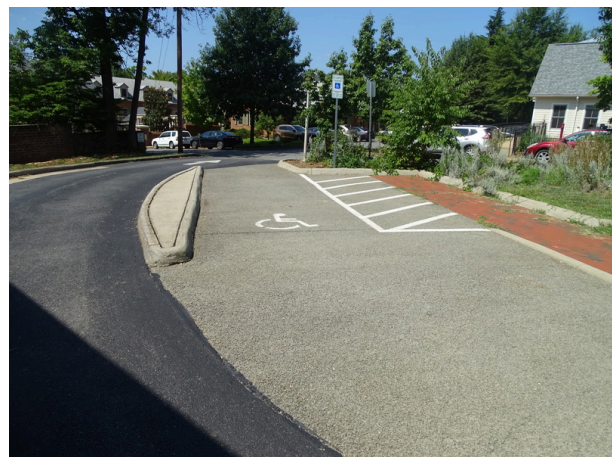
Van accessible parking space

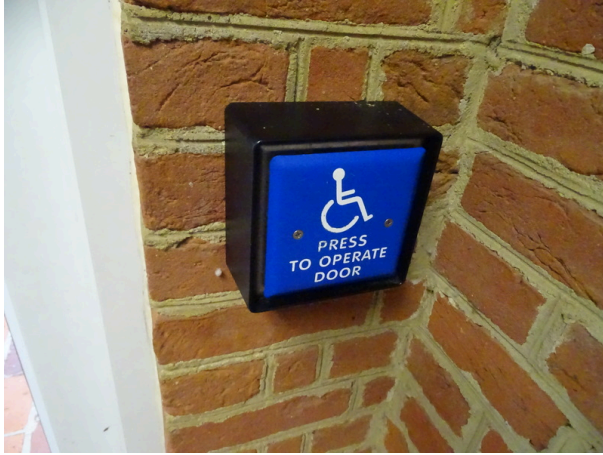
Accessible door controls at main entrance

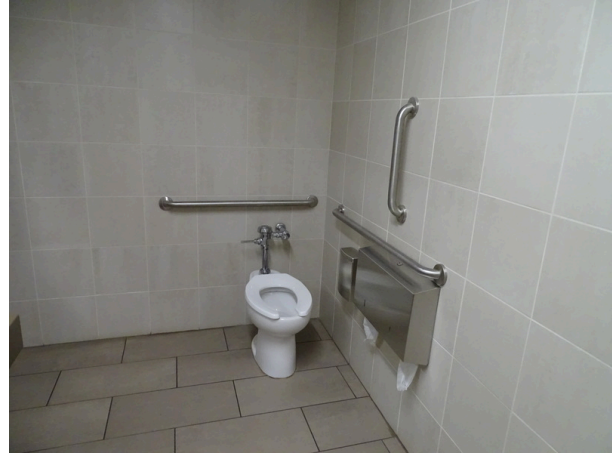
Accessible toilet

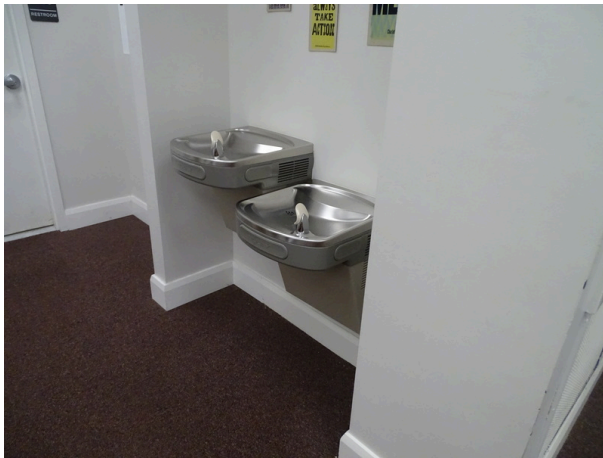
Accessible drinking fountain

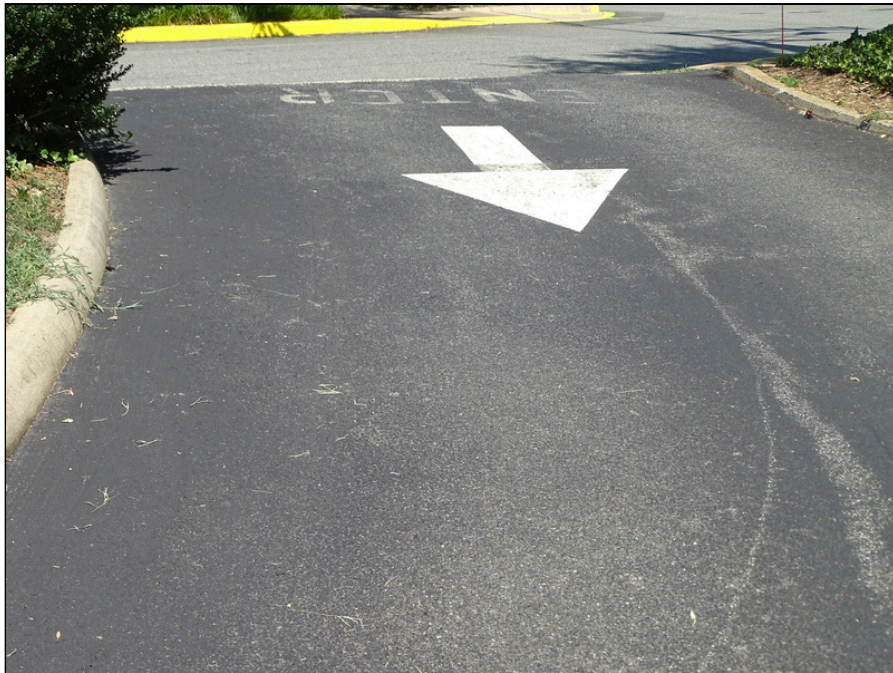
2 - Asphalt pavement and concrete apron west side of site

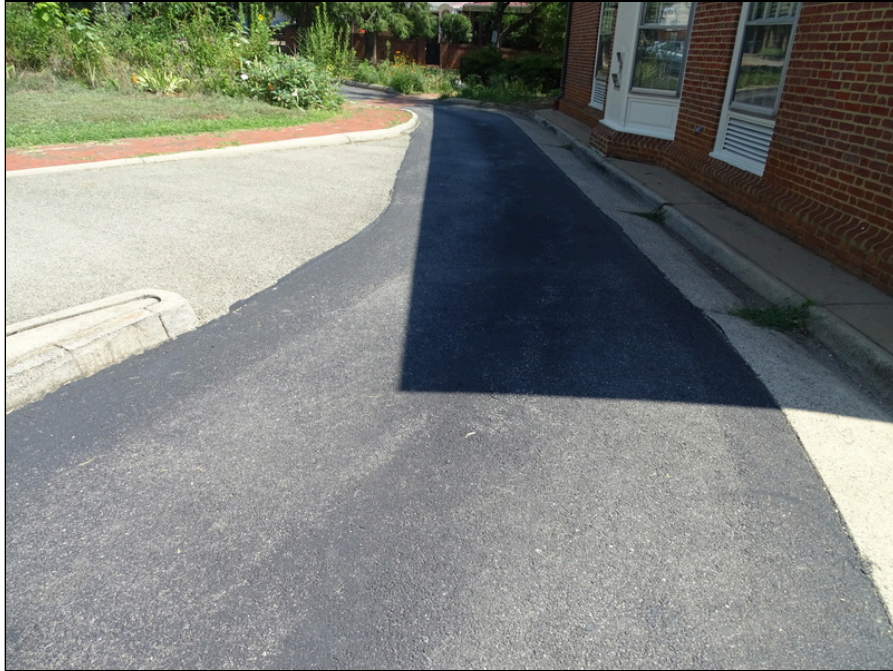
5 - New asphalt pavement installed

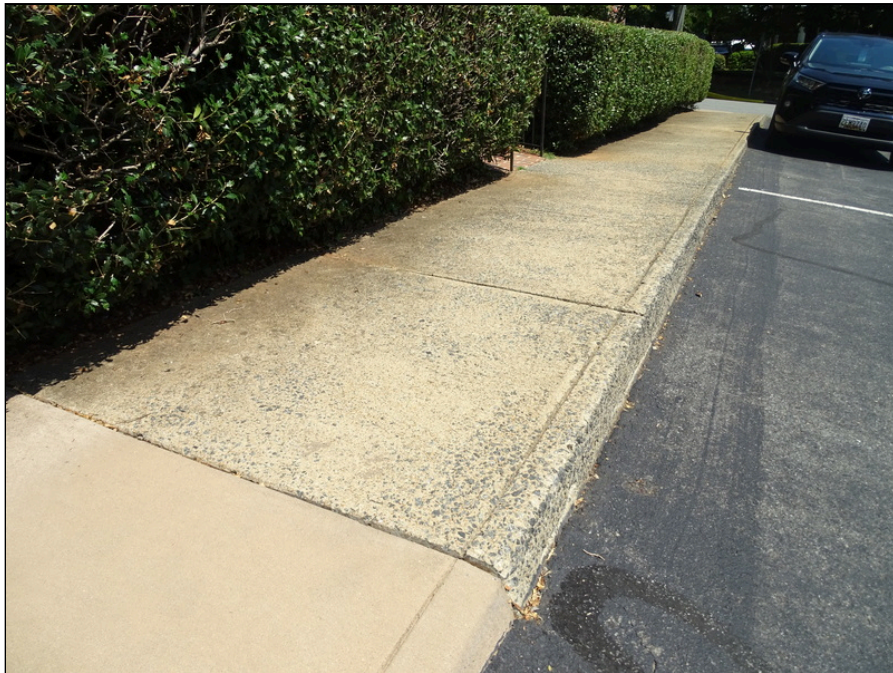
6 - Concrete sidewalk north side of the site

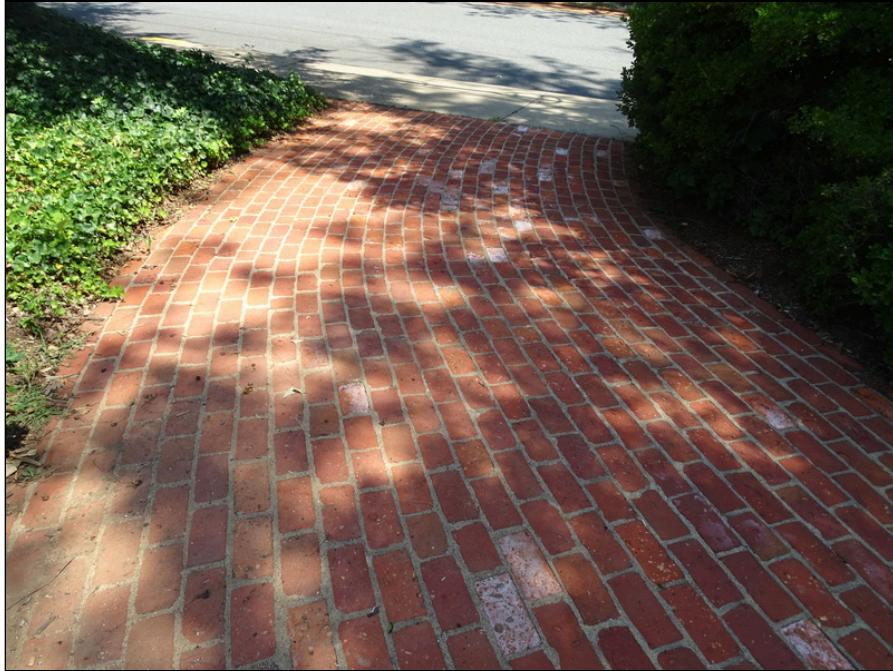
7 - Brick sidewalk north side of the site

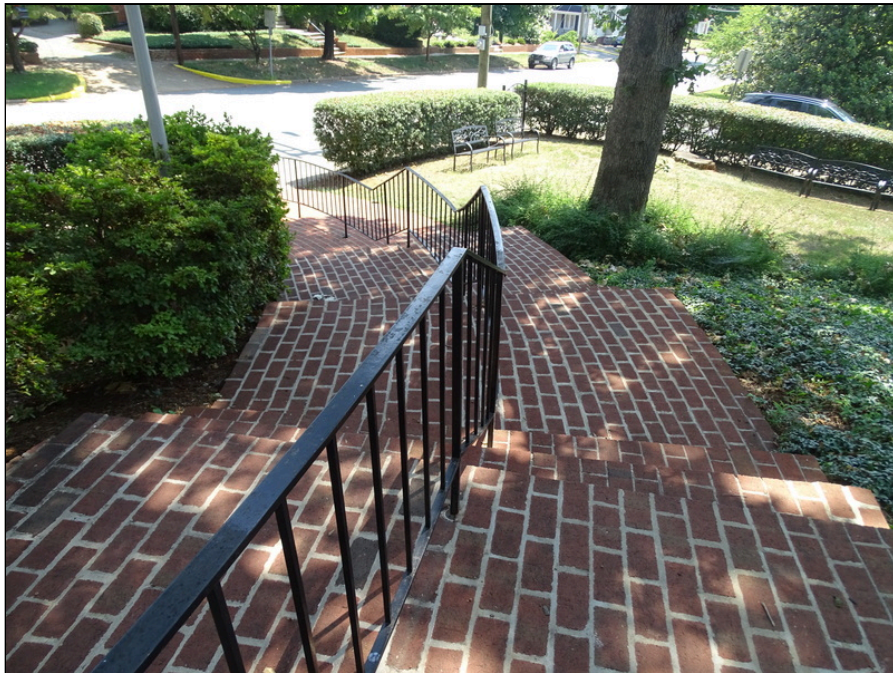
8 - Brick sidewalk and steps east side of the building

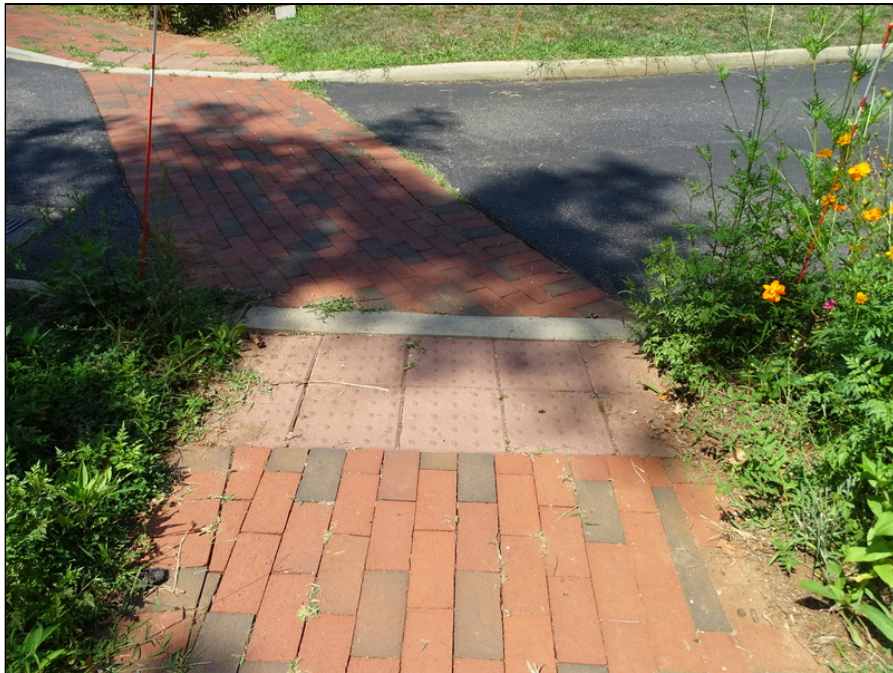
10 - Brick sidewalk with truncated domes

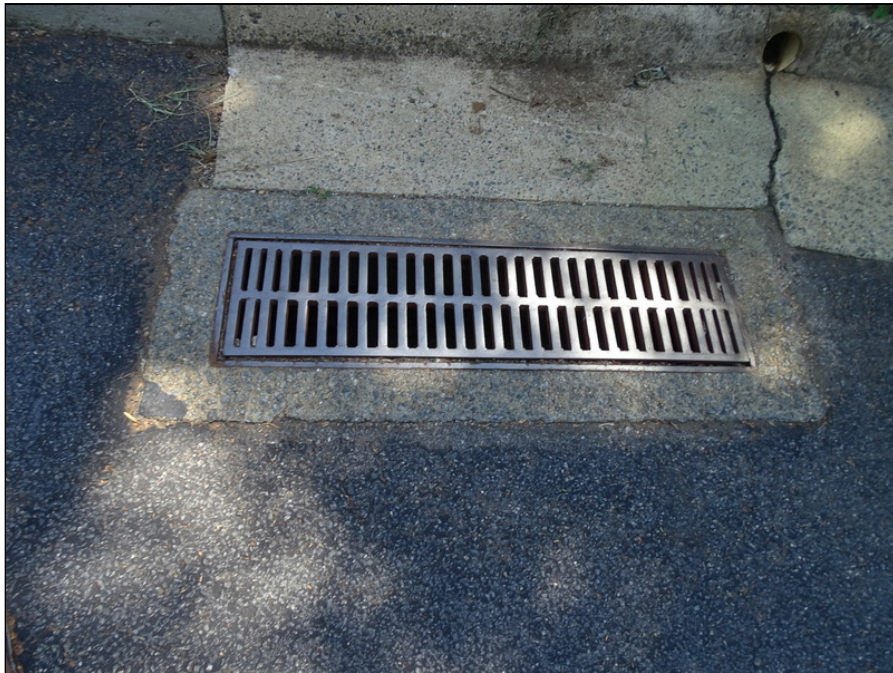
12 - Typical storm drainage

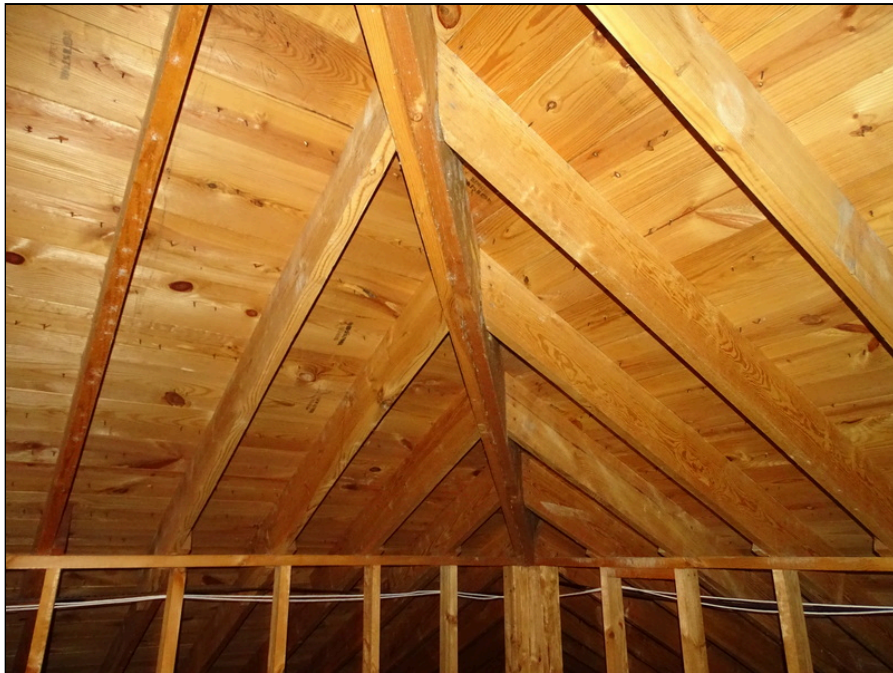
16 - Structural framing

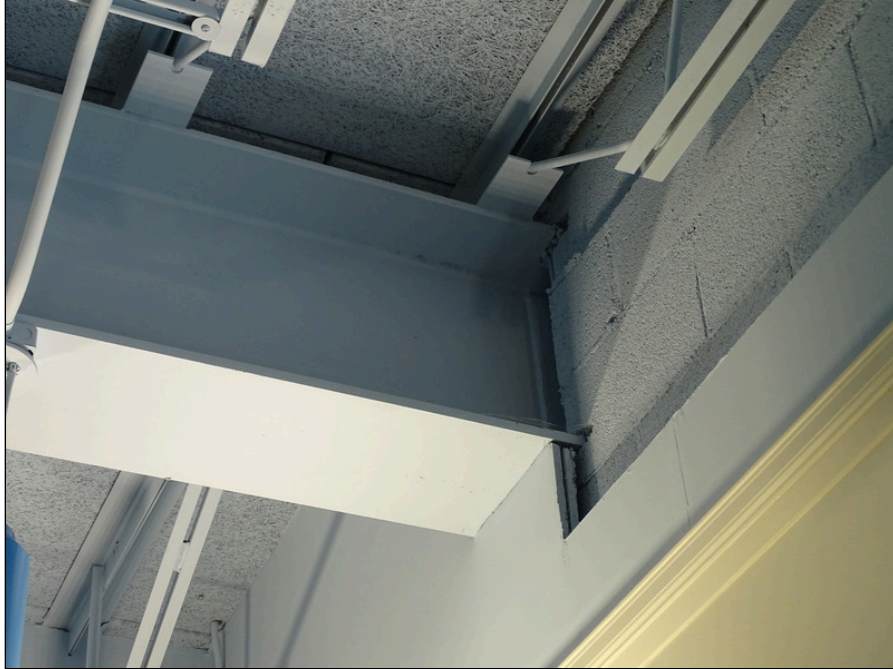
17 - Structural framing

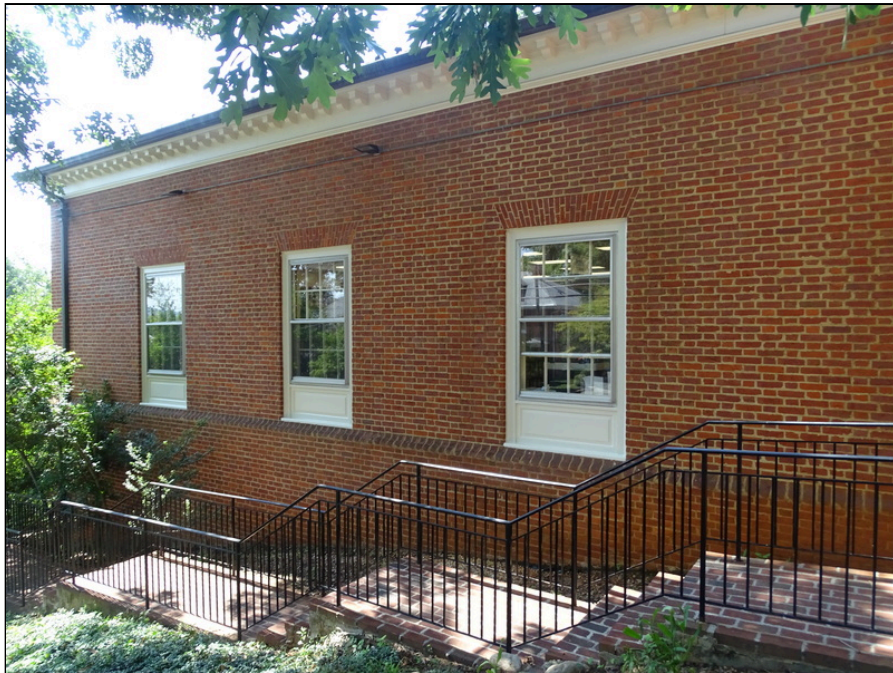
18 - Building exterior west side of the building

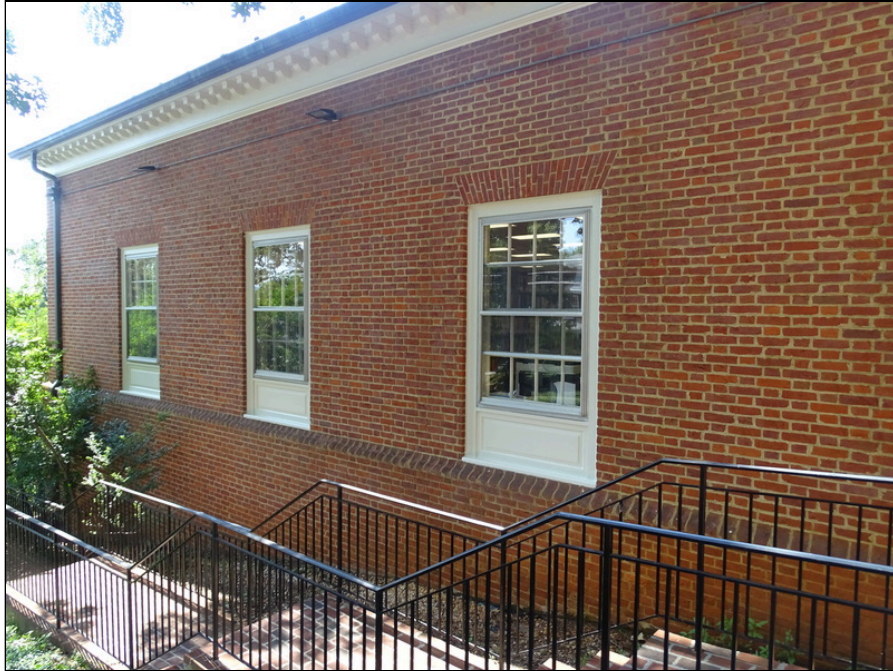
19 - Building exterior north side of the building

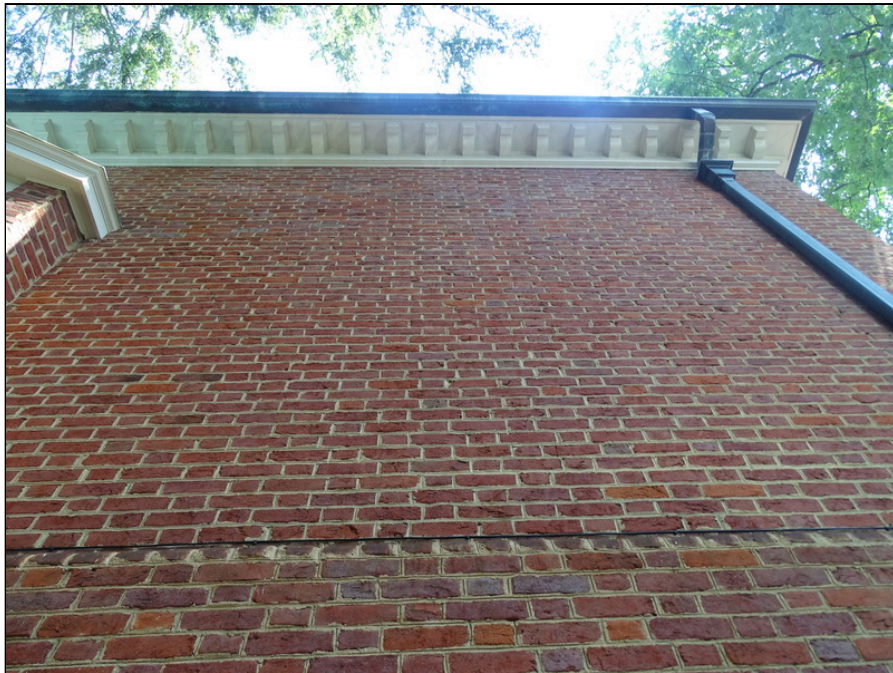
20 - Building exterior south side of the building

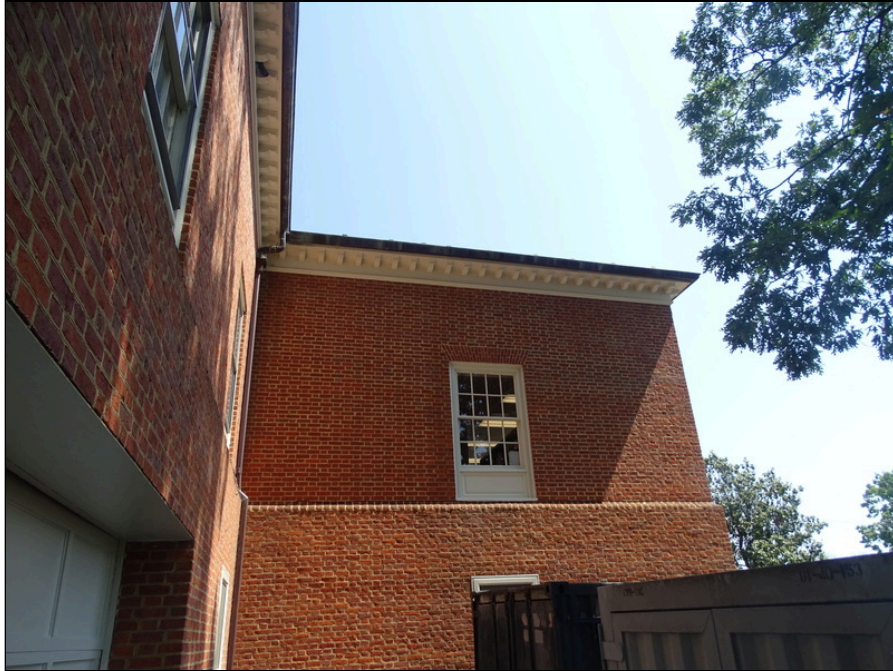
21 - Building exterior east side of the building

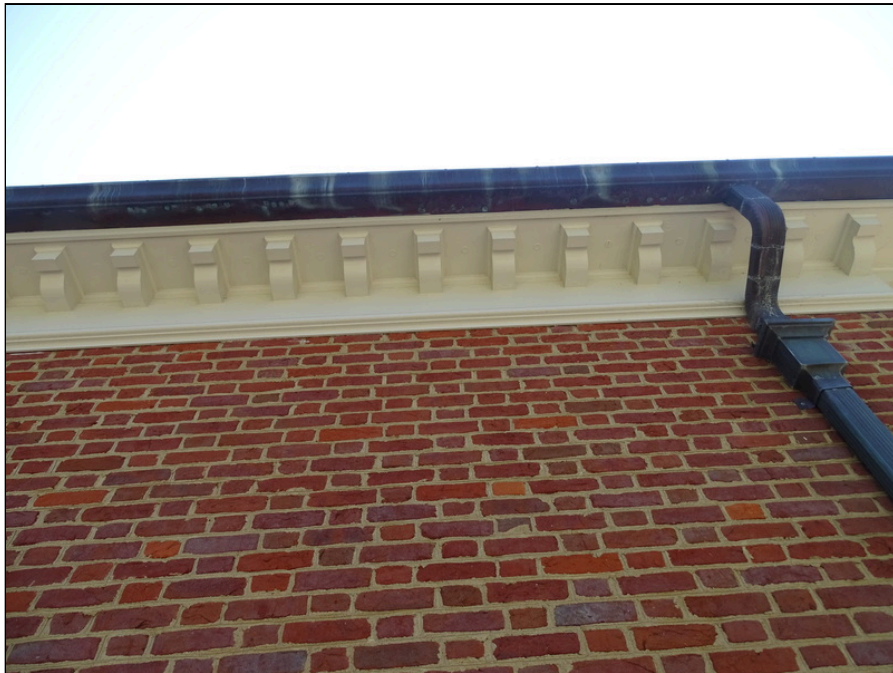
22 - Typical wood cornice at building exterior

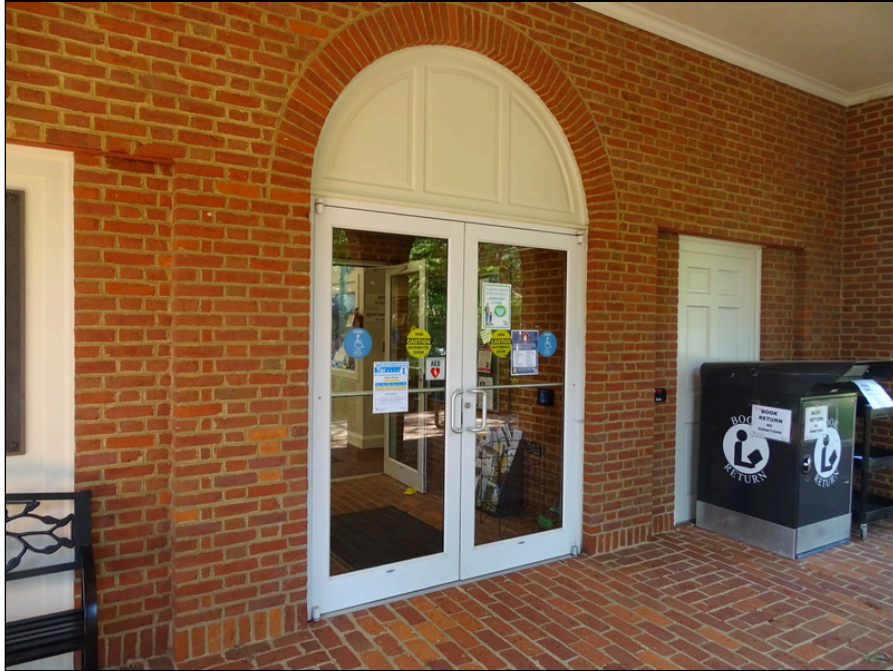
23 - Main entrance at north side of the building

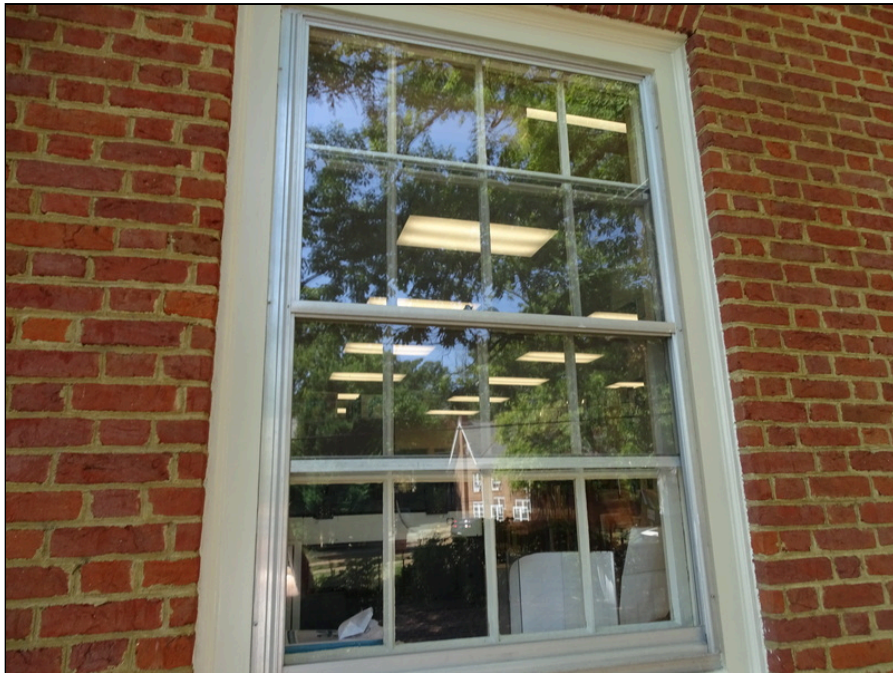
26 - Typical exterior window
