FACILITY CONDITION ASSESSMENT

GORDON AVENUE LIBRARY
1500 GORDON AVENUE
CHARLOTTESVILLE, VIRGINIA

ECS PROJECT NO. 46:6713

NOVEMBER 2, 2021

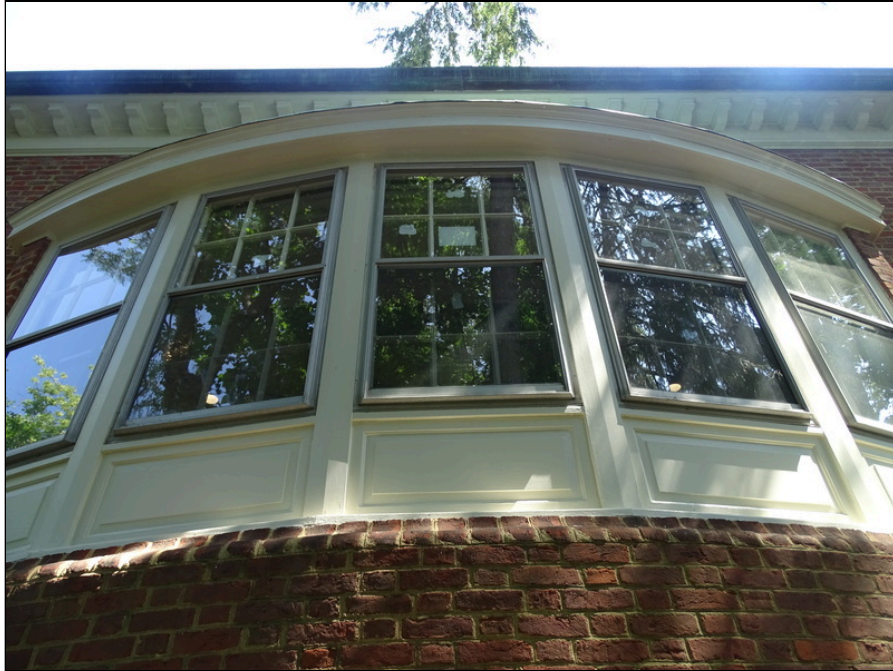
27 - Typical exterior window

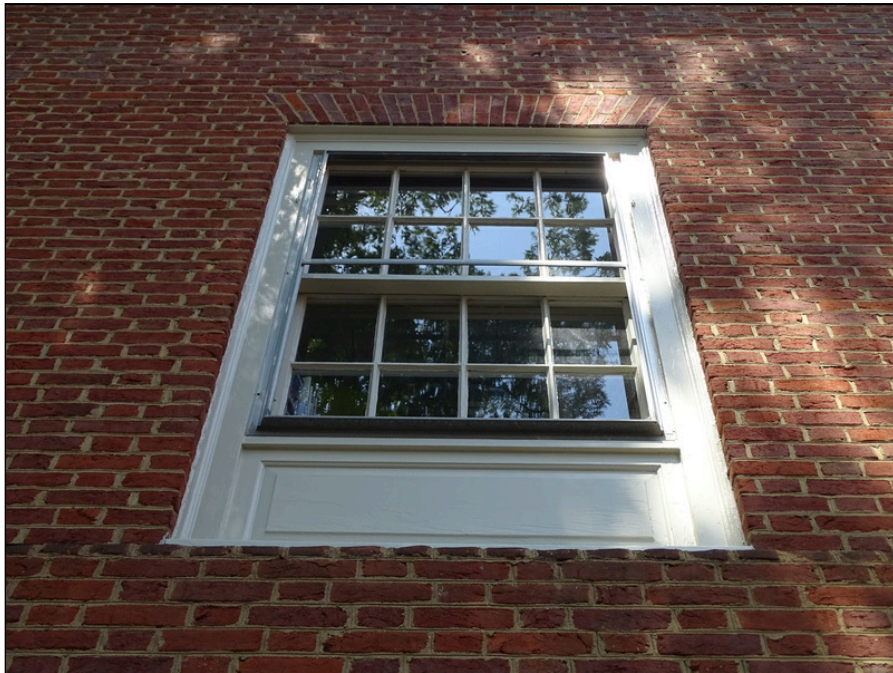
28 - Typical exterior window

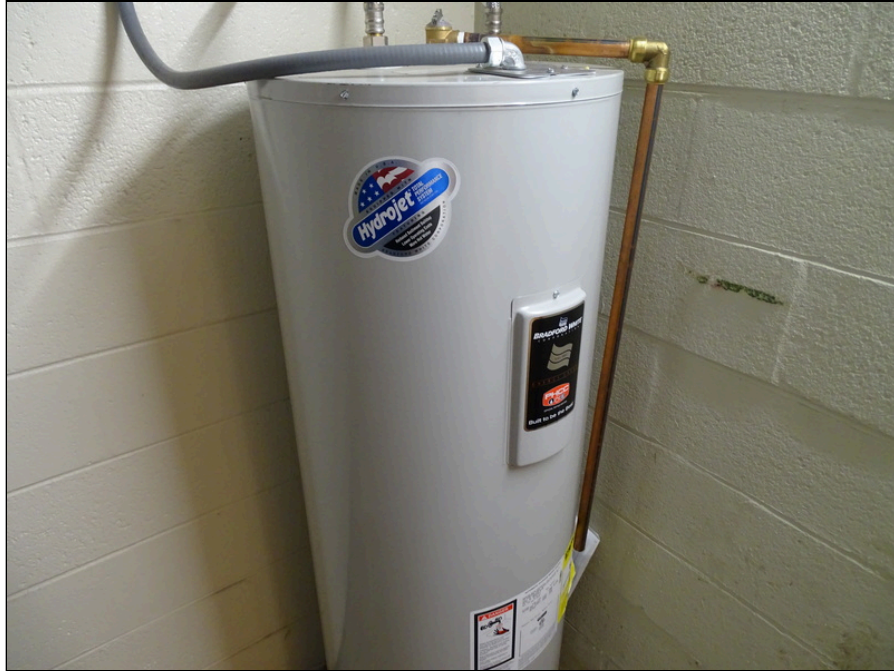
33 - Electric domestic water heater

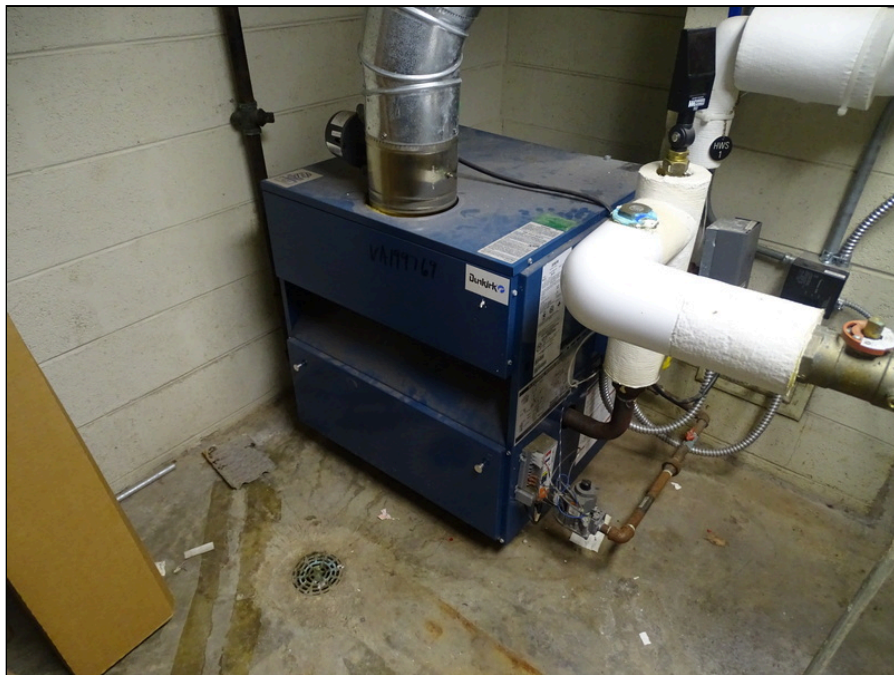
34 - Boiler located in main utility room

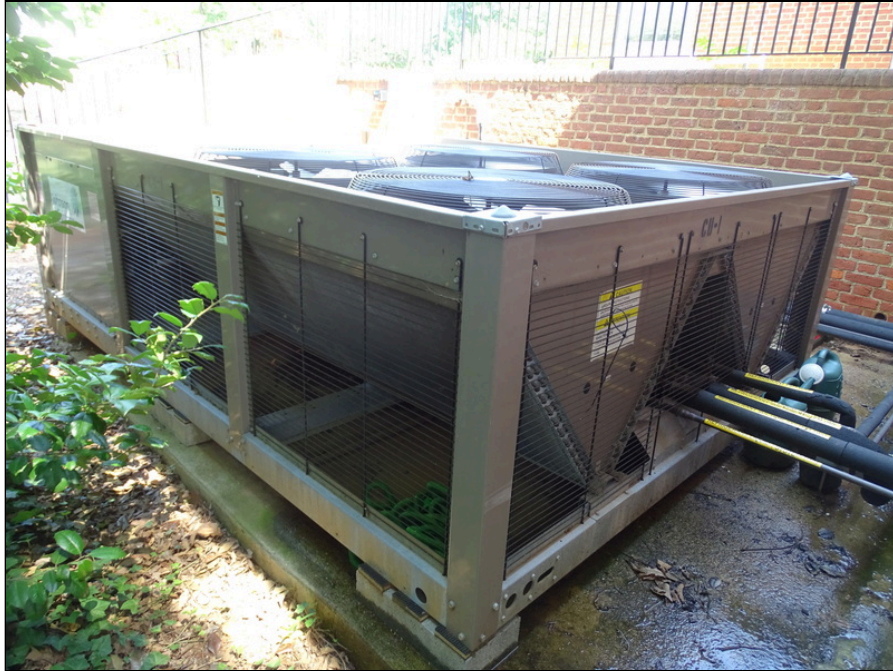
35 - Condenser Unit located at southwest side of the building

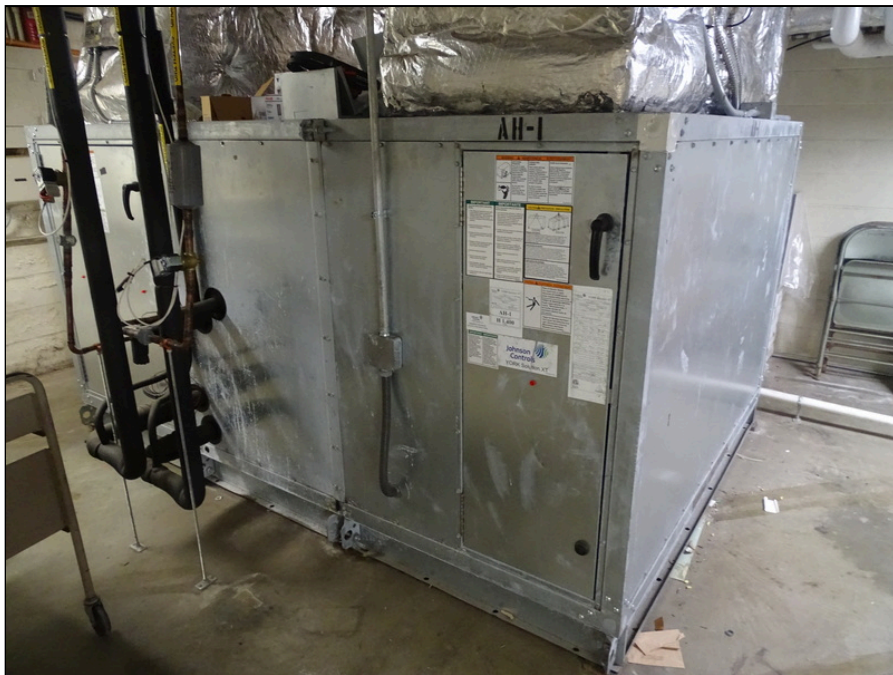
36 - Air Handler Unit located in main utility room

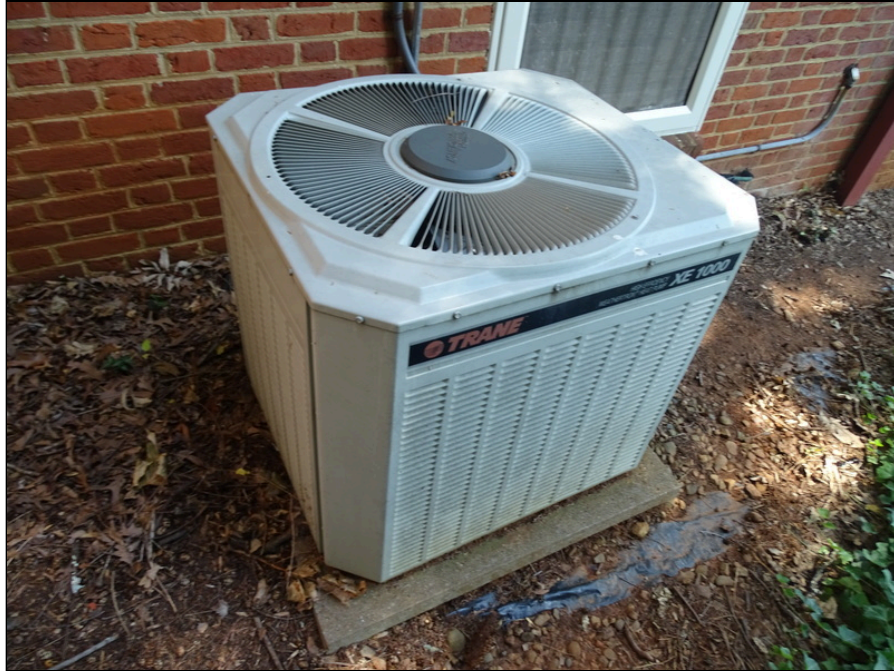
37 - Split System southeast side of the building

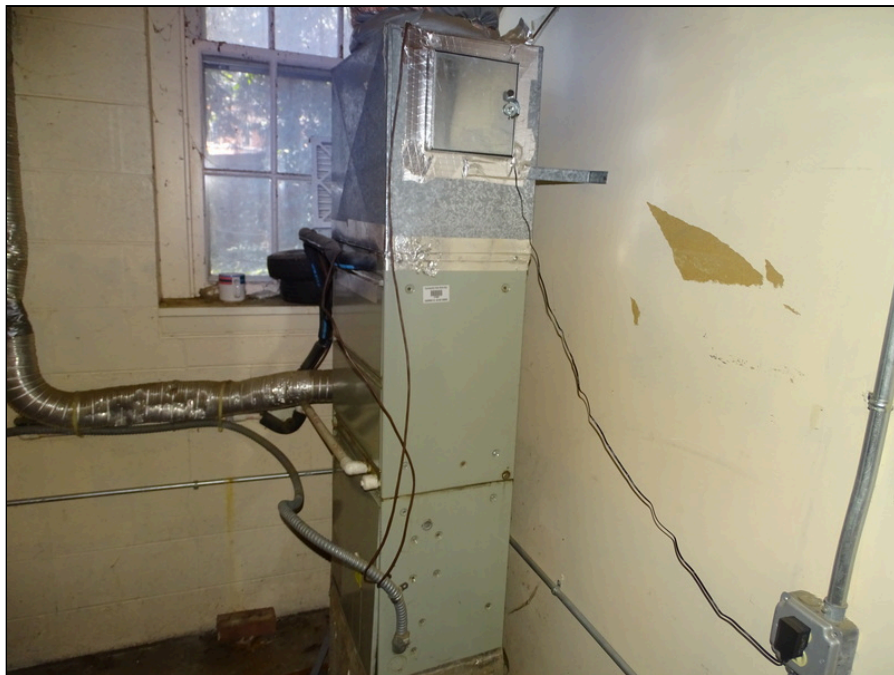
38 - Split System southeast side of the building

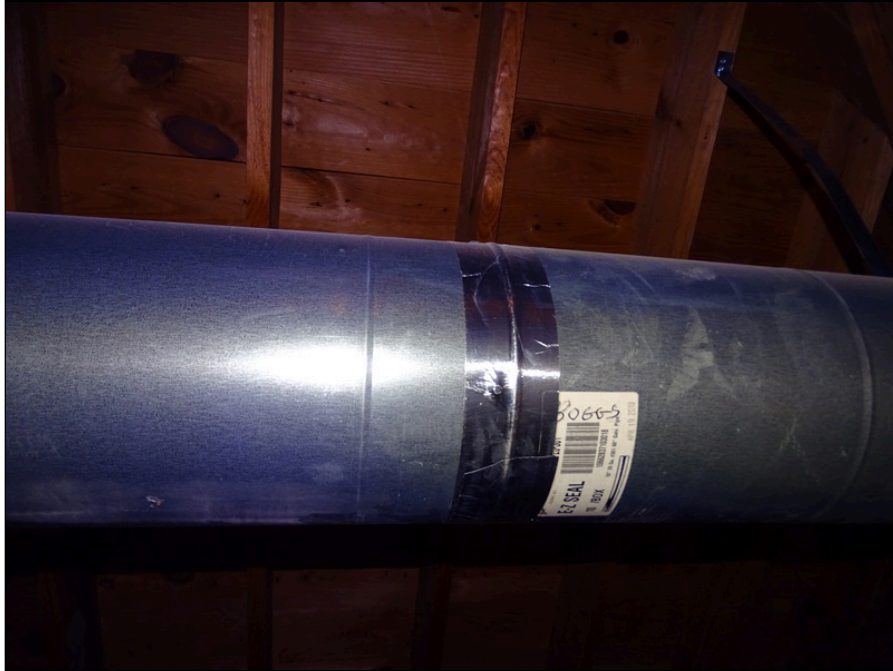
39 - Typical mechanical duct

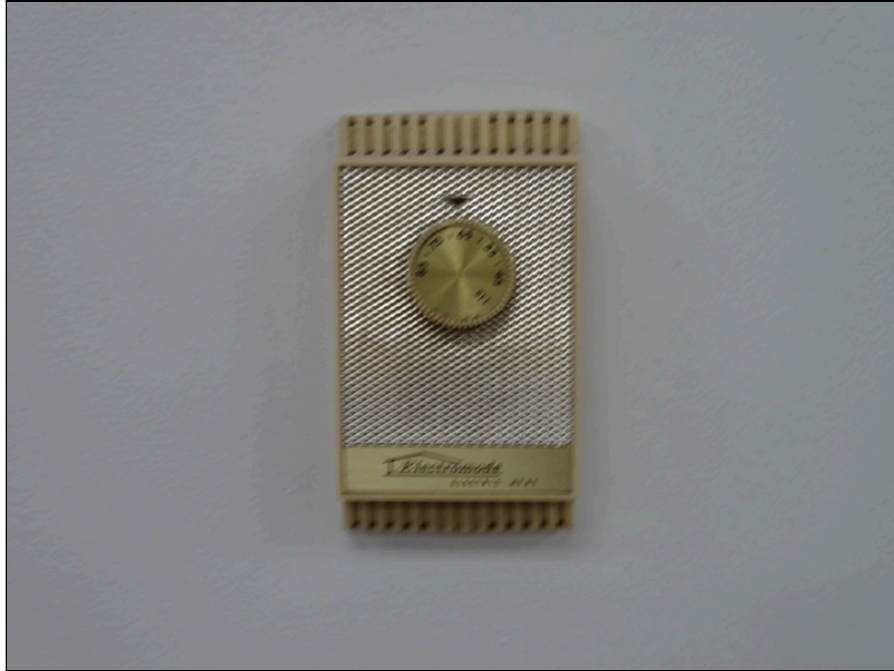
40 - Typical thermostat control

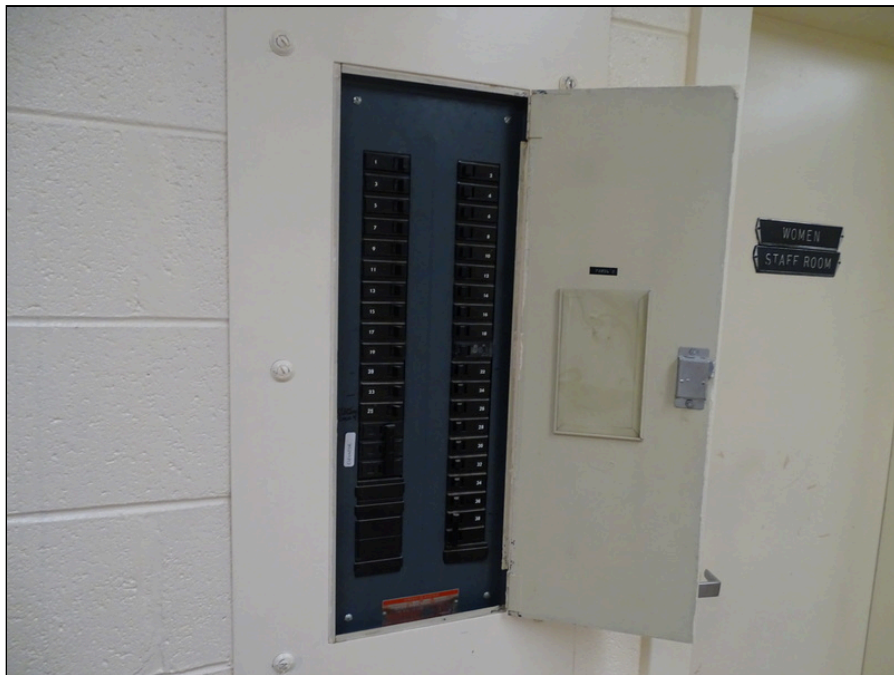
43 - Typical electrical circuit breaker panel

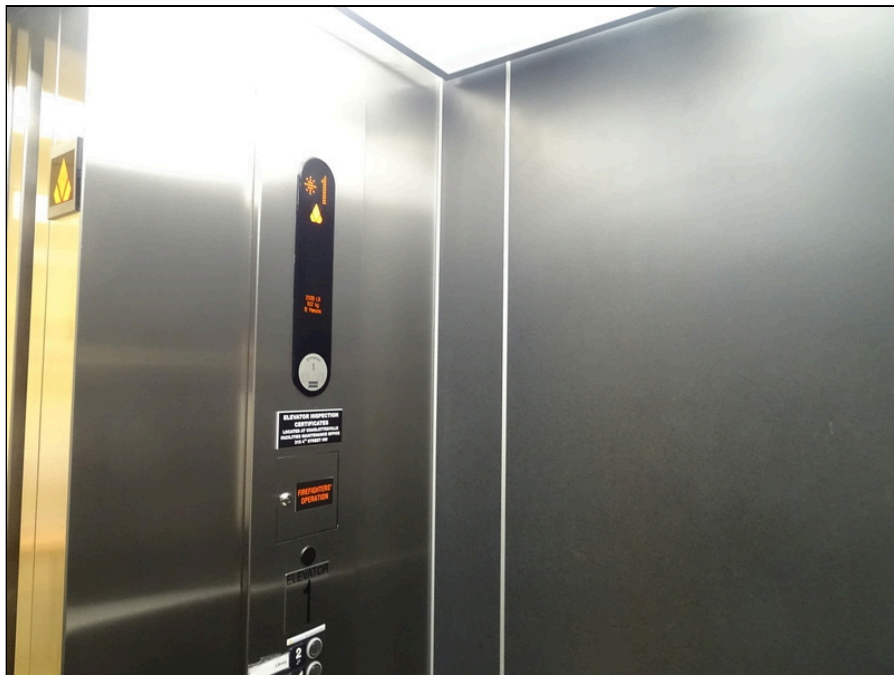
45 - Elevator System

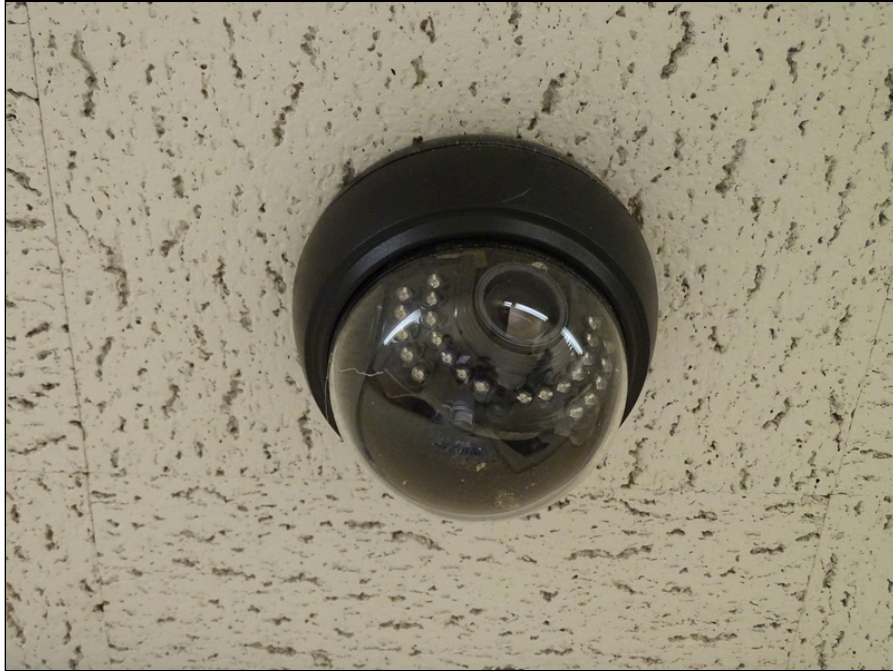
54 - Typical security camera

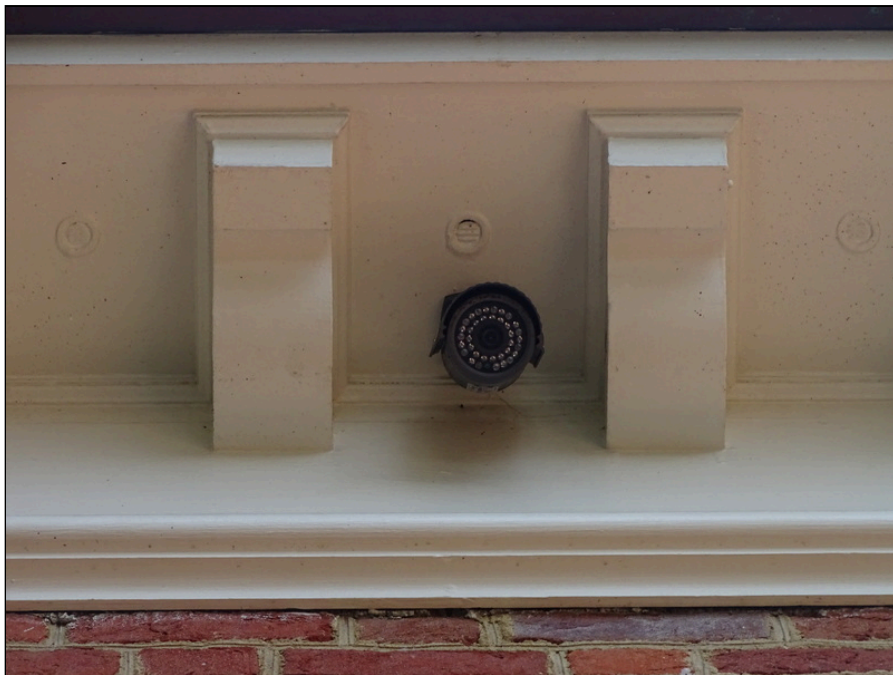
55 - Typical security camera

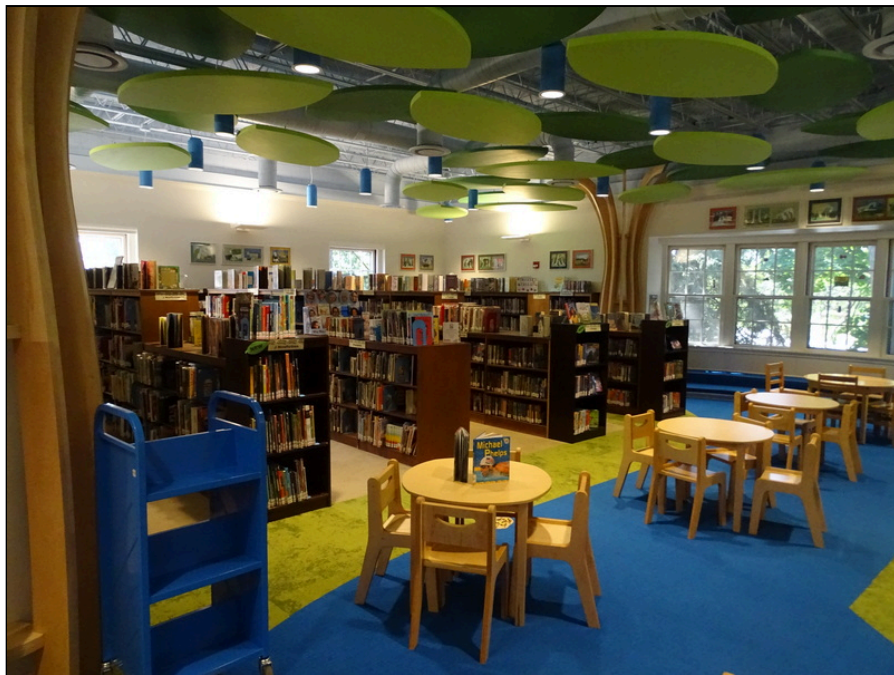
57 - Interior finishes of lobby - library area - note newer suspended acoustical tile ceiling

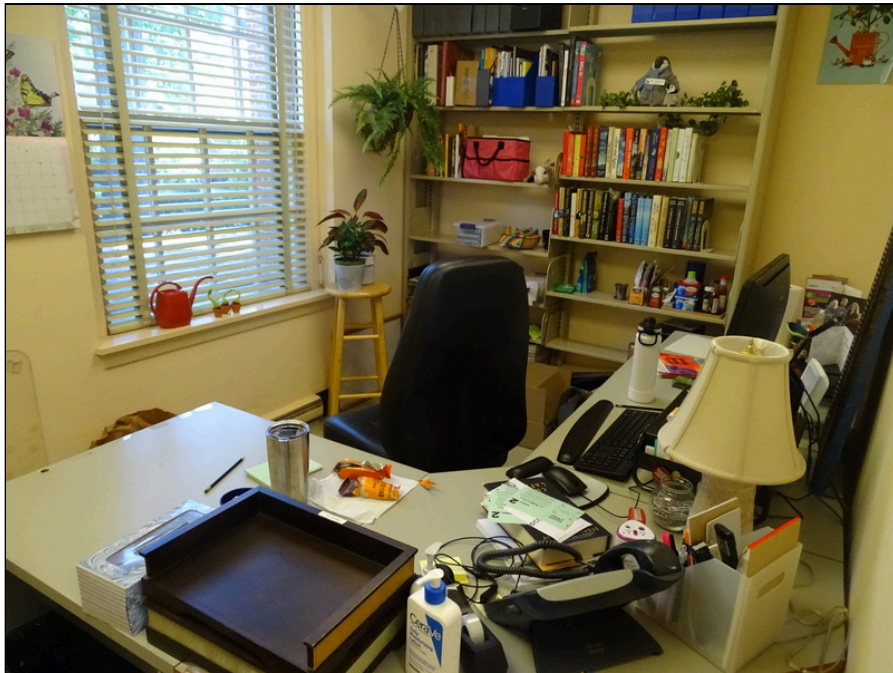
63 - Typical interior

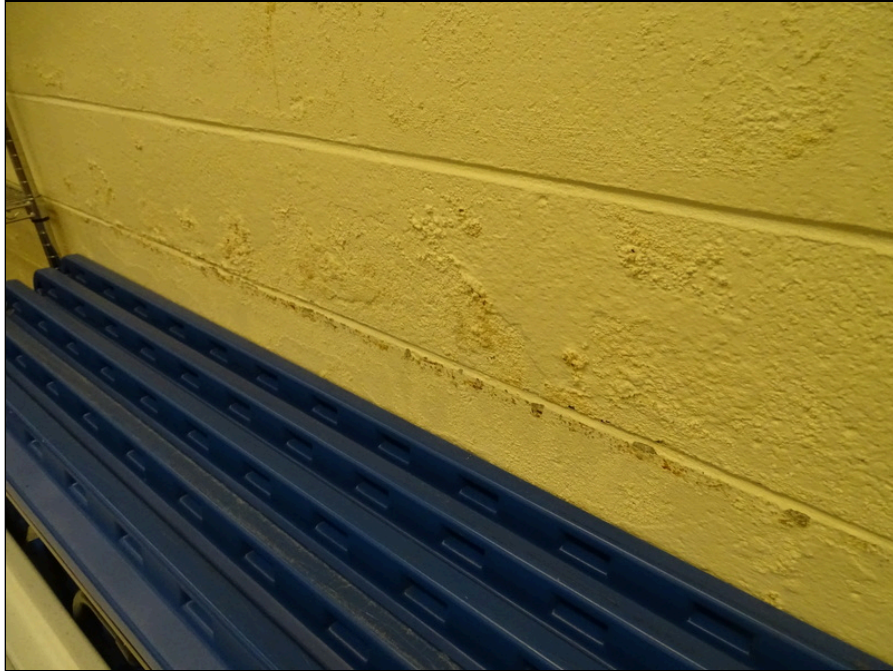
66 - Interior wall - note efflorescence

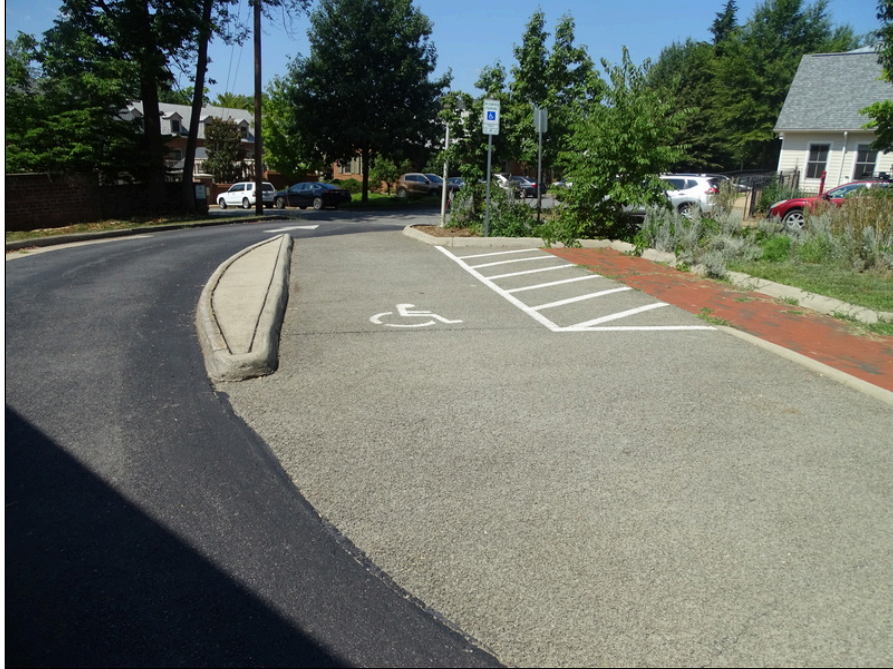
68 - Accessible parking
