GREENBRIER ELEMENTARY SCHOOL
2205 GREENBRIER DRIVE
CHARLOTTESVILLE, VIRGINIA

ECS PROJECT NO. 46:6713

CITY OF CHARLOTTESVILLE - FACILITIES DEVELOPMENT

Reference: Facility Condition Assessment Report for Greenbrier Elementary School, 2205 Greenbrier Drive, Charlottesville, Virginia

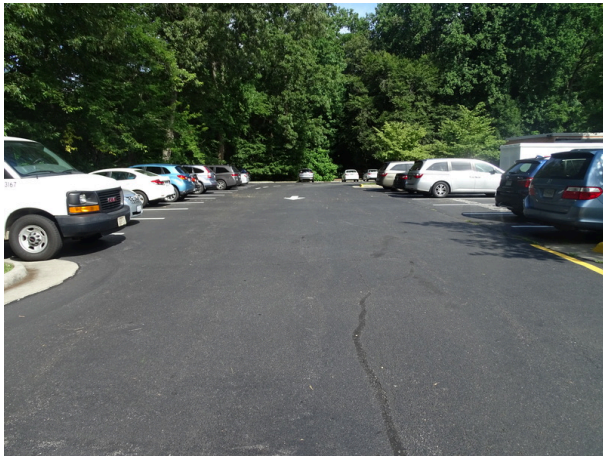
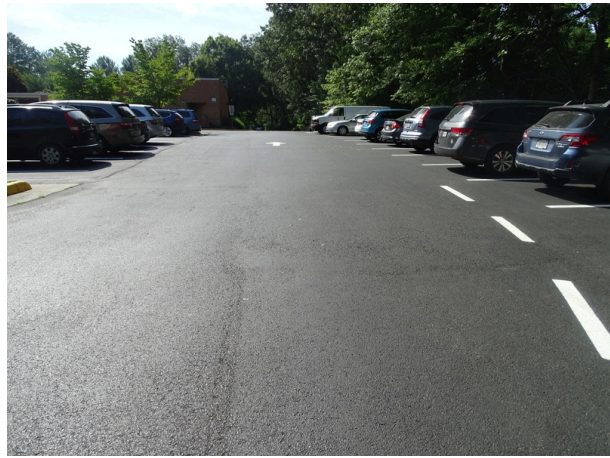
An asphalt-paved drive lane is located on the south side of the site which provides access to the parking lot. Additional parking is provided along the drive lane. The asphalt pavement was observed to be in generally fair condition with cracks and alligator cracking observed on the pavement. The expected useful life of asphalt pavement is 20 years. We have provided an allowance to overlay the asphalt pavement during the report period.

Overview of asphalt pavement and parking lot

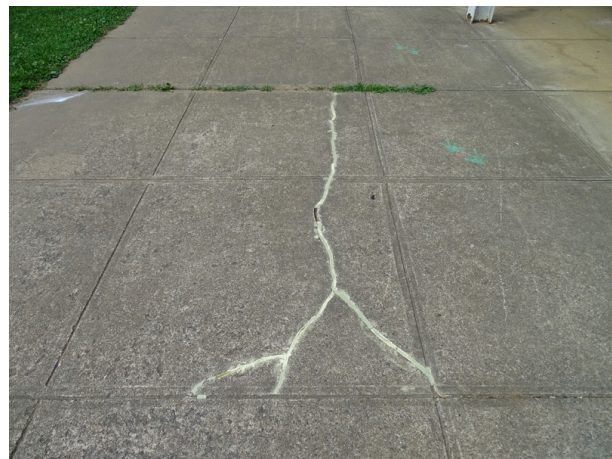
Concrete pavement - note sealant

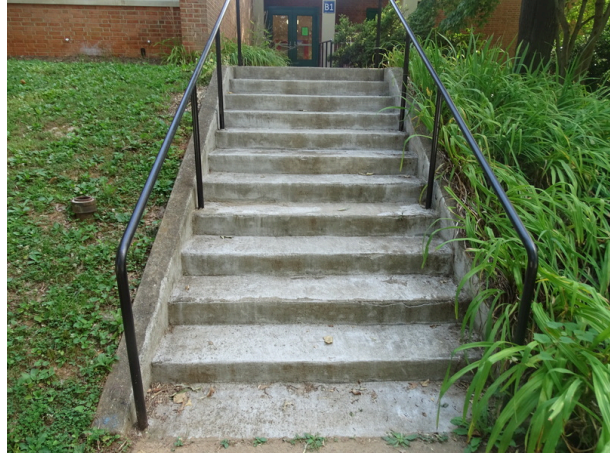
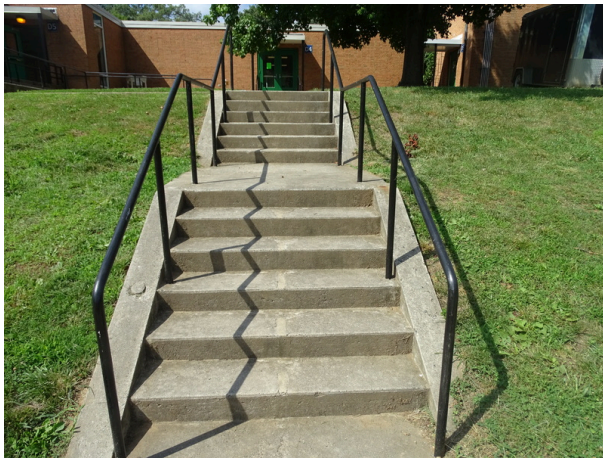
The steps and ramps were observed to be in generally good to fair condition. Previously repaired concrete sidewalks appeared to be in good condition. The handrails adjacent to the steps and ramps were observed to be in generally good condition. There is a concrete patio on the east side of the building. The patio was generally in good condition.

Concrete steps

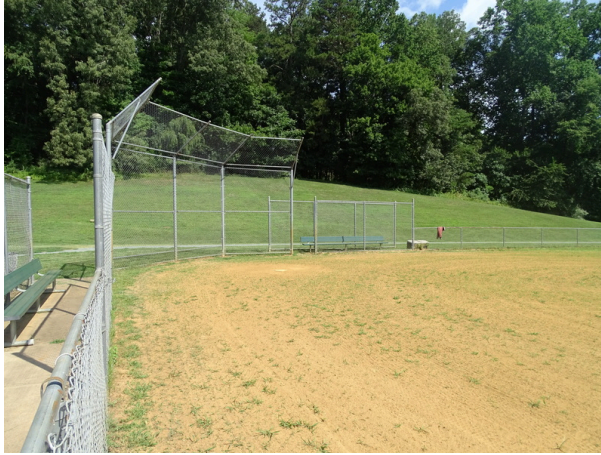
The softball is located at the north side of the property. Chain link fencing was observed at home base and was in overall fair condition as portions of the fencing we bowed. The field did not have lighting.

Softball field fencing

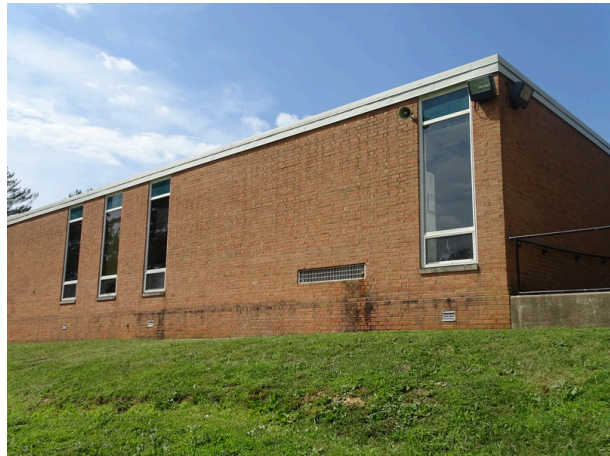
Exterior overview - note efflorescence

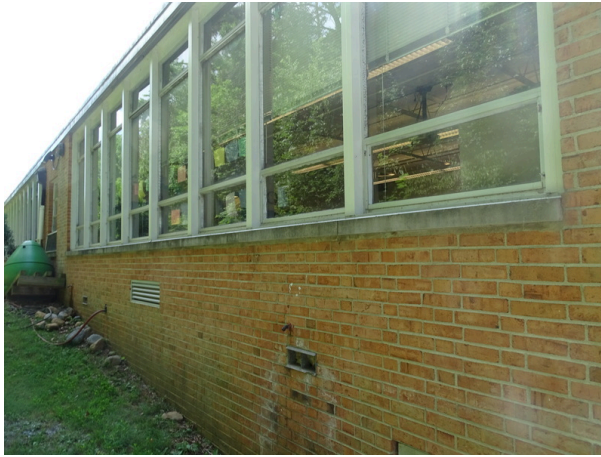
Exterior overview - note efflorescence

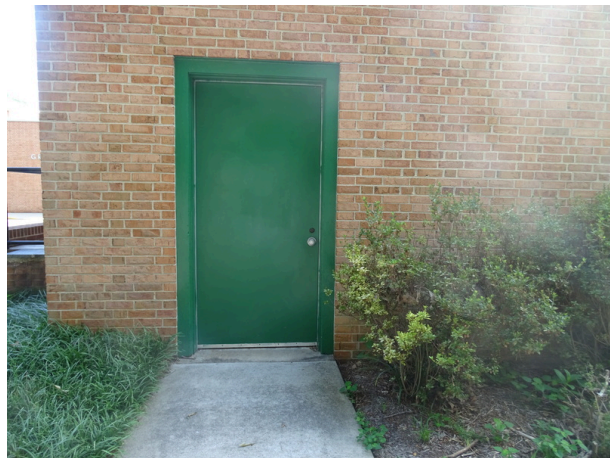
Steel personnel doors are located throughout the building. The personnel doors were generally in good condition. It also appeared that many of the doors had been replaced over time. Some of the personnel doors were observed to contain ADA approved hardware. Exterior doors typically have an expected useful life of 20 to 30 years. Allowances have been included to replace doors during the study period.

Typical personnel door

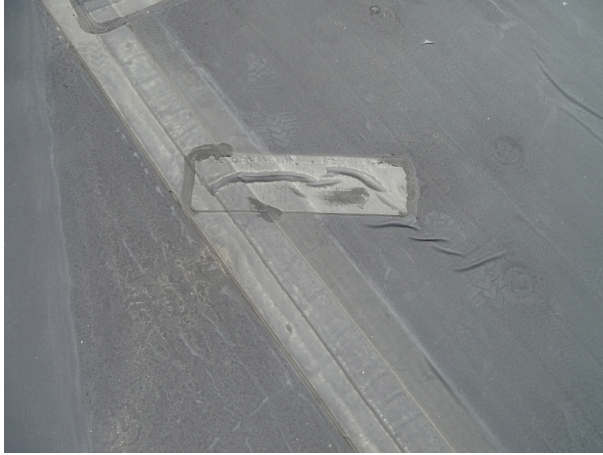
Typical patching

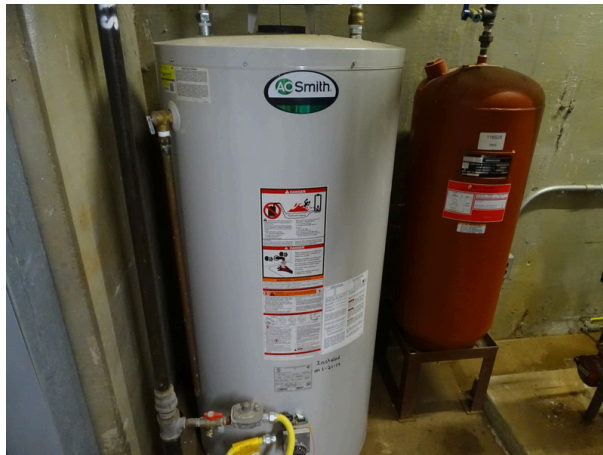
The expected useful life of a Gas domestic water heater is approximately 15 years with proper maintenance. We recommend the Gas domestic water heaters be replaced during the study period.

Water heater

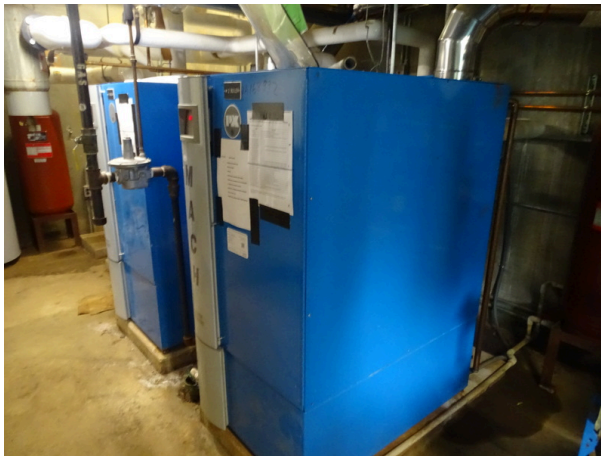
The PX Mach Boilers have an expected useful life of 20 years with proper maintenance. The two boilers were located in the mechanical room at the north side of the building. The boilers were installed in 2006 and were generally in good condition. We recommend replacing the boilers during the report period.

Typical boilers

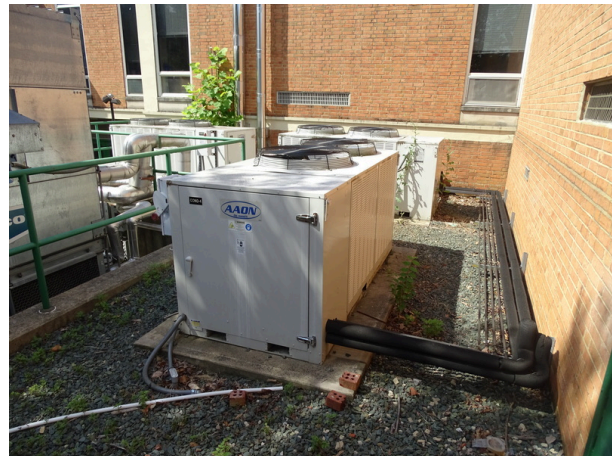
Three condenser units are located at the north side of the building at the exterior enclosure near the mechanical room. The condensing units were manufactured by AAON in 2013. The expected useful life of a condensing unit is 15 years with proper maintenance. The condensing units were observed to be in good condition. We recommend that the condensing units be replaced during the report period.

Condensers

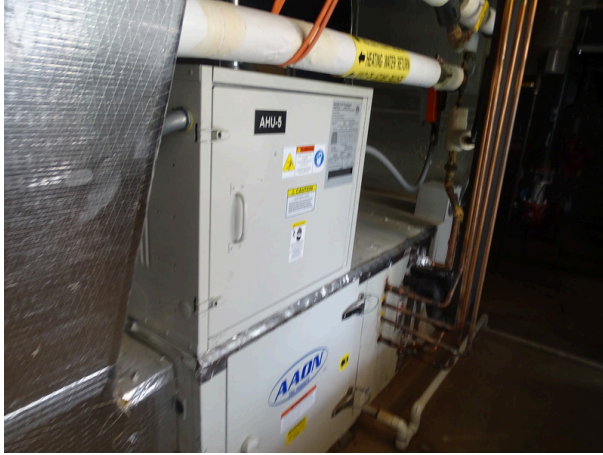
Three of the air handlers are located in the mechanical room on the north side of the building and two of the units are located at the northwest corner of the building exterior. The units in the mechanical room were manufactured by AAON in 2013 and were in good condition. The units at the exterior of the building were manufactured by AAON in 2011 and were in good condition. The expected useful life of air handlers is 15 years with proper maintenance. We recommend that the air handlers be replaced during the report period.

Air handler in mechanical room

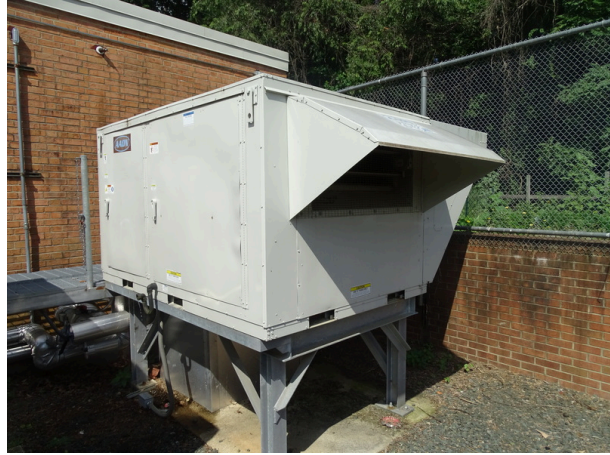
Air handler at building exterior

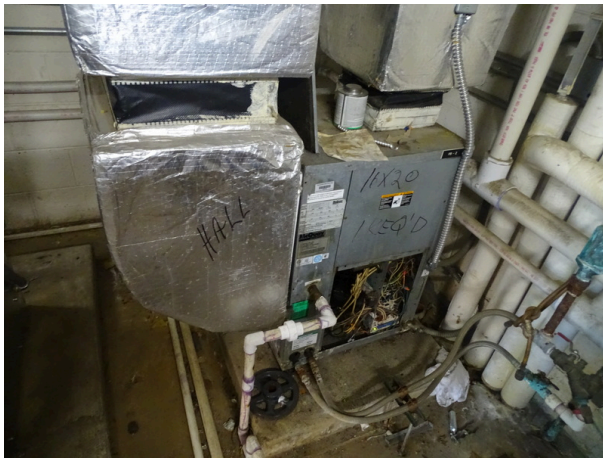
Two McQuay vertical heat pumps are located in each the kitchen mechanical room and one is located in the library mechanical room. The heat pumps were manufactured in 1996 and were in overall fair condition. The typical expected useful life of the heat pumps is 20 years. We recommend a scheduled replacement of the units.

Vertical heat pump

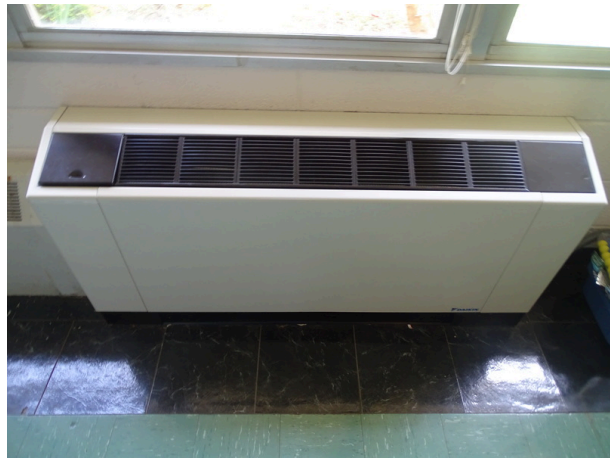
There are two WSHP units in each classroom and approximately 80 WSHP units within the building. The typical expected useful life of the heat pumps is 20 years and they were installed in 1996. We recommend a scheduled replacement of the units.

Water source heat pump

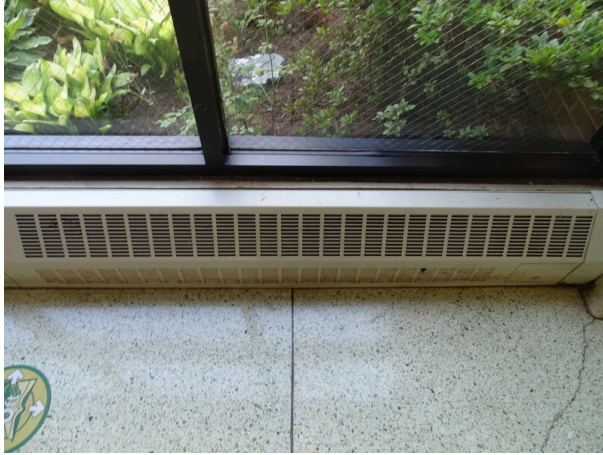
Water source heat pumps

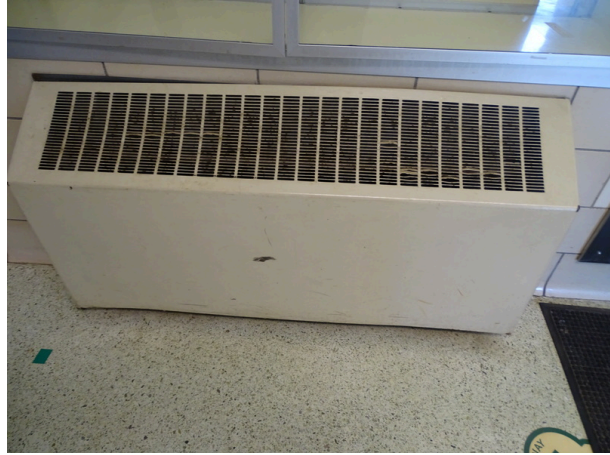
Fan coil units are located throughout corridors and were original to the building. Radiators were located in restrooms and were original to the building. Fan coils and radiators have a typical expected life of 20 years. Replacement or refurbishment of the units is recommended during the study period.

Fan coil unit

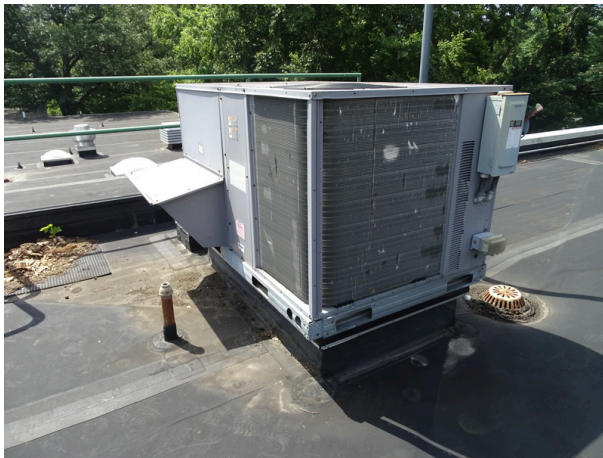
Four package units are located on the roof; two of the units serviced the auditorium and two serviced the gym. The two Carrier roof top units were installed in approximately 2006 and serviced the auditorium. The two Trane roof top units were manufactured in 2010 and serviced the gym. The expected useful life of package units is 15 years with proper maintenance. We recommend that the units be replaced during the report period.

Carrier package unit

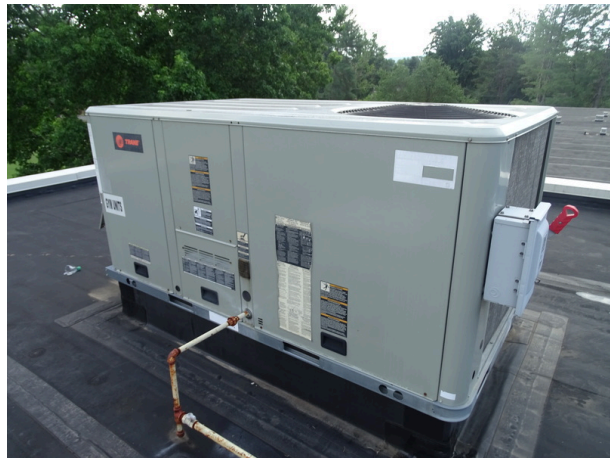
Trane package unit

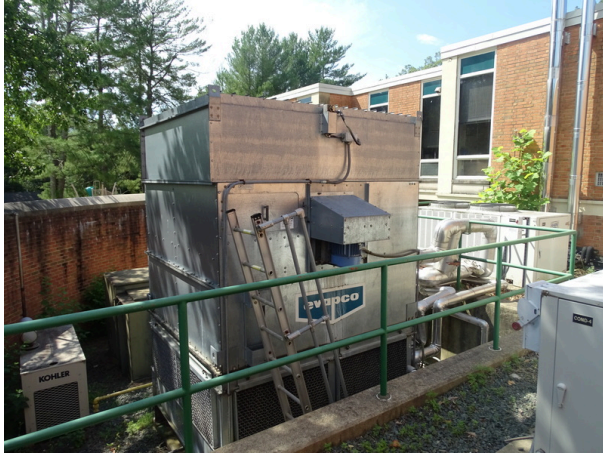
The cooling tower is located at the north side of the building at the exterior enclosure near the mechanical room. The Evapco cooling tower was installed in 2006 and was in good condition. Cooling towers have a typical expected useful life of approximately 18 years. The cooling tower should be replaced during the study period.

Cooling tower

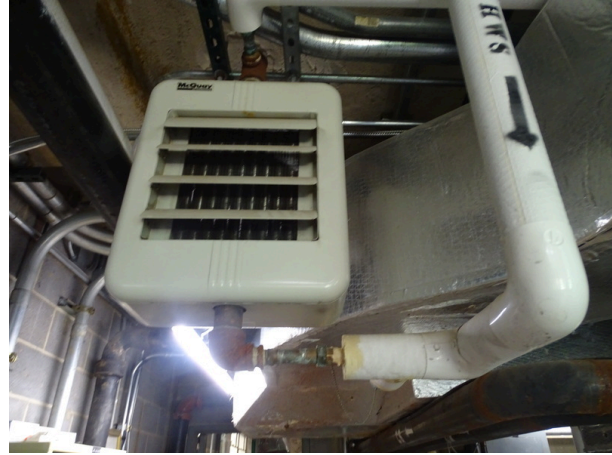
McQuay ceiling mounted space heaters were located in the mechanical room. The space heaters were in good condition. Replacement of the space heaters is included during the study period.

Space heater

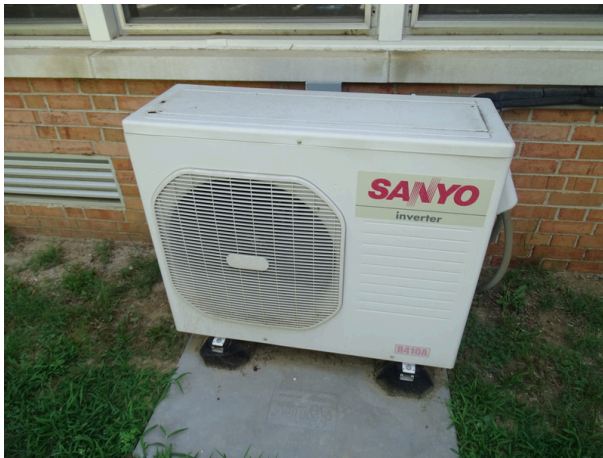
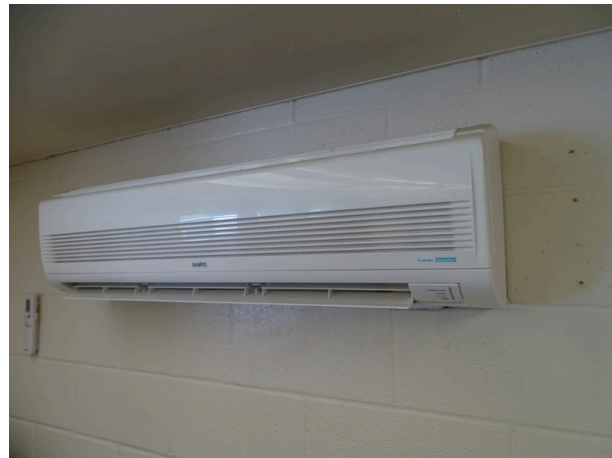
A Sanyo split system was located in the library IT room. The system was installed in 2011 and was in good condition. Split systems have an expected useful life of 15 years and should be replaced during the study period.

Split system

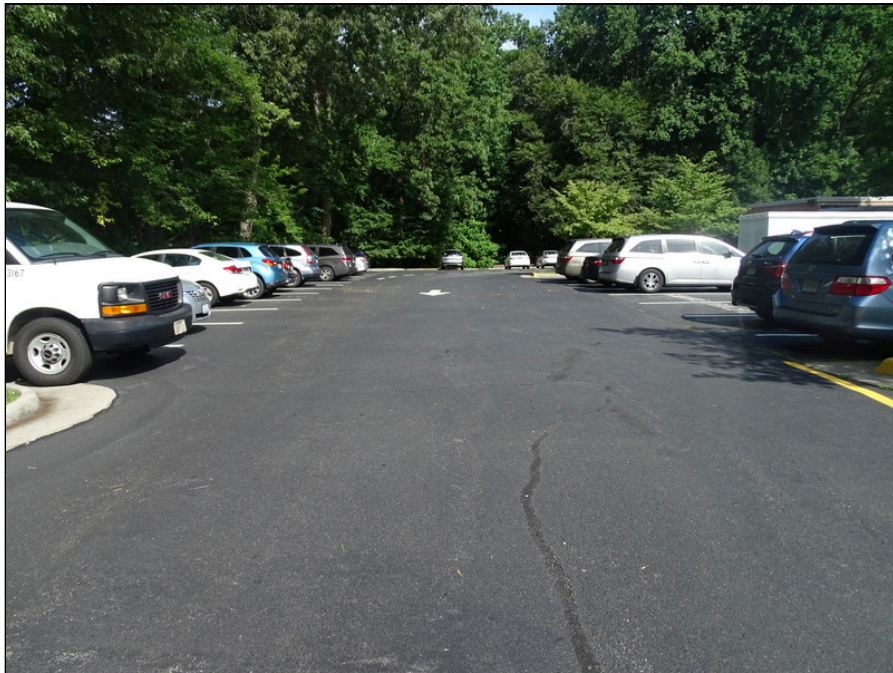
6 - Overview of asphalt pavement and parking lot

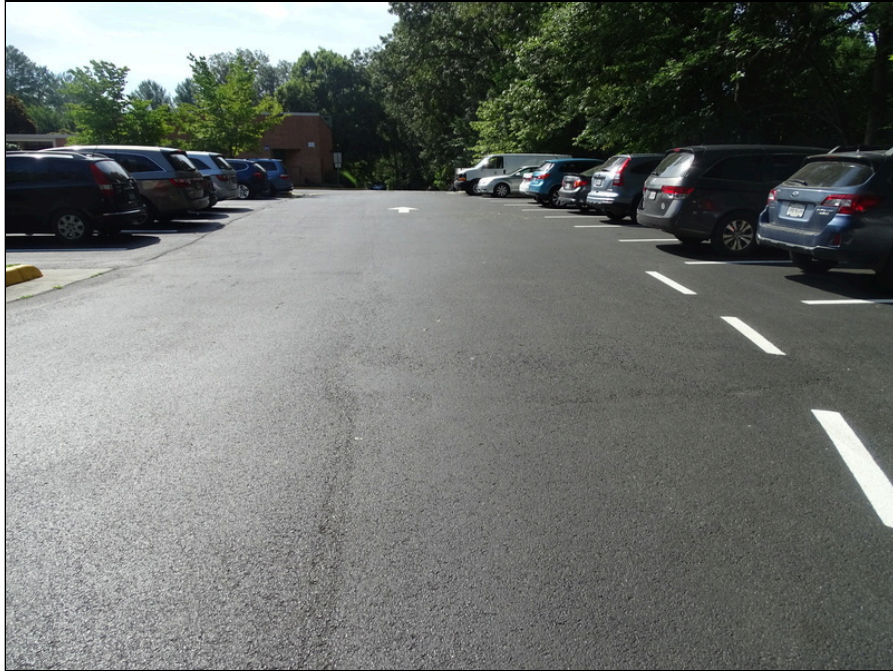
7 - Overview of asphalt pavement and parking lot

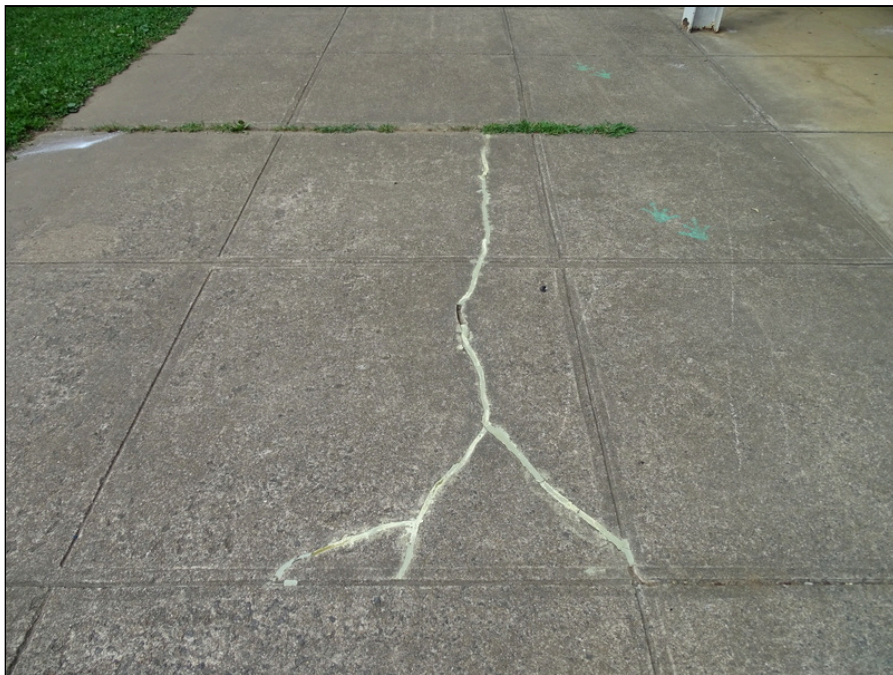
14 - Concrete pavement - note sealant

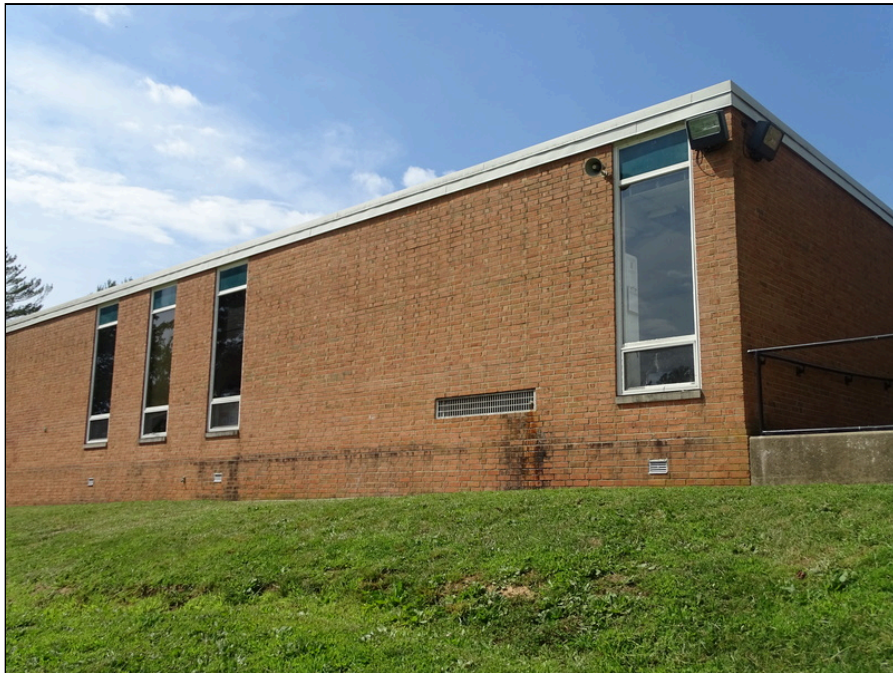
42 - Exterior overview - note efflorescence

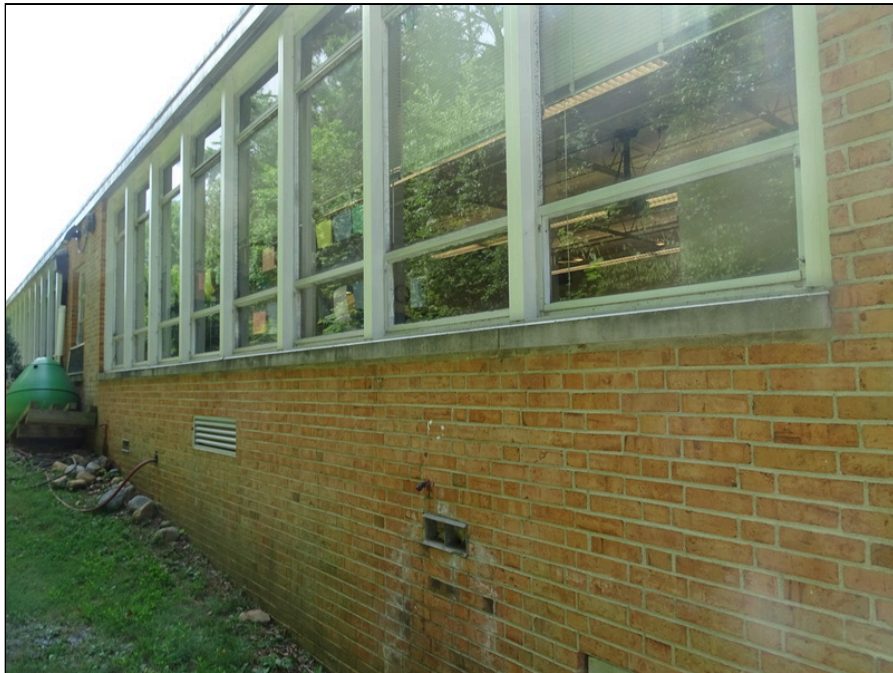
44 - Exterior overview - note efflorescence

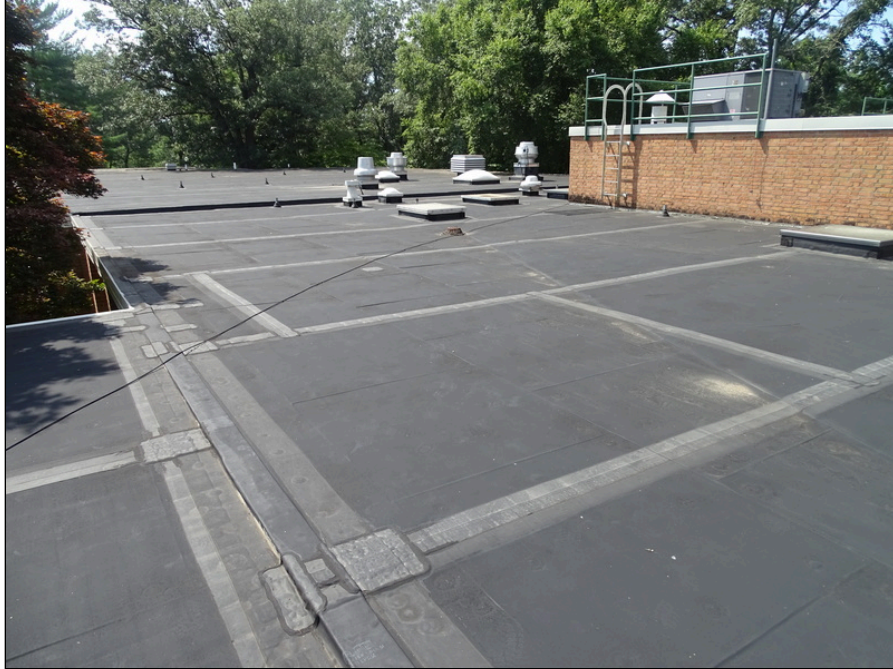
58 - Roof overview

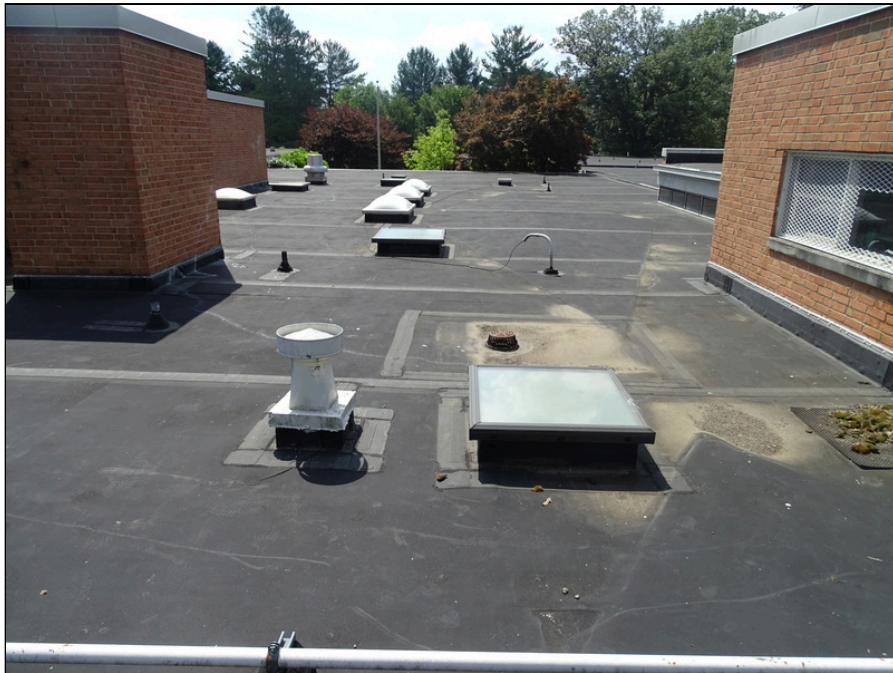
59 - Roof overview

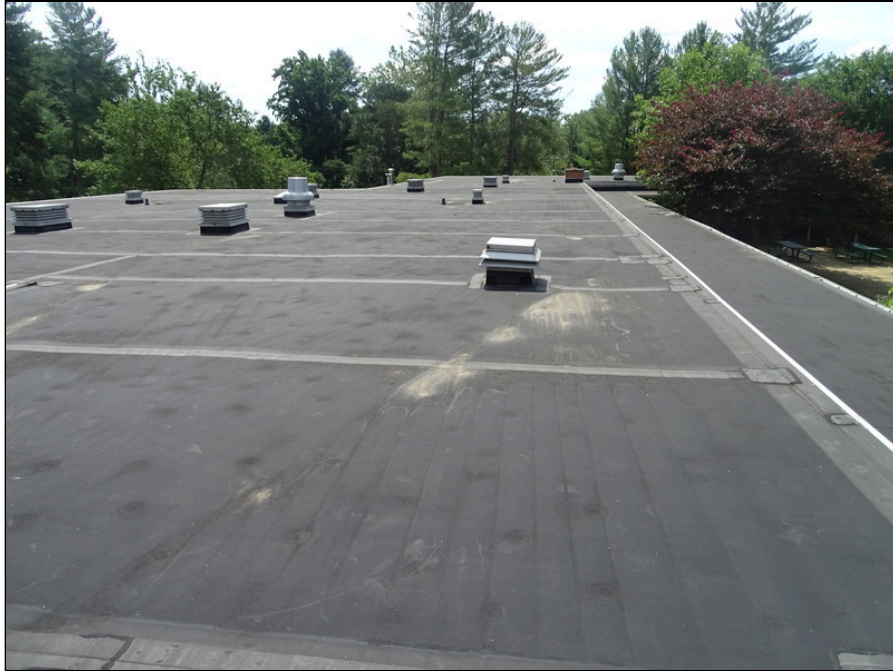
60 - Roof overview

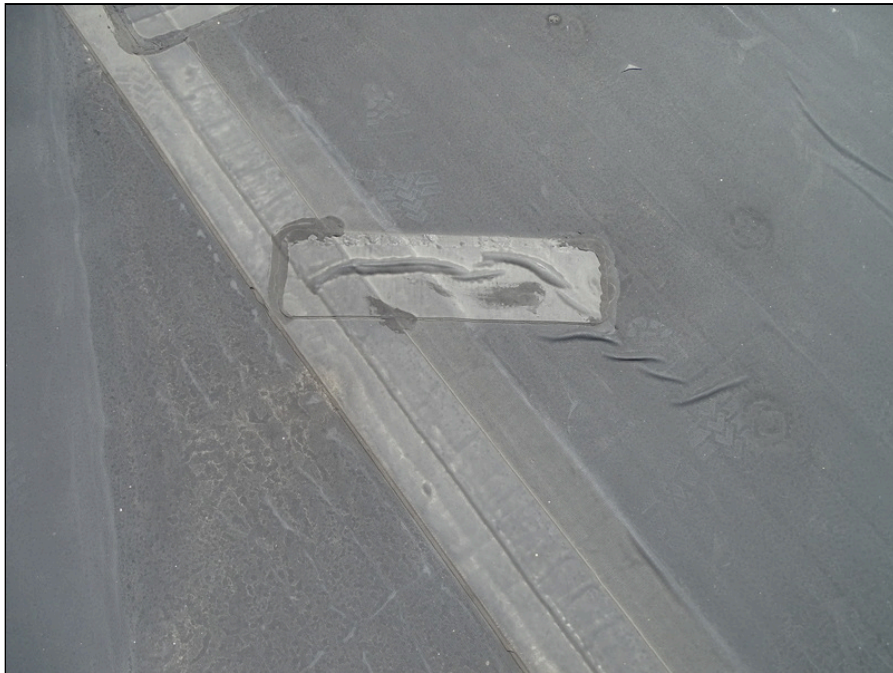
61 - Roof overview

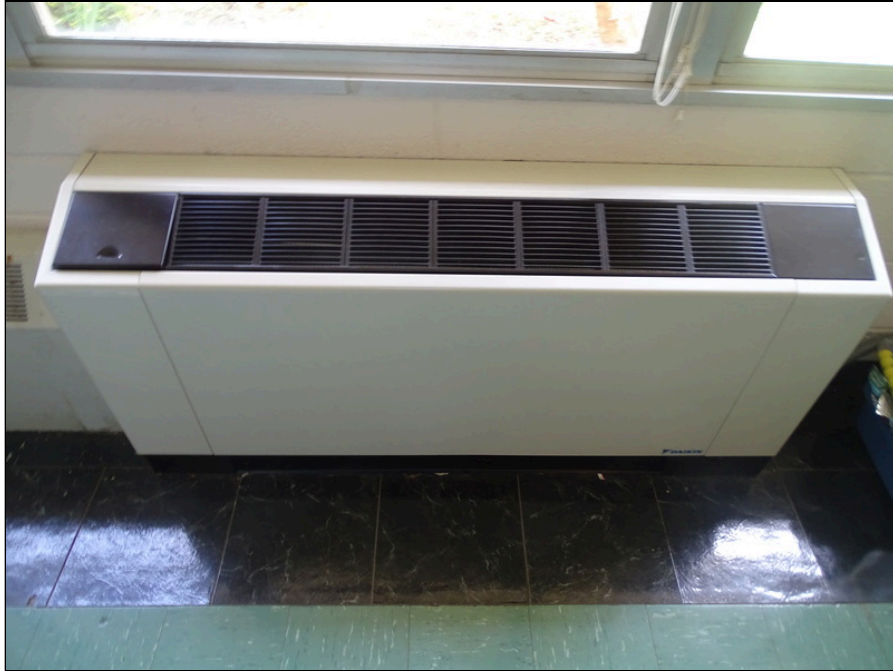
72 - Vertical heat pump

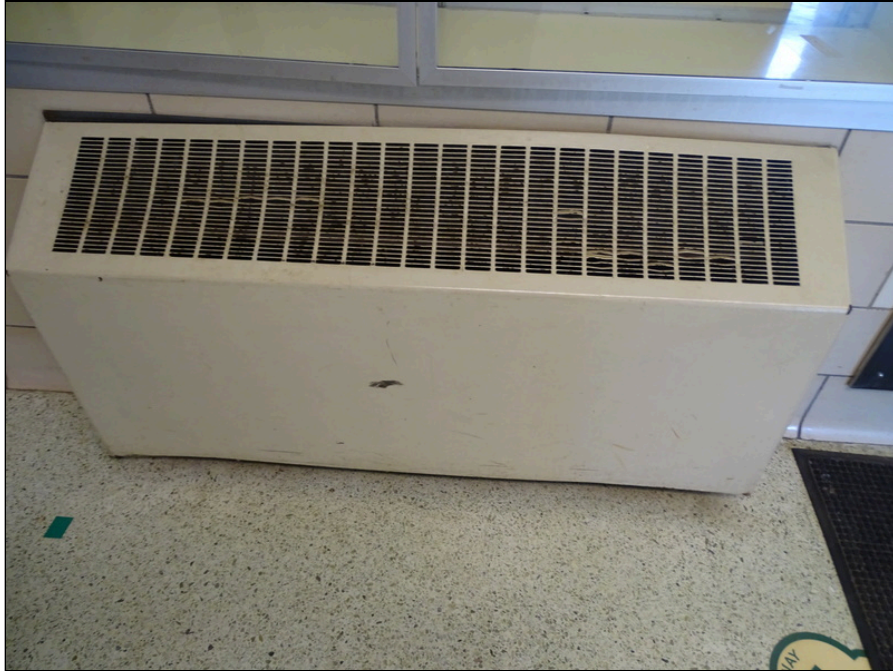
74 - Water source heat pumps

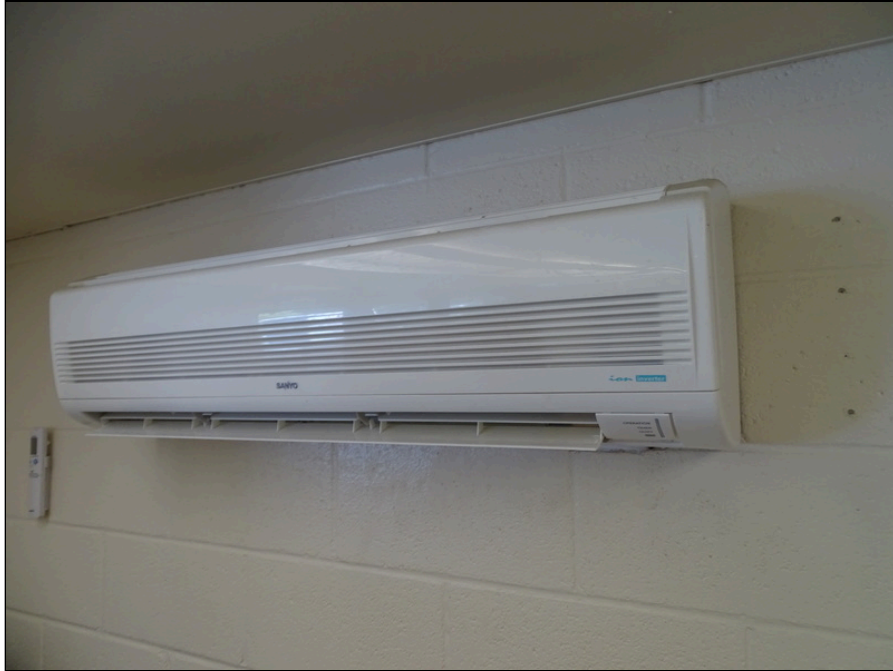
80 - Split system

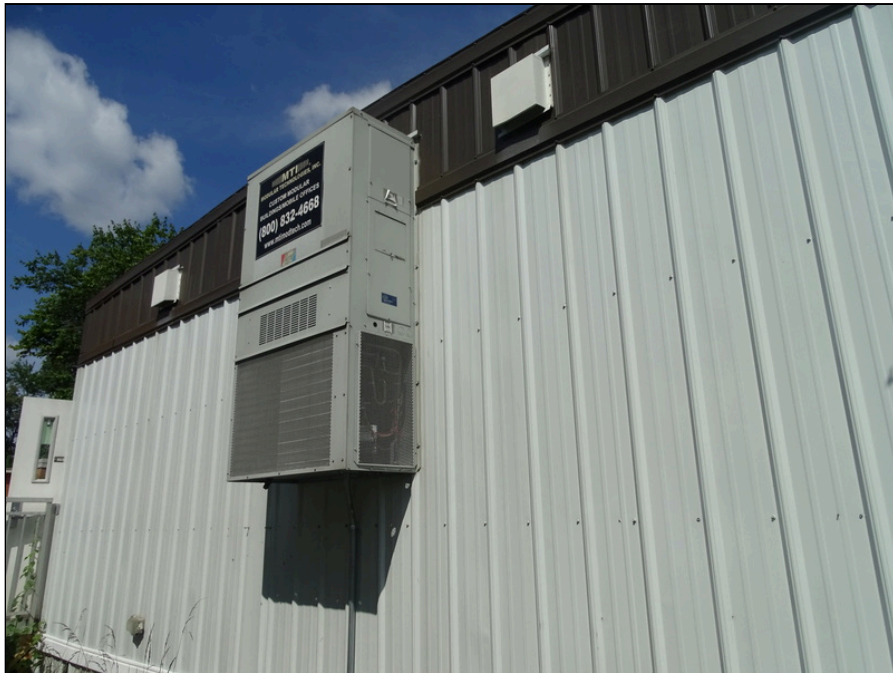
81 - Split system

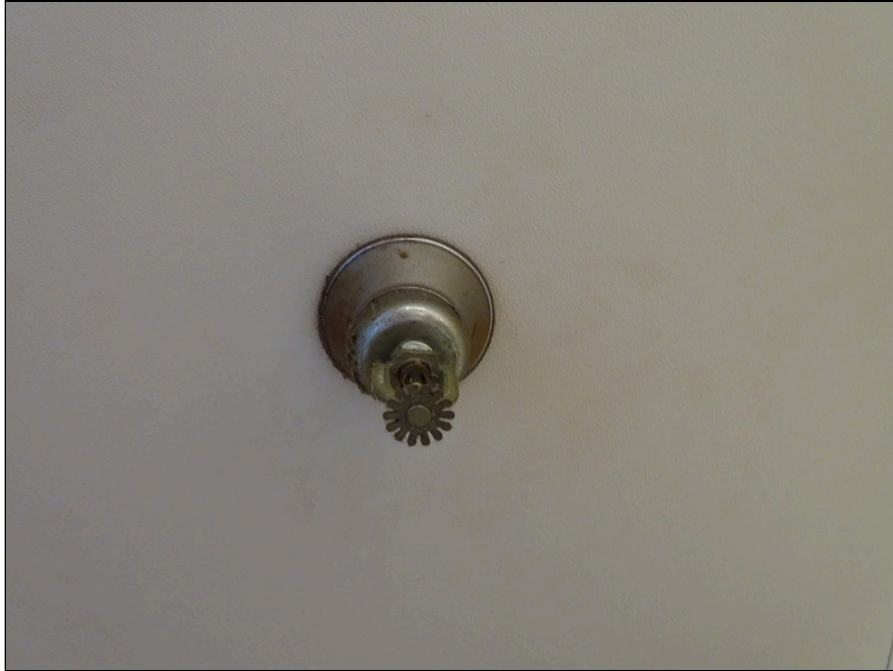
99 - Sprinkler head

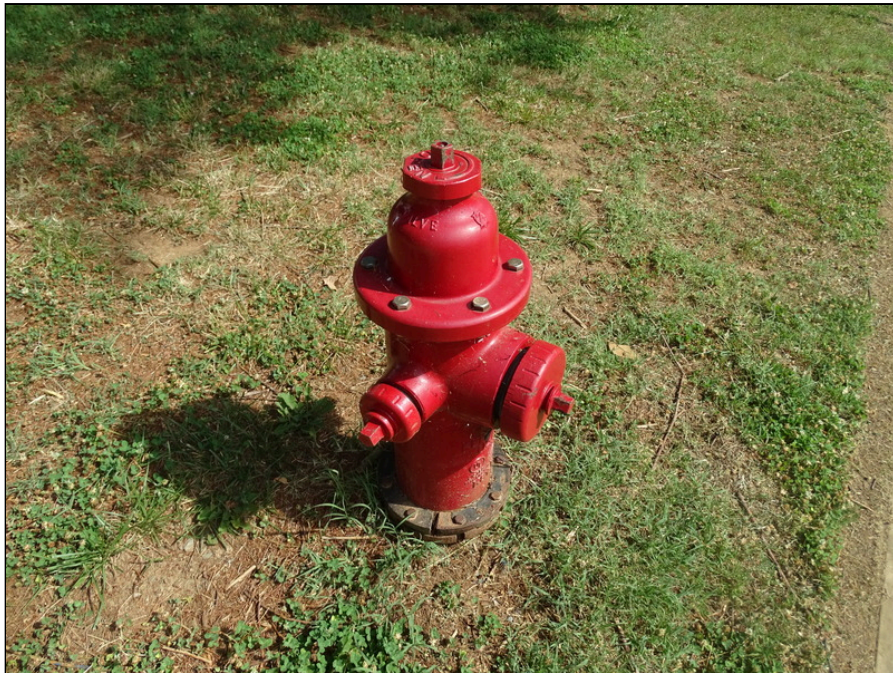
100 - Fire hydrant

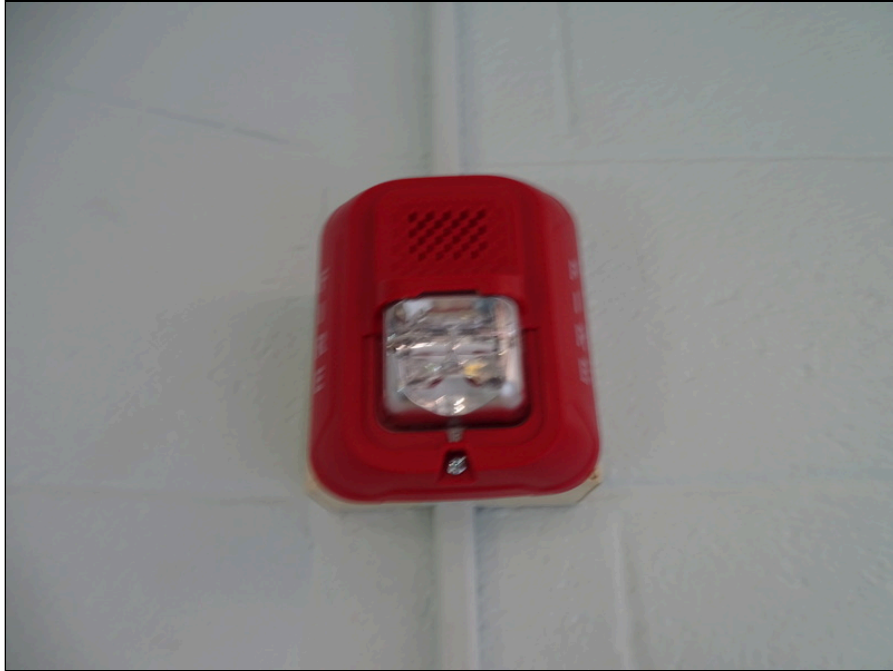
101 - Fire alarm bell and strobe

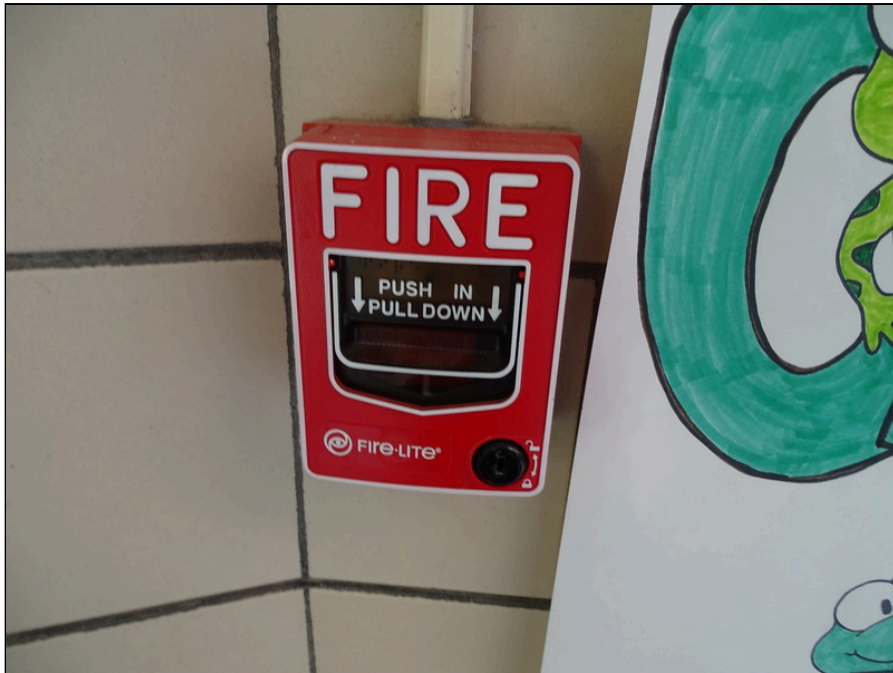
102 - Pull down station

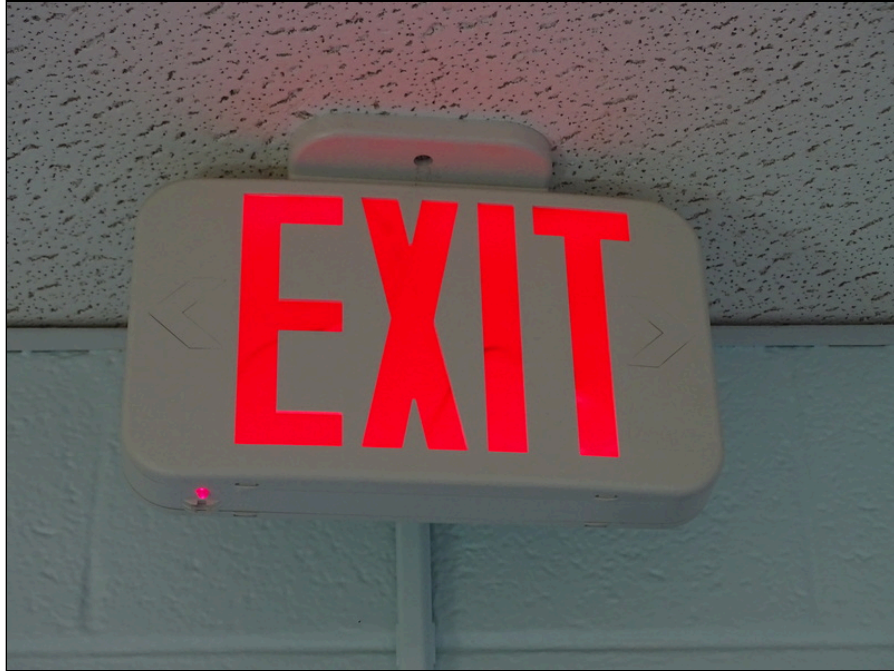
103 - Exit sign above door

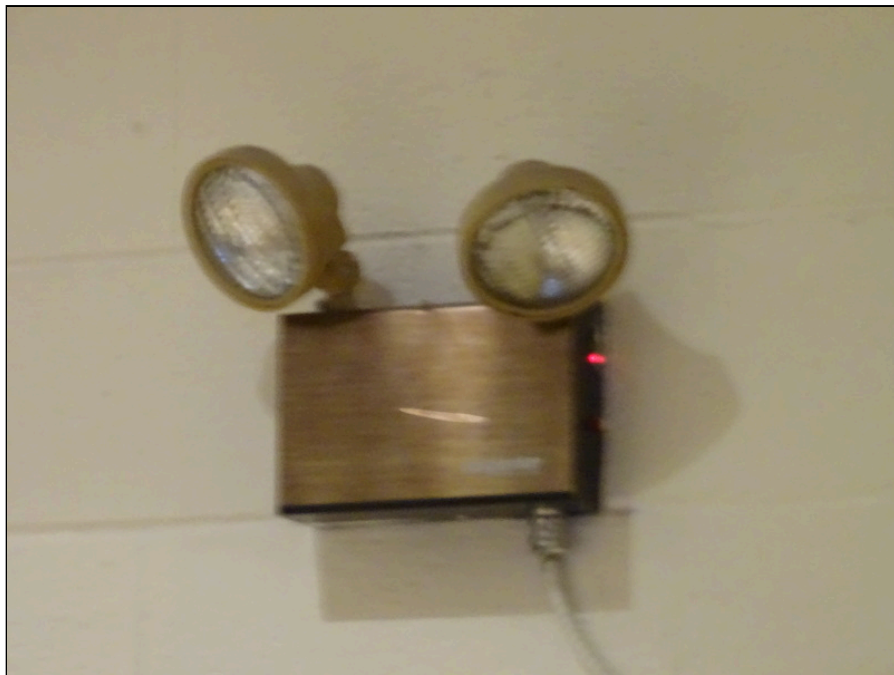
104 - Emergency exit light

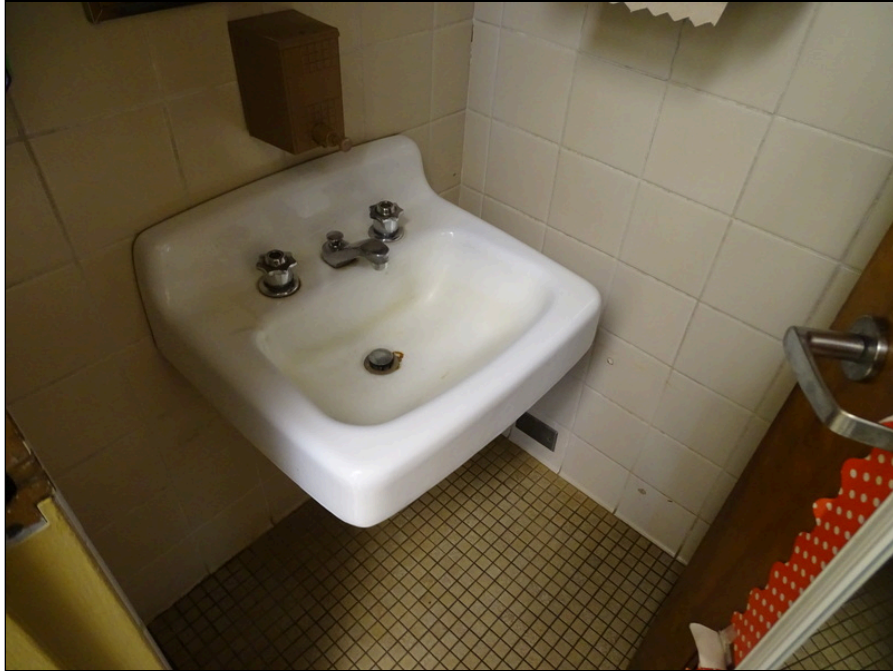
105 - Restroom sink

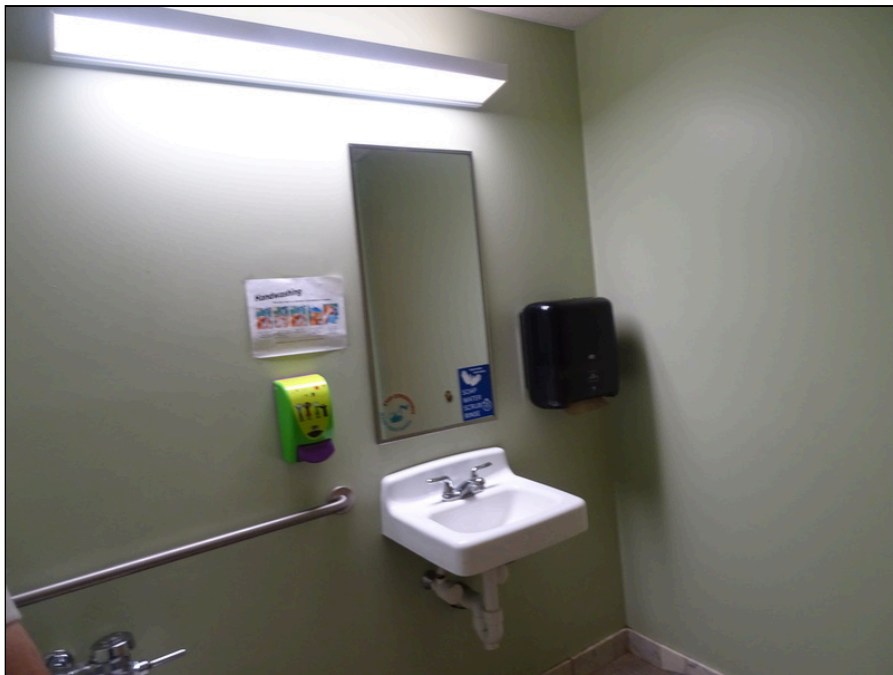
106 - Restroom mirror

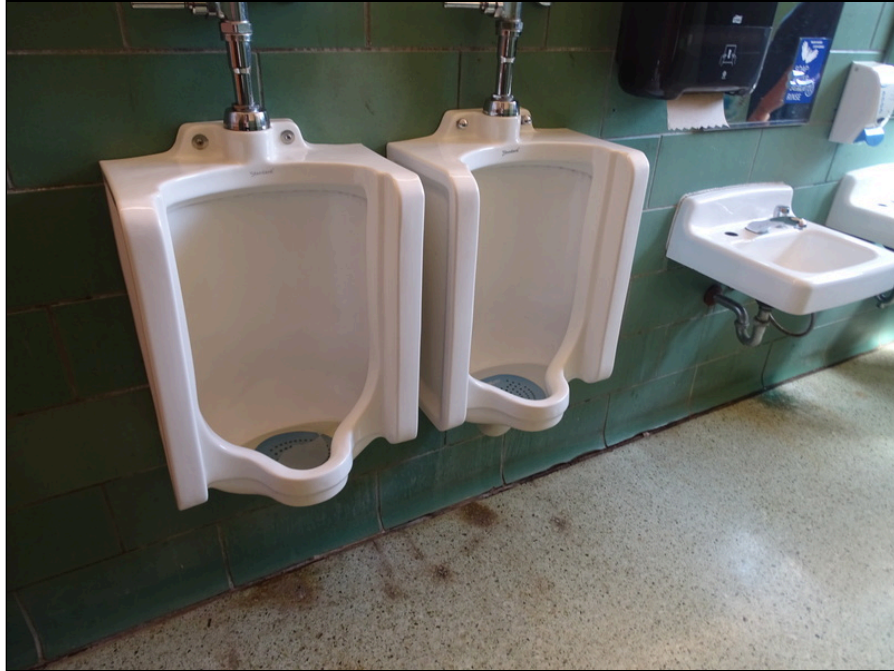
107 - Typical restroom

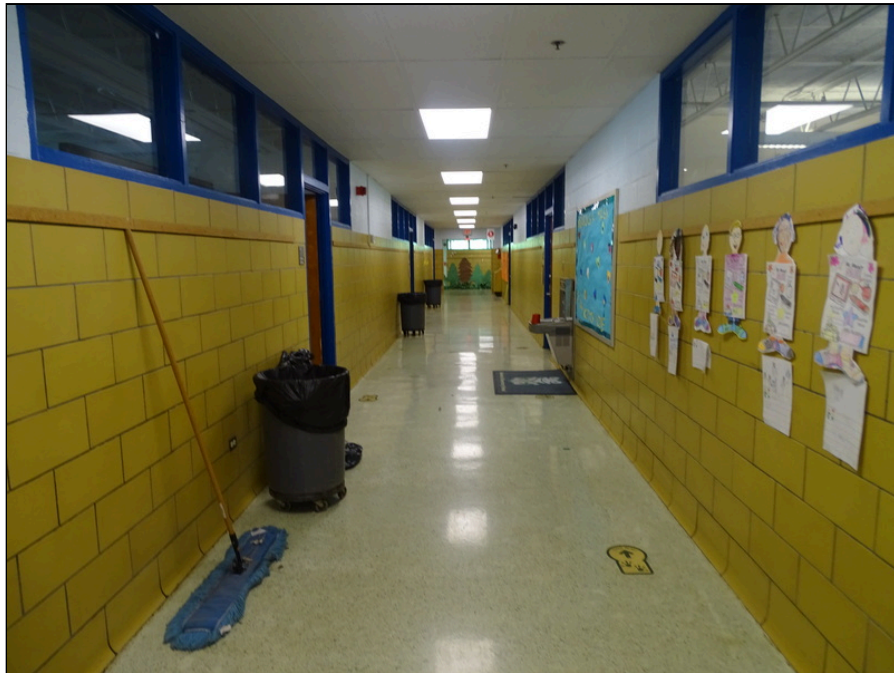
108 - Corridor overview

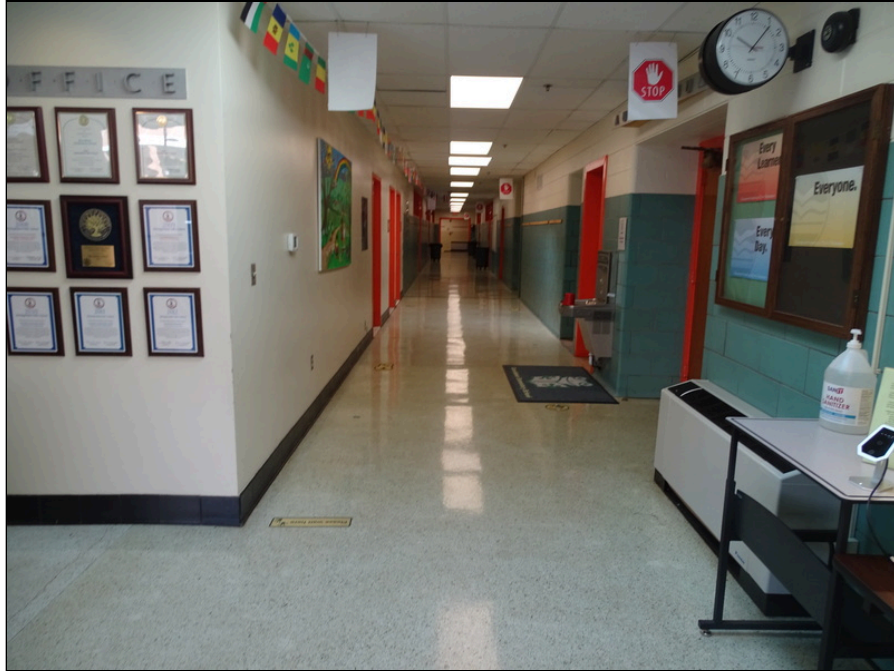
109 - Corridor overview
