GREENBRIER ELEMENTARY SCHOOL
2205 GREENBRIER DRIVE
CHARLOTTESVILLE, VIRGINIA

ECS PROJECT NO. 46:6713

CITY OF CHARLOTTESVILLE - FACILITIES DEVELOPMENT

Reference: Facility Condition Assessment Report for Greenbrier Elementary School, 2205 Greenbrier Drive, Charlottesville, Virginia

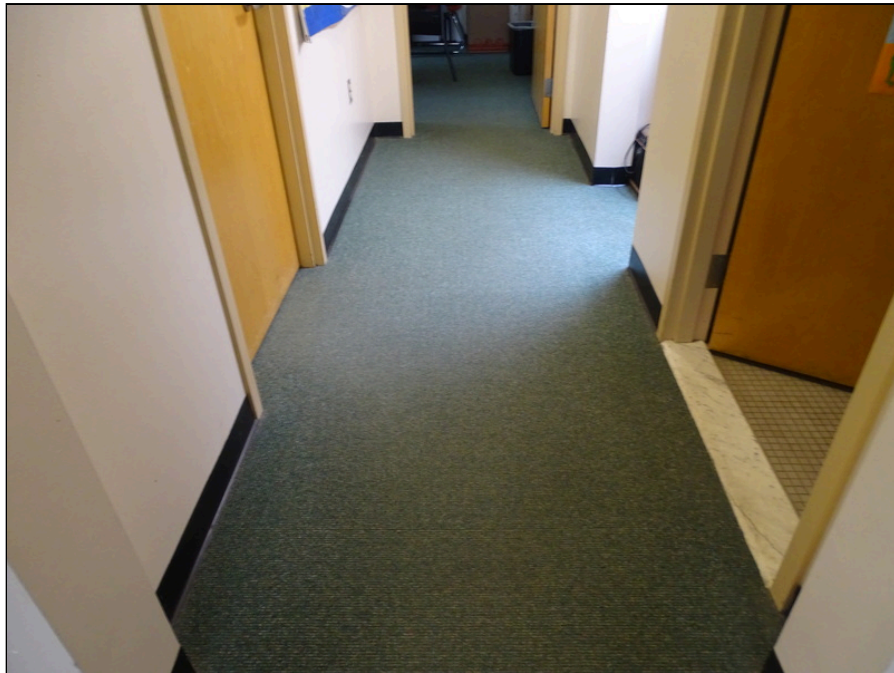
110 - Corridor overview

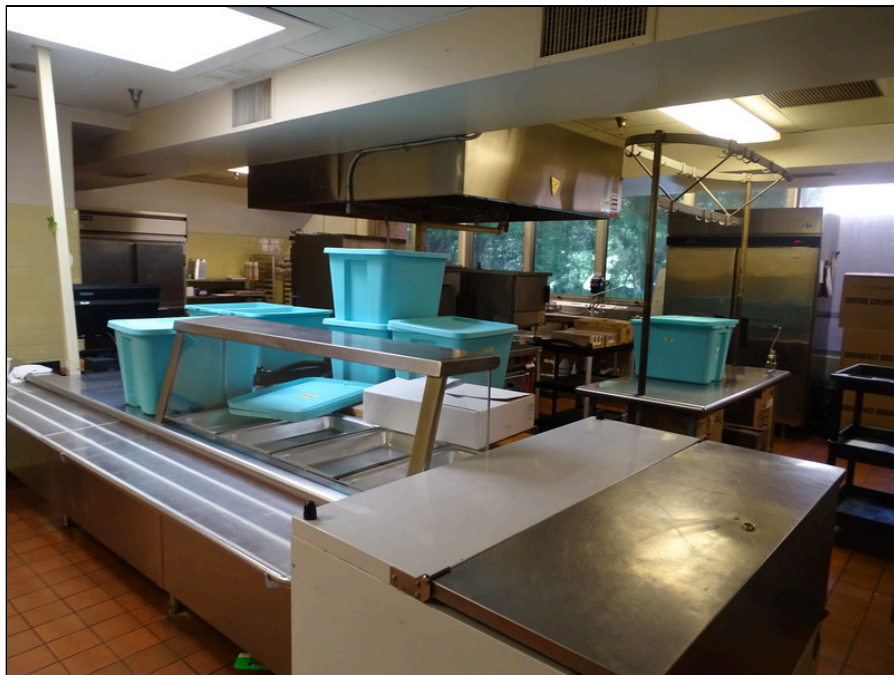
116 - Kitchen overview

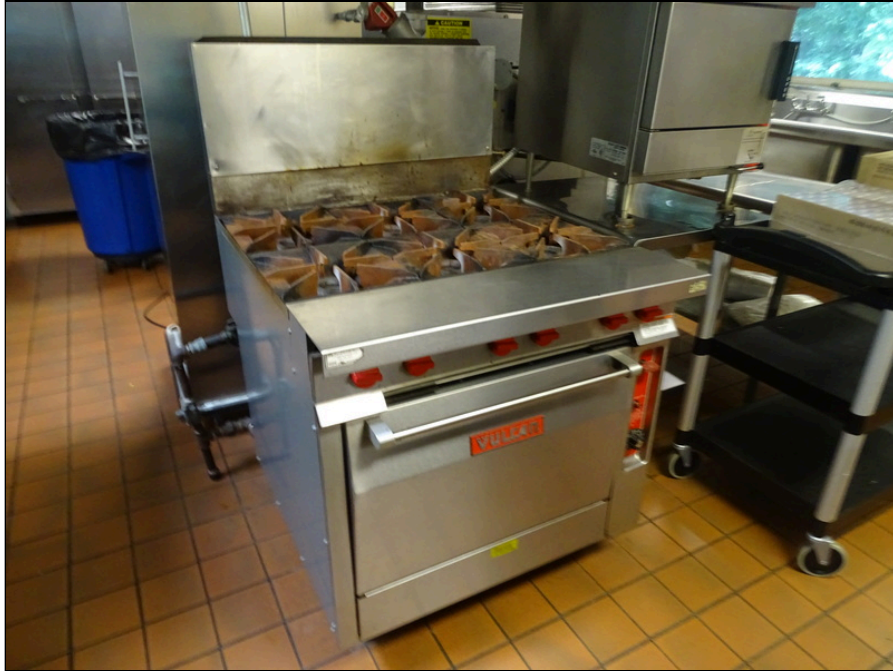
117 - Kitchen overview

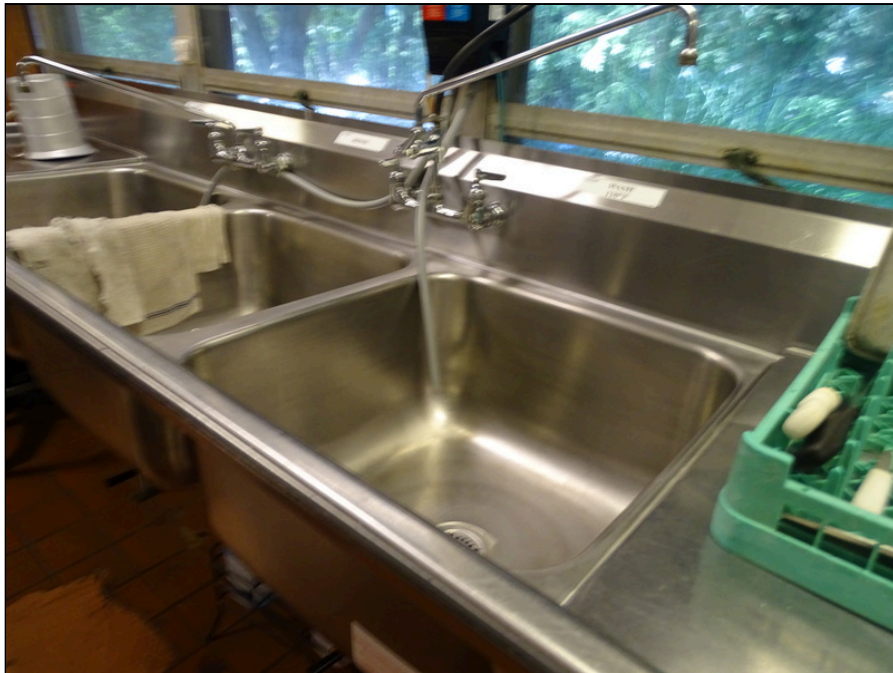
118 - Kitchen overview

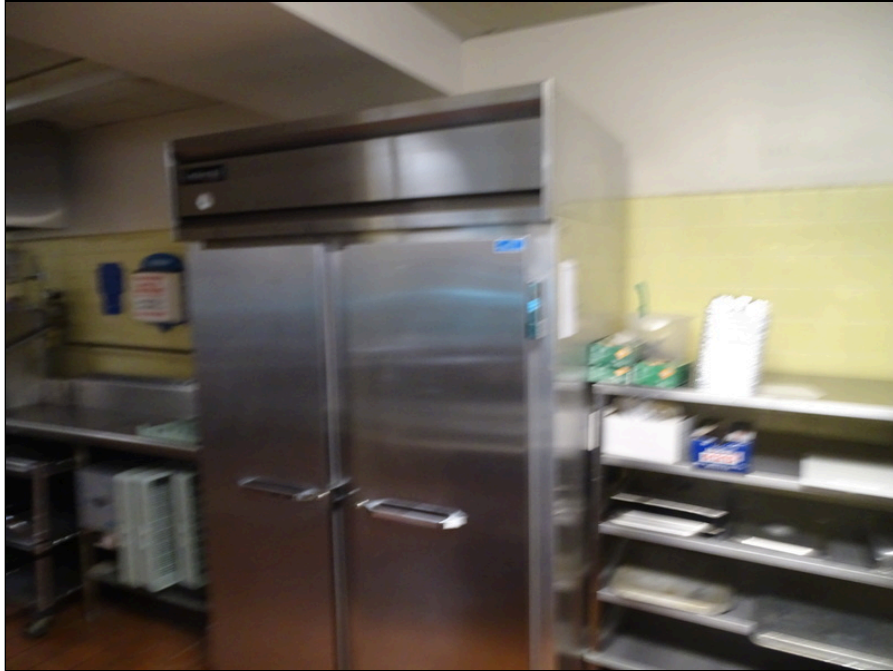
119 - Kitchen overview

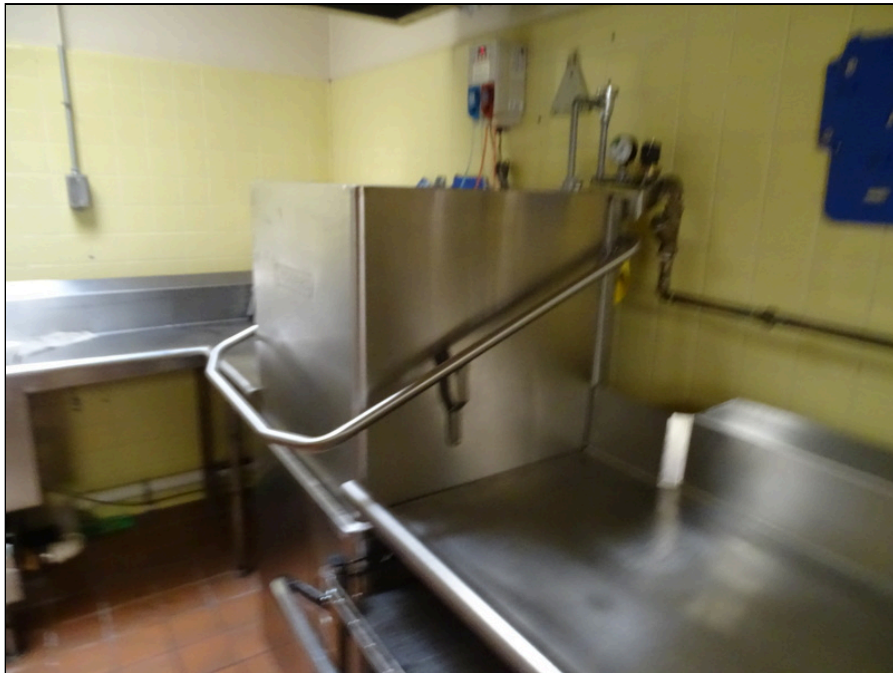
120 - Kitchen overview

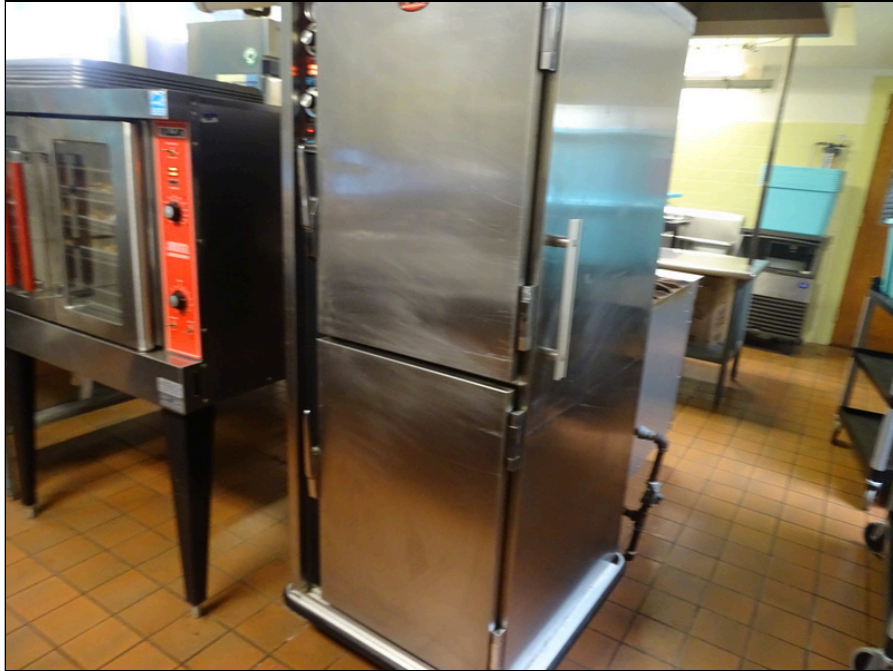
121 - Kitchen overview

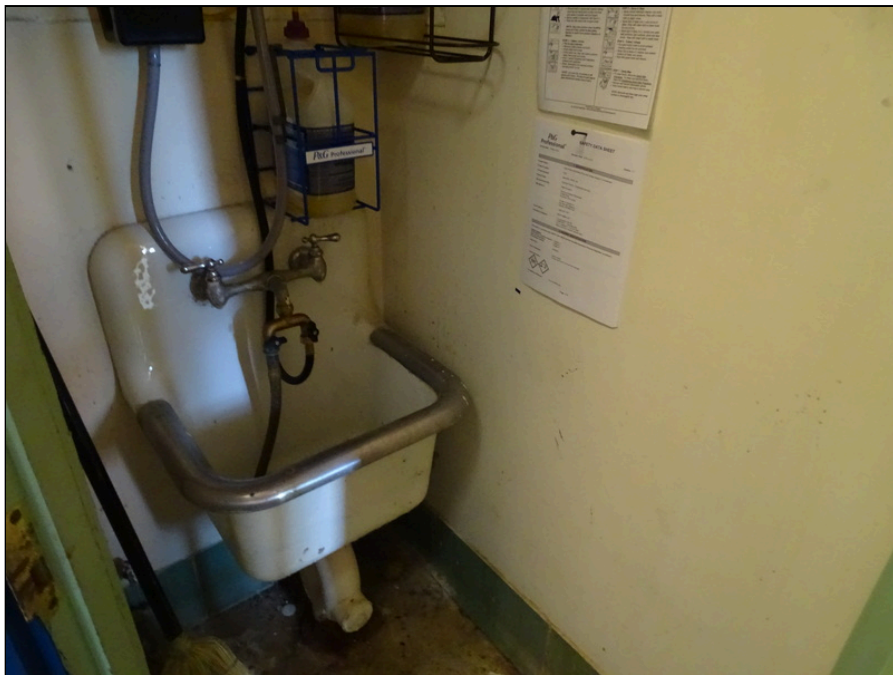
122 - Utility room

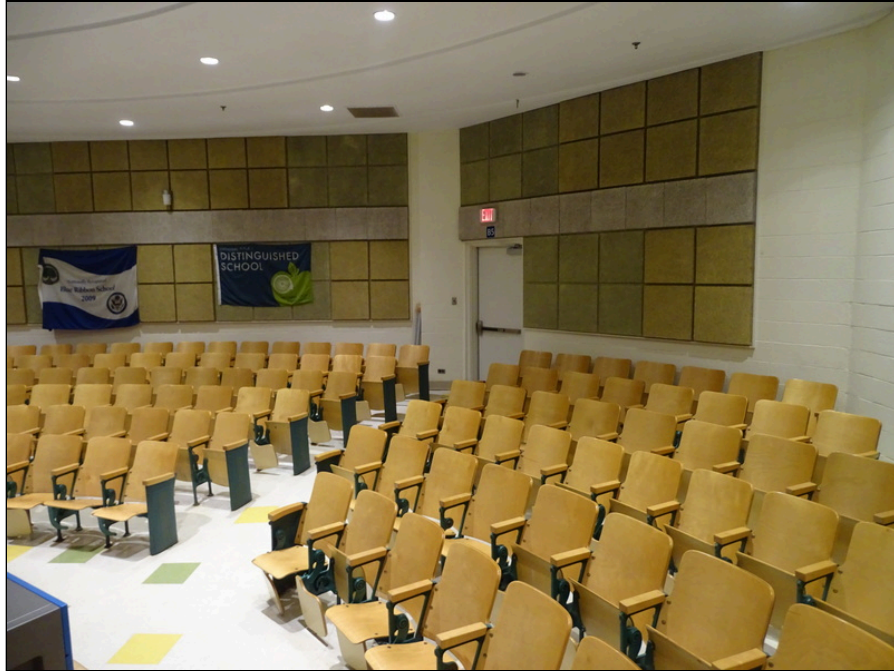
123 - Auditorium

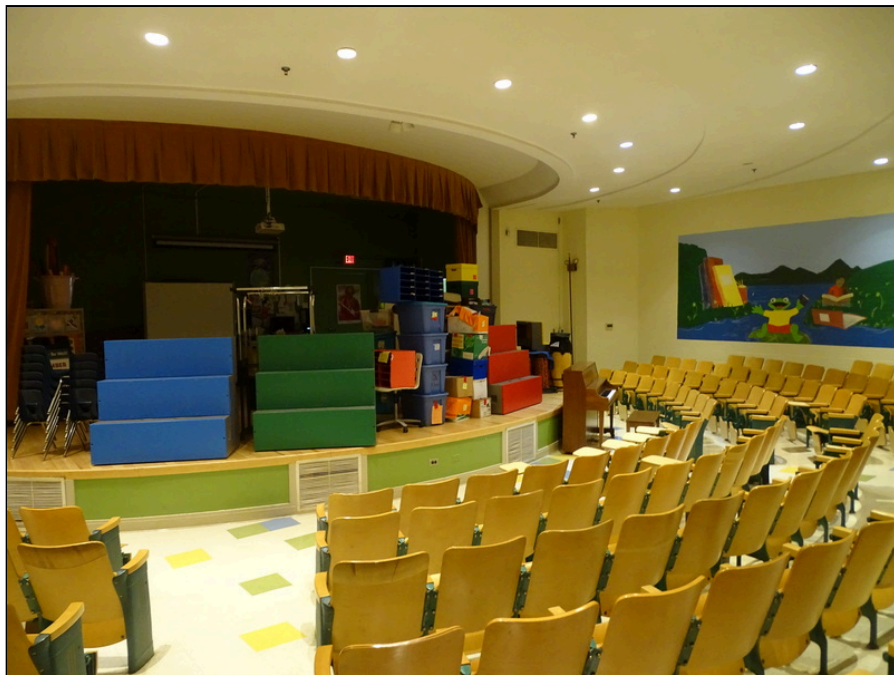
124 - Auditorium

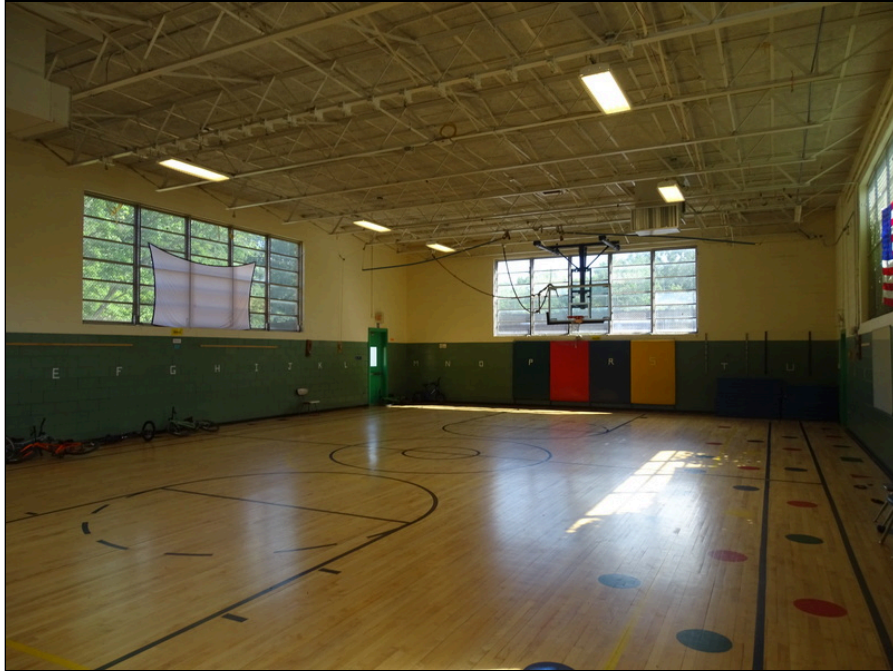
125 - Gym overview

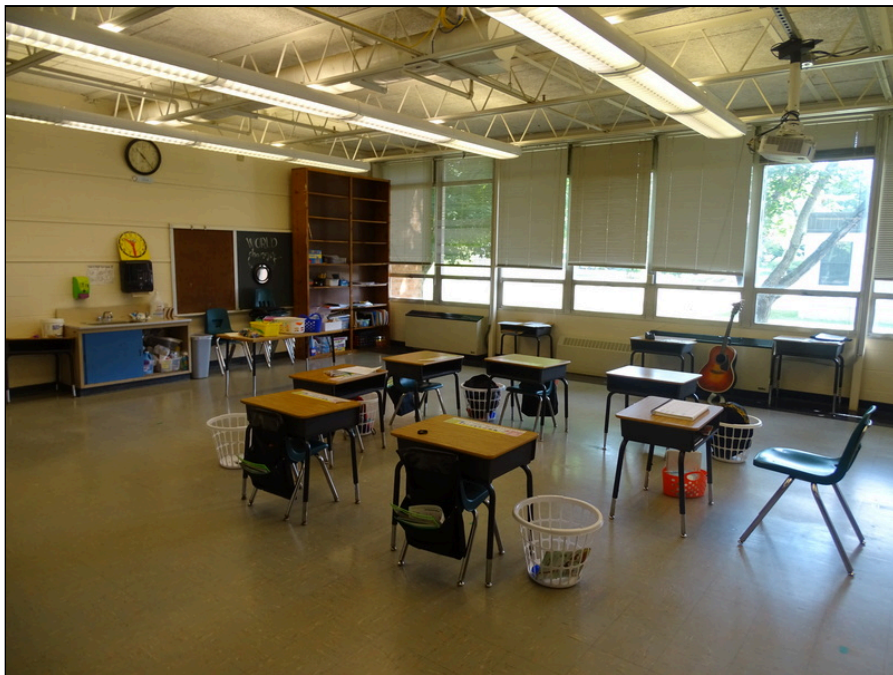
126 - Typical classroom

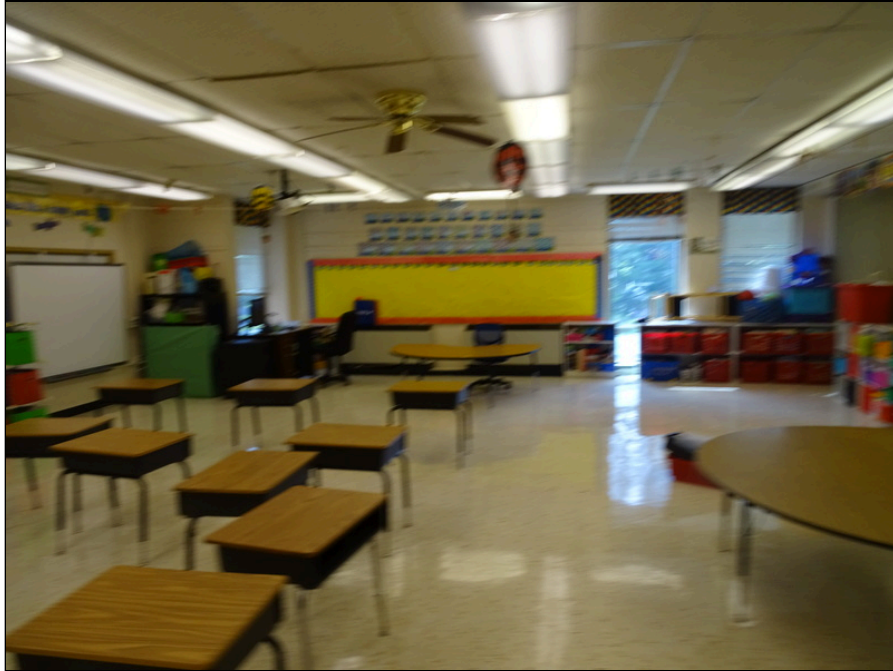
127 - Typical classroom

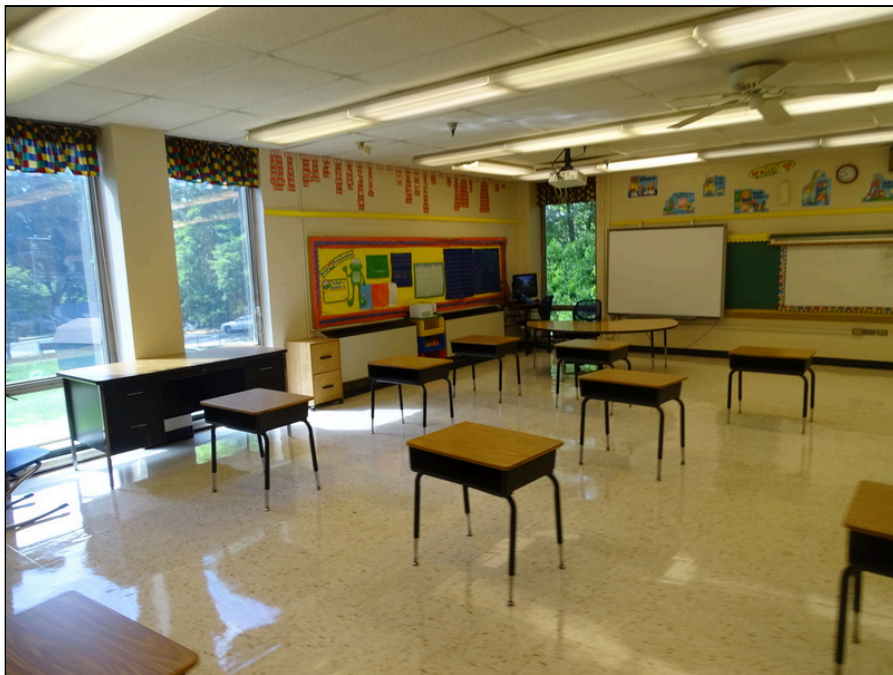
128 - Typical classroom

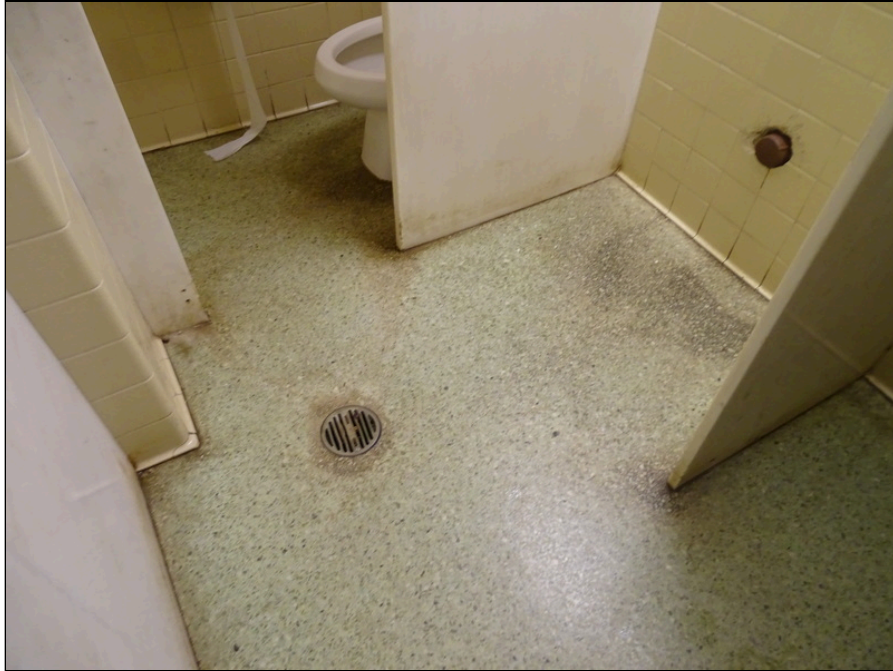
129 - Typical restroom

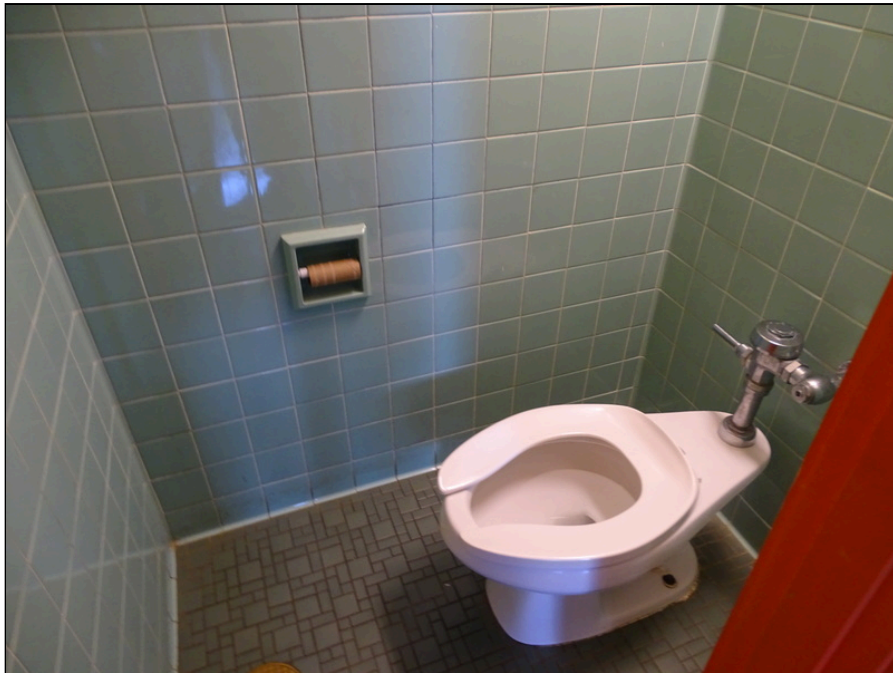
130 - Typical restroom

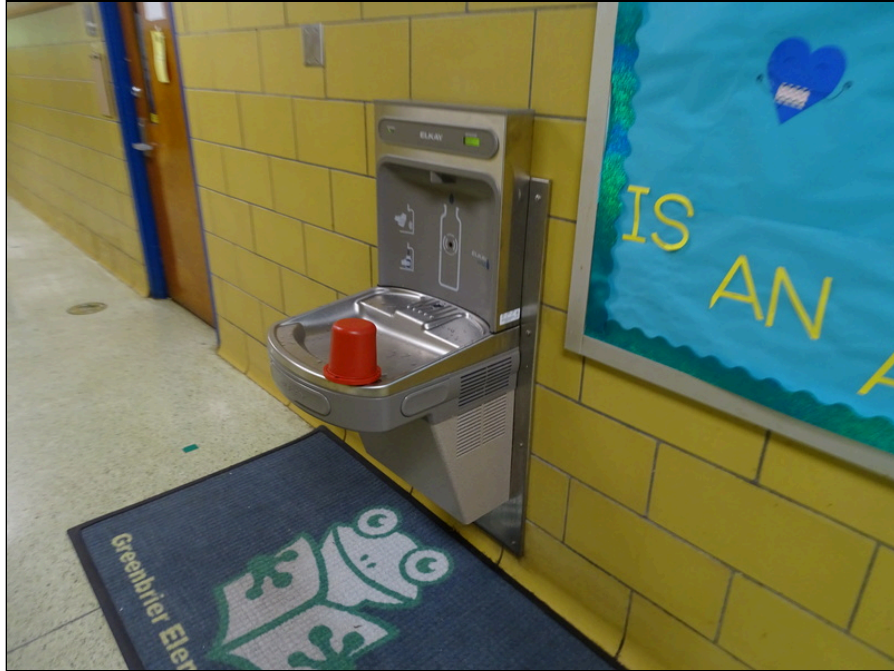
131 - Drinking fountain in corridor

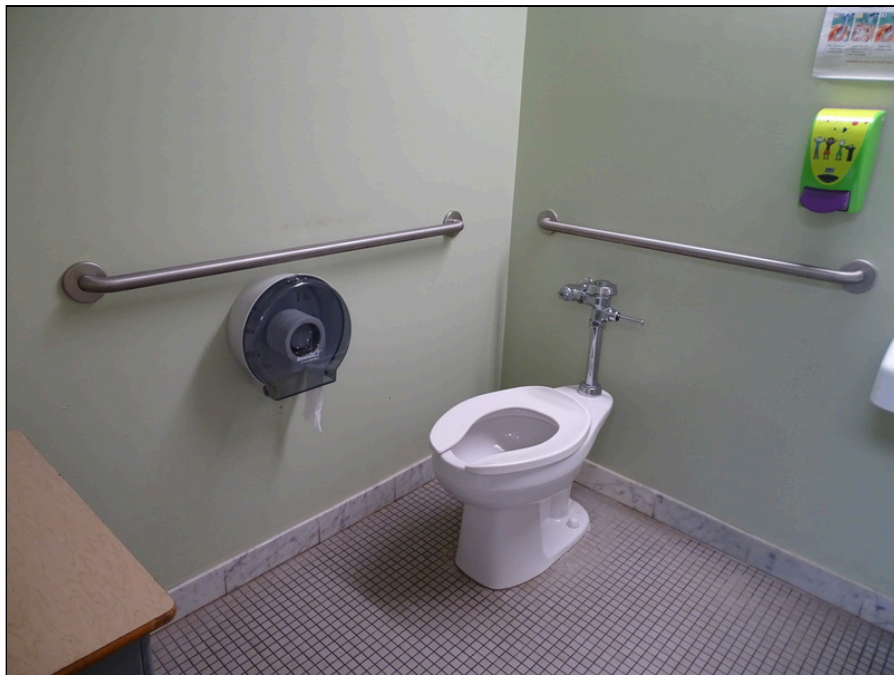
132 - Accessible restroom

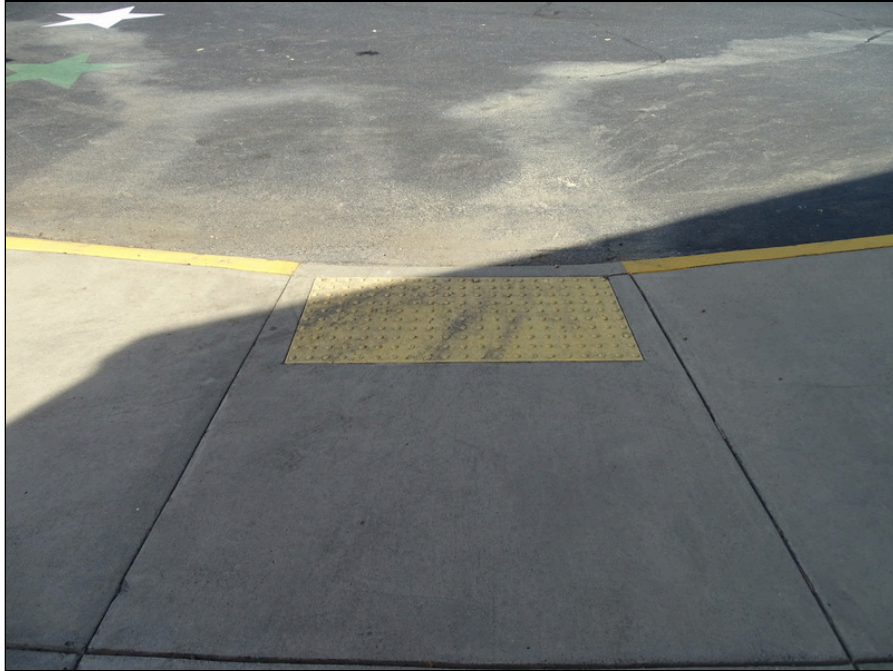
133 - Accessible curb ramp

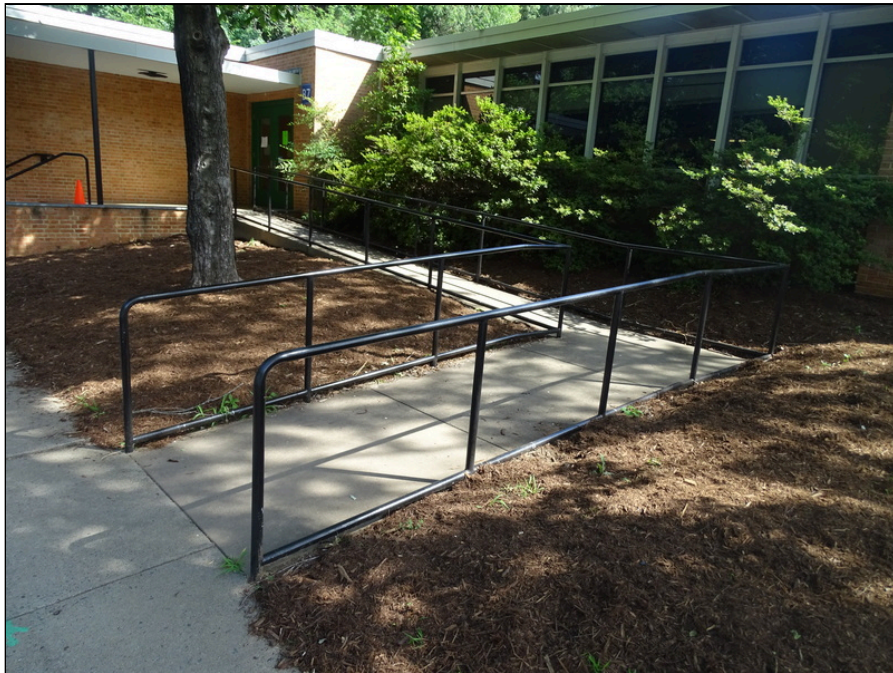
134 - Accessible concrete ramp

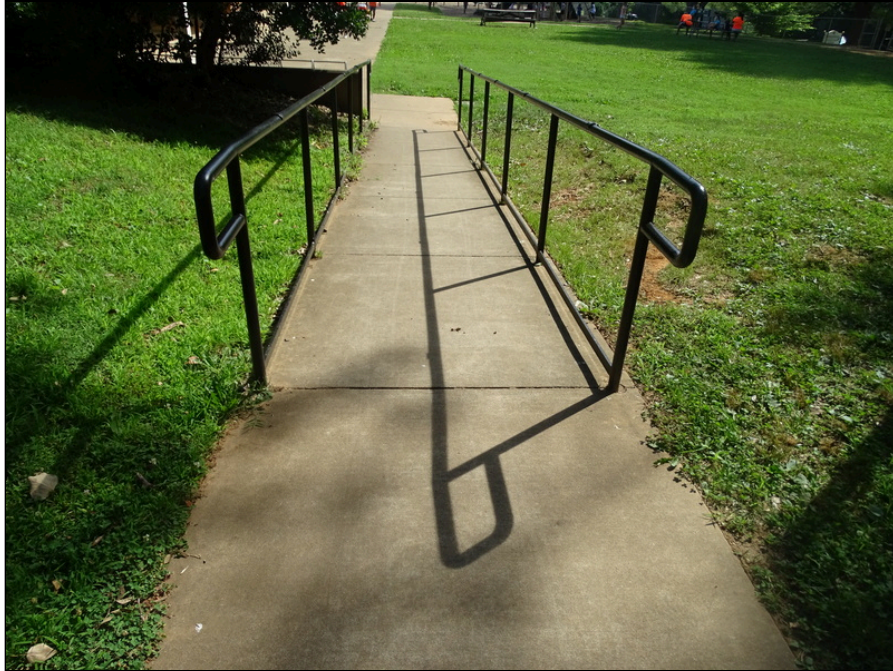
135 - Accessible concrete ramp

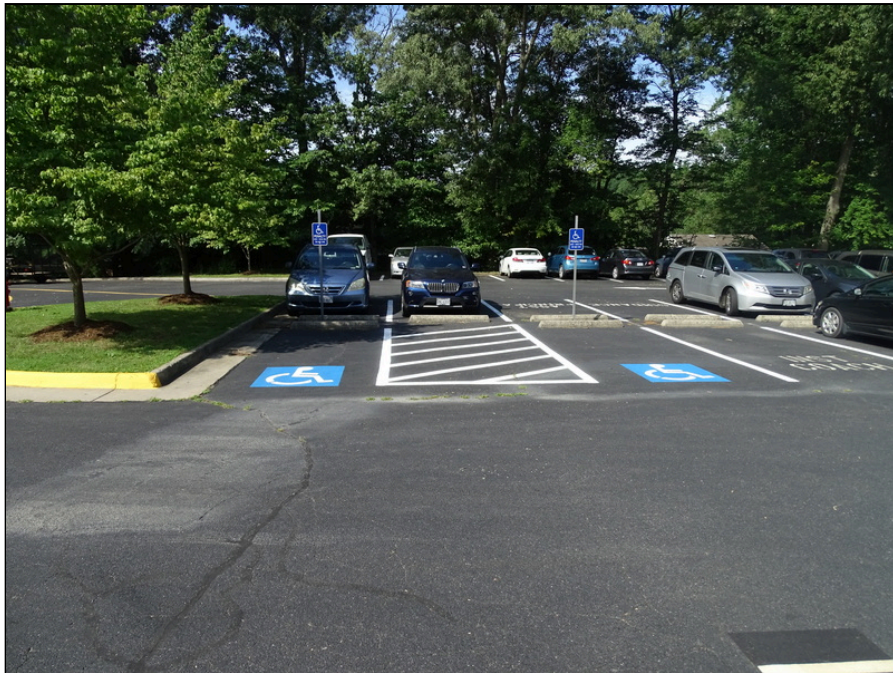
136 - Accessible parking spaces
