HEALTH DEPARTMENT  
1138 ROSE HILL DRIVE  
CHARLOTTESVILLE, VIRGINIA

OCTOBER 29, 2021

Reference: Facility Condition Assessment Report for Health Department, 1138 Rose Hill Drive,  
Charlottesville, Virginia

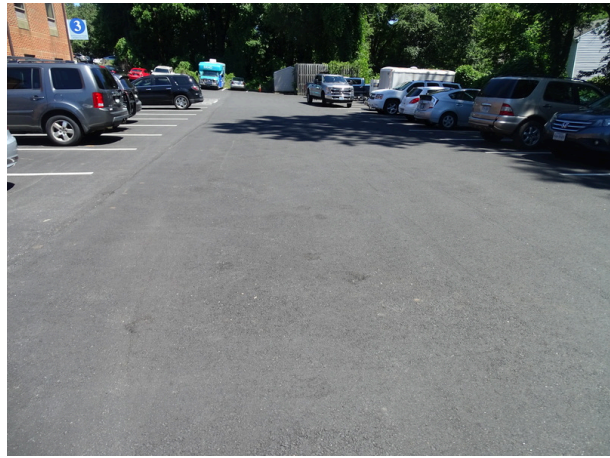
Asphalt pavement overview

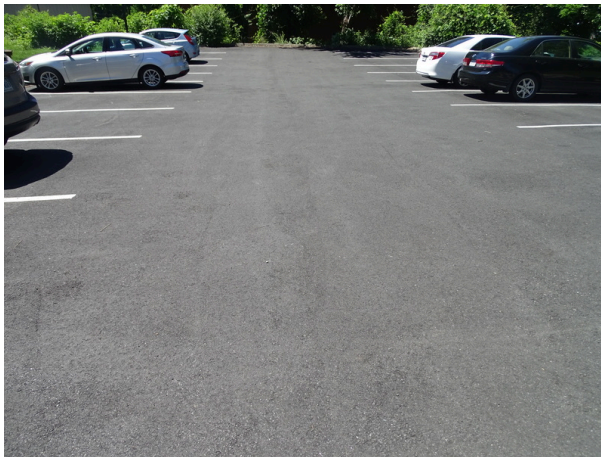
Asphalt pavement and parking overview

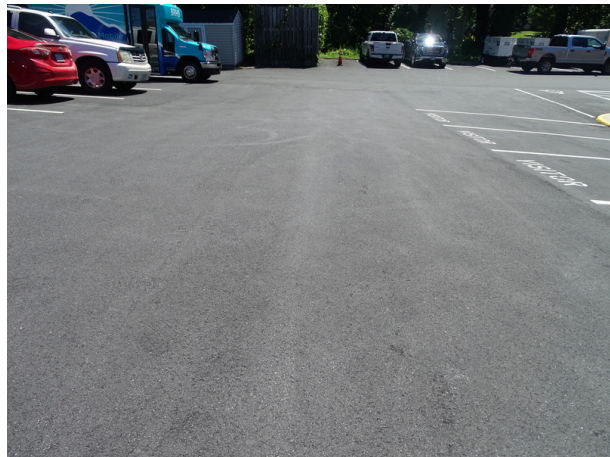
Asphalt pavement and parking overview

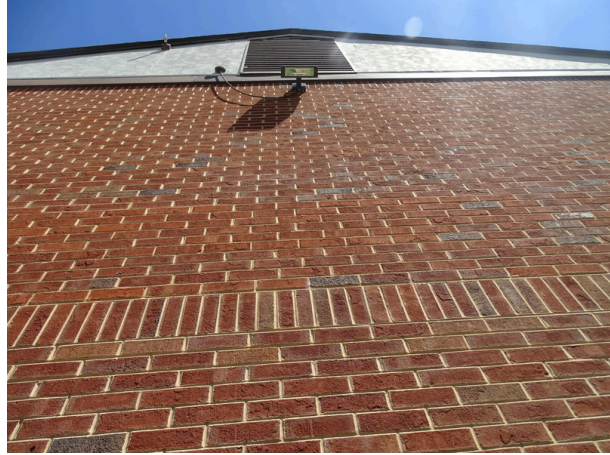
Exterior wall finishes

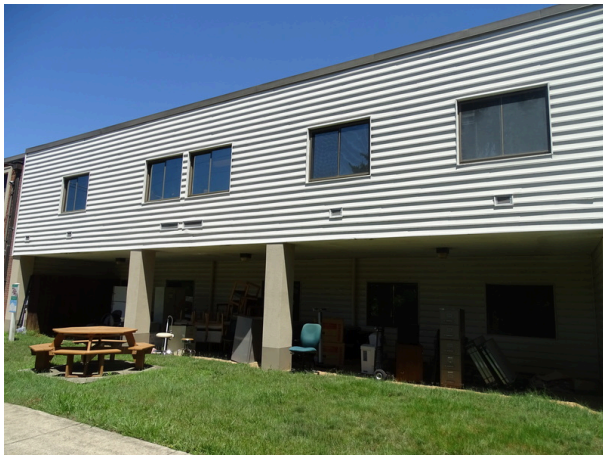
Exterior wall finishes

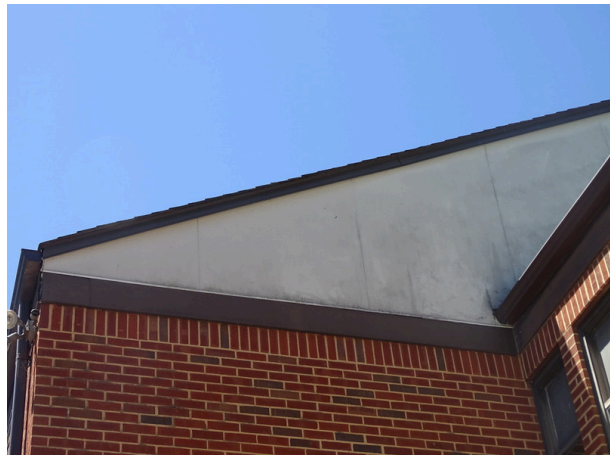
Exterior wall finishes

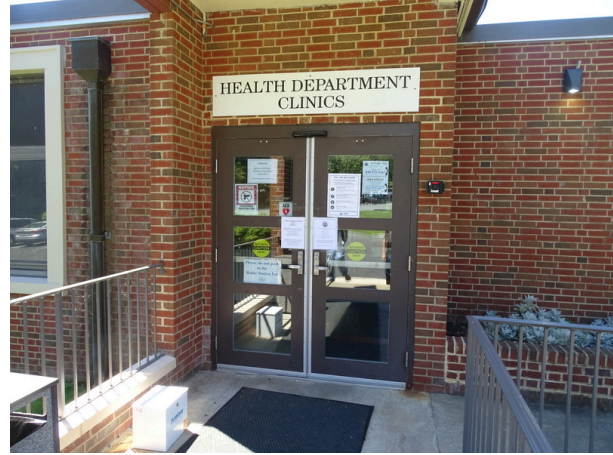
Typical exterior door

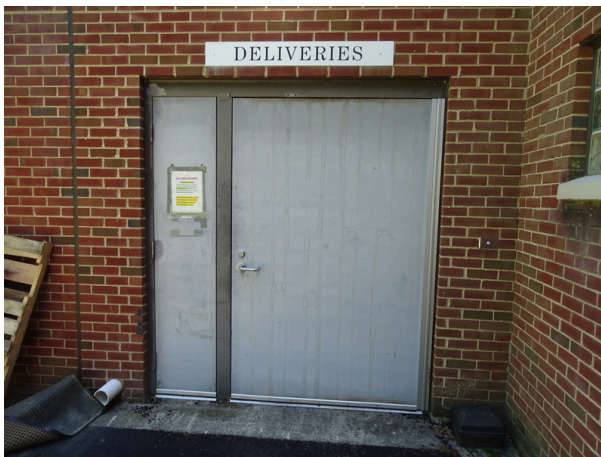
Typical steel door

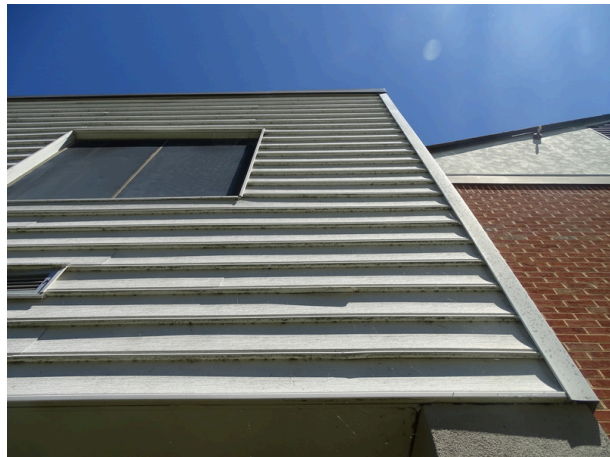
Exterior wall wood siding

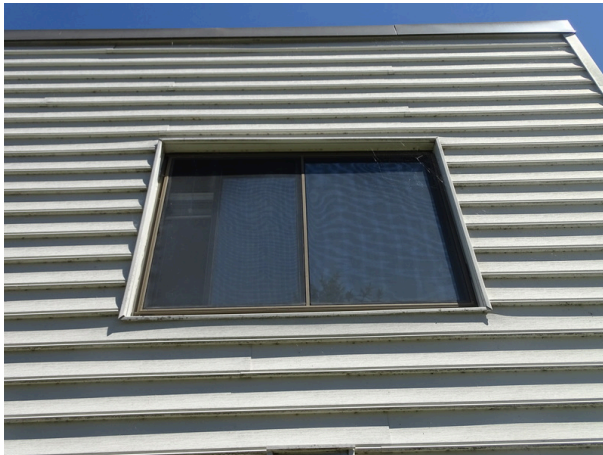
Exterior window

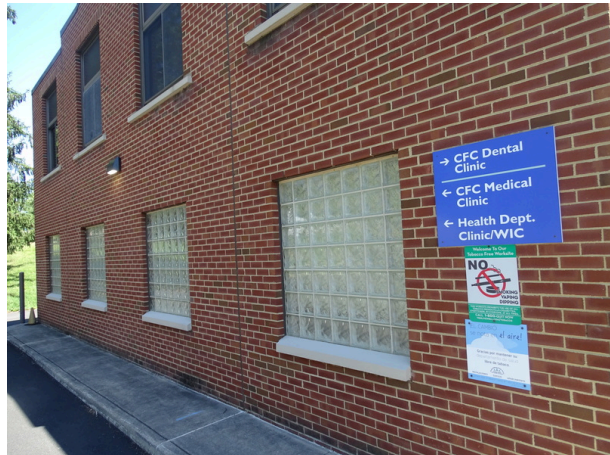
Exterior window finishes

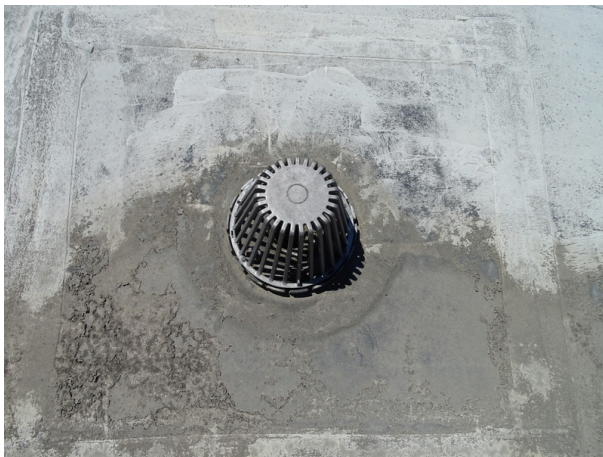
Single-ply roofing system side of the building -  
note internal drain

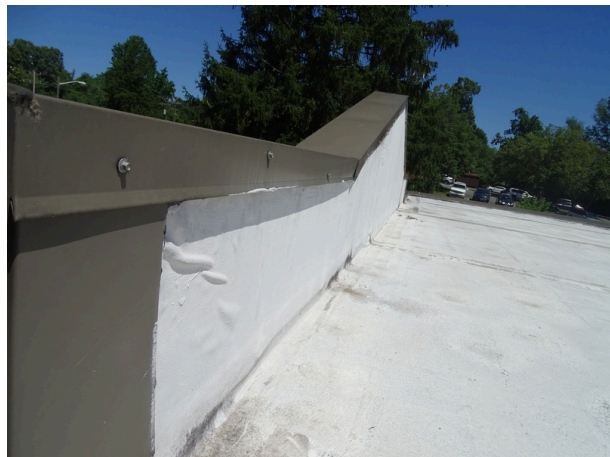
Single-ply roofing system side of the building -  
note metal coping

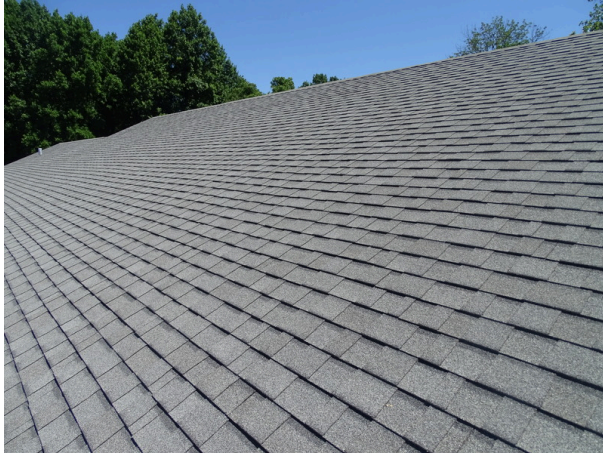
Asphalt shingle roofing

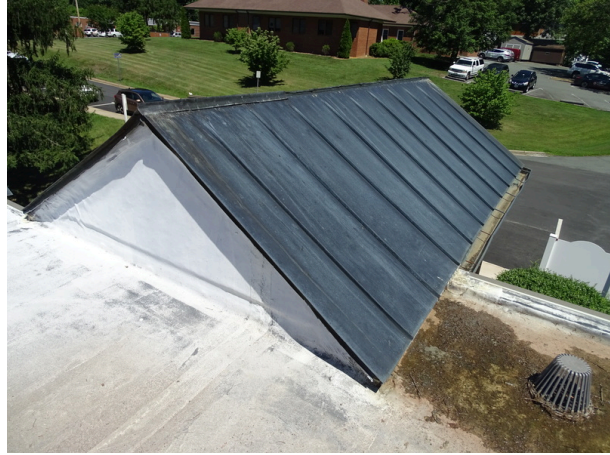
Metal roofing system

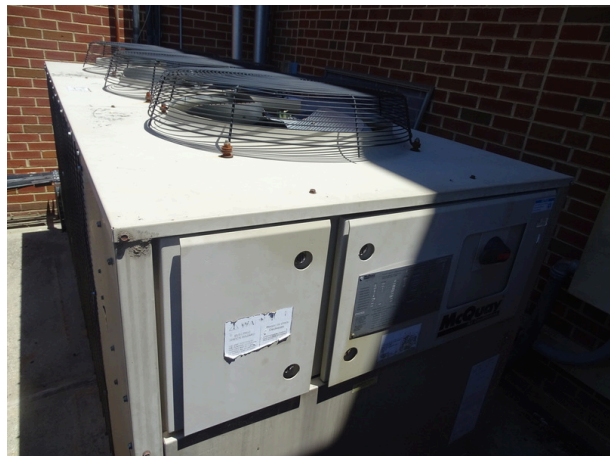
Chillers system

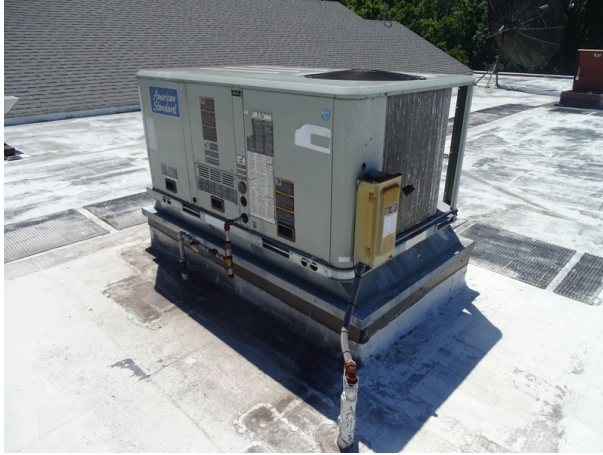
HVAC system

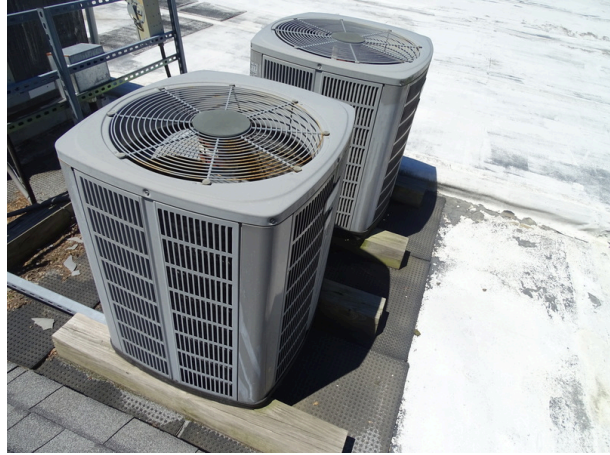
Condensers

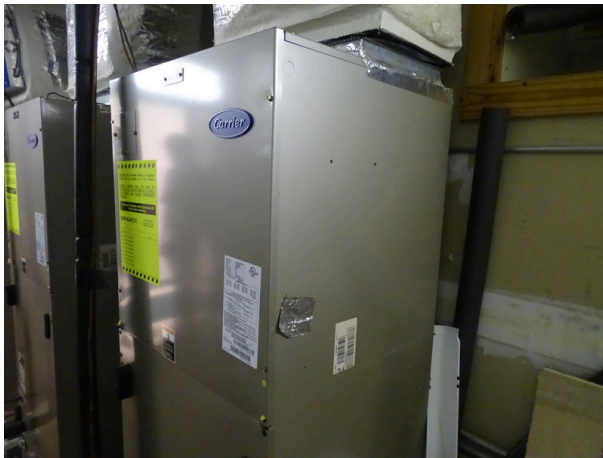
Typical air handler

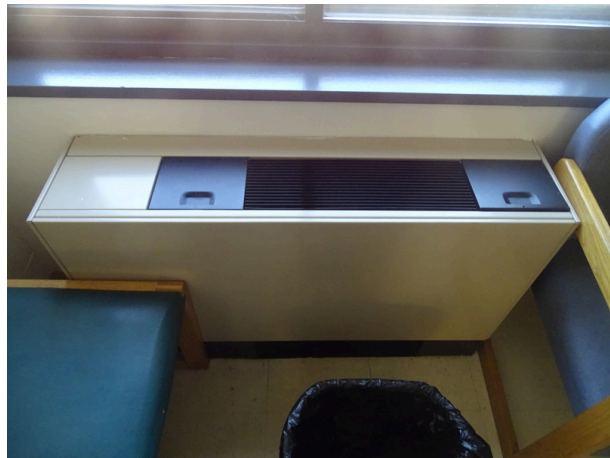
Typical Water Source Heat Pump

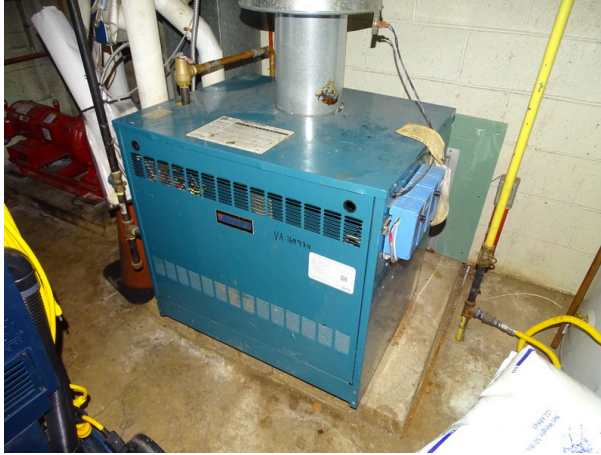
Boiler

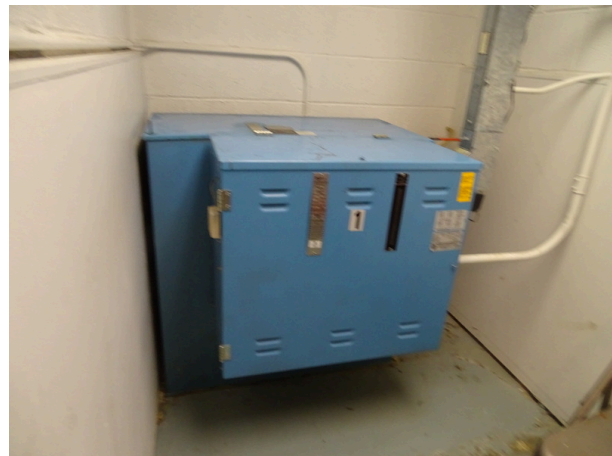
Elevator machine

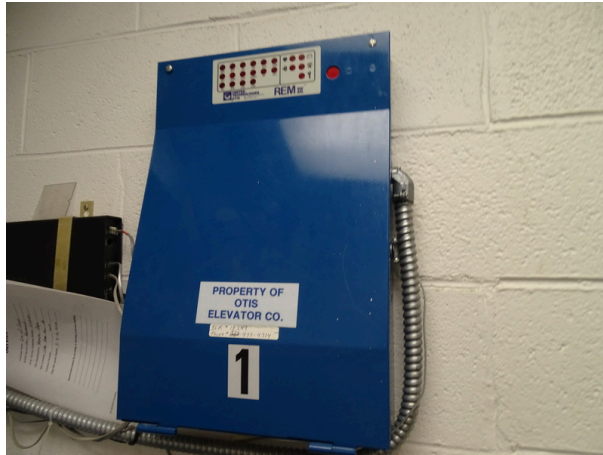
Elevator machine

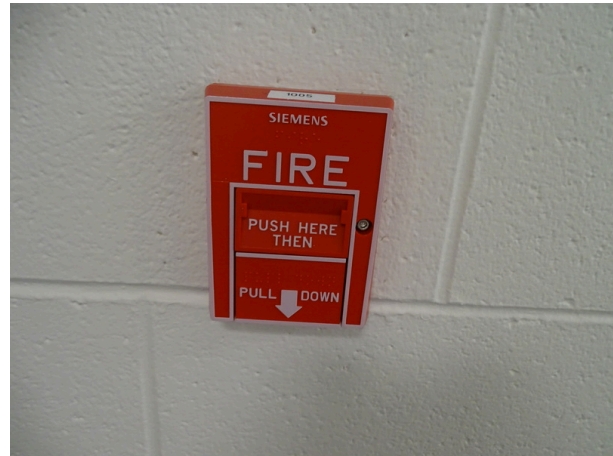
Typical Pull down station

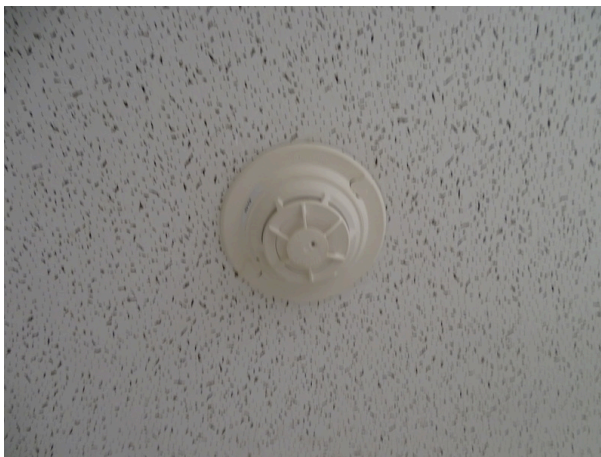
Typical smoke detector

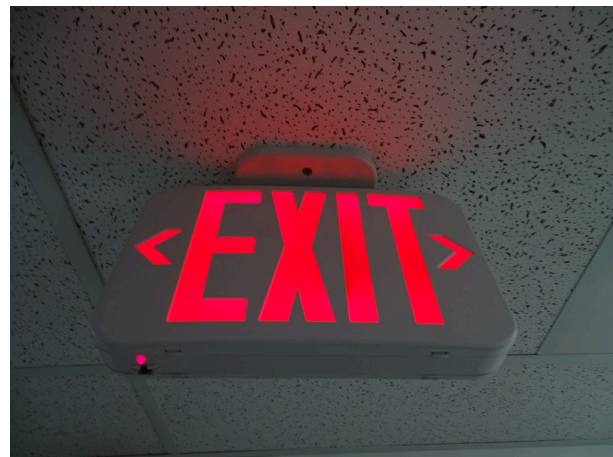
Typical exit sign

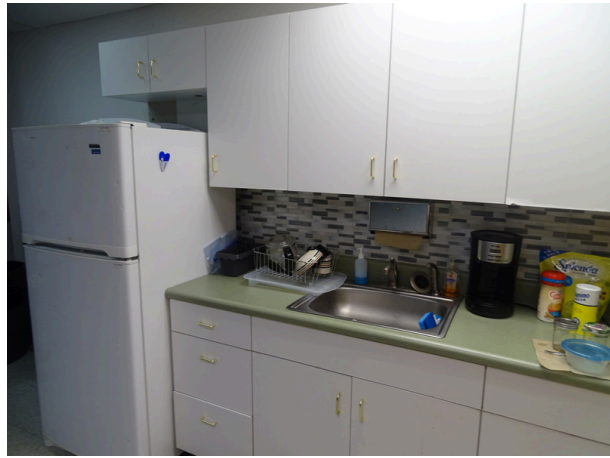
Interior finishes kitchen area

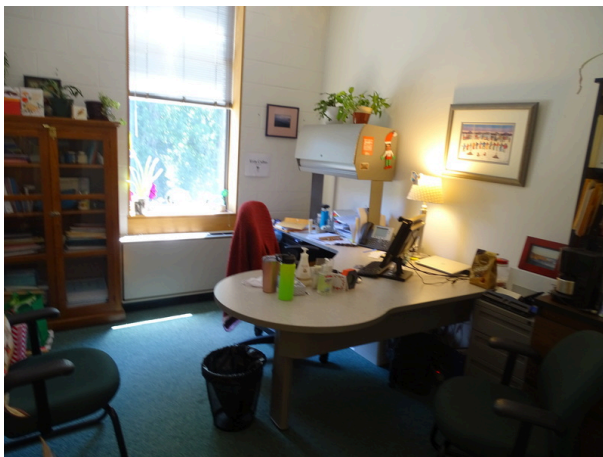
Interior finishes office area

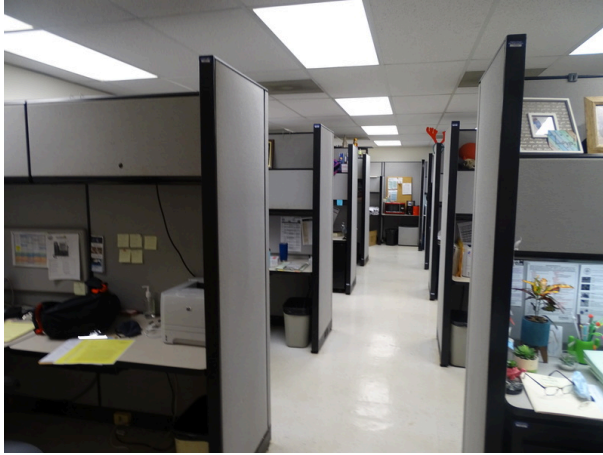
Interior finishes office area

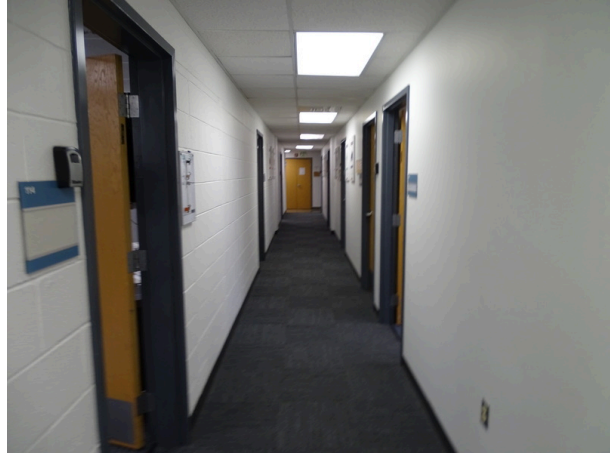
Interior finishes corridor area

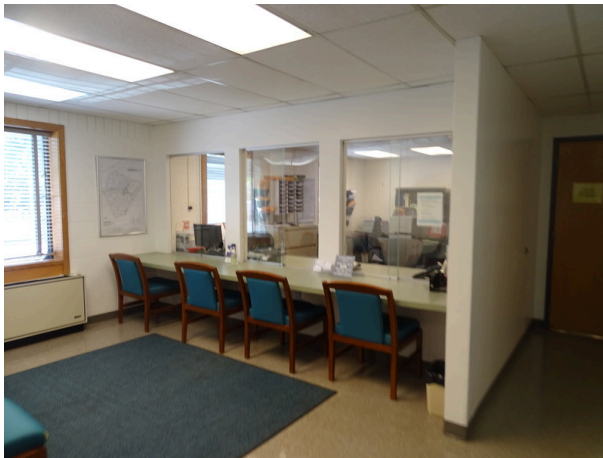
Interior finishes reception area

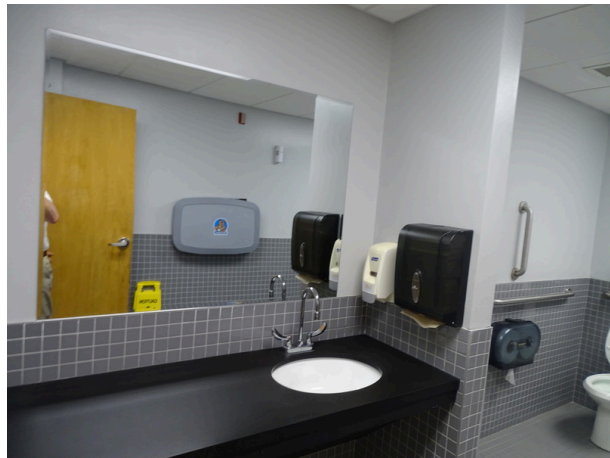
Interior finishes restroom area

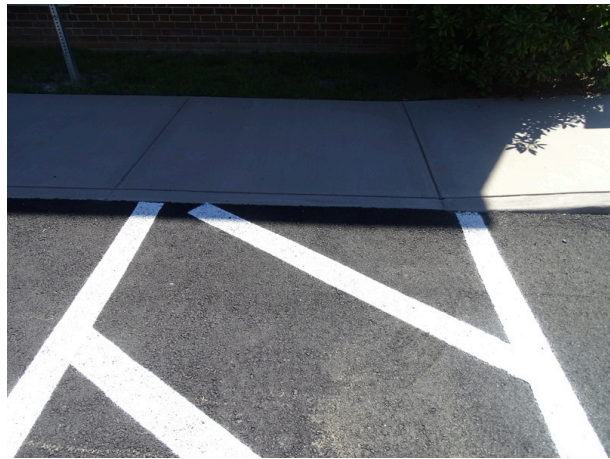
Accessible curb

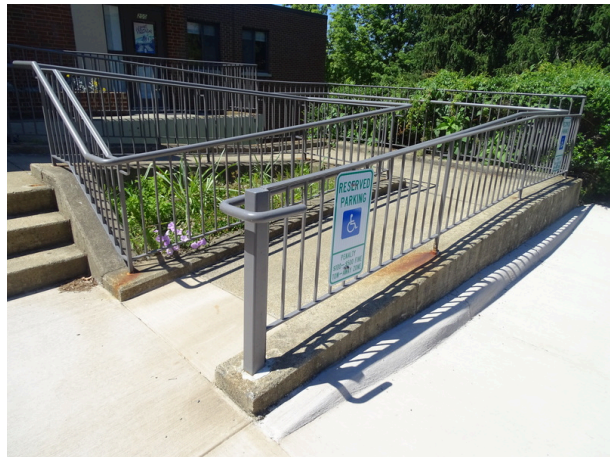
Accessible ramp

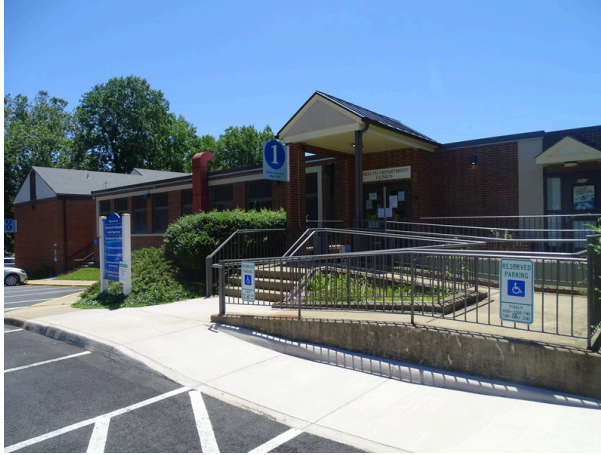
Accessible ramp

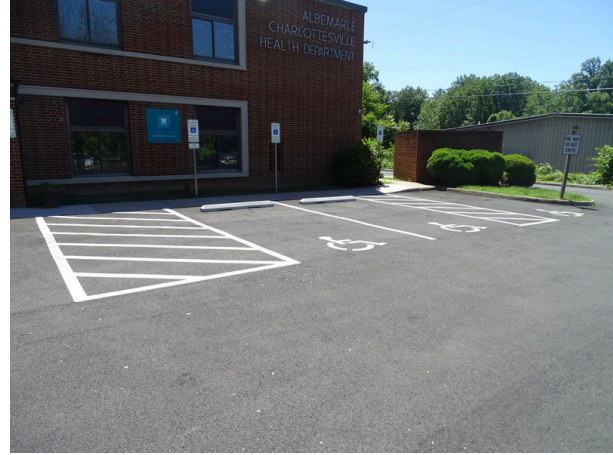
Accessible parking

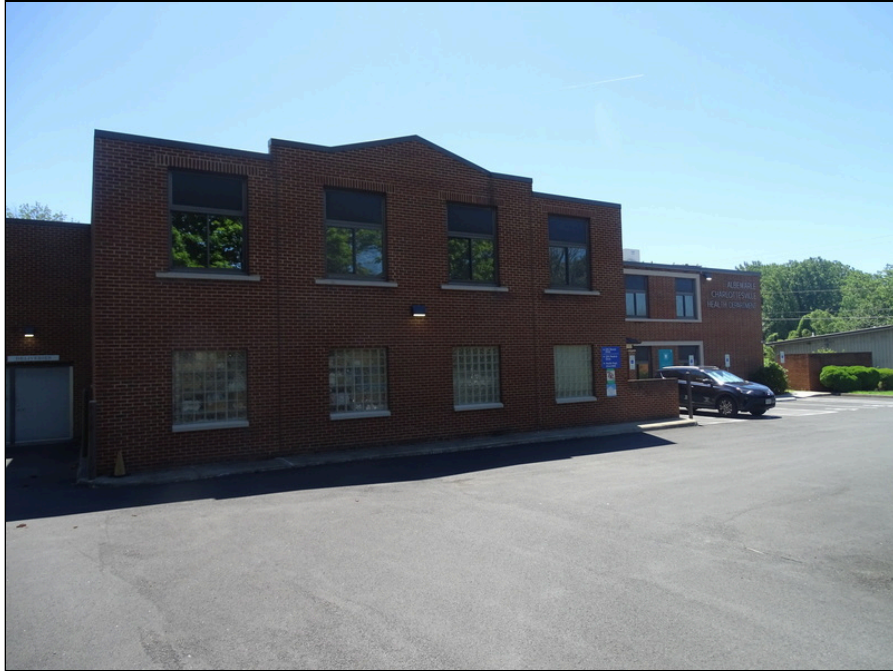
1 - Health Department overview

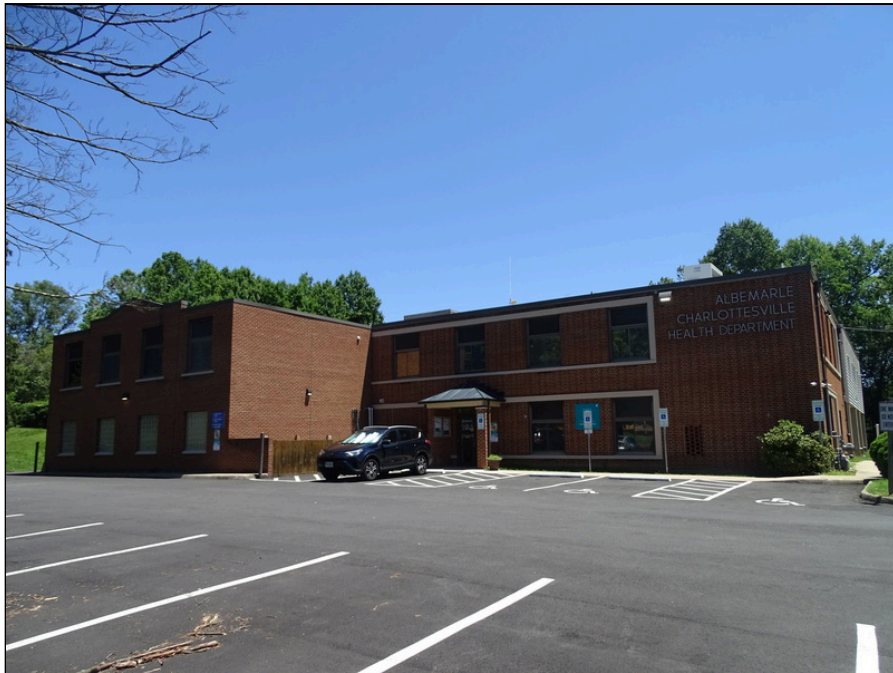
2 - Asphalt pavement overview

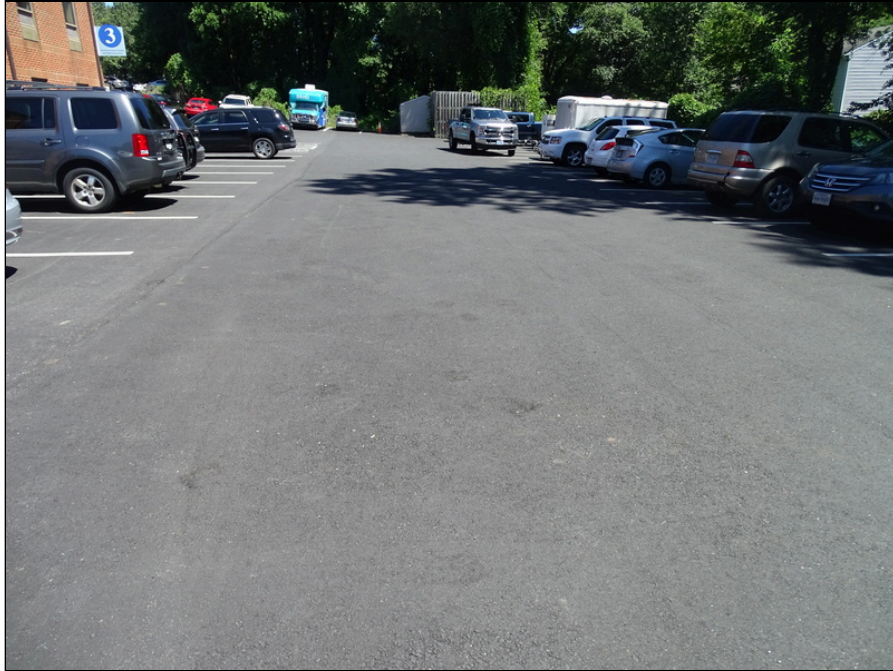
3 - Asphalt pavement overview

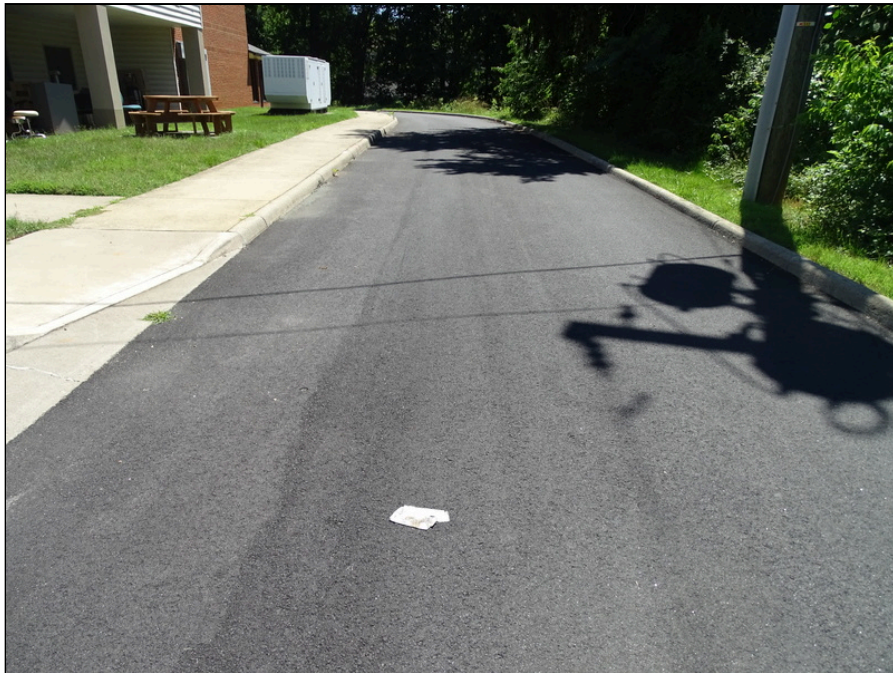
4 - Asphalt pavement overview

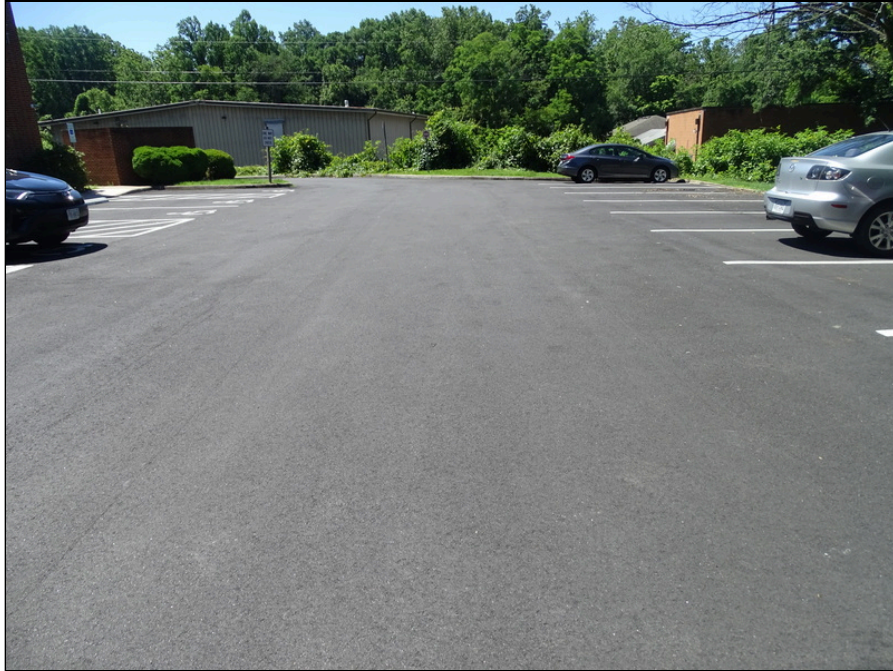
5 - Asphalt pavement and parking overview

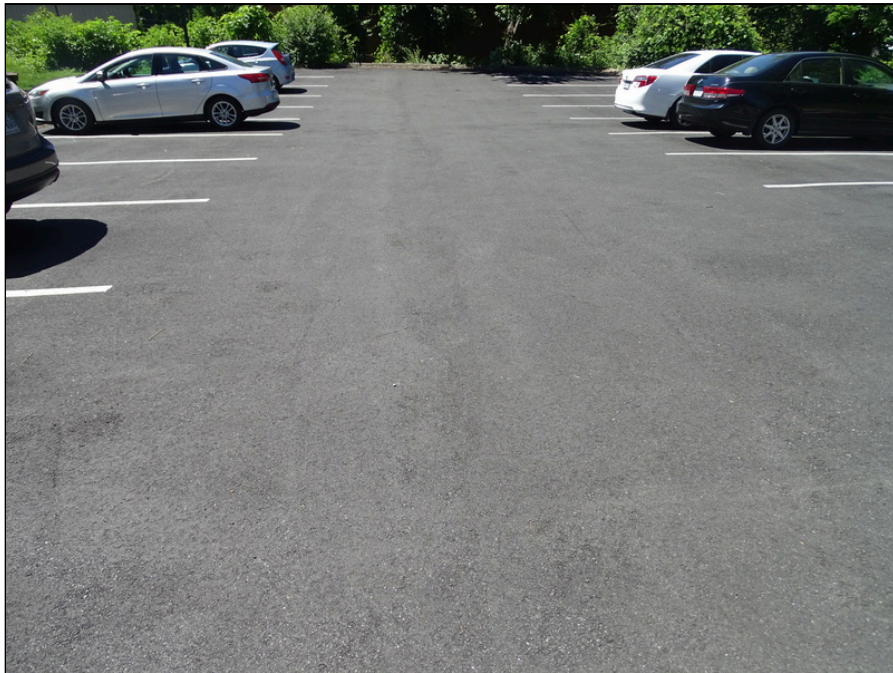
6 - Asphalt pavement and parking overview

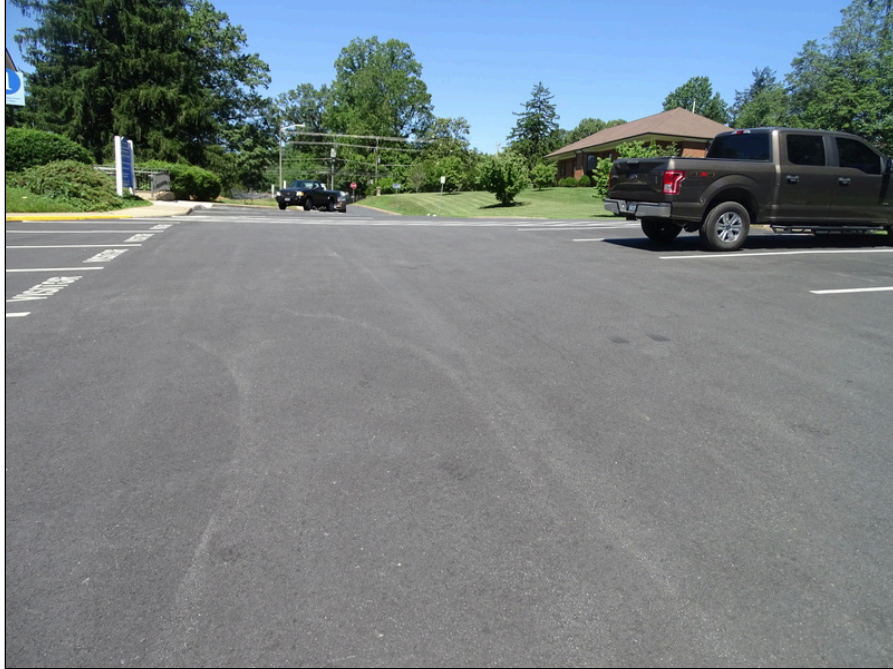
7 - Asphalt pavement and parking overview

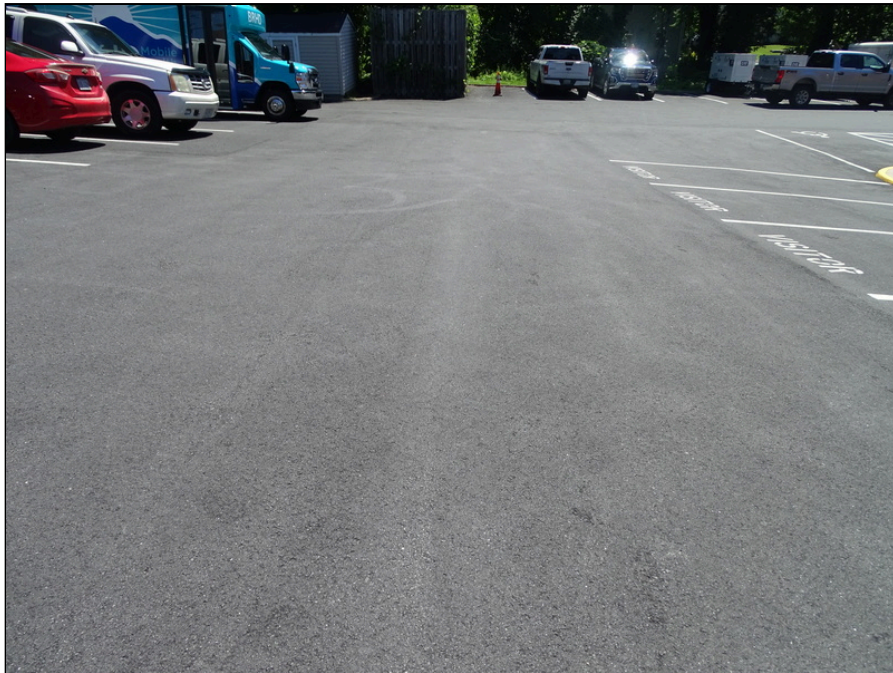
8 - Asphalt pavement and parking overview

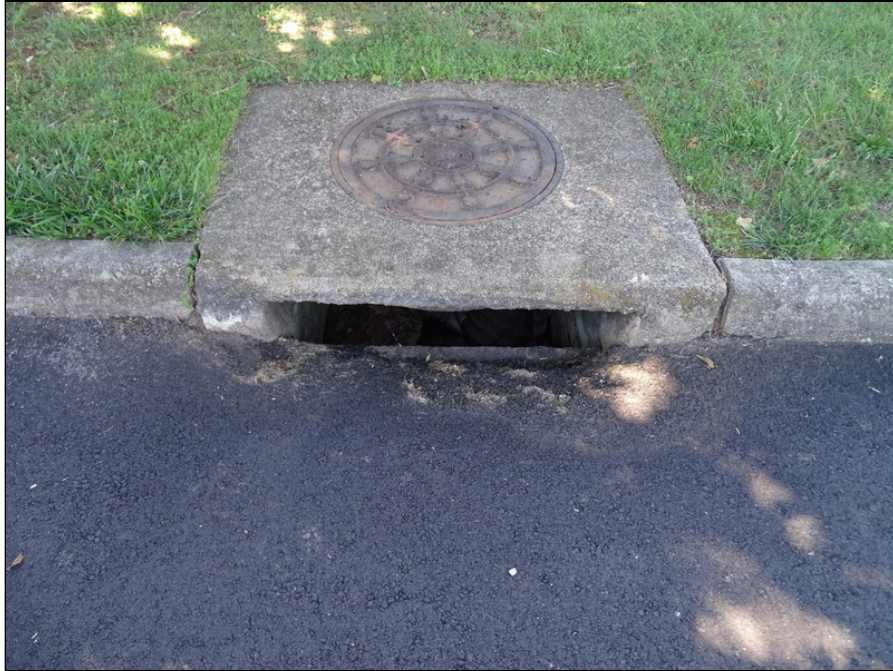
9 - Typical drainage

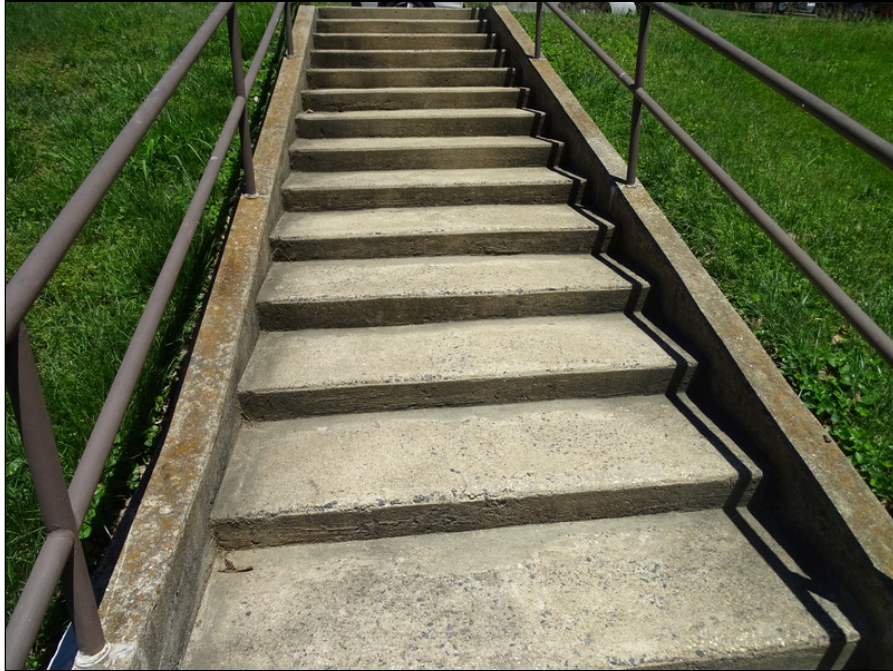
11 - Typical exterior stair

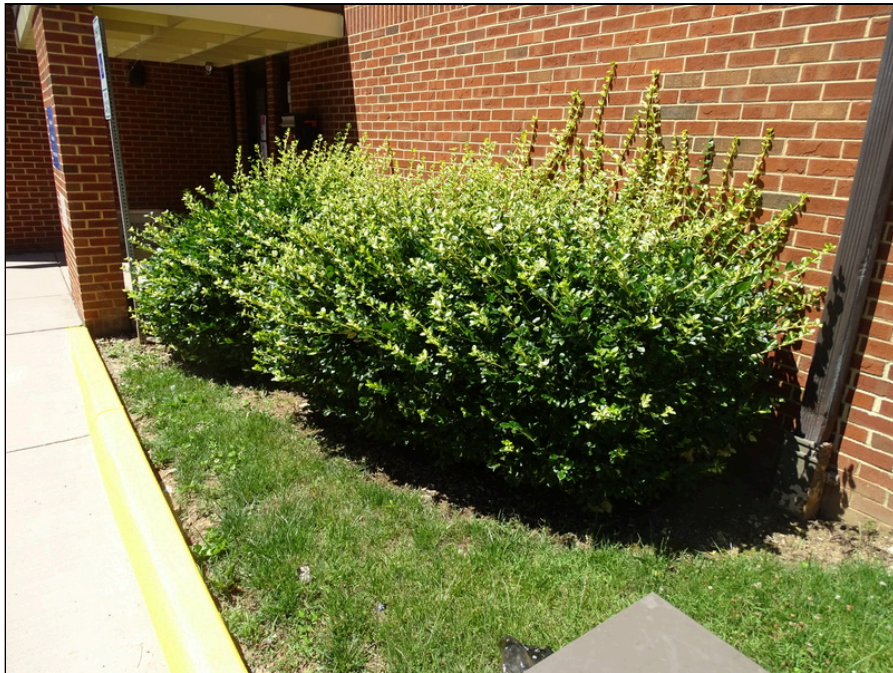
12 - Typical landscape

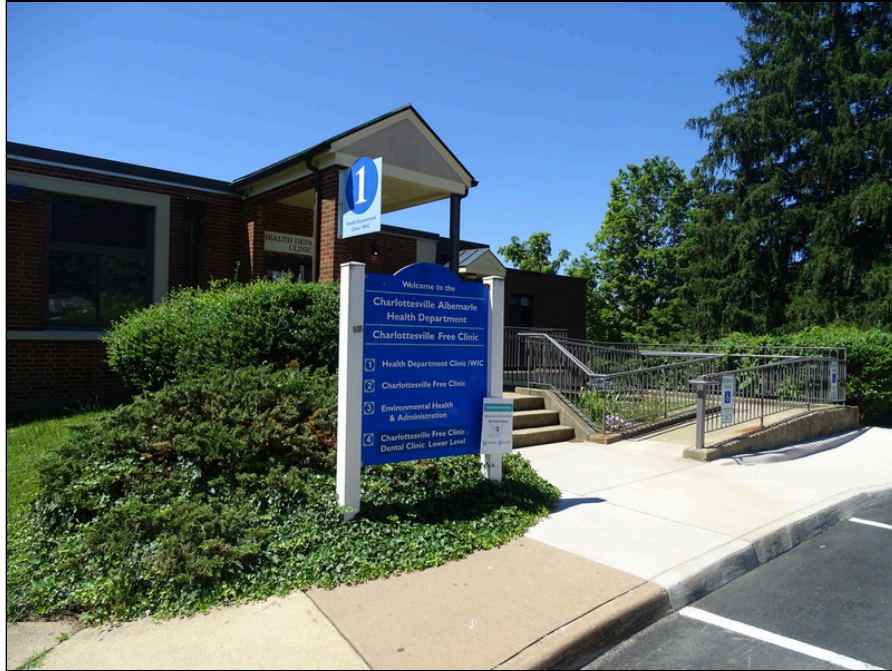
13 - Monument sign

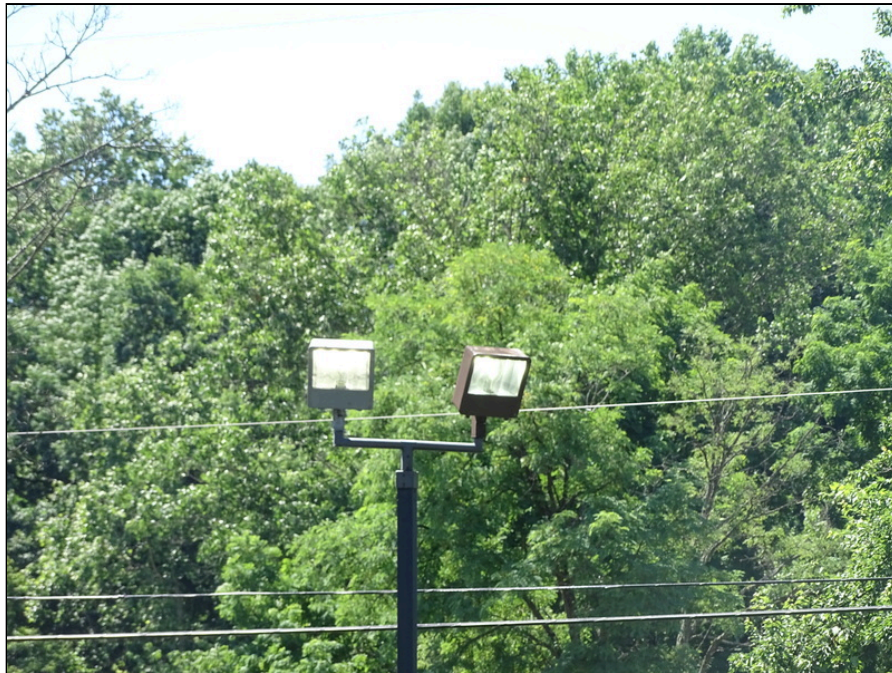
14 - Typical pole mounted lighting

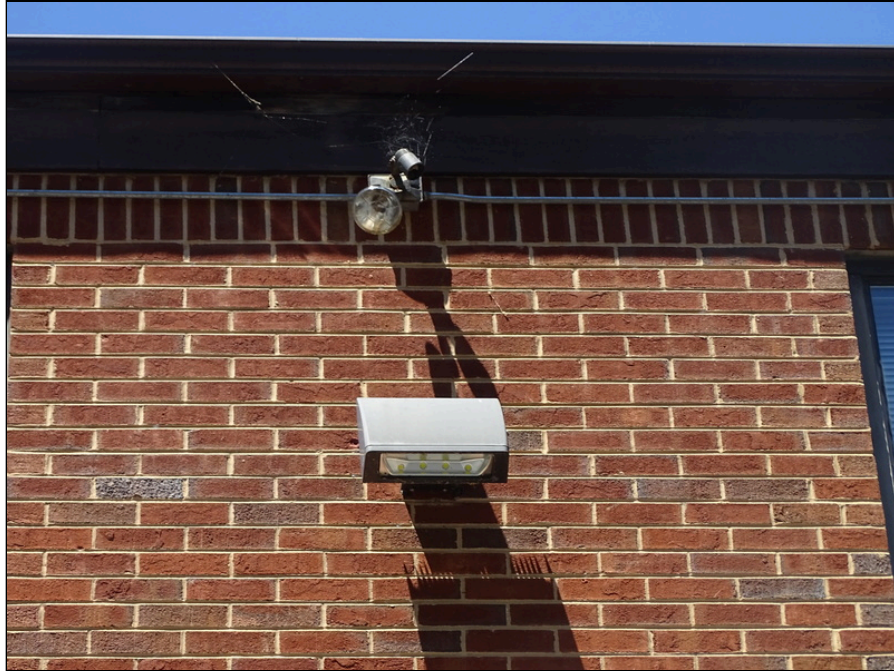
15 - Typical Building mounted

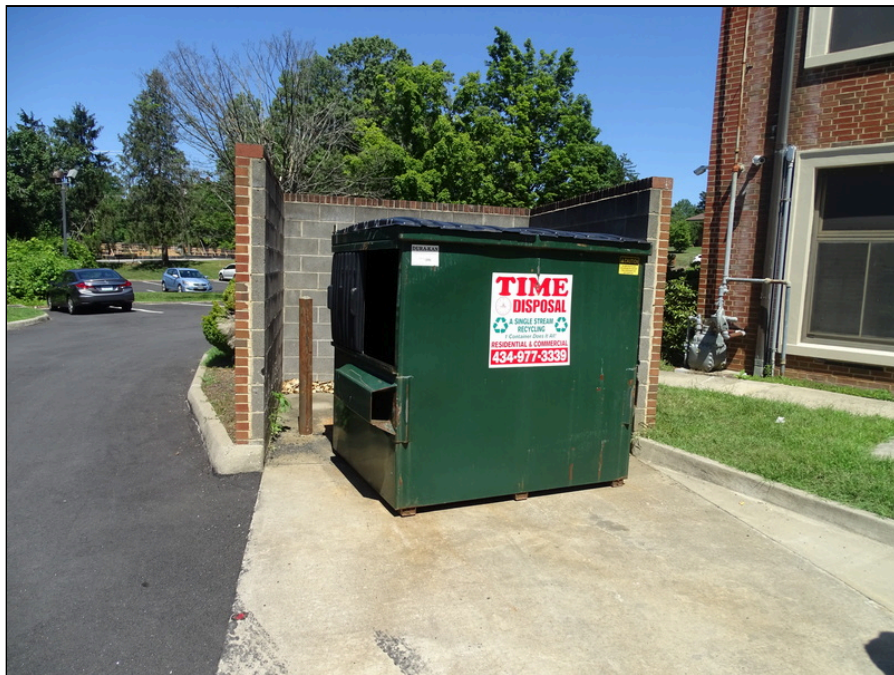
16 - Dumpster area

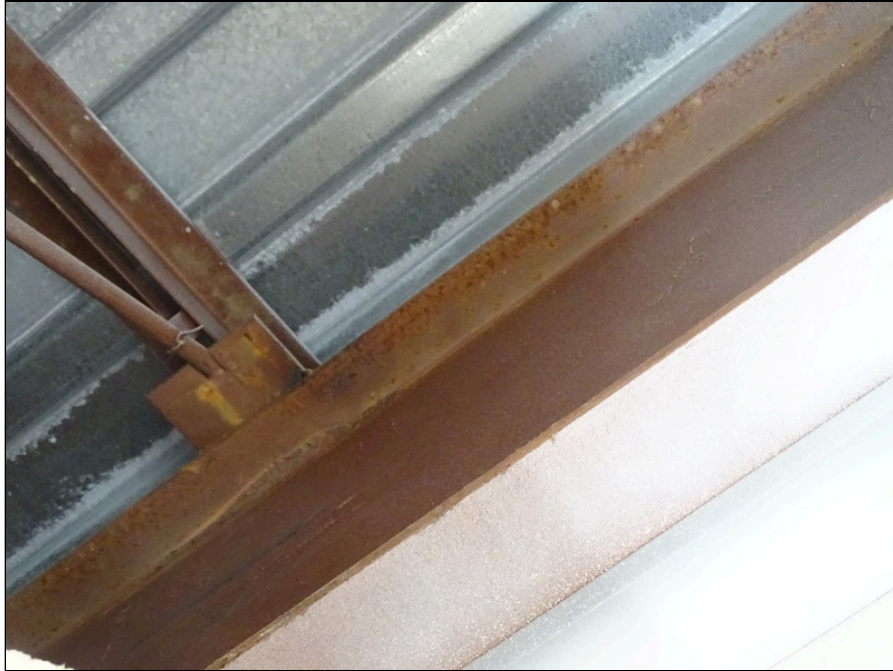
17 - Structural framing

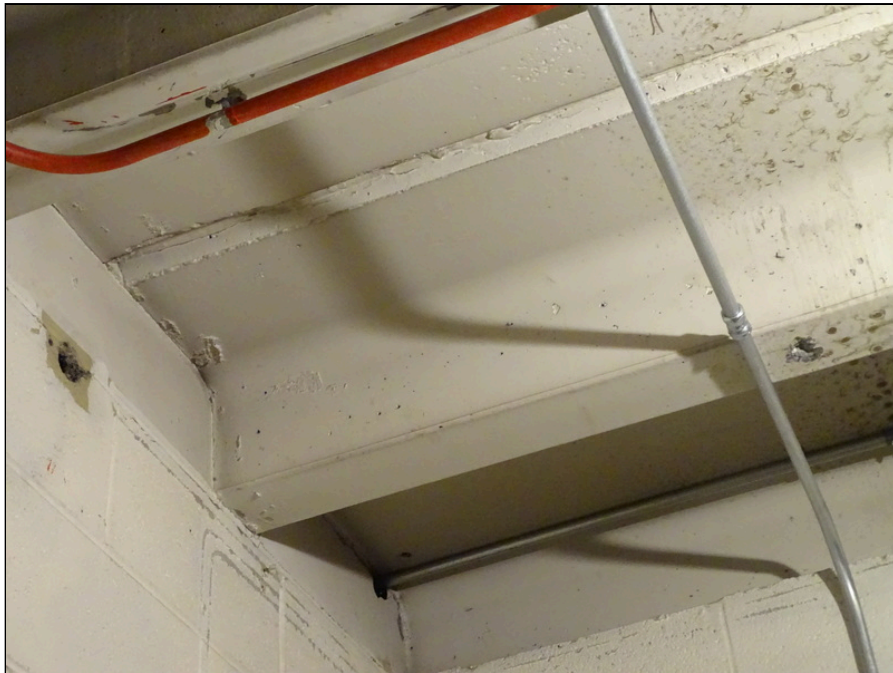
18 - Structural framing

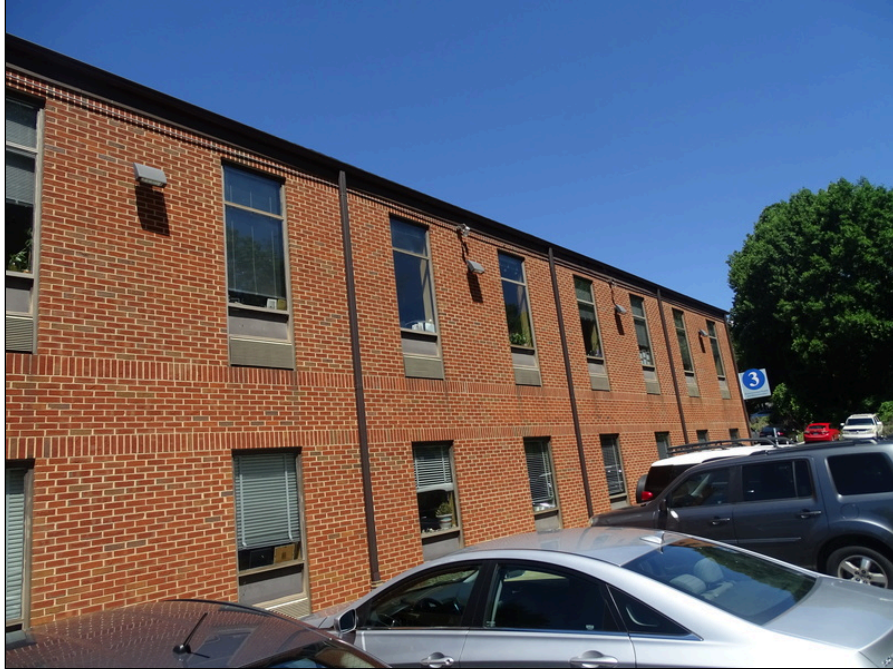
19 - Exterior wall finishes

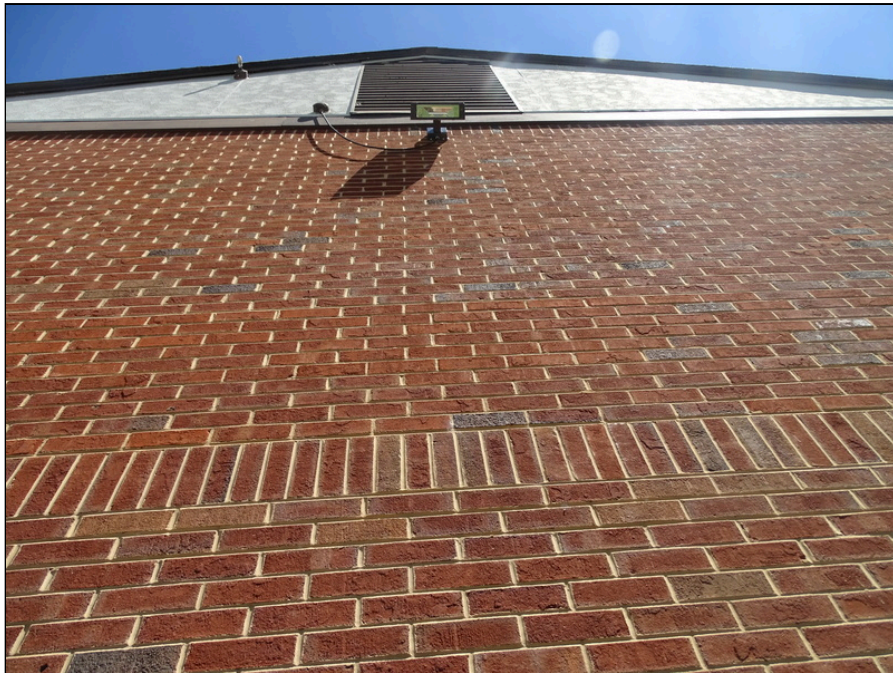
20 - Exterior wall finishes

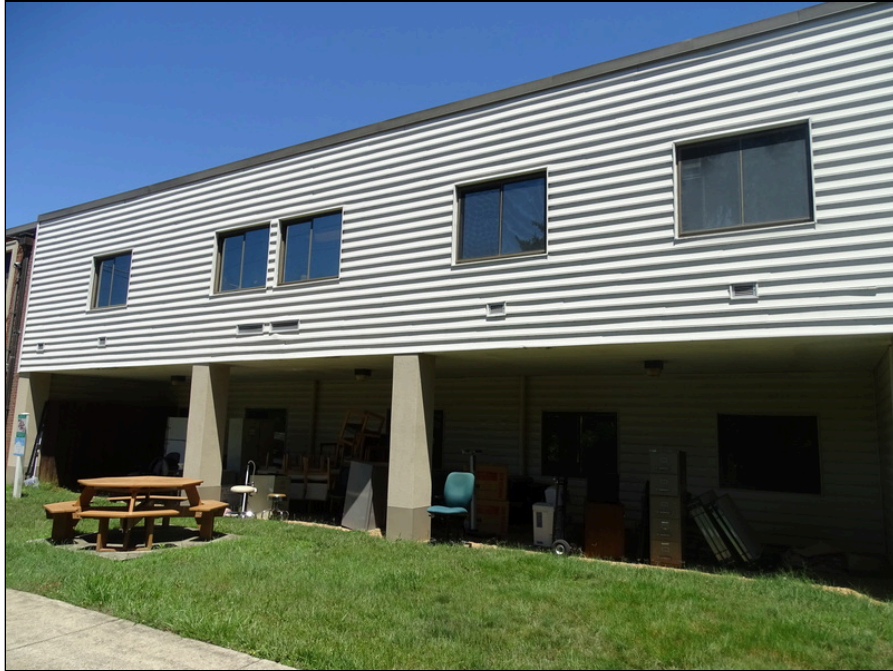
21 - Exterior wall finishes

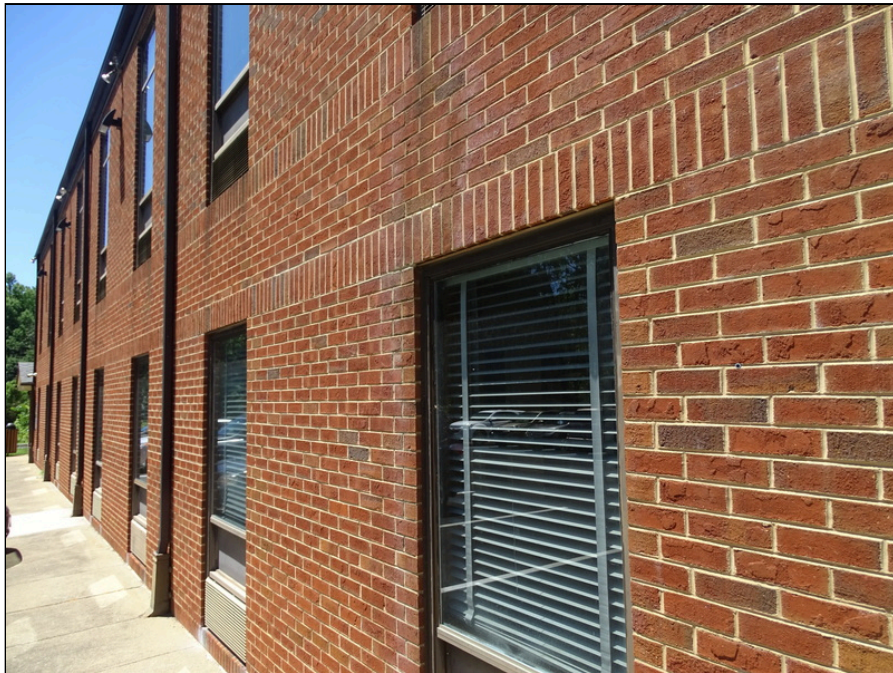
22 - Exterior wall finishes
