HEALTH DEPARTMENT  
1138 ROSE HILL DRIVE  
CHARLOTTESVILLE, VIRGINIA

OCTOBER 29, 2021

Reference: Facility Condition Assessment Report for Health Department, 1138 Rose Hill Drive,  
Charlottesville, Virginia

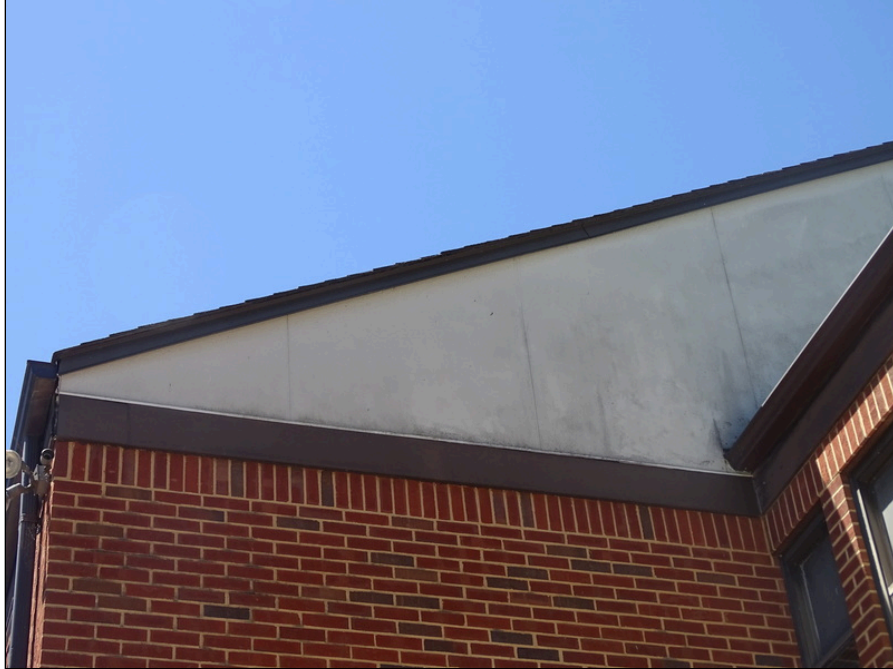
23 - Exterior wall finishes

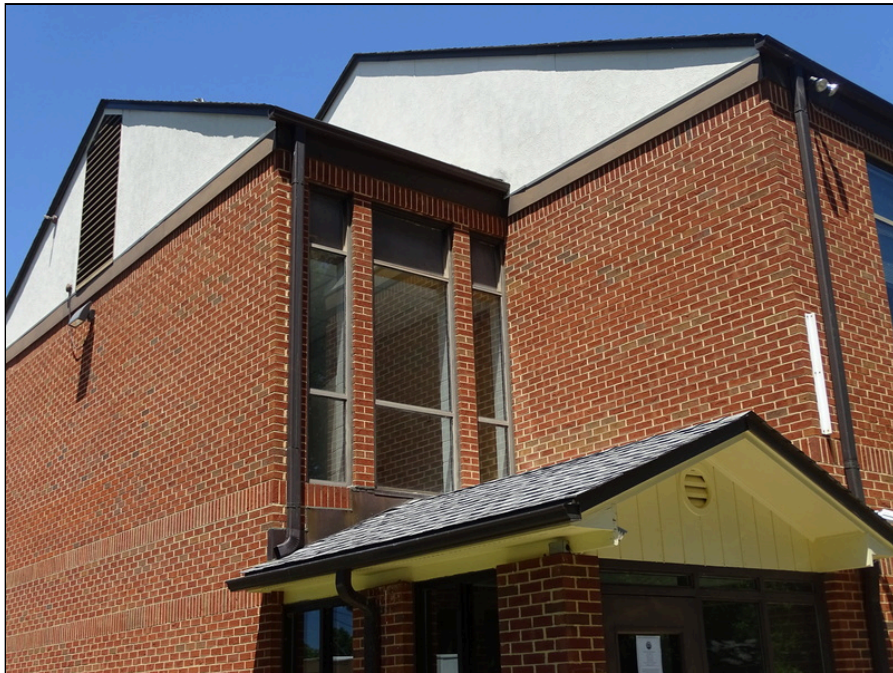
24 - Exterior wall finishes

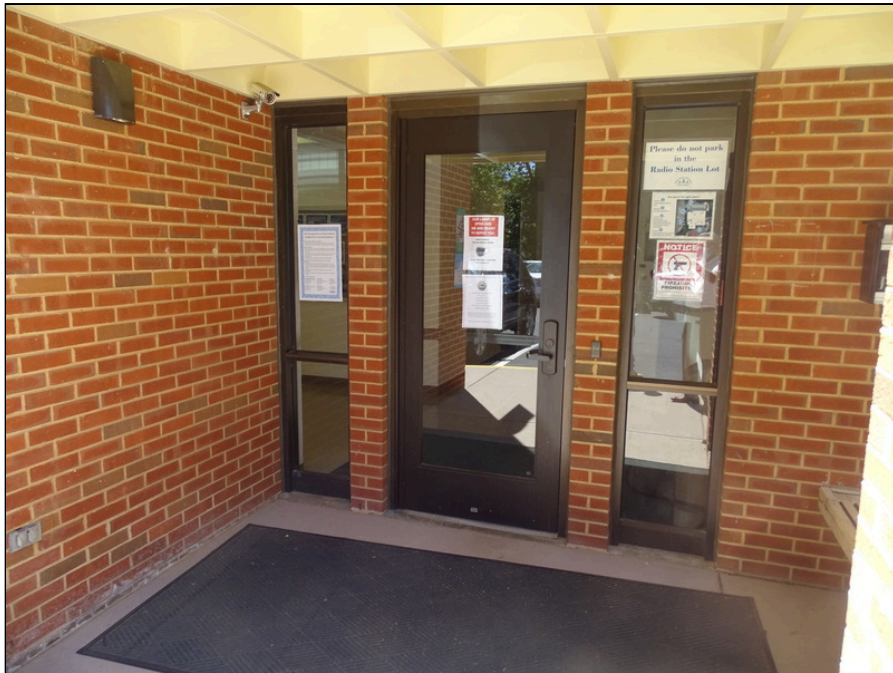
26 - Typical main entrance

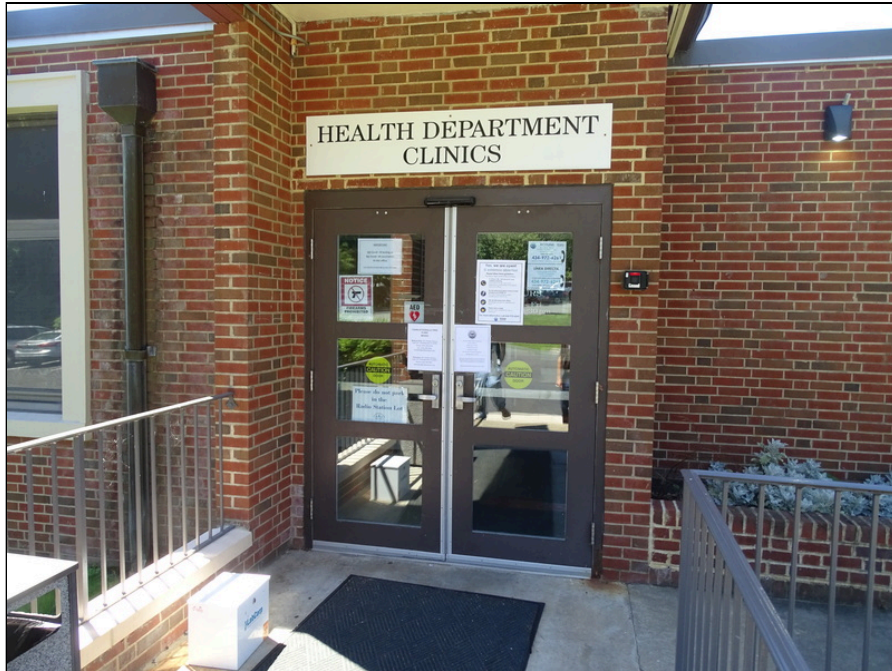
27 - Typical exterior door

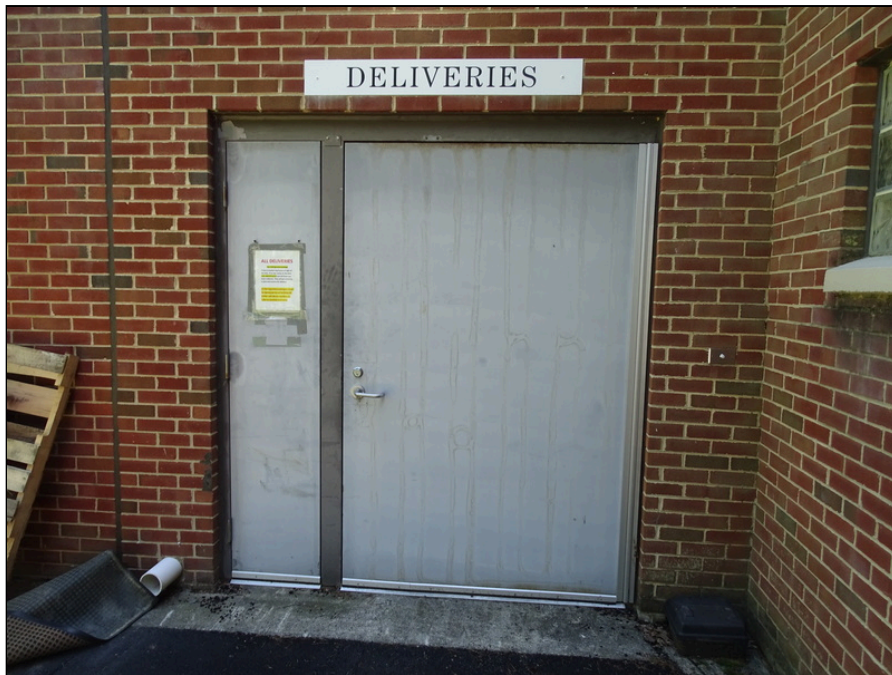
28 - Typical steel door

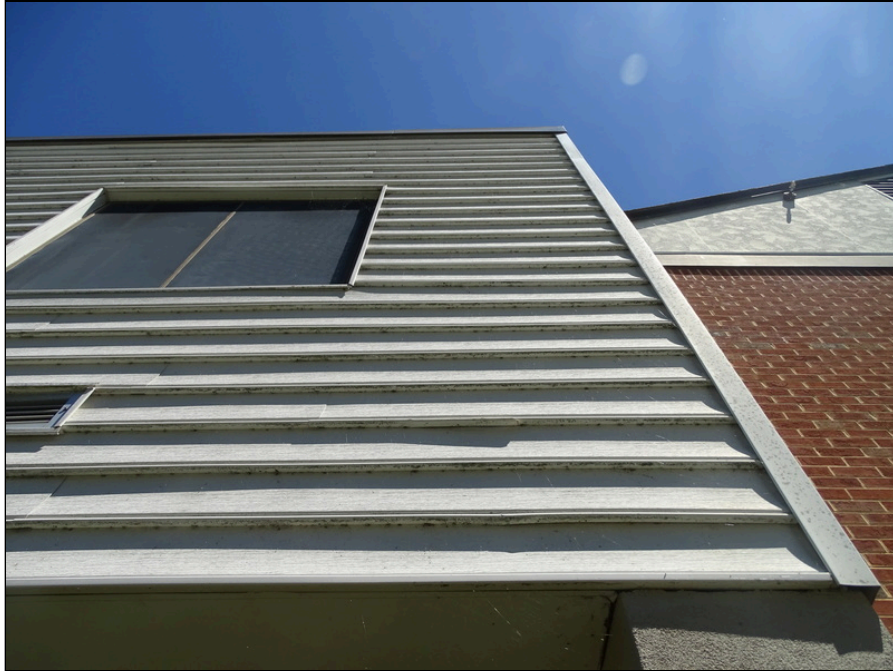
29 - Exterior wall wood siding

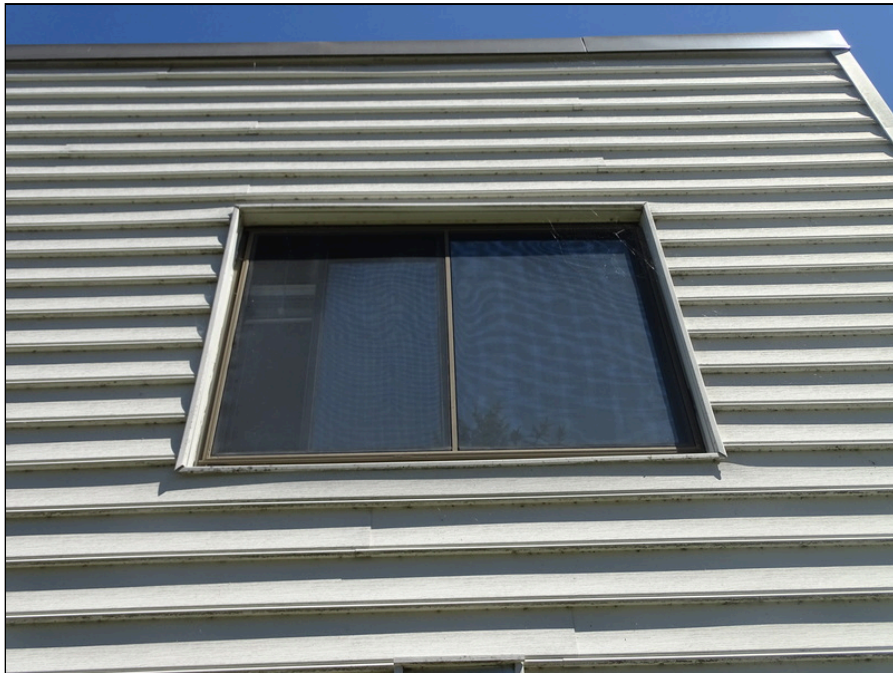
30 - Exterior window

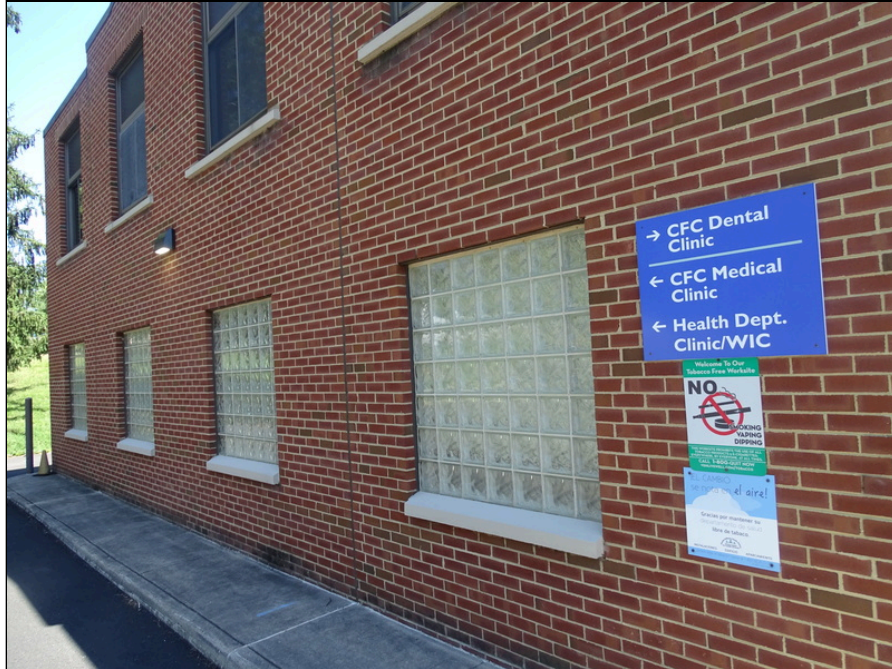
31 - Exterior window finishes

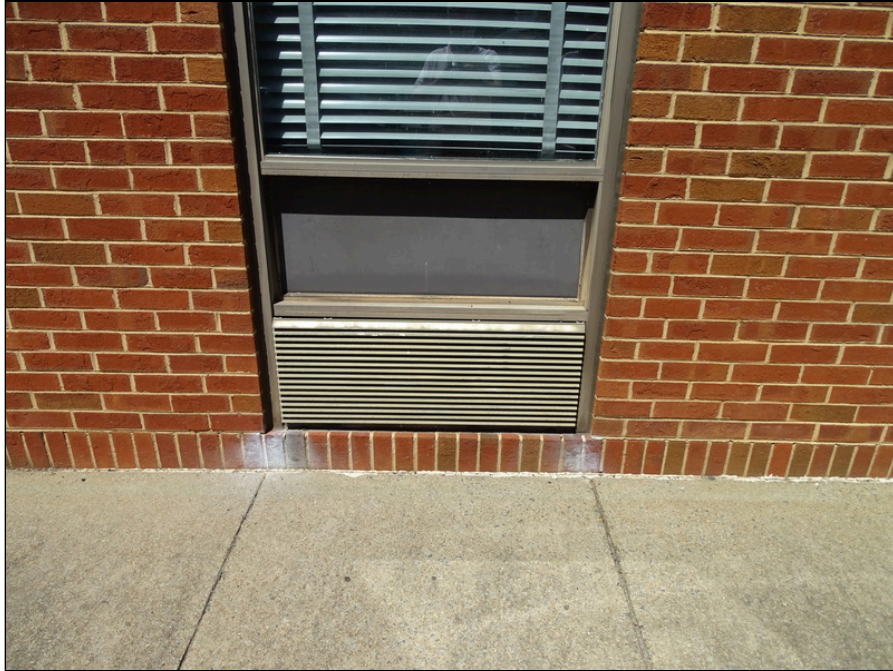
33 - Exterior window finishes

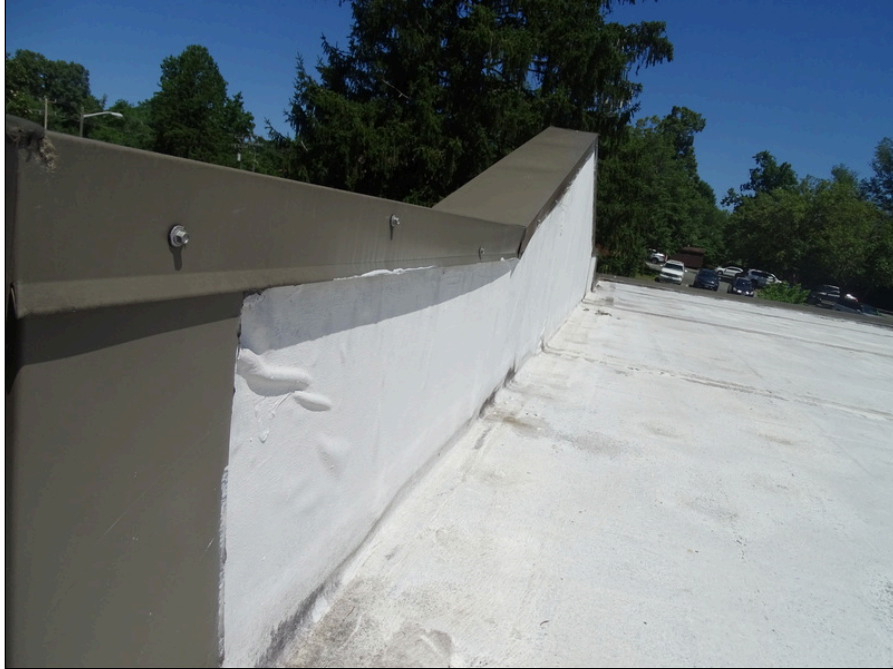
37 - Single-ply roofing system side of the building - note metal coping

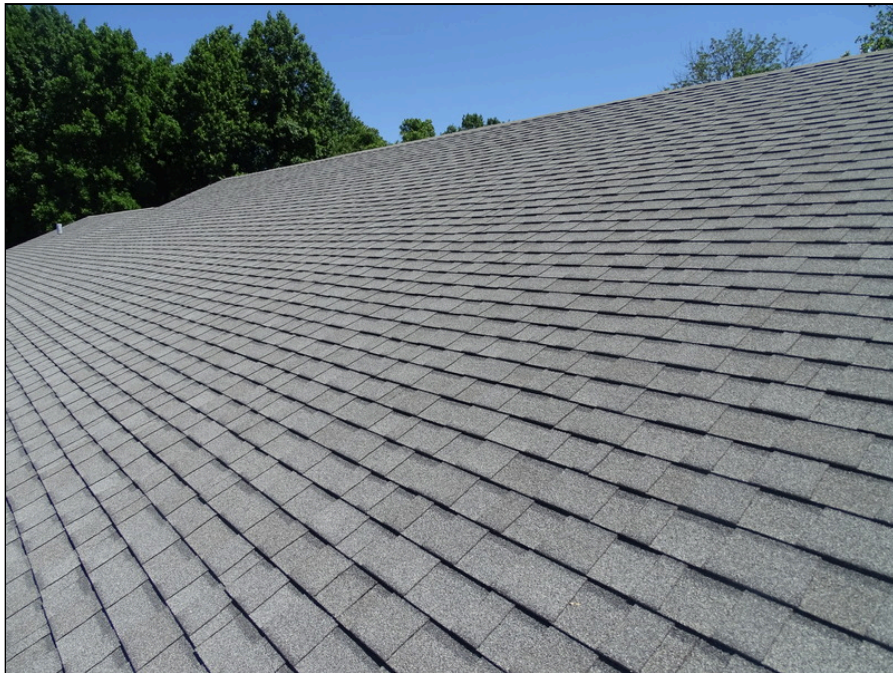
38 - Asphalt shingle roofing

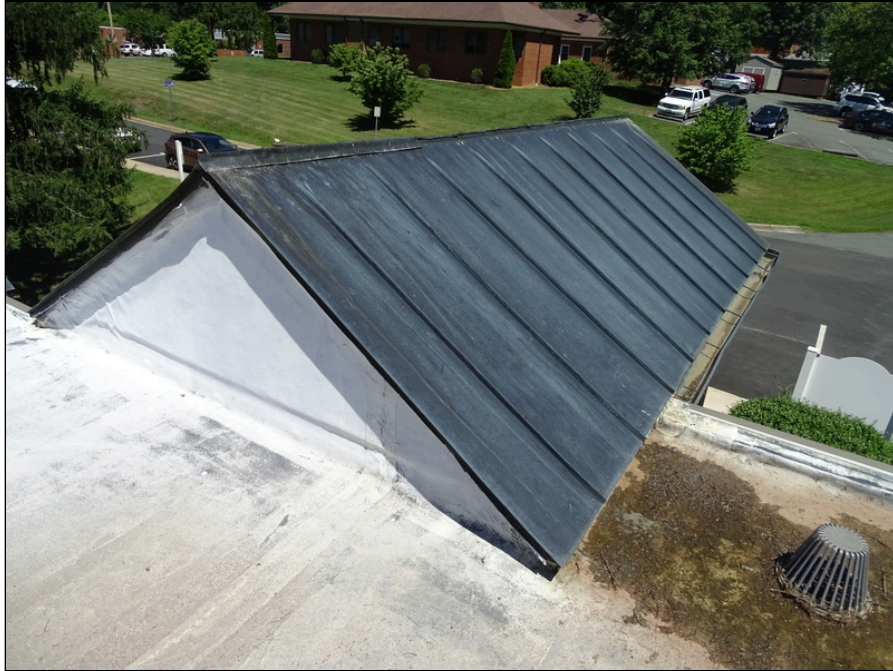
39 - Metal roofing system

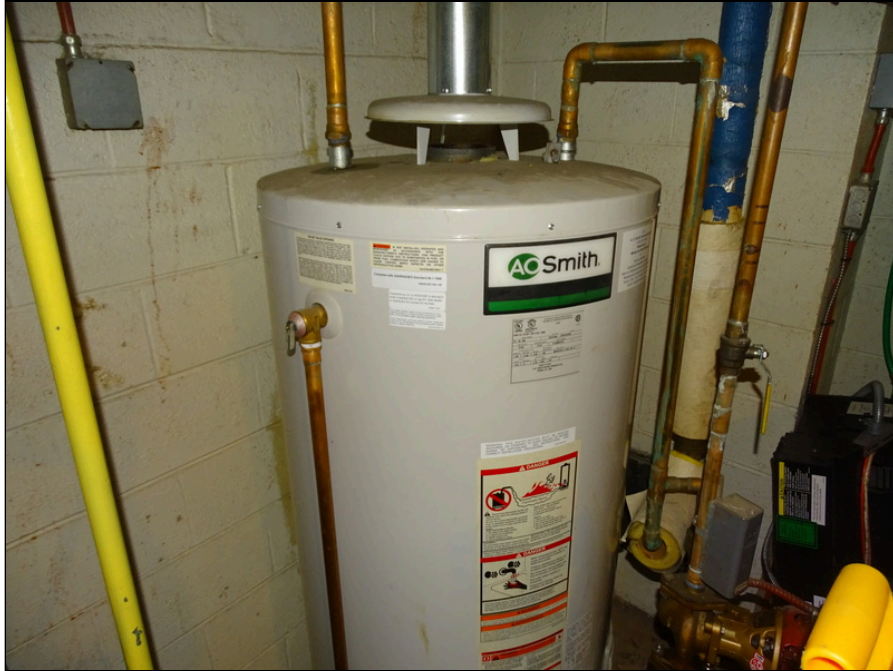
41 - Typical water heater

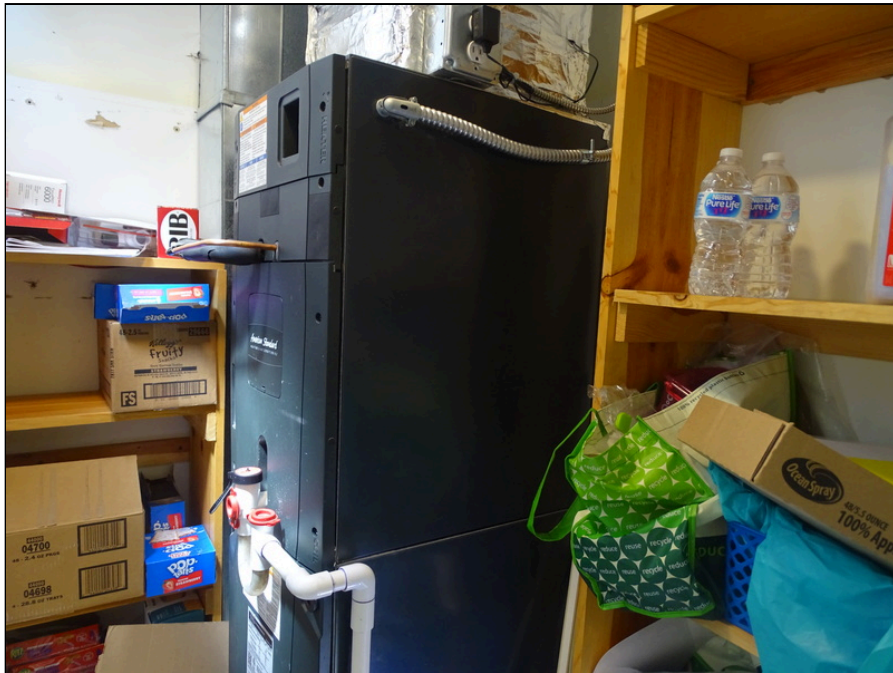
42 - Typical air handler

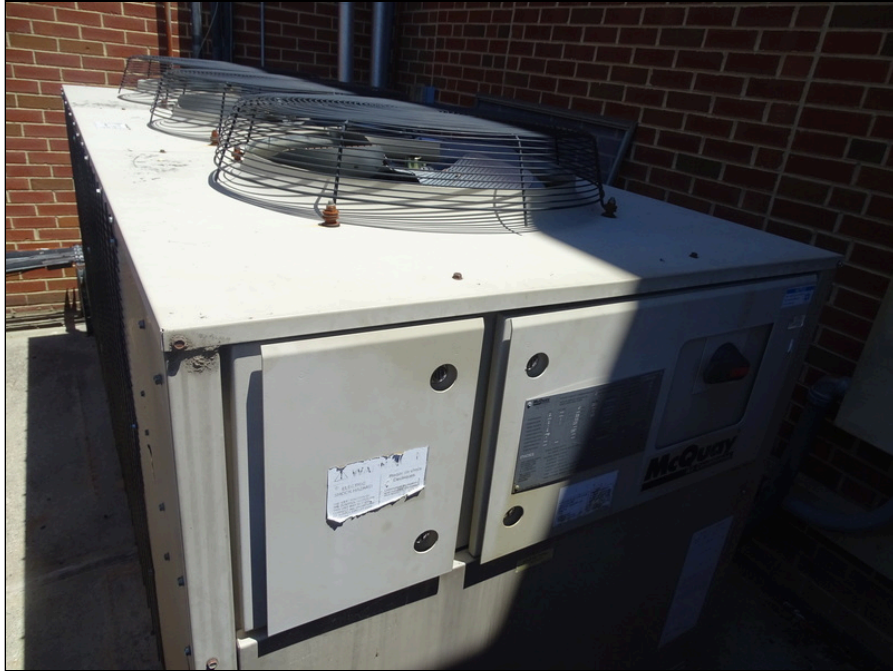
43 - Chillers system

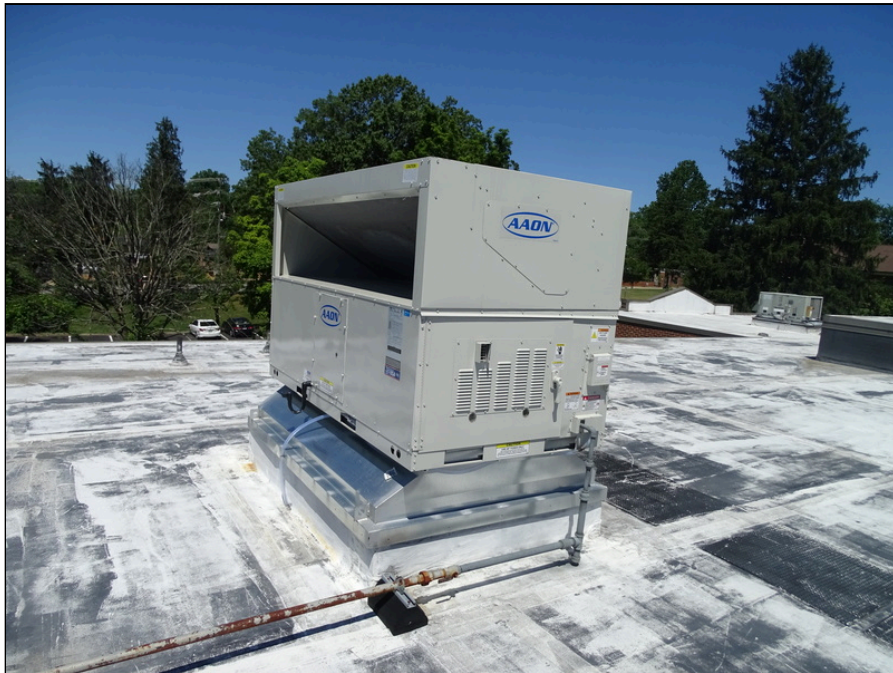
44 - Ventilation unit

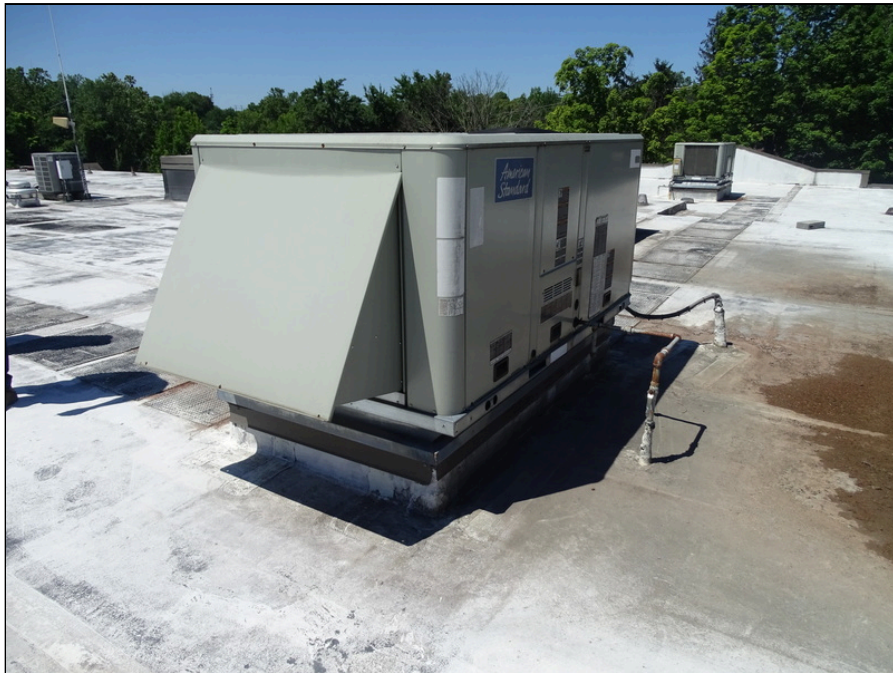
45 - HVAC unit

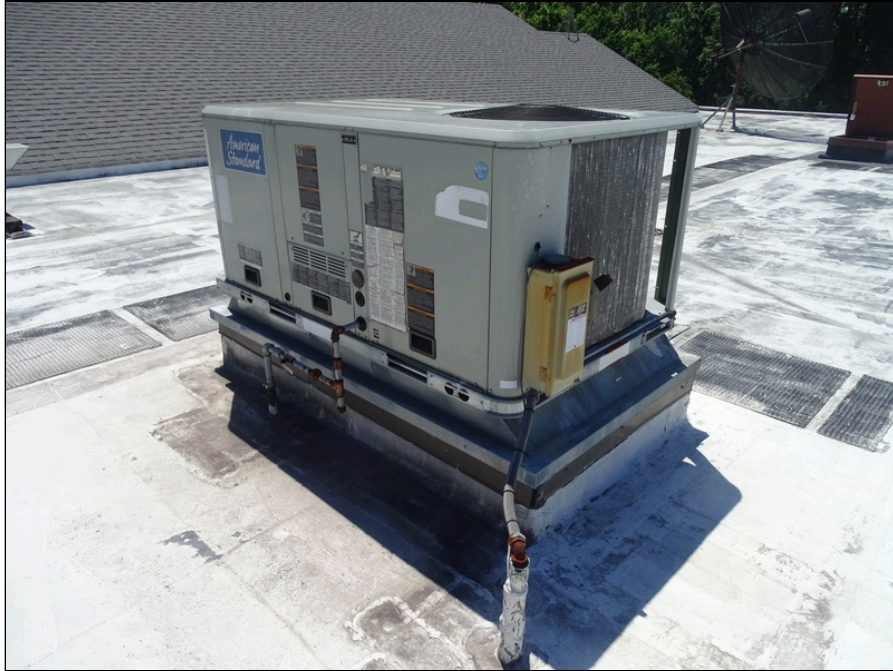
46 - HVAC system

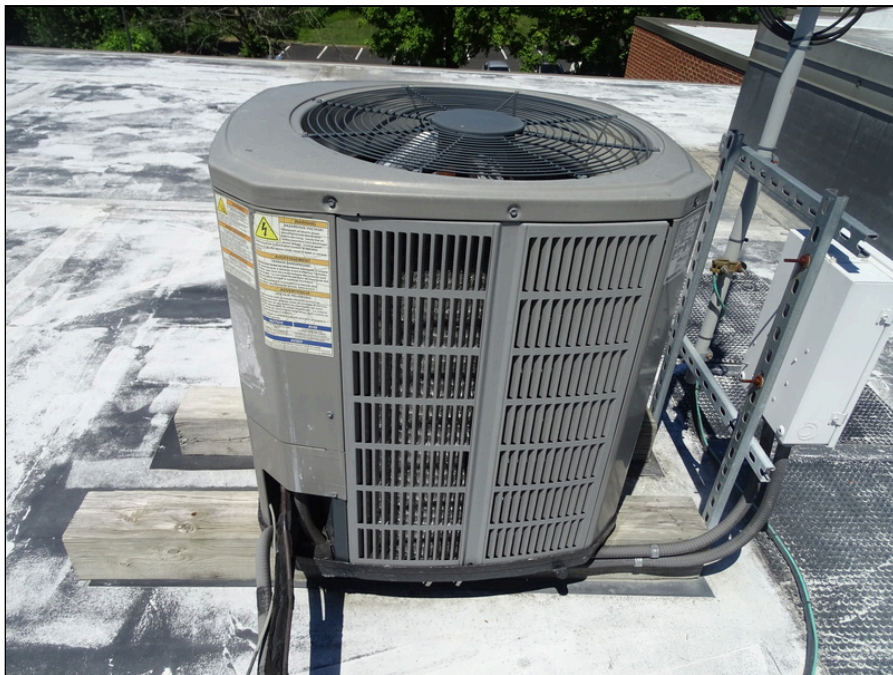
47 - HVAC system

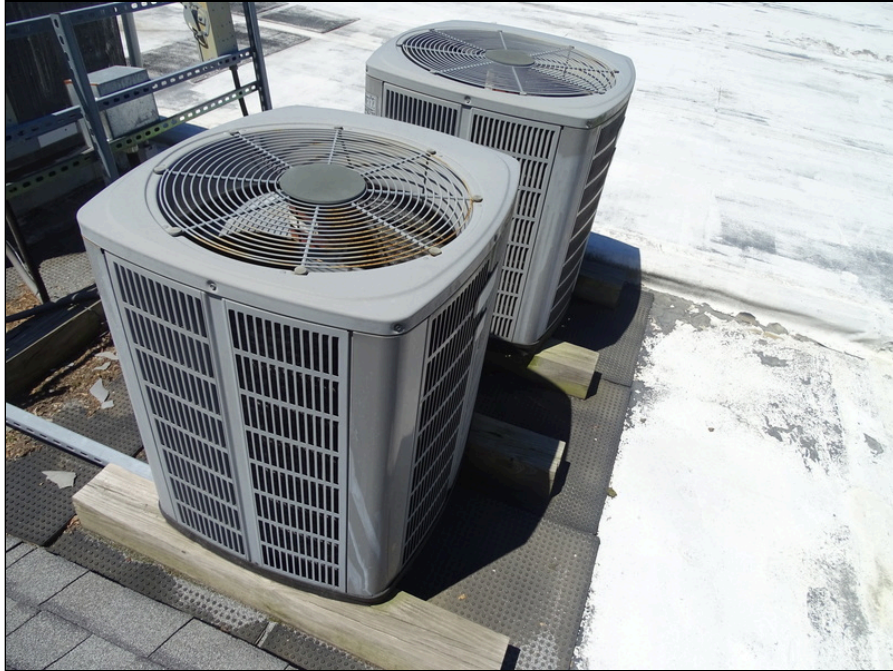
48 - Condenser

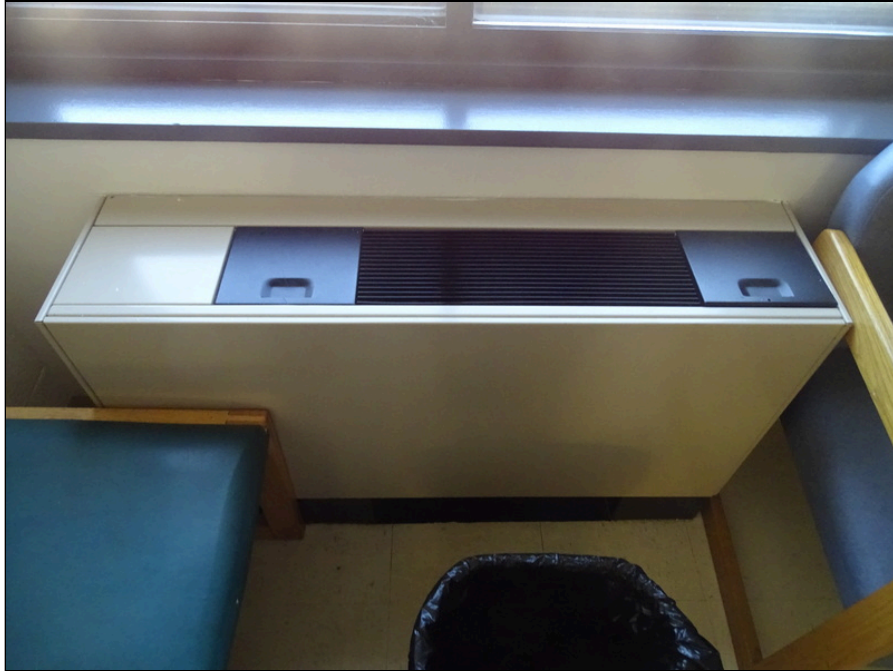
50 - Typical air handler

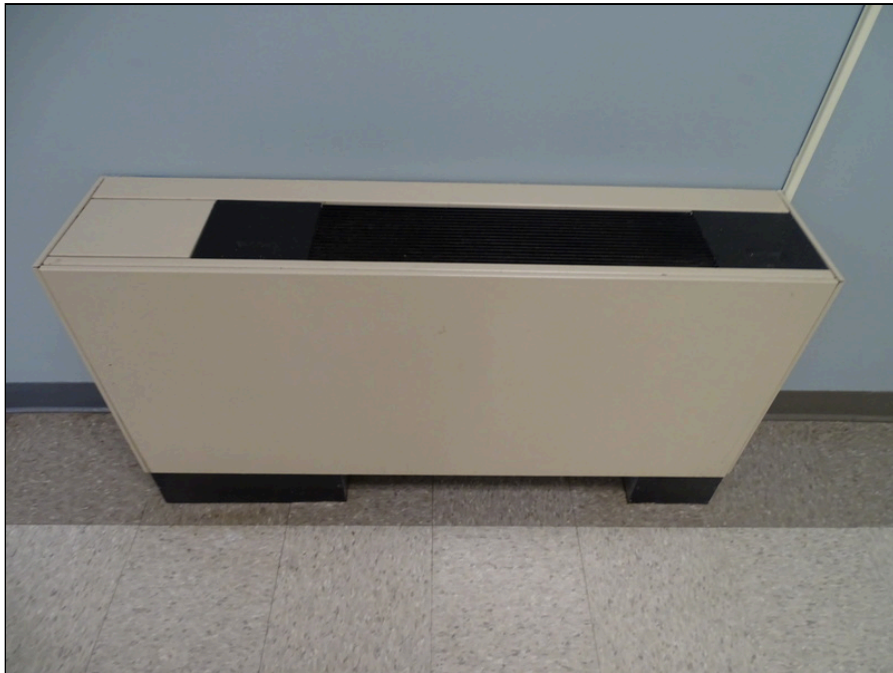
51 - Typical Water Source Heat Pump

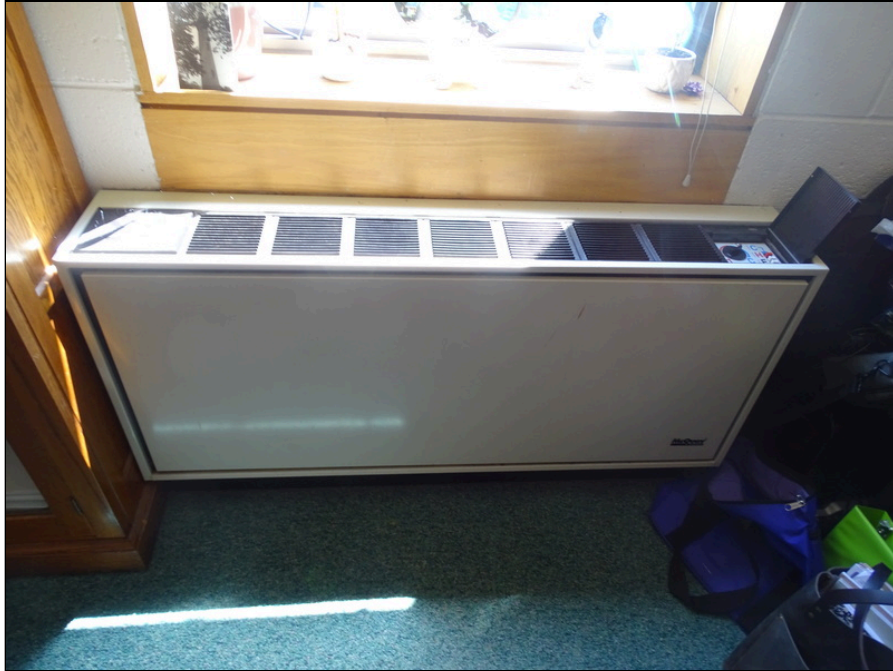
52 - Typical Water Source Heat Pump

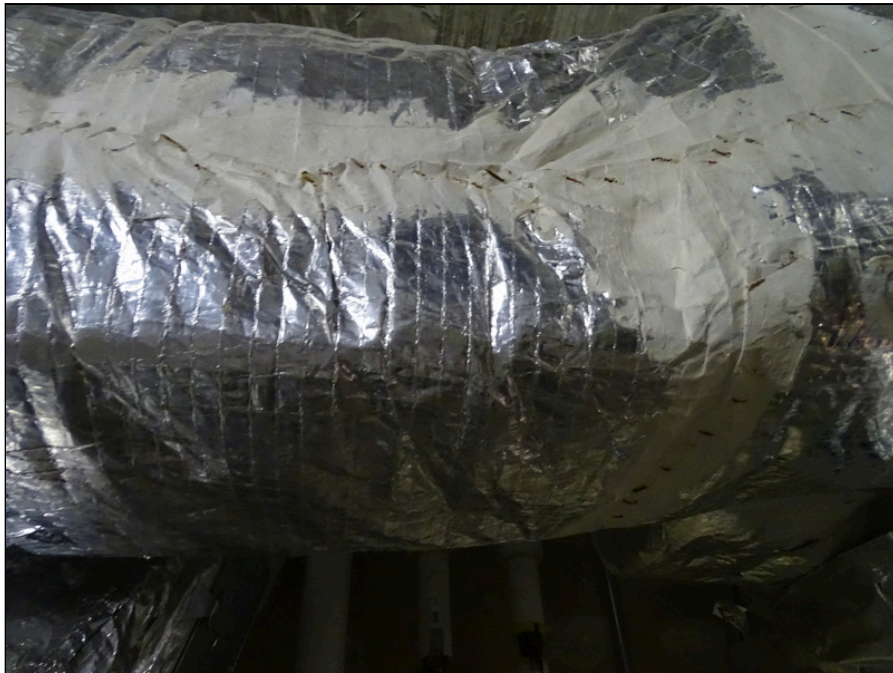
55 - Mechanical duct

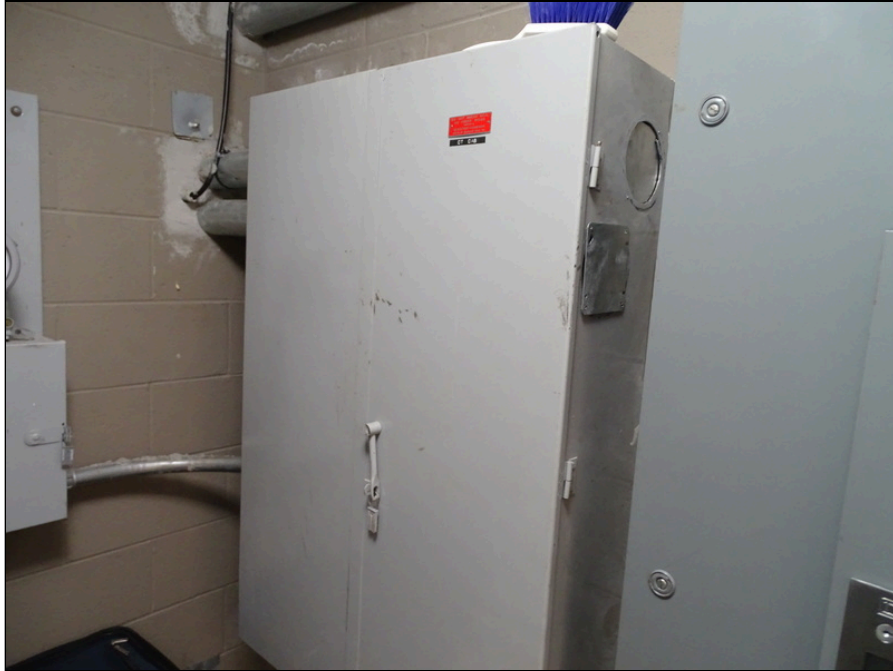
60 - Electrical entrance

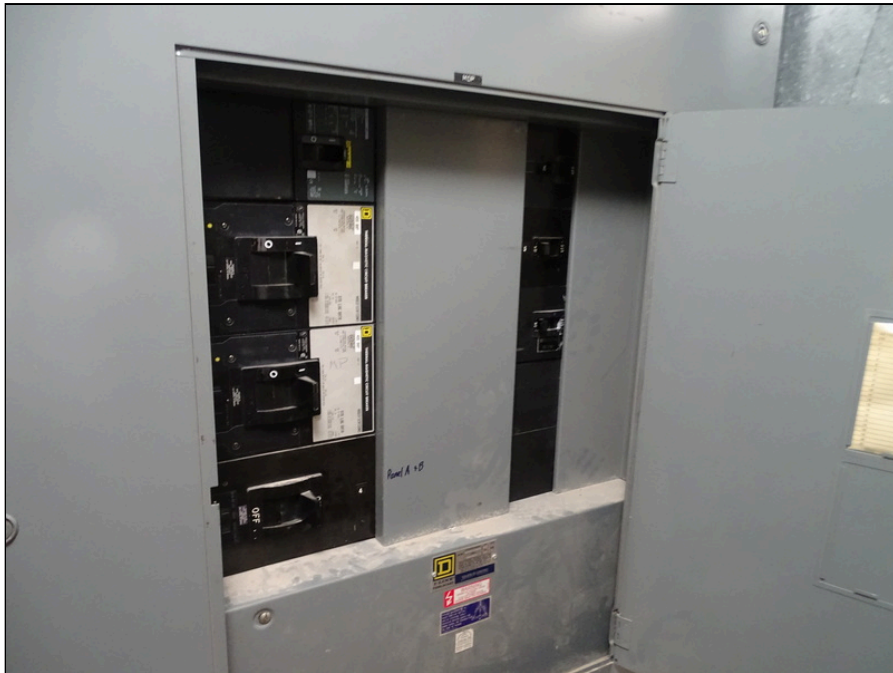
61 - Typical electrical circuit breaker panel

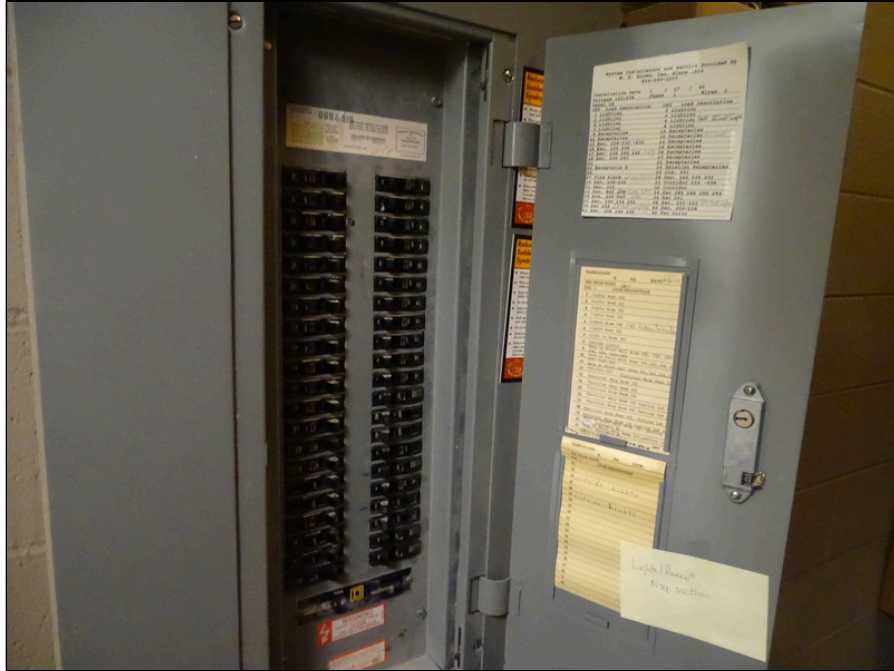
62 - Main electrical switchgear

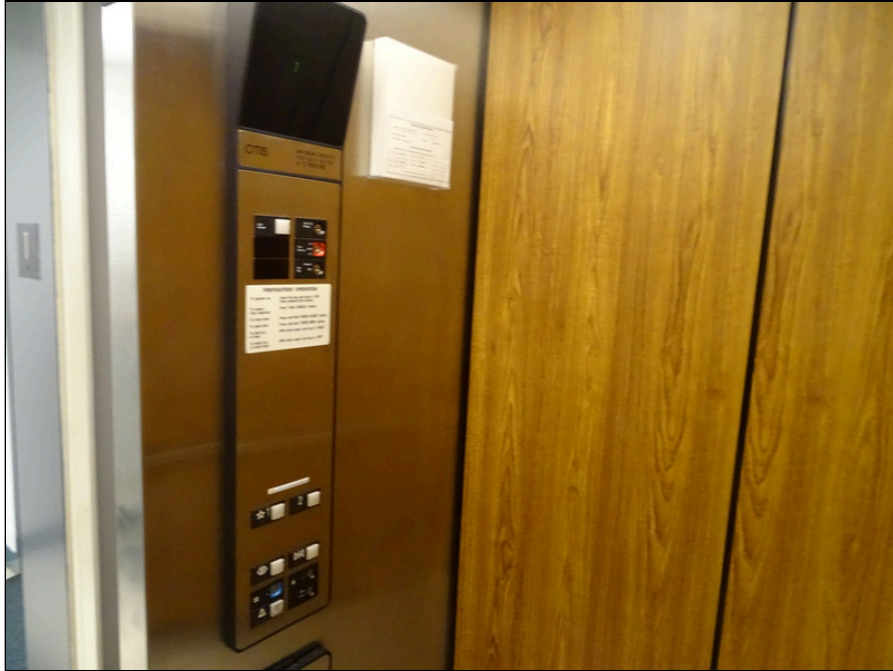
64 - Elevator

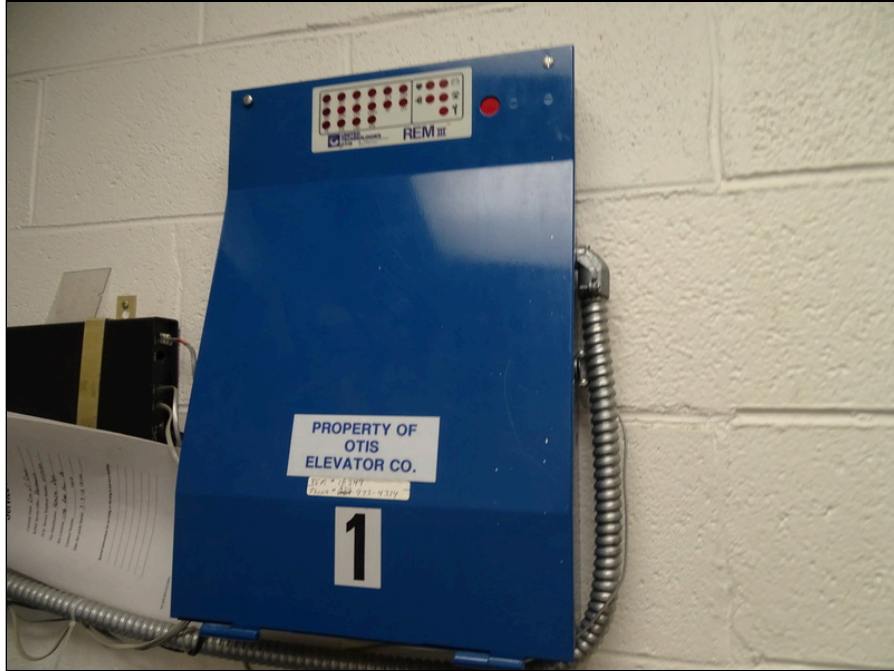
66 - Elevator machine

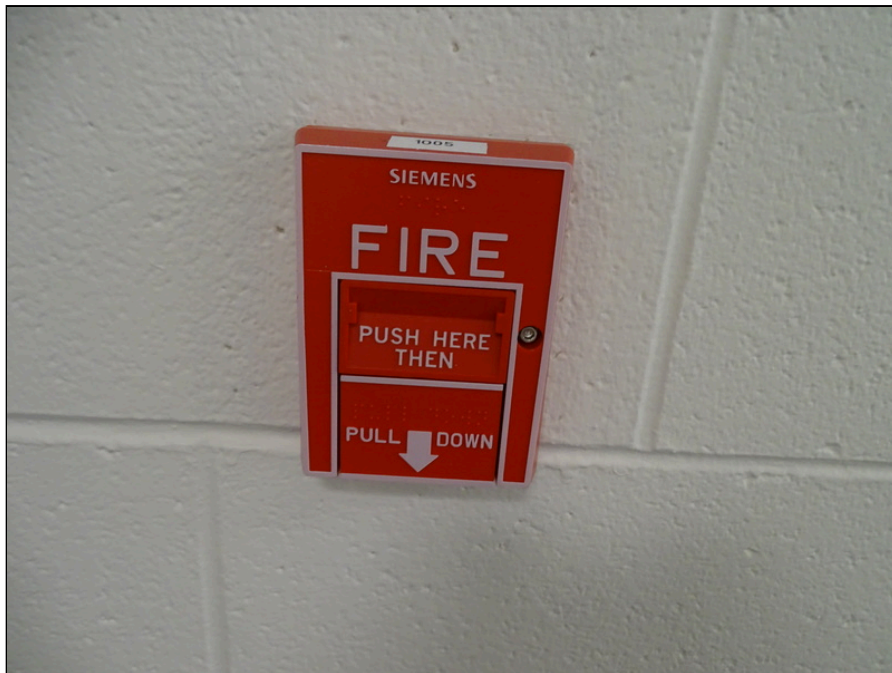
71 - Typical fire alarm

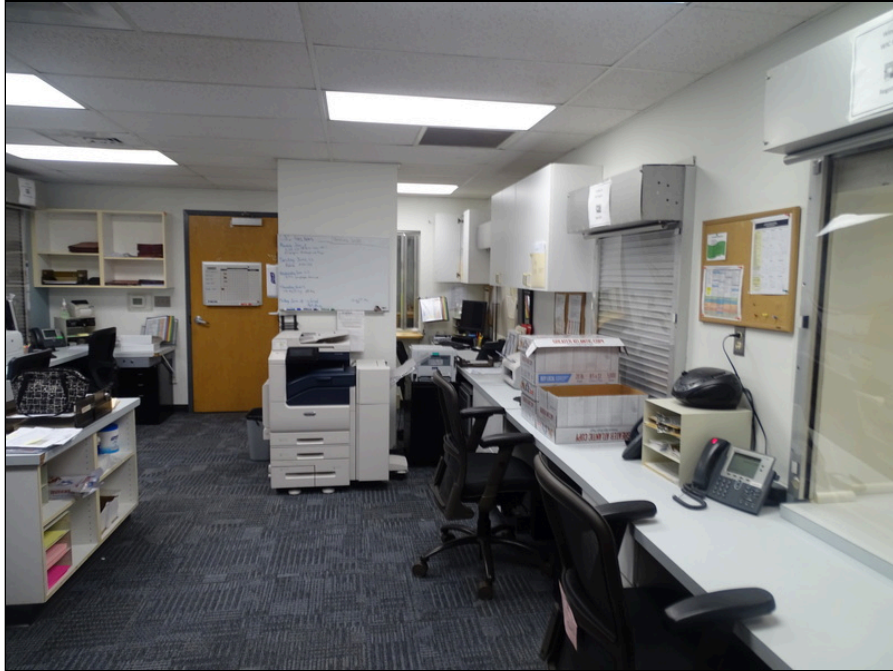
78 - Interior finishes office area

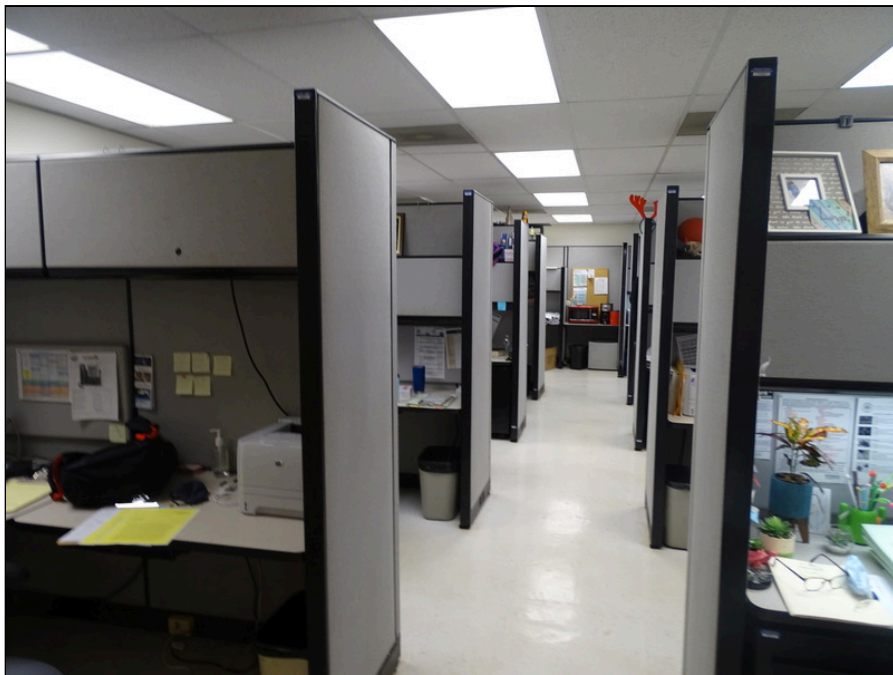
79 - Interior finishes office area

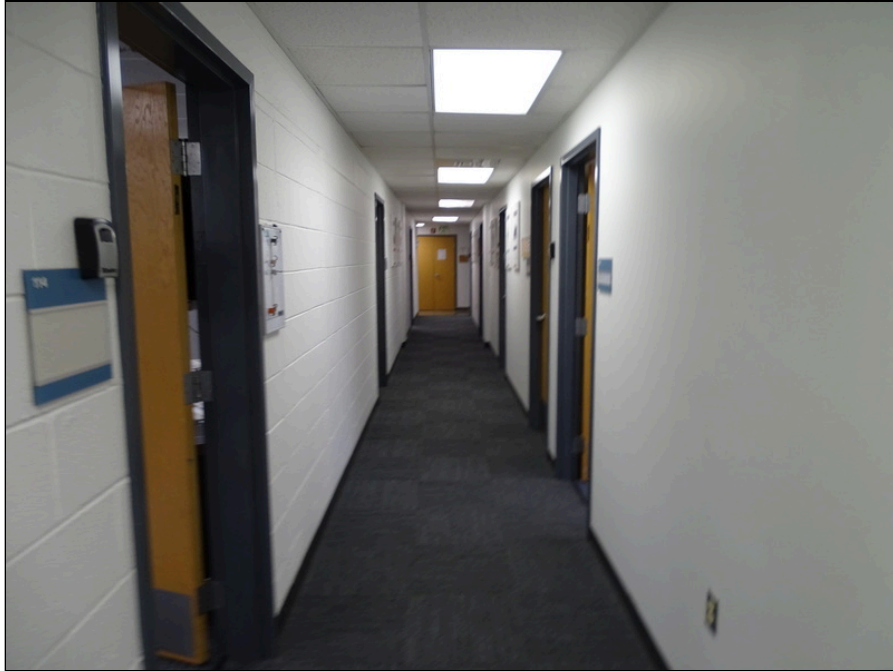
80 - Interior finishes office area

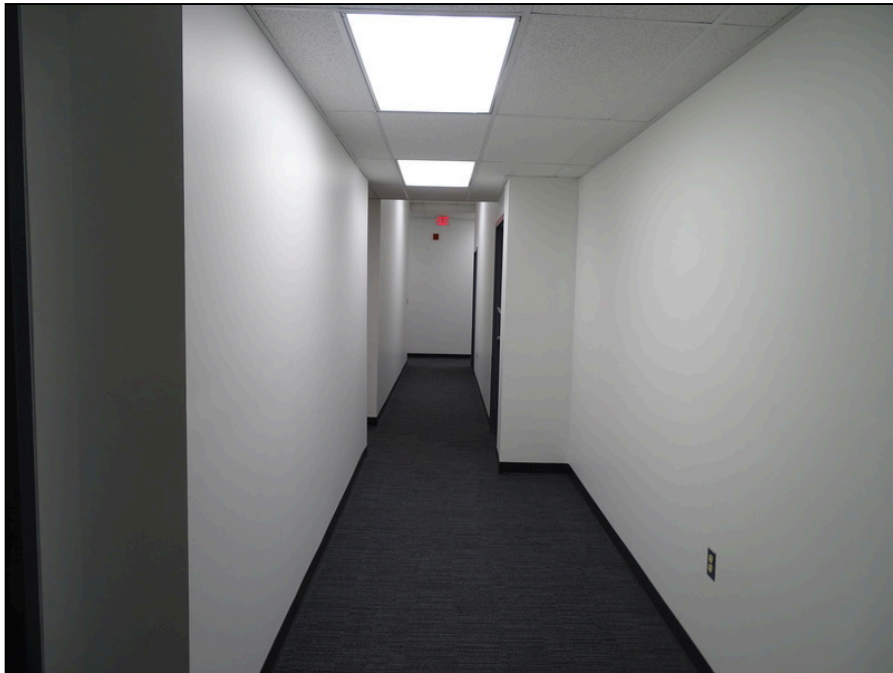
81 - Interior finishes corridor area

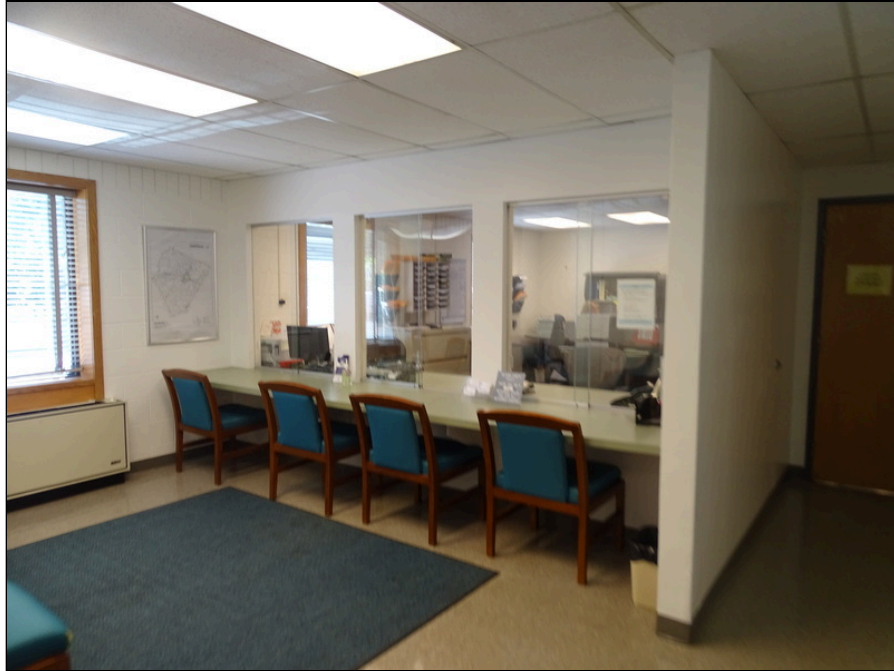
82 - Interior finishes corridor area

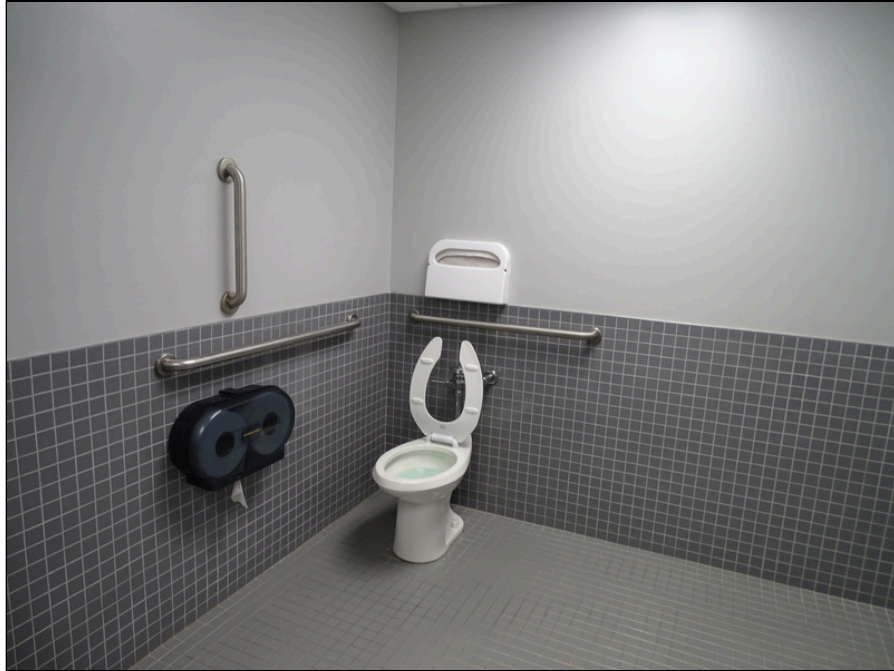
84 - Interior finishes restroom area

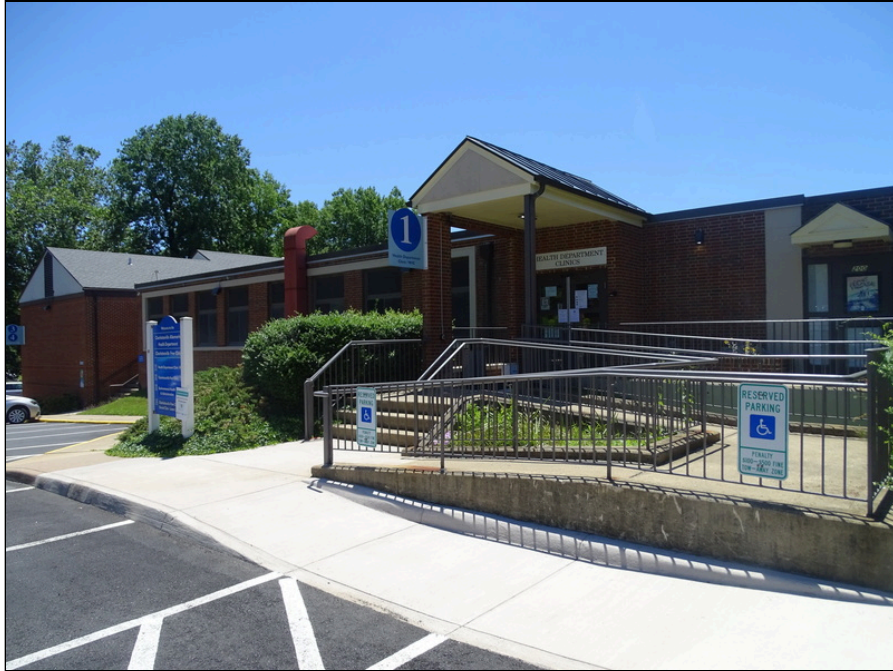
88 - Accessible ramp

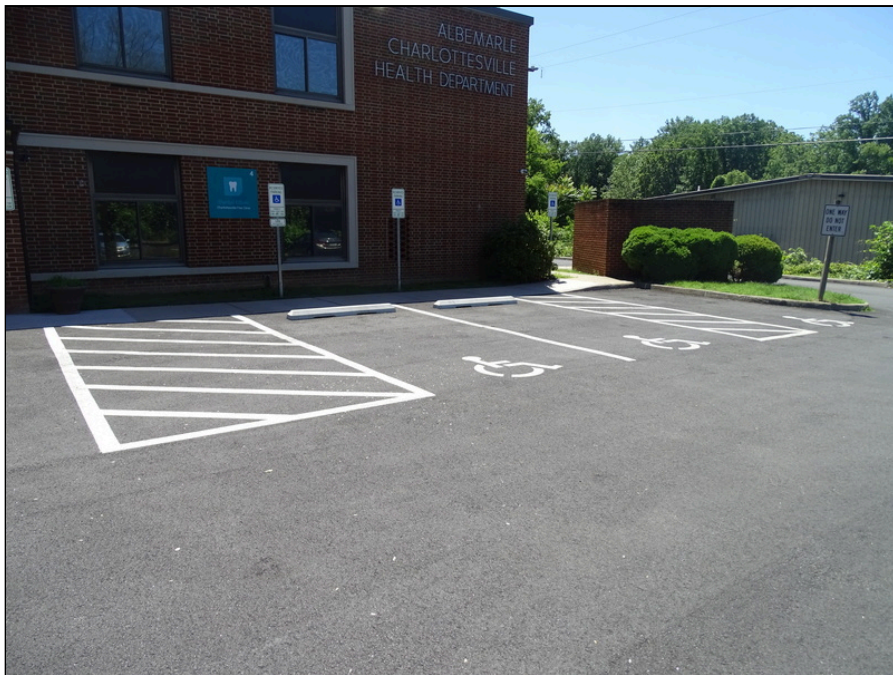
89 - Accessible ramp
