ATTENTION HOME
414 4TH STREET NE
CHARLOTTESVILLE, VIRGINIA

ECS PROJECT NO. 46:6713

CITY OF CHARLOTTESVILLE - FACILITIES DEVELOPMENT

Reference: Facility Condition Assessment Report for Attention Home, 414 4TH Street NE,
Charlottesville, Virginia

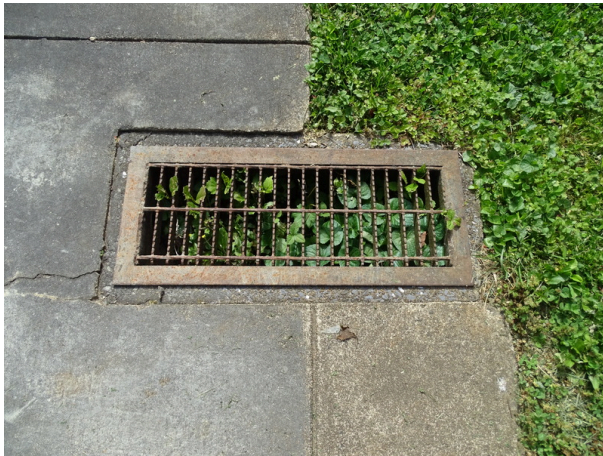
The storm water collection system includes a municipal system. The storm drainage connection from downspouts at some locations were damaged and vegetation was observed growing in the yard inlet. We recommend repairing damaged areas and removing vegetation as a maintenance item as needed.

Typical yard drop inlet

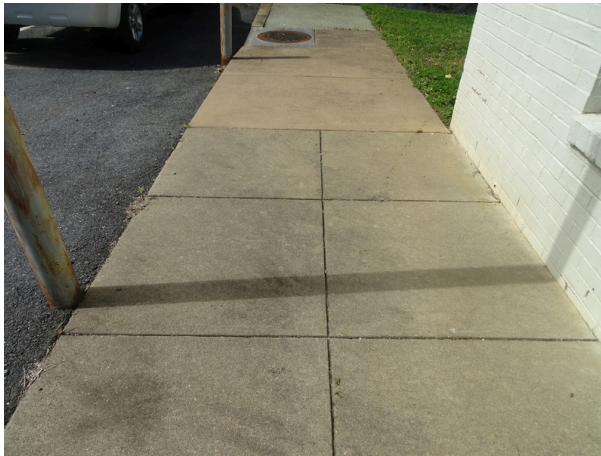
At the west and east sides of the building, Concrete sidewalks of undetermined thickness are provided. Regularly spaced control joints were observed. The Concrete sidewalks were generally in good condition. The steps and ramps were observed to be in generally good condition. The handrails adjacent to the steps and ramps were observed to be in generally good condition. There is a concrete patio on the south side of the building. The patio was generally in good condition.

Typical concrete sidewalk

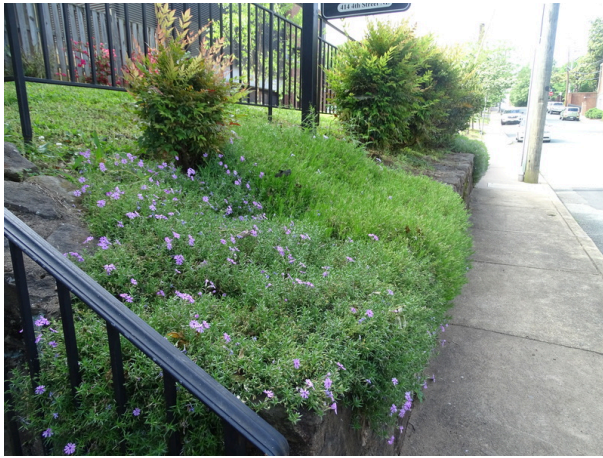
The landscaping consists generally of mature trees, and small shrubs and grassed areas around the site. The landscaping was observed to be in generally good condition. Trash containers are located at the east side of the site, but should be removed from the accessible aisle. The area consists of a asphalt and was generally in good condition. There is a stone and mortar retaining wall at the west end of the site. The retaining wall was generally in fair condition with deterioration of the mortar observed. We recommend an allowance during the report period to repair the retaining wall deterioration. A metal fence is located on the west side of the site and a wood fence is locate on the south side of the site. The fences were generally in good condition.

Typical landscaping

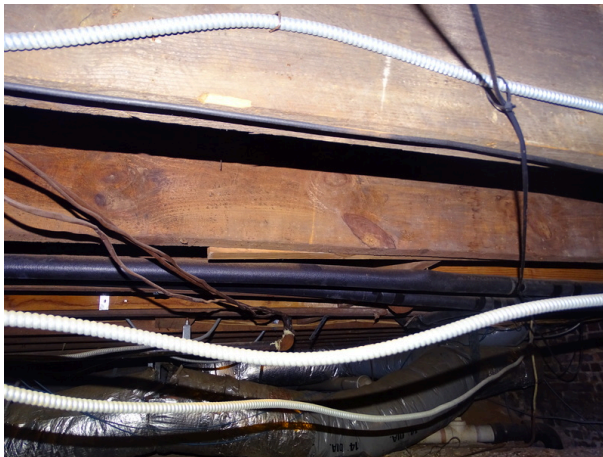
The structure of the building consists of Wood framing with brick masonry bearing exterior walls with brick masonry columns. The structural frame of the building was generally in good condition with reported repairs to basement stairs during our 2016 visit.

Typical structural framing

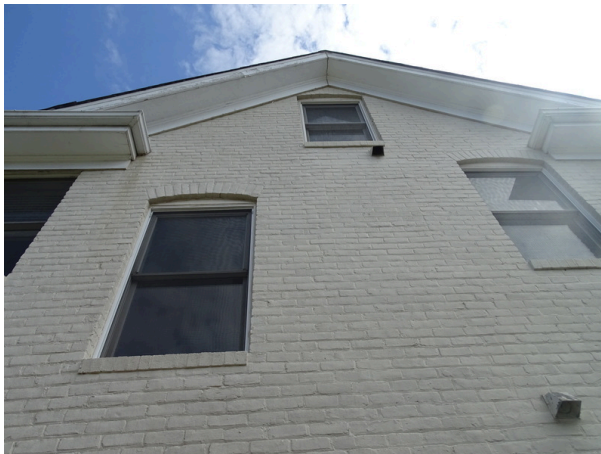
The wood trim and wood covered soffits are painted. The paint was generally in good to fair condition with some peeling and wood trim deterioration observed. Painting of exterior components is typically recommended every 5 to 7 years. We recommend the brick and wood trim be painted during the report period.

Building exteriors west side of the building

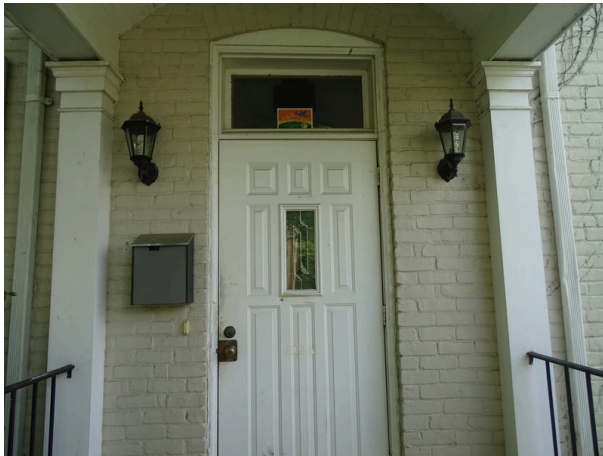
The main entrance is a Wood doors. The main entrance door was generally in good to fair condition. Exterior doors typically have an expected useful life of 20 to 30 years. We recommend replacing the entrance doors during the report period.

Main entrance door

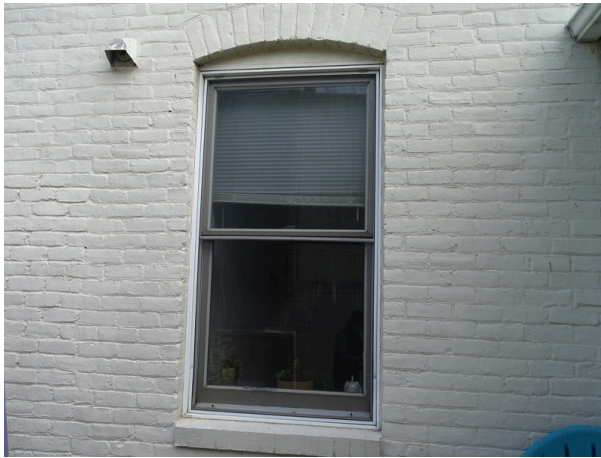
The window system for the building primarily consists of Wood-framed single-pane window units with some inoperable window units located at grade level. The expected useful life of windows is typically 30 years. The window units were in good to fair condition. We recommend the windows be replaced during the report period.

Exterior window

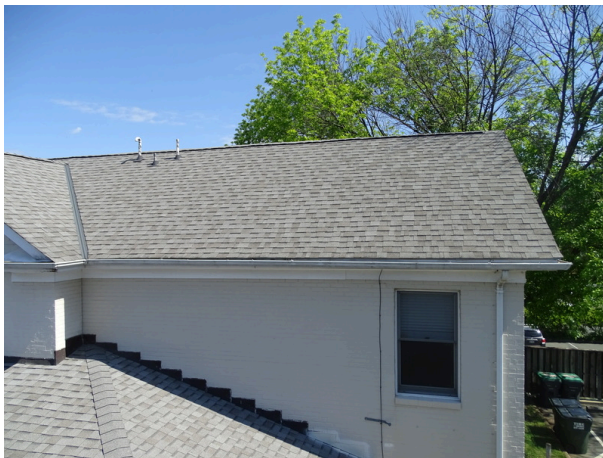
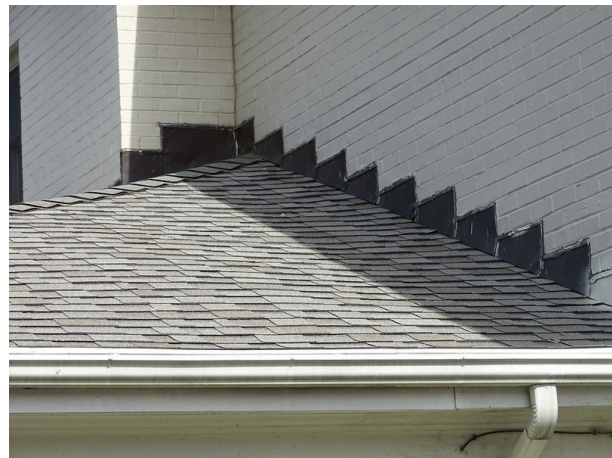
The main roofing system consists of an Asphalt shingle roofing system over the building. The roofing system appears to be replaced within the last 15 to 20 years. The expected useful life of an asphalt shingle roofing system is typically 20 years. We recommend replacing the roofing system when needed during the report period. Drainage for the roofing system is provided by gutters and downspouts. We recommend that the gutters and downspouts be replaced during the scheduled roof replacement. Roofing penetrations included plumbing vents and exhaust vents throughout the roofing system.

Roofing system

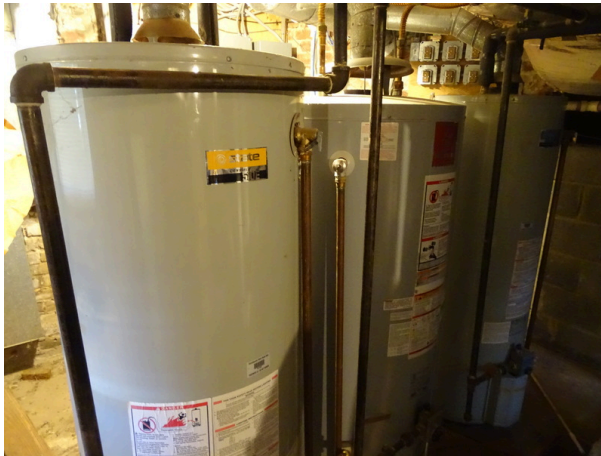
Domestic hot water to the building is provided by 3 Gas water heaters located in the basement. The Gas water heaters, of varied age, were manufactured by State Industries. The expected useful life of Gas water heaters are approximately 12 to 15 years. We recommend the Gas water heaters be replaced during the report period.

Domestic water heaters

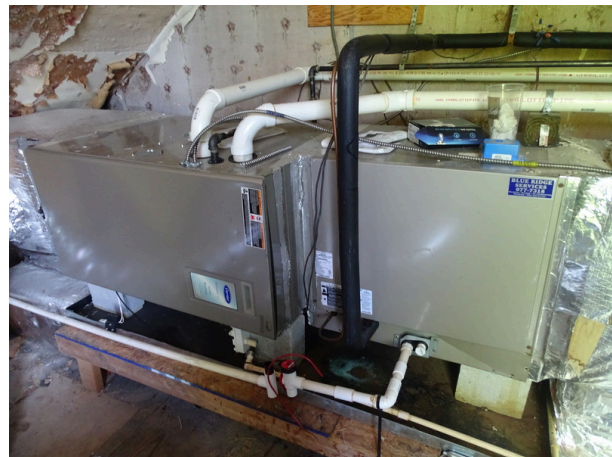
The furnace units are located in the basement, first floor, and attic. The furnace units were manufactured by Carrier in 2009. The expected useful life furnace units is 15 years with proper maintenance. The furnace units were observed to be in good to fair condition. We recommend that the air handlers be replaced during the report period.

Typical furnace unit and air handler

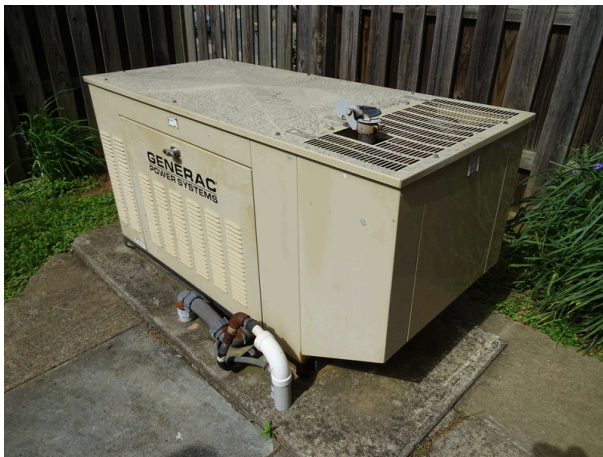
in 2006. The expected useful life of an emergency generator is 25 years with proper maintenance. The emergency generator was observed to be in fair condition. The emergency transfer switch is located in the basement. The expected useful life of an emergency transfer switch is 25 years with proper maintenance. The emergency transfer switch was observed to be in generally fair condition.

Emergency power generator

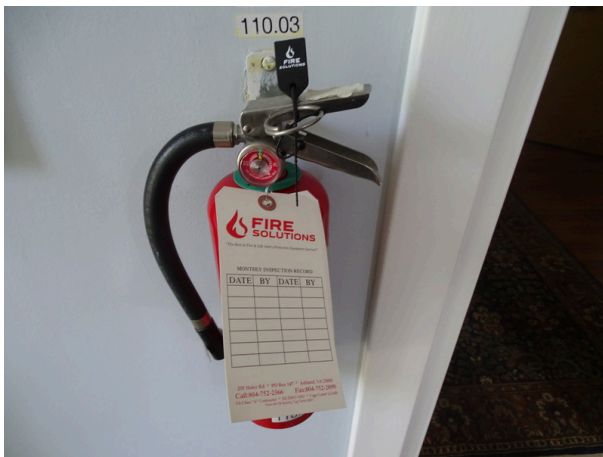
Fire extinguishers were observed throughout the building. The fire extinguishers were observed to have recent inspection tags issued by Lynchburg Fire Equipment in June 7, 2021. These devices are required to be inspected annually. Replacement of the fire extinguishers is considered routine maintenance.

Fire extinguisher

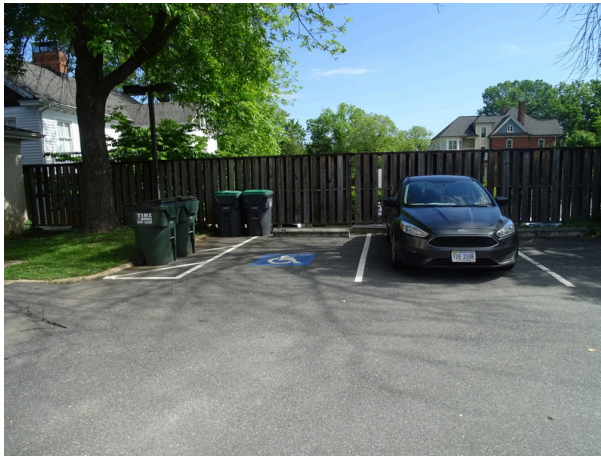
The parking area serving the property has a total of approximately Six parking spaces. Of the parking spaces, One are accessible with One being van accessible. Accessibility requires that 1 accessible parking space be provided in parking areas with a total of 1 to 25 spaces. One in six of the accessible parking spaces are required to be van accessible. A minimum of a 60-inch wide access aisle is required to be provided for every two accessible parking spaces. Accessible aisles were observed to be provided. The number of parking spaces provided meets accessibility requirements.

Accessible parking space

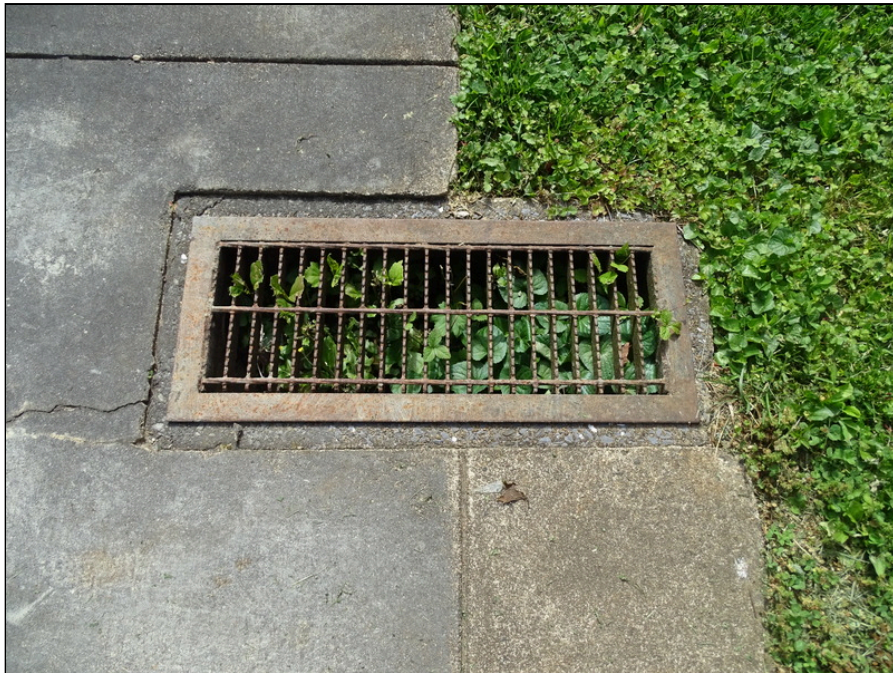
2 - Typical yard drop inlet

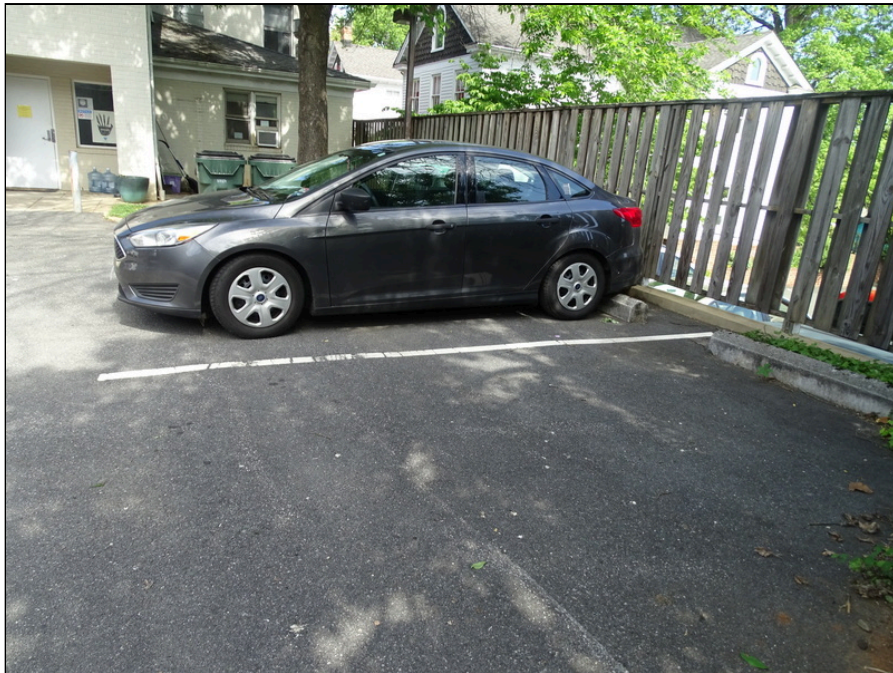
4 - Asphalt pavement at east side of the site - note recent repairs

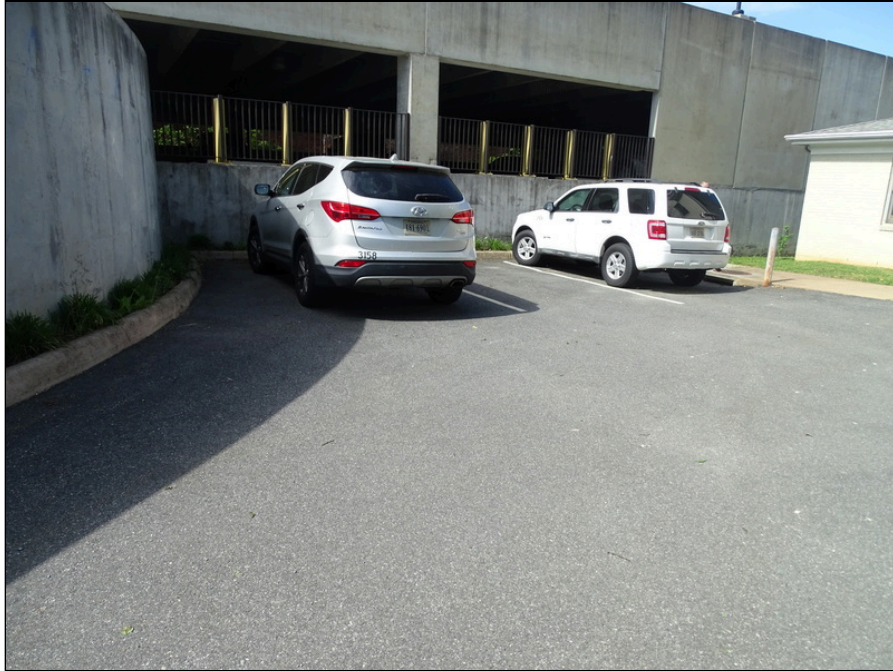
5 - Asphalt pavement at east side of the site - note recent repairs

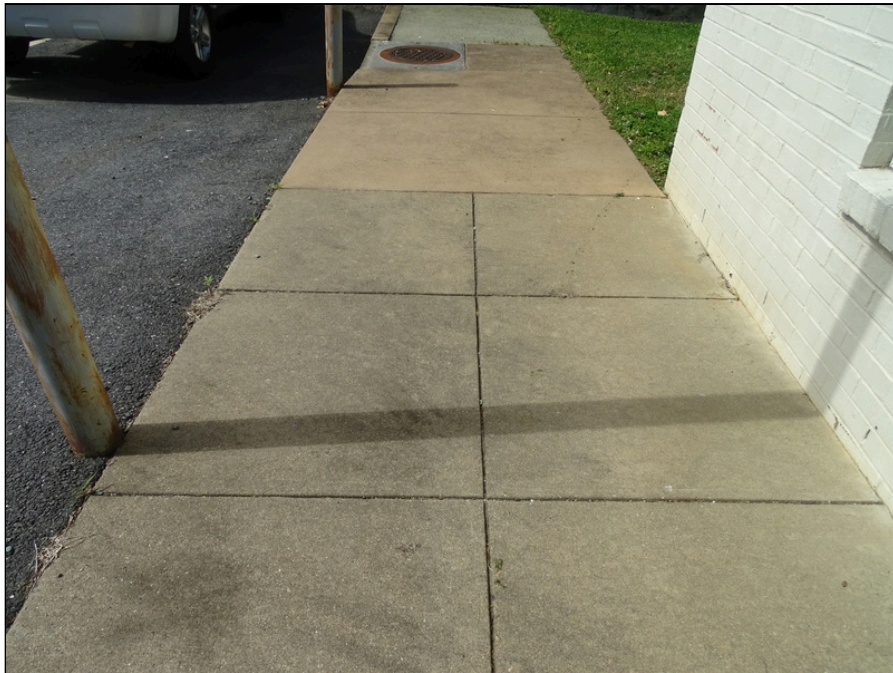
6 - Typical concrete sidewalk

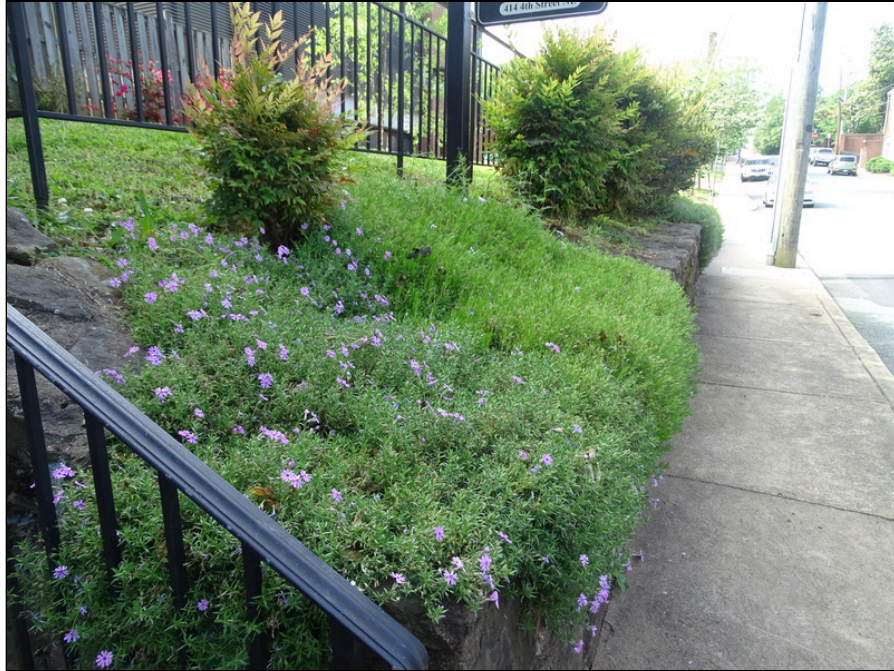
7 - Typical landscaping

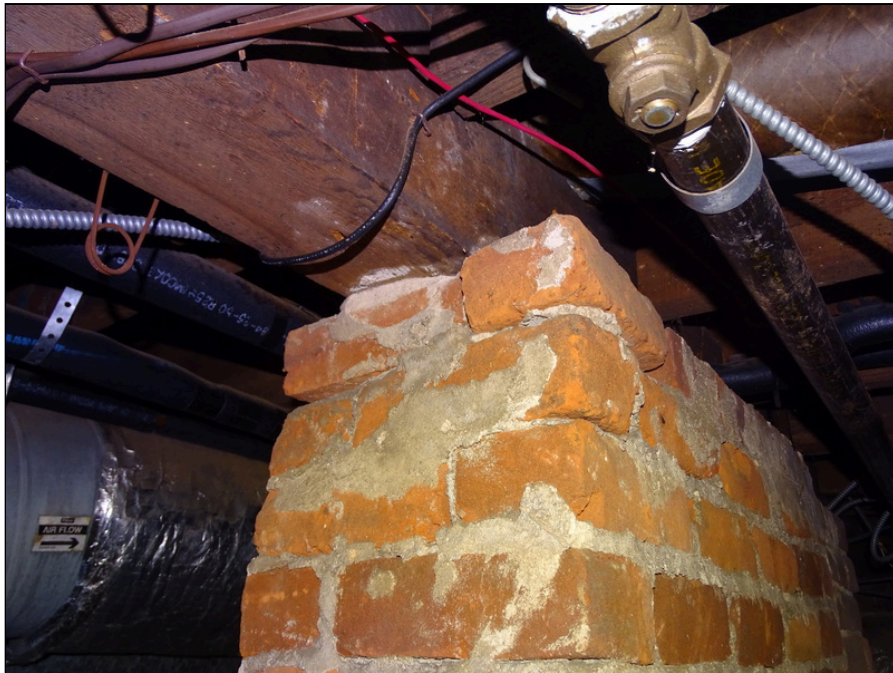
12 - Typical structural framing

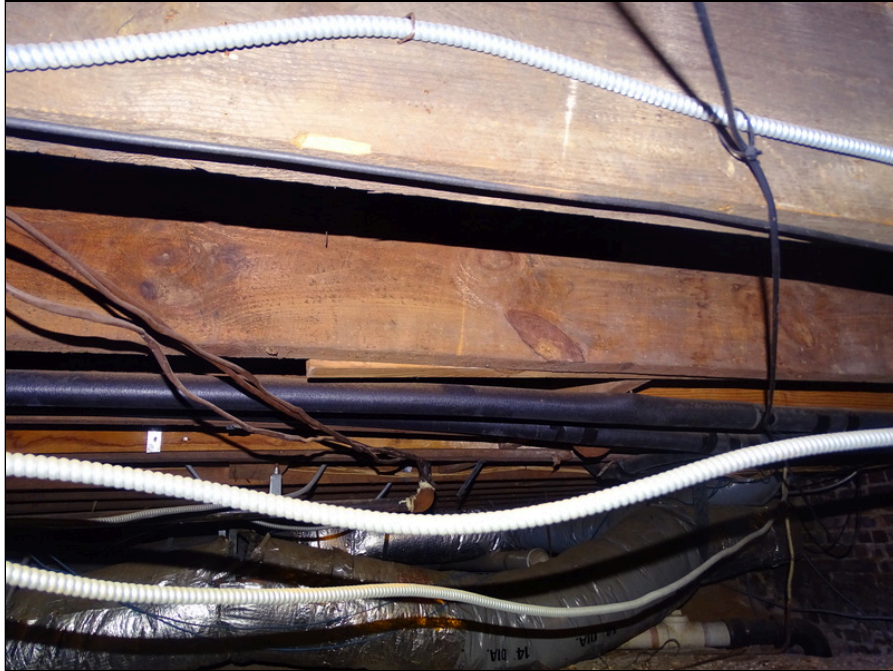
13 - Typical structural framing

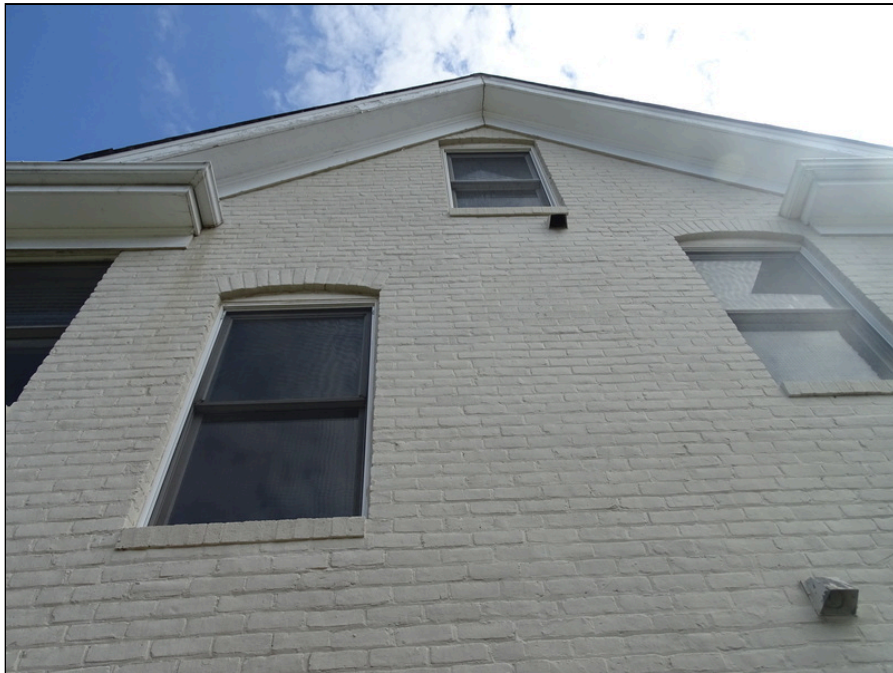
14 - Building exteriors west side of the building

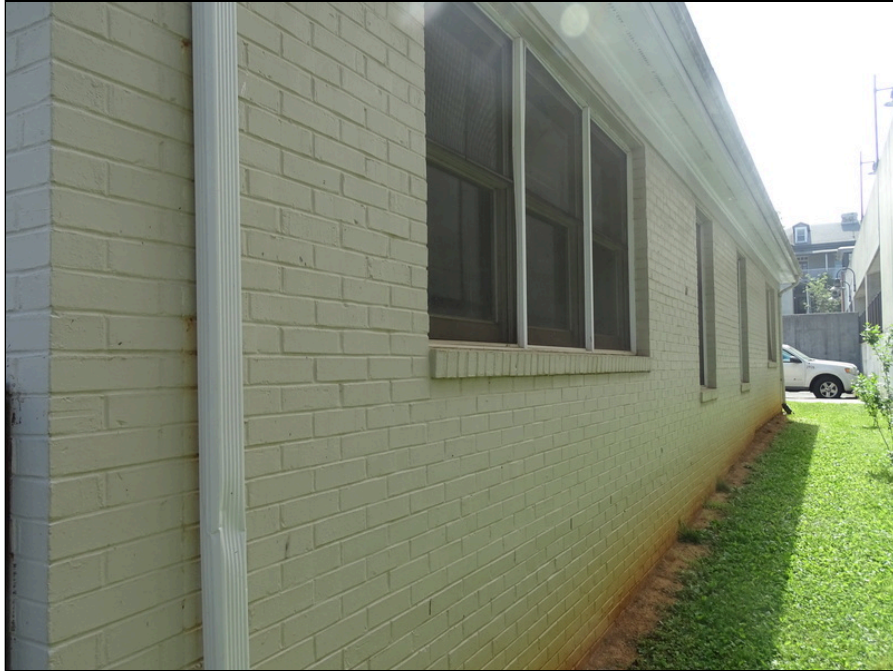
15 - Building exteriors south side of the building

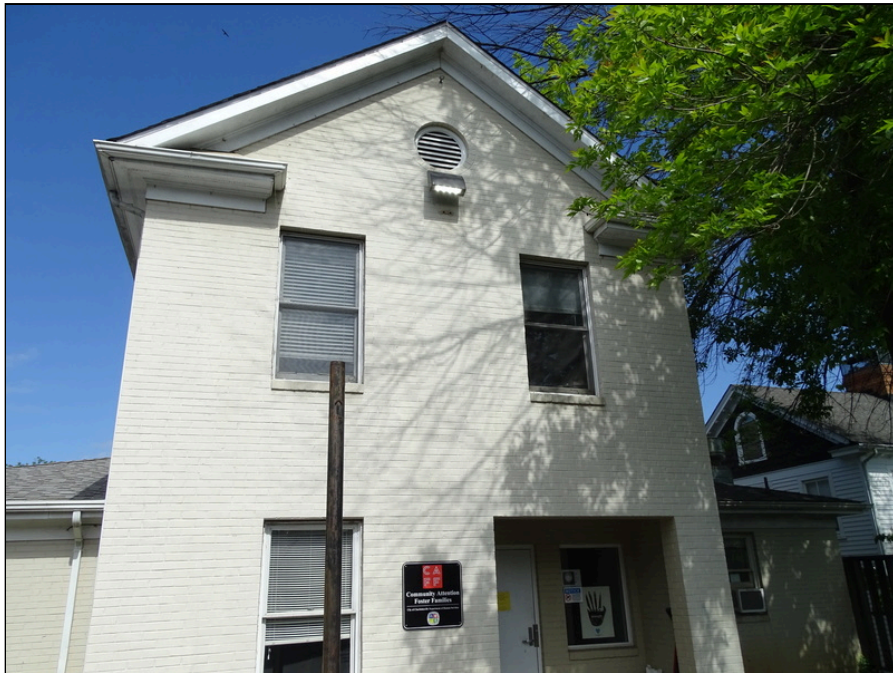
16 - Building exteriors east side of the building

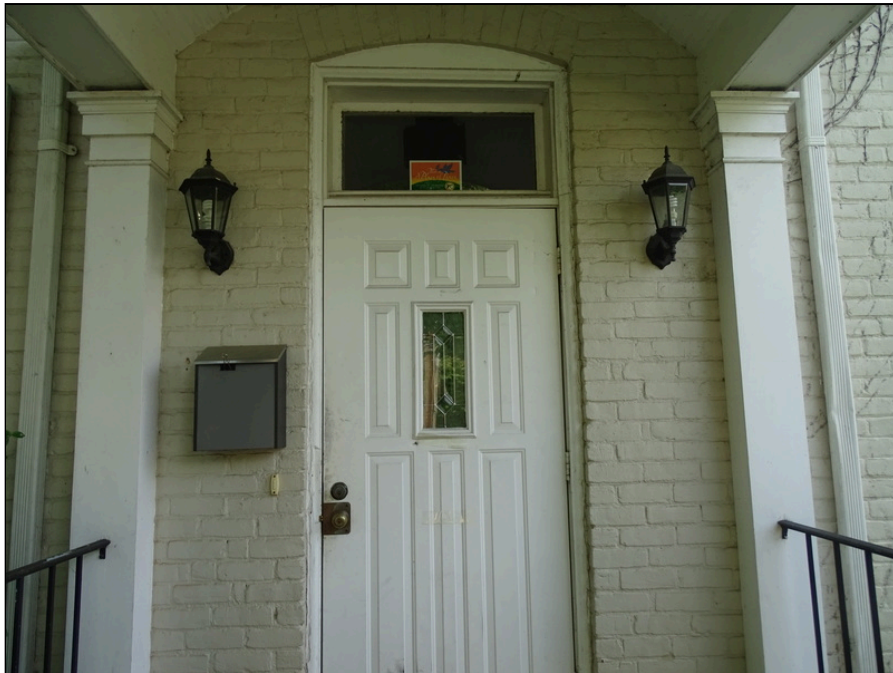
20 - Main entrance door

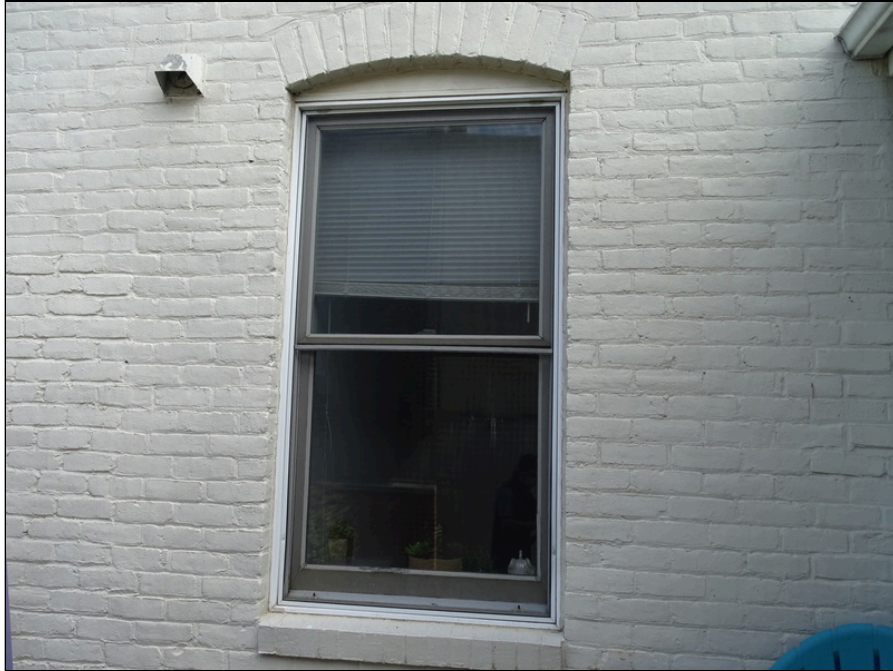
21 - Exterior window

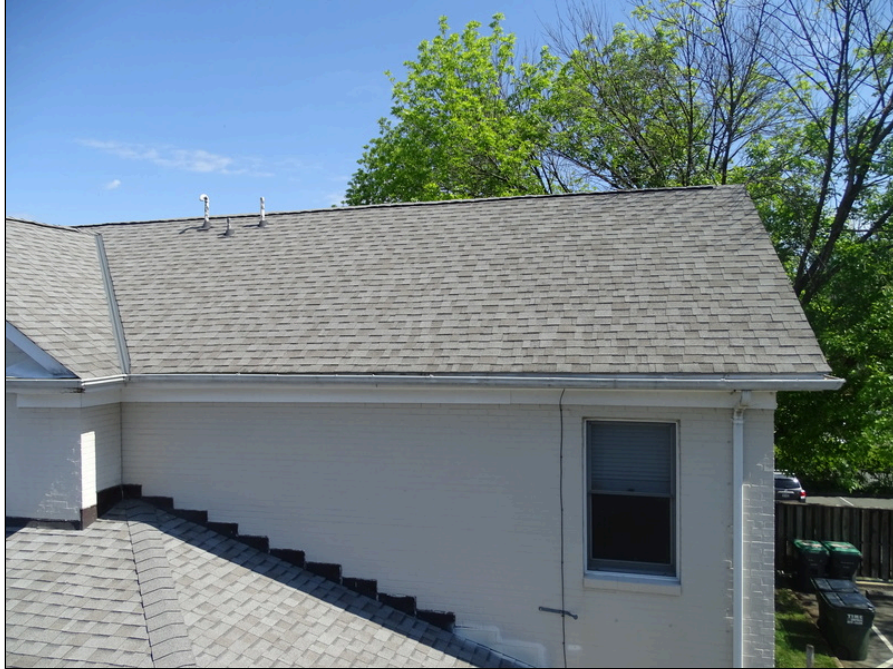
23 - Roofing system

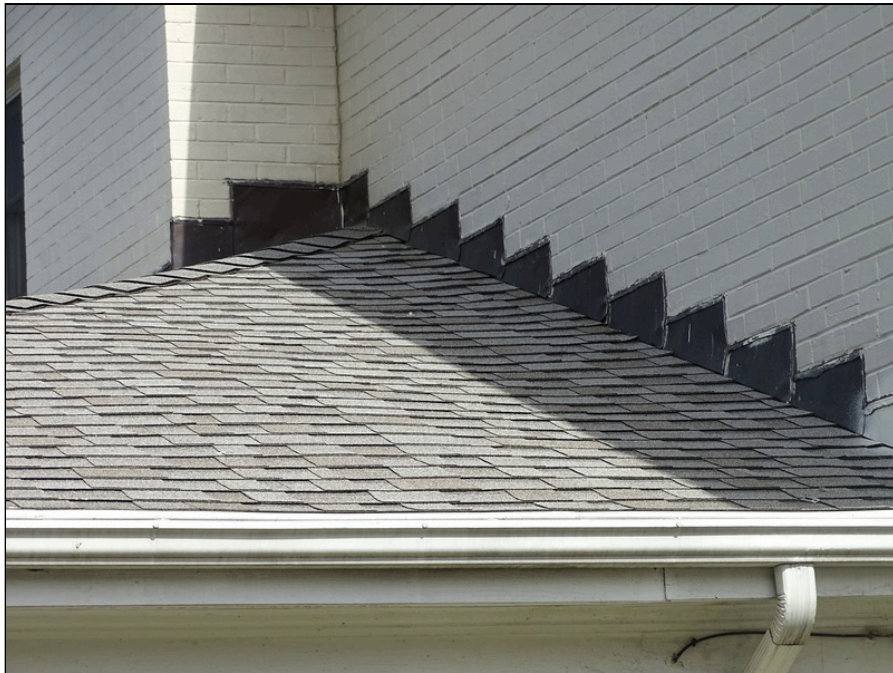
24 - Roofing system

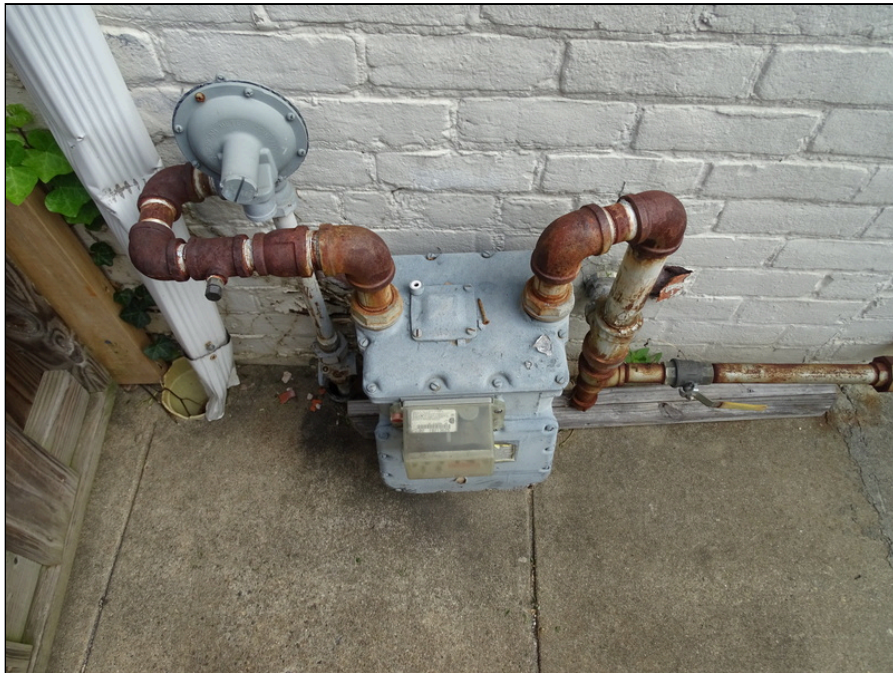
26 - Natural gas utility supply and meter

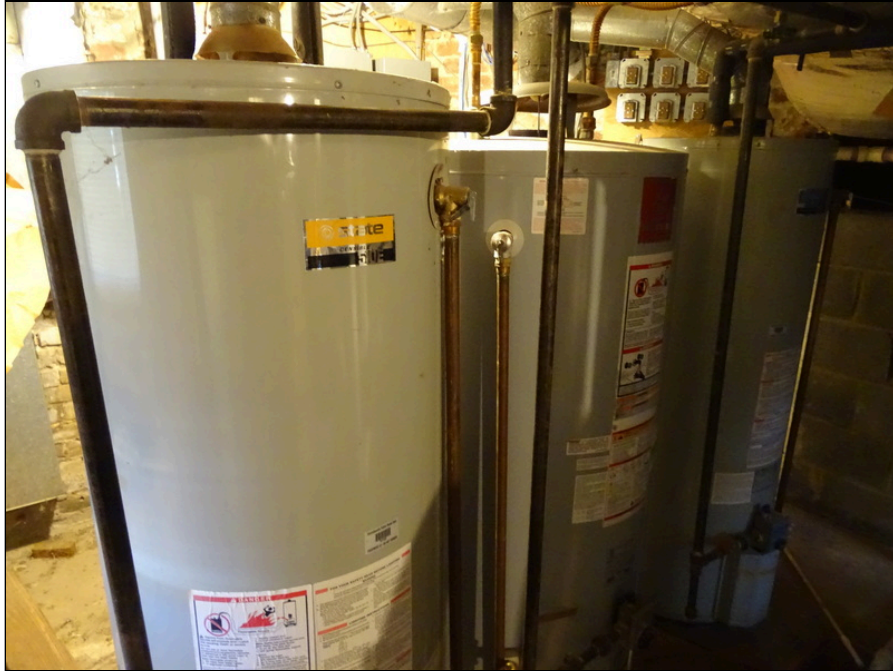
27 - Domestic water heaters

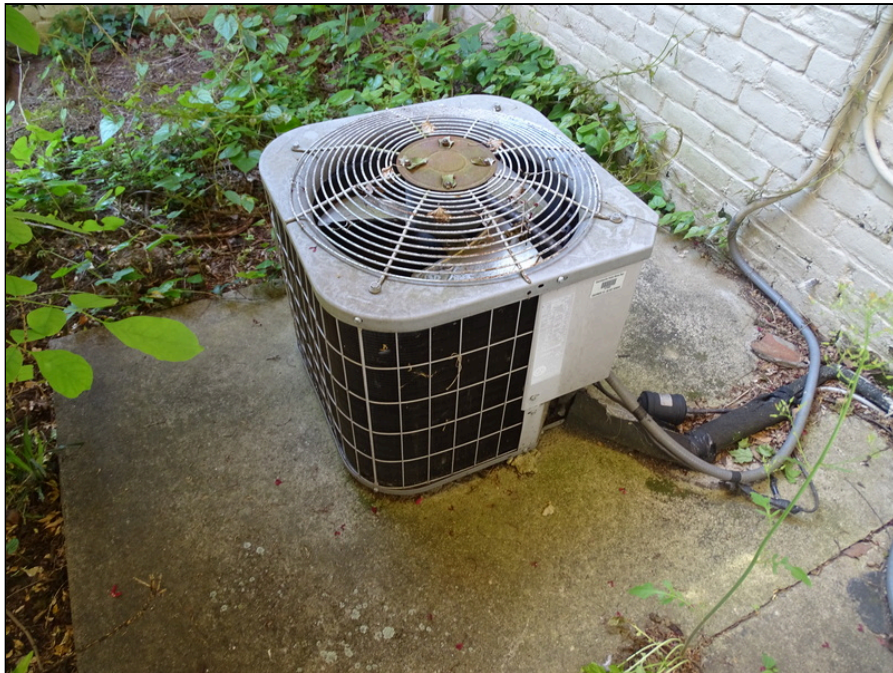
28 - Typical condenser unit

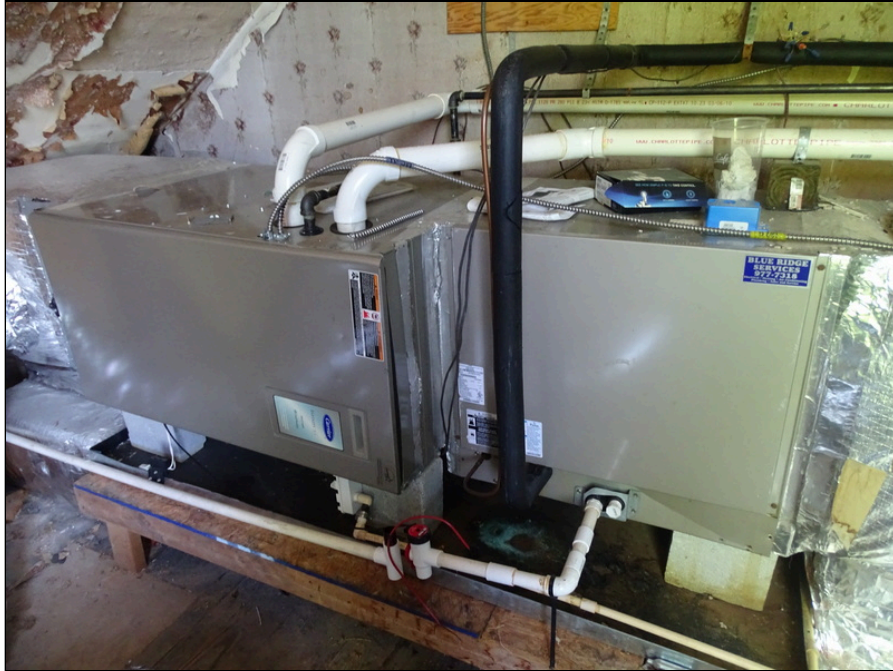
29 - Typical furnace unit and air handler

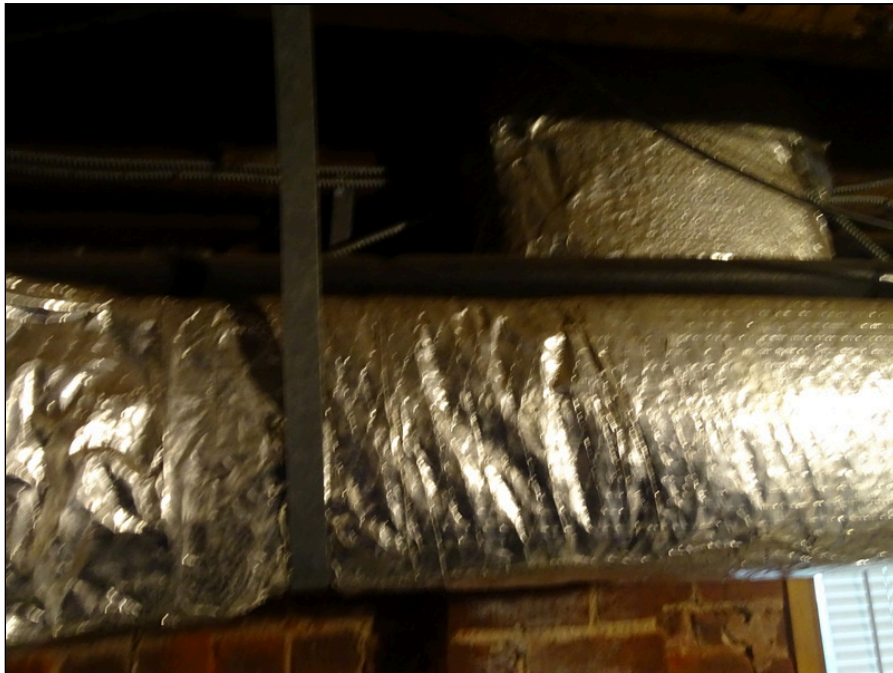
30 - Typical mechanical duct

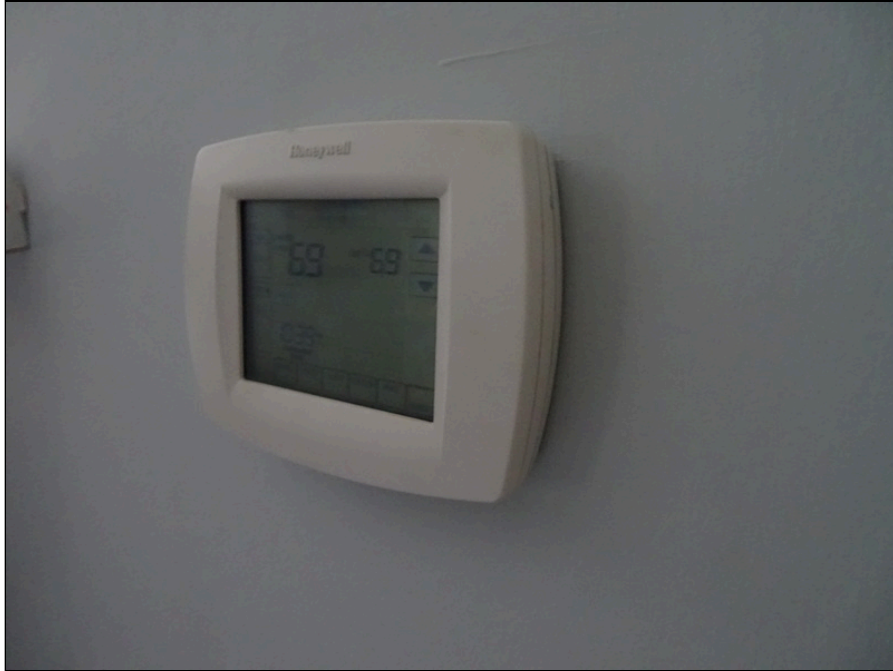
31 - Typical mechanical system thermostat control

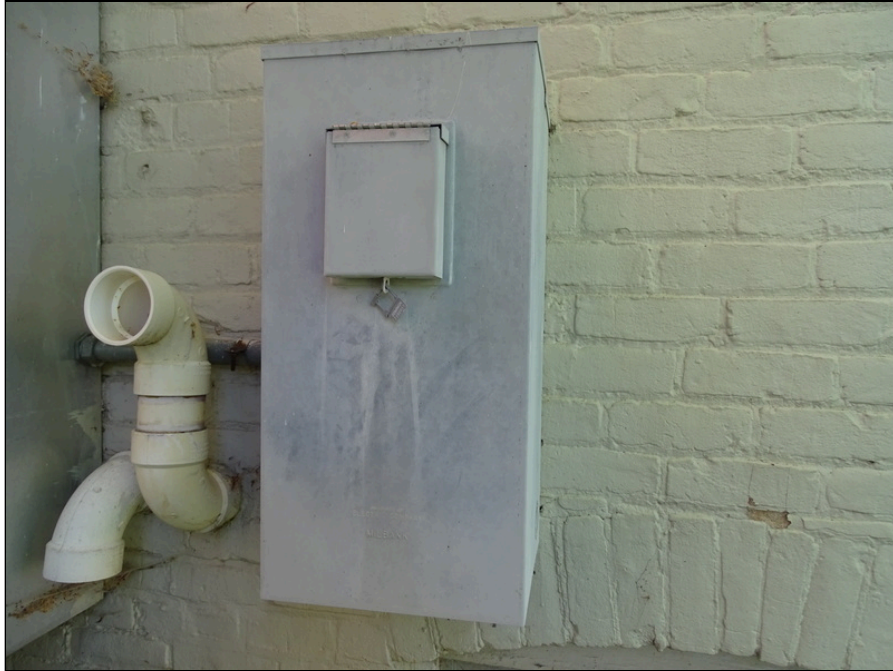
33 - Electrical utility meter

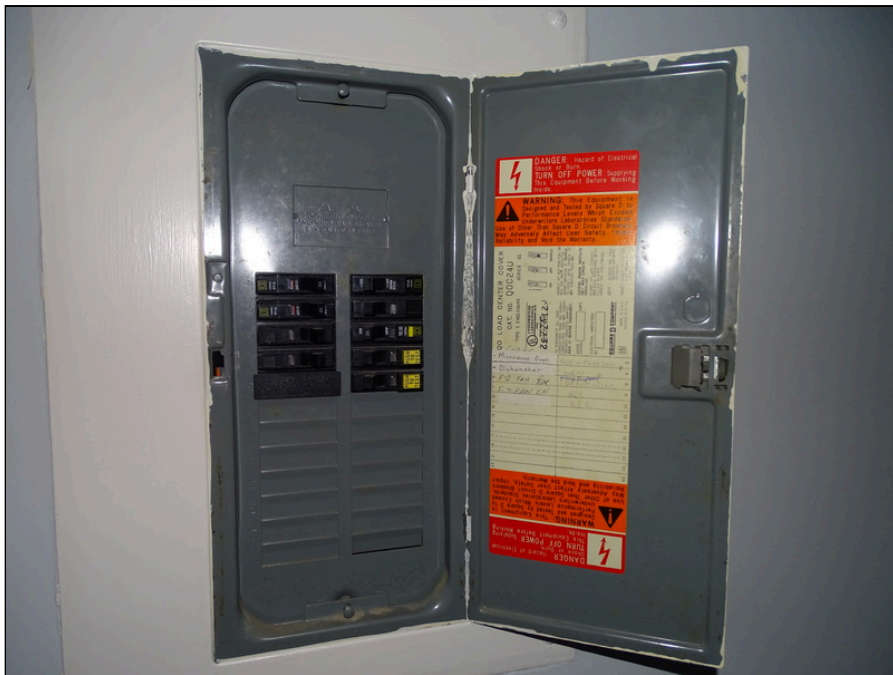
34 - Typical older circuit breaker panel

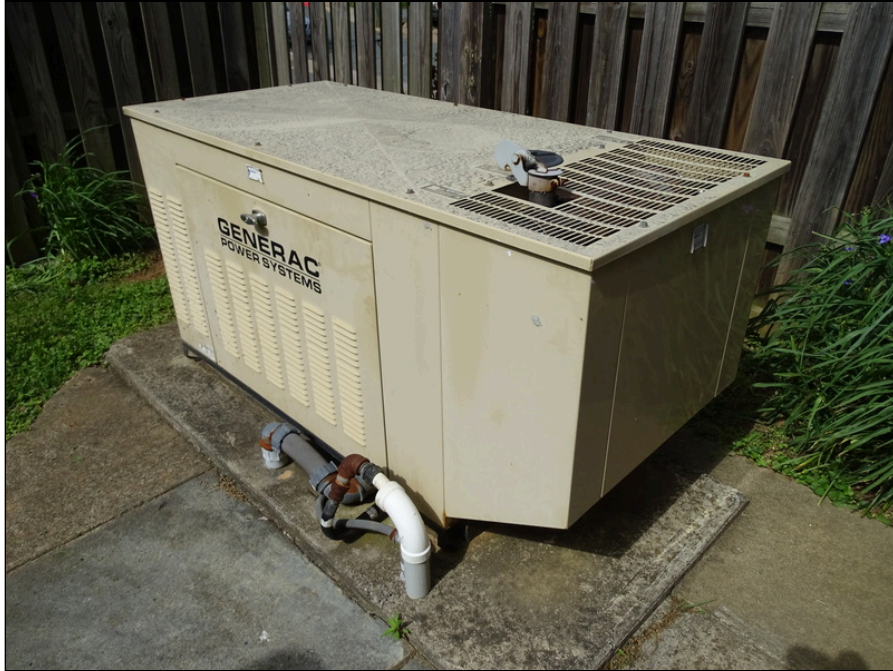
35 - Emergency power generator

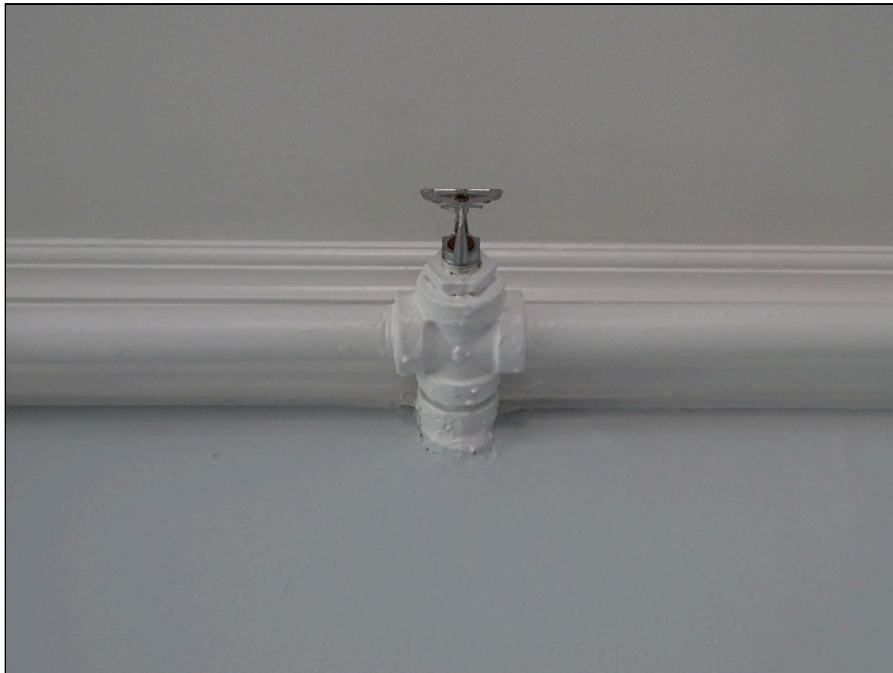
38 - Fire sprinkler piping and head

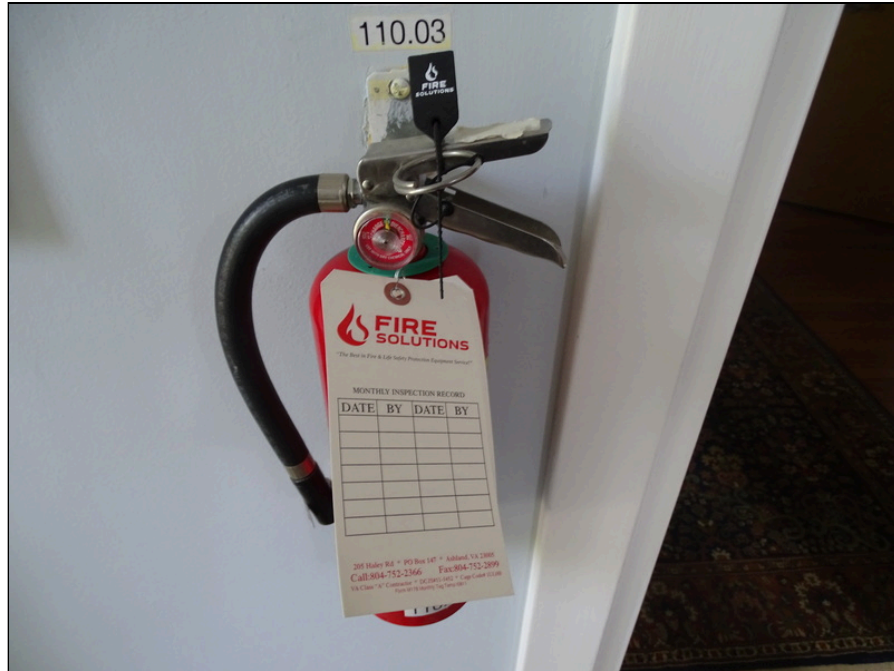
39 - Fire extinguisher

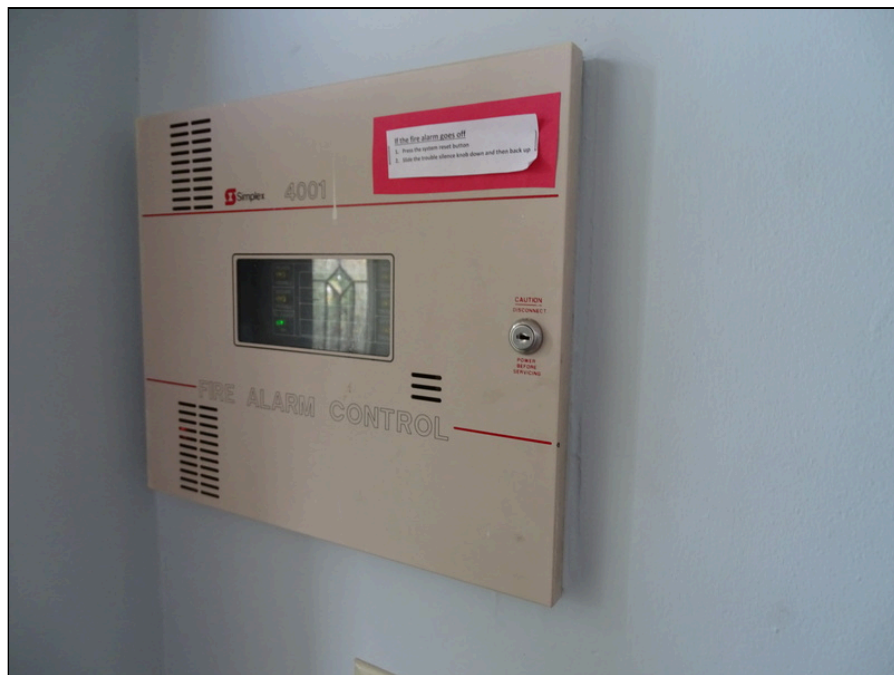
40 - Fire alarm control panel

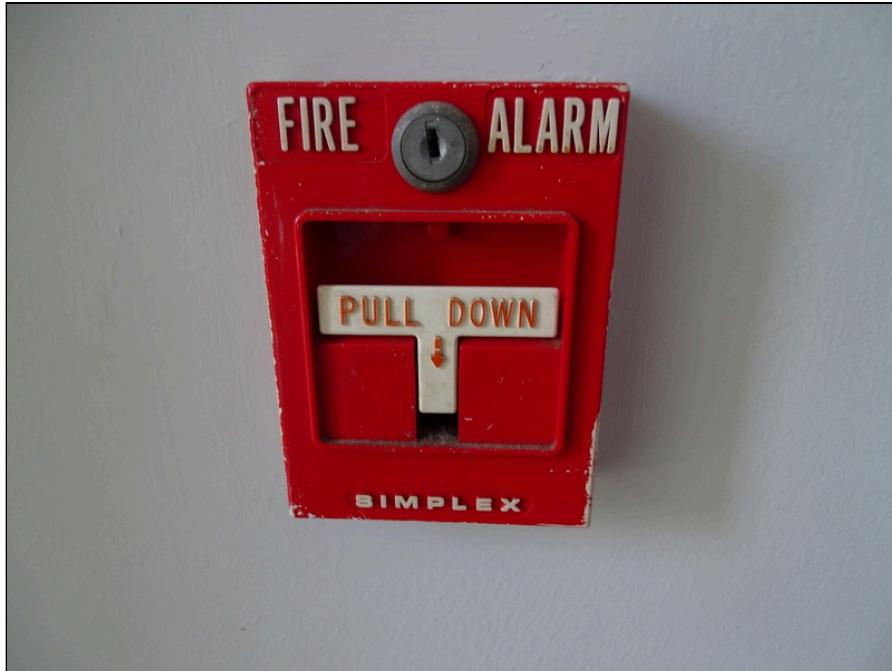
41 - Fire alarm pull station

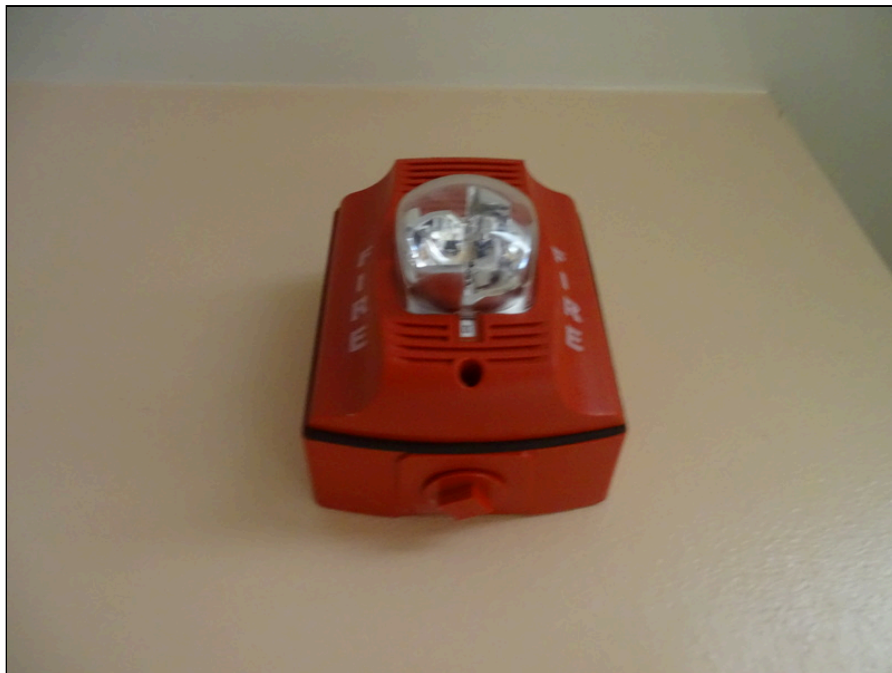
42 - Fire alarm bell and strobe

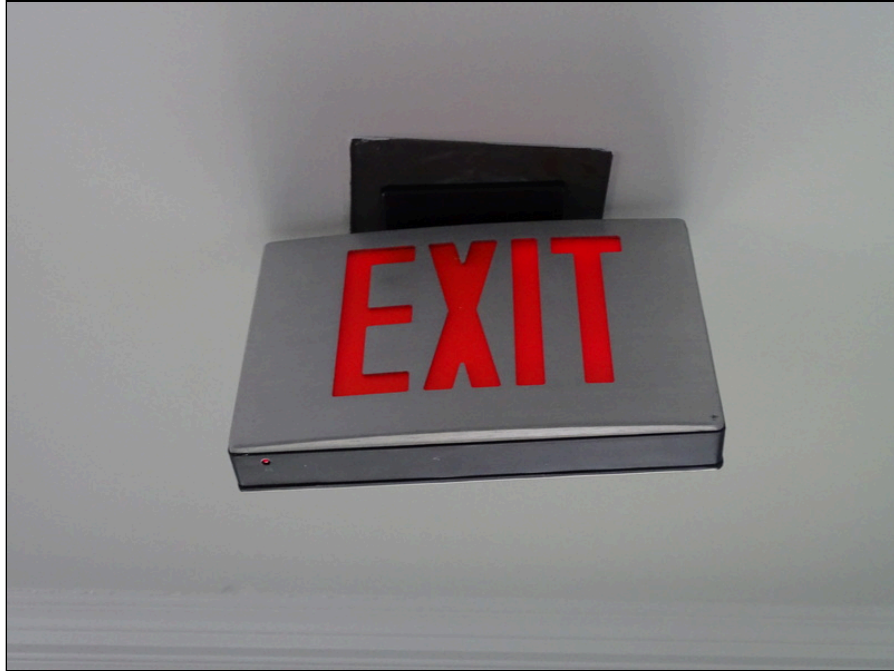
43 - Exit sign
