ATTENTION HOME
414 4TH STREET NE
CHARLOTTESVILLE, VIRGINIA

ECS PROJECT NO. 46:6713

CITY OF CHARLOTTESVILLE - FACILITIES DEVELOPMENT

Reference: Facility Condition Assessment Report for Attention Home, 414 4TH Street NE,
Charlottesville, Virginia

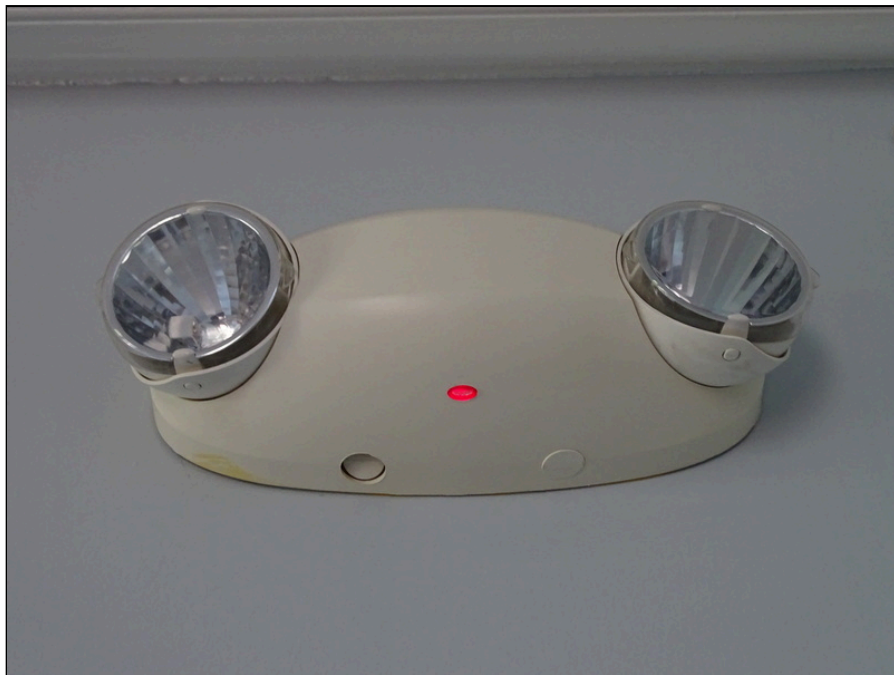
44 - Emergency lighting

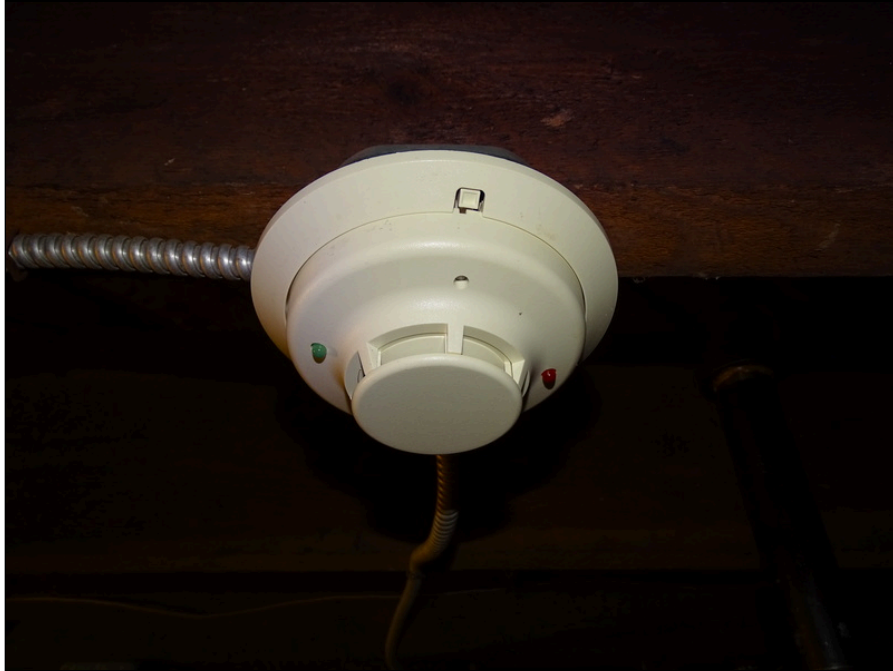
45 - Smoke detector

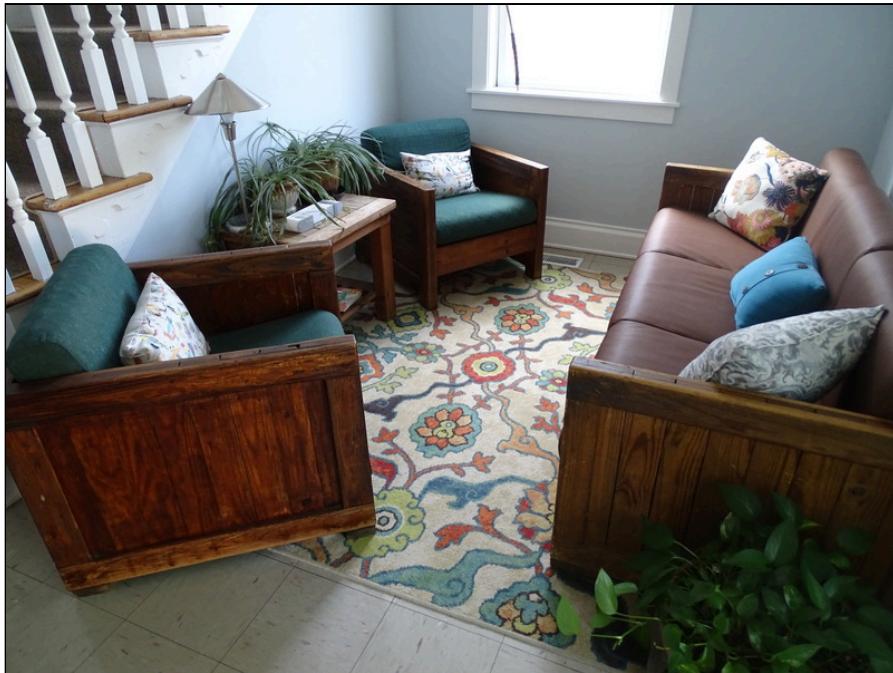
46 - Interior finishes of entrance area

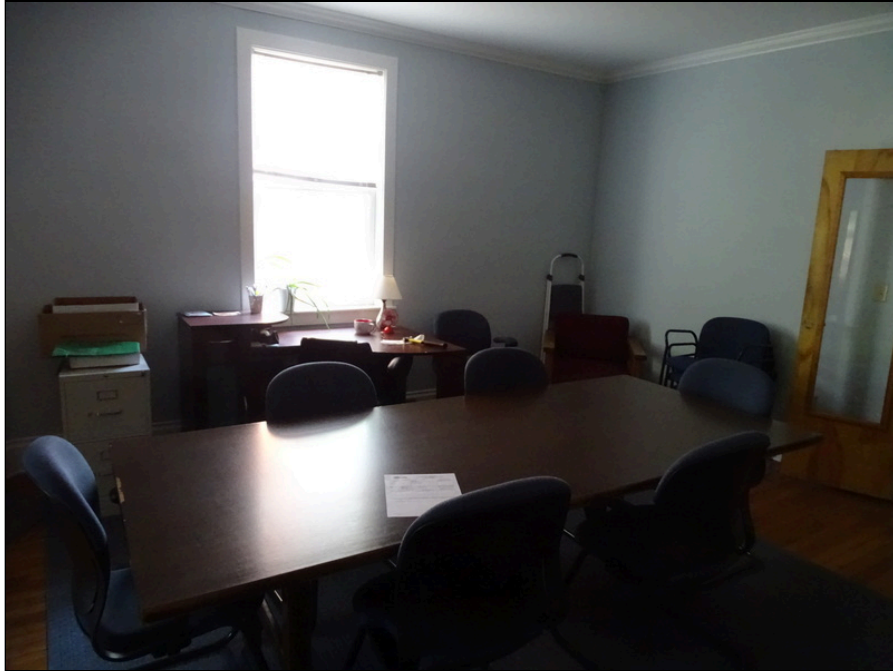
47 - Interior finishes of meeting area

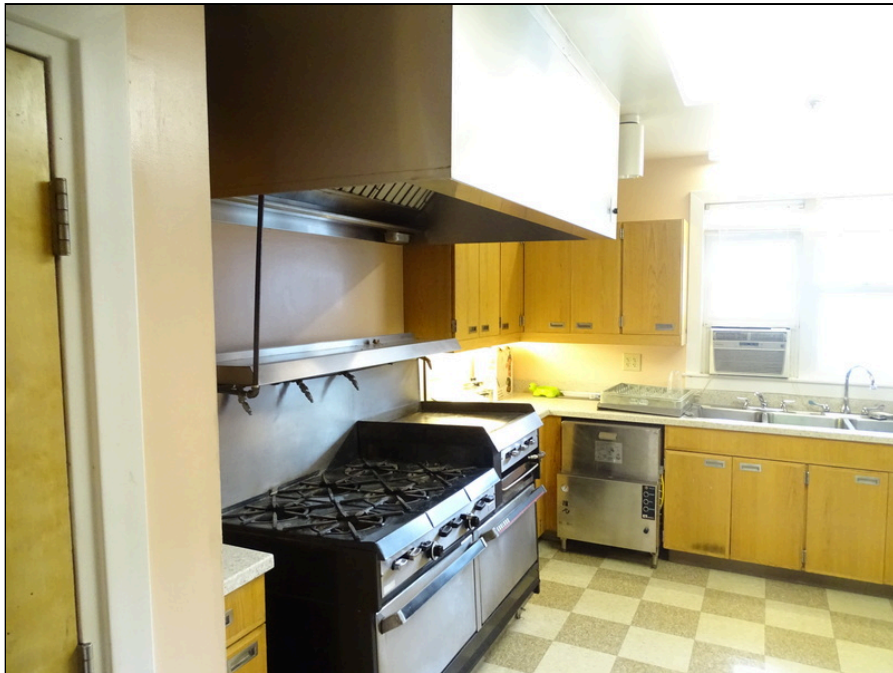
48 - Interior finishes of kitchen area

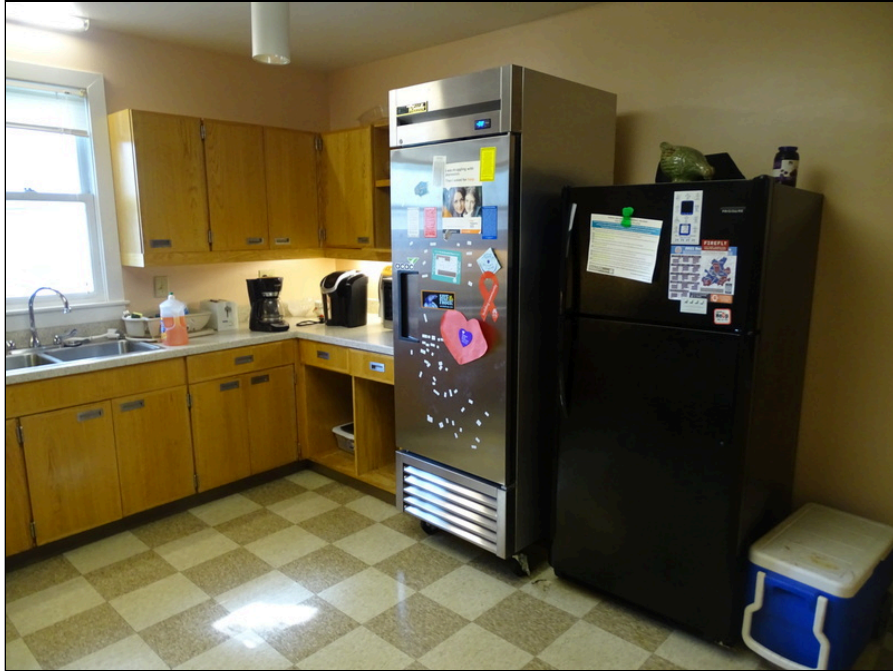
49 - Interior finishes of kitchen area

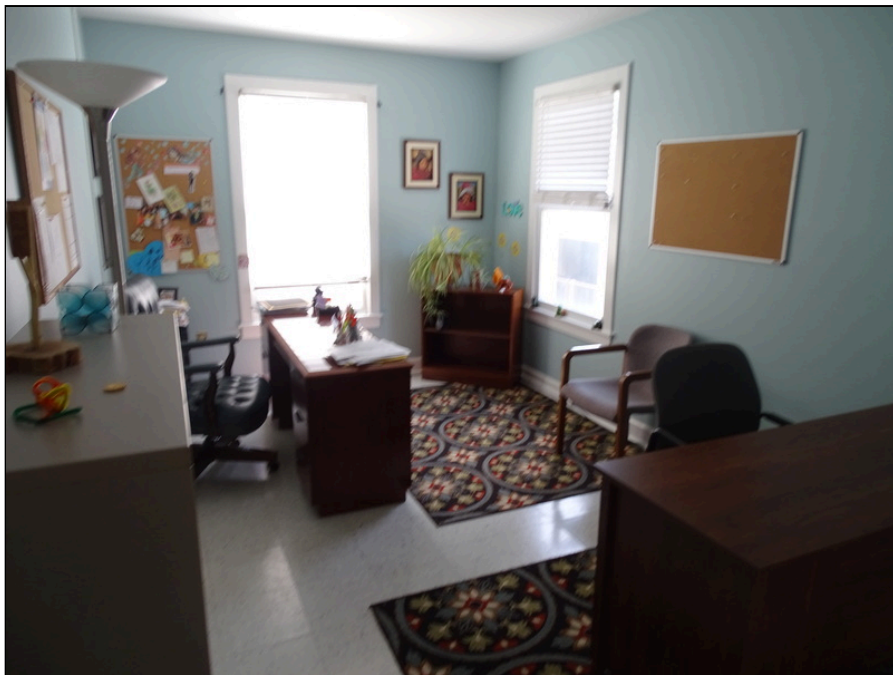
50 - Interior finishes of office area

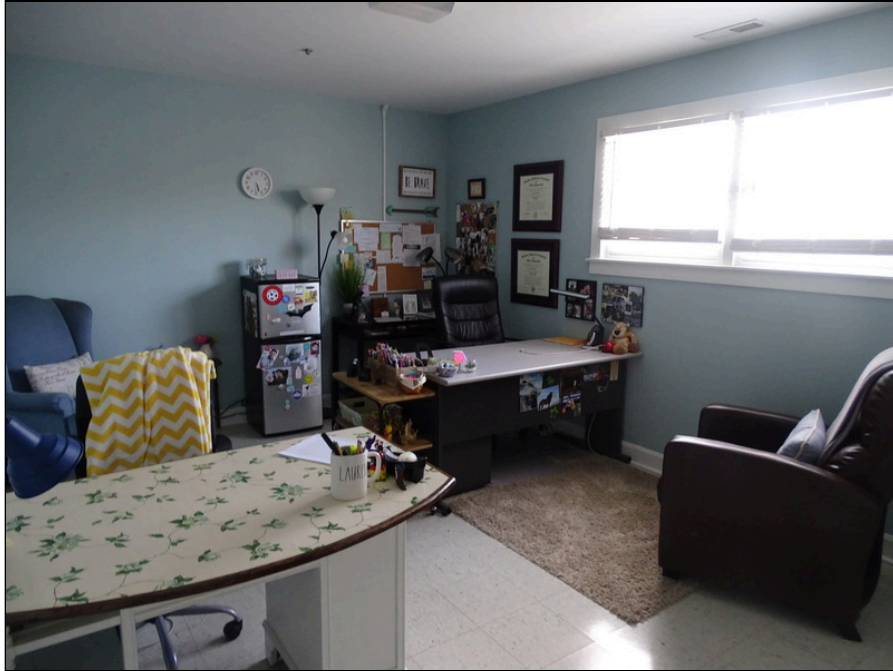
51 - Interior finishes of office area

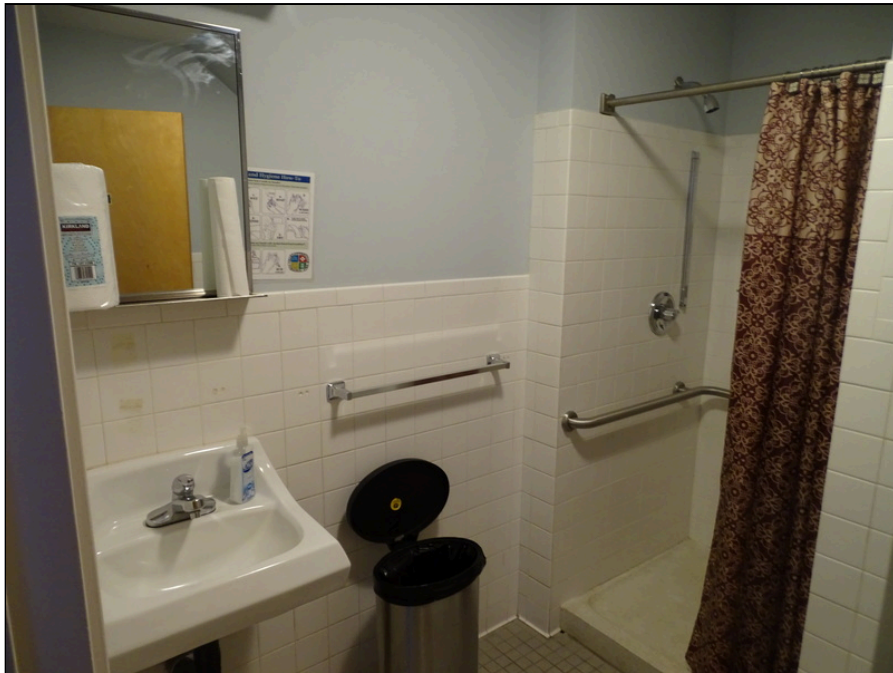
52 - Interior finishes of restroom area

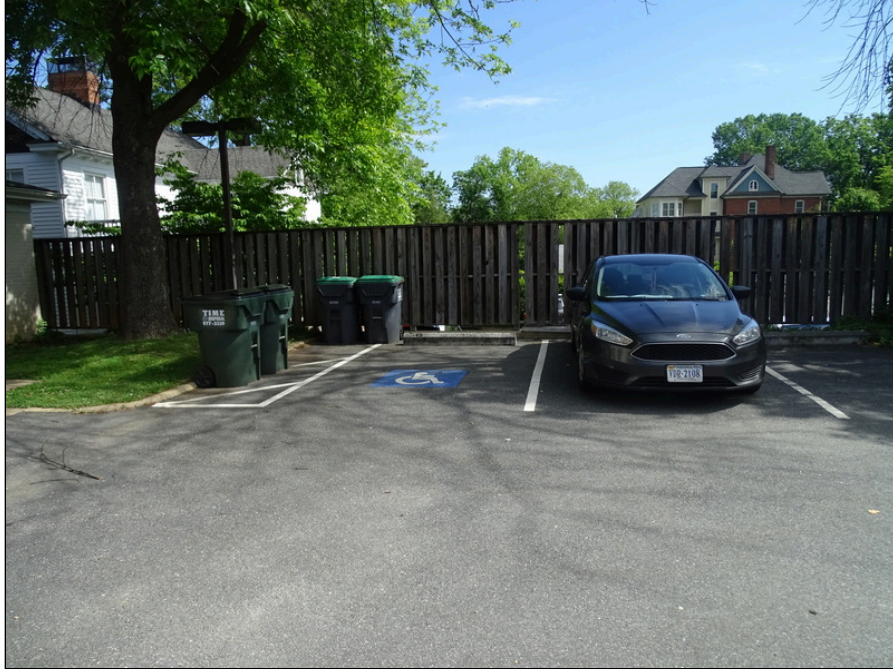
53 - Accessible parking space

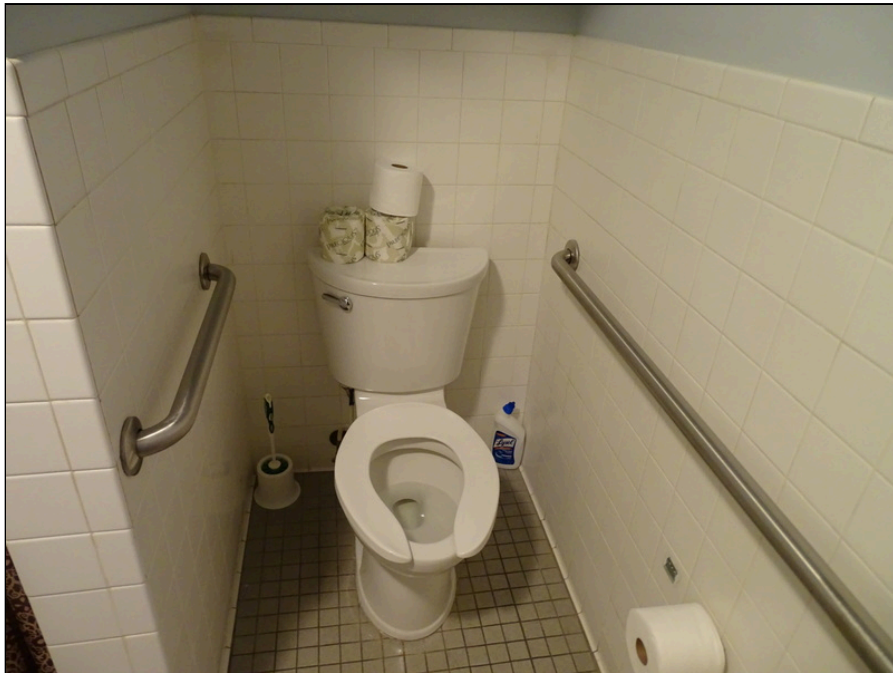
54 - Accessible toilet
