COMMUNITY ATTENTION BUILDING (E JEFFERSON)
907 EAST JEFFERSON STREET
CHARLOTTESVILLE, VIRGINIA

ECS PROJECT NO. 46:6713

CITY OF CHARLOTTESVILLE - FACILITIES DEVELOPMENT

Reference: Facility Condition Assessment Report for Community Attention Building (E Jefferson), 907 East Jefferson Street, Charlottesville, Virginia

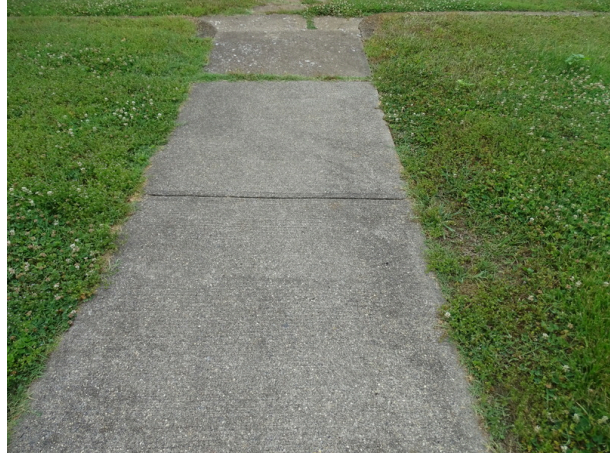
Concrete sidewalk overview

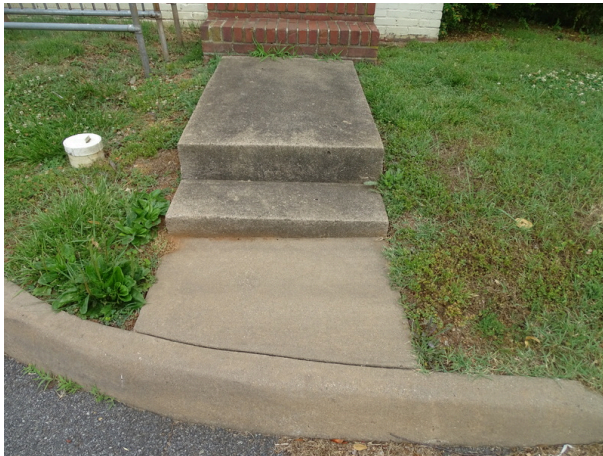
Concrete sidewalk and steps east side of the
building

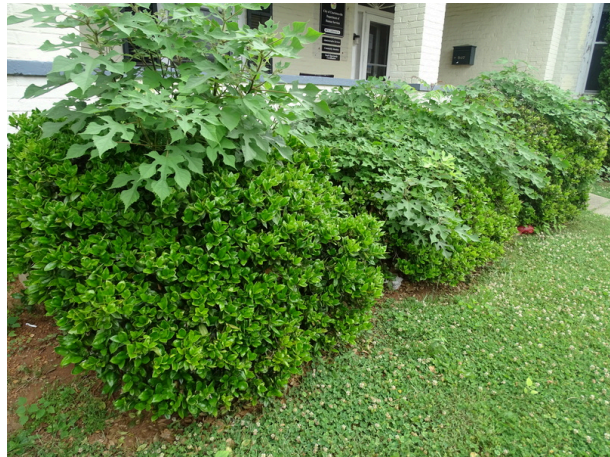
Typical landscape

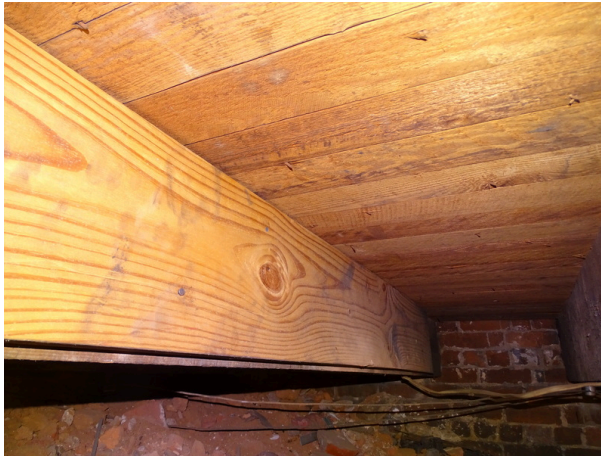
The structure of the building consists of Wood framing with brick masonry bearing exterior walls with masonry columns. The structural frame of the building was generally in good condition.

Structural framing

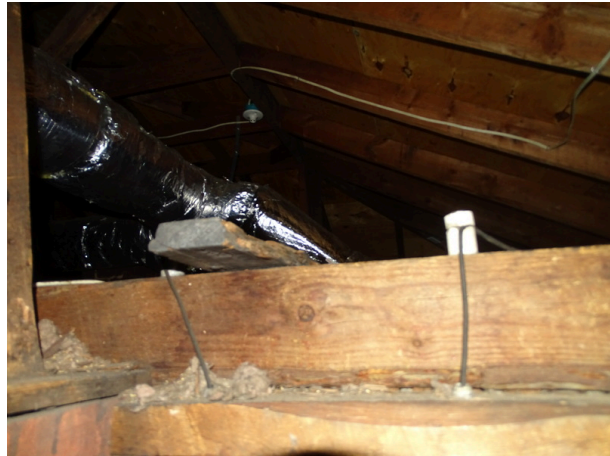
Structural framing

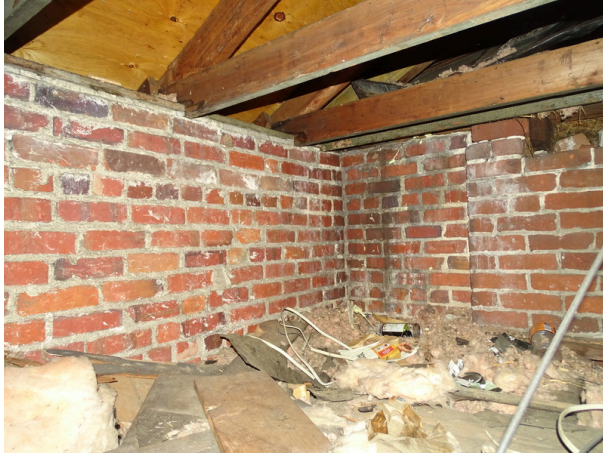
Structural framing

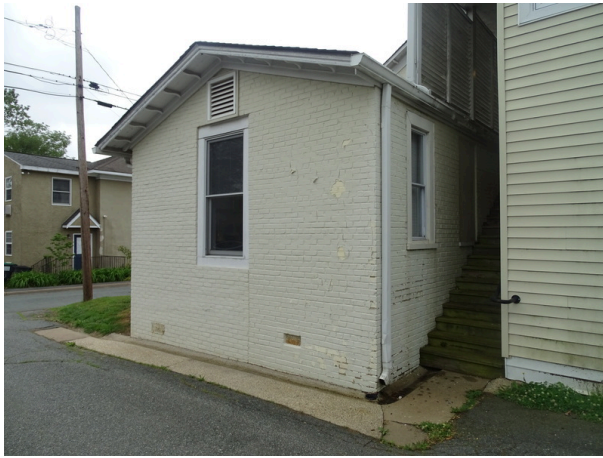
Building exterior north side of the building

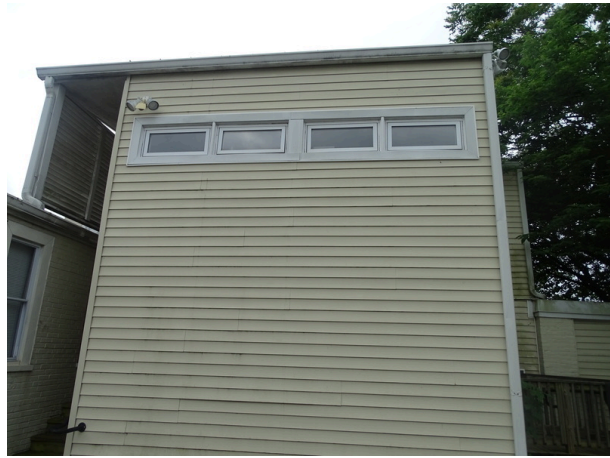
Vinyl siding at north addition

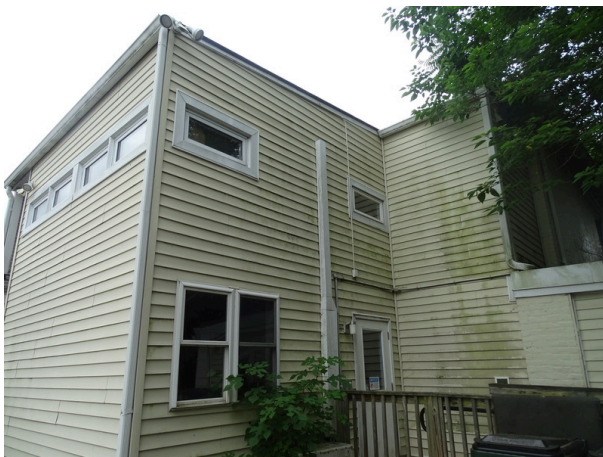
Vinyl siding at north addition

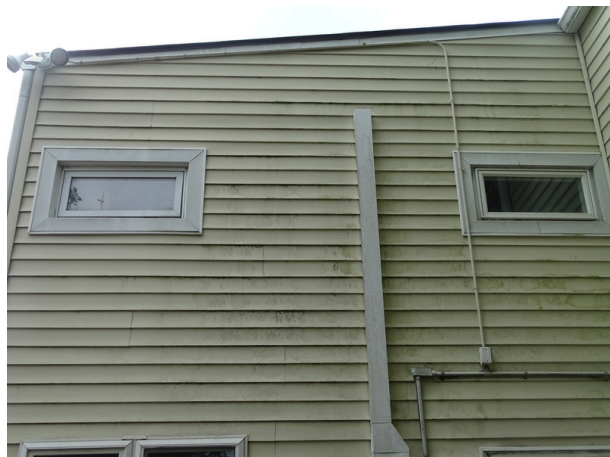
There is vinyl siding on the north addition. The vinyl siding was observed to be soiled on the north side. The expected useful life of vinyl siding is 25 years. The vinyl siding was generally in good condition. We recommend cleaning the siding as a maintenance item.

Vinyl siding at north addition - note needed
maintenance

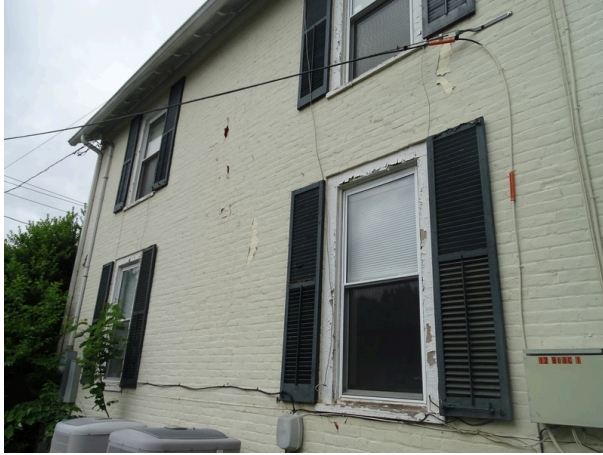
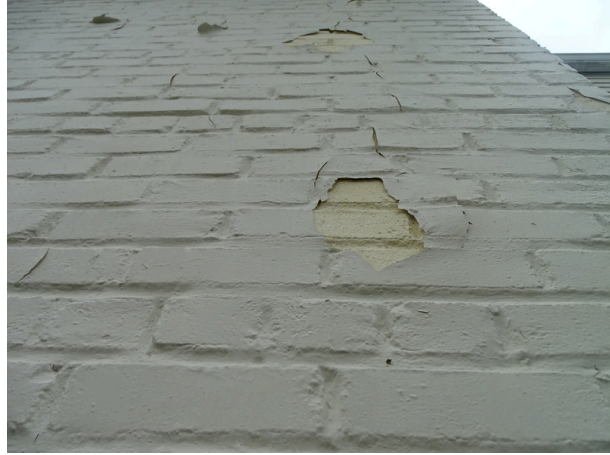
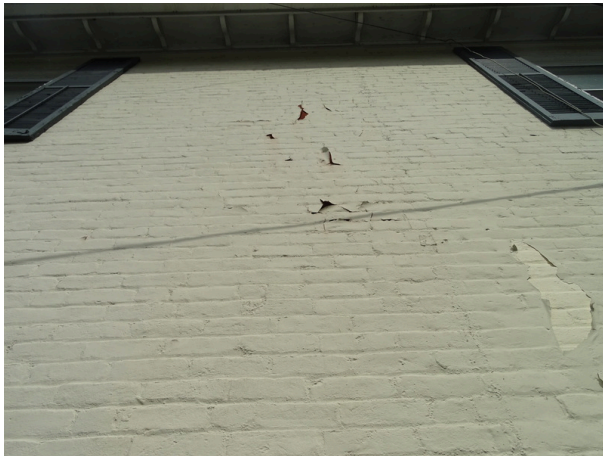
Building exterior east side of the building - note peeling paint

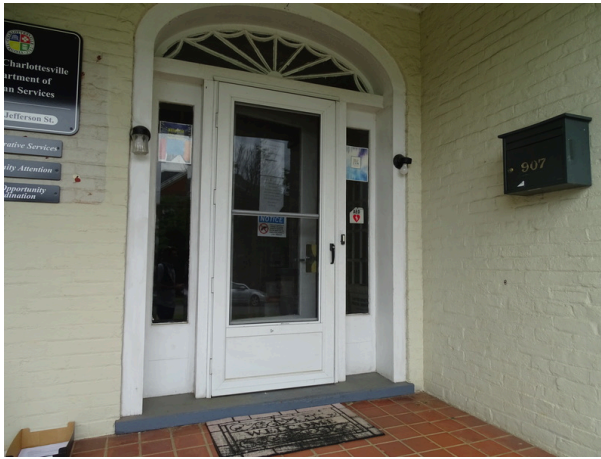
The main entrances are Metal door with glass. The main entrance doors were generally in good condition. Exterior doors typically have an expected useful life of 20 to 30 years.

Main entrance door

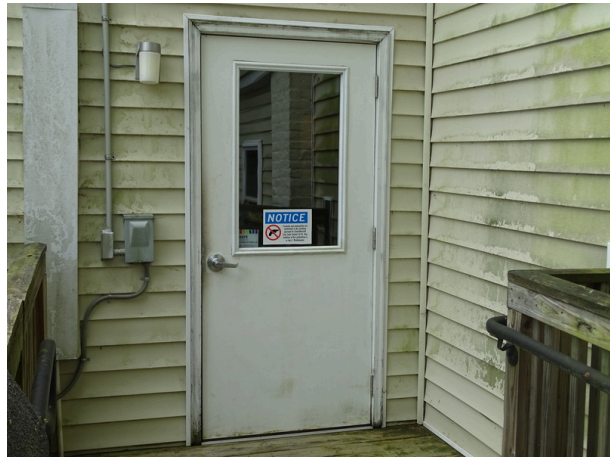
Personnel steel door

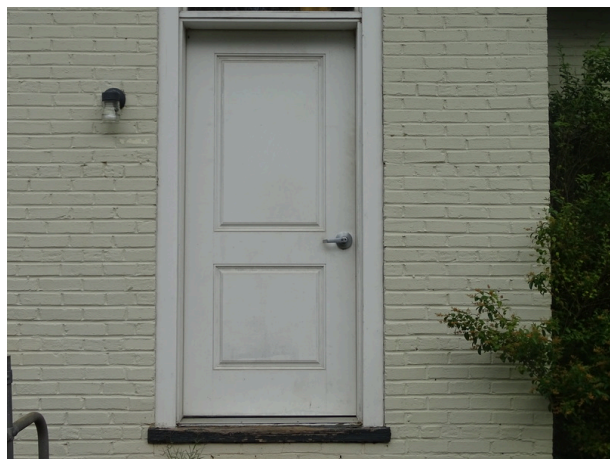
Personnel wooden door

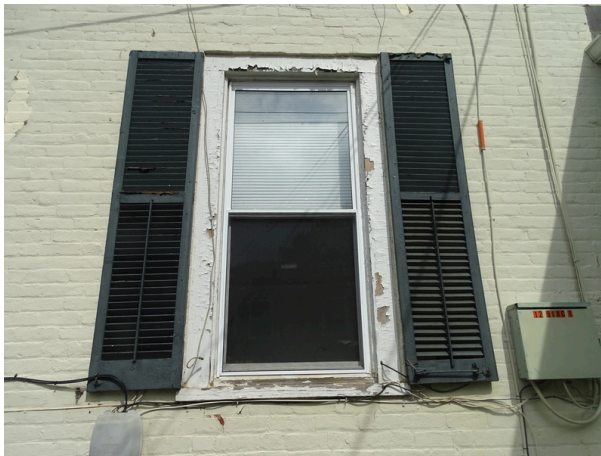
The window system for the building primarily consists of Wood frame double pane - operable window units. The window units were replaced with the older wood framing kept in place. The condition of the wood framing ranged from fair to poor. The expected useful life of windows is typically 30 years. The window units were in generally in fair condition. We recommend the wood framing be replaced with the window units during the report period as needed.

Exterior window with wood framing

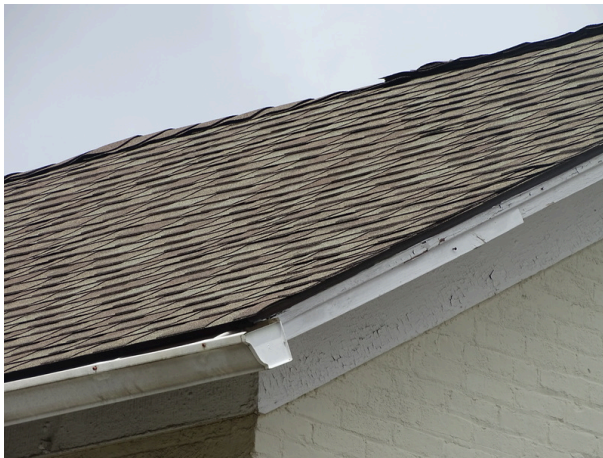
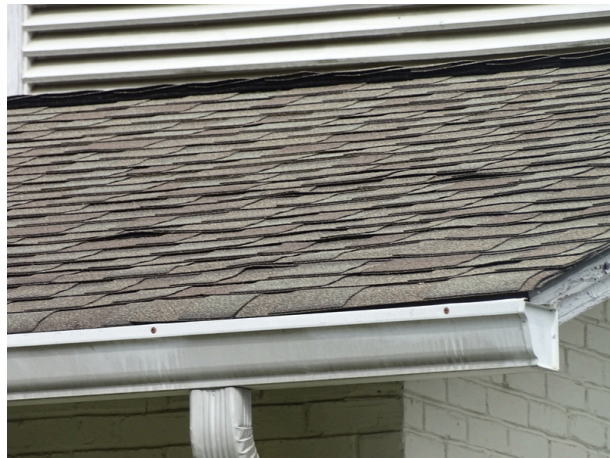
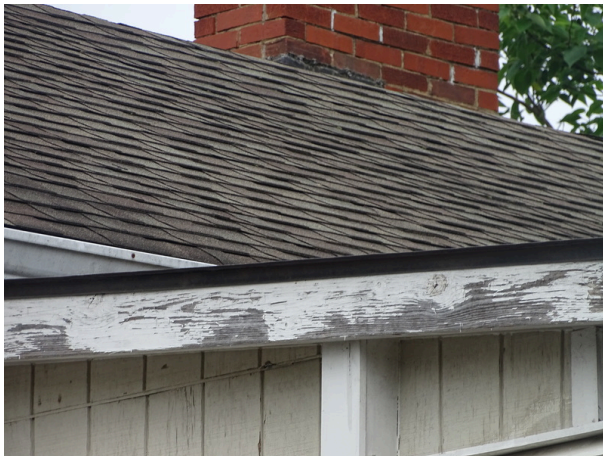
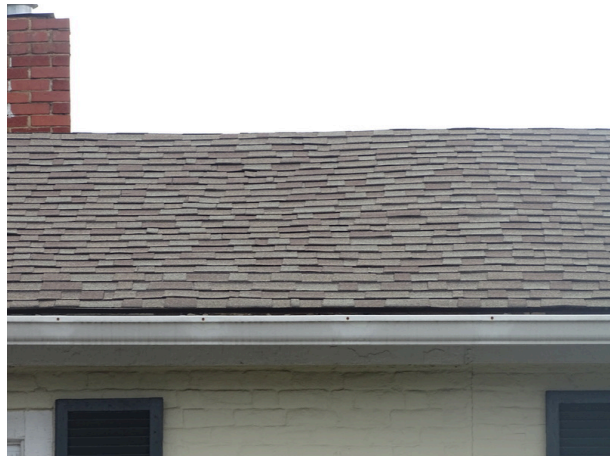
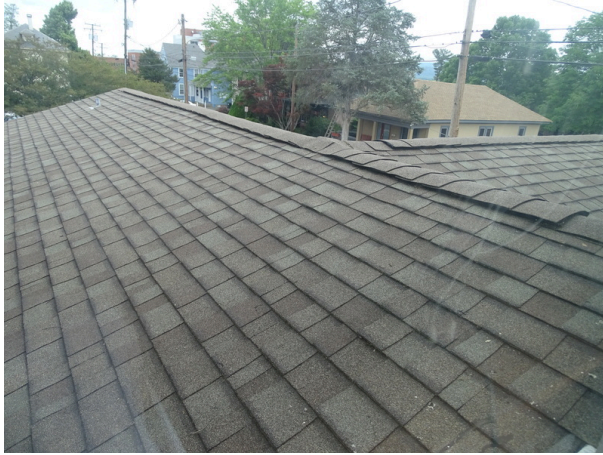
Asphalt shingle roofing system

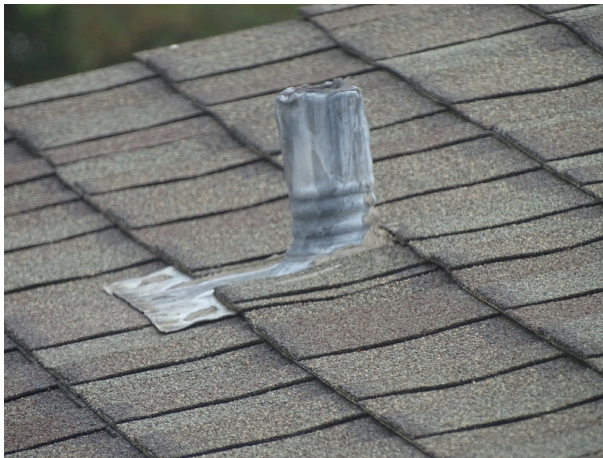
Typical plumbing penetration

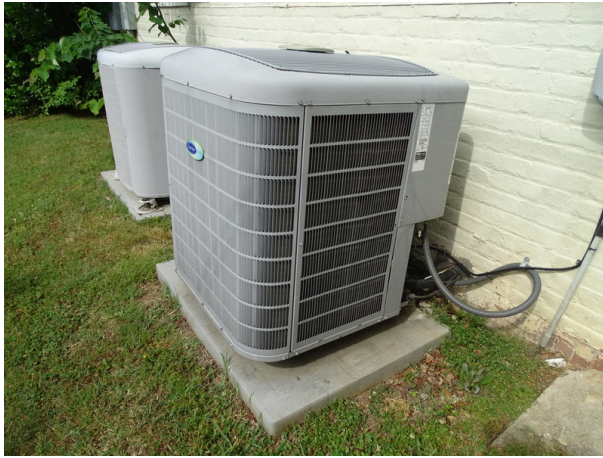
Condenser Units

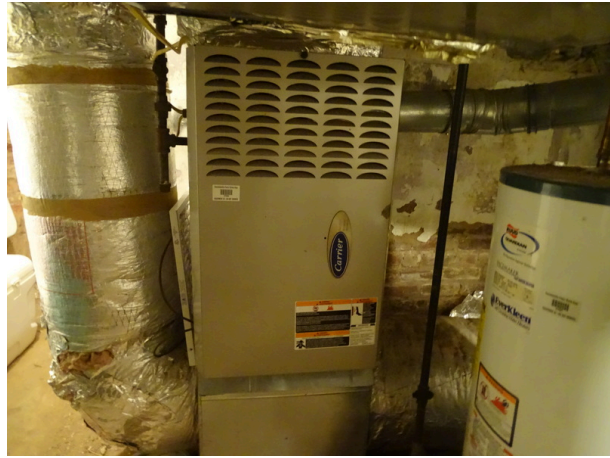
Gas furnace - air handler unit

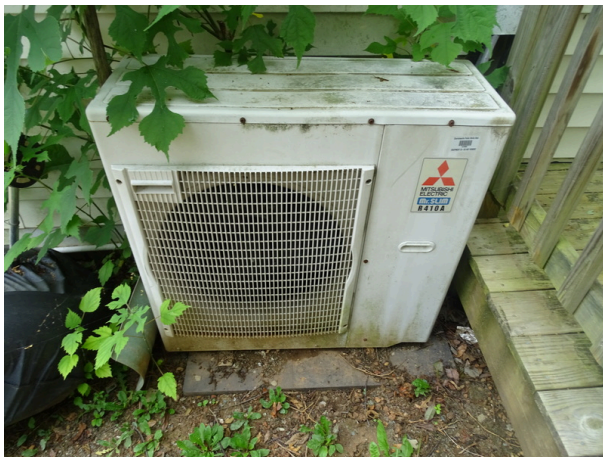
Split system exterior condenser

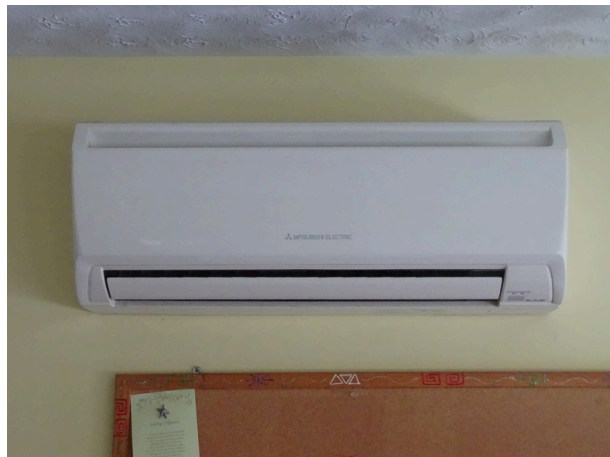
Split system wall mounted unit

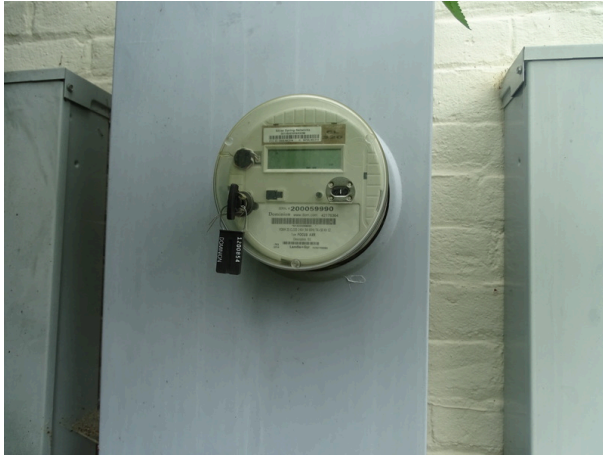
Electricity is provided to the building by Dominion Virginia Power through a pole mounted transformer. The main electrical entrance is located on the north side of the building and provides 120/240-volt, single-phase, 3-wire, 200 amp service.

Electrical meter on east side of the building

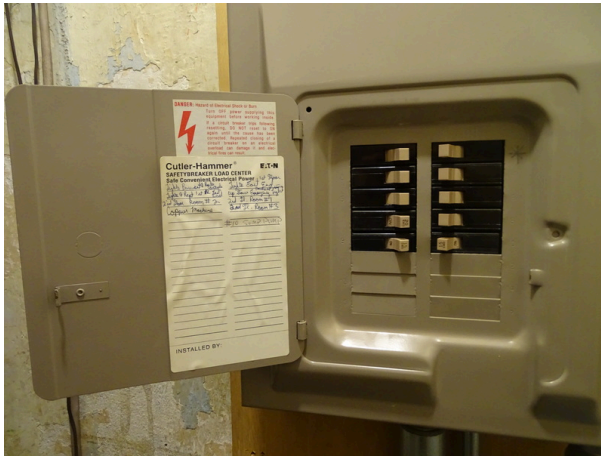
Power is distributed by copper wire from circuit breaker panels located throughout the building and are in generally in good condition.

Typical circuit breaker panel

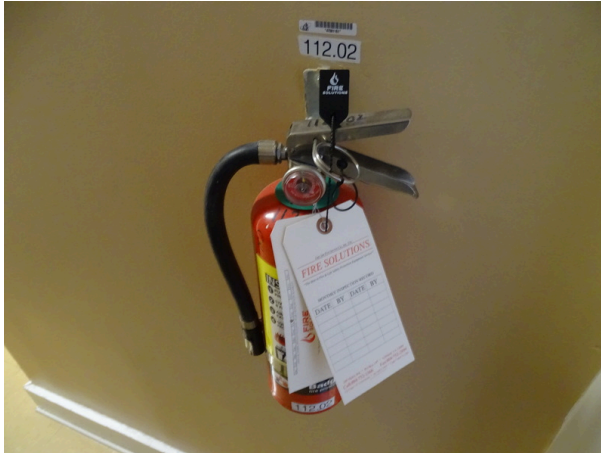
The fire suppression system consists of Fire extinguishers. The fire suppression system was observed but not tested. Fire extinguishers were observed throughout the building. The fire extinguishers were observed to have recent inspection tags issued by Fire Solutions in June 2021. These devices are required to be inspected annually. Replacement of the fire extinguishers is considered routine maintenance.

Typical fire extinguisher

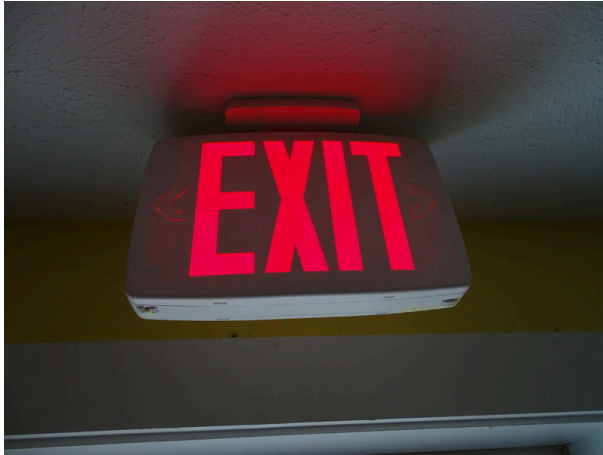
Typical exit sign

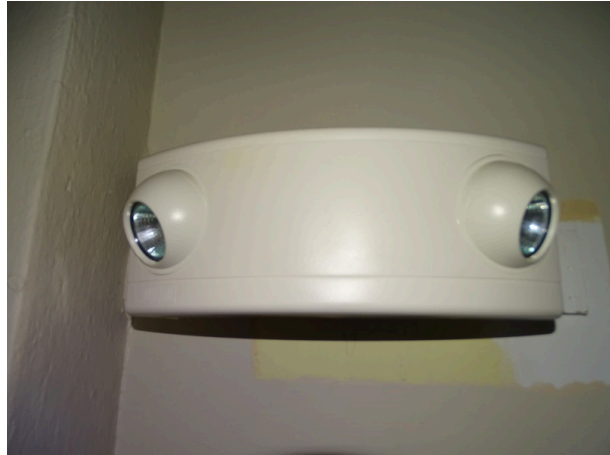
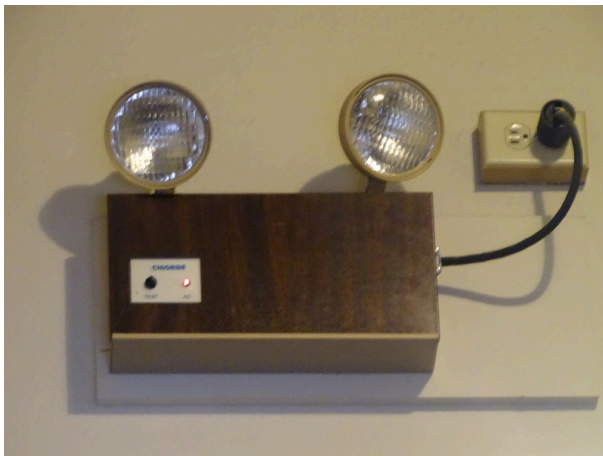
Typical emergency lighting

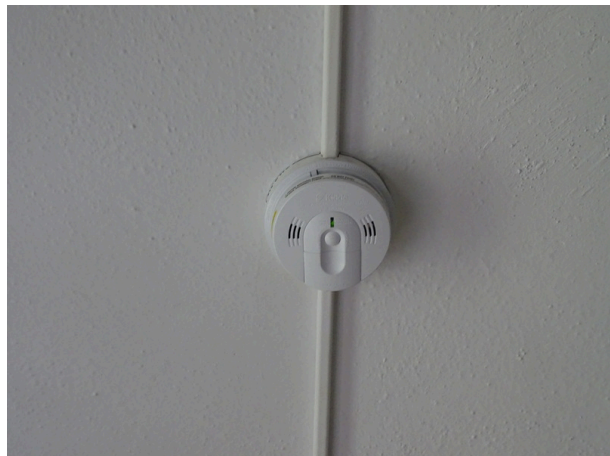
Typical smoke detector

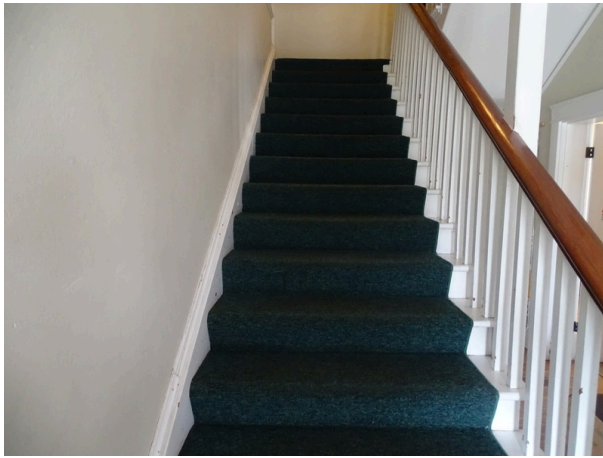
Interior finishes entrance area

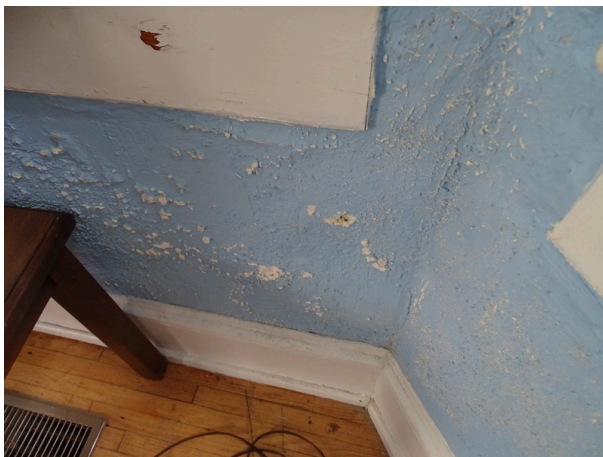
Interior finishes meeting area - note
efflorescence

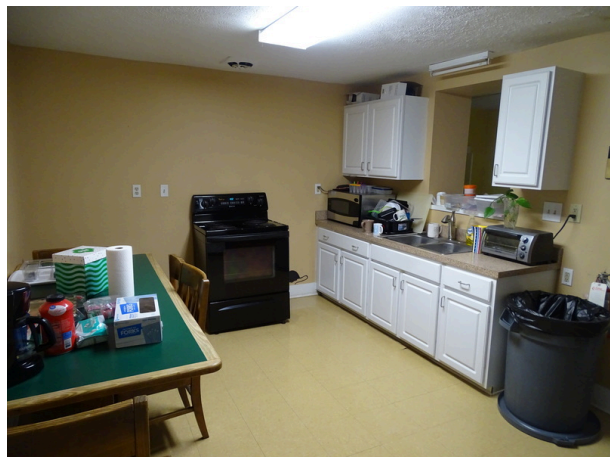
Interior finishes kitchen area

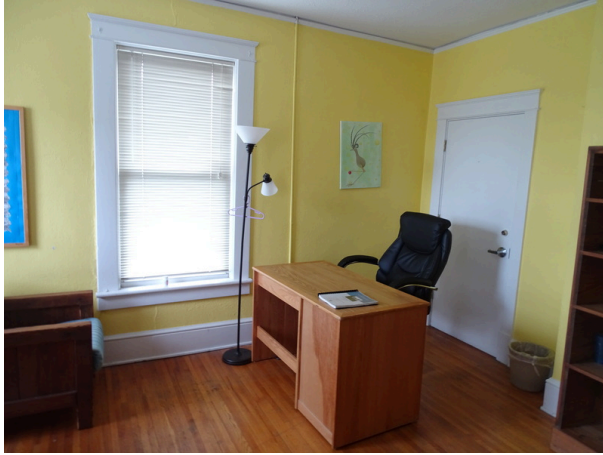
Interior finishes office area

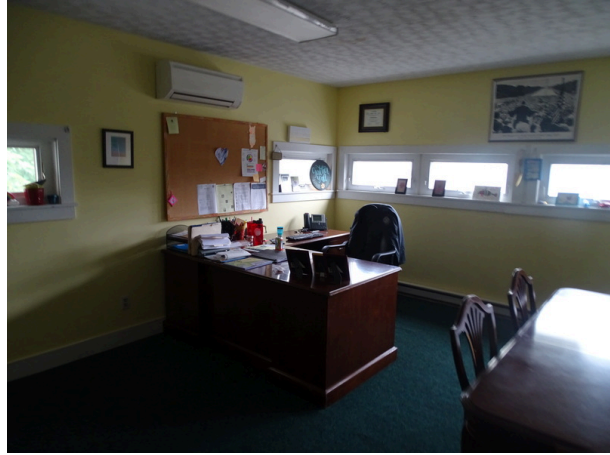
Interior finishes office area

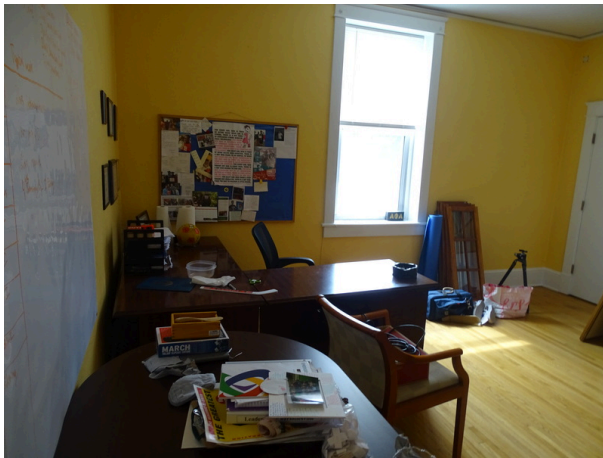
Interior finishes office area

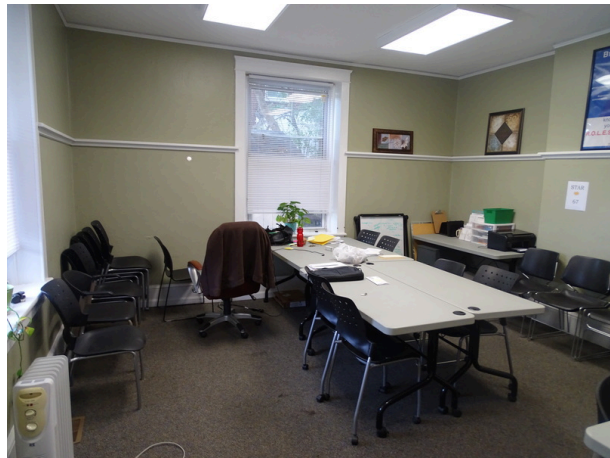
Interior finishes meeting room area

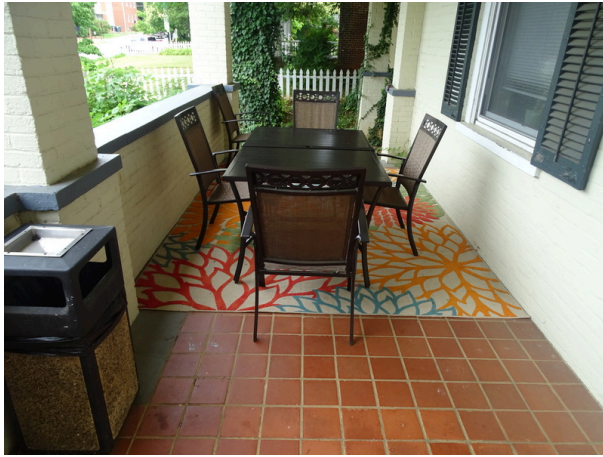
Interior finishes patio area

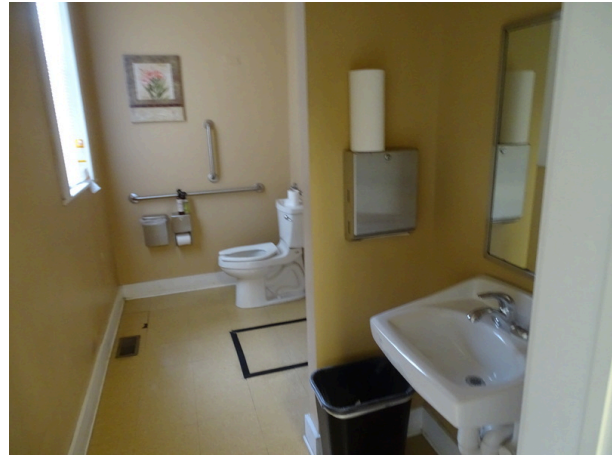
Interior finishes restroom area

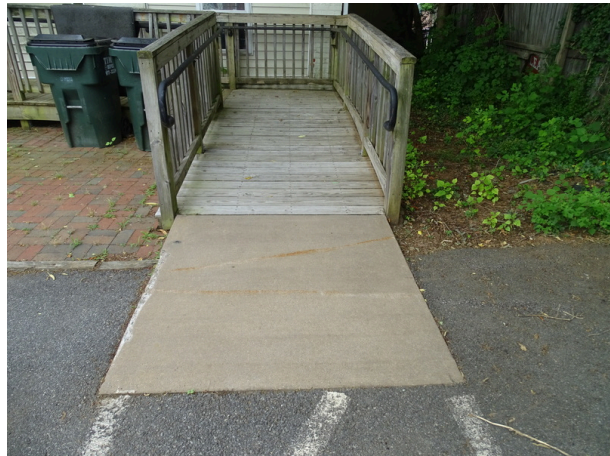
Accessible ramp

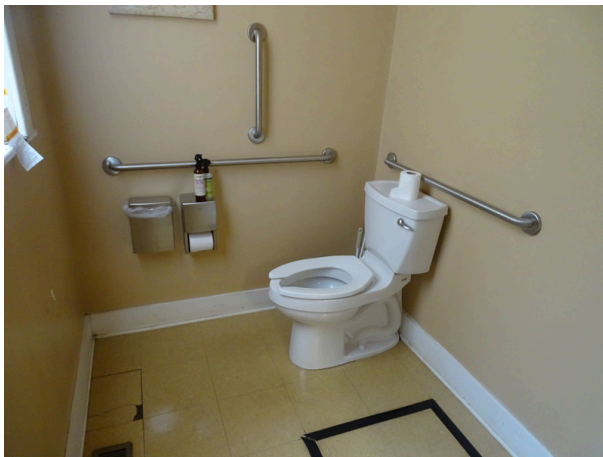
Accessible toilet

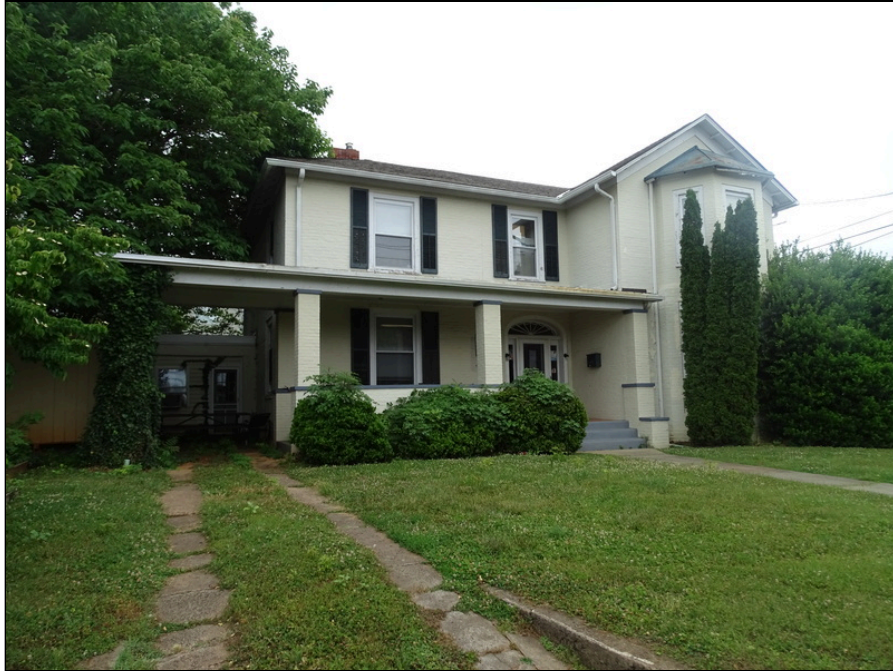
1 - Community Attention Building - south side of the building

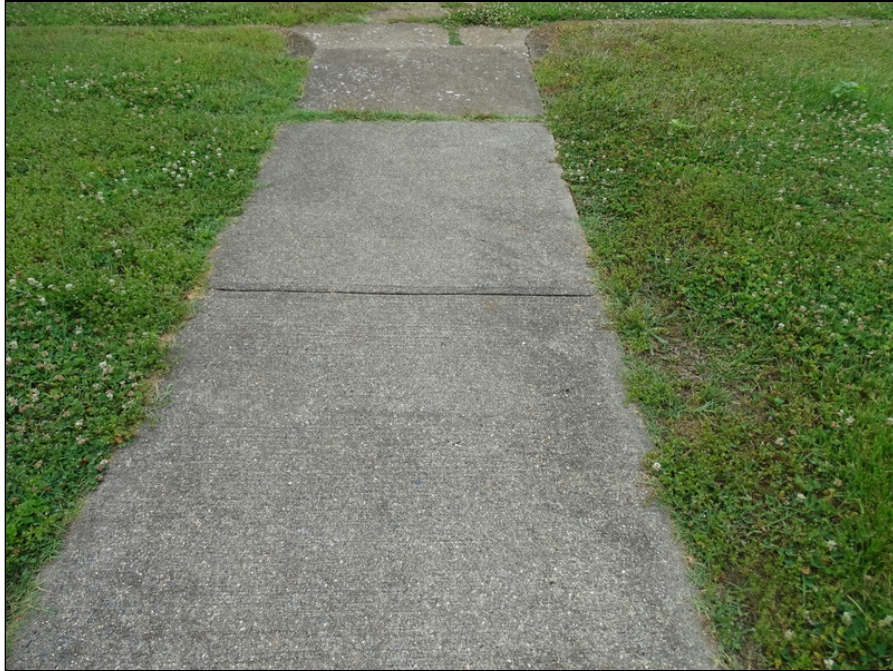
7 - Concrete sidewalk overview

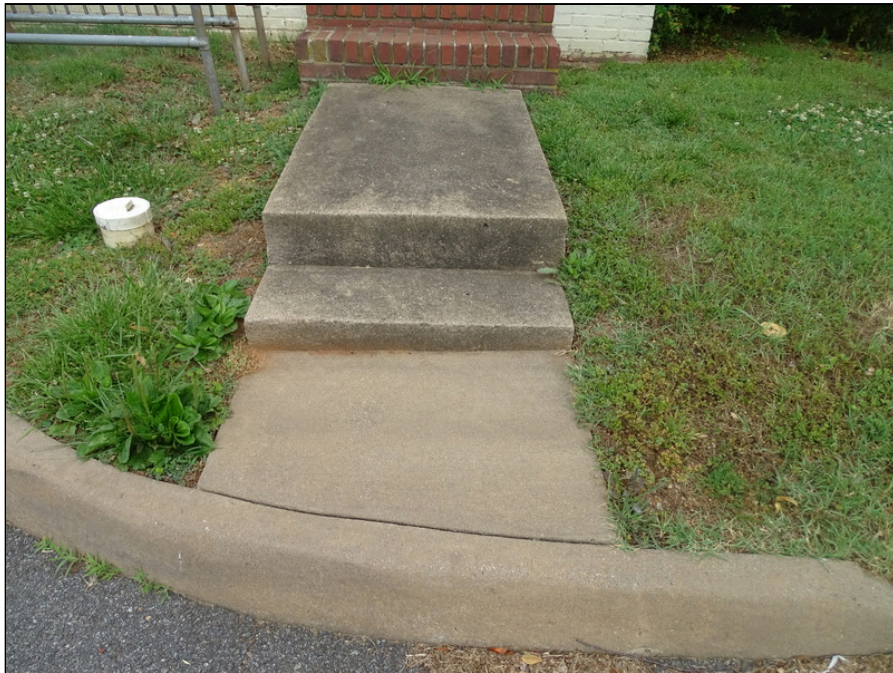
8 - Concrete sidewalk and steps east side of the building

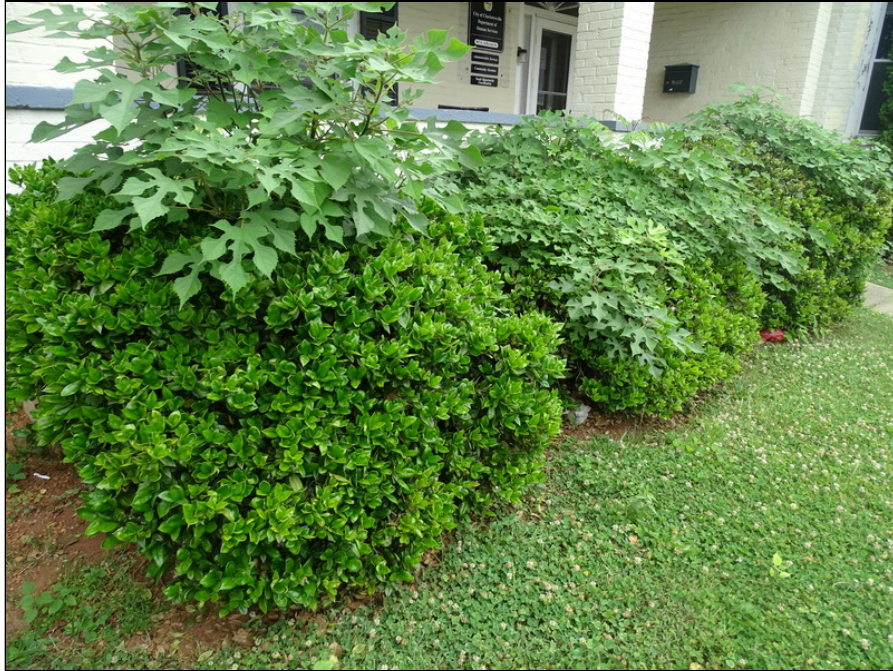
11 - Typical landscape

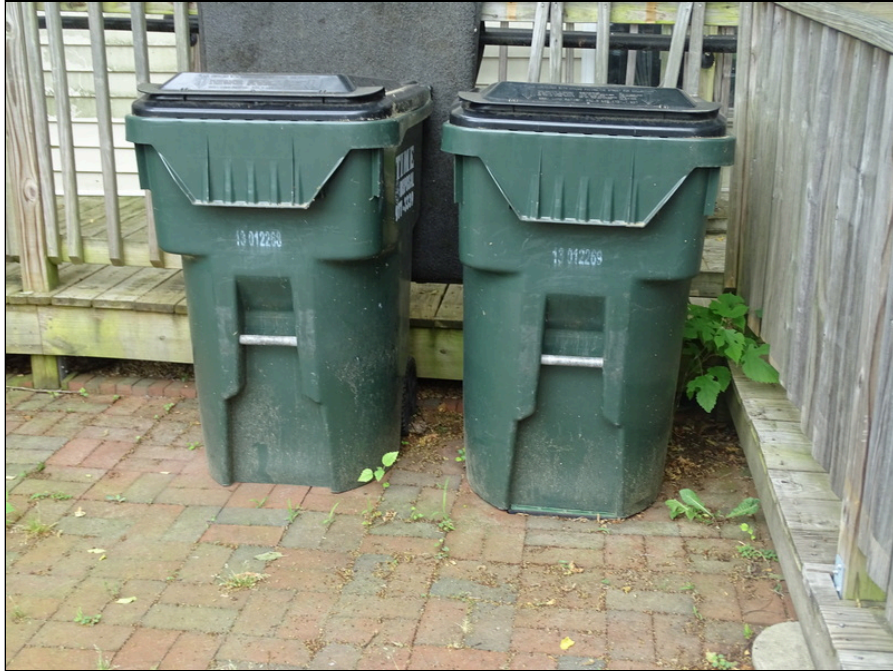
13 - Trash containers located at north side of the site

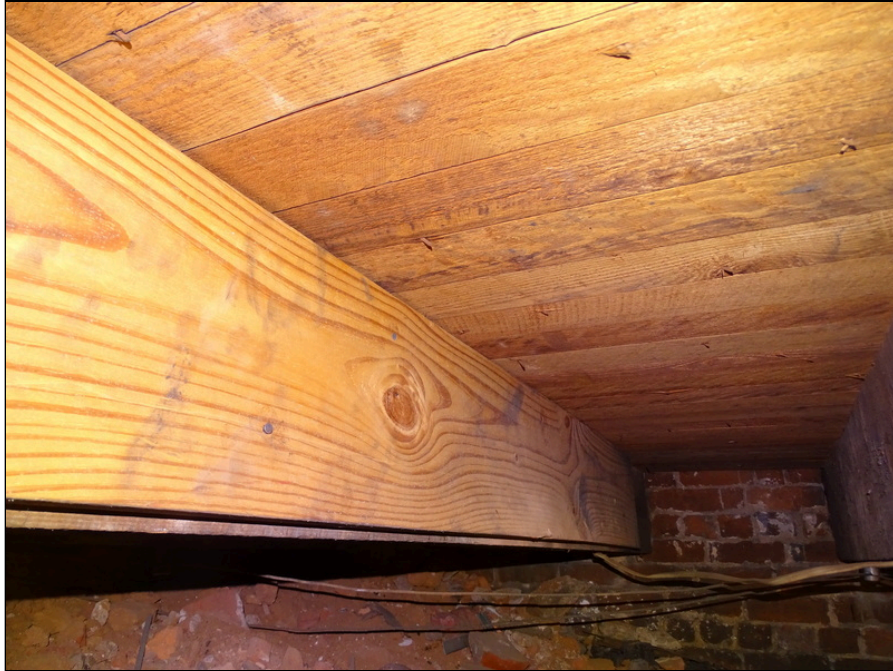
15 - Structural framing

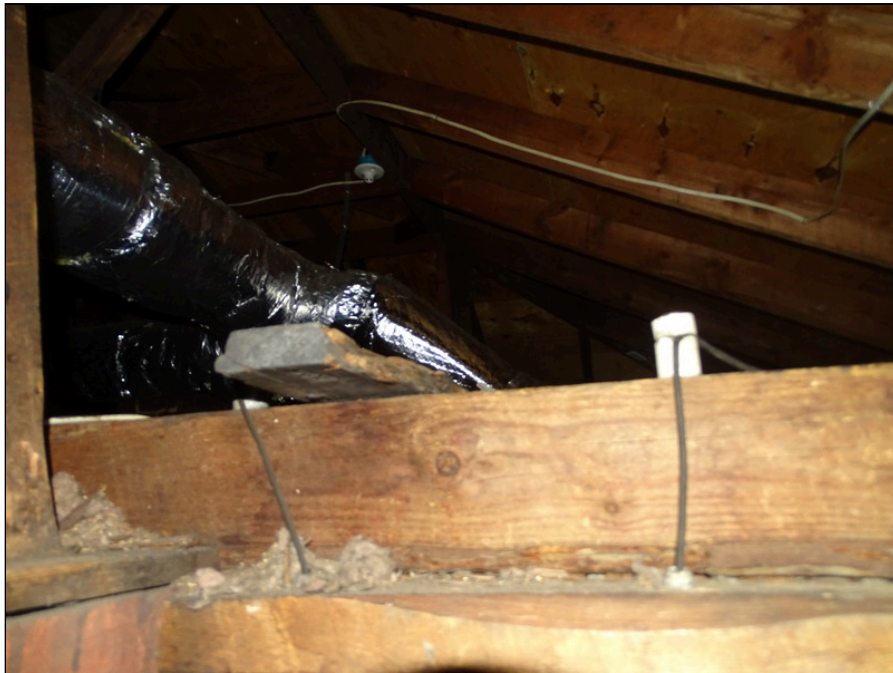
16 - Structural framing

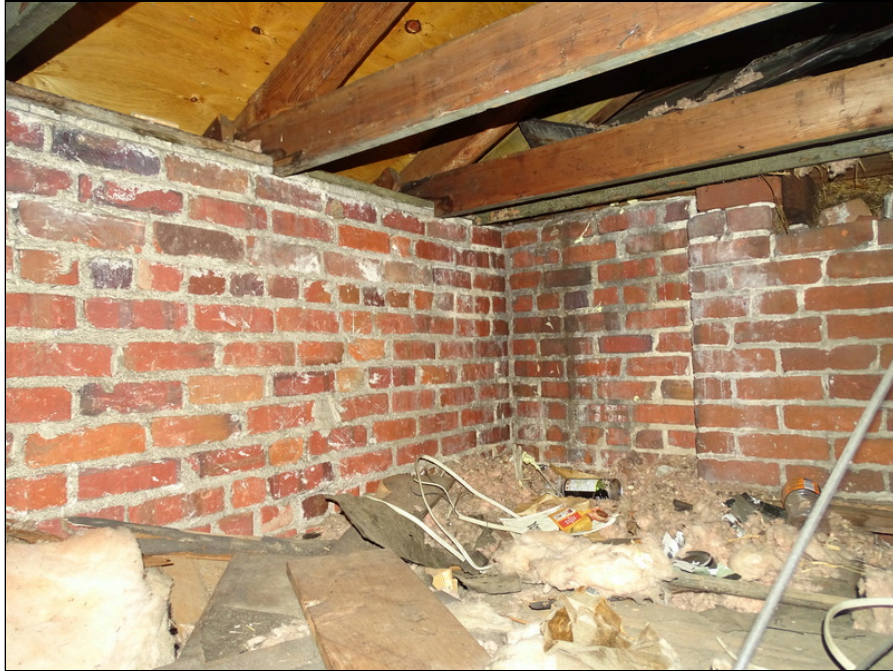
17 - Structural framing

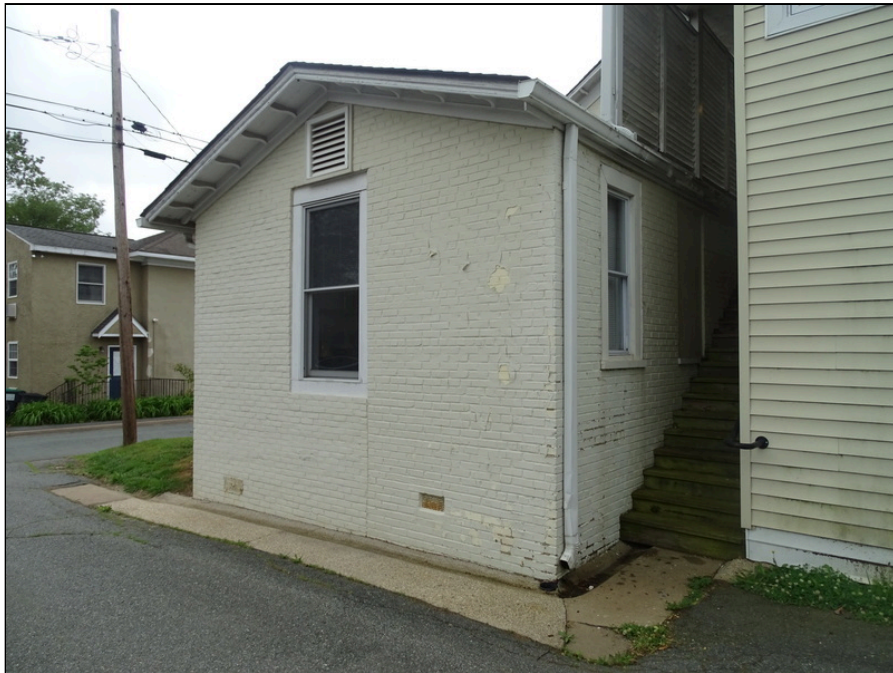
18 - Building exterior north side of the building

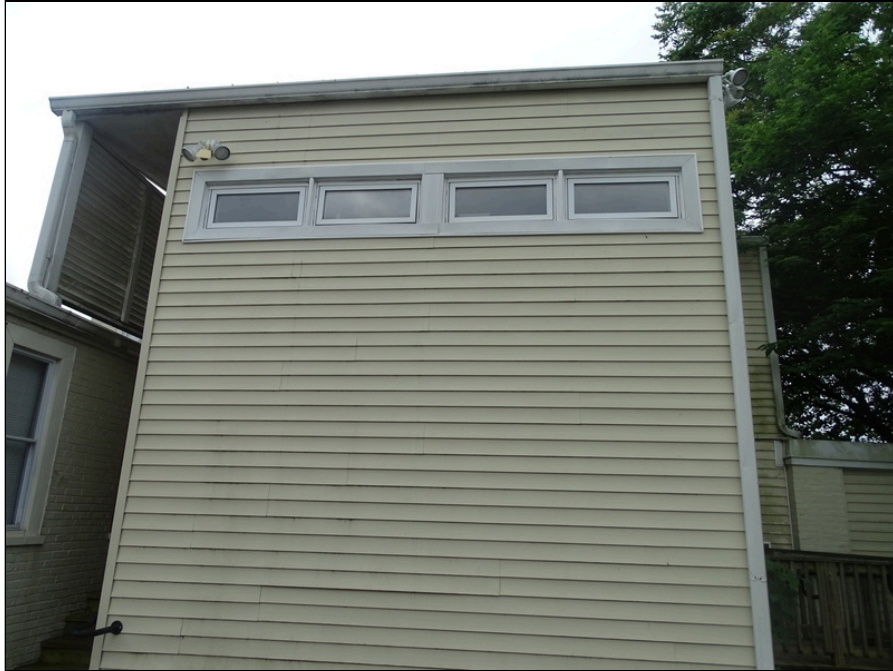
19 - Vinyl siding at north addition

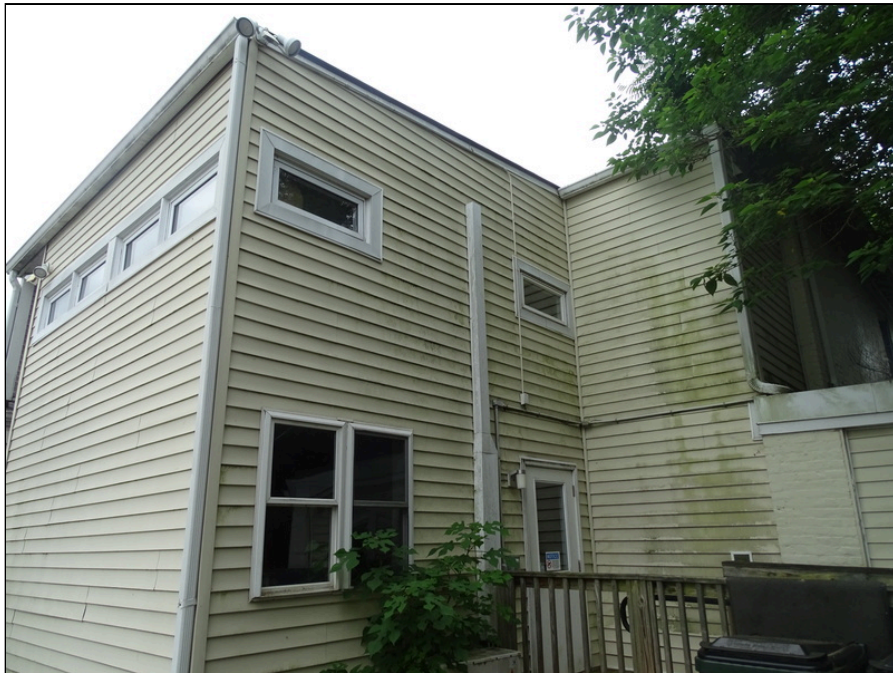
20 - Vinyl siding at north addition

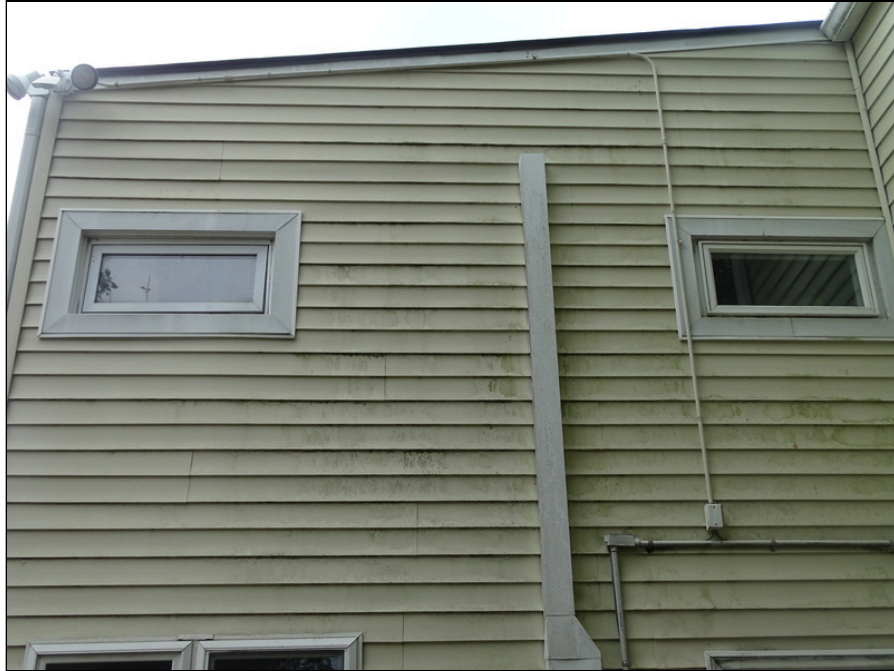
21 - Vinyl siding at north addition - note needed maintenance

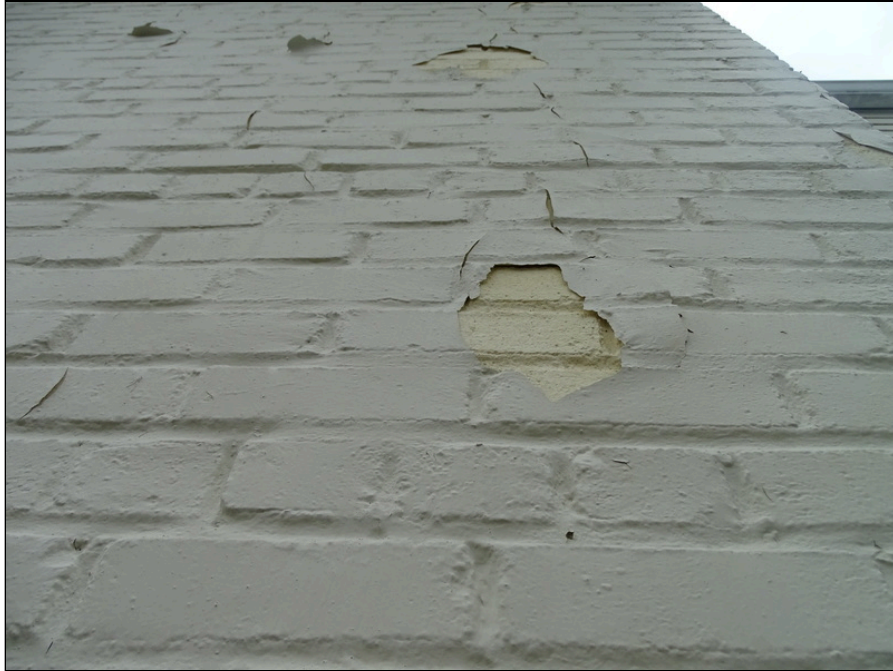
23 - Building exterior east side of the building - note peeling paint

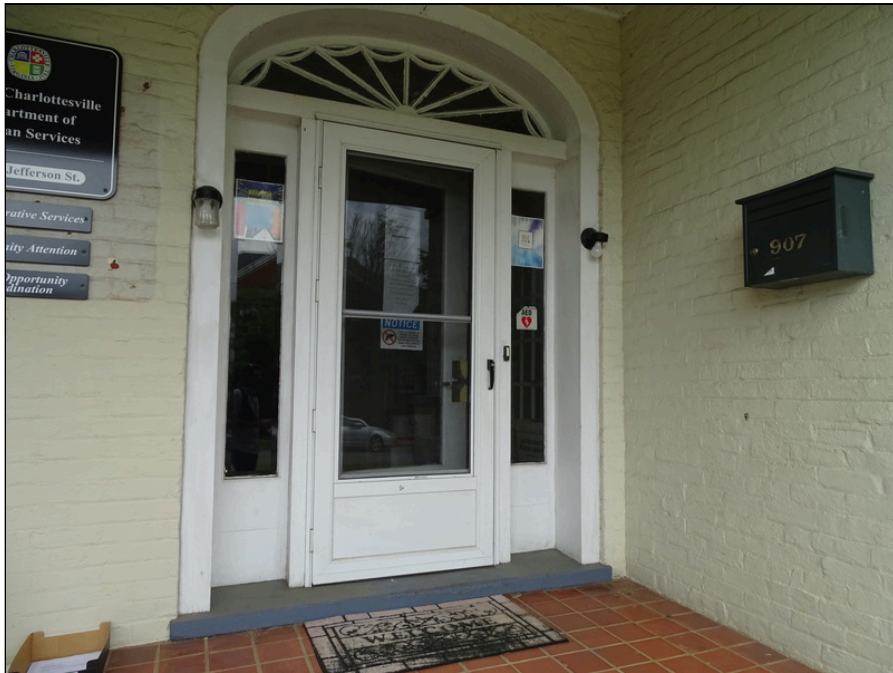
26 - Main entrance door

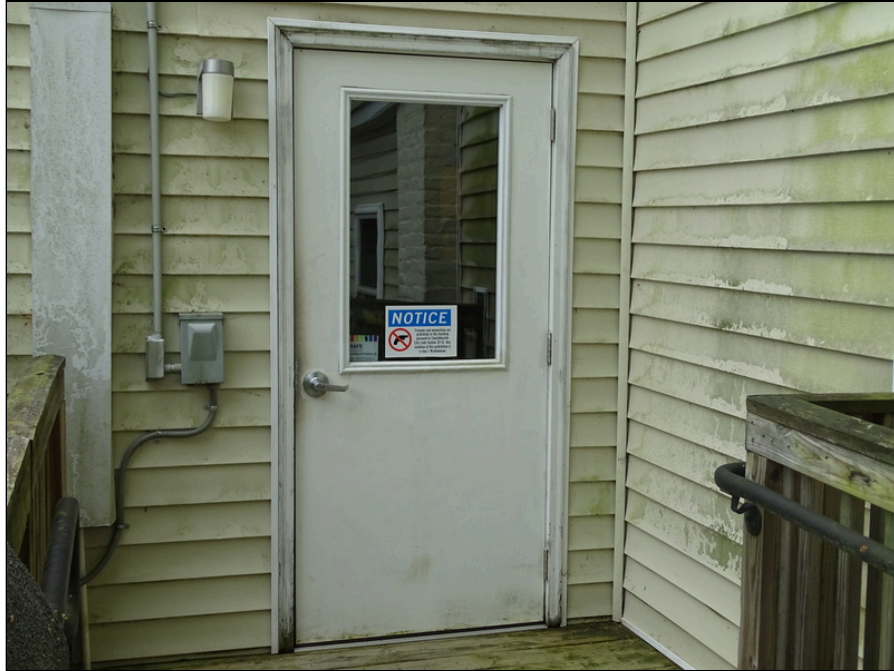
27 - Personnel steel door

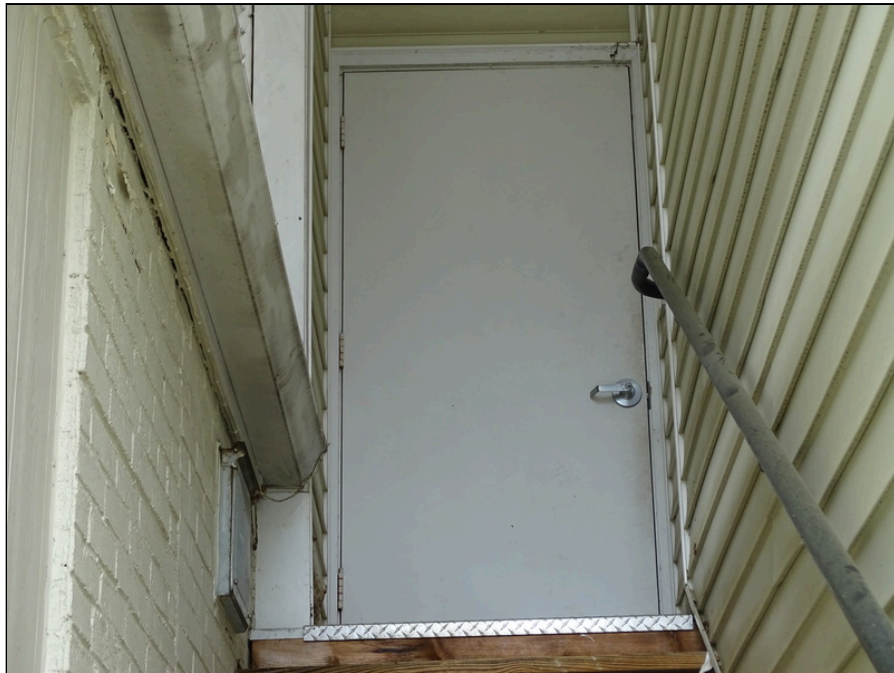
28 - Personnel steel door
